Report Number **SS 27.0**

THE OVAL SHAPED RAISED PAVEMENT MARKER

STATE DEPARTMENT OF HIGHWAYS
AND PUBLIC TRANSPORTATION

February 1987

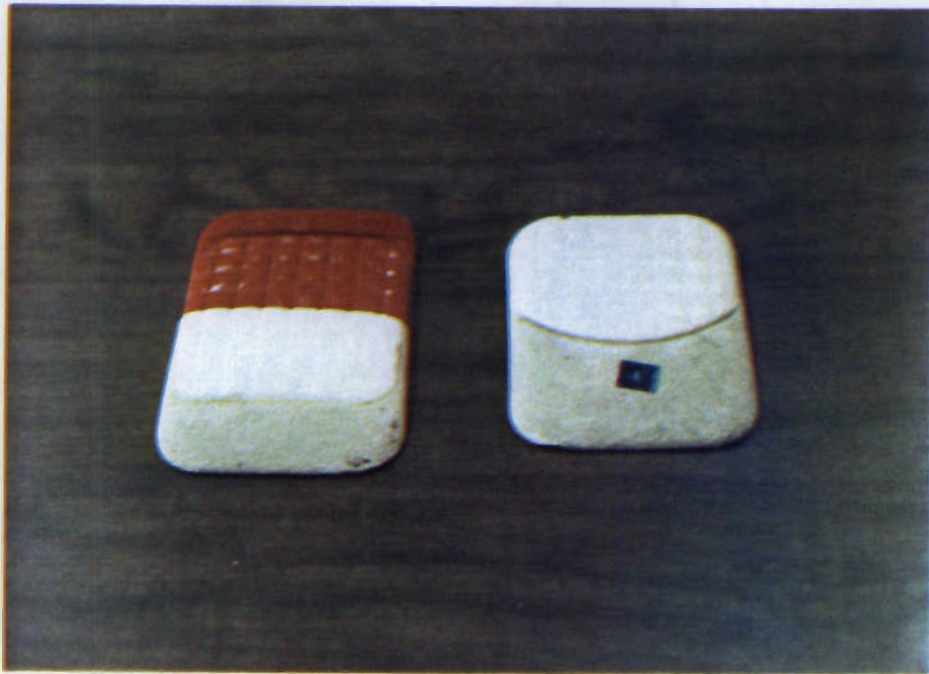
Figure 2: Showing the later version of the Botts Dots Markers. Circa early 1960's

The first buttons by Botts Dots Co. of California were thin, circular, flat plastic markers. The non-reflective markers had a slick top surface. The reflective markers were reflectorized by the means of paint and beads (Figure 1). The markers were too thin to be seen in the rain and the paint and beads quickly became non-reflective because of the accumulation of dirt and grime in the rough paint and bead surface. In addition the paint and bead surface was quickly ground off by the vehicular traffic. Botts then tried a thicker rectangular marker of the same materials (Figure 2). The new markers were more visible in the rain but the same dirt-wear failure occurred as before.

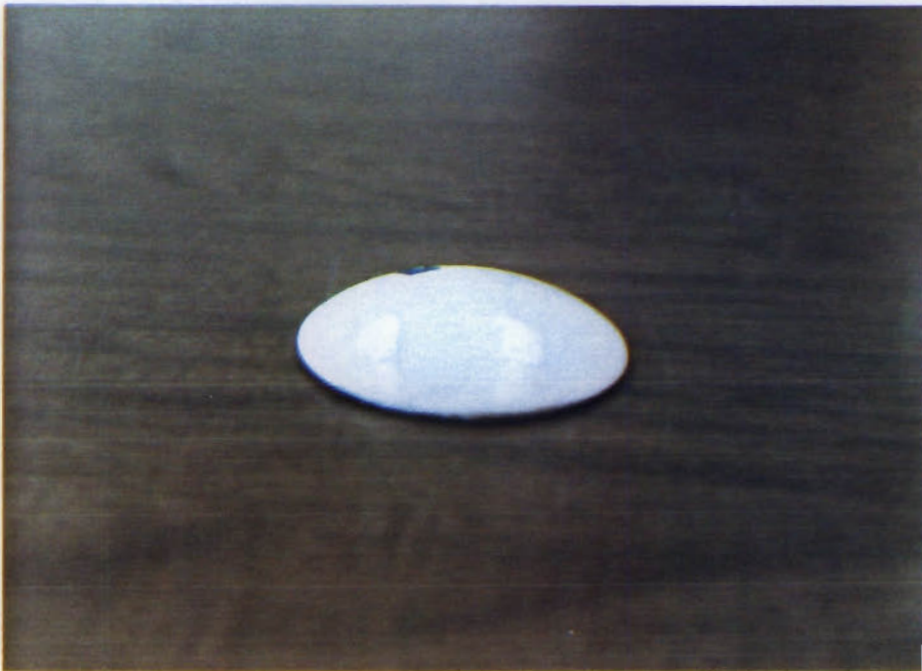
Figure 3: Most Widely Used Marker

Several manufacturers tried various shapes of markers but finally the dome shaped circular button 7/8" to 1" in height and approximately 4" in diameter proved to be the best shape in the early to middle stages of development (Figure 3).

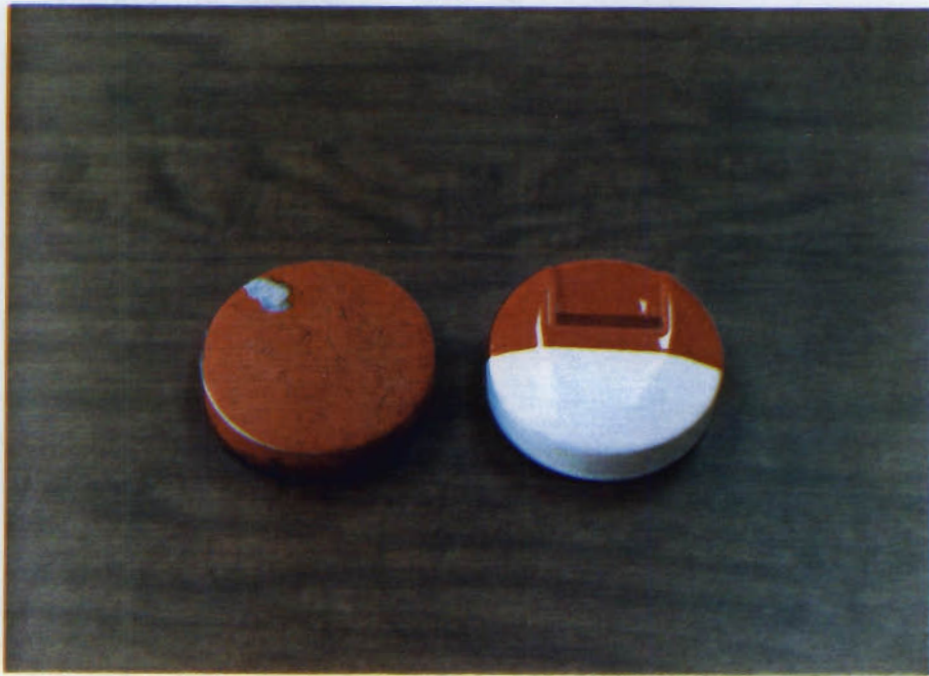
Figure 5: One Type of the Cast in to the Concrete Type Roadway Markers

Some markers were cast into the roadway surface (Figure 5). This method proved to be the most positive method of attachment, but it produced other problems. First, the cast in place markers were very labor intensive in placement. This made the cost of this type of attachment prohibitive. It also positively prohibits any revision to the pavement marking placement or alignment. This revision inability cannot be tolerated.

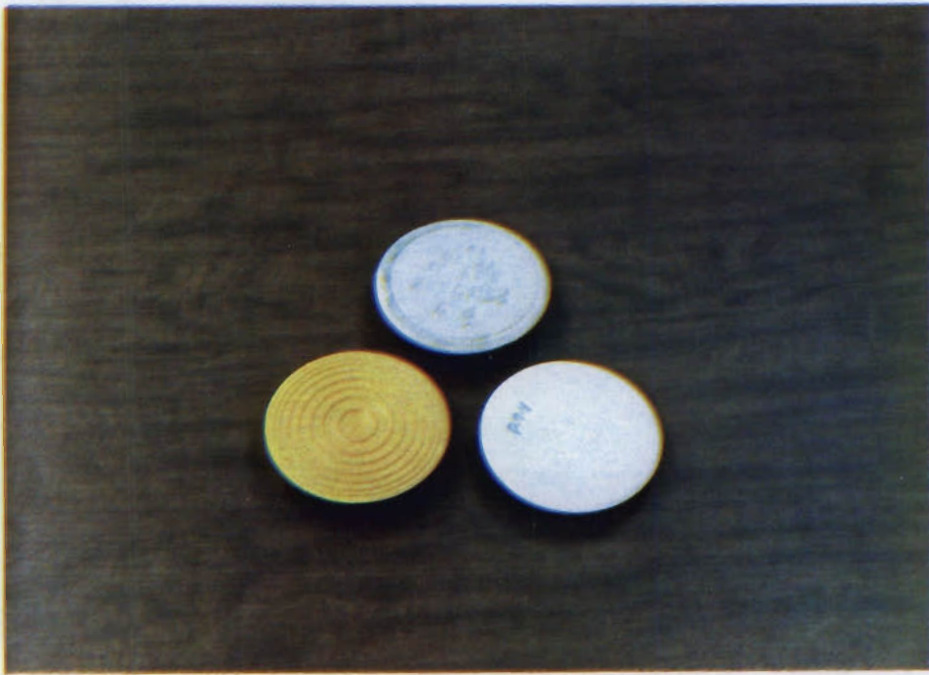
Figure 6: Showing the Plain and Concentric Rings on the Bottoms of Circular Markers

Numerous bottom surfaces of the markers were tried. Slick, rough, sand incased, waffle and circular concentric rings were all tried (Figures 6 and 7). The waffle and circular concentric ring bottoms trapped air and did not fill up with epoxy (Figure 7) thus less adhesion was realized than was produced by all the smooth or relatively smooth bottom surfaces.

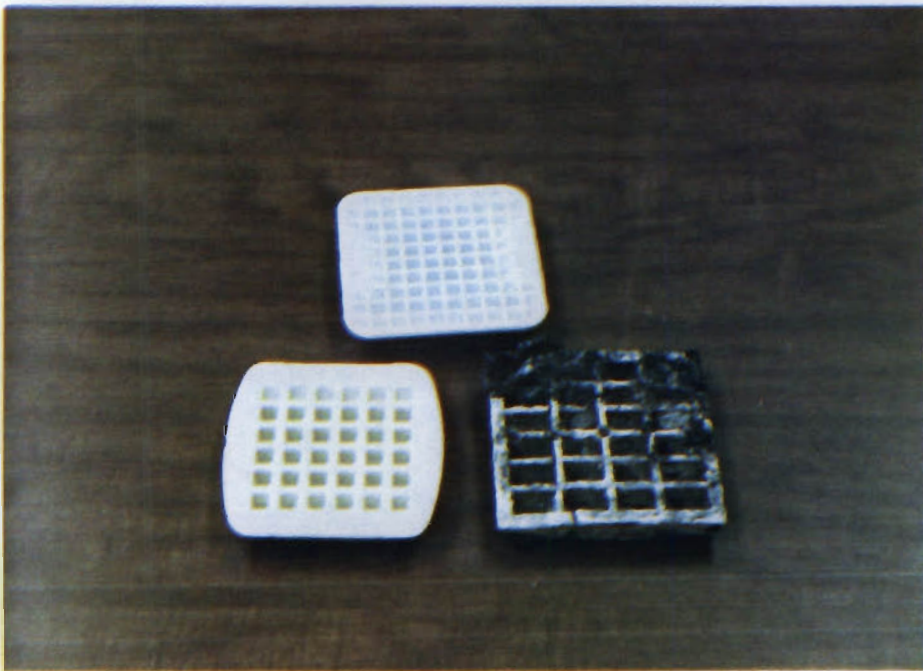
Figure 7: Various Waffle Bottom Markers. Note Epoxy did not fill the Waffle Bottom

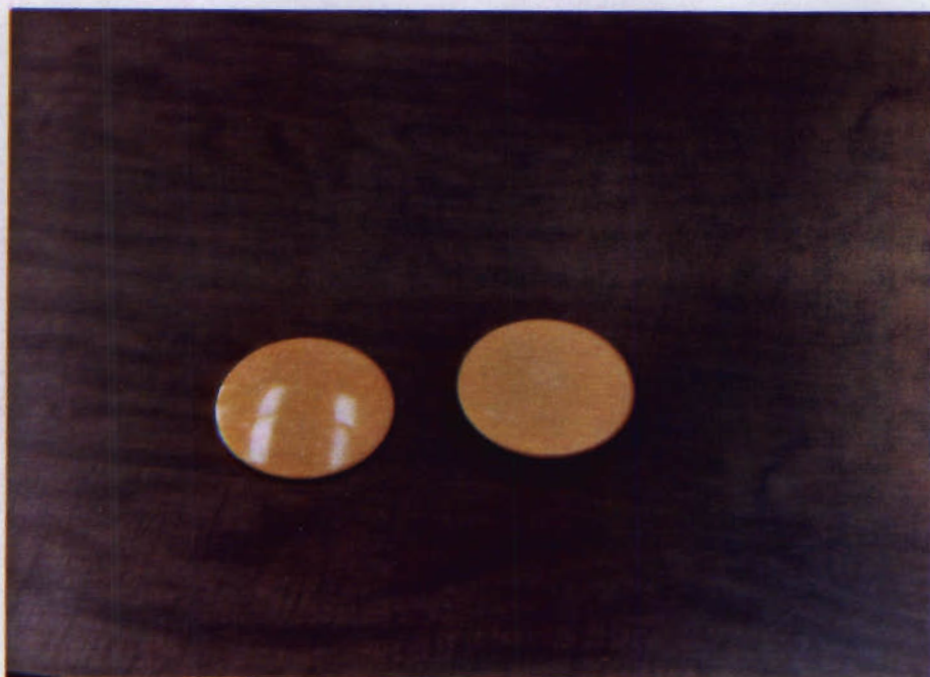
Figure 8: A Compression Molded Plastic Marker that Proved Successful in the Field

Various plastic materials were tried but it was found that only compression molded plastic would be strong enough (Figure 8). Cast plastics broke easily.

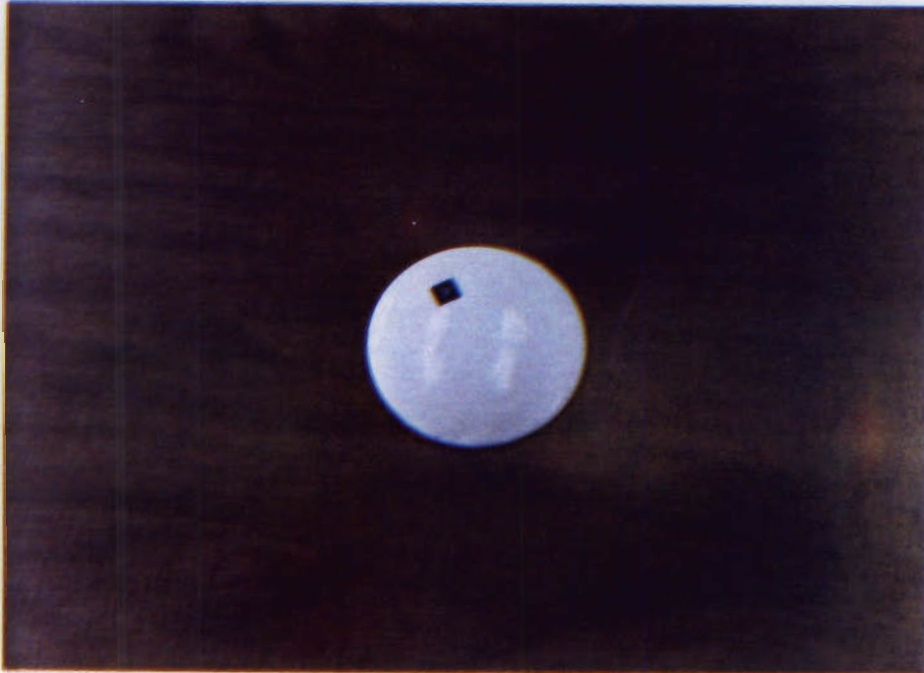
Figure 9: Circular Dome Marker

Extensive work with American Clay Forming of Tyler Texas finally produced a ceramic heat fired clay marker that produced the most desirable circular dome shape (Figure 9). This marker was and is the most widely used non-reflective marker in Texas and numerous other states. The markers were and are attached by the means of epoxy adhesive.

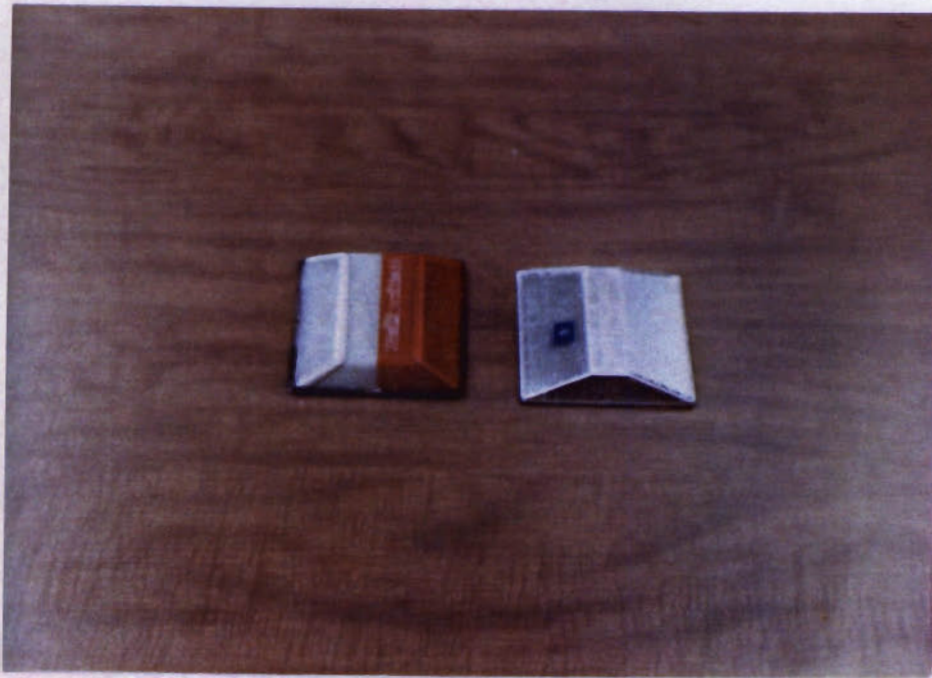
Figure 10: Stimsonite Reflective Marker. Right Marker has the 20° Incline. Left Marker has the 30° Incline

In the early 1960's the Stimsonite Division of ESNA Corporation introduced a 4" x 4" square, 3/4" high reflective marker. The reflectivity was accomplished by the use of encapsulated reflective prisms. The inclined reflective surfaces were originally 20° to the horizontal (Figure 10). The 20° markers adhered to the pavement well. To gain reflectivity Stimsonite changed the incline to 30° (Figure 10). Reflectivity was increased but the marker loss rate also markedly increased. The increased surface incline produced more severe tire impact, which in turn increased the shearing action and marker loss. The loss included not only increased loss of adhesion but also marker body failure (Figure 11). This type of marker has been strengthened and is the marker predominately used for reflective markers. It must be noted that this type of marker has no daytime delineation.

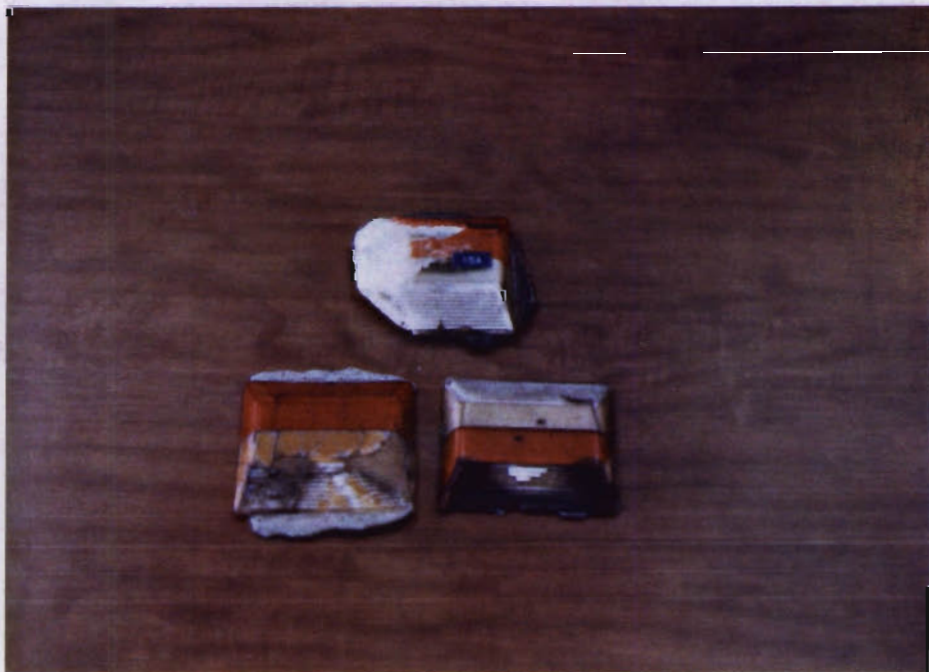
Figure 11: Typical Body Failures of Stimsonite Marker

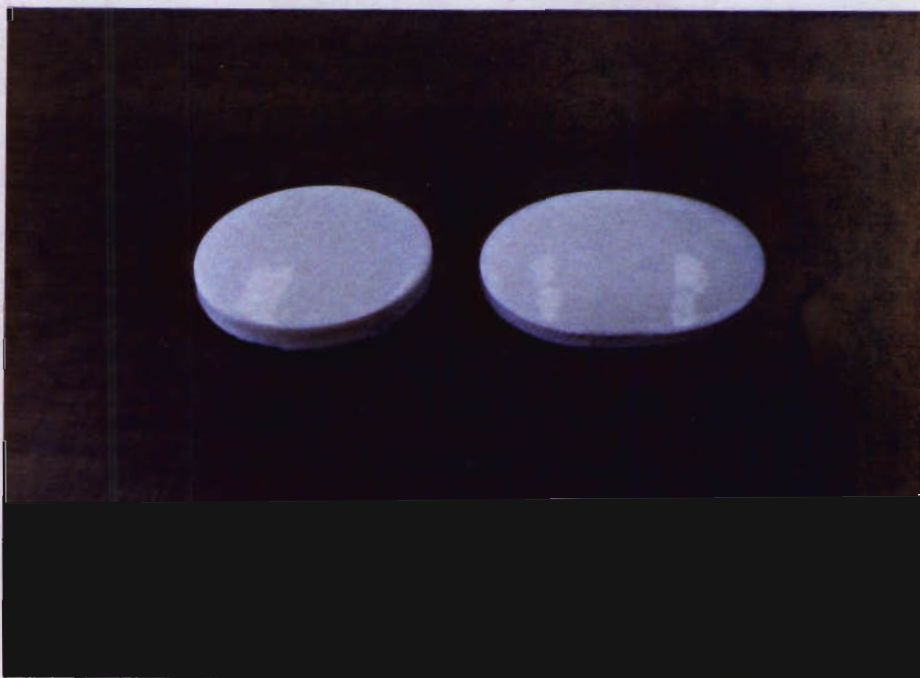
Figure 12: Showing Circular Dome Marker and the Original Oval Domed Flat Bottom Marker

In 1975 the author suggested a new marker shape to several marker manufacturers. American Clay forming acted on the suggestion and produced a 4" x 5" x 7/8" (approximate dimensions) oval shaped dome surfaced non-reflective marker with a bisque surfaced bottom (Figure 12). This shape and increased surface area increased adhesion to the pavement. In addition only 4 markers were required to produce the same visible stripe as the 6 circular marker.

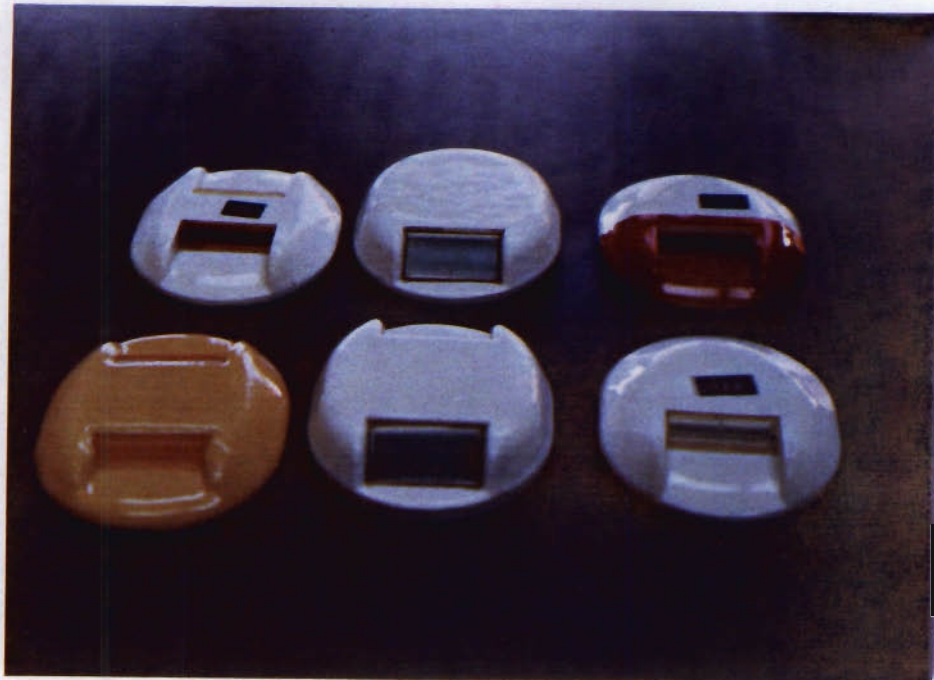
Figure 14: ACF Reflectorized Markers. Outside Markers contain the Encapsulated Reflectorized Strips. Center Markers are the new Encapsulated Prisms

A.C.F. tried several means of producing a reflectorized oval marker. Several reflectorized strips were recessed into the marker body. The strips were encapsulated with several types and shapes of plastic and glass. They are now experimenting with an encapsulated prismatic reflector even though the reflectorized strip type reflective marker has enjoyed reasonable acceptance (Figure 14).

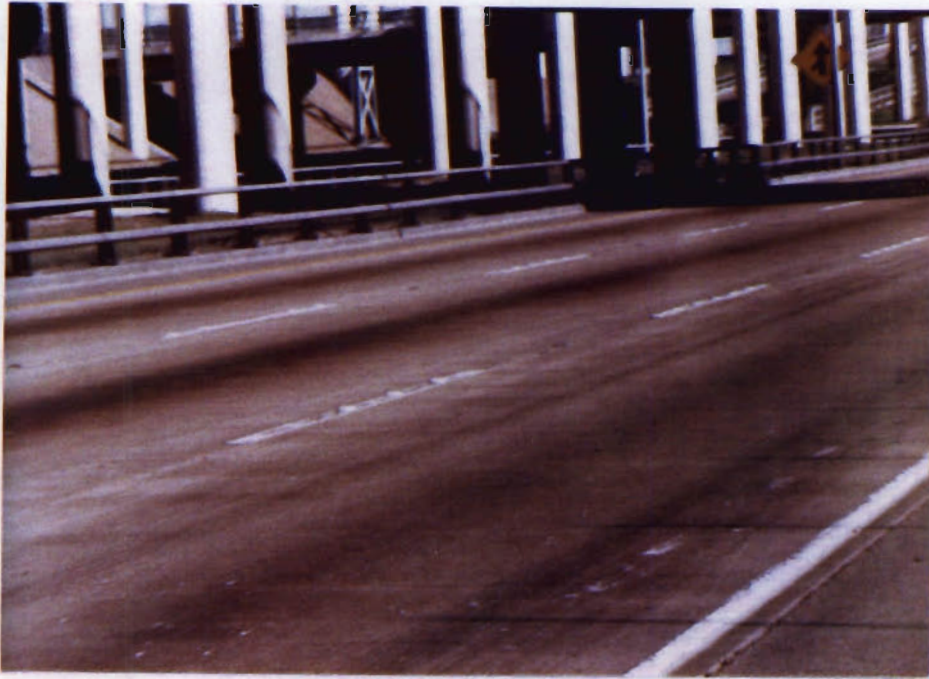
Figure 15: 1977 Test Section of Stud Bottom Oval Markers. Note Maintenance Forces have striped over the Markers. Picture taken on 1-26-87

In 1977 the Houston Urban office placed a test section of oval markers. Four hundred oval markers were placed on one lane line of a 3 lane portland cement concrete pavement section of Northbound US-59 in the I-45 interchange. The adjacent lane line was comprised of circular 6 marker stripe configuration. The oval dome markers were placed in the 5 marker configuration (Figure 15).

The US-59 freeway section had a 136,000 average ADT during the 10 years since placement. Heavy weaving movements were and are experienced in that section of freeway. The test section was frequently inspected. In six years the entire circular dome marker lane line was entirely replaced twice. The oval domed mar-

ker line experienced the loss of only 6 out of 400 markers in the same 6 year period. Never has such small loss figures been seen in all of the marker placements. After the sixth year of the test a previously unknown phenomenon was encountered. After 6 years the epoxy started releasing the markers. Heavy loss of the oval markers was experienced thereafter. Thus it was found that epoxy has a service life. It must be remembered that a marker installation never lasted over 2-3 years before this installation.

The epoxy service life does not seem to be a severe problem. On January 26, 1987 the test section was monitored. It was found that after 10 years of severe punishment 61 markers out of the 400 originally placed were missing. No maintenance of the oval marker lane line had been done in the 10 year period.

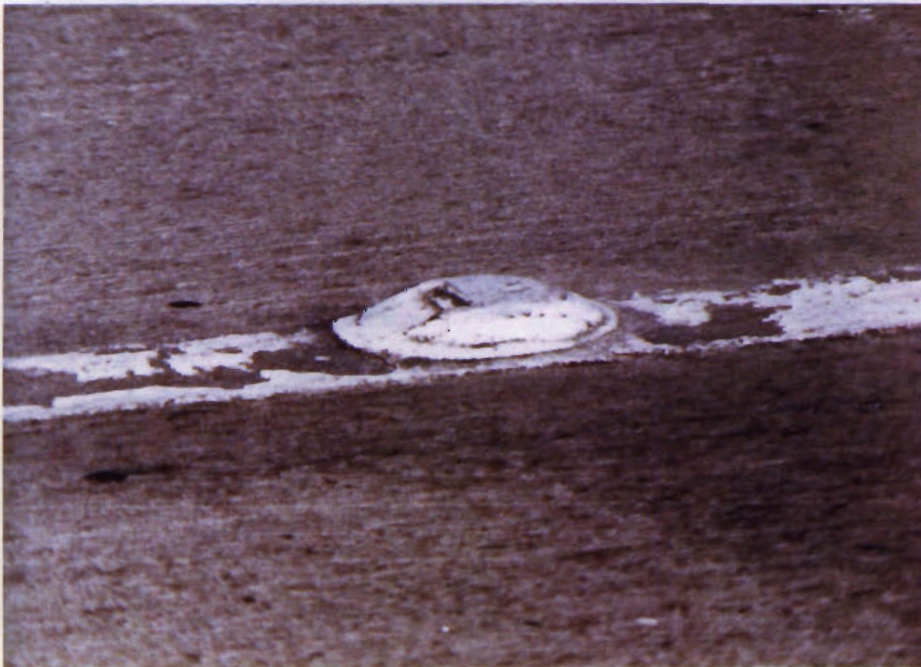
Figure 16: Ten Year old Marker in the 1977 Test Section. Note REFLECTIVE Rod is Missing. Picture taken on 1-26-87

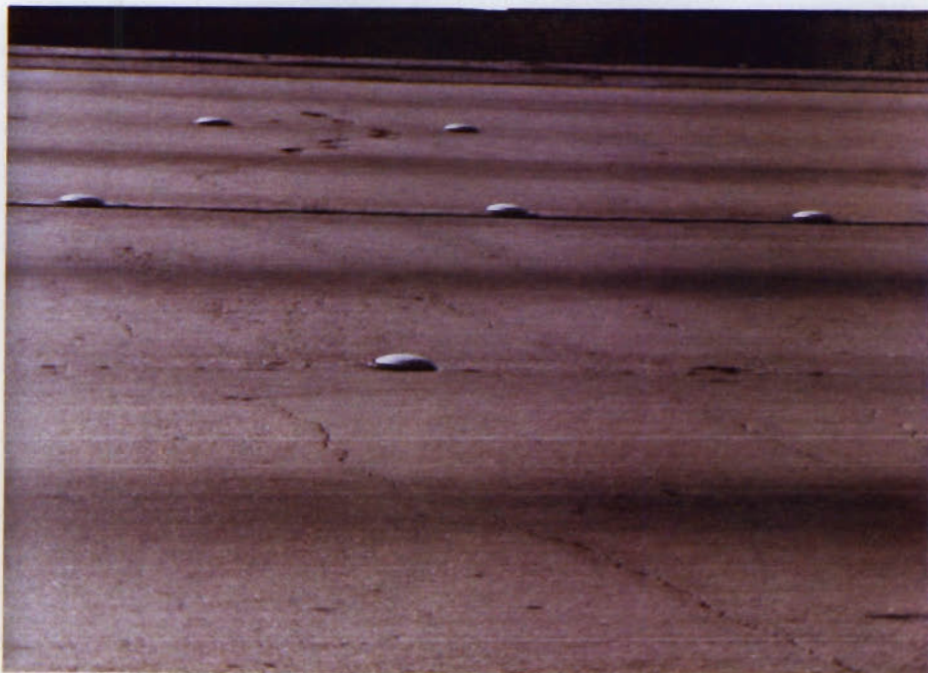
Figure 18: 1986 Contract Installation on I-45 (Gulf Freeway)

District 12 and Houston Urban were combined into one district in 1984. The Oval marker was reviewed by the combined district. The oval domed stud bottom markers are now being placed on all P.C.C. freeways in District 12 (Figure 18 and 19).

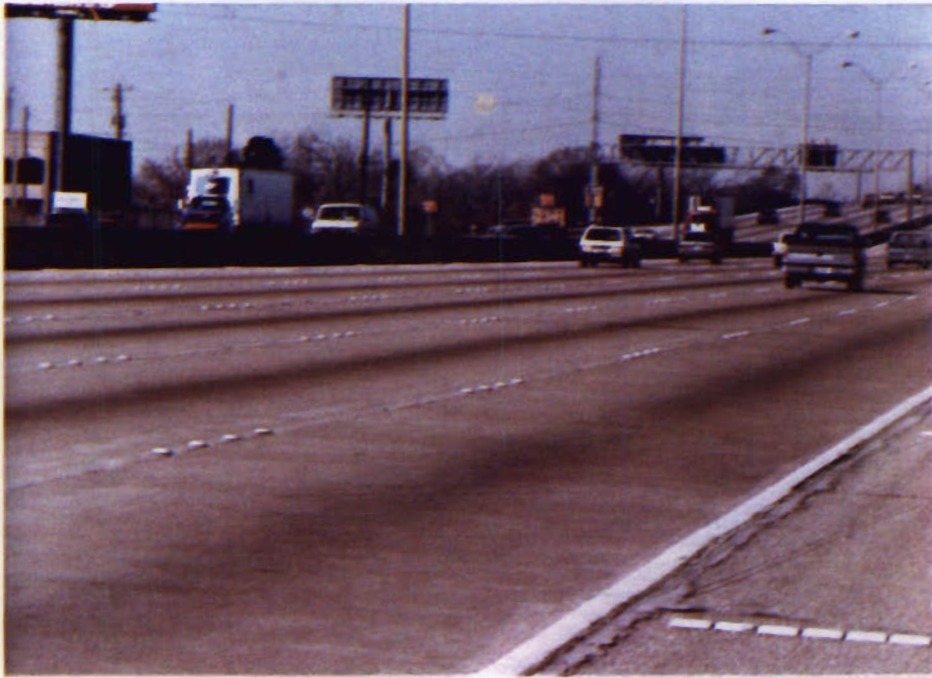
Figure 19: 1987 Contract Installation
on I-10 (Katy Freeway)
