Report No. FHWA-RD-74-18

**75-20  
#1**  
**NONMETALLIC COATINGS FOR  
CONCRETE REINFORCING BARS**

**J. R. Clifton, H. F. Beeghly and R. G. Mathey**

**February 1974  
Final Report**

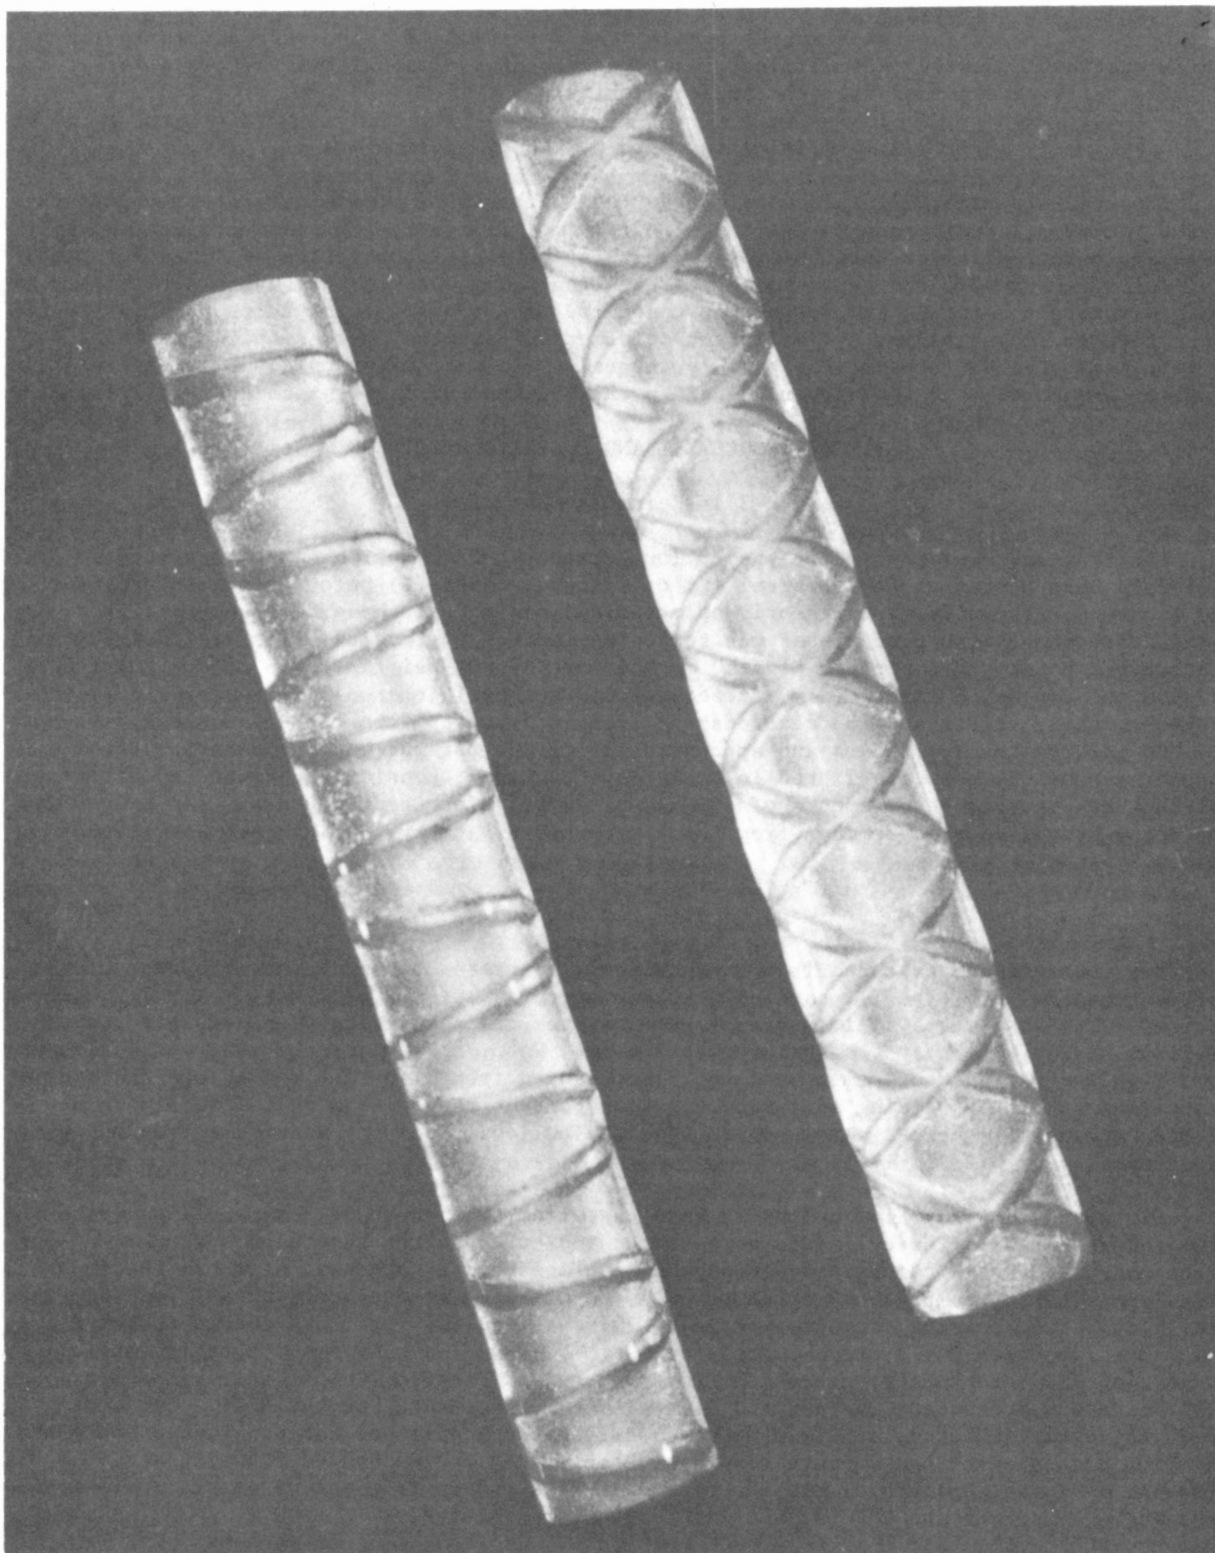
FIGURE 1. View of No. 6D (upper bar) and No. 6B (lower bar) reinforcing bars. D denotes diamond shaped deformation pattern and B indicates barrel pattern.

The tensile reinforcement in the pullout, creep, and corrosion tests consisted of No. 6 deformed bars having either a barrel (B) or diamond shaped (D) deformation pattern as shown in figure 1. The bars were randomly selected and may not all have been the same heat. A 4 foot length of each type of bar was tested to rupture in tension. The yield strengths determined by the "0.2 percent offset" method were 67,600 psi for No. 6 rebars (D) and 62,500 psi for No. 6 rebars (B). These bars did not exhibit a well-defined yield point, however, their stress-strain relationships (figure 2) were linear up to a stress of about 64,000 psi for the (D) rebars and approximately 62,000 psi for the (B) rebars. Tensile properties of the bars are listed in table 2. The yield, tensile strengths and deformations of the bars met the requirements of ASTM A 615-72 [25] for Grade 60 bars. The properties of deformations were determined from three coupons of each type of bar and are given in table 3.

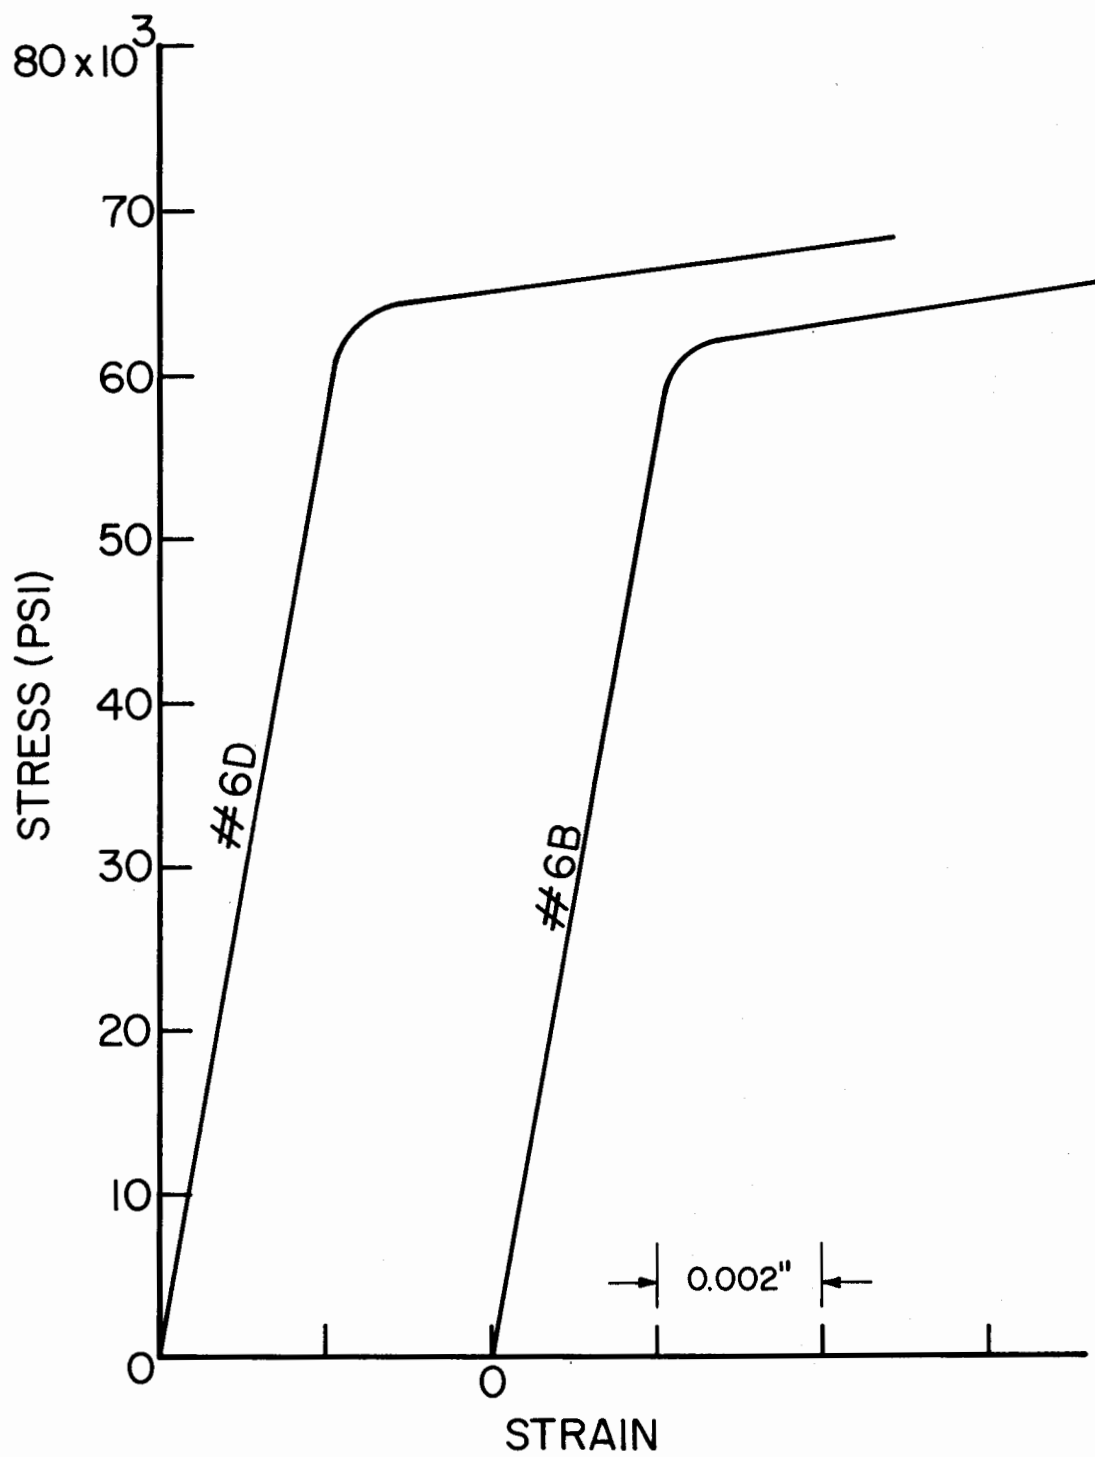
FIGURE 2. Typical stress-strain characteristics of reinforcing bars.

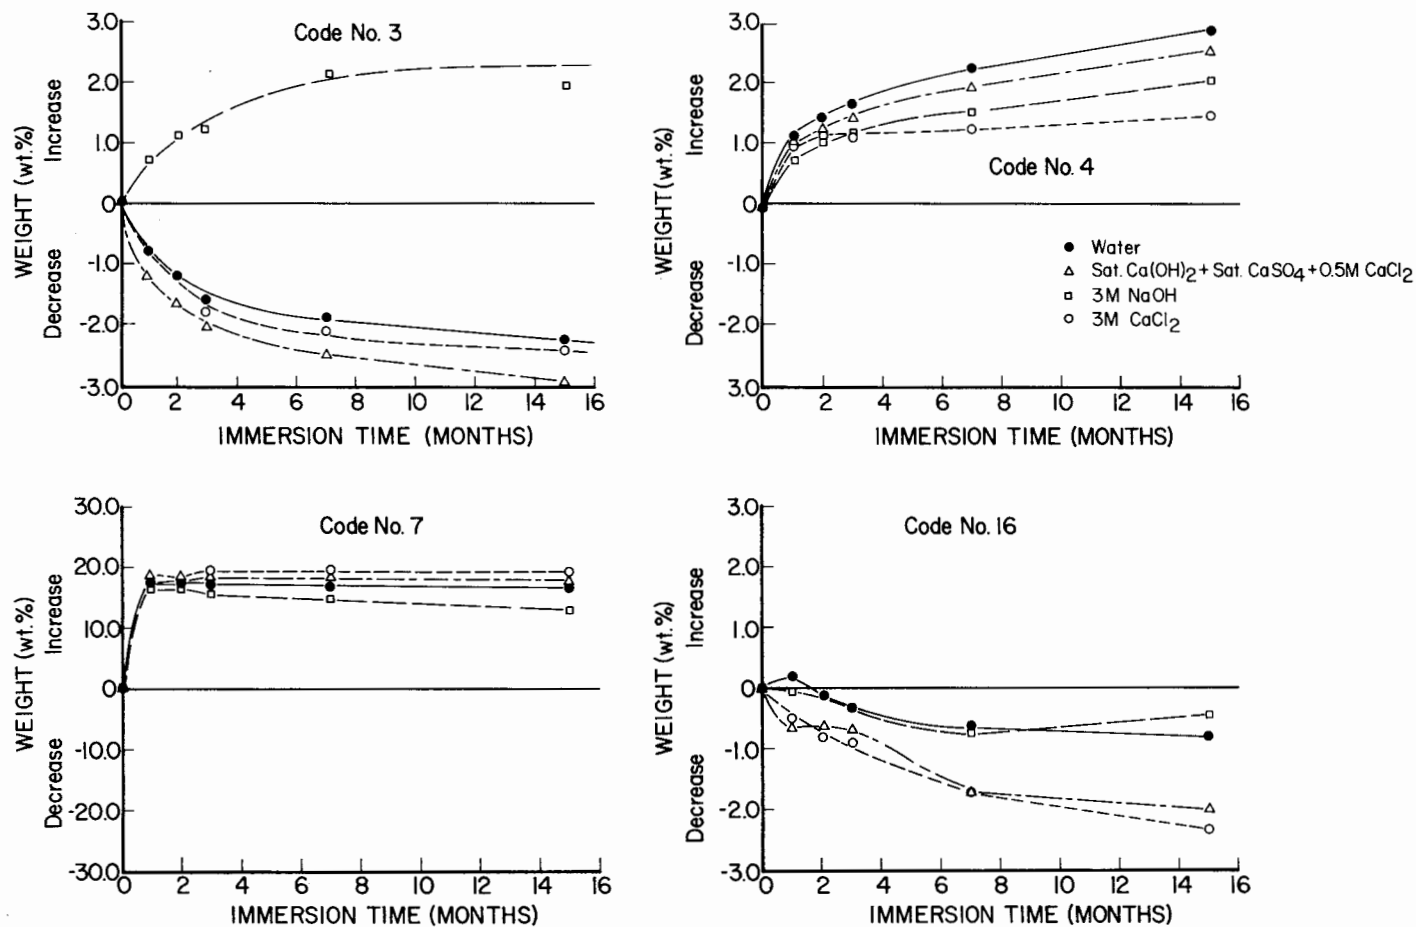
FIGURE 3. Weight stabilities of cured specimen discs, fabricated from four liquid epoxies, immersed in aqueous solutions.

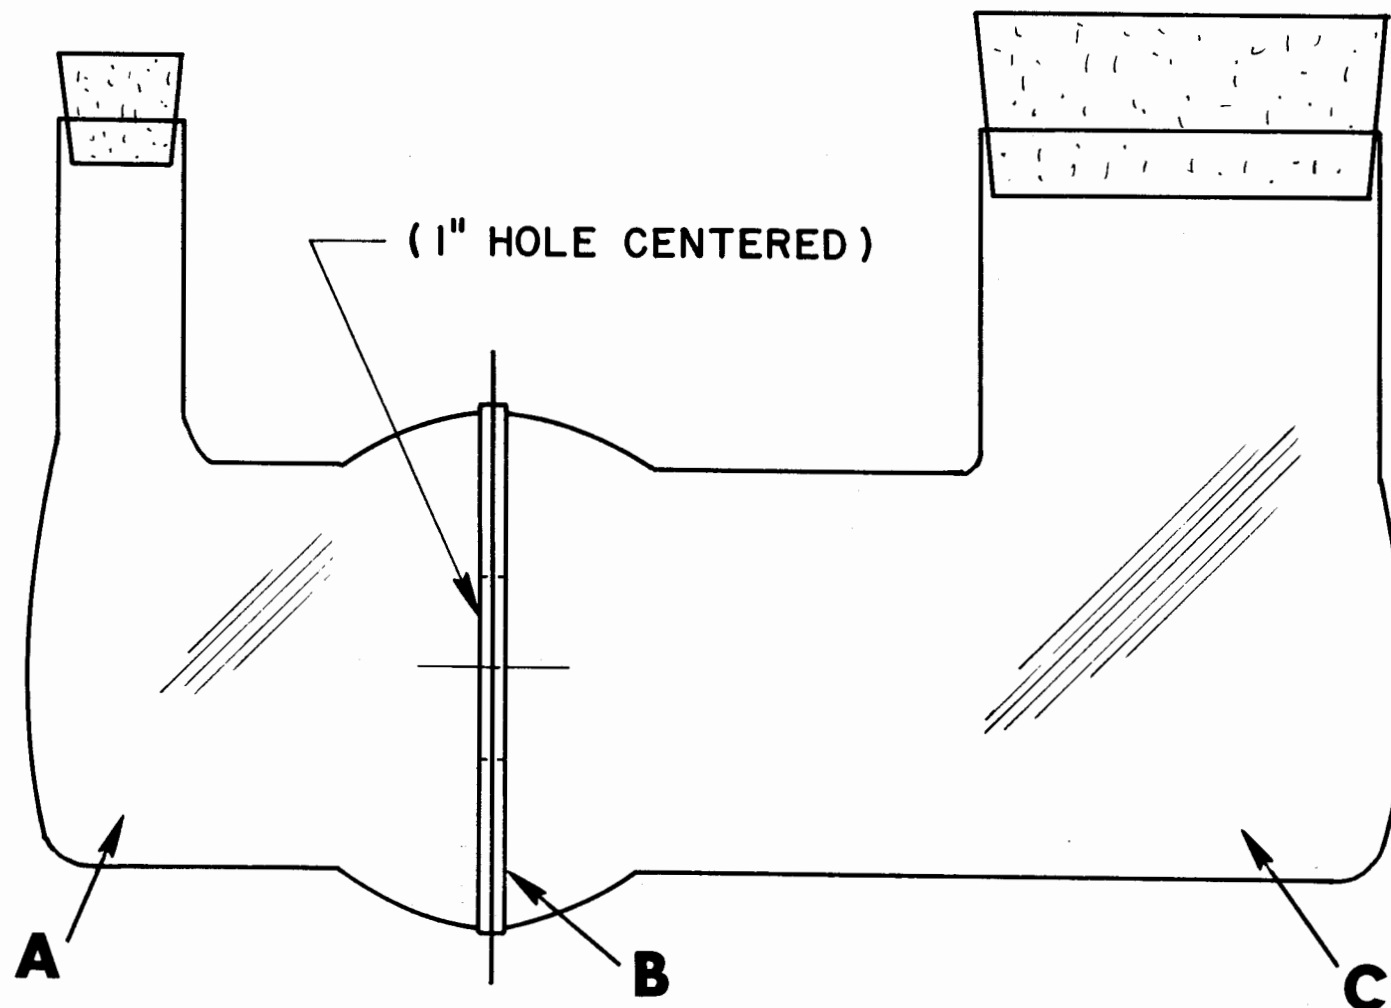
FIGURE 4. Permeability Cell

- Components:
- A. Compartment containing distilled water;
  - B. Epoxy film sandwich between two glass plates each having centered one-inch diameter hole;
  - C. Component containing 3M NaCl

The chloride permeability characteristics of thin films (3-7 mils) of cured epoxies were determined using permeability cells of the type shown in figure 4. Films selected for study were carefully handled, and examined for any defects prior to installation in the cell. The cell consisted of two glass compartments separated by an epoxy film sandwiched between two glass plates, each having centered 1 inch diameter holes. One compartment contained 175 ml of 3M NaCl and the other 115 ml of distilled water. The activity of chloride ions passing through the epoxy membrane was measured using a Model 401 Orion Specific Ion Meter, along with a Model 94-17 Orion Chloride Electrode, and a Model 90-02 Orion Double Junction Reference Electrode. Activity measurements were converted into concentration values of mole per liter with a conversion diagram, constructed by plotting measured chloride ion activities versus known chloride ion concentrations.

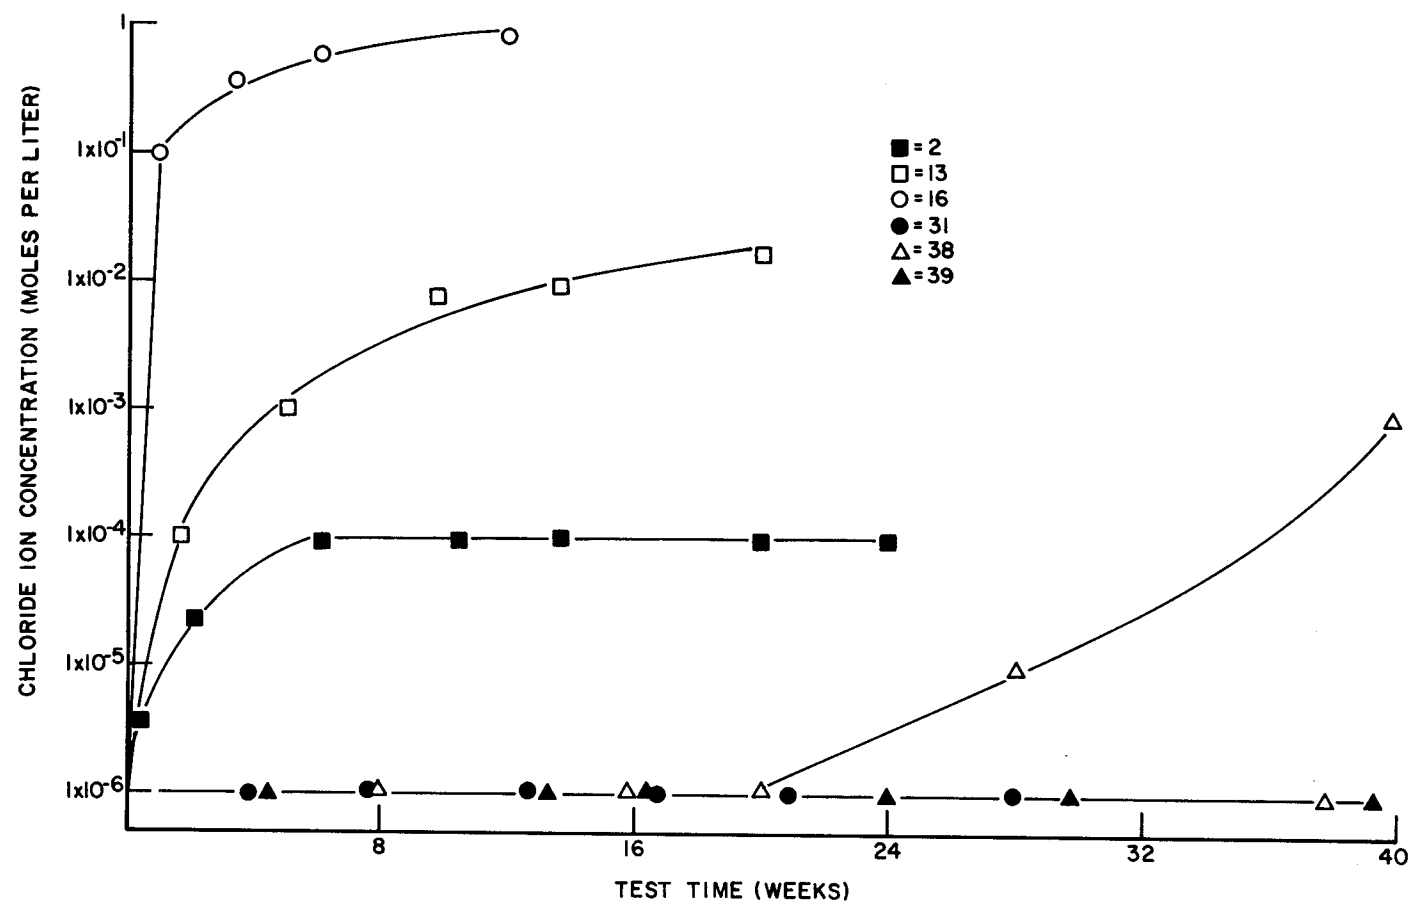
FIGURE 5. Concentration of chloride ions passing through epoxy films of materials Nos. 2, 13, 16, 31, 38 and 39. Film thicknesses were 3 mils.

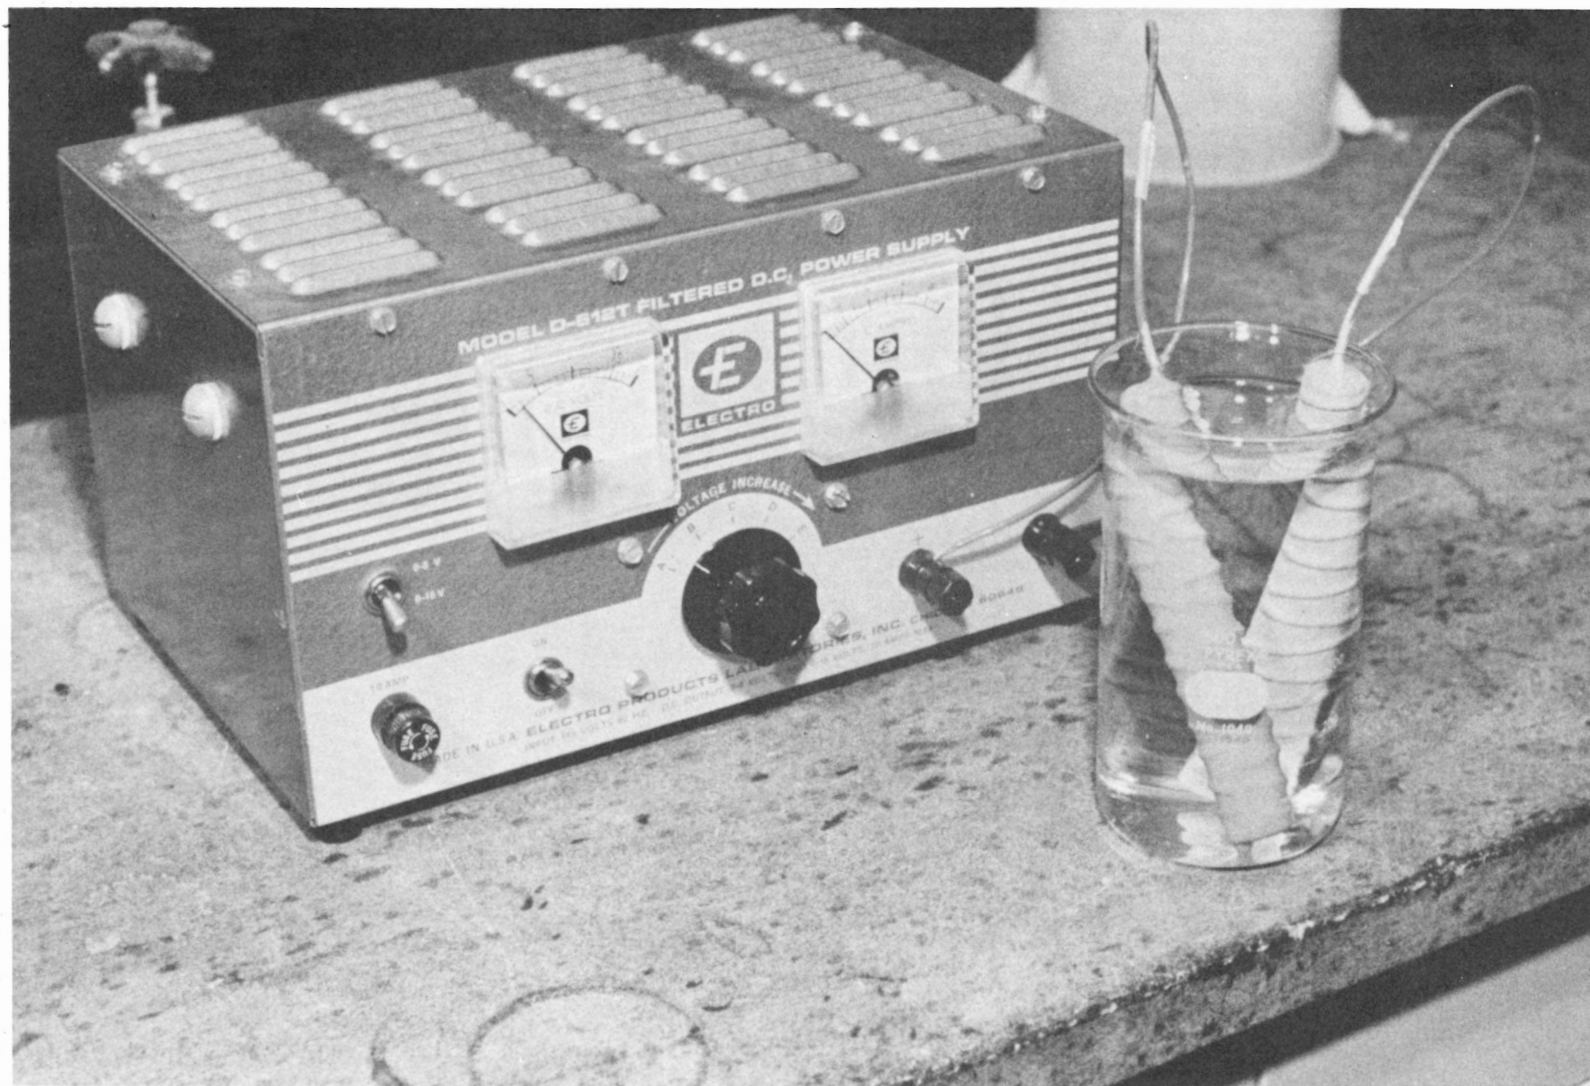
FIGURE 6.A. Applied voltage test at beginning of test. Anode and cathode coated with material No. 16.

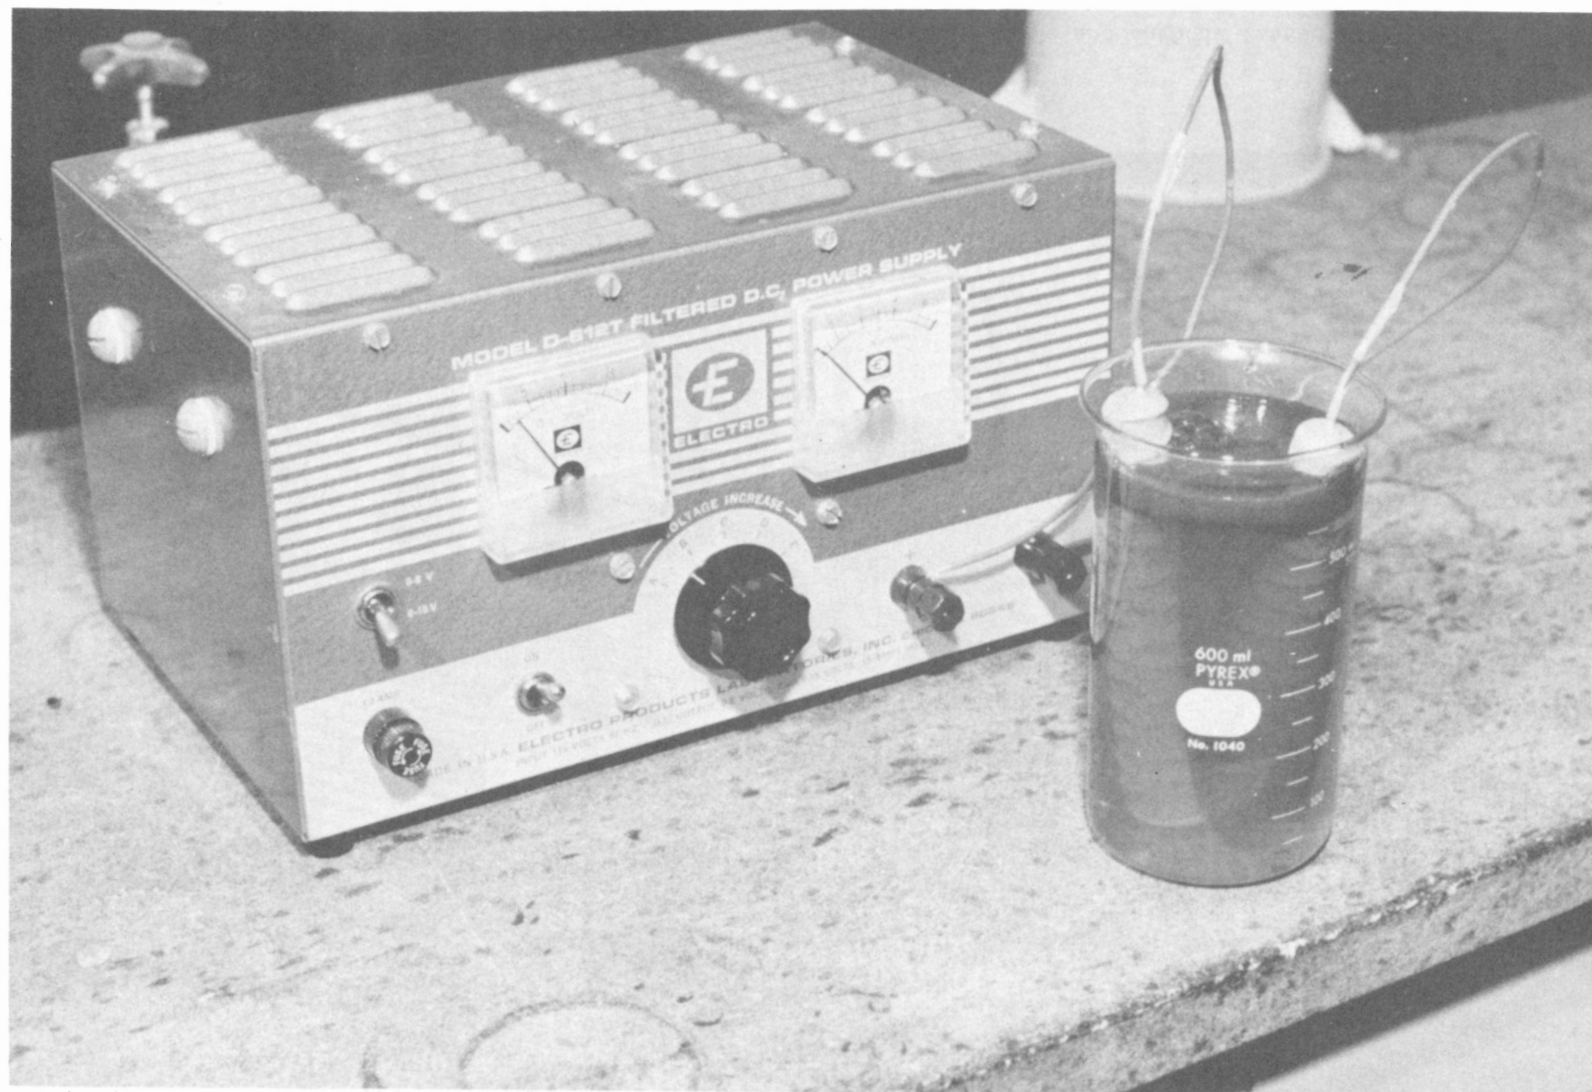
FIGURE 6.B. Results of application of 2 volts for 30 minutes.

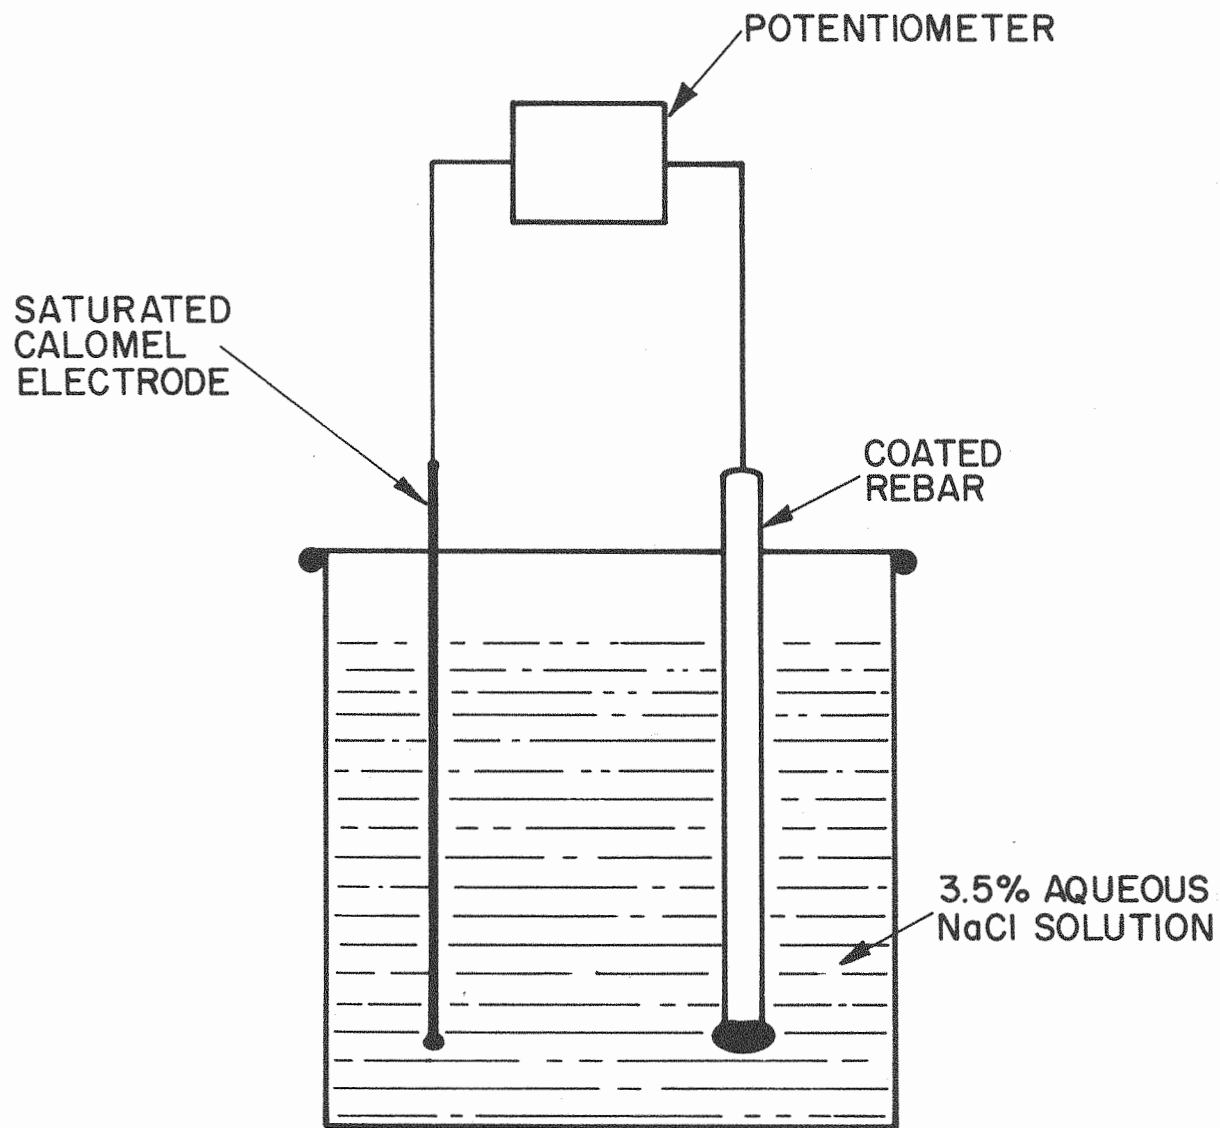
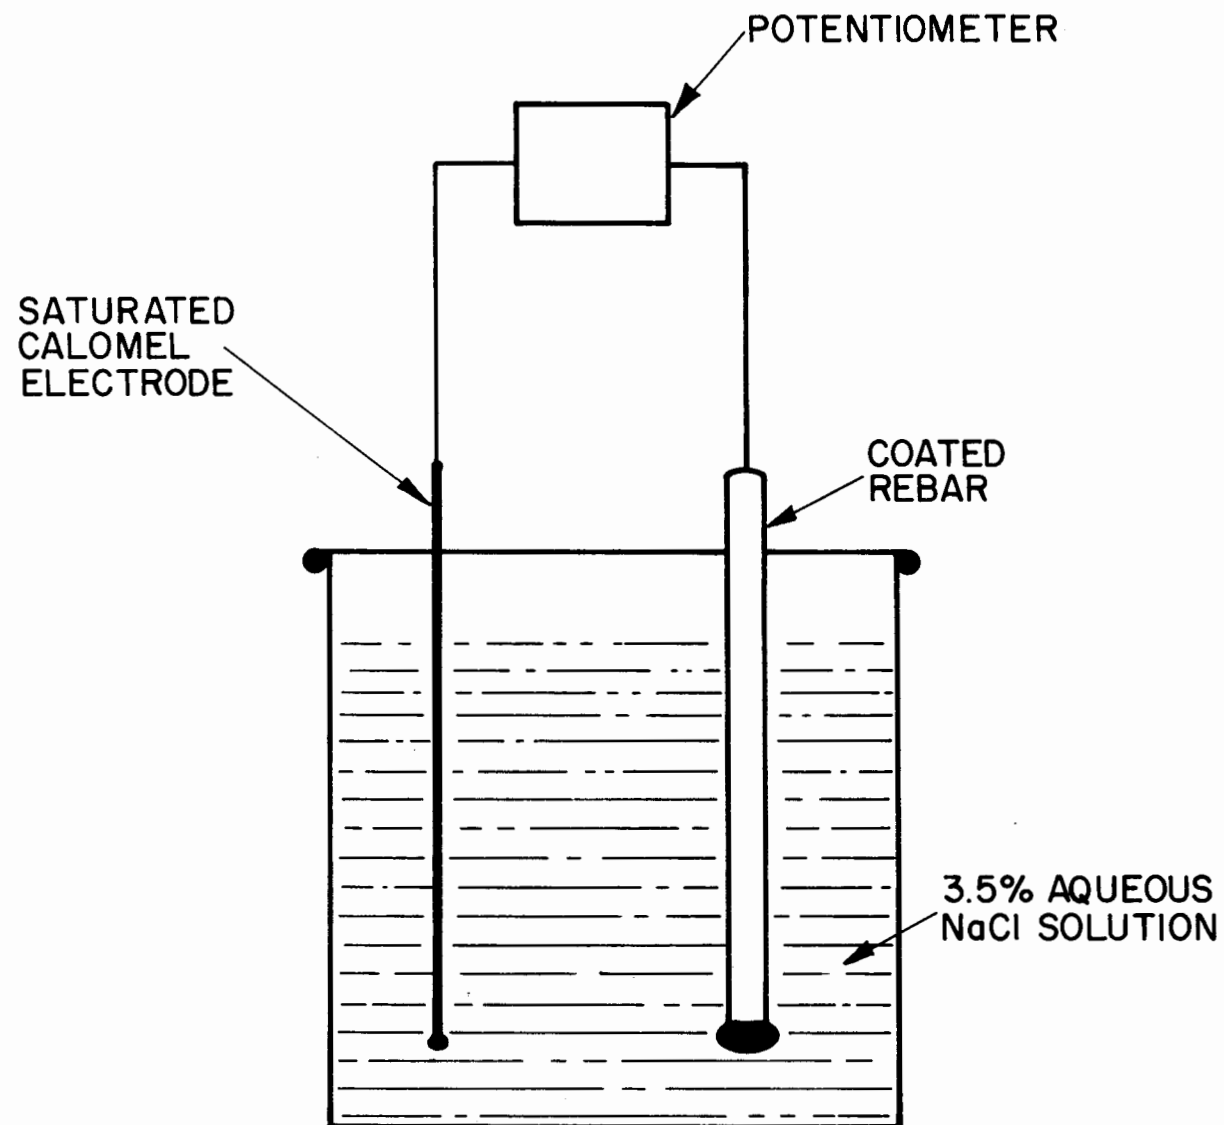
FIGURE 7. Measurement of electrical potentials of coated reinforcing bars immersed in 3.5 percent solution of NaCl.

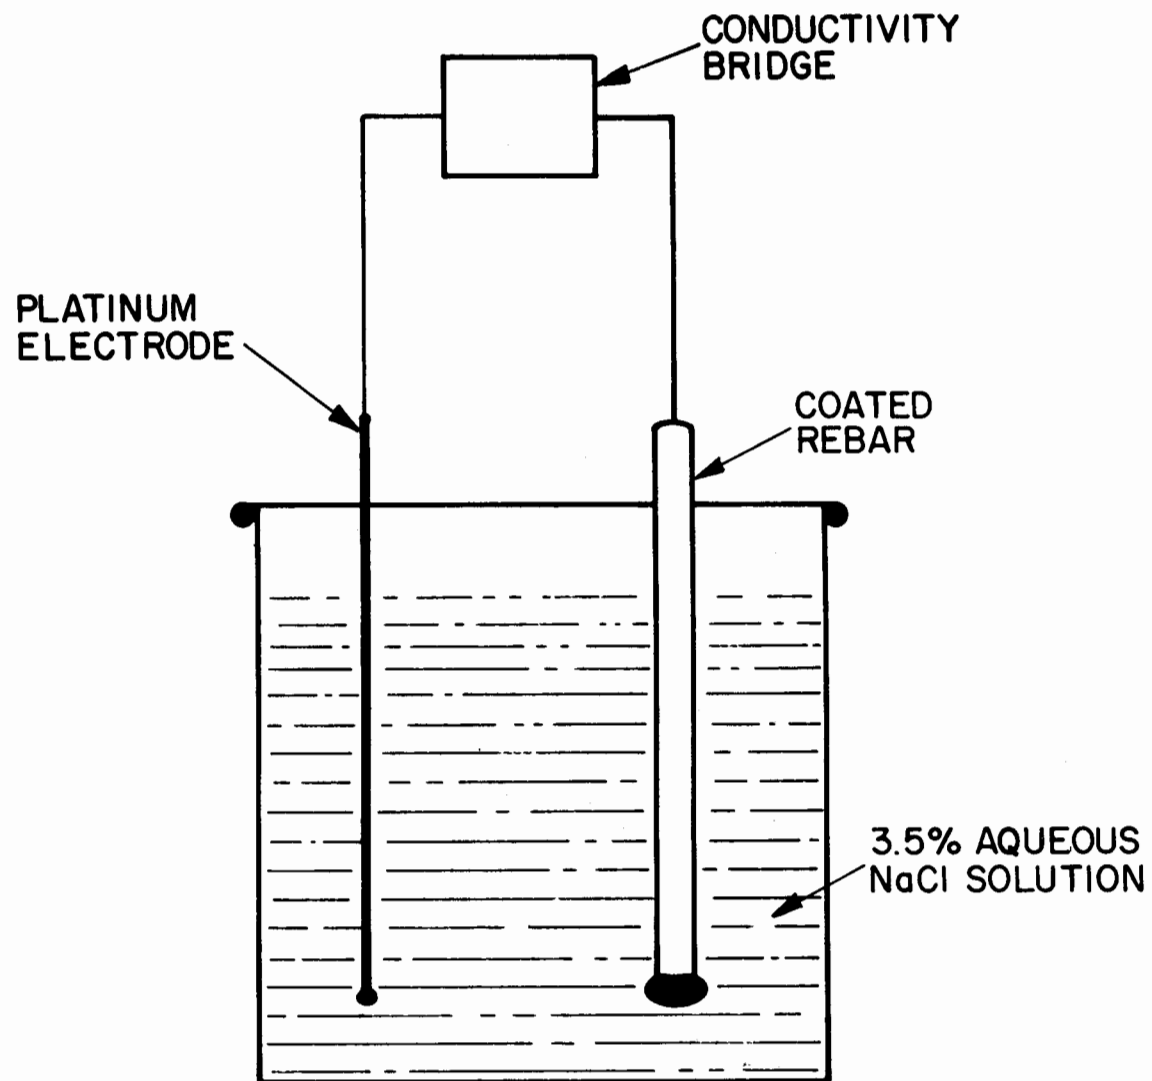
FIGURE 8. Measurement of electrical resistance of coatings on reinforcing bars immersed in 3.5 percent solution of NaCl.

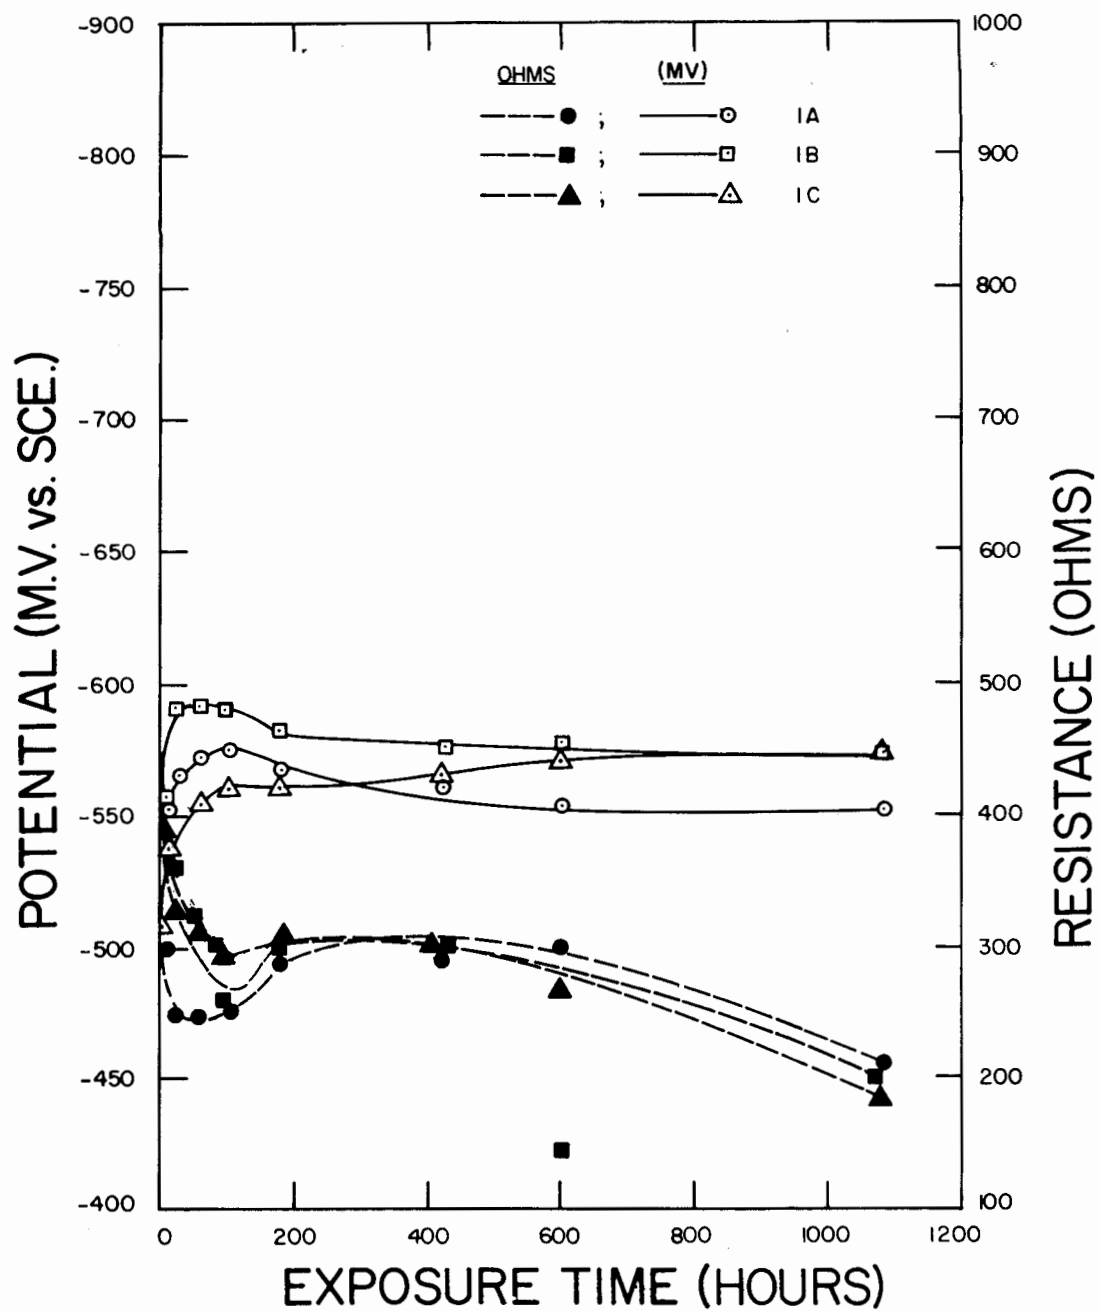
FIGURE 9. Electrical potential and resistance measurements of reinforcing bar coated with material No. 1 immersed in 3 1/2 percent NaCl. In the ordinate caption, M.V. vs. S.C.E. denotes millivolt reading taken using a saturated calomel electrode as the reference.

Potential and resistance data for three sets of reinforcing bars, each set coated with a different epoxy (Nos. 1, 25 and 31) are plotted versus test time in figures 9, 10 and 11 (initial plotted values measured after 24 hours of immersion of coated bars). The wide variance in the initial millivolt and ohmic readings of duplicate and triplicate specimens decreased rapidly during the first 200 hours of testing and after 1000 hours good agreements were obtained for companion specimens. A rapid decrease in the resistance of a coating probably can be attributed to the emergence of holidays, while an increase in resistance is probably indicative of some type of healing mechanism.

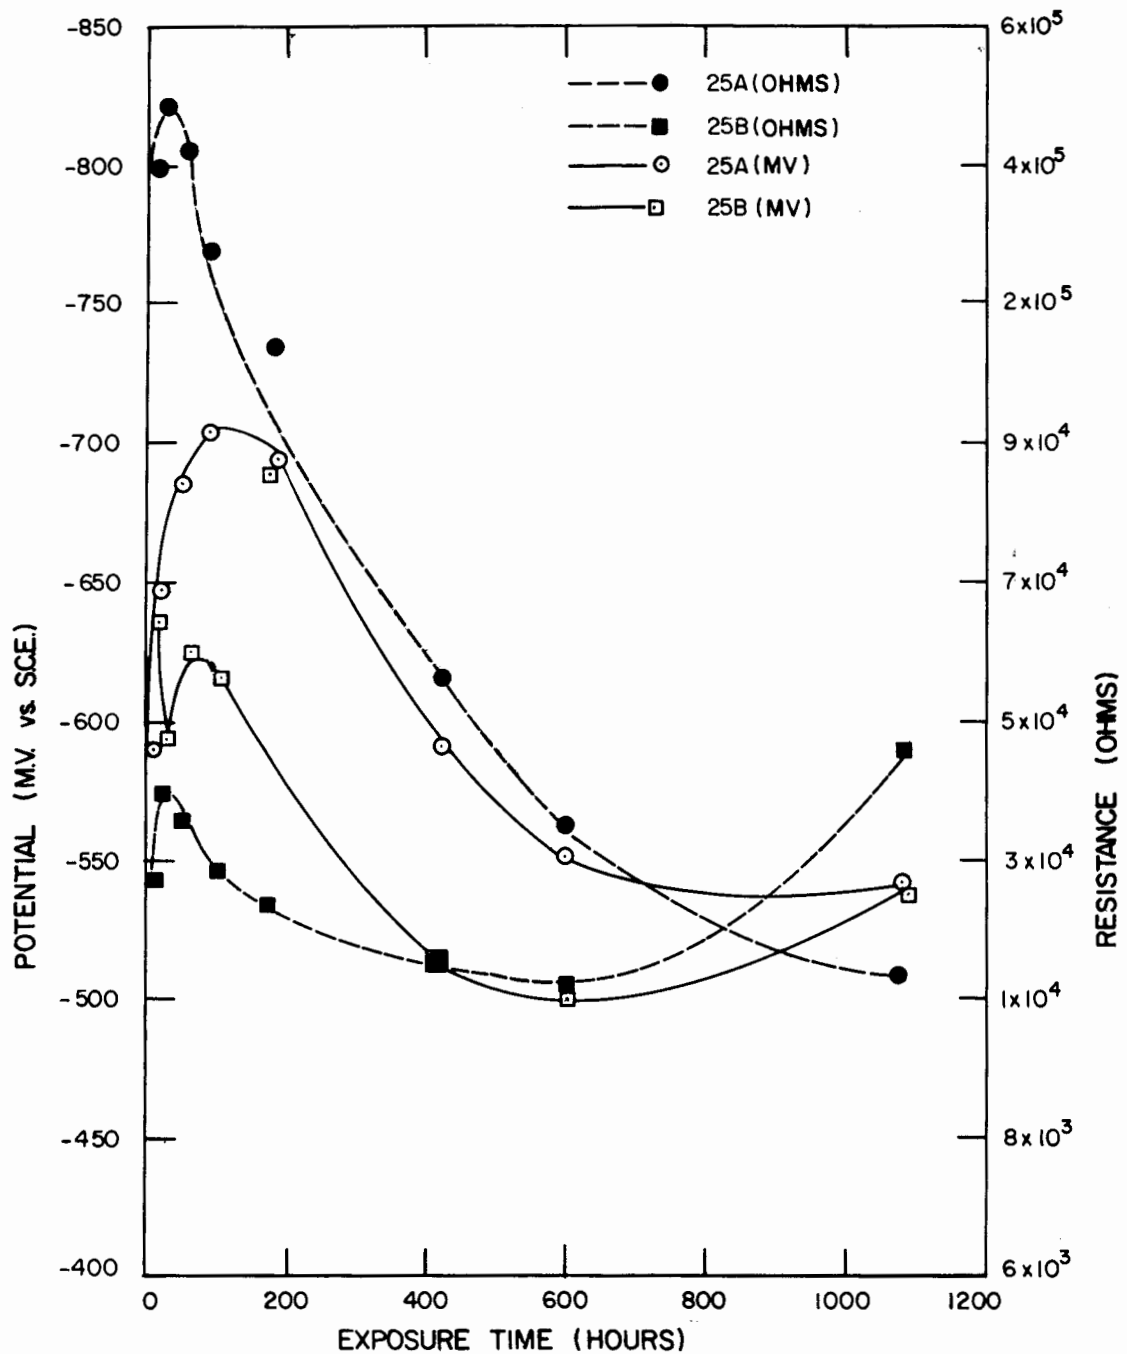
FIGURE 10. Electrical potential and resistance measurements of reinforcing bar coated with material No. 25 immersed in 3 1/2 percent NaCl. In the ordinate caption, M.V. vs. S.C.E. denotes millivolt reading taken using a saturated calomel electrode as the reference.

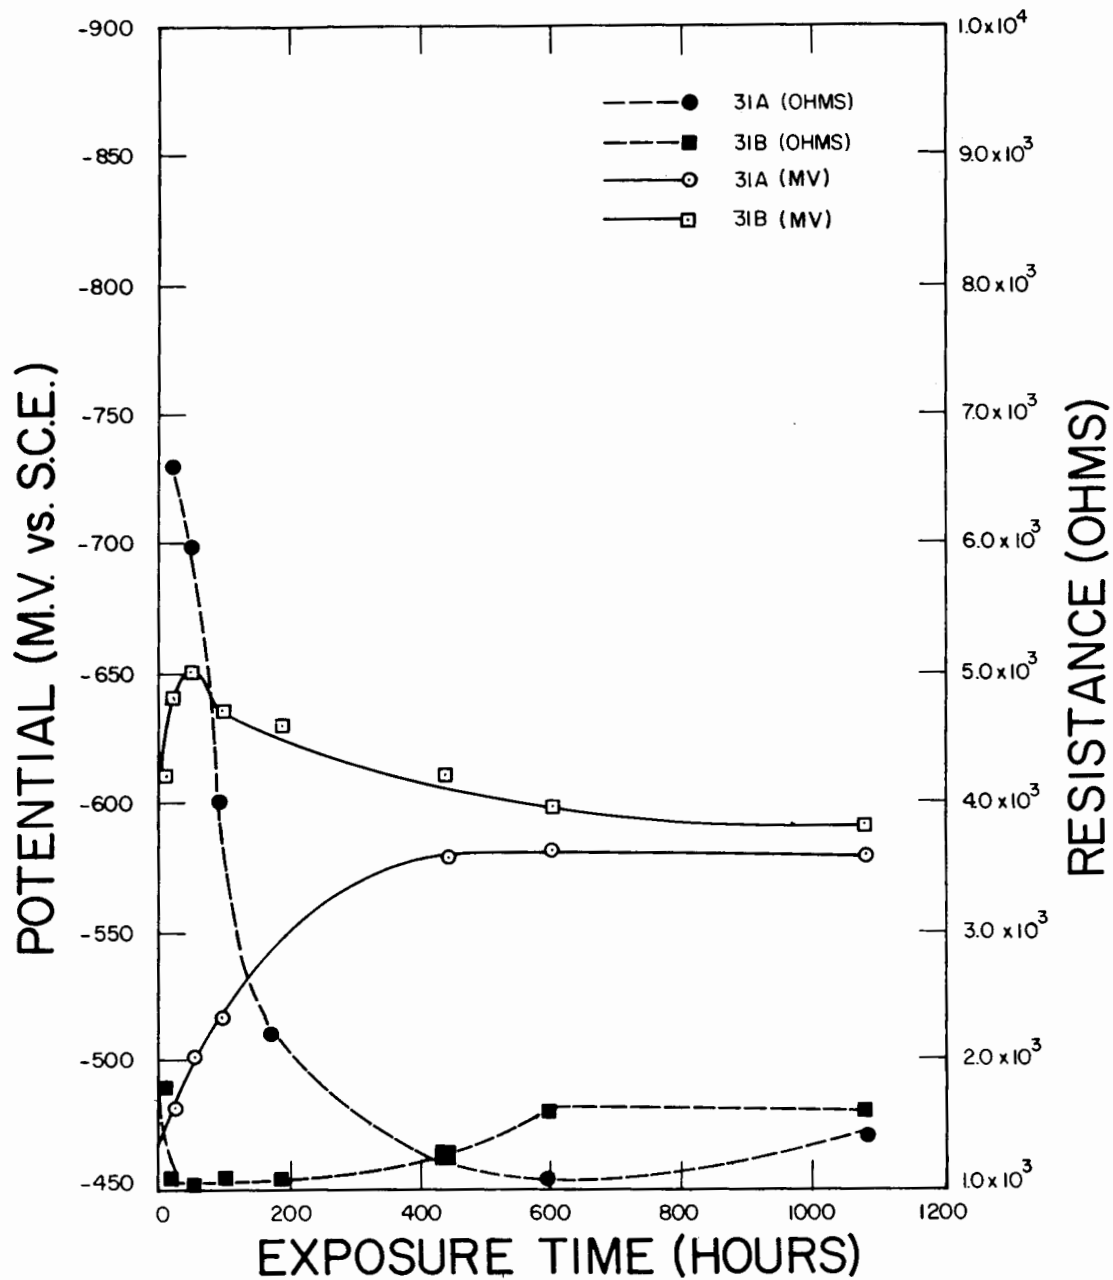
FIGURE 11. Electrical potential and resistance measurements of reinforcing bar coated with material No. 31 immersed in 3 1/2 percent NaCl. In the ordinate caption, M.V. vs. S.C.E. denotes millivolt reading taken using a saturated calomel electrode as the reference.

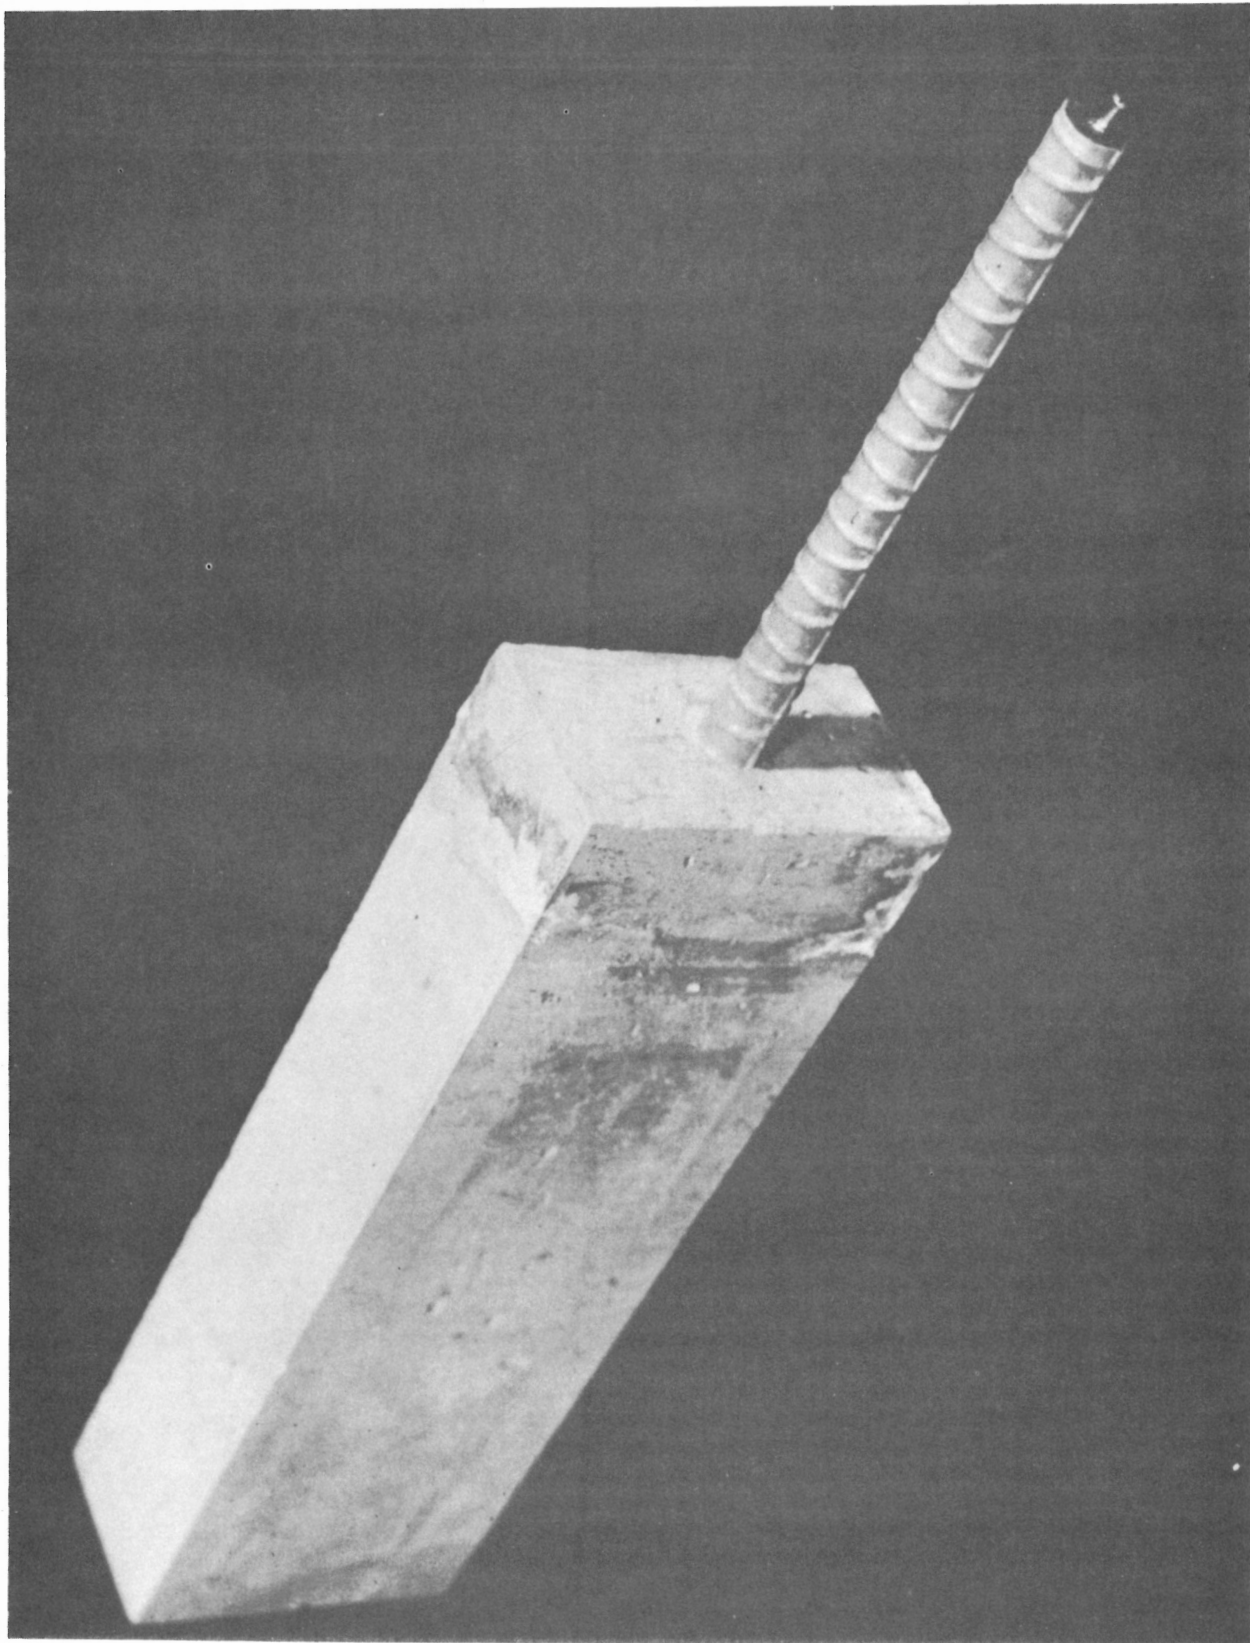
FIGURE 12. Corrosion-test specimen with coated reinforcing bar embedded in concrete block of dimensions  $2 \frac{7}{8} \times 4 \frac{7}{8} \times 15$  inches.

The corrosion test specimens were concrete blocks 2 7/8 x 4 7/8 x 15 inches in which were embedded a 24 inch length of No. 6 reinforcing bar concentric with the longitudinal axis of the block. The bars protruded out of the concrete blocks with exposed ends of 1 inch and 8 inches. The end of the block with the 1 inch of bar protruding which was to be immersed in the salt solution, was first coated with an "underwater" type of epoxy which bonded firmly to the concrete. Then the 1 inch exposed end of the bar and the epoxy were coated completely with a heavy layer of silicone rubber. The bond of the rubber to steel and to the epoxy was very good, although its bond to concrete in a salt solution is poor. A terminal was inserted into the long end of each reinforcing bar so that electrical connections could be made to a voltmeter or conductivity bridge.
