Report No. FHWA-RD-74-18

**75-20  
#1**  
**NONMETALLIC COATINGS FOR  
CONCRETE REINFORCING BARS**

**J. R. Clifton, H. F. Beeghly and R. G. Mathey**

**February 1974  
Final Report**

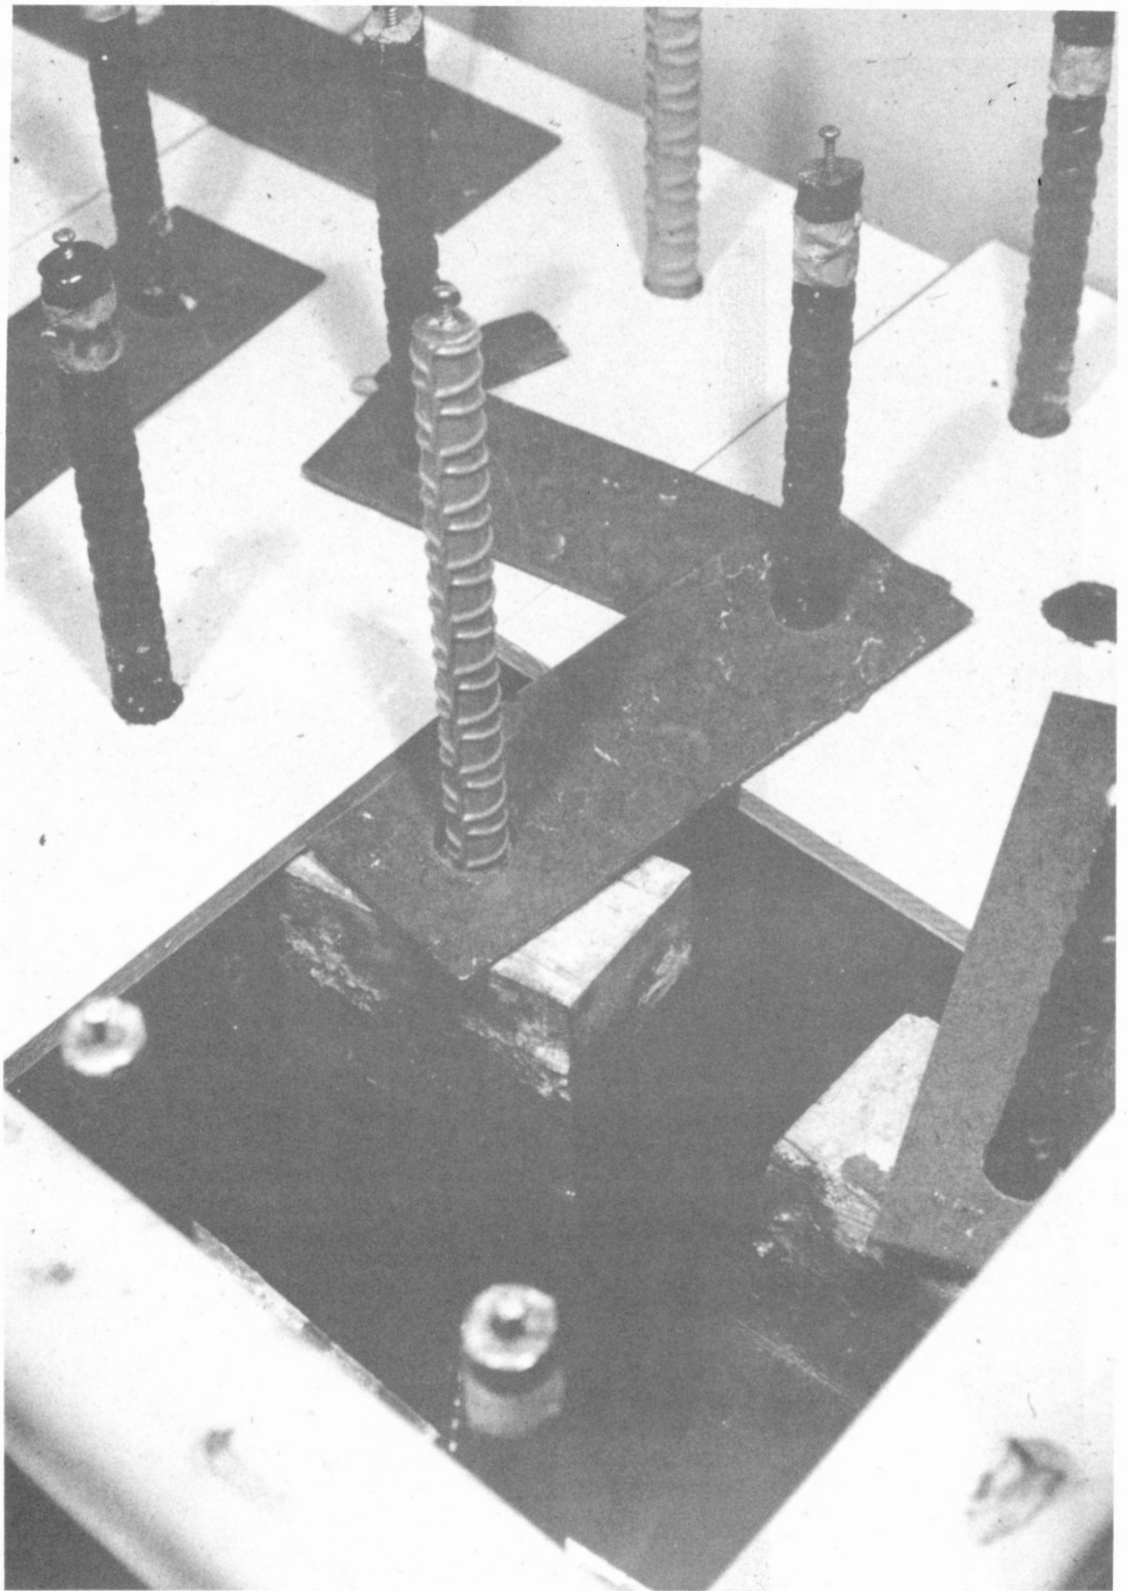
FIGURE 13. Corrosion-test specimens immersed in 3.5 percent solution of NaCl.

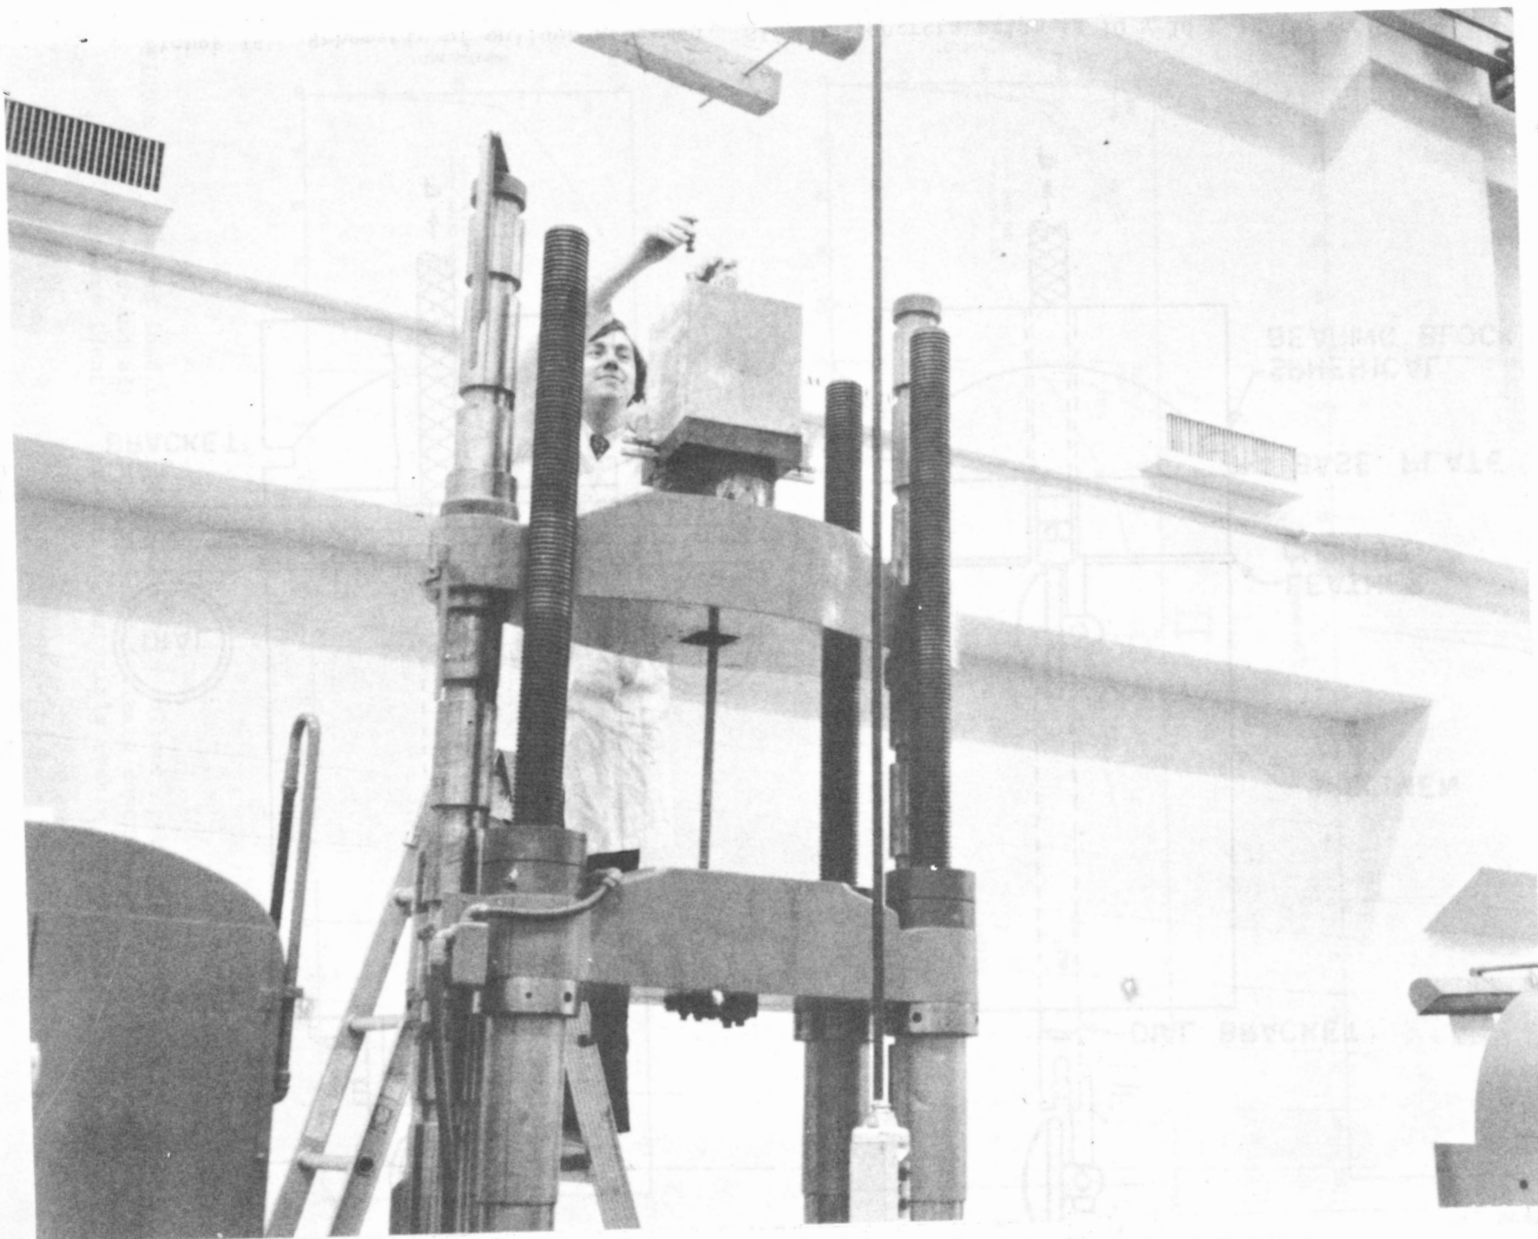
FIGURE 14. Pullout specimen on electromechanical testing machine being prepared for testing.

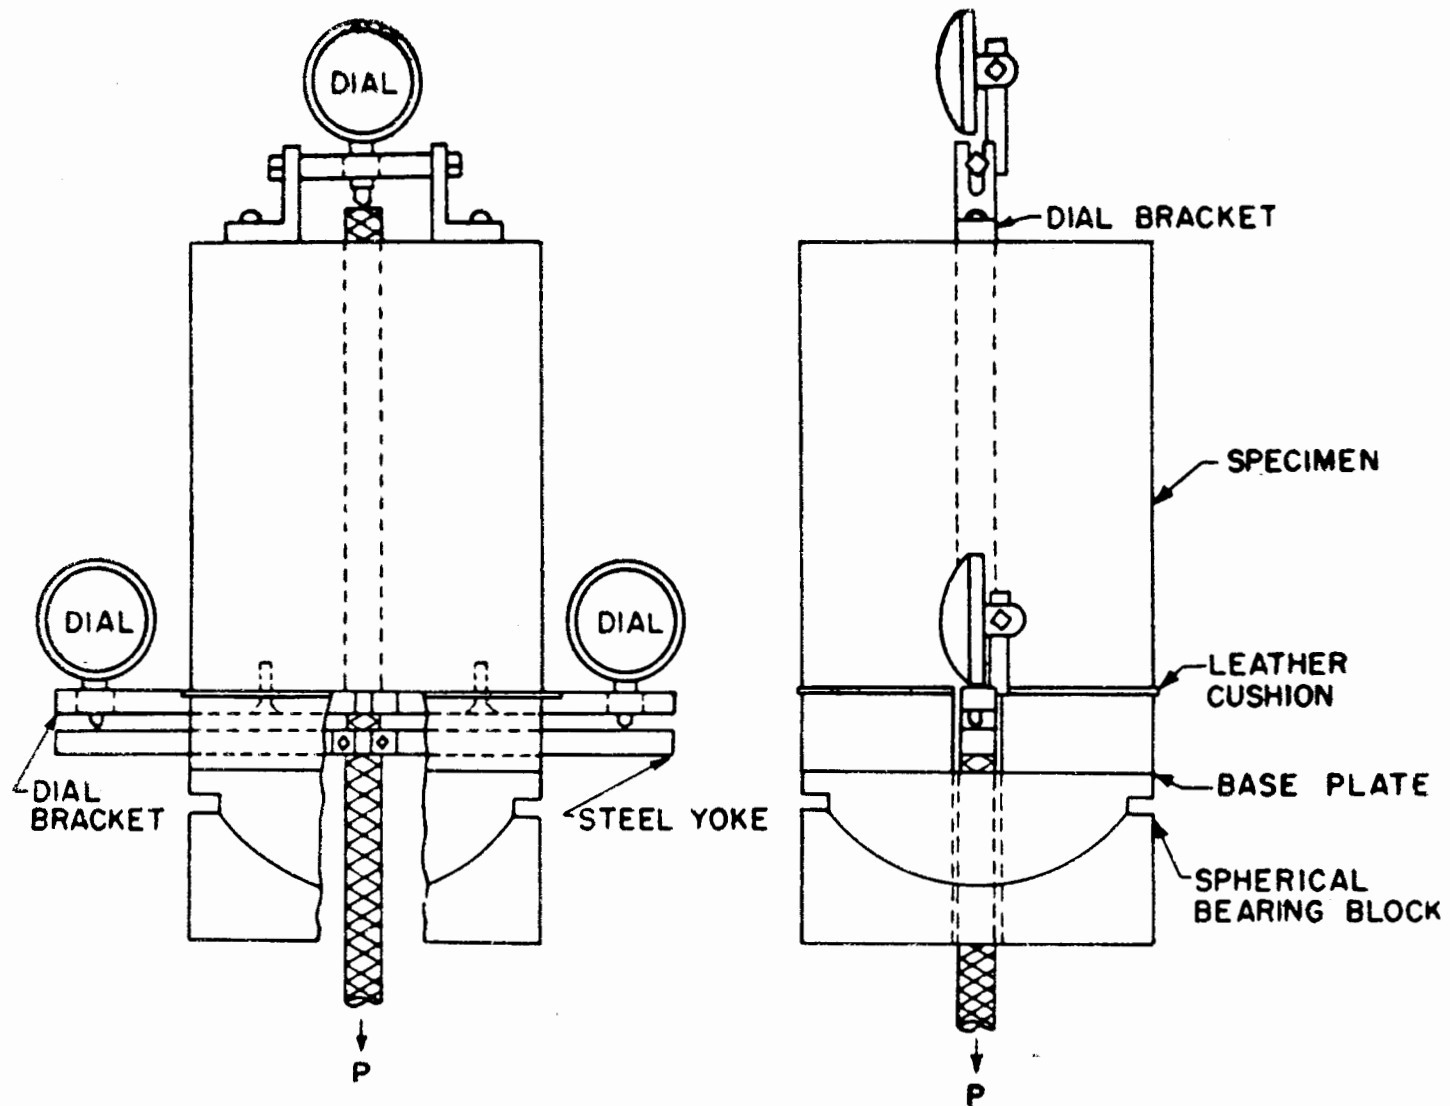
FIGURE 15. Schematic of pullout specimen. Size of concrete prism is 10 x 10 x 12 inches.

The pullout tests are tests in which increasingly higher loads are applied in equal increments to the reinforcing bar until either the bar yields or the bond strength between the reinforcing bar and concrete is greatly exceeded (estimated by measuring the slip of the reinforcing bar relative to the concrete prism).

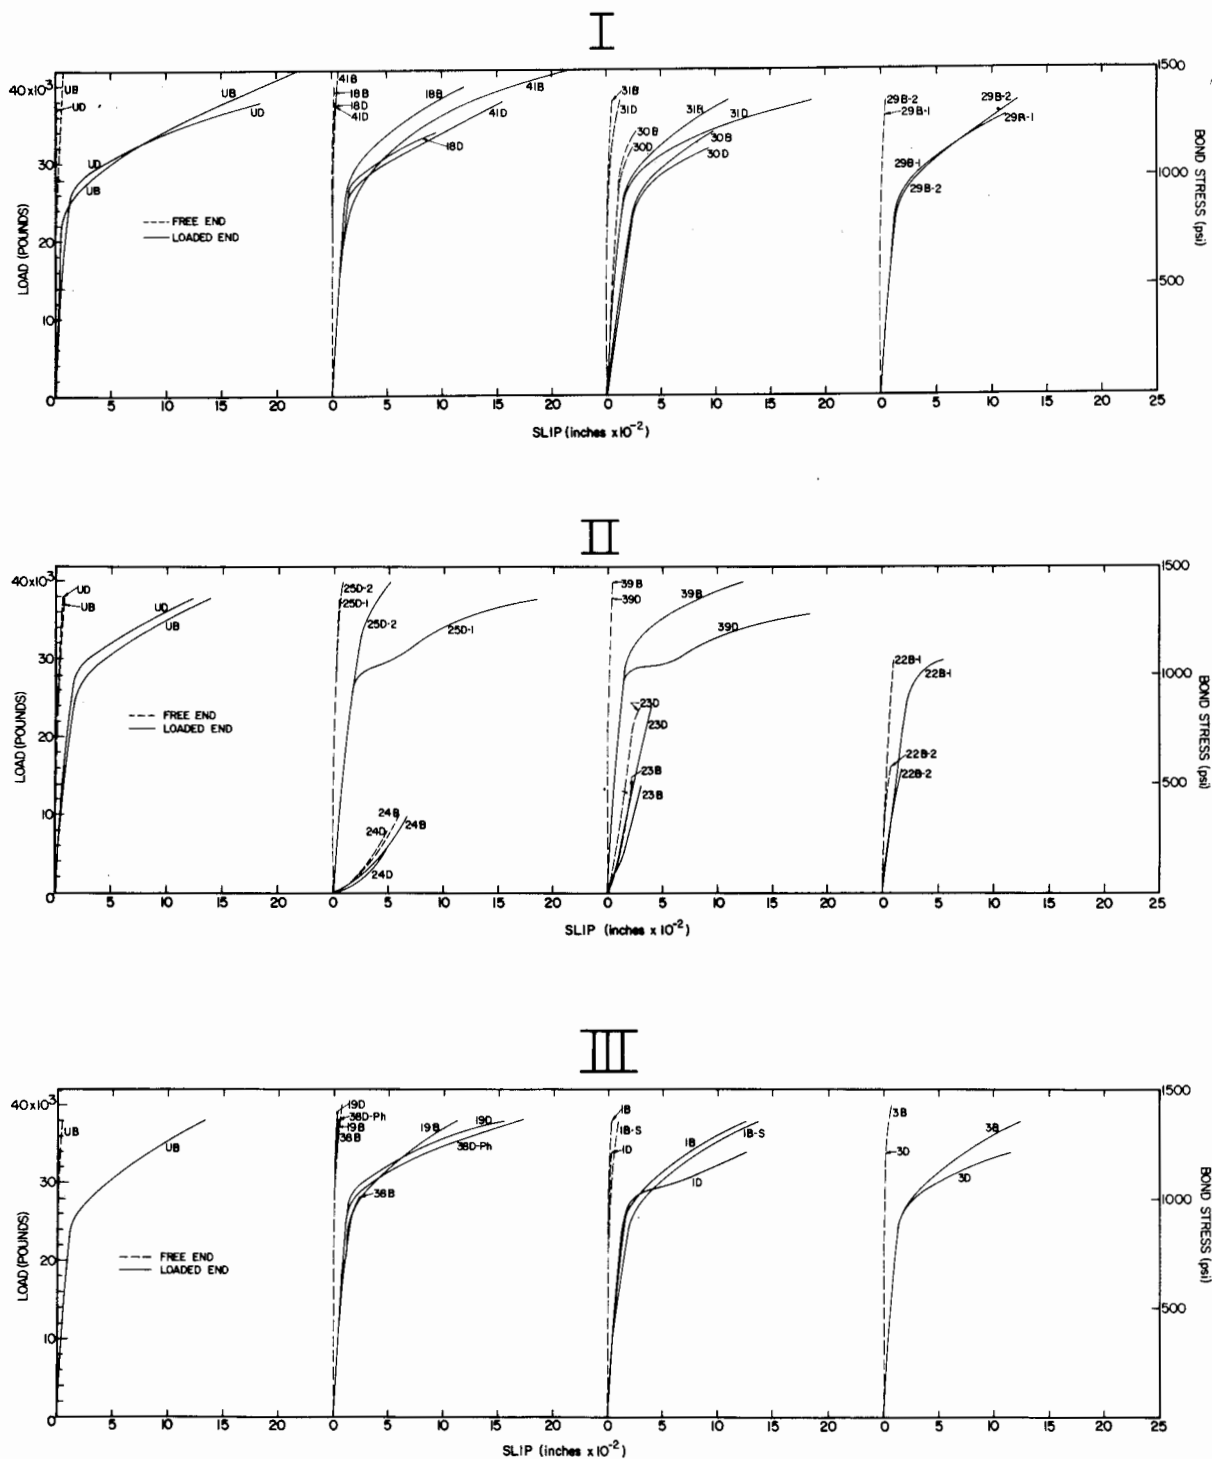
FIGURE 16. Applied load to reinforcing bar in pullout specimens versus free-end and loaded-end slip. Roman numbers indicate concrete batch number, while Arabic numbers identify the coating materials (table 1).

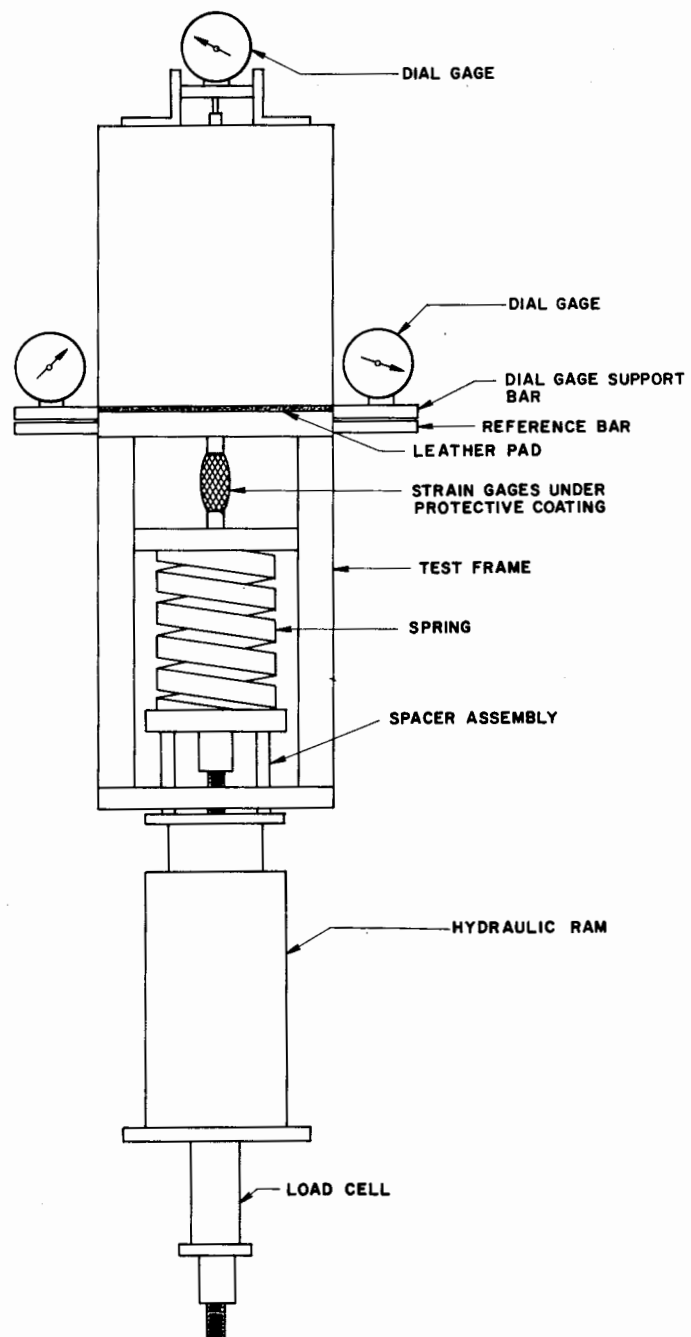
Specimen Loading Assembly

FIGURE 17. Schematic of creep specimen. Size of specimen is the same as the pullout specimen.

The strain gages, to monitor the tensile stresses, were attached to the reinforcing bars approximately 3 inches from the concrete prism with an epoxy adhesive. The gages were covered with a protective coating of wax followed by a coating of an epoxy material. Two strain gages, electrically connected in series, were attached diametrically opposite on each bar. These gages when attached as recommended by the manufacturer are claimed by the manufacturer to have only a small intrinsic creep of  $10 \mu\epsilon$  (microstrain units)/year. The strain values were measured with a Vishay Instruments Strain Indicator Model P 350 A. Strain measurements were converted to stress values in psi using a calibration diagram obtained from tensile tests of reinforcing bars instrumented the same as the bar in the creep specimens.

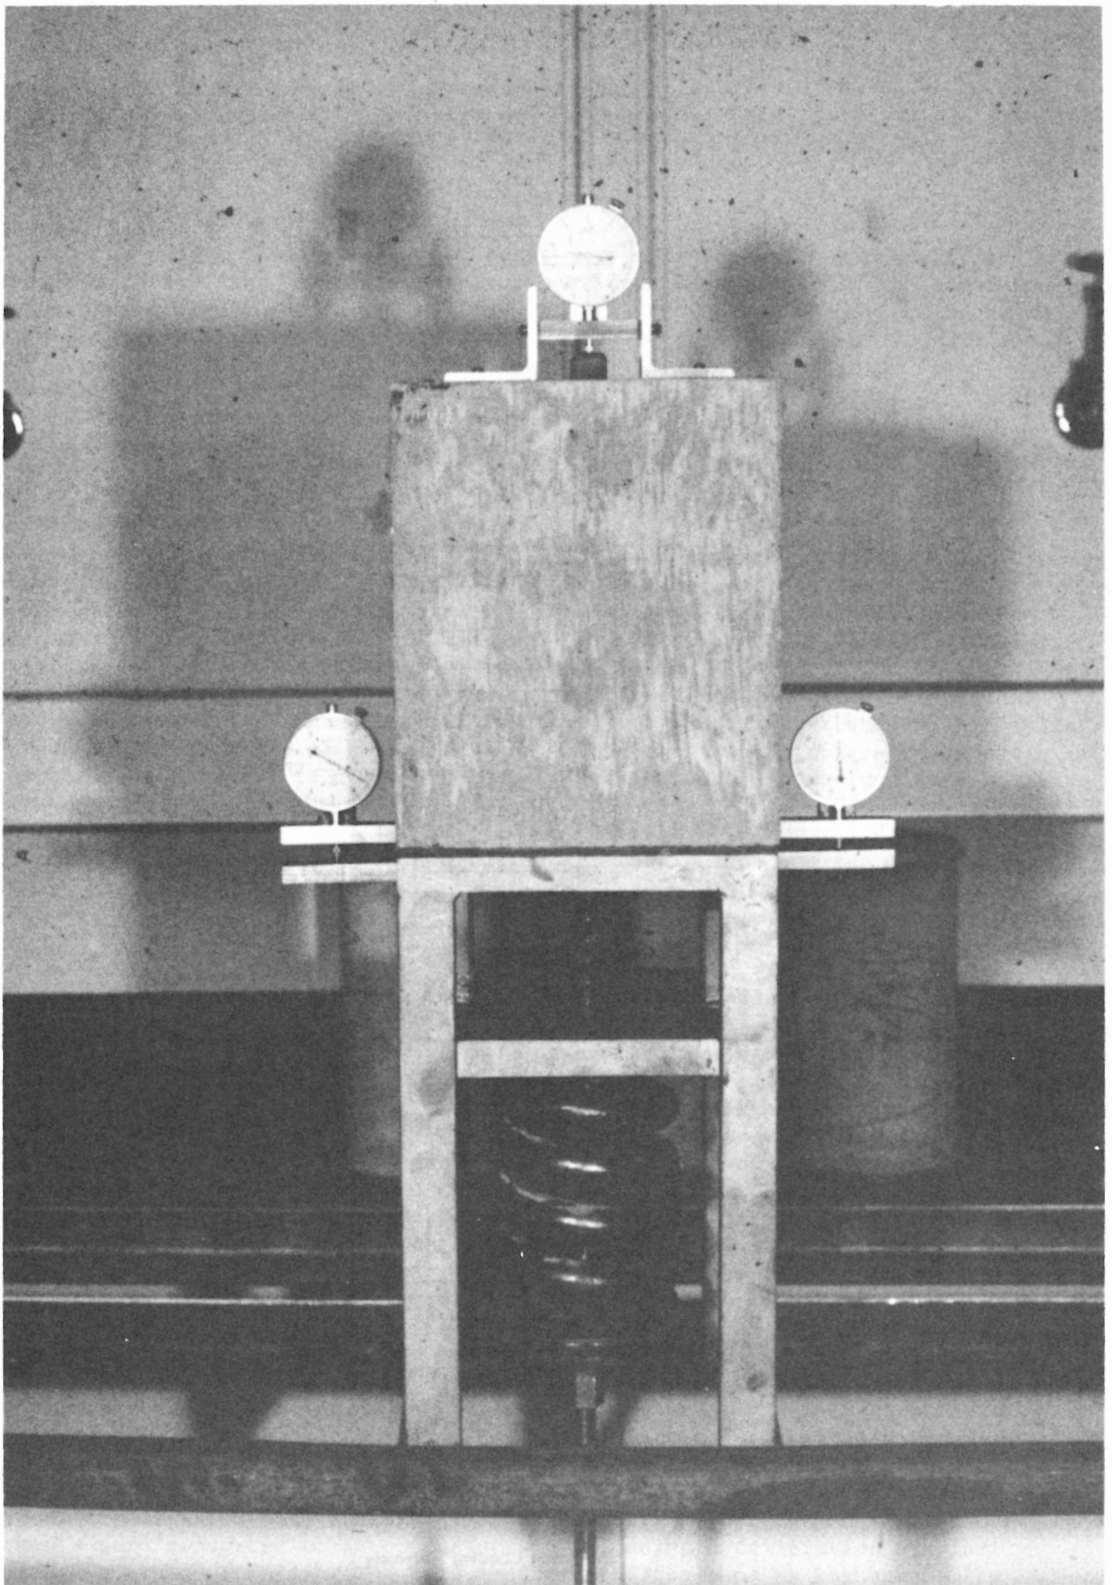
FIGURE 18. Creep specimen loaded to a tensile stress level of 30,000 psi (in the steel reinforcing bar).

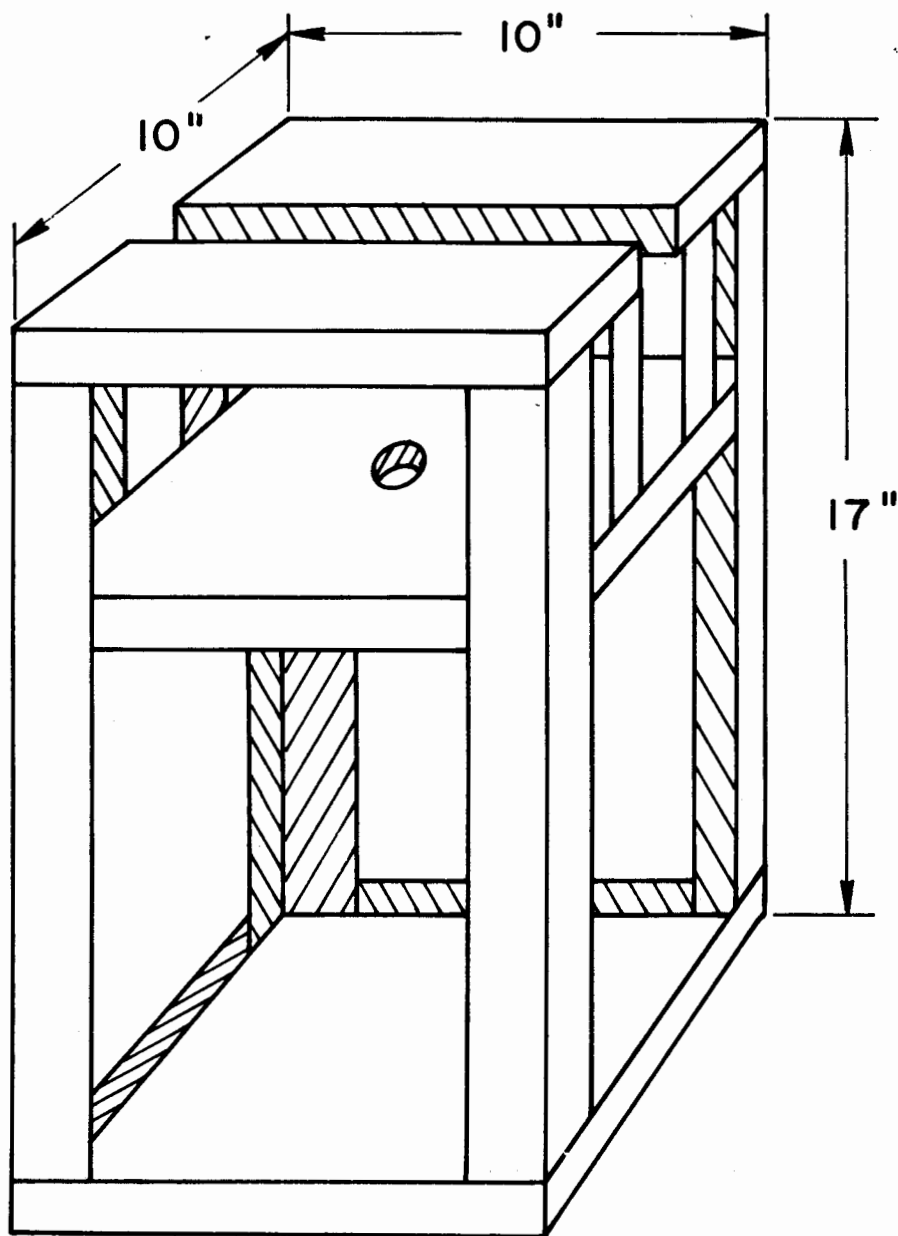
**Test Frame**

FIGURE 19. Schematic of creep test frame.

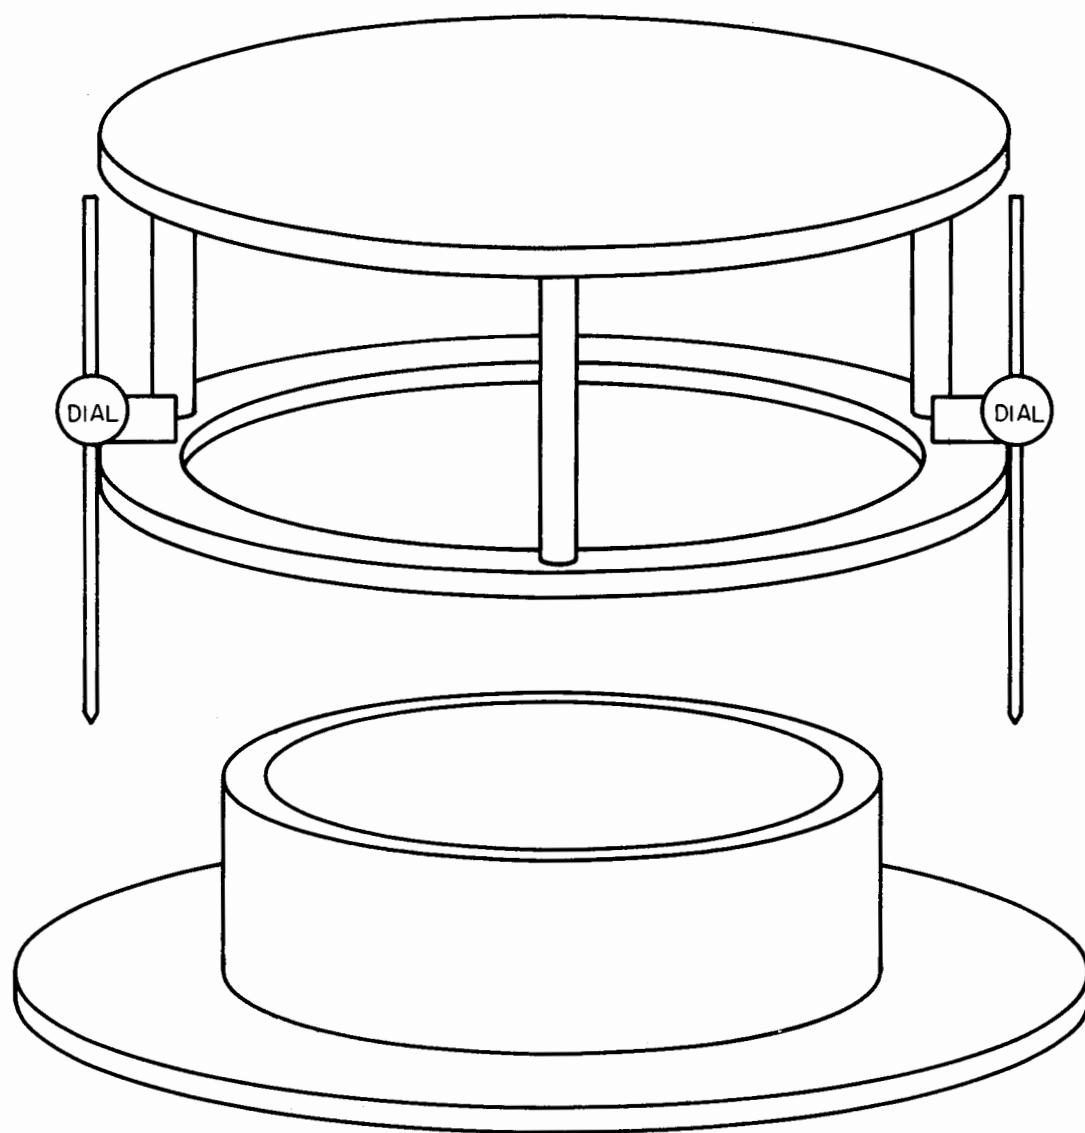
## SPRING CALIBRATION APPARATUS

FIGURE 20. Apparatus for calibrating steel springs used to exert tensile stresses in the creep study.

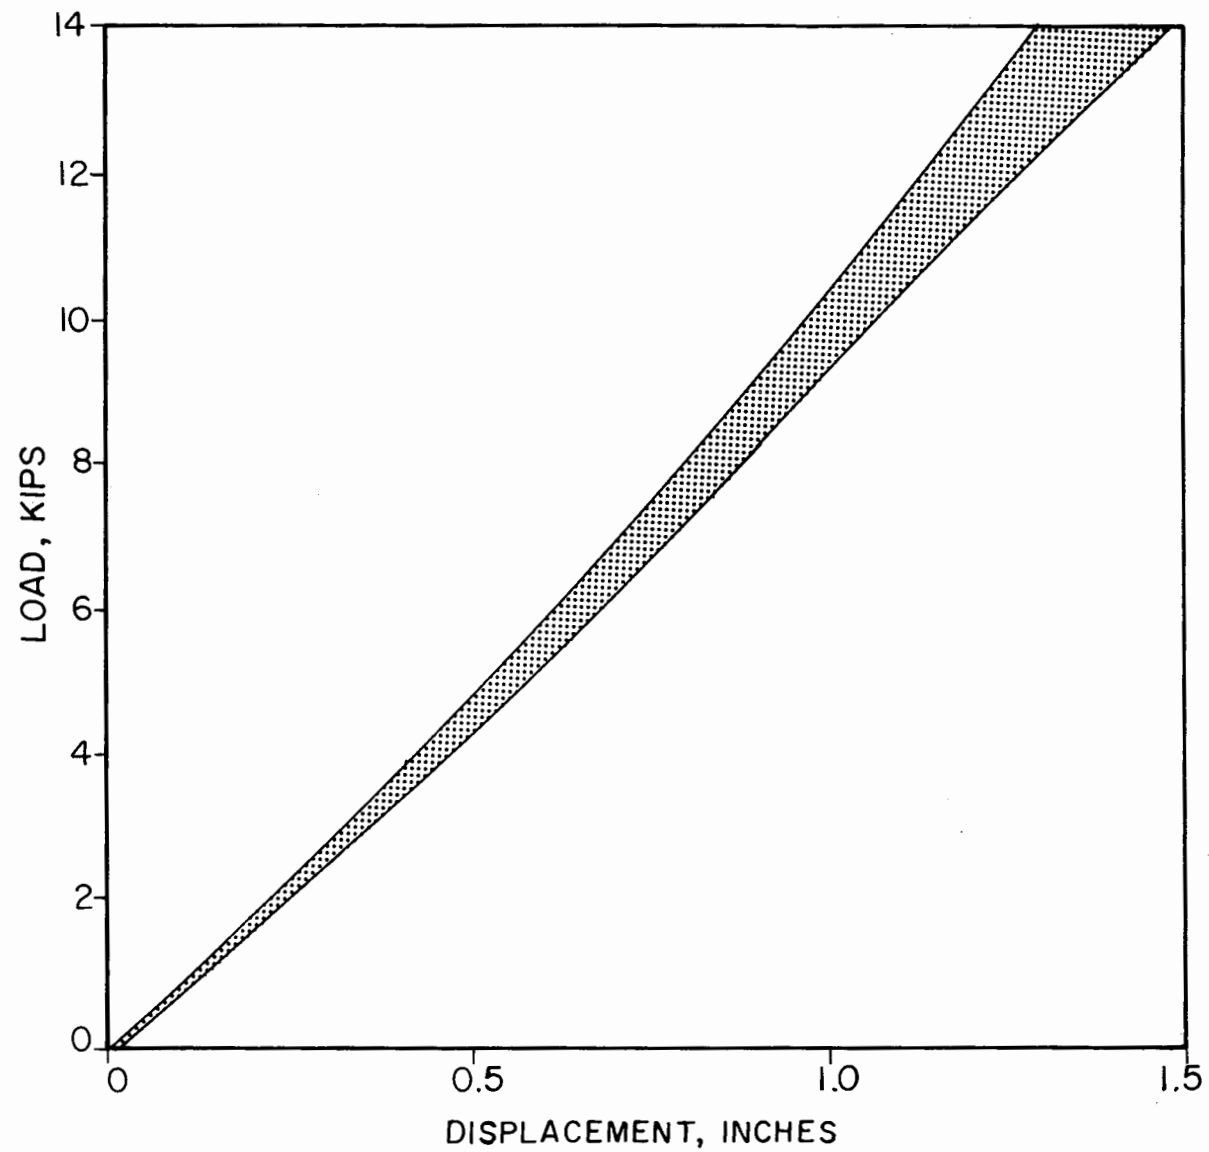
FIGURE 21. Range of displacement response of 24 steel springs used in the creep study.

calibration of the displacement response of springs to loading, any increase in the height of the compressed springs could be directly related to the amount of loss of tensile stress.

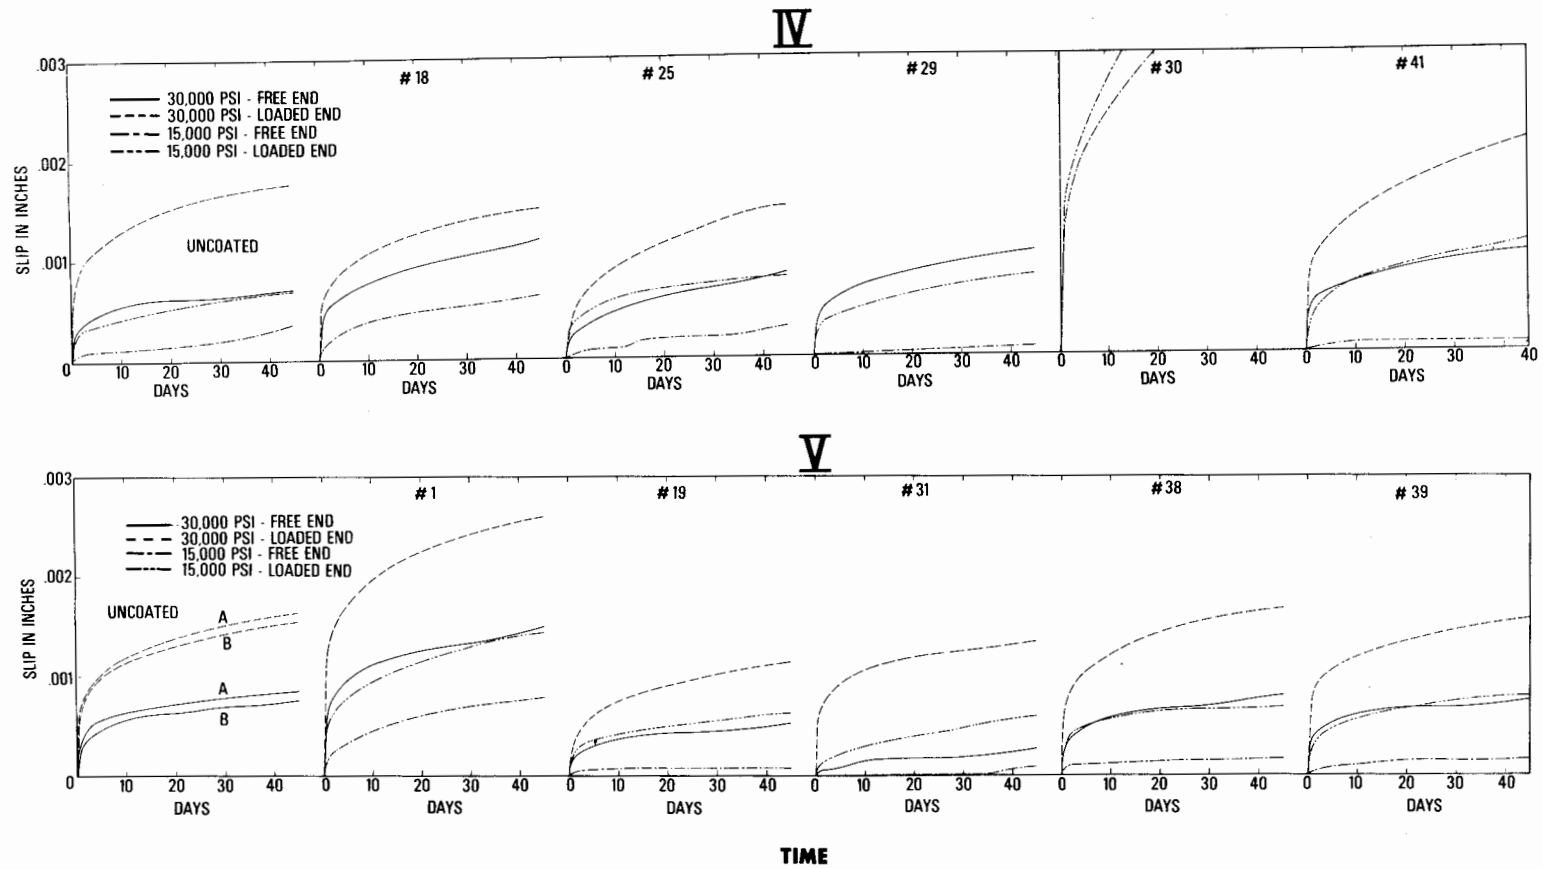
FIGURE 22. Free-end and loaded-end slips in creep specimens versus time. Roman numbers indicate concrete batch number, while Arabic numbers identify the coating materials (table 1).

Free- and loaded-end slip data, at 45 days, of coated and uncoated bars are listed in table 15. The slip data obtained at the tensile stress level of 30,000 psi will be emphasized. The respective slip values for both the coated and uncoated bars attained at the tensile stress of 15,000 psi were about 10 to 50 percent of the values obtained at 30,000 psi stress level. Furthermore, the same conclusions are derived by analyzing either set of data.

Three creep specimens with uncoated bars were tested at the 30,000 psi stress level and average loaded-end slip was .00164 inch and the average free-end slip was .00077 inch, at 45 days. The agreement between the three loaded-end slip values and also the three free-end values was excellent for this type of experiment. The range and percent coefficient of variation for the loaded-end data was 0.00022 inch and 4.0 percent, and .00013 inch and 7.1 percent for the free-end slip data. Because the variation in concrete strength was minor, no compensating adjustments were made in the slip values.
