TECHNICAL MEMORANDUM 505-16

Texas Transportation Institute  
Texas A&M Research Foundation

FEASIBILITY OF CONCRETE PIPE CRASH CUSHIONS

A Test And Evaluation Report On Contract No. CPR-11-5851

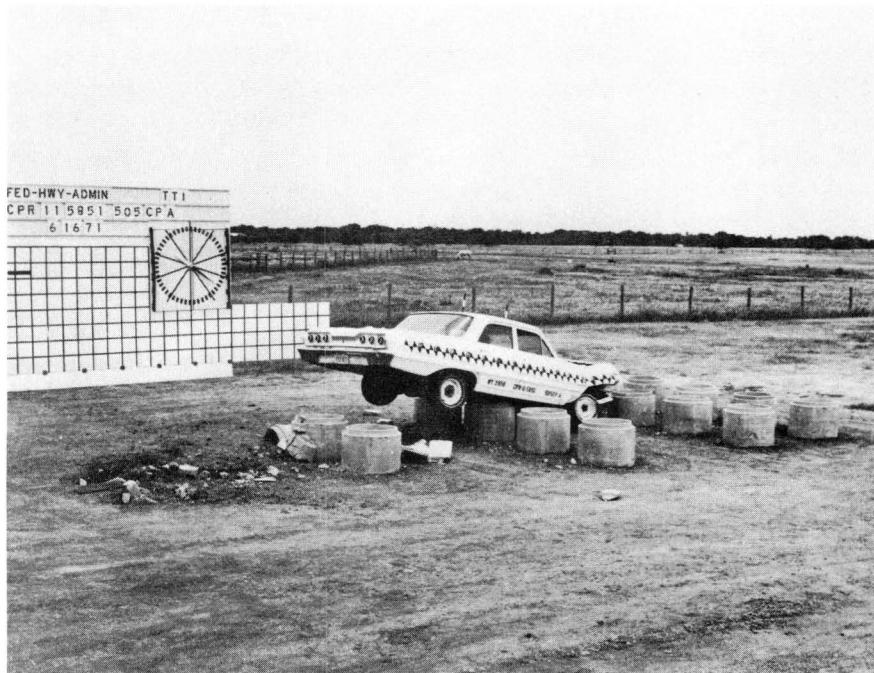
FIGURE 3, BARRIER BEFORE AND AFTER TEST 505 CP-A.

A 3950 lb Chevrolet impacted the system head-on at a speed of 40.5 mph. After shattering the two pipes in the first row, the vehicle ramped, became airborne, and finally came to rest on top of the third row of pipes (see Figure 3). The first row of pipes was completely shattered and the soil was disturbed when the pipes began to tilt in the ground (see Figure 4), but the rest of the system remained intact and sustained little damage. Average longitudinal deceleration from the film was 9.2 g's over 4.3 ft of travel and 0.105 sec (accelerometer traces showed no significant longitudinal forces on the vehicle after this time). Although vertical accelerations were obviously significant, they were not determined. Vehicle damage was moderate, with a front-end deformation of 1.3 ft.

One full-scale vehicle crash test was conducted on a system composed of reinforced concrete sewer pipes embedded 4 ft-3 in. in the soil. This crash cushion is shown in Figures 1 and 3. The results of this crash test are presented in this report.

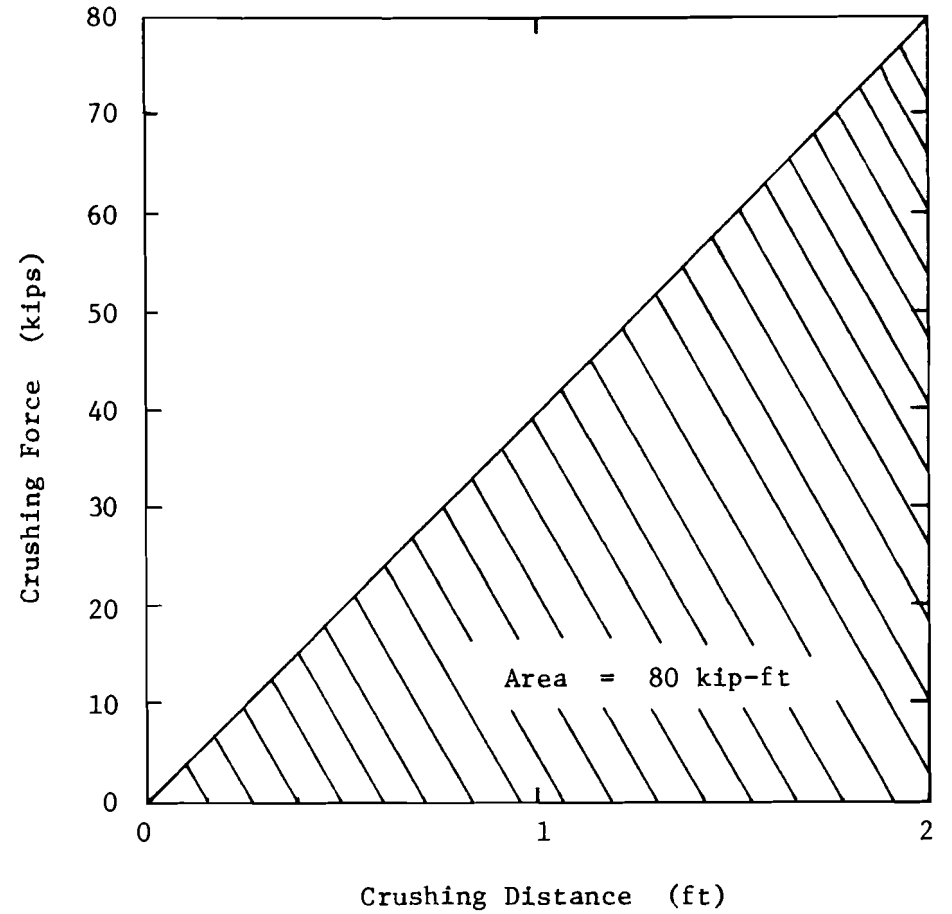
FIGURE 7

The total energy expended in crushing the vehicle front end under these assumptions would be the area under the force versus crushing distance curve which is shown in Figure 7. The area under this curve is:

$$E = \frac{F_m \times d}{2} = \frac{80 \text{ kips} \times 2 \text{ ft}}{2} = 80 \text{ kip-ft.}$$

ESTIMATED ENERGY EXPENDED  
IN CRUSHING OF VEHICLE FRONT

Therefore, during an impact with the first two pipes, it was estimated that the energy lost would be 160 kip-ft.
