1. Report No. FHWA/TX-1995/1243-4	2. Government Accession No.	3. Recipient's Catalog No.	
4. Title and Subtitle  PRELIMINARY STUDIES TO DEVELOP A TRAILER-MOUNTED SYSTEM TO DELINEATE IRREGULARITIES IN RIGID PAVEMENTS		5. Report Date December 1994	6. Performing Organization Code

**PRELIMINARY STUDIES TO DEVELOP A TRAILER-MOUNTED SYSTEM TO  
DELINEATE IRREGULARITIES IN RIGID PAVEMENTS**

**Research Report 1243-4**

Research Project 0-1243  
Automated Equipment for Characterizing the  
Properties and Thicknesses of Pavements

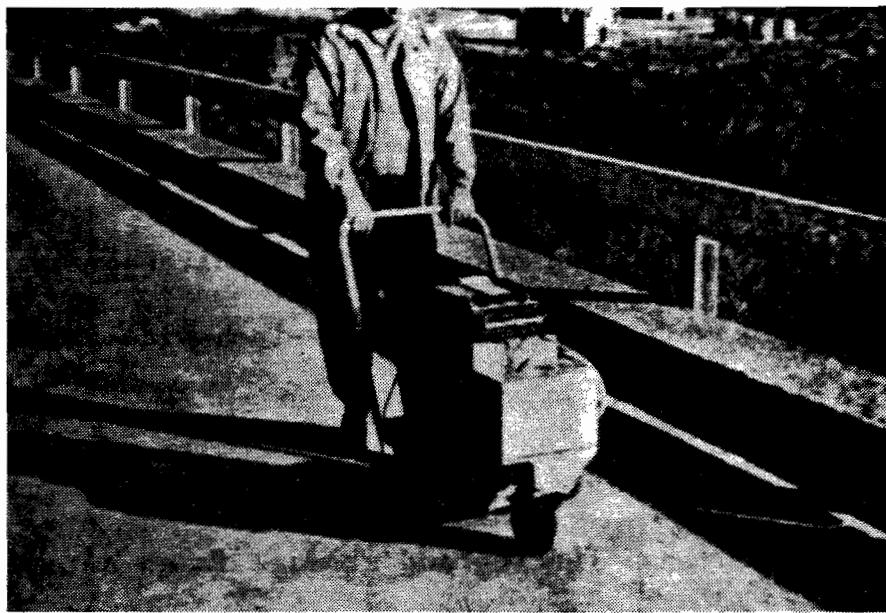
A: DelamTECT in Operation

Automatic sonic methods alleviate a majority of the problems associated with manual methods. The most reported automatic sonic delamination detection technique is DelamTECT. Developed at Texas A&M University and shown in Figure 2.4, DelamTECT is a three wheel push cart which contains a detection unit, a signal processing unit, and recording instrumentation (Joyce, 1985, and Hagen, 1984). DelamTECT introduces a signal into the pavement and then evaluates the acoustic response to detect delaminations. The tapping device (source) operates at 60 Hz. To enhance the ability to detect delaminations, a bandpass filter restricts the received frequencies to between 300 and 1200 Hz. In addition, the signal is gated, thereby receiving only the first 3 milliseconds of the

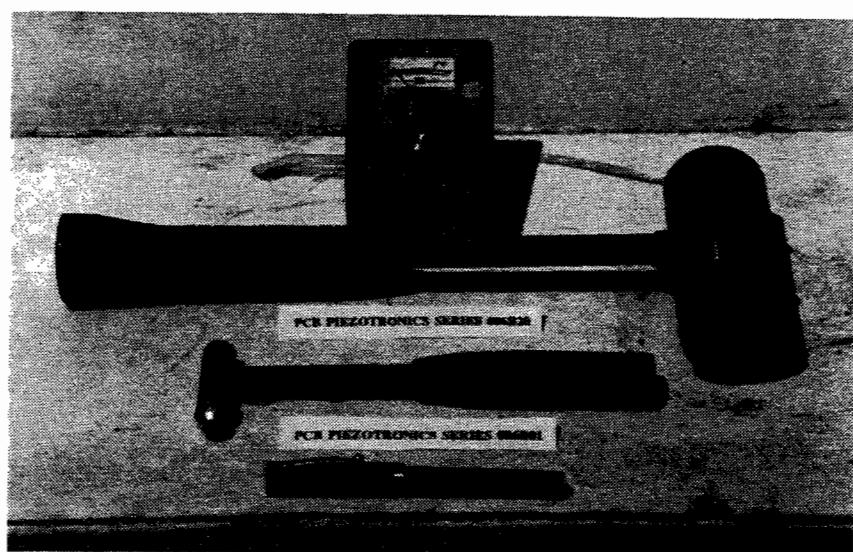
Figure 3.4: PCB Piezotronics Modally Tuned Impact Hammers

Impulsive sources generate a burst of energy over a wide range of frequencies. Generally, neither the exact frequency range nor the amplitude are controllable. A typical impulsive source is an instrumented hammer. Since not consistent with the design concept, an impulsive source was only used to simulate other methods of pavement analysis, such as the impact-echo method (Sansalone and Carino, 1989), as discussed in Chapter 2. The impulsive sources used at the University of Texas at Austin for this research were PCB Piezotronics Series 086B01 and 086B20 Modally Tuned Impact Hammers. These hammers, shown in Figure 3.4, are powered by PCB Piezotronics Model 480D06 Power Unit/Signal Amplifiers.

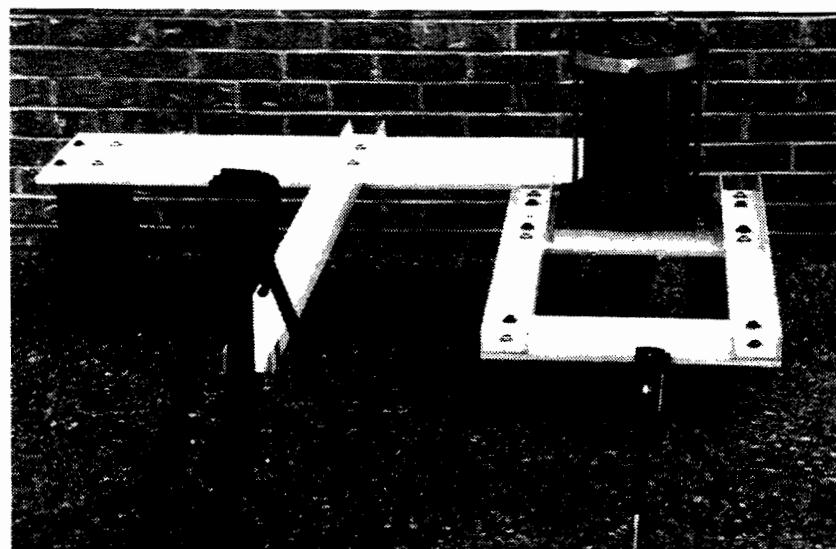
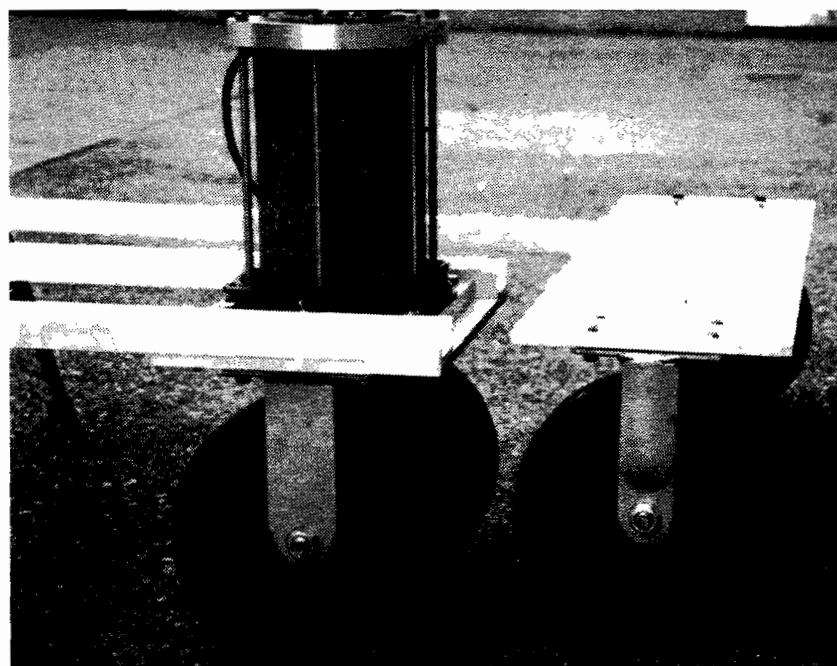
Figure 3.12: Prototype 1

A. Overall View

B. Detail of "Source Wheel" and "Receiver Wheel"

The first attempt at a prototype is shown in Figure 3.12. Solid rigid casters were chosen for both the "source wheel" and the "receiver wheel" to minimize signal loss. Separate trailers were designed for the source and receiver to insure the transmitted signal traveled through the pavement. Both trailers were constructed of aluminum to minimize the weight. The source trailer supported the M.B. Dynamics PM100 Vibration Exciter. The shaker was anchored

Testing was conducted in the basement of the Civil Engineering building, at the University of Texas, on Prototype 1 to assess its signal transmission capabilities. An accelerometer was placed at three locations on the source trailer to evaluate signal loss in the system. The three locations are shown in Figure 3.13 and are labeled A, B, and C. It should be noted that the testing was conducted on a polished concrete floor which, since that time, has been found to be an inaccurate representation of a typical pavement surface. (Signals are transferred to a polished concrete floor much better than to a brushed concrete pavement.) However, for the preliminary laboratory tests, this was considered acceptable.

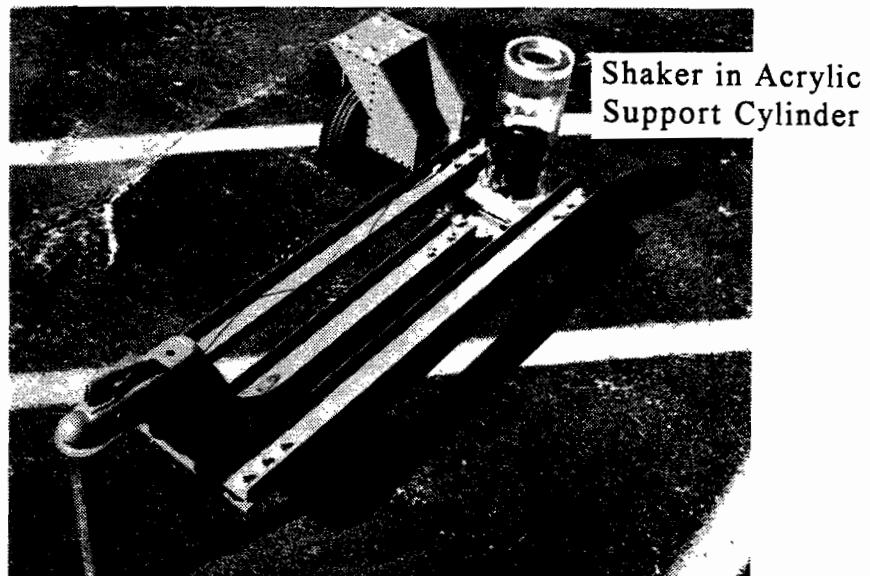
A. Overall View
