# **CONSOLIDATION OF CONCRETE WITH EPOXY-COATED REINFORCEMENT**

Research Report No. 1265-2

*“Structural Integrity of Epoxy-Coated Bars”*

**April 1997**

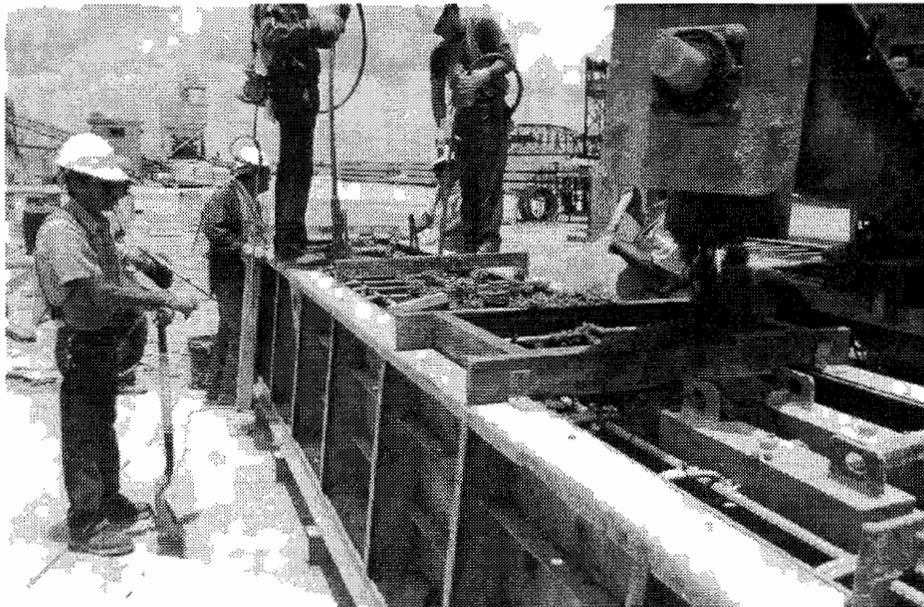
(a) Precast element reinforced with epoxy-coated steel

(b) Vibration of concrete in precast element

*Figure 1.2 Concrete placement procedure in precast pier cap*

Concrete placement is the last possible procedure during which the coating on reinforcement will be damaged before the rebar is put into service. Any damage during concrete placement cannot be seen nor repaired. Figure 1.2 shows the epoxy-coated reinforcing cage of a precast element bounded by metal formwork, and the same element in the midst of the concrete placement procedure.

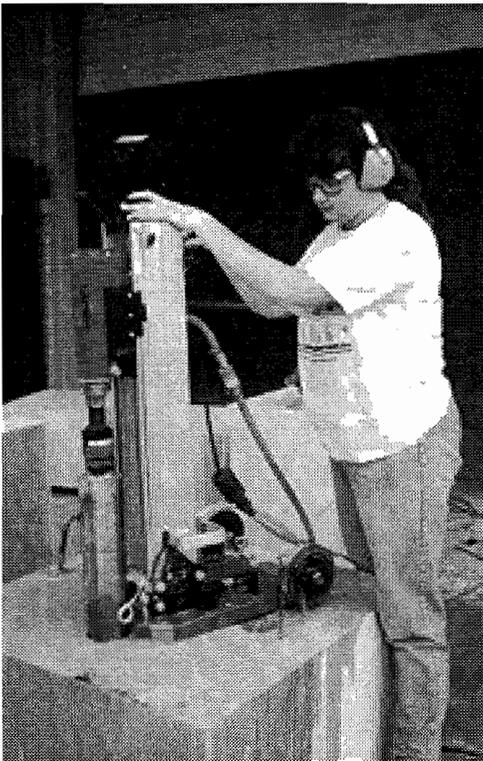
*Figure 4. 13 Coring reinforced concrete test specimen*

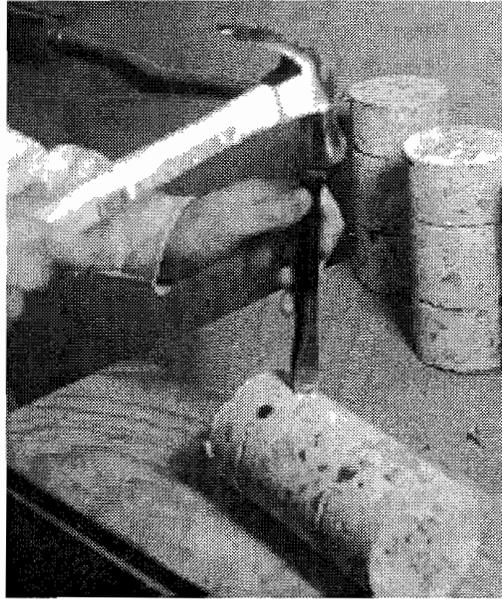
*Figure 4. 17 Splitting cores at level of reinforcement*
