DEVELOPMENT OF PHOTOGRAPHIC TECHNIQUES FOR PERFORMING CONDITION SURVEYS

Research Report Number 177-10

Development and Implementation of the Design, Construction,
and Rehabilitation of Rigid Pavements

Research Project 3-8-75-177

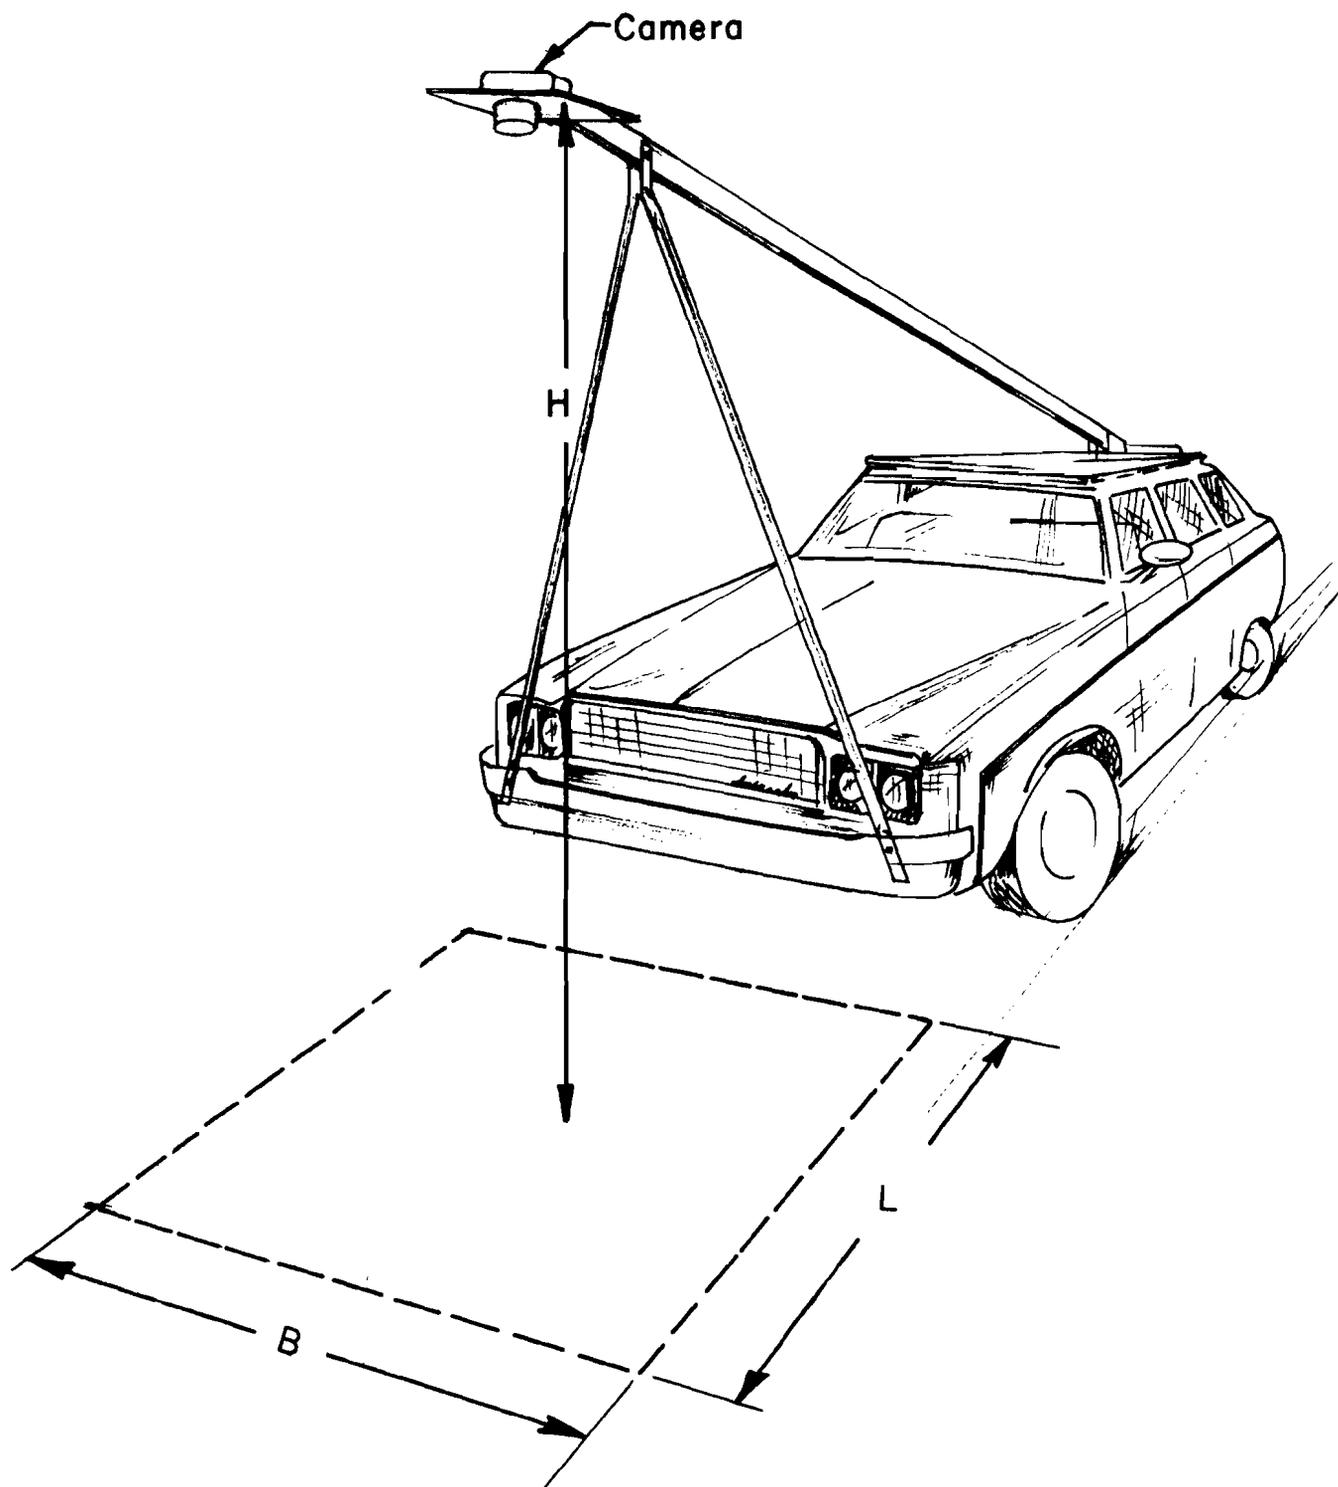
Fig 3.1. Relative position of camera on vehicle.

Equipment Characteristics. The speed of the vehicle as well as the restriction on clarity of pictures from which to survey transverse cracking and minor spalling immediately precipitated an important requirement, namely, that there be no or very little blur. This requires high speed equipment which has a shutter speed of 1/2000 second. Shutter speeds as high as 1/2000 second require relatively large lens openings, which is not a disadvantage if the range in field length is not critical. Thus, by mounting the camera on a boom hanging in front of the vehicle, so that a line through the camera lens is perpendicular to the road surface, a birds-eye view of the distress can be obtained on film. Figure 3.1 illustrates this concept.

The positioning of the camera as shown in Fig 3.1 has an additional advantage: it is possible to scale distances on the resulting picture, which facilitates the determination of sizes of structural failures as well as crack spacing. A further advantage is that depth of focus is not important since the plane of focus is the plane of the road surface.

The positioning of the camera as shown in Fig 3.1 implies that pictures can be taken at a frequency equal to the time it takes the camera, or vehicle, to travel a distance L . The different combinations of the height of the camera H , the length of L , and the width of the pavement B being photographed are summarized in Table 3.1 for different lenses. The values are approximations since lenses with the same focal may have different angles of acceptance.

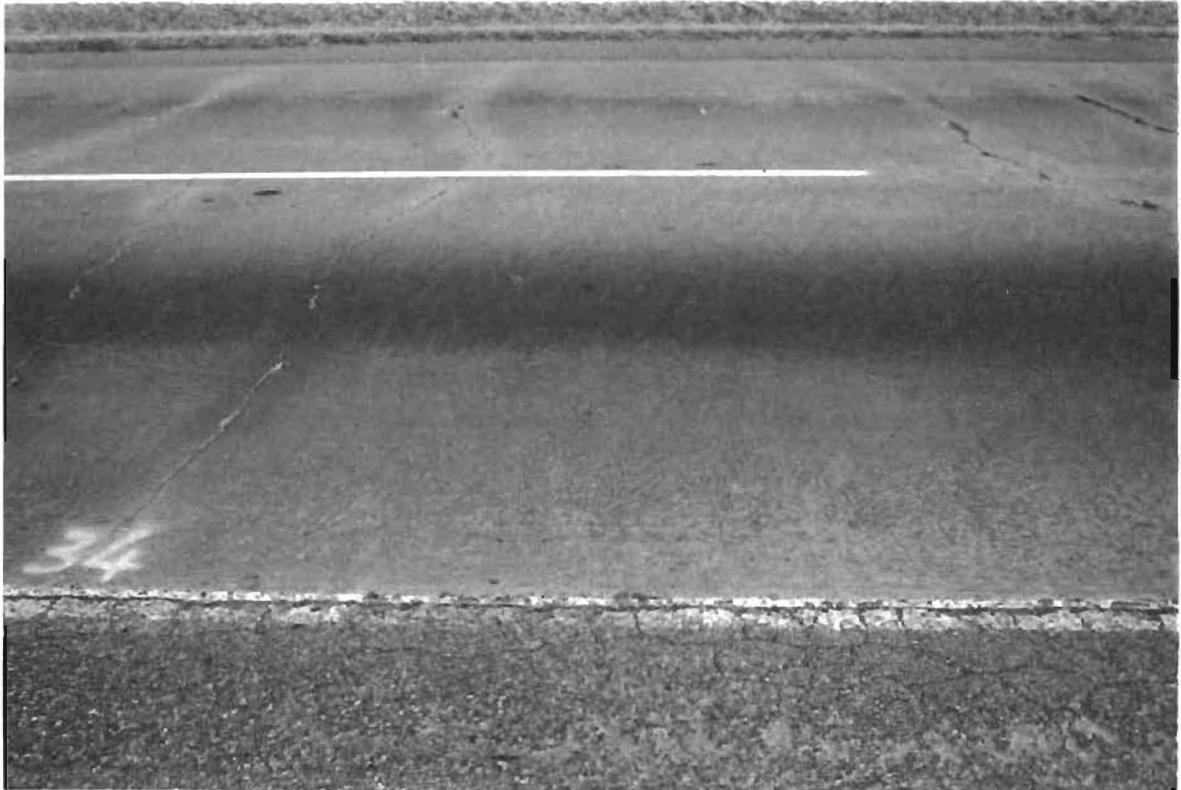
Fig 3.2. View from the shoulder
(Project 21 Survey).

Results from this study are depicted in Figs 3.2 through 3.5, where the subtitles explain the conditions during photographing. Figure 3.2 depicts an edge view or a view as seen from a vehicle travelling on the shoulder simulating the Project 21 survey technique. Figure 3.3 was taken at 10

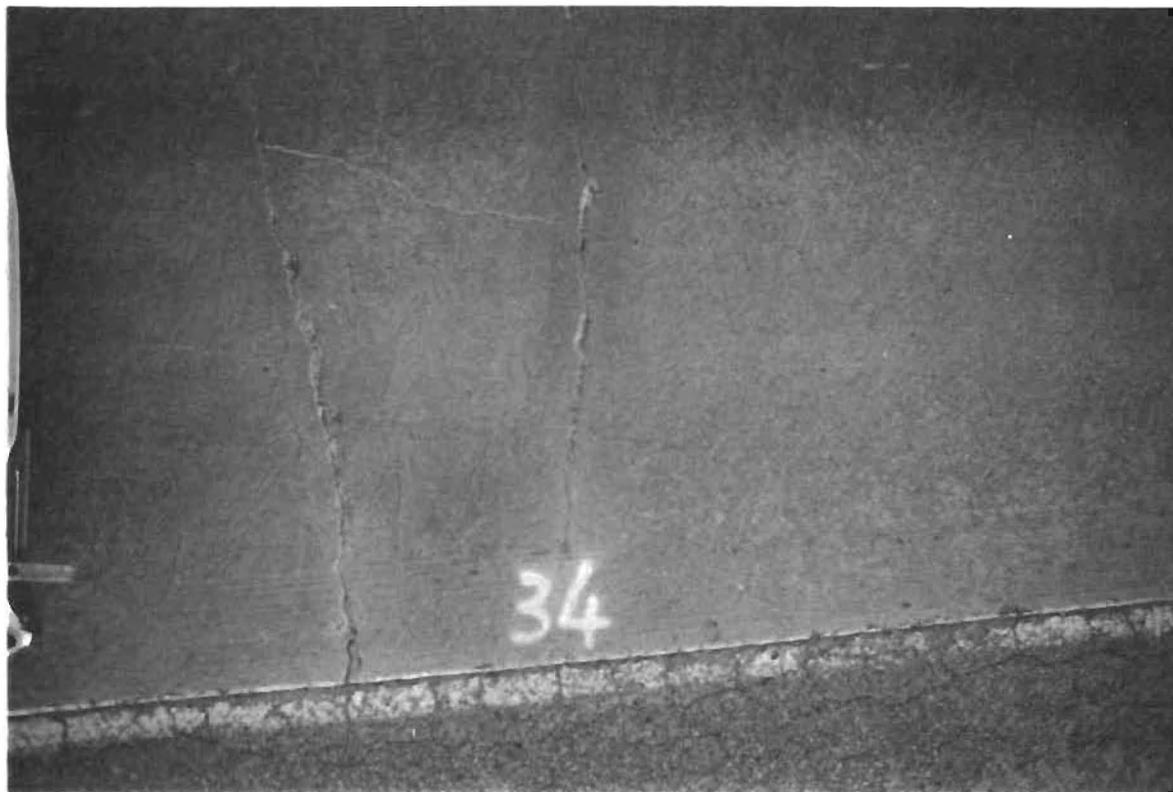
Fig 3.3. Picture taken from boom as shown in Fig 3.1
- 24-mm lens, 10 mph(16 km/h).

miles per hour (16 km/h) with a 24-mm lens and a 3.5 aperture at a 1/1000-second shutter speed using a 400 ASA film from 8 feet (2.4 m) above the pavement. The time was late afternoon with no cloud cover.

In conclusion, it can be said that a moving photographic record of distress is possible. No sacrifice is made in the quality of the survey, as can be seen from the pictures shown. The distress in the picture, minor spalling and the initiation of minor punchouts, is some of the most important, but also the most difficult, distress to recognize. Photographic survey seems to pass the test in this respect.

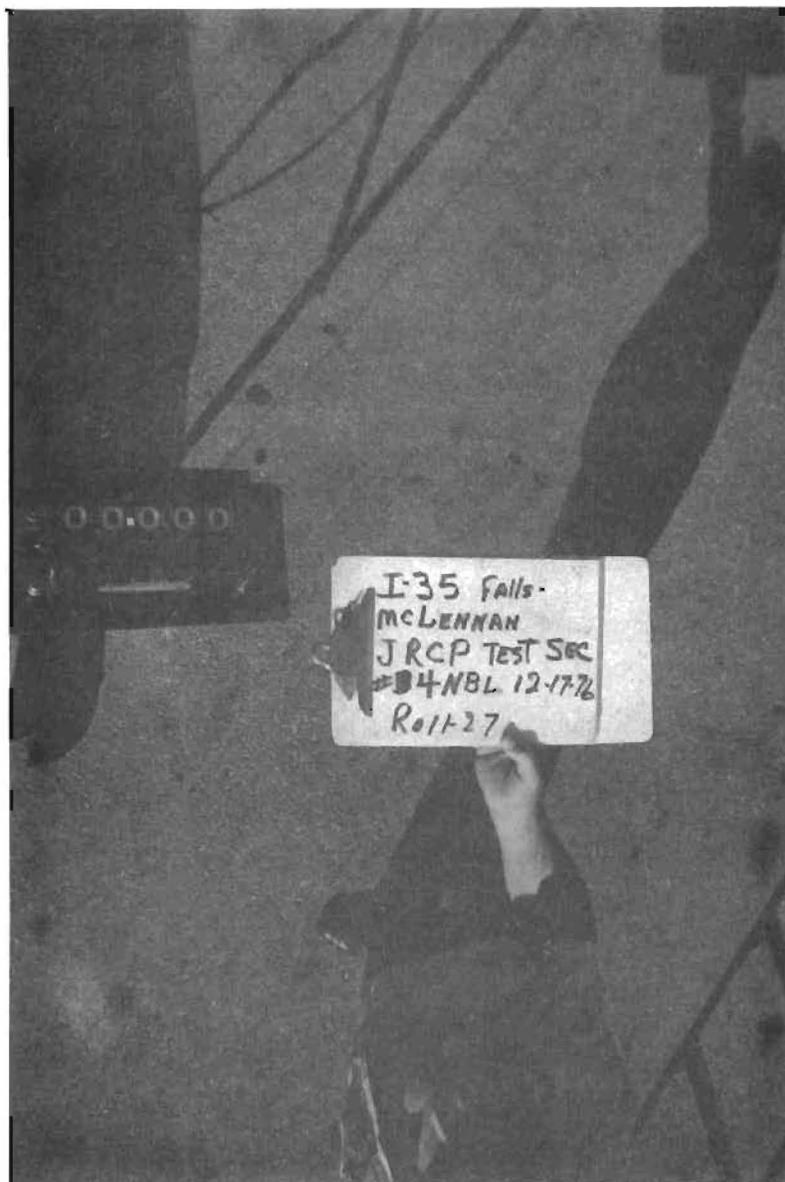
Fig 3.6. Photograph of pad showing descriptive features of the project.

One of the most important aspects of any photo-logging method is a technique for sequencing pictures and also identifying the exact location on the project. This was accomplished by two techniques. For a project, an initial photograph of a pad, is taken as shown in Fig 3.6. This shows the essential descriptive features of the project, such as project number, limits, lane direction, and lane being photographed. For individual pictures in the given project, the record is tied to the milepost. A digital mechanical

reader was mounted on the camera frame at approximately three feet from the camera. In this manner, a digital readout is picked up in each individual photograph. This is also illustrated in Fig 3.6. The left side of the photograph shows the digital readout. Thus, by setting the milepoint for the start of the project in the digital readout and tying it to the speedometer, every photograph has a record of milepoint recorded to the nearest .001 of a mile. Also, by this simple addition a permanent record of the location and a sequence for the photographs are achieved.
