A minerals research contract report
November 1980

POST-CONSTRUCTION EVALUATION
OF A
SAND-ASPHALT-SULFUR TEST SECTION
US 77, KENEDY COUNTY, TEXAS

14. Sponsoring Agency Code	
16. Abstract The results of a 3-year post construction, evaluation of a Sand-Asphalt-Sulfur (SAS) experimental test section placed on US 77 in Kenedy County, Texas is presented. Results of laboratory tests on cored samples along with dynaflect deflection, Mays Meter rideability and visual inspections are discussed. Laboratory tests include: bulk density and specific gravity, resilient modulus, Marshall stability and flow, Hveem stability and splitting tensile strength. In general, the in-service performance of the SAS pavement has been excellent and at the time of the preparation of this report no serious incipient distress patterns have been revealed.

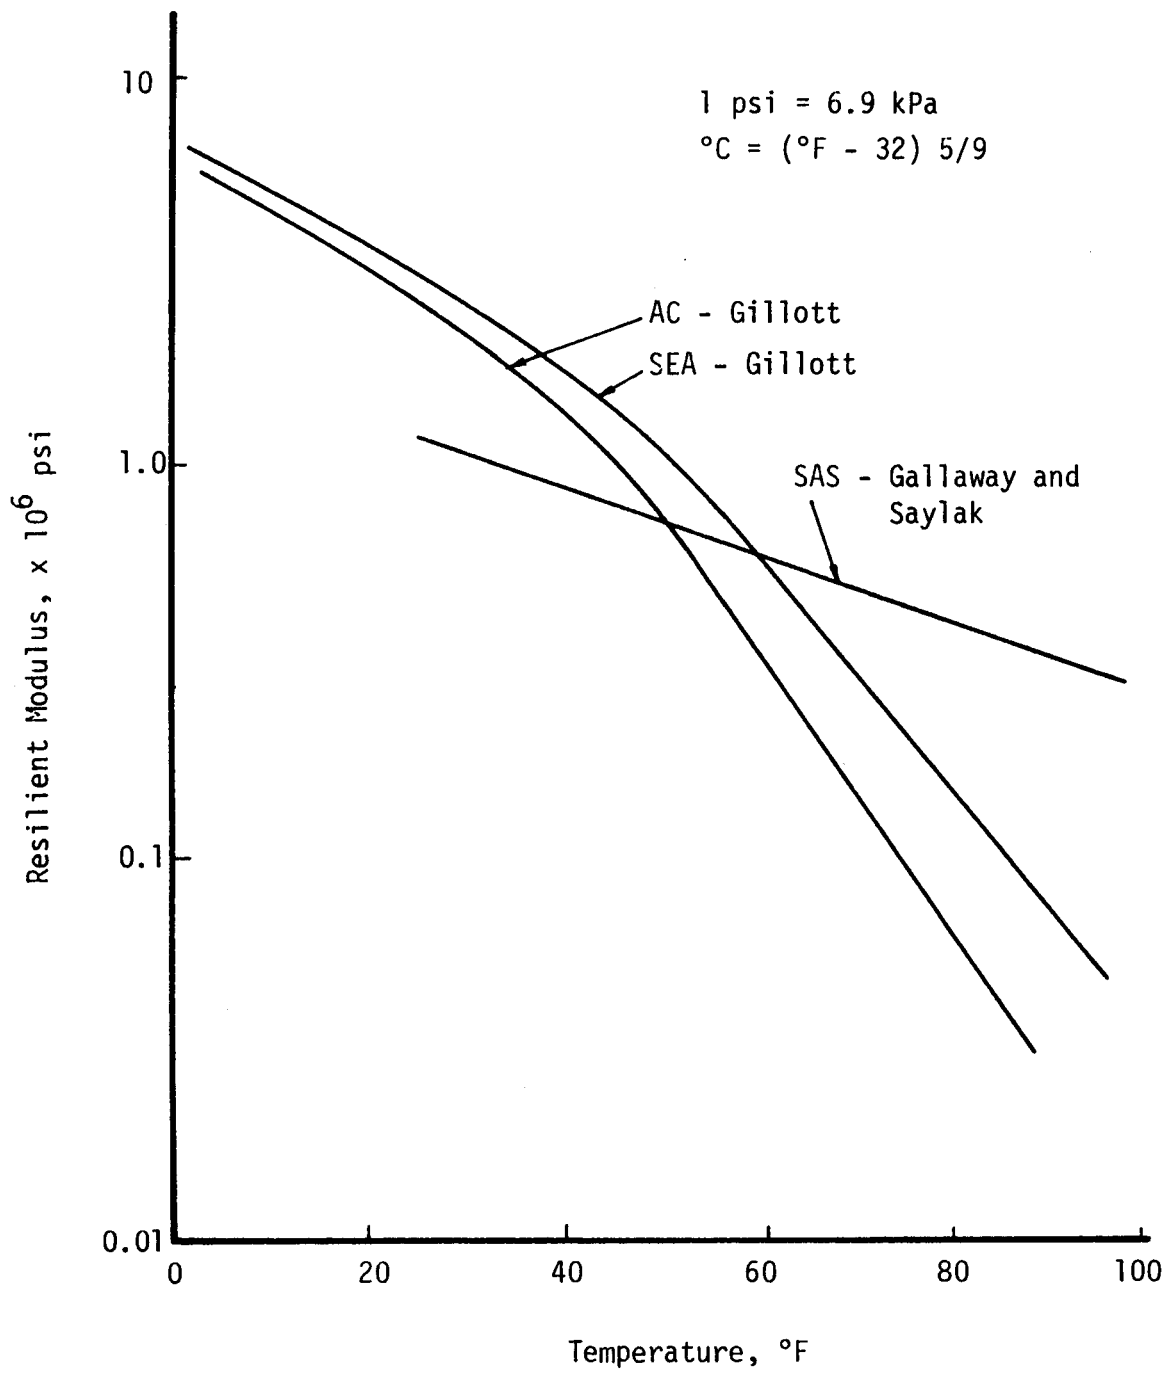
Figure 8. Resilient Modulus versus Temperature

Since the temperature dependency of sulfur-asphalt materials is somewhat different than that of conventional asphaltic concrete, a modified approach to temperature correction was needed. This modification was effected by first plotting the curve of resilient modulus versus temperature for SEA, SAS, and asphaltic concrete (Figure 8). These curves give an indication of the stiffness of the materials at different temperatures. From Figures 7 and 8, a curve was made of resilient modulus versus Dynaflect correction factor for conventional asphaltic concrete (Figure 9). To use the modified approach, the pavement temperature is entered on the temperature axis on Figure 8, a line is projected to the curve of the pavement material being evaluated, and a horizontal line is extended to the resilient modulus axis. Next the resilient modulus is

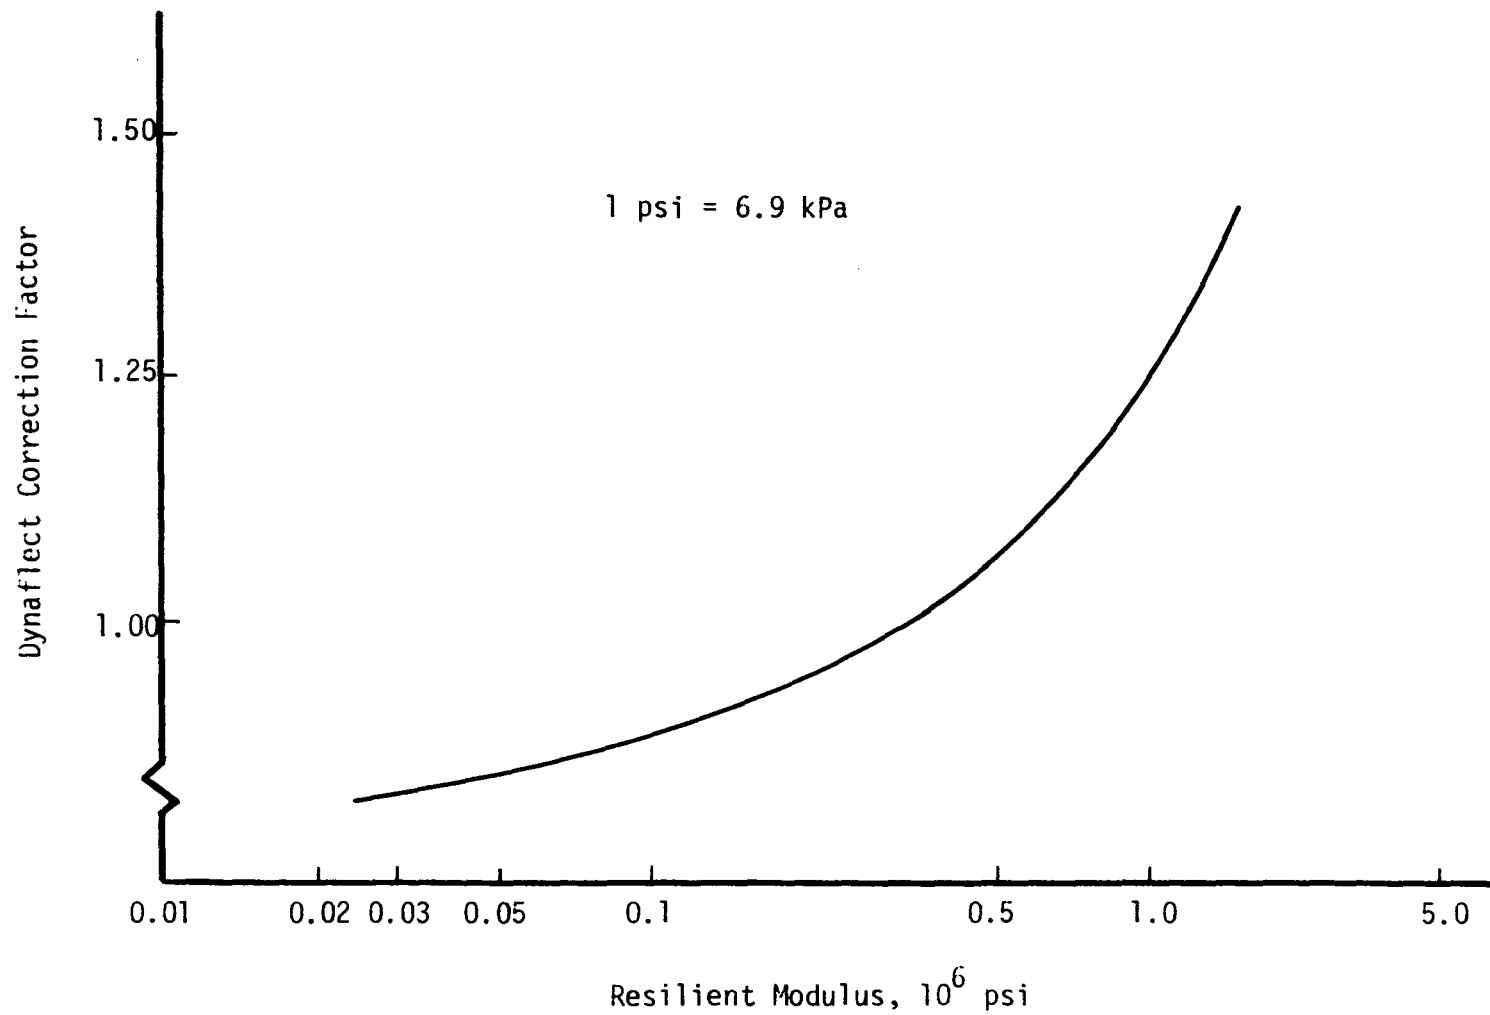
Figure 9. Dynaflect Correction Factor versus Resilient Modulus,

entered on the proper axis of Figure 9 and a line is extended to the curve. From this point a line is projected to the proper Dynaflect correction factor for the particular material.

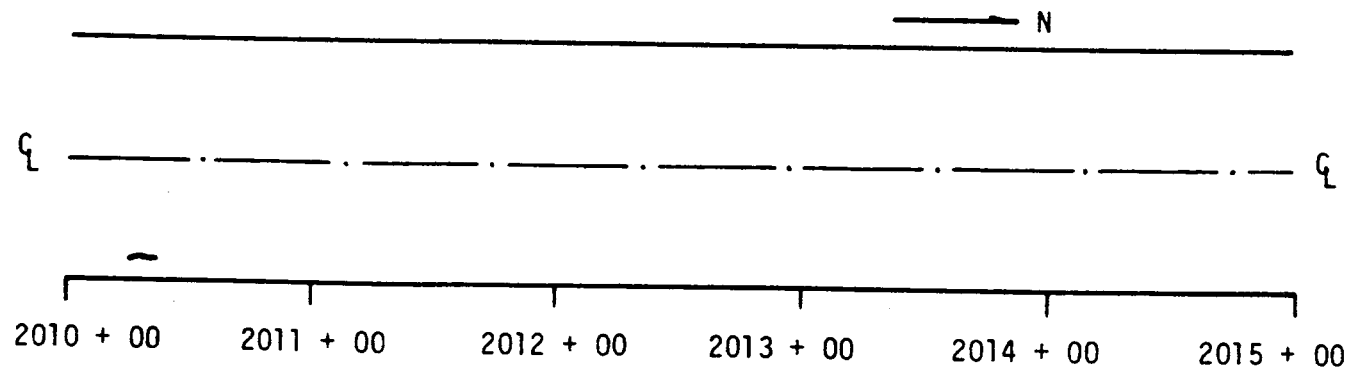
Figures 17 through 22 show the results of cracking surveys conducted on the subsections after the application of the chip seal in June, 1979. Of the cracking that has taken place in the 7 in (17.8 cm)

and 4 in (10.2 cm) SAS test subsections, sample corings taken from these cracks have shown that the cracking has occurred only in the surface course. They are not reflection cracks from the base course material. Figure 23 shows this cracking in the surface course of the core sample taken in the 7 in (17.8 cm) SAS section.

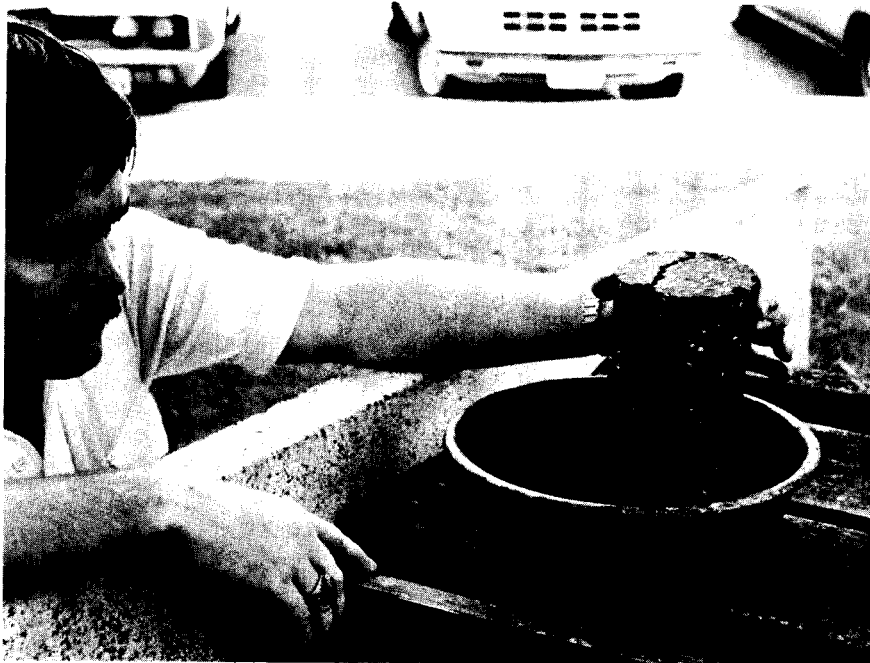
Figure 23. Photograph of core taken from cracked area of 7 in. (17.8 cm) SAS section. Crack stops at SAS base material.
