1. Report No.		2. Government Accession No.		3. Recipient's Catalog No.	
4. Title and Subtitle Investigation of Corrosion Protection Systems for Bridge Stay Cables				5. Report Date November 1995

**INVESTIGATION OF CORROSION PROTECTION SYSTEMS
FOR BRIDGE STAY CABLES**

Research Report No. 1264-3F

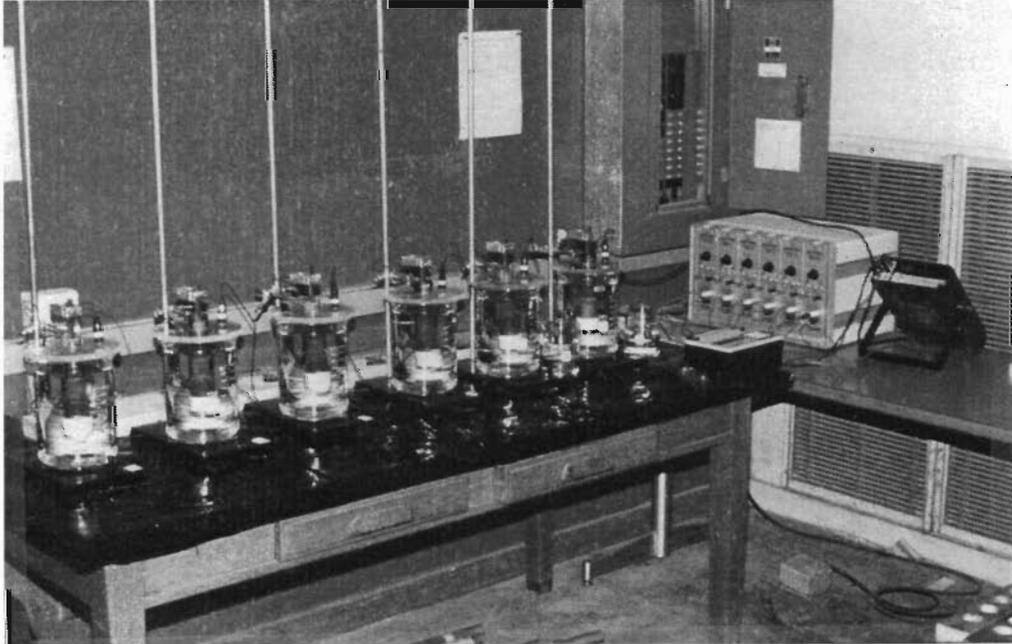
Figure 6-1 Modified accelerated corrosion test method setup

Because of several perceived problems in applying the original ACTM, in this present study several modifications were made to the specimen configuration and test procedures of the original ACTM in order to improve the ability of the test to evaluate precracked grout. The modified test method will be referred to subsequently as the "Modified ACTM." The overall test setup is shown in Figure 6-1. It should be noted that all tests performed in this series were on precracked specimens.

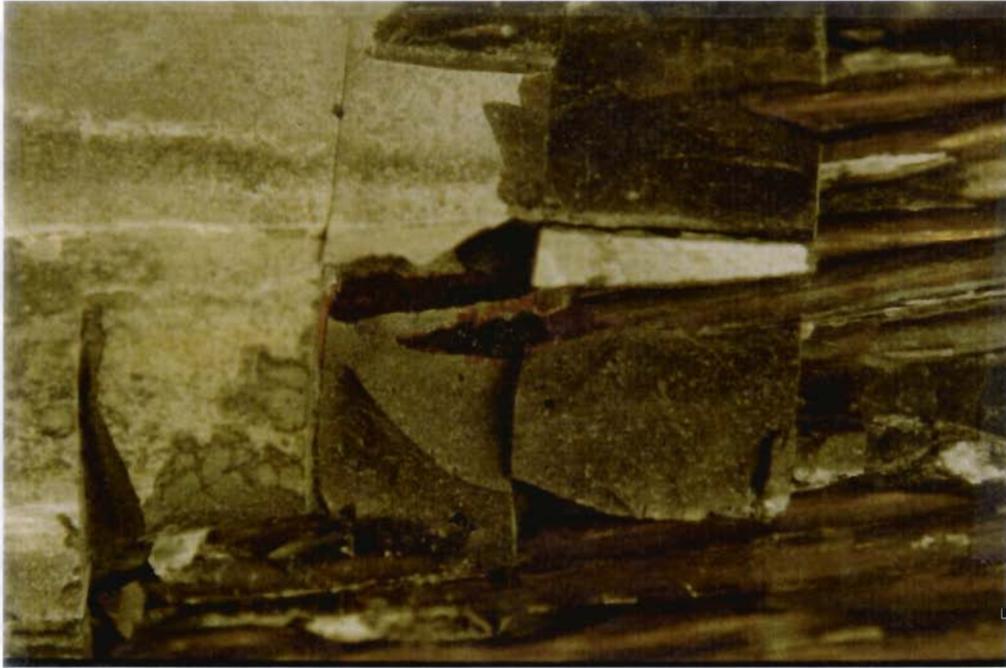
Figure 8-19 Typical corrosion at base of a grout crack

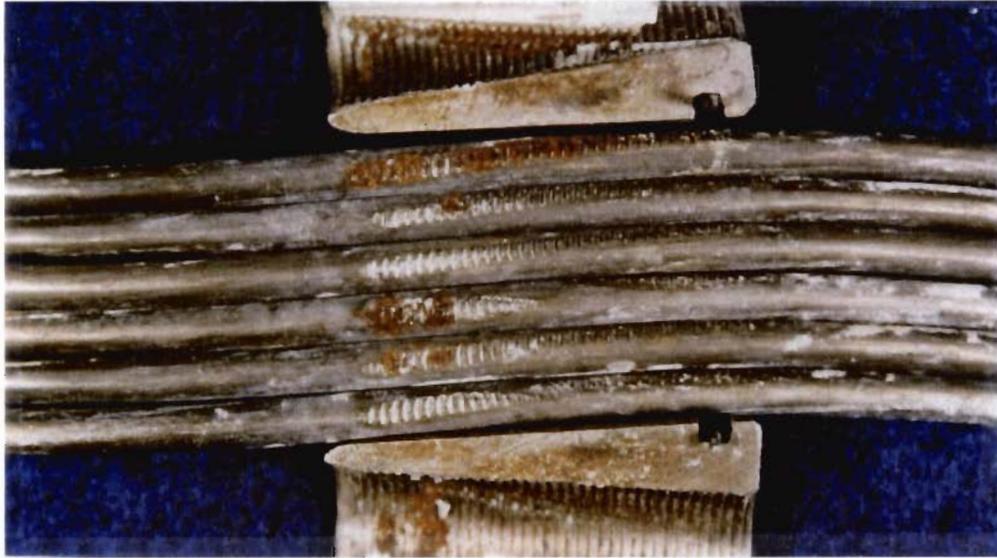
Figure 8- 24 Corrosion at the interface between the strand and wedge

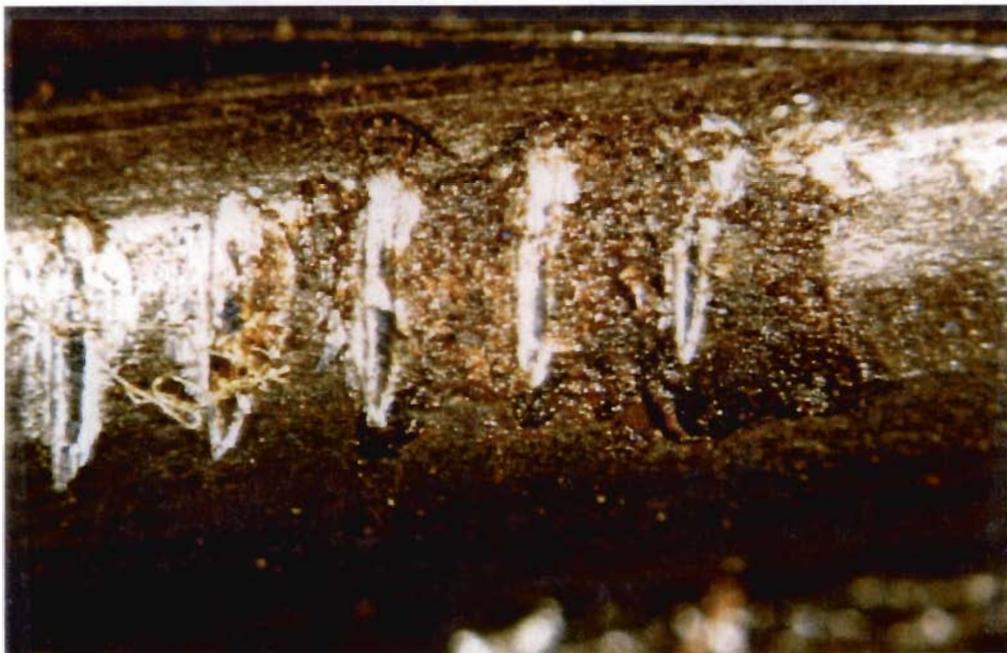
Figure 8- 25 Corrosion between tooth marks on strand

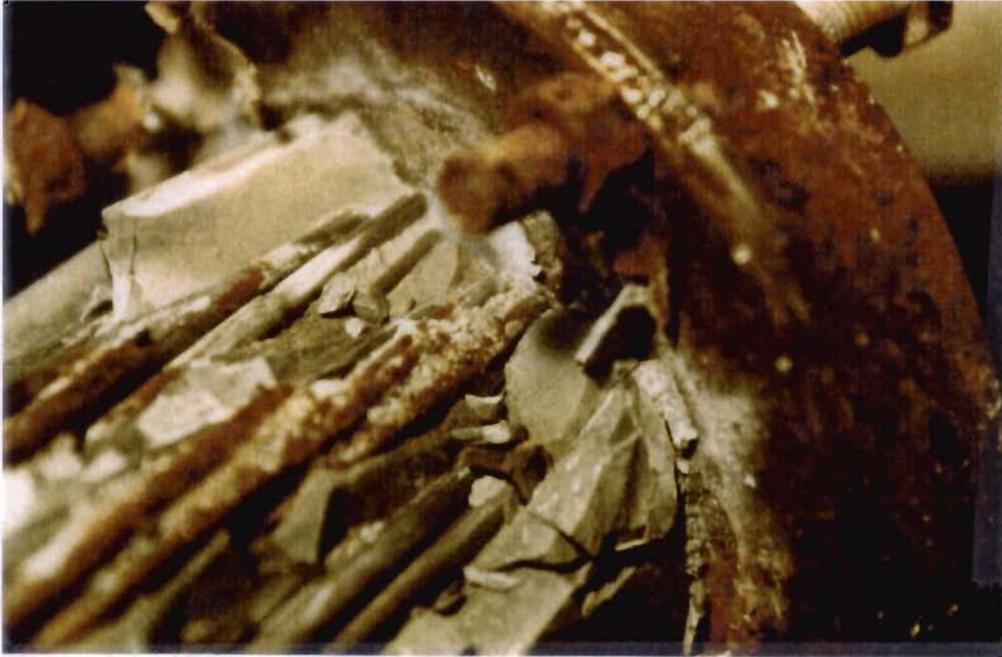
Figure 8- 26 Corrosion of strand adjacent to deviator ring

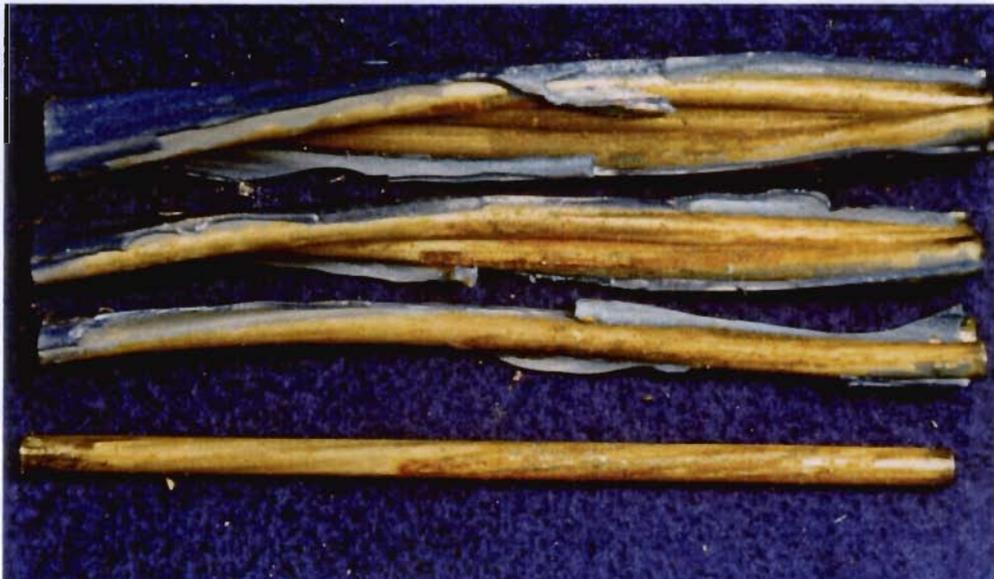
Figure 8- 29 Interstitial corrosion of epoxy-coated strand (not filled)

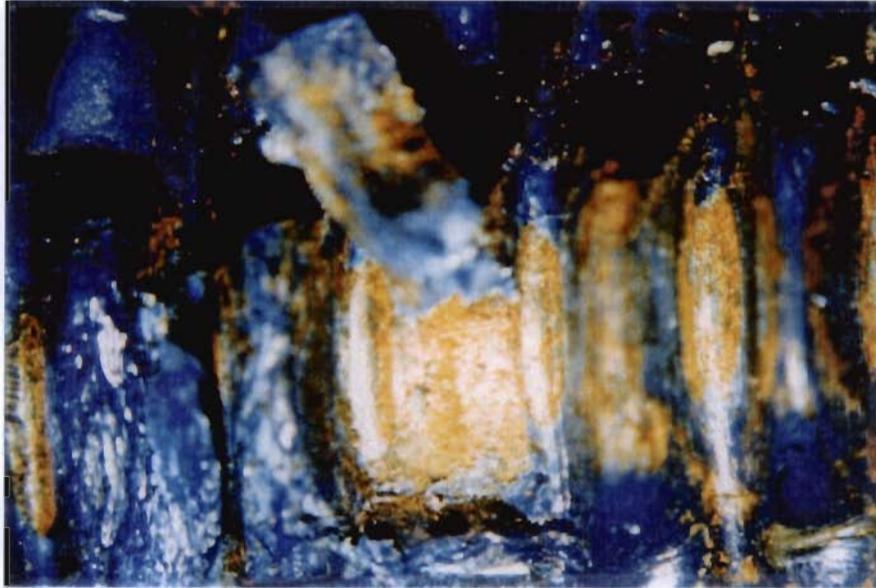
Figure 8- 31 Corrosion under epoxy coating between tooth marks

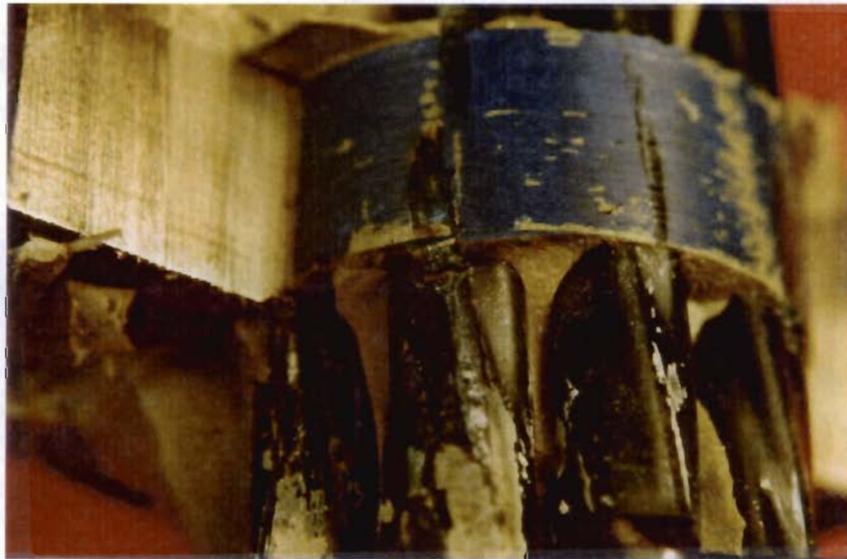
Figure 8- 32 Epoxy coating damaged by contact with deviator ring

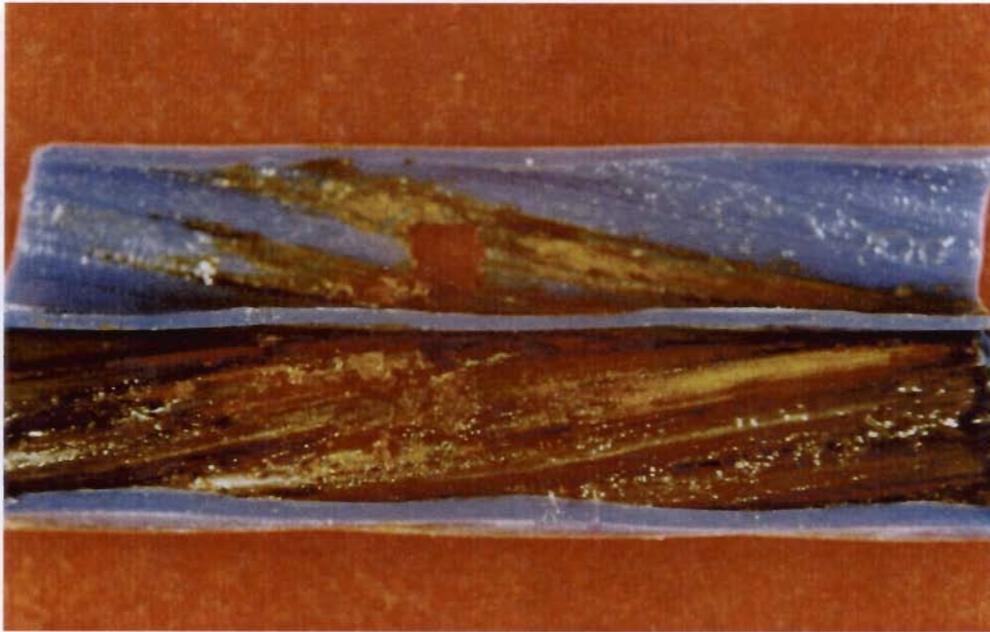
Figure 8- 37 Corrosion under sheathing

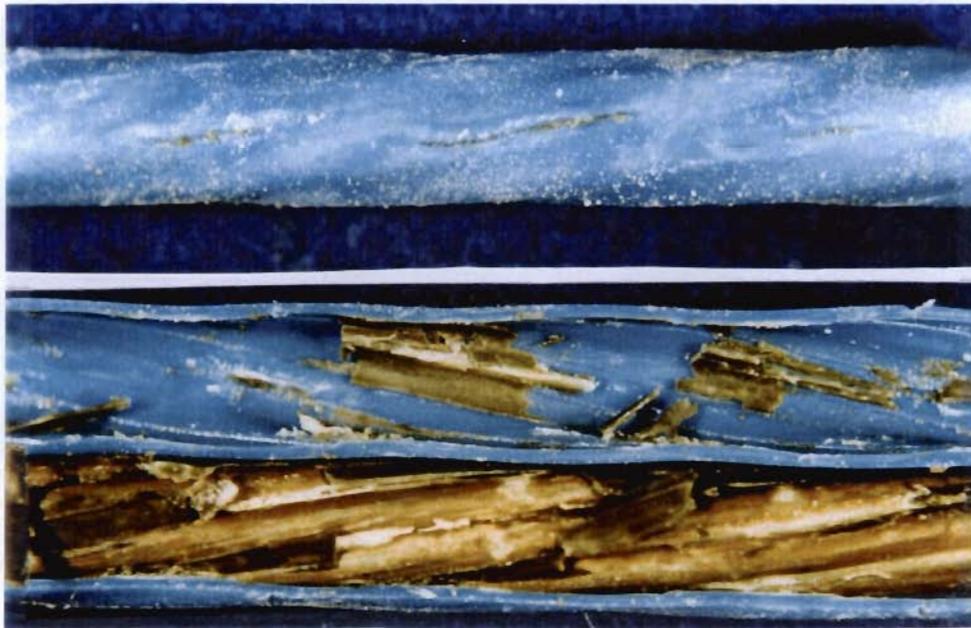
Figure 8- 38 Intrusion of grout into sheathing

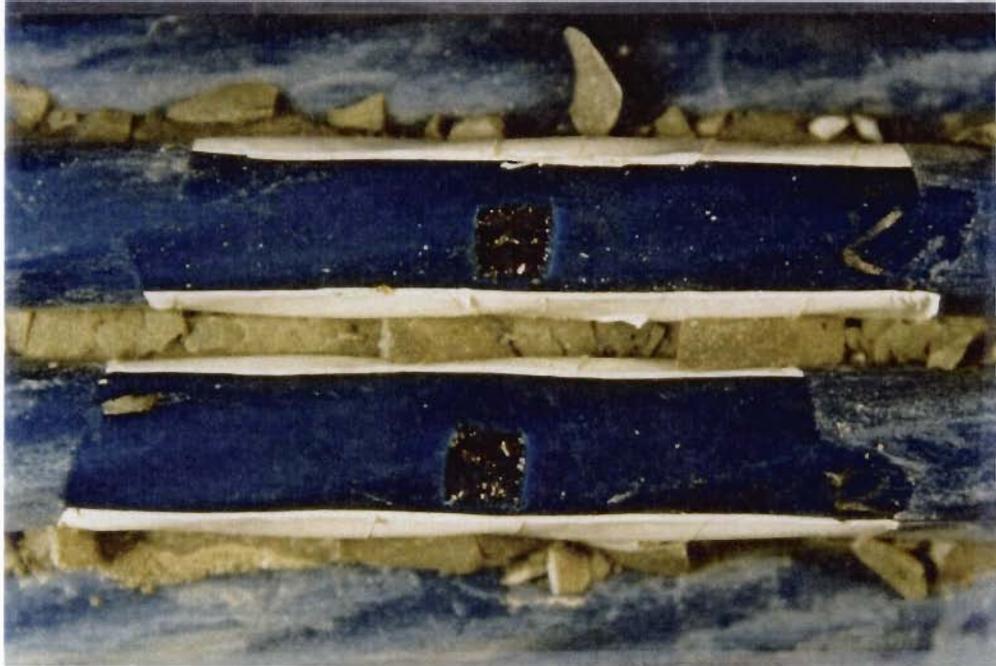
Figure 8- 39 Repaired damage location after completion of corrosion test

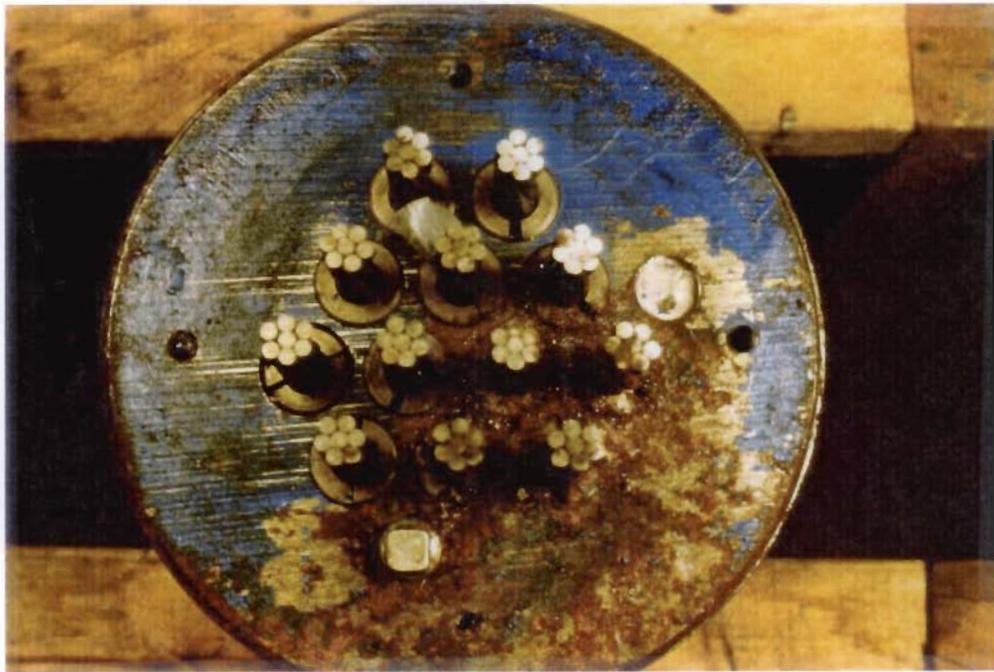
Figure 8-40 Corrosion damage to anchor head on LS-8
