Corrosion Performance of Epoxy-Coated Reinforcement – Summary, Findings, and Guidelines

Research Report No. 1265-S

Research Project 0-1265

STRUCTURAL INTEGRITY OF EPOXY-COATED BARS

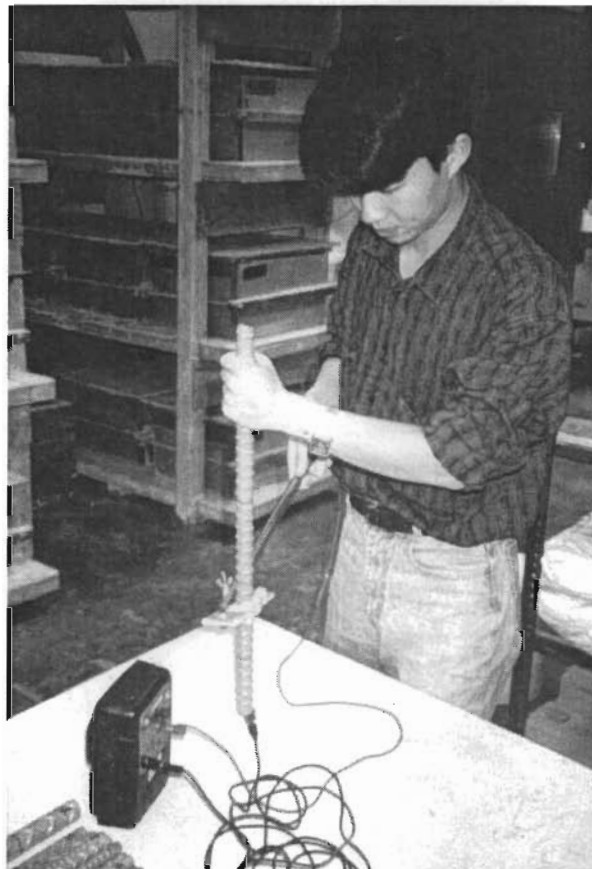
Figure 1.1 Operation of the holiday detector.

The reliability of sponge-type, hand-held holiday detectors was assessed and factors that may influence the results were evaluated. A series of tests on 12 epoxy-coated #4 and #8 bars were performed. Bars had different damage conditions: as-received, pinholes, and hairline cracks. Test variables included degree of moisture in the sponge (wet, squeezed once, and well-squeezed), speed of operation (fast, medium, and slow), and operator (three different operators). Figure 1.1 illustrates the operation of the holiday detector. The holiday detection study is discussed in more detail in Report No. 1265-1²¹ and in Reference 20.

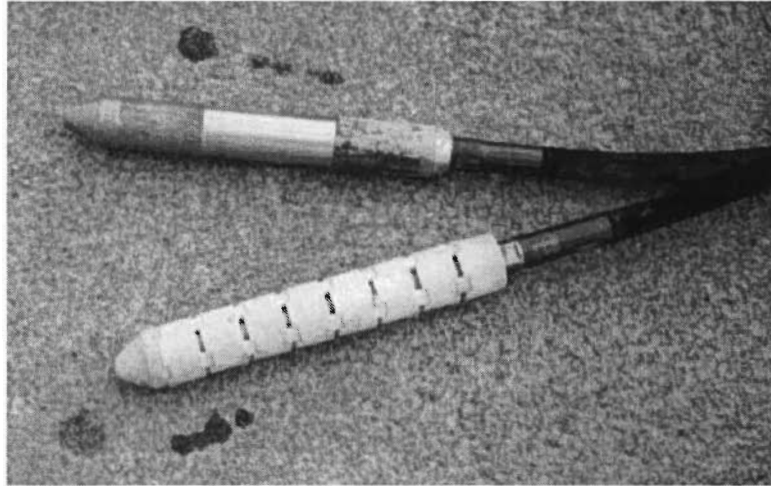
Figure 1.4 Metal (top) and rubber head vibrators.

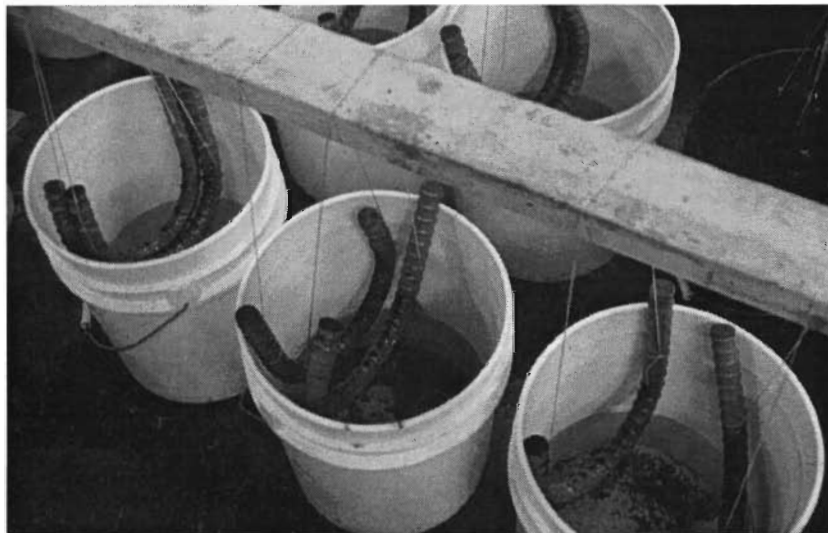
Figure 1.6 Test setup for immersion study.

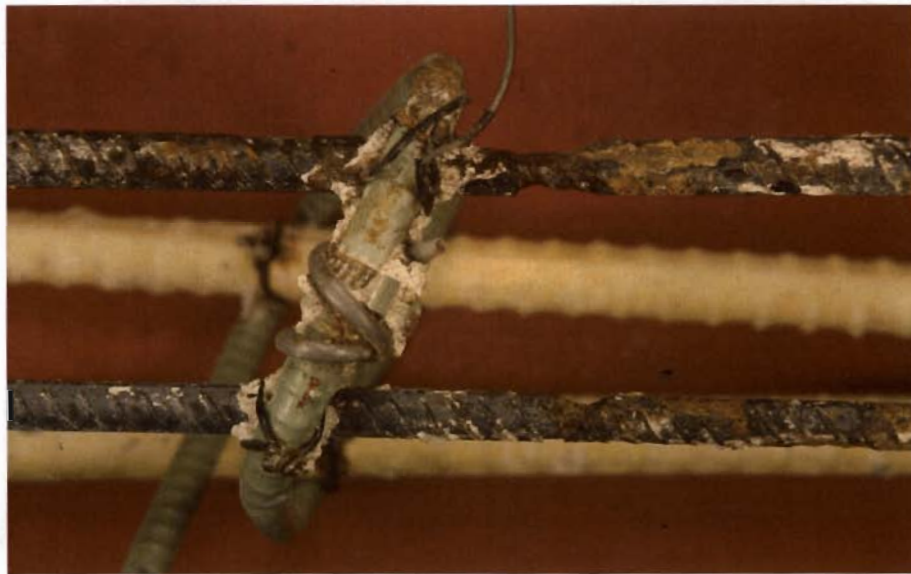
(b) Severe pitting on black bars near coated stirrup (beam B23).

Figure 2.2 Severe pitting and loss of cross section on uncoated bars near crack locations (beam specimens).

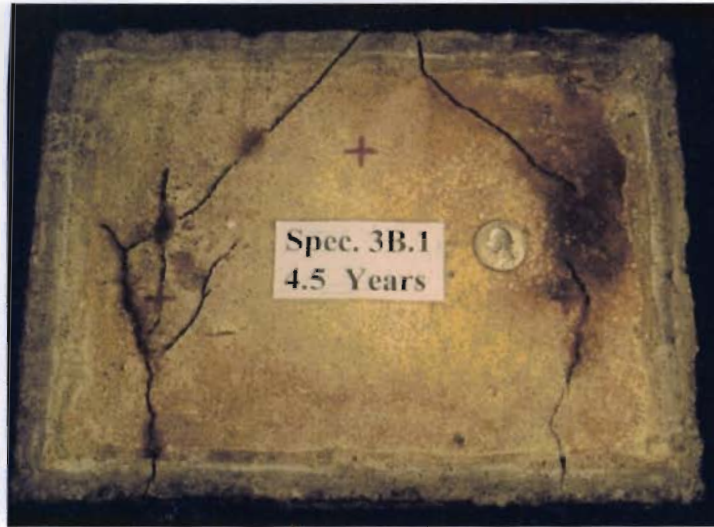
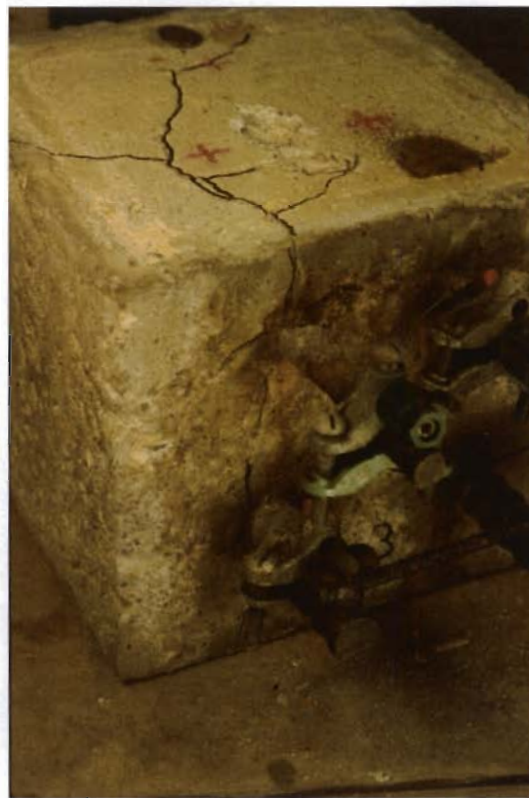
Figure 2.3 Specimen surface condition of specimen with uncoated bar.

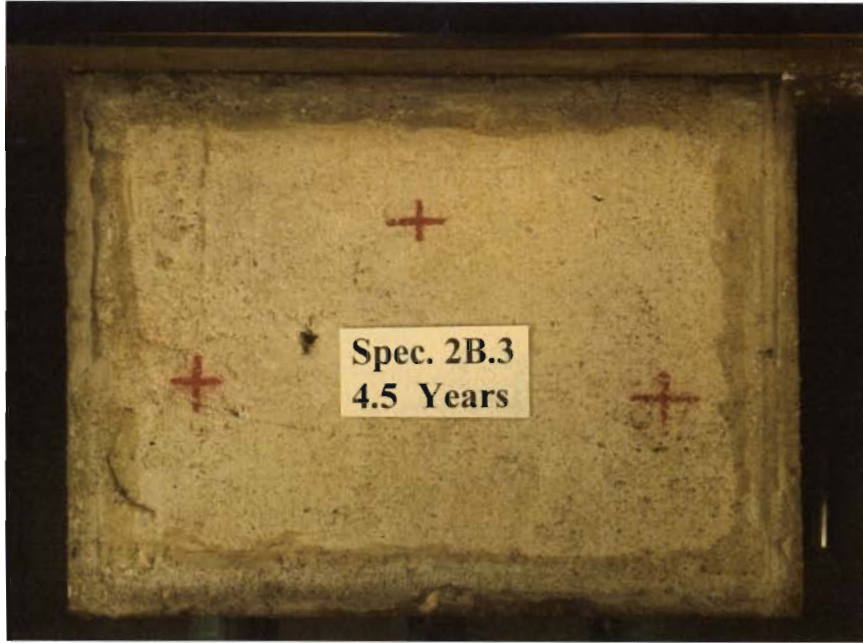
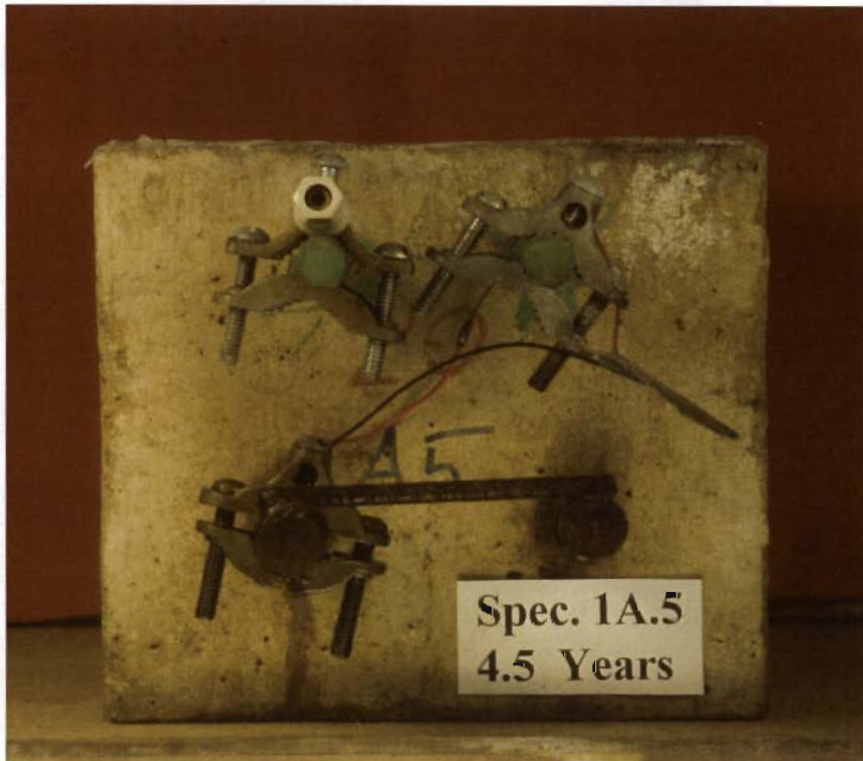
Figure 2.4 Surface condition of specimens with coated bars.

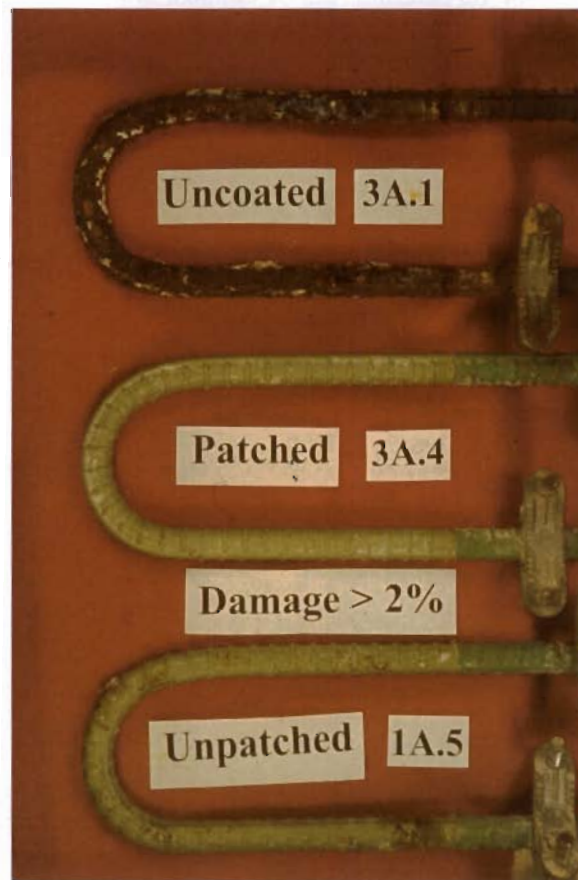
Figure 2.6 Comparative performance of uncoated and coated bars after 4.5 years of exposure (macrocell study).

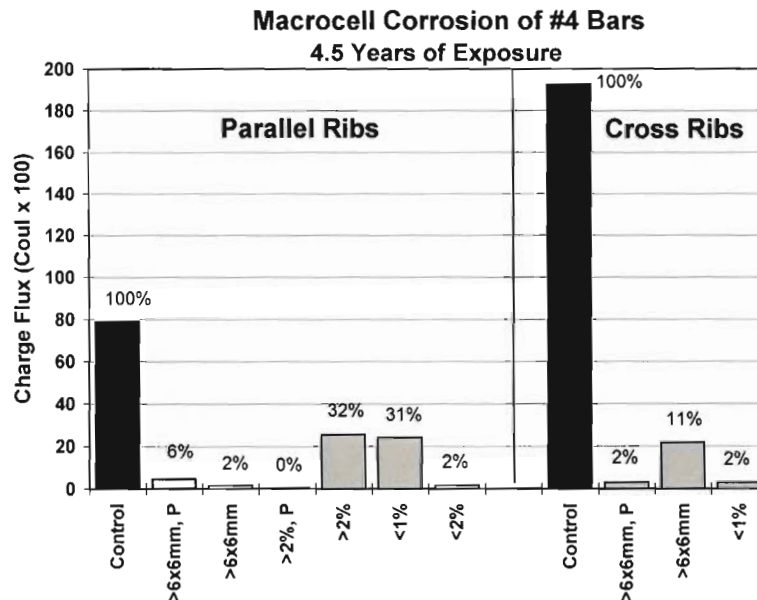
Figure 2.7 Charge flux for all A specimens (#4 bars).

Figures 2.7 and 2.8 show the amount of charge flux that was measured for the macrocell specimens. Three observations can be drawn from the charge flux plots: 1) Coated bars performed better than uncoated bars, 2) the greater the frequency of damage, the higher the amount of corrosion, and 3) patching coating damage reduced, but did not completely prevent corrosion. Bars with damaged spots greater than 2% of the bar surface suffered the worst corrosion among coated bars in macrocell specimens. Bars with damaged spots greater than 6x6 mm experienced similar levels of corrosion. The appearance of bars after autopsy confirmed these trends (Figures 2.9 and 2.10). Measured current versus time for macrocell specimens with varying degrees of damage are illustrated in Figures 2.11 and 2.12. The specimens with damage greater than 2% and the specimen with cracks in the coating less than 1% experienced the highest currents. Interestingly, after initial low currents during the first two years of exposure, the specimens with coating cracks and damage less than 1% experienced increasing current at the end of 4.5 years while other damaged specimens seemed to have reached steady-state behavior. Consequently, a large increase in metal consumption occurred during the last 2.5 years of exposure for specimens with coating cracks, and this increase was reflected in the relatively large amount of charge flux after 4.5 years (Figures 2.7 and 2.8). The presence of cracks in the coating may reduce performance of coated bars in the long term. There was good agreement, in general, between monitored currents and observed corrosion attack.

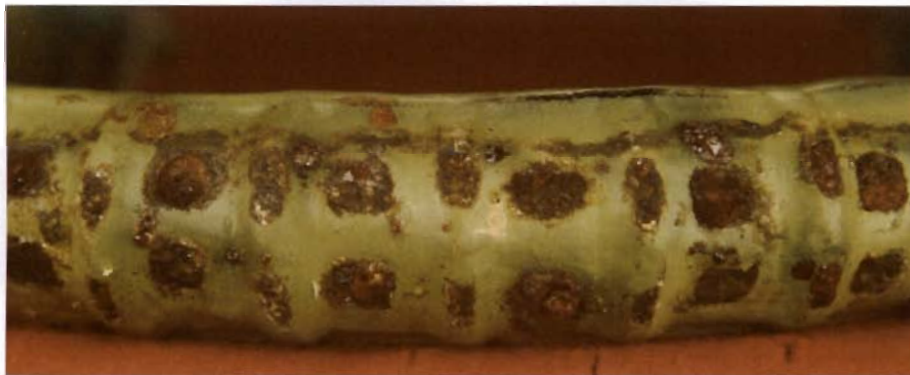
Figure 2.9 Corrosion of damaged areas at outside bend on #8 bar with damaged coating greater than 2%.

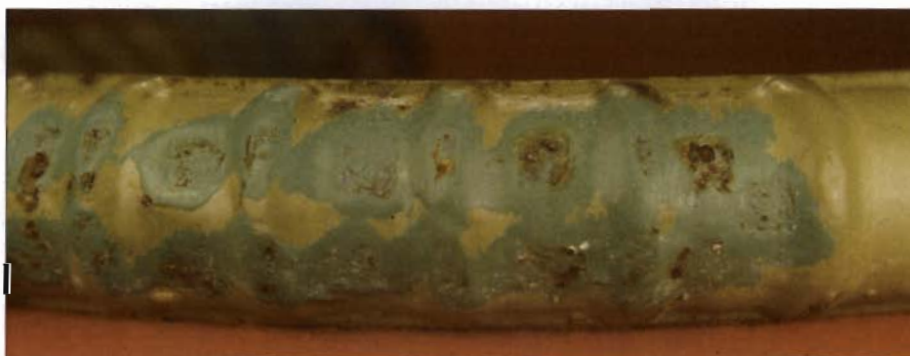
Figure 2.10 Corrosion of patched areas at outside bend on #8 bar with damaged coating greater than 2%.

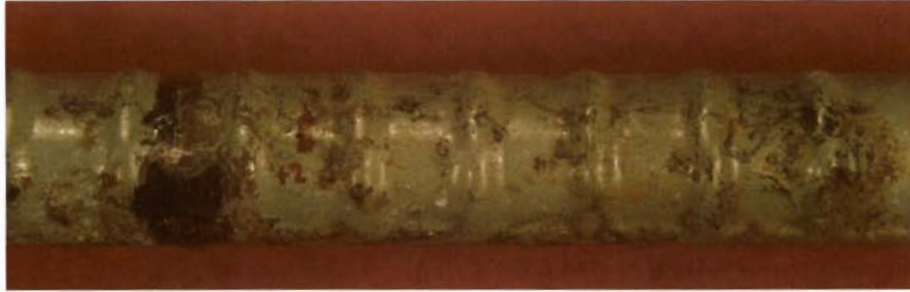
(a) Rust stains at lower bar of beam B10, portion within the wetted zone. Damaged spot at crack location.

(b) Appearance after removing the coating.

Figure 2.14 Corroded portion on coated bar with 3% damaged coating of cracked, unloaded beam B10 after 4.3 years of exposure.

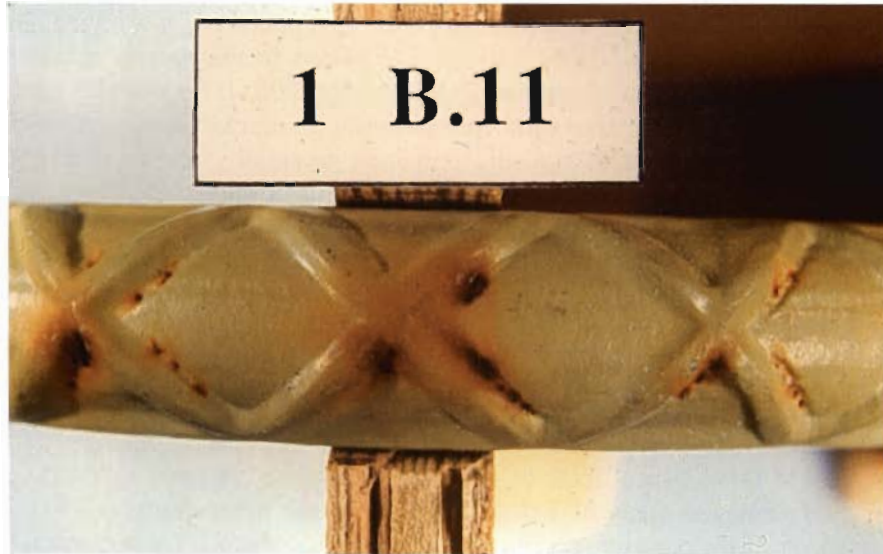
Figure 2.16 Corrosion at holidays not detected before immersion in 3.5% NaCl after about 8 months of exposure.

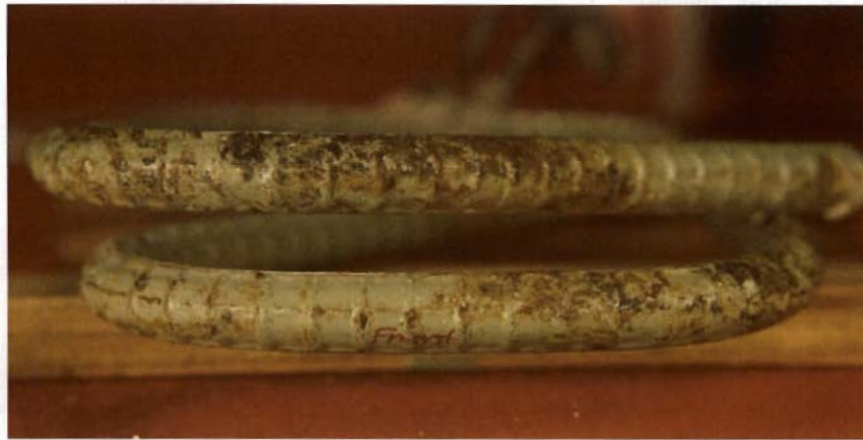
Figure 2.17 Rust staining of stirrup from beam B17.

Chen reported that fabricated bars were more susceptible to corrosion because of the higher incidence of damage introduced during bending.³⁴ In corrosion tests on concrete slabs by Treadaway and Davies, some coating deterioration in the form of underfilm corrosion was observed at ribs on the outside bends of bars. Corrosion was limited to the curved portion of the bar.³³ If the coating at bent areas is damaged, adhesion loss and underfilm corrosion commences at damaged areas and the progression of debonding and corrosion is facilitated by the weak steel-coating interface. The problem is exacerbated by the fact that fabricated bars, such as stirrups or transverse reinforcement, are usually closer to the exterior concrete surfaces. Moreover, in flexural members, coated transverse reinforcement will act as crack inducers, which means that cracks in the plane of the transverse reinforcement will be created. The combinations of all these factors make coated transverse reinforcement particularly vulnerable to corrosion, as was shown in the beam study (Figures 2.17 and 2.18).

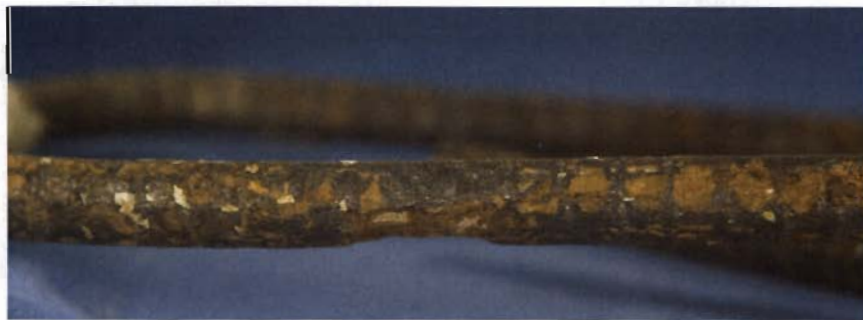
Figure 2.18 Pitting along stirrup leg surface beneath the coating (beam B27).

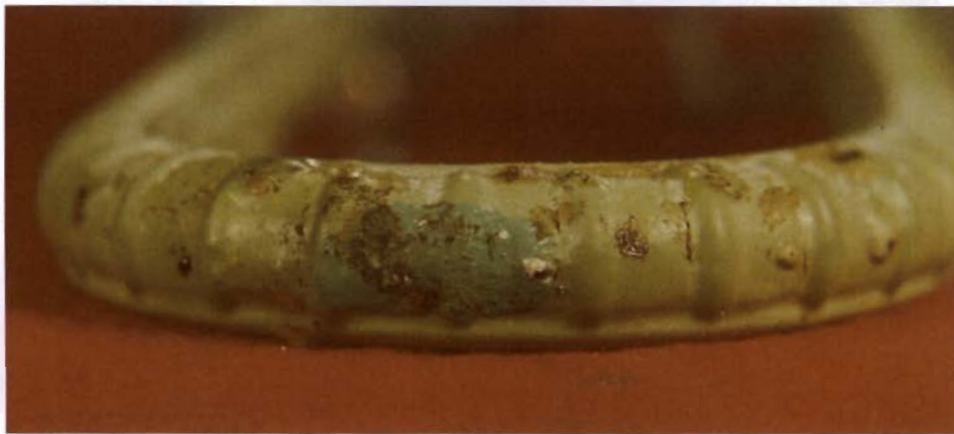
Figure 3.1 Corrosion of patched area of #4 epoxy-coated bar (macrocell study).

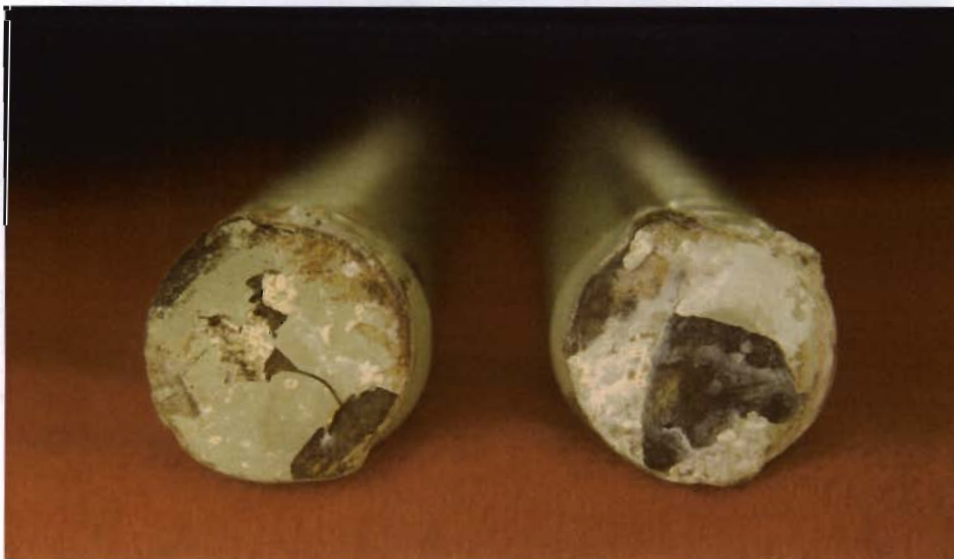
Figure 3.2 Patch at bar ends of splice bars broke during autopsy, showing a dark corroded surface underneath after 4.3 years of exposure (beam study).

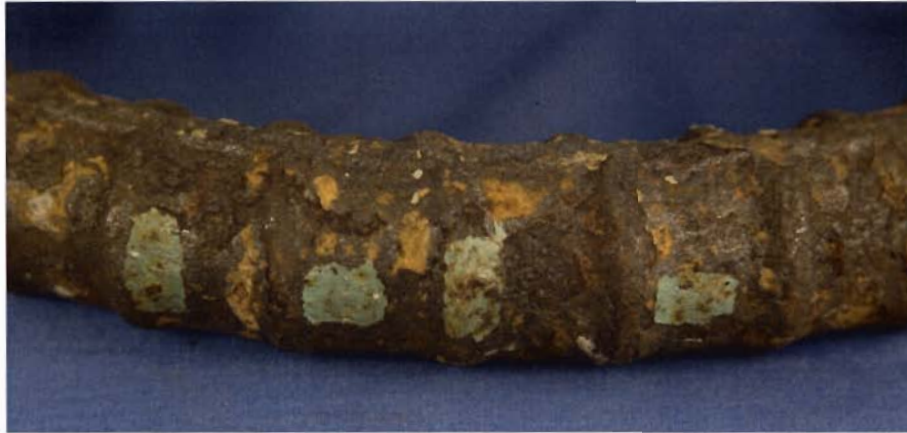
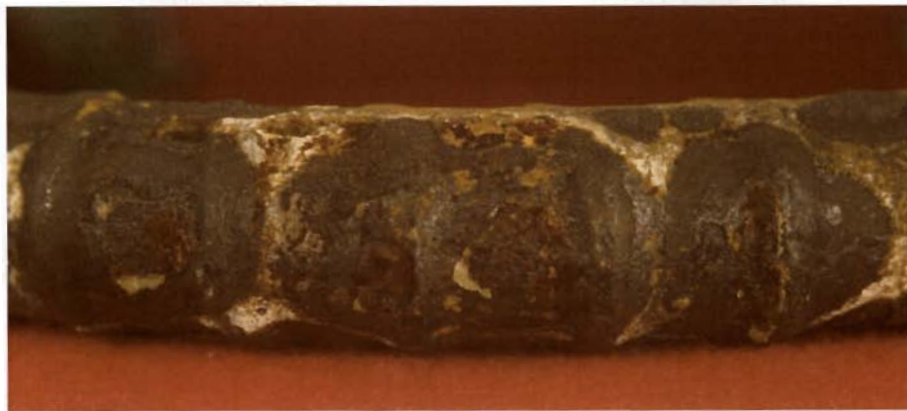
(a) Patched bar 3B.2, outside bend.

(b) Bar 2B.3 with unpatched damage at outside bend.

Despite displaying slightly lower currents, the steel surface of most bars with patched coating from macrocell specimens showed levels of corrosion similar to bars with exposed, damaged areas after 4.5 years of saline exposure (Figure 3.3). Corrosion products built up at exposed sites while only very light rust developed at patched areas. However, corrosion spread on the steel surface far beyond patched areas and was not dissimilar from the corrosion observed at bar surfaces beyond exposed areas. There was only one case in the macrocell study where a bar with patched coating presented a substantially improved steel surface condition relative to a bar with exposed areas (small bars with parallel ribs and damaged spots greater than 2% of the bar surface). These observations were in good agreement with measured macrocell currents.

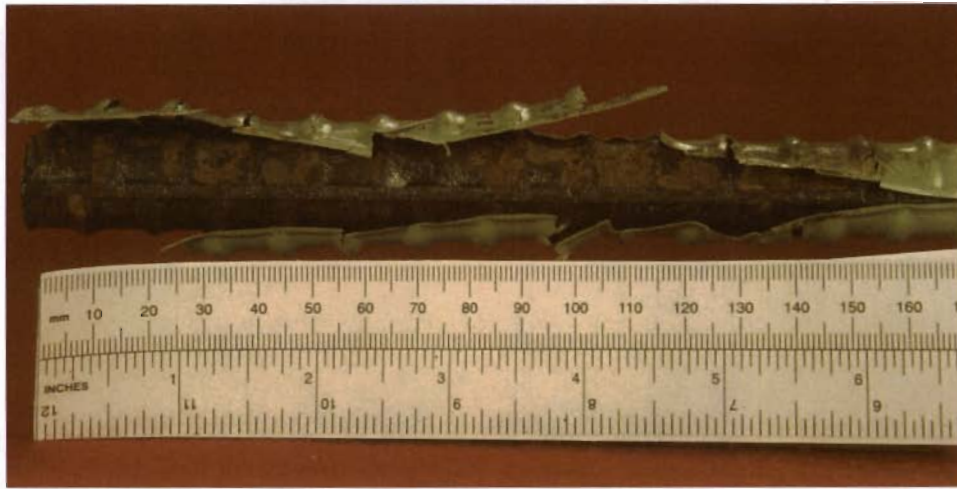
Figure 3.4 Coating debonding of splice bar (beam study).

Patched cut ends of splice bars in beam specimens experienced uniform dark corrosion beneath the patch, and coating debonding with underfilm corrosion progressed along the bar up to a distance of about 20 to 24 cm from the patched ends (Figures 3.4 and 3.5). Corrosion spread over the bottom (as in casting position) side of the bars, while the topsides of the bars exhibited a mostly mottled surface. Evidently, bar patched ends are vulnerable to corrosion and, if located at a crack, the situation is aggravated by the availability of chlorides, water, and oxygen. Once bar patched ends start to corrode, corrosion migrates underneath the coating over time.

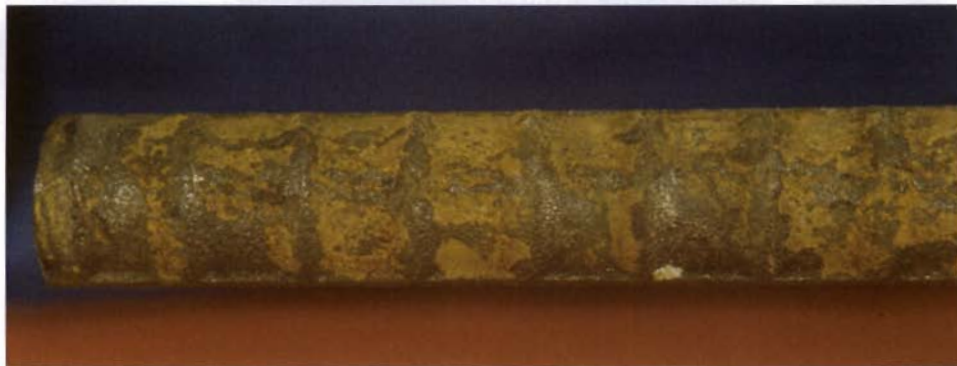
Figure 3.5 Underfilm corrosion of splice bar after 4.3 years of exposure (beam study).

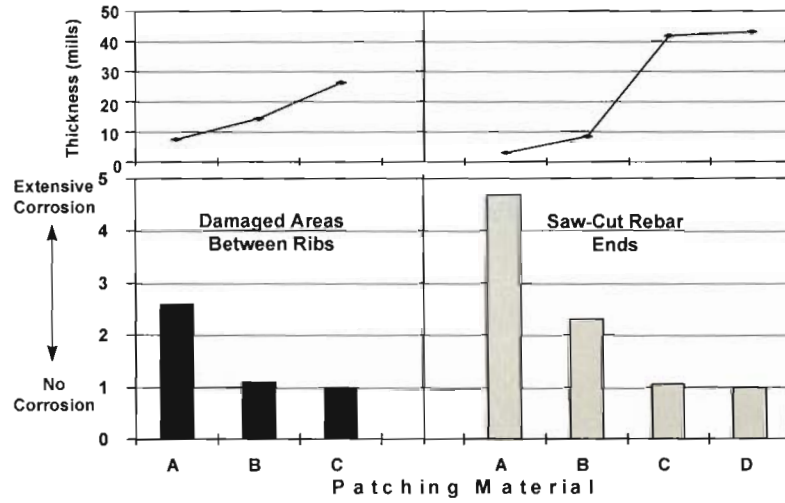
Figure 3.6 Comparative performance between 2 types of specimens repaired with different patching materials.

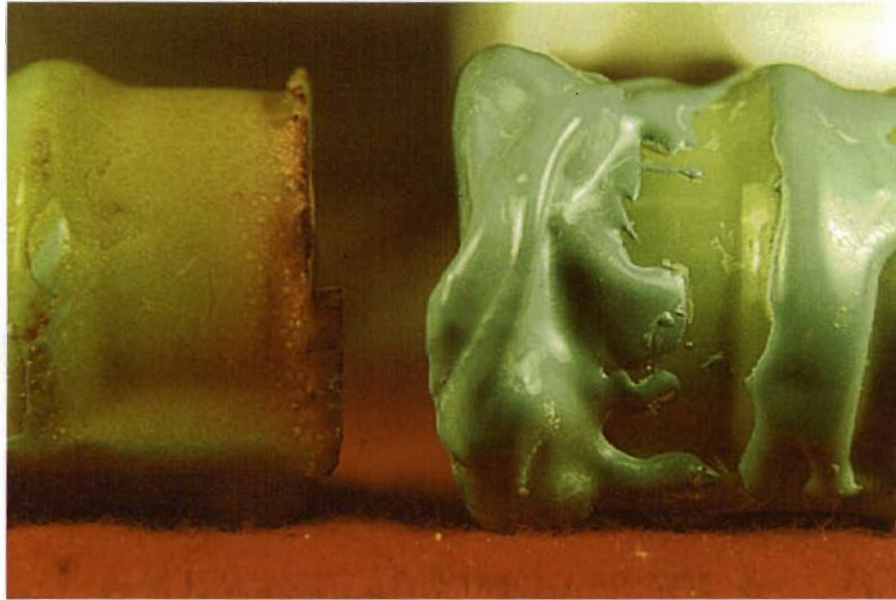
Figure 3.8 Patching material A (left side specimen) performed worse than material C (right side specimen).

Current specifications do not provide adequate guidelines for proper coating repair procedures. The coating repair study shed some light regarding performance of different patching materials and procedures. Manufacturers claim that thorough surface preparation is essential for adequate performance of patching materials. Research performed in this study indicated that the most important factor was the type and properties of the patching material, with surface preparation having little effect. Patching materials of sufficient viscosity to produce a thick coating provided the best protection. Figures 3.6 and 3.7 clearly show that as patch thickness increased, corrosion performance improved. Diffusion of chlorides through the patch was significantly delayed as patch thickness increased. Thicker patches provided good protection at vulnerable areas such as sharp edges of rebar ends, as shown in Figure 3.8.

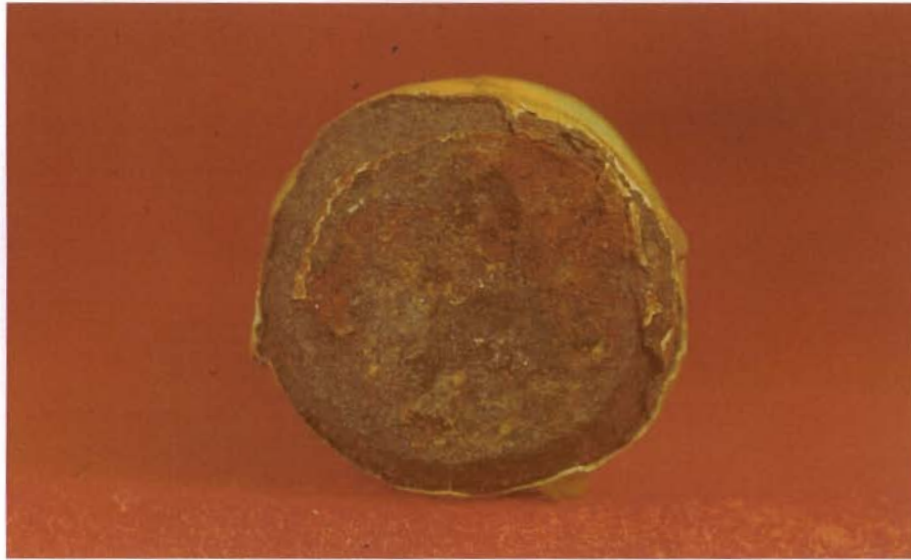
Figure 3.11 Corrosion of bar end surface that was specially cleaned before patch application.

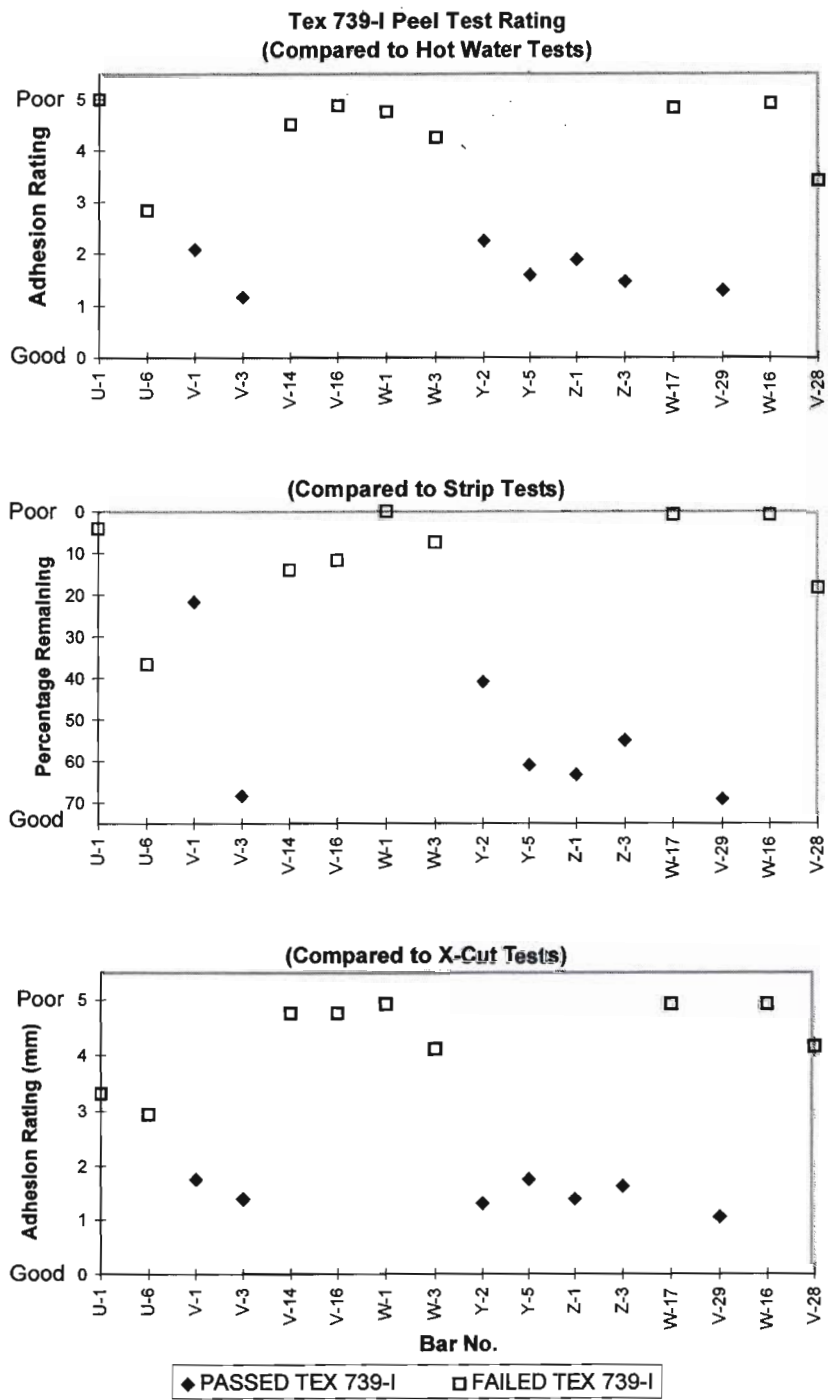
Figure 3.14 Adhesion test results from three test methods compared to TxDOT peel test.

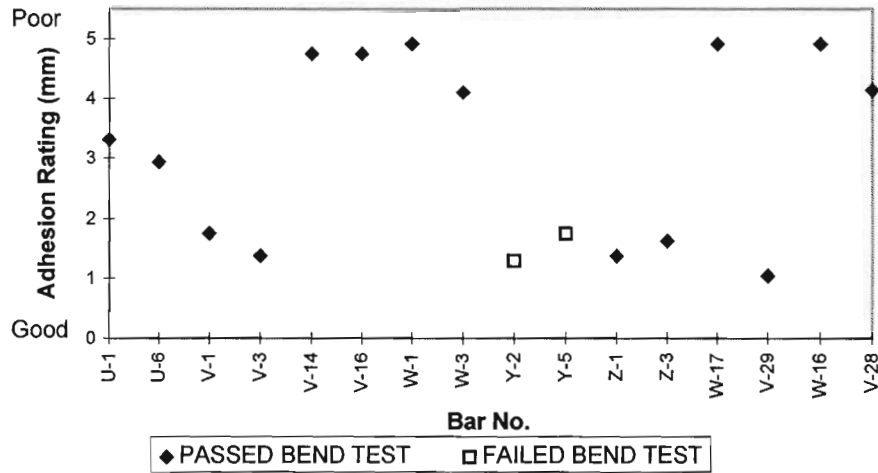
Figure 3.15 Adhesion test results from X-cut method compared to bend test.

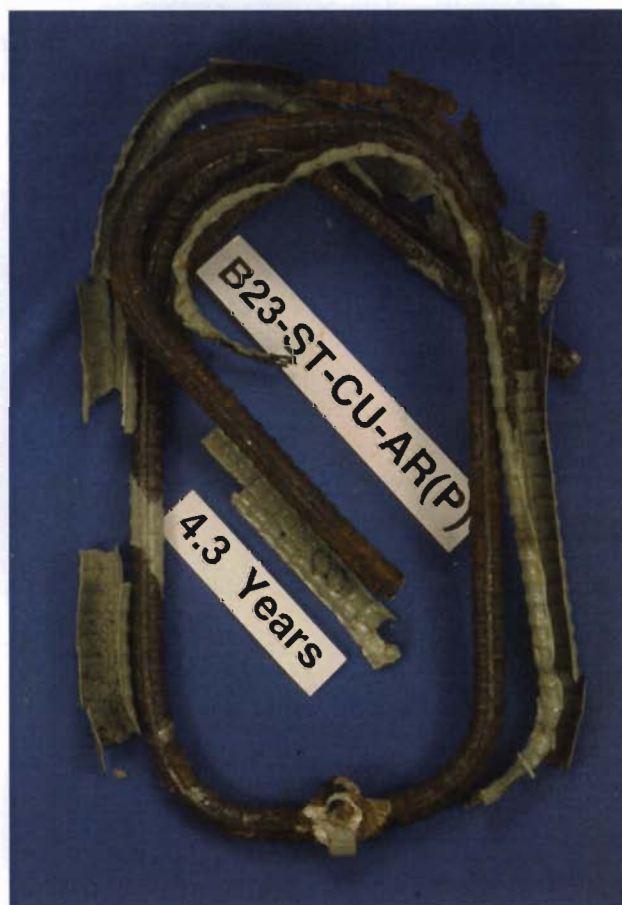
Figure 3.17 Coating extensively debonded on stirrups (beam study).

Fabrication (bending) of bars weakened coating adhesion. In hot water and knife adhesion tests, straight bars always performed better than bent bars (Figure 3.13). In durability studies, all macrocell specimens showed loss of adhesion at bend portions and adjacent straight legs after 2 and 4.5 years of chloride exposure, regardless of the level of corrosion activity. Likewise, coated stirrups in beam specimens showed widespread adhesion loss after one and 4.3 years (Figure 3.17). On most beams, adhesion loss was slightly more extensive on fabricated bars than on straight bars. Underfilm corrosion was noticeably more extensive on fabricated bars than on straight bars. Weakening of adhesion caused by bar fabrication seemed to be proportional to the observed adhesion loss and underfilm corrosion after chloride exposure. During fabrication, adhesion was weakened at bends in stirrups but was presumably preserved at the straight portions. After chloride exposure, adhesion loss and undercutting progressed from weakened (bend) portions to initially well-adhered (straight) portions. Other factors effecting stirrup performance were discussed in Reference 27.

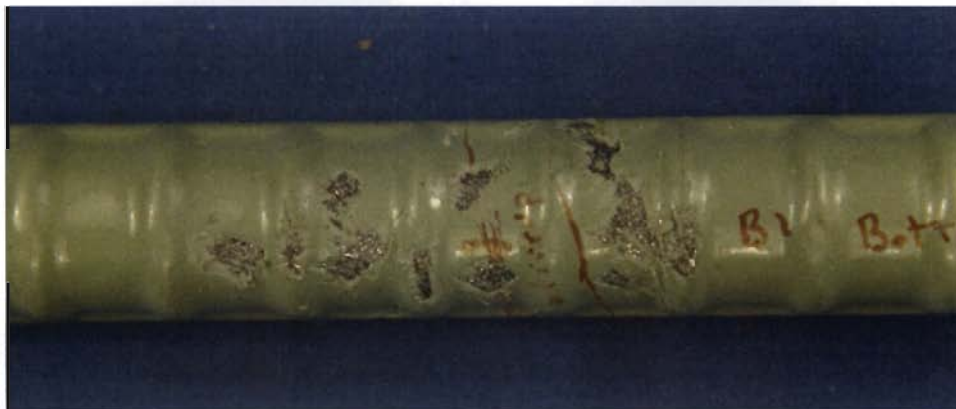
Figure 3.18 Coating adhered well throughout most portions of bars from beam B1.

The degree of adhesion loss after chloride exposure seemed to be affected by differences in coating integrity. Straight bars from beam B1 were in excellent condition with no visible damage before chloride exposure. The bar condition was preserved without signs of corrosion or extensive adhesion loss after 4.3 years of chloride exposure (Figure 3.18). Longitudinal bars in the remaining autopsied specimens had intentional damage, patched or unpatched, and experience adhesion loss within the wetted region with varying degrees of underfilm corrosion (Figure 3.19). Since bars for all beams came from the same lot, it is reasonable to assume that all bars had similar coating adhesion before chloride exposure. Clearly, coating integrity was fundamental in the preservation of adhesion and the protective capabilities of the coating. In addition, it was found that adhesion loss always occurred around areas of damaged coating and was least affected at locations farthest from damaged coating. Similar observations have been made by Sagüés.¹⁵ Visible holidays and coating defects were present on areas that experienced coating disbondment in coated bar segments extracted from four bridge decks in California.¹³ This evidence suggests that the agents causing coating disbondment migrated to the coating-substrate interface through coating defects rather than through the bulk of the coating.

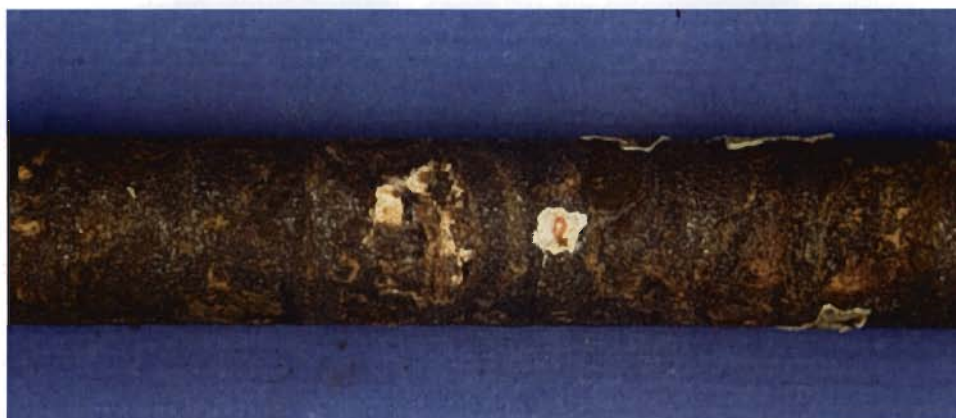
Figure 3.19 Dark corroded surface beneath debonded coating on longitudinal bar with 3% damaged coating within the wetted region (beam B8).

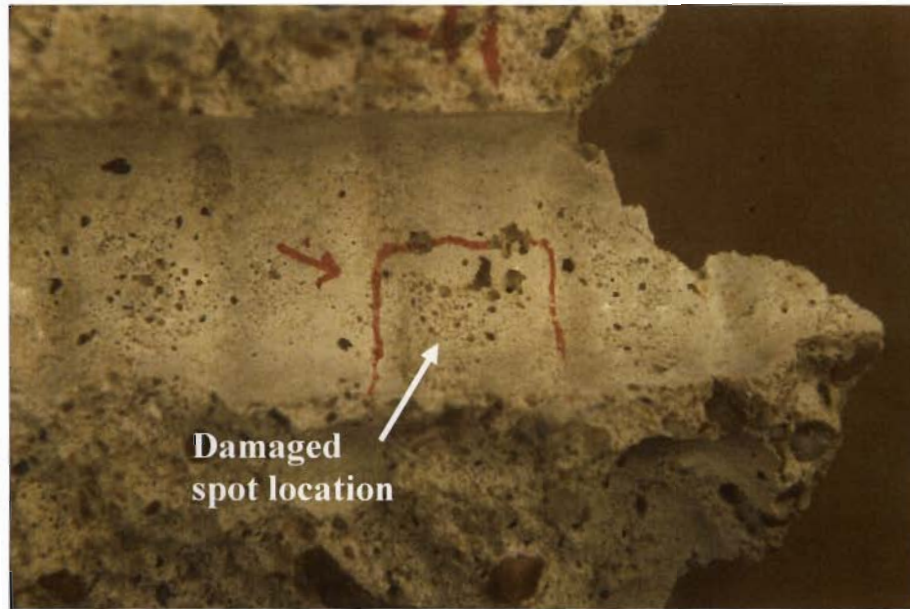
Figure 4.2 Concrete surrounding uncorroded damaged spot within the wetted region (Upper bar of beam B10).

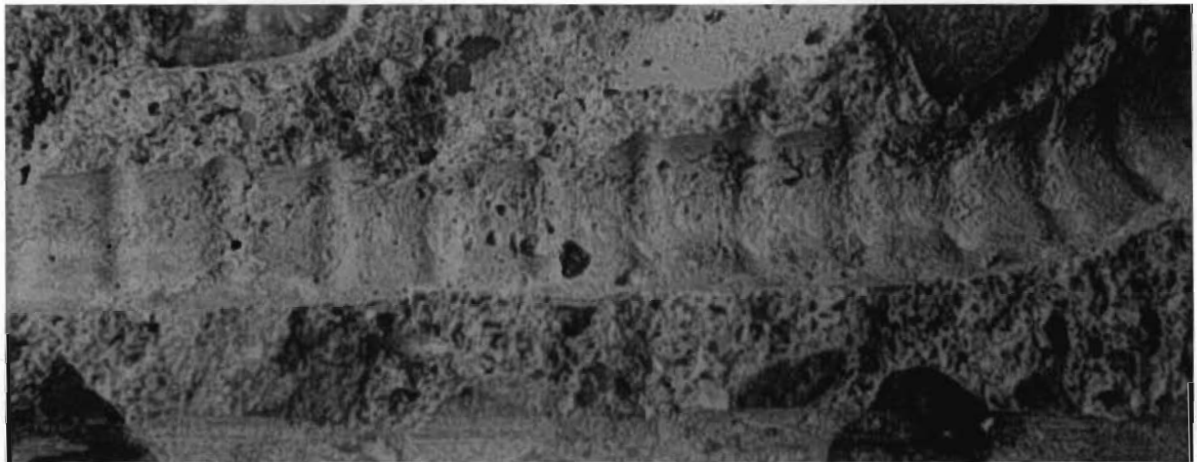
(a) Above the epoxy-coated bar.

(b) Below the epoxy-coated bar.

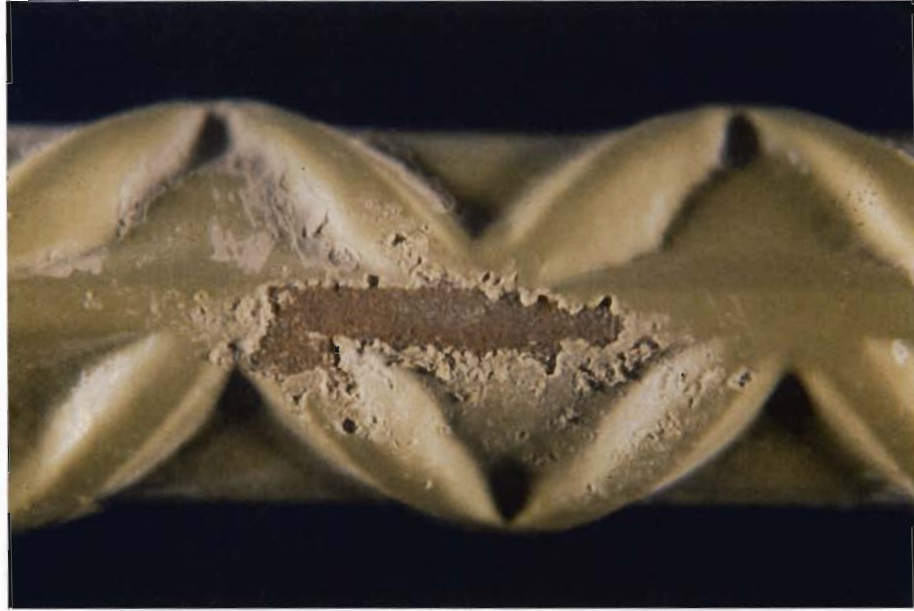
Figure 4.6 Damage to coating caused by metal head vibrator on test bar from Phase 1 study.

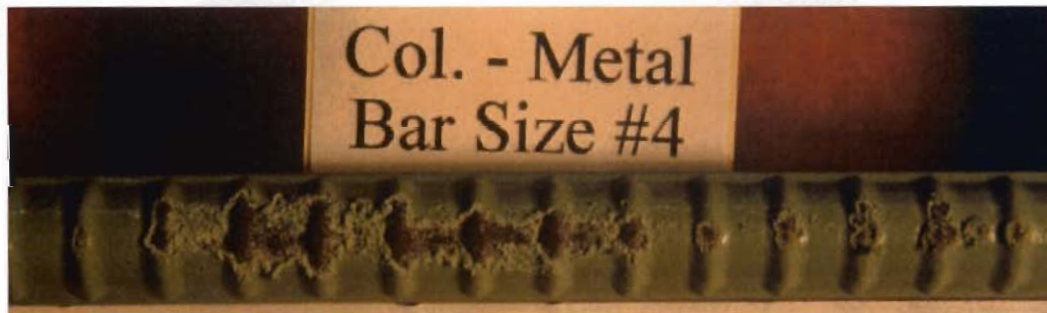
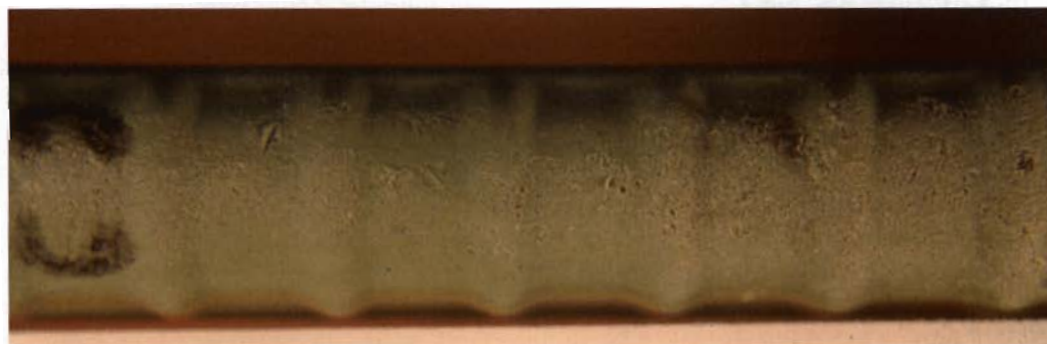
(a) Metal head vibrator.

(b) Rubber head vibrator.

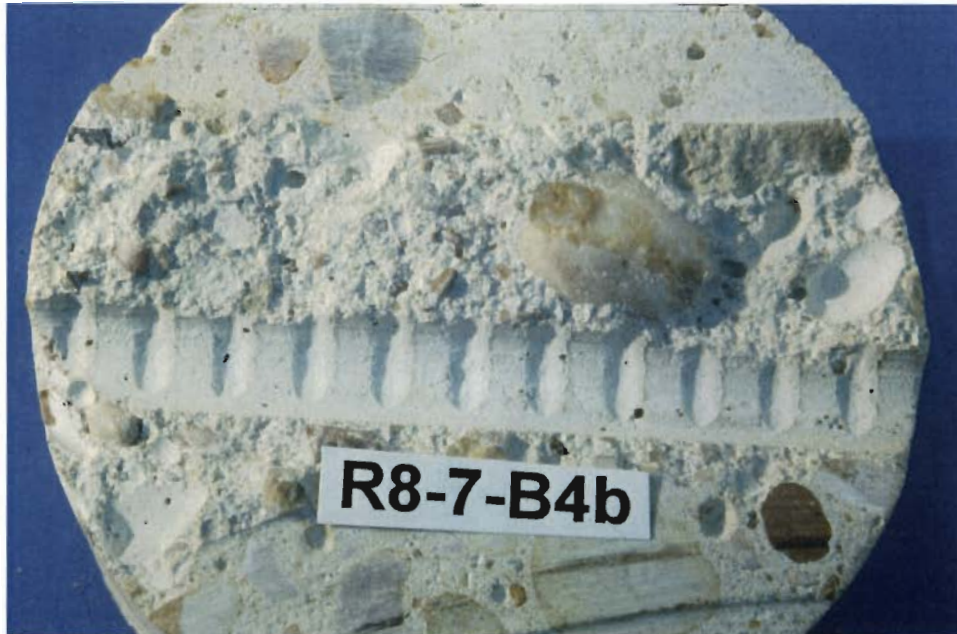
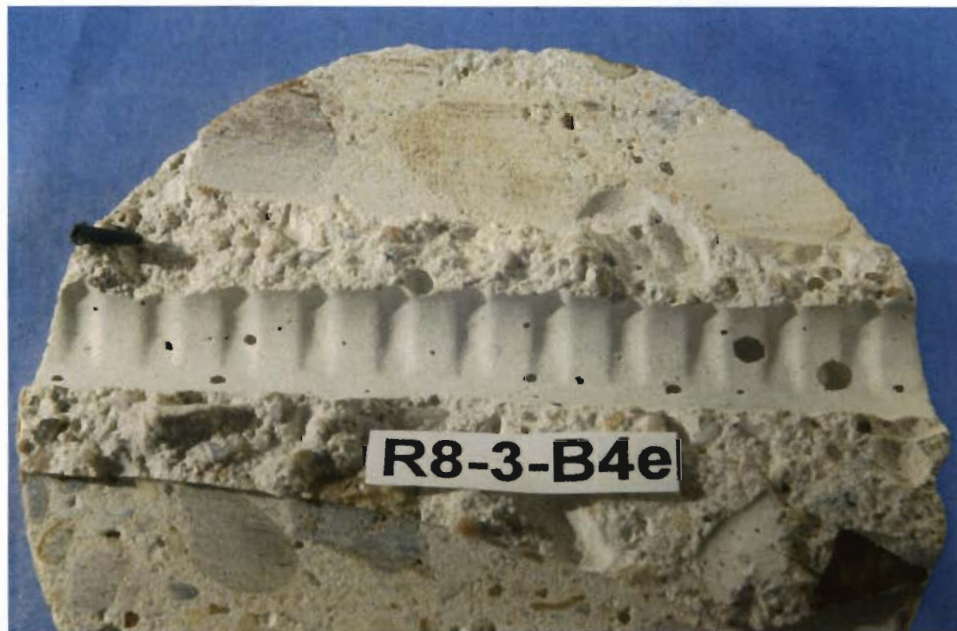
(a) Air voids close to point of vibrator insertion.

(b) Air voids farther away from point of vibrator insertion.

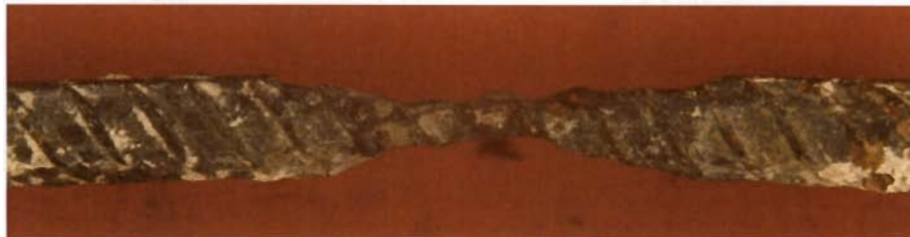
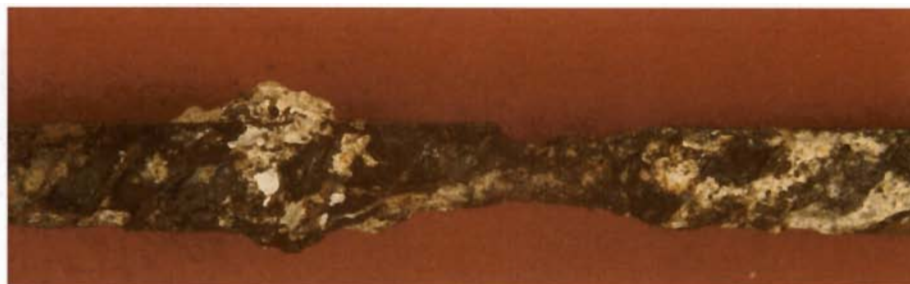
(a) Lower black bar of beam B27.

(b) Lower black bar of beam B23.

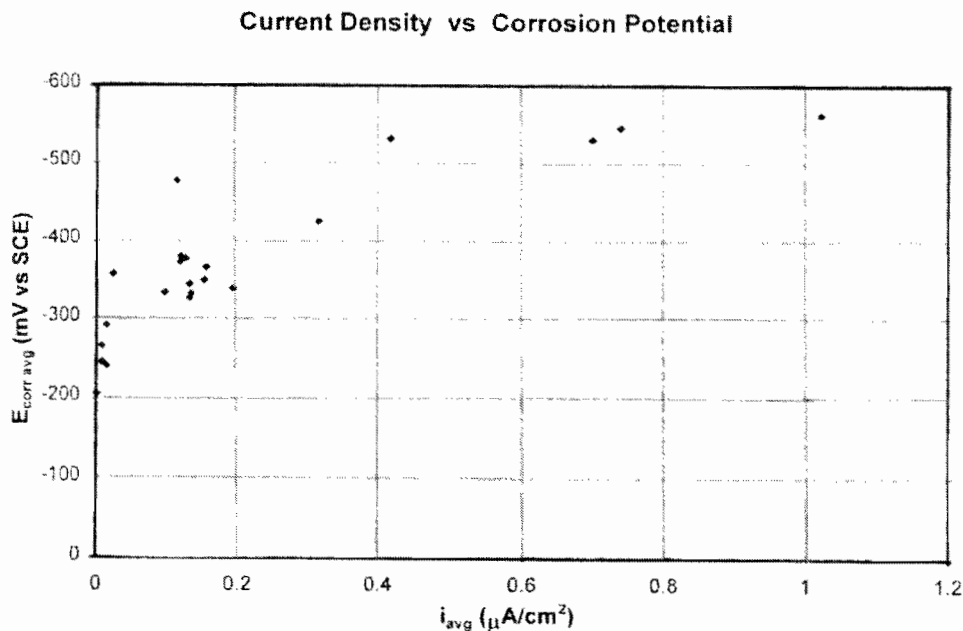
Figure 5.1 Average current densities vs. average corrosion potentials for macrocell specimens
