DETECTION OF VOIDS UNDERNEATH CONTINUOUSLY
REINFORCED CONCRETE PAVEMENTS

Research Report Number 177-18

Development and Implementation of the Design, Construction
and Rehabilitation of Rigid Pavements

CENTER FOR HIGHWAY RESEARCH
THE UNIVERSITY OF TEXAS AT AUSTIN

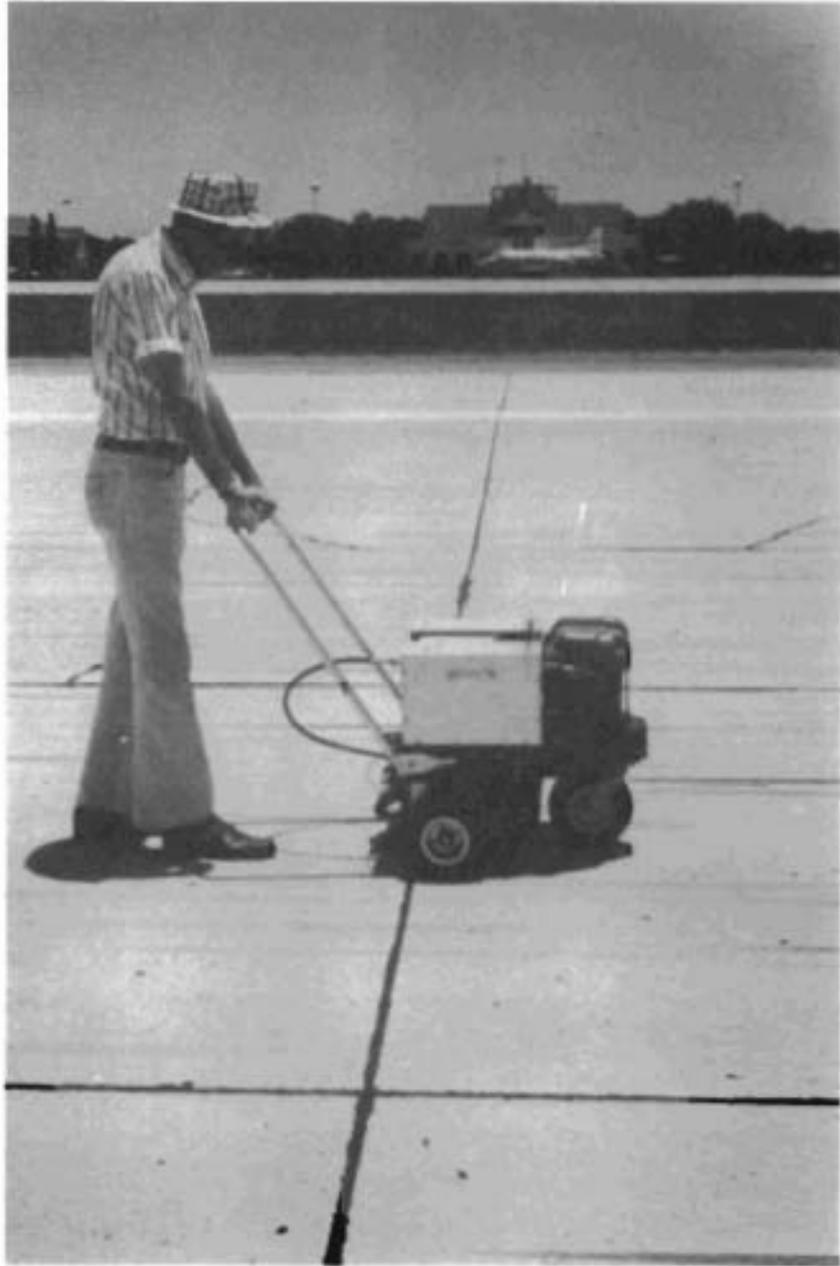
Fig 3. The vibrator.

The vibratory equipment selected for evaluation is basically a vibrator on steel wheels that applies small vibratory loads to the pavement. It is manufactured by S.I.E., Inc., under the trade name Delam Tek and is shown in operation in Fig 3. Basically, the equipment provides a continuous reading along the roadway. This provides an advantage over the Dynaflect, since the Dynaflect has to be stopped at a specific point to make a reading and then moved forward again to the next measurement point. It was felt that if the Delam Tek equipment was functional, a more extensive investigation could be made.

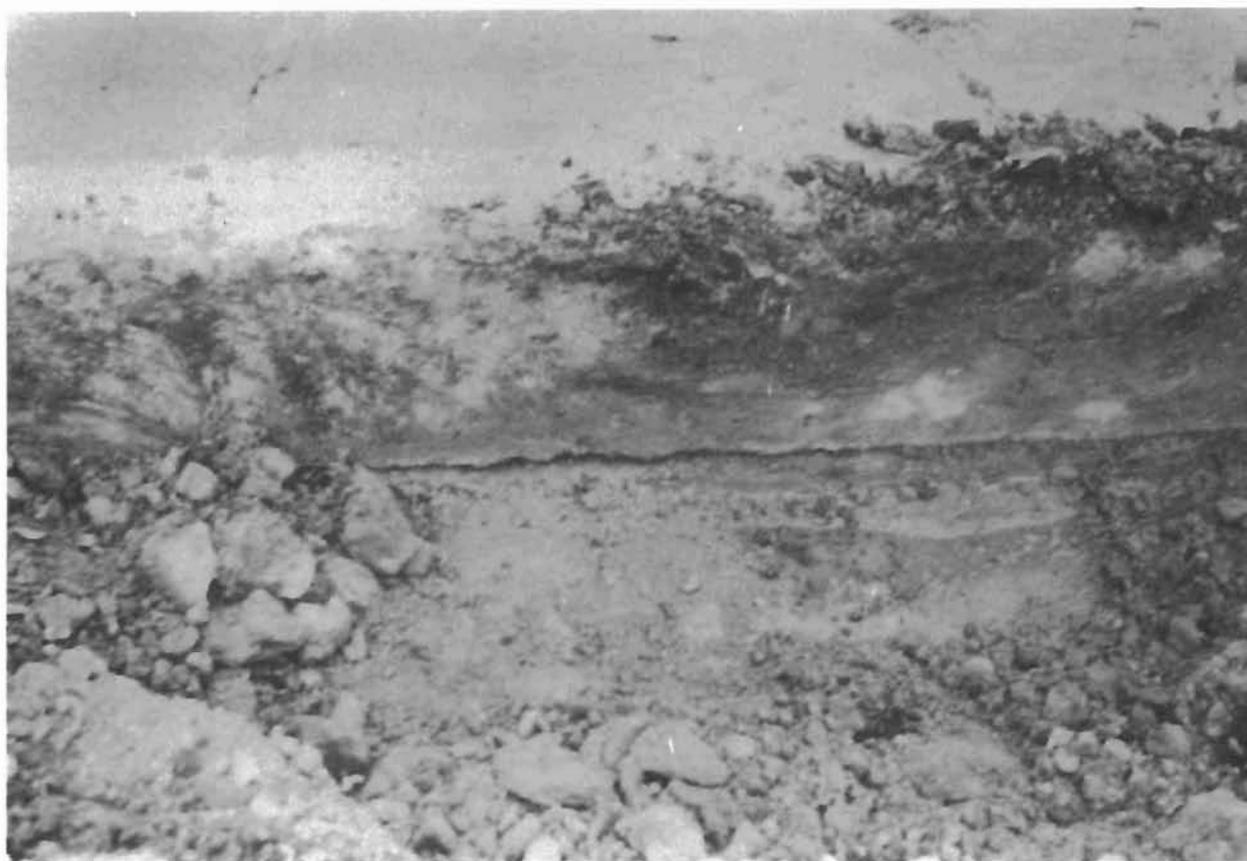
Fig 10. View of site excavation.

Figure 10 shows a typical excavation along the edge of the pavement on IH-10. A trench was dug approximately 14 inches (35.56 cm) deep and 18 inches (45.72 cm) wide with a backhoe. This permitted observers a side view of the void, as may be seen in Fig 11, which shows a typical edge condition where a void was present.
