1. Report No. FHWA/TX-84/04+257-1F		2. Government Accession No.		3. Recipient's Catalog No.	
4. Title and Subtitle INTEGRITY EVALUATION OF DRILLED PIERS BY STRESS WAVES				5. Report Date January 1984

INTEGRITY EVALUATION OF DRILLED PIERS BY STRESS WAVES

Research Report Number 257-1F

Evaluation of Drilled Shaft Integrity by Stress Waves
Research Project 3-5-80-257

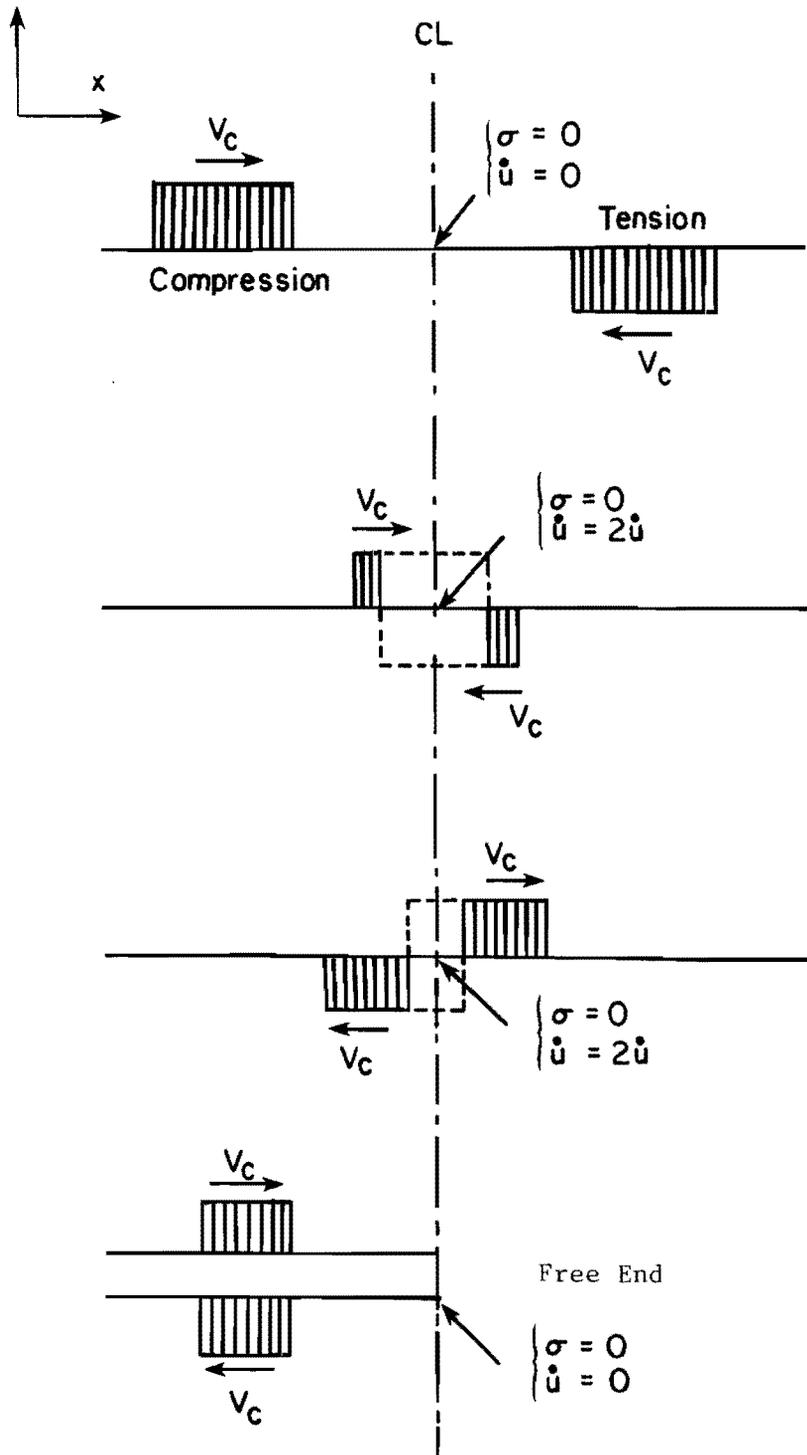
Fig. 2.2. Elastic waves in a rod illustrating a free-end condition.

Equation 2.9 mathematically states that the shape of the reflected wave is the same as that of incident wave but is of the opposite sign. In other words, a compression wave will be reflected from the free end of a rod as a tension wave of identical magnitude and shape. Similarly, a tension wave propagating in an elastic rod will be reflected from a free end as a compression wave of the same magnitude and shape. Wave reflection in an elastic rod with free-end conditions is illustrated in Fig. 2.2.

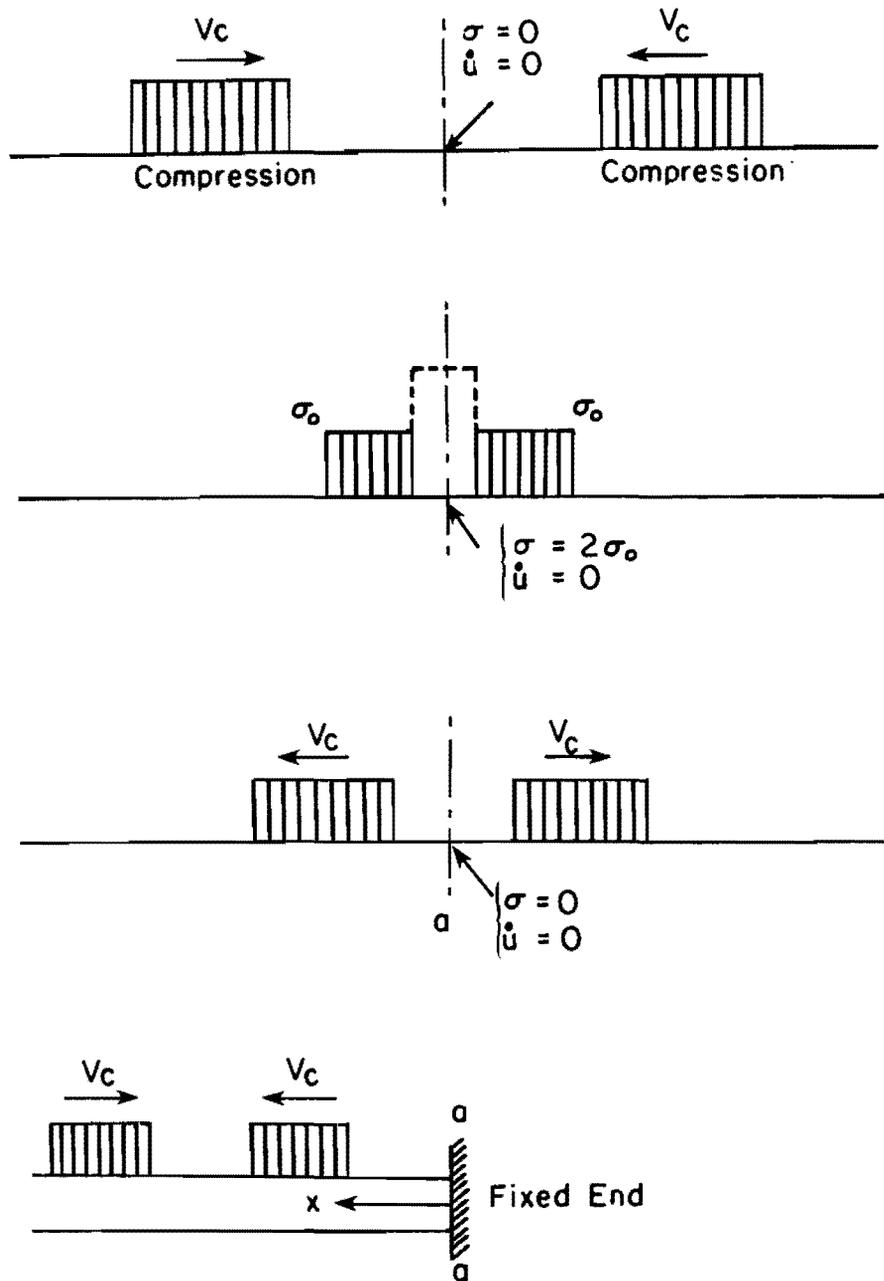
Fig. 2.3. Elastic waves in a rod illustrating a fixed-end condition.

For a stress wave reflected at the fixed end of an elastic rod, the appropriate boundary condition is that the displacement is zero at x equal 0. Applying the boundary condition to Eq. 2.10 reveals that the displacement of the reflected wave is equal and opposite to the displacement of the incident wave, and $E(\partial u_1 / \partial x)$ is now equal to $E(\partial u_2 / \partial x)$. Therefore, a stress wave, either tension or compression, is reflected from the fixed end of a rod unaltered, experiencing only a reversal in direction of propagation, as illustrated in Fig. 2.3.

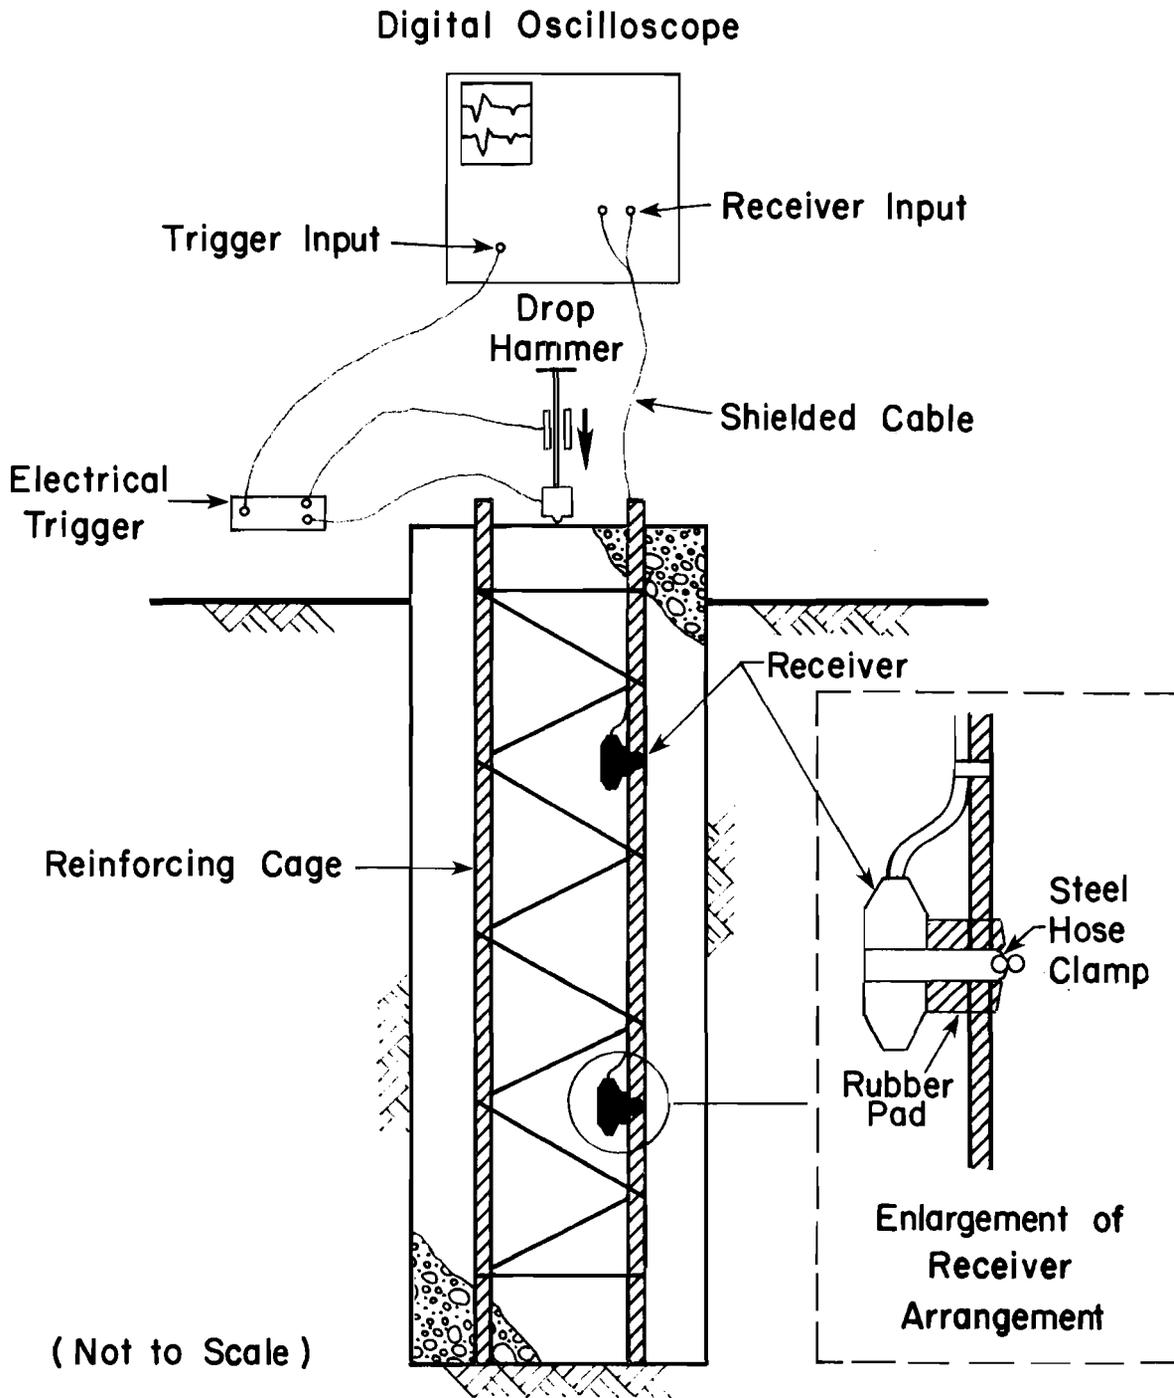
Fig. 3.1. Schematic of wave propagation testing with embedded receivers.

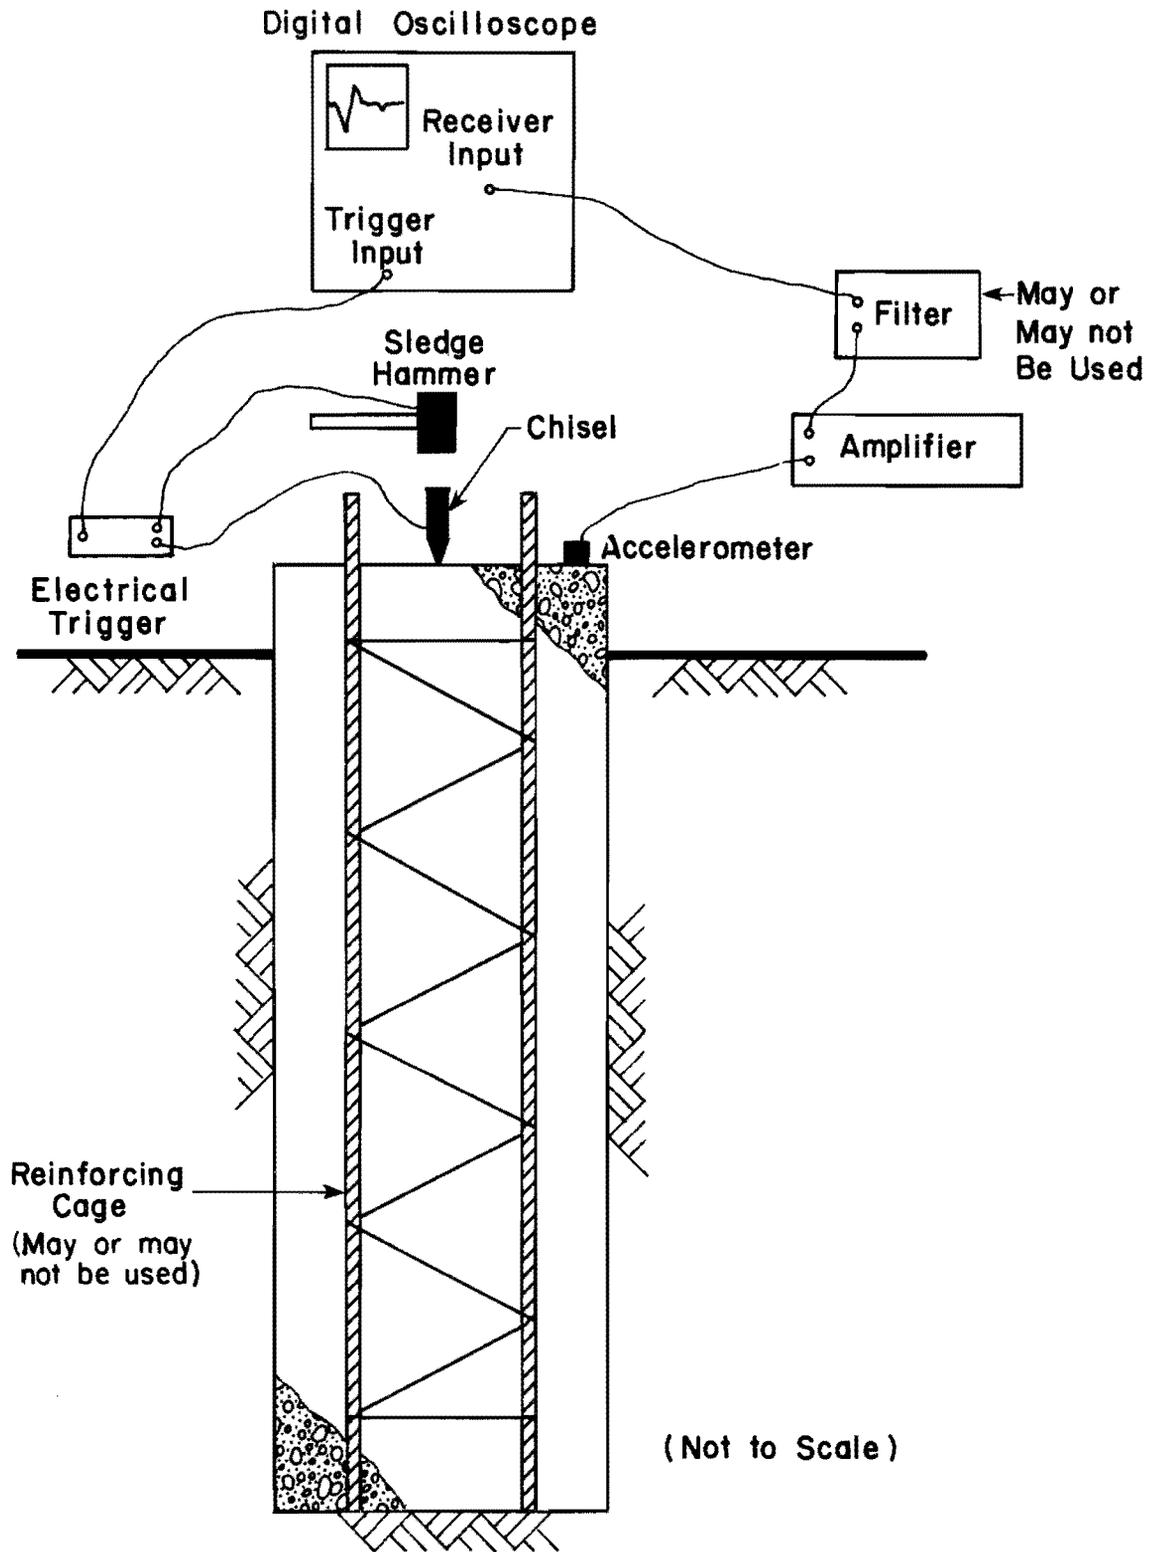
Fig. 3.4. Schematic of wave propagation testing with a surface receiver.

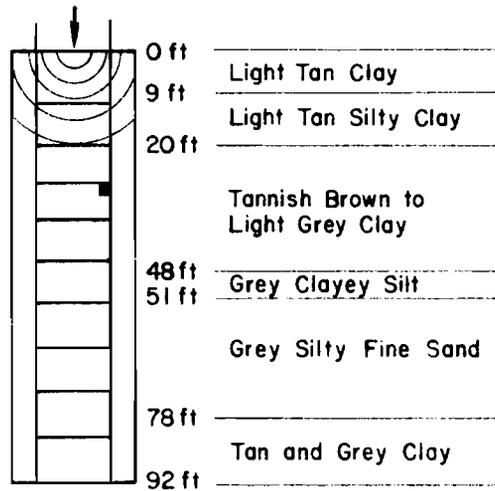
Fig. 3.5(a). Schematic of 92 ft. long drilled pier with embedded receiver and surrounding soil conditions.

To develop these concepts further, consider the case of a wave propagation test performed on a 84 in. (213.4 cm) diameter, 92 ft (28.0 m) long drilled pier constructed on a site in Beaumont, Texas. The structurally sound pier was instrumented with a vertical velocity transducer embedded at a depth of 29.2 ft (8.9 m) within the pier. Figure 3.5(a) illustrates the source-receiver configuration employed in the test, as well as the local

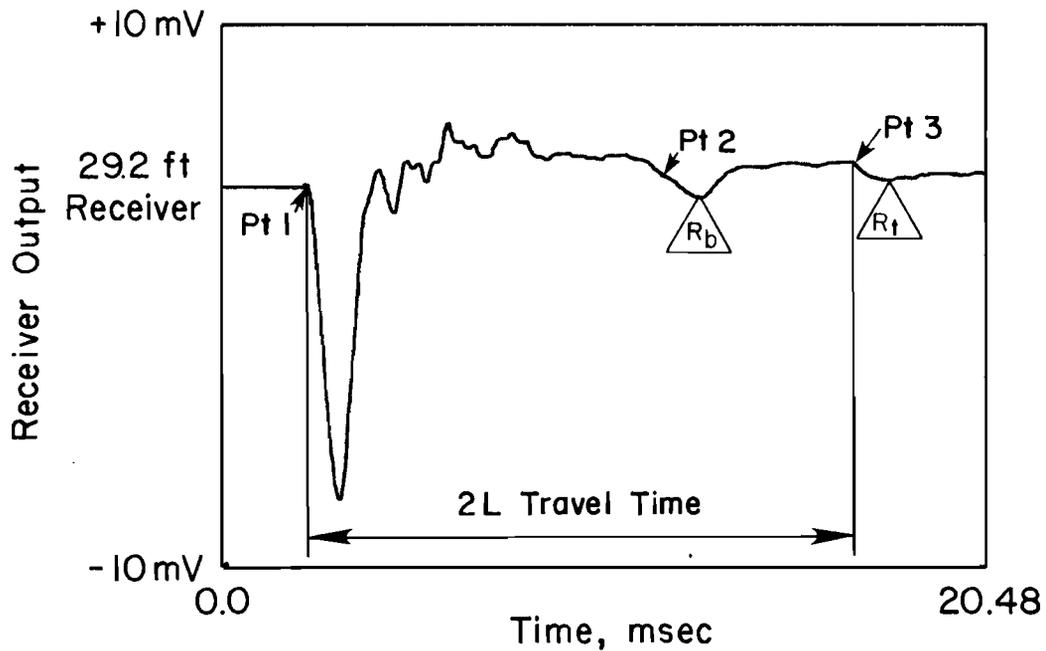
Fig. 3.5(b). Receiver output for velocity transducer embedded at a depth of 29.2 ft. in 92 ft. long drilled pier on site in Beaumont, Texas.

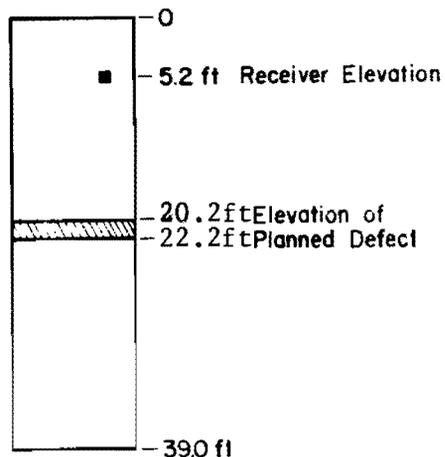
Fig. 3.6(a). Schematic of 39.0 ft (11.9m) drilled pier with embedded receiver.

For illustrative purposes, consider the case of a WAPER test performed on a defective pier in Granger, Texas. The pier, part of a research program conducted by Arias (1977), was constructed with a planned soil inclusion. A schematic representation of the 30 in. (76.2 cm) diameter, 39 ft (11.9 m) long drilled pier is given in Fig. 3.6, along with the receiver output

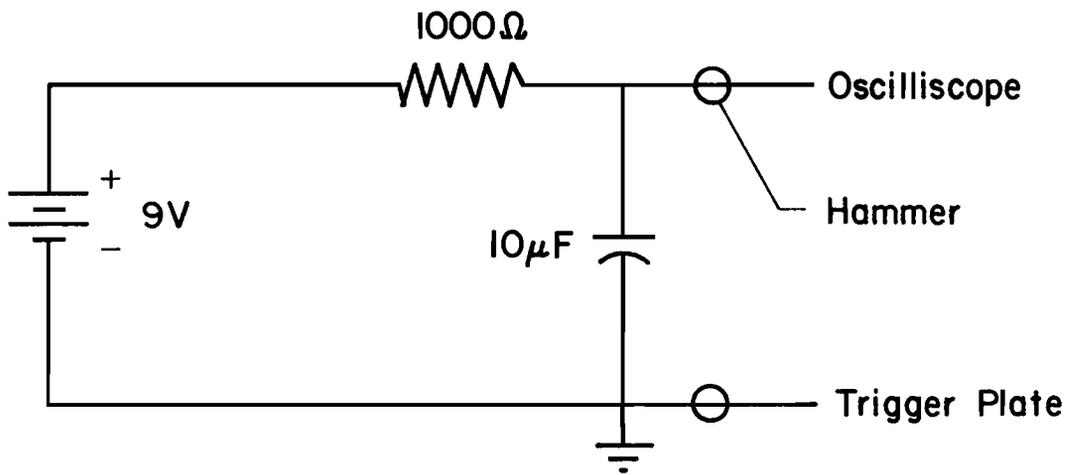
Fig. 4.4. Circuit diagram of resistance-capacitance (RC) trigger used in field tests.

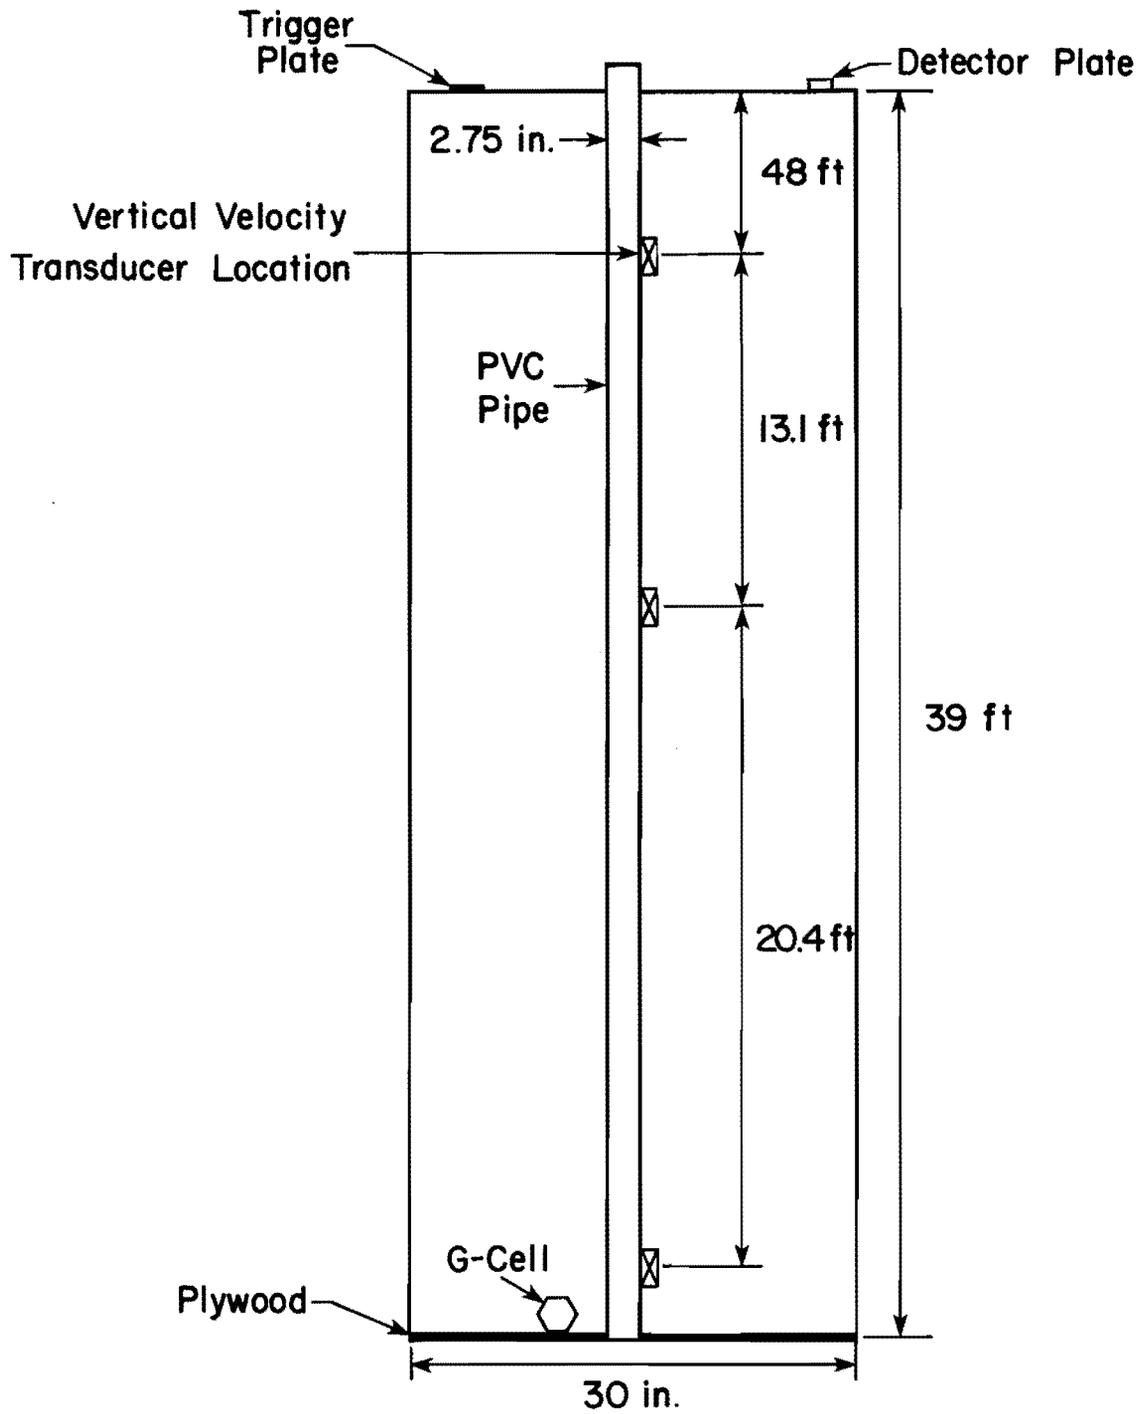
Fig. 5.1. Test shaft No. 1; sound shaft (Arias, 1977).

In terms of pier irregularities, Shaft 1 had no defects and hence was considered the control pier. Shafts 2 and 3 were constructed with various irregularities representing possible problems resulting during construction. The irregularities planned for Shaft 2 consisted of a 2 ft (0.61 m) thick defect, composed of soil from the augered borehole and a styrofoam-filled bag positioned at a depth of 20.2 ft (6.2 m) below the top of the pier. This defect was selected to simulate possible entrapment of slurry caused by elevating the concrete tremie above the concrete-slurry interface when utilizing the slurry displacement method of drilled pier construction.

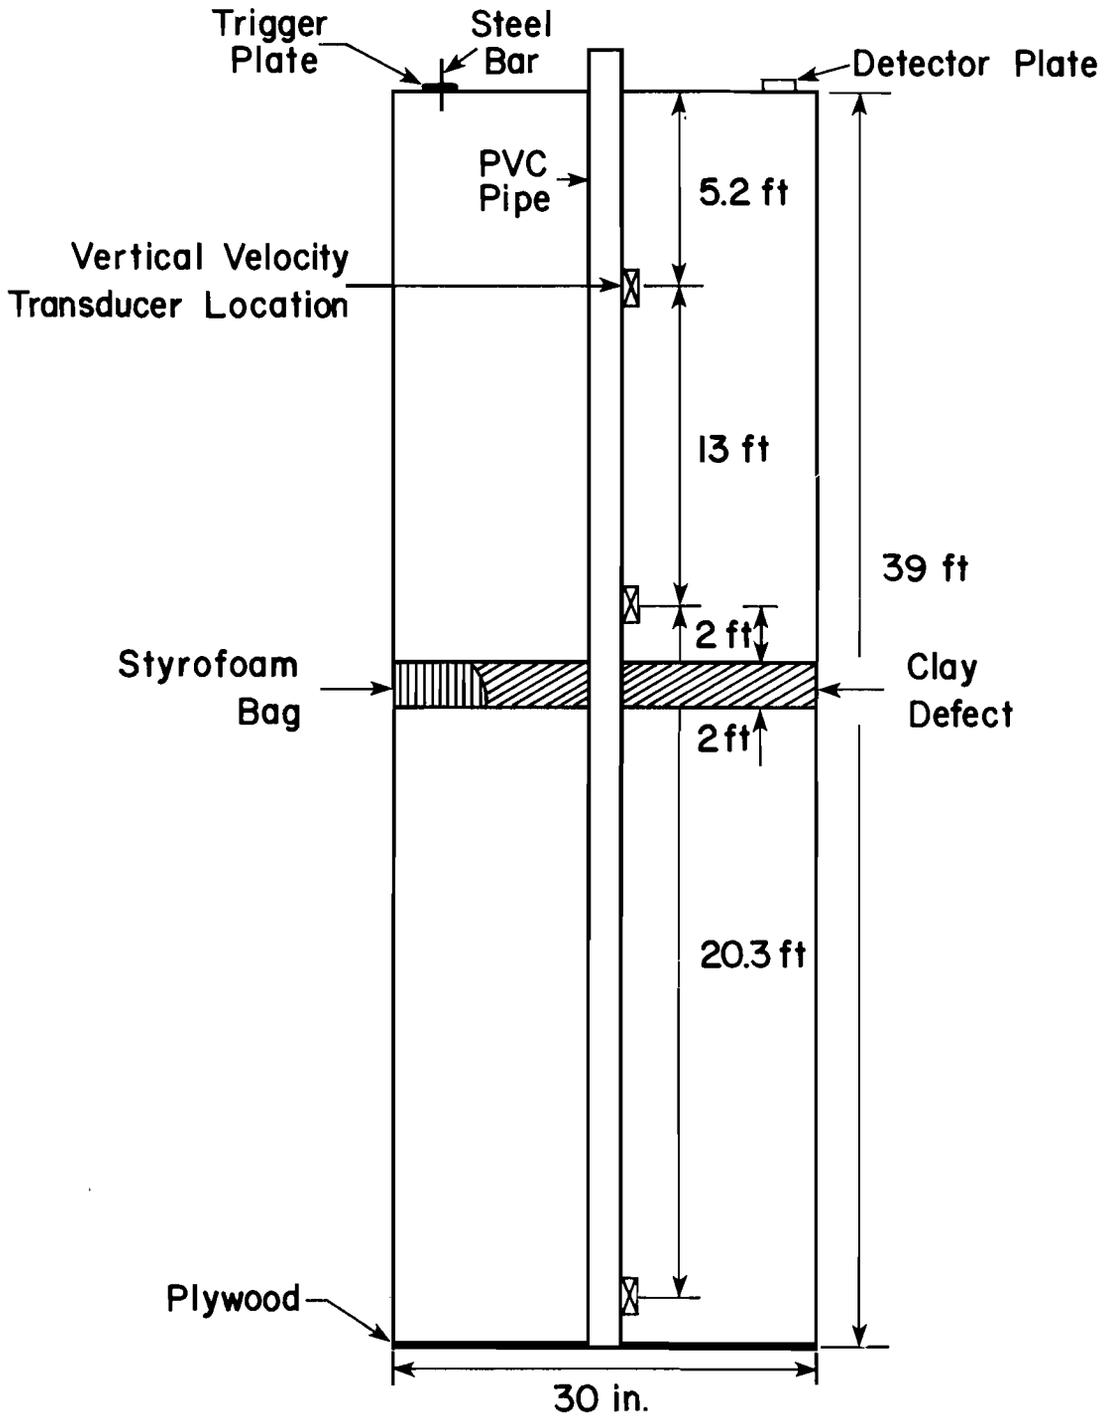
Fig. 5.2. Test shaft No. 2; defective shaft (Arias, 1977).

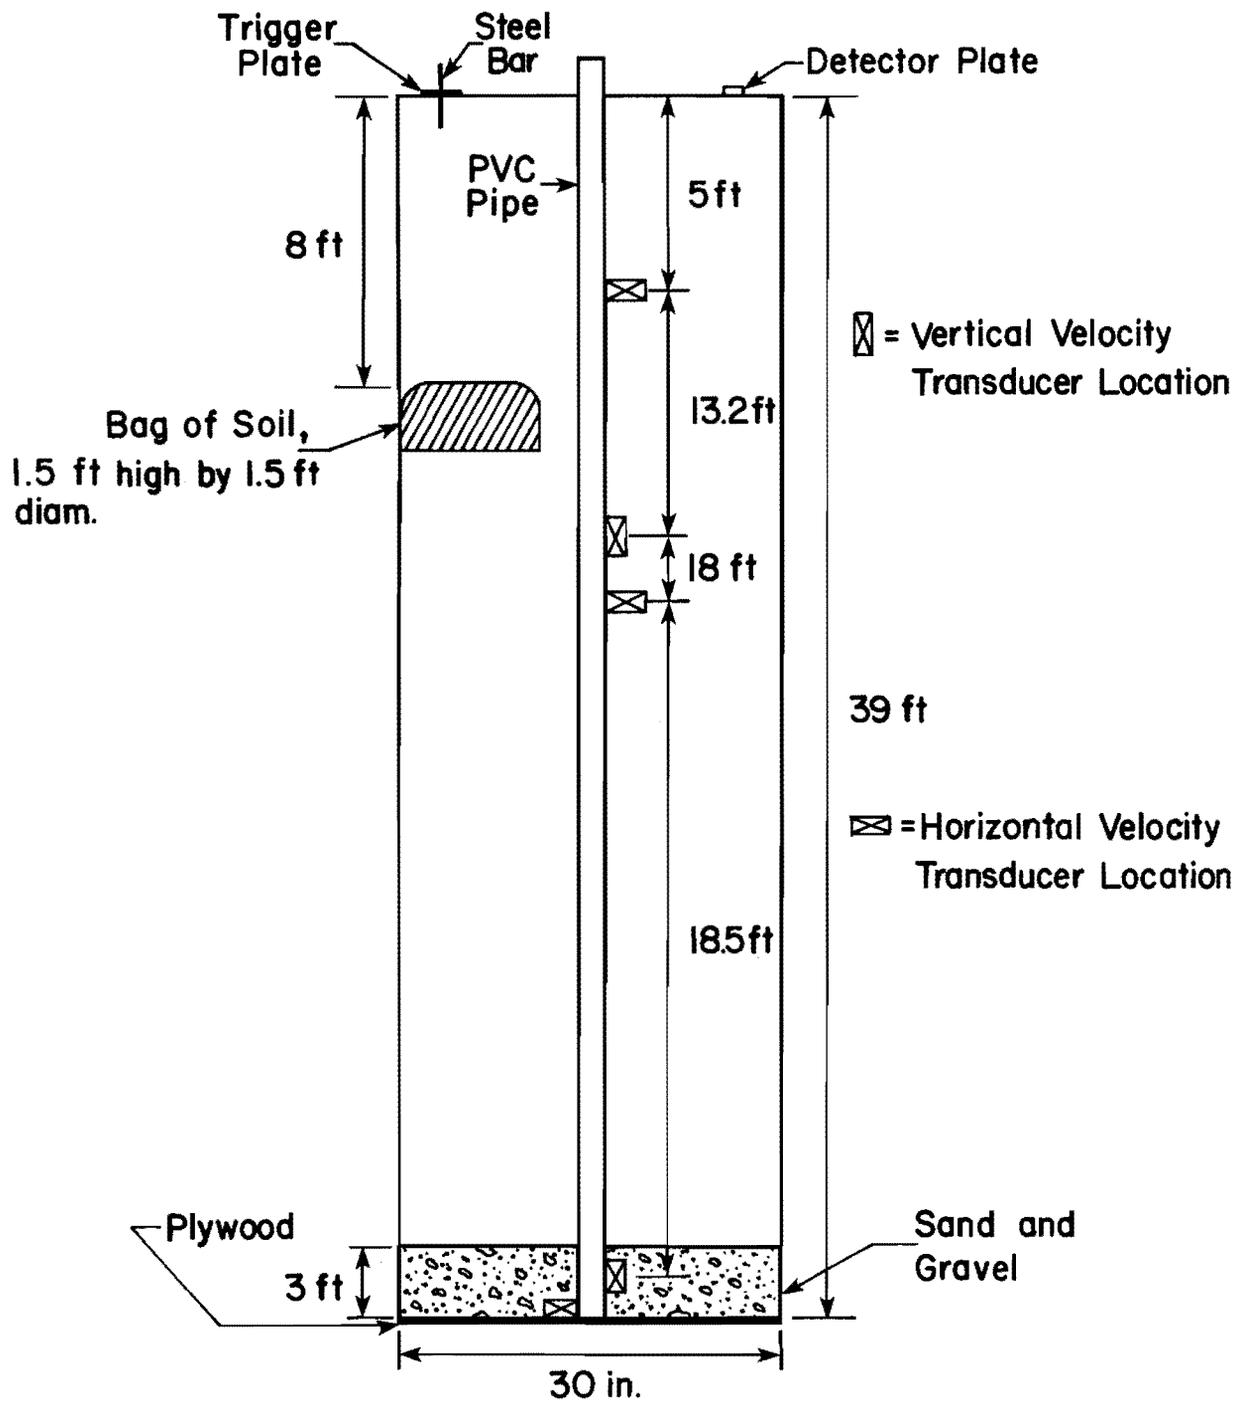
Fig. 5.3. Test shaft No. 3; defective shaft (Arias, 1977).

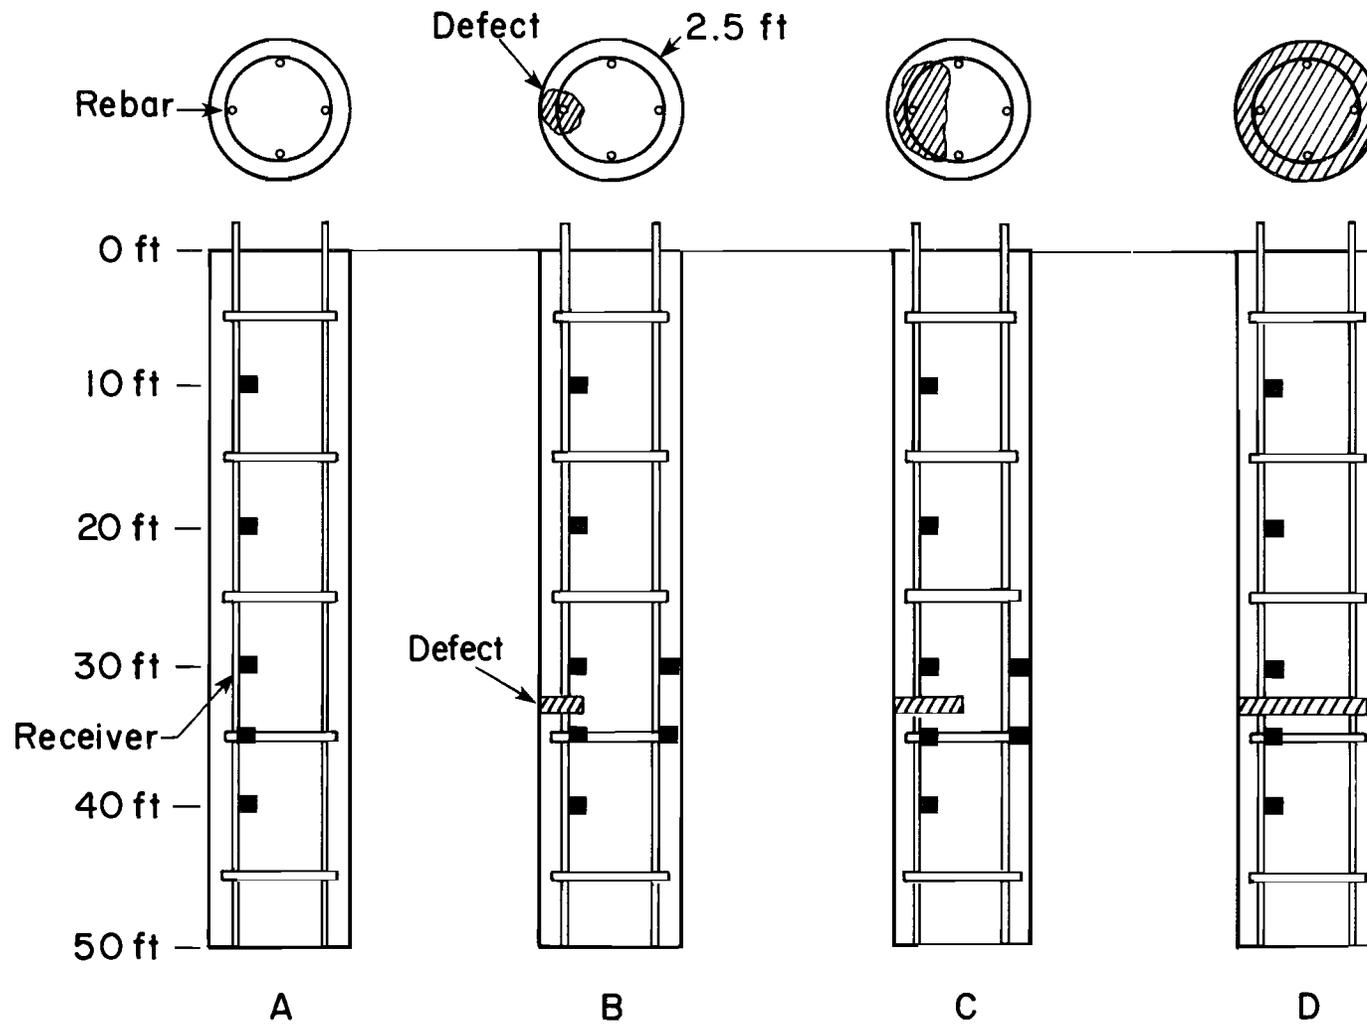
Fig. 5.7 Test piers constructed at second test site (Houston, Texas), showing defect and embedded receiver configurations.

To acquire pertinent information concerning the effects of cross-sectional dimensions of the irregularity on wave propagation measurements, especially in the attenuation phase of this investigation, it was necessary to design all defects to be of identical thickness. With this in mind, the following choices were made concerning the dimensions of the irregularities. Of the four test piers designed for this study, one pier would be absent of any irregularity. This sound pier, designated as Shaft A in Fig. 5.7, would be employed as a control pier with which to base comparisons with the

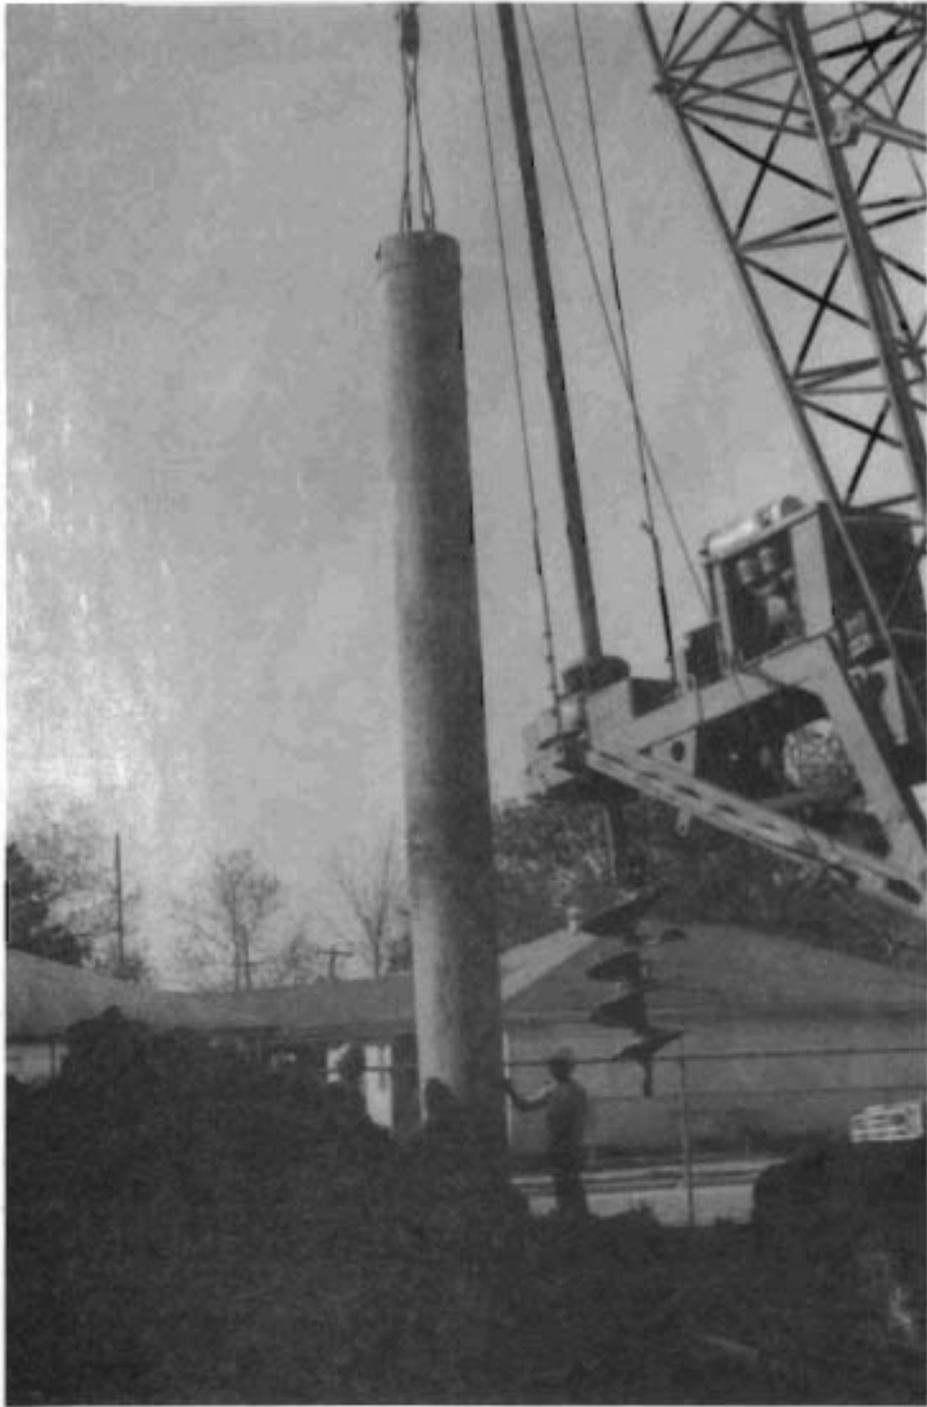
Fig. 5.10. Installing 30-in. (76.2 cm) diameter steel casing in augered hole.

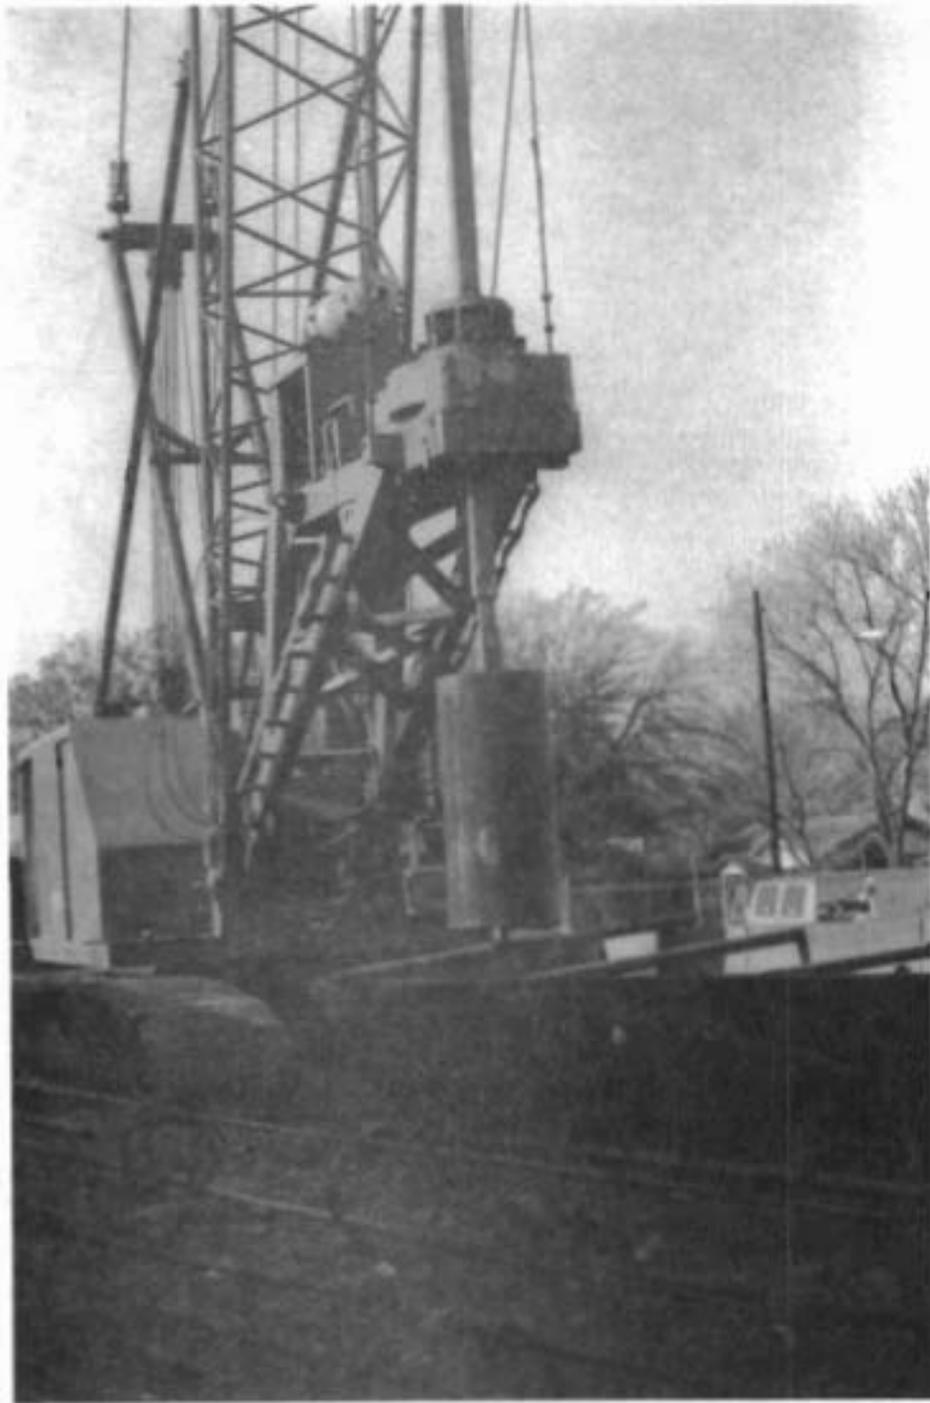
Fig. 5.11. Extracting bentonite slurry from within steel casing using plunger-type bucket.

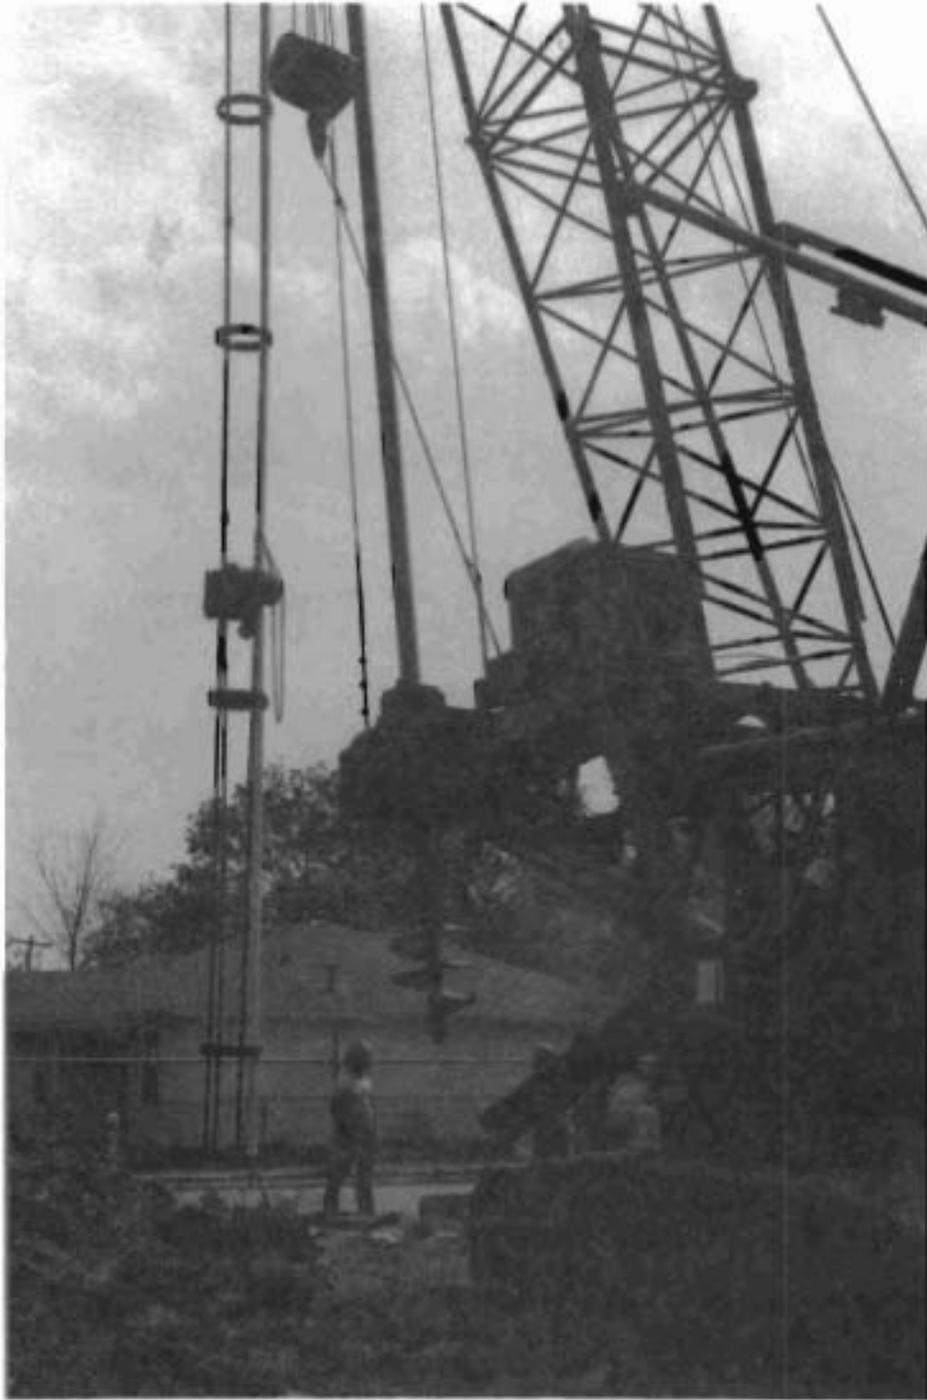
Fig. 5.17. Installing instrumented reinforcing cage with attached soil inclusion "defect".

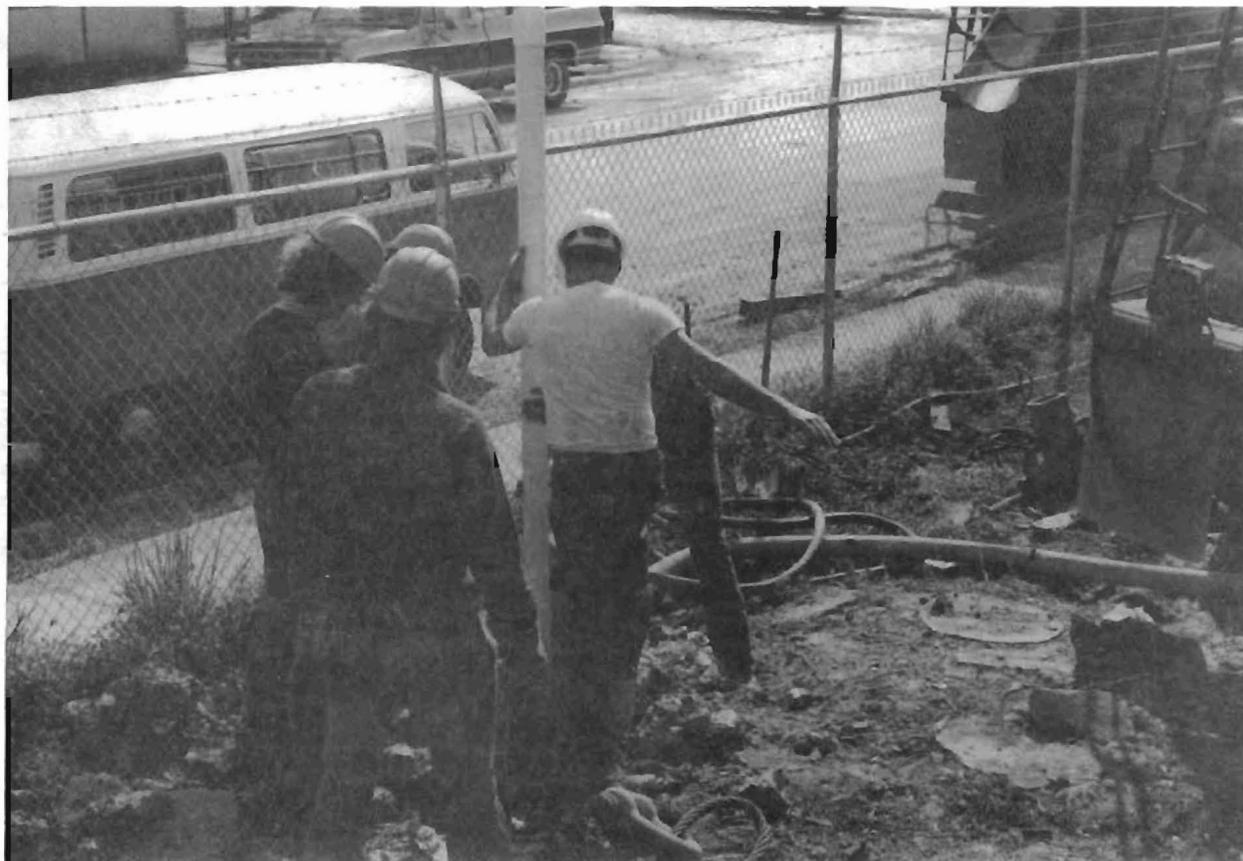
Fig. 5.18. Installing 2.5 in. (6.4 cm) diameter PVC pipe in test shaft.

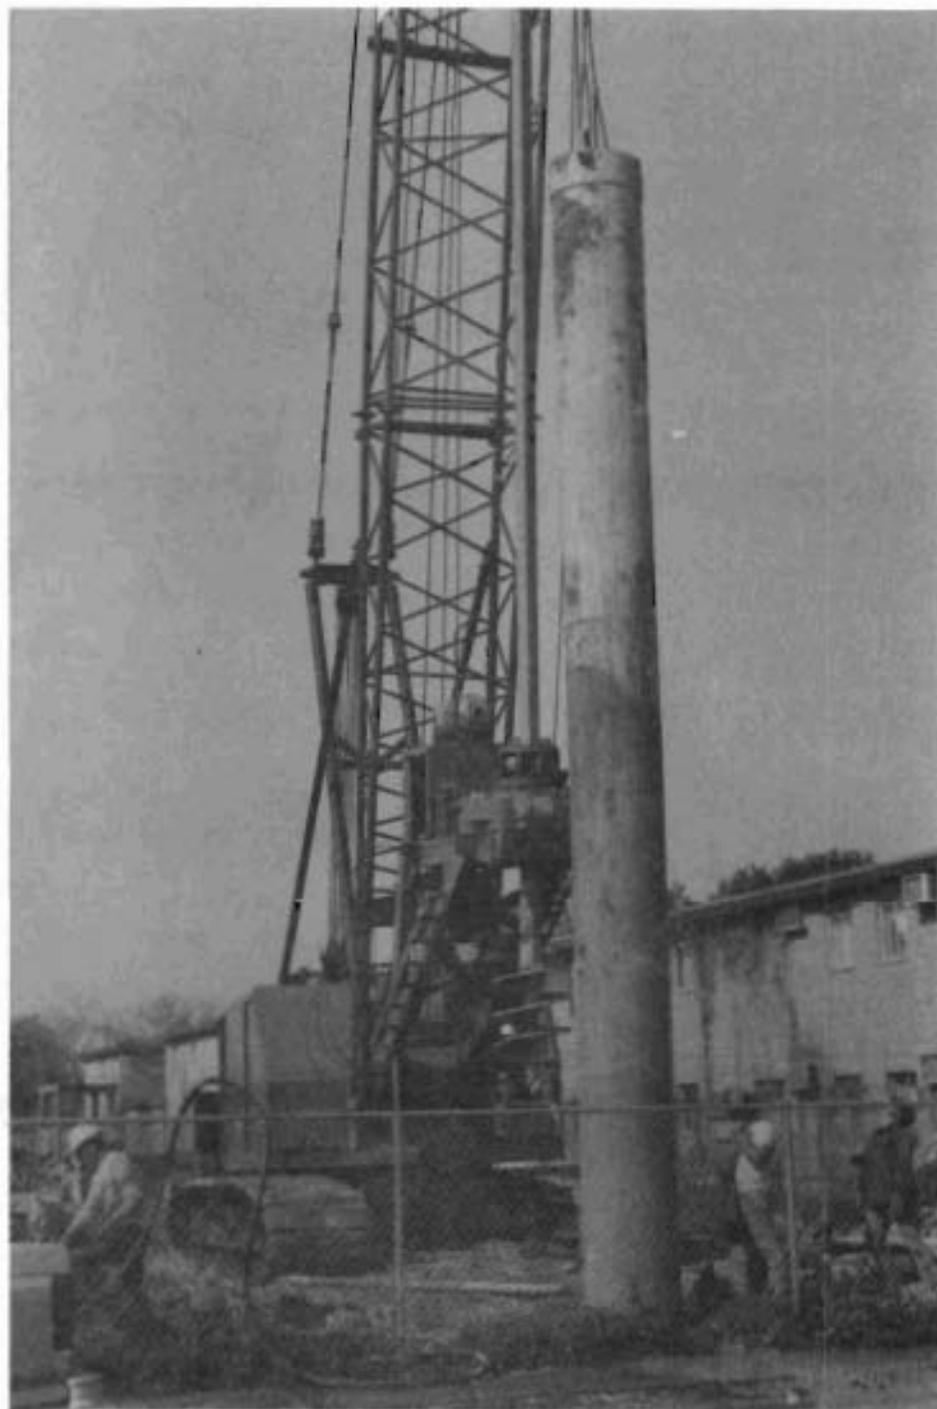
Fig. 5.23. Removing steel casing.

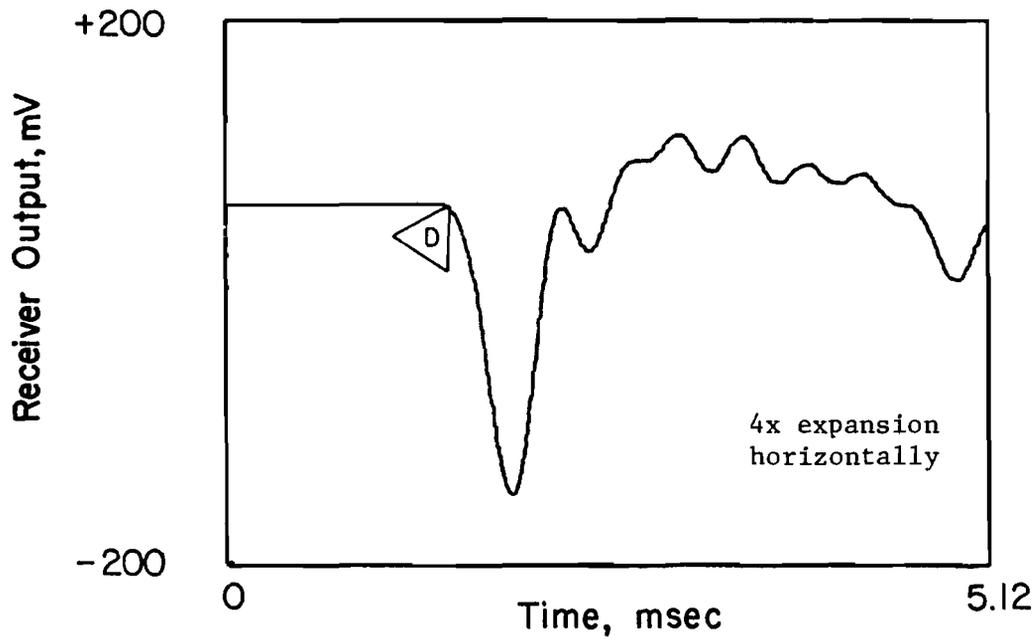
D = Direct Wave Arrival, 1.44 msec
Receiver Depth = 17.9 ft (5.5 m)
Pier Length = 39 ft (11.9 m)
Pier Diameter = 30 in. (76.2 cm)

First Test Site; Granger, Texas. A typical wave signature for a WAPER test performed on Shaft 1 is shown in Fig. 6.1. As described in Chapter 5, Shaft 1 was a 2.5 ft (0.76 m) diameter, 39 ft (11.9 m) long drilled pier, free of planned defects. As shown in Fig. 5.1, the pier was instrumented by Arias (1977) with three vertical velocity transducers positioned at depths of 4.8 ft (1.5 m), 17.9 ft (5.5 m), and 38.3 ft (11.7 m) below the top of the

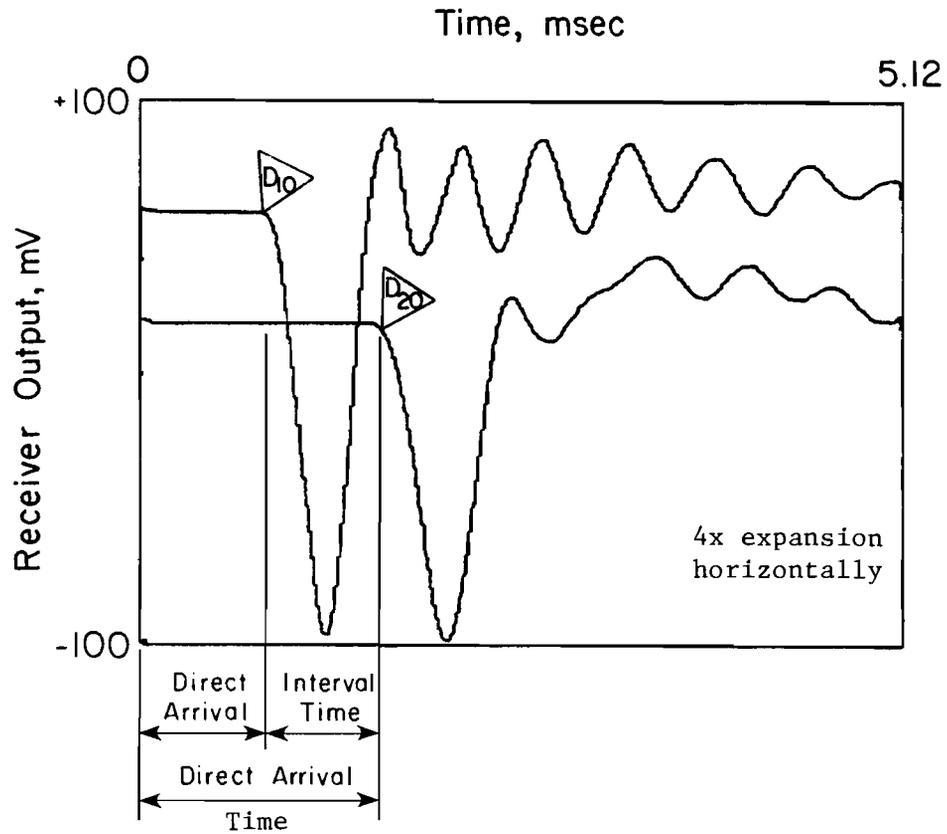
D_{10} = Direct Wave Arrival at 10 ft (3.0 m) receiver, 0.80 msec

Because numerous velocity transducers were embedded in Shaft A, assessment of P-wave velocity throughout the sound pier could be done. In Fig. 6.4, initial wave excitation recorded at the 10 ft (3.0 m), 20 ft (6.1
