1. Report No. FHWA/TX-84/04+257-1F		2. Government Accession No.		3. Recipient's Catalog No.	
4. Title and Subtitle INTEGRITY EVALUATION OF DRILLED PIERS BY STRESS WAVES				5. Report Date January 1984

INTEGRITY EVALUATION OF DRILLED PIERS BY STRESS WAVES

Research Report Number 257-1F

Evaluation of Drilled Shaft Integrity by Stress Waves
Research Project 3-5-80-257

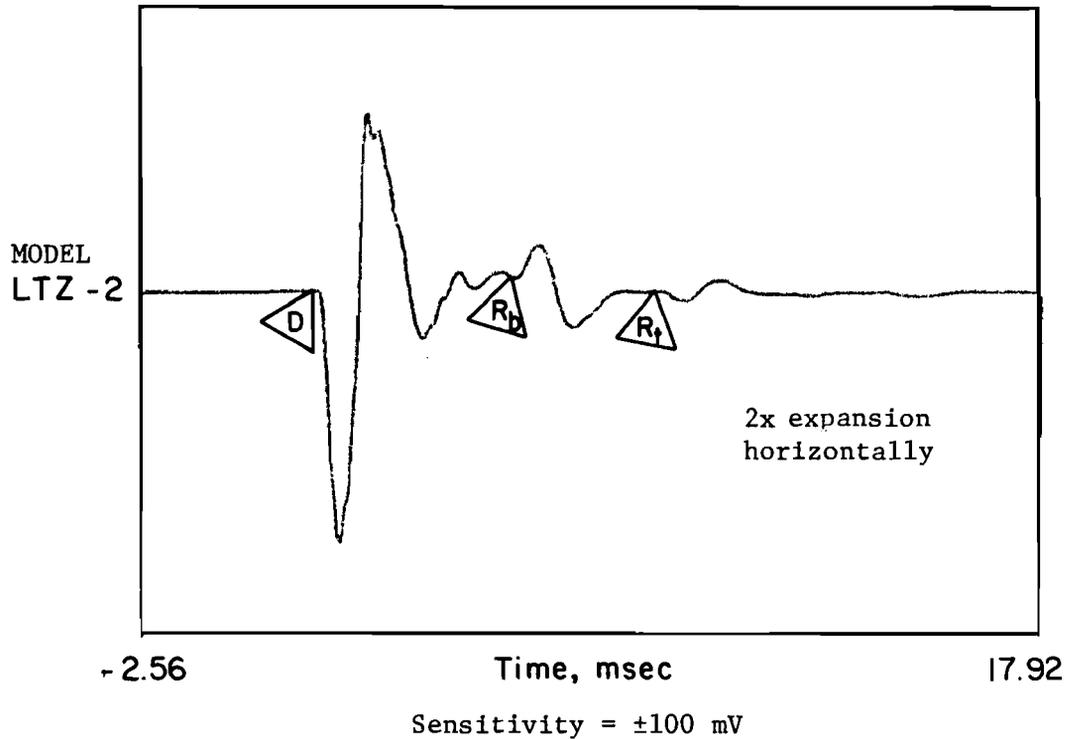
D = Direct wave arrival, 1.48 msec

A typical wave propagation record for a piezoelectric transducer embedded in Shaft A (Houston site) is shown in Fig. 6.9. The output shown in

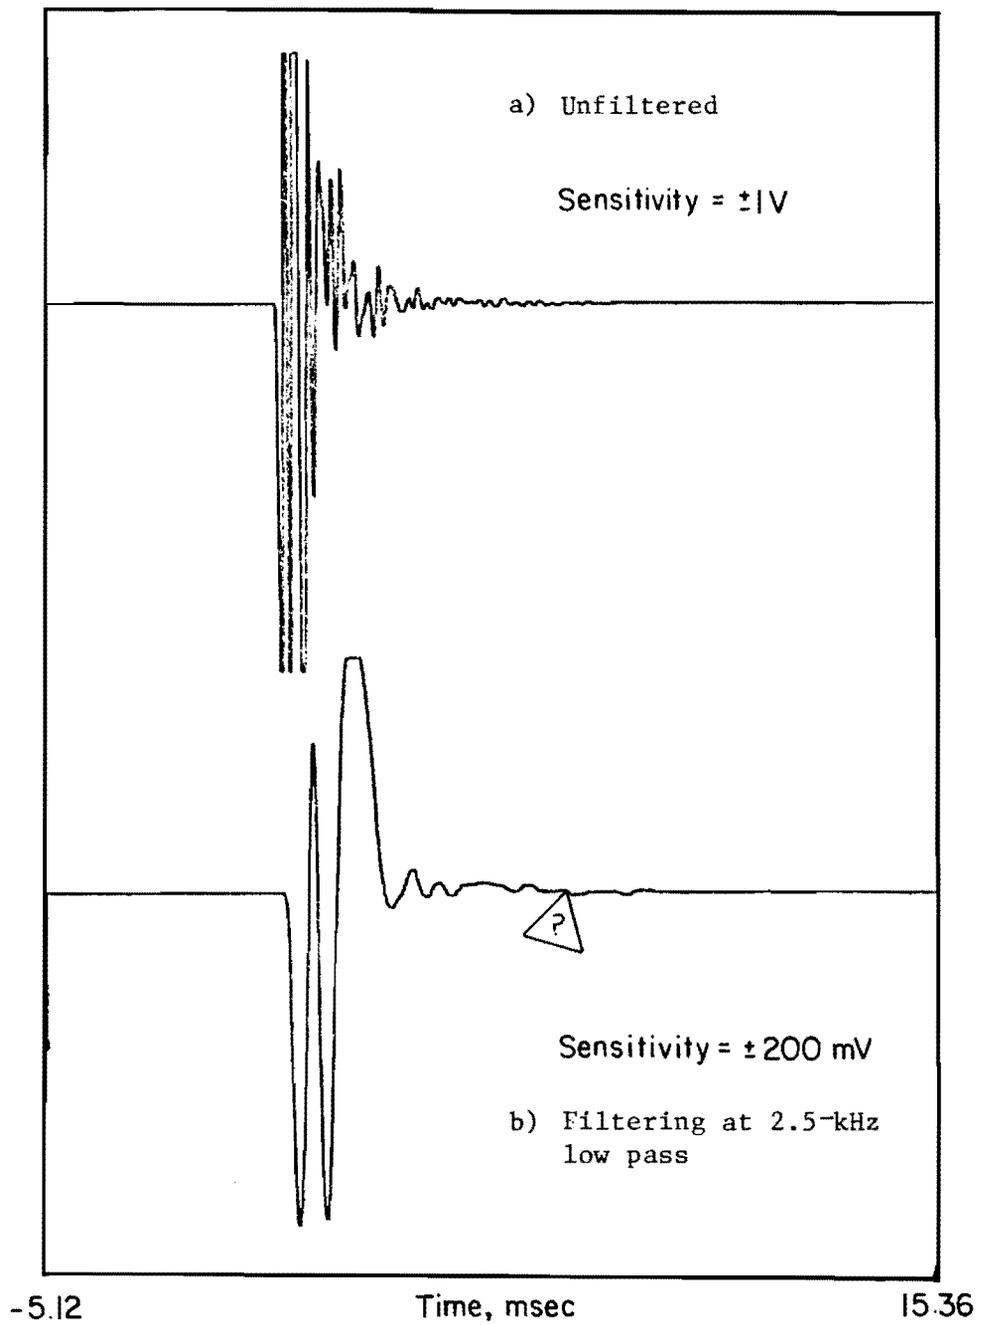
Fig. 6.16. WAPS test on Shaft A (Houston site) using drop hammer source and a velocity transducer as a surface receiver.

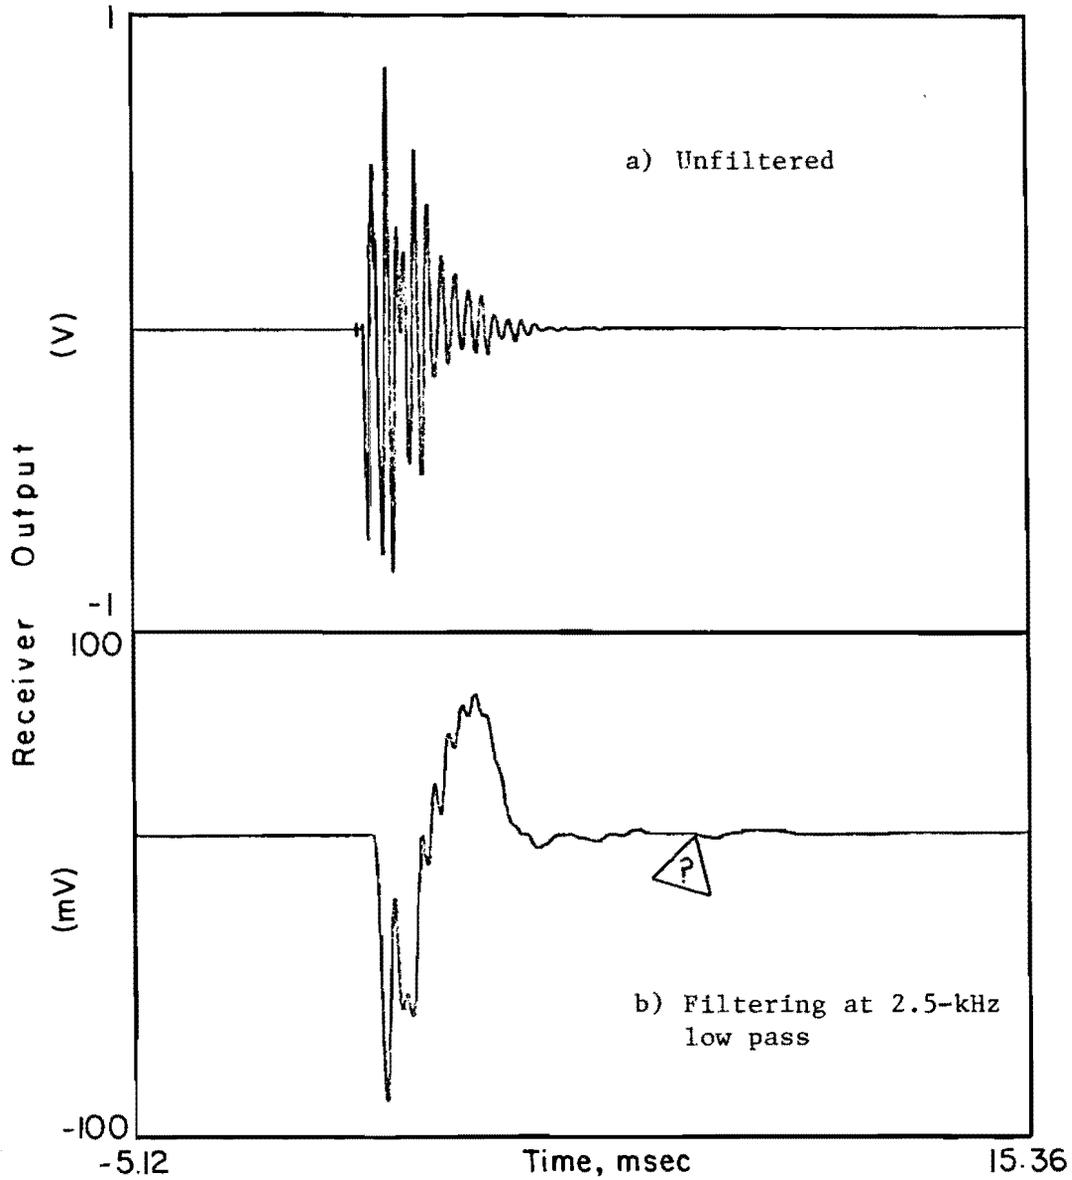
Fig. 6.17. WAPS test on Shaft A (Houston site) using hand-sledge-and embedded-nail source and a velocity transducer as a surface receiver.

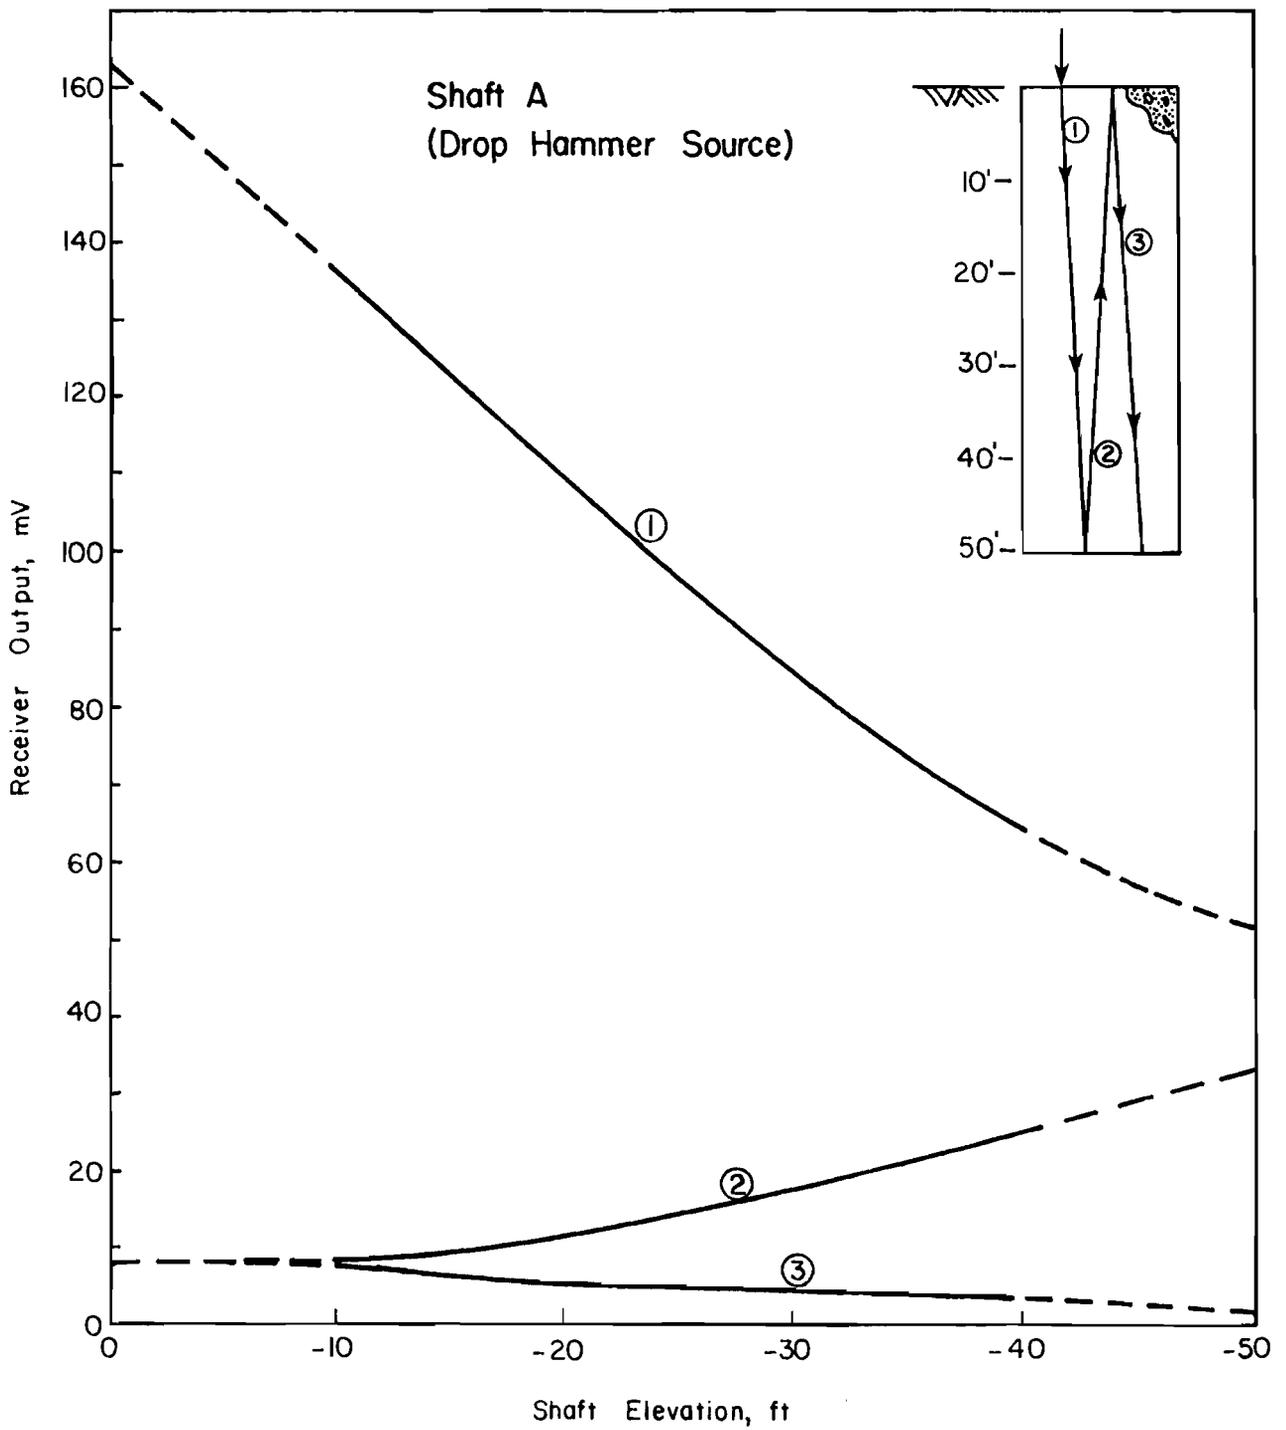
Fig. 6.21. Attenuation of P-wave in Shaft A (Houston site).

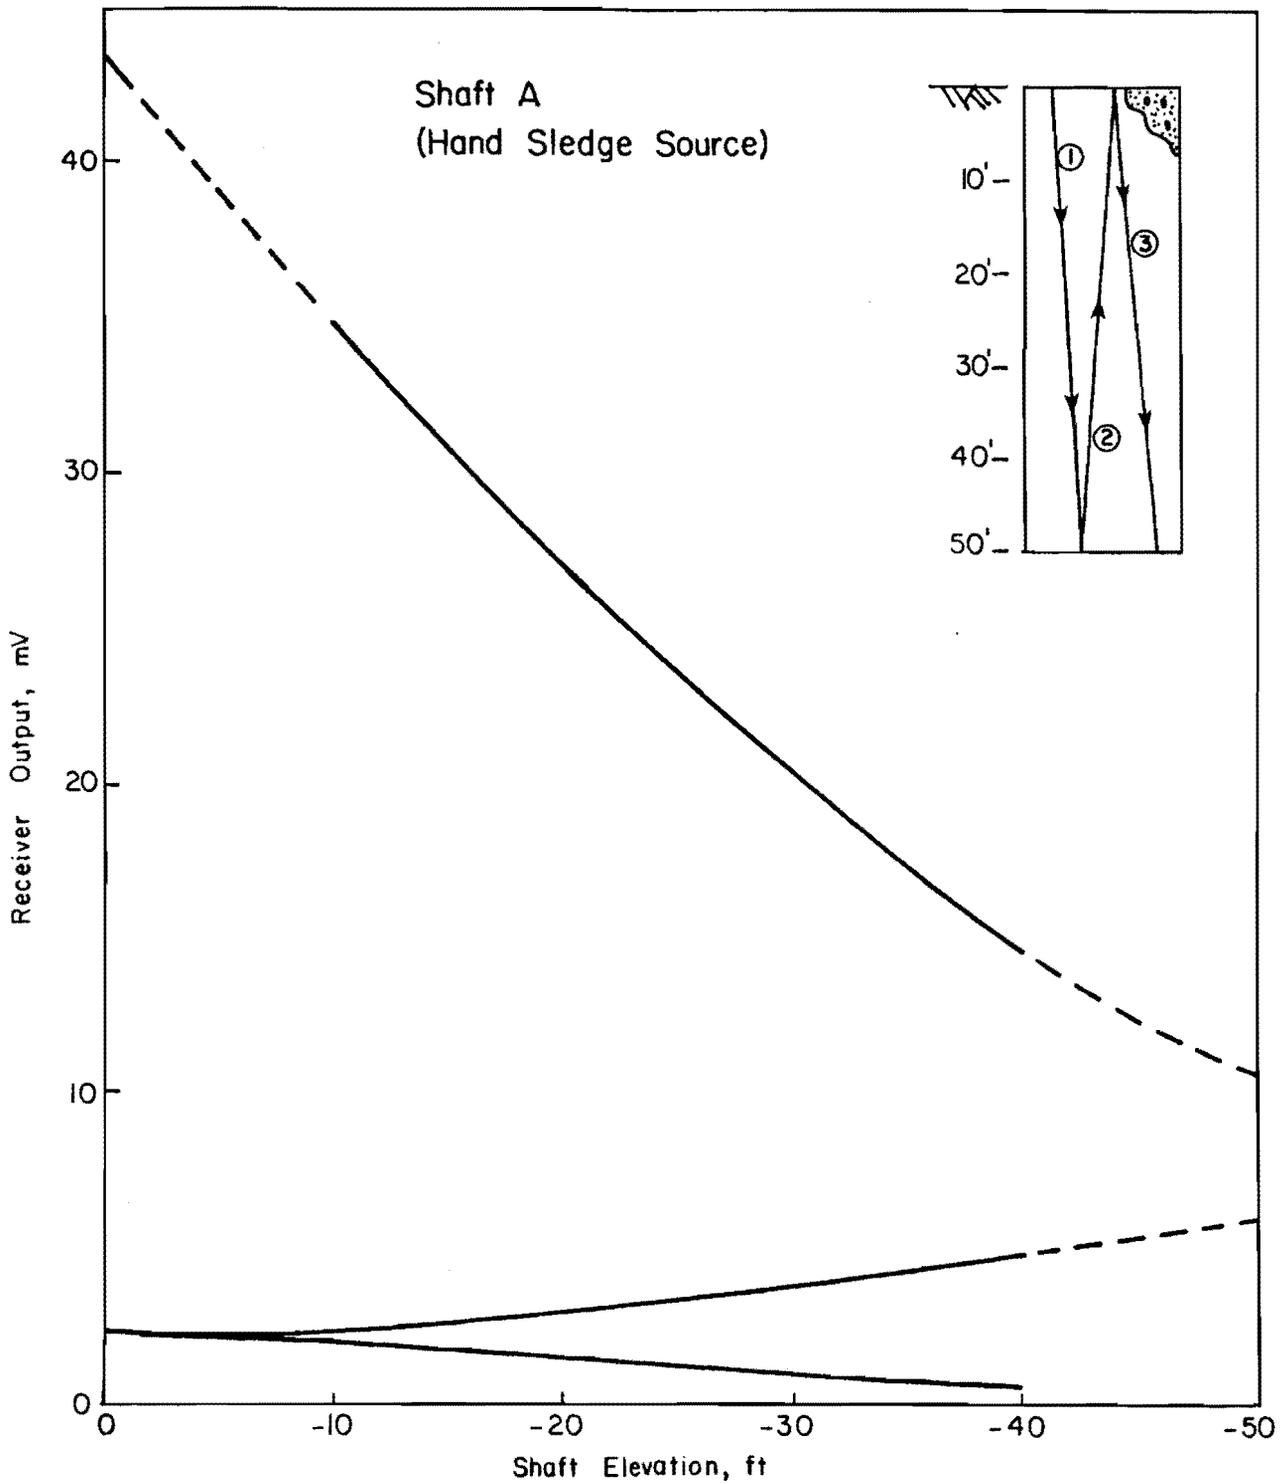
Fig. 6.23. Attenuation of P-wave in Shaft A (Houston site).

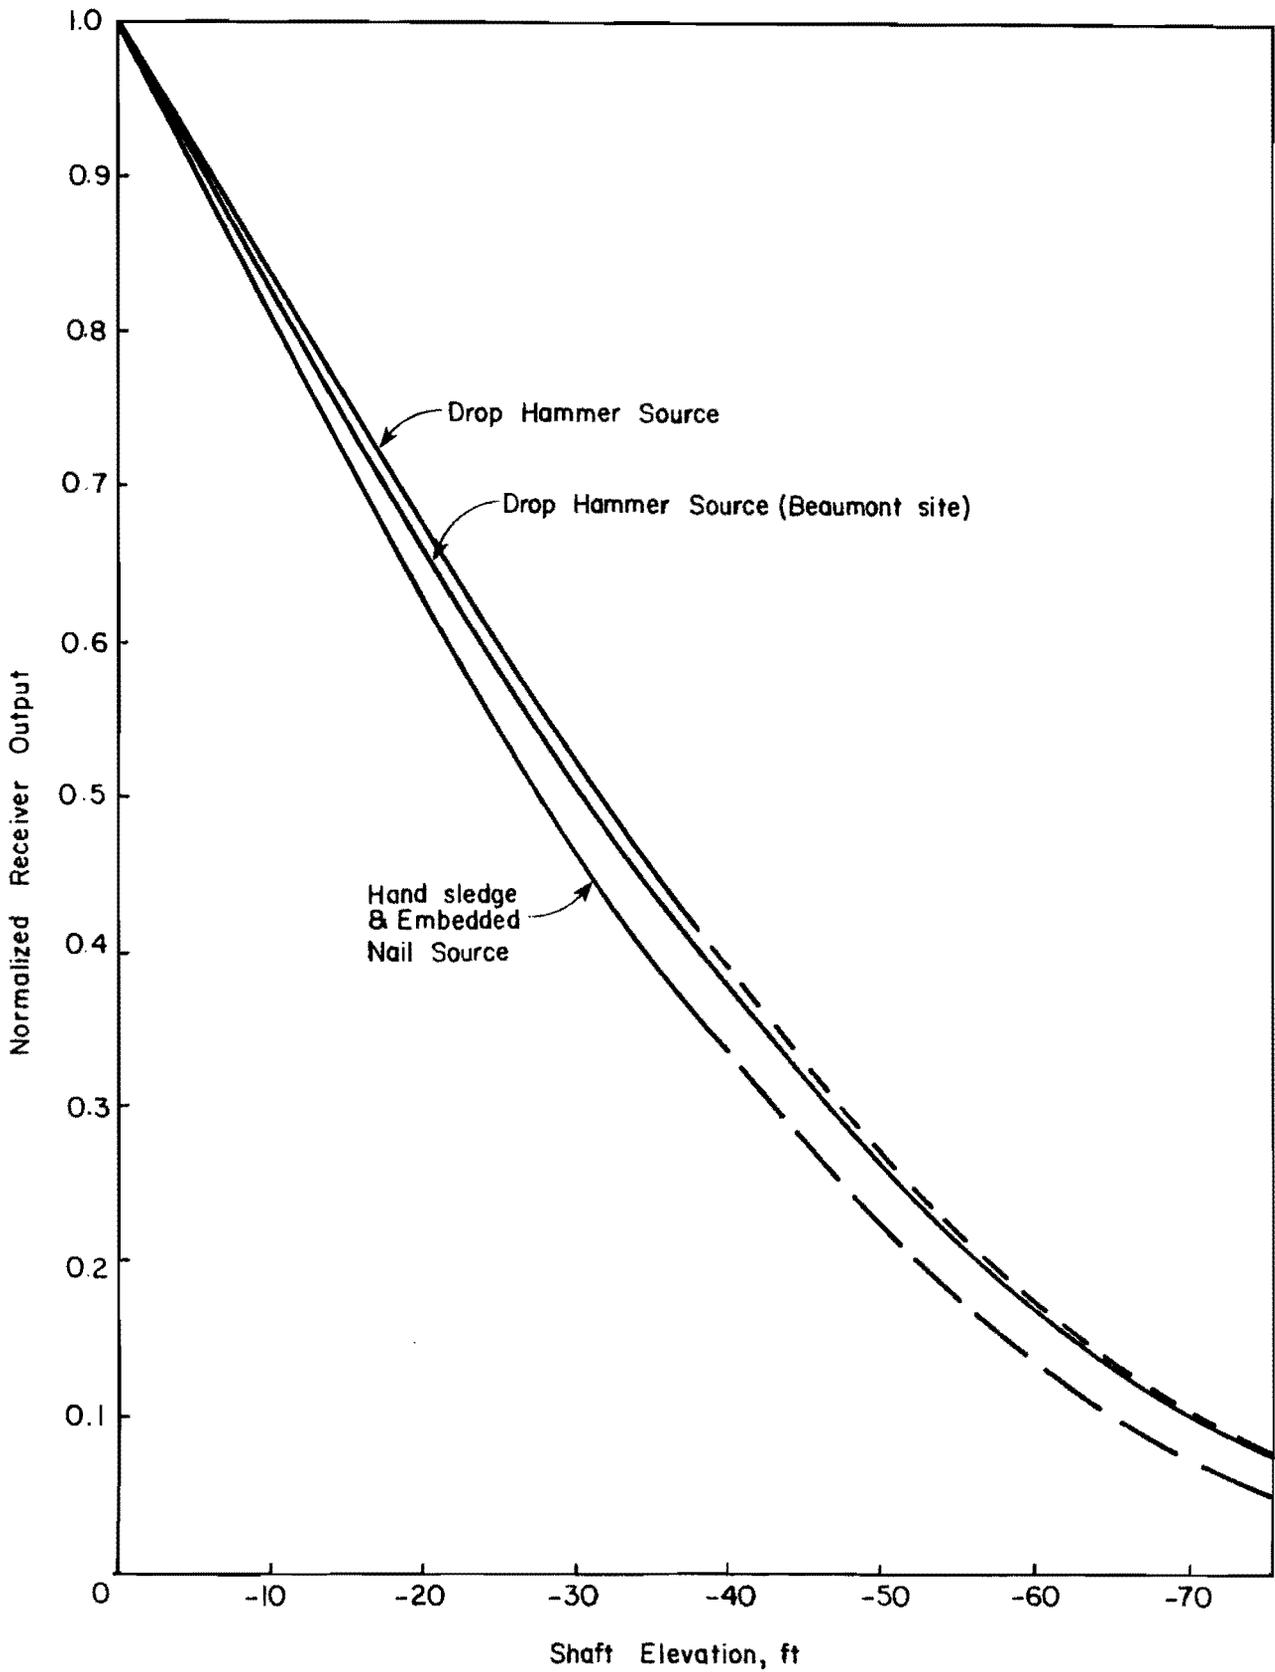
Fig. 6.24. Normalized attenuation of direct P-wave in Shaft A (Houston site).

One final point is that the data provided in Fig. 6.24 appears to be applicable only to small-diameter piers. A check of a 72 in. (183 cm) diameter, 92 ft (28 m) long, drilled pier constructed at the Beaumont site and evaluated as structurally sound showed considerable deviation from the extrapolated data in Fig. 6.24. Additional research will be required to determine the exact limits of the normalized data.

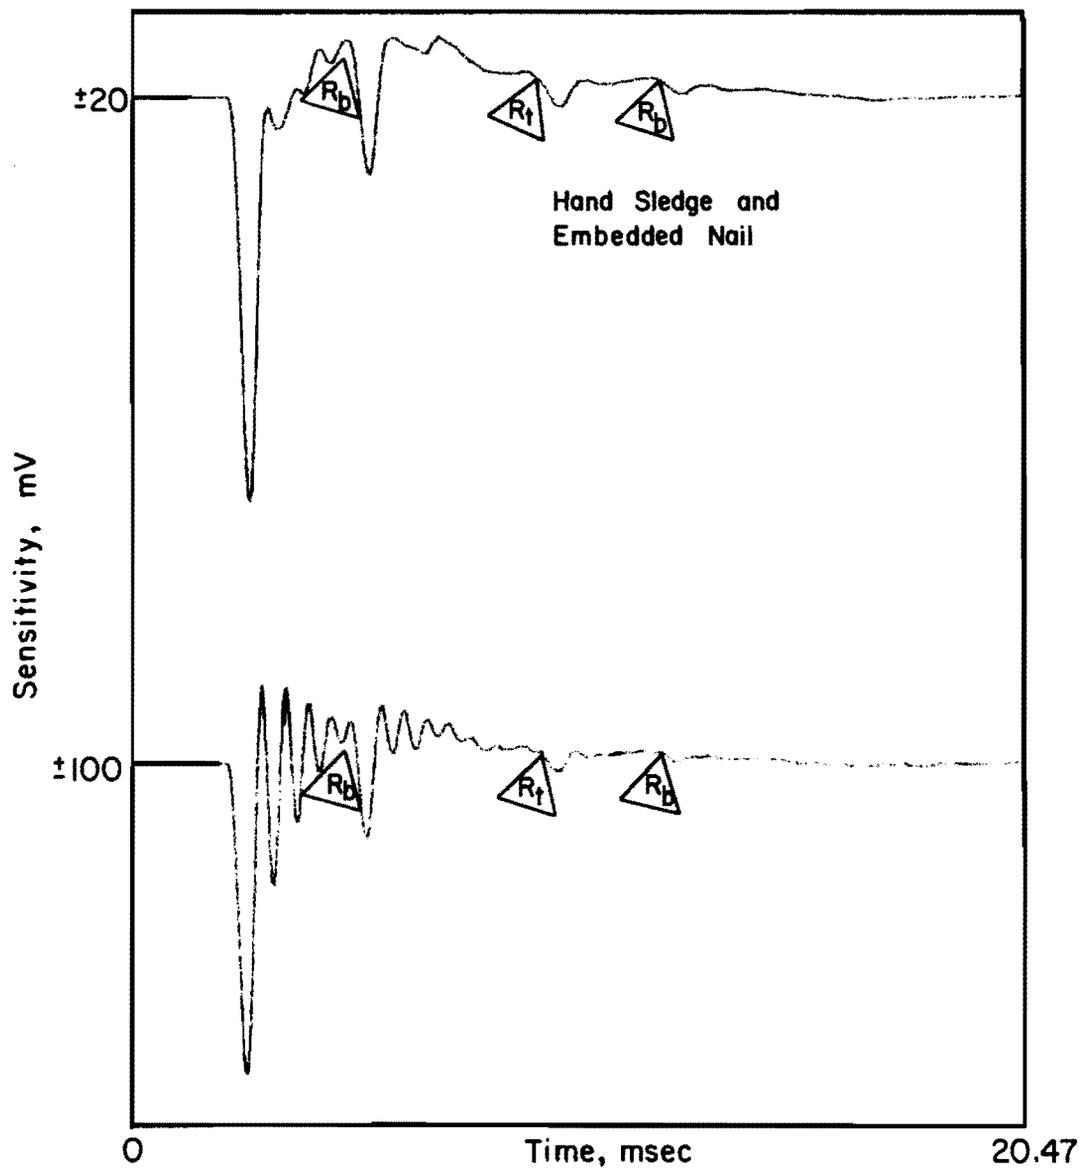
Fig. 6.26. Comparison of records generated with various sources; hand sledge and embedded nail versus drop hammer (Shaft A).

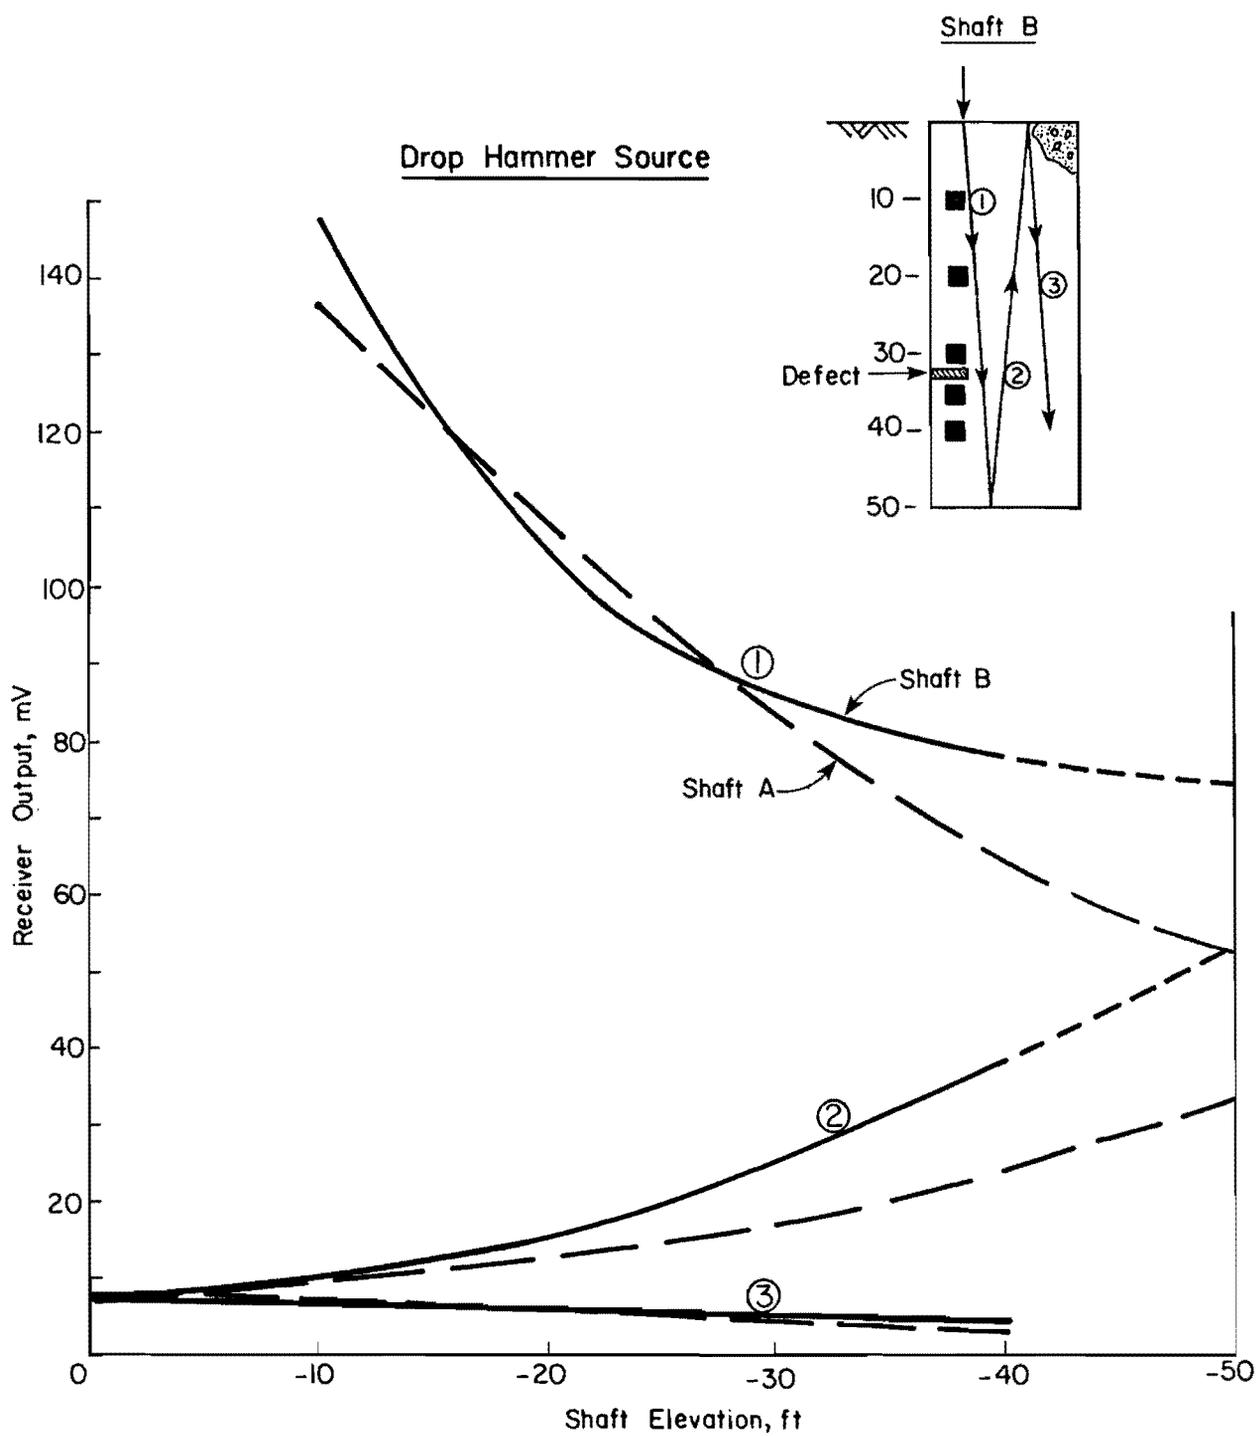
Fig. 7.11. Attenuation of P-wave in Shaft B (Houston site).

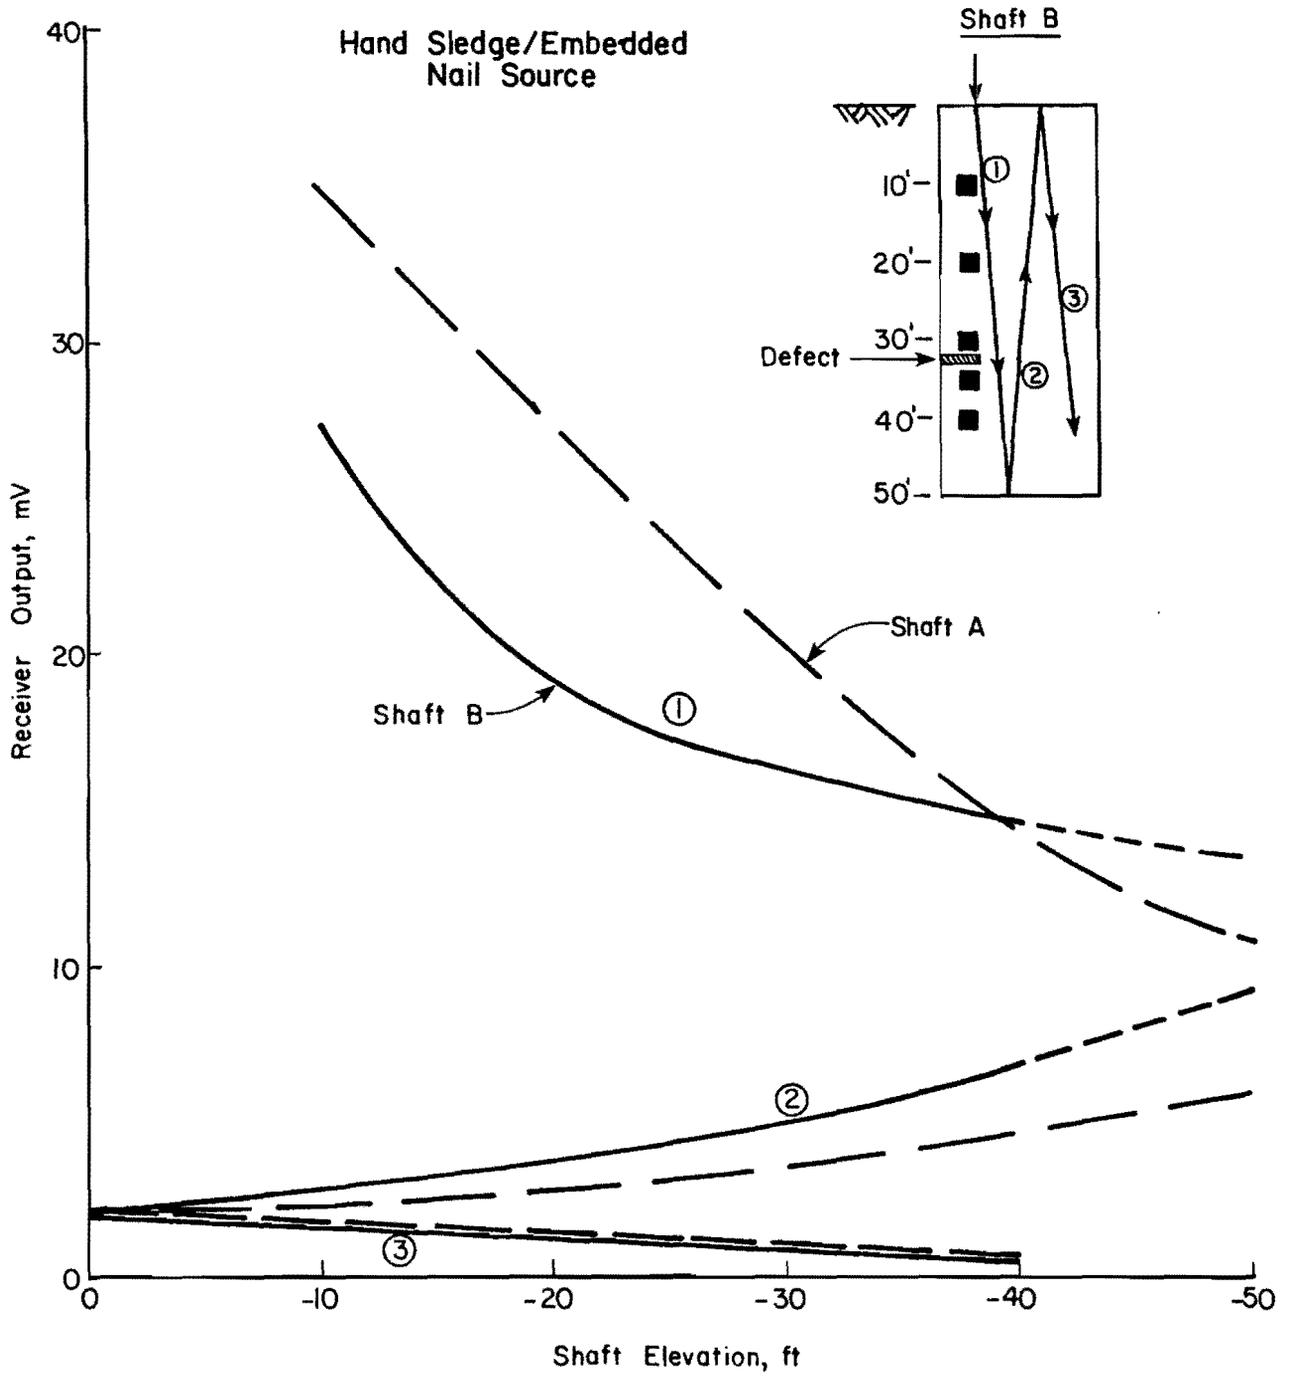
Fig. 7.12. Attenuation of P-wave in Shaft B (Houston site).

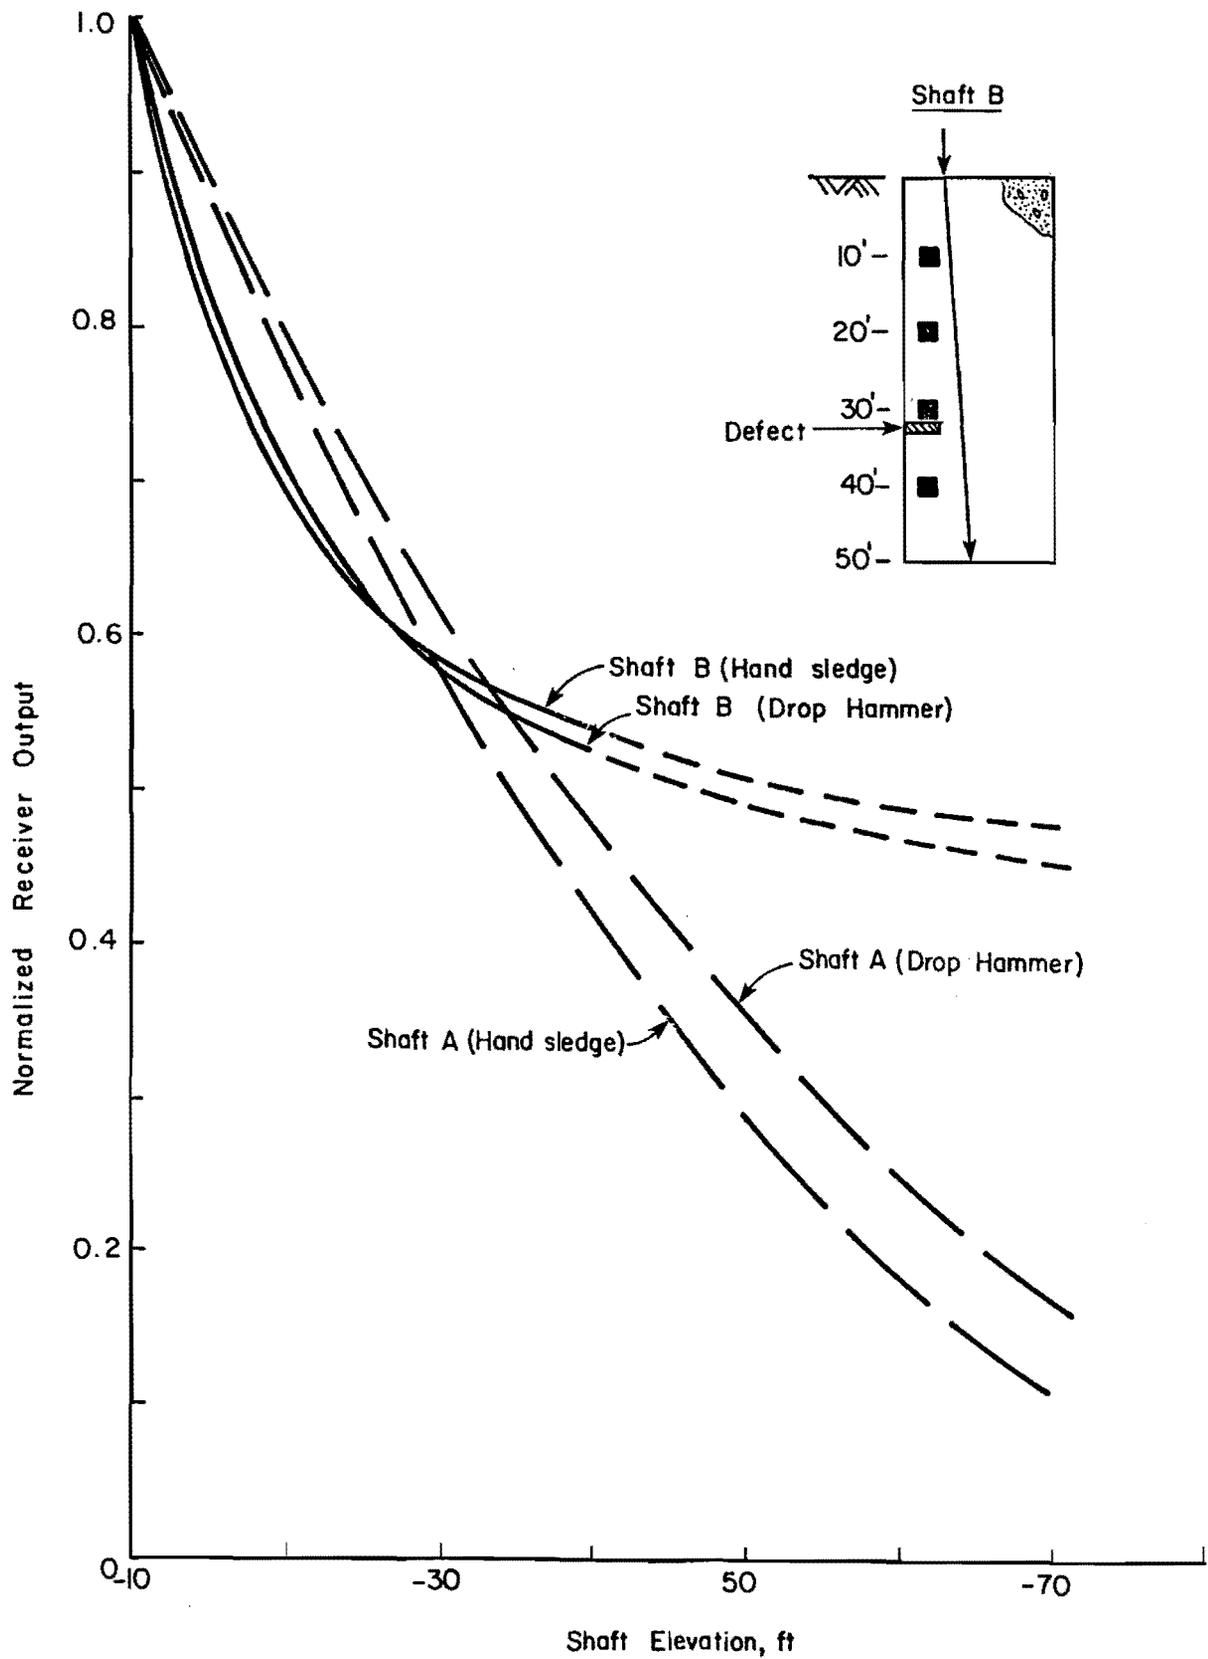
Fig. 7.13. Normalized attenuation of direct P-wave in Shaft B (Houston site).

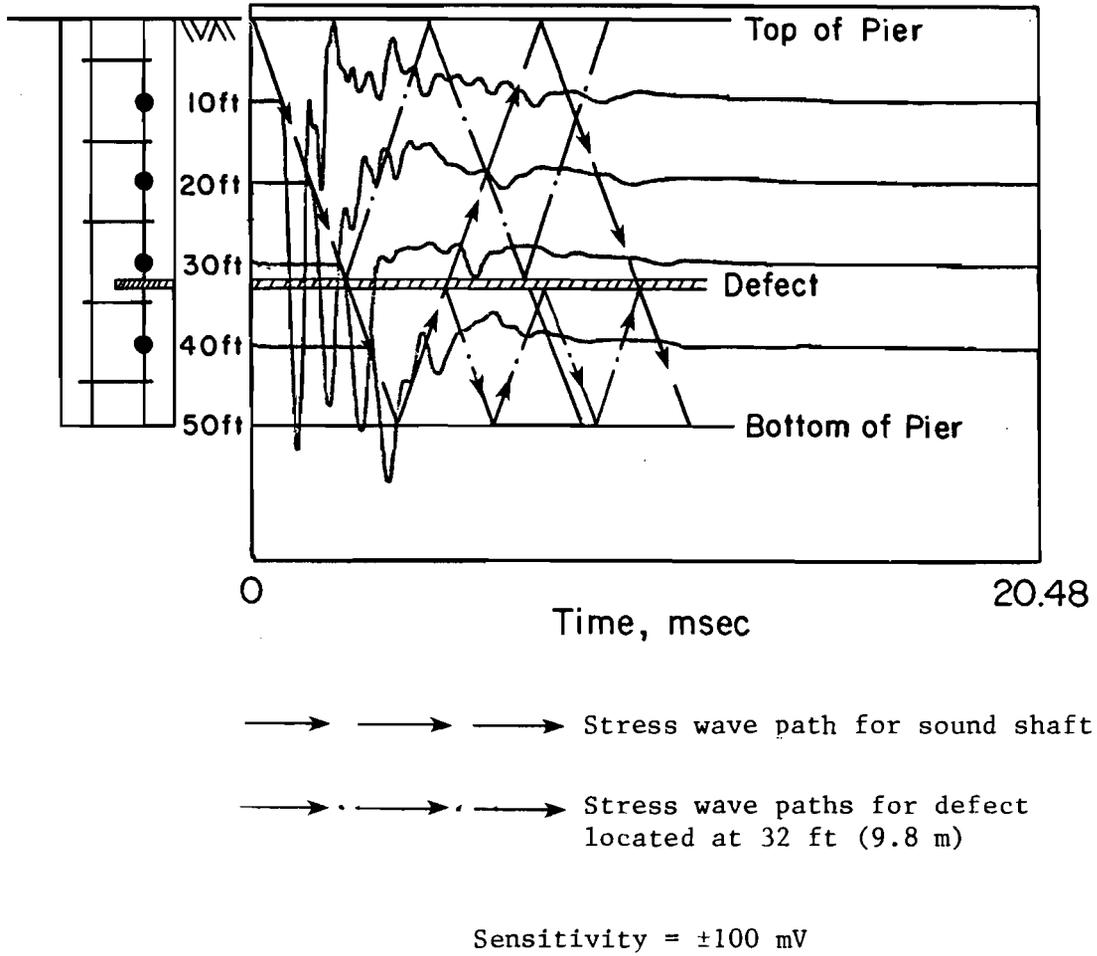
Fig. 7.17. Wave signatures for WAPER test showing wave reflections in Shaft C (Houston site) constructed with 1/2 cross-sectional area soil inclusion.

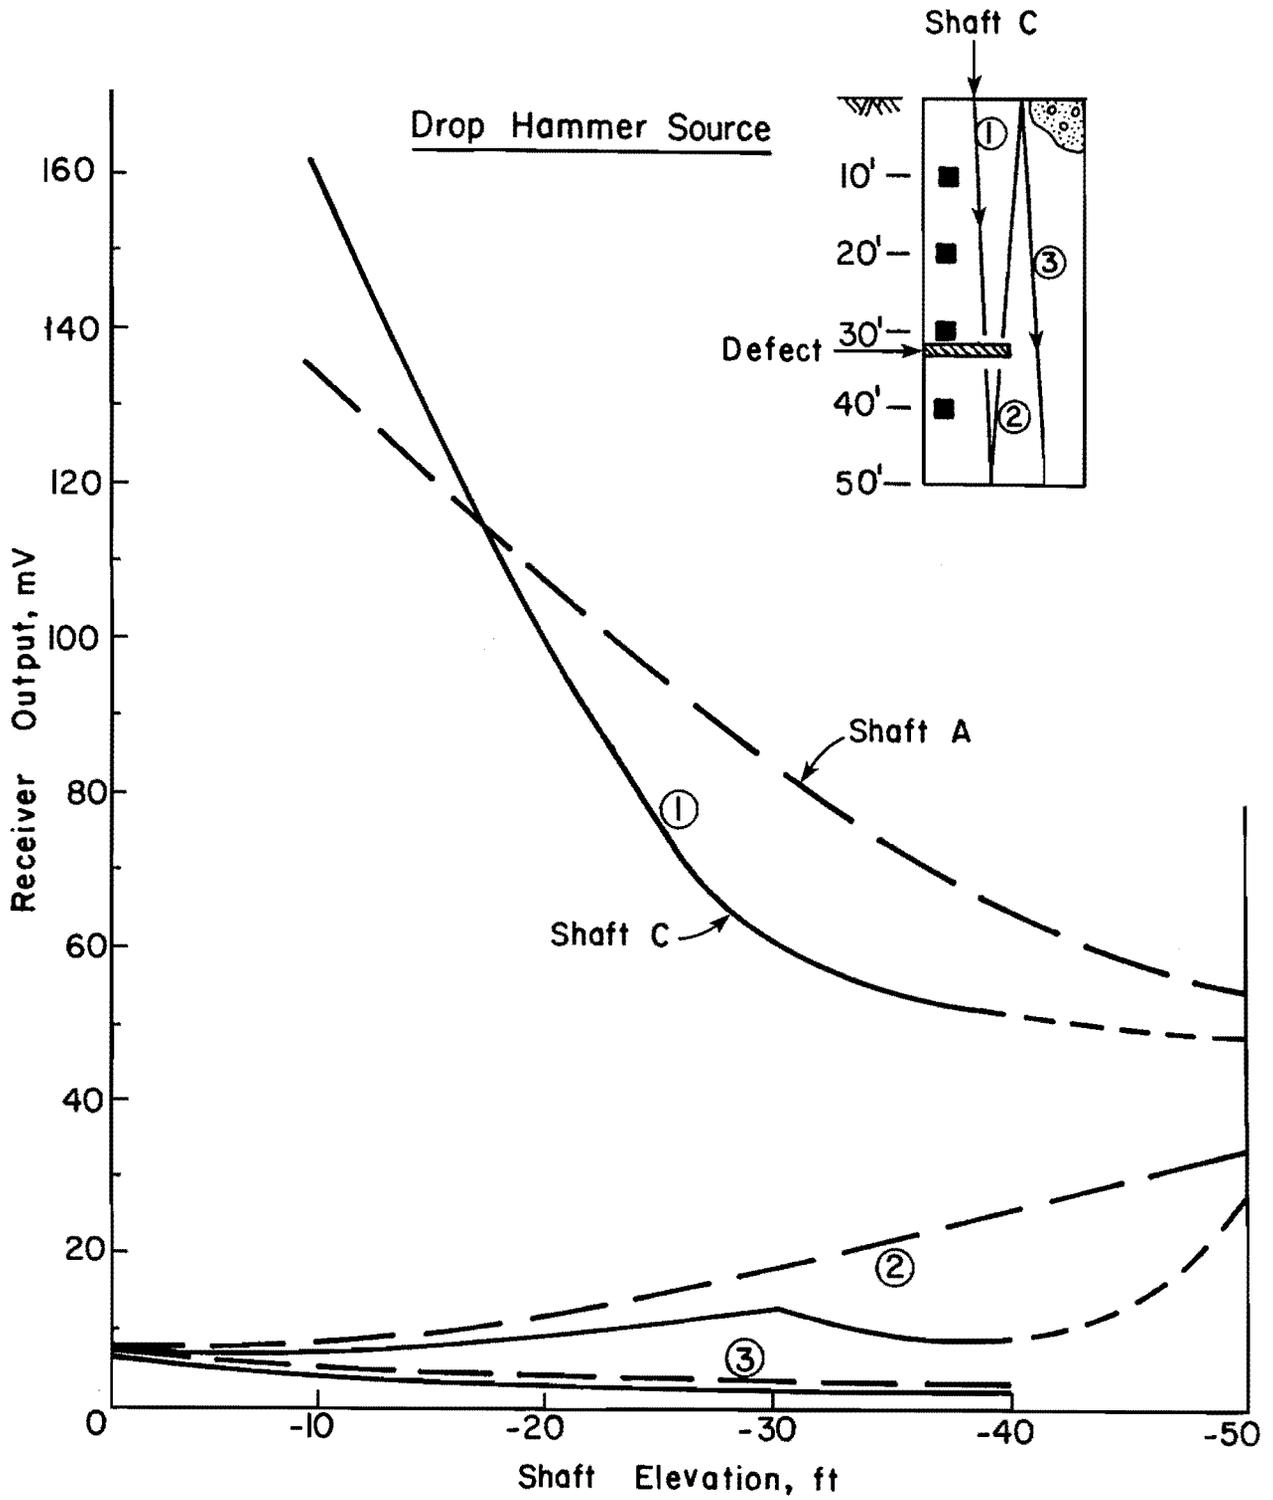
Fig. 7.25. Attenuation of P-wave in Shaft C (Houston site).

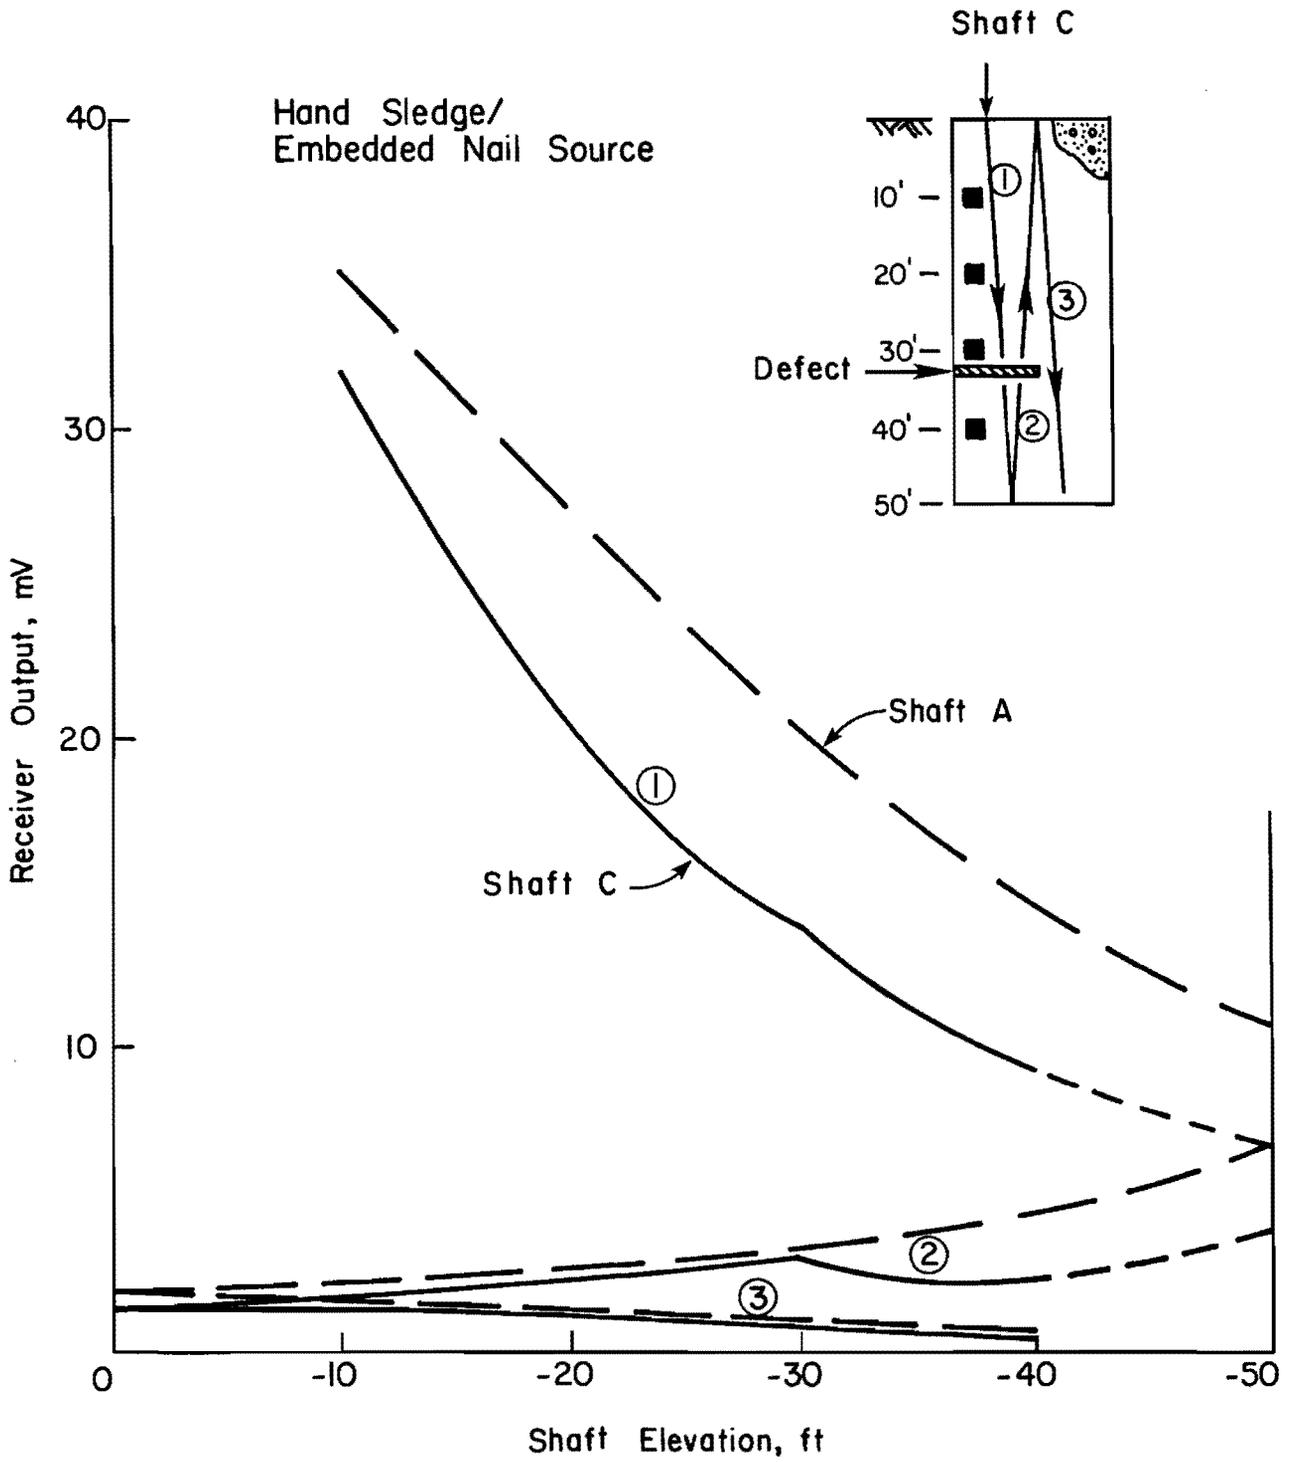
Fig. 7.26. Attenuation of P-wave in Shaft C (Houston site).
