1. Report No. FHWA/TX-84/04+257-1F		2. Government Accession No.		3. Recipient's Catalog No.	
4. Title and Subtitle INTEGRITY EVALUATION OF DRILLED PIERS BY STRESS WAVES				5. Report Date January 1984

INTEGRITY EVALUATION OF DRILLED PIERS BY STRESS WAVES

Research Report Number 257-1F

Evaluation of Drilled Shaft Integrity by Stress Waves
Research Project 3-5-80-257

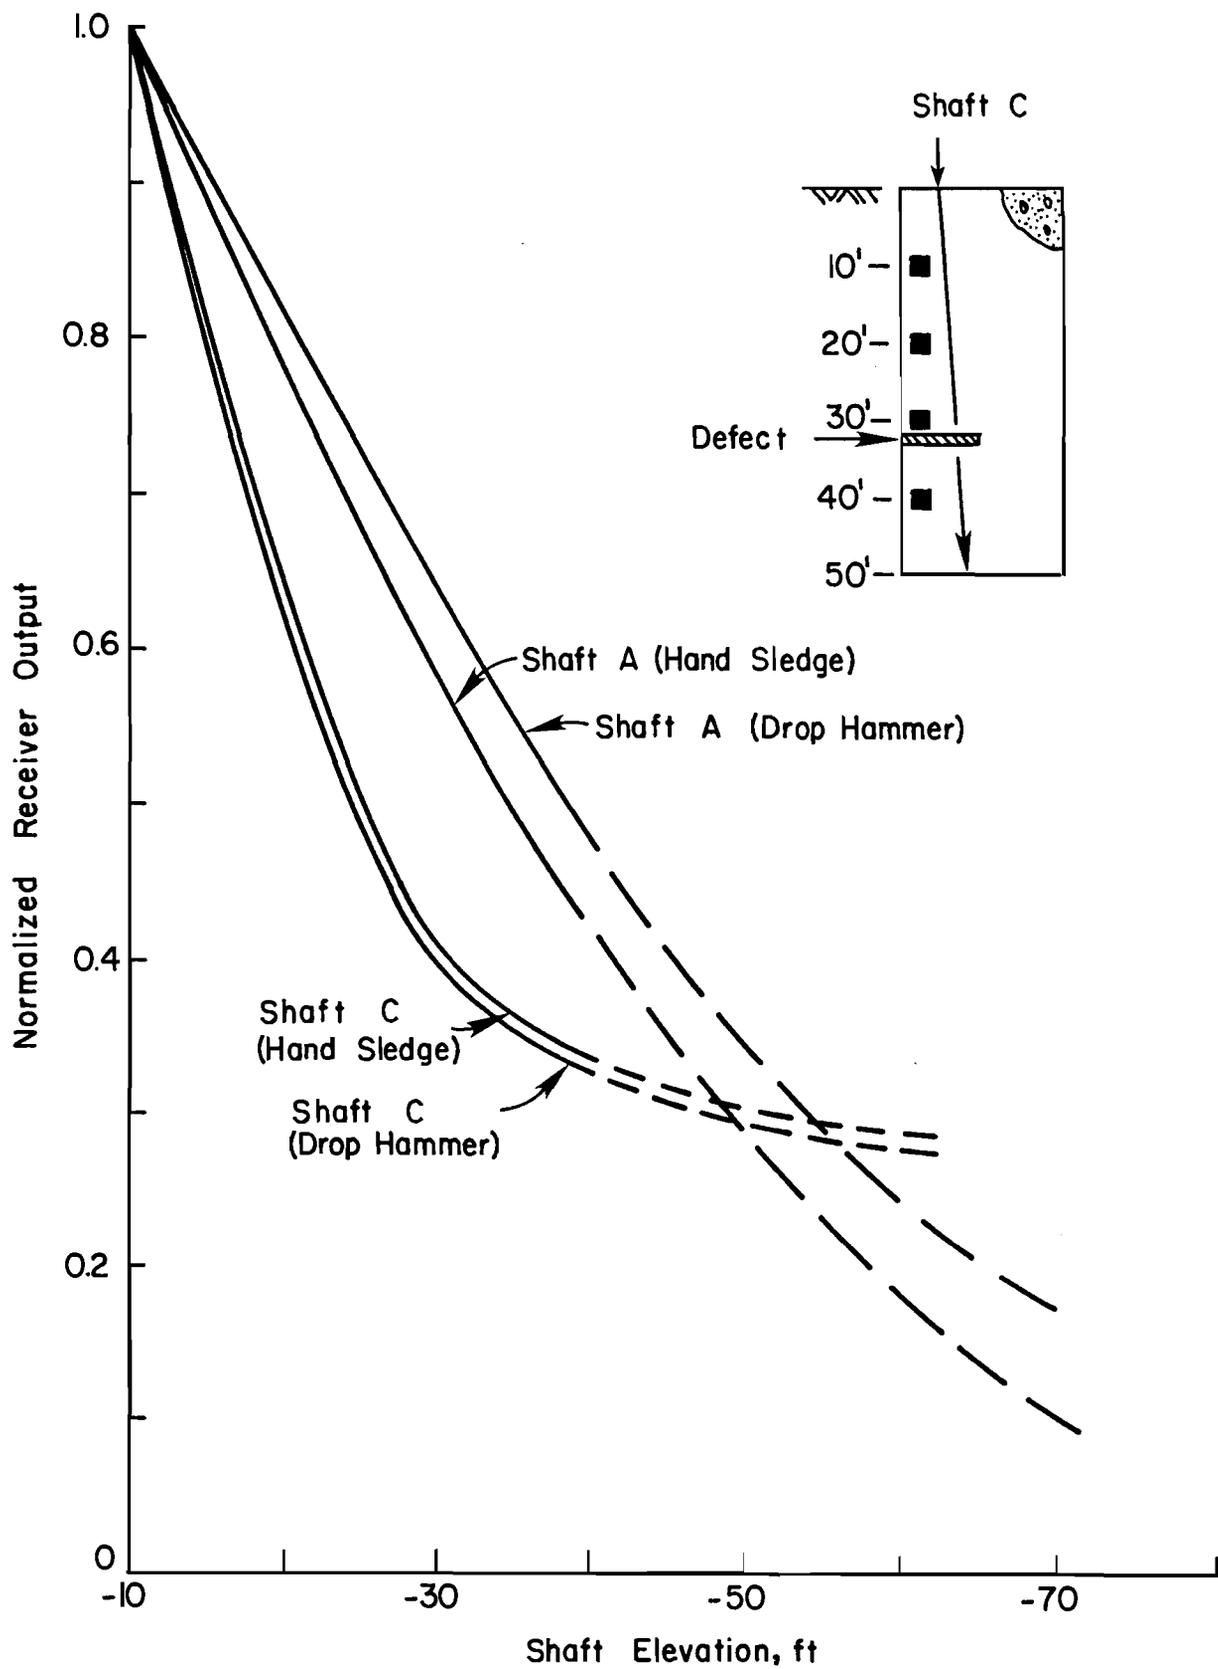
Fig. 7.27. Normalized attenuation of direct P-wave in Shaft C (Houston site).

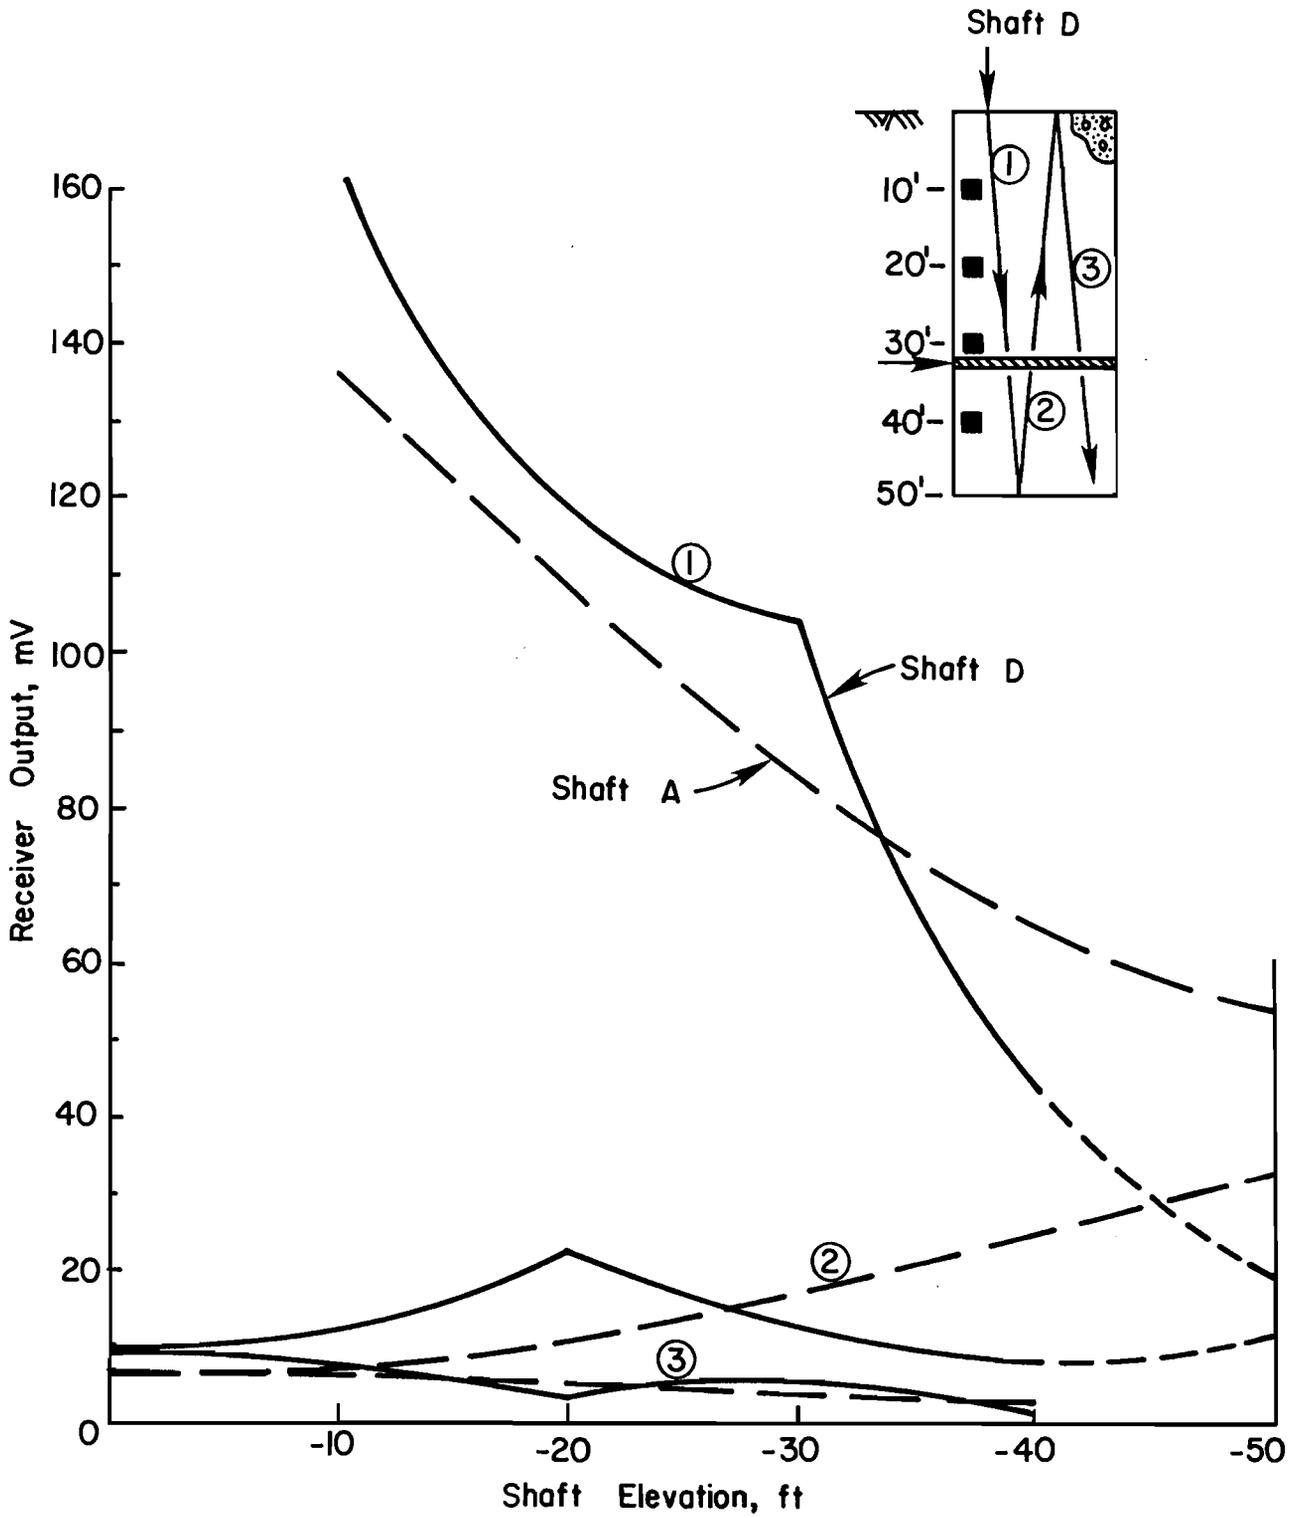
Fig. 7.37. Attenuation of P-wave in Shaft D (Houston site).

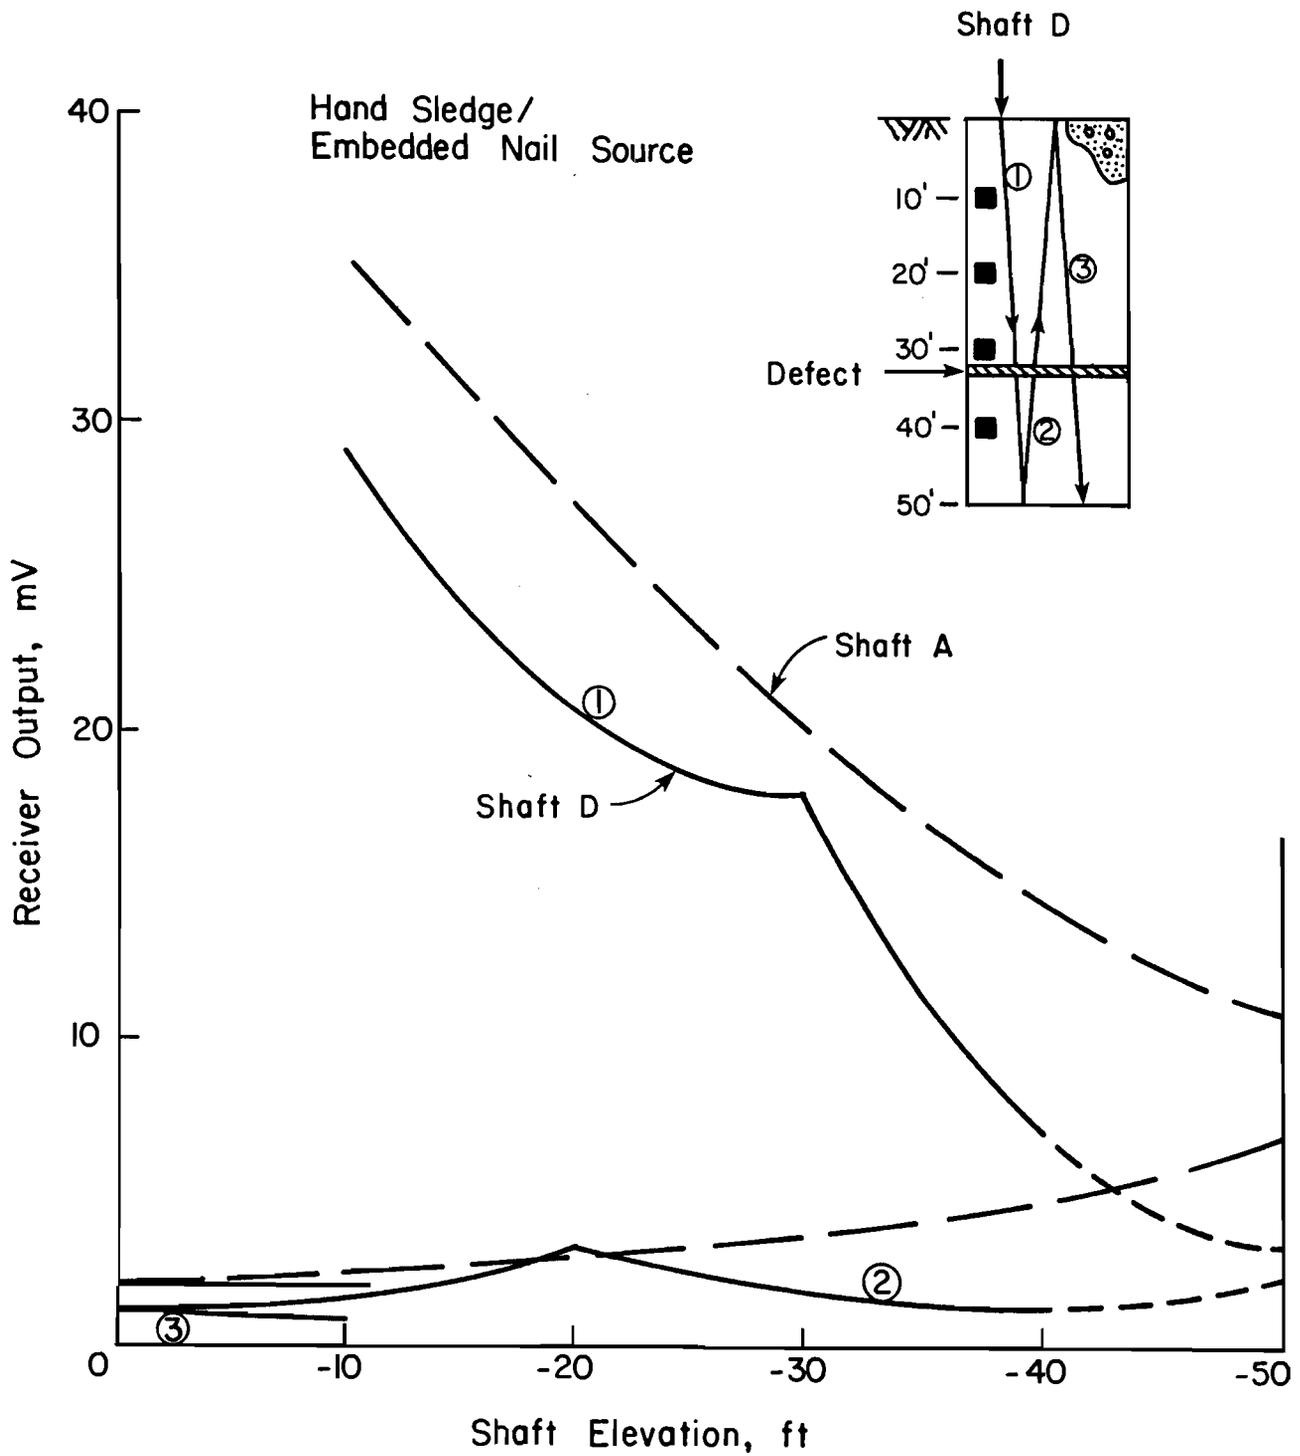
Fig. 7.38. Attenuation of P-wave in Shaft D (Houston site).

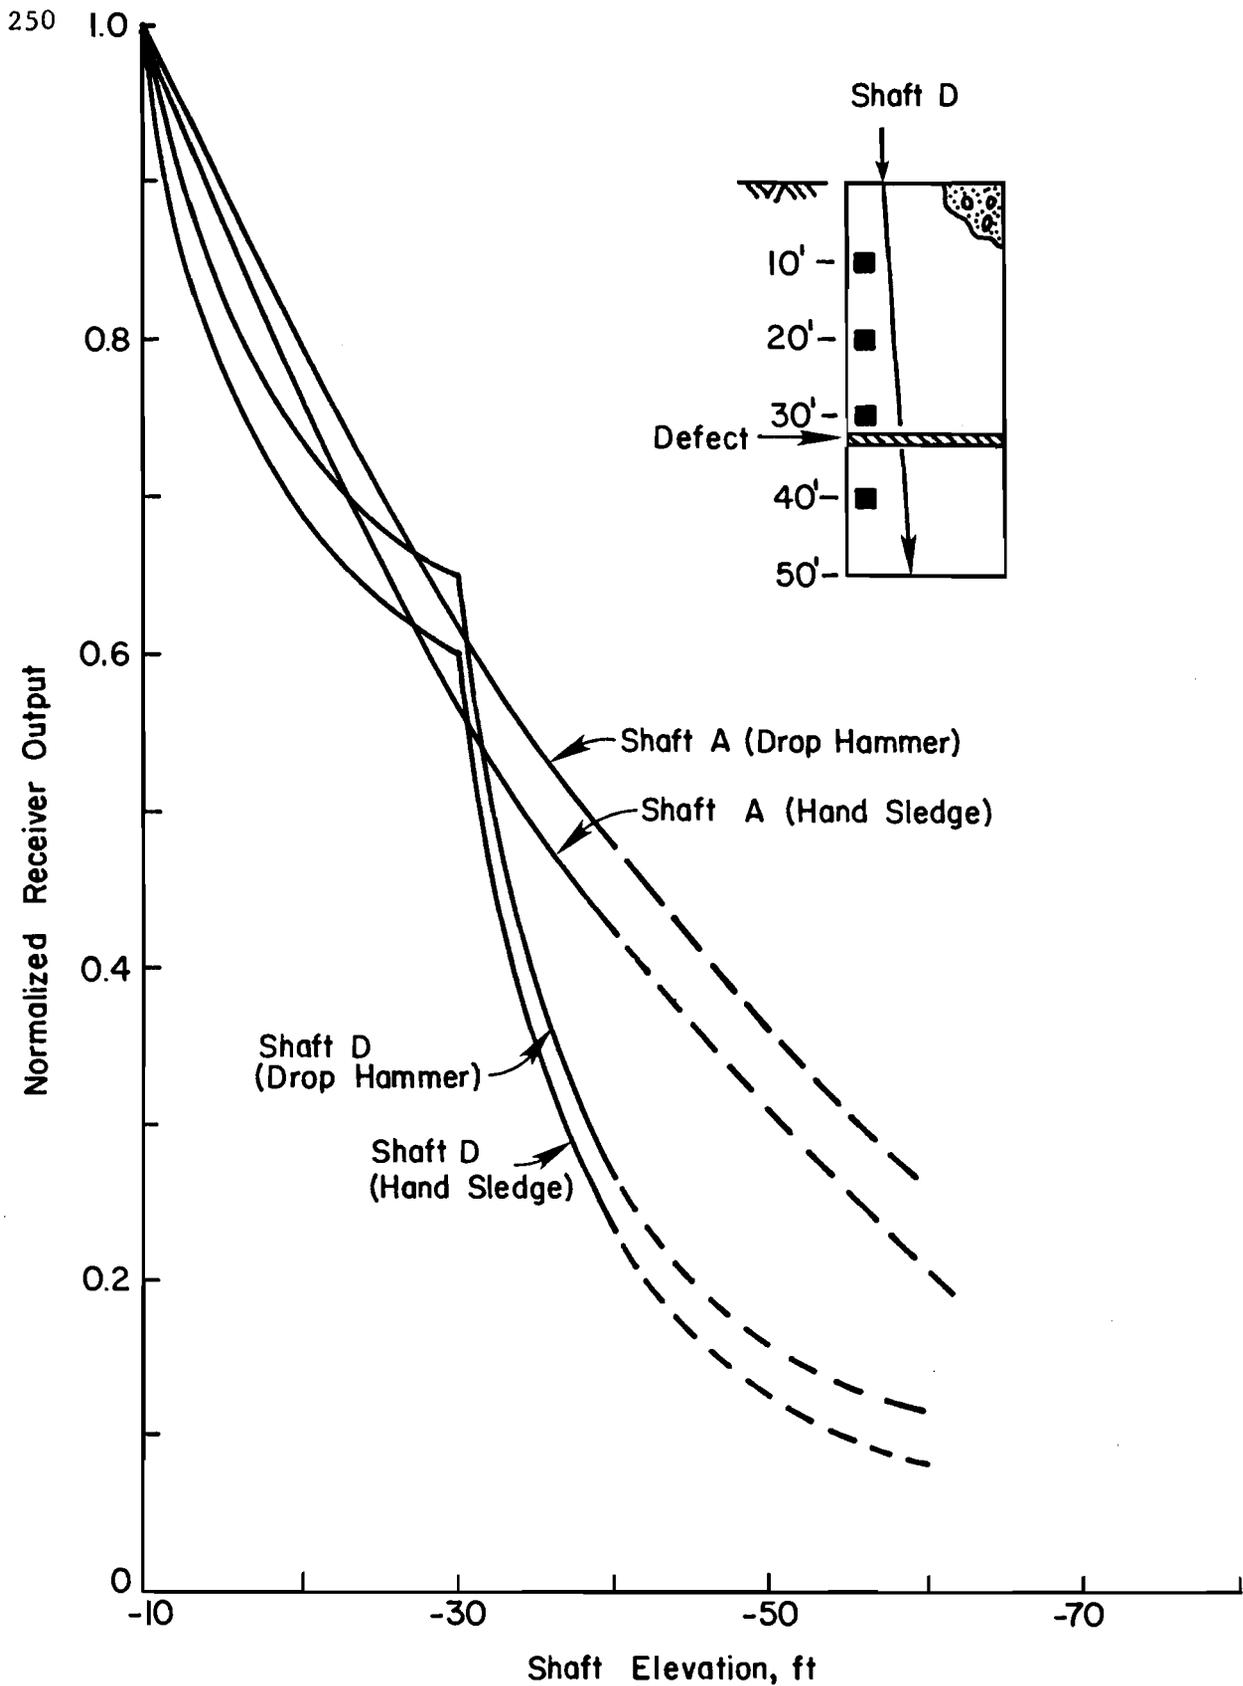
Fig. 7.39. Normalized attenuation of direct P-wave in Shaft D (Houston site).
