EVALUATION OF THE COMPOSITE WING GIRDER
BRIDGE AT BEAR CREEK

Research Report IAC(84-85)-0799-1F

Measuring and Predicting Stresses of Bear Creek Bridge on FM 1626

This report documents the construction monitoring and subsequent field testing to evaluate the performance of an innovative "loose-fit" composite post-tensioned concrete wing girder bridge constructed over Bear Creek, south of Austin, Texas. The structure was built as a trial evaluation of an early proposed design for an elevated interstate highway expansion.

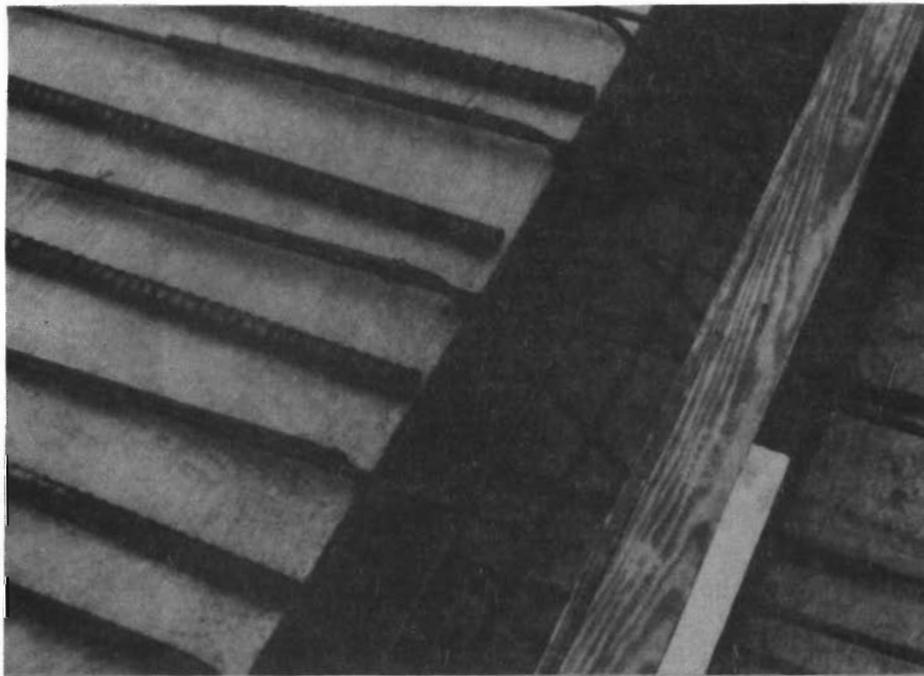
Fig. 2.19 Deck reinforcement cutoff detail over precast panels

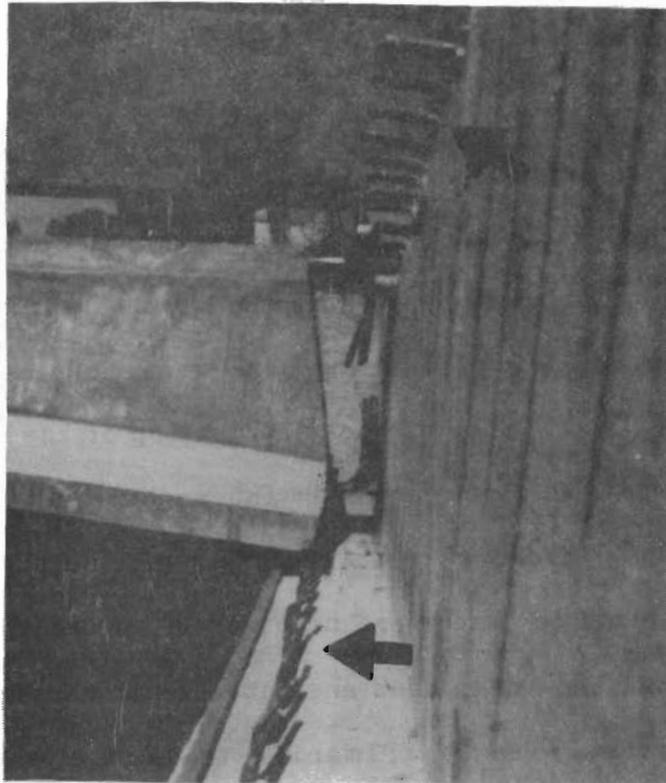
Fig. 2.20 Wing unit in place at abutment III; web hooks at the deck level and vertical closure bars protruding from the wing; ledge are clearly visible (arrows)

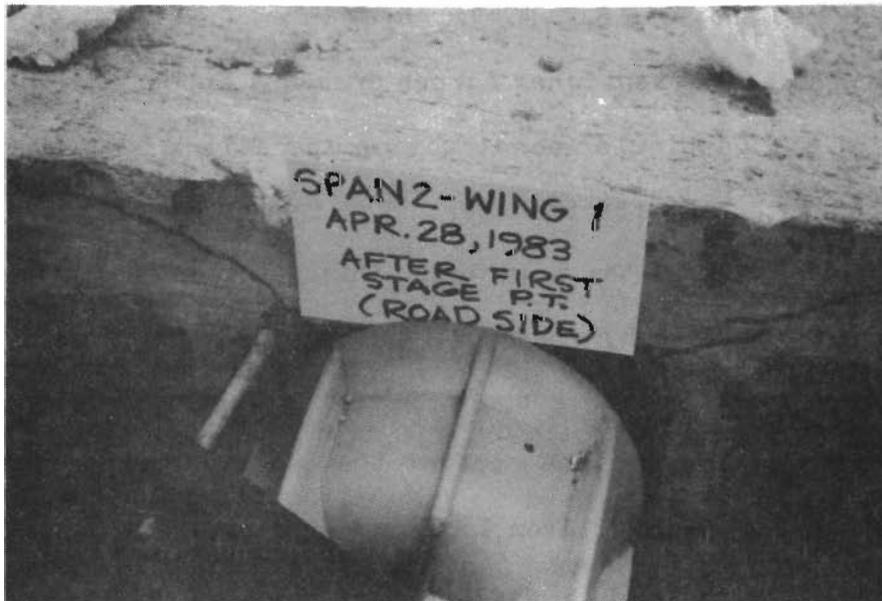
Fig. 4.41 Cracking in wing anchorage zones after first stage wing post-tensioning (cracks highlighted with black marker for better visibility)

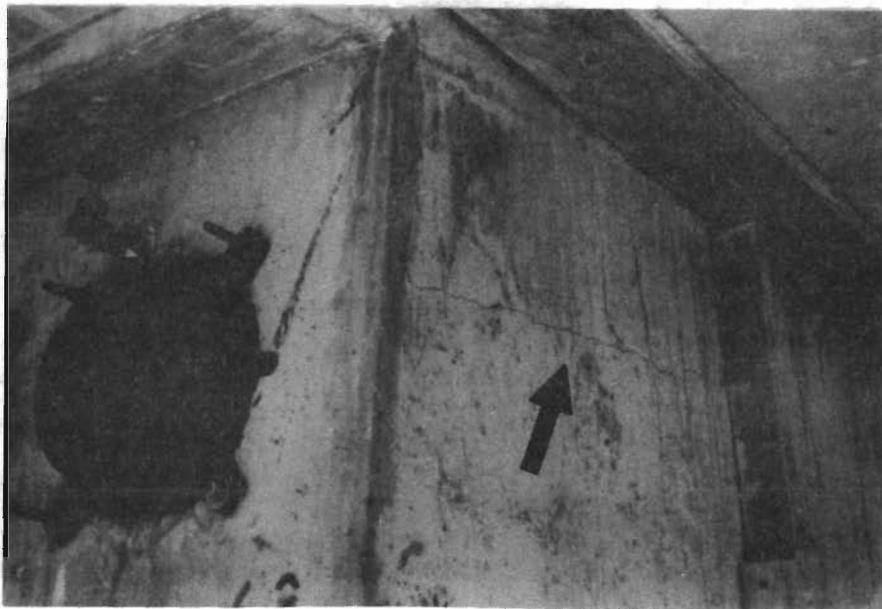
Fig. 4.42 Cracking in anchorage zone of abutment III diaphragm beam (cracks highlighted with black marker)

The only other significant problems during construction involved post-tensioning operations. These were the result of using either improper equipment or using the proper equipment incorrectly. When stressing the transverse diaphragm beam at abutment III, the post-tensioning jack was not centered correctly on the bearing surface. Several of the strands sheared off before reaching the design prestress level. The tendons had to be destressed, and the damaged strands were removed and replaced.

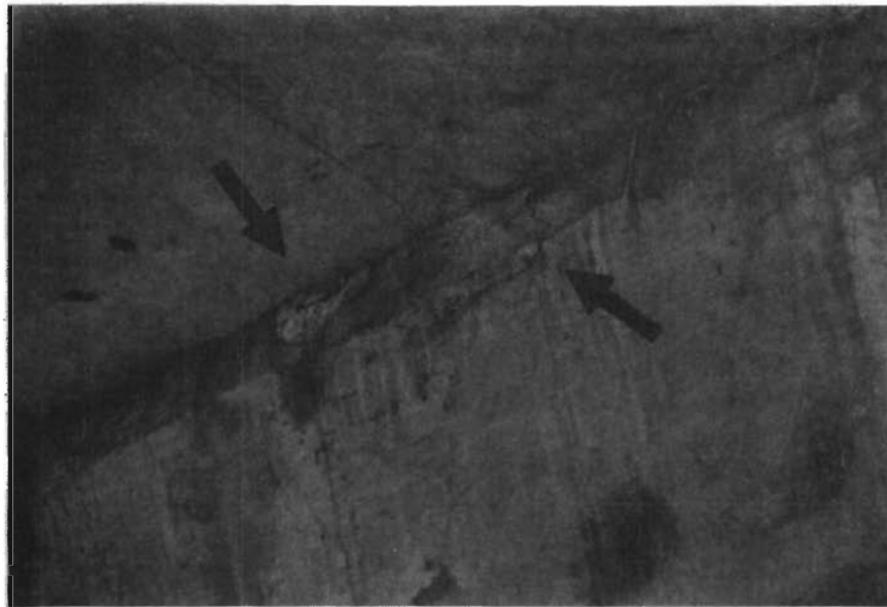
Fig. 4.44 Spalling of the spine beam ledge under the wing closure joint interface

For transverse wing stressing operations, an oversized jack was used throughout construction. The jack pressed against the 2-in. thick ledge at the base of the stressing pocket and cracked the ledge in a majority of the wing units. Some of the ledges were broken off completely. Although the cracked ledges did not affect the bridge structurally, they nevertheless had to be repaired. Thus, a reasonable effort should be made to prevent their occurrence.

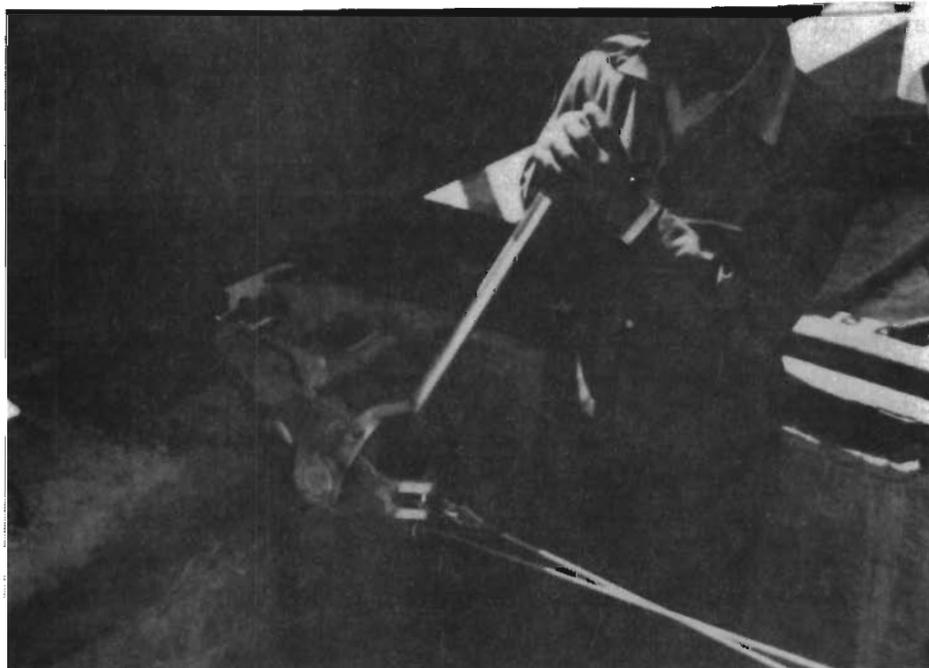
Fig. 5.3 Difficulty involved in exact positioning of wings and coupling of transverse tendon ducts
