**THE PERFORMANCE OF CONTINUOUSLY REINFORCED
CONCRETE PAVEMENTS IN TEXAS**

Tom Scullion, P.E.

National Asphalt Pavement Association
Riverdale, Maryland

October, 1987

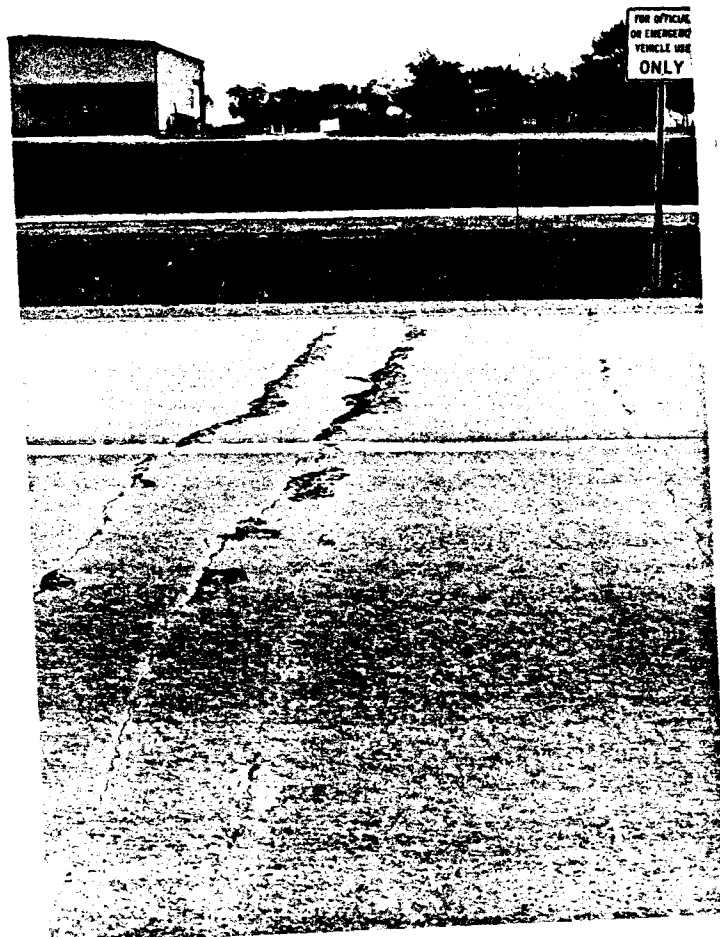
Figure 2. Closely spaced severely Spalled Cracks.

Severe Spalling. Spalling is defined (4) as the widening of existing transverse cracks by secondary cracking or breaking of the crack edges. The severity of the crack is determined by the width of the spall. Only cracks in which the spall has widened by an inch or more are counted. The whole crack is defined by the most severe condition, the presence of only a small length of spalling which is wider than one inch defines that crack as severely spalled. Spalled cracks are shown in Figure 1 and 2.

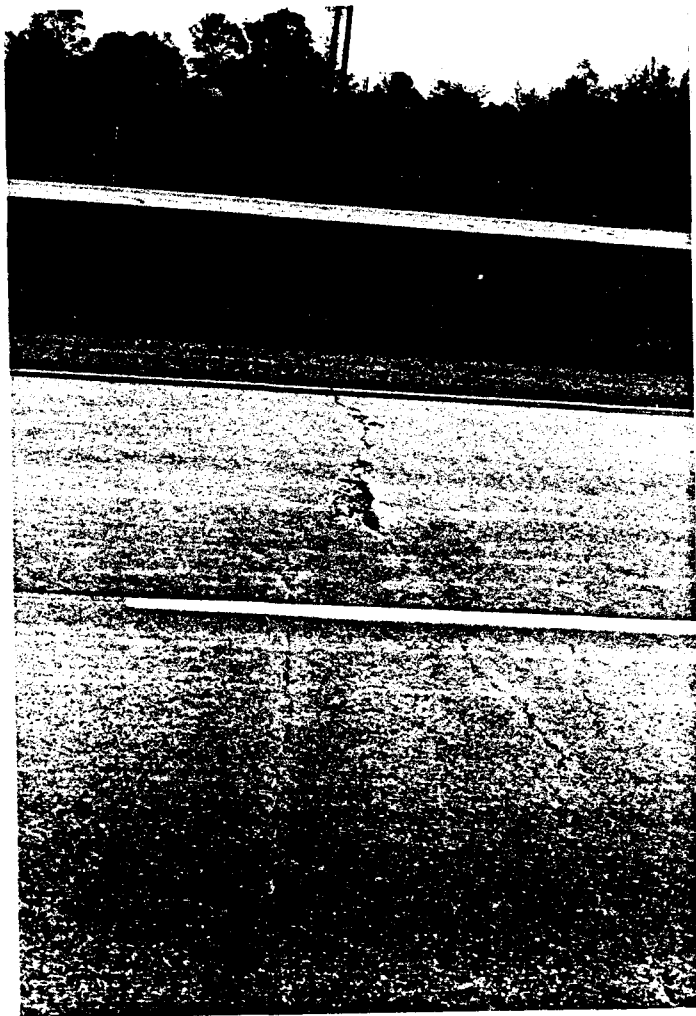
Punchouts are invariably associated with either short transverse crack spacings [less than 2 ft] or with Y-cracks as shown in Figure 4.

Figure 4. Y-cracking in CRCP

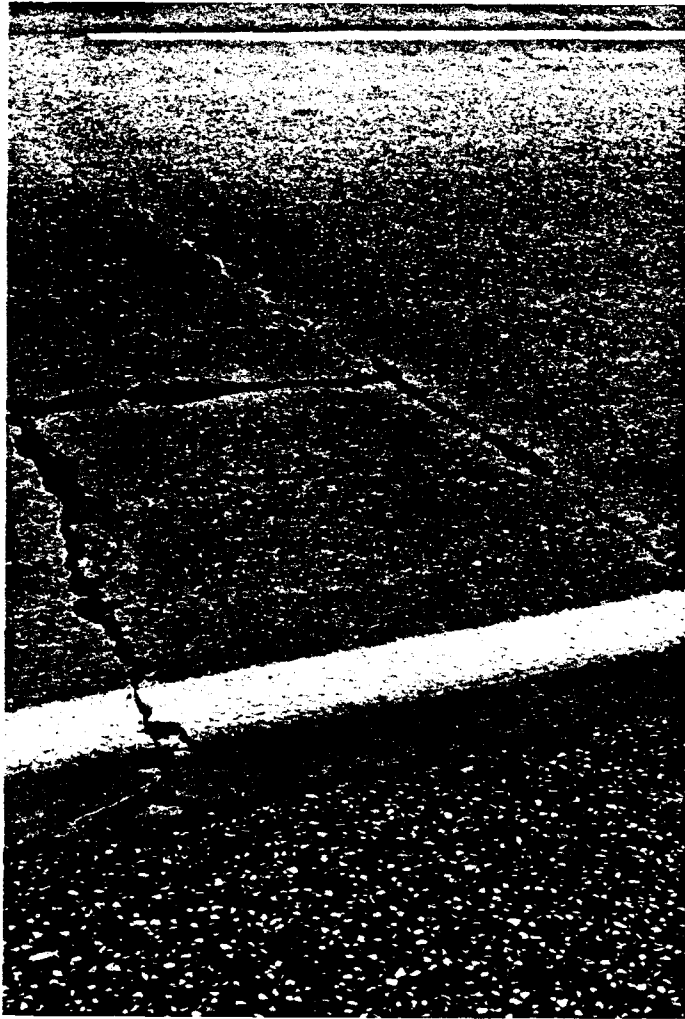
In the Texas rating system (4), a minor punchout is defined as a condition where, although a block has formed, no sign of movement under traffic is apparent. The cracks surrounding the punchout are narrow. In a severe punchout, the surrounding cracks are fairly wide and pumping or severe spalling around the edges may be present. This is caused by the movement of the punchout block under traffic loads. Figure 5 shows a severe punchout, wide cracks such as these could indicate that steel rupture has occurred.

Figure 5.-
Severe Punchout

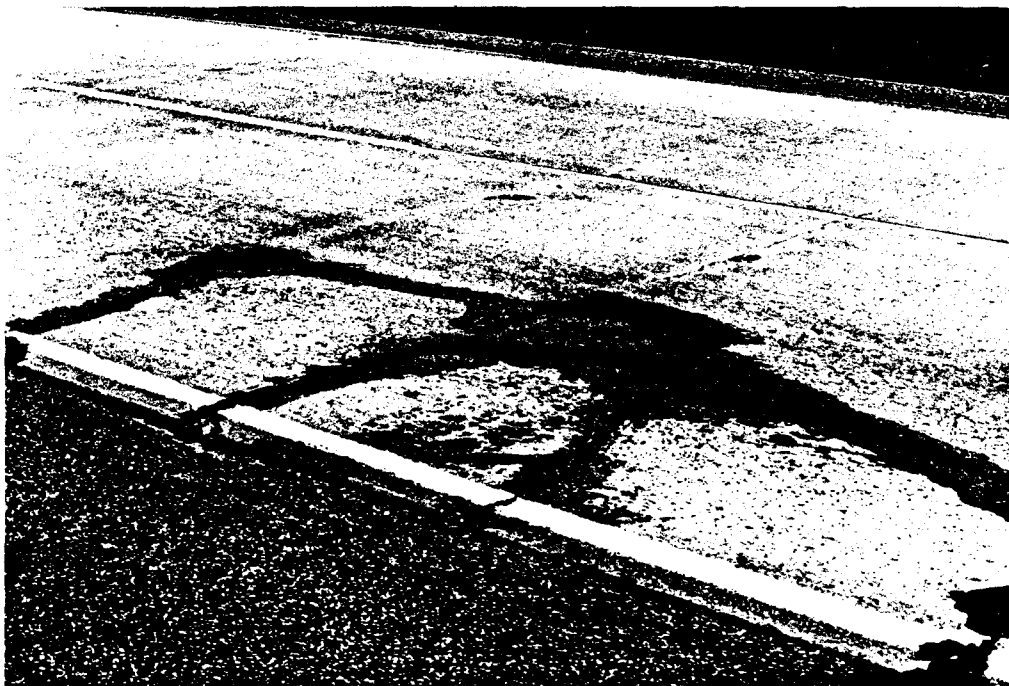
In Texas, only the number of severe punchouts per section are recorded. A long punchout can be recorded as a number of smaller punchouts if the longitudinal crack has a distinct offset (4). A potential multiple punchout is shown in Figure 6.

Figure 6. Multiple Punchouts in CRCP

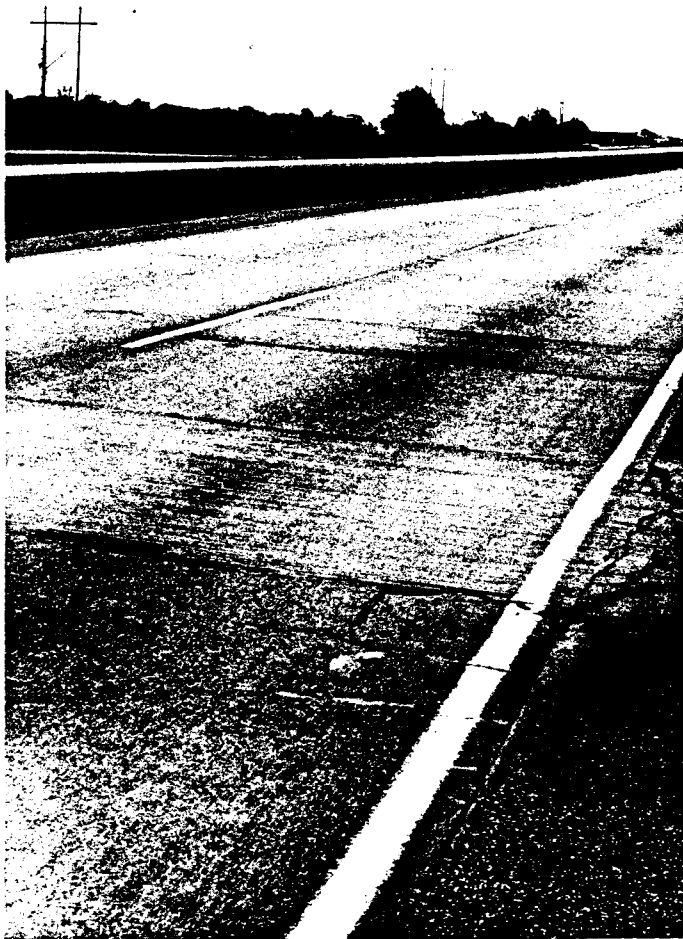
Asphalt and Portland Cement Repair Patches. Severe punchouts require removal of the damaged area, restoration of the base, possibly the addition of drainage and a permanent patch. In Texas a repair patch is defined as a repaired section of pavement where the repair work has been carried out to the full depth of the concrete. Hot Mix Asphalt (HMA) patches, CRCP patches and failed patches are counted separately. The size of the patch is not recorded although frequently PCC patches cover the full lane and are 10 to 15 feet in length as shown in Figure 7. Reference (5) gives a good description of the recommended CRCP repair procedure.

Figure 7. Typical PCC repair patches in CRCP

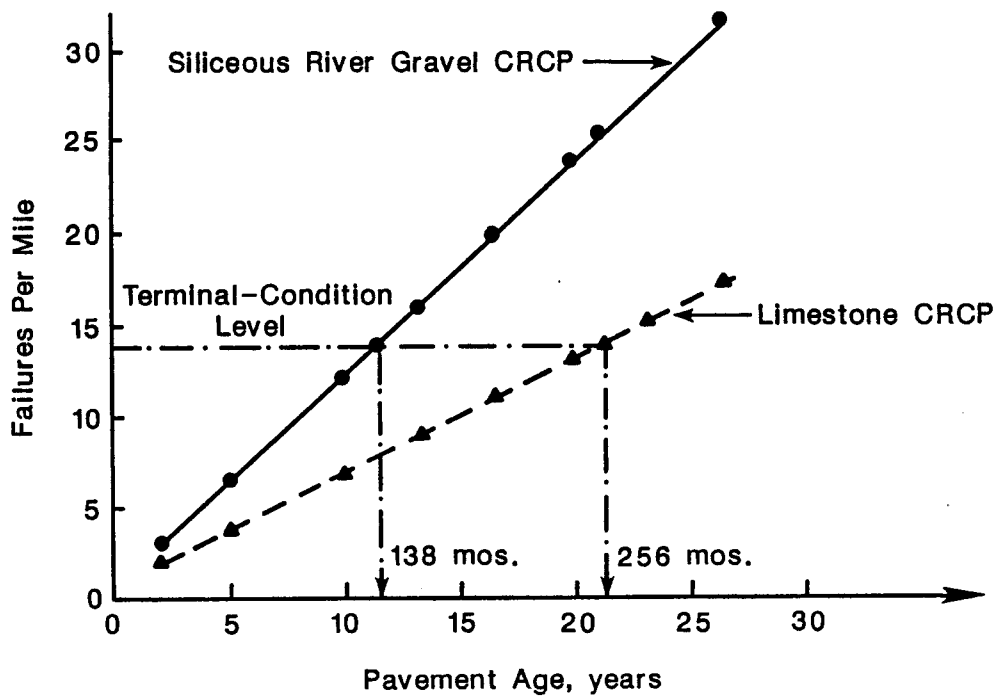
thickness equivalencies for CRCP. In summary they concluded that each approach gave similar results namely that 10% more slab thickness would be required to equate limestone and siliceous river gravel performance. For example, if a 10 inch limestone slab were designed then an 11 inch siliceous river gravel slab would be required to ensure similar performance. In one of the three approaches the regression equations developed by Machado (7) were used to predict performance. The results are reproduced below in Figure 12.

Figure 12. Predicted performance of CRCP pavements (9) using regression equations developed by Machado (7)

The value of 14 failures per mile was recommended (11) as the critical level at which the CRCP should require an overlay. (Although this number is thought appropriate for rural highways it appear high for urban highways.) As noted in Figure 12 this is reached in 11.5 years for a pavement constructed using siliceous river gravel and 21.3 years for an equivalent thickness limestone pavement.

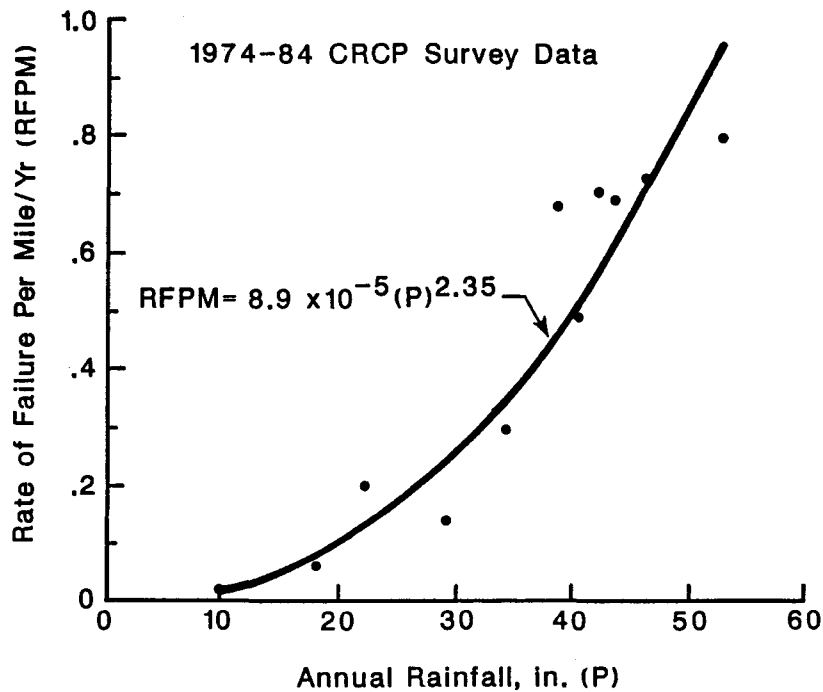
$$\log (\text{RFPM}) = - 4.05 + 2.35 \log (P) \quad R^2 = 0.94$$

This relationship is shown graphically in Figure 13 (taken from reference (12))

Figure 13. Correlating Failures per mile per year with Rainfall (12)

Using this equation and failure criterion of 14 failures per mile for rural highways and 10 failures per mile for urban highways it is possible to calculate the time till failure under different rainfall conditions. These results are tabulated below.

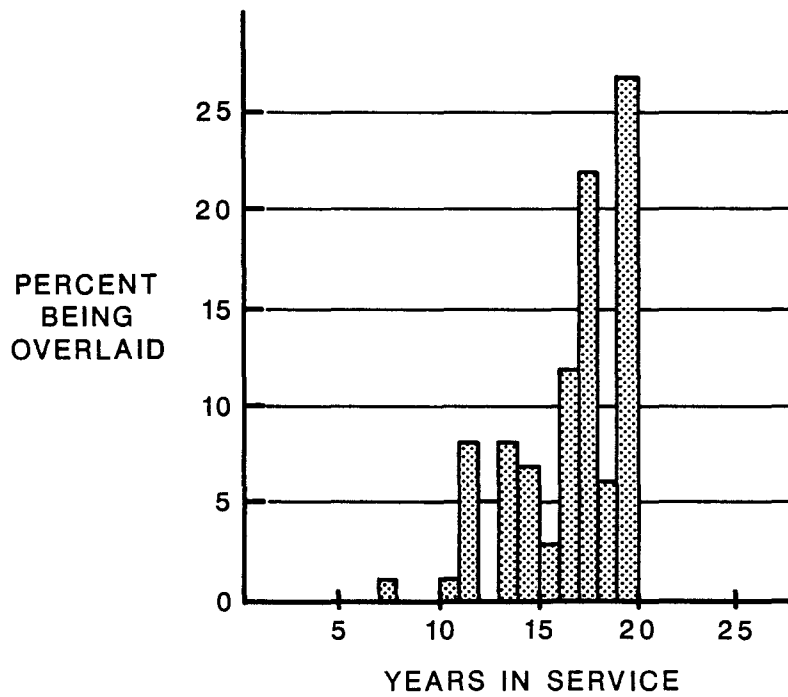
Figure A3. Percentage of CRCP overlaid each year of service

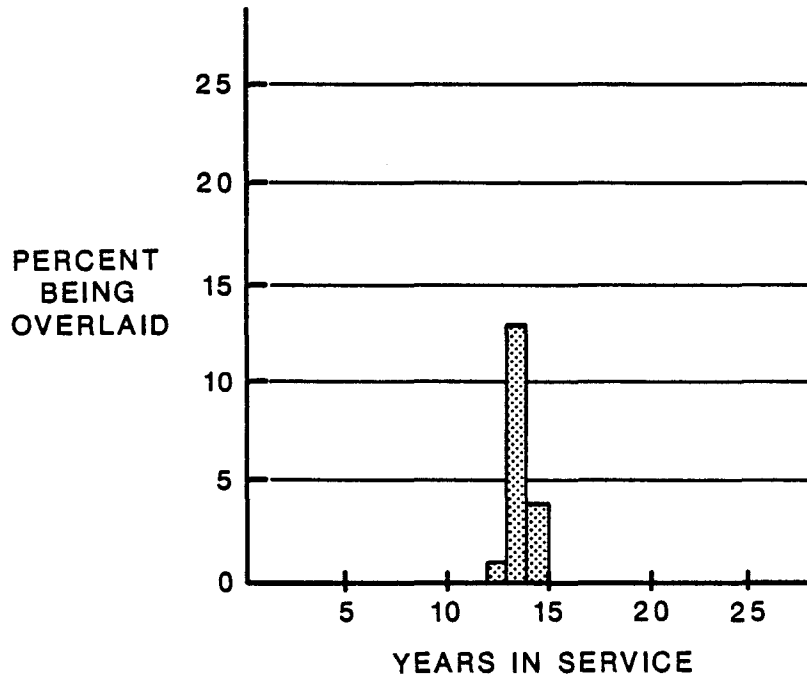
Figure A15. Percentage of CRCP overlaid each year of service
