F I N A L R E P O R T

CONTRACT NO. CPR-11-5851

TEST AND EVALUATION

VEHICLE ARRESTING, ENERGY ABSORBING, AND IMPACT ATTENUATION SYSTEMS

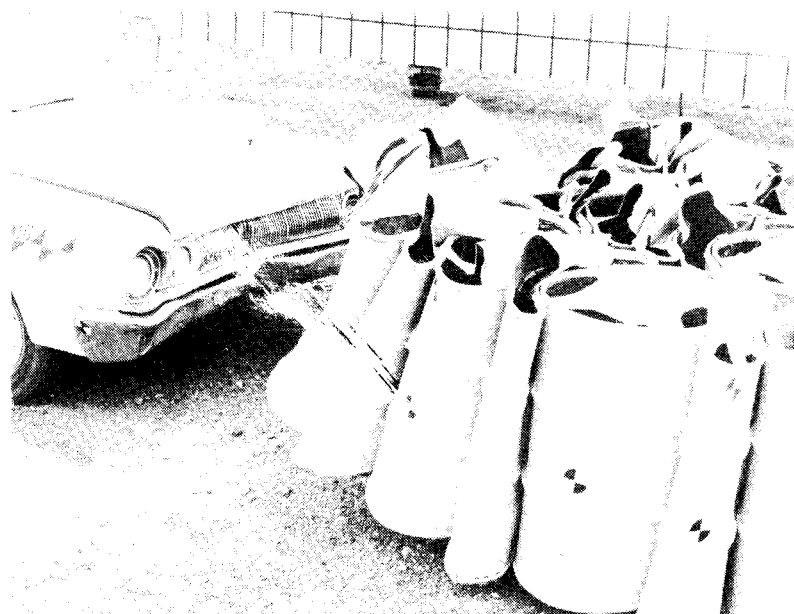
Figure 5. View of Minor Vehicle Damage. Only one of four headlights was broken. Bumper and Grill deformed approximately 4 in.

3,200 lbs. and was a 1964 Dodge four-door sedan. Its initial velocity before impact was 60.2 mph. The vehicle penetrated the barrier 13.3 ft. before coming to a complete stop. The average deceleration force on the vehicle was 9.1 g's. The peak deceleration on the vehicle was 12.7 g's. As can be seen from the photographs, only minor damage was inflicted on the vehicle. One of the four headlights was broken, and the front bumper and grillwork were mashed in approximately 4 in. The vehicle was in running condition immediately after the impact.

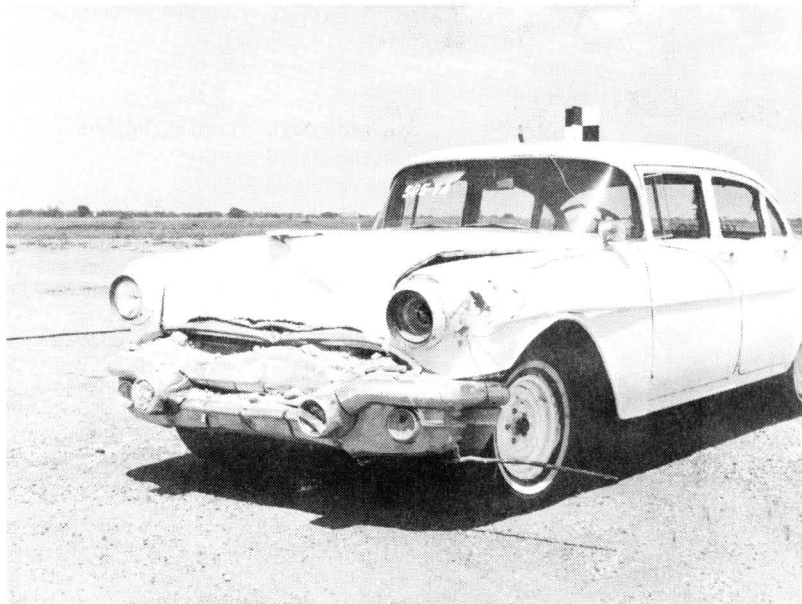
Figure 13, Damage to Vehicle in Test 505V-A

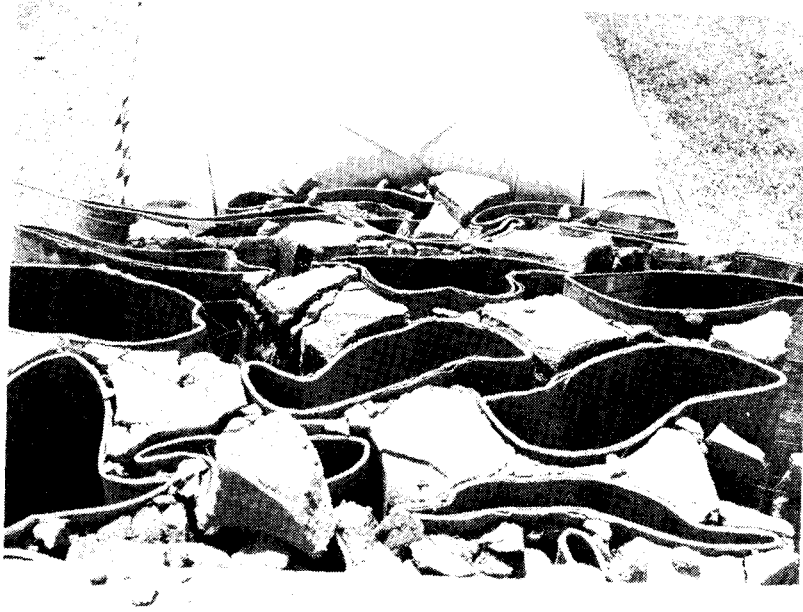
Figure 14, Top View of Crash Cushion
After Test 505V-A

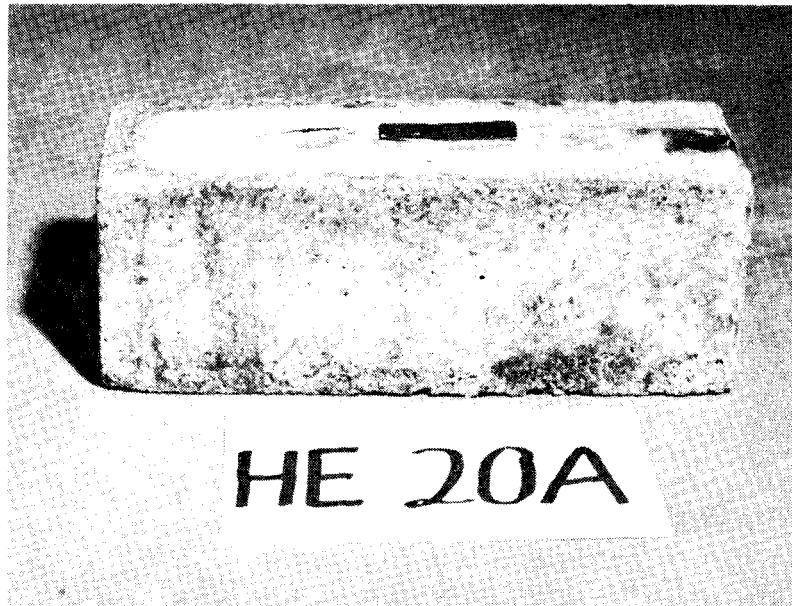
Figure C15 Condition of specimen HE1-20A after 16 cycles of freezing and thawing.

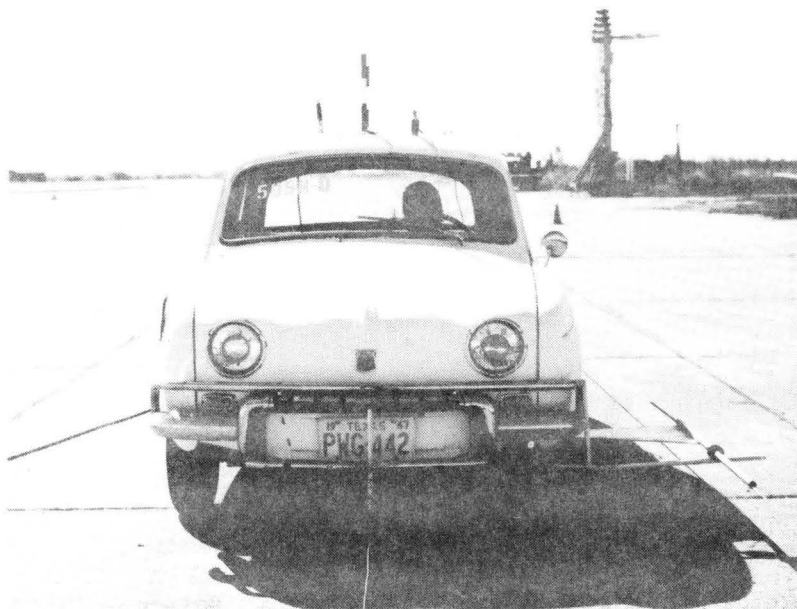
Figure 24, Front of Vehicle Showing Tow Cable (center) and Guidance Cable (right).

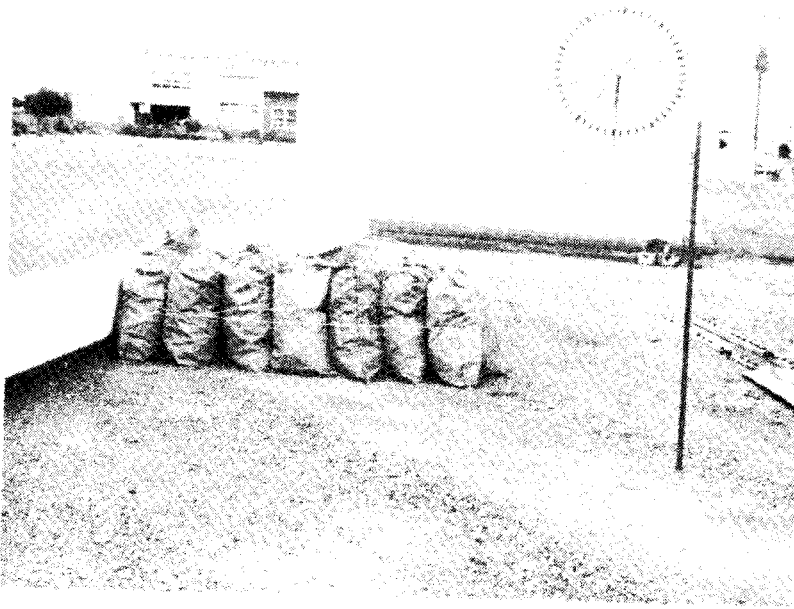
FIGURE 1. BURLAP BAGS FILLED WITH EMPTY BEVERAGE CANS BEFORE TEST 505-1A.
