TEXAS
~~SEARCH~~ TRANSPORTATION
INSTITUTE

CYCLIC LOAD TESTS OF COMPOSITE
PRESTRESSED-REINFORCED
CONCRETE PANELS

RESEARCH REPORT 145-4F
STUDY 2-5-70-145
PRESTRESSED CONCRETE

Research Report No. 145-4F

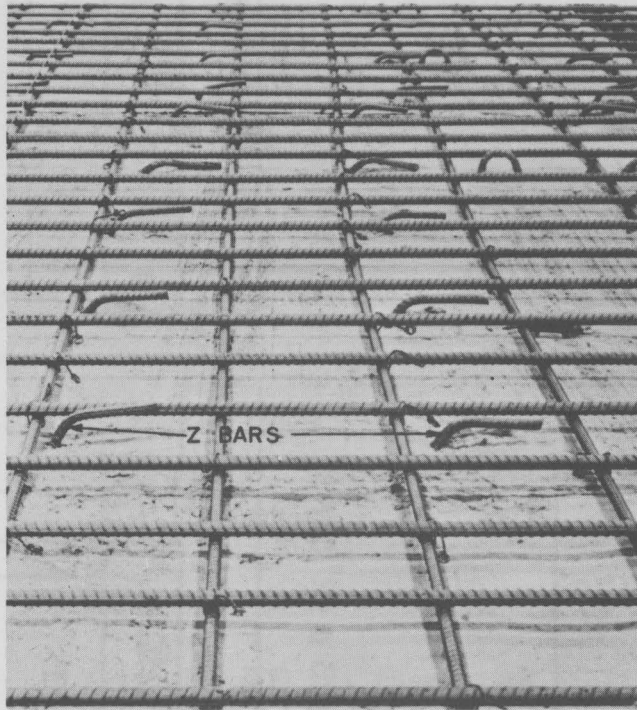
Figure 1. Z-Bars Used in Selected Panels to Aid in Providing Structural Connection Between Panel and Cast-in-Place Deck.

Mechanical interlock was provided between the prestressed panel and the cast-in-place concrete in 3 of the 7 panels. Number 4 reinforcing rods, bent to a rounded Z configuration, were used for the interlock. They were cast in the prestressed panel and were later engaged by the cast-in-place concrete. Details of the interlocking steel elements are shown in Figures 1 and 2. The prestressed panels were given a rough surface finish with a stiff broom. They were cured under wet mat for 6 days after which they were stored in the yard prior to being hauled some 170 miles to the testing laboratory. No curing compound was used on the panels.
