1. Report No. FHWATX-77-2-2F		2. Government Accession No.		3. Recipient's Catalog No.	
4. Title and Subtitle Equipment and Methods for Collecting Pavement Performance Information				5. Report Date October, 1977

Equipment and Methods For Collecting
Pavement Performance Information

Research Report 2-2F

Research Study 1-10-74-2
Equipment for the Measurement of Pavement
Performance in Texas

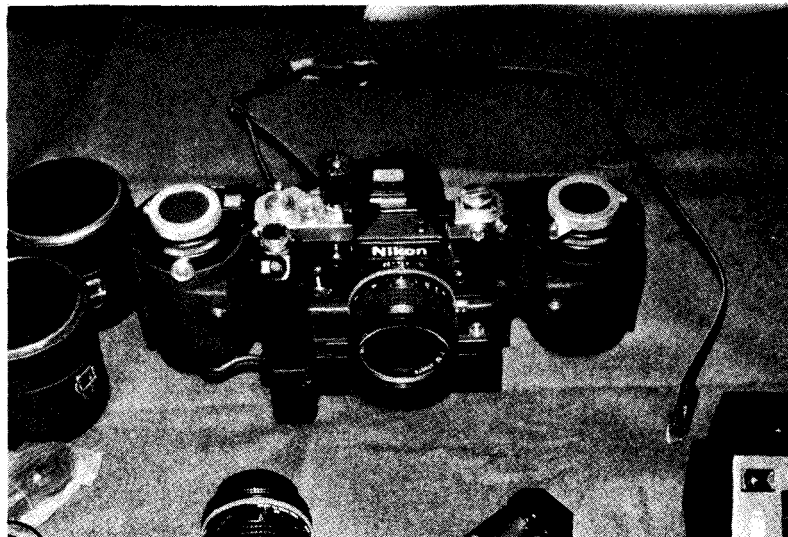
Figure 11
Camera System

The low bidder made available a Nikon F25 system with a frame back equipped with a 250 frame magazine. The camera with accessories is shown in Figure 11. The camera has a motorized film advance and shutter speeds of

one second to 1/2000-second. The motorized film advance allows exposures at a rate up to 5 frames per second along with manual activation of a single frame if desired.

A 24 mm, F2.8 wide angle lense was selected to obtain a 35 mm slide covering an approximate 8 X 12 - foot surface area from the eight foot height. A small amount of distortion may be noted at the edges of the slide, but this distortion was not believed to be important because of the type and accuracy of the data needed from the photograph.
