INCREASED SKID RESISTANCE THROUGH THE UTILIZATION OF A HEATER-PLANER

Report 618-1

State Department of Highways
And Public Transportation

June , 1976

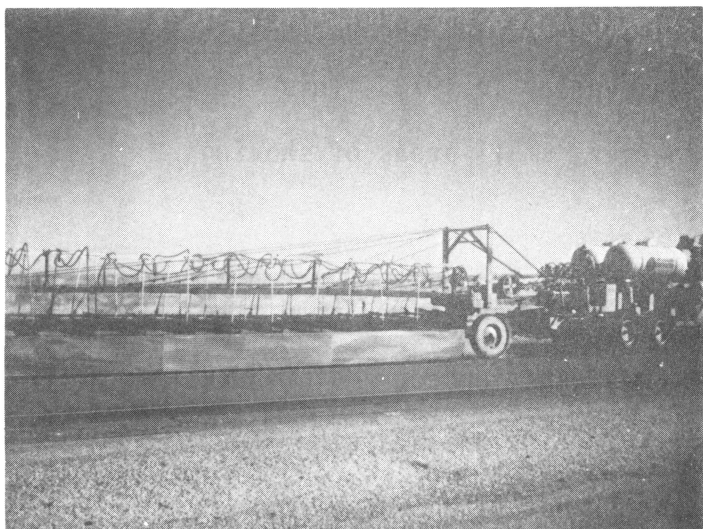
#1 - Modified Motor-Grader

A Heater-Planer unit was leased to apply the heat. This machine is a modified motor-grader. The Heater unit is 12 feet wide and 36 feet long and is composed of 13 rows of burners mounted at three-foot centers. Each row of burners has 24 orifices spaced at 6" centers. Each orifice opens into a 2" pipe, which is 6" in length. The lower ends of these pipes are suspended approximately 8" above the pavement. Fifteen feet behind the heater are two rows of "spring-loaded" scarifier teeth. These rows are spaced 26" apart, with the scarifier teeth located 2" apart.

The machine also has an hydraulically powered screed which was utilized most of the time. See photos #1, 2 and 3 for the modified motor-grader, burners and scarifiers.

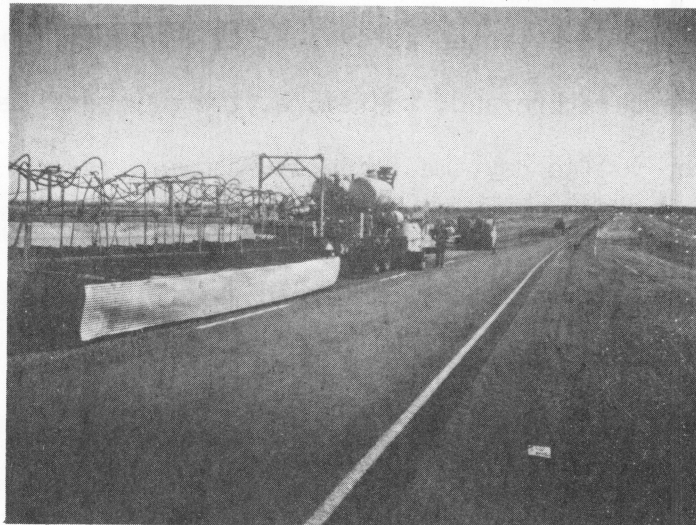
#4 - Equipment Train

Aggregate was applied at a rate varying from 1 cubic yard per 200 square yards to 1 cubic yard per 300 square yards. The average for the entire project was 1 cubic yard to 230 square yards. A self-propelled spreader-box was used to apply a grade 4 aggregate which has good wearing qualities. The aggregate was spread ahead of the heater, in order that the raw aggregate might be heated, as well as to heat the existing surface; two 8-ton flat-wheeled rollers immediately followed the heaters and immediately following the flat-wheeled rollers were 2 pneumatic rollers. After the rolling operation was completed, the treated surface was allowed to cure, for a while, then the surface was lightly broomed to remove the excess aggregate from the roadway. The travel speed of the heater was maintained at approximately 1800 LF per hour (See photo #4 for equipment "train").

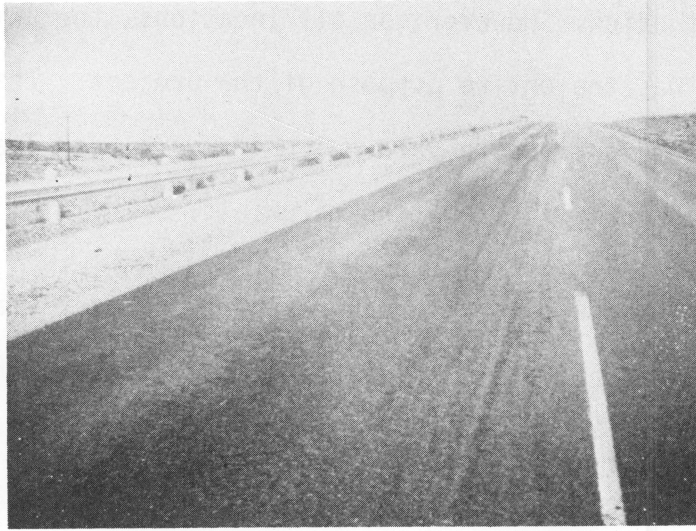
#5 Note Rich Spots

There were some areas of work where, even after having added aggregate ahead of the heater, the roadway still looked "rich". (See photo #5). On these areas, the surface was hand-sprinkled with additional, cold aggregate.

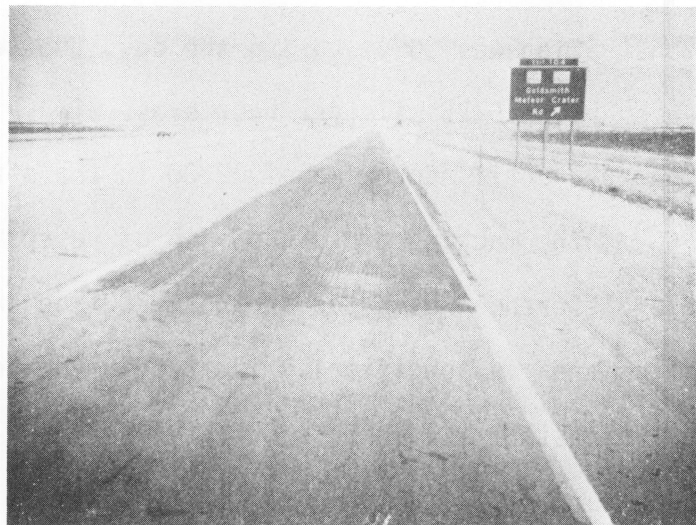
#6 Scarification Only

On some areas both the scarifier and screed attachments were used. The operation yielded a very nice looking finished project; also, all of the aggregate "sticks". On other areas, only the scarifier was utilized. The latter procedure helps to stick more aggregate, but it has the disadvantage of tending to leave slight streaks in the surface. This creates some discomfort in steering a motor vehicle and tends to make a car "weave". (See photo #6).
