"Field Evaluation of Bottom Ash in Hot Mix Asphaltic Concrete"       February, 1982         "Author13       Performing Organization Code         R. E. Long, R. W. Floyd       B. Performing Organization Reservice         "Performing Organization Name and Address Texas State Department of Highways and Public Transportation Materials and Tests Division Austrin, Texas 78763       10. Work Unit No.         12. Spansering Agency Name and Address Texas State Department of Highways and Public Transportation Research Section - P. 0. Box 5051 Austin, Texas 78763       13. Type of Resort and Penod Covered Final - June 80 - January 82         13. Supplementary Nemes       Final - Supplementary Agency Code       14. Spansaring Agency Code         Performed in cooperation with the Federal Highway Administration.       14. Abstract         Aggregate shortages and increased transportation costs have greatly increased prices of related construction items in areas of Texas not blessed with natural aggregates are not performing up to expectations as documented by stripping, rutting and other visual signs of pavement distress noted throughout the Department. Because of these spiraling construction cos

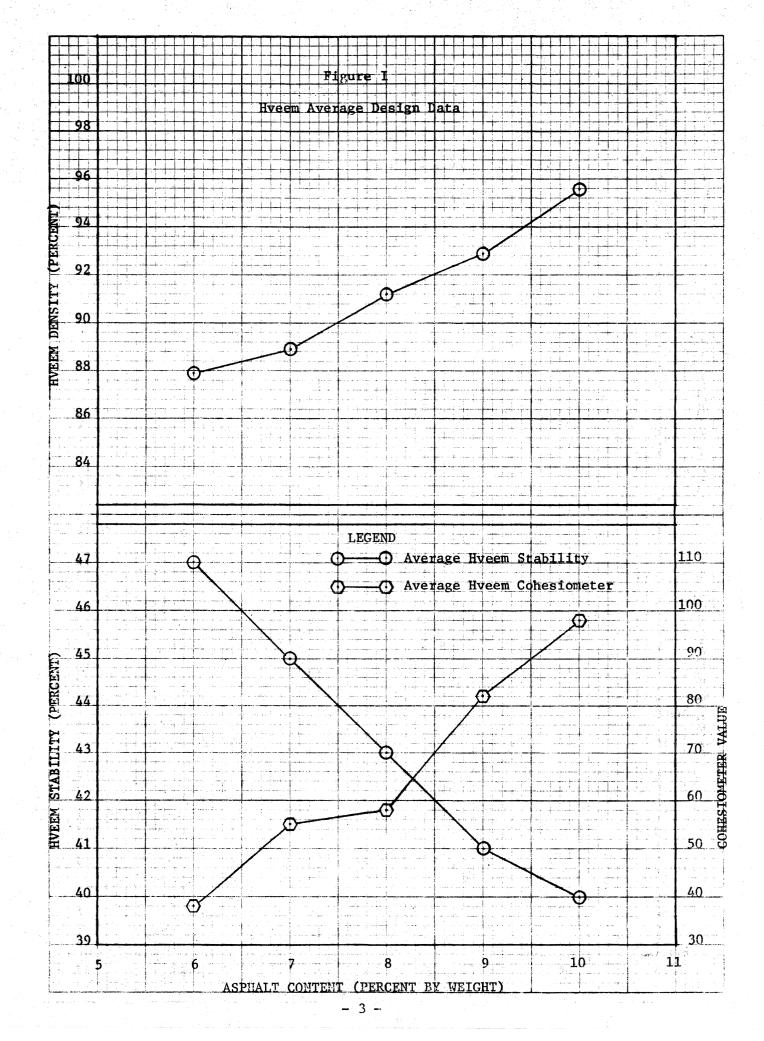
Hveem specimens fabricated in the District 1 Laboratory and submitted to the Materials and Tests Division gave the following additional design data shown in Table II and presented graphically in Figure 1.

This mix produced low Hveem densities which is an indication of high void contents. Because of field experience with moisture-susceptible aggregates, these design Hveem specimens were subjected to wetting by the pressure pycnometer test method. This test method forces water into the Hveem specimen under 1200 psi pressure which is maintained for a minimum of 15 minutes. Results of this laboratory testing are shown in Figure 2. When an asphalt content is selected that holds moisture absorption under 5 percent, current experience indicates the mix will be less susceptible to stripping, shelling and other moisture-related problems causing poor performance.

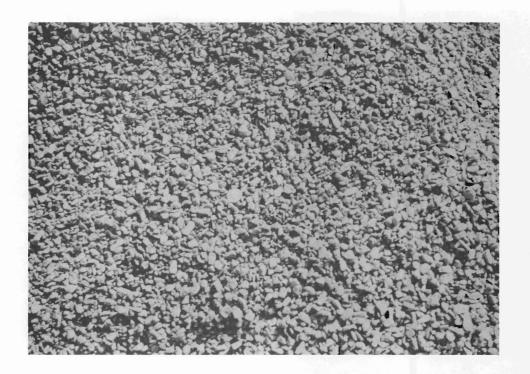
Photograph 1. Siliceous gravel from Frogville, Oklahoma, stockpiled at the HMAC plant.

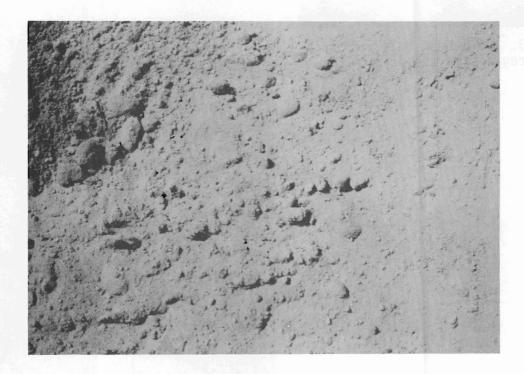
Photograph 2. Pit run bottom ash from the Monticello Power Plant, stockpiled at the HMAC plant.

The Monticello bottom ash is deficient in large sizes, but is a well graded material from the No. 4 mesh sieve through the No. 200 mesh sieve sizes. This pit run gradation blends well with the poorly-graded Frogville gravel to produce a grading that meets the requirements of the Standard Specifications for Item 340, Type D.

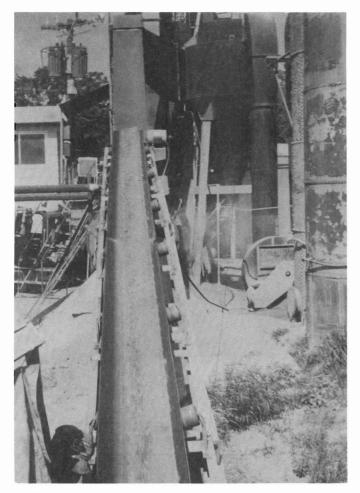
Photograph 3. Cold Feed belt moving the two aggregates to the dryer.

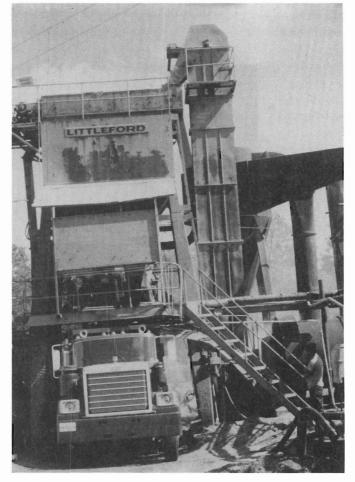
Photograph 4. The Netex HMAC Batch Plant located at Sulphur Springs.

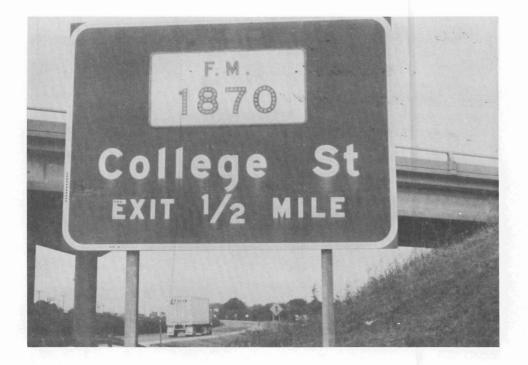
Photograph 5. The first test site constructed was located approximately one mile SE of IH 30 on FM 1870.

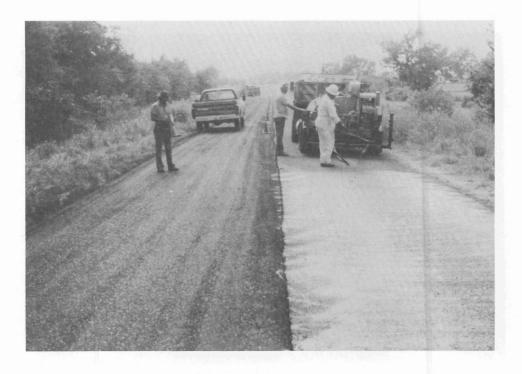
Photograph 6. An RC-2 tack coat was applied by the Sulphur Springs' Maintenance Forces, who are under the immediate supervision of Mr. Walter B. Darling.

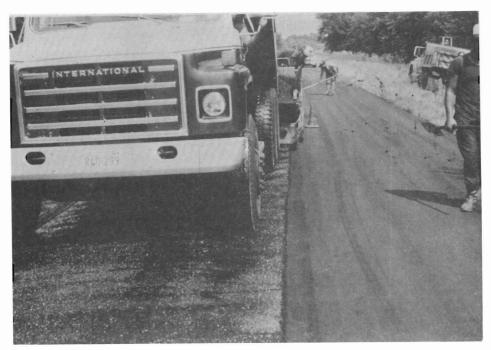
Photograph 7. A heavy tack coat was applied to insure bonding between the existing seal coat and the new bottom ash HMAC. Optimum asphalt content was 10 percent but there was no apprehension about the tack flushing up through the asphalt.

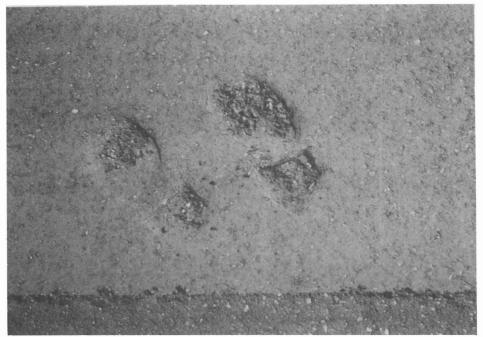
Photograph 8. The uncompacted bottom ash mix displayed a tendency to stick and pull apart when placed in contact with cold, dry objects. A flat wheel roller was used for breakdown rolling. A light coat of diesel prevented the asphaltic concrete pavement from sticking to the roller drum.

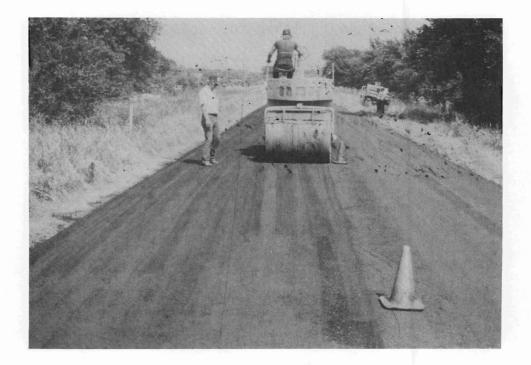
Photograph 9. The bottom ash mix cooled fast and required immediate rolling for proper densification. There was no lateral displacement normally associated with smooth gravel mixes. Mr. Charles Wingfield is monitoring the breakdown rolling for mix pickup.

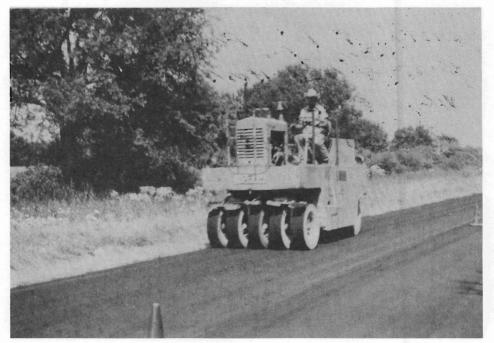
Photograph 10. The breakdown rolling was followed by compaction from a pneumatic tire roller. This roller gave a uniform appearance to the completed pavement.

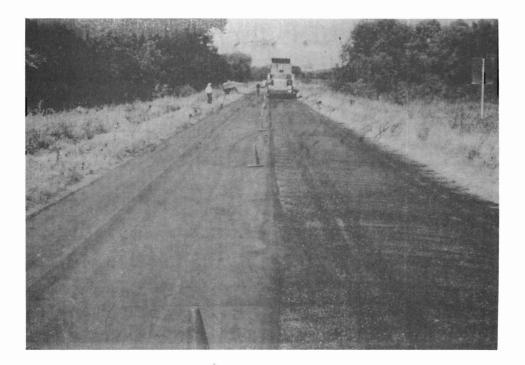
Photograph 11. Overall view of the test site on FM 1870 with SE lane paved. The paving operation is progressing toward IH 30. Again note the heavy tack coat.

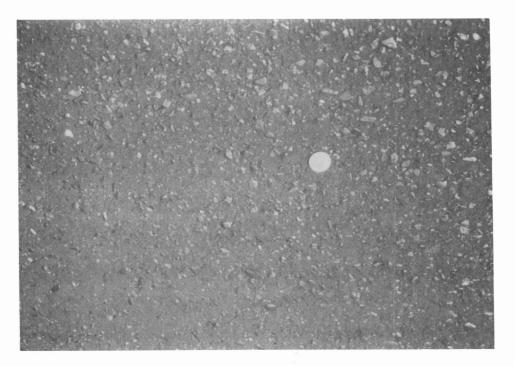
Photograph 12. A close-up view of the completed mix. Note the predominance of uncrushed siliceous gravel in the completed surface.

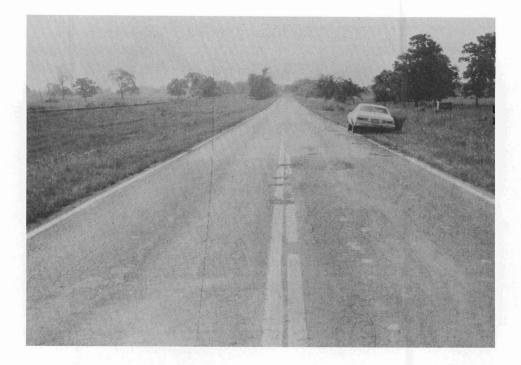
Photograph 13. Overall view of the test section site on SH 11 before overlaying with the bottom ash mix.

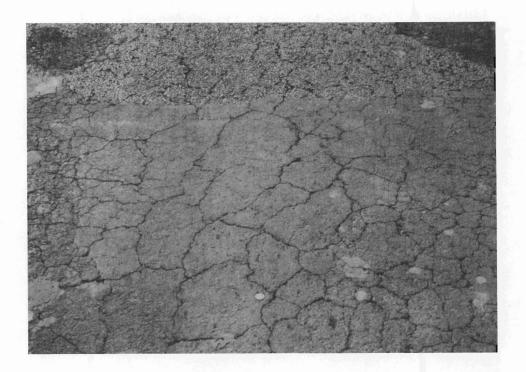
Photograph 14. Close-up view of a patched area at the west end of the test site. This road has considerable deflection and considerable cracking was observed throughout the test section.

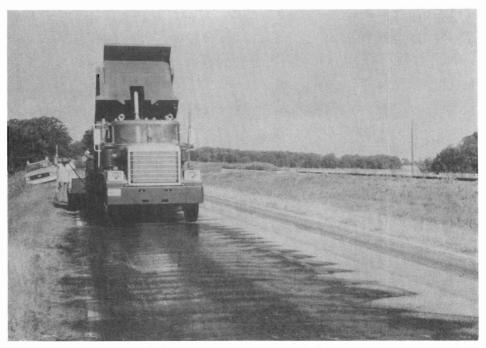
Photograph 15. A heavy hand-sprayed RC-2 tack was used in the EBL of SH 11. Since an optimum asphalt content of 12 percent was selected to hedge against deflection cracking, there was some apprehension about this tack flushing through the compacted bottom ash mat. This has not occurred to date.

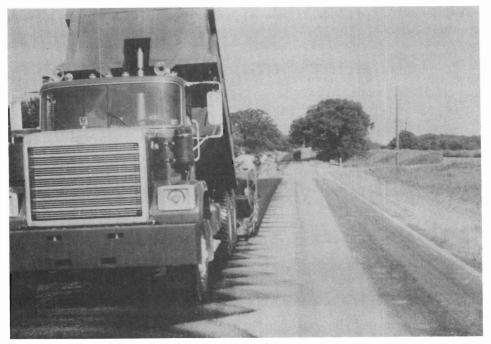
Photograph 16. Depicts the ability of the bottom ash mix to be placed in neat lines.

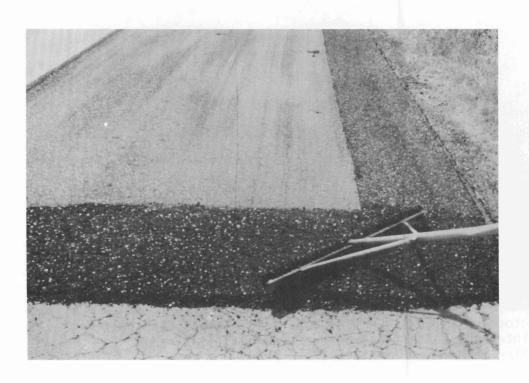
Photograph 17. There was some concern about being able to rake this high-friction bottom ash mixture. This tapered start was hand-constructed without difficulty.

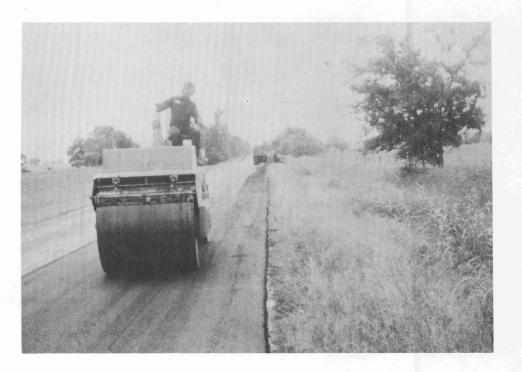
Photograph 18. Flat-wheel breakdown rolling of the bottom ash mix on SH 11.

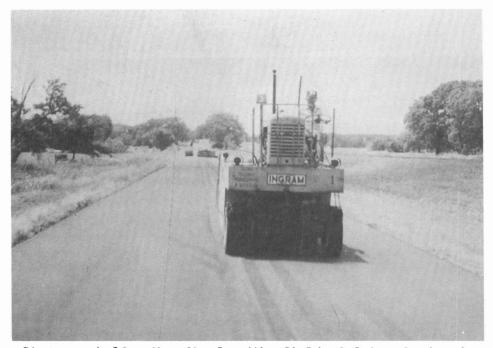
Photograph 19. Mr. Charles Wingfield, Sulphur Springs' Maintenance Forces, operating the pneumatic-tired roller to complete the overlay operation.

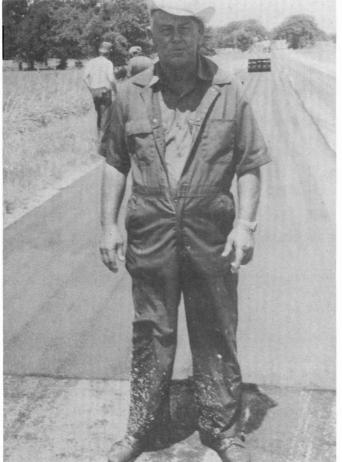
Photograph 20. This RC-2 asphalt is both tacky and sticky, as evidenced by Mr. Bobby Stone's coveralls. The tack coat in the WBL was greatly reduced. To date, there is no noticeable difference in the performance of the two lanes.

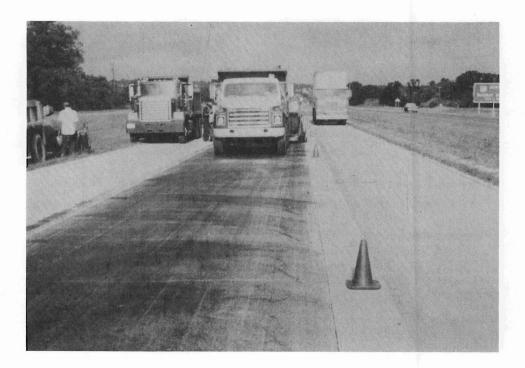
Photograph 22. An 11 percent optimum asphalt content and lighter tack was utilized in this bottom ash test section. There has been no slippage or rutting after 1.5 years service.

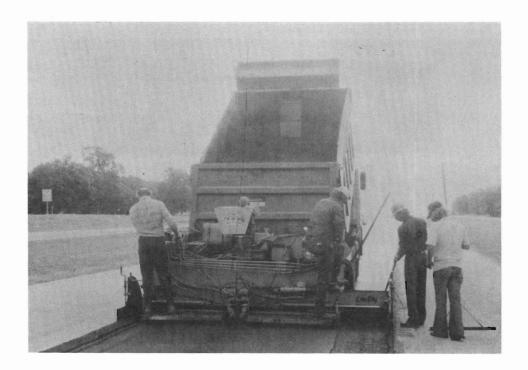
Photograph 23. Laying operations on IH 30 at Sulphur Springs. Maintenance Forces rented the equipment shown.

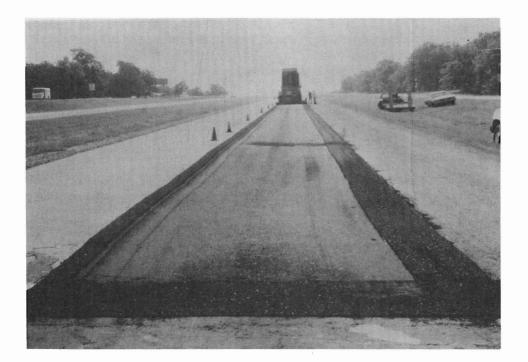
Photograph 24. Dark textured lines on each site were caused by a box extension on the left and a tapering extension on the right. Raking in the foreground made for a smooth transition from existing concrete pavement to the bottom ash and gravel asphalt concrete pavement.

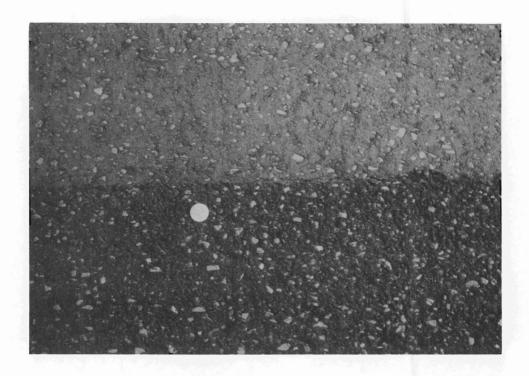
Photograph 25. Close-up view of the uncompacted mat. Again, note the abundance of siliceous gravel in the mix.

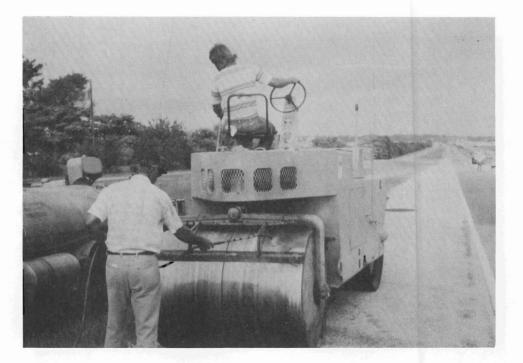
Photograph 26. A light coat of diesel being applied to the flat-wheel roller by Mr. Charles Wingfield prior to the breakdown rolling. This prevents pickup of the bottom ash-gravel asphaltic concrete pavement.

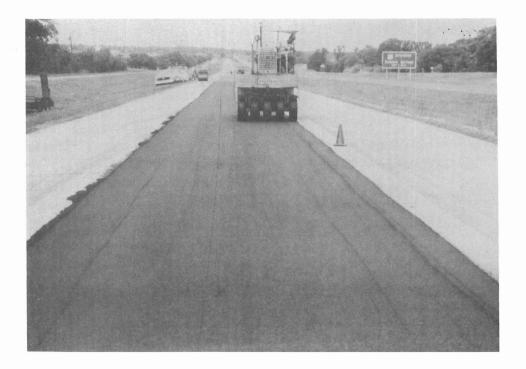
Photograph 27. Finish rolling being applied to the bottom ash-gravel mat in the EBL of IH 30.

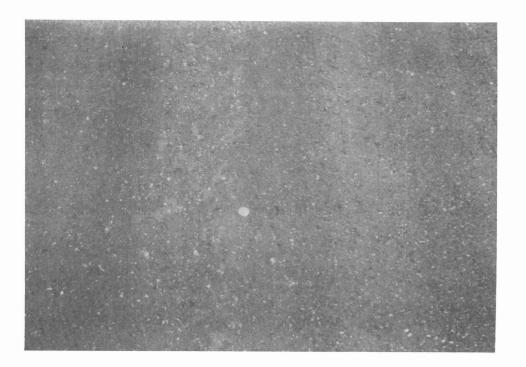
Photograph 28. Close-up view of the compacted bottom ash-gravel mat.
