REPORT ON CONCRETE PAVEMENT
GROOVING IN TEXAS

HIGHWAY DESIGN DIVISION
TEXAS HIGHWAY DEPARTMENT

Presented at the Western Summer Meeting of
Highway Research Board

Denver, Colorado
August 1968

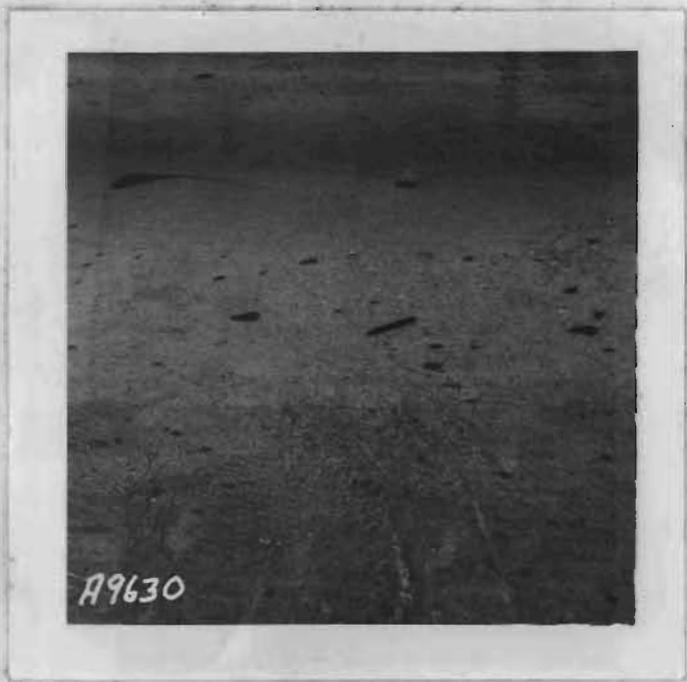
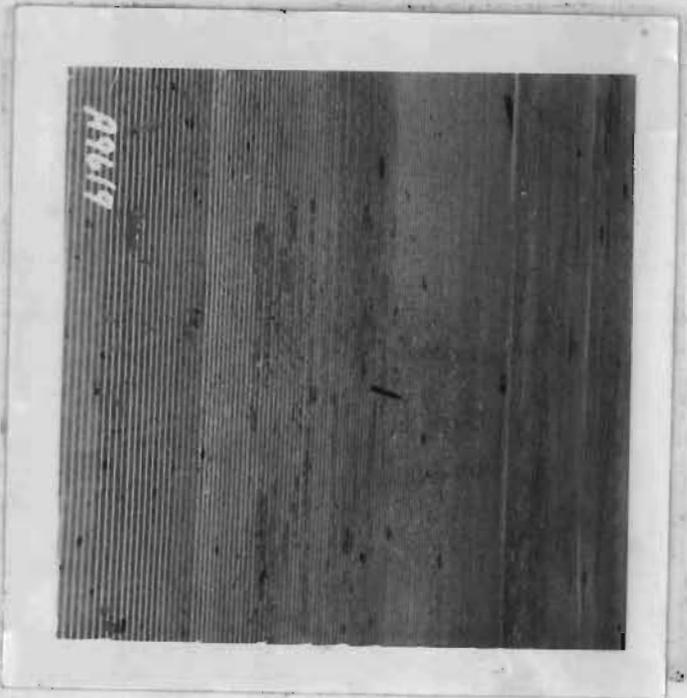
FIG. 3 Results of Stopping Distance Tests Before and After Sawing

The results of the stopping distance test are presented by Figure 3.³ You will note that the saw-cut operation increased the coefficient of friction from 0.32 before sawing

to 0.42 after sawing as measured by the stopping distance method at 30 miles per hour with wet pavement conditions. Later measurements utilizing a skid trailer on the sawed concrete pavement indicated that the coefficient of sliding friction was 0.28. The skid trailer had not been completed in time to measure the before sawing coefficient.

The main benefit obtained by pavement sawing was a change in the skidding pattern. In the before condition, some degree of skidding was always experienced on both wet and dry pavements and the wet pavement vehicle generally always ended up in the other lane. After the pavement was sawed, the vehicle always skidded in a straight line for the both wet and dry pavement conditions. Side skidding was not experienced in any of the after condition tests. The driver of the test vehicle stated, he had absolute control of the vehicle during the after-condition test whereas in the before-condition, he felt as if the vehicle was completely out of control during emergency stops.

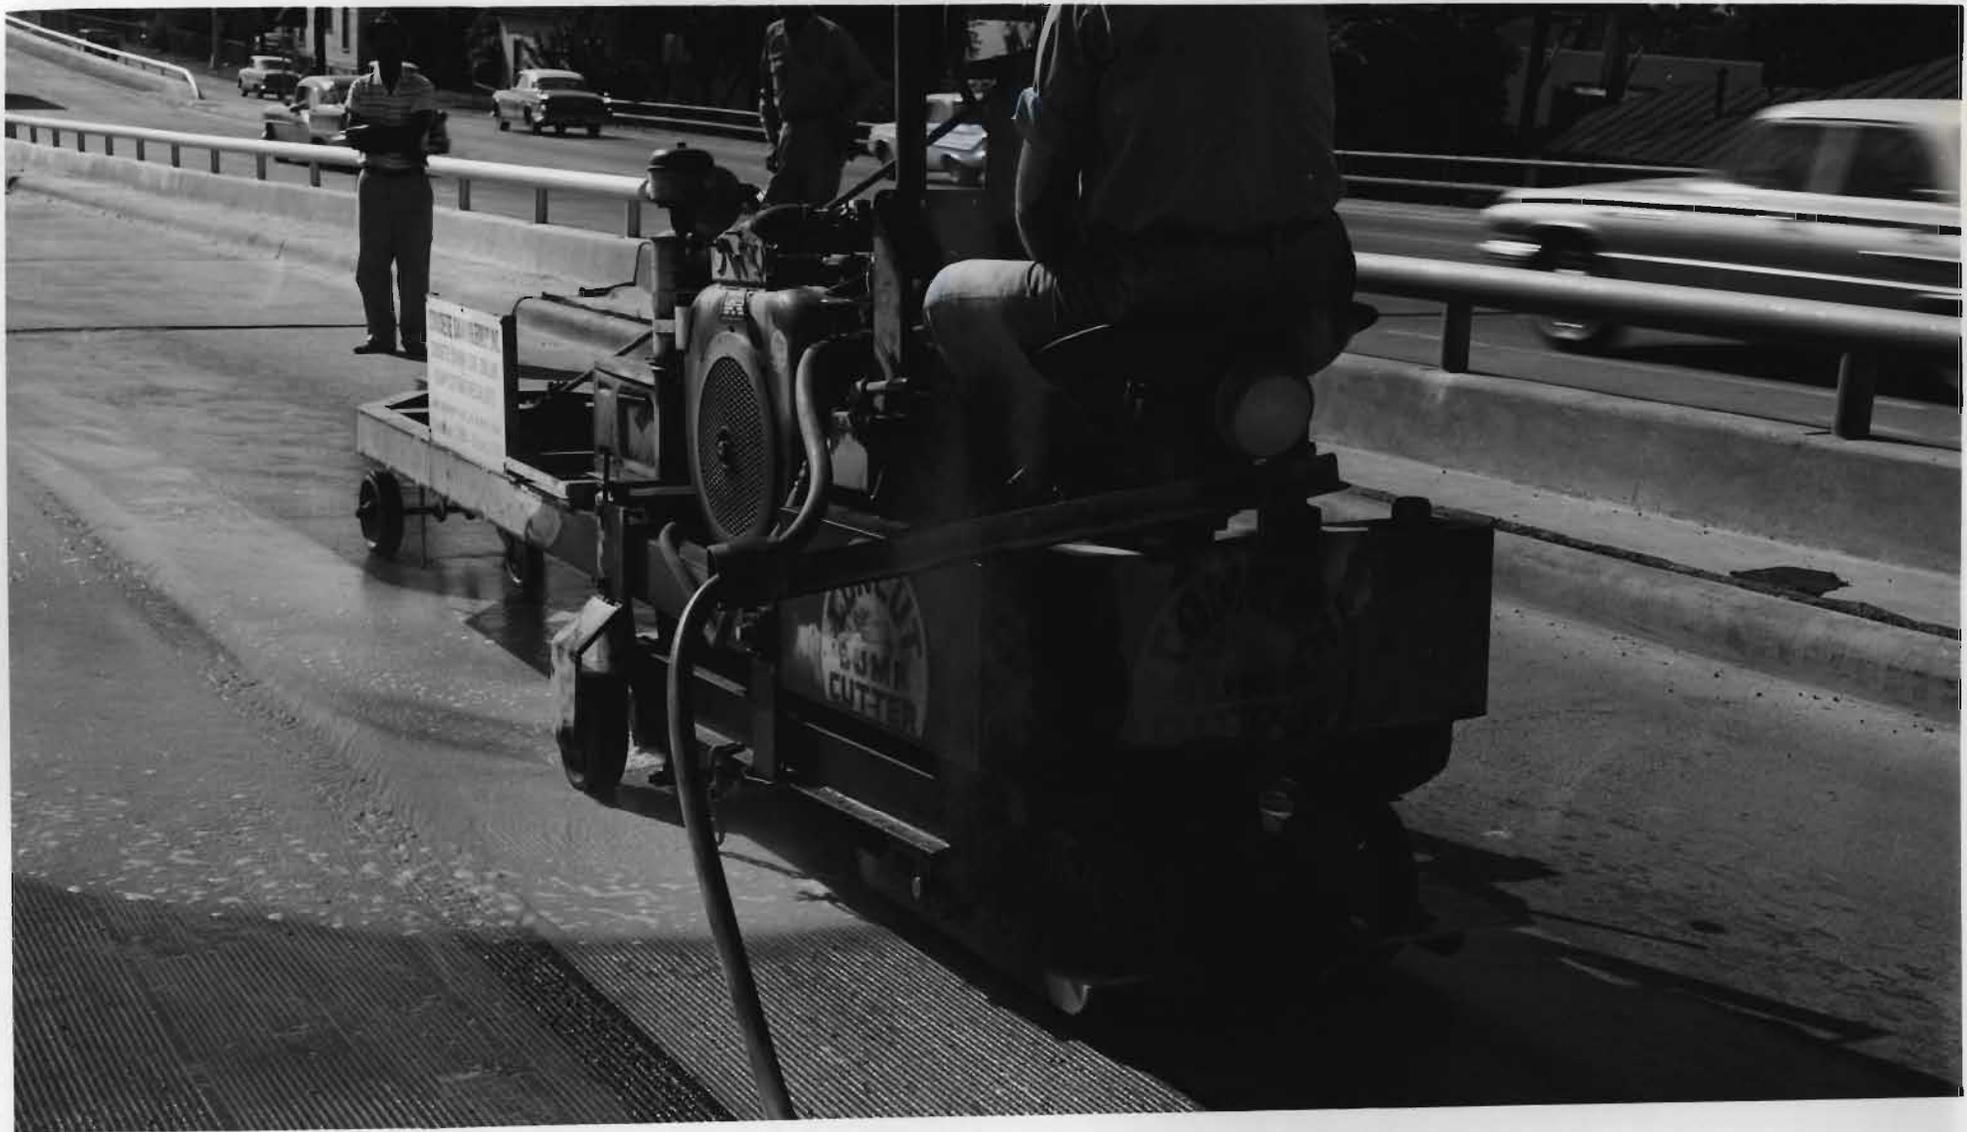
FIGURE 2

VIEW OF CONCUT BUMP CUTTER

A view of the con-cut bump cutter used in the project is shown in Figure 2.¹ This machine was very portable and maneuvered quite easily considering that it was some twenty-four feet in length. The blades were spaced at one-half inch centers and were operated at an average depth of one-eighth of an inch. A longitudinal cutting pattern was selected in order to increase the production rate and also to prevent interference with traffic operation and cut down on road noise. The operation of the machine utilized a considerable quantity of water to cool the blades and under normal conditions, according to the operator, the blades should last approximately nine months, but without water they would only last about forty five seconds.
