Maintenance Solutions for Bleeding and Flushed Pavements Surfaced with a Seal Coat or Surface Treatment

William D. Lawson, Michael Leaverton, Sanjaya Senadheera

Technical Report 0-5230-1
www.techmrt.ttu.edu/reports.php

February 2007

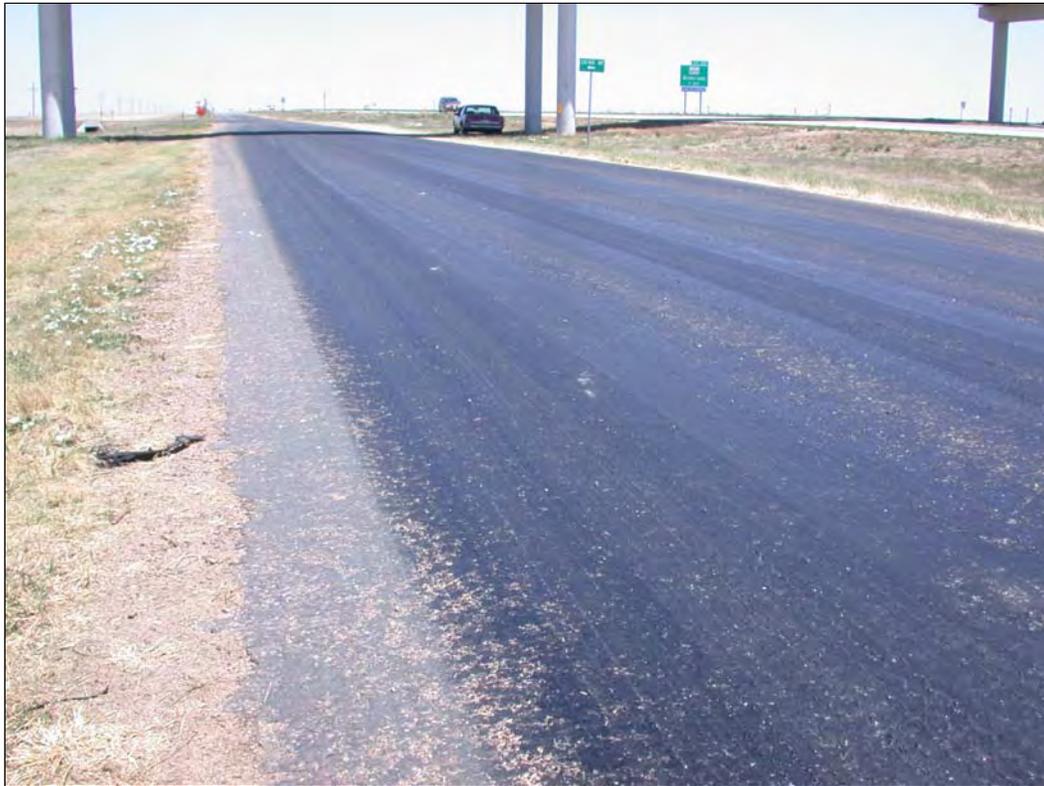
As used in this document, bleeding is the upward movement of asphalt in a seal coat or surface treatment resulting in the formation of a film of asphalt on the roadway surface (Figure 3.2). Bleeding occurs when excess asphalt binder fills the voids in the aggregate mat and then moves upward to the pavement surface under traffic and with heat expansion in a non-reversible, cumulative process.

Figure 3.2 Bleeding Asphalt Caused by Excessive, Heavy Truck Traffic and Hot Weather

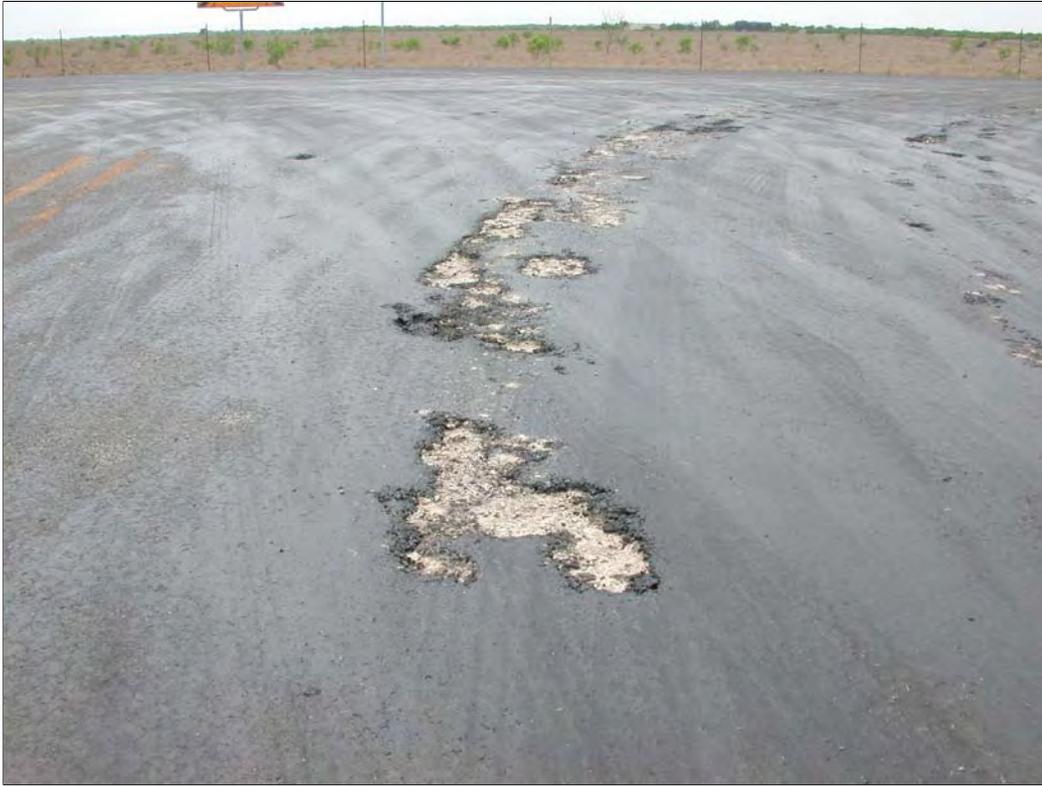
Bleeding asphalt sticks to aggregate and tires and causes tracking. Left unattended, bleeding can result in the seal coat or surface treatment aggregate rolling over and being picked up. This can lead to “pitting out” or pulling up chunks of pavement — “slinging” as opposed to “singing.” With reference to Figure 3.3, both the asphalt *and* the aggregate are picked up, effectively ruining the seal.

Figure 3.3 Pavement Damage – Picking Up of Seal Coat – Caused by Bleeding

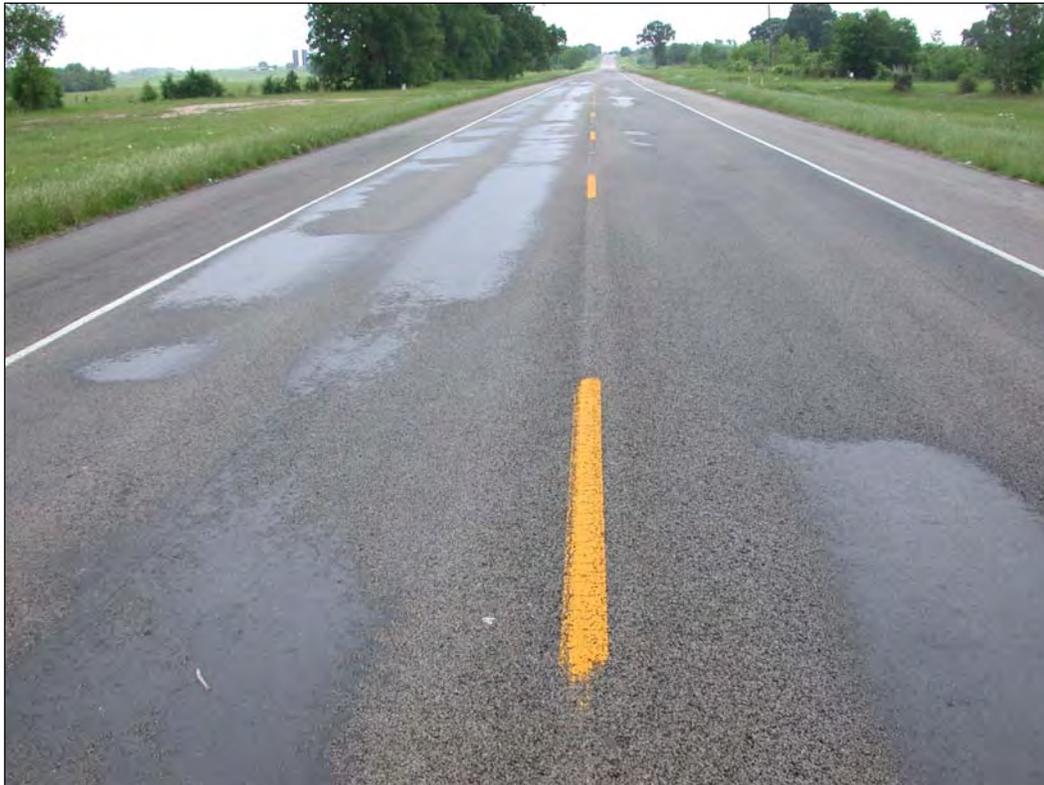
First and foremost, flushing is typically not an immediate maintenance problem and may not be a maintenance problem at all. In a flushed pavement, asphalt fills the voids in the aggregate mat and comes up flush with top of rock, but the binder is not liquid — it is solid or semi-solid. A flushed pavement is still holding its seal, so in a very real sense, the seal coat is still performing at least one critical aspect of its function (Figure 3.4).

Figure 3.4 Flushed Pavement

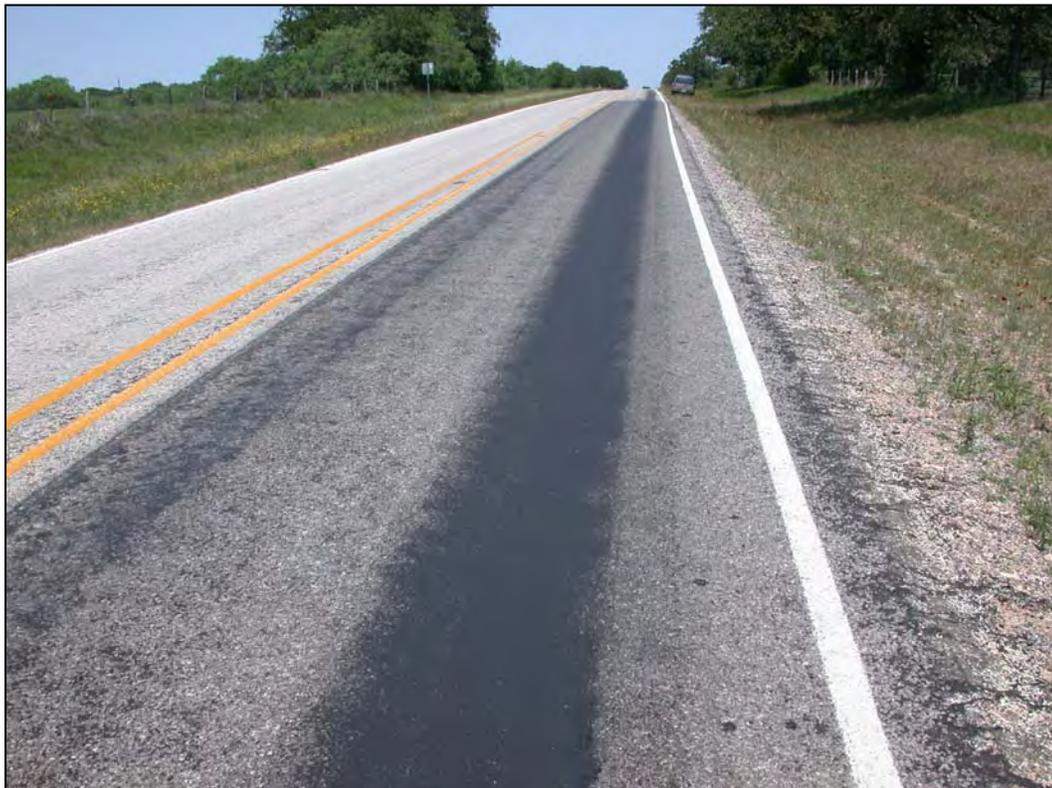
When a seal coat or surface treatment loses its rock, flushing and/or bleeding will be the result (Figure 4.1). Aggregate issues include rock loss, application of too much rock, use of dirty rock, use of soft rock, and judicious use of modified aggregate grades.

Figure 4.1 Flushing in Wheel Paths

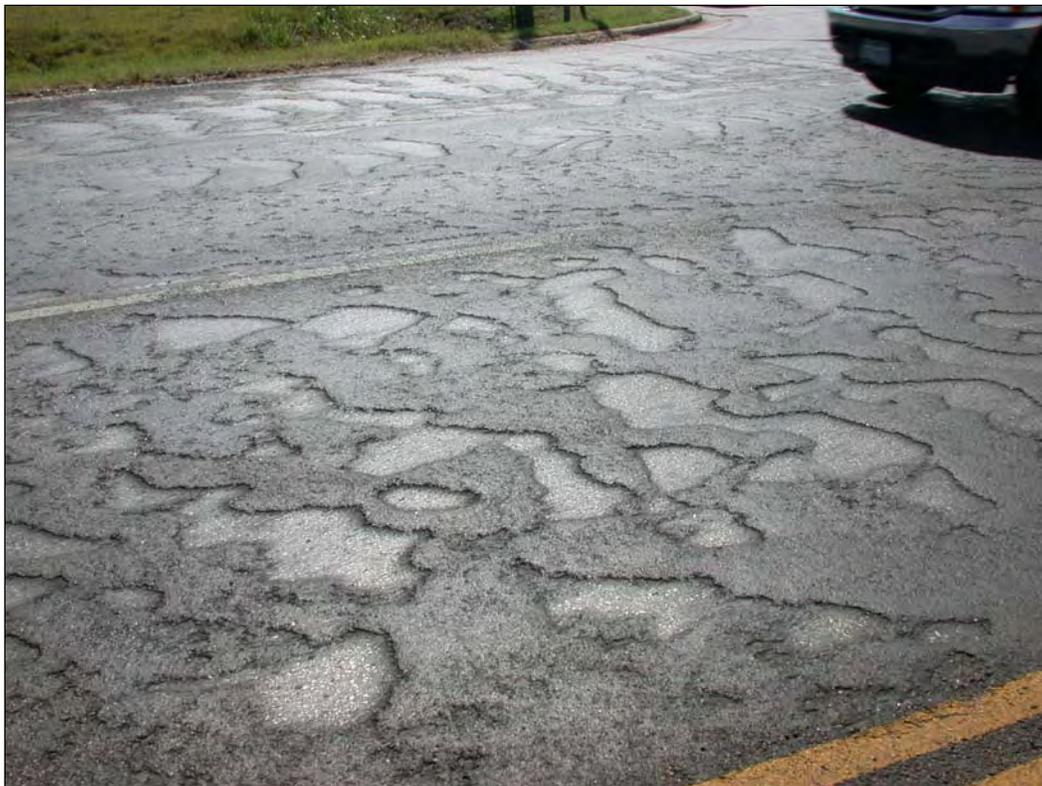
Turning causes the aggregate to mound up and shove. The reason is that, unlike cars and most other vehicles, the rear tandem axles of trucks do not have differentials that allow the rear wheels to turn at different rates as the vehicle makes a turn. This twisting action of tandem axle tires as they essentially slide across the pavement surface is one of the main causes of scrubbing at intersections and curves. The result is a “washboard” effect on the pavement surface (Figure 4.3).

Figure 4.3 Pavement Distress Caused by Starting/Stopping and Turning Maneuvers

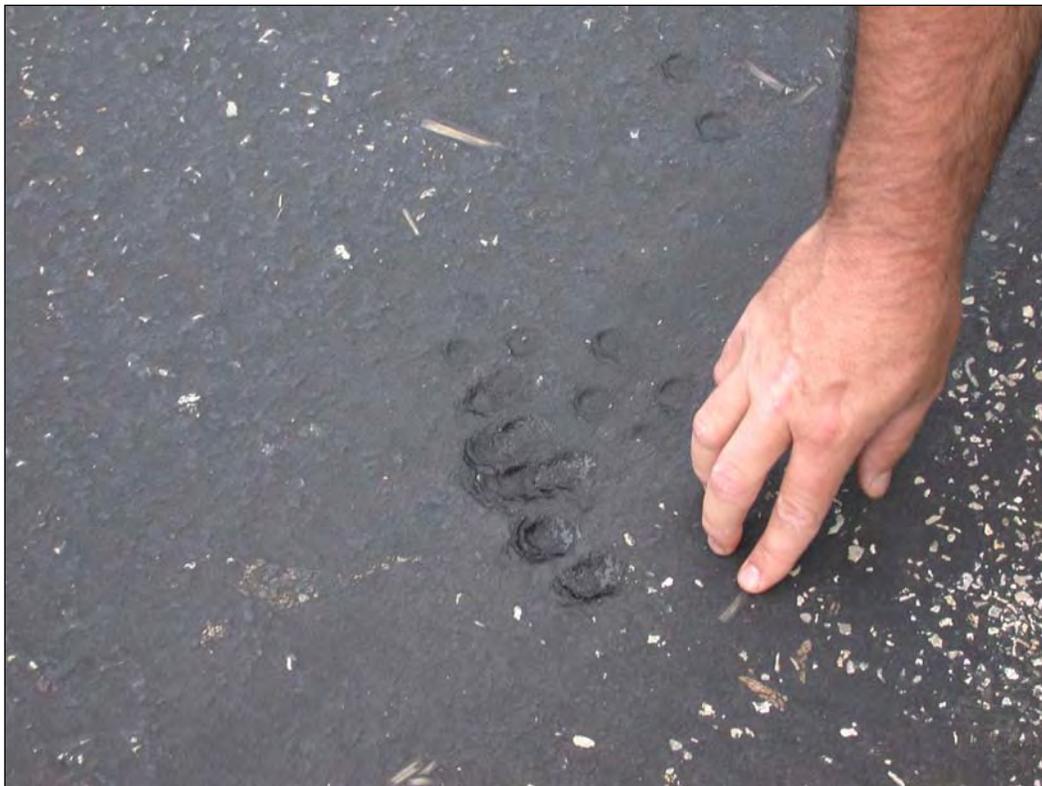
Figure 4.4 Soft Pavement (Flushing) Resulting From High Temperature/Humidity

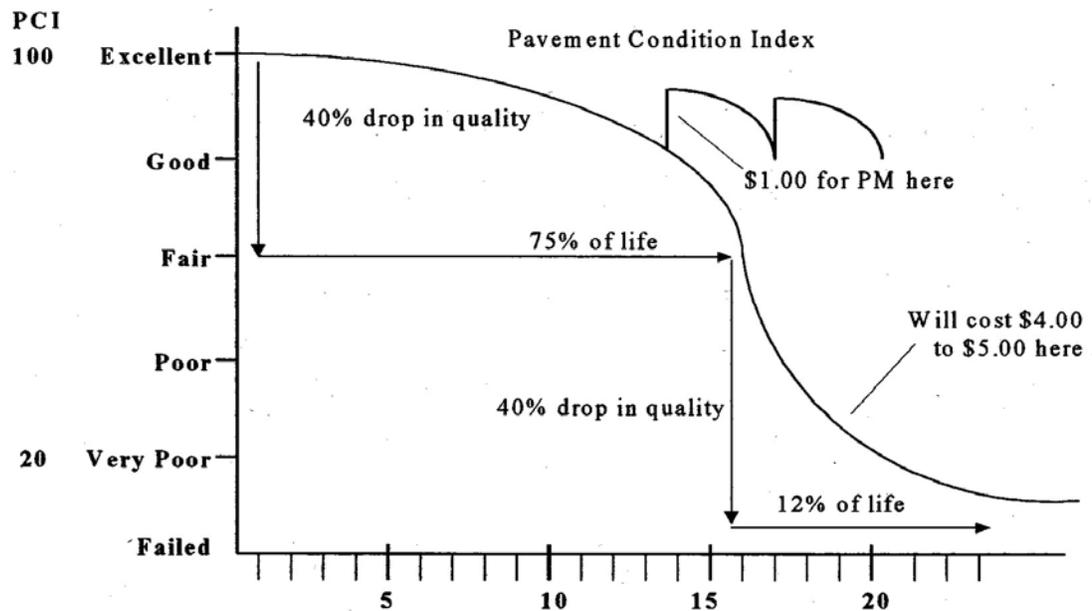
Figure 5.1 illustrates the typical pavement life cycle. It shows that speed of deterioration increases rapidly in the latter part of the performance curve. Moreover, the cost of a possible rehabilitation at the late stages in the performance cycle is three to four times more expensive than when applied early in the life of pavement. Therefore, preventive maintenance makes sense provided it is used at the appropriate time.

Figure 5.1 Typical Pavement Life Cycle (*Source: Hicks, et al. [35]*)

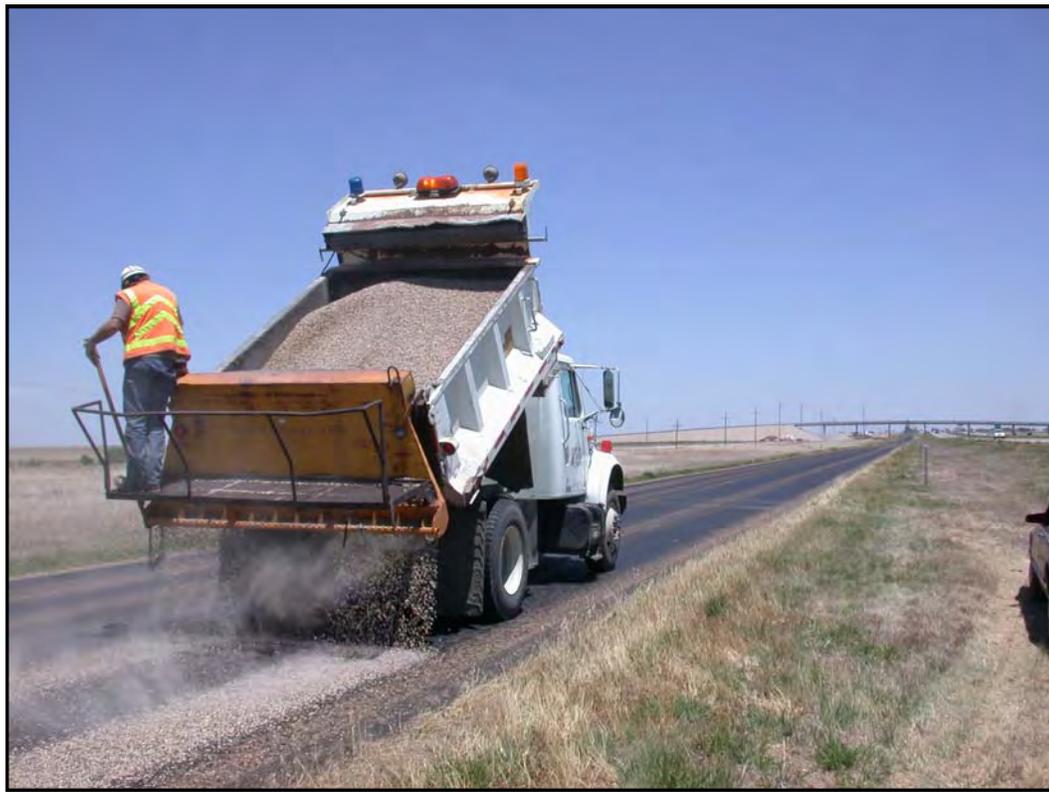
This method is typically used to treat light to moderate bleeding. The key with any aggregate remedy is to get the rock to stick to the pavement surface, and the primary objective is to get the tires out of the asphalt. Some maintenance forces use this treatment in conjunction with lime water.

Figure 6.1 Applying Small-Size Aggregate to Treat Bleeding Pavement

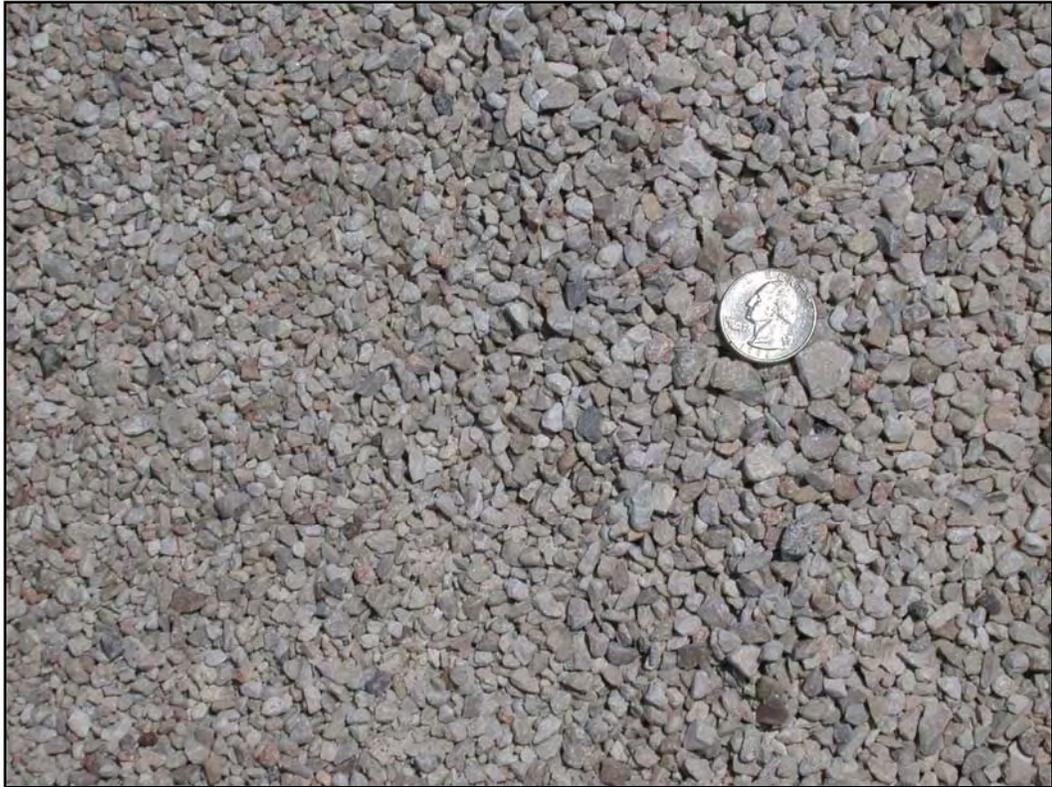
The application of Grade 5 aggregate is the most commonly-used maintenance solution for the treatment of bleeding asphalt pavements in Texas.

Figure 6.2 Small-Size (Item 302, Grade 5) Aggregate

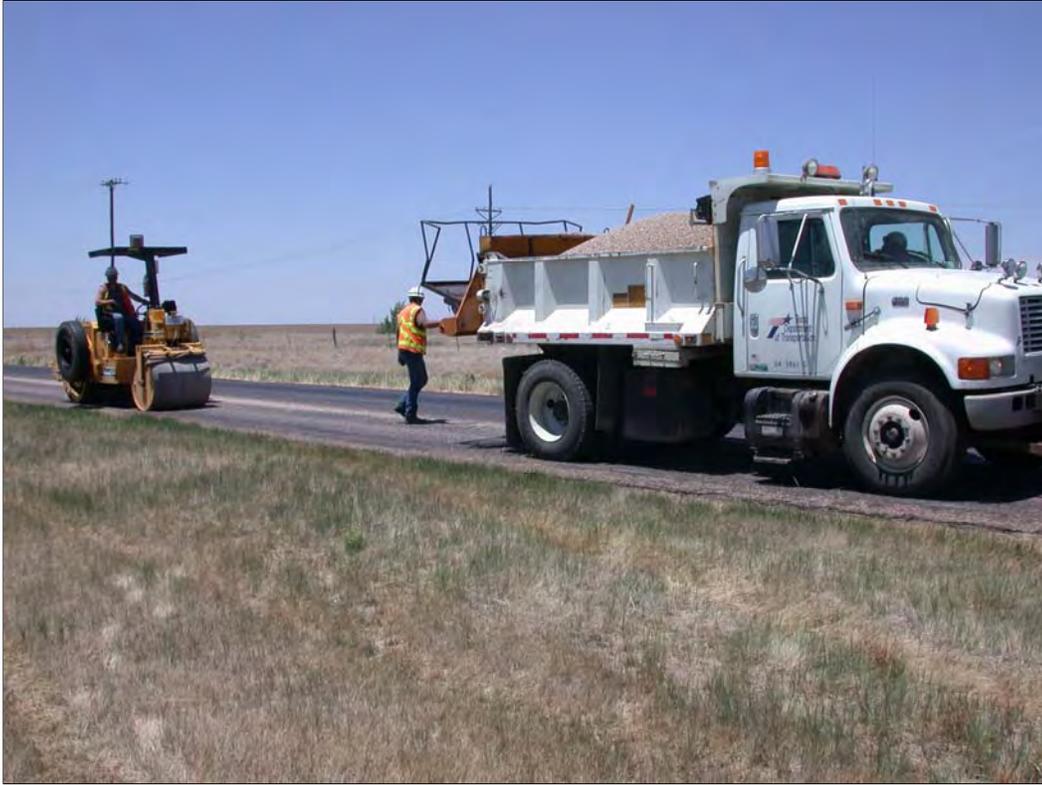
An aggregate spreading operation typically uses one dump truck with a tailgate spreader (one driver and one spreader operator), one steel wheeled roller with operator, and a crash attenuation vehicle with driver (see Figure 6.3). Sometimes an additional dump truck is used. Traffic should be slowed or stopped (controlled) during the treatment process.

Figure 6.3 Application of Grade 5 Aggregate to Treat Bleeding

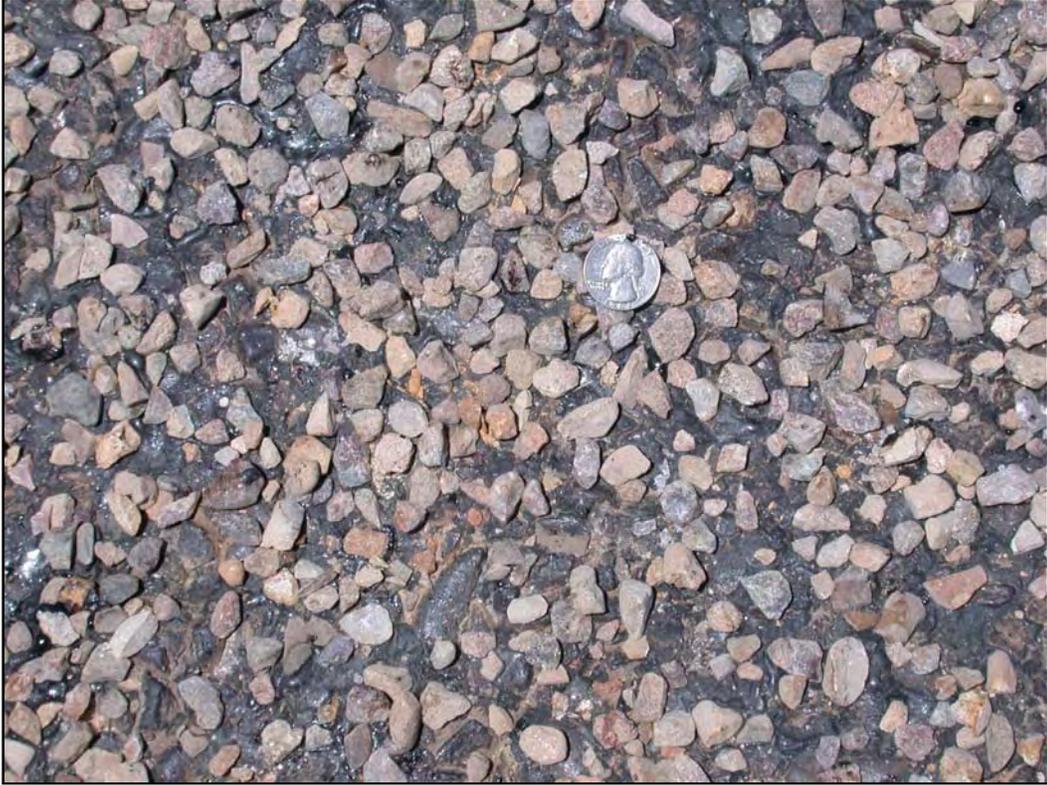
Larger aggregates (Grade 3 and Grade 4) are used when bleeding is severe. This solution is typically employed by construction contractors for treatment of bleeding that occurs *during* or *shortly after* seal coat construction. Here, the contractor applies the same rock that was used for the original seal coat, these original aggregate materials being still available (stockpiled) on site.

Figure 6.4 Grade 3 Aggregate to Treat Bleeding

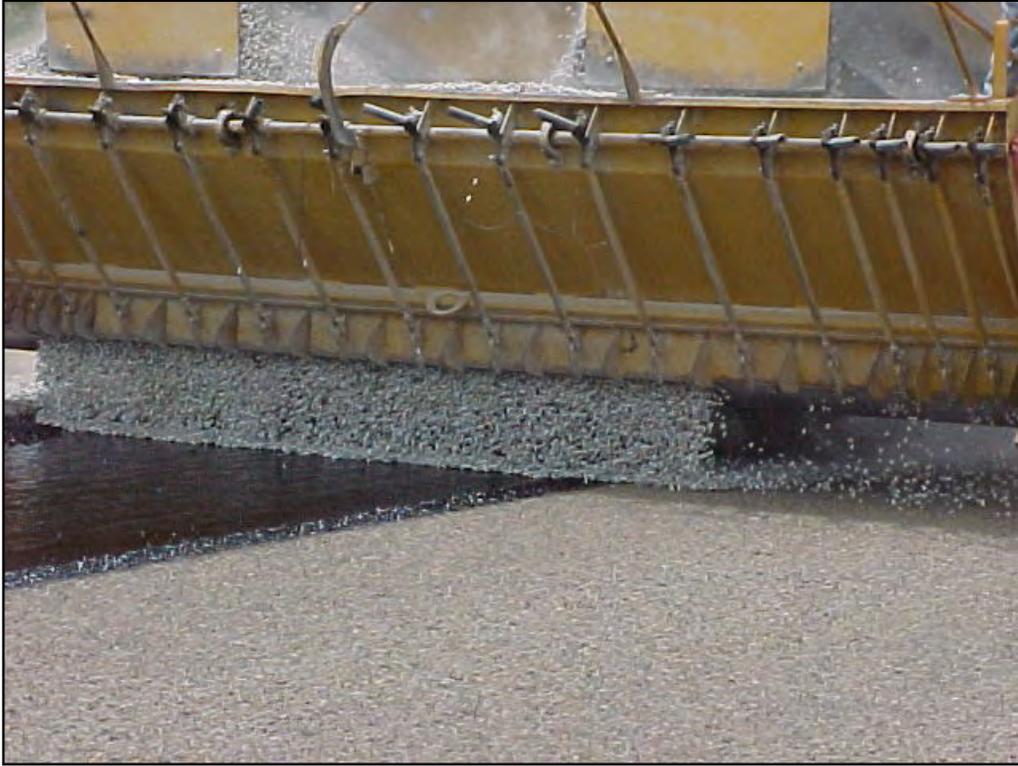
TxDOT will occasionally purchase back excess seal coat rock (Grade 3 and Grade 4) from a contractor after construction and leave it stockpiled by the road in the event maintenance forces need to re-rock an area or treat a bleeding asphalt pavement.

Figure 6.5 Application of Grade 3 Seal Coat Aggregate

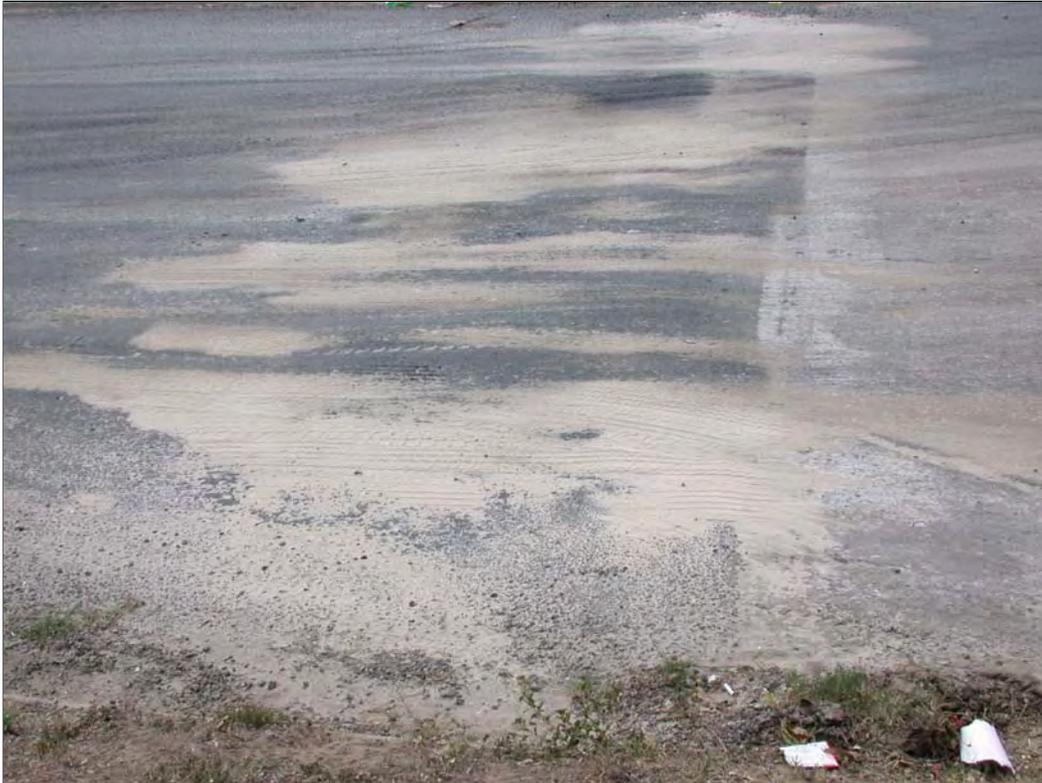
Aggregate with finer particle sizes (smaller than Grade 5) – for example, sand, ice

Figure 6.6 Application of Sand Blotter Material to Treat Bleeding Pavement at an Intersection

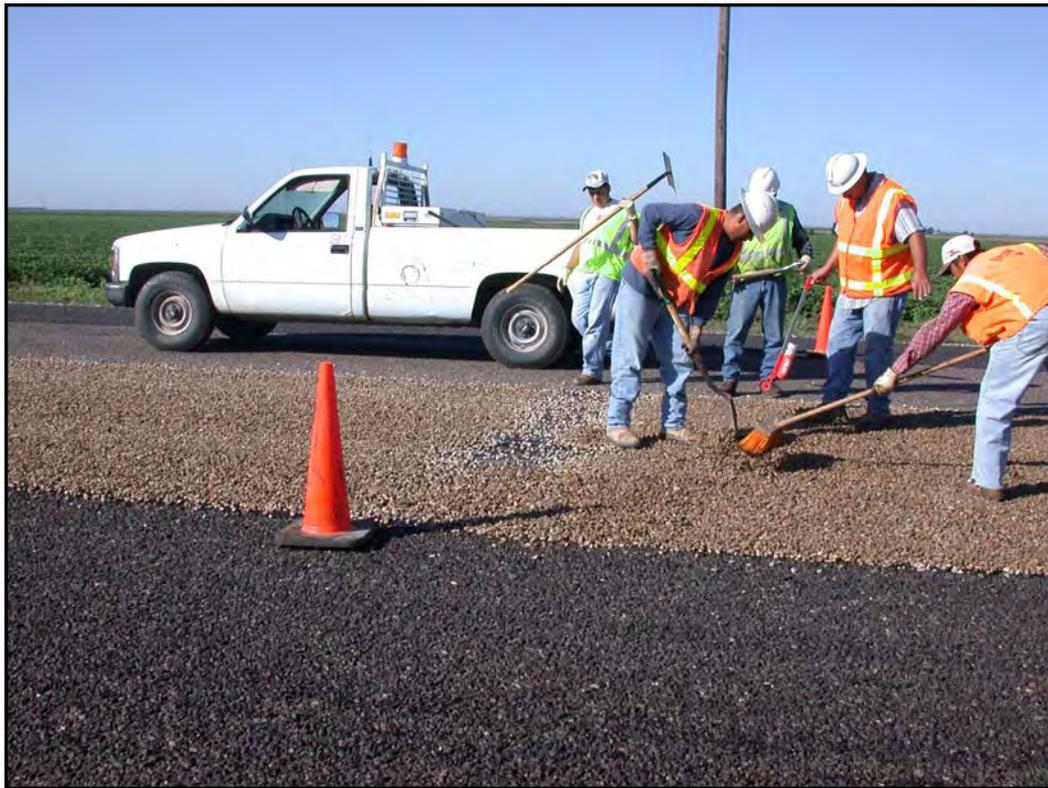
Timing of this treatment is essential. These materials should be spread in the heat of the day when bleeding is active and there is liquid asphalt on the pavement surface.

Figure 6.7 Hand Application of Aggregate to Treat Bleeding Pavement

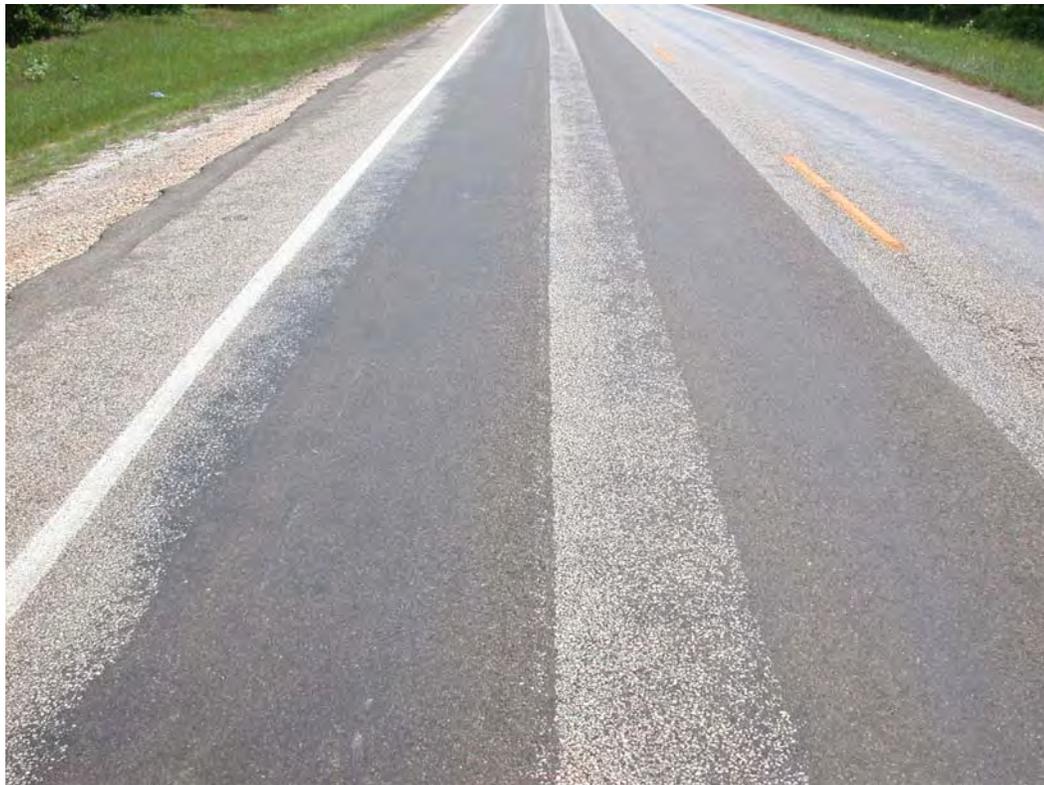
To construct a sandwich seal, first, a clean coarse aggregate (seal coat rock) is spread on top of the bleeding asphalt. A layer of asphalt binder is then sprayed on top of the untrafficked coarse aggregate, and then a second layer of finer seal coat rock is placed over

Figure 6.8 Sandwich Seal Used to Treat Bleeding Pavement in the Wheel Paths

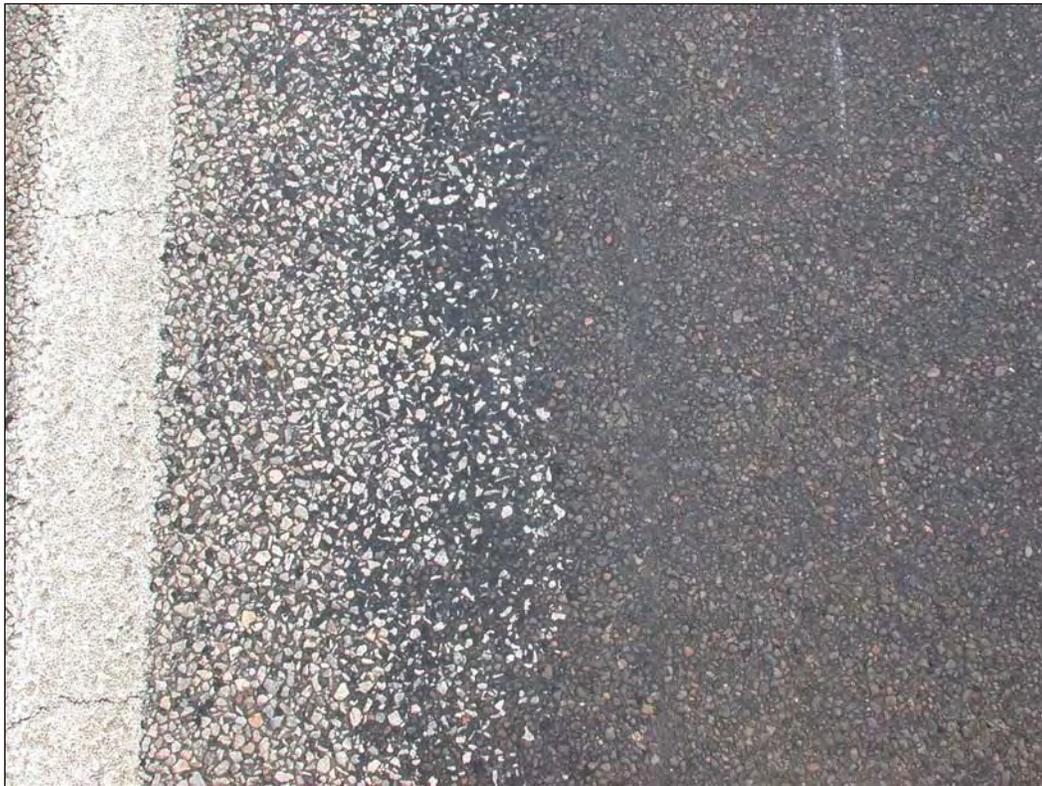
The sandwich seal is typically applied as a strip seal to correct moderate to severe bleeding and minor rutting in the wheel paths. This method yields exceptional friction or skid resistance properties with good macrotexture in the surface (Figure 6.8). Another benefit is that no coarse aggregate is loose and flying, considerably decreasing the chances of headlight and windshield breakage.

Figure 6.9 Improved Macrotexture in the Wheel Paths Using a Sandwich Seal

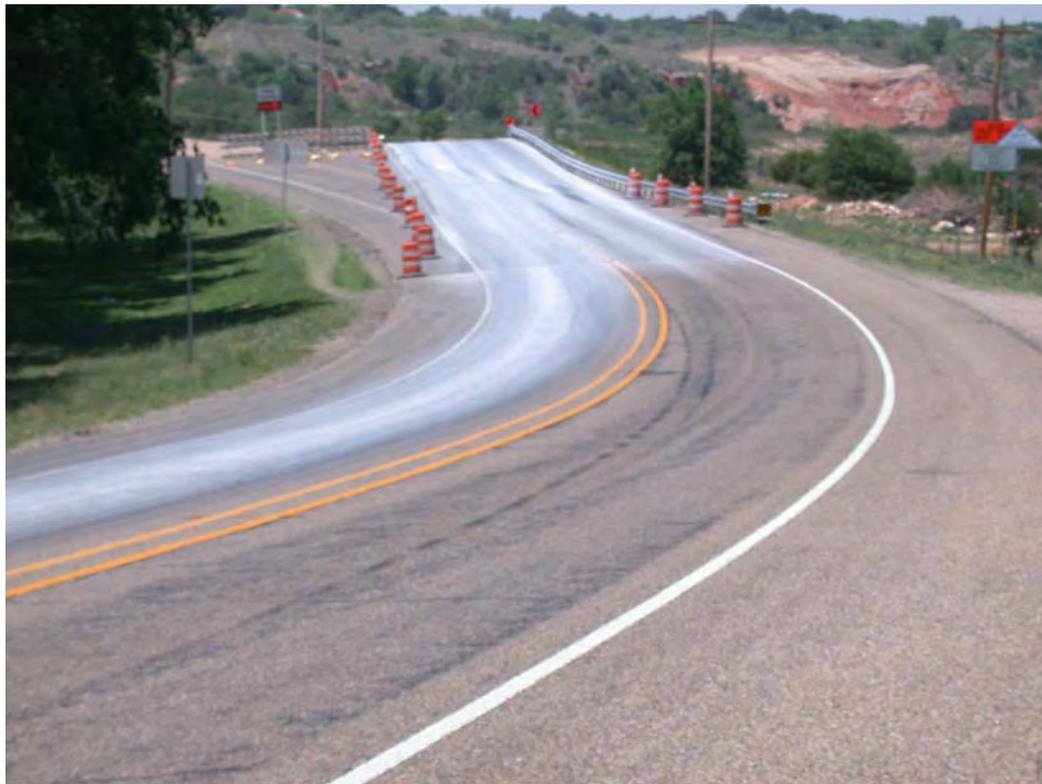
The application of hydrated lime mixed with water is one of the most commonly-used maintenance solutions for the treatment of bleeding asphalt pavements in Texas (Figure 6.9). Customary practice is to mix lime water using a portable 1000 gallon water tank unit that slides into the back of a dump truck. The tank unit comes with an agitator pump to keep the lime in suspension, and the lime water is applied to the bleeding pavement surface using a spray bar.

Figure 6.10 Application of Hydrated Lime to Cool Bleeding Pavement

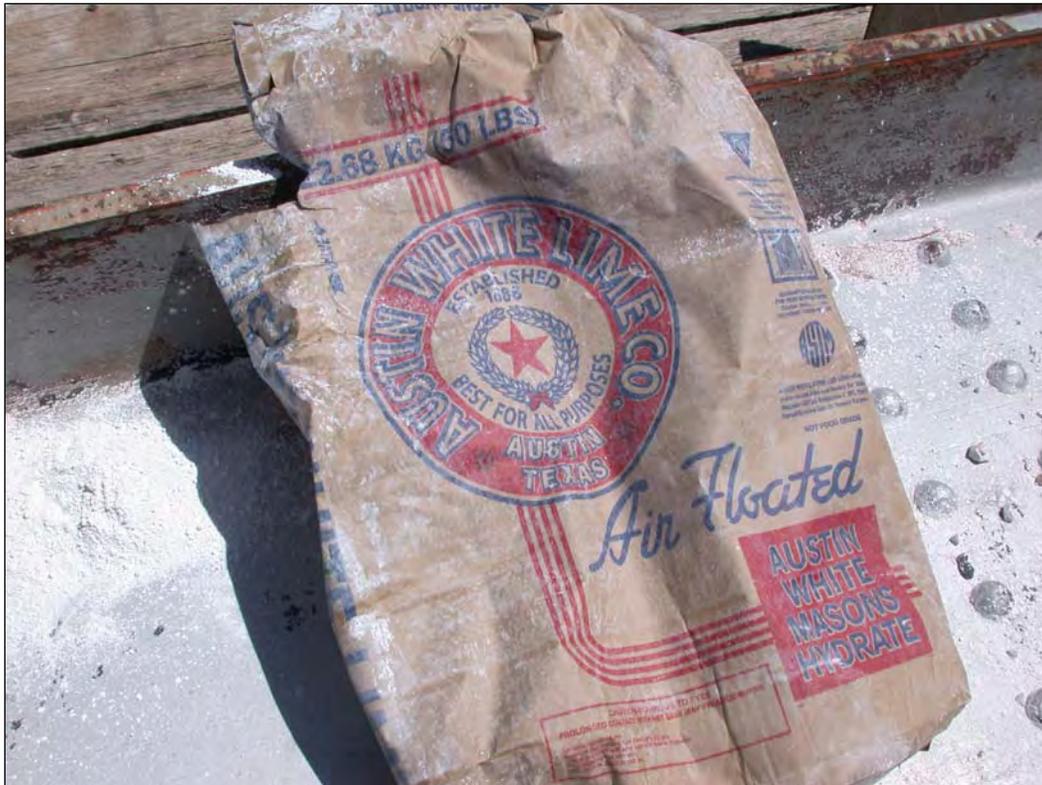
No standard specification exists for the lime water method, so considerable variation exists in treatment practices. A successful lime water operation requires, at a minimum, Type A hydrated bag lime (50 pound bags, typical) and a potable water source (Figure 6.10).

Figure 6.11 50-lb Bag, Type A Hydrated Lime

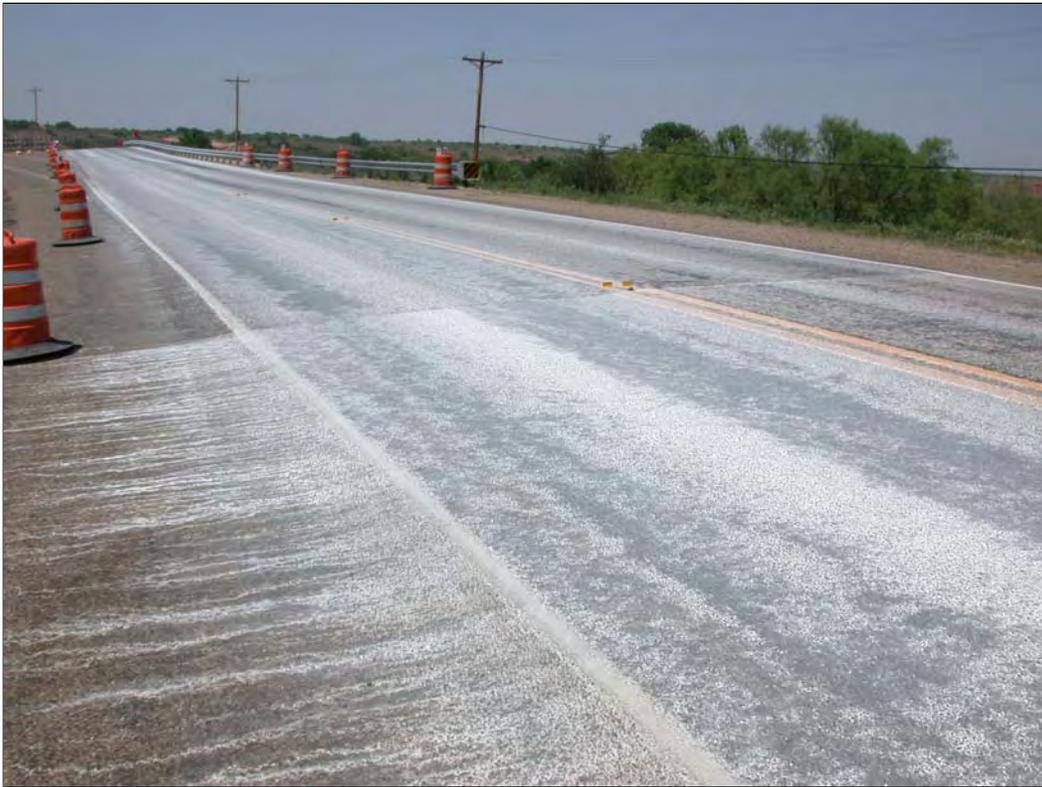
Recipes for lime water concentrations vary with individuals and is more art than science. An incremental approach to lime water treatment is the recommended practice. This approach starts with a higher lime concentration for the first treatment and then reduces the lime water concentration with each successive treatment until the bleeding is under control.

Figure 6.12 The Lime Application Rate Should Achieve Good Splatter (Dosage) of Lime Water Solution on the Affected Pavement Surface

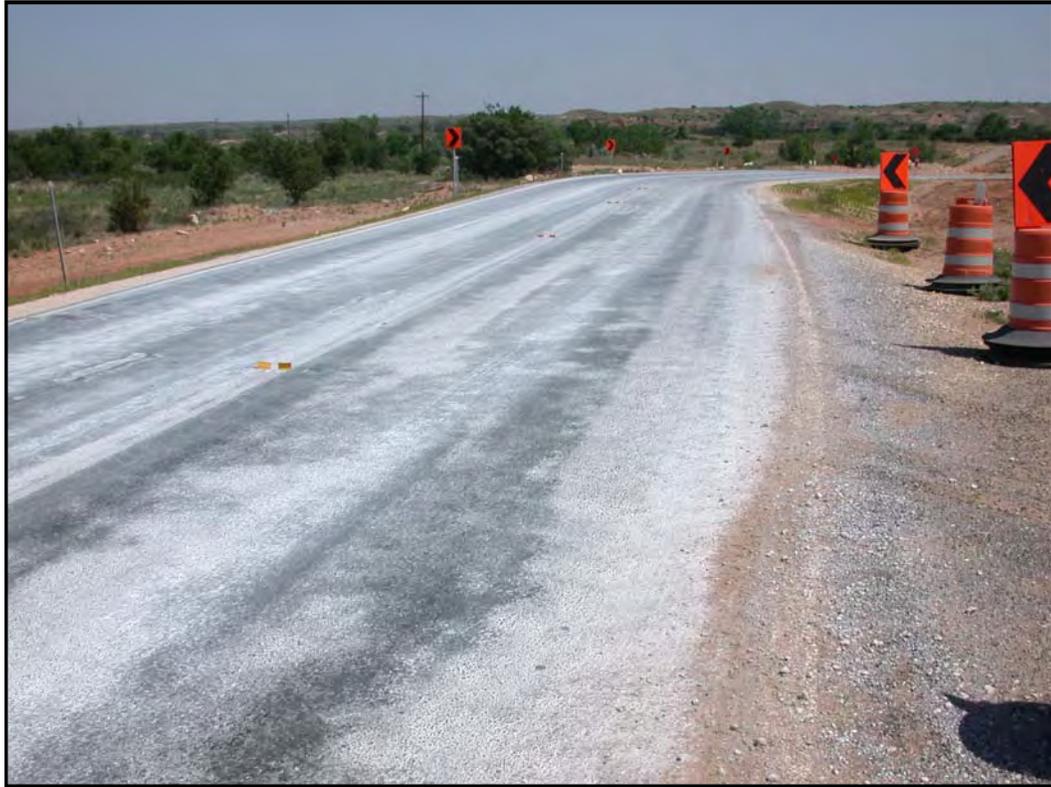
One of the disadvantages of this treatment is that lime water puts a white film on everything and kills the reflectability of pavement markings and striping (Figure 6.12).

Figure 6.13 Lime Can Obscure the Reflectability of Pavement Markings and Striping

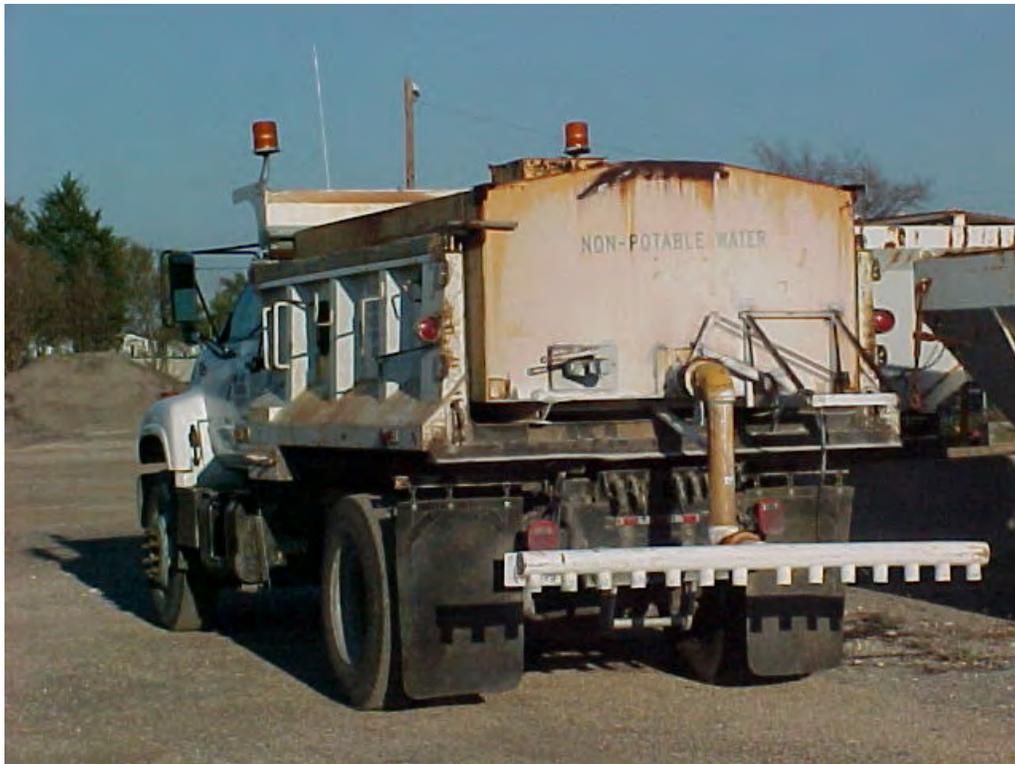
Customary practice is to apply water using a standard construction water truck equipped with a spray bar (Figure 6.13).

Figure 6.14 Application of Water Using a Standard Construction Water Truck

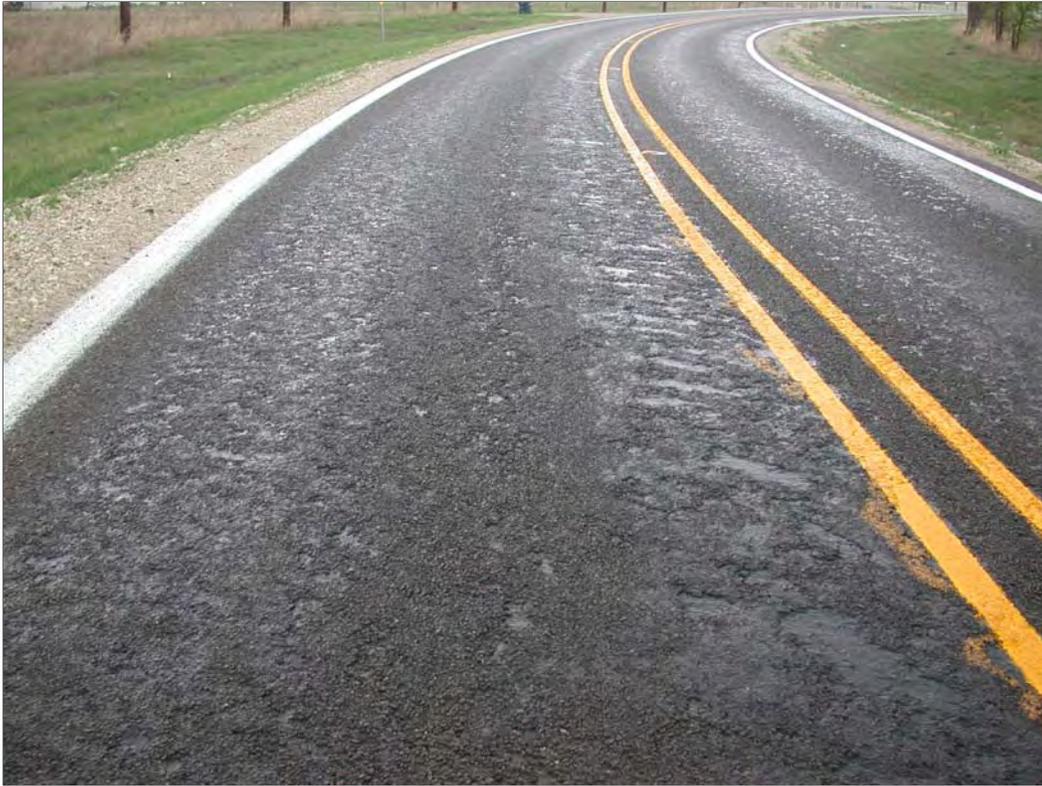
Figure 6.15 Removal and Replacement May Be Necessary When a Fresh Seal Coat Totally Fails

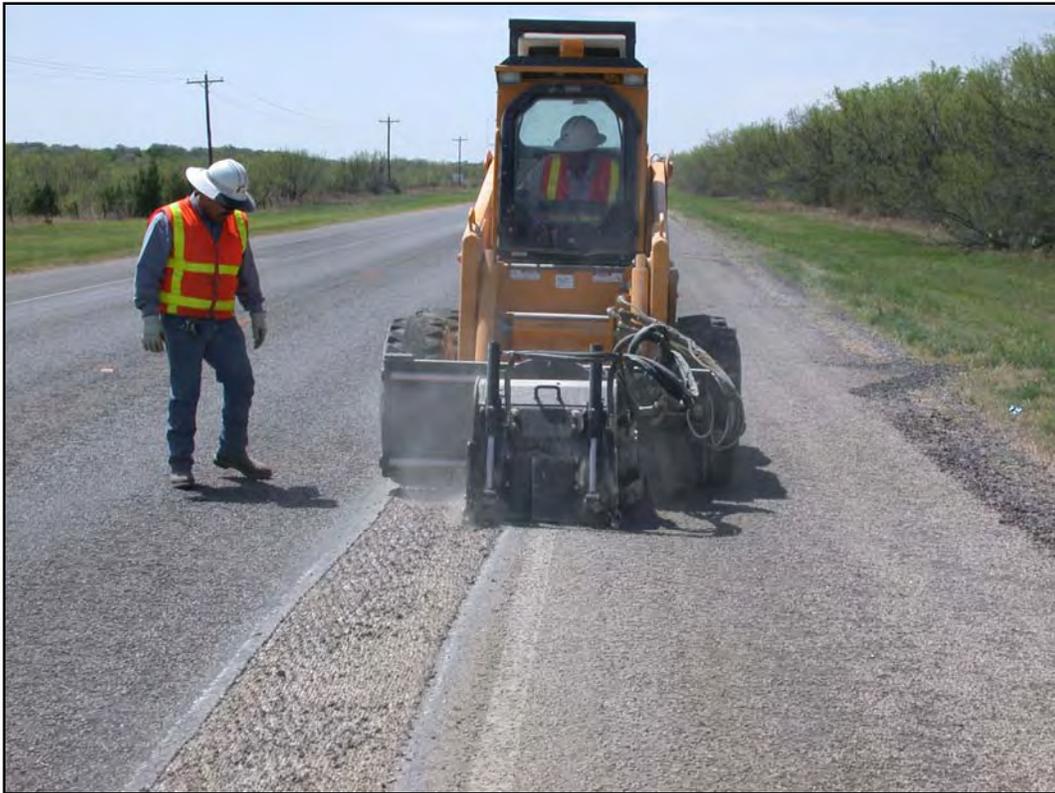
Cold milling is the controlled removal of the surface of the existing pavement to the desired depth, with specially designed milling equipment (Figure 7.1). Milling is done either to prepare the surface to receive overlays (by removing rutting, flushing, and surface irregularities), to restore the pavement cross slopes and profile, or to re-establish the pavement's surface friction characteristics. Surface removal is typically done with a milling machine which uses a drum equipped with carbide-tipped teeth that impact and chip the pavement surface. The resulting textured pavement can be used immediately as a driving surface.

Figure 7.1 Cold Milling to Retexture Flushed Pavement in the Wheel Paths

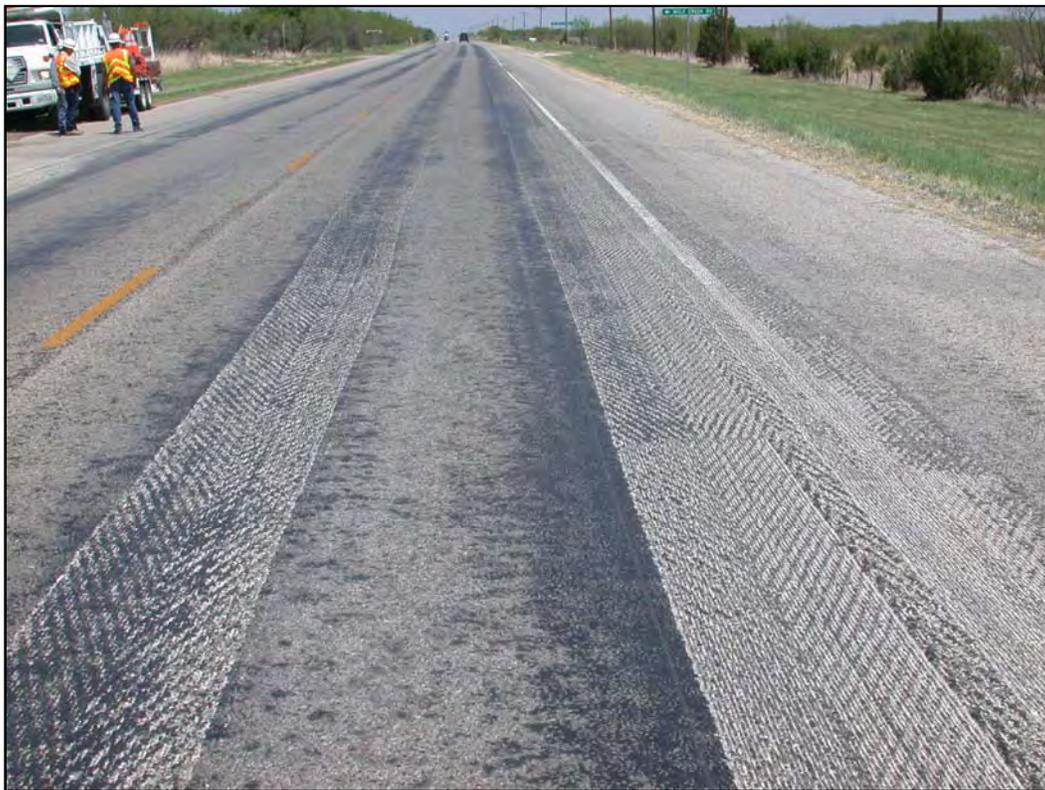
The pavement surface is often left in a milled condition for extended periods of time until subsequent treatments such as a new seal coat or hot mix overlay are applied. In some cases, maintenance crews will go back over the milled areas with premix patch materials using blade level-up methods in advance of subsequent seal coat or overlay operations.

Figure 7.2 Cold Milling Yields a Grooved Surface Texture Along the Longitudinal Axis of the Roadway

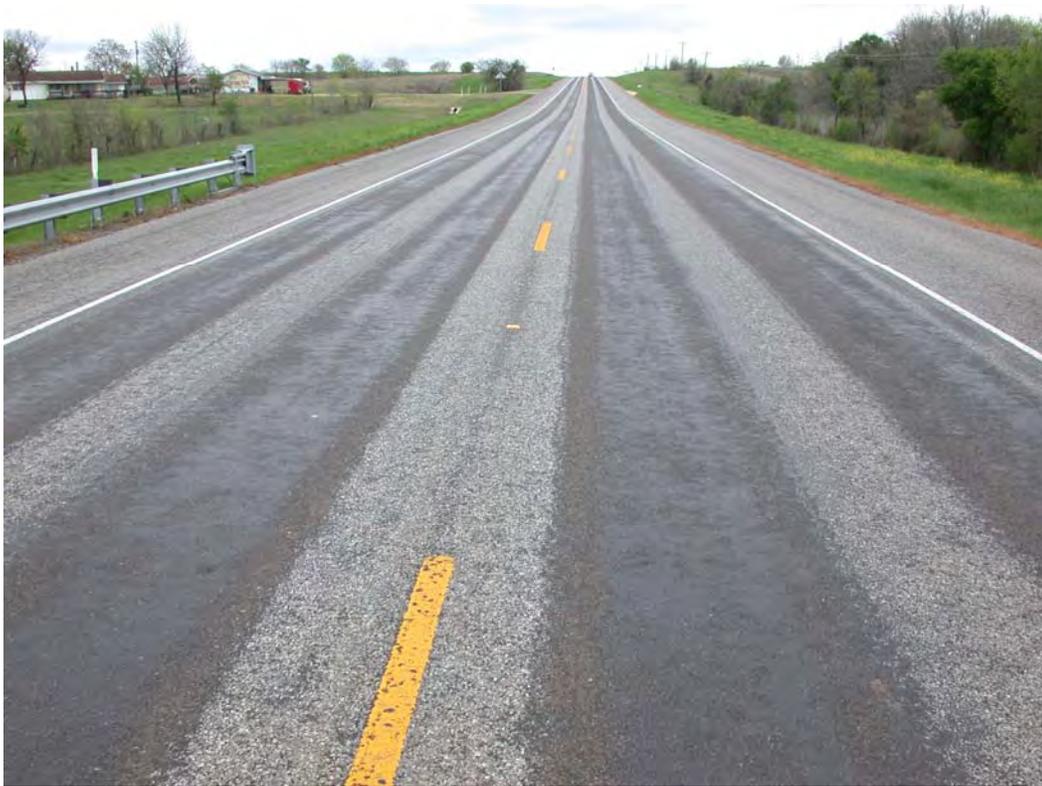
Some claim that the same concern exists relative to flushing. That is, preexisting flushing may presumably reappear through the new seal coat, especially in the wheel paths.

Figure 7.3 Strip Seals (a New Seal Coat in Wheel Paths) to Control Flushed Pavement Must Be Carefully Designed to Avoid Additional Flushing
