Maintenance Solutions for Bleeding and Flushed Pavements Surfaced with a Seal Coat or Surface Treatment

William D. Lawson, Michael Leaverton, Sanjaya Senadheera

Technical Report 0-5230-1
www.techmrt.ttu.edu/reports.php

February 2007

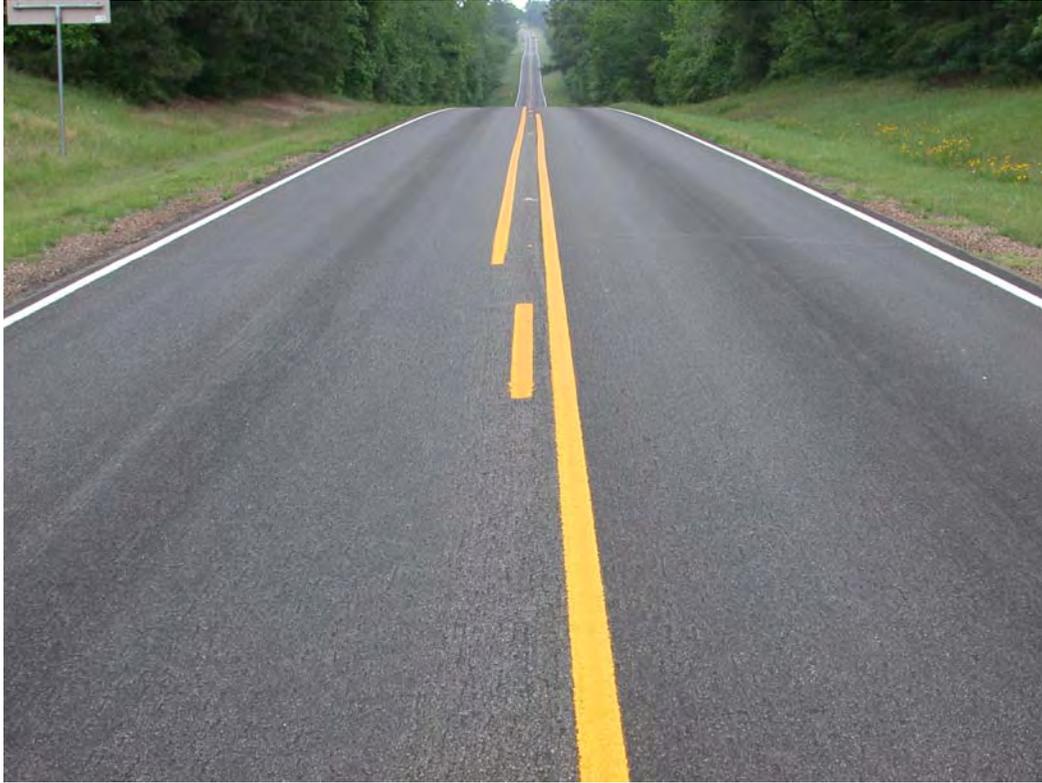
Microsurfacing is considered to be a long term treatment for flushed pavements and has to be done by specialty contractors under an engineer's contract. Maintenance personnel indicate that they have used this solution successfully and can get about 5 to 7 years of

Figure 7.4 Microsurfacing Can Be Used to Remediate Minor Rutting, Flushed Pavement, Poor Ride Quality and Low Skid Resistance

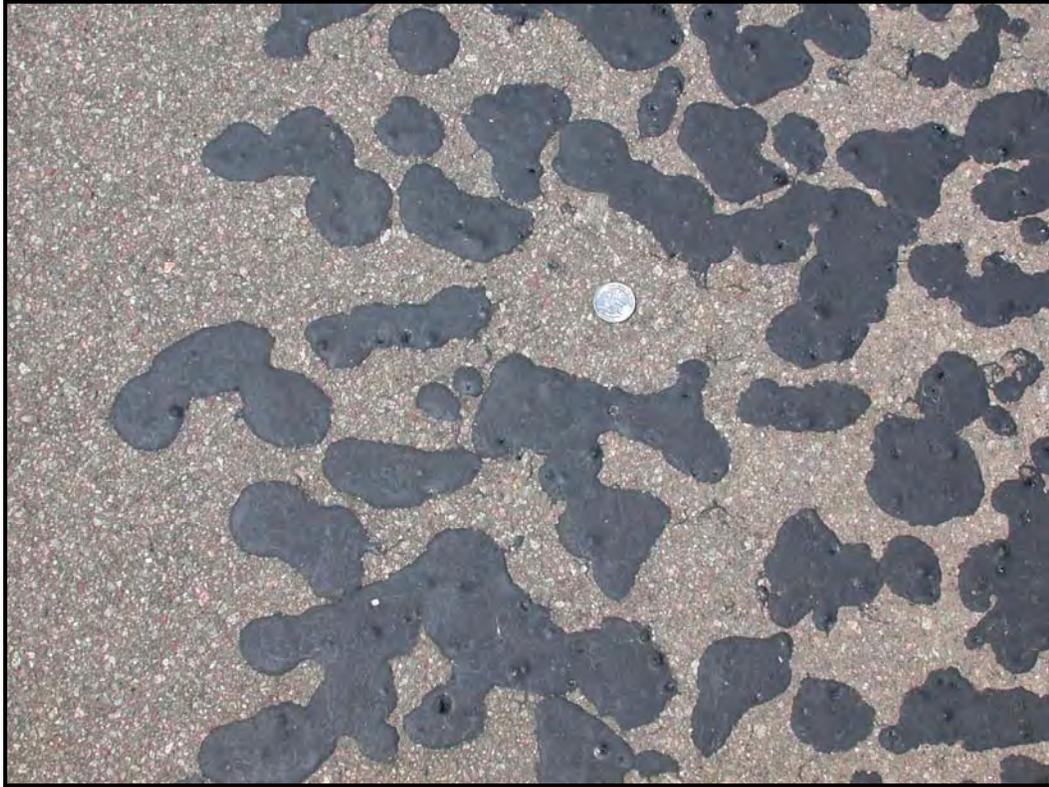
Figure 7.5 Excess Asphalt from Flushed Pavement Can Work Its Way Through Microsurfacing

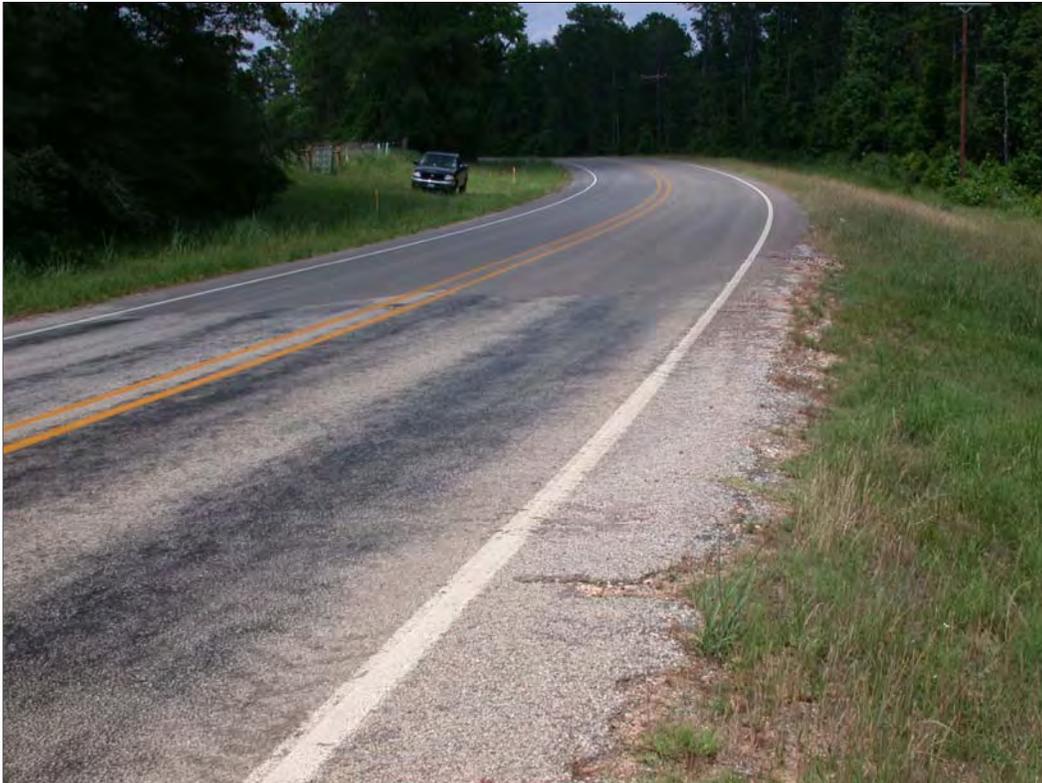
Mill and fill operations, where the overlay is constructed with a laydown machine, may be used at intersections where start-stop and other abusive traffic movements occur. This type of overlay is considered as the final, last-resort type of treatment where no other solution seems to work.

Figure 7.6 Blade Level-ups and Other Thin Asphaltic Concrete Overlays Restore Friction and Skid Resistance

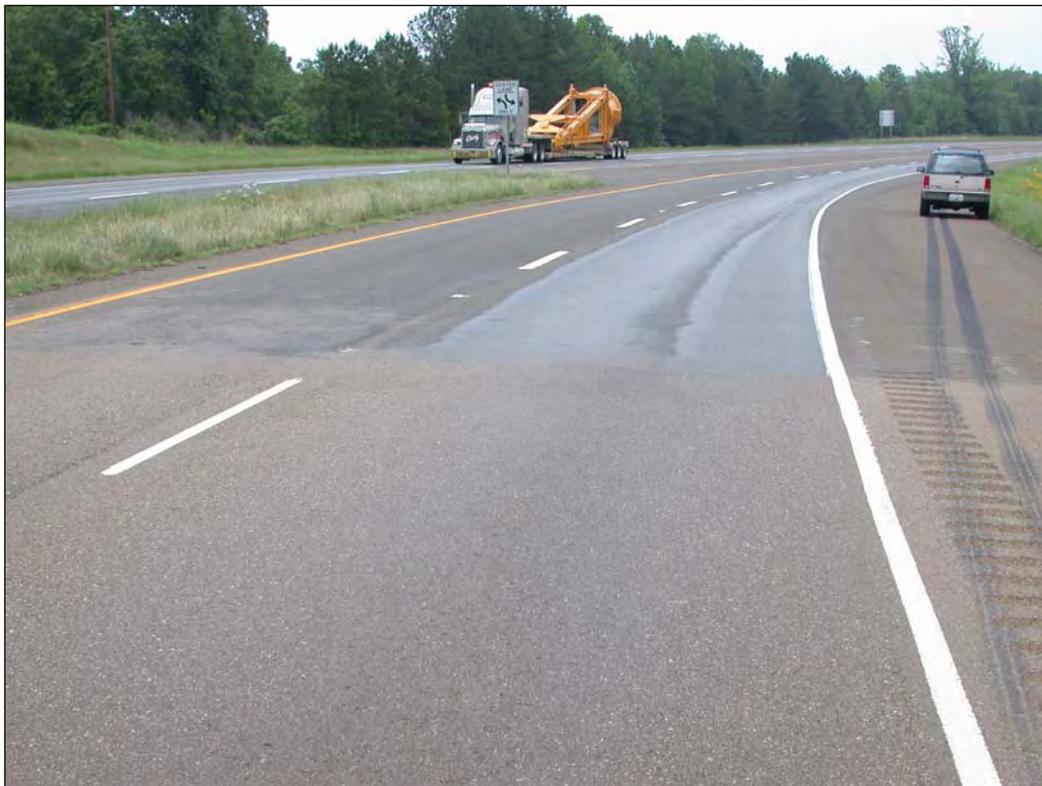
Figure 7.7 Thin Overlays to Treat Flushed Pavement Can Be Applied Using Asphalt Laydown Machines

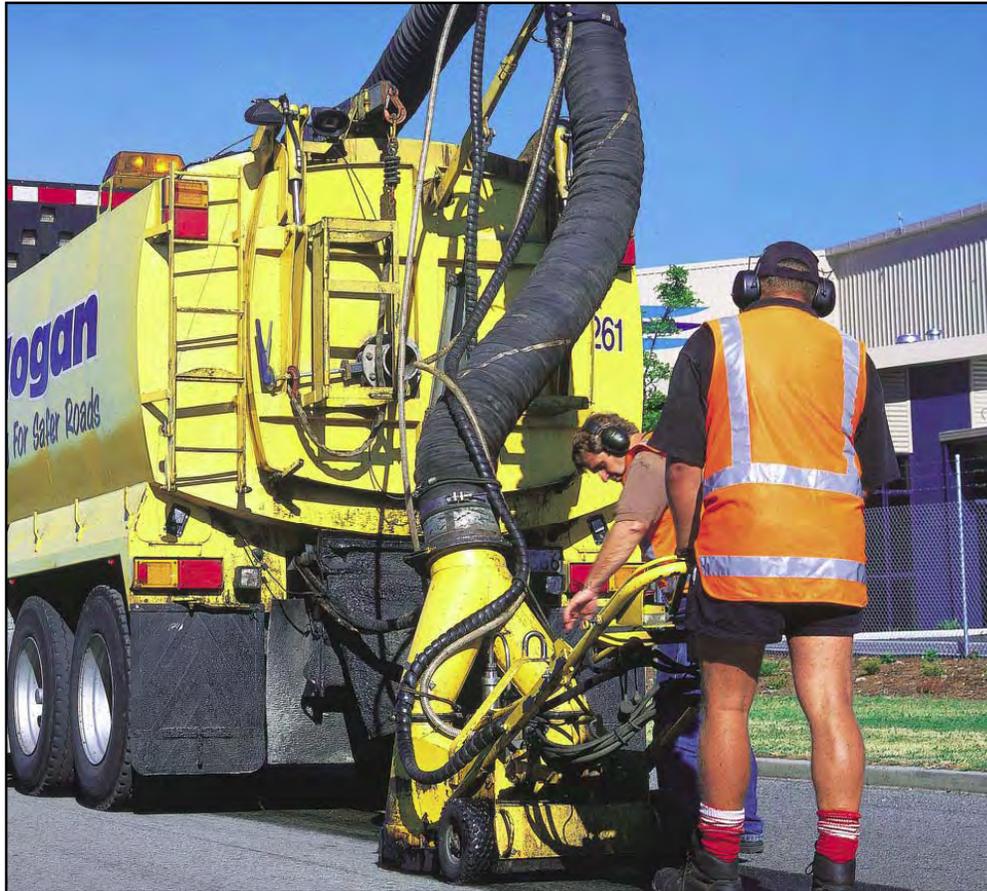
Figure 7.8 The UHP Watercutter Combines a Truck-Mounted UHP Pump, Water Supply, and Vacuum Recovery System with an Independently Operated Umbilical Deckblaster.
Source: Fulton Hogan, Ltd. [www.fh.co.nz]

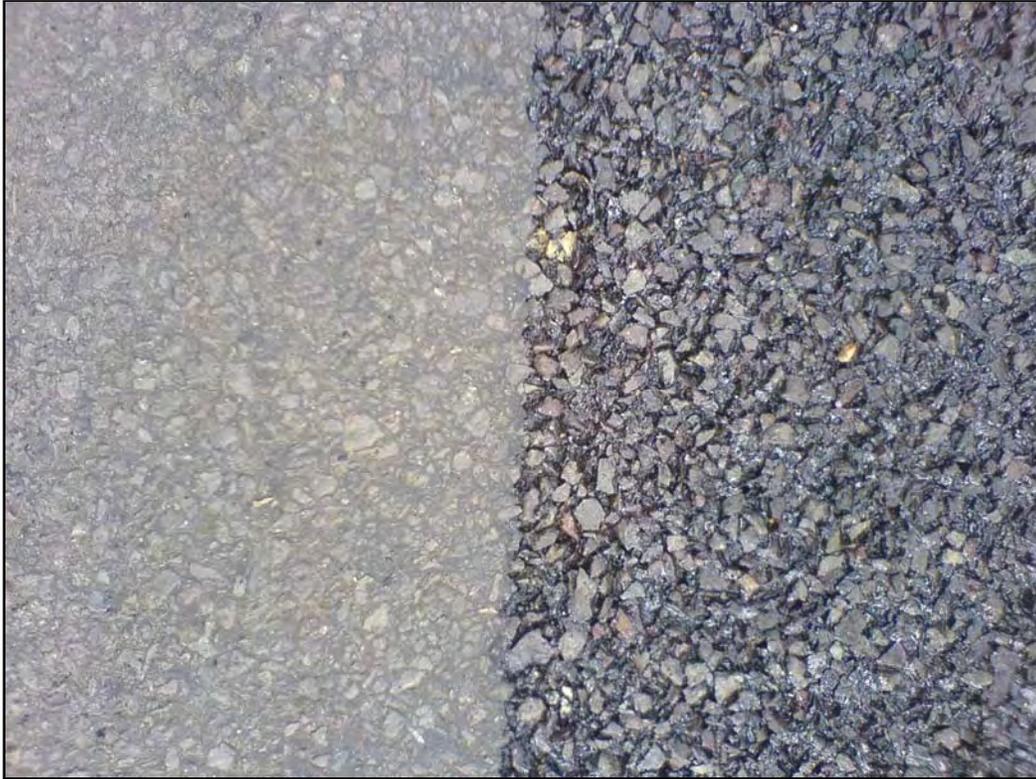
Precise control of pressure, water volume and speed allows effective removal of excess asphalt binder and surface contamination with minimal damage to the surface or dislodgement of coarse aggregate particles (Figure 7.9). Powerful suction heads are used to collect water and debris from the surface for later disposal.

Figure 7.9 Ultra High Pressure Watercutting Allows Effective Removal of Excess Asphalt Binder *Source:* Fulton Hogan, Ltd. [www.fh.co.nz]

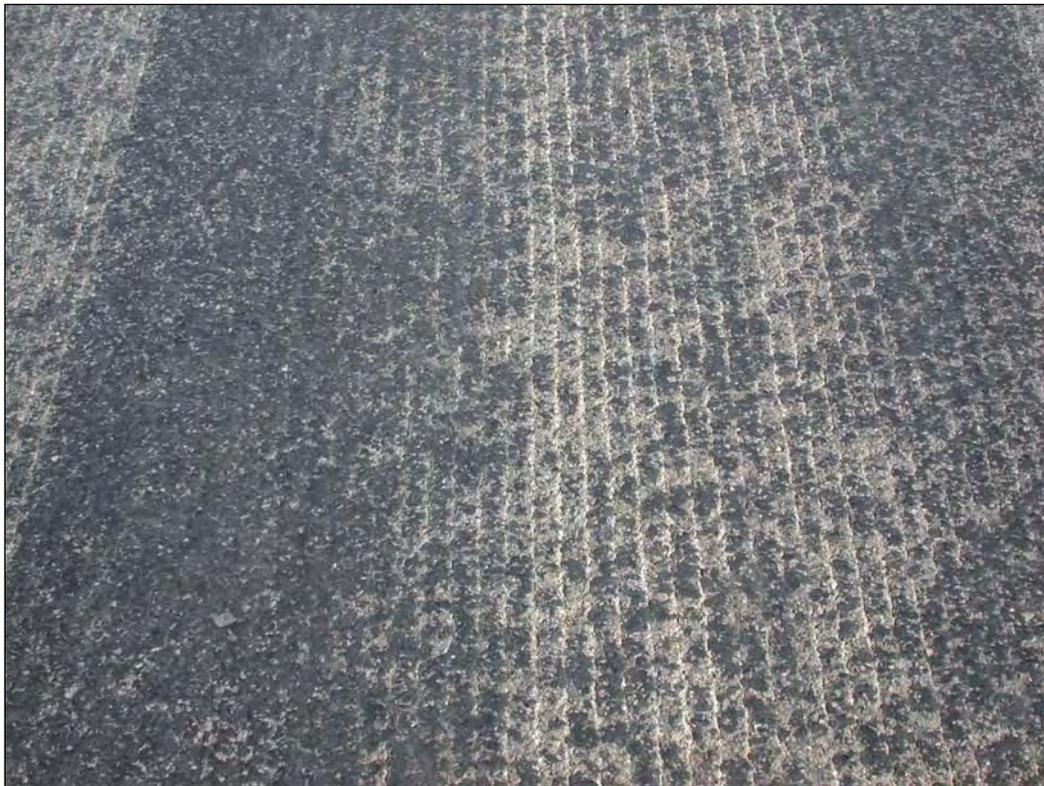
A similar approach consists of welding carbide bullet tips on the mold board. Either approach creates a tool which can be used to score/texture the pavement surface.

Figure 7.10 Grooves in a Motor Grader Mold Board Can Score the Flushed Pavement to Improve Surface Texture

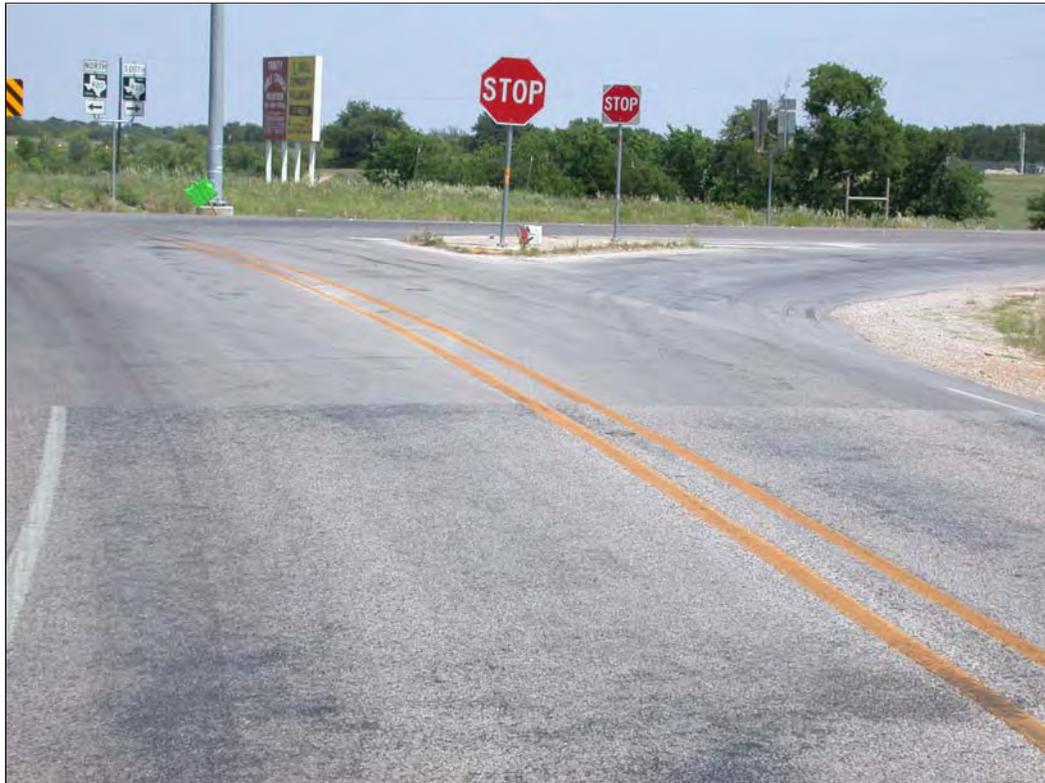
To perform well, an intersection pavement must have adequate thickness to provide the structural capacity to meet traffic needs. Pavement thickness design must account for normal factors such as subgrade strength, drainage and traffic. Any failed or weak layers in the existing pavement structure must be removed since paving over existing failed material will likely result in recurring failure.

Figure 8.1 Use of Hot Mix Asphalt at an Intersection Largely Depends on Economic Considerations Including Life Cycle Costs

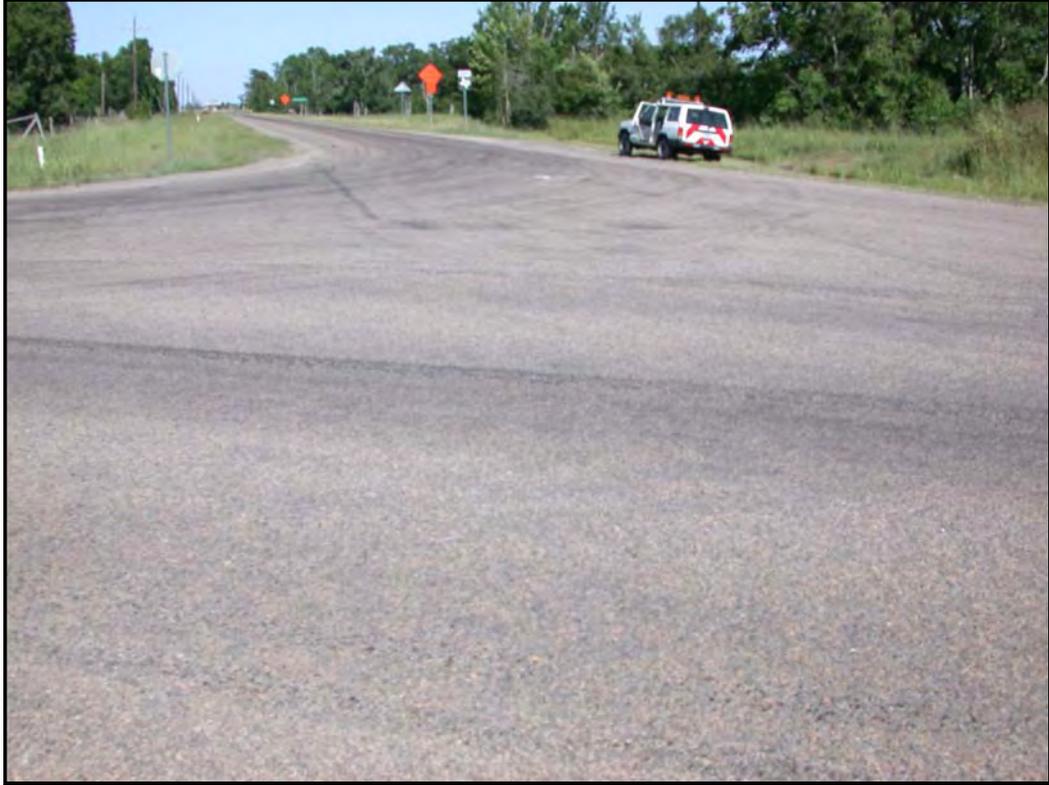
The racked-in seal is a variation to the single course seal coat (Figure 8.2). The racked-in seal consists of one heavy layer of binder followed by two layers of cover aggregate. The second layer of aggregate, or scatter coat, is smaller than (one-third to one-half size) the first layer. The smaller aggregate fills the voids and displaces the binder further upward on the larger stone, thereby mechanically locking the larger aggregate in position and producing a stable matrix.

Figure 8.2 The Racked-In Seal Can be Used at Intersections to Improve Seal Coat Performance Under Heavy Traffic or Abusive Traffic

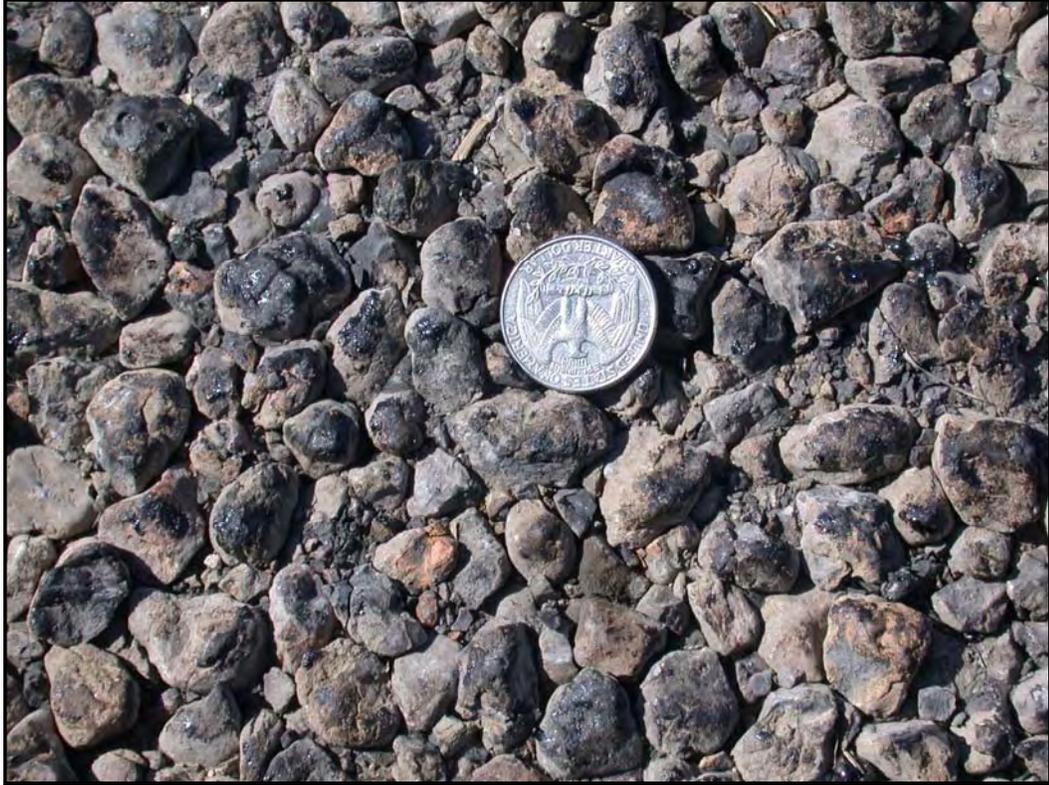
Figure 8.3 The Racked-In Seal Involves a Light Application of Small Size Aggregate (Scatter Coat) Over a Traditional Coarser Aggregate Seal Coat
