# Horizontal Cracking in Continuously Reinforced Concrete Pavements

Texas Department of Transportation

Report #: 0-5549-3  
[www.techmrt.ttu.edu/reports.php](http://www.techmrt.ttu.edu/reports.php)

August 2011

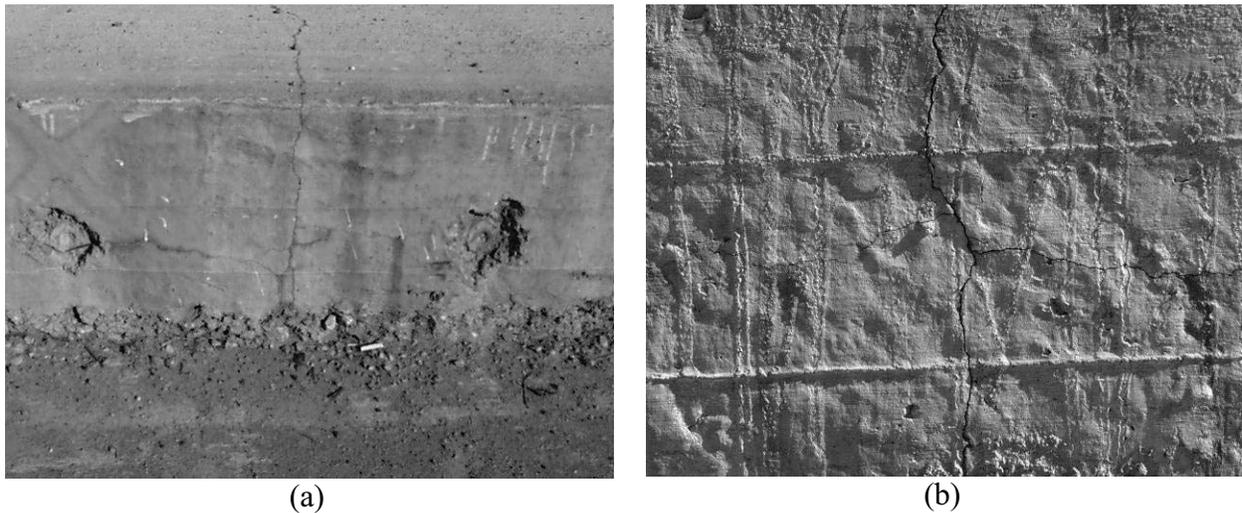
*Figure 2.1: Horizontal cracking in CRCP (Phase I) on IH 35 in Waco District*

In 1999, the Waco District was constructing 14-in CRCP on IH-35 in Hillsboro. The coarse aggregate used was limestone gravel. As described in the previous chapter, during the field evaluation of the pavement for curing issues, HC was observed at the depth of the longitudinal steel, as shown in Figure 2.1. This evaluation included coring in vertical and horizontal directions to identify the extent of the horizontal cracking. There were two phases in this project, and Table 2.1 summarizes the differences between the two phases.

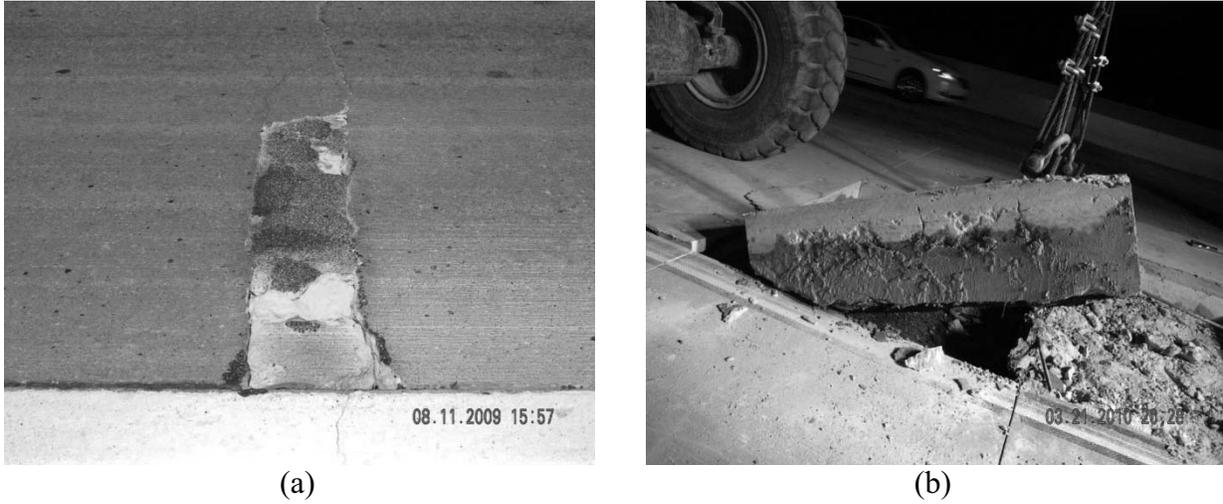
*Figure 2.2: CRCP distress caused by horizontal cracking*

section, and none in the Phase II section. It appears that the number of steel mats and temperature condition played a role in HC development. Distresses resembling traditional puchouts were first observed in 2009, 10 years after the concrete placement. Figure 2.2-(a) shows a typical distress observed in the Phase I section in 2009, and Figure 2.2-(b) confirms the existence of HC in the distressed area.

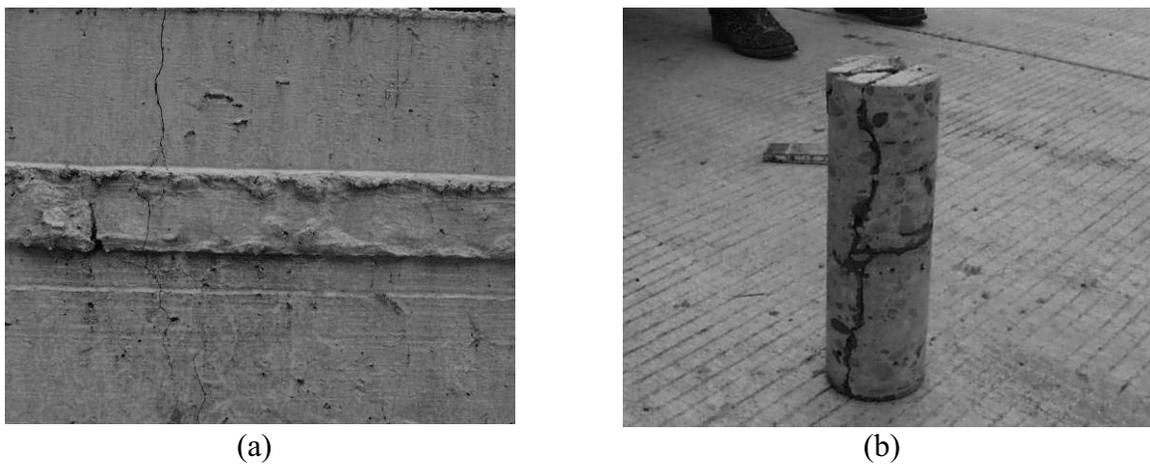
*Figure 2.3: Horizontal cracking in new CRCP*

In 2001, the Atlanta District constructed CRCP on US 59 in Cass County. During the field evaluation for low concrete strength problems, horizontal cracking was observed as shown in Figure 2.3. Figure 2.3-(a) shows HC on the side of the pavement edge, and 2.3-(b) shows a horizontal crack at the steel depth in a core taken in the middle of the lane. This pavement was new and was not open to traffic at the time this picture was taken, which indicates that this horizontal cracking was caused by factors other than wheel loading. The coarse aggregate used was siliceous river gravel.

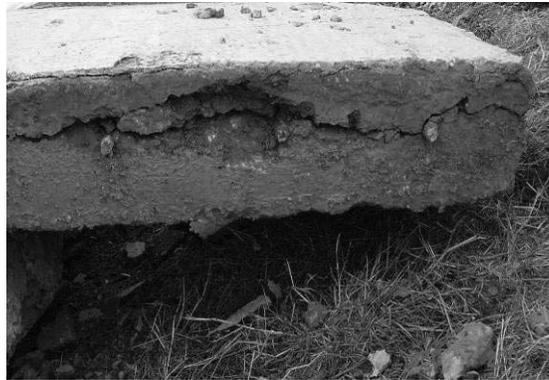
*Figure 2.4: Horizontal cracking in CRCP*

In 2001, the Dallas District repaired pavement distresses on a CRCP section on IH-35W in Denton County. This CRCP section was built in the mid-1960's and scheduled for an asphalt concrete (AC) overlay. Before the overlay, the district was repairing distresses. During the repair of what appeared to be punchout, horizontal cracking was observed in the slab taken out from the pavement, as shown in Figure 2.4. It shows that there were delaminations at the depth of steel. The slab was 8-in thick, siliceous river gravel was used as the coarse aggregate and soil-cement was the subbase type used. It is not known whether this HC was due to environmental loading or a combination of environmental and wheel loading applications.

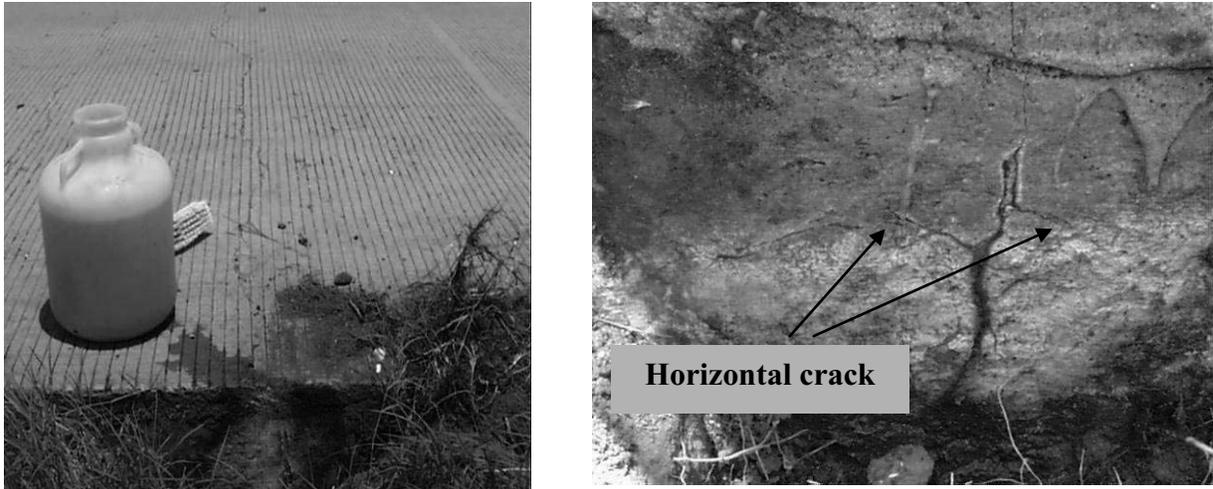
*Figure 2.5: Horizontal cracks observed on the side of the slab*

The CRCP section on US 290 in the Hempstead area of the Houston District was completed in 1995. Siliceous river gravel was used as the coarse aggregate in the east bound lanes, while crushed limestone was used in the west bound lanes. The slab was 10-in thick, which was placed on top of a 1-in AC bond breaker over a 6-in cement stabilized subbase. A condition survey of these sections done in 2001 showed no distress, except for minor to moderate spalling in the east bound lanes (siliceous river gravel section). This roadway provided an excellent opportunity to evaluate whether coarse aggregate type has an effect on HC. In 2001, the side of the concrete shoulder was exposed at the transverse crack area and the side of the pavement was evaluated for HC. Figure 2.5 shows the HC at the mid-depth of the slab in the east bound lanes. However, no horizontal cracks were observed in the west bound lanes. As discussed, siliceous river gravel was used in the east bound and limestone was used in the west bound lanes. This might indicate the effect of coarse aggregate type on HC. Concrete with limestone aggregate has, in general, lower CoTE and modulus of elasticity compared with concrete containing siliceous river gravel. Accordingly, it appears that concrete with higher CoTE and modulus is more prone to HC. A condition survey conducted as recently as February 2010 under TxDOT's rigid pavement database project indicated no pavement distress resulting from HC in both westbound and eastbound lanes. Continued monitoring of the condition of this pavement section will provide important information on whether horizontal cracks will necessarily result in distresses.

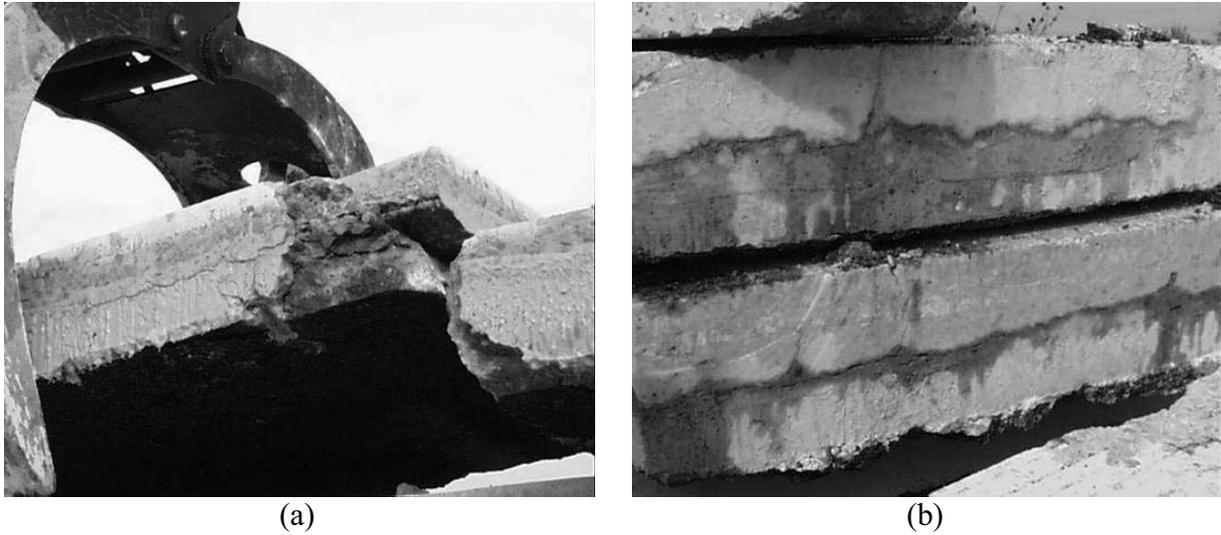
Figure 2.6: Horizontal cracks in slabs removed from IH30 in Paris District

In the late 1990's, Sulphur Springs Area Office in the Paris District noticed distresses in CRCP on IH-30. The pavement was built in the mid-1980s. The slab is 13-inch thick and sandstone was used as the coarse aggregate. The concrete slab was placed over old jointed concrete pavement, with an AC bond breaker. Therefore, this pavement can be classified as unbonded overlay. The Area Office hired a contractor to repair distresses with full-depth repair. During the removal of the distressed slabs, it was noted that the slabs had horizontal cracks at the mid-depth, as shown in Figure 2.6-(a). In 2001, the site was visited where the contractor stored removed slabs, and it was noticed that most of the slabs had horizontal cracks at the mid-depth as shown in Figure 2.6-(b).

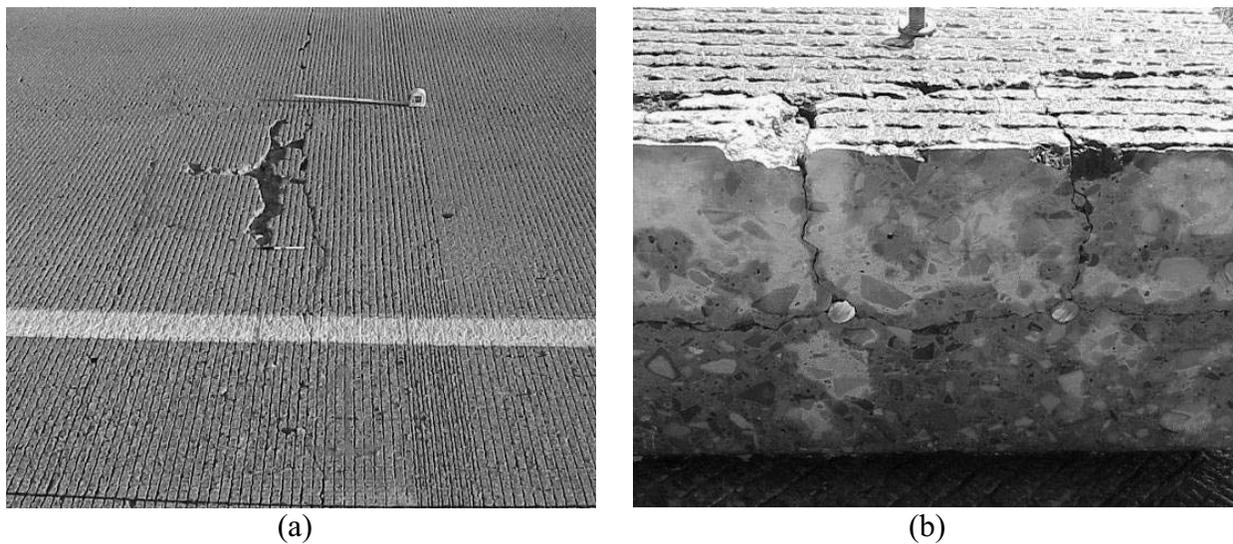
Figure 2.7: Surface distress caused by horizontal cracking

Despite the repair of the pavement, the Area Office noticed that the distresses continued to develop and in 2001, contacted TxDOT's Construction Division, Materials & Pavements Section (CSTMP) for an in-depth forensic study. The purpose of the study was to evaluate the pavement condition and make recommendations regarding the best rehabilitation option. During the forensic study, two areas were investigated – one with apparent surface distress, and the other with no surface distress. Figure 2.7-(a) shows the surface distress and 2.7-(b) shows a slab segment taken out from the distressed area. It clearly shows horizontal cracking at the mid-depth of the slab. It also shows that longitudinal cracks developed over the longitudinal steel, did not propagate below the middle of the slab depth where horizontal crack developed.

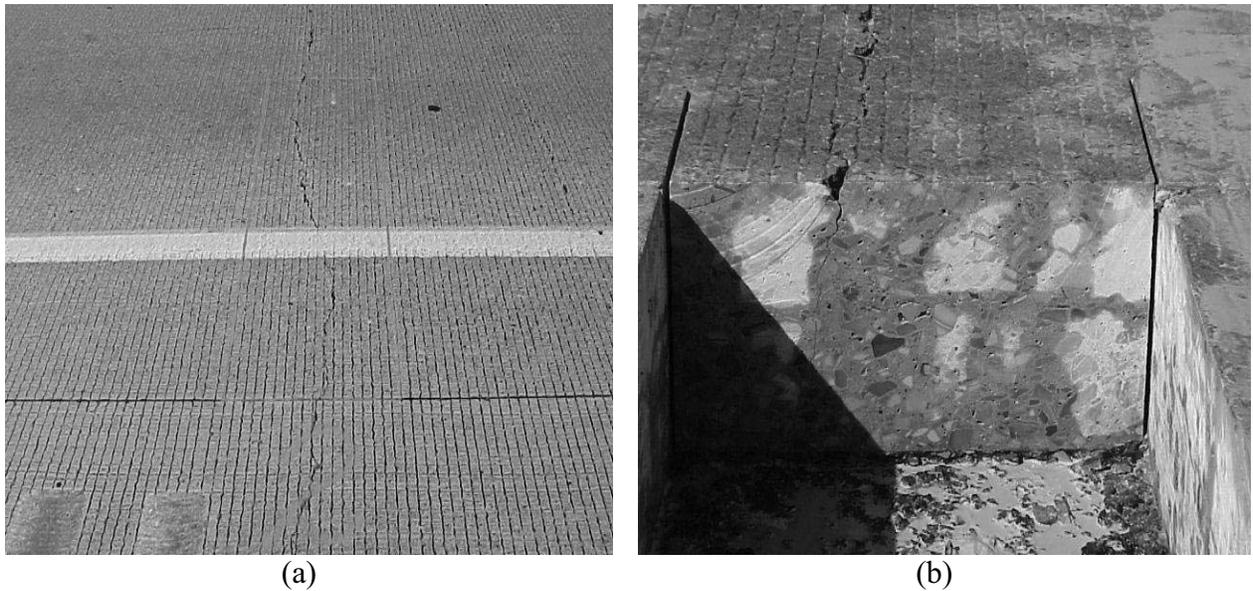
*Figure 2.8: No surface distress with fine horizontal cracking*

The investigation of an area with no surface distress shows that even though there was no apparent distress on the pavement surface, fine horizontal cracking existed at the depth of longitudinal steel. The pavement surface and fine horizontal cracking are shown Figure 2.8.

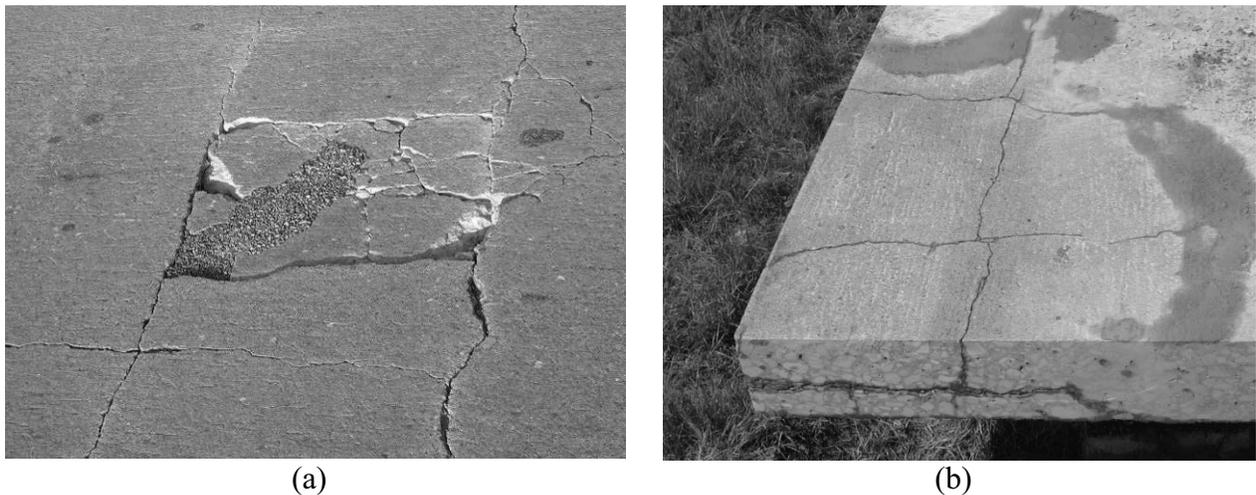
*Figure 2.9: Surface distress and horizontal cracking*

In 2002, a major full-depth repair of concrete pavement was underway on US 281 in the Wichita Falls District for the preparation of a 4-in bonded overlay. The existing pavement was built in the early 1960's. Limestone was the coarse aggregate type used. The slab was 6-in thick over natural soil. The major distress type in this pavement was surface distress that resembles punchout as shown in Figure 2.9-(a). Upon removal of the distressed slab segment, it was noted that there was HC, which was over longitudinal steel as shown in Figure 2.9-(b). Since limestone was used as coarse aggregate, HC in this section might have been due to wheel loading applications.

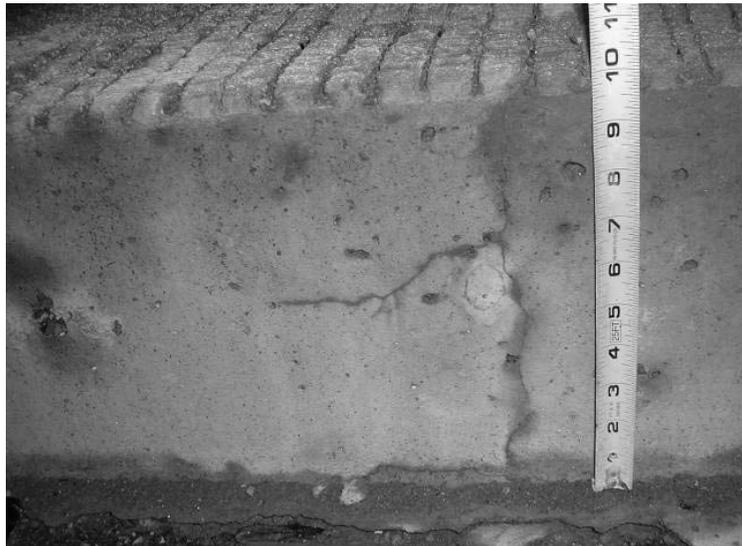
*Figure 2.10: Horizontal crack in new pavement*

Figure 2.10 shows HC on US 59 southbound lane in Sugarland in the Houston District. This pavement was constructed in 2003 and not opened to traffic when this picture was taken, indicating that this horizontal cracking occurred quite early. In other words, traffic loading may not be a factor; rather, this cracking was caused by the combined effects of environmental loading and concrete material properties, and possibly steel design. The slab was 10-in thick, siliceous river gravel was used as the coarse aggregate, and the subbase was 1-in AC bond breaker on top of 6-in cement stabilized subbase.

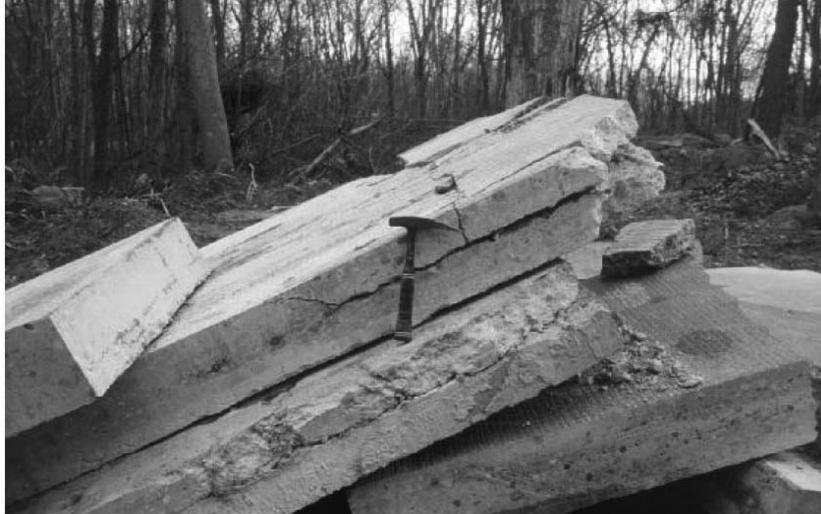
*Figure 2.11: Slabs with horizontal cracks*

Virginia DOT started using CRCP a few years back and has gained experience in the design/construction and performance of CRCP. Mohamed Elfino (Assistant State Materials Engineer of Virginia DOT) was contacted for Virginia DOT's experience with horizontal cracking. He stated that Virginia DOT has had distresses due to horizontal cracking. However, the distresses were confined to transverse construction joints where additional longitudinal steel was used. Figure 2.11 shows the slabs with HC at the level of longitudinal steel. To minimize horizontal cracking, Virginia DOT was considering the use of thicker slabs.

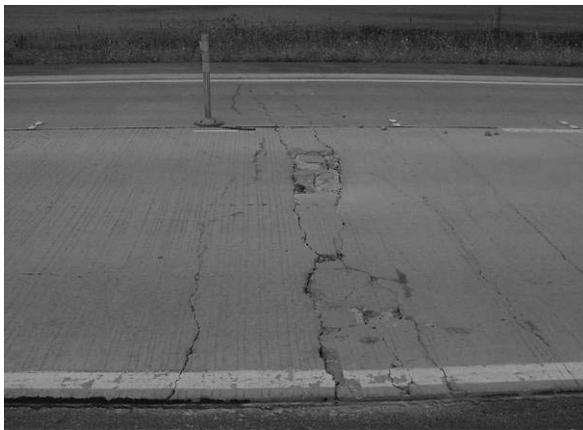
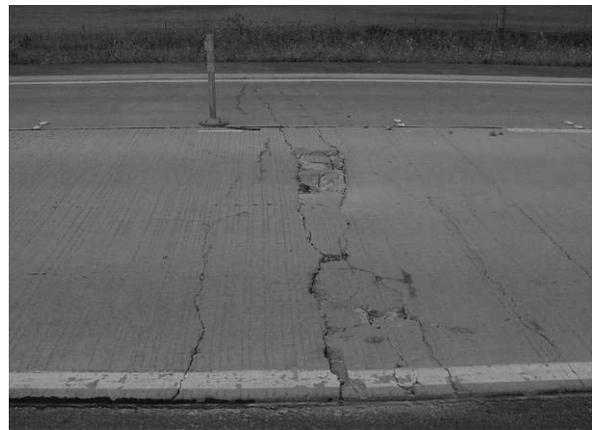
*Figure 2.12: Surface distress and horizontal cracking*

Ms Andrea Talley of CRSI (Concrete Reinforcing Steel Institute) provided pictures of horizontal cracking in South Dakota. Mr. Brian Raecke of the South Dakota DOT (Surfacing Plans Engineer) was contacted for further information. Mr. Raecke stated that horizontal cracks in South Dakota are limited to steel lap areas. He provided a Powerpoint presentation file he developed. Figure 2.12 shows the pavement failure due to HC and the slab taken out, which shows delamination at the steel depth. TxDOT experienced this type of failure in the past when the steel splicing was not properly staggered. Since then, TxDOT revised steel splicing standards and this type of failure has been eliminated in Texas. Mr. Raecke stated that the South Dakota DOT is revising steel splicing standards to prevent HC problems.

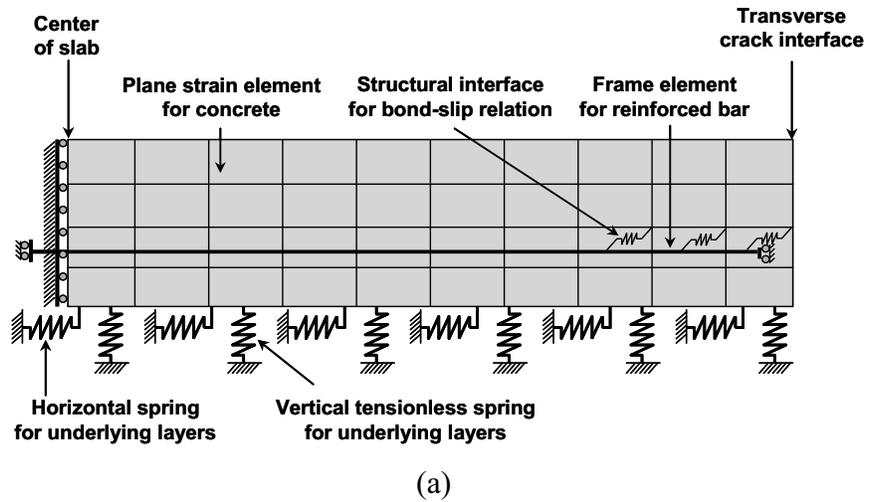
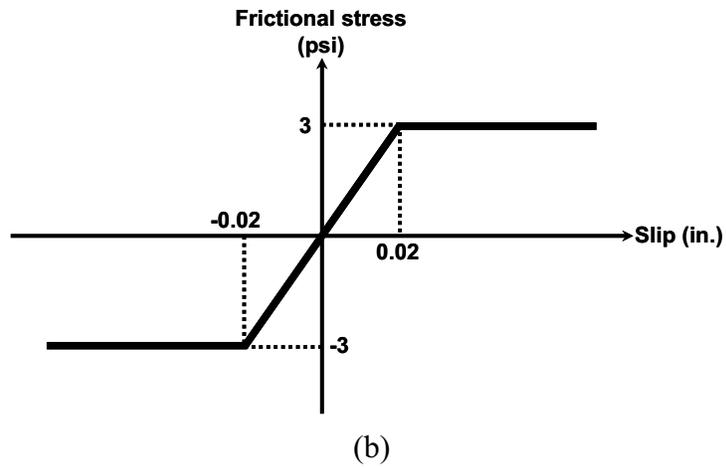
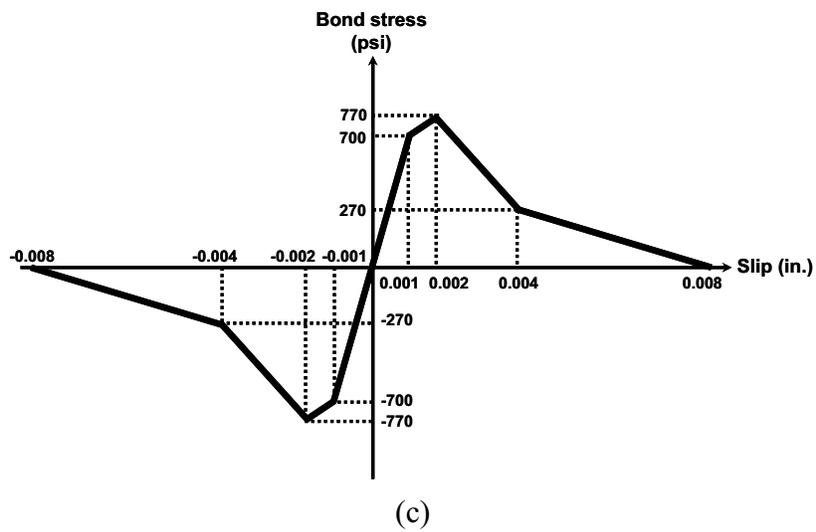
Figure 3.1: Finite element model for prediction of horizontal cracking in CRCP

Cracking in concrete takes place when the stress exceeds the strength. In order to identify the appropriate horizontal cracking mechanism, it is required to accurately predict the distribution of strain and stress fields in concrete at the depth of reinforcement. The state of stress in concrete near the reinforcement can be analyzed through a two-dimensional finite element method. Environmental loadings due to changes in temperature and moisture were considered in the numerical analysis. Figure 3.1-(a) shows the finite element model for prediction of horizontal cracking in CRCP. If CRCP is subject to environmental loading, the CRCP behavior can be assumed to be symmetric with respect to the center of the two adjacent transverse cracks. Therefore, one-half of the slab was considered in the numerical model. The concrete slab and longitudinal steel were modeled using two-dimensional plane strain and frame elements, respectively. The boundary conditions of the finite element model should be defined to obtain the correct prediction of structural behavior under environmental loadings. At the transverse crack, it is assumed that no restraint was applied to the concrete. Longitudinal and rotational displacements were fixed at the point of the reinforced bar at the transverse crack interface. At the center of the slab, a vertical degree of freedom existed and longitudinal and rotational displacements were restrained due to symmetry.

The bond-slip relation between concrete and longitudinal steel bars was considered through the interface element with horizontal springs. The frictional slip that occurs at the interface between the bottom of the concrete slab and the base layer was considered through the horizontal spring element. A vertical tensionless spring was used to properly consider the curling effect. The vertical tensionless spring stiffness per unit area in this study was 300 psi/in. Figure 3.1-(b) indicates the frictional stress-slip relationship between concrete and subbase [1]. Horizontal stiffness for the interface between the concrete and subbase was assumed to be 150 psi/in. In order to predict the strain of tie bar, the bond stress-slip relationship in Figure 3.1-(c) was used [1]. The vertical stiffness of structural interface for bond-slip, which will be discussed later with experimental data, was  $1 \times 10^7$  psi/in. The finite element program DIANA [2] was used in the numerical analysis.

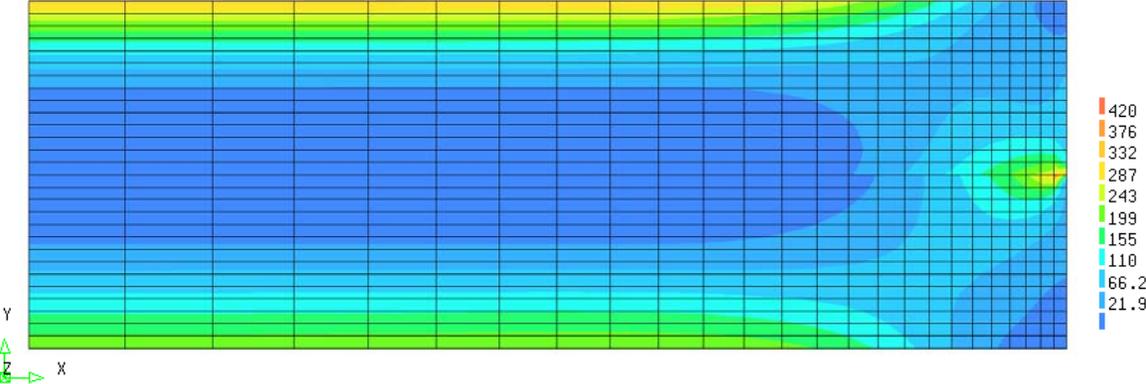
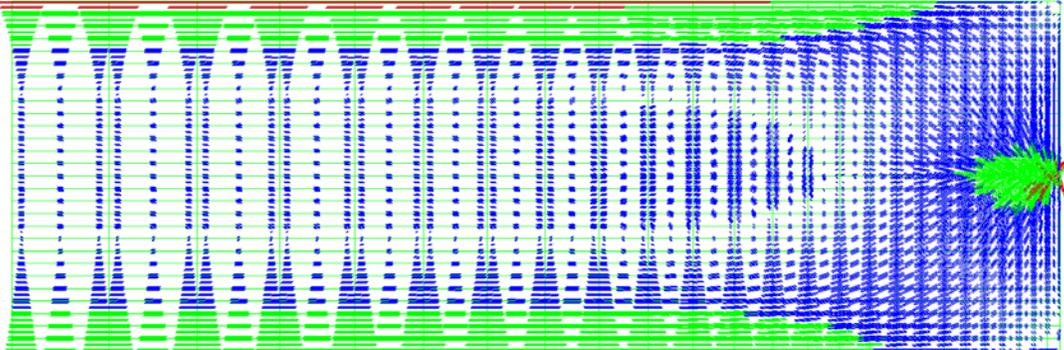
(a) Distribution of principal stress in CRCP

(b) Directional vector of principal stress in CRCP

Figure 3.2: Finite element model for prediction of horizontal cracking in CRCP

Figure 3.2 shows distribution and directional vectors of principal stress in CRCP between transverse cracks in the numerical analysis. The spacing of the transverse crack was assumed to be 7.0 ft with a pavement thickness of 14 in. A single layer of steel, using #6 bar (0.75-in. diameter), was arranged at the depth of 7.0 in. from the surface. A nonlinear temperature gradient with a 3rd degree parabola was assumed [3]. The temperature difference of 21 °F between the top and bottom of the slab was applied as an environmental loading. The CoTE and elastic modulus of concrete were assumed to be  $6 \times 10^{-6}/^{\circ}\text{F}$  and  $6 \times 10^6$  psi, respectively. The maximum principal stress of 464 psi developed at the depth of steel, and the direction was nearly vertical with a slight upward or downward direction. Therefore, the horizontal cracking can occur near the reinforced steel.

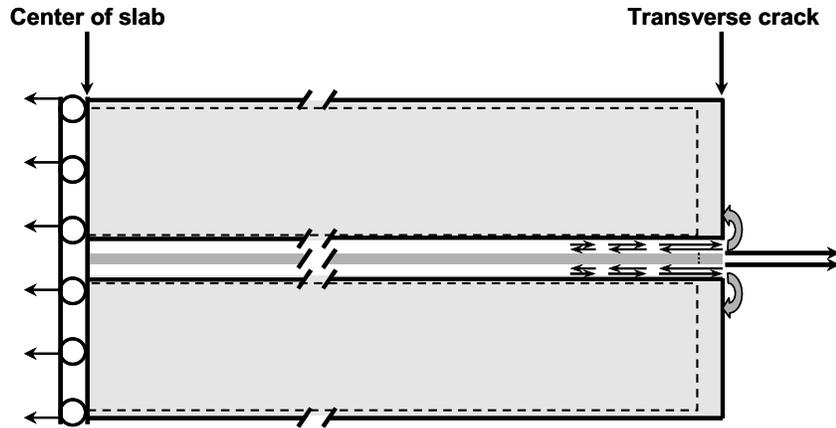
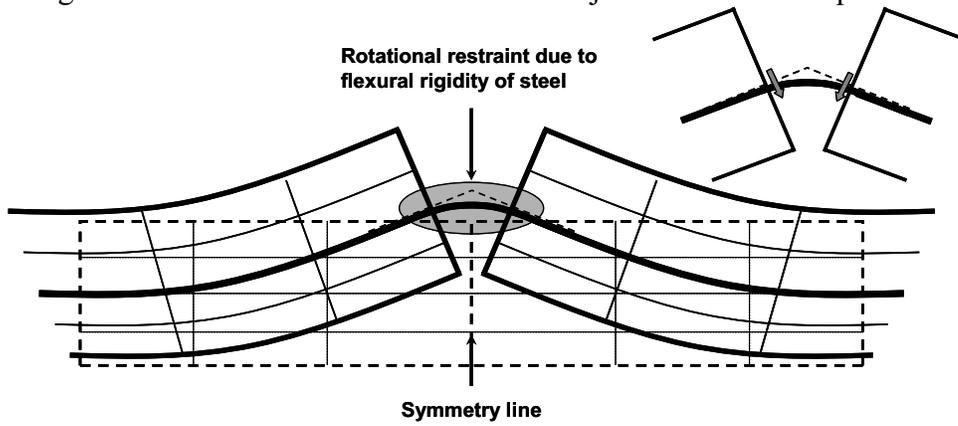
(a) Longitudinal restraint of steel on concrete subject to uniform temperature drop

(b) Rotational restraint of steel on concrete subject to linear temperature gradient

*Figure 3.3: Restraint of steel on CRCP movement at transverse crack*

The longitudinal movement of the slab in a cracked surface, which is proportional to uniform temperature drop, will be restrained by the steel because the steel is continuous across the transverse crack, as the two adjacent slabs across the crack create a line of symmetry. Figure 3.3-(a) illustrates one slab with steel under uniform temperature drop. The longitudinal restraint of steel due to symmetry creates forces in steel, bond stress, and reaction at the center of the slab. Because the restraining force of steel is applied eccentrically to the upper and lower halves of the slab, local bending moment will be generated. This local moment may cause vertical stress of the concrete element near the steel.

Figure 3.3-(b) explains how the concrete element near steel is restrained by the longitudinal steel when the concrete is subject to a linear temperature gradient. The curling-up of the two adjacent slabs across the transverse crack is rotationally restrained by the flexural rigidity of steel due to the symmetry at the transverse crack. This rotational restraint will give rise to additional force that is vertically exerted to the concrete at steel depth. As a result, a substantial stress in the vertical direction, which is closely related to the horizontal cracking, could develop in concrete at the steel depth. Because slab curling is dependent on the temperature difference between the top and bottom surfaces of a slab [4], it is expected that greater vertical stress would develop in concrete as the temperature difference increases.

force created by the steel's flexural rigidity restrained the curling-up of slab, as shown in Figure 3.3-(b), and thus higher stress developed in the concrete near steel. Unlike stress development due to uniform gradient, tensile and compressive stresses existed at concrete elements above and below steel, respectively. This is because the vertical force was acting downward to the concrete through the steel.

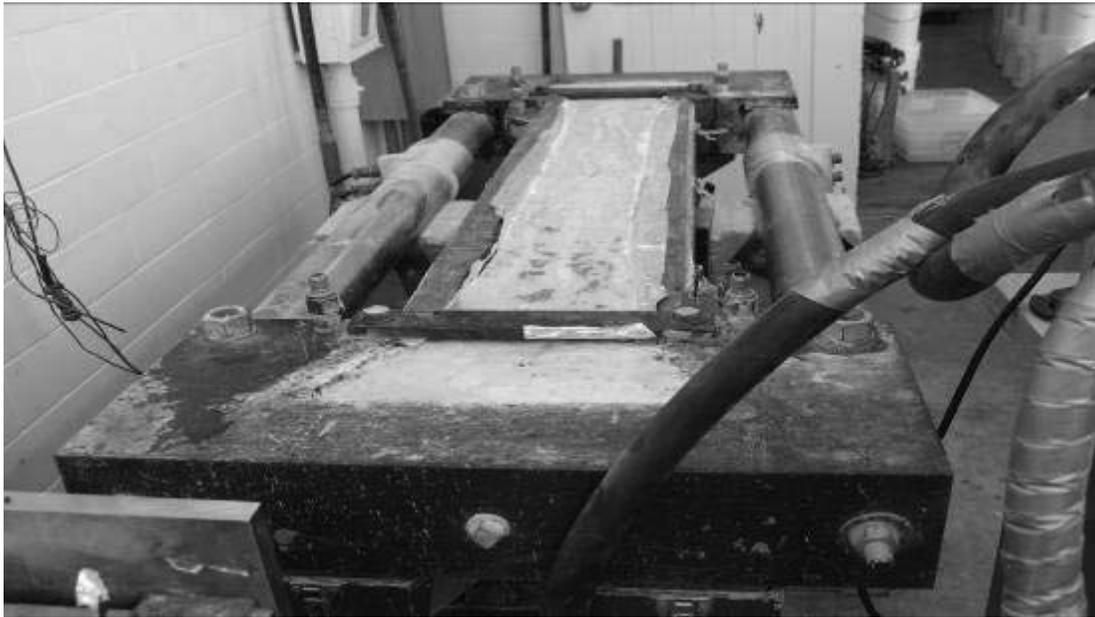
*Figure 4.1: Cracking frame*

In order to identify the horizontal cracking mechanism in CRCP, a cracking frame was slightly modified, deemed the Horizontal Cracking Frame (HCF) [5]. As shown in Figure 4.1, the original cracking frame consists of a frame with two cross heads and two massive steel frame bars. Each steel frame bar, made of invar to minimize displacement due to temperature variations, has a diameter of about 4 in. The water circulated through the pipe in the thermally insulated formwork can be adjusted so that the temperature of the specimen in the frame can match the target concrete temperature.

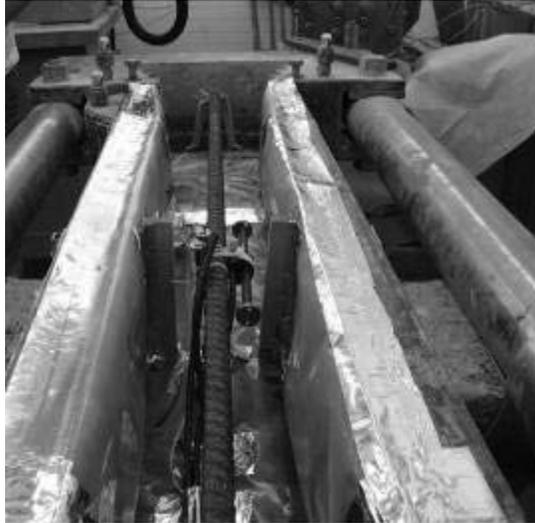
Figure 4.2: Horizontal cracking frame

A primary reason for the modification to the original cracking frame was to include reinforcing steel in the middle of the concrete specimen as shown in Figures 4.2 and 4.3. It is shown that a rebar is inserted in the middle of the concrete specimen, simulating the longitudinal steel of #6 (0.75-in. diameter) bar in CRCP. The concrete specimen in the HCF is highly restrained by the massive cross head, forcing the specimen to represent the initial behavior of CRCP, which is considerably restrained by the subbase friction and longitudinal steel. HCF can also simulate the behavior of CRCP after a transverse crack occurs because, after a crack in the specimen, each end of a specimen is still restrained by the cross head.

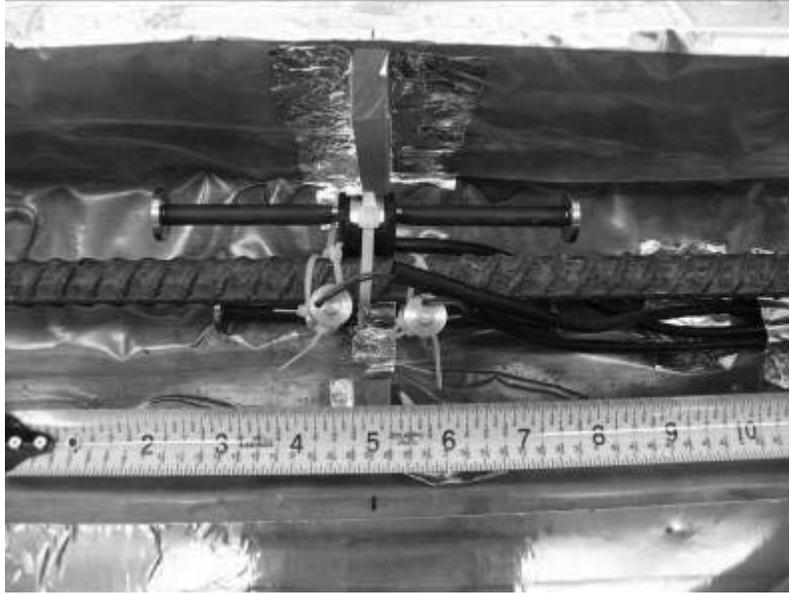
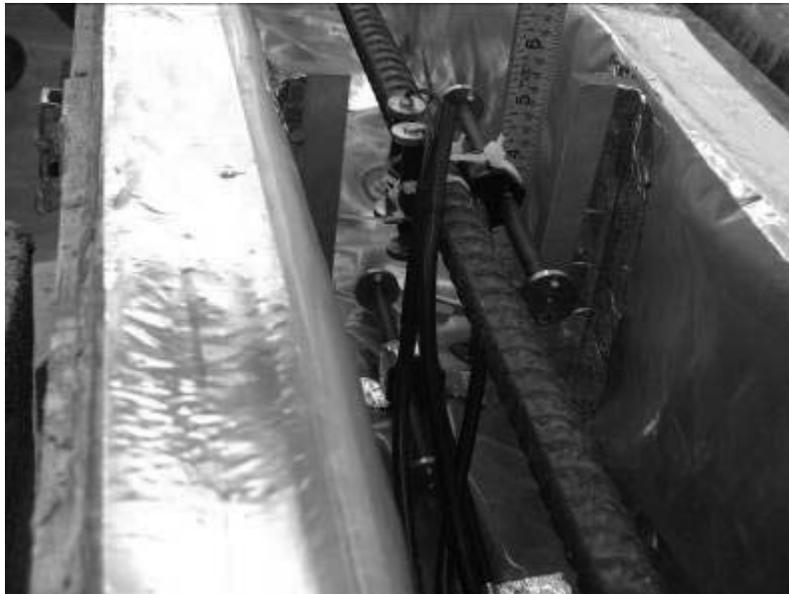
(a) Plan view of installed VWSGs

(b) Installed VWSGs

*Figure 4.4: Installed VWSGs to measure transverse and horizontal cracks*

Vibrating wire strain gages (VWSGs) were installed to measure the temperature and strain in concrete specimen. As shown in Figure 4.4., three EM-5 VWSGs were installed in the longitudinal direction at different depths (1-in., 3-in., and 5-in.) from the top surface. These gages measured the longitudinal strain and it is expected that a sudden increase in concrete strain will be observed if a transverse crack occurs in the specimen. In order to induce a crack at the center of the specimen, two acrylic plates (6-in. high, 1-in. wide, and 0.5-in. thick) were placed at the center of the specimen. Two EM-2 VWSGs were also installed vertically at the mid-depth (3-in.) in the center of the specimen. It is expected that these EM-2 gages will exhibit a different trend of strain variation when transverse cracking occurs.

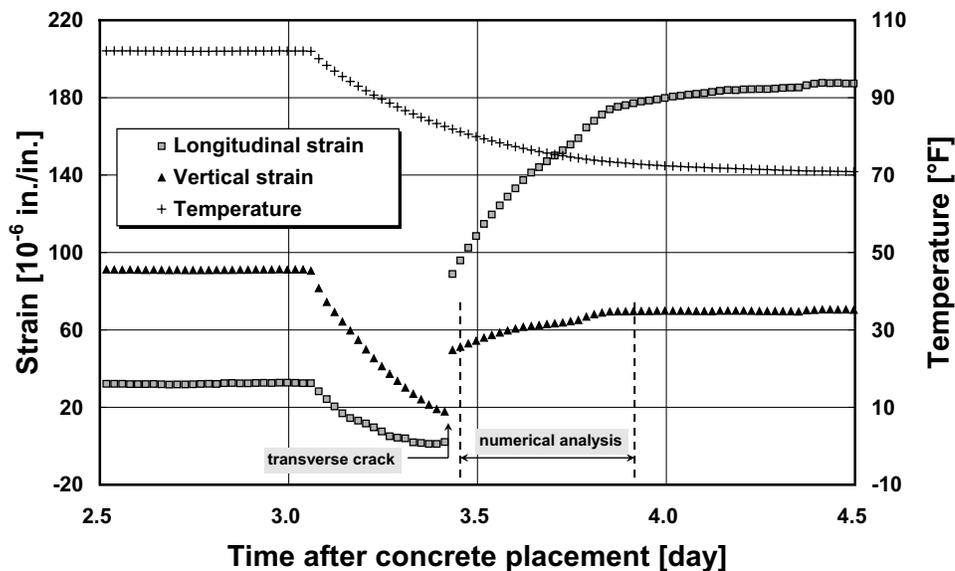
Figure 4.5: Measured strain and temperature histories

Figure 4.5 shows the measured temperature and strain histories in the testing. The concrete temperature was maintained at 105 °F for three days. During this period, the concrete hardened. In order to simulate the actual temperature condition in CRCP which induces transverse cracking, the specimen was cooled down to 70 °F. Because the volume change of the specimen was restrained by the frame, the tensile stress would build up in the specimen during cooling stages. At the age of 3.4 days, the longitudinal concrete strain at the horizontal VWSGs suddenly increased and the researchers concluded that this sudden increase was due to the crack occurrence. The variation of longitudinal strain showed significant increase when the transverse crack occurred. The vertical strain also suddenly increased. After the transverse crack occurred, the vertical strain was still increasing even though the temperature was decreasing.

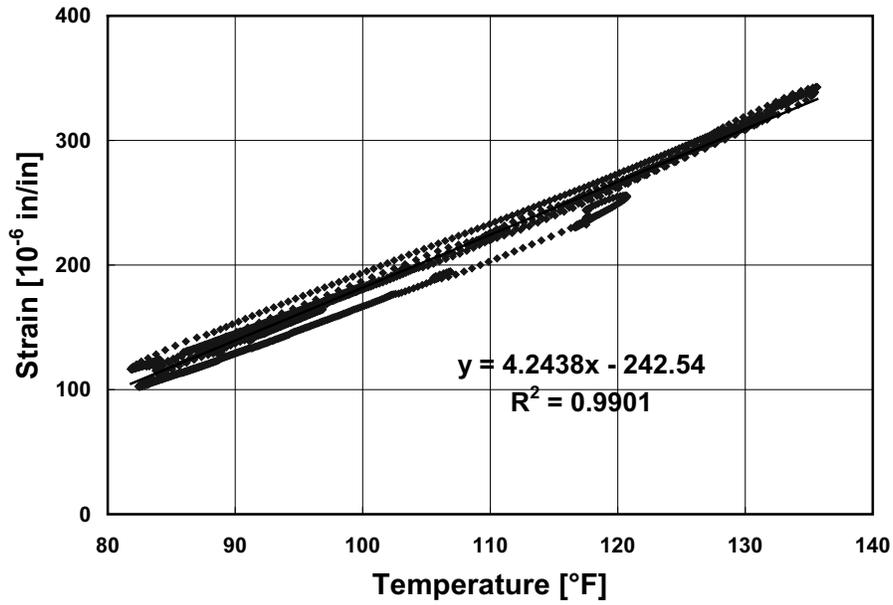
Figure 4.6: Measured coefficient of thermal expansion

HCF testing was analyzed with the numerical model described previously, in which the measured temperature variations along with mechanical and material properties were incorporated. The concrete's behavior from 3.4 days to 3.8 days was analyzed in the numerical analysis. The measured elastic modulus was  $3.6 \times 10^6$  psi. Figure 4.6 shows measured CoTE of concrete material in testing using stress-free cylinders and it was  $4.24 \times 10^{-6}/^\circ\text{F}$ . Figure 4.7 presents variations of measured and predicted vertical strains during the specified period. The concrete element near steel in the HCF specimen slowly expanded under a uniform temperature drop. This result agreed with the mechanism introduced in the previous section. Figure 4.6 also indicates that the predicted strain varied with different vertical stiffness values of the structural interface between steel and concrete. Among the three interfacial stiffness values evaluated,  $8.5 \times 10^6$  psi/in. provided the closest prediction to the measured data. This value can be used in accurately evaluating the horizontal cracking potential. The validity of this value was examined again with a field experiment, which is shown in the next chapter.

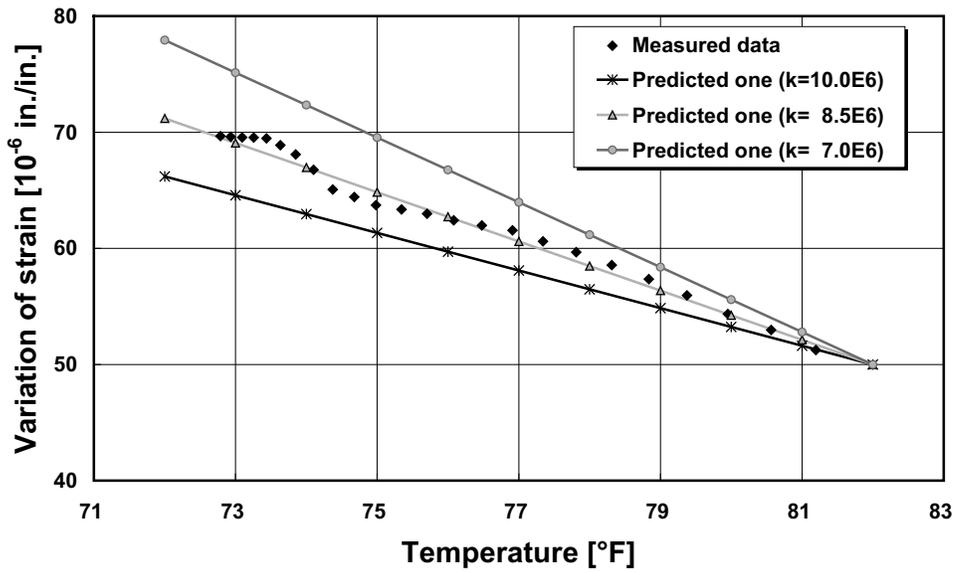
Figure 4.7: Variation of measured and predicted vertical strains

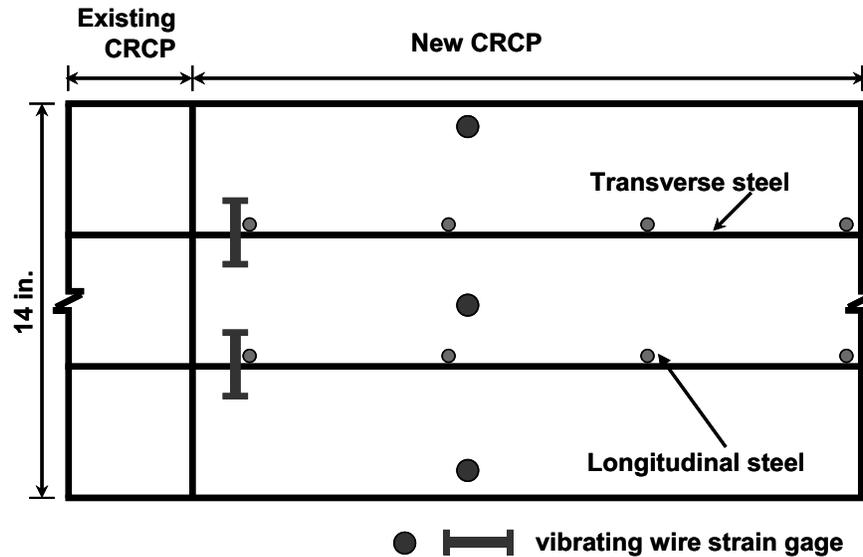
Figure 5.3: Field instrumentation in section view

As shown in Figures 5.3 and 5.4, three VWSGs were installed at different depths in the longitudinal direction to monitor transverse crack occurrence. Two VWSGs were also installed in the vertical direction near two layers of longitudinal steel: one near the top layer of steel and the other near the bottom. Additionally, seven temperature sensors were installed at different depths to evaluate the temperature gradient in the test slab with 14-in. thickness. A transverse crack was induced with a saw cut. The saw cut of 1.5-in. depth was made 15 hours after concrete placement.

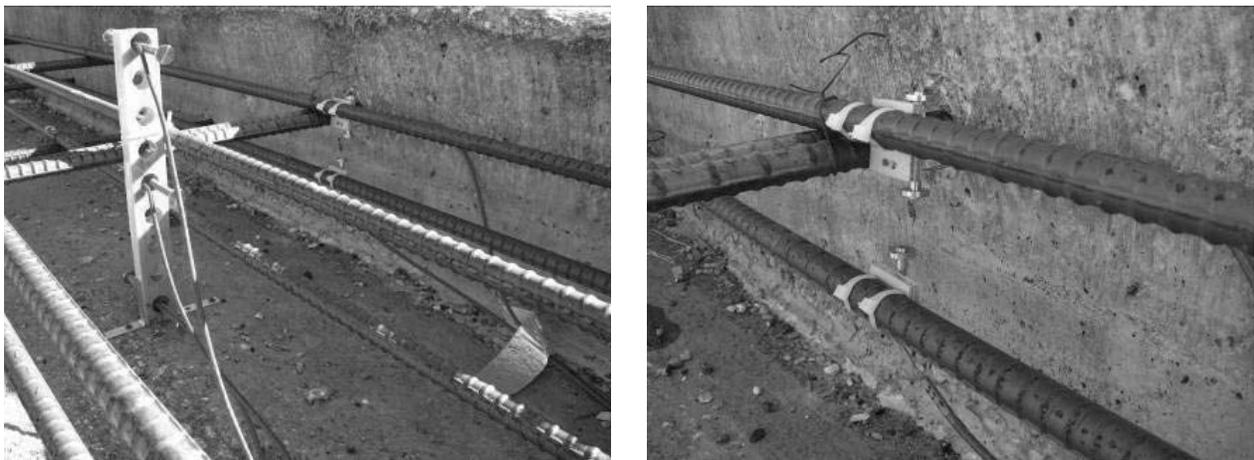
Figure 5.4: Installed strain gages in longitudinal and vertical direction

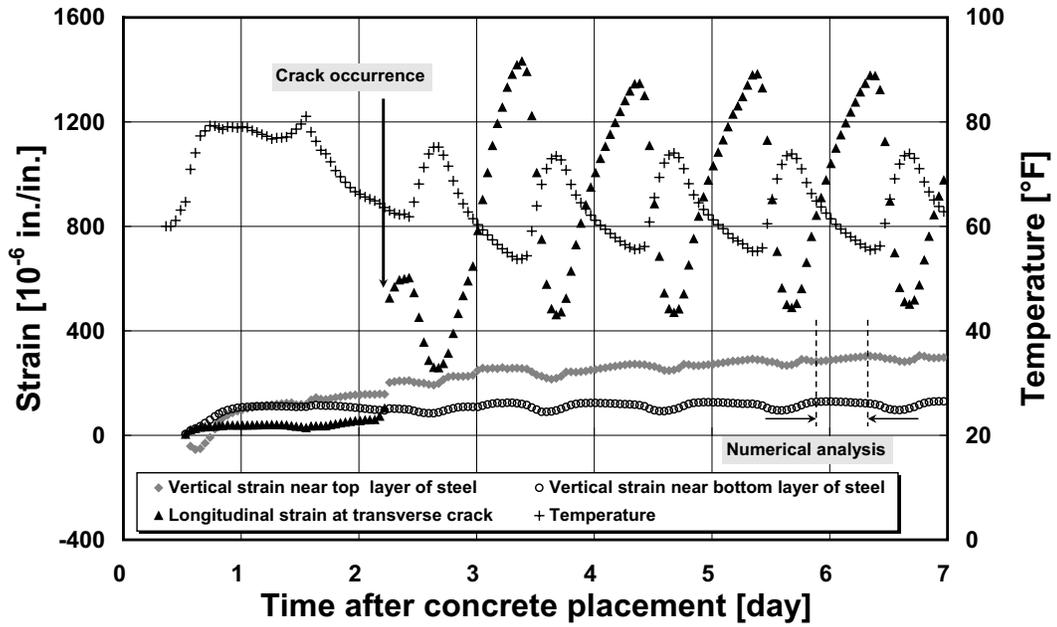
Figure 5.5: Measured strain and temperature histories in field testing

Figure 5.5 illustrates strain and temperature histories over time. In the x-axis, the whole number denotes midnight of the day after the concrete placement. For example, 5 means midnight of the 5th day after concrete placement. There was a sudden increase of longitudinal strain at the 2nd day early morning, caused by the induced transverse crack. Compared to the variation of longitudinal strain at the transverse crack, the vertical strain changed little. Measured vertical strains from 10:00 p.m. on the 5th day to 7:00 a.m. on the 6th day were selected to compare with the results predicted by the numerical analysis.

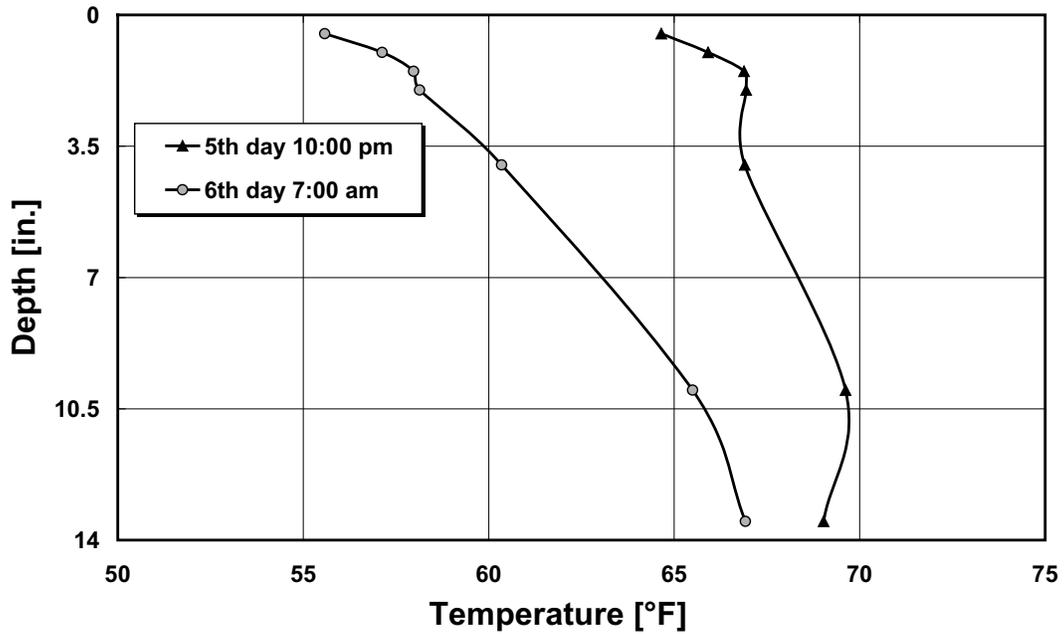
Figure 5.6: Measured temperature profiles

Figure 5.6 shows the measured temperature profile in the test slab. As expected, the variation of temperature at the surface was greater than that observed at the middle and bottom of the slab. A measured profile was used as an environmental loading input in the numerical analysis. Figure 5.7 shows the variation of measured and predicted strains due to non-linear temperature distribution through the slab depth. For the measured temperature gradient shown in Figure 5.6, the concrete vertical strains near the top layer of steel increased while the ones near the bottom decreased. The variation was greater near the top layer. Unlike the strain variation under uniform temperature changes, the concrete element with the two-mat steel bar was affected not only by the uniform component but also by linear and nonlinear components in temperature gradient. Therefore, the strain varied at different depths. The numerical prediction is also shown in Figure 5.7 using the material property values obtained in the field as discussed next. Figures 5.8 and 5.9 show the measured CoTE and elastic modulus of concrete, respectively. Considering the effect of temperature on the development of strength and modulus of concrete, the estimated elastic modulus in numerical analysis was  $4.7 \times 10^6$  psi. The measured CoTE of  $4.2 \times 10^{-6}/^\circ\text{F}$  were used in the numerical analysis.

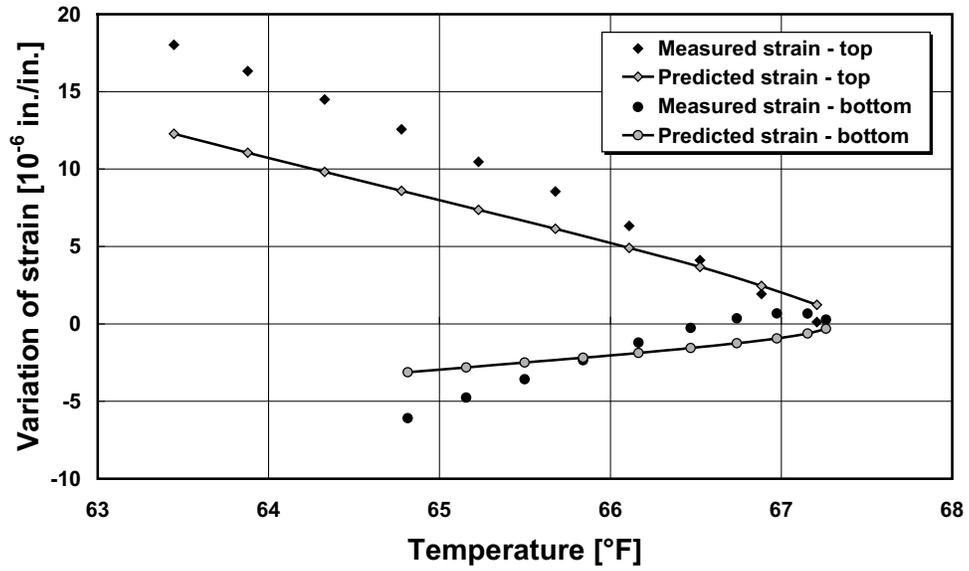
Figure 5.7: Measured vertical strains compared with predicted ones

In this analysis, the use of  $1.8 \times 10^7$  psi/in. as the interfacial stiffness between steel and concrete yielded predicted strain values that were close to the measured values. Even though the stiffness value used in this analysis was almost twice as large as the one used in the analysis for HCF testing described in the previous chapter, this difference is smaller than the one used in a recent study [6]. In the study, the interfacial stiffness was assumed to be sufficiently large without experimental data so that the numerical problem of relative displacement between steel and concrete can be prevented [6]. The stiffness varied from  $3.68 \times 10^6$  psi/in. to  $3.68 \times 10^8$  psi/in. in a recent study [6].
