# Horizontal Cracking in Continuously Reinforced Concrete Pavements

Texas Department of Transportation

Report #: 0-5549-3  
[www.techmrt.ttu.edu/reports.php](http://www.techmrt.ttu.edu/reports.php)

August 2011

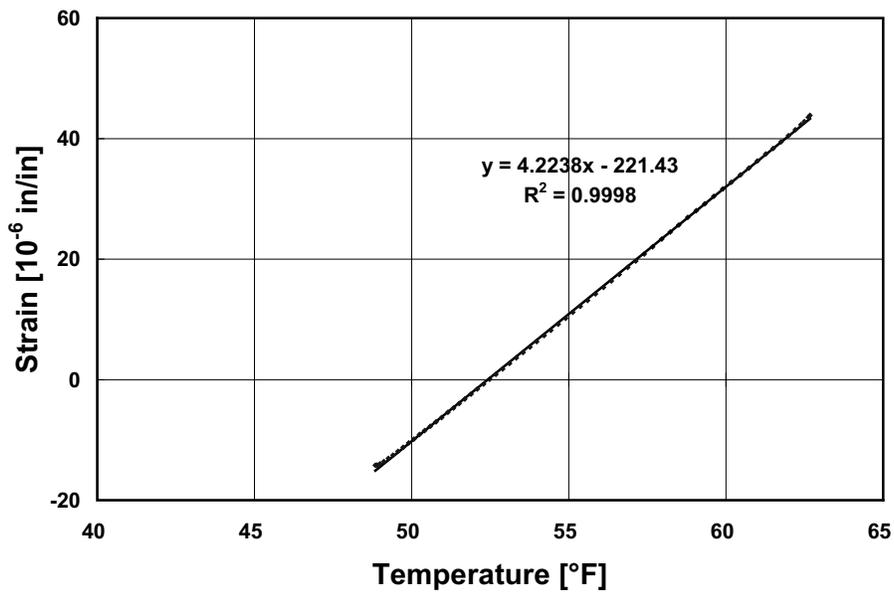
Figure 5.8: Measured coefficient of thermal expansion in the field testing

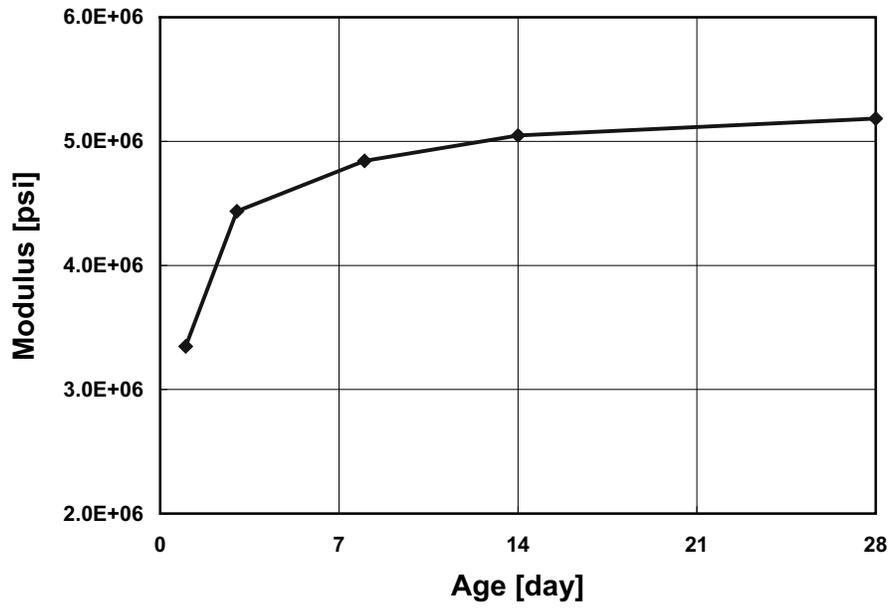
*Figure 5.9: Measured elastic modulus of concrete material*

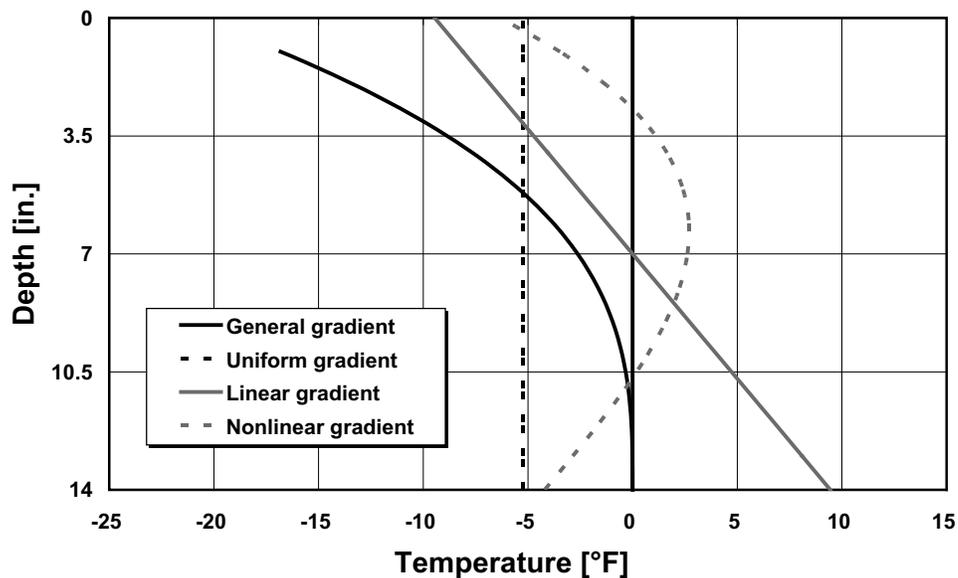
Figure 6.1: Decomposition of general nonlinear temperature gradient

HC developed on IH 35 in the Waco District was simulated in the analysis. It was shown that temperature variations could have played a role as discussed in Chapter 2. Figure 6.1 illustrates the decomposition of a general nonlinear temperature gradient into three equivalent components: uniform, linear, and nonlinear [5]. A parabola of 3rd degree was assumed for the temperature profile along the depth of the slab [3]. The temperature difference of 21 °F was assumed between the top and bottom of the slab. The concrete element near steel at the transverse crack had three stress components, i.e., horizontal, vertical, and shear stresses. Compared to other components, however, the vertical stress, which is closely related to the horizontal cracking potential, was dominant in stress development as shown in Figure 3-2(b). Therefore, the vertical stress was mainly presented in this study. One steel mat was placed at a depth of 7.0 in. and #6 bar was used in the analysis. CoTE and elastic modulus at 28 days were assumed to be  $6 \times 10^{-6}/^\circ\text{F}$  and  $6 \times 10^6$  psi, respectively.

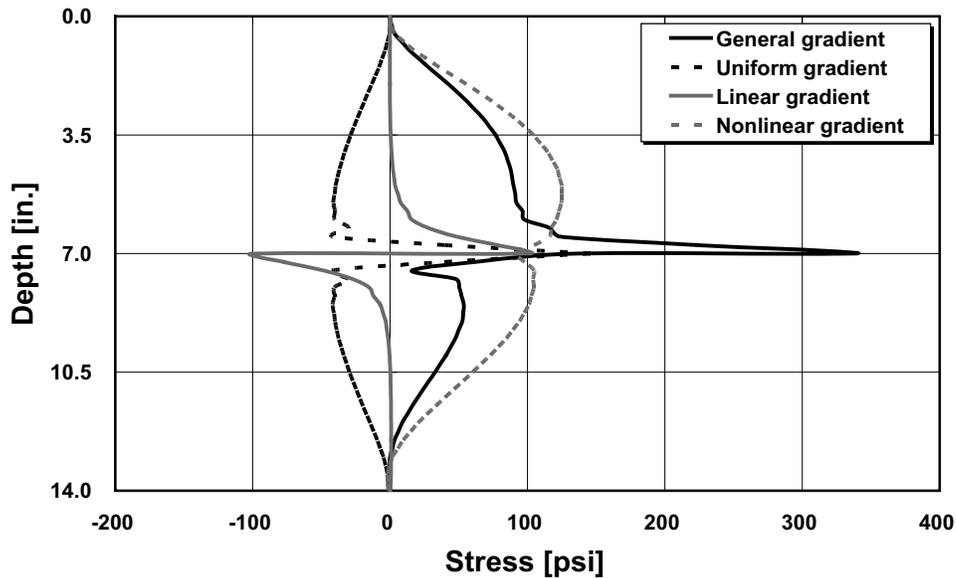
Figure 6.2: Distribution of vertical stress in CRCP at transverse crack subject to general nonlinear temperature gradient

Figure 6.2 indicates the distribution of vertical stress in concrete under a general temperature gradient. While vertical stress was negligible at the top and bottom slab surfaces, significant tensile stress developed at the concrete element near longitudinal steel when the slab was subject to a general temperature gradient. The uniform gradient generated symmetric vertical stress along the slab depth because the same amount of bending moment, as shown in Figure 3.3-(a), would be applied to two split slabs through the longitudinal steel. A linear gradient, which causes curling movement in the slab, also led to vertical stress in the concrete near steel. The vertical

force created by the steel's flexural rigidity restrained the curling-up of slab, as shown in Figure 3.3-(b), and thus higher stress developed in the concrete near steel. Unlike stress development due to uniform gradient, tensile and compressive stresses existed at concrete elements above and below steel, respectively. This is because the vertical force was acting downward to the concrete through the steel.

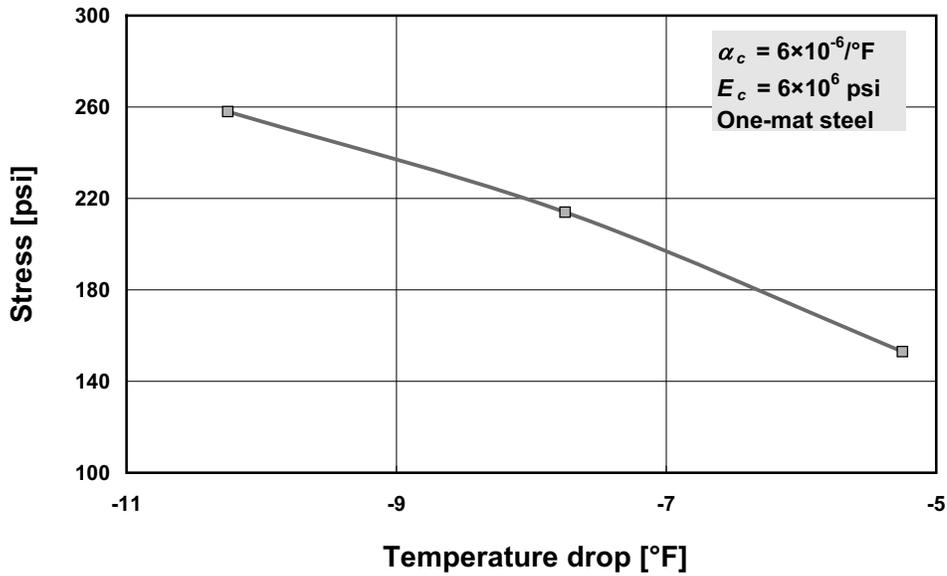
Figure 6.3: Effect of uniform temperature drop on vertical stress development

Figure 6.3 shows the effects of uniform temperature drop on the vertical stress development of concrete at transverse crack. As expected, a higher vertical stress developed as the uniform temperature decreased. The effect of CoTE is shown in Figure 6.4, where CoTE varied from  $4 \times 10^{-6}/^{\circ}\text{F}$  to  $6 \times 10^{-6}/^{\circ}\text{F}$ . It shows dominant effect of CoTE on vertical stress development. The effect of crack spacing and the number of steel layers was investigated. Because the vertical stress was caused by a uniform temperature gradient, which is related to the slab's length change, it is expected that crack spacing may also affect vertical stress development in concrete near steel. Figure 6.5 indicates that the vertical stress changed over the transverse crack spacing in CRCP. The longer slab would accompany more slab movement under a uniform gradient and thus the steel's restraining force would be increased. Because the bending moment is proportional to the restraining force in steel, the developed vertical stress would be greater. Figure 6.5 also explains that HC may occur frequently at relatively early ages. As CRCP ages, more transverse cracks develop and the cracks become closer to each other. The reduced crack spacing reduces the restraining force in steel and thus vertical stress will be decreased in concrete near steel.

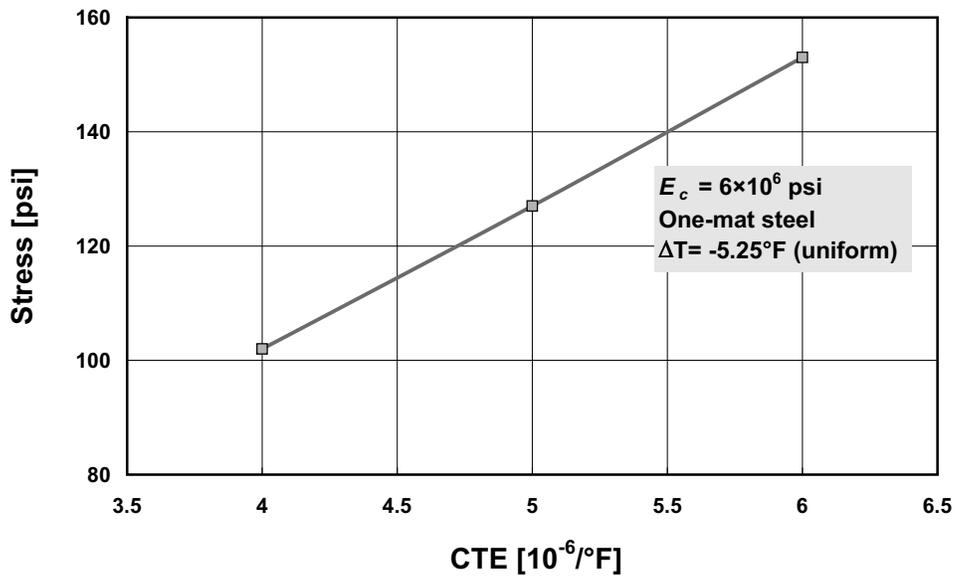
Figure 6.4: Effect of CoTE on vertical stress development

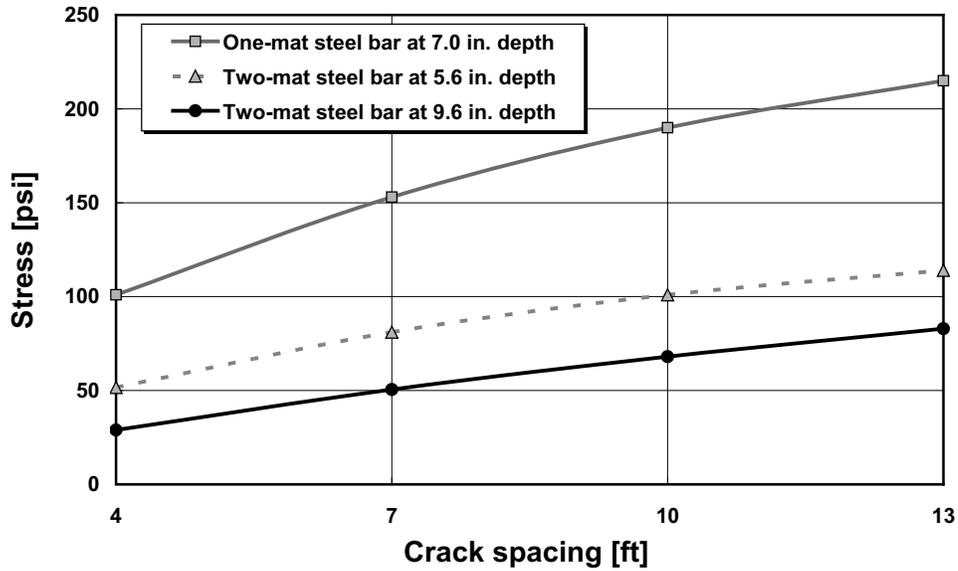
Figure 6.5: Effects of transverse crack spacing and number of steel layers on vertical stress development

Figure 6.5 implies the advantage of a two-mat steel bar in preventing horizontal cracking in CRCP. Even though the steel ratio of a slab with two-mat steel placement was the same as one-

mat, vertical stress was significantly reduced. This is because the distance between the steel's restraining force and the resultant reaction at the slab's center was reduced. As shown in Figure 3.3-(a), the bending moment, which caused the vertical stress in concrete, would decrease due to the reduction in lever arm length. The stress of concrete near the bottom layer of steel developed less than near the top because not only was the lever arm reduced but also the subbase friction lessened bending moment near the bottom layer of steel. The slab's curling-up is directly proportional to the temperature difference of the linear gradient at the top and the bottom surfaces of slab [4]. This analysis results are in consistent with the HC development on IH 35 in the Waco District where HC was in one-mat steel section and non-existent in two-mat section.

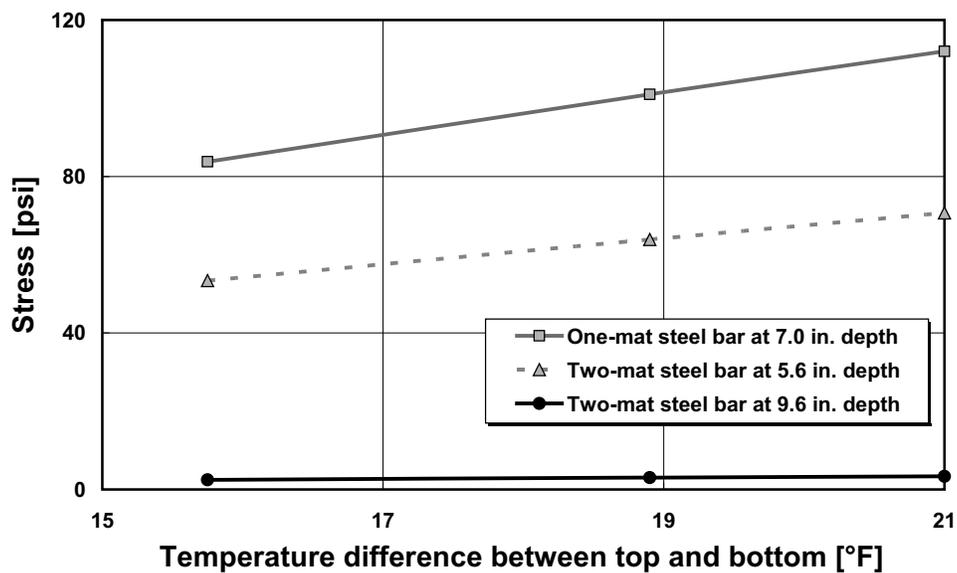
Figure 6.6: Effect of temperature difference on vertical stress development

Figure 6.6 illustrates the changes of vertical stress in concrete over temperature differences in linear gradient. As temperature difference increased, the vertical force to restrain the slab's movement increased and consequently higher vertical stress developed. Two-mat steel bar also reduced vertical stress in concrete subject to linear temperature gradient.

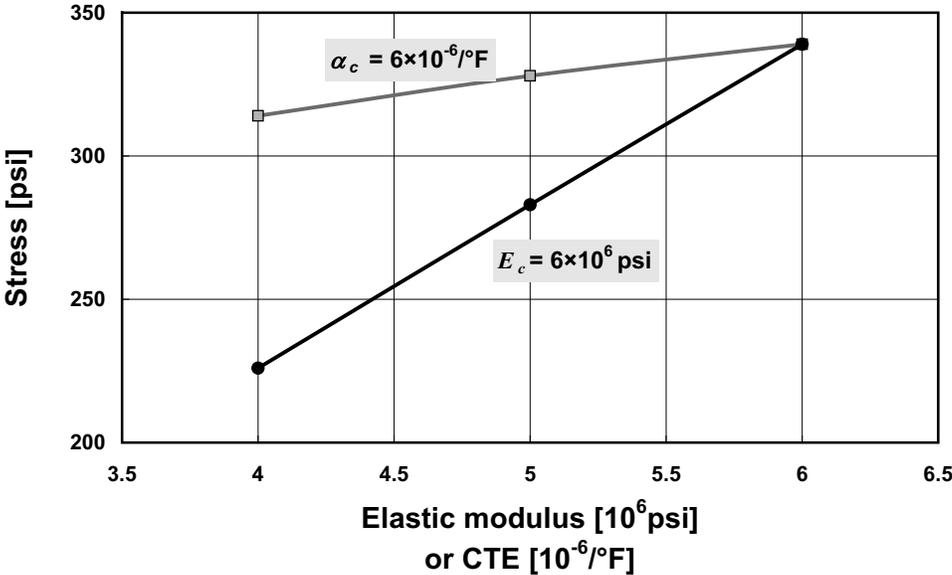
*Figure 7.1: Effect of elastic modulus and CoTE on vertical stress development*

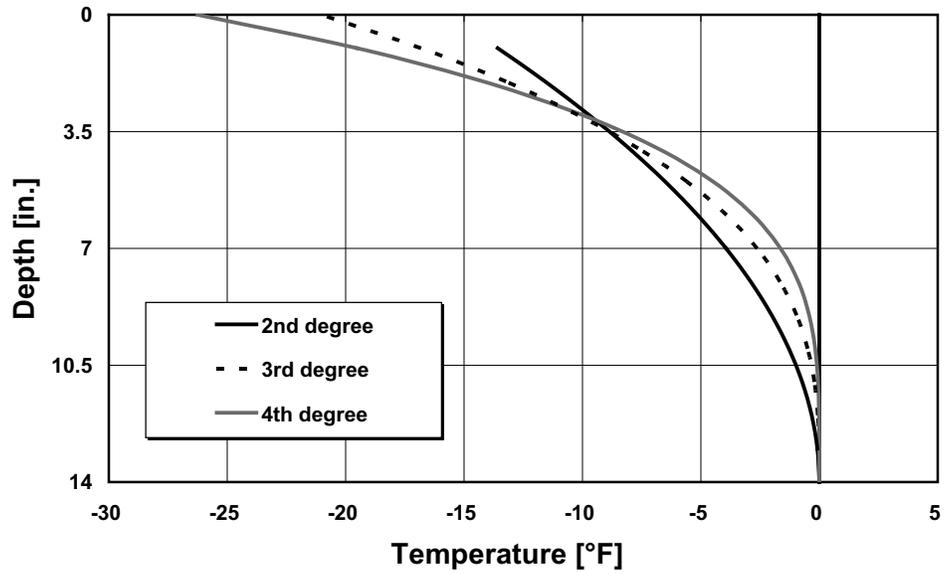
Figure 7.2: Nonlinear temperature gradient with different degree of nonlinearity

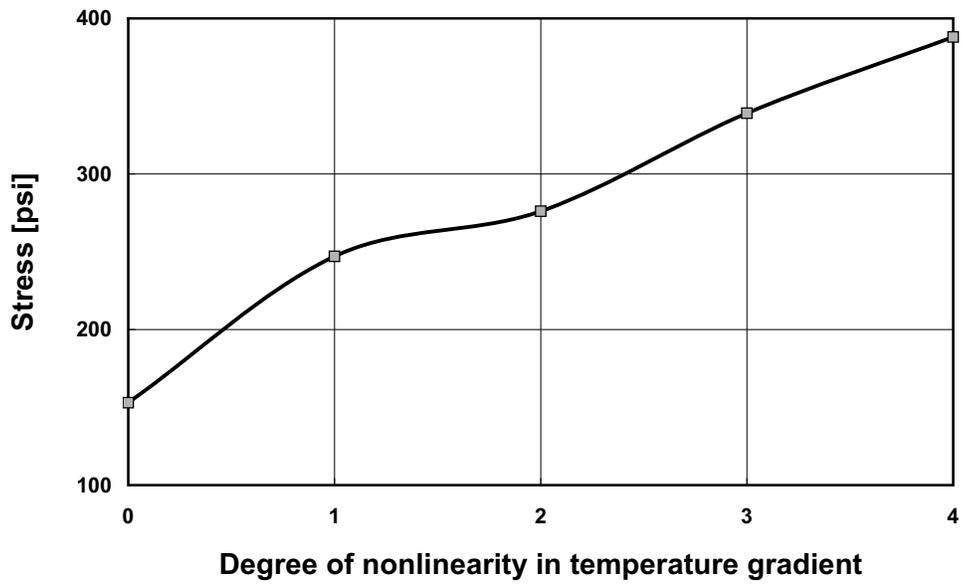
Figure 7.3: Effect of degree of nonlinearity in temperature gradient on vertical stress development

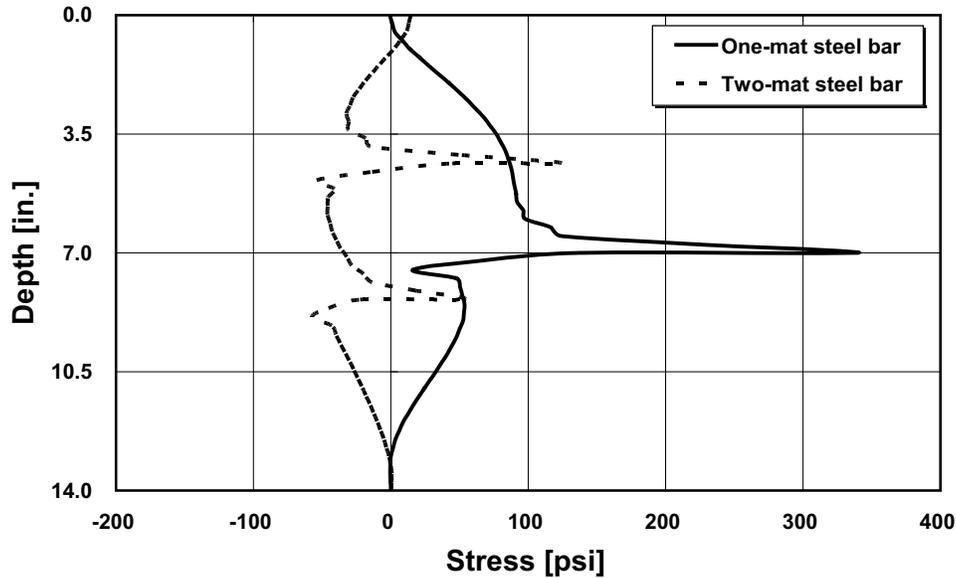
Figure 7.4: Distribution of vertical stress in CRCP at transverse crack

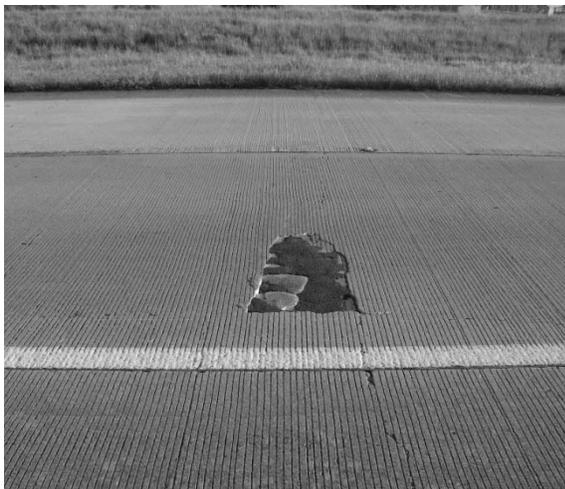
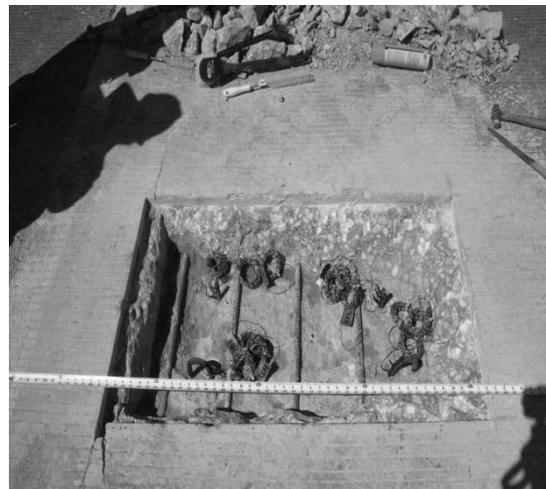
*Figure 8.1: Distressed concrete slab with horizontal cracking*

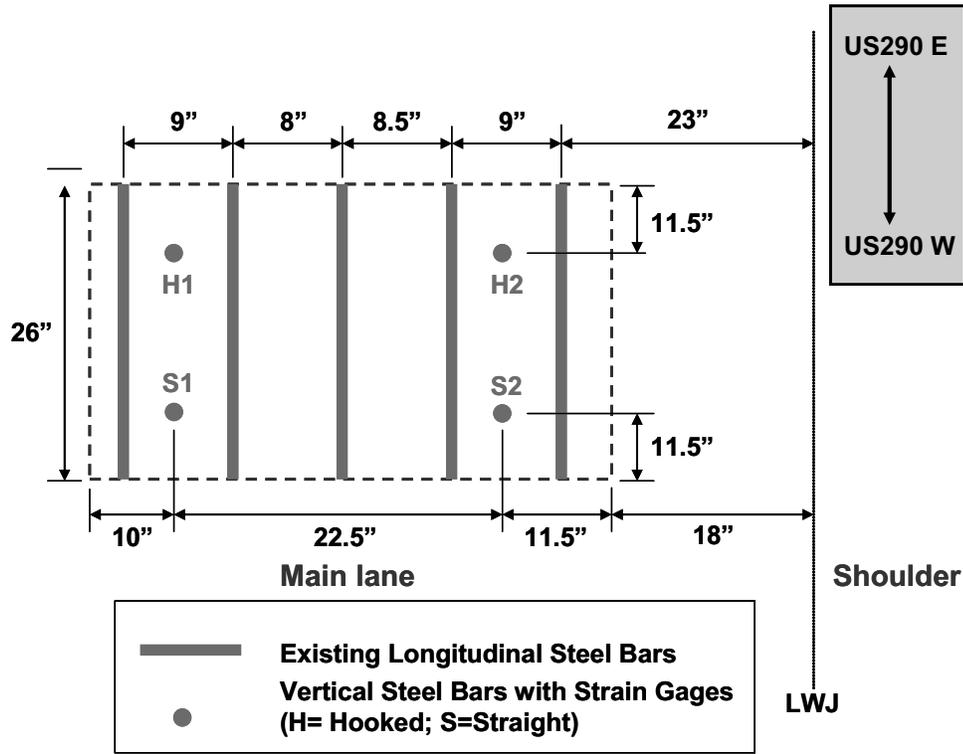
Figure 8.2: Plan view of test section

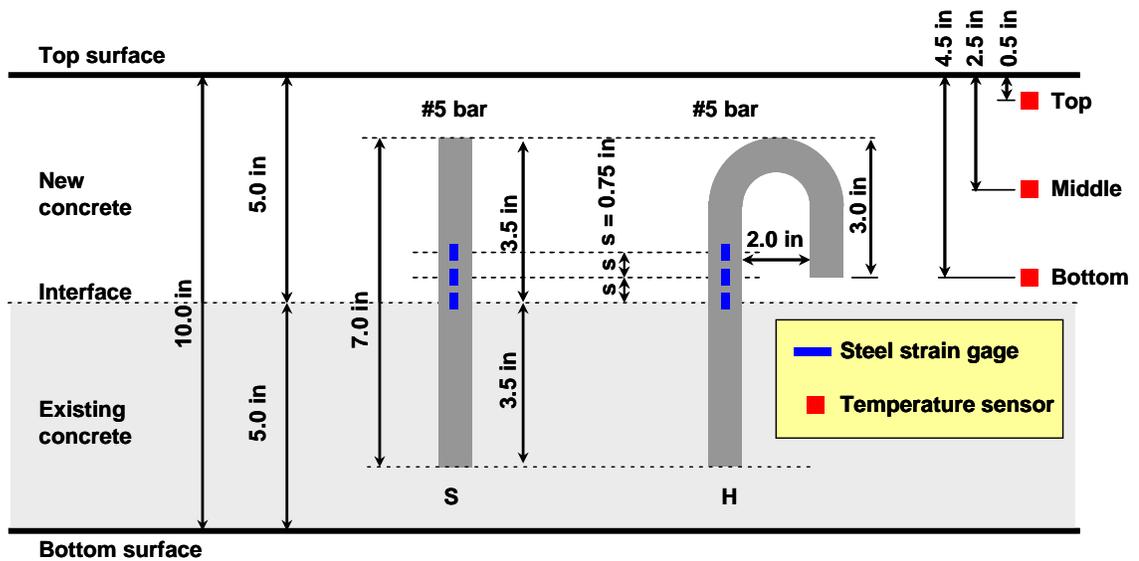
Figure 8.3: Instrumentation in the field

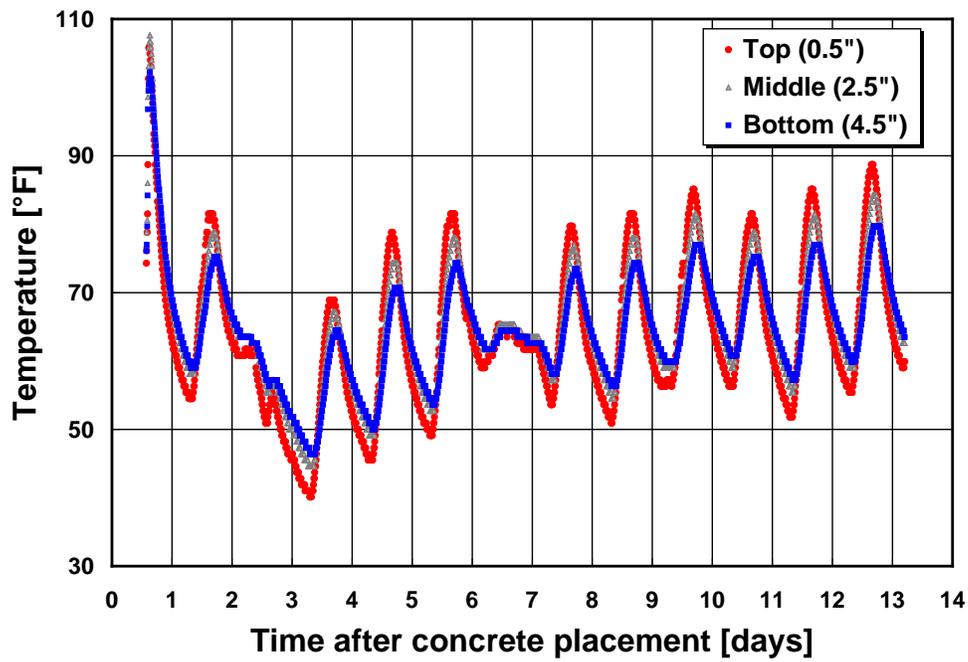
Figure 8.4: Measured temperature histories

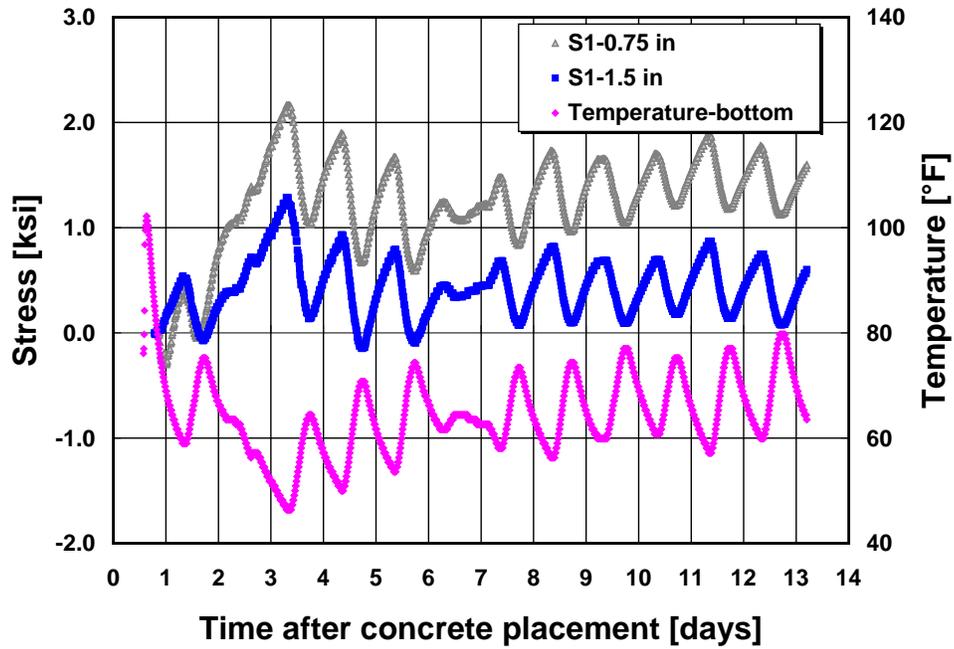
Figure 8.5: Variation of steel stress in S1 bar

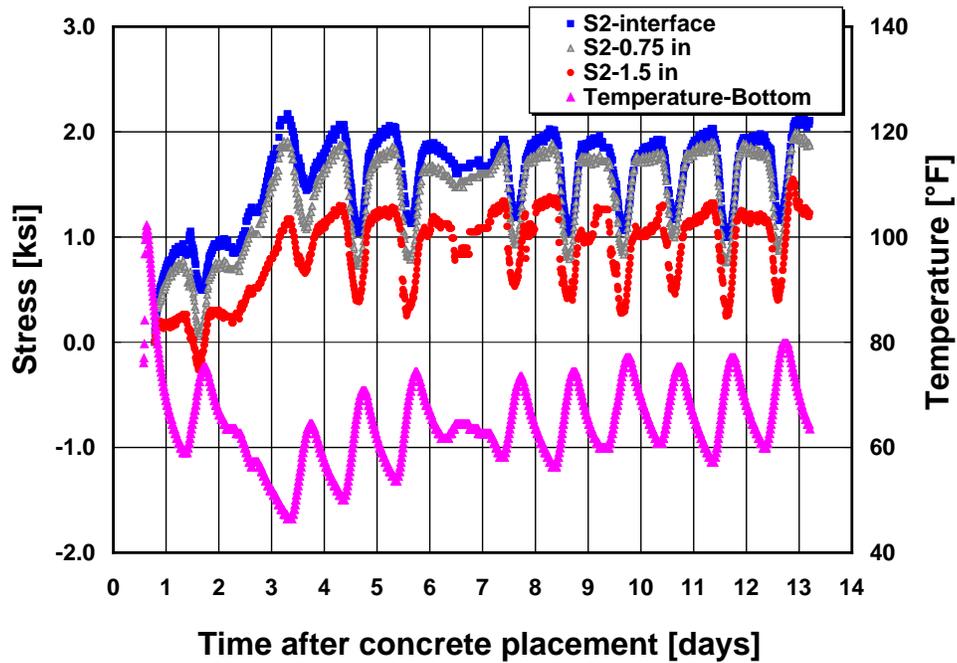
Figure 8.6: Variation of steel stress in S2 bar

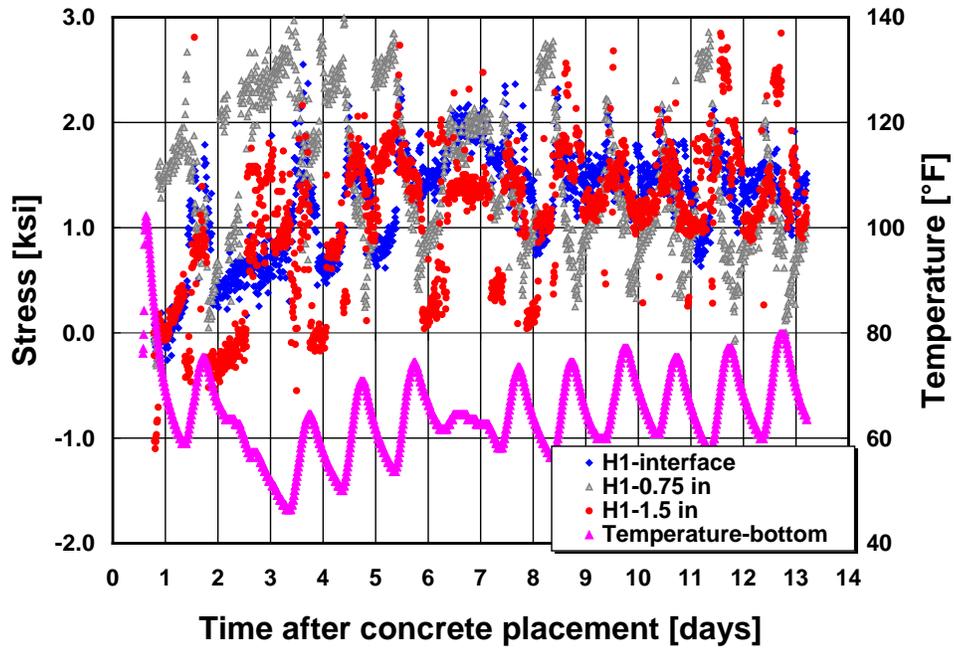
Figure 8.7: Variation of steel stress in H1 bar

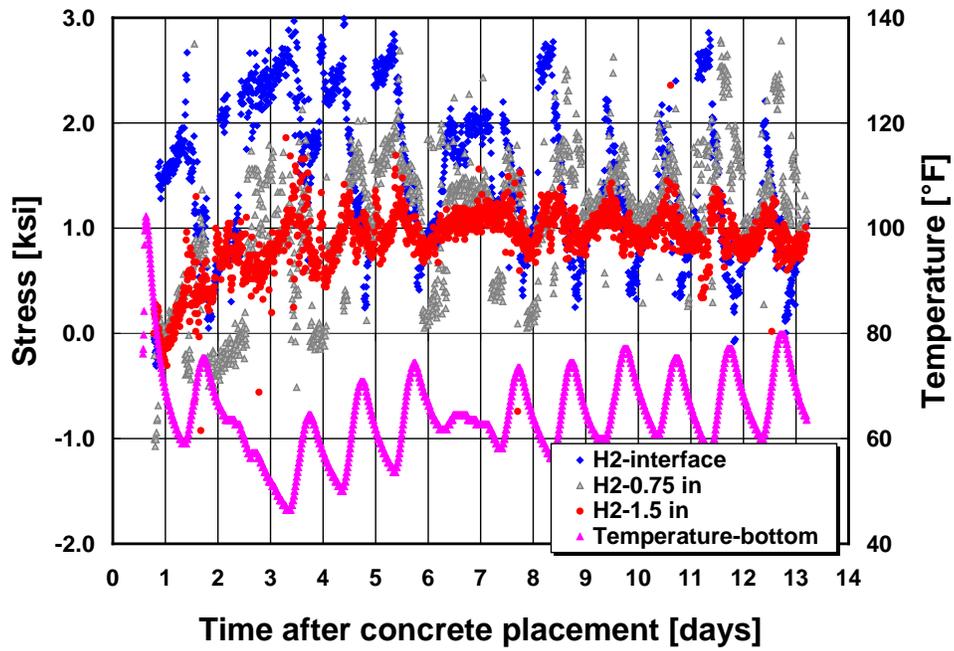
Figure 8.8: Variation of steel stress in H2 bar
