Project Level Performance Database for Rigid Pavements in Texas, II

Pangil Choi, Sungwoo Ryu, Wujun Zhou, Sureel Saraf,
Jungheum Yeon, Soojun Ha, Moon Won

Research Project #: 0-6274
Research Report #: 0-6274-2
www.techmrt.ttu.edu/reports.php

October 2014

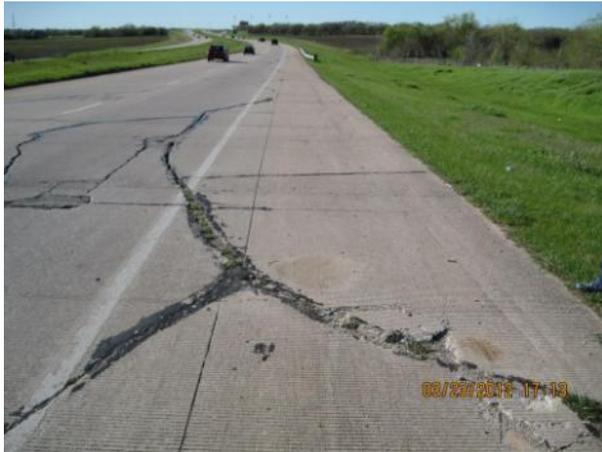
Figure 2.3 SL 288 - Dallas District-Denton County

Figures 2.3 and 2.4 illustrate distresses due to the volume changes in base or subgrade. During the field survey, it appeared that the majority of CPCD distresses were due to volume changes in the base or subgrade.

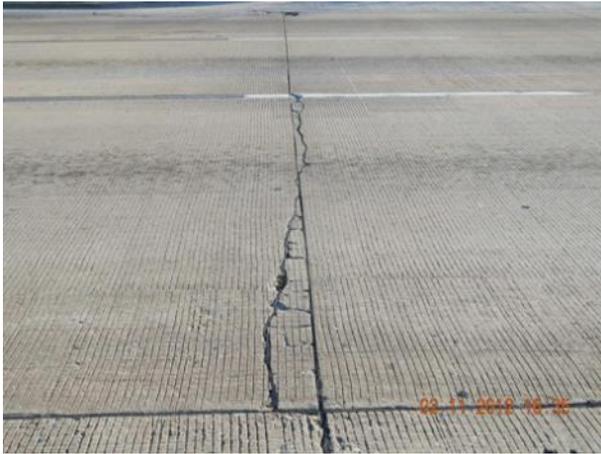
Figure 2.5 US 380 - Dallas District, Collin County

Figures 2.5 and 2.6 illustrate distresses due to delayed saw cut, which means the saw cut joint did not propagate to the full depth. This distress can occur due to shallow saw cut depth or delayed saw cut. Shallow saw cut depth is more prevalent when siliceous river gravel (SRG) is used as coarse aggregate, due to the difficulty of saw cutting when hard rocks like SRG are used.

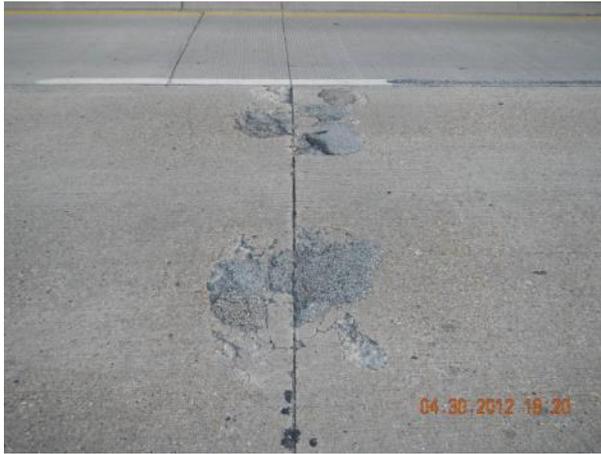
Figure 2.7 SH 78 - Dallas District, Dallas County

Figures 2.7 and 2.8 illustrate typical distresses at the joint due to wheel load. The distresses are located in the wheel paths. Figure 2.8 shows a section on IH 35 in Dallas District, Denton County. In 1988, this section was overlaid with 11-in CPCD over a 2-in asphalt concrete layer level, which was on top of existing 10-in CPCD. It can be considered that support condition in this unbounded overlay was good. The original CPCD was built in 1960, which means that the 10-in CPCD provided 28 years of service before the unbounded overlay was applied. Figure 2.9 shows the typical section of both the original and the current section. The research team surveyed the entire section and could not find any other types of distresses including faulting. Accordingly, it is considered that truck traffic and/or concrete materials/construction were the cause of this distress. Traffic analysis was conducted and Figure 2.10 illustrates the cumulative truck traffic. The cumulative ESALs were evaluated to be more than 35 million, which is rather large considering the age of unbounded overlay pavement. On the other hand, there are a number of CPCD sections with high ESAL applications but with no distress of this type. It is believed that concrete materials/construction was a primary cause for this distress, with heavy traffic potentially exacerbating the problem.

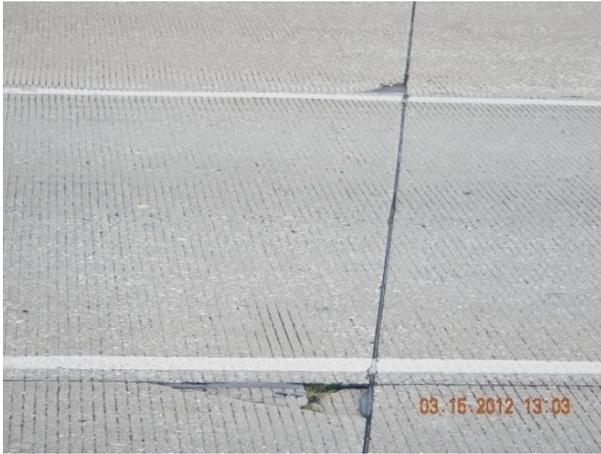
Figure 2.11 IH 10 L RM 816±5 - Beaumont District, Chambers County

Figures 2.11 and 2.12 illustrate distresses due to skewed transverse joint. This joint type was considered a good design because both wheels in one axle are not placed in one side of the joint, thus relieving wheel load stresses and deflections in the joint area. This CPCD is on IH 10 in Chambers County, Beaumont District. As can be seen in Figure 2.11, concrete at acute angle experienced corner cracking. Figure 2.12 shows concrete cracking along the skewed joint.

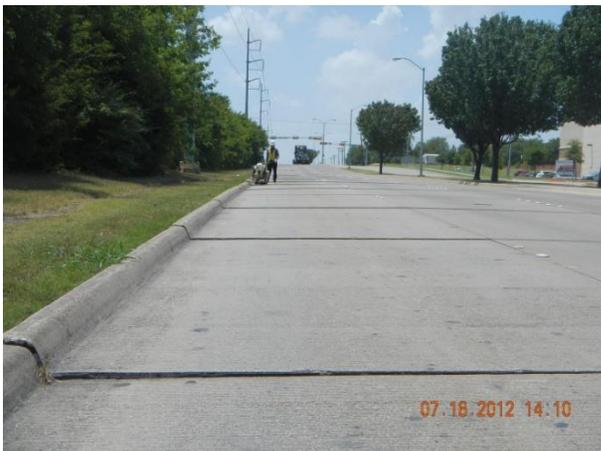
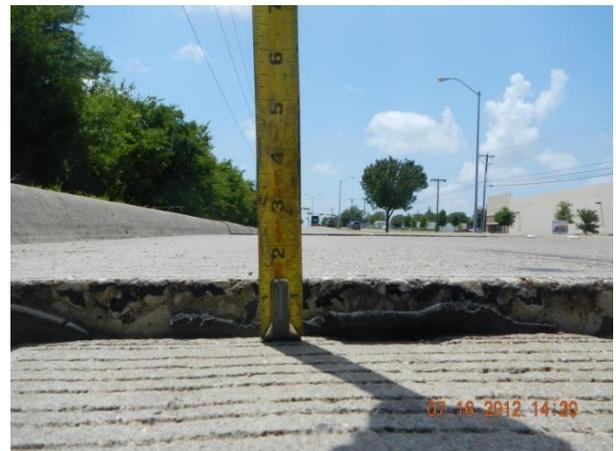
Figure 2.13 Samuell Blvd – Dallas City Road

Since TxDOT CPCD design has required the use of dowels since the 1940s, faulting at transverse contraction joints has not been a problem in Texas, except where dowels were not placed for unknown reasons. On the other hand, severe faulting was observed in a city street in Dallas. Figure 2.13 shows the faulting example on a city road at Samuell Blvd in Dallas. In this project, dowels were not used.

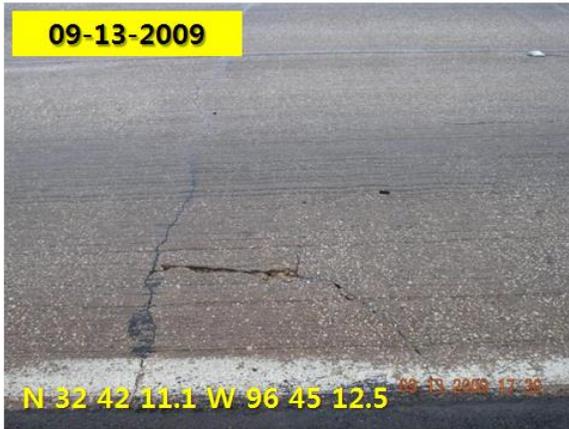
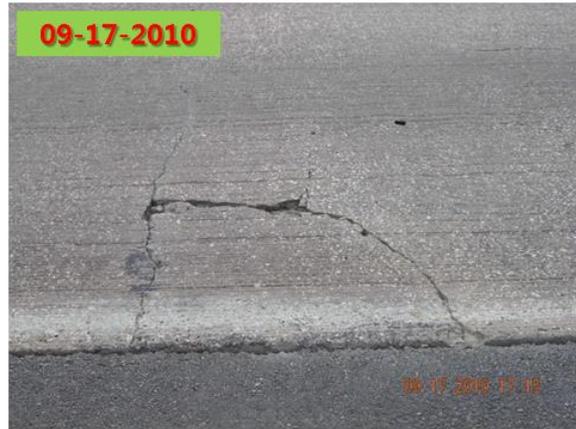
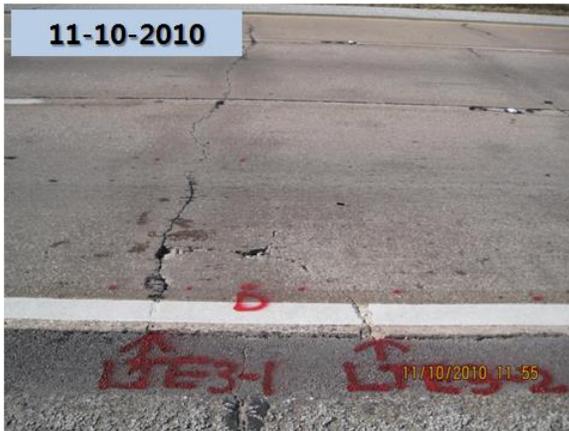
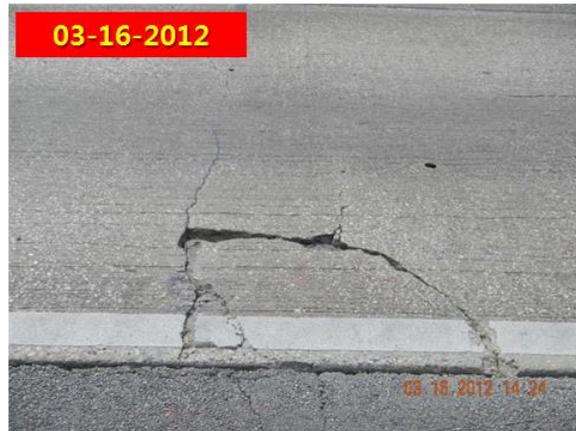
Figure 2.15 E-PCH Progress History on IH 45 in the Dallas District

Figures 2.15 (a), (b), (c), and (d) illustrate the chronological progress of an E-PCH on IH 45 in the Dallas District during a three-year period. This CRCP was constructed in 1975 with an 8-in. thick slab on top of soil cement base. As can be seen in Figure 2.15 (a), there is only one transverse crack and no longitudinal crack as observed on 09/13/2009. One year later on 09/17/2010, this E-PCH was evaluated again and there was no difference at two different times. To further evaluate the cause of the distress, field testing including FWD and LTE were conducted on November 10th, 2010.

LTE tests were performed upstream and downstream of the punchout slab as shown in Figure 2.15 (c). LTE values of about 100 were obtained as shown in Figure 2.17. As will be discussed in the next chapter, LTE is not the most important indicator of CRCP performance.

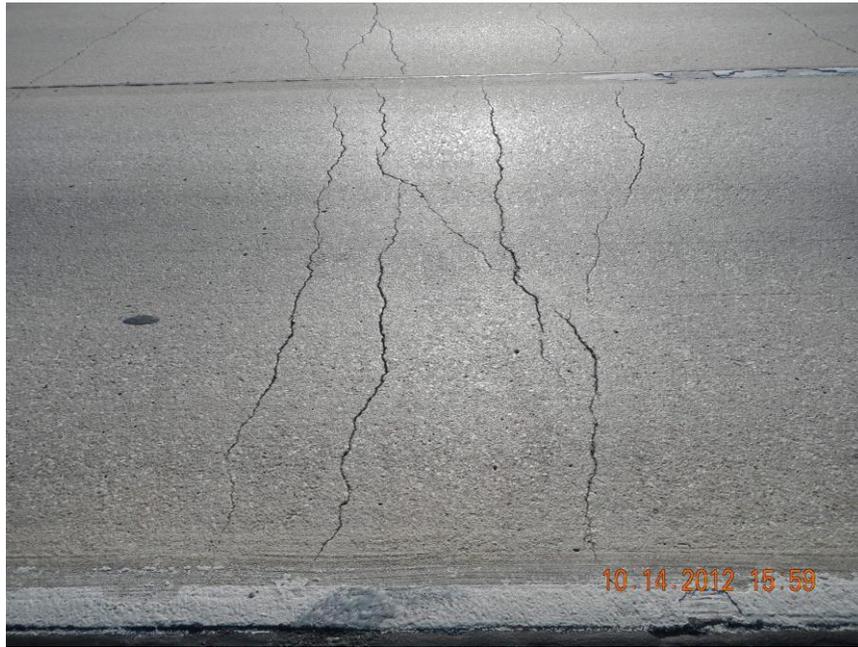
Figure 2.18 Y-Crack and Narrow Crack on US 81 in the Wichita Falls District

Even though LTPP states that Y-crack is a distress, field evaluations conducted in this study indicate that is not the case. Figure 2.18 shows the Y-crack and narrow crack on US 81 built in 1972 in the Wichita Falls District. Based on the widths of the cracks, those cracks appear to have existed for more than 40 years, without developing into distresses under relatively heavy truck traffic.

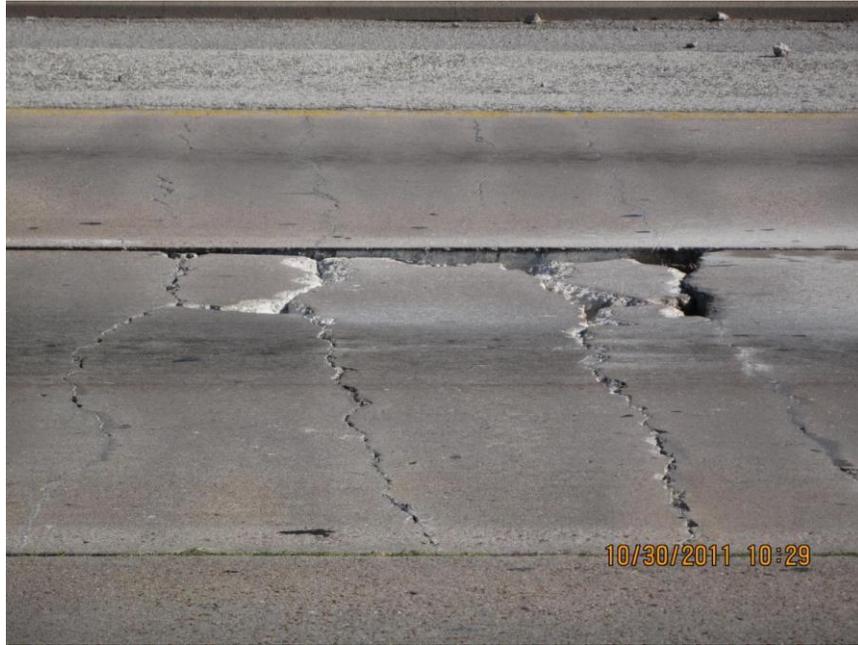
Figure 2.19 PCH (IH 45, Houston District)

Figure 2.19 illustrates the typical punchout due to pumping and resulting in loose base on IH 45 in the Houston District. Spalling is not observed in the inside lane. However, chipping in cracks is observed in the middle lane. Since trucks usually pass through the outside lane, a distress such as structural punchout due to traffic loadings should occur in the outside lane first. However, the punchouts were observed at the middle lane as shown in Figure 2.19. This finding indicates that a major cause of punchouts in Figure 2.19 is not only traffic loading, but the loose support condition. The pumping material was also observed. This type of distress is classified as PCH in Table 2.3.

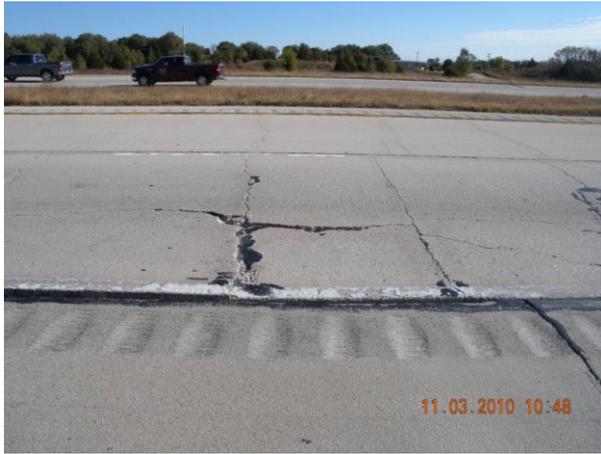
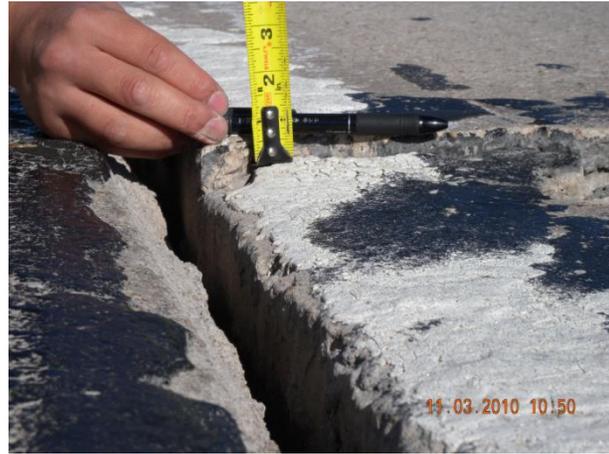
Figure 2.20 E-PCH (US 287, Wichita Falls District)

Figure 2.20 (a) illustrates an example of typical edge punchout on US 287 in the Wichita Falls District. As shown in Figure 2.20, the shoulder type is asphalt concrete. Since the traffic loading cannot be transferred to the shoulder, the pavement edge deflection due to traffic loading is relatively larger than when there is a tied concrete shoulder. Evidence of pumping between the outside lane and asphalt concrete shoulder was observed and settlement of asphalt shoulder was also observed, as shown in Figure 2.20 (b). This finding indicates that there was a deficiency in the slab support. This can be classified as the typical edge punchout (E-PCH).

a. Typical edge punchout

b. Joint separation and slab settlement

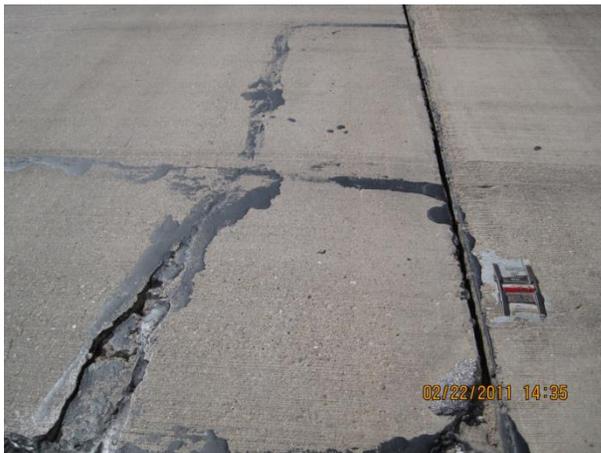
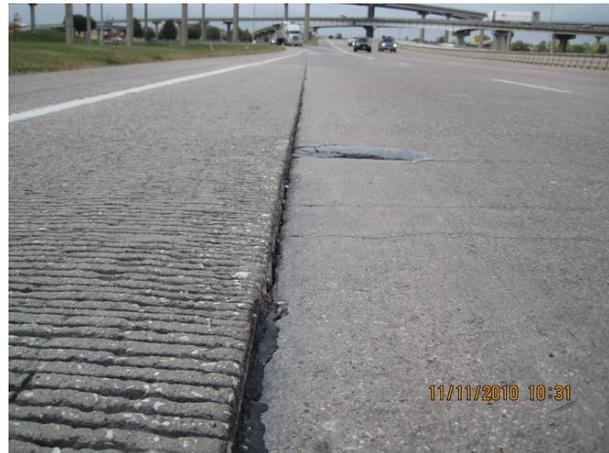
Figure 2.21 Edge Punchout Due to Inadequate Tie bar Design and Installation

Figures 2.21 (a) and (b) illustrate the distresses in the form of edge punchout due to inadequate installation of tie bars and poor base support. As can be seen in Figure 21 (b), longitudinal joint faulting was also observed, which indicates that the load transfer efficiency must be low and support condition was also poor. Hence, the primary reason for the distress would be a poor load transfer from deficient tie bar installations, and also poor slab support.

a. E-PCH-PTB (IH 40, Amarillo District)

b. E-PCH-PTB (IH 30, Dallas District)

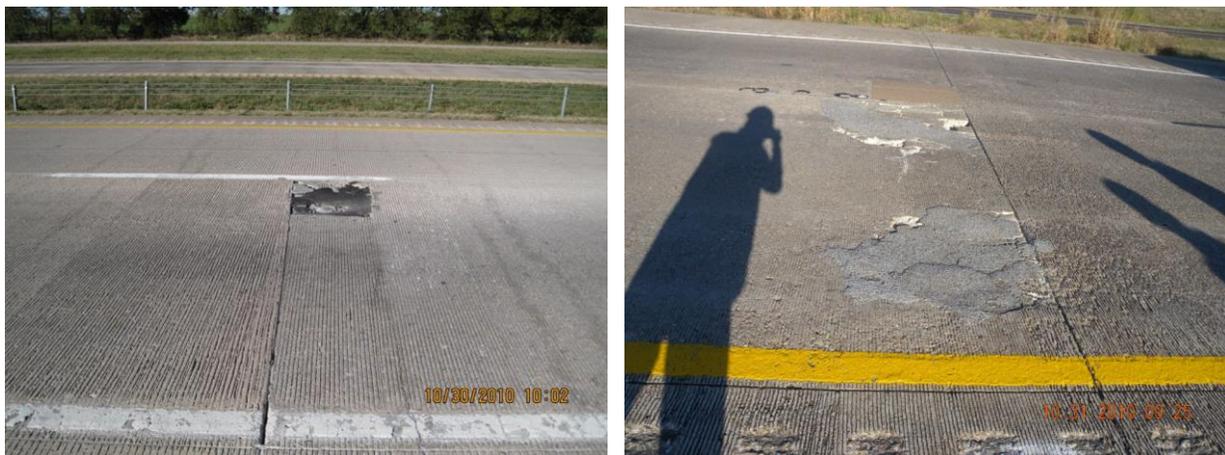
Figure 2.22 Punchout at Construction (PCH-CJ)

As discussed in Table 2.3, about 21 percent of the total punchouts surveyed in CRCP were observed at the transverse construction joint (TCJ). Figure 2.22 (a) illustrates a typical punchout at TCJ, and PCH-CJ is usually observed at a distance of two feet from the TCJ.

a. PCH-CJ (IH 35, Wichita Falls District)

b. PCH-CJ (IH 35, Wichita Falls District)

Another cause for the distresses at TCJ could be the quality of the in-place concrete. The concrete placed in the morning is the first batch of concrete of the day, and its quality might differ slightly from that of the later batches. The concrete placement in this area, including consolidation, is done primarily by manual work. A larger amount of longitudinal steel at a TCJ (regular steel plus additional steel) might hinder proper consolidation of concrete. Figures 2.22 (b) shows distresses possibly due to inadequate construction practices or poor concrete material and resulting in distresses at TCJ.

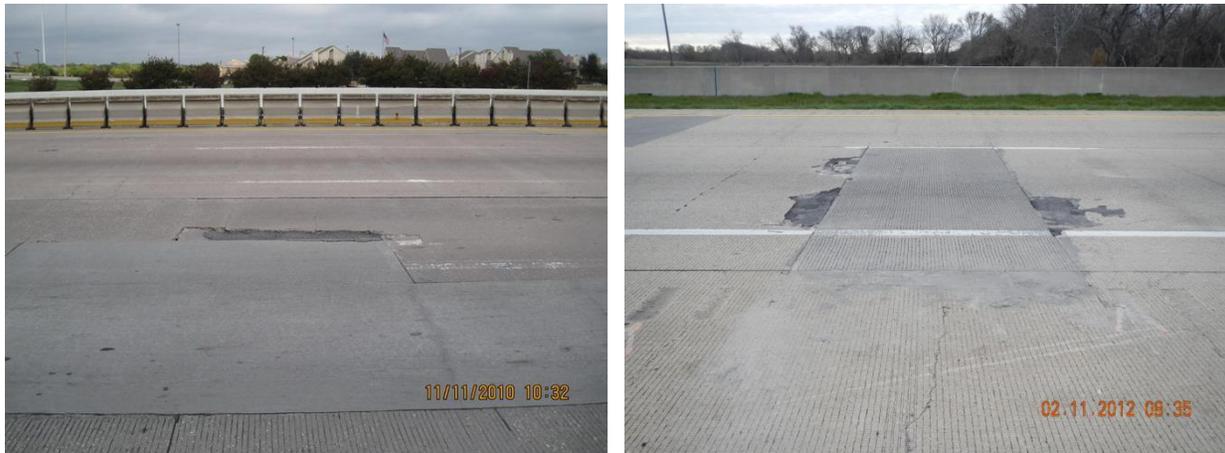
a. PCH-RJ (IH 30, Dallas District)

punchout at repair joints is not also structural capacity related. Figures 2.23 (a) and (b) show distresses at the repair joints. Well-organized special specifications, guidelines and design standards were developed under the research project 0-6611, and it's believed their implementation will reduce the frequency of the punchouts at repair joints in Texas.

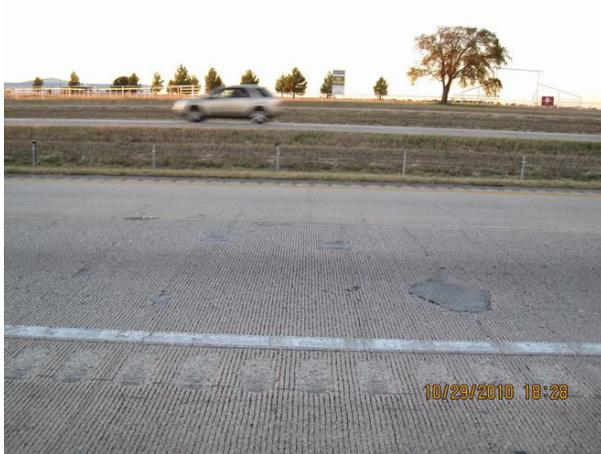
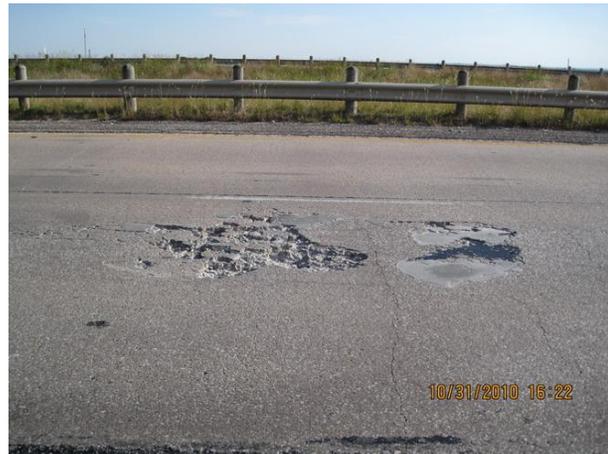
Figure 2.24 Big Spalling with Poor Concrete Work

According to the current TxDOT Pavement Management Information System Rater's Manual, a surface defect greater than 12-in long or wide is rated as a punchout (TxDOT, 2009). Figures 2.24 (a) and (b) illustrate surface defects that were greater than 12-in long or wide and therefore rated as punchout in the TxDOT PMIS condition survey. These distresses should be classified as spalling. Figures 2.24 (a) and (b) are the surface defects on IH 35 in the Wichita Falls District and on SH 114 in the Dallas District. As shown in Figure 2.24, the surface defects are not related to transverse cracks. Normally, spalling occurs at transverse cracks. It is believed that this distress occurred due to construction quality issues during concrete placement. Accordingly, BS-PCW also is not a structural related distress.

a. BS-PCW (IH 35, Wichita Falls District)

b. BS-PCW (SH 114, Dallas District)

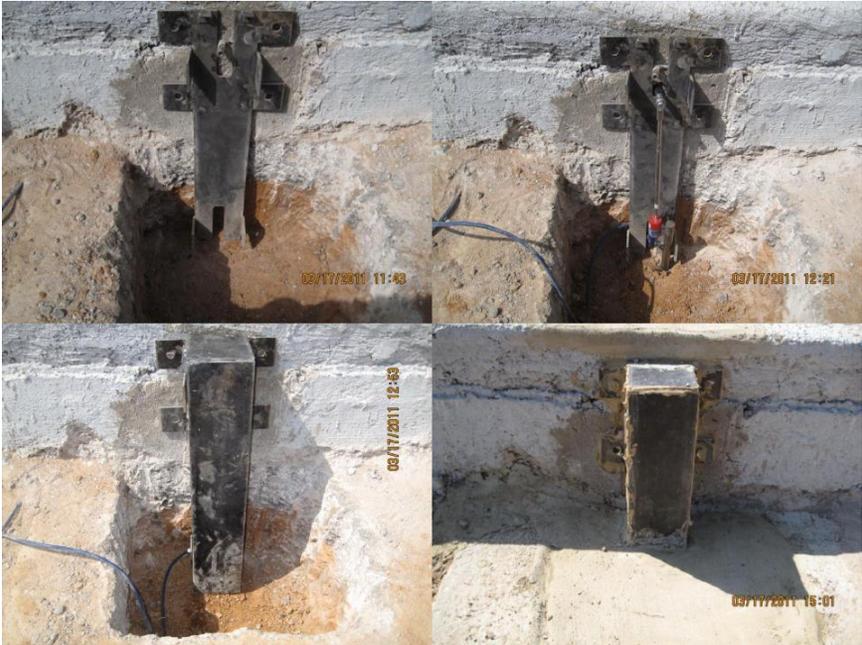
Figure 3.1 Crackmeter Installation

Figure 3.1. Customized steel plate box were installed to protect crackmeters. Table 3.1 shows the information on the base type used for each section.

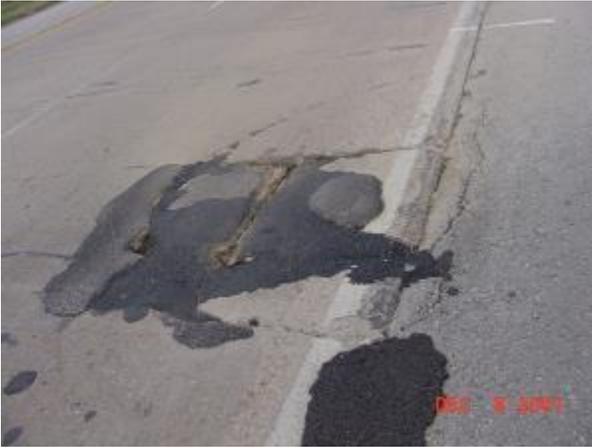
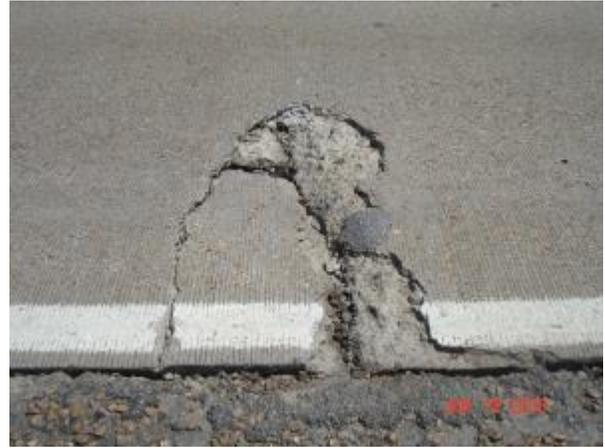
Figure 3.4 Typical Punchout Distress and Distress in Post-Tensioned Pavement

1. From the asphalt patching (more asphalt patching material was placed near the wheel path than at pavement edge), it appears that the slab was pushed down by the traffic loading at the location of wheel path.
2. The condition of transverse cracks in the left half of the outside lane is excellent – cracks are tight with no indication of spalls.
3. The overall shape of the depressed slab is that of a half-moon.
4. It appears that the deteriorated transverse cracks were a product of the distress, not the cause of the distress.

The distress shown in Figure 3.4 (b) is 6-in. cast-in-place post-tensioned concrete pavement in Missouri. In this project, post-tension was applied in the longitudinal direction to eliminate transverse cracking and to reduce slab thickness. This distress was not caused by transverse crack; rather, it was due to the localized inadequate slab support. From the Figures 3.4 (a) and (b), it can be hypothesized that those distresses were due to inadequate slab support confined to that location, and were not related to transverse cracks.

a. Typical punchout distress in Texas

b. Distress in post-tensioned pavement

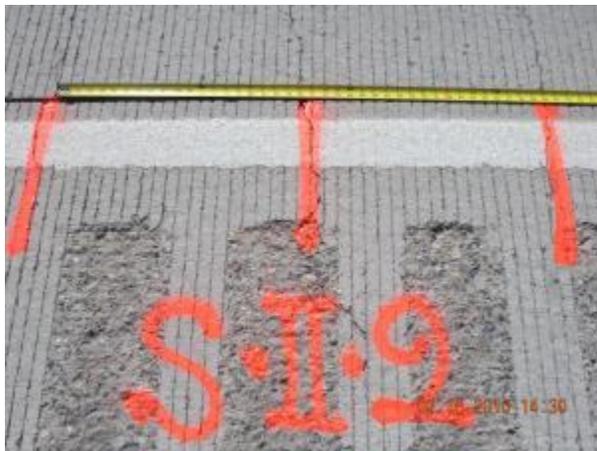
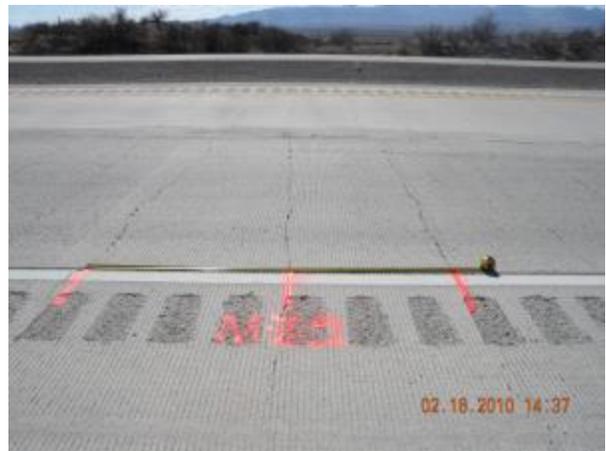
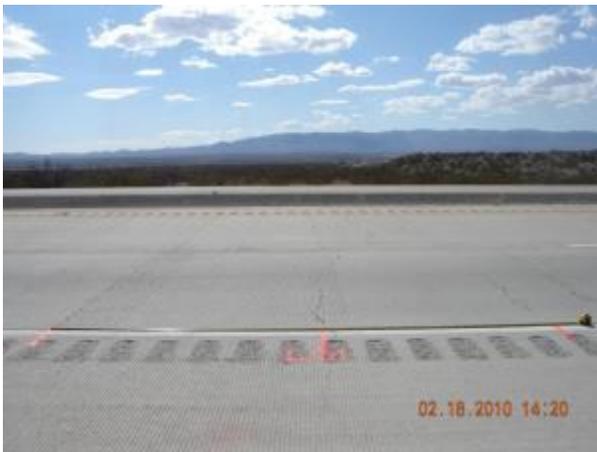
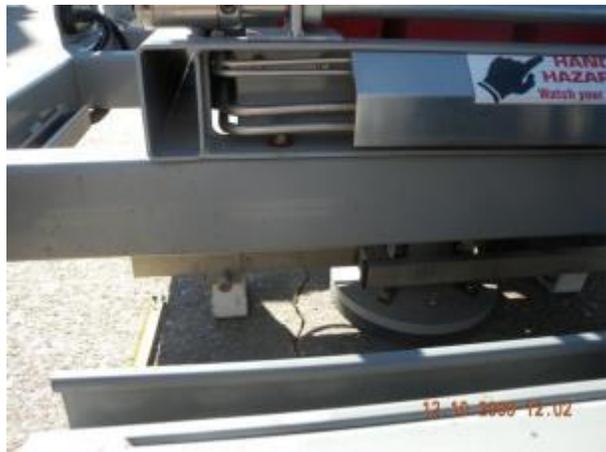
Figure 3.5 FWD Test for Small Medium, and Large Crack Spacing

Since crack spacing, LTE and concrete setting temperature were among the variables whose values needed to be obtained for the calibration of MEPDG model for TxDOT's use, which was the initial intent of 0-5445, slab segments with small, medium, and large crack spacing were selected. A total 12 slab segments – 2 of each small, medium, and large crack spacing at one side of the TCJ – were selected for each test section. The crack spacing for small spaced cracks is 2-3 feet, for medium spaced cracks 4-6 feet and for large spaced cracks 7-10 feet. To evaluate the behavior of a transverse crack with a specific crack spacing, two slab segments with comparable spacing at both sides of the crack were selected. Figures 3.5 (a), 3.5 (b), and 3.5 (c) show slab segments selected for the evaluation of a transverse crack with small, medium, and large crack spacing, respectively.

a. Crack with short crack spacing

b. Crack with medium crack spacing

c. Crack with large crack spacing

d. LTE evaluation at downstream

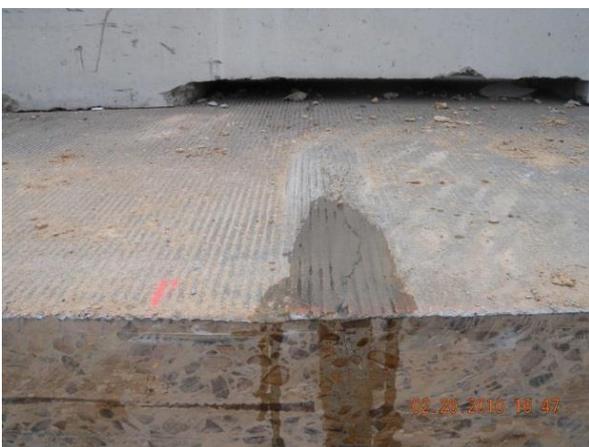
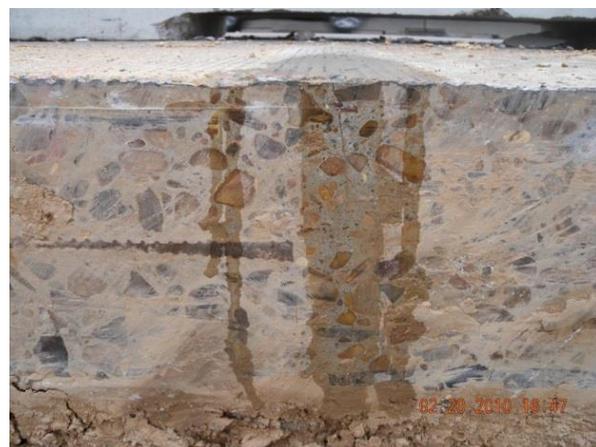
Figure 3.11 Transverse Crack (Surface and below Surface)

Part of the reason for the sensitivity of LTE on temperature in MEPDG is the assumption that transverse cracks go through the slab depth, as is the case for transverse contraction joint in CPCD. Another reason is the over-prediction of crack width in MEPDG. Figures 3.11 (a) and (b) show that transverse crack stopped at few inches from the concrete surface, even though the crack opened in the surface. This 10-in CRCP section on US 290 was built in 1977, and provided excellent structural performance except for spalling issues. This picture was taken on February 20, 2010, and the ambient temperature on that day varied from 46 °F to 70 °F. Even though this temperature range is not low, but not that high either in Houston area. Regardless, the crack was still quite tight. It doesn't appear that this crack width will vary as much as shown in Figure 3.10 (a). As a matter of fact, the concrete about 2 inches below the surface didn't even crack. Considering the crack width variations shown in Figure 3.10 (a) are at the location of longitudinal steel, it is not easy to visualize the crack in Figure 3.11 (b) will experience as large variations as shown in Figure 3.10 (a).

a. Transverse crack on the surface

b. Tight crack width below the surface

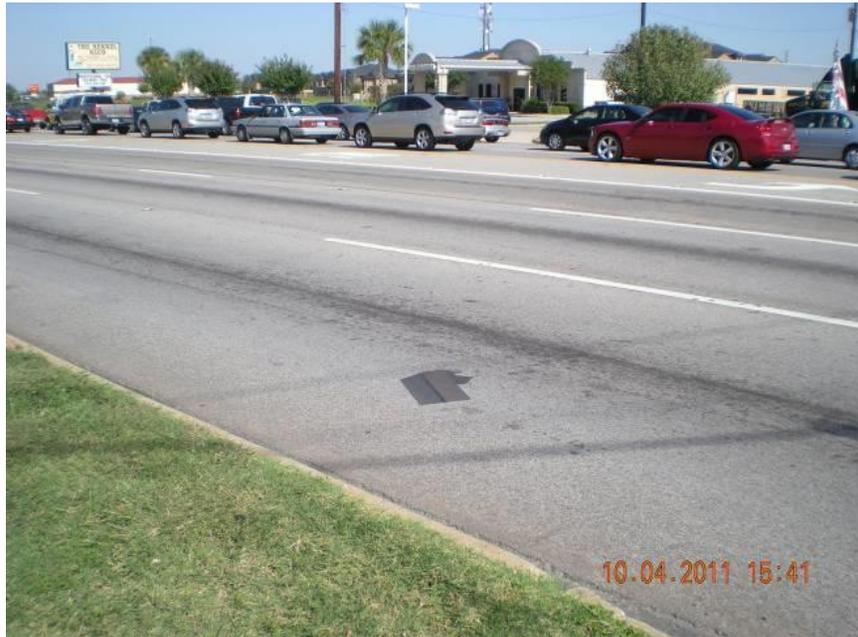
Figure 4.2 SH 6 Section Overlaid with Asphalt

Among the four sections, two on SH 6 were asphalt overlaid with hot mix asphalt in the mid-2000s due to severe spalling problems, as shown in Figure 4.2. The other two experimental sections—one on the IH 45 in Spring Creek and the other on the BW 8 frontage road—are in good condition except for spalling problems on sections containing siliceous river gravel (SRG) as coarse aggregate, and thus field evaluations were conducted in the remaining two locations: BW 8 and IH 45. Both of them were constructed in the late 1989 and early 1990, and have been in service for more than 23 years.

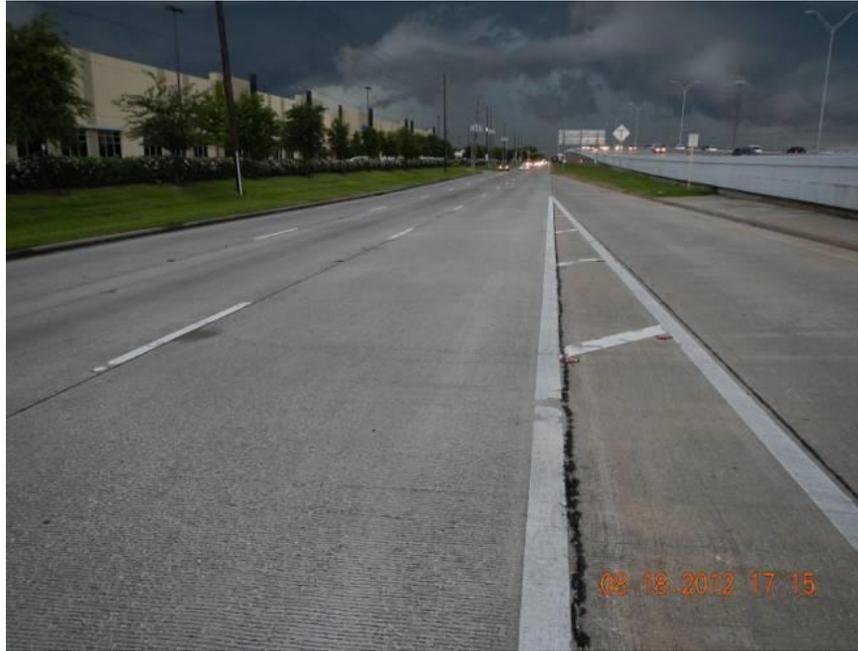
Figure 4.6 General Condition of LS Section

A series of field investigations revealed that there was even no single punchout distress found in both LS and SRG sections. However, there was a huge difference in the surface condition between those sections; while the SRG section had numerous deep spallings and spalling repairs, general condition of the LS section was highly fair and sound. Figures 4.6, 4.7 and 4.8 show the general surface condition of the LS section, deep spalling in the SRG section and close-up view of spall repairs, respectively. In Figure 4.7, it is important to note that another spalling begins to develop right next to the existing deep spalling repair.

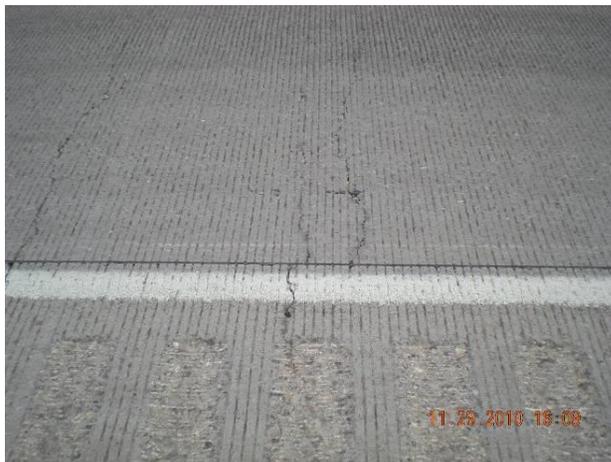
Figure 4.33 Transverse Cracks in Van Horn IH 10

Even though this CRCP section was placed in the winter and had been in service for only eight-and-a-half years at the time of the latest field evaluation, the surface crack width was larger than the other sections, which is not consistent with the commonly accepted belief that the lower the setting temperature (or zero-stress temperature), the tighter the crack width. Also, it is interesting to note that even though this section employed LS as coarse aggregates, a few shallow spalling distresses already occurred and some indication of probable spalling distresses was observed at transverse cracks. Figures 4.33 and 4.34 show the typical condition of transverse cracks and shallow spalling distress found in the section.

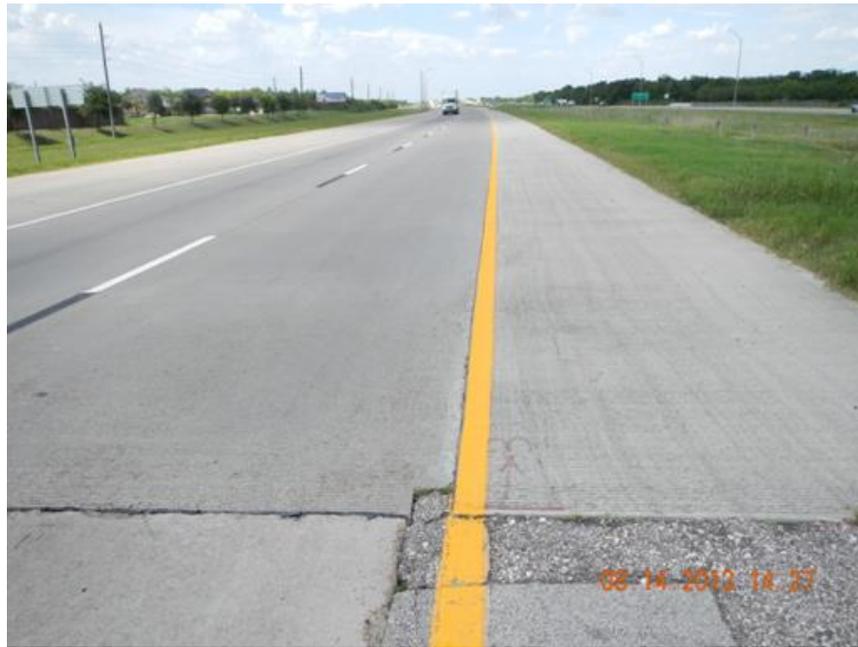
Figure 4.37 Overview of Pearland SH 288 Sections

This section is 12 in.-thick CRCP located south of Houston near Pearland. It is 1747 ft-long and is at the inside main lane on SH 288 southbound, just south of Croix Road. The GPS coordinate of this section is 29.506624, -95.388193. The section was placed on November 16th, 2005. Figure 4.36, 4.37, and 4.38 depict the location map, overview, and close-up view of the test section by construction sequence, respectively.

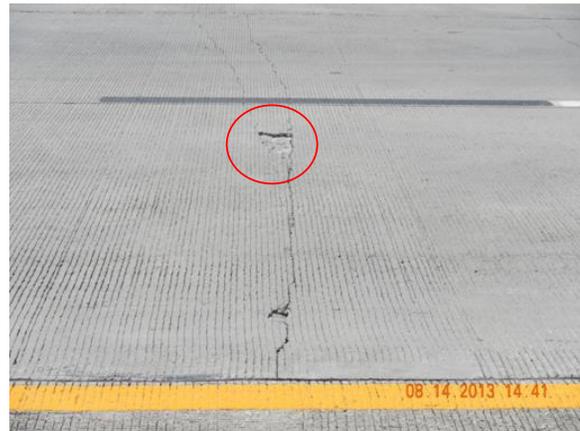
(b) Section 5

transverse crack, which could be deep spalling and partial-depth delamination. Sections 5 and 6 also showed the similar type of distress or pre-distress behavior as noted in Figures 4.44 (b) and (c), respectively. Particularly in Section 5, shallow-depth delamination was already developed to some extent, which is not a good sign for the long-term performance. In Section 2, there was a full-depth repair as shown in Figure 4.44 (d). It is not confirmed whether the full-depth repair in Section 2 was due to severe spalling or punchout distress, and if one or both was the reason. The field condition survey revealed that the overall condition of all the sections is in the process of spalling distress. In other words, it can be concluded that, irrespective of batching sequence, mixture design, and curing method, this test section exhibited severe spalling distresses as well as a high risk of partial-depth delamination, and this appears to be closely related to the coarse aggregate used, SRG. Based on the findings to date, mixture design (fly ash replacement), curing method, and batching sequence do not seem to have significant effects on the spalling prevention in CRCP. To examine the effects of the variables on the spalling and delamination distresses more clearly, this section needs to be continually monitored on a regular basis.

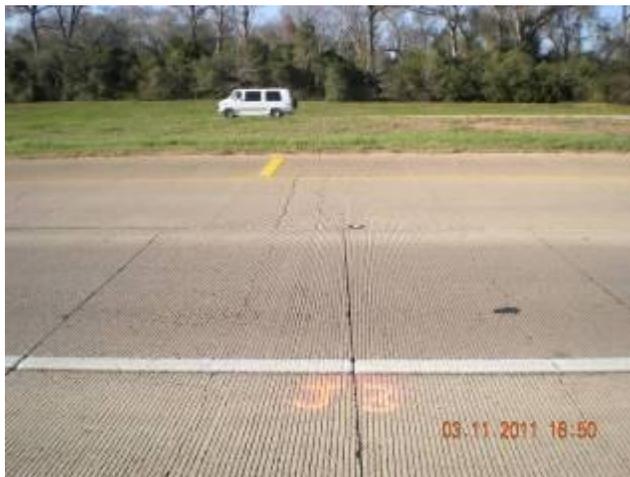
(a) Close-Up View

The first half (500 ft) of US290SPS-1E section introduced saw cuts with an almost consistent spacing (6 ft) at the initial construction stage, while the rest of the section did not. Figure 4.47 (a) indicates the existence of transverse saw cuts in this test section. The transverse joint or crack spacing information (see Figure 4.47 (b)) shows that majority of joint or crack spacing fell between 1 and 4 ft. Also, the calculated average joint or crack spacing was 2.44 ft, which implies that, on average, each slab segment had at least one transverse crack around the mid-slab. In this saw cut section, no punchout distress was found. However, there was some indication of spalling distress, either at the saw cut joint or natural transverse cracks. In the mid of 2000s, 10 years after construction, there was no visible spalling distress at the saw cut joint. Since then, spalling and joint failure started to be visible. It appears that these spalling and joint failures evolved from the micro-damage cumulated when the saw cut was introduced, and it worsened as the pavement exposed to successive climate changes and traffic loads.

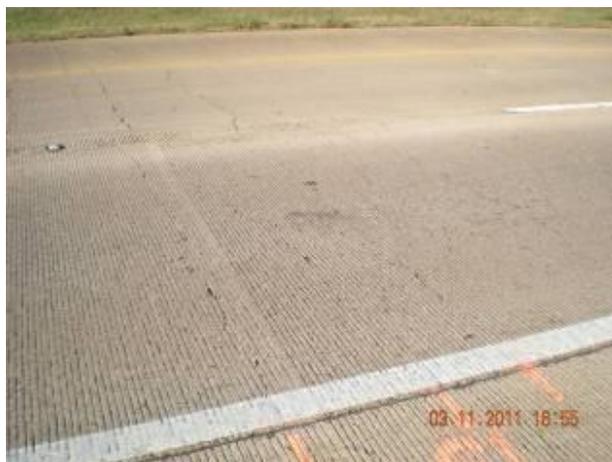
(a) Close-up View

The general condition and crack spacing distributions for US290SPS-1E regular (uncut) section are presented in Figure 4.48. The crack spacing information shows that about 62 percent of transverse crack spacing fell between 1 and 3 ft, which is quite short, but there was no punchout distress found in this section. When it comes to spalling, there was no severe and deep spalling recorded. However, almost every transverse crack started to show clear indication of early-age spalls that can develop into severe spalling distress. It seems that these spalling distresses are due to the use of SRG which has a smoother surface texture and high CoTE, as previously described.

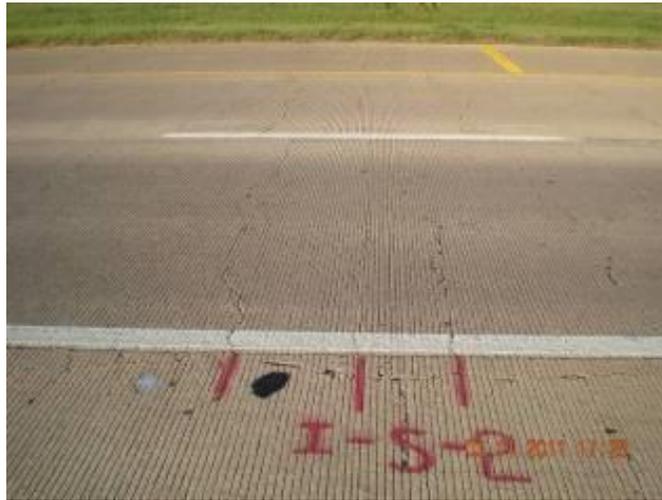
Figure 4.50 Close-up View of US 290-2E Section

The US290-2E section also used SRG as coarse aggregates, and showed a high risk of severe spalling distress. Moreover, there were many longitudinal cracks especially almost parallel with the longitudinal saw cut joint as shown in Figure 4.50. This is most likely because the longitudinal saw cut was introduced too late with an inappropriate depth. There were several longitudinal cracks in the main lanes as well. However, the US290-2E section did not reveal any punchout distress while transverse crack spacing was quite narrow and carrying a significant portion of heavy trucks as well.

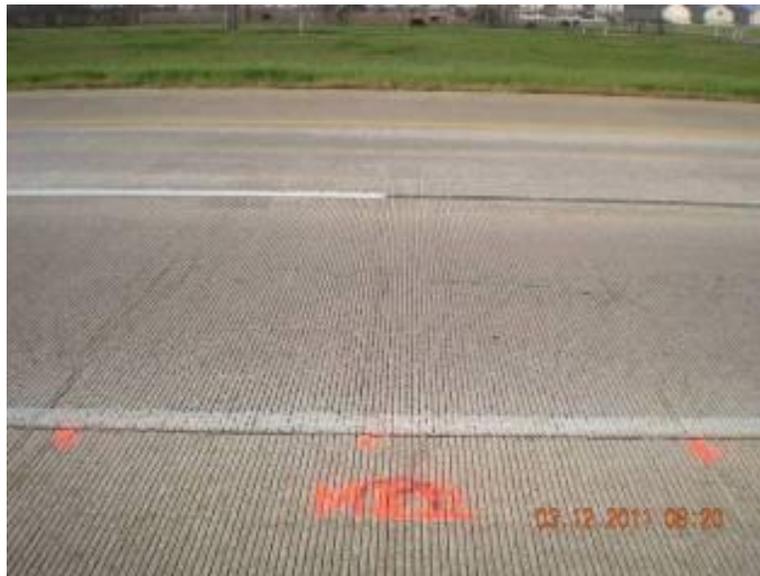
Figure 4.52 Close-up View of US 290-3W Section

As for the pavement distress, this section showed much better performance compared to US290SPS-1E and US290-2E, as can be seen in Figure 4.52. This is because this section used LS, which has a lower CoTE, modulus of elasticity and strong bond characteristic between coarse aggregate and cement paste, which resulted in better integrity of the material. Also, different from the previous section, this section did not show any indication of spalling distress and almost every crack was kept quite tight. No punchout distress was found in this test section. As of February 2013, there were twenty Y-cracks in this section.

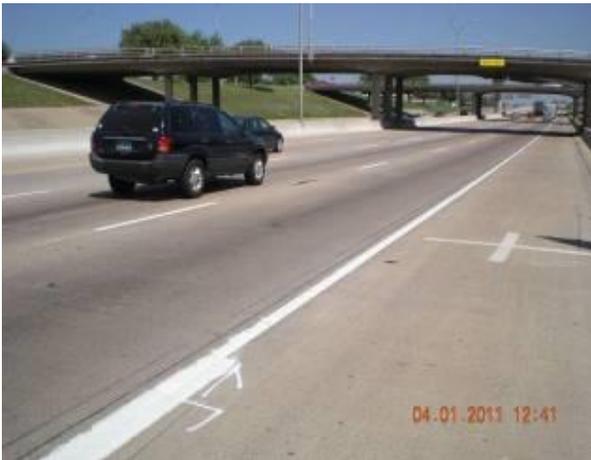
Figure 4.54 Overview of Waco IH 35 Section

This section was built on IH 35 northbound in the Waco District near exit post 333B. The section used LS as coarse aggregates and the section length is 1,000 ft across a transverse construction joint. The GPS coordinate is 31.522439,-97.134853. Figures 4.53, 4.54, and 4.55 present the detailed location information, overview, and close-up view of the I-35 Waco test section, respectively. The test section was at the outermost lane. The measurement items for field evaluations were transverse crack spacing, deflection, and performance in terms of punchout and spalling distresses.

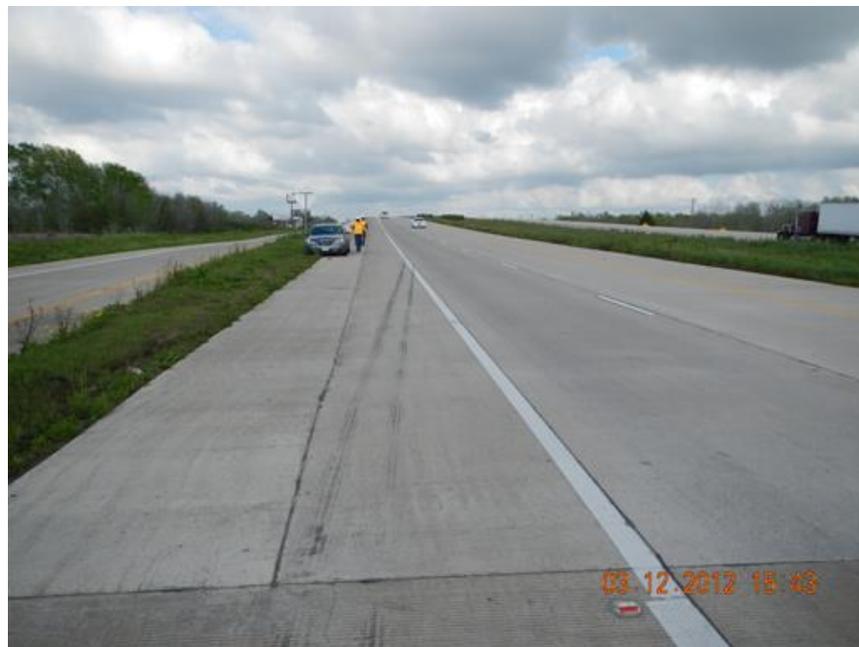
Figure 4.58 General Condition of Kendleton US 59S Section

This experimental section is located in the outermost lane on US 59 south bound in the Houston District near Kendleton. The GPS coordinate for this section is 29.446241, -96.000091. It is 15 in.-thick CRCP with SRG coarse aggregates and was constructed in 2007. Figures 4.57 and 4.58 show the location and the general condition of the section, respectively. The field surveyed section extends 1,210 ft from the wide flange in the south.

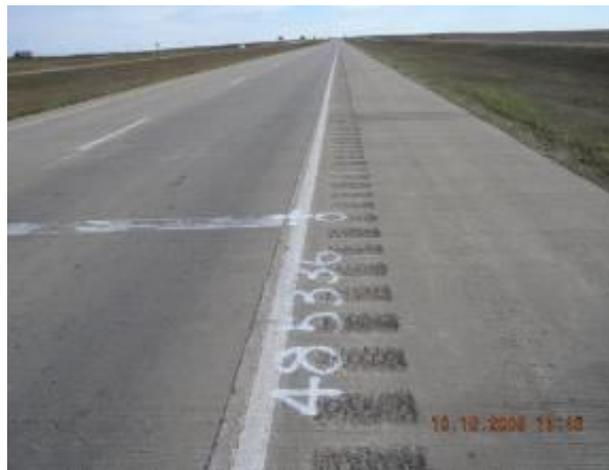
Figure 4.60 LTPP-485336 Section on IH 27 in the Amarillo District

Field evaluations revealed no structural and functional distresses existed in LTPP-485336 section (see Figure 4.60). On the other hand, two sections—LTPP-485323 in the Amarillo District and LTPP-485141 in the Yoakum District—were overlaid with asphalt concrete as indicated in Figures 4.61 and 4.62, respectively, and thus the condition of the concrete layer itself cannot be monitored. Figure 4.63 shows the overview of LTPP-483569, wherein one full-depth repair was recorded.

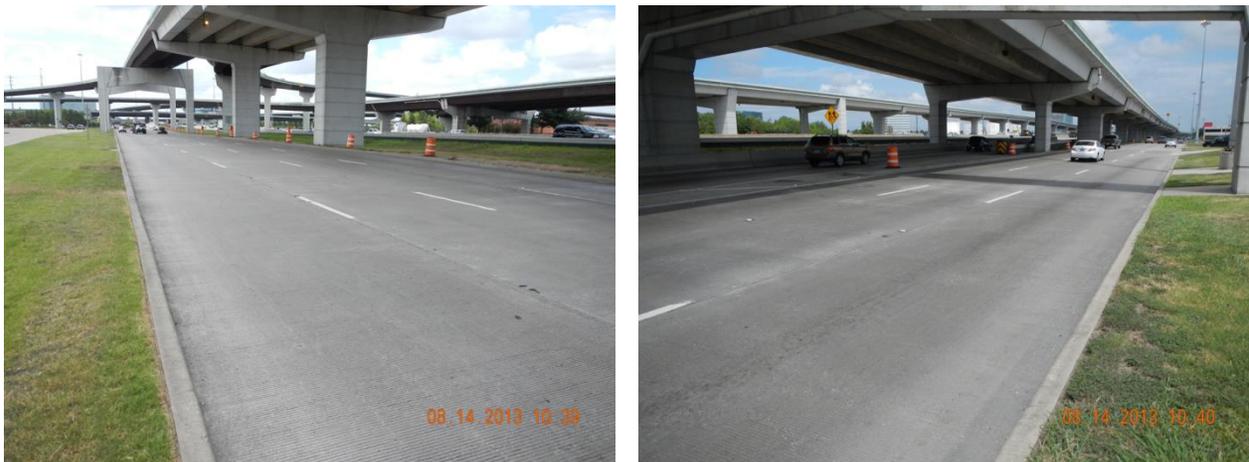
**Figure 5.2 FT-CRCP Section on IH 45 Frontage Road
(GPS Coordinate: 29.943761,-95.414565)**

- IH 45 frontage road was built in 1993, which makes this section almost 20 years old. The section is in a good condition, except for tight longitudinal cracks, as shown in Figure 5.2.

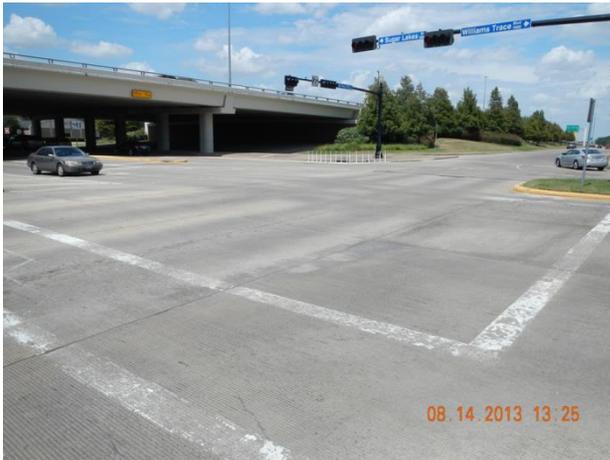
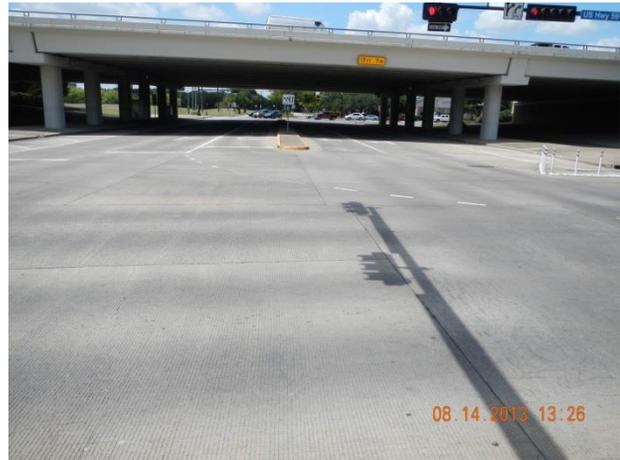
Figure 5.3 FT-CRCP Section on IH 6 at US 59 (GPS Coordinate: 29.598354,-95.621965)

- Spur 2691 section was built from 1986 to 1989. Even though it is in the heavy Metro bus route, the performance has been good.
- The SH 6 under US59 South section is unique in that siliceous river gravel was used as coarse aggregate. Also, the concrete was cured for 24-hours with wet-mat curing. This section was built in 2001. The section is now 11 years old and in excellent condition, as shown in Figure 5.3. A possible reason for the excellent performance could be to the low temperature variations of the section under the bridge.

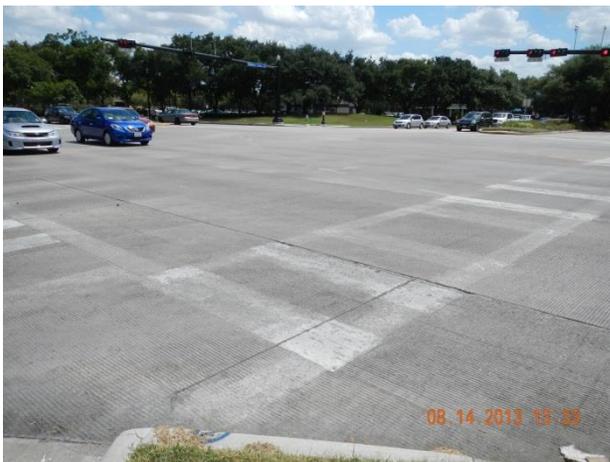
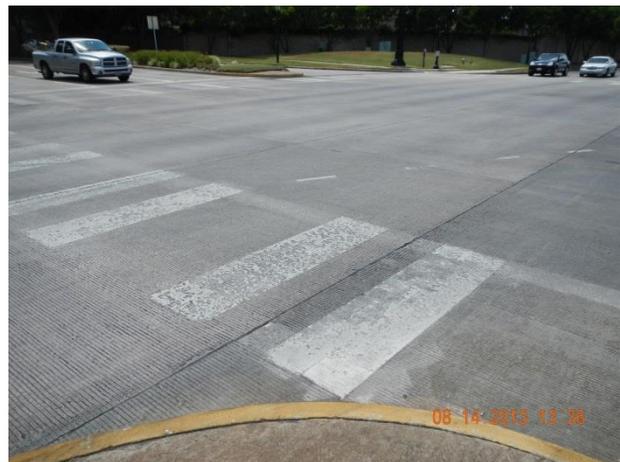
**Figure 5.4 FT-CRCP Section on William Trace at SH 6
(GPS Coordinate: 29.59215,-95.604903)**

- Williams Trace at SH 6 section was built in 1993 with limestone aggregate. It is almost 20 years old and in an excellent condition as seen in Figure 5.4.

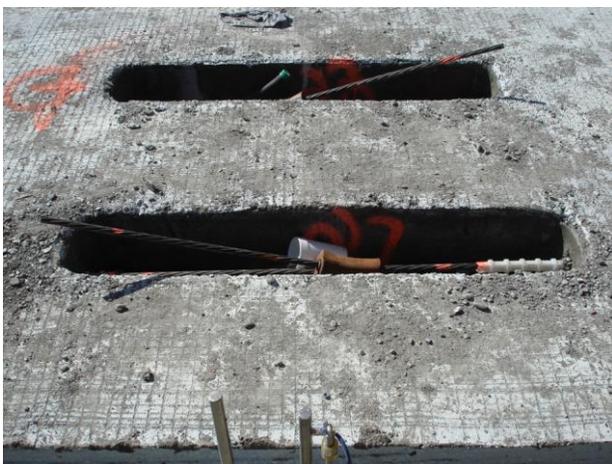
Figure 5.8 Post-Tension (longitudinal)

Encouraged by the satisfactory performance of the test pavement, TxDOT built a section of over seven miles on IH 35 near Hillsboro, about 30 miles north of Waco. The GPS coordinate of this section is 32.007939,-97.095398. In the Hillsboro PTCP project, concrete was placed between transverse armor joints 300 ft apart. Subsequently, post-tensioning was introduced through the central stressing pockets two separate times in the longitudinal direction at the ages of 0.56 and 3.06 days, respectively (see Figure 5.8). In addition, transverse post-tensioning was introduced at 7.10 days after concrete placement as shown in Figure 5.9.
