Project Level Performance Database for Rigid Pavements in Texas, II

Pangil Choi, Sungwoo Ryu, Wujun Zhou, Sureel Saraf,
Jungheum Yeon, Soojun Ha, Moon Won

Research Project #: 0-6274
Research Report #: 0-6274-2
www.techmrt.ttu.edu/reports.php

October 2014

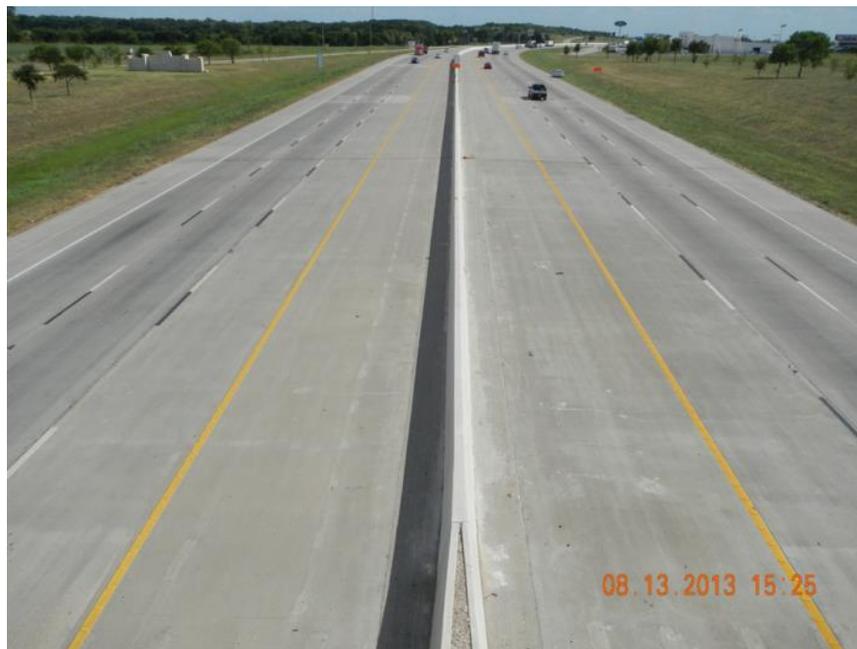
Figure 5.10 PTCP Section Built in 2008 in Hillsboro

Falling weight deflection (FWD) testing was conducted in the section, and the average deflection was a little larger than that of 9-in CRCP. A 14-in CRCP section was built next to 9-in PTCP, with the objective being to compare life-cycle costs (LCC) of both pavements. LCC comparisons will require the performance evaluations for at least 20 to 30 years. The task in this study is to evaluate performance in terms of visual observations. So far, no structural and/or functional distresses have been observed in the 9-in PTCP section, performing in an exceptional condition even with a high level of heavy truck traffic. Figure 5.10 shows the overview of PTCP in Hillsboro.

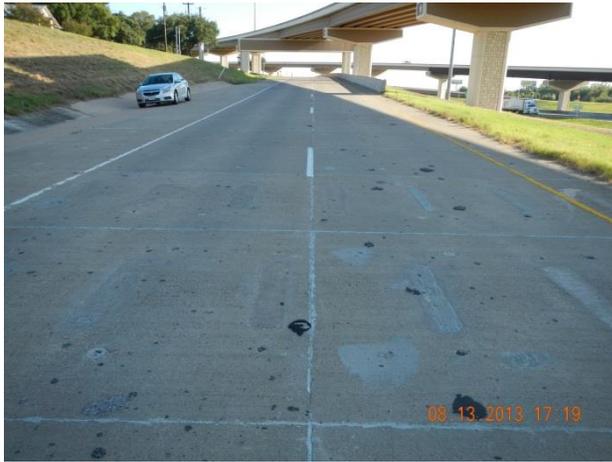
a. Overview

Figure 5.12 (a) shows the condition of the southern part of the PCP section in Georgetown. As can be seen Figure 5.12 (b), there were some joint failures and faulting across the slabs. These distresses do not seem to be related to traffic because this section has been a part of service road, carrying a quite light traffic to date. Rather, it probably appears that the existence of voids underneath the slabs might play a role in this deteriorative behavior. Figure 5.13 (a) and (b) present the condition of the northern part of the PCP section in Georgetown, showing the existence of longitudinal cracks in the slabs. Since there is no longitudinal joint to release warping and curling stress, longitudinal cracks seem to occur. Figure 5.14 shows the asphalt concrete patch at joint.

Although the level of traffic has been quite low in this test section, distresses have started to appear. Even though these distresses may be regarded as minor distresses, they are not good sign for pavement performance. Hence, the performance of this section needs to be continually monitored for better understanding of PCP's long-term behavior.

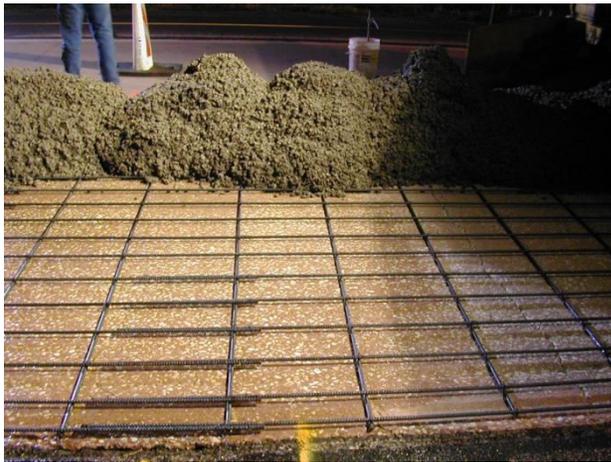
Figure 5.15 4-in BCO construction

Four inches BCO was placed in 2002 on US 281 just south of the city of Wichita Falls. Figure 5.15 shows that longitudinal steel was placed on top of transverse steel, which is sitting directly on top of existing concrete slab. Figure 5.16 depicts the overall condition after 11 years of construction. Overall, the performance has been quite excellent.

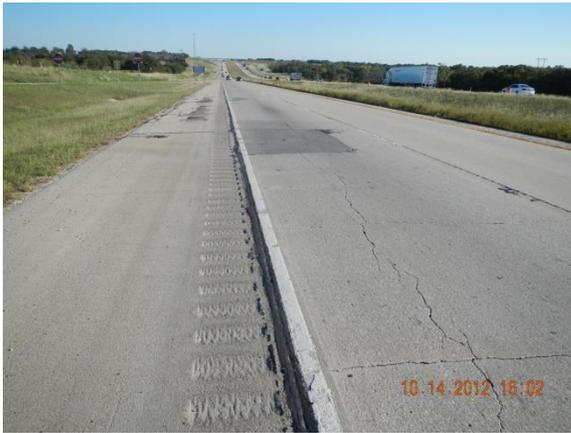
a. Pavement condition before BCO

US 287 was originally built in 1972 with 8-in slab thickness in the Wichita Falls District. The shoulder type was constructed with asphalt shoulder so that most of the distresses were observed at the outside lane, as shown in Figure 5.17 (a). Figure 5.17 (b) shows the FWD testing picture and the test was conducted at every 40 ft. FWD test results were illustrated in Figure 5.17 (c) and significant deflection variations were observed in 1,000 ft long test section, as marked with red chain lines. The deflections were estimated larger than 20 mils at the 650 ft location in the FWD test section, and a DCP test was conducted at the same point with high deflection area. Test results showed that the modulus of base is also low as shown in Figure 5.17 (d).

Figure 5.20 (a) and (b) show the pictures taken August 13th, 2013, which is nine months after BCO construction. The distresses have been already observed at the beginning of BCO location and outside lane. As can be seen in Figure 5.20 (b), longitudinal crack and distress were observed at the outside lane. Since the base support condition was not good, the existing distresses seem to be reflected under repetitive truck traffic similar to Figure 5.17 (a). This means that BCO design should include criteria for base support condition.

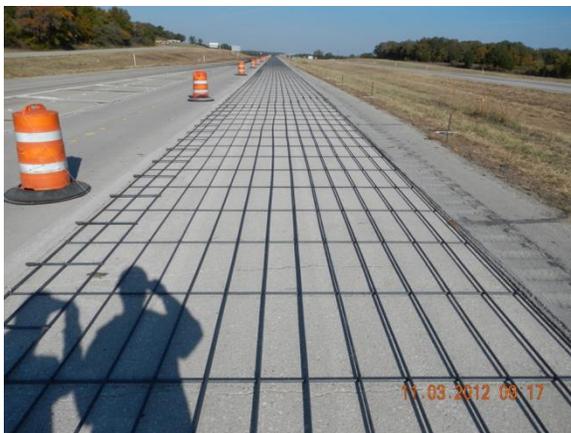
a. Steel placement

As shown in Figure 5.18 (a), longitudinal steel was placed on top of transverse steel as it was in the US 281 section, and tie bars were placed on top of longitudinal steel at 4 ft spacing. BCO was constructed in 2012 as shown in Figure 5.18 (b).

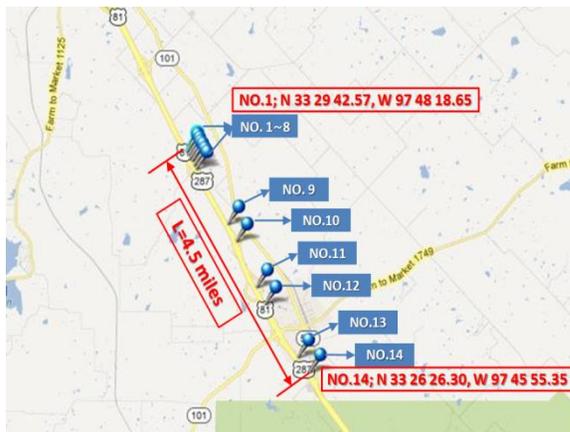
a. Bond strength test locations

The bond strength was evaluated between existing concrete and overlaid concrete throughout the BCO section (4.5 miles). Figure 5.19 (a) and (b) shows the test locations and testing pictures for the bond strength test, respectively. Figure 5.19 (c) illustrates the bond strength test result. Among 14 test locations, two locations were failed during coring and one location was broken in interface during the bond strength test, which is test No.1 at the beginning location of BCO. The result shows that old CRCP and new BCO were bonded well except in test No.1.

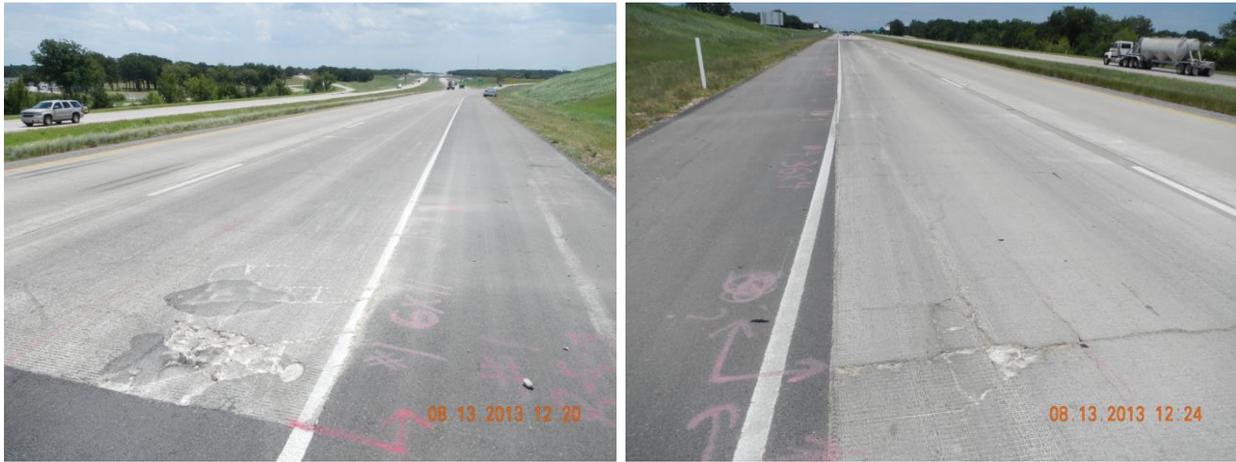
Figure 5.20 Distresses in BCO

a. Beginning of BCO

b. Edge distress and longitudinal crack

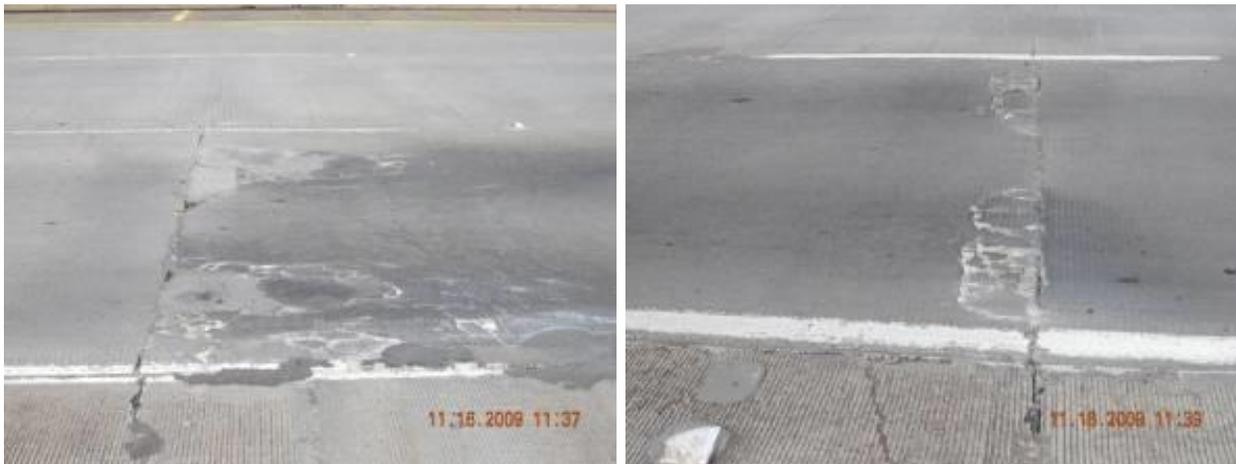
Figure 5.21 Distress in 2-in BCO on SH 146

Two-in BCO was placed in the late 2000s and the performance has been quite poor. Eventually, the section was overlaid with asphalt. Figure 5.21 shows typical distresses observed. Because it was 2-in BCO, no longitudinal reinforcement was used. As will be discussed later, BCOs without longitudinal reinforcement with steel bar show quite poor performance, and their use should be discouraged.

Field evaluations of CRCP BCO performance indicate a large difference in the performance between 2-in and 4-in BCOs. It appears that the primary difference is whether longitudinal reinforcement was used. For 2-in BCO, longitudinal reinforcement is not used, and concrete volume changes in the new concrete due to temperature and moisture variations are not fully restrained, causing debonding between old and new concrete. On the other hand, if the BCO thickness is equal to or greater than four inches, longitudinal steel is used, which restrains concrete volume changes and ensures good bond. It is strongly recommended that TxDOT always use longitudinal reinforcement regardless of BCO slab thickness.

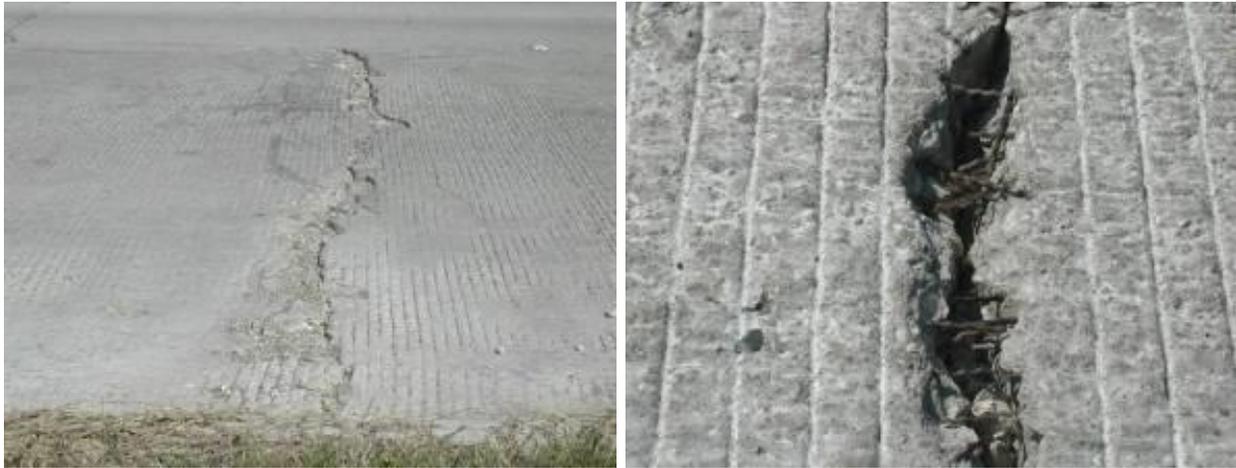
Figure 5.22 Distress in 2-in BCO on SH 146

Two inches BCO was placed on Loop 610 S, and the performance has been poor, as can be seen in Figures 5.22 (a) and (b). Longitudinal steel was not used; instead, steel fiber was used. Figure 5.22 (b) shows that steel fiber is not effective in preventing chipping of concrete.

a. BCO distress on SH 146

b. Close-up view

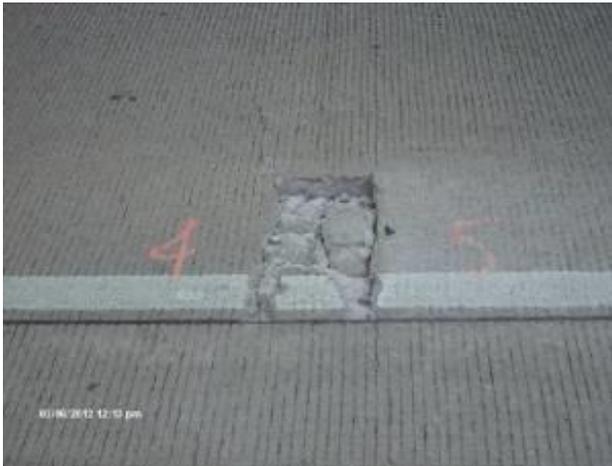
Figure 5.23 Distress in BCO

Seven inches CRCP BCO was placed on US 75 in Sherman in 2010. The existing pavement is 10-in CPCD with 15-ft joint spacing, which was built in 1984. The performance of CPCD was quite poor, requiring an average of between 0.5 and 1.0 million dollars every year. The 7-in CRCP BCO performance has been satisfactory, even though there were distresses at five locations, as shown in Figure 5.23. Repair had to be performed in 2012. Figure 5.24 shows the concrete after the loose particles were removed. The distresses were directly over the existing transverse contraction joints. Non-woven fabric was placed to retard any reflection cracking, and it appears that the fabric increased deflections and caused deteriorations of concrete in the overlay. There were control section where fabric was not placed, and no distresses occurred at the section. Based on the performance so far, the fabric should not be placed at transverse contraction joints.

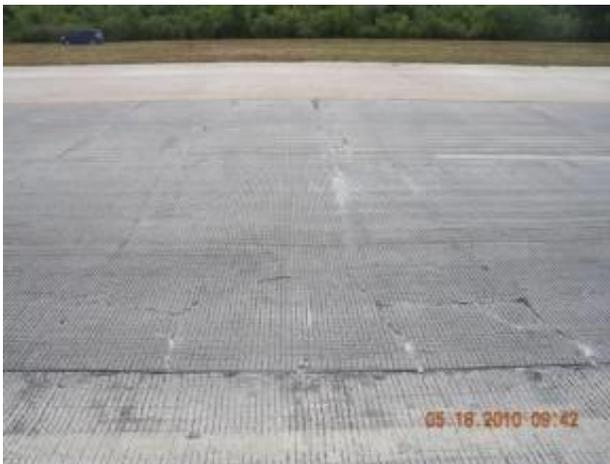
Figure 5.25 Delaminations in BCO

Two inches BCO in the southbound lanes in SH 288 south of Beltway 8 in the Houston District experienced distresses as shown in Figures 5.25 and 5.26. In this section, longitudinal steel was not used. Figure 5.25 shows that severe delaminations occurred. As discussed earlier, longitudinal reinforcement should be used in BCOs.

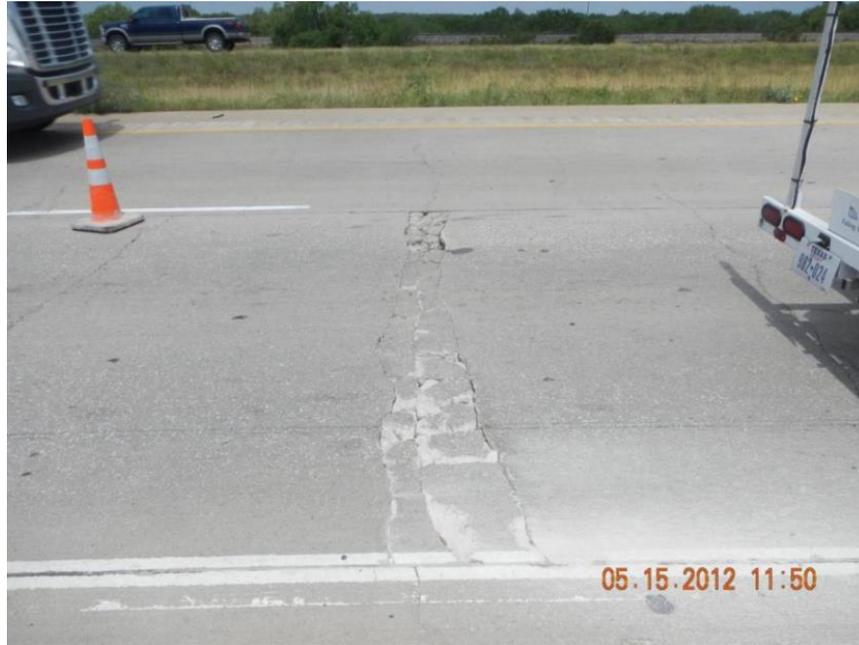
Figure 5.27 Distresses in BCO

When the section was constructed, concrete material qualities including curing process were controlled very tightly and limestone aggregate was used as well to prevent premature distresses and spalling. However, the distresses were observed as shown in Figure 5.27. Test section was selected as shown in Figure 5.28 (a). The crack on the left is a natural CRCP crack due to environmental loading, while the crack on the right is due to horizontal cracking. Hence, the test location was selected and MIRA test was conducted to evaluate the distress mechanisms. Figure 5.28 (b) shows the MIRA analysis and image, illustrating the existence of horizontal cracking.

The red color illustrates delamination in the concrete. To confirm MIRA analysis results, coring was made and horizontal cracking was observed, as shown inside picture of Figure 5.28 (a). This indicates that most of distresses are shallow punchout due to horizontal cracking.

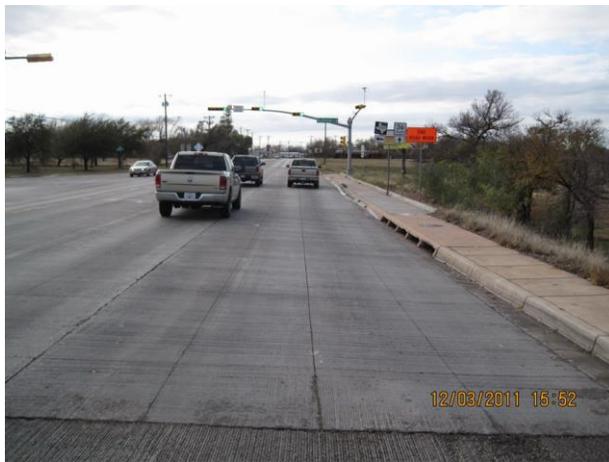
Figure 5.30 Whitetopping in Abilene (SH 36 at FM 1750)

As Figure 5.30 shows, the Abilene whitetopping section on SH 36 at FM 1750 (GPS coordinate: N 32°26'11.38", W99°42'45.53") performed relatively well, even though some diagonal cracks were observed across the joints, as shown in Figure 5.31. The poor support condition might contribute to this failure mode in the concrete layer. Moreover, at some locations, a wide joint opening was discovered as the slab segments moved away from each other due to sliding—the bond between the existing asphalt and concrete appears to be broken. However, the extent of the sliding was not as severe as the ones in Odessa and Midland, as will be presented later. The other whitetopping section on SH 226 at SH 279 (GPS coordinate: N 32.106715, W 99.168434) also performed fairly well as shown in Figure 5.32, although there were a number of cracks along the joints as shown in Figure 5.33. These joint failures seem to be associated with inappropriate saw cut installation related to time or depth, rather than traffic, because this section has been under a low level of traffic. Figure 5.34 shows that some of the saw cut joints did not pop, which indicates that a 4 ft by 4 ft spacing of saw cut would not function as suitable design spacing.

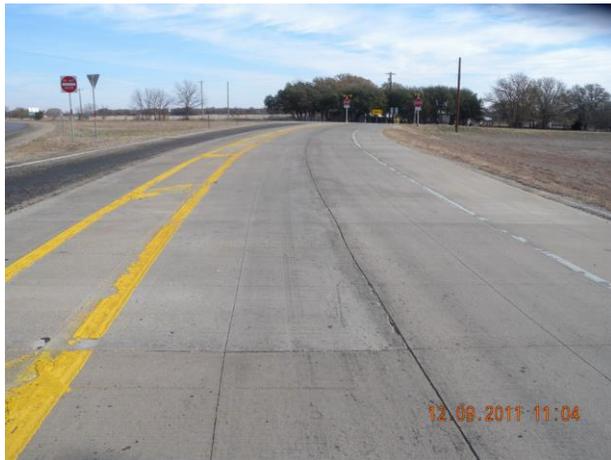
Figure 5.32 Whitetopping in Abilene (SH 226 at SH 279)

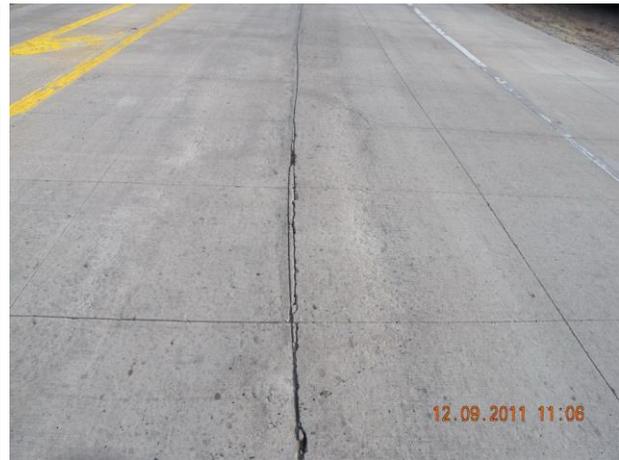
Figure 5.33 Cracking along the Joints in Abilene Whitetopping Section (SH 226 at SH 279)

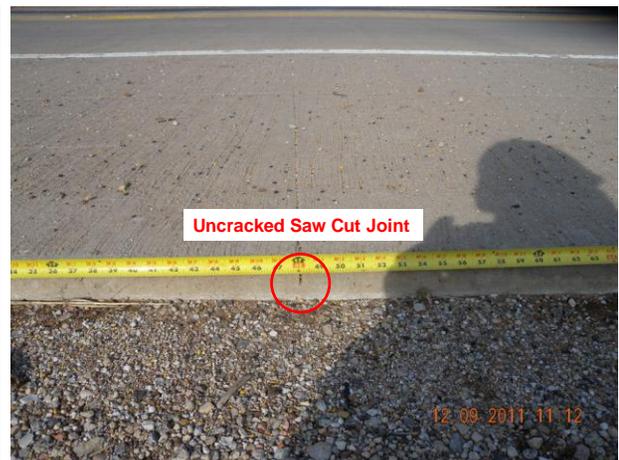
Figure 5.34 Cracked and Uncracked Saw Cut Joints in Abilene Whitetopping Section (SH 226 at SH 279)

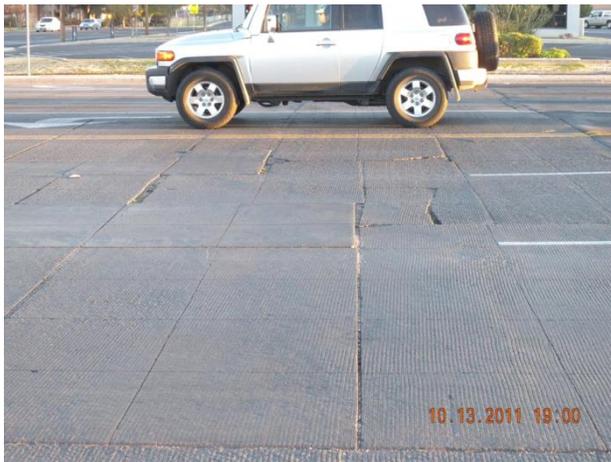
Figure 5.35 Whitetopping in Odessa

Three-in thick and 3-ft by 3-ft square whitetopping slabs in Midland and Odessa revealed substantial distresses. The sections in Midland and Odessa were built in 2002. Figures 5.35 and 5.36 show the whitetopping sections in Odessa and Midland respectively. The primary cause for the distresses was sliding of the concrete slabs. Again, it appears that the bond between asphalt

and concrete was broken. The current whitetopping design assumes full bond between concrete and asphalt. The design algorithm needs to be revised.

Based on the field performance evaluations in the Abilene and the Odessa Districts, it appears that slab sizes of 3 ft by 3 ft and 4 ft by 4 ft do not function effectively for whitetopping as the sections underwent severe sliding and cracking problems. Rather, the lessons from the Paris District indicate that the use of 6 ft by 6 ft slabs may be beneficial for better-performing whitetopping. However, the performance needs to be monitored for the long term evaluation because the sections in the Paris District were built within the last two years.

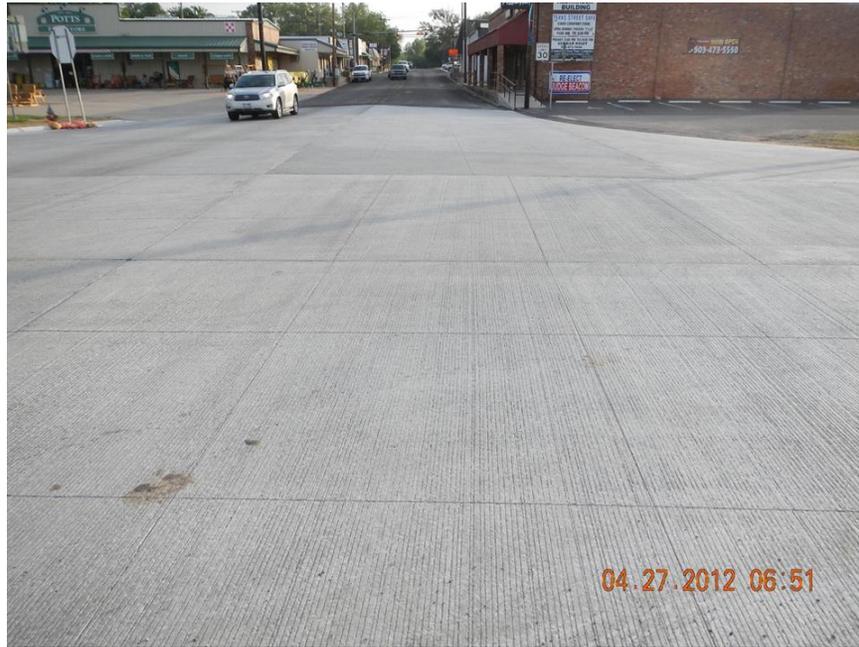
Figure 5.37 Whitetopping in Emory

The other section in Emory is located at the intersection between US 69 and SH 19. Saw cuts were also made at every 6 ft by 6 ft spacing. This section was built in April, 2012. Various gages were installed to monitor the structural response of whitetopping. Figure 5.37 presents the whitetopping section after concrete placement in Emory.

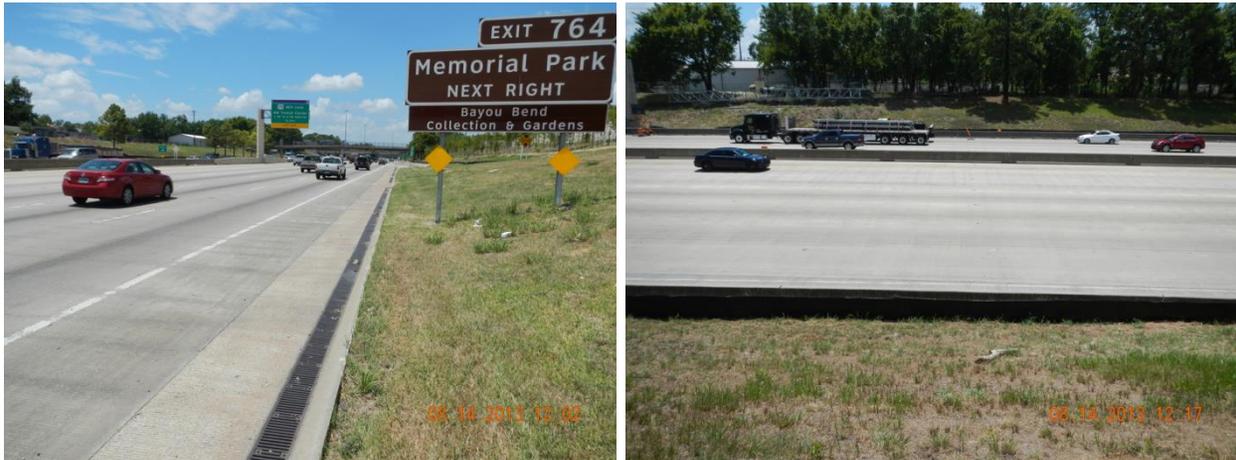
Figure 5.39 Overview of Houston RCA Section

In this project, no virgin aggregates were used. In place of them, crushed concrete was used as both coarse and fine aggregates for concrete. The original aggregate for the recycled concrete was SRG, which is considered to be highly spalling-susceptible. However, as seen in Figure 5.39, overall performance of this section has been satisfactory, with relatively tight crack widths, minor spalling, and no punchout even after 18 years of service with heavy truck traffic. This is surprising since, in most of the cases, spalling distress has been prevalent when SRG was selected for concrete pavings. This favorable performance is most likely because crushed recycled concrete has a rougher and more angular surface texture than virgin SRG, providing good bond between old and new phases. This good bond characteristic could be quite beneficial in increasing spalling resistance. Also, the concrete pieces survived during crushing operations would have a remarkably strong bond between aggregate and paste, performing exceptionally when used as aggregates for concrete.

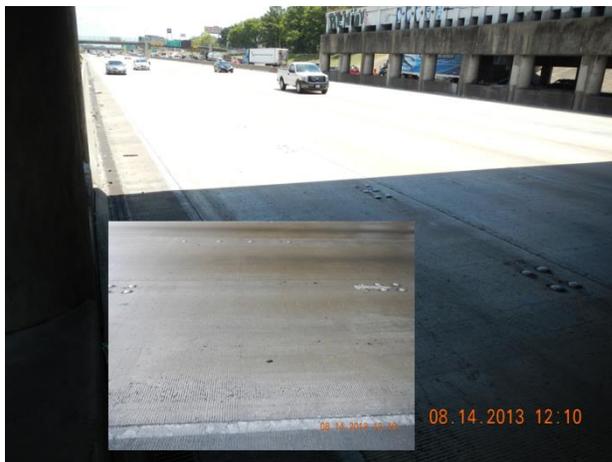
Figure 5.40 Condition of Shaded Section

Another interesting finding is that there was a significant difference in a surface condition between the sections in shaded (under the bridge) and unshaded areas. As seen in Figures 5.40 and 41, the shaded section exhibited a sound performance, while the unshaded one had a lot of cracks in various directions. The probable cause would be that the concrete in the unshaded area has been exposed to much larger temperature fluctuations than the one in the shaded area, and thus experience higher stress variations. In addition, a curing temperature difference between the sections might cause the performance discrepancy because concrete cured at elevated temperature tends to form more unstable matrices, which leads to lower later-age strength. This comparative case again provides important insights about a proper curing operation to ensure better-performing concrete pavements.

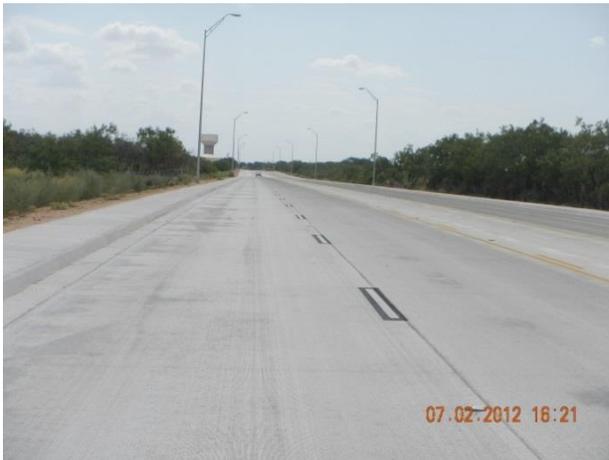
a. Overview of RCC pavement in San Angelo

Roller compacted concrete (RCC) is a new type of concrete material, with lower water-cement ratio than normal concrete. A section of RCC pavement was built in San Angelo in October, 2011 on Grape Creek Road and in April, 2012 on 50th street. Both pavement structures consist of 6-in RCC on 8-in lime and cement treated subgrade. Figure 5.42 (a) shows the overview of RCC pavement on Grape Creek Road. Since RCC is quite dry mix concrete, adequate level of compaction is needed to obtain surface condition for highways. If the compaction is not adequate, the surface condition shown in Figure 5.42 (b) will result. In this project, dowels were not used for obvious reasons of dry mix. It is not known whether this type of pavement would be applicable to roadways with a high speed. Long-term evaluation is needed before its viability for TxDOT is determined.

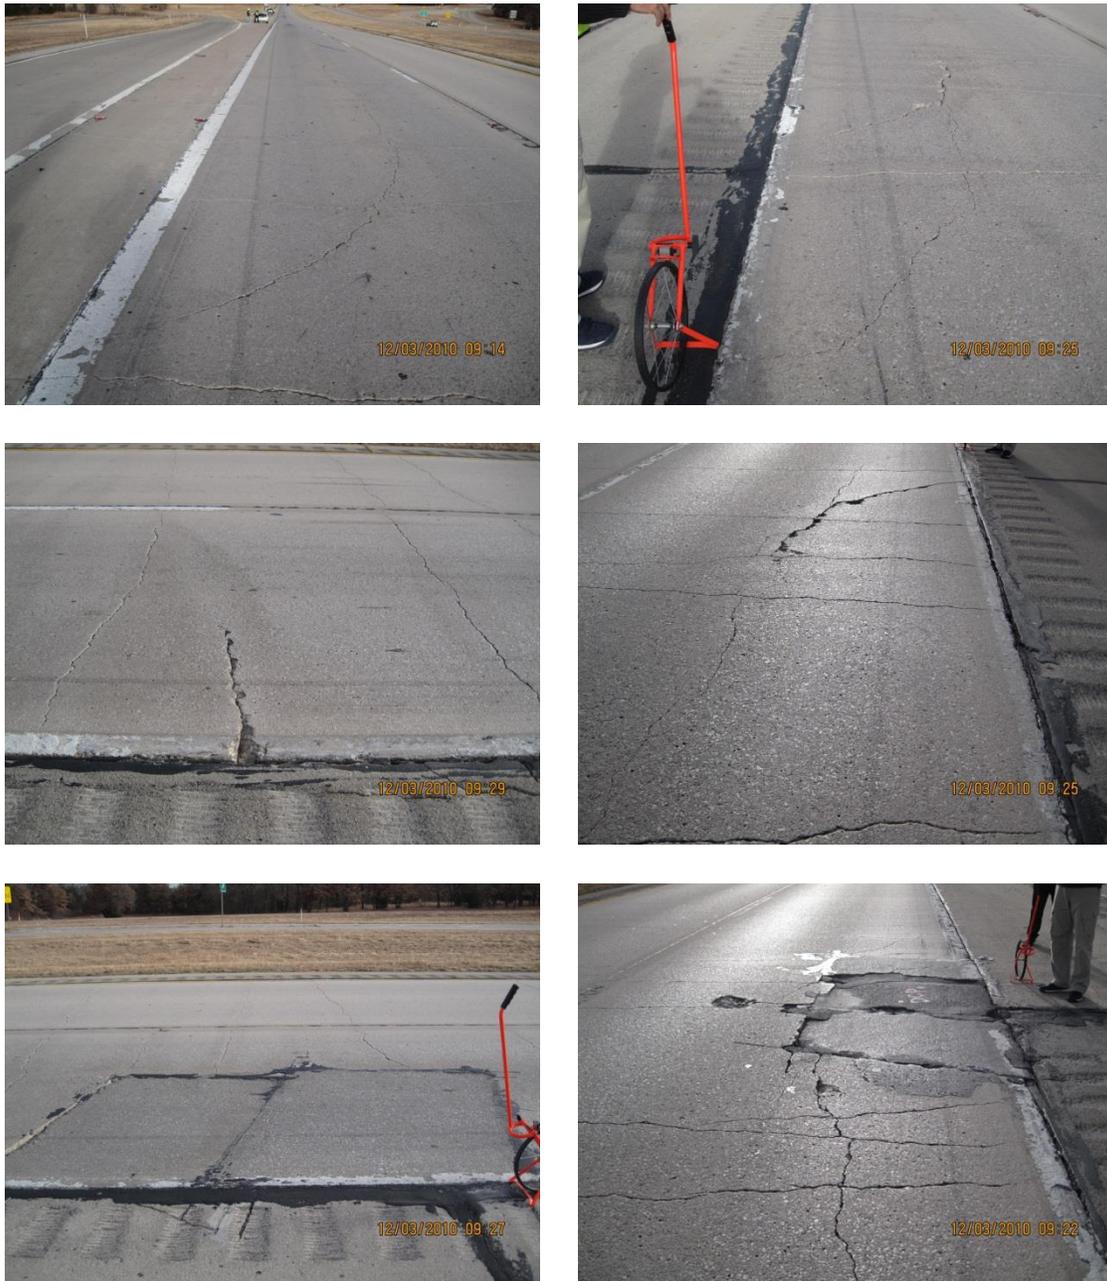
Figure D.1 US 287 Pavement Evaluation in the Wichita Falls District – Pavement Condition (12/03/2010)

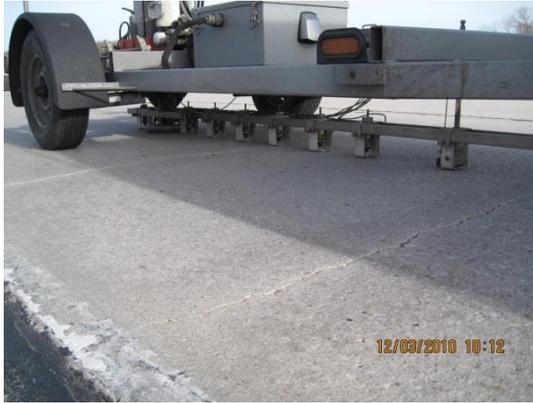
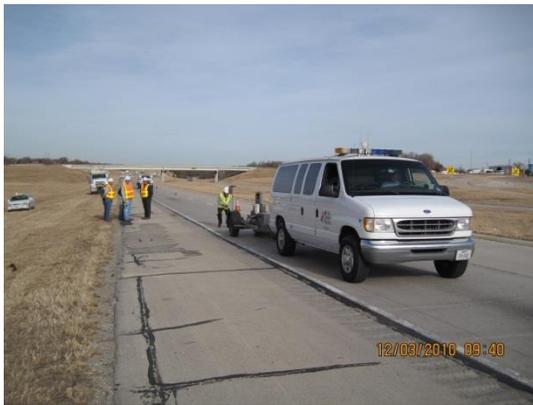
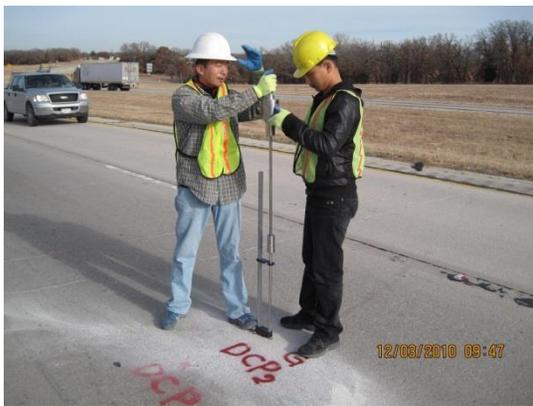
Figure D.2 US 287 Pavement Evaluation in the Wichita Falls District – Field Tests (12/03/2010)

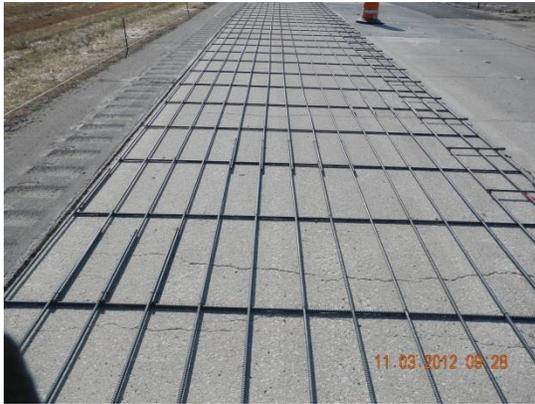
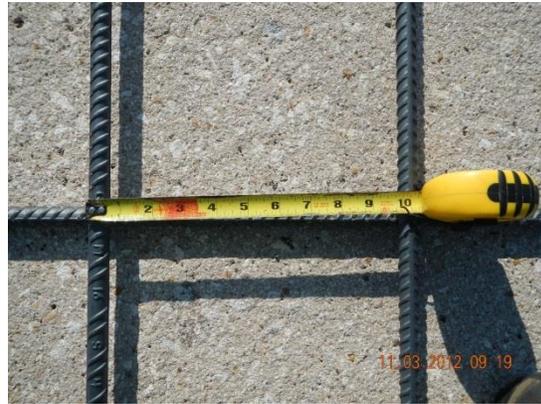
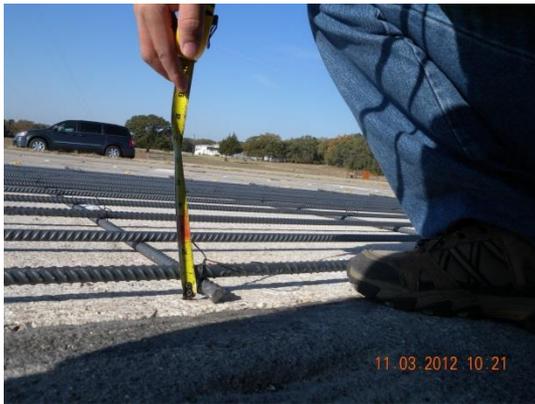
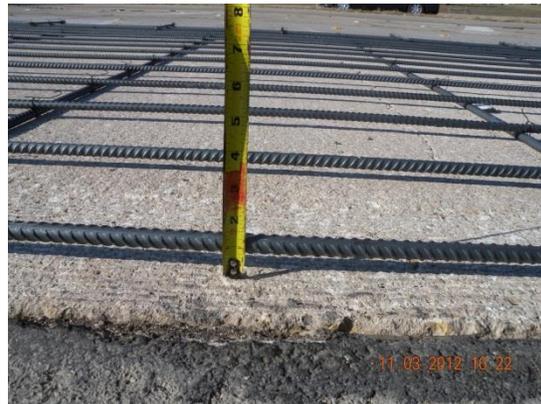
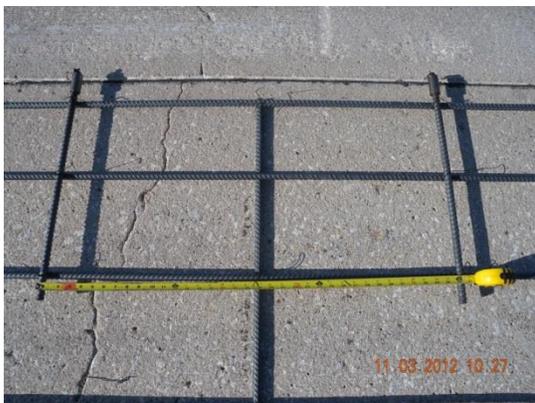
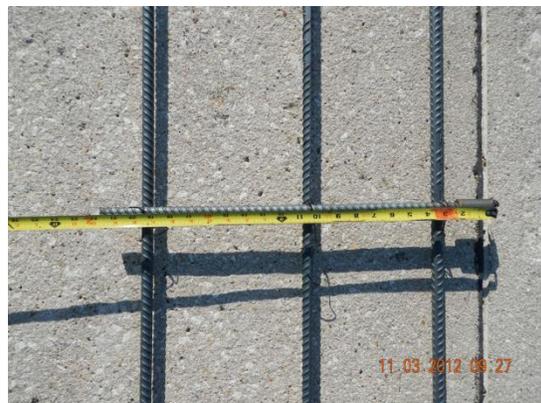
Figure D.3 US 287 Pavement Evaluation in the Wichita Falls District – Steel Placement (11/03/2012)

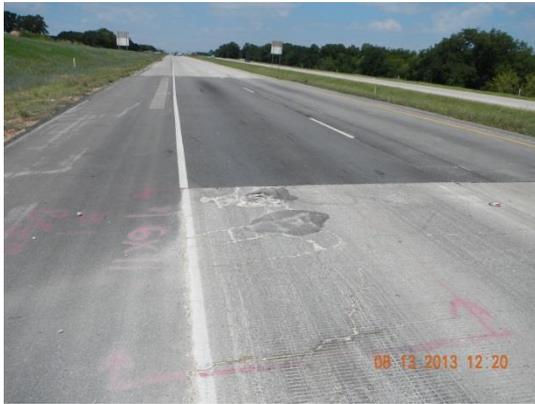
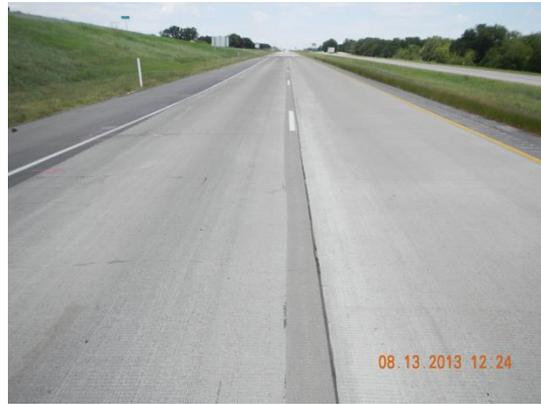
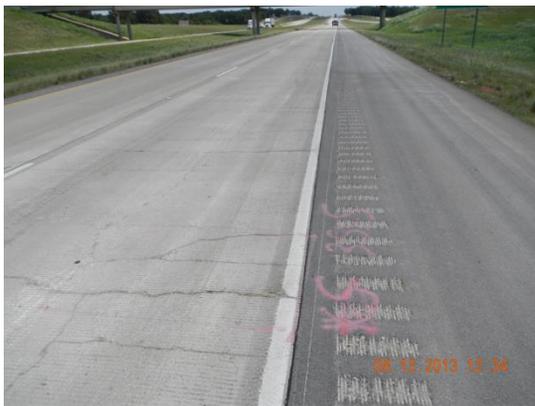
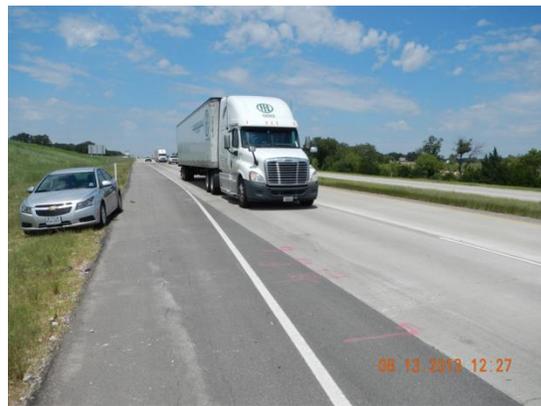
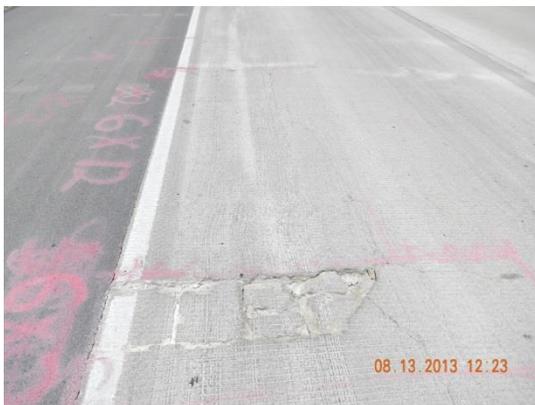
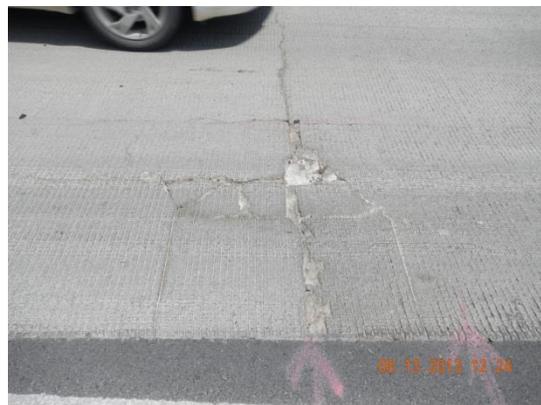
Figure D.5 US 287 Pavement Evaluation in the Wichita Falls District – 9 Months after BCO (08/13/2013)
