Optimizing Concrete Pavement Type Selection Based on Aggregate Availability

Texas Department of Transportation

Research Project #: 0-6681
Research Report #: 0-6681-1
www.techmrt.ttu.edu/reports.php

September 2013

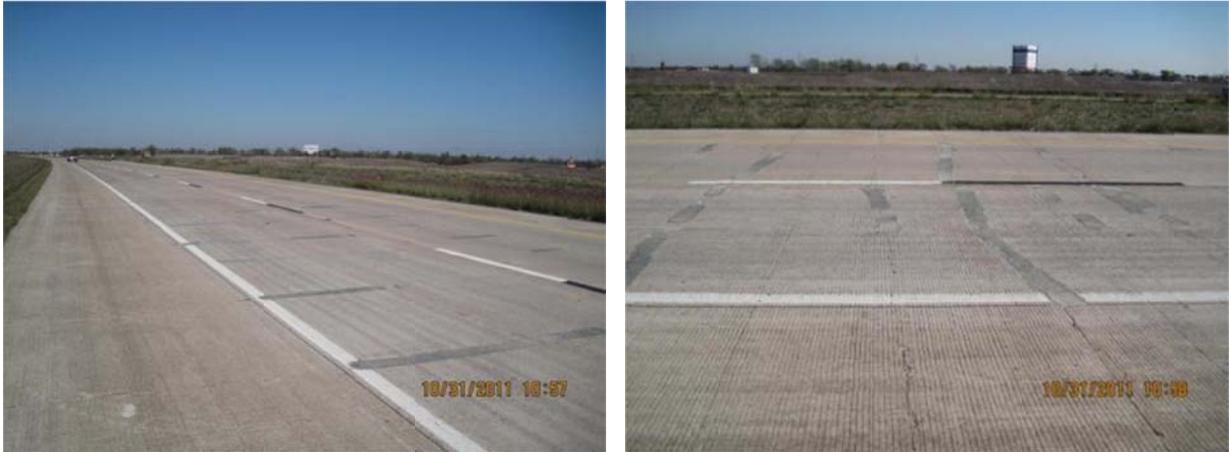
Figure 2.1 Houston, SH 99

Figures 2.1 and 2.2 show the pavement condition of SH 99 and US 59 in Fort Bend County, Houston District. Spalling repairs were observed at almost every crack on SH 99. Figure 2.2 shows concrete patches.

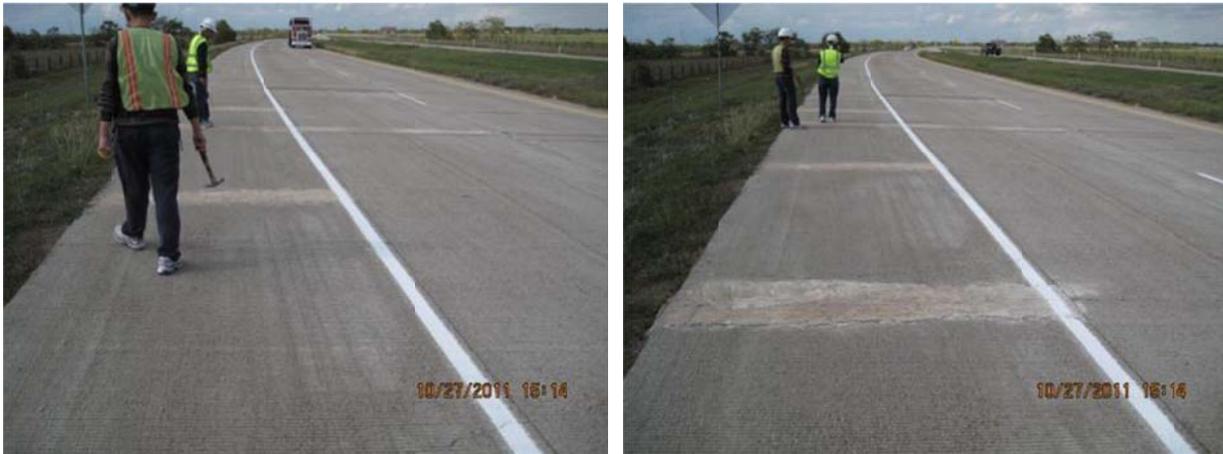
Figure 2.3 Houston, FM 523

Figure 2.3 shows the pavement condition of FM 523 in Brazoria County, Houston District. It is interesting to observe a large number of spalling repairs done on the outside shoulder. Table 2.3 shows the distress and cumulative traffic information on FM 523 from the 2010 PMIS. Cumulative traffic is at a low level; however, a large number of patches were observed in October, 2011, more than the numbers recorded in the 2010 PMIS. It appears that most of the patches were made after the 2010 PMIS survey. To address deteriorated ride quality due to severe spalling and repairs, the Houston District plans to place hot mix asphalt overlay on this section.

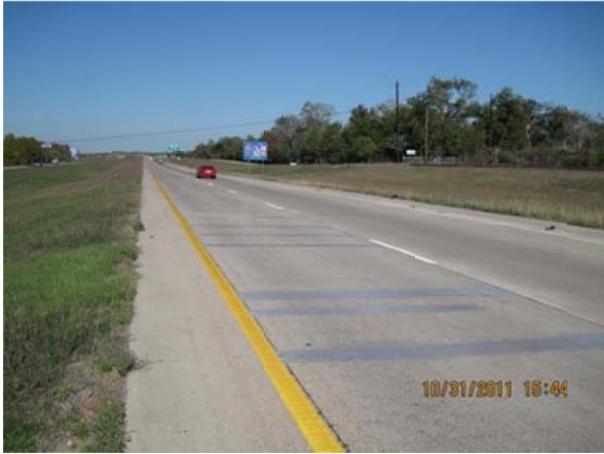
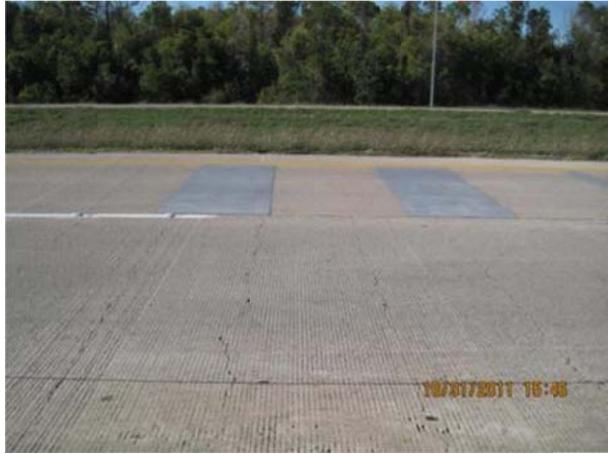
Figure 2.4 Houston, US 90

Figure 2.4 shows the condition of US 90 in Harris County, Houston District. A large number of concrete patches are observed. The primary distress on this highway was delamination of concrete at about 2 in depth, and resulting severe spalling at transverse cracks.

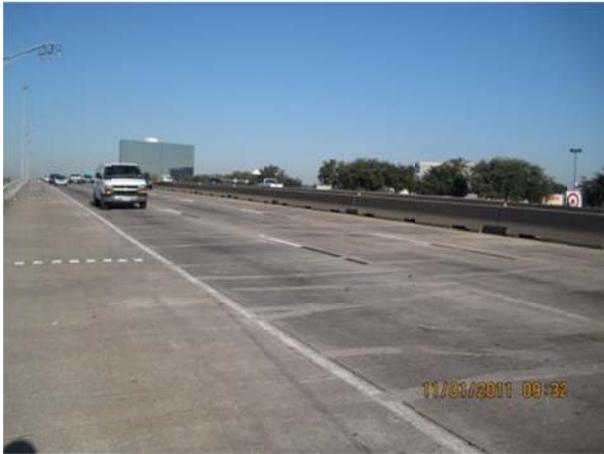
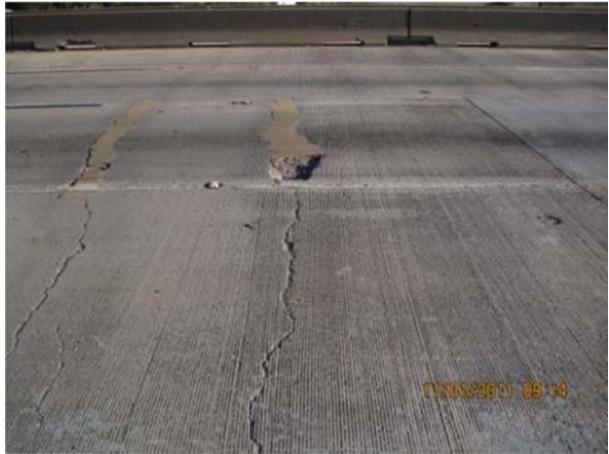
Figure 2.5 Houston, US 290

Figure 2.5 shows numerous patches to repair severe spalling on US 290 in Harris County, Houston District. The ride quality of this roadway has deteriorated substantially due to severe spalling and short longevity of repair materials.

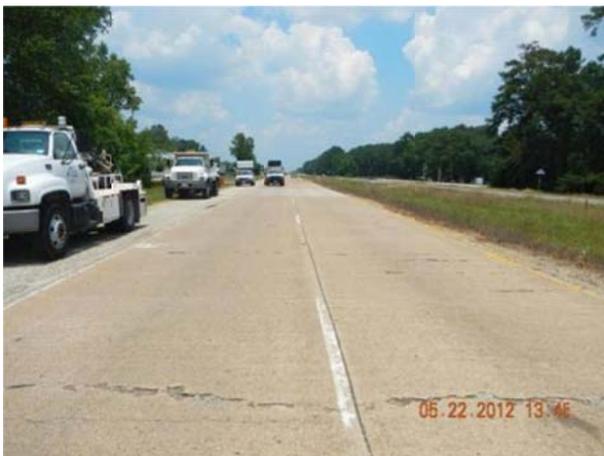
Figure 2.6 Beaumont, SL 573

Figures 2.6 and 2.7 show the pavement condition of SL 573 in Liberty County and FM 366 in Jefferson County in the Beaumont District, respectively. Even though spalling was observed in both highways, its condition was rather mild compared with those observed in the Houston District or Atlanta District.

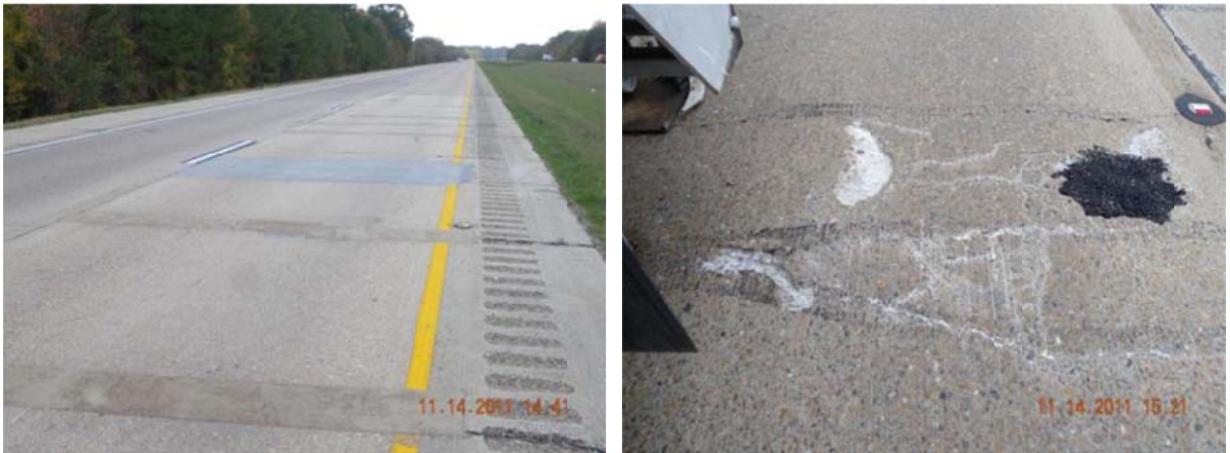
Figure 2.8 Atlanta, US 59

Figure 2.8 shows a number of surface patches on US 59 in Cass County, Atlanta District. The picture on the right indicates shallow delaminations, with calcium hydroxide leaching out. Figure 2.9 shows the spalling and faulting on SL 151 in Bowie County, Atlanta District. This section was built in 2004 and is relatively new. Figure 2.9-(b) shows a faulting at a transverse crack. This type of faulting is unexpected in CRCP. However, this type of faulting was observed during the repair of distress on IH 45 in the Dallas District. The higher elevation at one side of a transverse crack is due to horizontal cracking at the depth of longitudinal steel at that side. Subsequent warping and curling resulted in the “lift” of the concrete surface at the transverse crack. With continued truck traffic applications, a new transverse crack will develop at the end of the delaminated area. Figure 2.9-(c) shows transverse cracks with narrow spacing. However, close examinations of the cracks reveal that there are actually two different types of transverse cracks – wide (2nd and 4th cracks from left) and tight cracks.

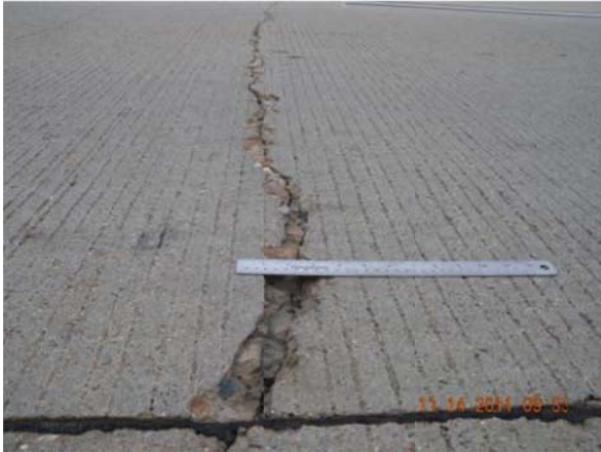
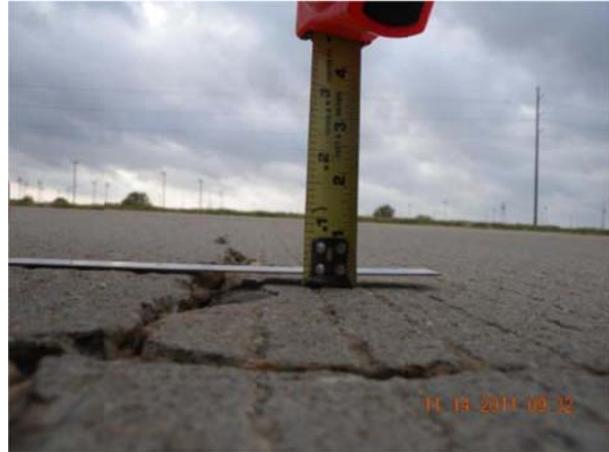
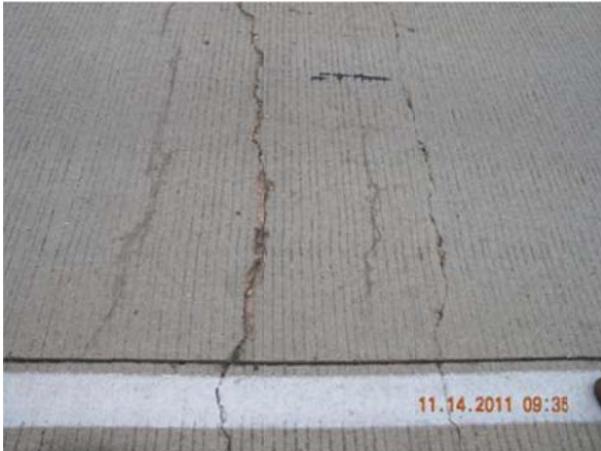
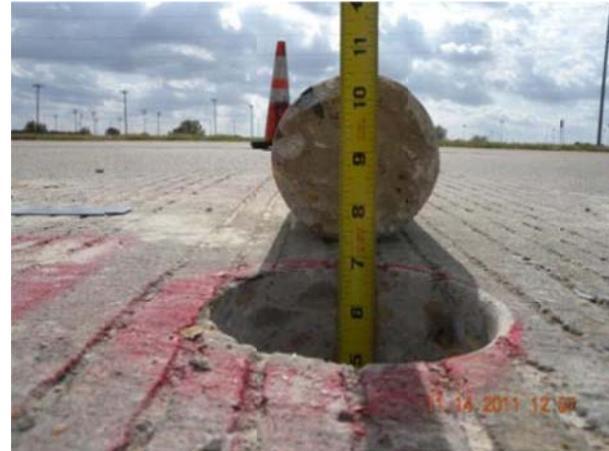
Figure 2.9 Atlanta, SL 151

(a) Typical spalling on SL 151

(b) CRCP faulting

(c) Narrow cracks

(d) Horizontal crack

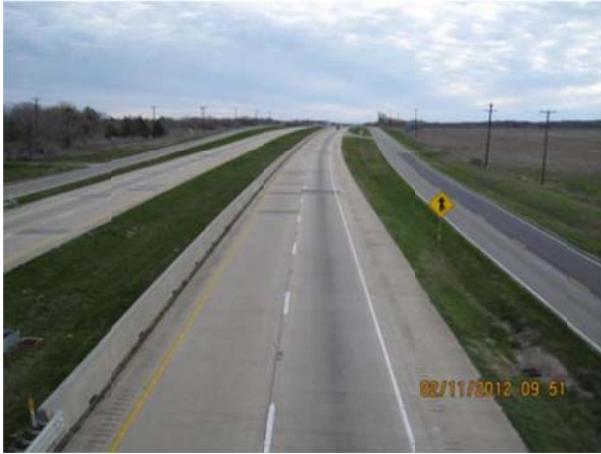
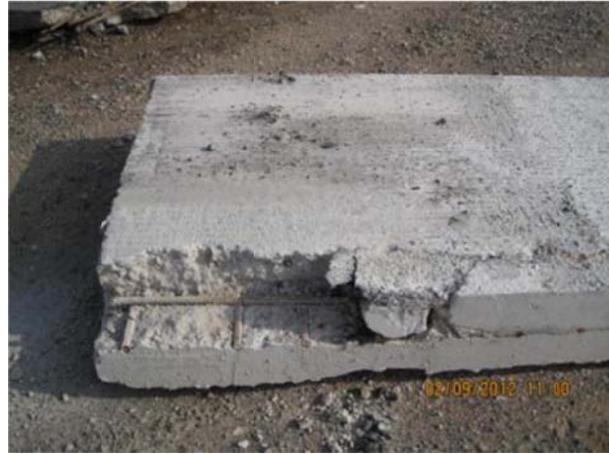
Figure 2.12 shows the CRCP condition on IH 30 in Hopkins County in the Paris District. This pavement was constructed by the tube feeding method with two-lift construction. As shown in Figure 2.12 (b), transverse steel is above longitudinal steel and the longitudinal steel spacing is not uniform. Severe delaminations at the depth of longitudinal steel are observed. There are numerous concrete patches in this highway. The cause of the distresses was horizontal cracking at the depth of longitudinal steel. The exact cause of horizontal cracking is not known; however, it could be related to the two-lift paving method.

(a) Pavement Condition

(b) Transverse Steel above Longitudinal Steel

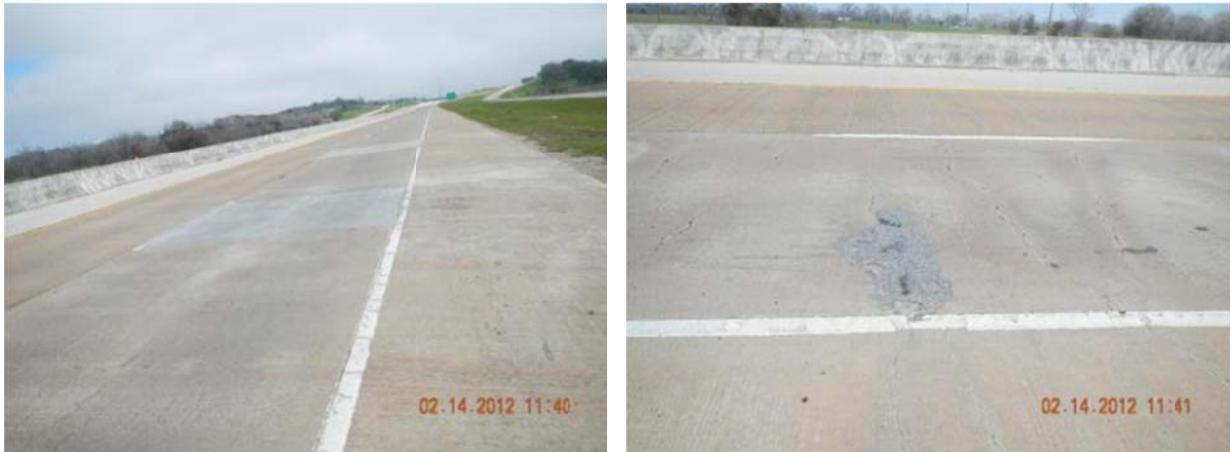
Figure 2.13 Yoakum, SH 71

Figure 2.13 shows the condition of SH 71 in Fayette County in the Yoakum District. This section was built in the late 80s and early 90s, and this is the project where the first ride specifications were applied. The spalling observed in this section was mild. Figure 2.14 shows the repair of delamination on IH 45 in Navarro County in the Dallas District.

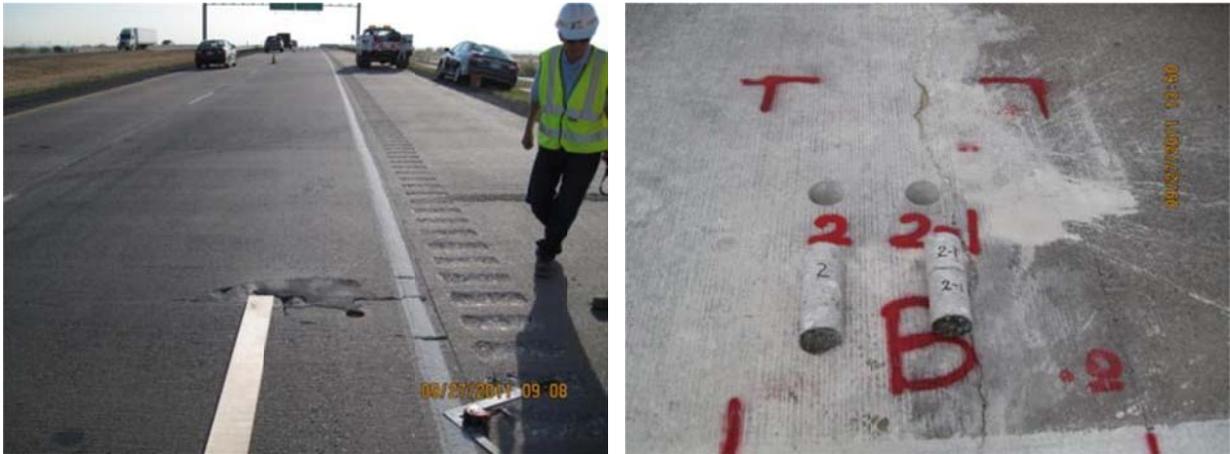
Figure 2.15 Fort Worth, IH 20

Figure 2.15 shows the severe spalling due to delamination on IH 20 in Parker County in the Fort Worth District. The steel was placed by the tube feeding method, and the two-lift method was used for the concrete placement. It is not known whether two-lift concrete placement method caused delaminations at the interface between two lifts.

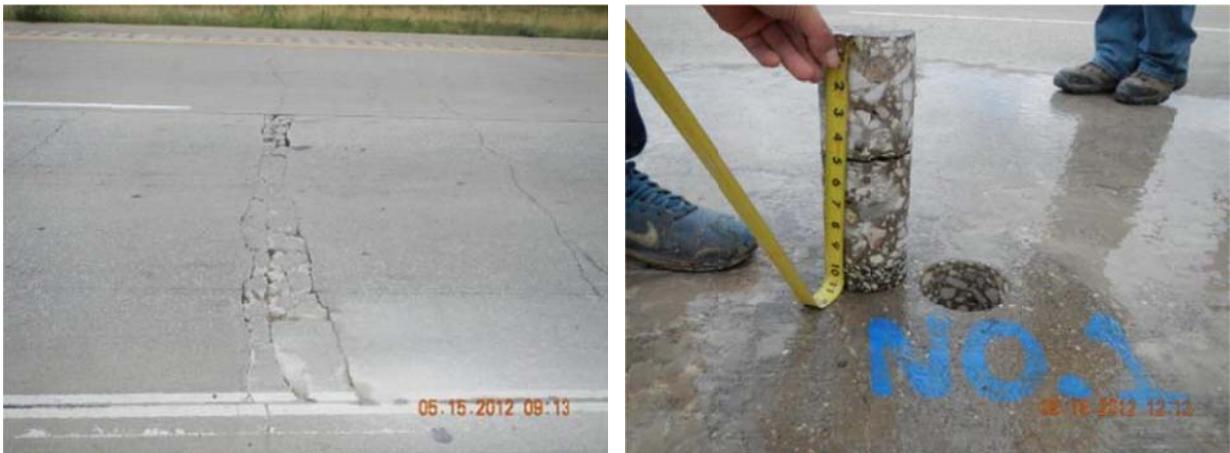
Figure 2.16 Laredo, IH 35

Figure 2.16 shows the condition of IH 35 in La Salle County in the Laredo District. This section of 9-in CRCP was built in the early 2000s as a test section to investigate the viability of concrete overlay on existing asphalt pavement. Three transverse cracks are close to each other, and concrete was fractured into smaller pieces. Traffic data from a WIM (weight-in-motion) station installed in this section revealed the applications of heavy trucks, whose weights were far greater than legal limits. Based on the analysis conducted in TxDOT research study 0-5832, it is concluded that over-weight trucks caused these delaminations and distresses.

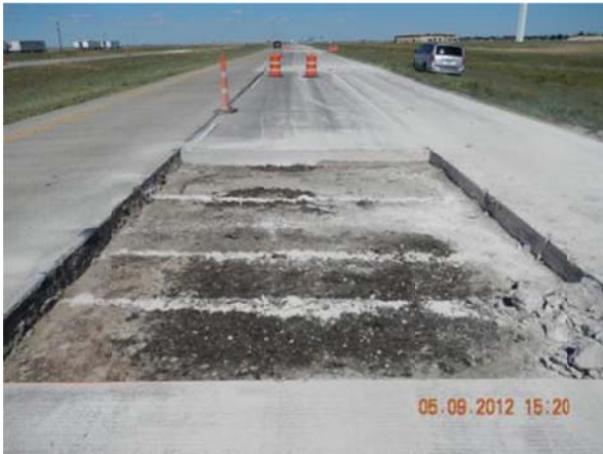
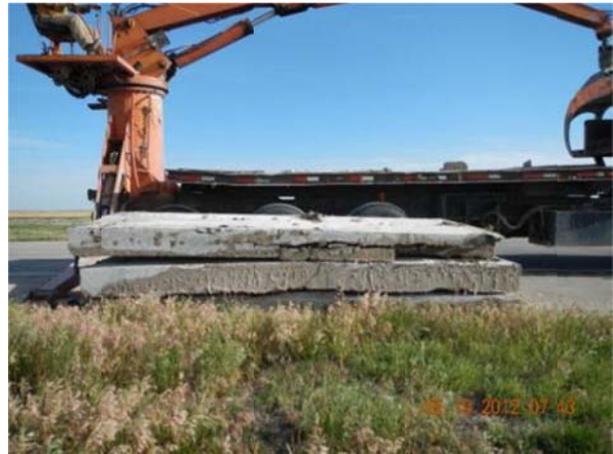
Figure 2.17 shows full-depth CRCP repairs on IH 40 in Gray County in the Amarillo District. Delaminations at the depth of longitudinal steel and resulting distresses are observed. Asphalt base deteriorated apparently due to moisture infiltration.

(a) Loose Base Condition

(b) Delamination

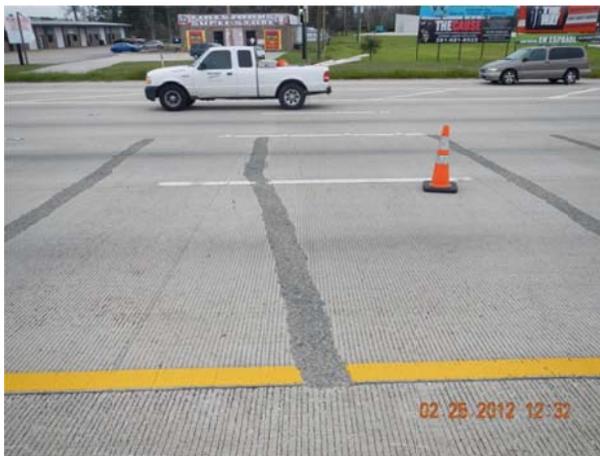
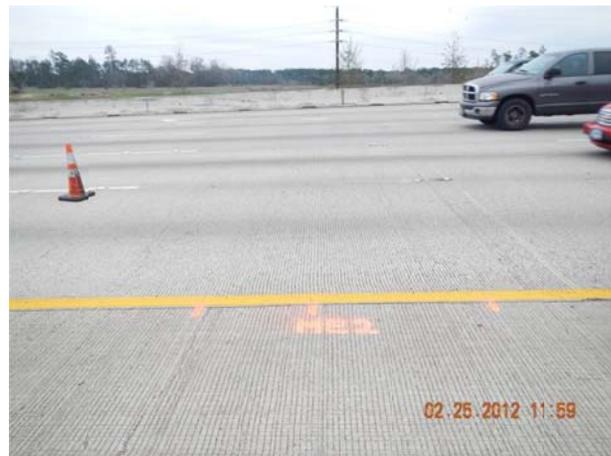
structural distress or punchout. However, there was a huge difference in the spalling performance. There was no single spalling in LS section, while there were numerous repairs done for spalling in the SRG section. Figure 2.18 shows the surface condition in both sections. The pavement in this highway north of Spring Creek was built with LS coarse aggregate, except for a 920 ft test section where SRG was used. It is interesting to note that the surface condition of the outside two lanes where LS was used is quite good, with no spalling even though truck traffic was higher. Detailed evaluations were made in concrete properties with various coarse aggregates in Texas by Green et al in 1987. There was no practical difference in the properties of concrete made with SRG and LS, except for CoTE and modulus of elasticity. There were other studies that found the same information. There might be other concrete properties responsible for the vast difference in spalling performance of CRCP sections built with SRG and LS coarse aggregate. However, extensive research effort since the 1980s has not identified those except for CoTE and modulus of elasticity. In this research study, CoTE and modulus of elasticity were evaluated on the cores obtained from the field.

(a) SRG section

(b) LS section

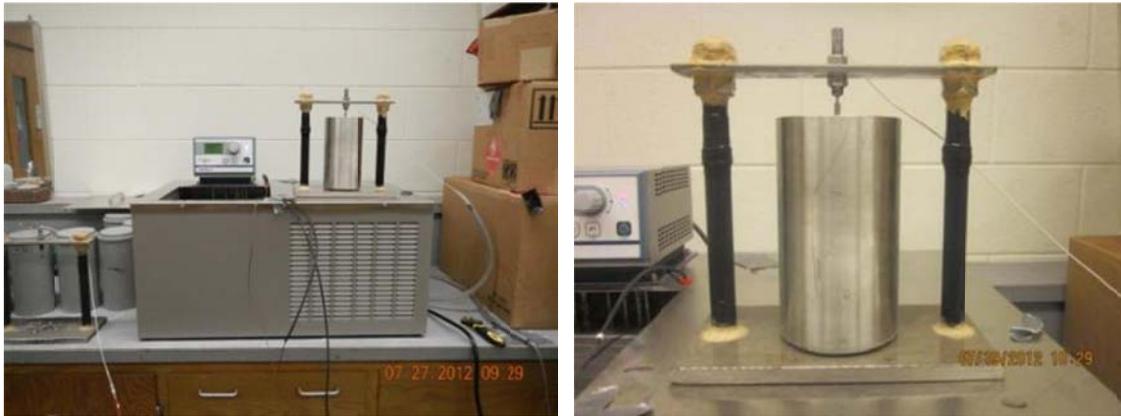
Figure 2.19 Schematic for CoTE Test

Volume changes induced during CoTE testing were quite small, about 3 mils for full temperature changes between 10 °C and 50 °C . It takes about 2.5 hours for temperature variation from 10 °C to 50 °C. Accordingly, the rate of concrete length change of a 7 in specimen is about 0.02 mils per minute, or 0.00002 in per minute. This is an extremely small change rate, and to obtain accurate CoTE values, it is important that a displacement gage has a high accuracy as well as a good stability. Extensive evaluations at TxDOT CSTMP showed that LVDT (linear variable differential transformer) does not provide accurate results. CSTMP staff identified DVRT (differential variable reluctance transducer) as a more accurate and stable displacement gage. A CoTE testing setup was established at Texas Tech University in consultation with TxDOT CSTMP staff, which is shown in 2.19.

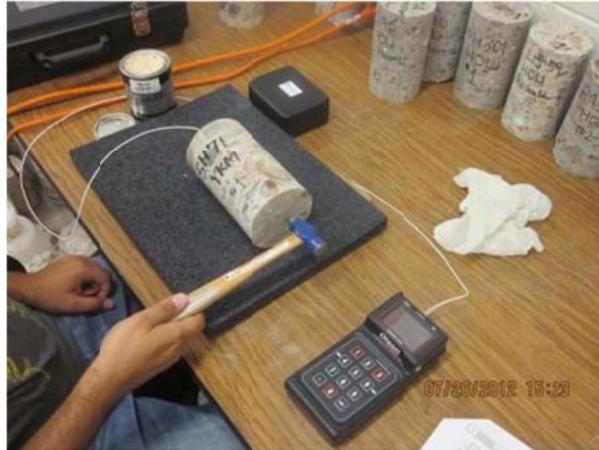
Figure 2.21 Resonant Frequency Test

Modulus of elasticity of concrete cores was estimated by the free-free resonance method in accordance with ASTM C 215-08, “Standard Test Method for Fundamental Transverse, Longitudinal, and Torsional Frequencies of Concrete Specimens.” The concrete specimen was placed on the rubber pad so that it could vibrate freely in the longitudinal mode. An accelerometer was firmly attached at the center of one end surface of the concrete specimen. The accelerometer was attached to the main body acquisition and display unit. The other end of the concrete specimen was hit by the ball-peen hammer, while making sure to provide a perpendicular impact on the surface of the concrete specimen as shown in Figure 2.21. This process was repeated until getting a stable resonant frequency value. With the measured resonant frequency, and mass and dimensions of the concrete specimen, modulus of elasticity was estimated.

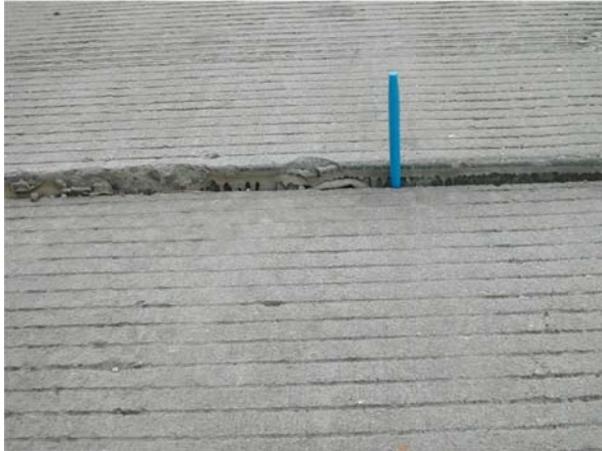
Figure 5.1 Faulting in Transverse Joint

Mid-slab transverse cracking or joint faulting is quite rare in Texas. The reason for rare incidents of mid-slab cracking or faulting is that TxDOT design standards as early as 1944 required transverse joint spacing of 15 ft and the use of dowels at transverse joints. There have been some exceptions, where design engineers tried something deviant from TxDOT CPCD standards. For example, Figure 5.1 shows severe faulting in CPCD. In this project, dowels were not used. Instead, slab thickness was increased by using a larger value for load transfer coefficient (J) in the 1993 AASHTO Pavement Design Guide. This distress could have been prevented by the use of dowels. This example illustrates the fact that slab thickness does not necessarily make up for deficiencies in other design elements. A CPCD section on US 75 in the Paris District showed some faulting at the longitudinal construction joint between the outside lane and retrofitted outside shoulder. However, faulting at TCJs was almost negligible, even though a 10-in concrete slab was placed directly on subgrade and truck traffic has been quite heavy. Figure 5.2 illustrates transverse cracks observed in CPCD projects in Texas. If slab thickness was deficient or saw-cutting was delayed, transverse cracks are expected to develop in the middle area of the slab

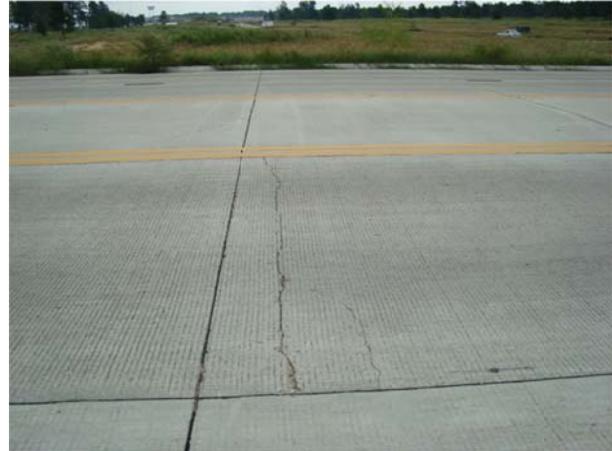
between transverse contraction joints (TCJs). In Figure 5.2, transverse cracks are rather close to a TCJ. These cracks are due to interactions through tie bars in the displacements of slabs placed at different times. This type of crack can be prevented by improved design standards and quality construction practices.

Figure 5.2 Transverse Cracks Near Joint

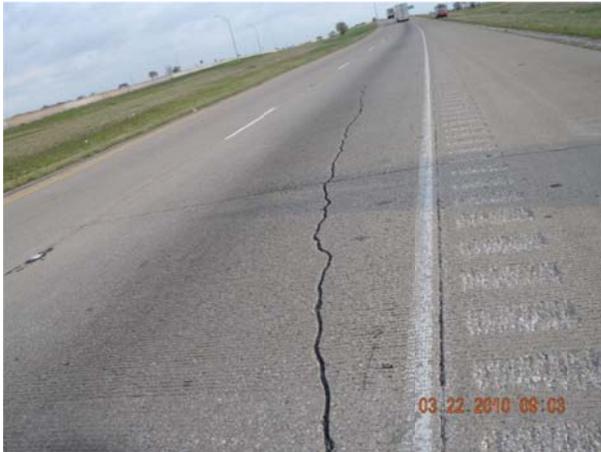
Figure 5.3 Longitudinal Cracking in CPCD

Longitudinal cracks in CPCD are not frequent. The primary cause for longitudinal cracks in CPCD in Texas is the volume changes in the base and/or subgrade. Figure 5.3 shows longitudinal cracks in CPCD. When volume changes are excessive in the base and/or subgrade, longitudinal cracks occur in CRCP as well, as shown in Figure 5.4. Increasing slab thickness or modifications in joint layouts will not prevent longitudinal cracking. Reducing volume change potential in the base and/or subgrade is the best way to minimize longitudinal cracking potential in both CPCD and CRCP.

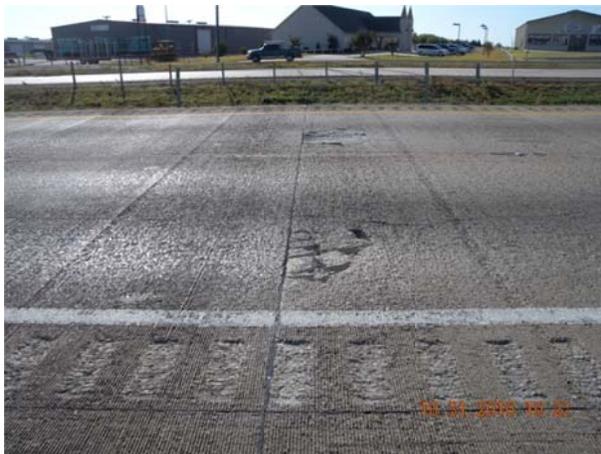
Figure 5.5 Distress at TCJ

The primary distress type in CPCD in Texas is failure near TCJs. Figure 5.5 illustrates typical distress at TCJ, and Figure 5.6 shows the repairs of distresses at TCJ. Distresses and repairs at TCJs negatively impact pavement condition score, and are one of the primary reasons for lower condition score of CPCD than that of CRCP or ACP.

Accordingly, joint deterioration associated with freeze-thaw, the application of de-icing chemicals, and deficient air void system in concrete are not considered the cause for joint deterioration as shown in Figure 5.5.

Even though detailed investigations were not made in this study to identify the causes of the joint distress as shown in Figure 5.5, it appears that two potential causes exist. One is the saw cutting that could have caused micro-damages and the other might be related to dowel bar placement. Concrete with a high CoTE normally contain aggregates that are quite hard. Saw cutting at early ages when paste is still developing strength and is not as strong as coarse aggregates, could cause micro-damage to paste surrounding coarse aggregates that are under being cut. Saw cutting could dislodge the aggregates because aggregates are quite hard. Figure 5.7 shows the evidence of micro-damage near the transverse saw cut, and resulting spalling at the joint (Figure 5.8). In this project, a CRCP section on US 290 in the Houston District, an early-entry saw cut method was applied to induce a transverse crack at this location. The saw cut was applied at 4 to 5 hours after concrete placement. The coarse aggregate used was siliceous river gravel, which is quite hard. It took more than 10 years before the micro-damage developed into spalling. Since coarse aggregates with a high CoTE are usually siliceous aggregates, which are quite hard and durable, saw cutting timing should be adjusted not to cause micro-damage to paste surrounding coarse aggregate during the saw cut. Considering the short joint spacing used in Texas and the evidence of few mid-slab cracking in Texas due to environmental loading (temperature and moisture variations), saw cutting should be delayed until adequate concrete strength is achieved. Another reason for damage to the concrete at the joints could be wobbly action of the saw blades. This is an equipment issue, and adequate inspection of the sawing machine should address this issue.

The other cause for the distress shown in Figure 5.5 could be dowel misalignment. A number of studies were conducted over the years on this issue. However, disagreements exist regarding

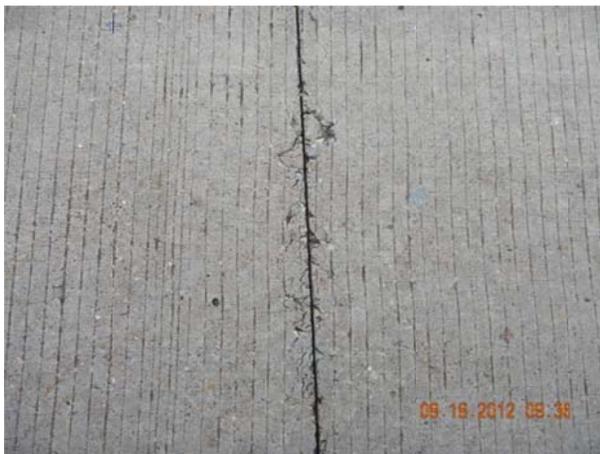
Figure 5.7 Micro-Damage Due to Early Entry Saw Cut

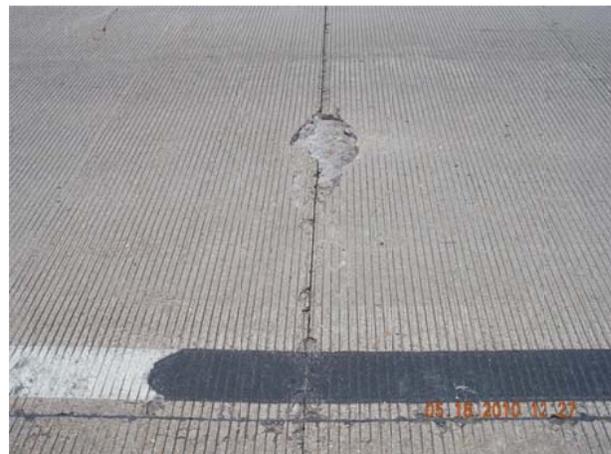
Figure 5.8 Spalling at Saw Cut Joint Due to Micro-Damage in Concrete
