TEXAS TECH UNIVERSITY

# FRP Reinforcing Bars in Bridge Decks Field Instrumentation and Short-Term Monitoring

Research Report 9-1520-04

August 2003

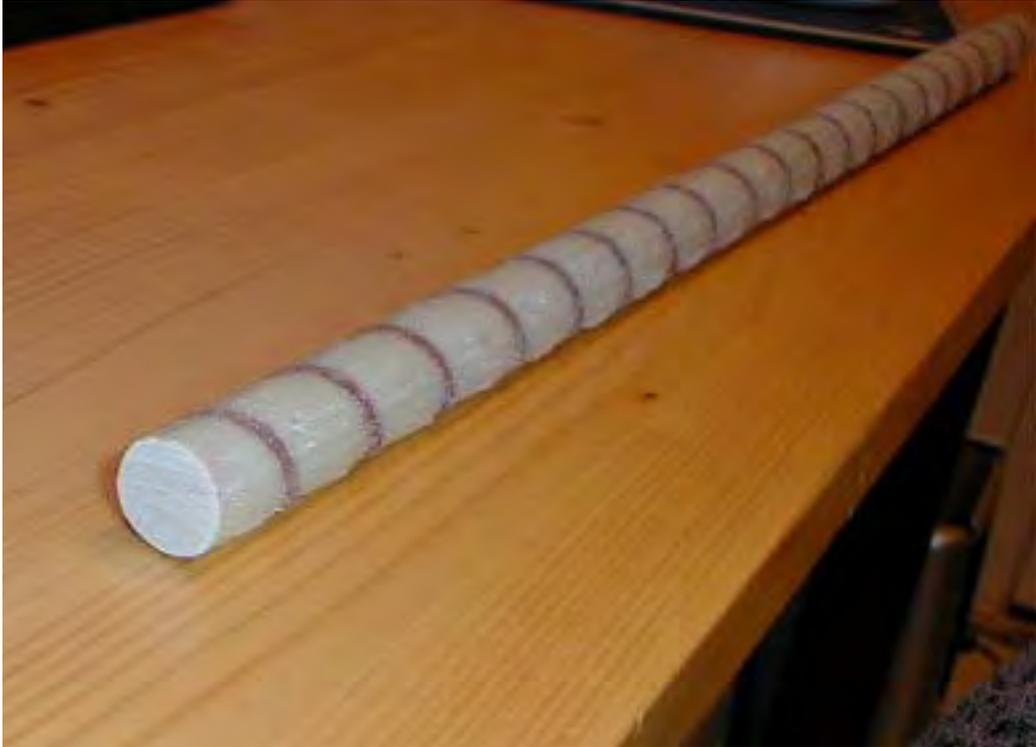
**Figure 1.3** Hughes Brothers Aslan 100 GFRP Bar Sample

The top mats in Spans 6 and 7 of the bridge were reinforced with No. 5 and No. 6 Hughes Brothers Aslan 100 GFRP rebar with a nominal fiber content of 70% by volume (Hughes Brothers 2002). As shown in Figure 1.3, these bars have embedded sand and helical wrapping surface treatments for bond to the surrounding concrete. In the steel-reinforced spans, the top mat had No. 4 bars at a spacing of 9 inches in the longitudinal direction of the bridge and No. 5 bars at a spacing of 6 inches in the lateral direction. In the corresponding GFRP-reinforced spans, No. 5 Aslan 100 bars were spaced at 6 inches in the longitudinal direction and No. 6 Aslan 100 bars were spaced at 5.5 inches in the lateral direction. The GFRP combinations could be considered to be more than equivalent to the steel combinations for strength. However, in both directions the GFRP reinforcement provided only about one-half to two-thirds as much stiffness. This was due to the much smaller modulus of elasticity of the GFRP, as discussed further in Chapter 2. Table 1.1 compares the four rebar types and spacings on an equivalent stiffness (i.e.,  $E \cdot A$ ) basis. It should be noted that because of the flexibility of the GFRP bars the top mat reinforcement was designed on the basis of stiffness and expected crack controlled, rather than strength. As a result, examination of the cracking in the top of the deck was given a high priority in the tests described in Chapter 4.

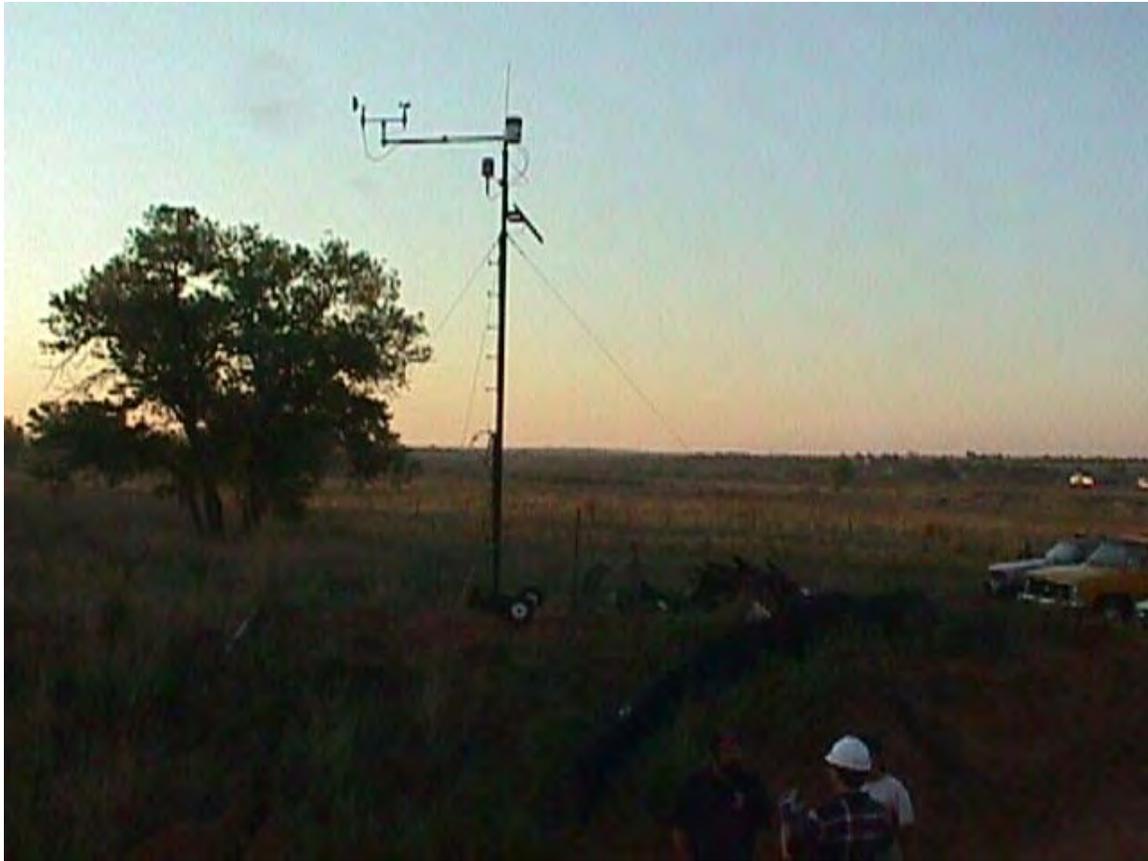
**Figure 3.1** Weather Tower at Bridge Site

were stored in a Campbell Scientific CR10X battery powered datalogger. Originally the contractor planned to supply A/C power and a phone line to the bridge. When these plans changed, TTU researchers modified the data acquisition procedure.

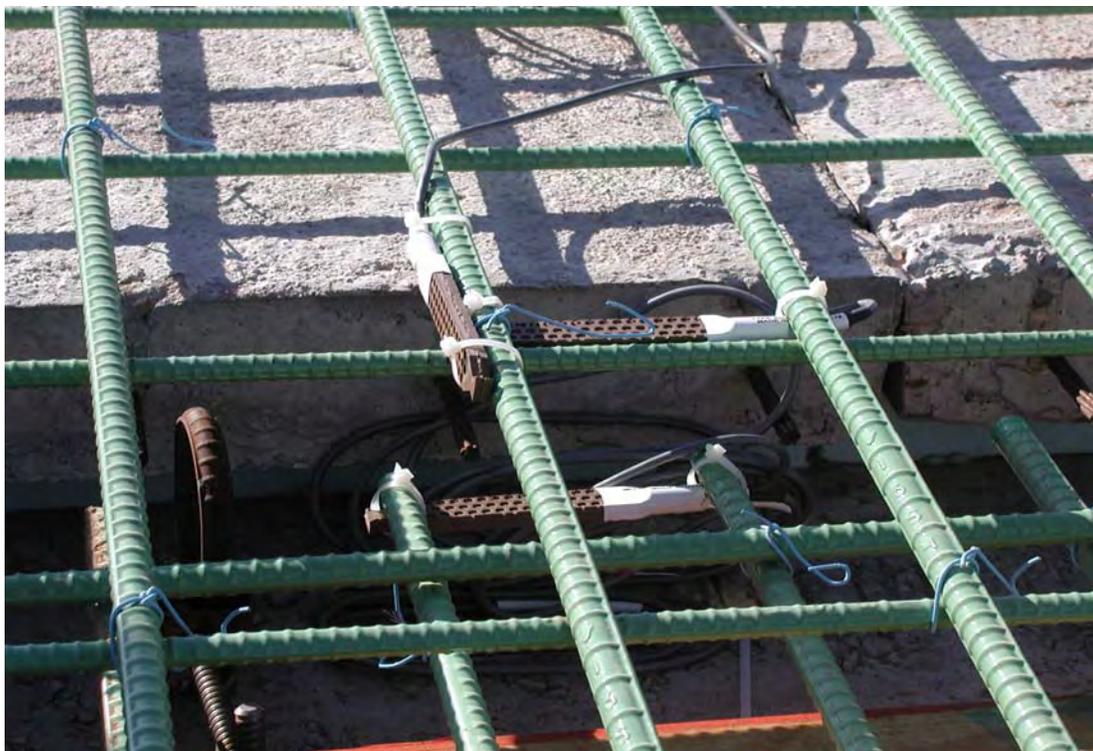
**Figure 3.4.** Embedded Concrete Strain Gauges Over an Interior Beam

Figure 3.4 shows longitudinally and laterally oriented embedded concrete strain gauges attached to ECS bars in the top mat of reinforcement over an exterior beam as well as one longitudinal gauge at the level of the bottom mat of reinforcement. Figure 3.5 shows where longitudinal and transverse surface gauges have been installed on the bottom of a precast panel and protected and waterproofed with pieces of neoprene. Finally, Figure 3.6 shows how pressure was applied during curing of a surface gauge mounted on the bottom of one of the beams.

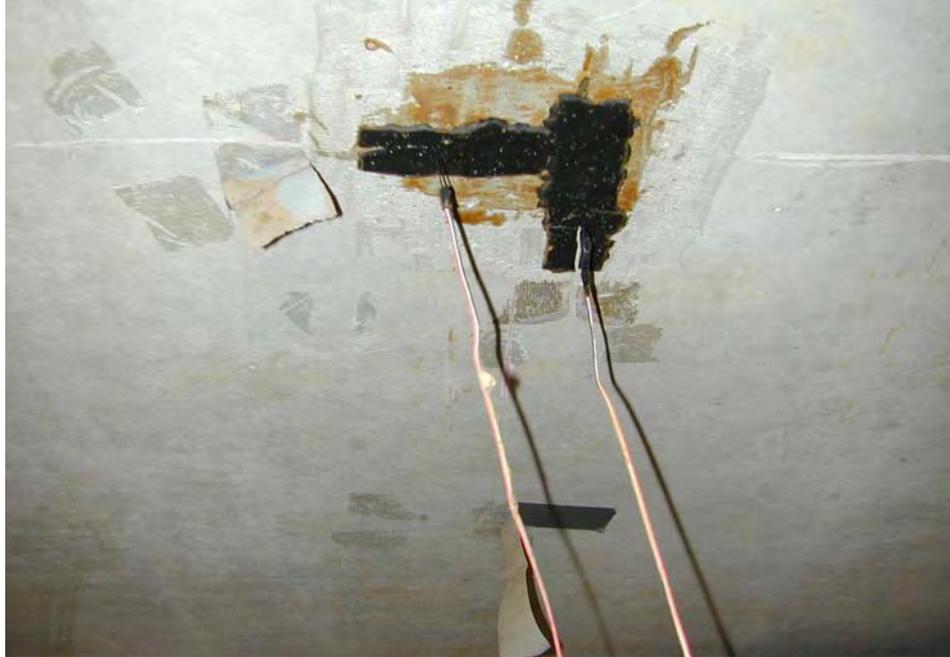
**Figure 3.5** Surface Strain Gauges Centered on the Bottom of a Precast Concrete Panel

The locations of the embedded and surface-mounted concrete strain gauges are shown in Figures 3.7 and 3.8, respectively. These figures are for the FRP-reinforced Span 6; mirror image figures would apply for the ECS-reinforced Span 2. In many places both longitudinal and lateral gauges were positioned together, as illustrated in Figure 3.5.

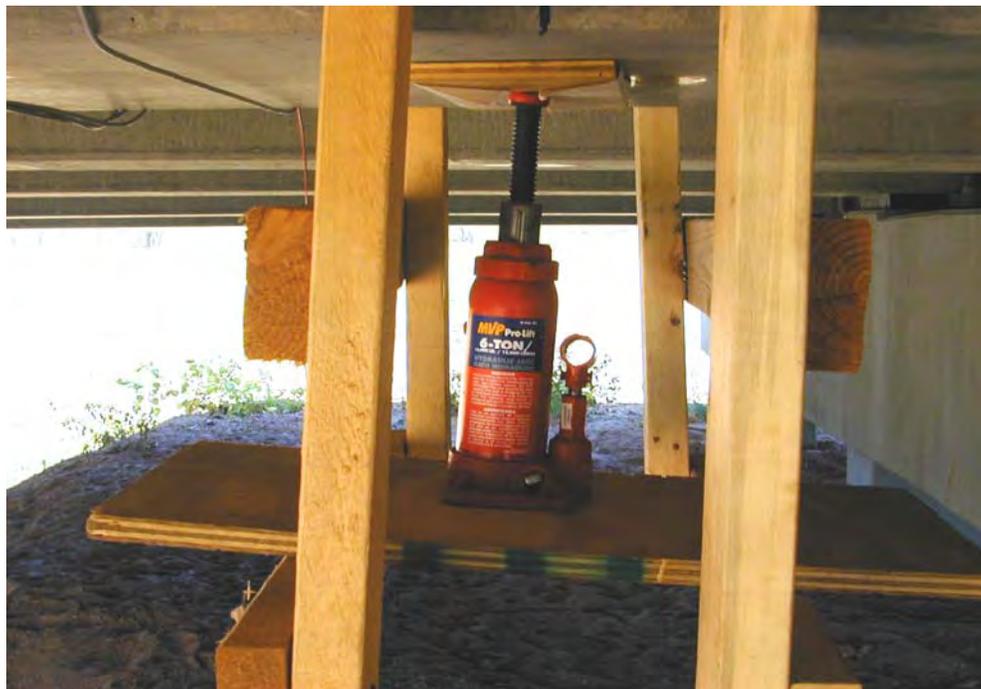
**Figure 3.6** Jack System for Installing a Surface Strain Gauge on the Bottom of a Beam

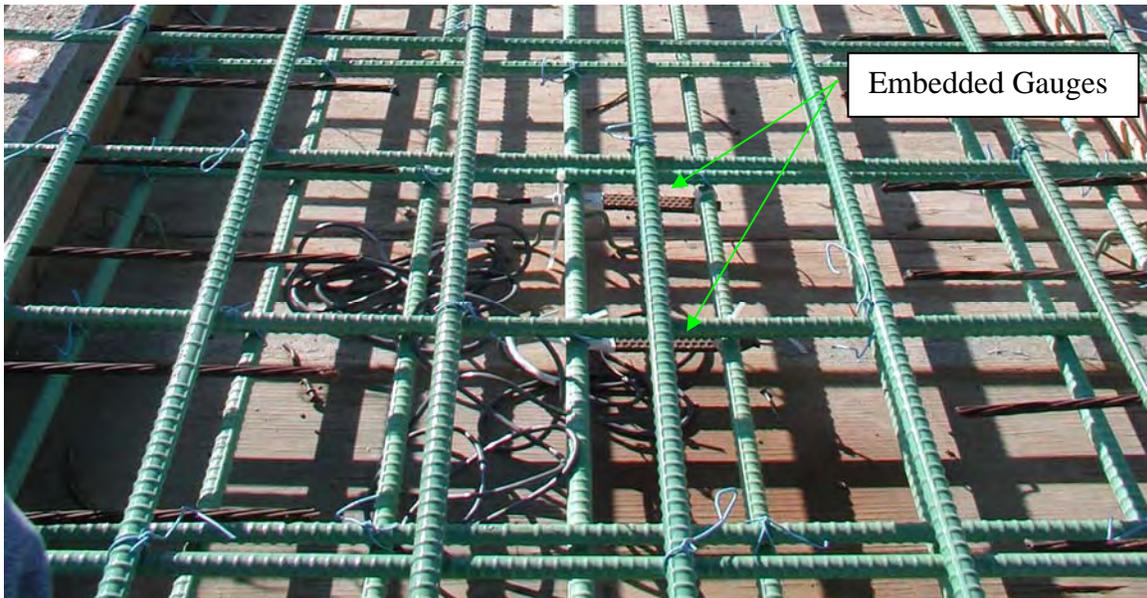
**Figure 3.10** Embedded Gauges in the Controlled Joint Between Spans 1 and 2

Embedded strain gauges placed at a controlled joint location are illustrated in Figure 3.10. These gauges were centered over the plane between the zip strip and the chamfer. This strategy was intended to allow the gauges to span across a crack in the concrete, secured to either an FRP or an ECS top mat bar. These gauges were placed to allow a direct comparison of the strains in the respective bars at these locations when wheel loads are placed on the adjacent spans.

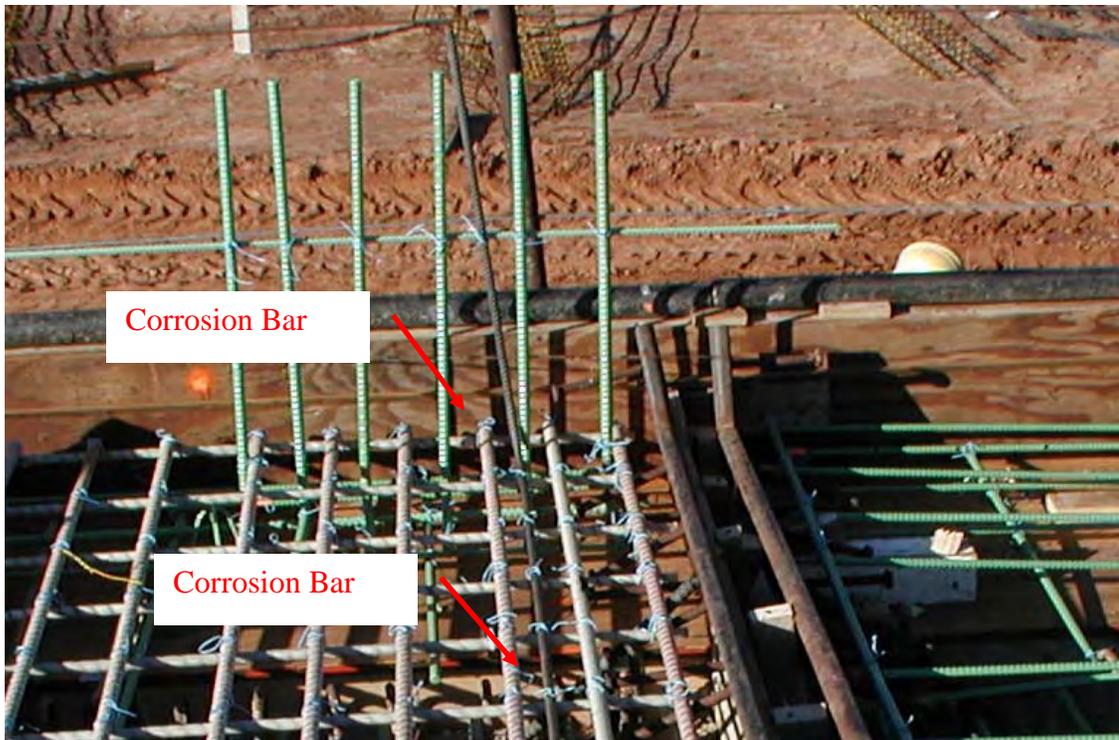
**Figure 3.13** Corrosion Bar at the Sealed Expansion Joint (Discontinuous End) of Span 6, Phase I

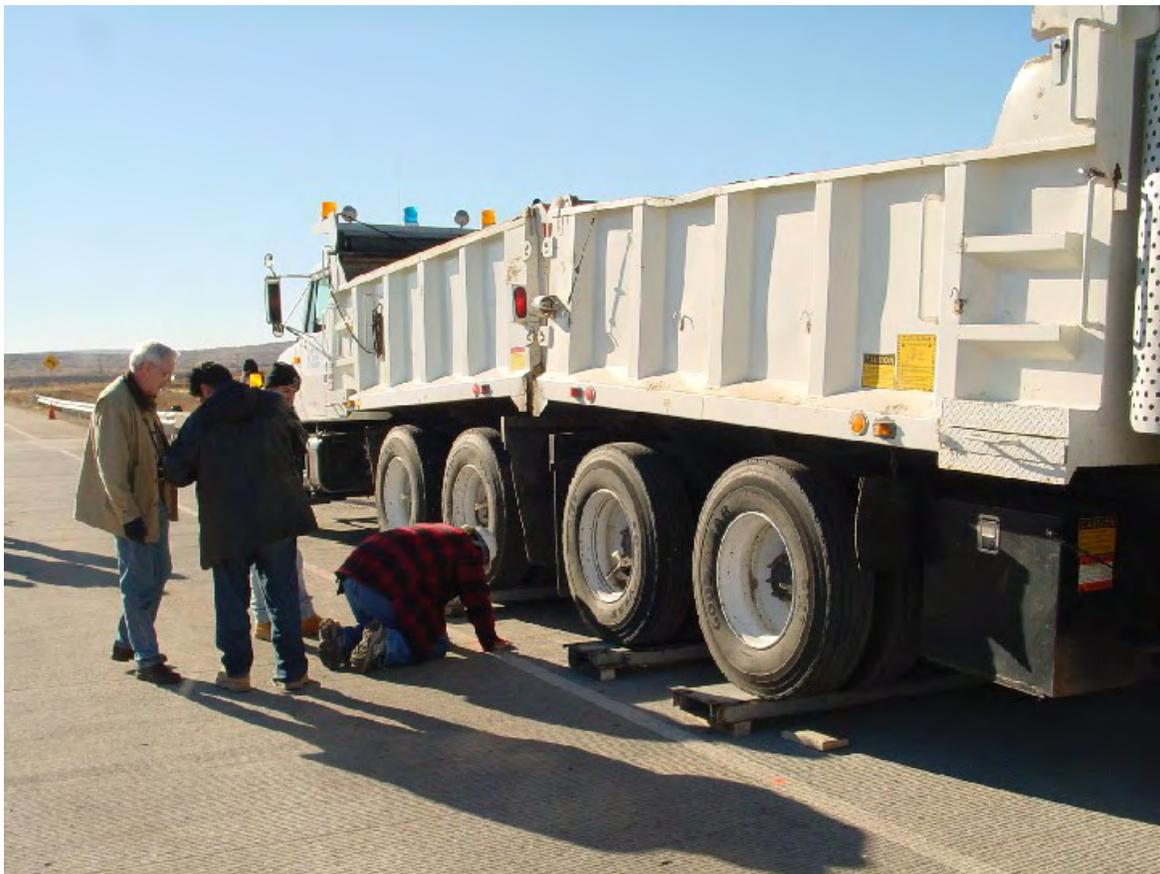
**Figure 4.3** Crack Measuring with TxDOT Dump Trucks in a Back-to-back Load Case  
Photograph: Courtesy of Alvin Gutierrez, FHWA

Figure 4.3 shows the two dump trucks being positioned back-to-back in Span 6 with their outside wheels as far out on the overhang as possible. In this case the rear wheels were ridden up onto two transverse steel channel sections supported by 4x4-inch wooden blocks to cause the rear axle loads on the deck to be concentrated on smaller areas than the tire prints would have allowed. This technique was used throughout the Span 6 tests, but in the tests in Span 2 the channel sections were not used because it took extra time and it was not expected to affect the results significantly.

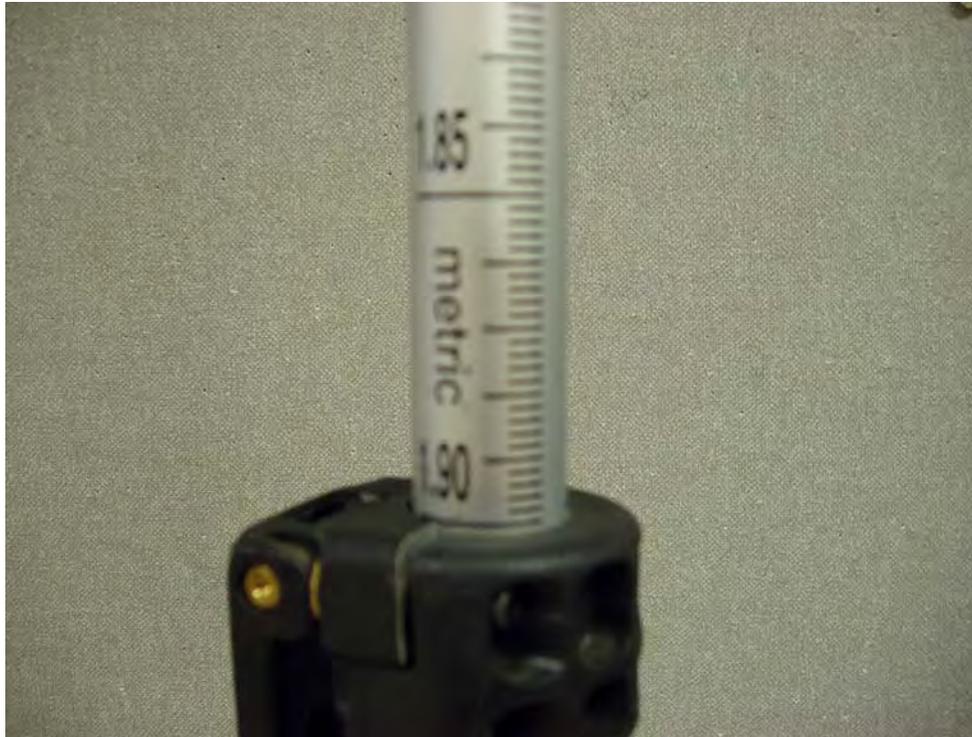
**Figure 4.8** Surveyor's Rod Used for Deflection Measurements of September, 2002

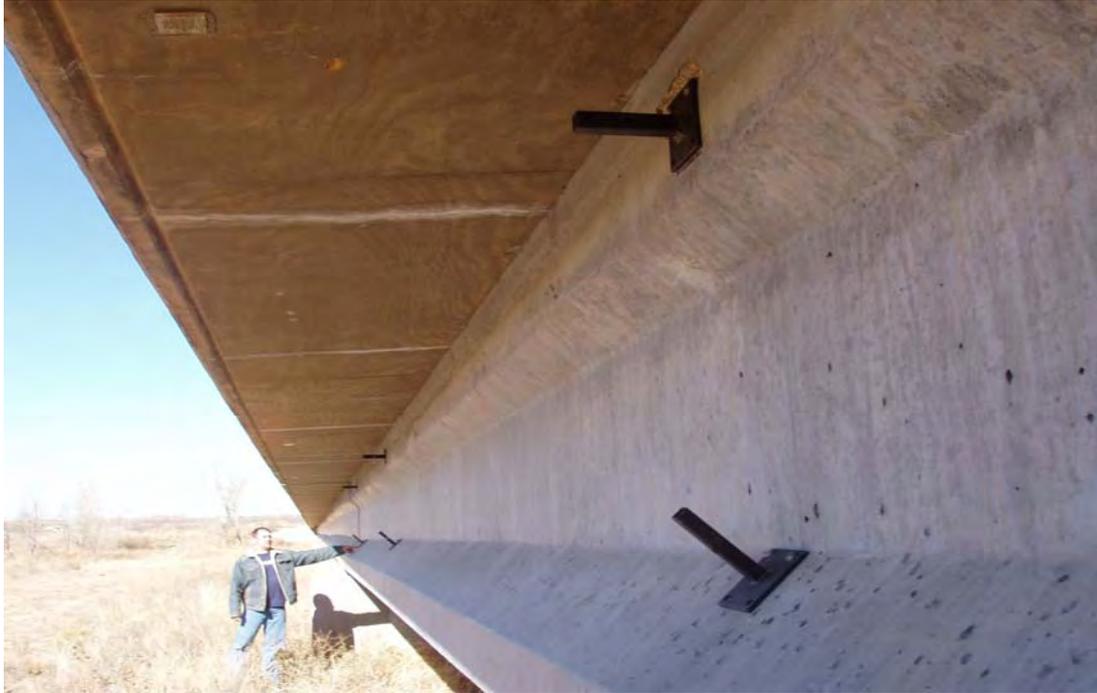
**Figure D.1** LVDT Mounting Brackets on Span 6
