TEXAS TECH UNIVERSITY

Construction and Evaluation of Post-Tensioned Pre-Stressed Concrete Pavement

Seongcheol Choi, Moon Won

Texas Department of Transportation

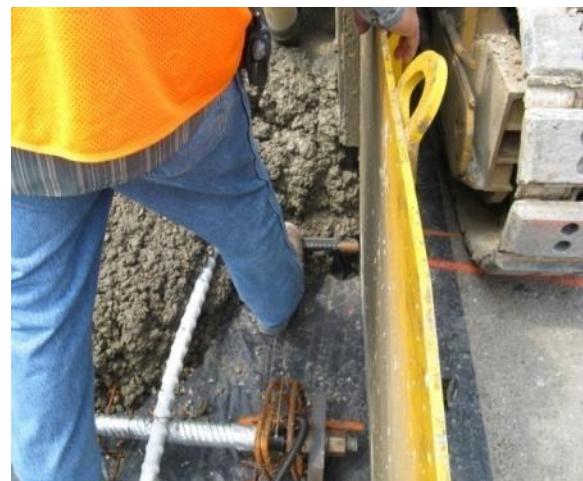
Figure 2.3 Contractor trying to hold transverse bars in place

During the paving on the first day of PCP construction on May 27, 2008, it was noticed that longitudinal tendons were pushed by the concrete, which again pushed transverse post-tension bar and transverse steel, as shown in Figure 2.2. To prevent this, the contractor personnel had to push transverse post-tension bars and steel with his foot, as shown in Figure 2.3.

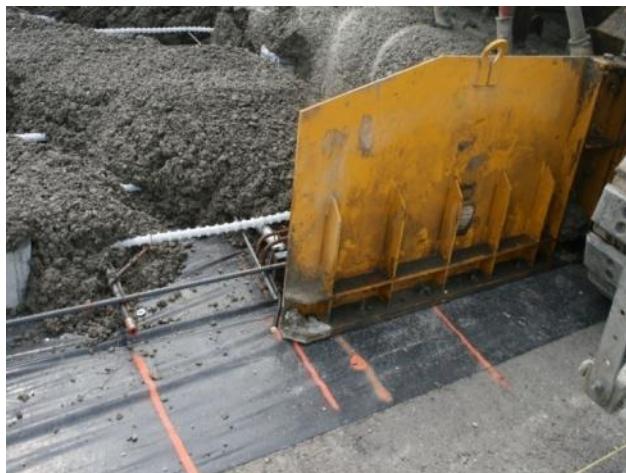
Figure 2.4 Longitudinal rebar placed to correct the problems of bars being pushed by concrete

The contractor shortly came up with the idea of placing #6 rebar longitudinally and tying transverse post-tension bars and transverse rebar to the longitudinal #6 bars. Figure 2.4 shows the longitudinal rebar placed. This system of placing longitudinal bars, with one bar at each side of the slabs and one bar in the middle for more than 30-ft wide placement, was incorporated for the rest of the project, as shown in Figure 2.5. This system of placing longitudinal bars helped keep the transverse post-tensioning bars and transverse steel in place a little. However, it did not prevent the transverse post-tensioning bars and transverse steel from being pushed. As discussed below, the contractor started staking bars to the asphalt to keep the transverse post-tensioning bars in place during concrete placement.

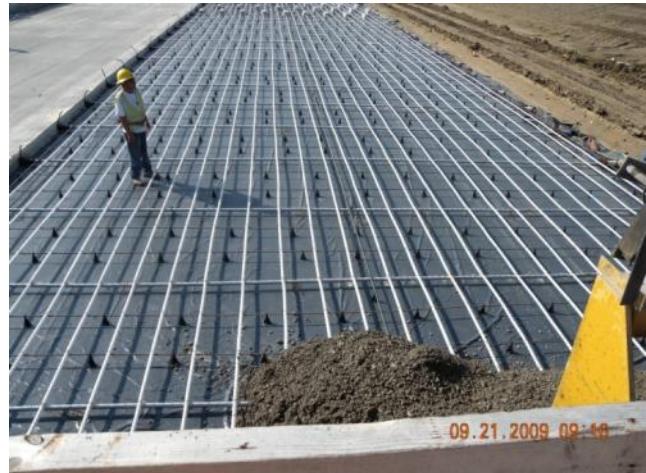
Figure 2.5 Longitudinal rebar placed at both sides and in the middle of the slab

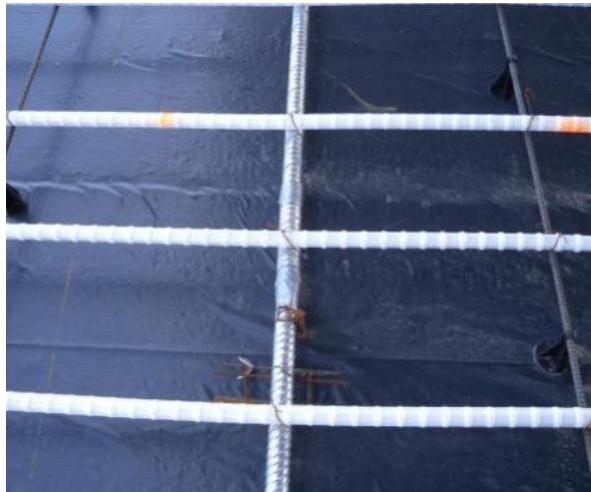
Figure 2.6 Bar installed to keep transverse post-tensioning bar in place

Due to the transverse reinforcement being pushed by concrete placement even after the placement of longitudinal rebar as described above, the contractor decided to install steel bars into the asphalt subbase as shown in Figure 2.6, which is called "vertical bars" in this report. These vertical bars, four bars at a location of transverse post-tensioning steel, were

installed every third transverse post-tensioning steel. When the two transverse post-tensioning steel where vertical bars were not installed were not tightly fixed with longitudinal tendons, the transverse post-tensioning bars were bent as shown in Figure 2.7 due to the concrete pushing the bars.

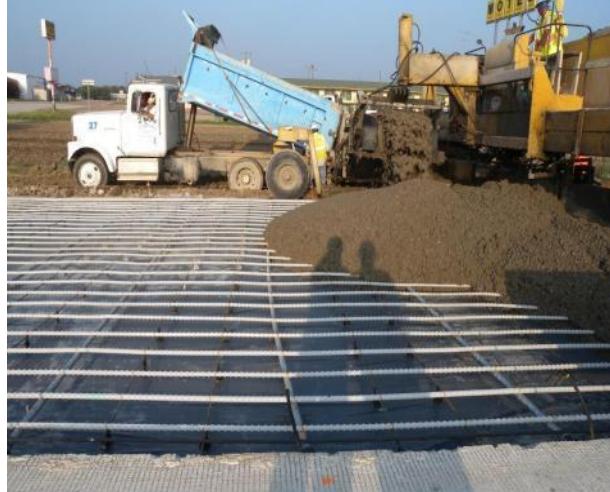
Figure 2.7 Transverse post-tensioning bar being bent due to concrete pressure

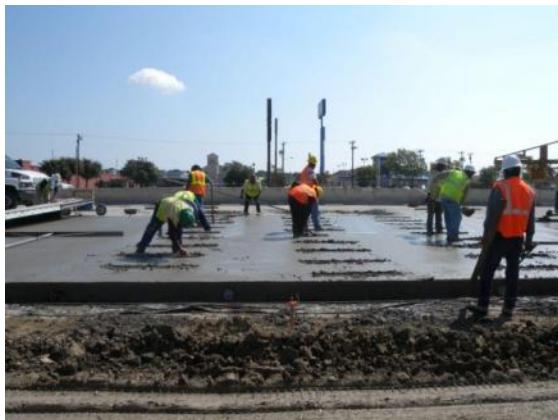
Figure 2.8 Removing concrete from the top of stressing pocket cover

Since 1-in bar is used for transverse pre-stressing, there was a need for providing enough space for the connection of the bars at the longitudinal construction joint. This is quite similar to locating and exposing the female portion of the tie bars when the multi-piece tie bar system is used. The difference is that, in PCP construction, the slab thickness is only 9-in while the female piece is much larger. As a result, there were edge slumps as shown in Figure 2.9. This problem was more prevalent at the early stage of PCP construction. The contractor improved their practice of installing the female pieces closer to the edge and clearly identifying their locations, and this issue was resolved.

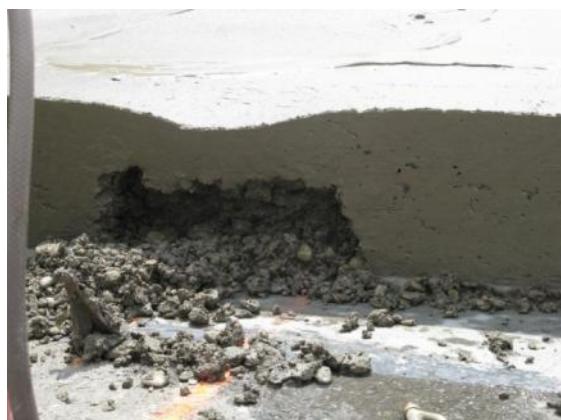
Figure 2.9 Edge slump due to the removal of concrete for the space for the connection of transverse bars

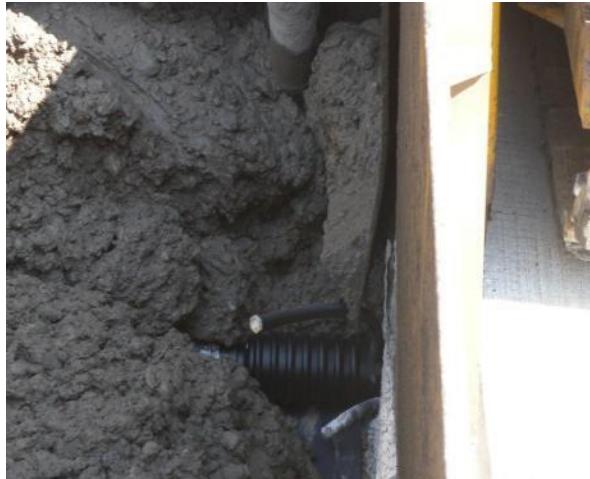
Figure 2.10 Grouting hose at longitudinal construction joint not interfering with placement

Grouting hoses for transverse post-tensioning bars or those at the stressing pockets for longitudinal tendons did not interfere with the concrete placement as can be seen in Figure 2.10. On the other hand, those at the armor joints did interfere with concrete placement if they were not embedded below the concrete surface. Due to the constructability issue, the grouting hoses at the armor joints were positioned below the slab surface and later they were exposed by chipping the concrete

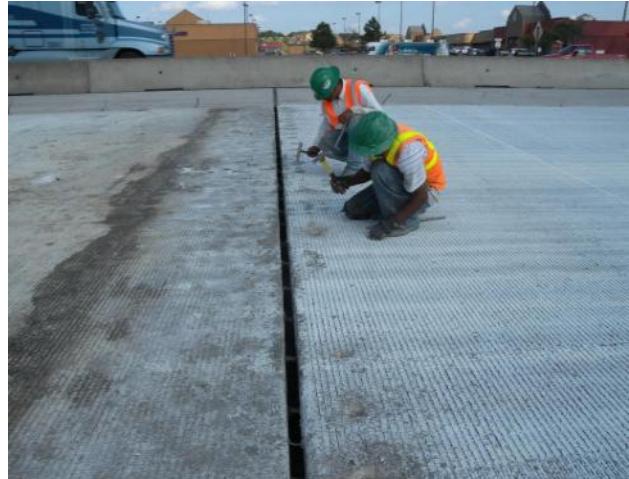
Figure 2.11 Chipping concrete to expose grouting hoses at armor joints

manually. Identifying the exact location of the grouting hoses and exposing them by chipping concrete was time consuming and labor intensive, as can be seen in Figure 2.11. Improved method could enhance the productivity of the PCP construction.

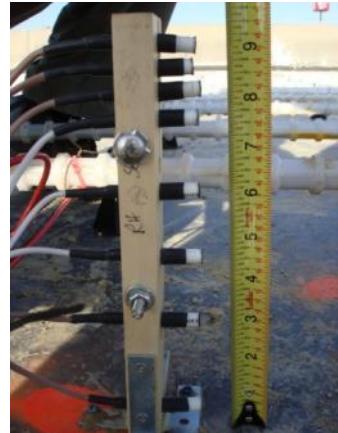
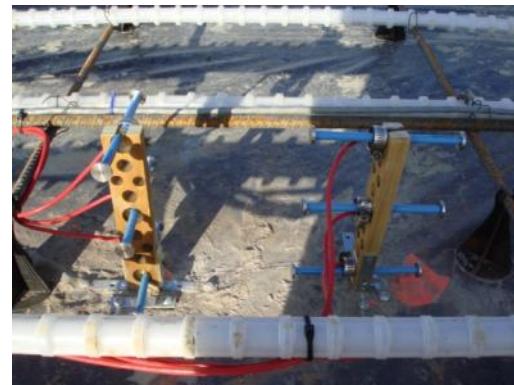
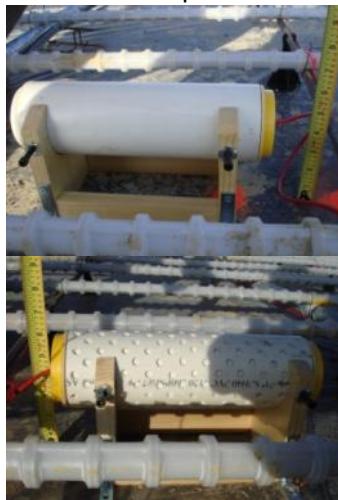
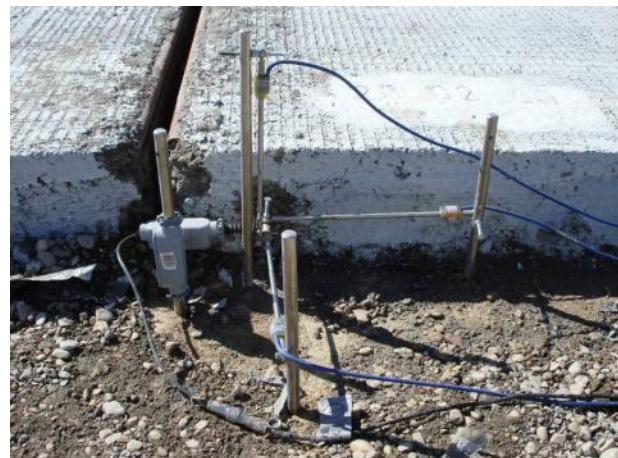
(a) Sensor for temperature and RH

(b) VWSG at different depths

(c) Non-stress cylinders

(d) Crackmeter at armor joint

Figure 3.2 Various gages installed

movement were placed at different distances from the slab center before the first longitudinal PT application (see Figure 3.1). As shown in Figure 3.2-(d), each crackmeter set can measure slab movement in longitudinal, transverse, and vertical directions.
