# Just in Time Technology Transfer for Portland Cement Concrete Pavement Construction and Rehabilitation

Research Project 5-9045-05  
Research Product 5-9045-05-1  
<http://www.techmrt.ttu.edu/reports.php>

1. Report No. FHWA/TX-12-5-9045-05-1	2. Government Accession No.:	3. Recipient's Catalog No.:	
4. Title and Subtitle: Just in Time Technology Transfer for Portland Cement Concrete Pavement Construction and Rehabilitation		5. Report Date: August 2012

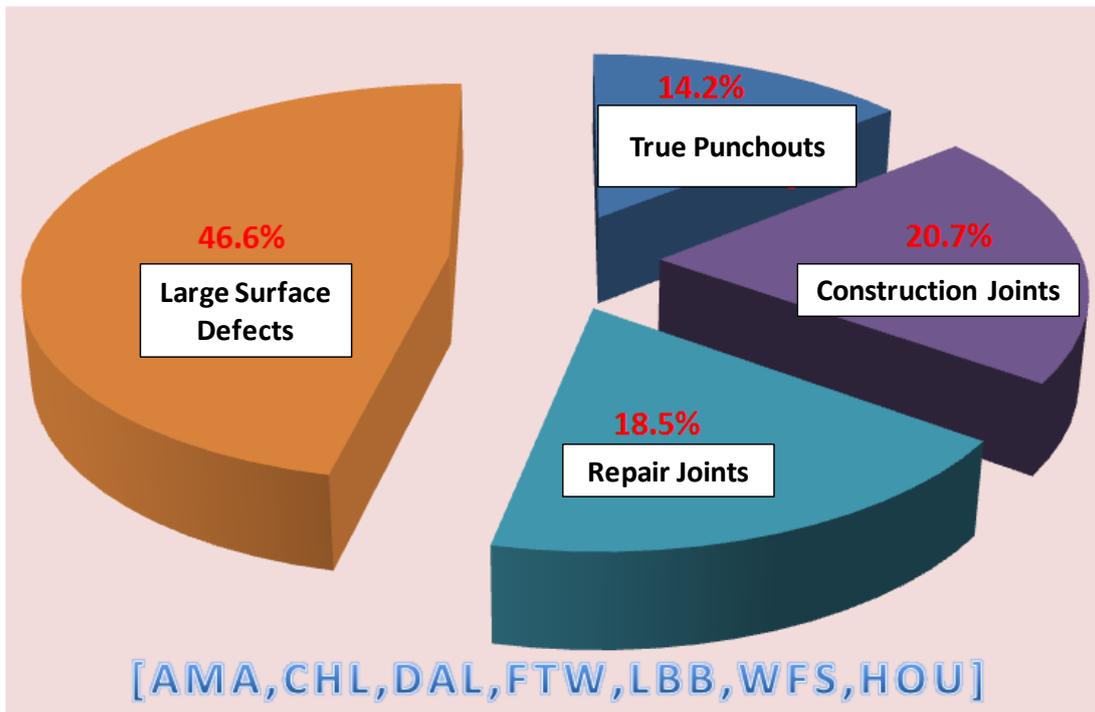
Figure 1 Classification of CRCP distresses in Texas

Figure 1 shows that about half of all the punchouts recorded in TxDOT PMIS are actually large surface defects. These defects, shown in Figure 2, are primarily due to the use of a specific coarse aggregate type, or poor finishing practices. The distress in Figure 2-(a) is due to poor workmanship during the finishing operations. Large spalling and subsequent repairs as shown in Figure 2-(b) are due to the use of a coarse aggregate with high coefficient of thermal expansion (CoTE). Efforts are currently underway in TxDOT to address the coarse aggregate issue.

Continuously reinforced concrete pavement (CRCP) is the most widely used rigid pavement type by the Texas Department of Transportation (TxDOT), primarily due to its excellent performance. Many miles of CRCP have provided longer performance period or more traffic than design traffic with few distresses. However, this does not mean that CRCP performance has been perfect. Field evaluations conducted on CRCP performance under TxDOT’s “Rigid Pavement Database” research projects 0-5445 and 0-6274 revealed that even though overall distress rates in CRCP are low, there are distresses observed in CRCP. Also discovered is that most of the distresses – more than 85 percent – were related to quality issues on materials and construction. Figure 1 illustrates the classification of CRCP distresses in Texas.

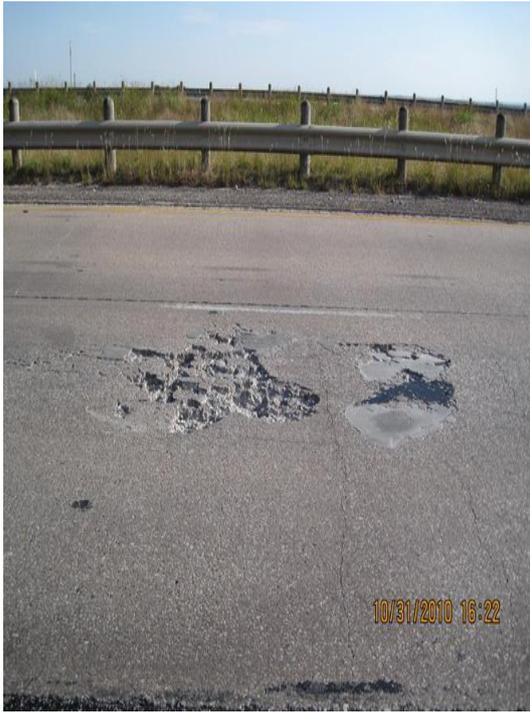
Figure 2-(a) Large surface defect

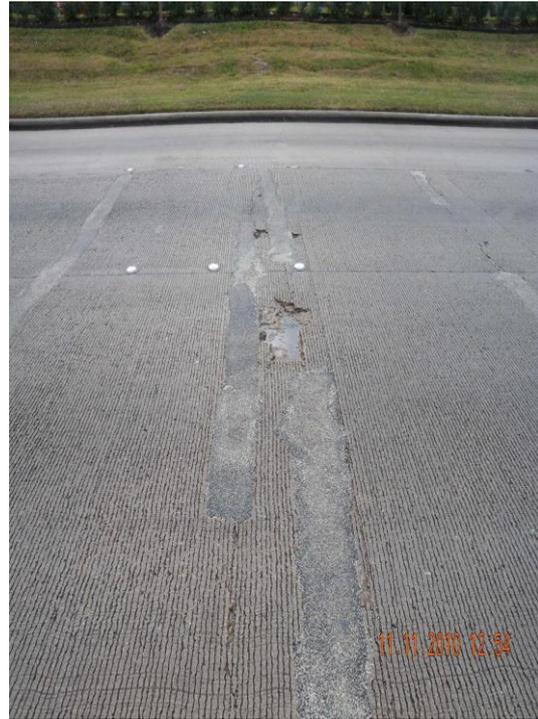
Figure 2-(b) Spalling and repairs

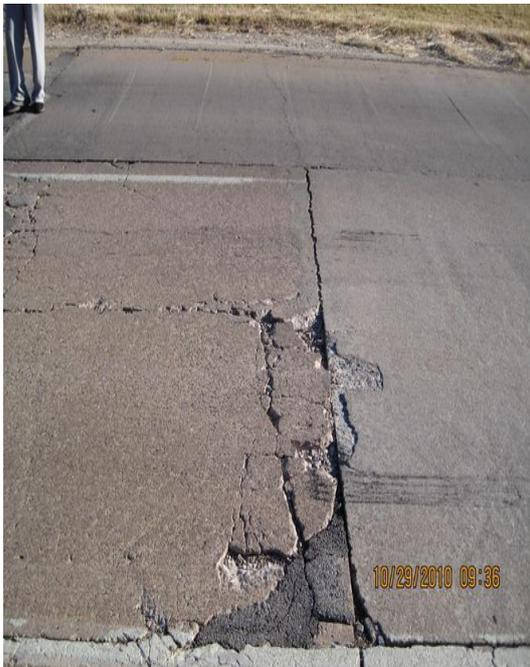
Figure 3-(a) Distress at repair joint

About 19 percent of punchouts recorded in TxDOT PMIS are actually distresses related to previously repaired joints. Figure 3 shows the distresses next to the repair joints.

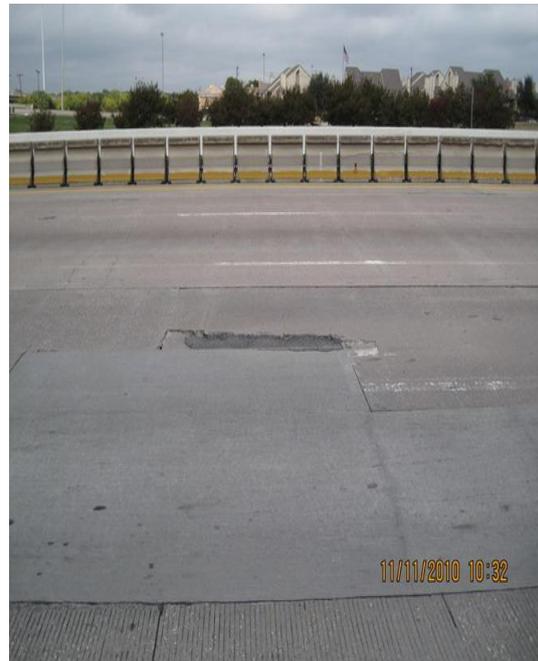
Figure 3-(b) Distress at repair joint

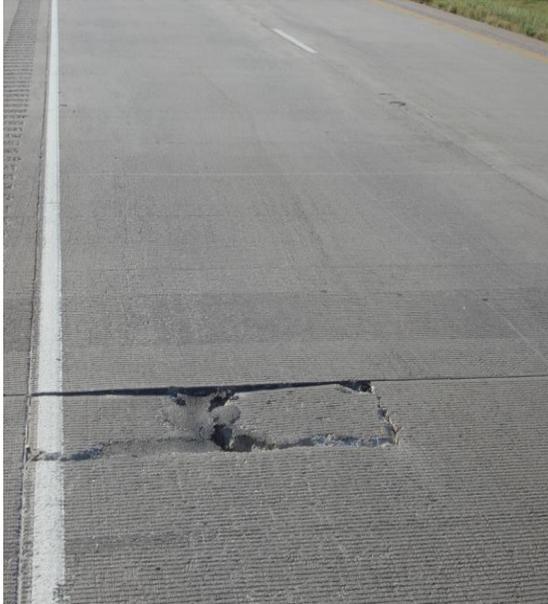
Figure 4-(a) Distress at transverse construction joint

About 21 percent of the punchouts recorded in TxDOT PMIS occur at transverse

construction joints, as shown in Figure 4. This could be due to the materials or construction practices in the joint area. Currently, research efforts are under way to identify the causes of this type of distress.

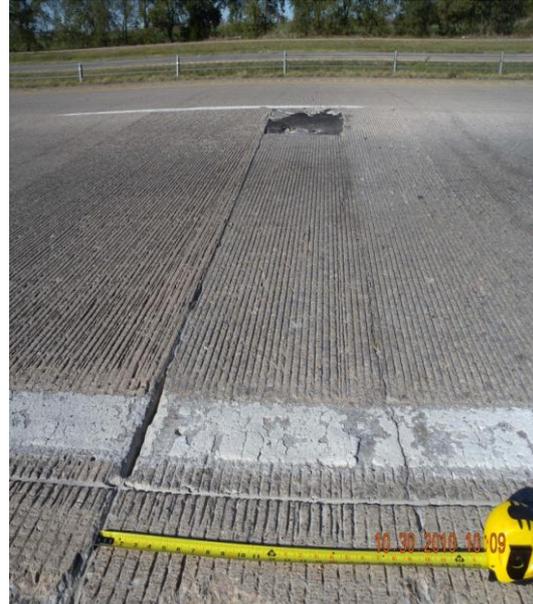
Figure 4-(b) Distress at transverse construction joint
