TEXAS TECH UNIVERSITY

Continuously Reinforced Bonded Concrete Overlay of Distressed Jointed Concrete Pavements

Report #: 5-4893-01-1
www.techmrt.ttu.edu/reports.php

March 2011

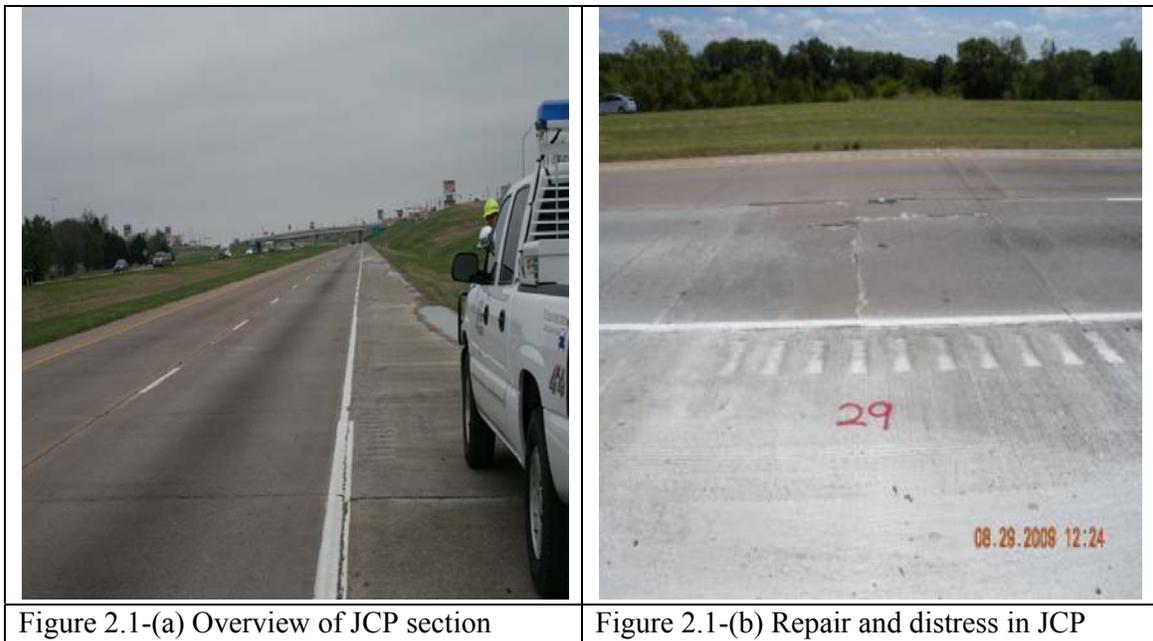
Figure 2.1-(a) shows the overall condition of the JCP section that will be overlaid with CRCP. Figure 2.1-(b) illustrates typical distress and repairs in JCP. There were numerous cracks and repairs in this section. The slabs were numbered from Exit 64, southbound. For example, the slab shown in Figure 2.1-(b) is 29th slab from Exit 64.

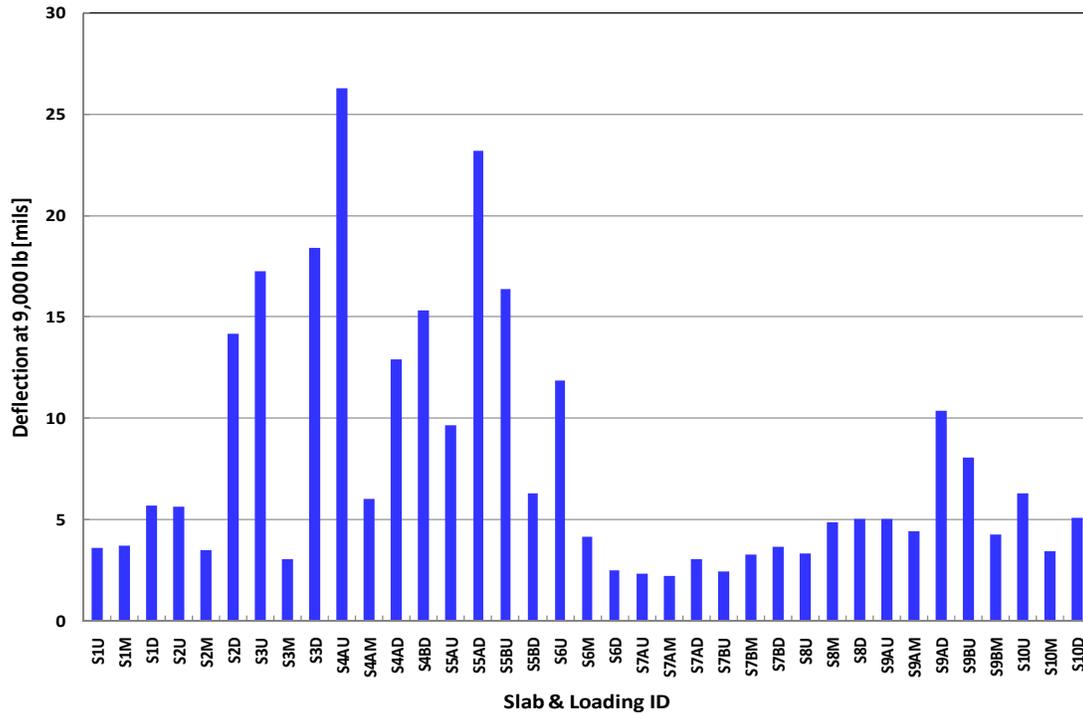
Figure 2.2 Slab deflections at various locations in Slab 1 thru Slab 10

three locations in each slab – upstream, middle of the slab, and downstream. If there were repairs, additional testing was conducted at the repaired transverse joints. Figure 2.2 illustrates the deflections in the first 10 slabs. In the x-axis, in SnU, S stands for Slab, n indicates the slab number, and U stands for Upstream (D is for Downstream). Where there were repair joints in the slabs, A or B is inserted between the slab number and the location of the drop (Upstream or Downstream). For example, S4AM indicates the drop at slab number 4, middle between upstream joint and first transverse repair joint. The crack map in Appendix A should be consulted when interpreting the deflection data. Figure 2.2 shows that there is a large variation in deflections, depending on the location of the FWD drops – smallest at the middle of the slab and largest at the upstream or downstream at transverse or repair joints. Two deflections with more than 20mils were both at repair joints, which indicates poor LTE at repair joints. The large deflections at transverse repair joints resulted most probably from poor tie bar insertion practice. Deflection information for the rest of the slabs is included in Appendix B.

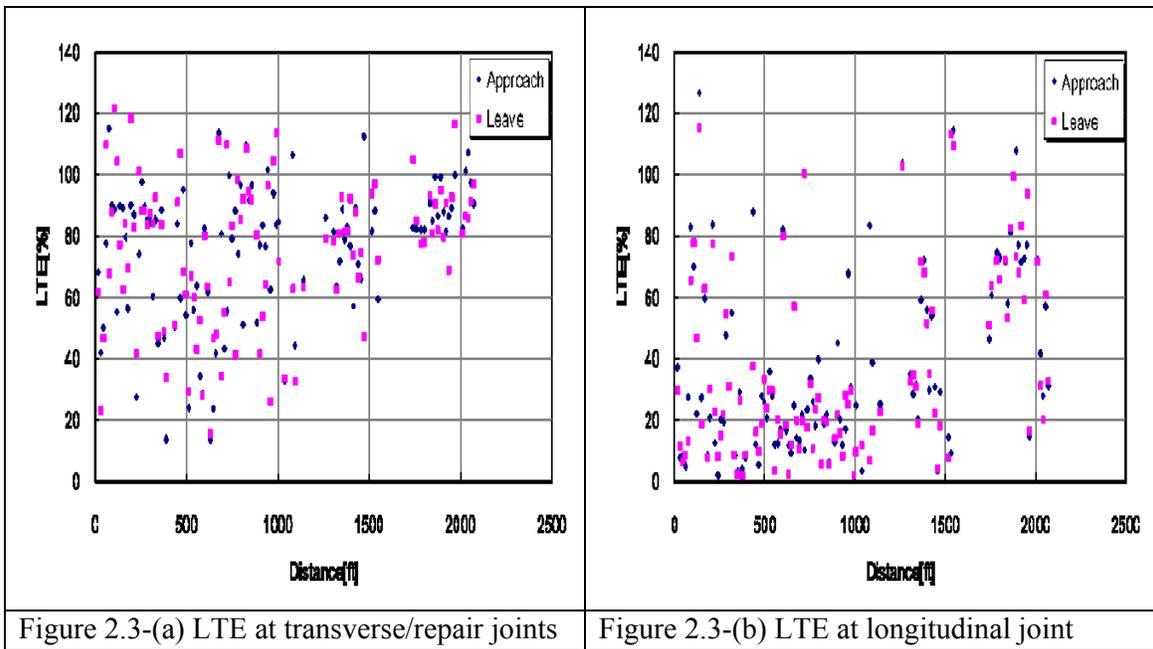
Figure 2.3-(a) illustrates LTE at transverse contraction and repair joints. It shows that LTEs were low in many joints, even though dowels were used. The low LTEs are of concern because the potential for reflection cracking at transverse and repair joints will be more likely, unless things are done to prevent or minimize the reflection cracking. Figure 2.3-(b) shows LTE along the longitudinal joint between outside lane and outside shoulder, which was retrofitted in 1998.

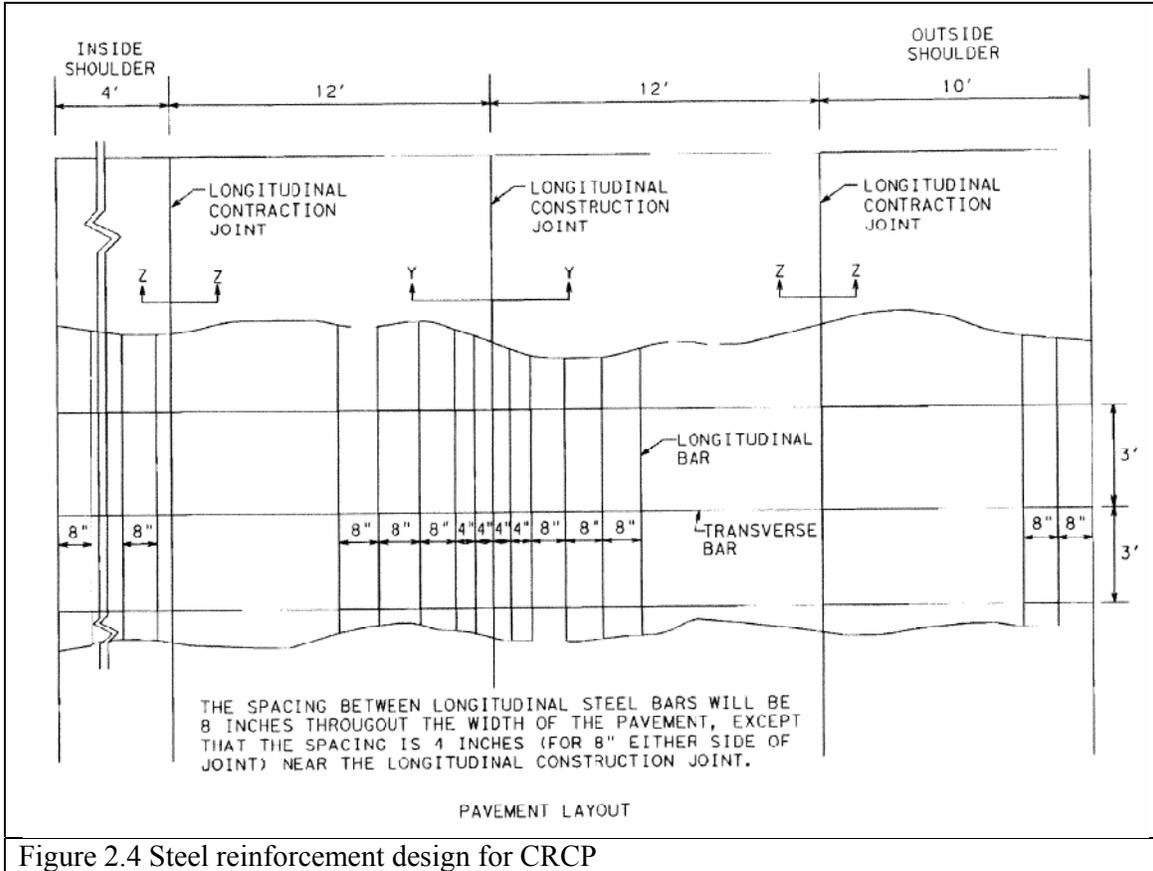
Figure 2.4 Steel reinforcement design for CRCP

Longitudinal steel was determined based on the experience in Texas. Currently in TxDOT, 0.68% of longitudinal steel is used for 15-in CRCP. The combined slab thickness was 17-in and it was decided that 0.7% steel would be used. In new CRCP, this steel percentage is based on the cross-sectional area of the whole section. In the bonded overlay, a decision has to be made as to whether the combined cross-sectional area or just the new CRCP overlay cross-sectional area should be used. The purpose of the longitudinal steel in CRCP is to induce transverse cracks due to temperature and moisture variations in concrete and hold them tight for good load transfer. It can be assumed that there will be little further drying shrinkage that will develop in the existing CPCD, since the concrete is more than 15 years old. Also, after 7-in concrete over the CPCD, the temperature variations in CPCD will be minimal. Most of the transverse cracks occur in places other than transverse joints. Accordingly, the load transfer efficiency at cracks in CRCP will be enhanced. As a result, it was decided that the use of CRCP cross-sectional area was appropriate for the estimation of the amount of longitudinal steel. Number 6 bars were used for longitudinal steel. Steel was placed 4-in from the surface of CRCP, which is 0.5-in lower than mid-depth. The reason for lowering the steel was to provide more restraint on concrete volume changes in the lower half of the CRCP slab, which will enhance the bonding of new concrete to old concrete. The spacing for transverse steel was at 3-ft with No. 6 bars. Transverse steel was placed below longitudinal steel, as in normal CRCP construction. Figure 2.4 shows the steel reinforcement design for this project.

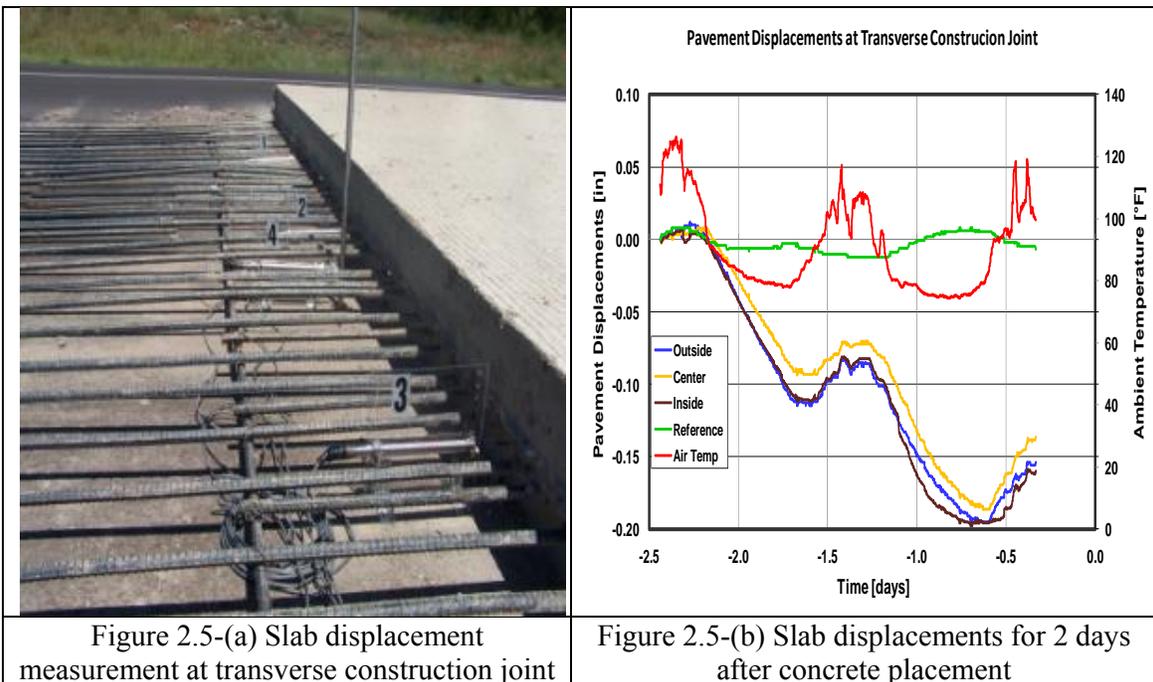
Figure 2.5-(a) Slab displacement measurement at transverse construction joint

Figure 2.5-(b) Slab displacements for 2 days after concrete placement

Large contractions of concrete were noted. In the x-axis, a whole number indicates midnight. Minus 2.0 indicates midnight on Friday. Minus 1.5 and -1.0 indicate Noon Friday and midnight on Saturday, respectively. By Sunday morning, there was about 0.2 in. of concrete contraction. Based on the ambient temperature history, it appears that drying shrinkage played a dominant role in concrete displacement. As will be discussed later, wet-mat curing was specified in the rehabilitation project to minimize shear stress at the interface between old and new concrete in the transition area, and to minimize potential wide transverse cracks. Concrete contraction of this magnitude could cause substantial stresses in concrete at the interface in the transition area.

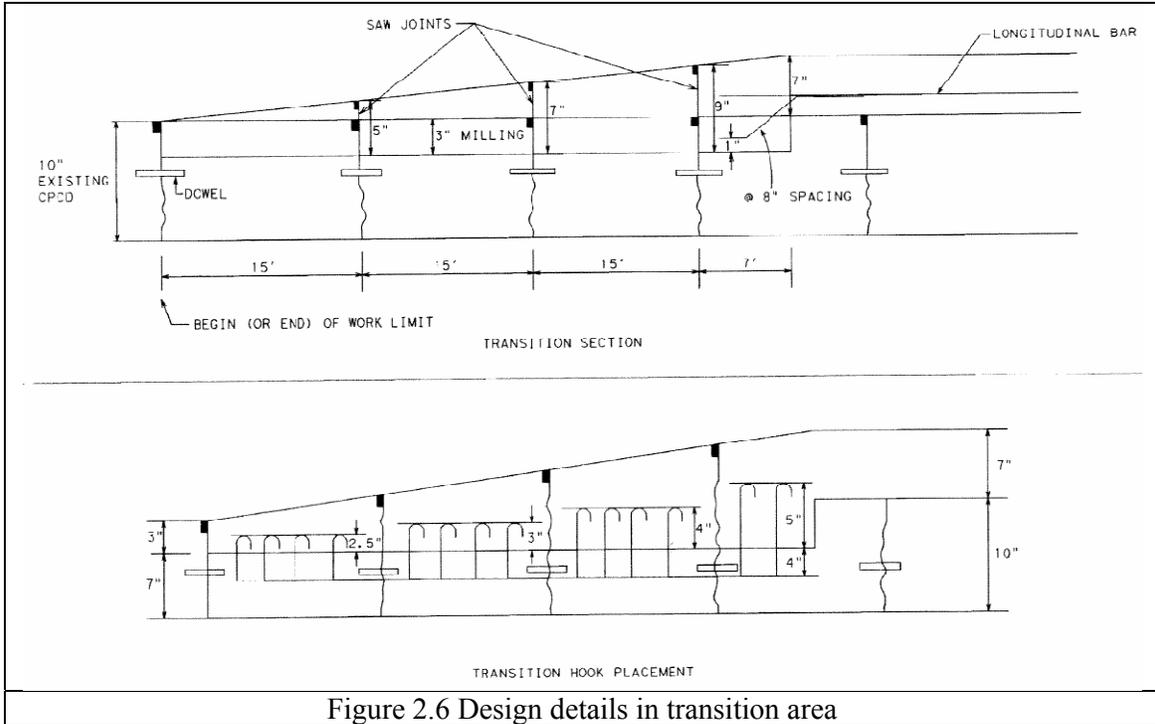
Figure 2.6 Design details in transition area

Figure 2.6 shows the design details in the transition area to minimize the potential for debonding at the interface between old and new concrete. In research project 0-4893, it was observed that most of the distresses in bonded concrete overlay were caused by debonding at the interface. Figure 2.7-(a) shows two transverse cracks at the transverse construction joint on US281 CRCP bonded overlay project in the Wichita Falls District. In this project, 4 in. of CRCP bonded overlay was placed on 6 in. of existing CRCP. Sounding testing in this area showed debonding. It is important to provide effective restraints on concrete volume changes in the transition area. It is shown that providing good bonding at the interface is of utmost importance in ensuring good performance of this rehabilitation project. Figure 2.6 shows that transition was provided in three jointed concrete pavement slabs plus 7 ft. This decision was made to provide one percent of vertical profile difference. Since the elevation difference between existing JCP and the overlaid section was 7 in., the difference in vertical profile is $7 \text{ in.} / ((3 \times 15 + 7) \times 12) \times 100 = 1.12$ percent. The plan called for the milling of the top 3 in. of JCP in the transition area. During construction, a decision was made to mill the top 5 in. of JCP as shown in Figure 2.7-(b). Figure 2.7-(b) shows the beginning of the transition from JCP. The milling of 5 in. resulted in exposing dowels, since the slab thickness of the existing JCP is 10 in. Hook bars were required as shown in Figure 2.7-(b). The hook bars were installed at 4 ft

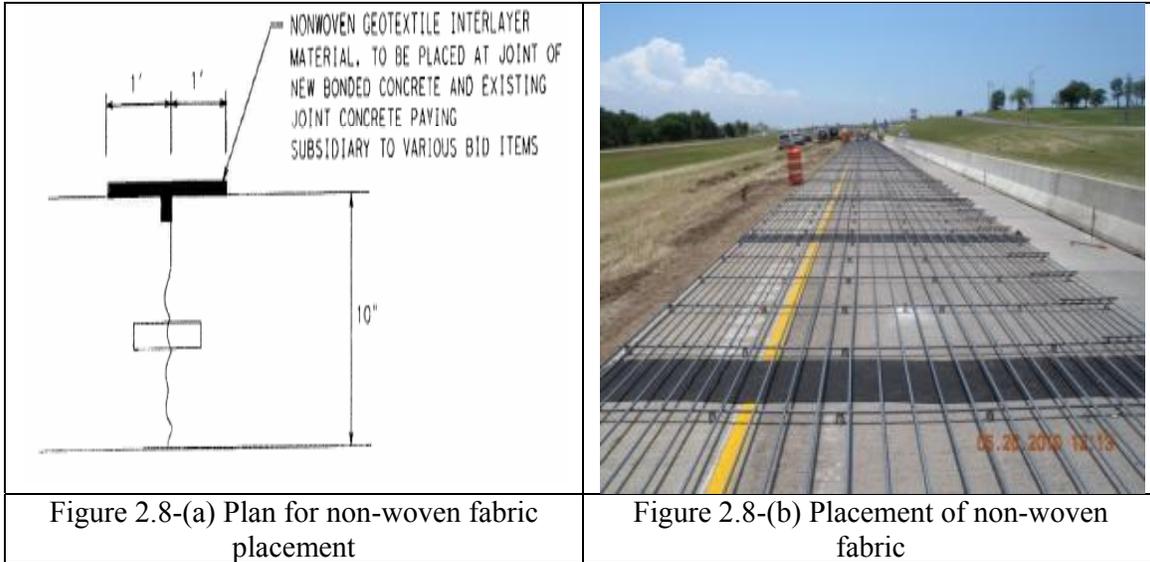
One of the most critical areas in this rehabilitation project was how to minimize the reflection cracking potential at the transverse contraction joints. As shown in Figure 2.3-(a), LTEs in some transverse joints were quite low, even though dowels were used. Joints with low LTEs could cause reflection cracking in CRCP overlay and result in distresses. Research study conducted in 1989 on SH 6 in Houston clearly indicated the potential for reflection cracking when concrete was placed on an asphalt layer with cracks.⁽³⁾ To minimize the reflection cracking potential, a decision was made to place 2-ft wide non-woven fabric on top of transverse joints. Figure 2.8-(a) shows the plan requirement and Figure 2.8-(b) shows the non-woven fabric installed. The non-woven fabric used was Mirafi 1450BB from Tencate Company. The material properties of the fabric are shown in Table 2.1.

Figure 2.8-(a) Plan for non-woven fabric placement

Figure 2.8-(b) Placement of non-woven fabric

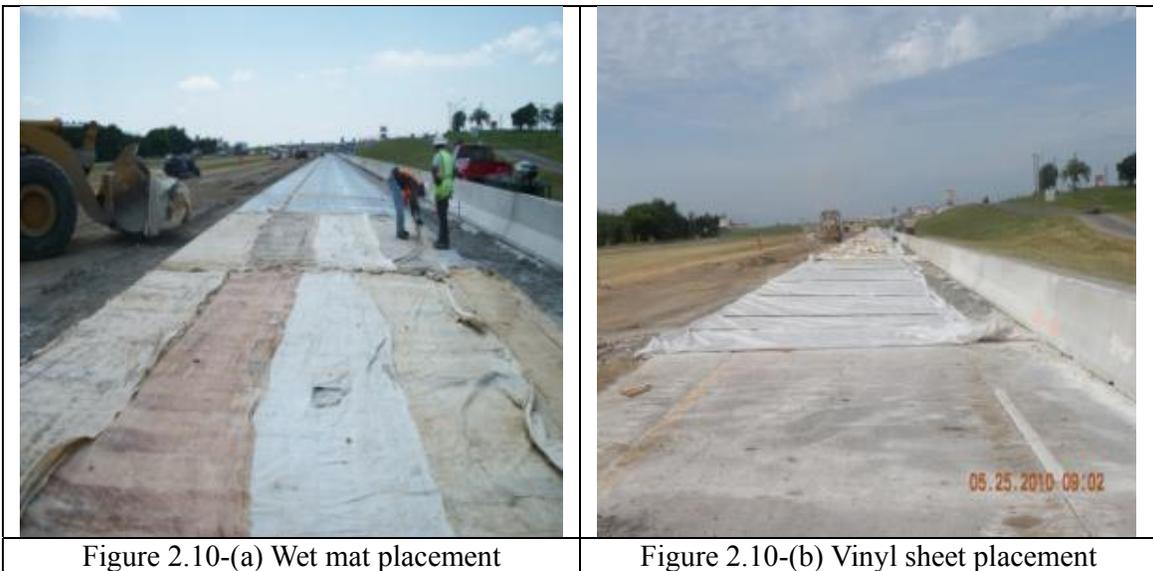
Figure 2.10-(a) shows the wet-mat curing applied in this project on the day of concrete placement (May 24, 2010). Cotton mat was placed and kept wet by water spraying. On the same day, vinyl sheet was placed on top of the cotton mat to prevent drying of cotton mat, as shown in Figure 2.10-(b). Steel rebar was placed to keep vinyl sheet in place. Cotton mat was kept in place for 7 days.

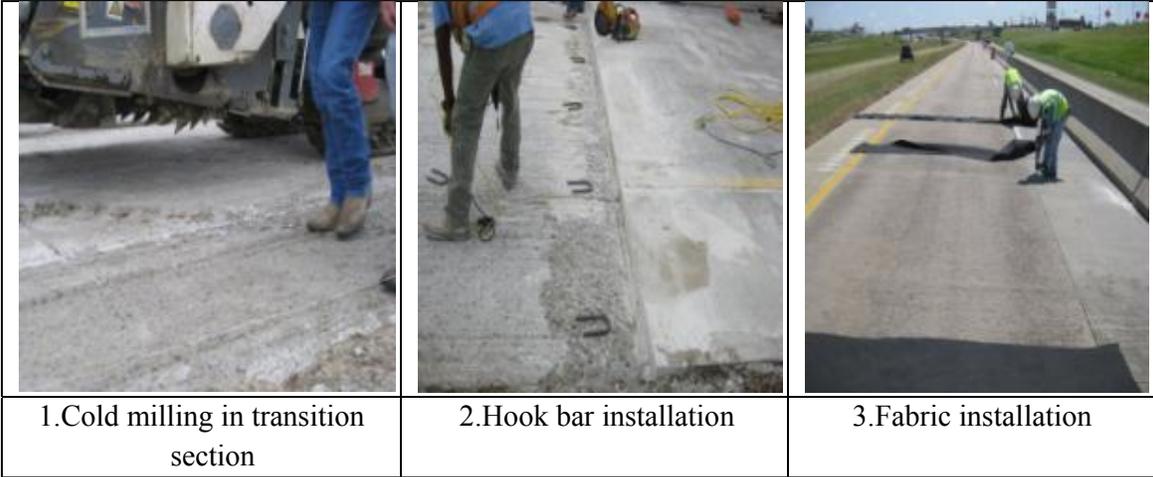
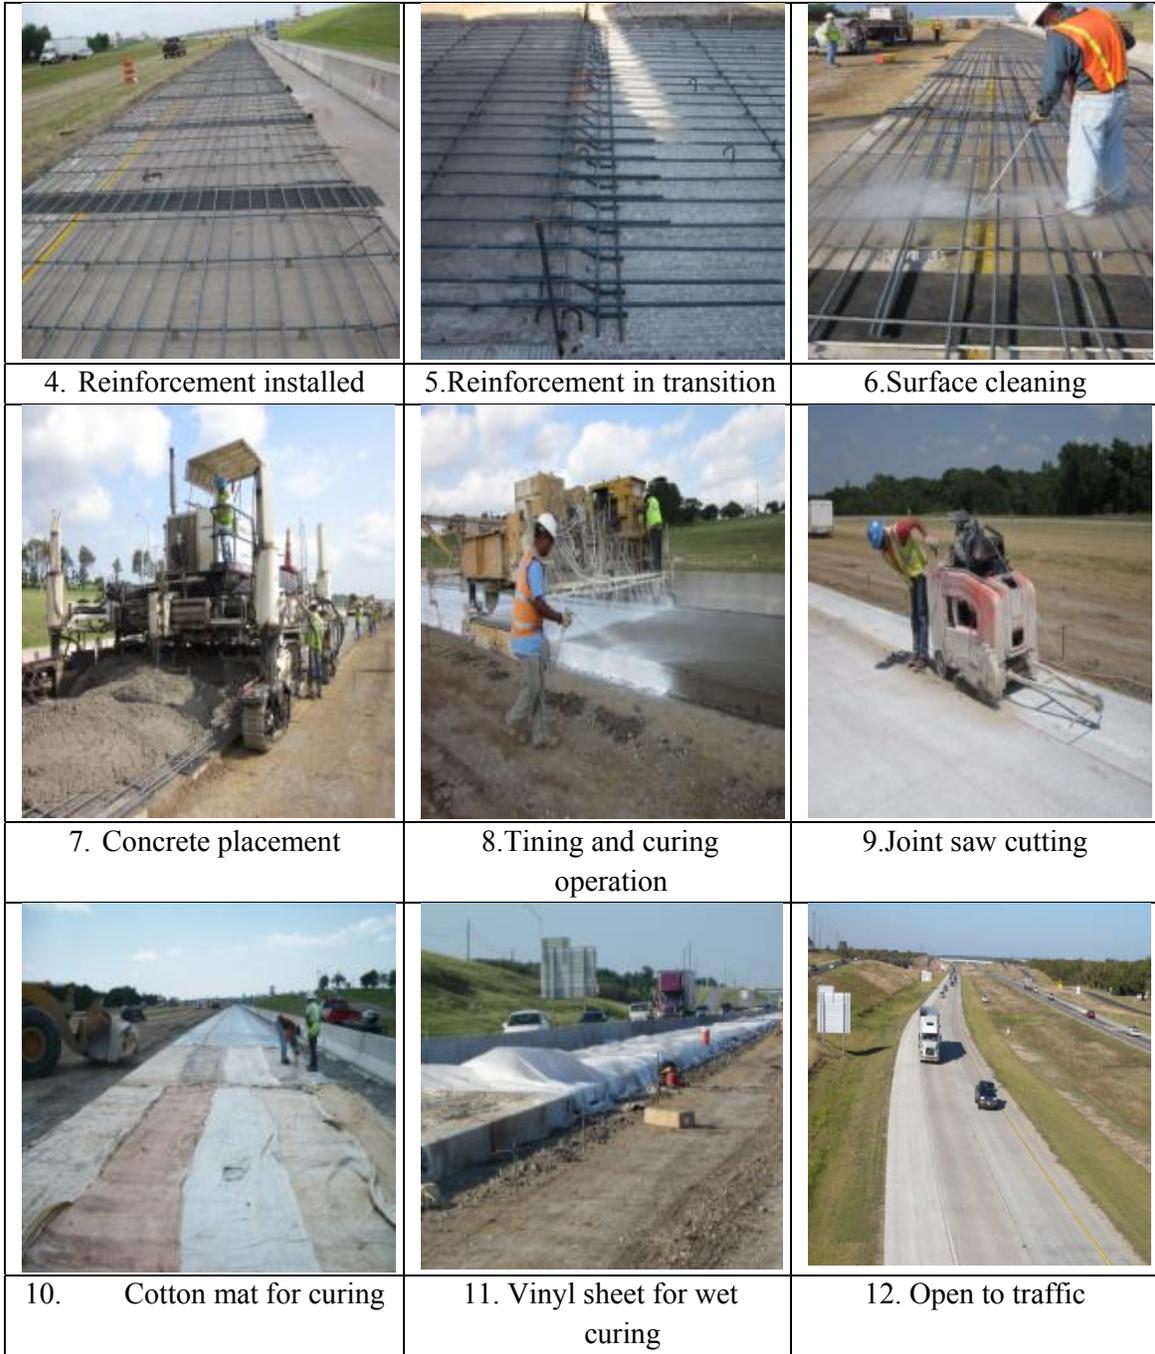
Figure 3.1 Construction sequence of CRCP BCO

Figure 3.1 shows the sequence of the construction utilized in the Phase 1 construction.

Transition sections in the north and south ends consisted of three slabs plus half a slab each, for a total of 52.5 ft long. The top 5 in. of concrete was removed by cold milling. Hook bars were installed every 4 ft in both directions in the transition sections, and longitudinal steel was placed. Non-woven fabric, 2 ft wide and 16 ft long, was installed at transverse contraction joints with nails and epoxy. Longitudinal and transverse steel was placed with

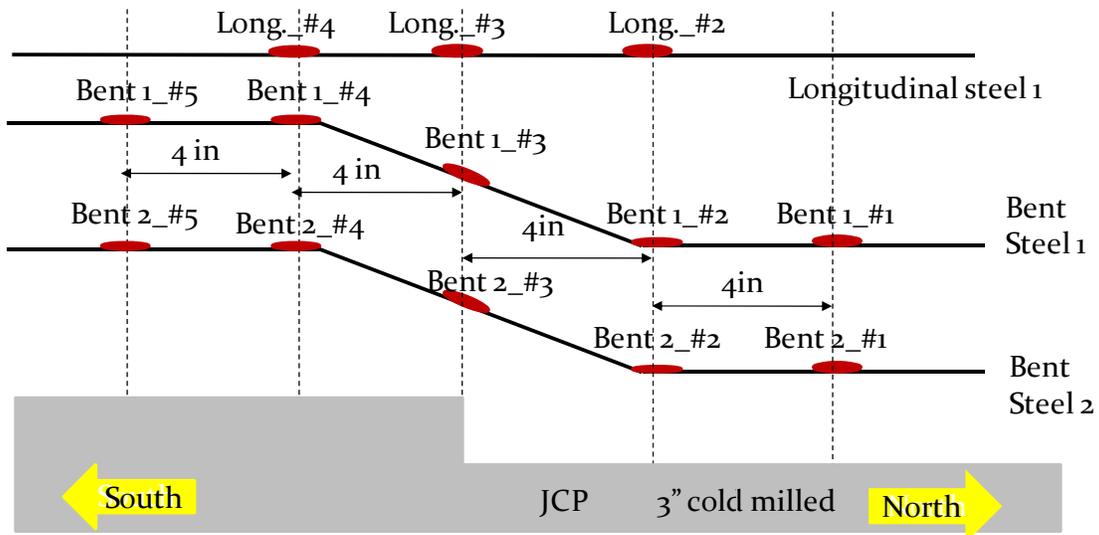
Figure 3.3 Steel strain gages installed in north transition section

Figure 3.3 illustrates SSGs installed in the transition area at the north limit of the project. A total of 13 SSGs were installed – 10 of them in the bent bars and three in the longitudinal steel.

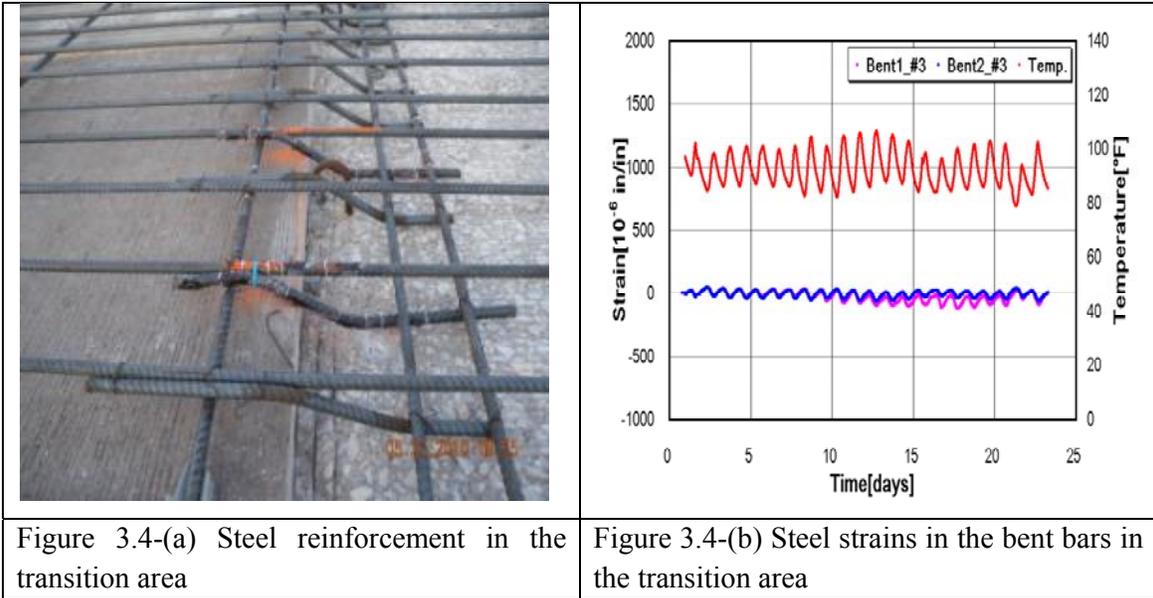
Figure 3.4-(a) illustrates steel configuration at the intersection between normal overlay and transition area. Bent bars were installed to strengthen the rigidity of the concrete in this area, because of the differences in structural rigidity of concrete slabs (7 in. vs 12 in. thick slabs). The comparison of steel strains in bent bars 1 and 2 are shown in Figure 3.4-(b). There is little variation in steel strains in the bent bars at location #3, where concrete thickness varies from 7 in. to 12 in. It should be noted that the direction of the steel at this location is not horizontal, and that the steel strains measured are in the inclined direction.

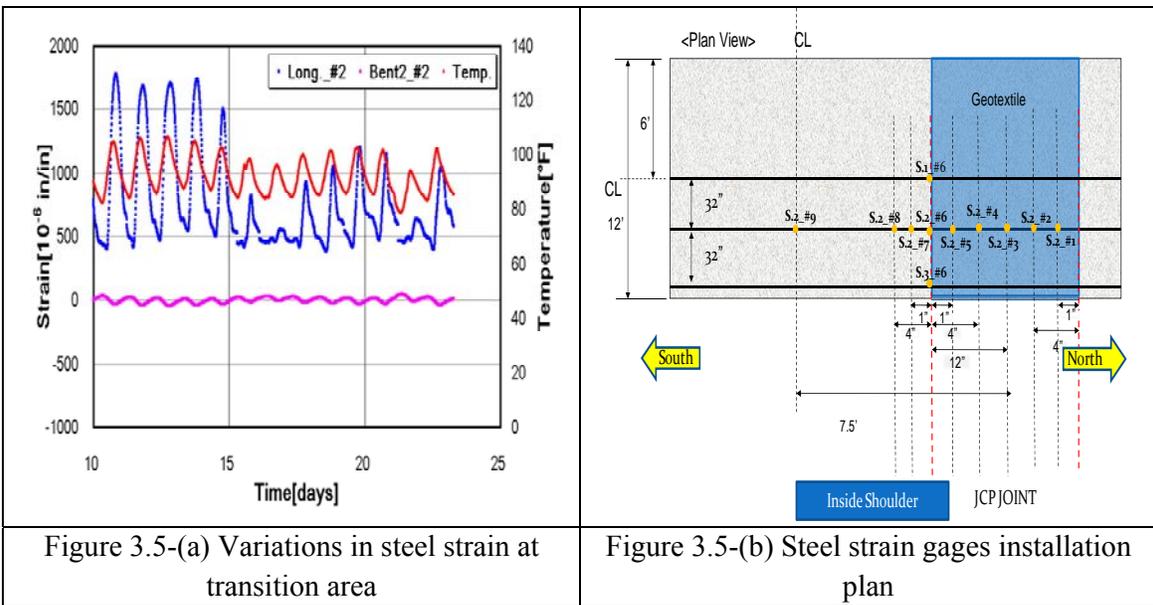
Figure 3.5-(a) compares steel strains at longitudinal steel and bent bar at location 2, which is 4 in. north from the intersection between normal overlay and transition area. Very little variation was observed in the steel strain in the bent bar, whereas quite large variations in steel strain, up to 1,300 $\mu\epsilon$ a day, were observed in the longitudinal steel.

Large strain variations in the longitudinal steel could have been caused by transverse micro-cracks in concrete in this area, even though no cracks were visually observed in this area at that time. Temperature and moisture variations, and resulting concrete strains and stresses, were maximum in the concrete near the surface. Once micro-cracks develop, the stresses in the concrete are relieved and cracks do not propagate. Low steel strains in the bent bar, which is below the mid-depth of 7 in. concrete slab, indicate the micro-cracks did not

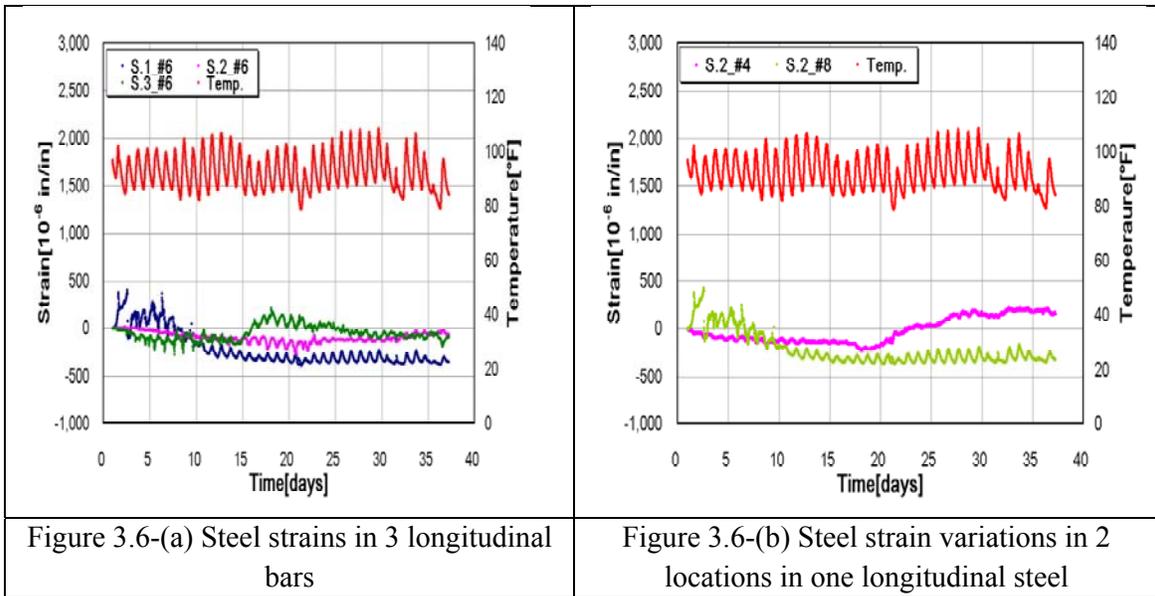
Figure 3.6-(a) presents the steel strains in three longitudinal bars at the end of the fabric. Daily steel strain variations were quite small, which indicates no transverse cracks in this area and illustrates that the bond between new CRCP and JCP with no fabric was quite good. It also indicates that almost no bonding between new CRCP and JCP due to the use of fabric does not necessarily alter the steel and concrete stress distributions in this area. This finding is supported by the transverse cracking in this project. About 80% of transverse cracks were developed at transverse steel locations, which indicates that the concrete stresses due to environmental loading were much more affected by the interactions between steel and concrete, not by the bond strength at the interface between old and new concrete. This finding should be interpreted with a caution. Stresses in longitudinal steel are affected by transverse cracks. Steel stresses could be quite large at transverse cracks, and diminish quite rapidly as the distance from the crack increases. In 2004, steel strains were measured on CRCP in US 59 in Cleveland, Houston District.⁽⁴⁾ Figure 3.7-(a) illustrates the steel strain gage

Figure 3.6-(b) presents steel strains in a longitudinal steel bar at two different locations – one at 4 in. from the end of fabric into the fabric area and the other at 4 in. from the end of fabric into the no fabric area. It is shown that steel strain variations are quite small in both locations, even though those outside the fabric area have larger daily variations than those inside the fabric area.

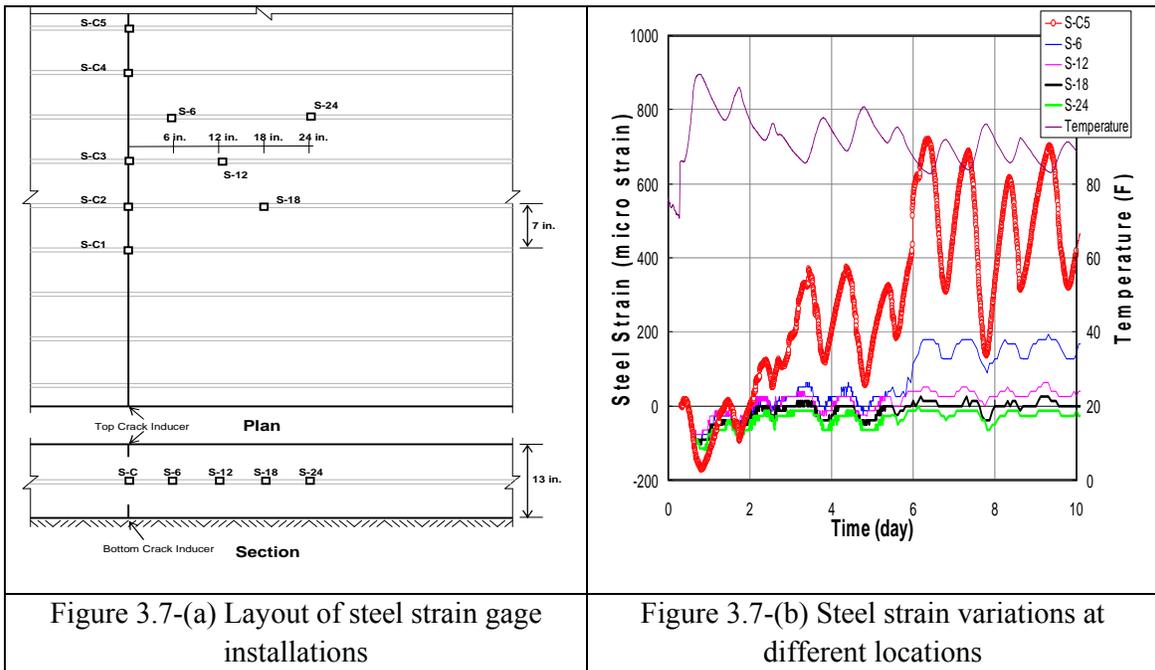
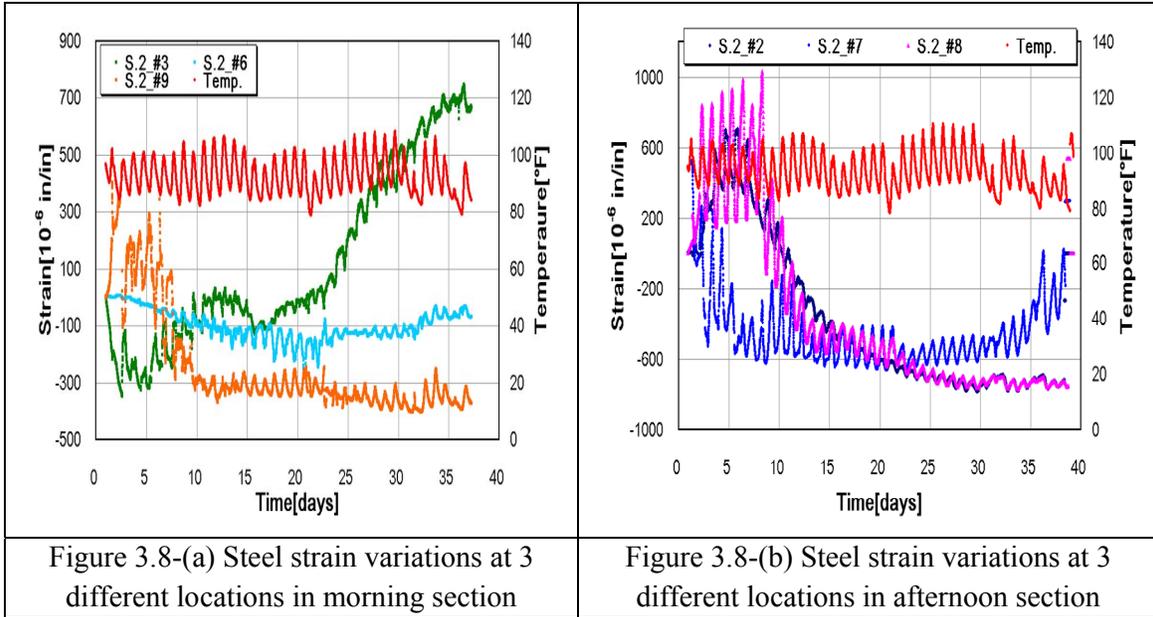
Figure 3.8-(a) Steel strain variations at 3 different locations in morning section

Figure 3.8-(b) Steel strain variations at 3 different locations in afternoon section

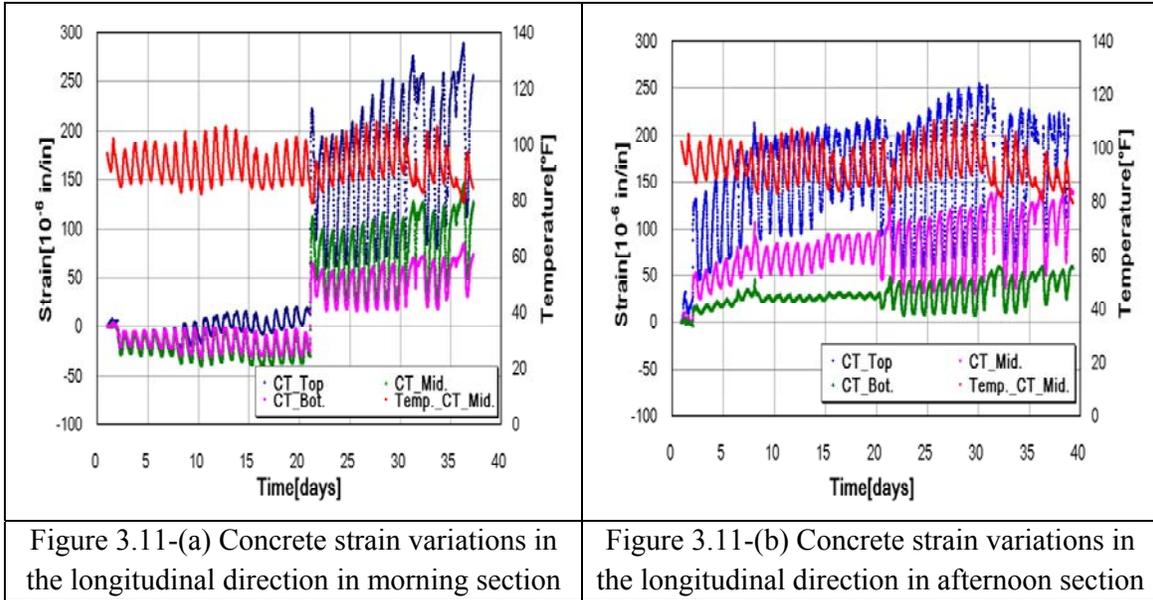
Figure 3.11-(a) Concrete strain variations in the longitudinal direction in morning section

Figure 3.11-(b) Concrete strain variations in the longitudinal direction in afternoon section

Figures 3.11-(a) and 3.11-(b) illustrate the concrete strains in the longitudinal direction in the morning and afternoon section, respectively. Comparison of the morning and afternoon sections indicates that concrete strain variations in the afternoon section are much larger than those in the morning section, up to day 21. In CRCP, concrete strains are maintained quite small, unless transverse cracks occur within the gage length of VWSG. In Figure 3.11-(a), large variations of concrete strains are observed at day 21. This indicates a transverse crack occurred at day 21. On the other hand, Figure 3.11-(b) shows large concrete variations at day 2, which indicates a transverse crack occurred at that time. Also noted in the figures is that concrete strains are largest at the top and smallest at the bottom. The increase in the concrete strains at the bottom after the crack occurrence indicates that debonding at the interface occurred in the vicinity of the transverse crack.

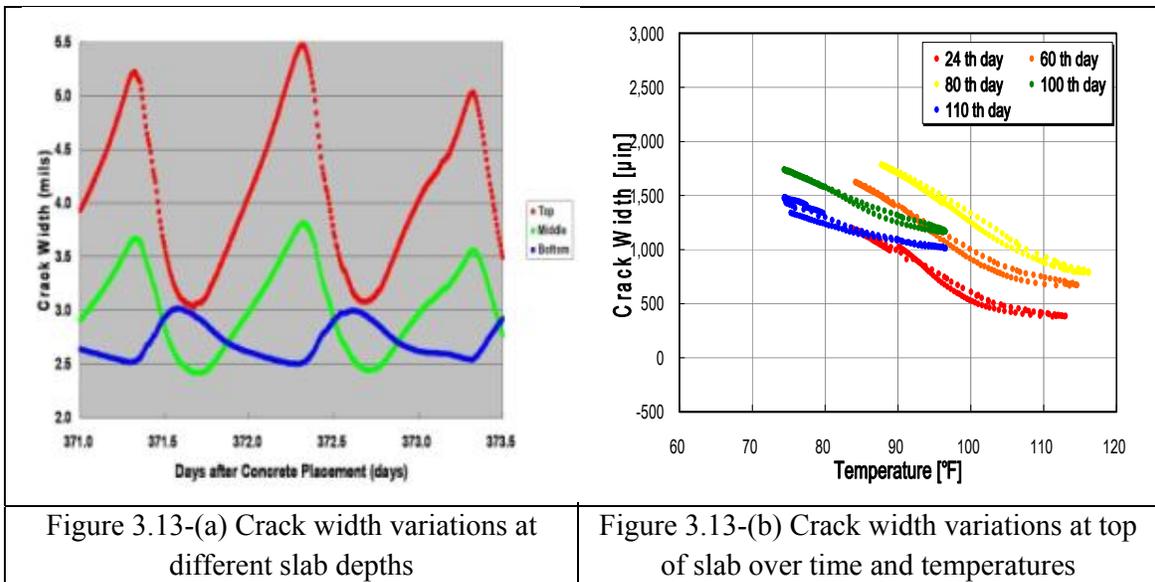
Figure 3.13-(b) shows the crack width variations at the top of the slab over time of the crack in the morning section. Crack width increased from day 24 to day 60 to day 80. On the other hand, crack width actually decreased on day 100 and further on day 110, even though concrete temperature decreased in that time period. This finding is consistent with the observations made in other CRCP sections, where crack widths decreased over time.⁽¹⁾ The difference is that the observations made in Reference 1 were at an induced transverse crack, while in this project, the crack occurred naturally. The prevailing current theory on CRCP crack behavior is that crack width increases over time, and load transfer decreases with the increase in crack width, ultimately resulting in punchouts. The findings in this study and reference (5) indicate otherwise. Long-term monitoring will be made on the behavior of this crack and included in the report under TxDOT Project 0-6274.

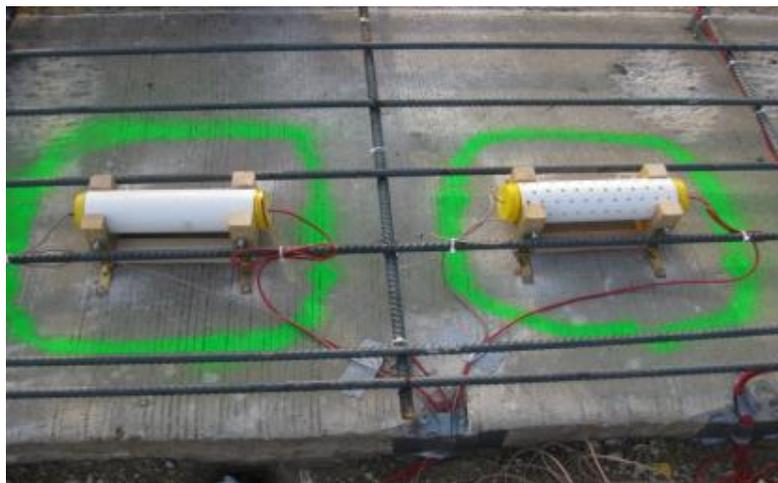
Figure 3.14 Impervious (left) and pervious (right) NSC

Non-stress cylinders (NSC) were installed in the morning and afternoon concrete sections. Two NSCs were installed in each location – one with impervious NSC (INC) and the other with pervious NSC (PNC), as shown in Figure 3.14. The center of the NSCs was 4 in. from the surface of the CRCP. In Figure 3.14, the cylinder on the left is INC and the one on the right is PNC. The concrete inside of the INC remains almost saturated, since it does not lose any moisture and initially sufficient moisture is provided on the inside wall of the INC. The only shrinkage in the concrete in INC could be chemical and autogenous shrinkage. Since excess water was provided in the INC using cotton, both shrinkages are assumed to be negligible, and the concrete strains in INC are due to temperature variations only. The slope of a line between concrete temperatures and concrete strains in INC, therefore, will be in-situ CTE. On the other hand, the concrete in PNC will lose or gain moisture through holes by moisture exchange with the surrounding concrete and it is assumed that there is moisture equilibrium in concretes inside and outside of the PNC. Accordingly, the concrete strains in the PNC will be due to both thermal and moisture variations. The difference in concrete strains in INC and PNC will be drying shrinkage.

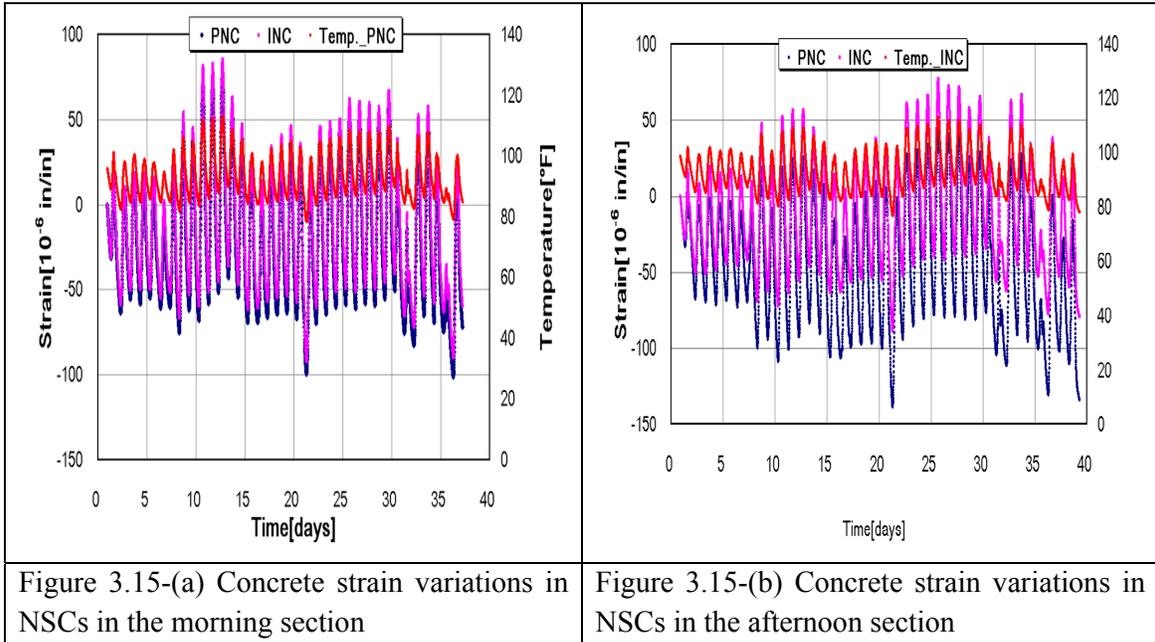
Figures 3.15-(a) and 3.15-(b) show the INC and PNC data from the morning and afternoon sections, respectively. They show that concrete strains vary along with concrete temperature. Also, the difference in concrete strains between INC and PNC in the morning section is much smaller than that in the afternoon section. This indicates that the drying shrinkage in the morning section would be smaller than that in the afternoon section.

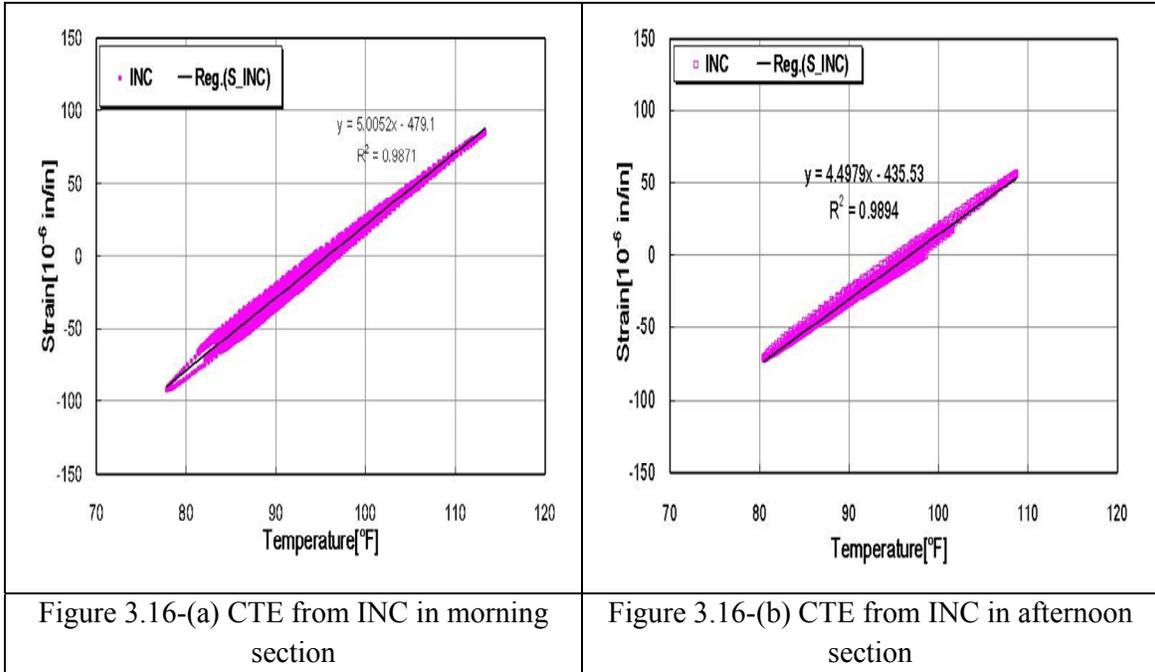
3.3.2.3.1 In-situ CTE Evaluation: In-situ CTE was estimated from the data in INC in the morning and afternoon sections, as shown in Figure 3.16-(a) and 3.16-(b), respectively. CTE values of 5.0 and 4.5 microstrain/ °F were obtained in the morning and afternoon sections, respectively. A difference of 0.5 microstrain/ °F was observed between morning and afternoon sections. It is well known that concrete paste has higher CTE than coarse aggregate. ^(6,7) It could be that, when concrete was put into INC in the morning section, the proportion of cement paste was larger than that in the mix design. The CTE value of concrete with this coarse aggregate as evaluated by CSTMP was less than 4.6 microstrain/ °F. For the accurate evaluation of in-situ CTE, efforts should be made to ensure that the proportions of the concrete mixture in the non-stress cylinders are similar to those of the concrete supplied. This finding also illustrates the requirement of a fixed mix design for the evaluation of CTE of coarse aggregate.

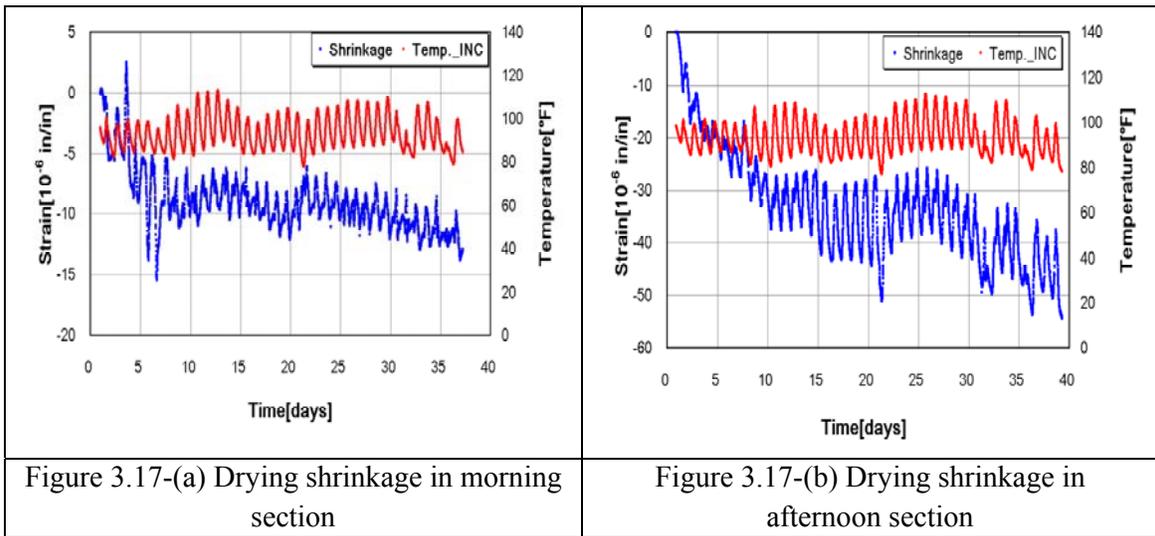
3.3.2.3.2 In-situ drying shrinkage evaluation: In-situ drying shrinkage was estimated from the data in INC and PNC in the morning and afternoon sections, as shown in Figure 3.17-(a) and 3.17-(b), respectively. Since the NSCs were installed in the lower part of the CRCP overlay (the center of NSCs was 4 in. from the surface of the slab), it is expected that the drying shrinkage will not be high. Figures 3.17-(a) and 3.17-(b) show that, overall drying shrinkage is quite small, less than 15 and 60 microstrains in the morning and afternoon sections, respectively. These values are much smaller than drying shrinkage of concrete exposed to normal ambient condition. Wet-mat curing of the concrete surface might have contributed to the small drying shrinkage. The smaller drying shrinkage in the morning section could be due to the larger CTE value in that section compared with that in the afternoon section.

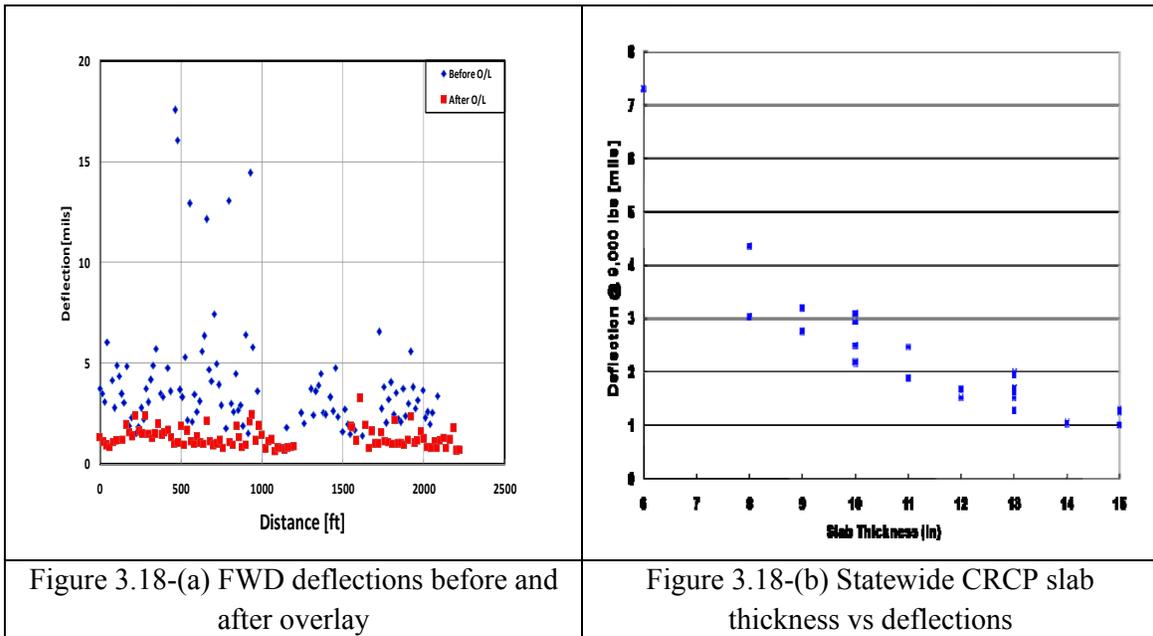
The primary benefit of bonded concrete overlay (BCO) is to enhance the structural capacity of the existing pavement system. The structural capacity of the JCP was evaluated using FWD (falling weight deflectometer) along the project before and after the overlay. Figure 3.18-(a) shows the testing results in the FWD deflections at the mid-slab conducted in the outside lane. The distance is from the beginning of the project in the north limit. Before overlay, overall deflections were large, and deflections larger than 10 mils were observed in several locations. After overlay, the deflections were reduced substantially. The average deflection at 9,000 lb loading after overlay was 1.02 mils. Figure 3.18-(b) illustrates the deflections in CRCP with various slab thicknesses in Texas. This information was obtained from the testing in Research Project 0-6274. The average deflection of 1.02 mils after overlay in this project is comparable to the deflections of 14 in. or 15 in. CRCP. The performance of 14 in. and 15 in. CRCP in Texas has been excellent and it is expected that this rehabilitation section will provide good performance for years to come. This section will be included in 0-6274 as an experimental section and deflection testing will be conducted on a regular basis.
