Evaluation, Presentation and Repair of Microbial Acid-Produced Attack of Concrete

Technical Report 0-6137-1
Cooperative Research Program

TEXAS STATE UNIVERSITY SAN MARCOS
DEPARTMENT OF ENGINEERING TECHNOLOGY
SAN MARCOS, TEXAS

TEXAS DEPARTMENT OF TRANSPORTATION

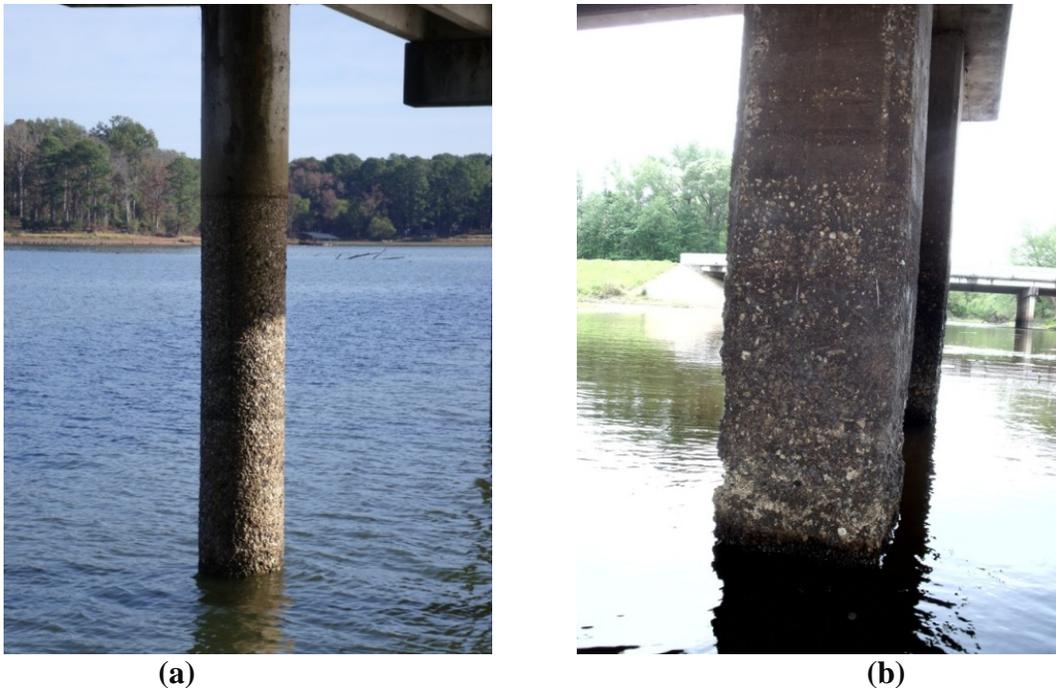
Figure 1. Examples of Deteriorated Concrete Bridge Columns with Suspected MID.

The Texas Department of Transportation (TxDOT) has approximately 50,000 bridges in its inventory. The deterioration of concrete under bridge structures, most of which is reinforced, has been a critical issue affecting the service condition of these bridges. In addition to well-known concrete durability problems associated with alkali-silica reactions (ASR), sulfate attack, delayed ettringite formation (DEF), carbonation, and freeze-thaw damage, another surface deterioration phenomenon, microbial induced deterioration (MID) has recently been identified on concrete of Texas bridges and generated strong concern at the Texas Department of Transportation (TxDOT). Figure 1 shows examples of typical TxDOT bridge columns with suspected MID issues.

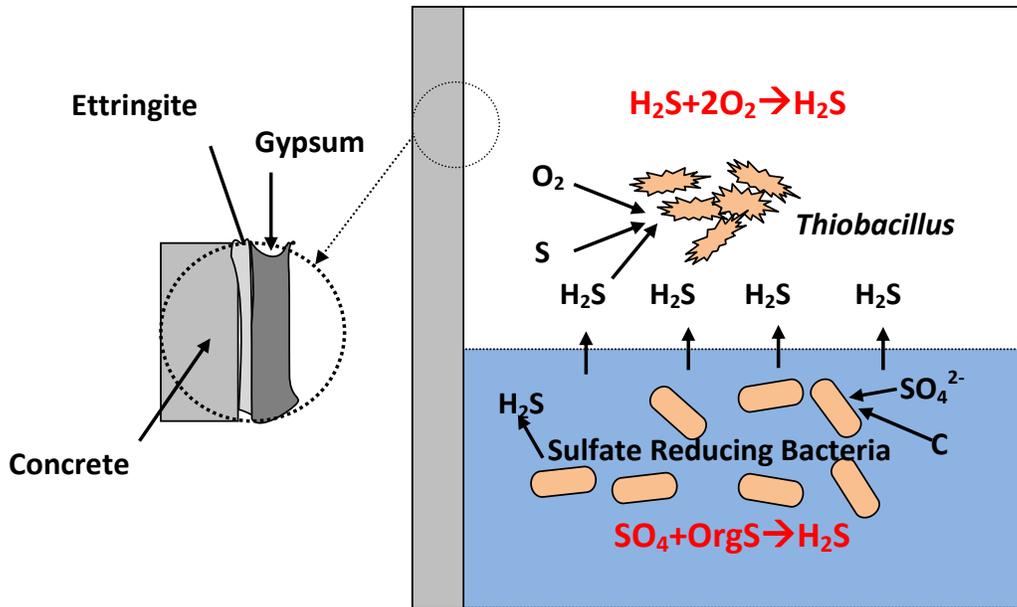
Figure 2. Mechanism of Microbial Induced Deterioration (MID).

This secondary ettringite is in an unstable state under the condition of strong acidity, and it will be decomposed into CaSO₄·2H₂O and Al₂(SO₄)₃·nH₂O by sulfuric acid. While gypsum does not provide structural support, especially under high moisture conditions which dissolve the gypsum, the delayed formation of ettringite inside hardened concrete can generate internal stress and further result in concrete deterioration (Bock and San 1986, Lauer 1990, Berndt 2001, Roberts 2002, Zhang and Zhang 2006).

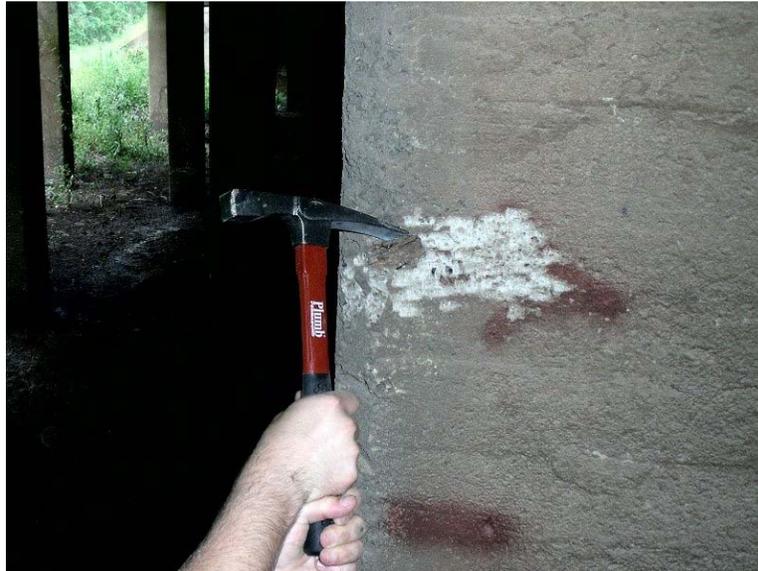
Figure 4. Hammer Test of Concrete Condition.

soundness of the surface and near-surface concrete; the test involved striking areas of surface delamination. Information such as visual evidence of concrete cracking, spalling, delamination, efflorescence, softening of concrete and corrosion of steel were recorded. Based on the visual inspections, locations for *in situ* testing and specimen extraction were determined, and generally three to four representative columns from each bridge were selected.

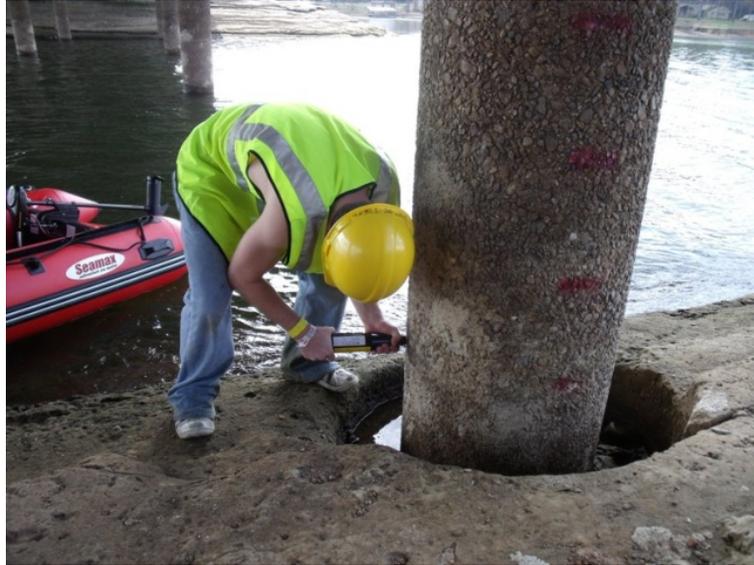
Figure 5. Schmidt Rebound Hammer Test.

In order to evaluate the level of deterioration under a variety of conditions, a number of *in situ* tests were performed on selected bridge columns. Most tests including Schmidt rebound hammer, half-cell corrosion potential, and covering thickness were generally performed at twelve inch intervals, starting at six inches above water or ground level and up to seven feet above (depending upon accessibility). At each measured height, five to seven measurements (with intervals of at least six inches) were taken, outliers (results with differences equal to or greater than 20% of the average value) were removed, and the average reading from each nominal height were reported. The ultrasonic pulse velocity (UPV) and in situ phenolphthalein pH tests were performed only at selected locations. An abrasive stone was used to remove the loss (soft) mortar on concrete columns prior to testing on an as-needed basis, in order to expose the underlying concrete.

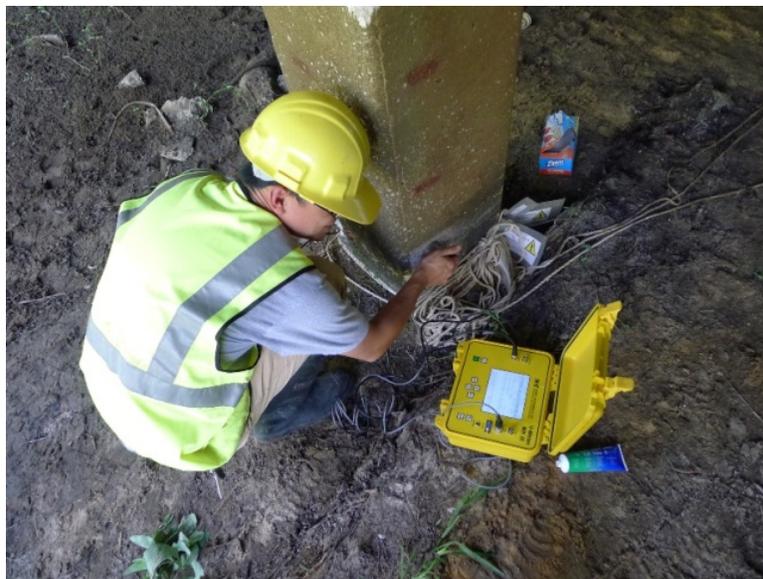
Figure 6 Ultrasonic Pulse Velocity (UPV) Test.

The Ultrasonic Pulse Velocity (UPV) test as shown in Figure 6 was performed on bridge columns to measure the velocity of an ultrasonic wave passing through the concrete, so as to

estimate the degree of internal concrete deterioration. UPV tests were performed according to ASTM C 597 “*Standard Test Method for Pulse Velocity through Concrete*”, with direct transmission, i.e., two transducers lined up directly opposite each other on the column. 50K Hz frequency P-wave was applied in the measurement. It should be noted that the test was not performed on cylindrical columns or columns with high levels of surface deterioration (i.e. greater than ½ inch of penetration) due to the lack of full contact between the concrete surface and the transducers.

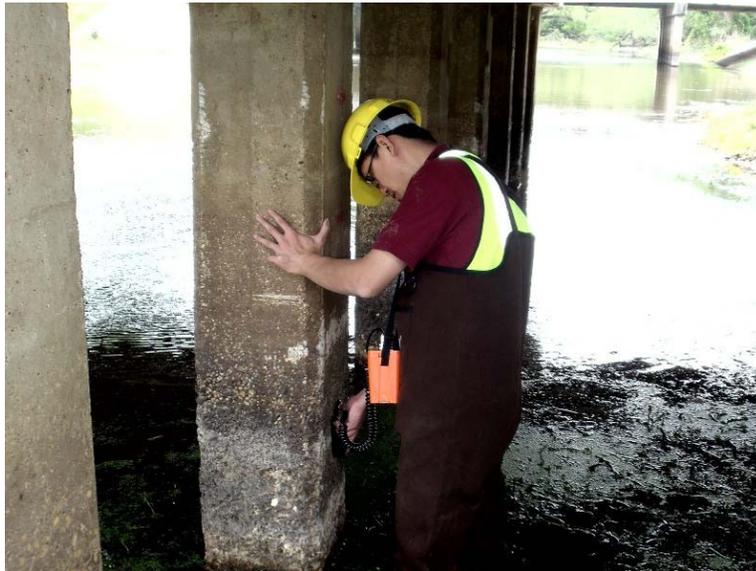
Figure 7. Covermeter (Rebar Locator) Test.

A covermeter (rebar locator) as shown in Figure 7 was used to locate rebar underneath concrete. The covering thickness of the concrete encircling the rebar was estimated through the measurement based upon an electromagnetic pulse-induction method. It should be noted that the measurements were only performed in the direction parallel to the main reinforcement direction (i.e., vertical direction) in this study.

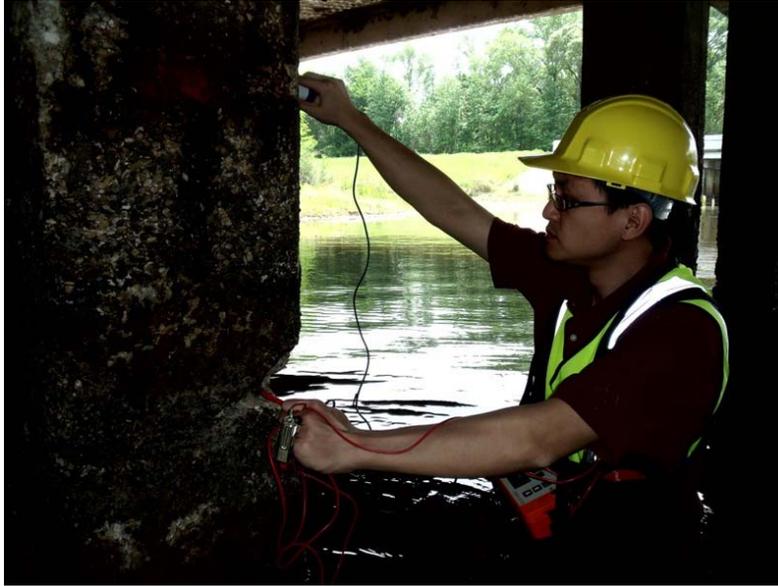
Figure 8. Half-Cell Corrosion Potential Test.

cell corrosion potential tests were only performed at selected columns, and that depended on accessibility and level of deterioration.

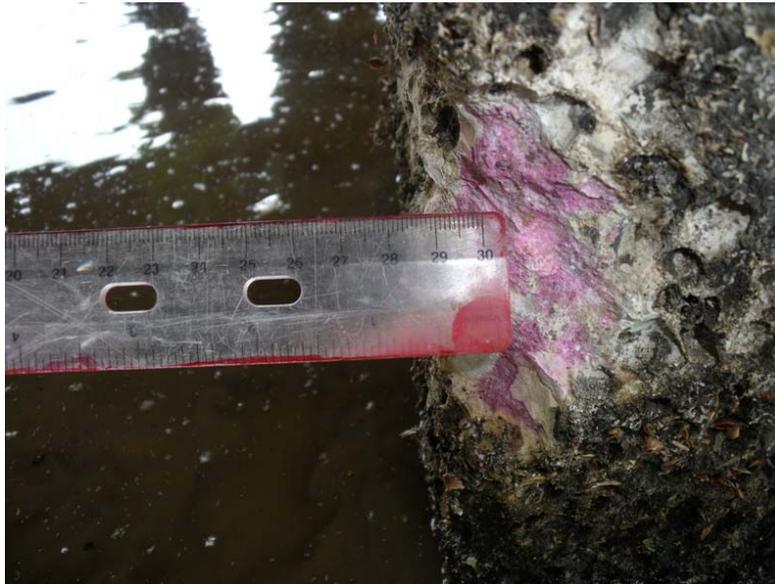
Figure 9. *In Situ* Phenolphthalein pH Test.

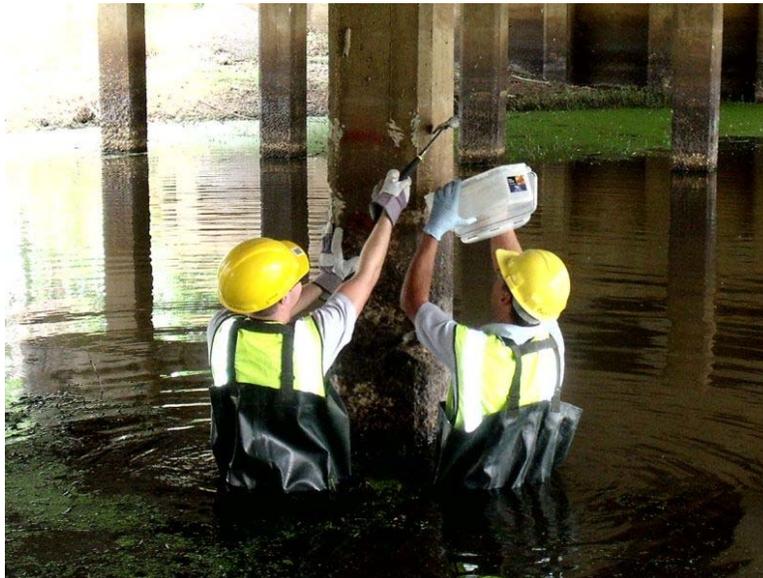
Figure 10. Chemical and Microbial Specimen Collection.

deteriorated and non-deteriorated organic surface scrapings were obtained from selected bridge columns supporting the bridge span. Generally, deteriorated specimens were taken at approximately 6 inches to 12 inches above water level, non-deteriorated specimens were taken at approximately 4 feet to 6 feet above the water level (depending on the accessibility) and semi-deteriorated specimens were taken approximately at a midpoint between the other two heights.

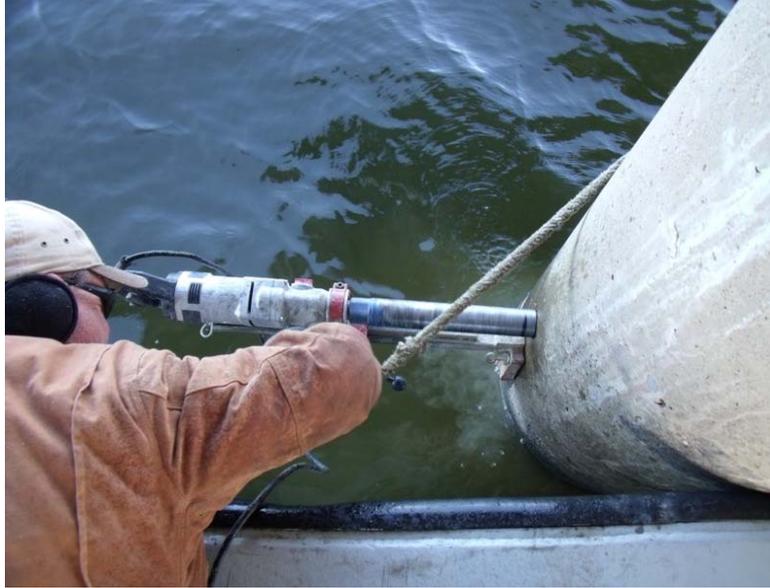
As shown in Figure 11, core specimens, one and a half inches in diameter and two to three inches deep were extracted from various columns. It should be noted that nearly all core specimens were in good condition with no sign of crumbling after they were removed from the drill pit. This observation is consistent with the visual observation and hammer tests which demonstrated that most bridge columns appeared to be in fairly good condition with different levels of deterioration on the concrete surface but no sign of internal deterioration or cracking.

Figure 11. Core Specimen Collection.

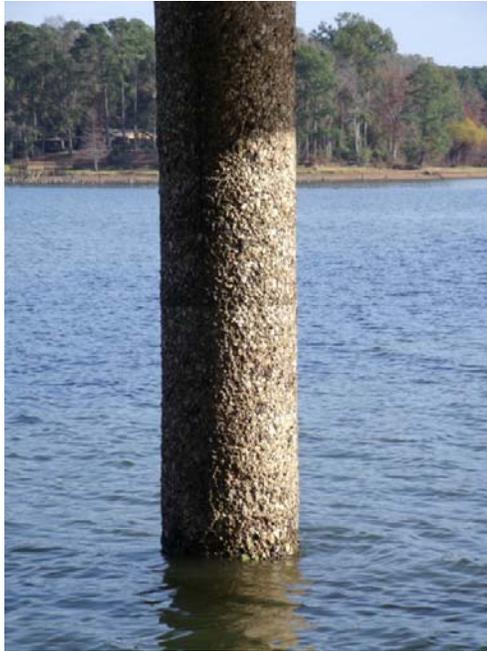
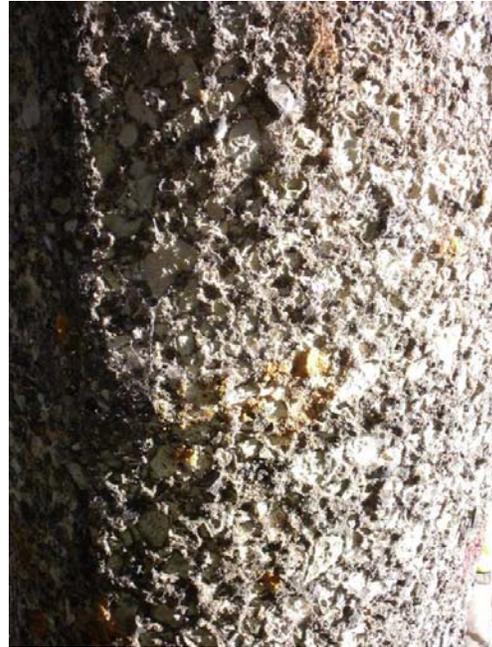
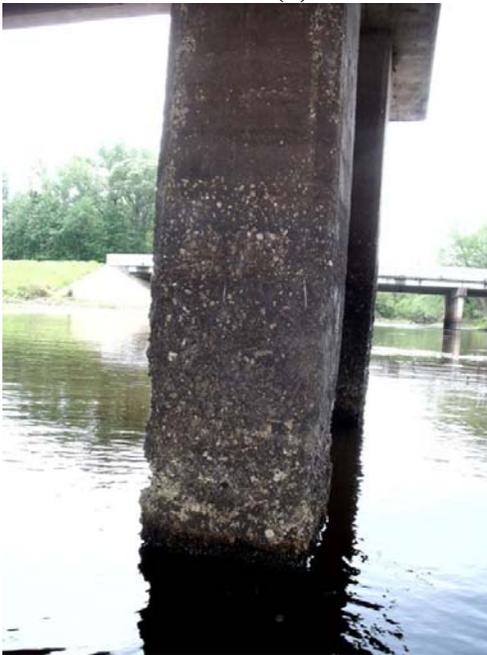
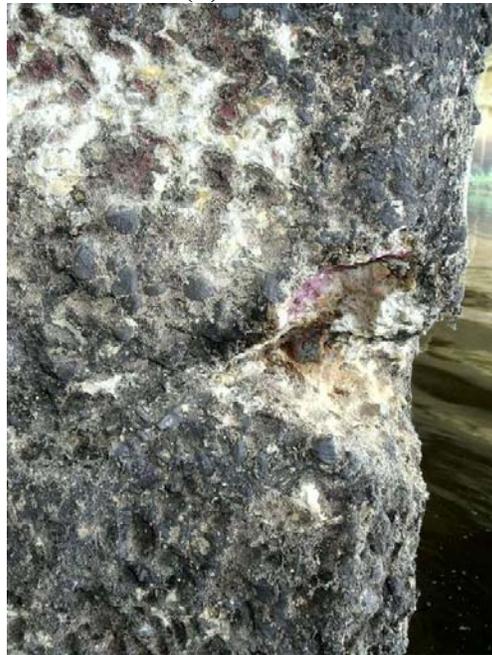
Table 3. Examples of Visual Inspection. (a) Bridge 5 (overview), (b) Bridge 5 (close up view), (c) Bridge 9 (overview), (d) Bridge 9 (close up view).

Examples of overview and close up looks for deterioration are shown in Table 3. It should be noted that due to seasonal changes at the time of visit, water levels varied significantly, which may result in a lack of accessibility to selected sections of bridge columns (i.e. Bridge 3) or full exposure of sections of bridge columns that are under water most of the time (i.e. Bridge 5, Bridge 6 and Bridge 7).

Observations during visual inspection are summarized in Table 4. Visual inspections indicated that all twelve bridges have different levels of deterioration, mostly with softening of the surface and near surface concrete and light to medium levels of scaling (indicated by penetration depths of less than half an inch). Generally, the higher above water level, the less

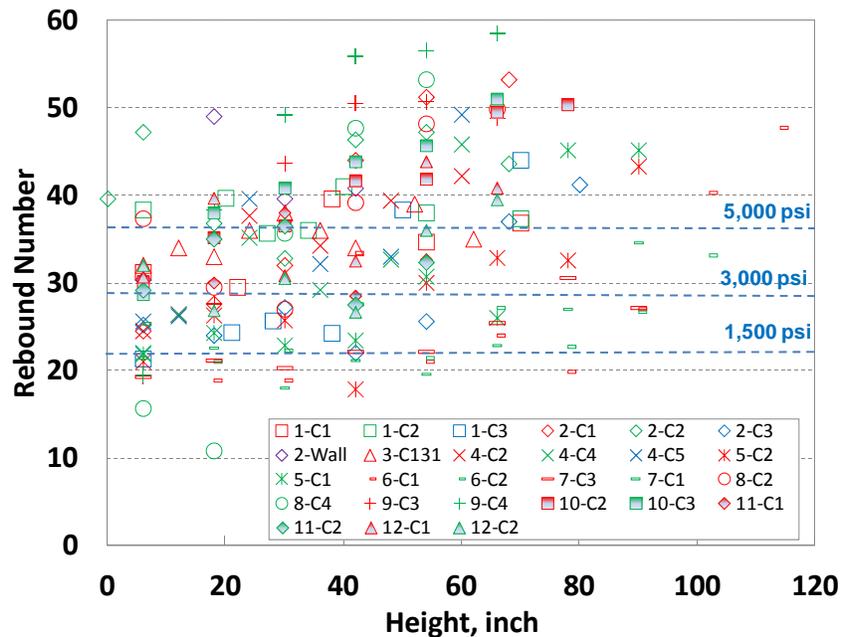
In spite of this, the rebound results are highly scattered, and generally standard deviations increase at lower elevation, with up to a 50% variation observed in some locations, which is reasonable as the estimation of strength of concrete is related to surface hardness, and the direct exposure of aggregate apparently increases the variation in test results.

Figure 12. Summary of Rebound Hammer Test Results.

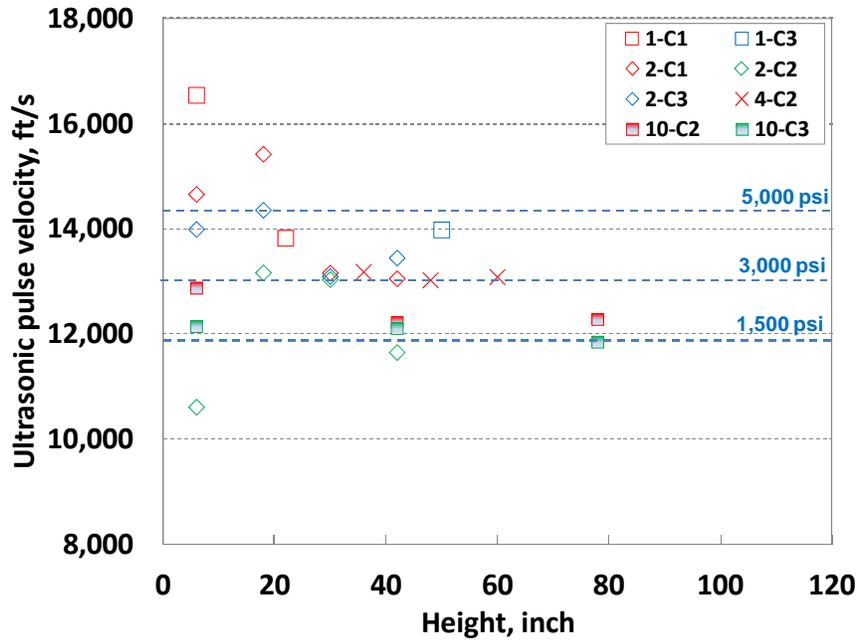
The UPV results as shown in Figure 13 indicate that most of the wave velocity falls between 12,000 to 14,000 ft/s, yielding an estimated strength of 3,000 to 5,000 psi (Malhotra and Carino 2004). The UPV readings indicate a good quality of concrete underneath the deteriorated surfaces. It should be noted that due to the high level of surface deterioration in Bridge 8 and Bridge 9, UPV readings were not reliable because of insufficient contact between the transducers and concrete and therefore were disregarded. Comparing the surface hardness measurements with the rebound hammer test, a lower degree of variation was observed from the UPV test, which is probably due to the UPV test measuring overall concrete quality instead of surface concrete condition. However, no clear relationship between UPV and height of testing location was observed.

Figure 13. Summary of UPV test results.

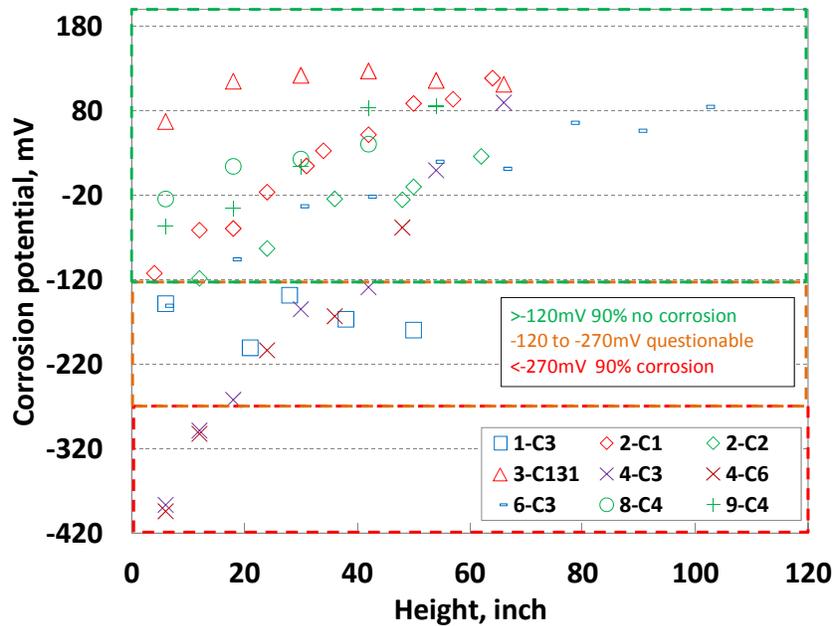
Results from half-cell corrosion potential tests as shown in Figure 14 demonstrate a clear trend of decreasing corrosion potential with an increase in the height of the column. It should be noted that the trend of decreasing corrosion potential is not unexpected as changes in moisture content, dissolved oxygen and changes in the concentration of chloride, sulfate or other ions in the concrete as one progresses upward from the waterline will result in an increase in the corrosion potential readings (i.e., less potential of corrosion), regardless of the present of MID. However, despite the above mentioned parameters that can influence corrosion, most of the bridge columns show only a low to medium level of corrosion potential and only one site (Bridge 4), has a high level of corrosion potential which may have been caused by a significant amount of vertical cracking.

Figure 14. Summary of Half Cell Test Results.

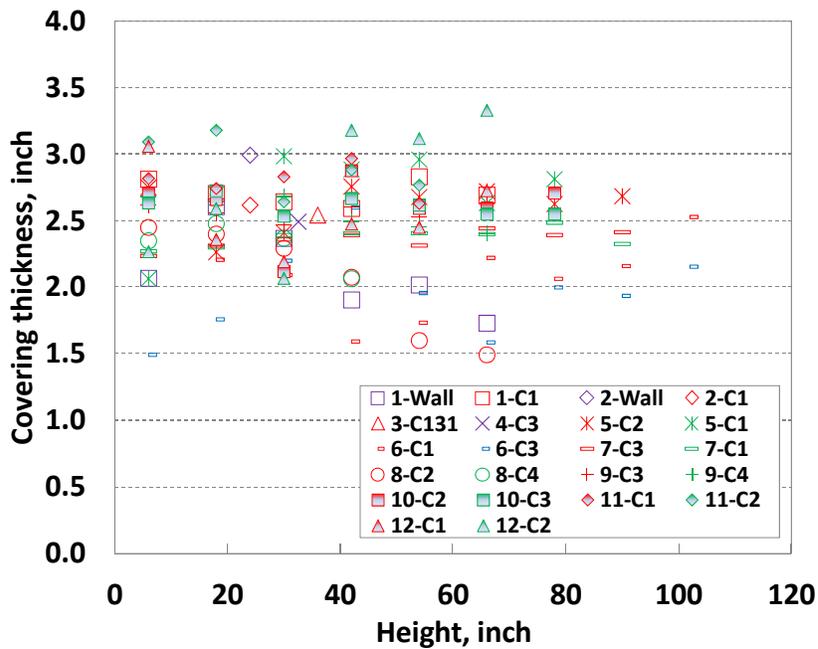
Results from the cover meter test as shown in Figure 15 indicate that most of the bridge columns still have more than one and a half inches of concrete covering, with standard deviations mostly less than half an inch, which indicates that the reinforcement is still well protected.

Figure 15. Summary of Covering Thickness Test Results.

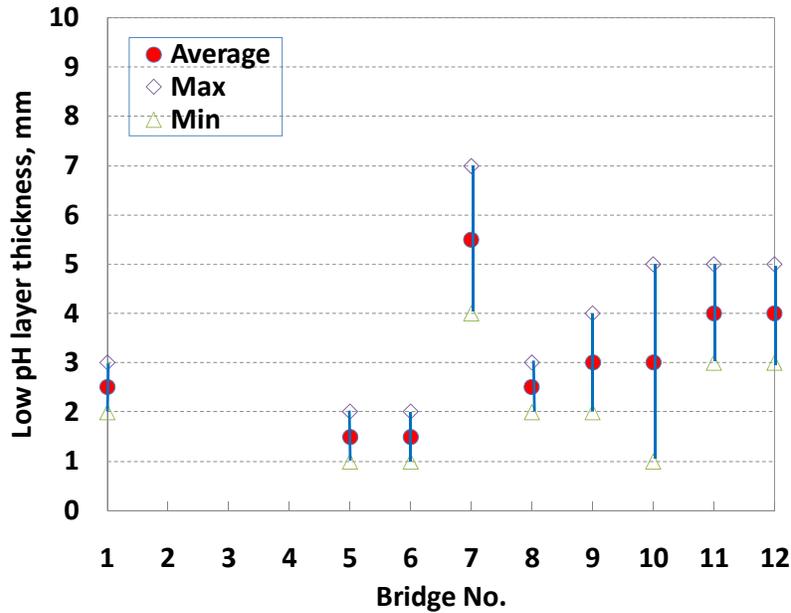
Phenolphthalein pH indicator showed acidification of surface concrete in most tested bridge columns. However, results as shown in Figure 16 indicate that for all the columns tested, there was generally less than 5 millimeters of neutralized surface concrete. It should be noted that Figure 16 is presented differently than Figure 12 to Figure 15, as only a couple of measurements were taken at each of the bridges.

Figure 16. Summary of *In Situ* Phenolphthalein pH Test Results.

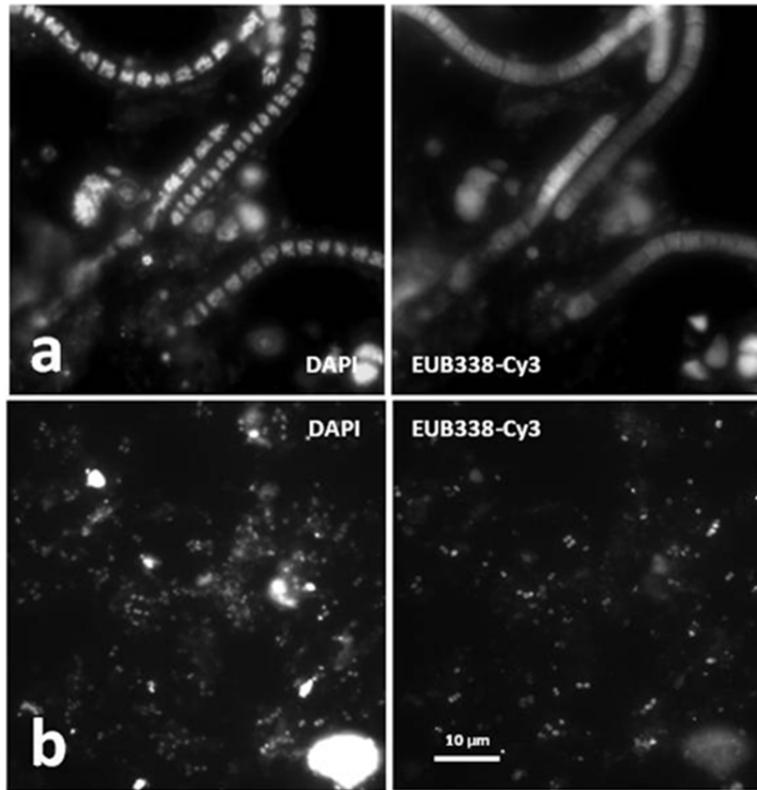
In situ detection of bacteria in biofilm samples obtained from visibly deteriorated (a) and non-deteriorated (b) concrete sections retrieved from Bridge 3 is shown in Figure 17. Samples from both sections clearly show the presence of different communities of bacteria as indicated by differences in size and morphology both after DAPI-staining (left panel) and hybridization with Cy3-labeled probe EUB338 detecting most members of the Domain Bacteria (right panel).

Figure 17. Example of Bacteria Communities of Deteriorated and Non-Deteriorated Concrete Surfaces.

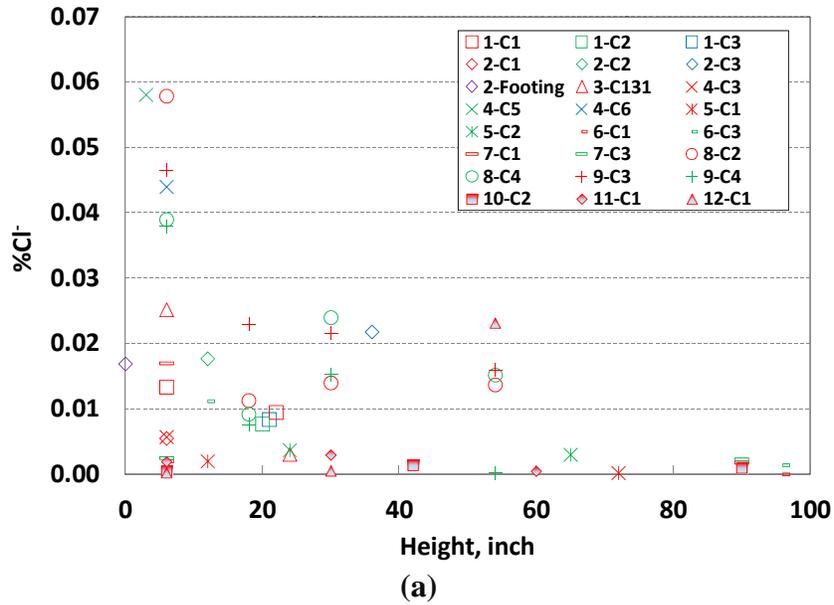
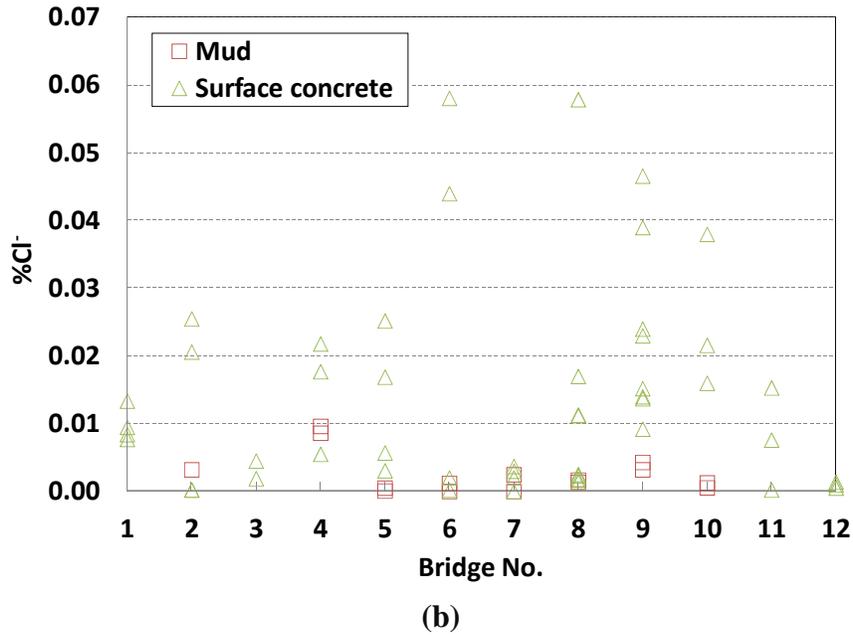
Figure 22. Chloride Content of Mud and Surface Concrete Samples. (a) Chloride Content at Different Specimen Heights, (b) Chloride Content in Different Bridges.

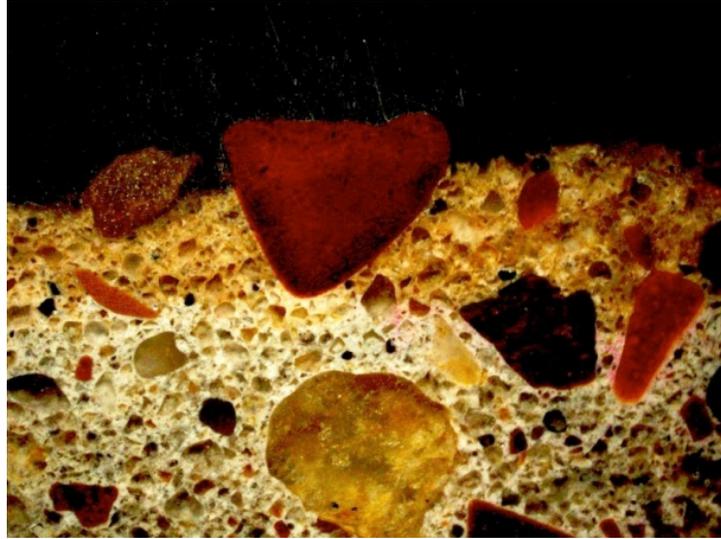
(a)

Petrographic analysis was performed on samples collected from selected bridges. Examples of petrographic images are shown in Figure 23. It should be noted that both polarized light source (Figure 23a and Figure 23b) and fluorescent light source (Figure 23c and Figure 23d) are used in the petrographic analysis, with fluorescent light was mainly used to identify microcrackings. As shown in Figure 23c and Figure 23d, there are no obvious signs of micro or parallel surface cracks, which basically eliminates a mechanism based on freeze/thaw and chemical attack as causes of deterioration (Walker et al. 2006). In most cases, loss of surface mortar was observed, which results in exposure of coarse aggregate (Figure 23a and Figure 23b). In selected concrete specimen (Figure 23a), there are signs of carbonation as indicated by the clear color difference to the concrete surface. In some cases, eroded aggregate (generally limestone) was found. In addition, there was no clear evidence of ettringite or gypsum on the concrete surface, which is probably due to the fact that most of these materials were dissolved or washed away during a long exposure process. However, both paste and aggregate are generally in good shape below the surface layer. The observations are consistent with a mechanism that suggests that the cause of deterioration in bridge columns is likely due to erosion from the slight acidity of the water bodies that surround these concrete columns.

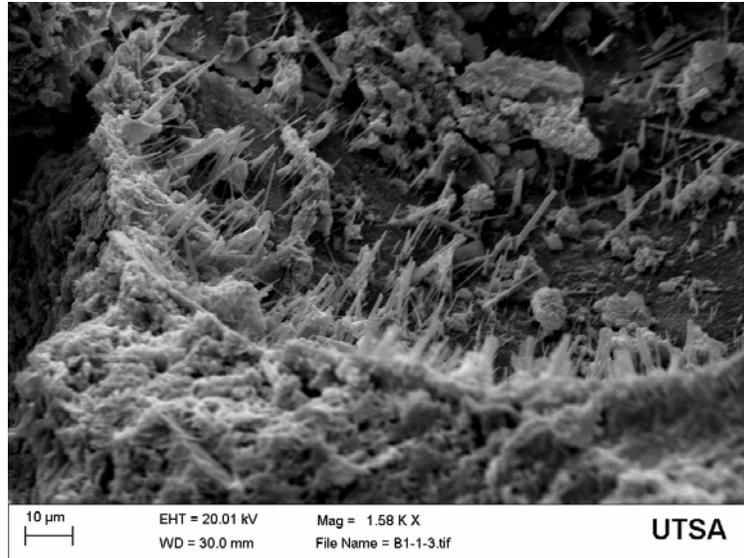
(a)

Results from semi-quantitative XRD analysis show that the results are highly dependent on the type of aggregate used in the mix. Quartz and calcite were found in all the specimens. Feldspar and gypsum were found in minor quantities. Portlandite, $\text{Ca}(\text{OH})_2$, and ettringite ($6\text{CaO}\cdot\text{Al}_2\text{O}_3\cdot 3\text{SO}_3\cdot 31\text{H}_2$) were found as the main hydration products of the cement and no XRD data could be obtained showing C-S-H (calcium silicate hydrate); the latter must be amorphous if it is present.

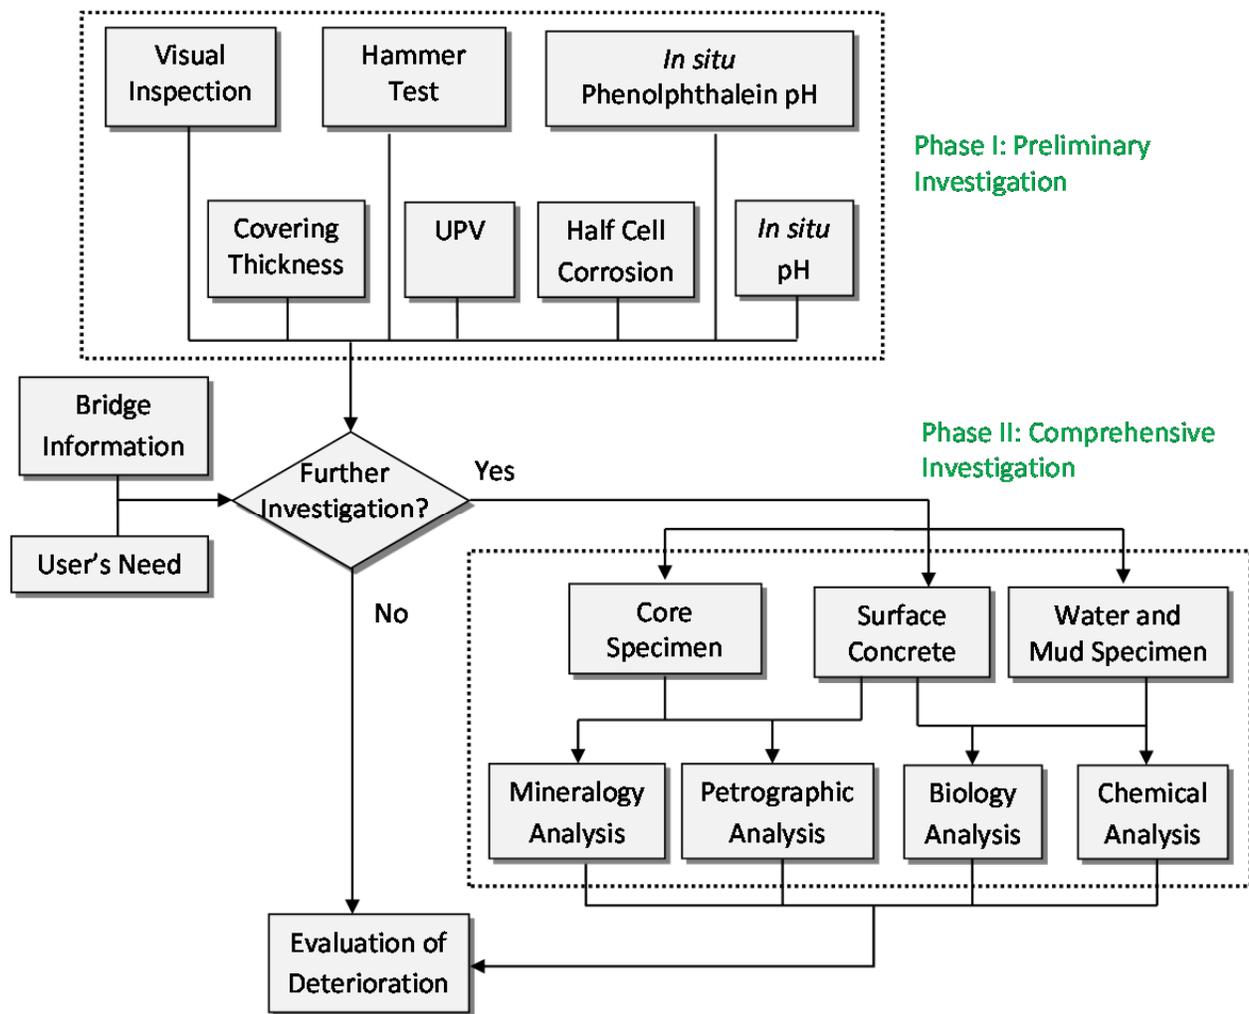
Based on the effectiveness of each of the tests, a two-stage approach is recommended to identify MID and evaluate the extent of MID for TxDOT structures. With Stage I as a preliminary survey to roughly evaluate the extent of MID, Stage II should serve as an extension of Stage I when needed, in order to confirm the MID and to further identify the extent of defects revealed by Stage I. A flow chart with tests recommended during the different stages is shown in Figure 25:

Figure 25. Flow Chart of Recommended MID Identification and Evaluation Procedure.

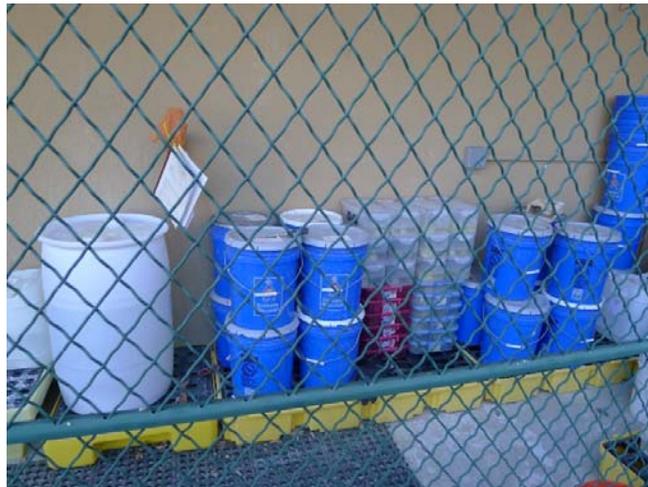
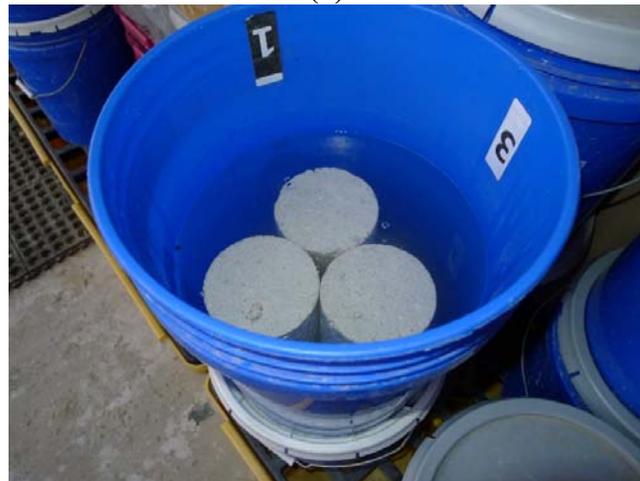
Figure 26. Laboratory specimen placement.
(a) Secured Storage Area, (b) Concrete Cylinder Specimens in Sulfuric Solution.

In the laboratory simulation, concrete and mortar specimens were fully submerged in sulfuric acid solutions. Regular five gallon buckets and rectangular containers (approximately 15”x3”x4” in dimension) were used for storing the concrete and mortar specimens respectively. In order to maintain consistent exposure conditions, two 4”x8” concrete cylinders, fifteen 2”x2”x2” mortar cubes, and four 1”x1”x11” mortar prisms were stored in each of the containers. It should be noted that specimens were grouped in a manner such that only specimens from the same mix design were placed in the same container. It should also be noted that due to the

different size of specimens, exposure conditions for the different specimens, i.e., solution volume vs. total specimen surface area ratio was different; the concrete specimen exposure is approximately five times higher than that of mortar specimens. Each container was labeled with information concerning the specimen, and the concentrations of the solution to distinguish different specimens and conditions. Due to the aggressiveness of solutions used in this study, all the containers were placed in a secured storage area as shown in Figure 26. As the release of substances from concrete and mortar specimens can cause the reduction of acidity, with the pH value of the solutions changing with time, the pH values of solutions were monitored on a regular basis. In order to maintain relatively stable simulation conditions, when the pH values increased by 1, new solutions were prepared and replaced the earlier solutions. More information of solution selection, preparation, and measured pH values can be found in Appendix F.

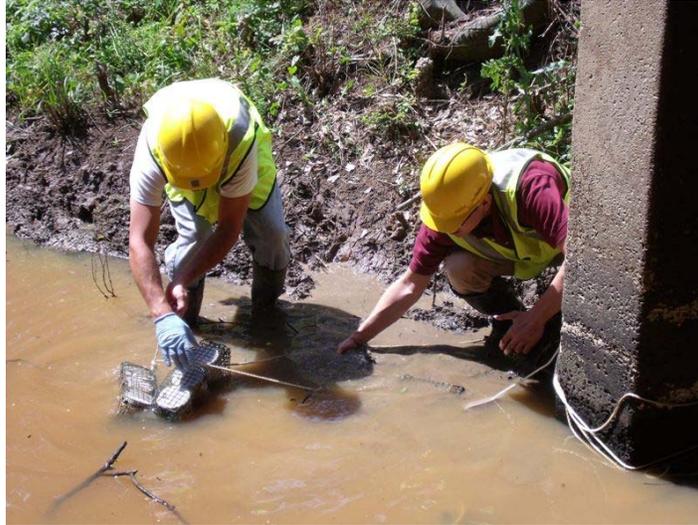
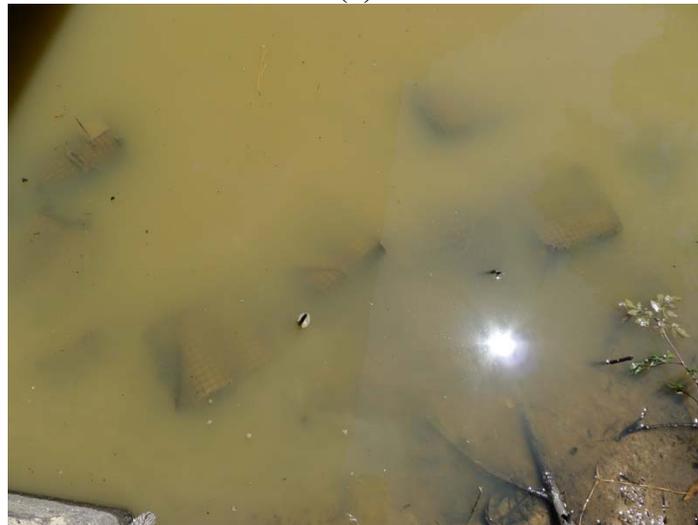
Figure 27. Field Specimen Placement.
(a) Specimen Placement; (b) Exposure of Specimens.

During the site exposure, specimens were wrapped in prefabricated plastic laminated wire cages to allow the full exposure of the specimens. Similar to laboratory exposure, only specimens with the same mix design, usually two concrete cylinders or two mortar prisms or eight mortar cubes, were placed in each cage. All cages were labeled with plastic laminated tags with information related to the mix design and exposure conditions. Cages with the same type of mixture and exposure condition were tied together with ropes and then tied to adjacent bridge columns for tracking purpose. Figure 27 shows the placement and exposure of specimens in the field.

In addition to the laboratory simulation, field exposure was also used for microbial attack simulation. Site A, a water body that hosts Bridge 1 (FM 787@ Tarkington Bayou) was carefully chosen because of the easy accessibility and relatively aggressive water body (with pH between 5.4 and 6.1 during the first visit). It should be noted that because of drought condition in Texas, the water level was low and did not fully cover the specimen and therefore specimens were relocated to Site B after 62 days of exposure at Site A. Site B, a water body that hosts Bridge 10, is located approximately a quarter mile east of Site A. Site B and Site A were essentially the same water body, with a pH of approximately 7 and a water level of approximately five feet. The pH values of field water were measured each time the site was visited and the pH values were found to be relatively stable. Detailed information on the pH values during the field exposure trials can be found in Appendix F.

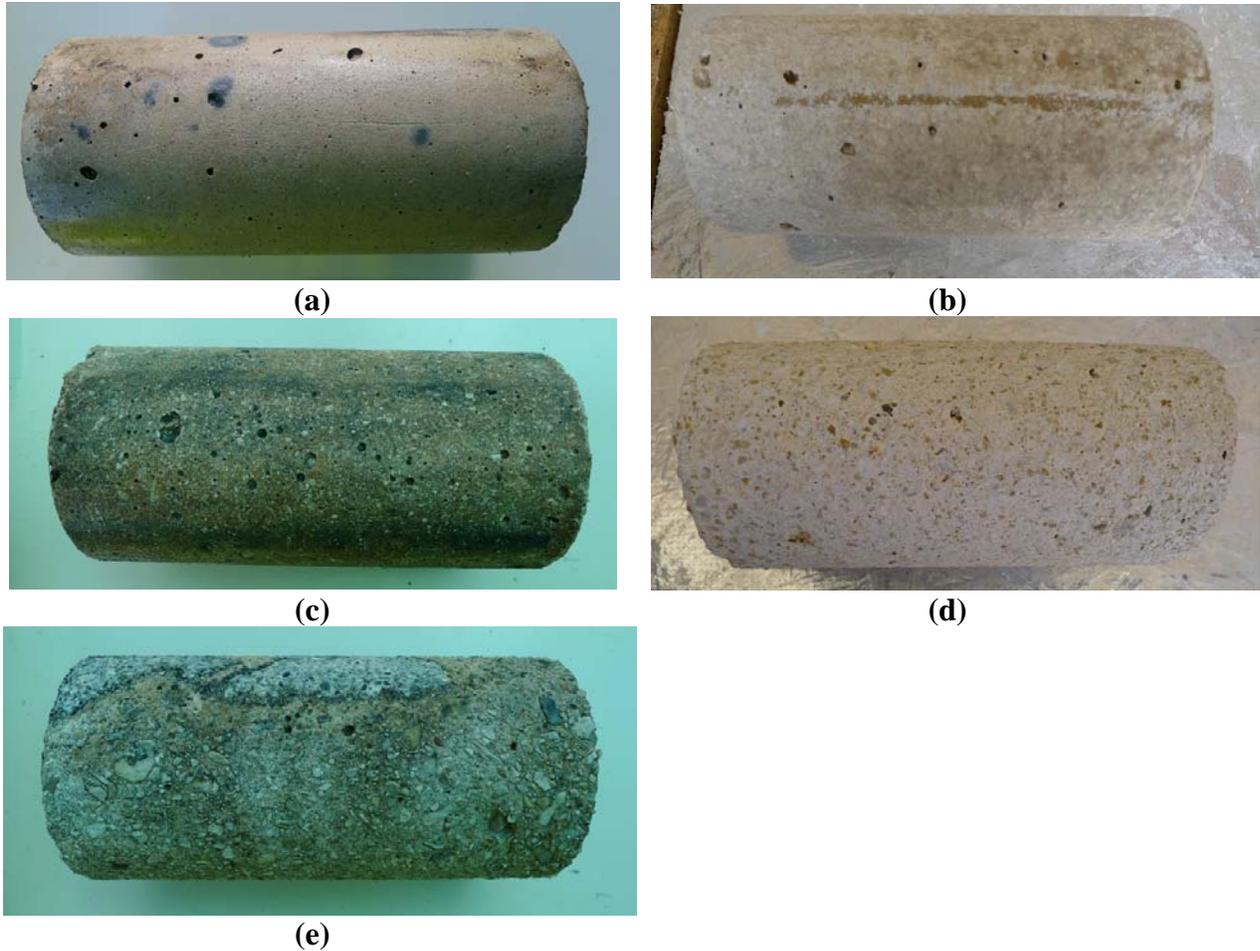
A visual inspection of the level of deterioration of specimens exposed to different scenarios was conducted on a regular basis. It was observed that soft and white reaction products were generated on the surface of specimens after being placed into the sulfuric acid solution. In general, the longer the specimens were exposed to the sulfuric acid solution, the more reaction products were generated. As expected, specimens in Scenario IV (3% sulfuric acid solution) were found to have a higher level of deterioration comparing to those stored in Scenario II (1% sulfuric acid solution). Examples of concrete deterioration observed during different exposure scenarios are shown in Figure 28.

Figure 28. Examples of Concrete Deterioration under Different Exposure Conditions. (a) C-I in Scenario I after 96 Days of Exposure, (b). C-I in Scenario II after 126 Days of Exposure, (c) C-I in Scenario III after 96 Days of Exposure, (d) C-I in Scenario IV after 102 Days of Exposure, (e) C-I in Scenario V after 34 Days of Exposure.

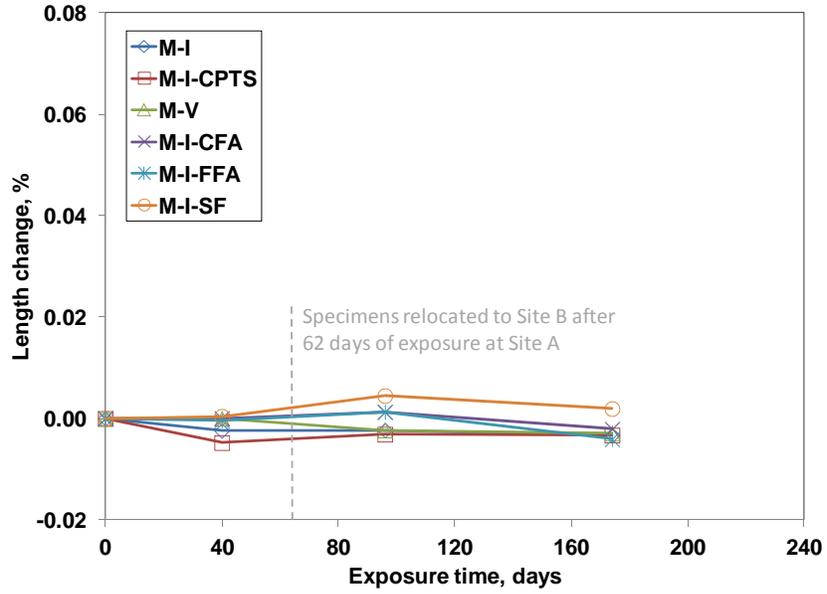
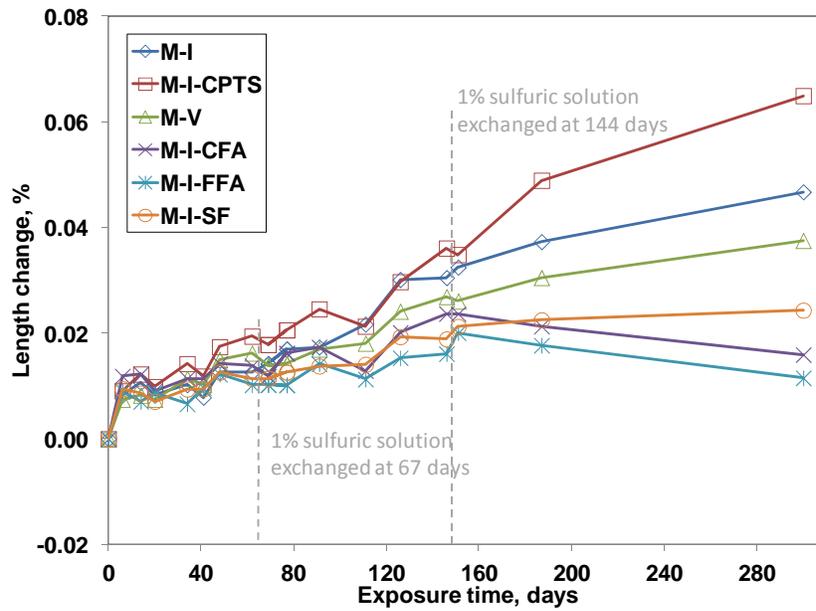
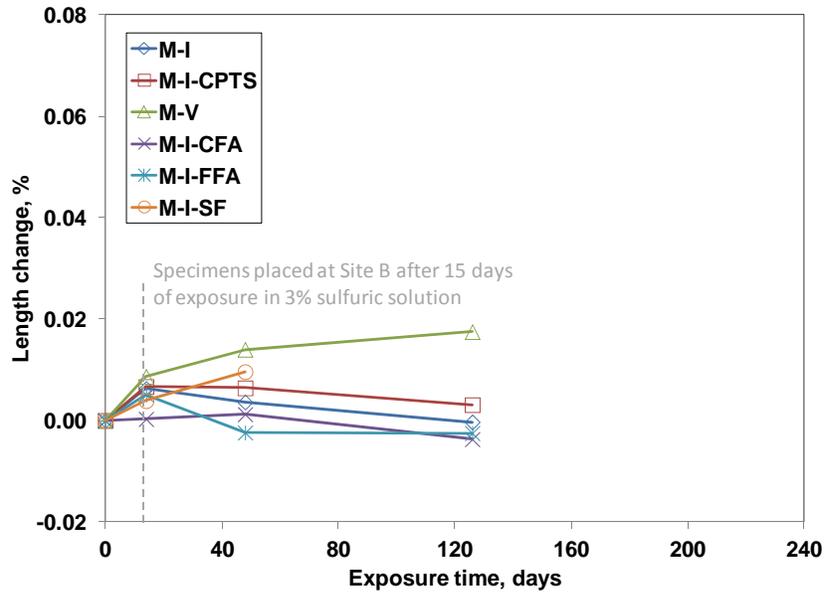
After mortar prism specimens were placed into different scenarios, changes of lengths were measured with a length comparator on a regular basis. Results of length changes of specimens under different exposure conditions are summarized in Figure 29. As expected, all specimens experienced different levels of expansions, which was likely due to reaction between sulfuric acid and cement hydration products, which resulted in the production of ettringite and gypsums and a volume increases.

Figure 29. Length Change of Mortar Prism Specimens under Different Scenarios (continuous). (c). Scenario III, (d). Scenario IV.
