Evaluation, Presentation and Repair of Microbial Acid-Produced Attack of Concrete

Technical Report 0-6137-1
Cooperative Research Program

TEXAS STATE UNIVERSITY SAN MARCOS
DEPARTMENT OF ENGINEERING TECHNOLOGY
SAN MARCOS, TEXAS

TEXAS DEPARTMENT OF TRANSPORTATION

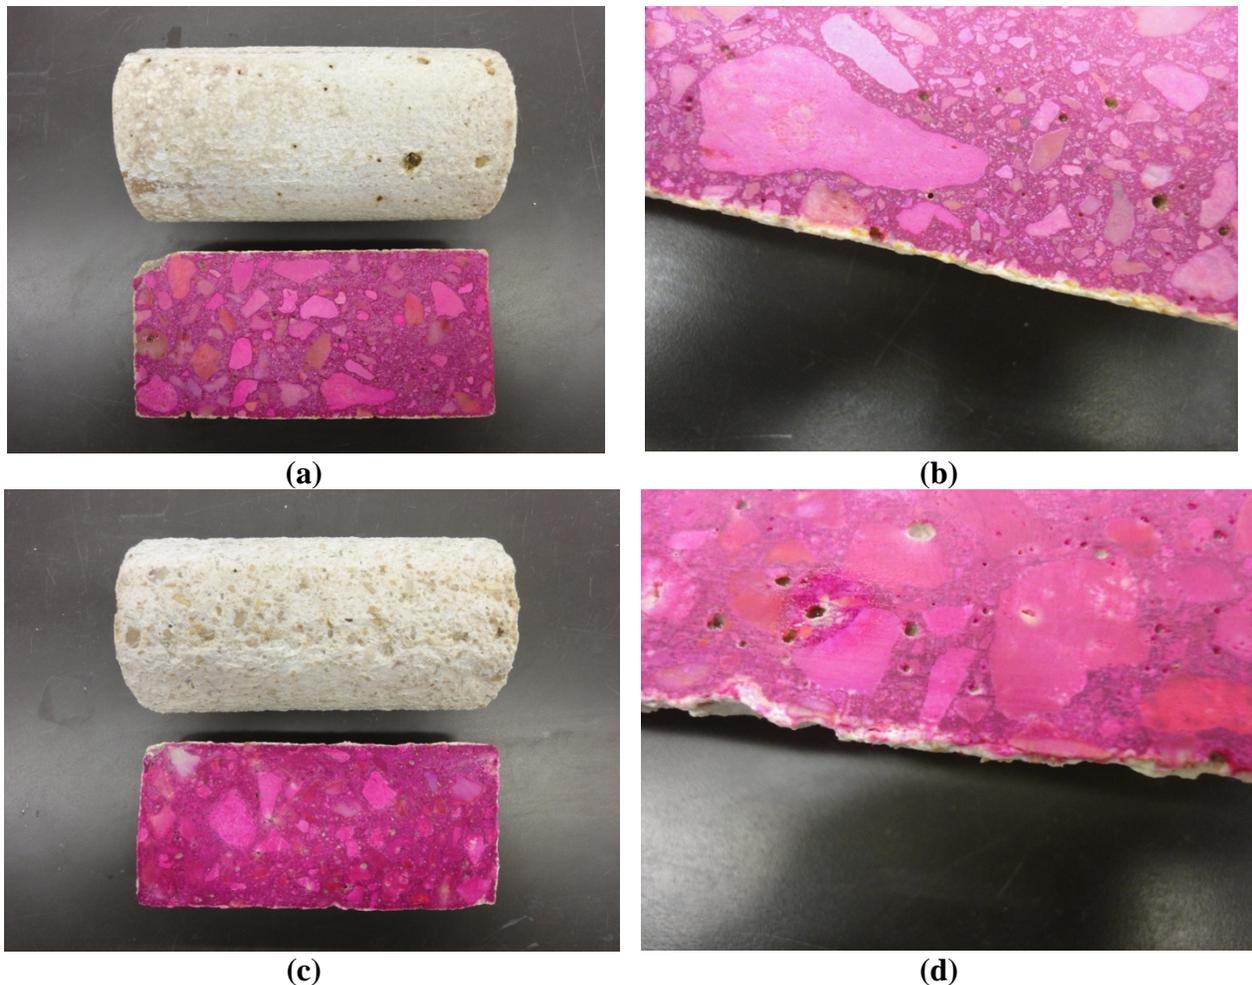
concrete specimen exposure to Scenarios II and IV are shown in Figure 33. Results show that despite the higher level of surface deterioration observed in specimens from Scenario IV due to the more aggressive environment, there were only a few millimeters of neutralized layer observed in the remaining concrete. Results were consistent with field evaluations, which regardless of different levels of surface deterioration, a low pH level only was observed a few millimeters beneath the concrete surface.

Figure 33. Examples of Deterioration and Phenolphthalein Color Change Tests.
(a) Scenario II 238 days exposure (overview), (b). Scenario II 238 days exposure (close up),
(c) Scenario IV 55 days exposure (overview), (d). Scenario IV 55 days exposure (close up).

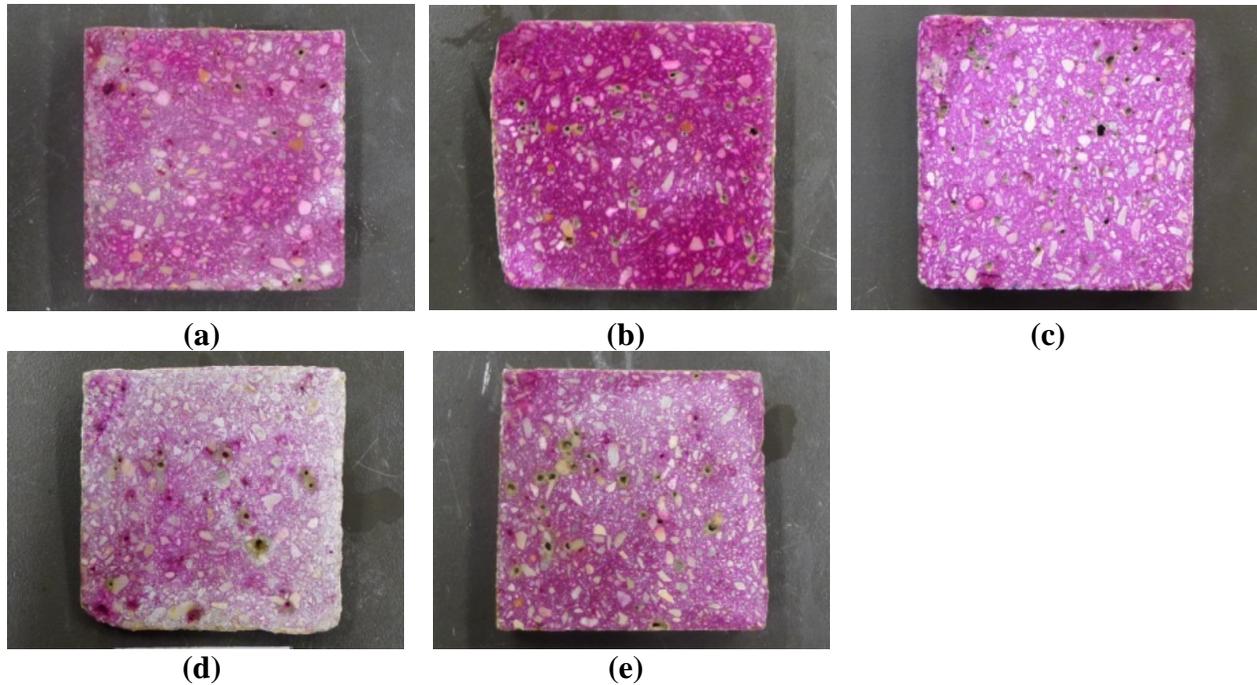
A study was also conducted with mortar specimens exposed to different scenarios over different periods of time. As shown in Figure 34, while exposure in Scenario IV shows a higher level of deterioration, the depth of neutralized concrete proceeding from the surface is very low (generally less than 1mm), which indicates that the remaining concrete is unaffected. The phenolphthalein color changes associated with other samples are shown in Appendix F.

Figure 34. Examples of Phenolphthalein pH Test.

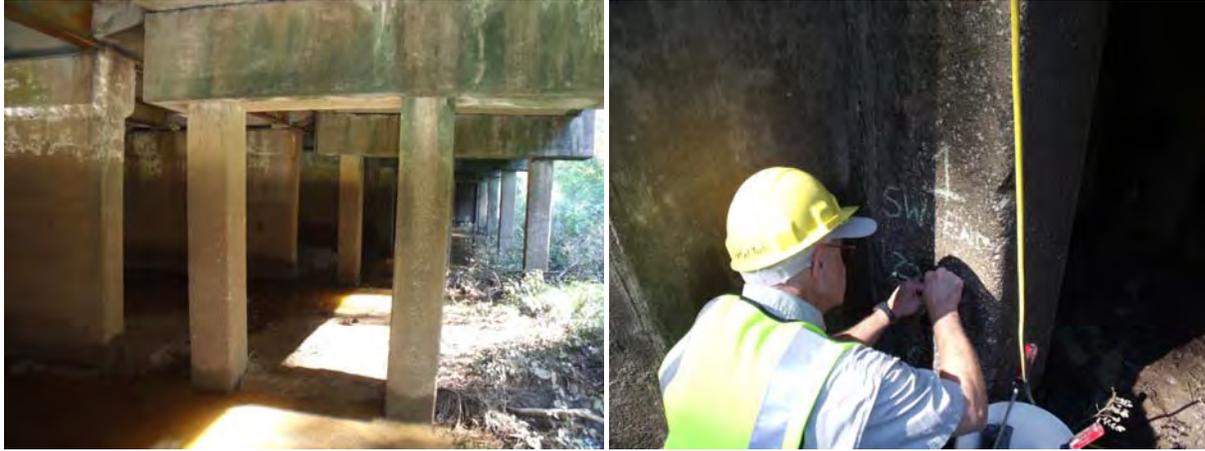
Figure B. 1. Overview of Bridge Deterioration (Bridge 1).

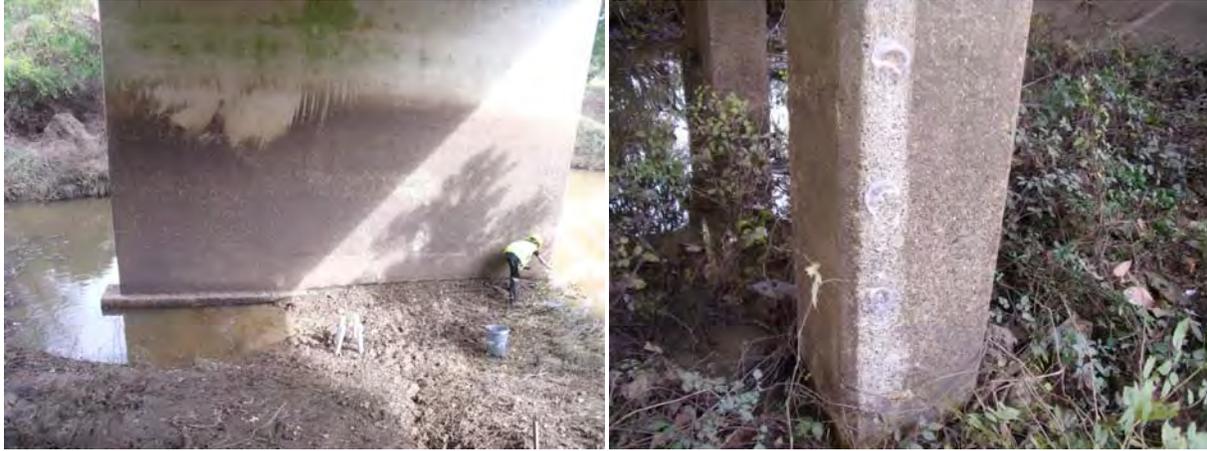
Figure B. 2. Overview of Bridge Deterioration (Bridge 2)

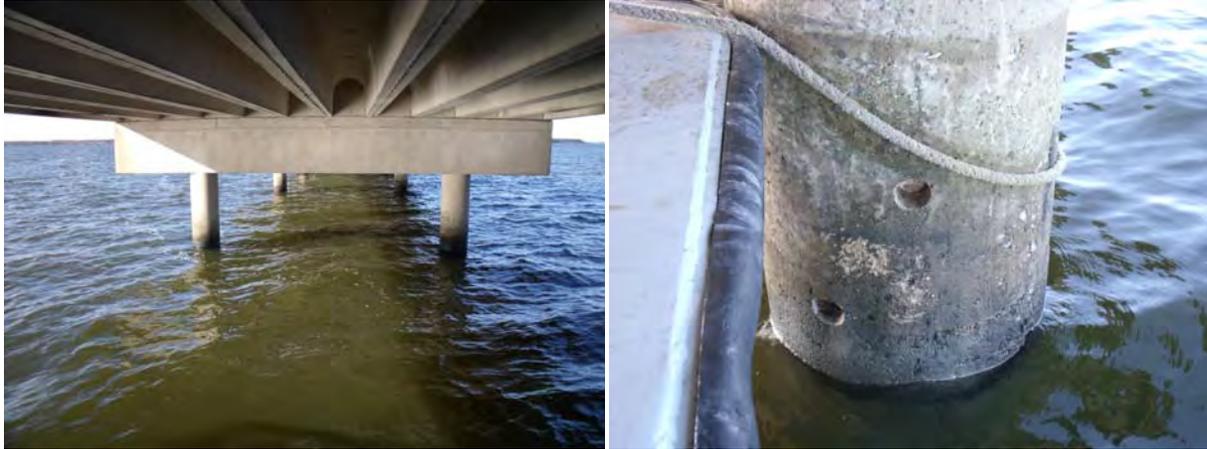
Figure B. 3. Overview of Bridge Deterioration (Bridge 3).

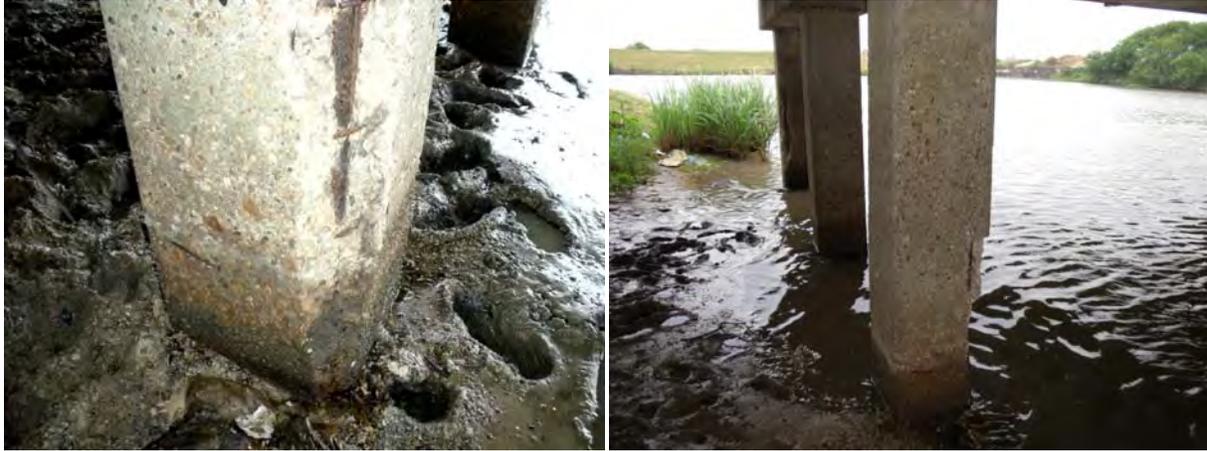
Figure B. 4. Overview of Bridge Deterioration (Bridge 4).

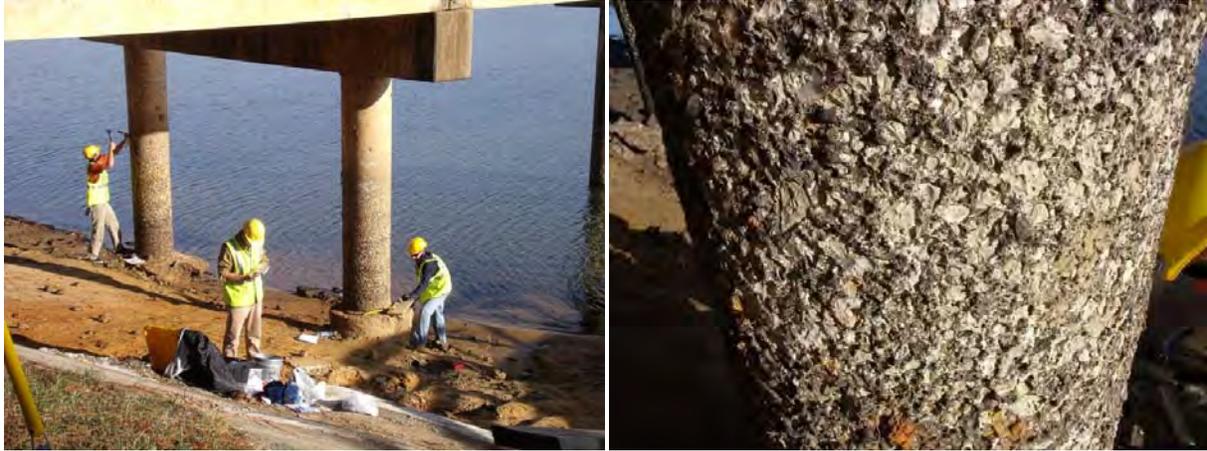
Figure B. 5. Overview of Bridge Deterioration (Bridge 5).

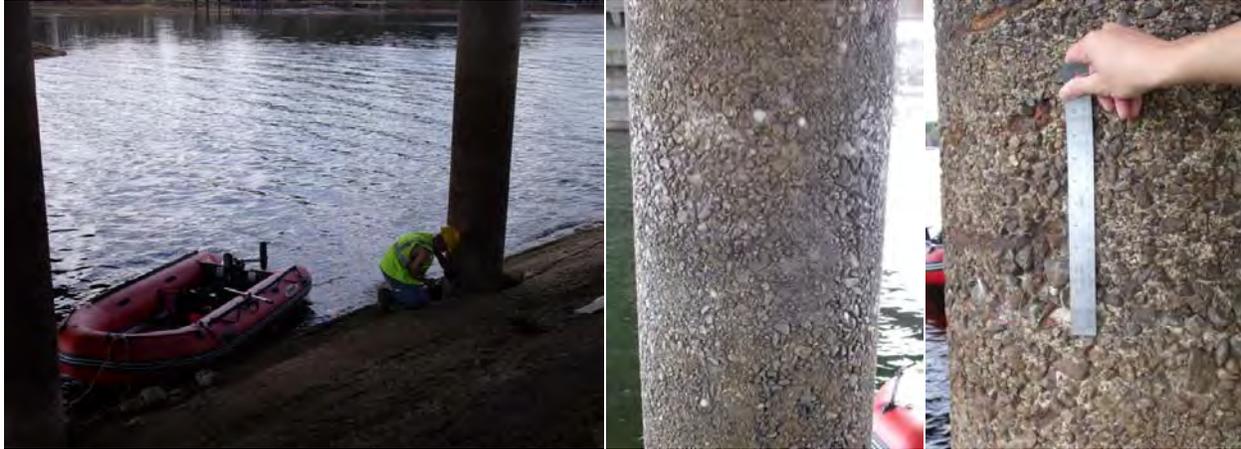
Figure B. 6. Overview of Bridge Deterioration (Bridge 6).

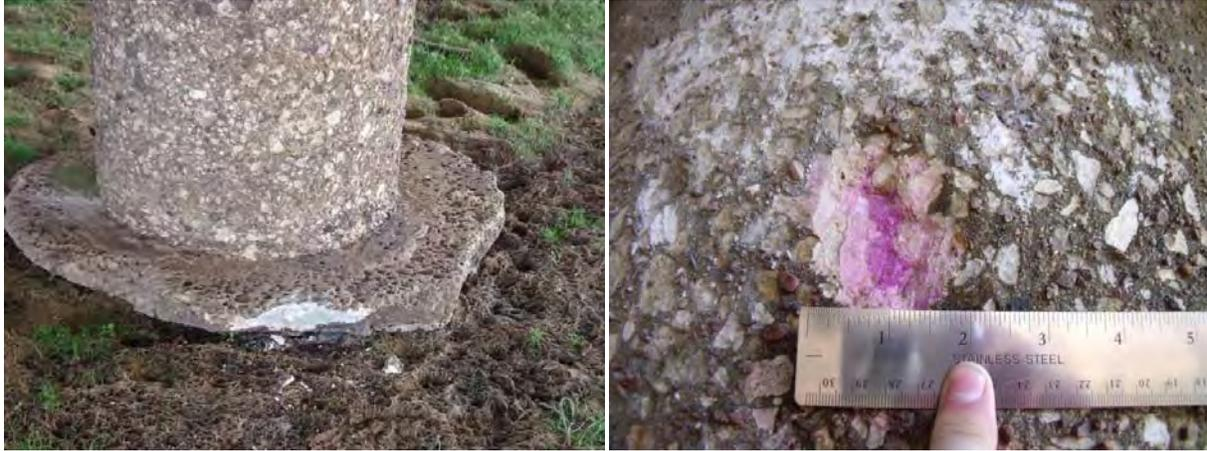
Figure B. 7. Overview of Bridge Deterioration (Bridge 7).

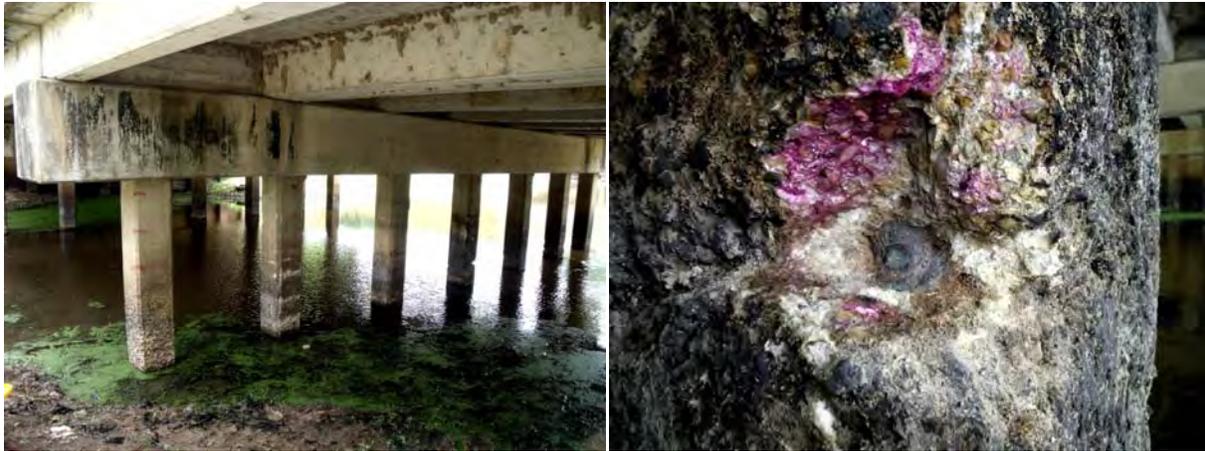
Figure B. 8. Overview of Bridge Deterioration (Bridge 8).

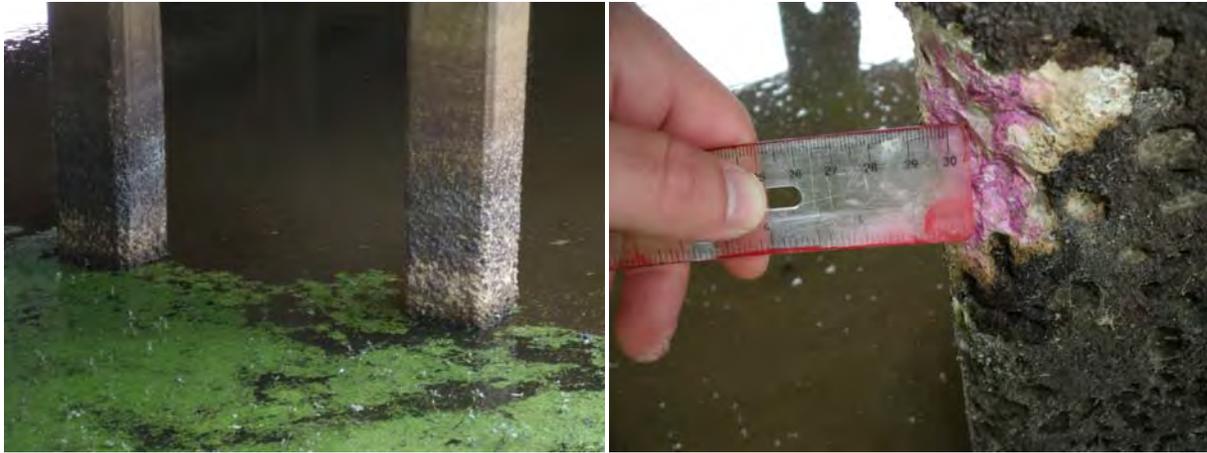
Figure B. 9. Overview of Bridge Deterioration (Bridge 9).

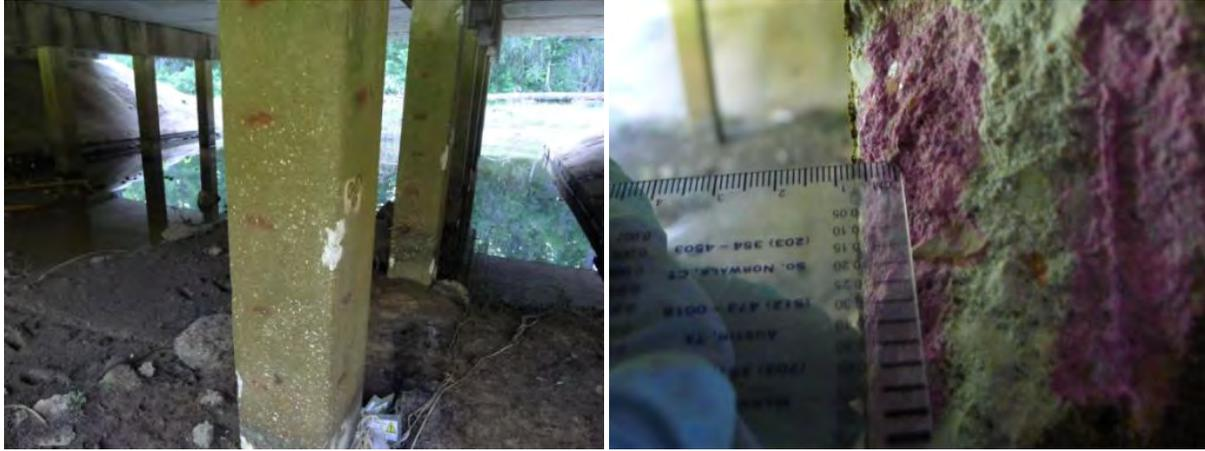
Figure B. 10. Overview of Bridge Deterioration (Bridge 10).

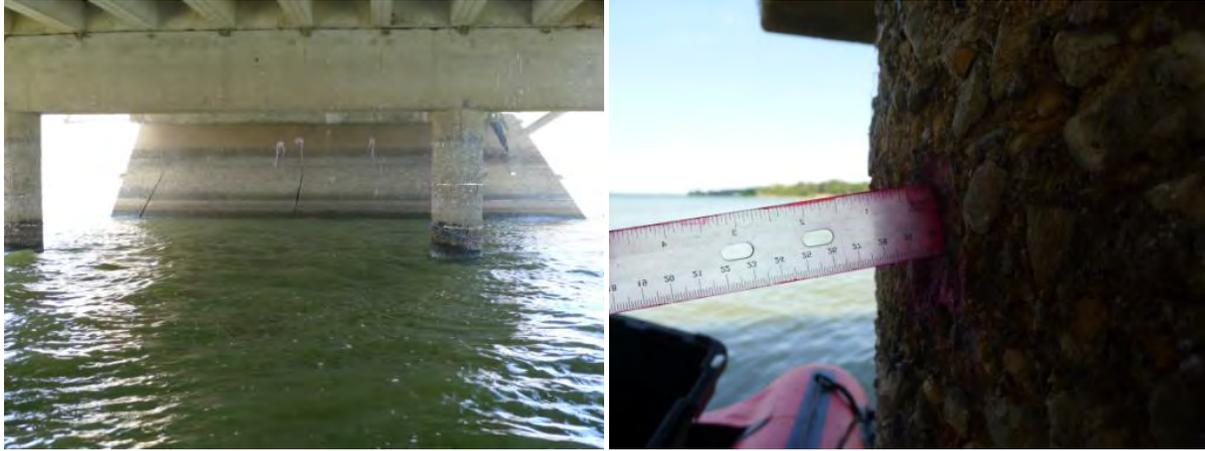
Figure B. 11. Overview of Bridge Deterioration (Bridge 11).

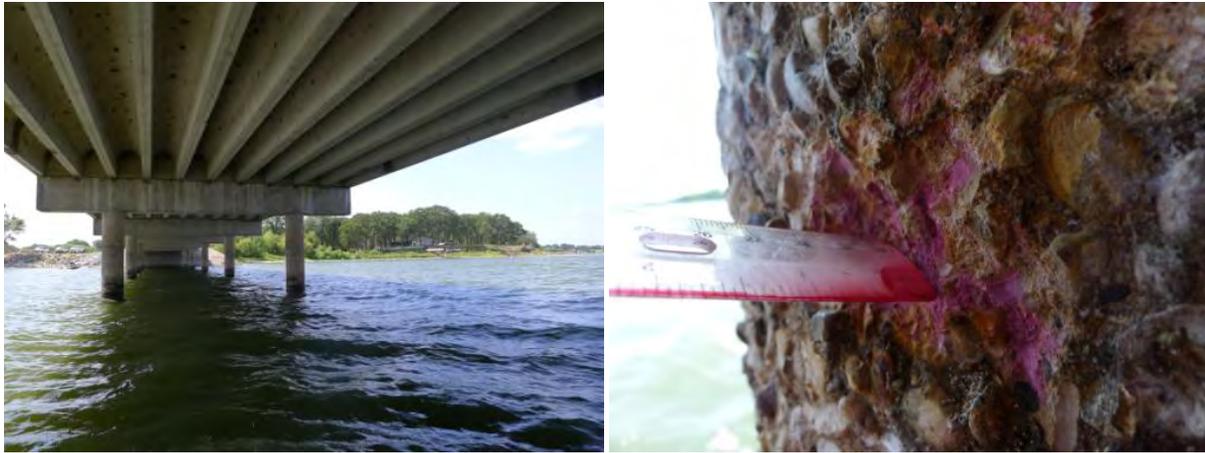
Figure B. 12. Overview of Bridge Deterioration (Bridge 12).

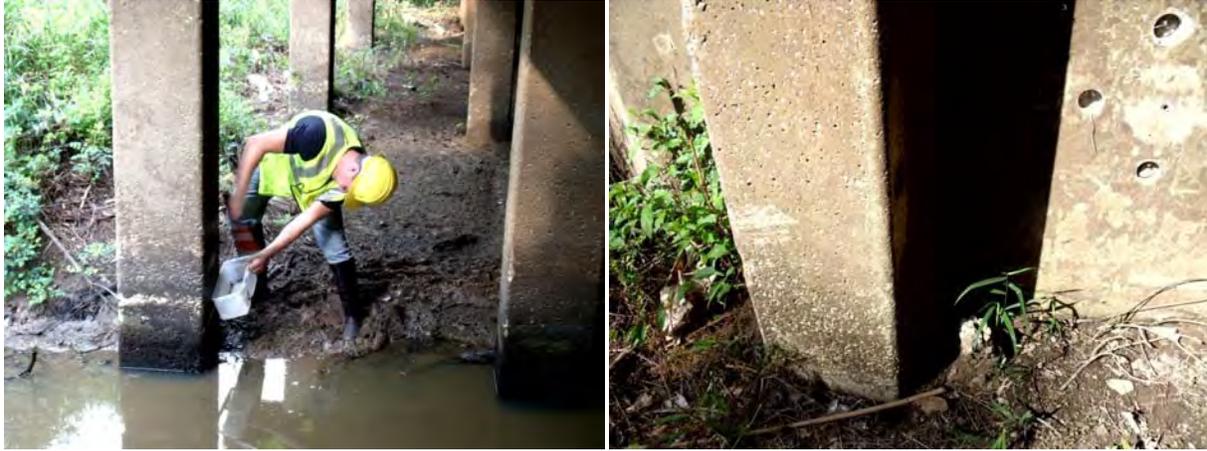
Figure B. 13. Overview of Bridge Deterioration (Bridge 1R).

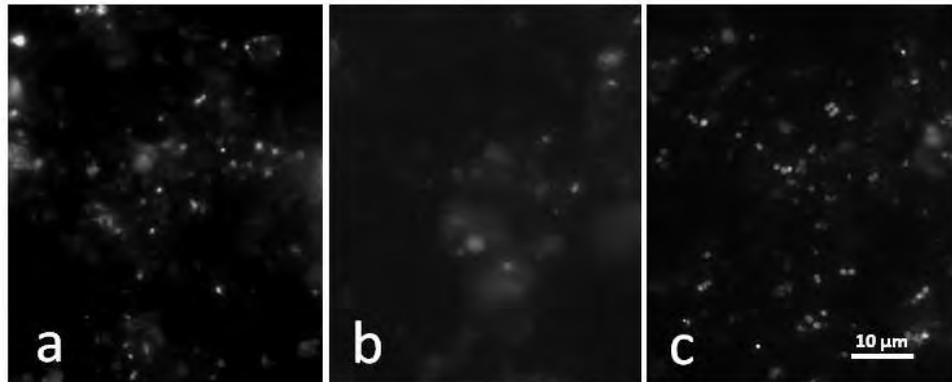
Figure C. 1. *In Situ* Hybridization with Cy3-labeled Probe EUB338 on Surface Concrete Samples (Bridge 3). (a) Standard Hybridization Protocol, (b) Additional Blocking Before and During Hybridization, (c) Lysozyme Pre-treatment and Subsequent Blocking Before and During Hybridization.

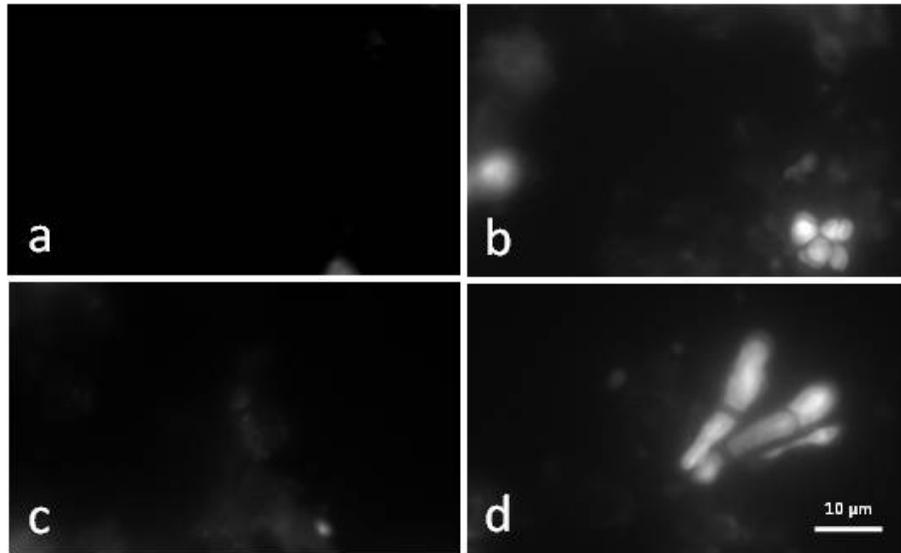
Figure C. 2. Detection of Cell-like Structures After *In Situ* Hybridization Without (a and c) and With Cy3-labeled Probes (b and d).

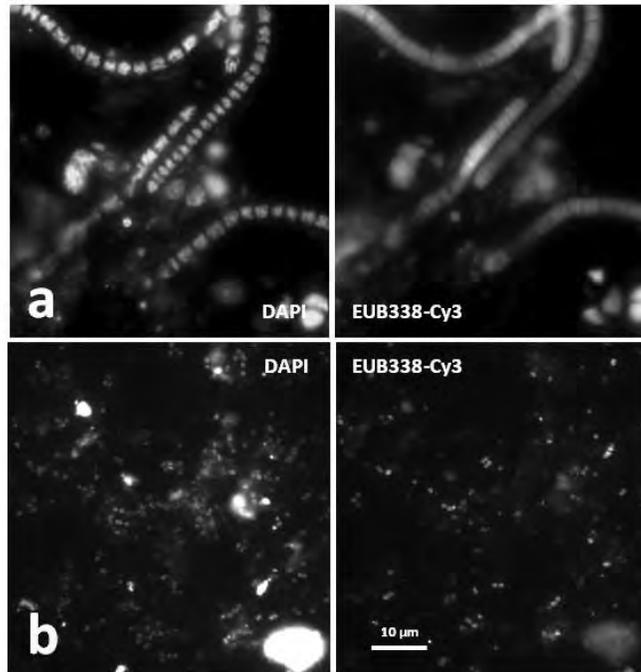
Figure C. 3. *In Situ* Detection of Bacteria in Biofilm Samples Collected from Bridge 3 Visibly Deteriorated (b) Non-Deteriorated Concrete Surface Samples.

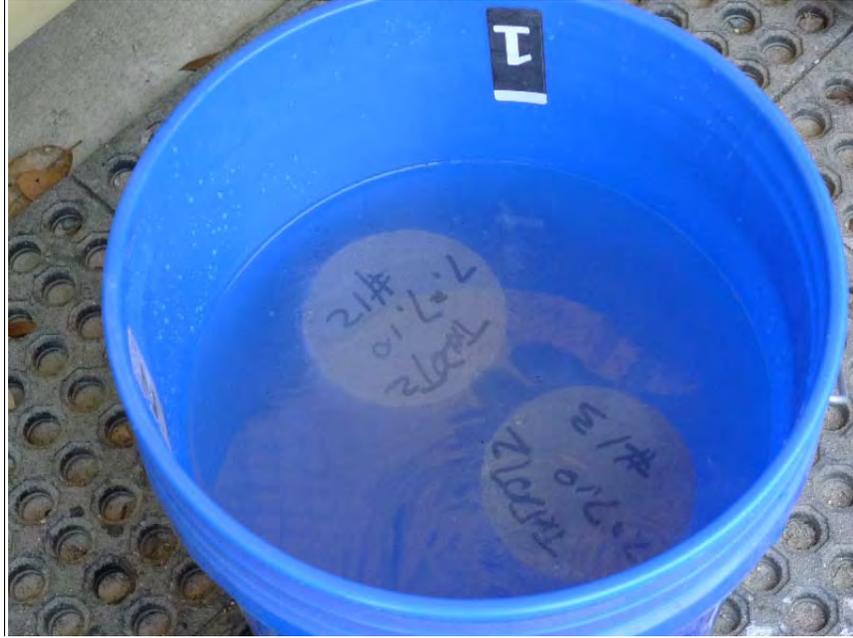
Figure F. 2. Storage of Concrete Specimen in Laboratory Simulation.

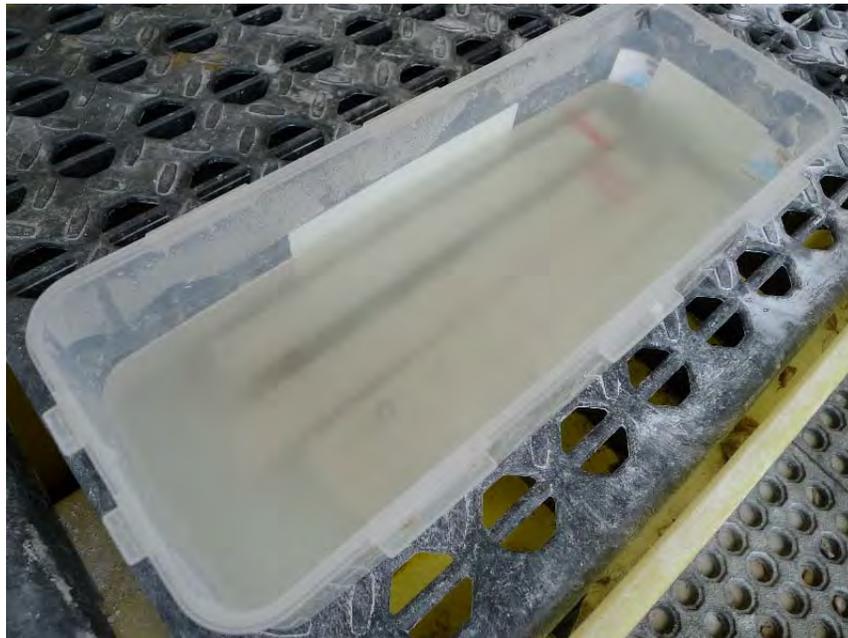
Figure F. 3. Storage of Mortar Specimen in Laboratory Simulation.

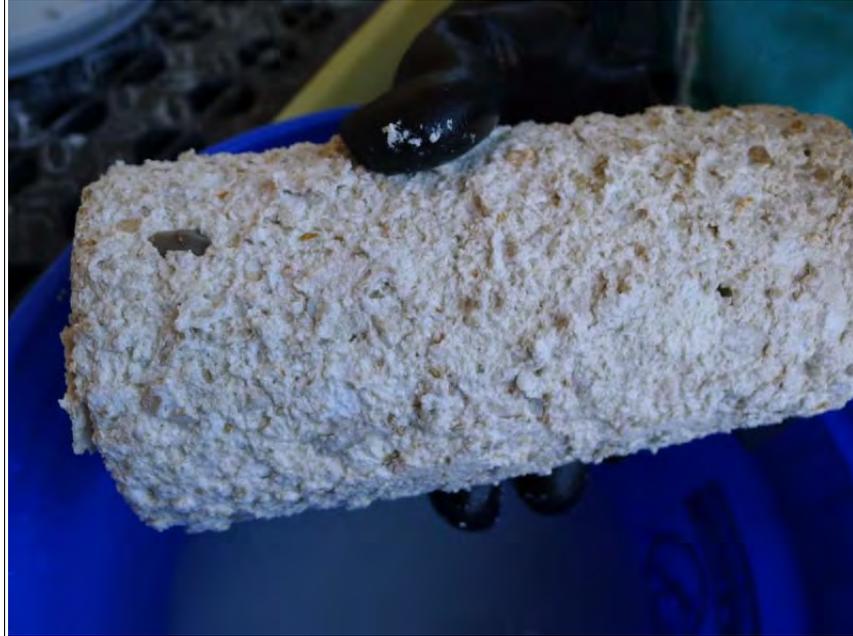
Figure F. 4. Reaction Products on the Surface of Specimen (C-I) after 83 days' Exposure in 3% Sulfuric Solution.
