**USING ROLLING DEFLECTOMETER AND GROUND PENETRATING  
RADAR TECHNOLOGIES FOR FULL COVERAGE TESTING OF  
JOINTED CONCRETE PAVEMENTS**

Report 0-4517-2  
Project Number 0-4517

Project Title: Develop Statewide Recommendations for Application of PCC Joint Reflective  
Cracking Rehabilitation Strategies Considering Lufkin District Experience

TEXAS TRANSPORTATION INSTITUTE  
The Texas A&M University System  
College Station, Texas 77843-3135

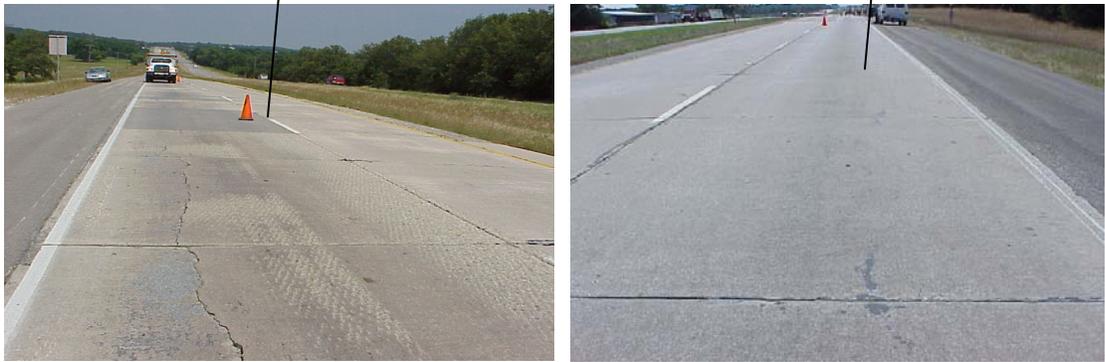
In Project 0-4517 Rolling Dynamic Deflection data were collected on an 11-mile section of US 82 in the Wichita Falls District. Considerable variation in RDD deflection profiles was observed along the highway. The upper plot in [Figure 5](#) shows the RDD deflection profile for a 700 feet section of US 82 where high pavement deflections were recorded. The blue, red, and yellow plots are for the sensor locations 1, 3, and 4 as described in [Figure 2](#). At the left of [Figure 5](#) the pavement condition was poor with several broken slabs and some slab faulting. At the right of the figure, the slab condition was good with no apparent surface distress. The RDD

deflection data are different from the distressed to the non-distressed section. In the distressed section, there is considerable variation in sensor 1 but relatively small changes in sensors 3 and 4 are the RDD rolls over joints. However, in the non-distressed areas, all three sensors show substantial changes in deflection. The interpretation is that in the distressed areas the joint load transfer is poor and this results in large differences in deflections as the sensors straddle the joint. Whereas in the non distressed area, the load transfer is good but the sub-slab support is poor.

a) Raw RDD data for a 700 feet section of highway

b) Pavement condition in the distressed and non distressed area

**Figure 5. Rolling Deflectometer Data from US 82 in the Wichita Falls District.**

The RDD patterns in the high deflection areas should be contrasted with those obtained in other areas of US 82 such as shown in Figure 6. The vertical deflection axis in Figure 6 uses the same scale (0 – 25 mils) as that used in Figure 5 to emphasize the difference in magnitudes that are observed as the RDD tests a project. Figure 6 shows deflections from five slabs. Clearly, in this location, the load transfer is excellent and the center slab deflections are very low.

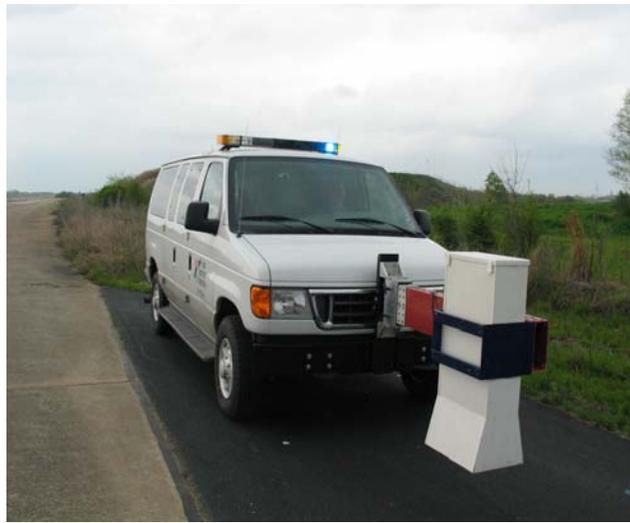
Ground Penetrating Radar technology was implemented with TxDOT in the mid 1990s. TxDOT has a fleet of three units which are used routinely for forensic investigations and pavement rehabilitation studies. [Figure 15](#) shows one of TxDOT's most recent air-coupled GPR units. The background to GPR and the discussion of TxDOT's analysis program COLORMAP are given elsewhere ([Scullion et al., 1995](#)). However, most GPR applications have focused on its usage on flexible pavements where it is possible to estimate layer thicknesses and identify subsurface defects.

**Figure 15. TxDOTs Air-Coupled GPR Unit.**
