1. Report No. FHWA/TX-05/0-4749-1		2. Government Accession No.		3. Recipient's Catalog No.	
4. Title and Subtitle DEVELOPMENT AND EVALUATION OF AN ACTIVE WARNING DEVICE FOR SCHOOL BUS LOADING AND UNLOADING POINTS IN AREAS OF LIMITED VISIBILITY				5. Report Date February 2005

**DEVELOPMENT AND EVALUATION OF AN  
ACTIVE WARNING DEVICE  
FOR SCHOOL BUS LOADING AND UNLOADING POINTS  
IN AREAS OF LIMITED VISIBILITY**

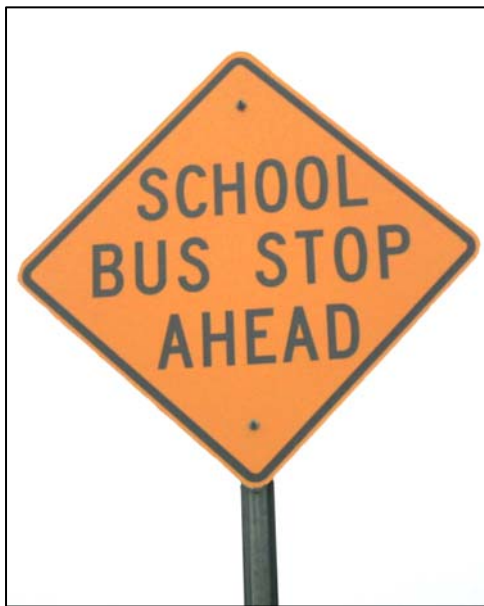
**Figure 1. SCHOOL BUS STOP AHEAD Sign (S3-1).**

The SCHOOL BUS STOP AHEAD advance warning sign is diamond shaped, with 30-inch sides and a black legend and border on a yellow background. The design and size of this sign is compliant with *MUTCD* recommendations for conventional roadways.

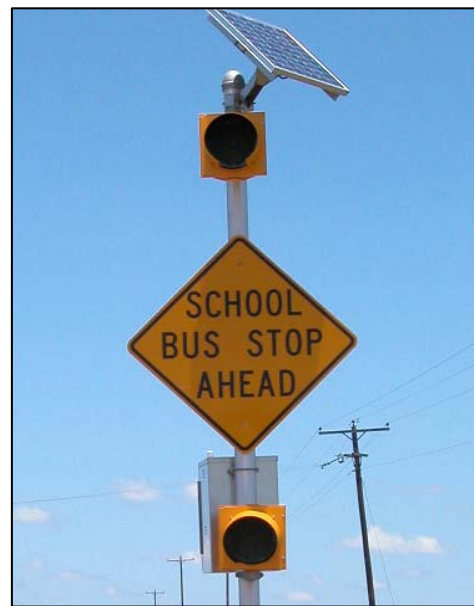
**Figure 2. SCHOOL BUS STOP AHEAD Sign (S3-1) with Flashing Beacon.**

Flashing beacons can be used to add conspicuity or emphasis to static warning signs and reduce the likelihood for motorist desensitization (U.S. Department of Transportation 2000) (see [Figure 2](#)). The use of these “active” warning devices is governed by the *MUTCD* and enhances the sign’s ability to command attention. The *MUTCD* provides recommended applications for flashing warning beacons:

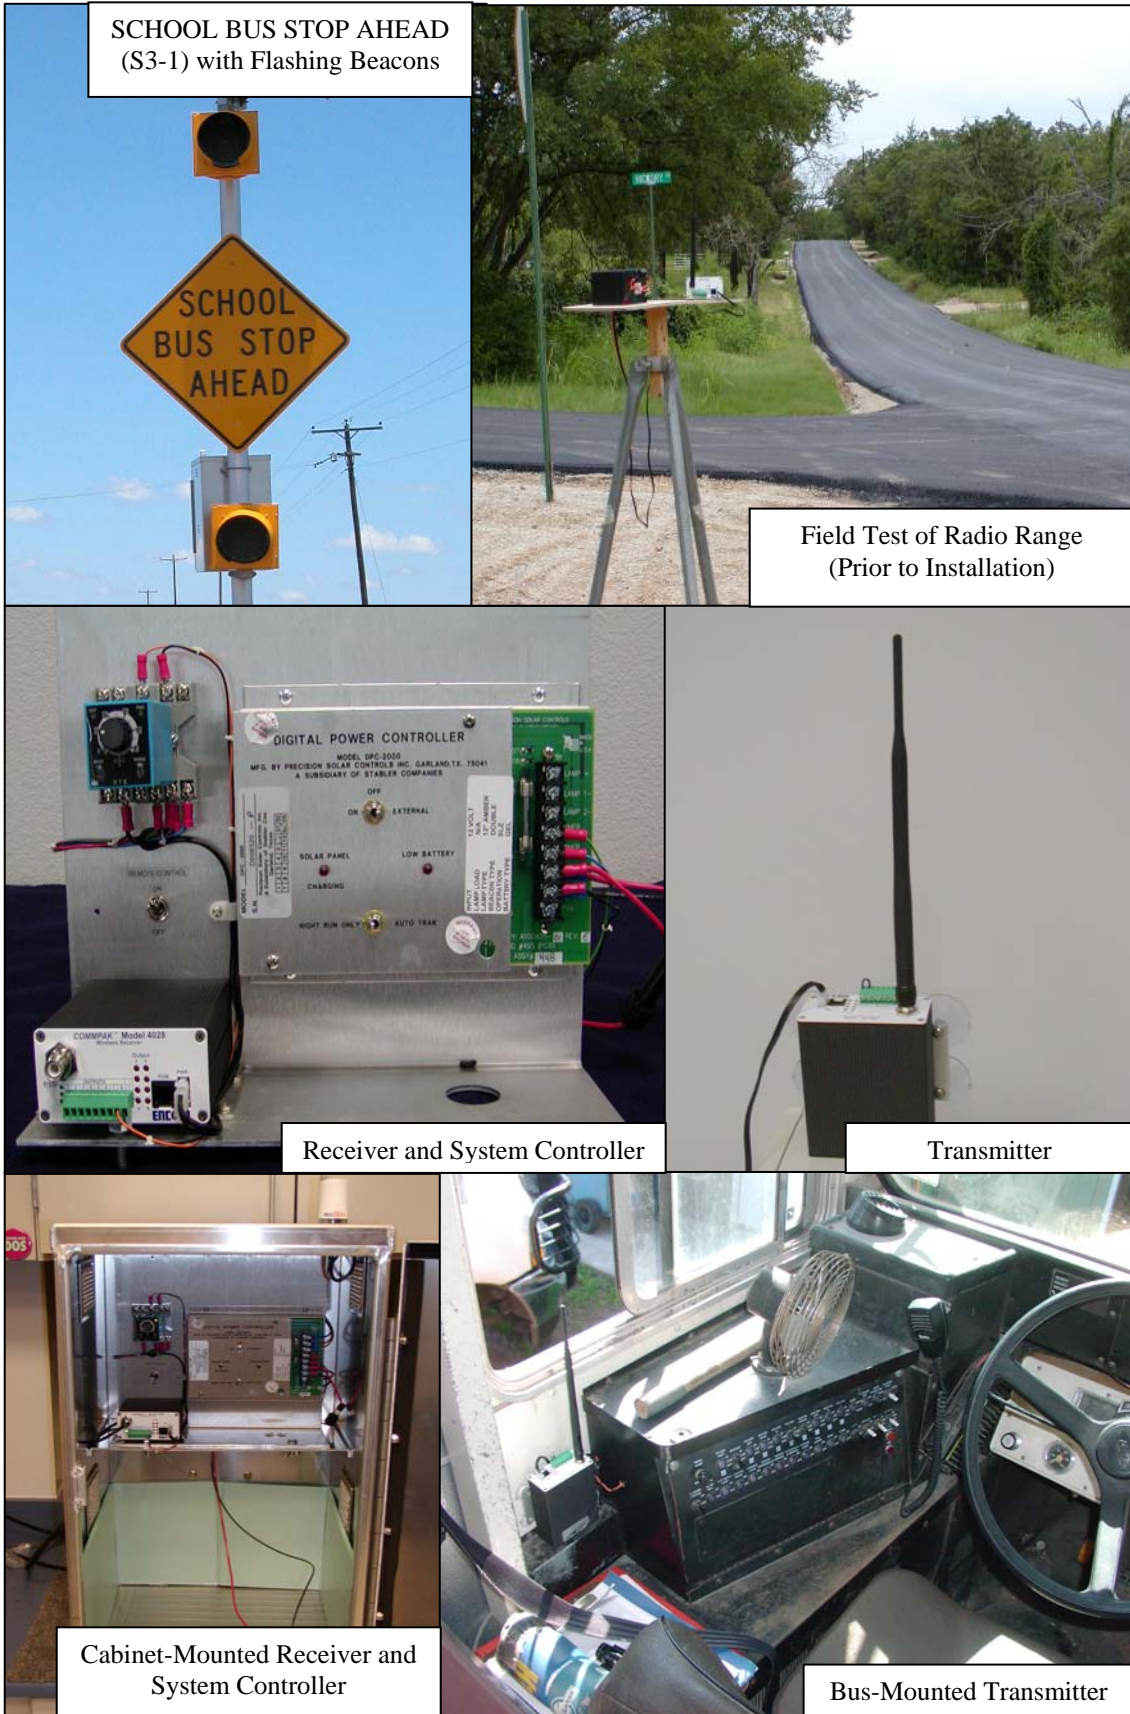
**Figure 3. Active Advance Warning Device Components for School Bus Loading/Unloading Zones.**

Two vertically aligned, flashing circular yellow beacons are mounted above and below the SCHOOL BUS STOP AHEAD sign on the same assembly but outside of the border of the sign. The yellow beacons, with nominal diameters of 8 inches, flash alternately at a rate of not less than 50 nor more than 60 times per minute with an illumination period of each flash not less than one-half and not more than two-thirds of the total cycle, as recommended in the *MUTCD*. The power to operate the flashing beacons is derived from solar cells charging a storage battery.

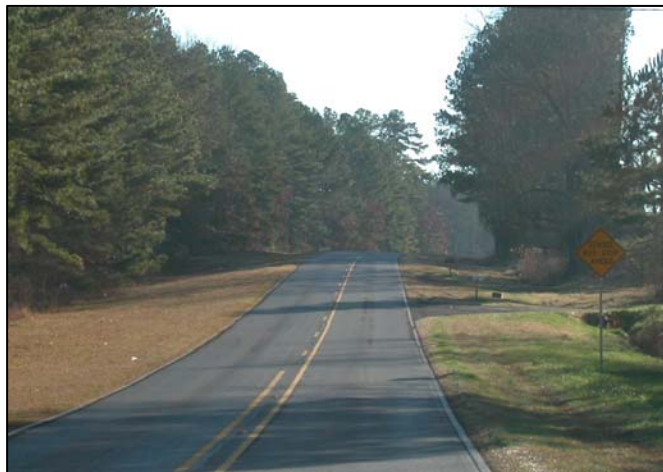
**Figure 4. Typical Field Study Site Environment.**

- limited visibility,
- high speed,
- rural environment,
- reasonably high traffic volumes, and
- “simple” environment, without distracting stimuli (see [Figure 4](#)).

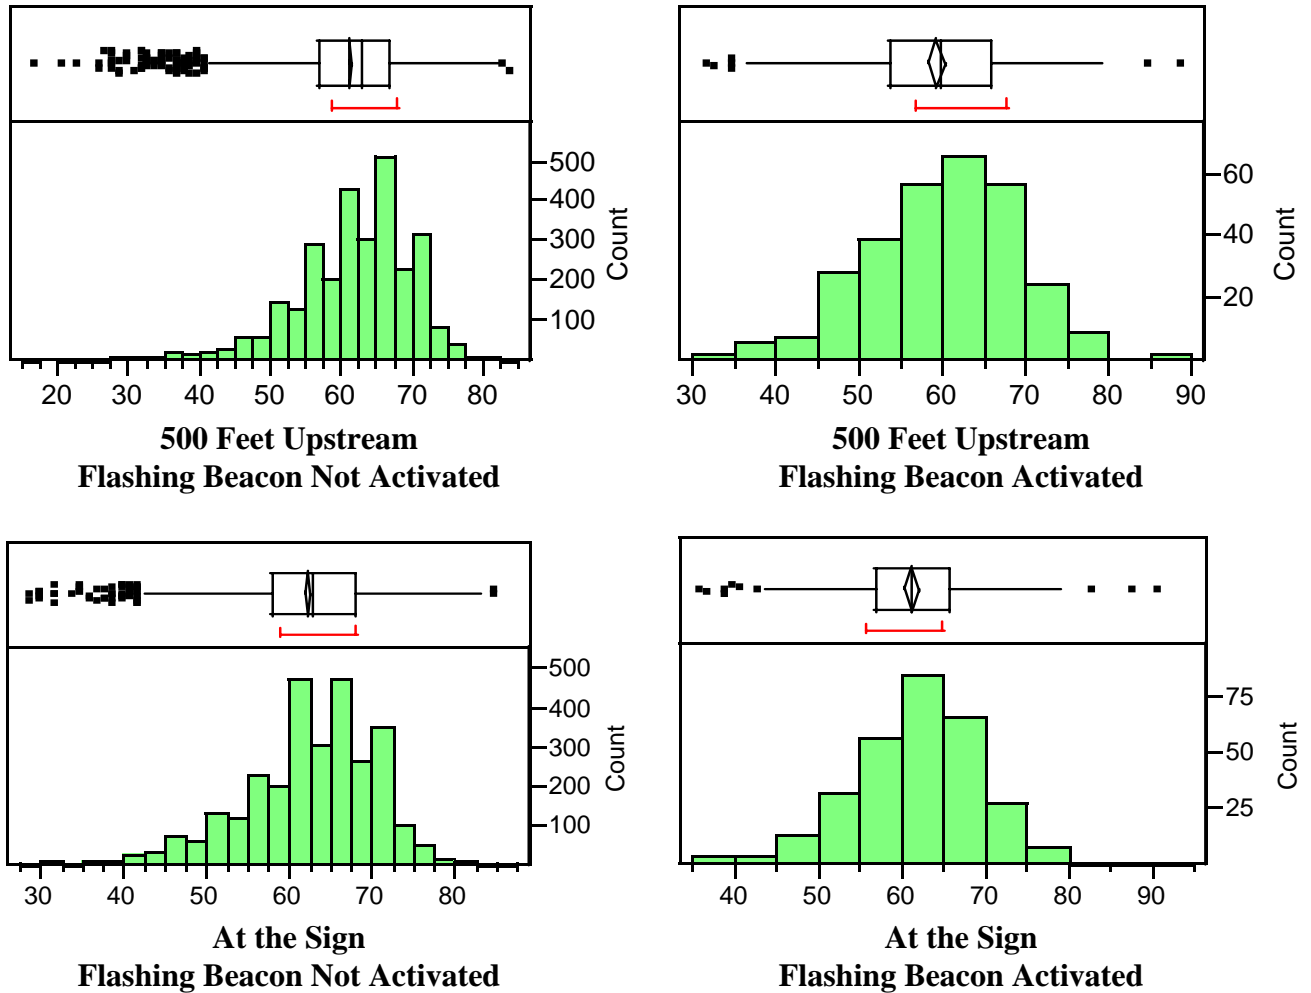
**Figure 5. Approaching Vehicle Speed Profiles.**

Tables 13 and 14 summarize the results of the statistical analysis for speeds recorded 500 feet upstream of and at the SCHOOL BUS STOP AHEAD sign. At 500 feet upstream, the measured difference in the average vehicle approach speeds between non-flashing and flashing conditions is only 2.02 mph; however, this speed reduction under flashing conditions was proven to be statistically significant with 99.98 percent confidence (p-value=0.0002). The Wilcoxon Test

confirms these findings ( $p\text{-value} < 0.0001/2 = 0.00005$ ). Thus, it can be concluded that the average speed 500 feet upstream is lower when the beacon is flashing than when the beacon is not flashing at  $\alpha = 0.05$ .
