1. Report No. FHWA/TX-07/0-4863-2	2. Government Accession No.	3. Recipient's Catalog No.	
4. Title and Subtitle EVALUATION OF RIDE SPECIFICATION BASED ON DYNAMIC LOAD MEASUREMENTS FROM INSTRUMENTED TRUCK		5. Report Date March 2007 Published: May 2007

EVALUATION OF RIDE SPECIFICATION BASED ON DYNAMIC LOAD MEASUREMENTS FROM INSTRUMENTED TRUCK

Report 0-4863-2

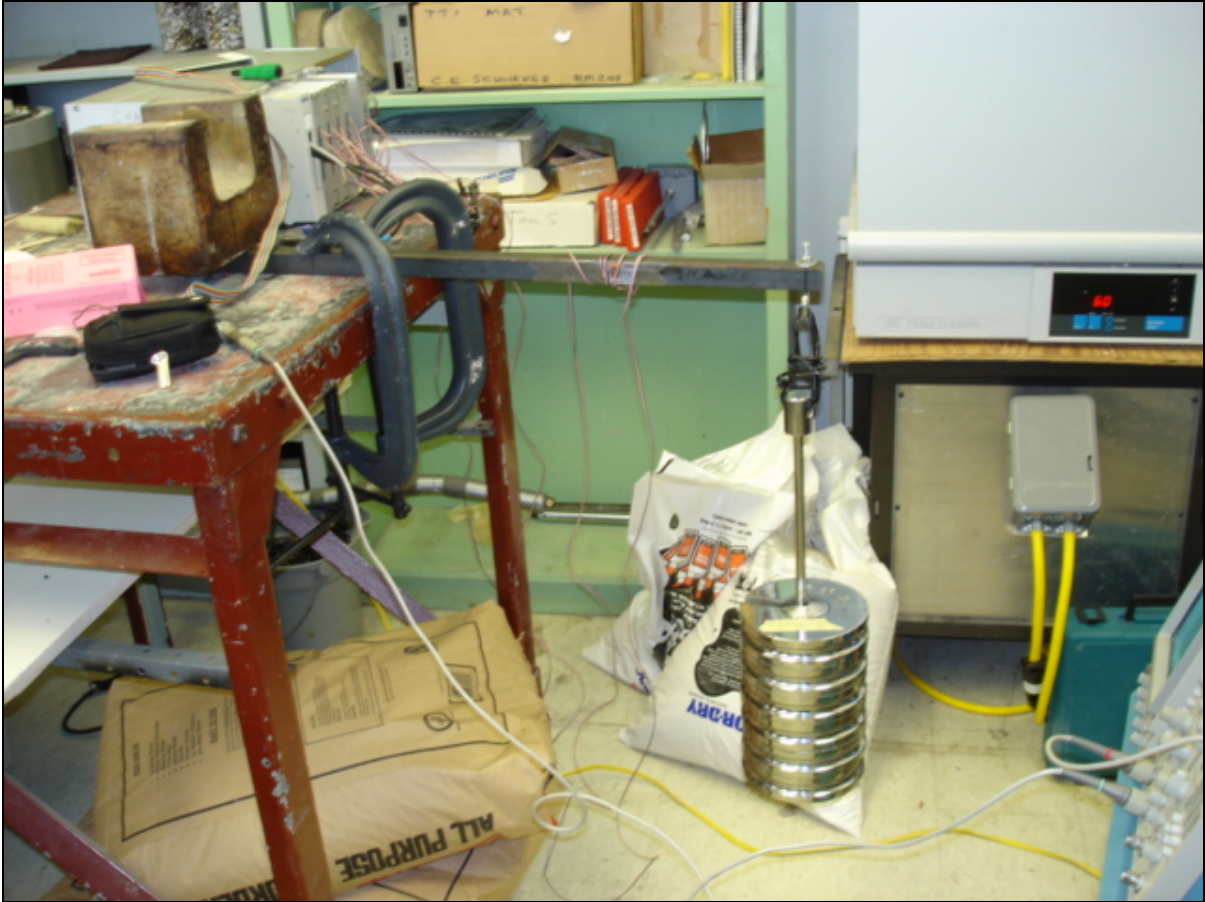
Figure 2.4. Shear Beam Load Cell Experimental Setup.

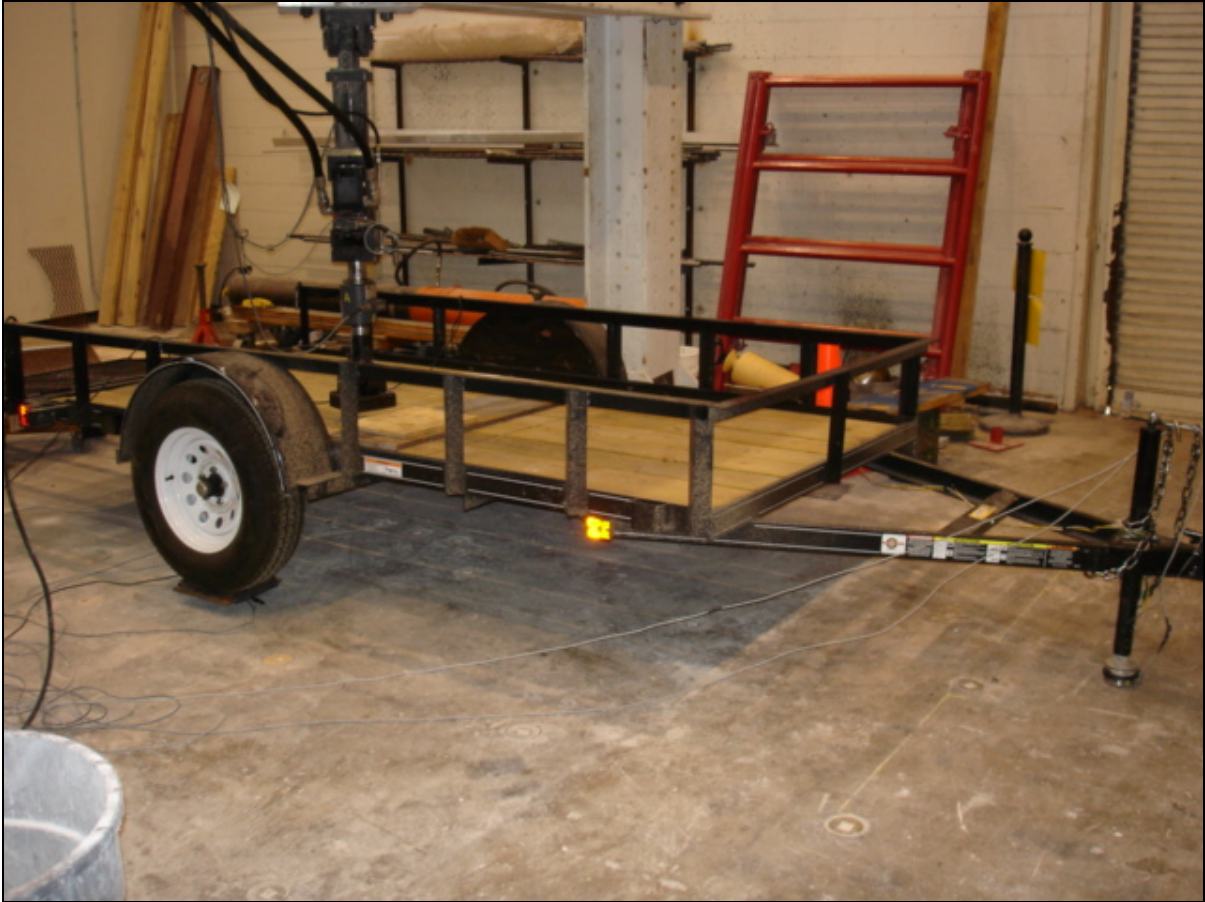
Figure 2.5. Small-Scale Trailer Used to Verify Strain Measurement Methodology.

Following up on the laboratory test with the shear beam load cell, researchers instrumented a small trailer with shear strain gages to verify the intended method of measuring dynamic loads. Considering the high cost of renting, instrumenting, and calibrating an 18-wheeler for the tests planned in this project, researchers believed that a small-scale experiment to verify the intended method of dynamic load measurement was a prudent step to take. For this experiment, researchers instrumented the single-axle trailer shown in Figure 2.5. For this instrumentation, researchers instrumented the left side of the

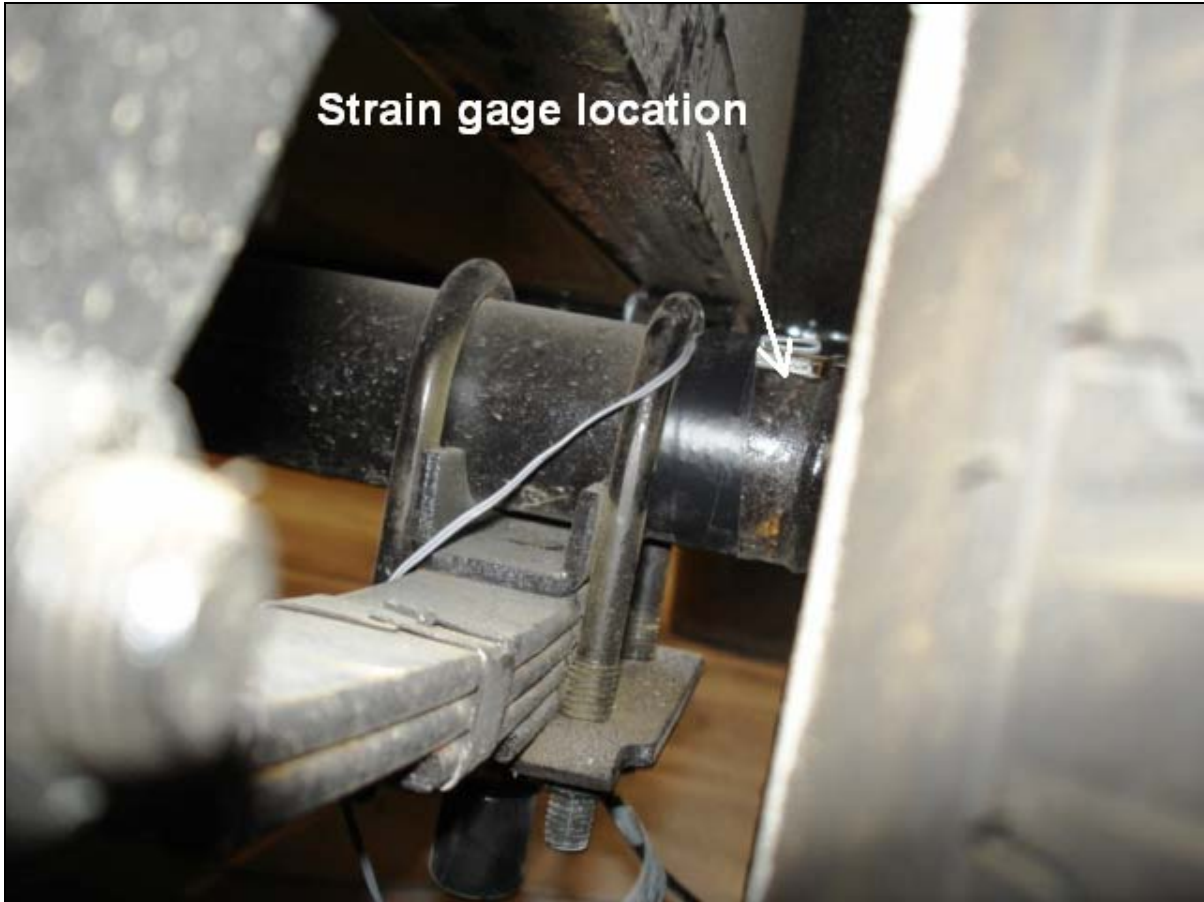
Figure 2.6. Strain Gages Positioned between Suspension and Tire of Small Trailer.

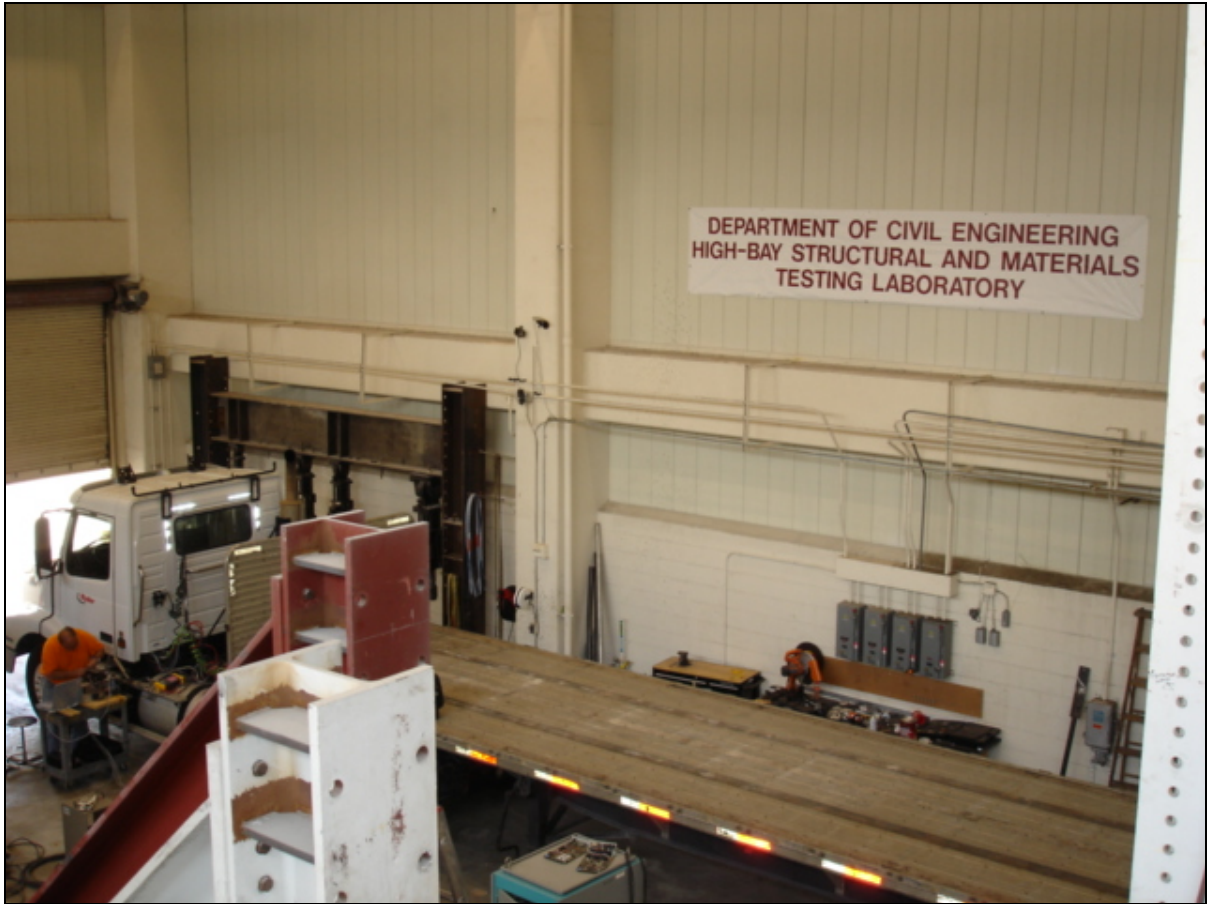
Figure 2.14. Instrumentation and Calibration of Test Vehicle in the Laboratory.

[Figure 2.14](#) shows a picture of the tractor-semitrailer combination that researchers tested in this project. To select a vehicle combination for instrumentation and testing, researchers considered the findings of a truck survey conducted by [Wang et al. \(2000\)](#) in an earlier TxDOT project. In that survey, researchers identified the tractor-semitrailer as the most common truck configuration used by truck carriers in Texas. The survey also identified radial tires as the most common truck tire used by truckers, and leaf and air springs as the most popular suspensions. These suspensions were never observed to be on the same axle for the trucks that were sampled, with air spring suspensions commonly found on the drive axles, and semi-elliptic leaf springs on the trailer axles. In view of these findings, researchers selected an 18-wheeler with air bag suspensions on the drive axles and leaf springs on the trailer axles for instrumentation and testing in this project. In terms of truck tire use,

As shown in Figure 2.14, the 18-wheeler was driven into the high-bay structural and materials testing laboratory of the civil engineering department at Texas A&M University. This facility provided ample space and test equipment for instrumenting and calibrating the tractor-semitrailer in an air-conditioned environment. The instrumentation work covered the installation of the same types of sensors (shear strain gages, distance encoder, and start sensor) used for the small-scale trailer testing, except that more strain gages were used to permit measurement of tire loads for all five axles of the tractor-semitrailer. Additionally, researchers added thermocouple sensors to monitor temperatures at the steering, drive, and trailer axle assemblies during testing. Researchers note that temperature sensitivity of the strain measurements is not considered to be an issue in view of the temperature-compensated strain gages and the full bridge configuration used in the truck instrumentation. Nevertheless,

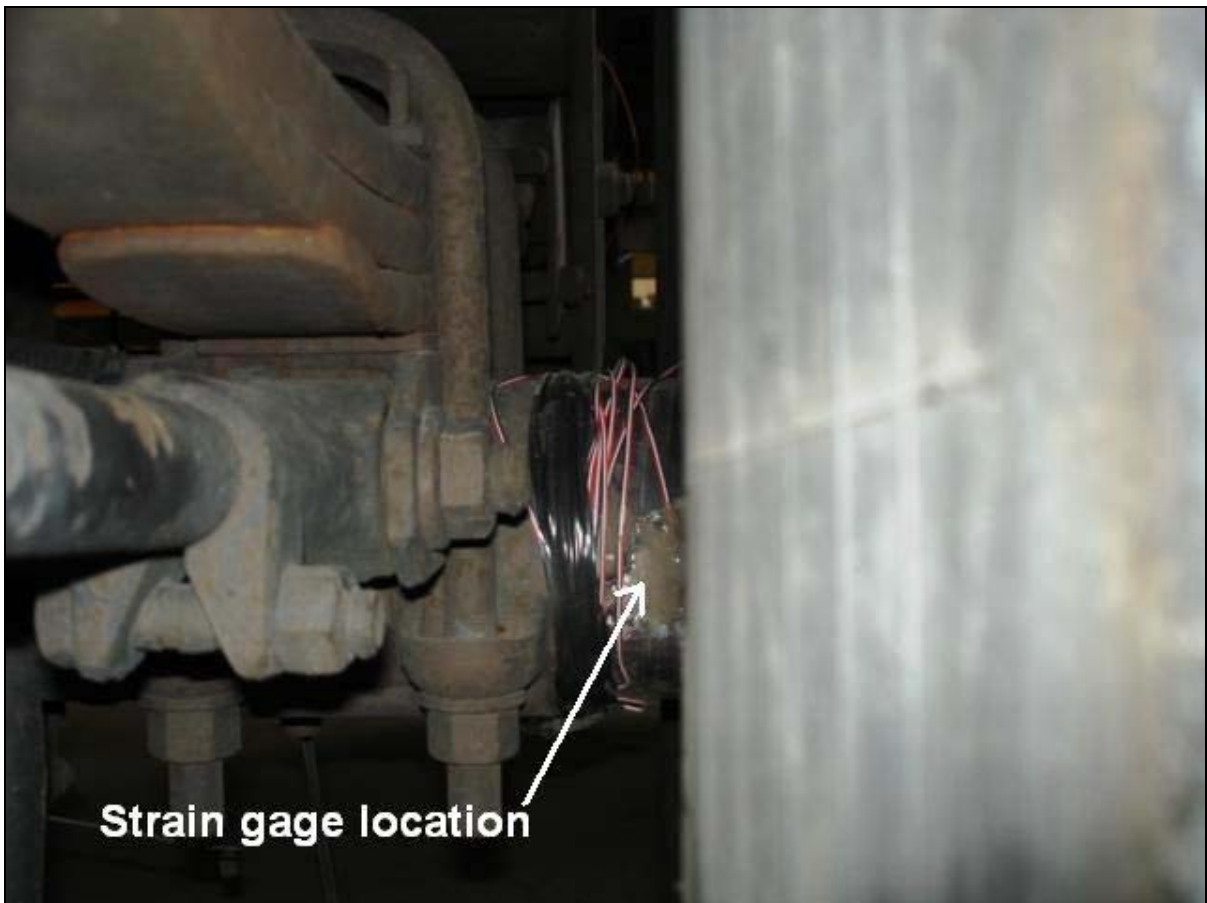
Figure 2.16. Strain Gage Mounted on Trailer Axle.

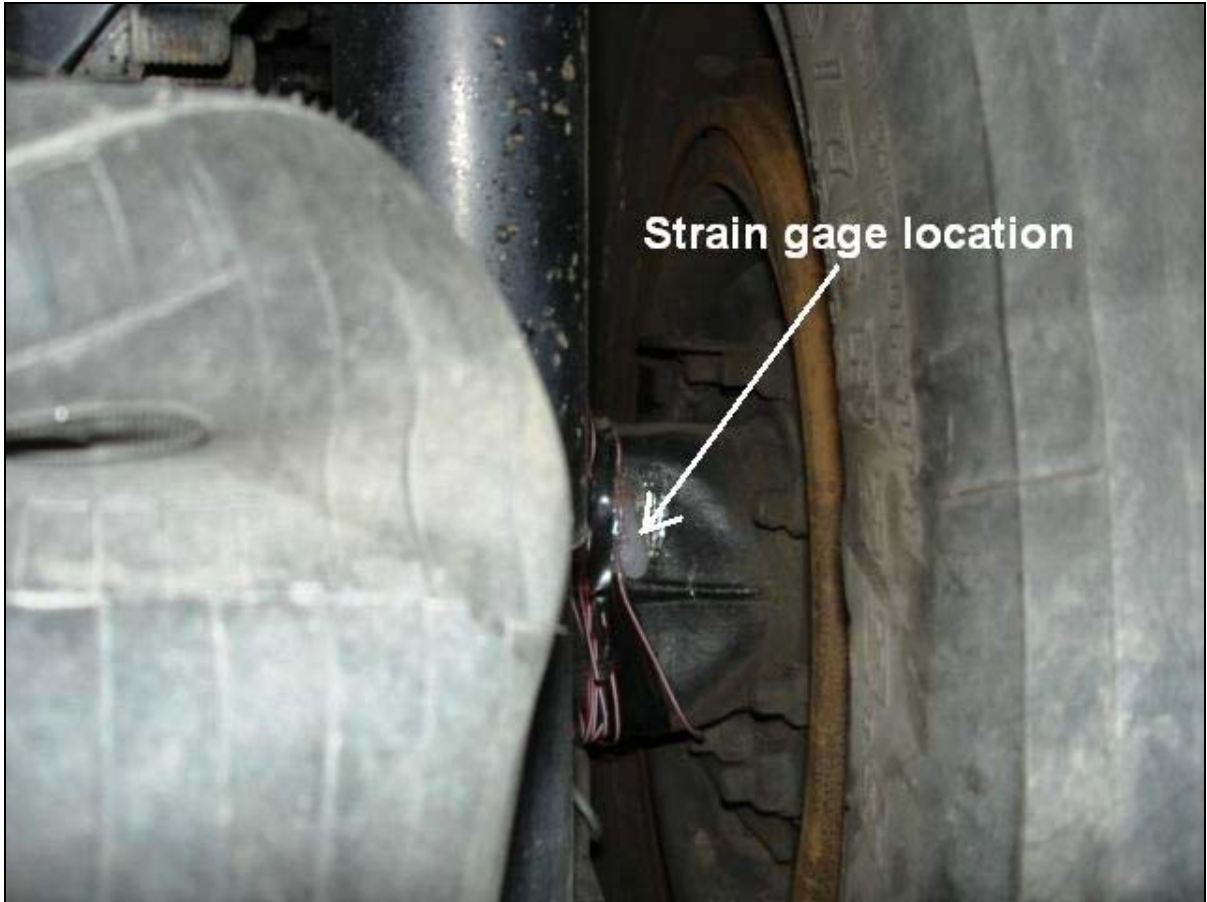
Figure 2.17. Strain Gage Mounted on Drive Axle.

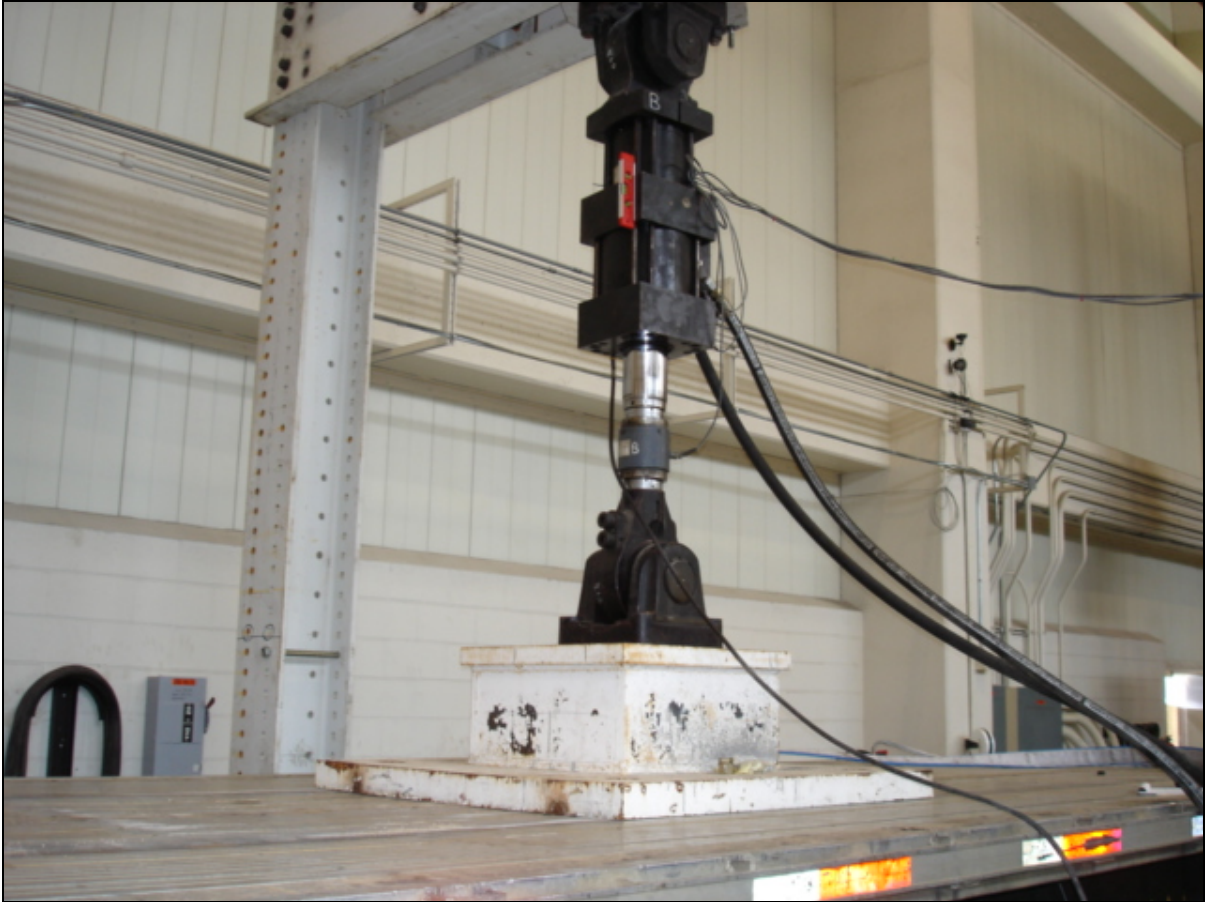
**Figure 2.18. Application of Load to Axle Assembly through Loading Plate.
(axle assembly underneath the loading plate and load ram)**

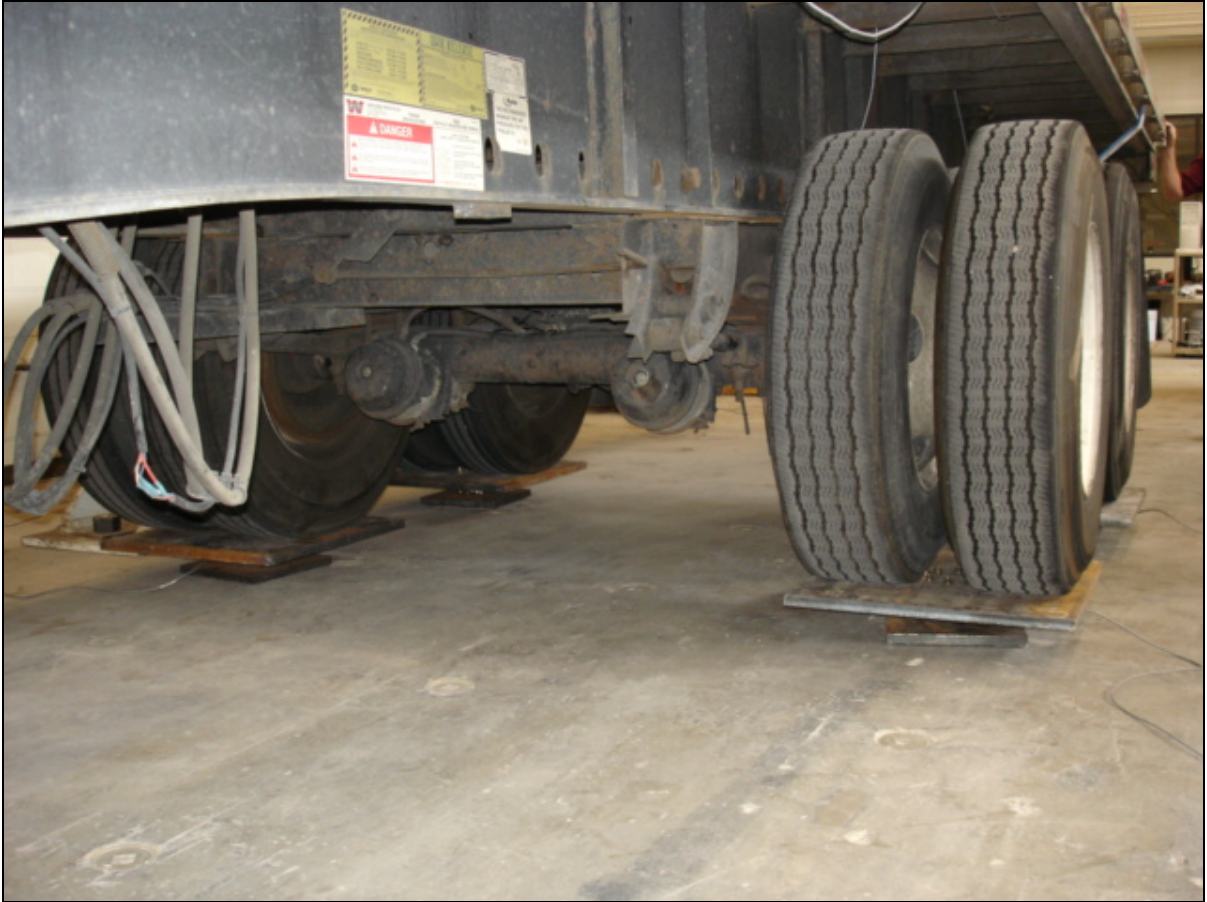
Figure 2.19. Load Cells Positioned under Dual Tires of Trailer Axle Assembly.
