1. Report No. FHWA/TX-13/0-6643-1		2. Government Accession No.		3. Recipient's Catalog No.	
4. Title and Subtitle GUIDANCE FOR EFFECTIVE USE OF PYLONS FOR LANE SEPARATION ON PREFERENTIAL LANES AND FREEWAY RAMPS				5. Report Date Published: May 2013

GUIDANCE FOR EFFECTIVE USE OF PYLONS FOR LANE SEPARATION ON PREFERENTIAL LANES AND FREEWAY RAMPS

Report 0-6643-1

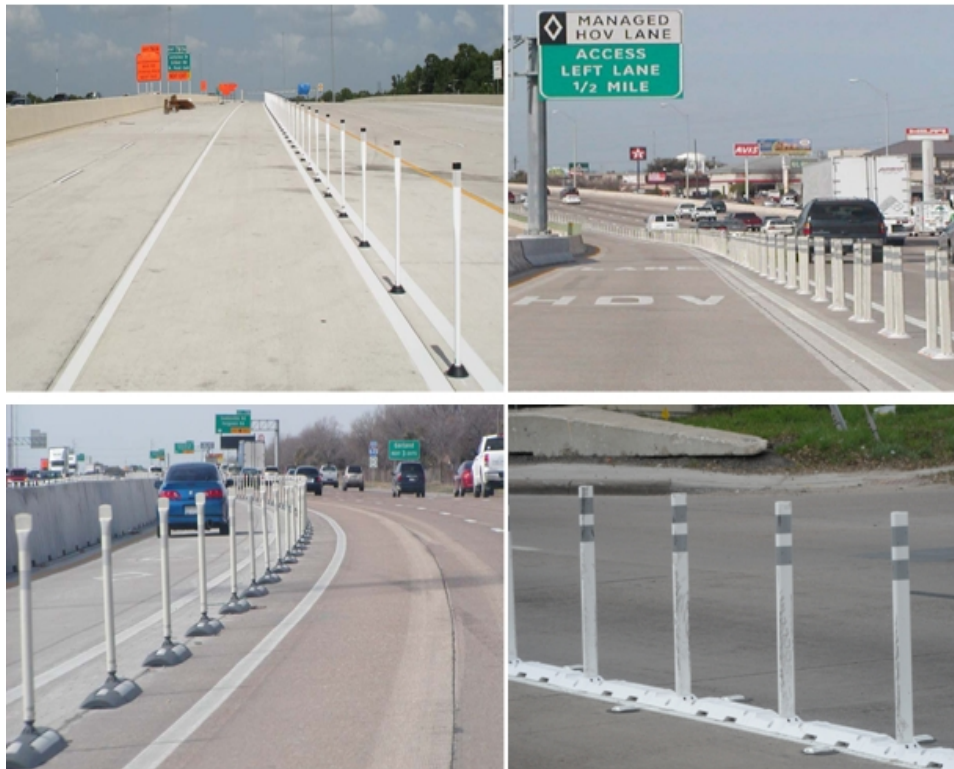
Figure 1. Examples of Pylon Devices.

Over the past decade, flexible pylons have been increasingly used on Texas roadways for the purposes of lane delineation and separation. Numerous terms have been used to describe the devices herein referred to as pylons, including *flexible pylons*, *delineator posts*, *candle sticks*, *tubular markers*, and *channelizing posts*. Figure 1 shows examples of pylon traffic control devices.

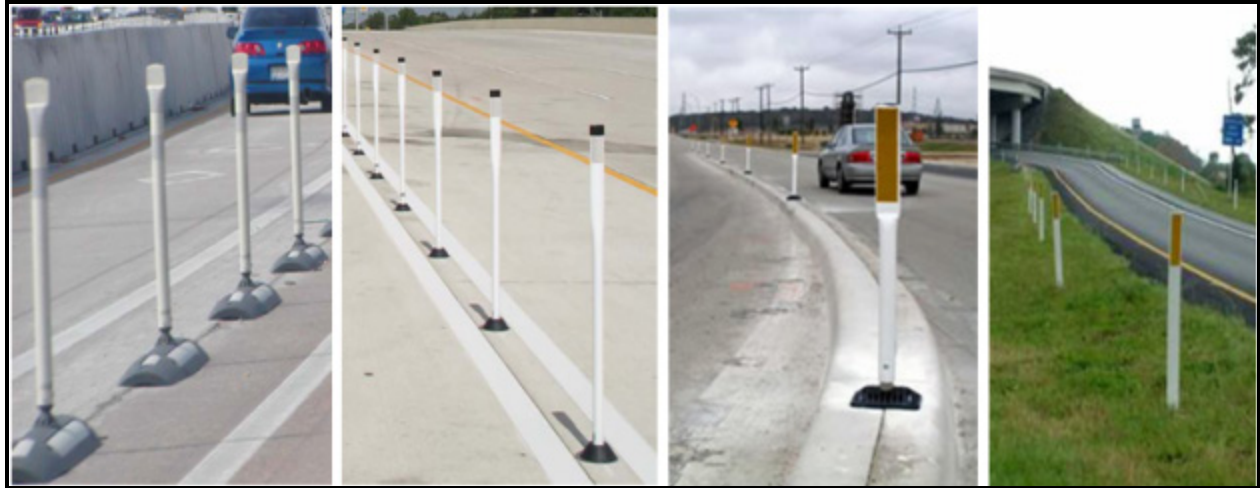
(a) Curb Mounted (b) Pavement Mounted (c) Surface Mounted (11) (d) Embedded (11)

Flexible pylons are classified based on how they are installed, either as *curb-mounted* pylons, *surface-mounted* pylons, or *embedded* pylons. In the curb mounted pylons (shown in [Figure 4a](#)), the pylon posts are fixed to a raised plastic curb, whereas in a surface mounted pylon (shown in [Figure 4b](#) and [Figure 4c](#)), the pylon posts are directly affixed (glued or bolted) to the pavement or to the concrete surface using a pylon base. Embedded pylons ([Figure 4d](#)) are usually installed by the side of the roadway (soil-driven) for hazard or curve delineation purposes. Curb mounted pylons and surface mounted pylons are typically used in lane separation on high speed facilities due to their relative ease of installation and replacement.

When curbs are connected or closely spaced, curb mounted pylons provide a picket fence visual effect. The use of pylon mounting curbs may discourage more drivers from crossing across the pylons as compared to directly mounted pylons to the pavement, although this has not been scientifically evaluated. However, curb mounted pylons may, in some conditions, impede drainage capacity when closely spaced. Hence, when curb mounted pylons are used, drainage requirements at the specific site may influence the minimum spacing between the pylon units. Some of the newer curb designs make provision for drainage using a lateral channel to allow water to pass under the curb. Curbs may collect debris against (and between) them, which can present both maintenance and drainage issues. Ice build-up can also be a problem with some curb designs.

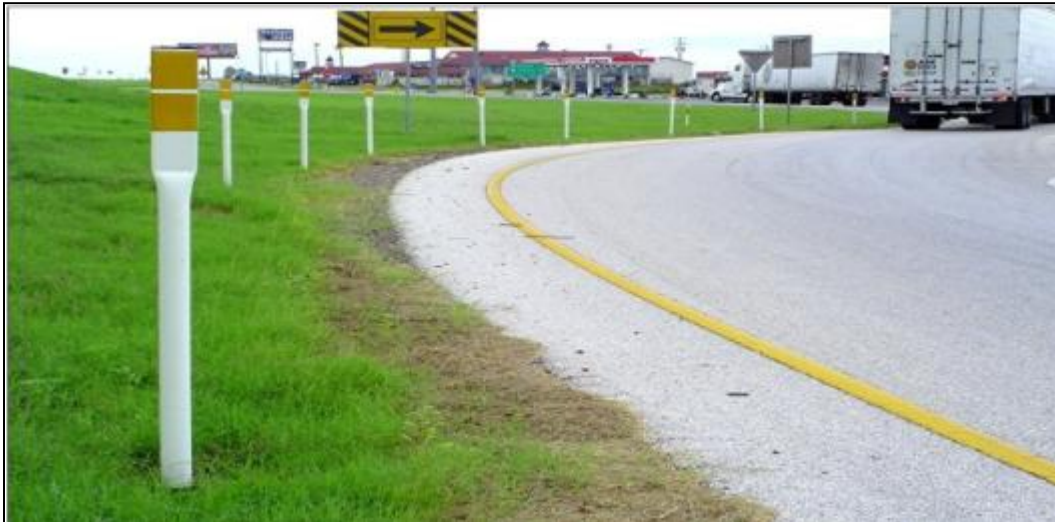
Figure 5. Example of Pylons Used for Curve Delineation (11).

Flexible pylons have been used in various roadway applications. One of the early uses of flexible pylons was as a replacement for steel delineator posts for delineation of horizontal curves. [Figure 5](#) shows an example of flexible pylons used in the delineation of a freeway exit ramp. Embedded (soil-driven) pylons near the roadside (not mounted directly on the pavement surface) are commonly used in the curve delineation applications. Flexible pylons can take more hits compared to steel posts resulting in less frequent replacement. Flexible pylons also cause less damage to vehicles when hit as compared to steel delineator posts. Given these benefits, flexible pylons are now widely preferred for horizontal curve delineation. However, one study

reported that replacement of broken pylons is more tedious than replacing the steel posts due to the accumulated debris at the base of the pylons that makes pylon replacement difficult (12).

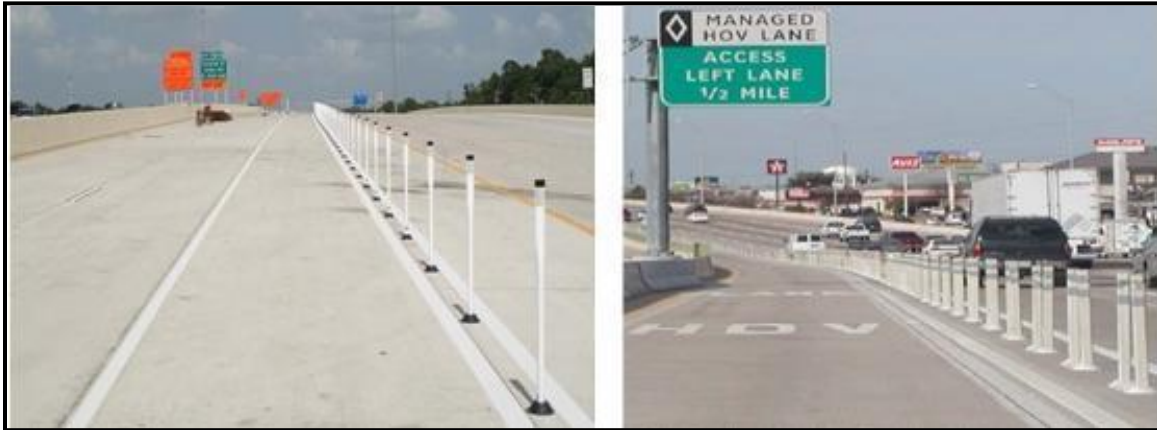
Figure 6. Pylon Implementation on IH 10 Katy Managed Lane (Houston) and US 75 HOV (Dallas) ([6](#)).

Pylons have also been popular devices to delineate HOV lane and managed lane facilities, both of which the MUTCD refers to as “preferential lanes” (1). Pylons used on HOV and managed lanes are used to both delineate and separate these facilities from the general purpose lanes. Concrete barriers and painted buffer spaces were traditionally used for separating HOV lanes from the general purpose lanes, however pylons have increasingly being used in these applications due to the lower initial cost of implementation when compared to concrete barriers. While flexible pylons provide emergency access between preferential and general purpose lanes, they are more likely to discourage illegal lane crossing when compared to painted buffer stripes (7). Figure 6 shows examples of pylon use on HOV/managed lane facilities in Texas. To the left in Figure 6 are two-part, tubular, flat-front pylons used on the Katy Managed Lane facility in Houston, Texas. To the right in Figure 6 are curb mounted T-shaped pylons used on the US 75 HOV lane in Dallas, Texas.

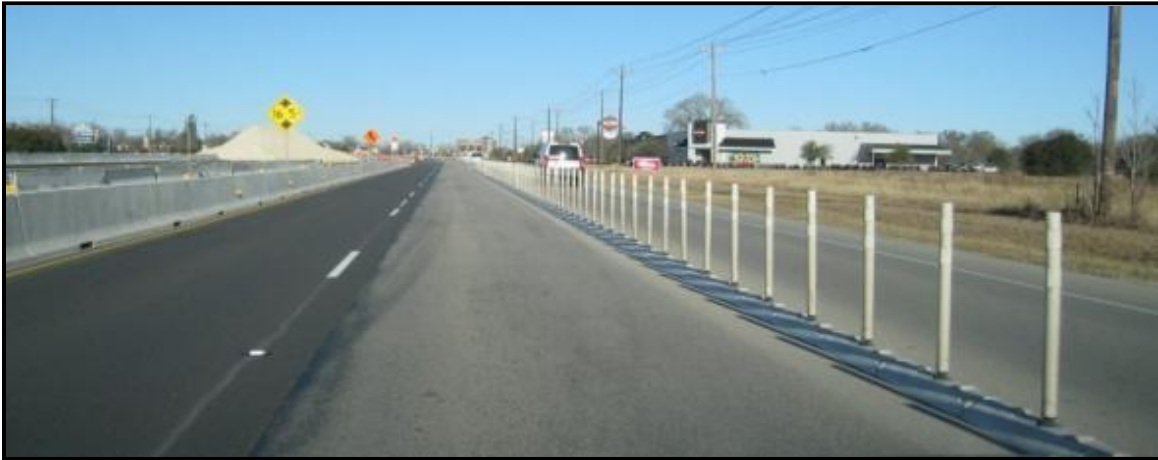
Figure 8. Pylons Used in a Work Zone to Separate Mainlanes and Frontage Road.

Pylons are often used in work zones to channelize traffic, separate traffic, and delineate the travel way. [Figure 8](#) shows the use of pylons in separation of mainlanes (two-lanes on left) and frontage road (far right lane) near a work zone area on State Highway 6, south of College Station, Texas. White pylons were used near a work zone (instead of orange color pylons)

because these pylons were deployed for long-term use and MUTCD requires channelizing devices to be orange only when used in a temporary traffic control zone.

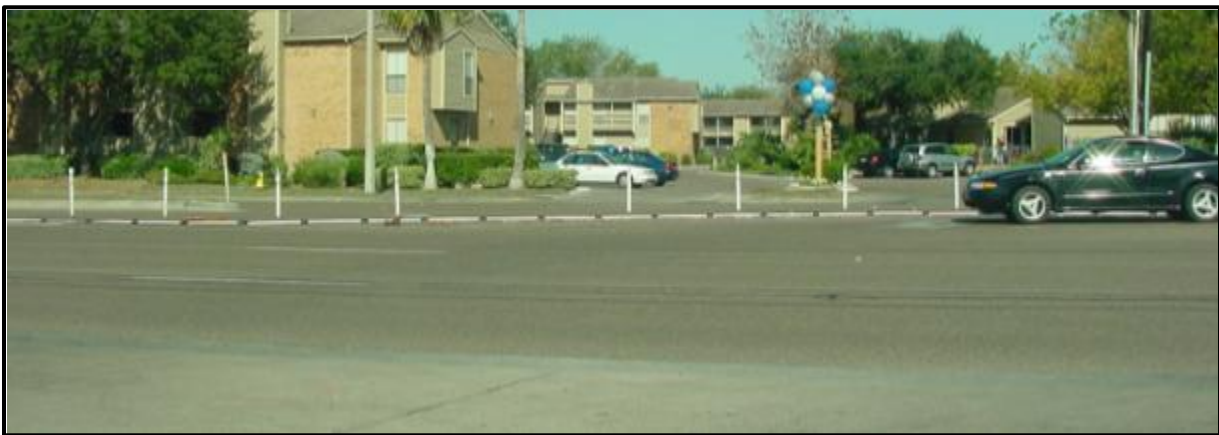
Figure 9. Curb-Pylons Used as a Median Separator on an Arterial Street, Corpus Christi, Texas.

Pylons are also used in many access management applications on arterials and highways. [Figure 9](#) shows curb pylons being used as median separators on an arterial street in Texas. [Figure 10](#) (left) shows an access management application where pylons are used to discourage merging vehicles from making quick lane changes and turning into the driveways. In one situation, pylons provide left turning lanes at an intersection in Texas, as shown in [Figure 10](#) (right).

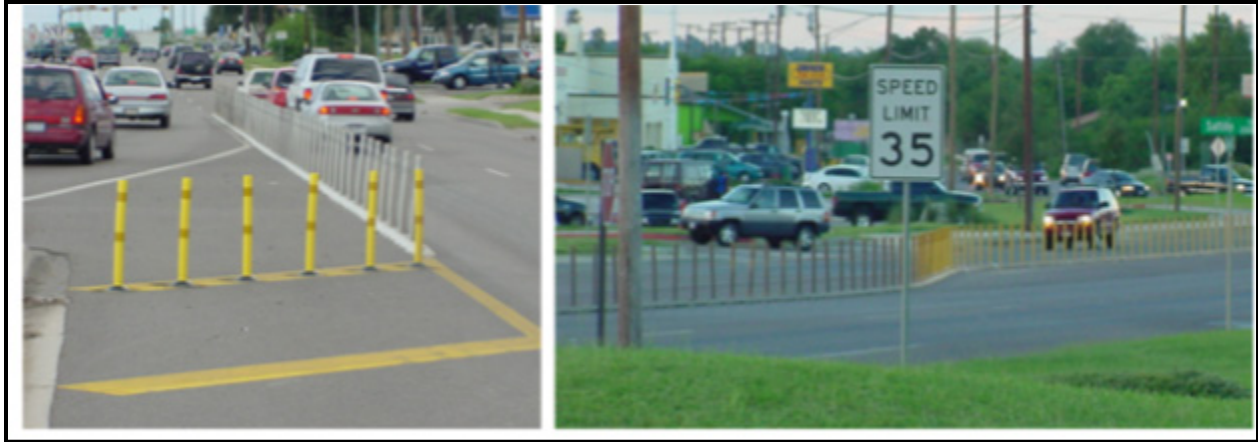
Figure 10. Access Management Applications of Pylons in Laredo, Texas: Left – Blocking Access to Driveways, Right – Delineating Left Turn Lanes.

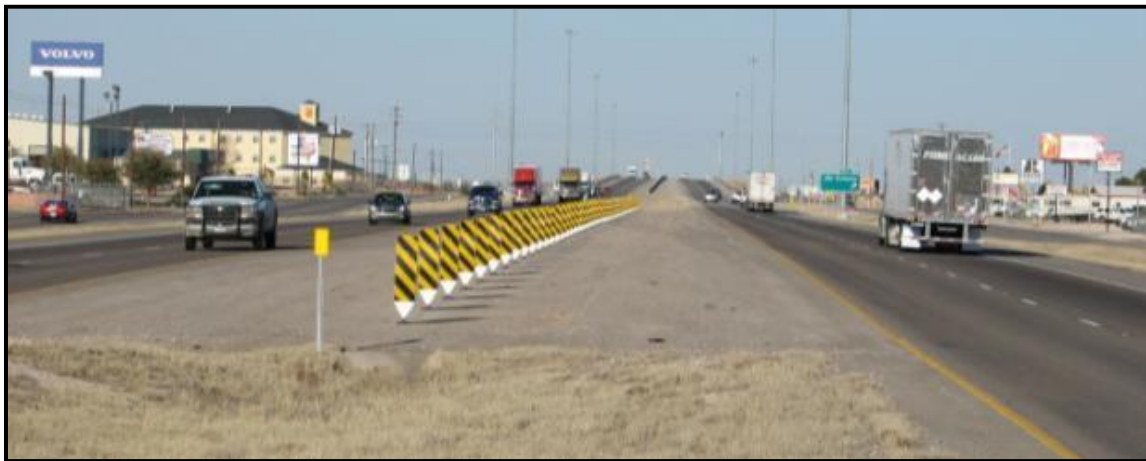
Figure 11. Use of Vertical Panels to Prevent Crossover Movements on IH 20, Odessa, Texas.

Figure 11 and Figure 12 show the application of pylons to block crossover movements on a high speed urban highway and rural highway, respectively. Flat-front (paddle type pylon) vertical panels, as shown in Figure 11, provide more surface area for retroreflective sheeting and have higher target value. In the rural application shown in Figure 12, tubular pylon posts are used to delineate a median. Figure 12 also shows a vertical panel (wide-front orange pylons with chevrons) used for lane closure on a rural interstate highway.

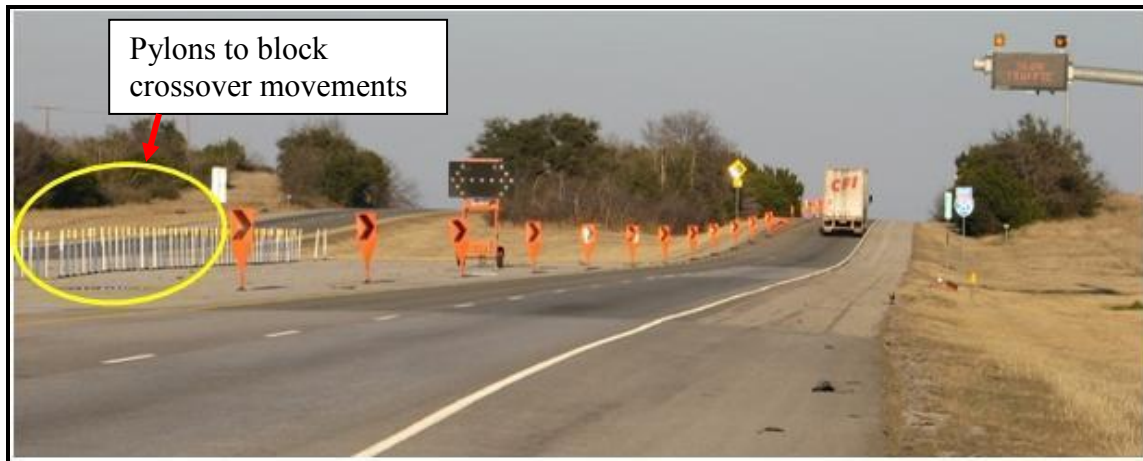
Figure 12. Pylons Blocking Crossover Movements, Rural Highway, IH 20, Ranger Hill, Texas.

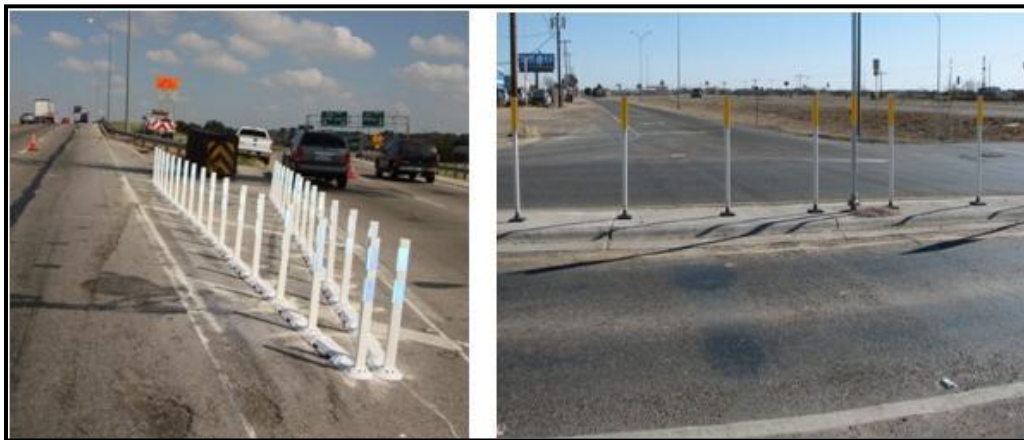
Figure 13. Examples of Application of Pylons at Freeway Gore Areas.

Pylons have also been used for exit ramp gore delineation, raised median delineation, and traffic island creation. [Figure 13](#) (left) shows an example of pylons used to delineate a freeway exit ramp gore on IH 35 in the Dallas/Fort Worth area where a crash cushion was frequently struck. [Figure 13](#) (right) shows a low raised median at an intersection along Business IH 20 frontage in Odessa, Texas, made more visible to motorists by installing pylons. [Figure 14](#) provides an example of pylons used for traffic calming. In this case, the pylons create a center island widening on a two-lane two way county highway in Slater, Iowa. This widening causes a slight path deviation for motorists. A reduced speed limit was also installed to further encourage motorists to slow down ([13](#)).

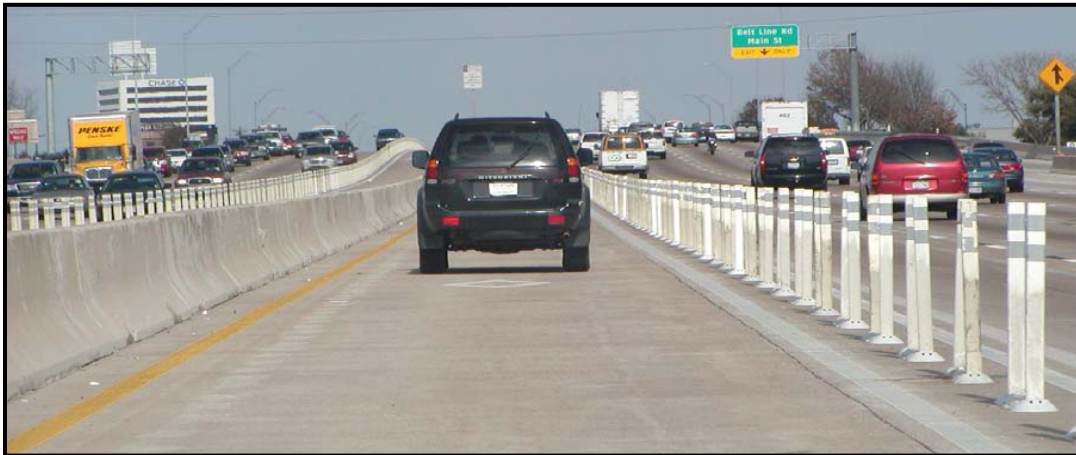
Figure 15. Curb-Pylon Implementation on US 75 HOV in Dallas (6).

The curb-pylon system installed on the US 75 HOV facility consists of a curb that is 44 in. long and 2.5 in. high. There are two pylons on each curb with 37 in. spacing between them. The curb spacing between curb assemblies is 100 in. to accommodate drainage requirements. This results in 144 in. (12 ft.) between the first pylons on adjacent curbs. The pylon height is 36 in., which includes the curb height. The pylons are fitted with two 3-inch strips of abrasion-resistant retroreflective sheeting at the top end of the pylon to provide retroreflectivity at night. On this particular project, the quoted price for a single curb section with two pylons was \$260 (6).

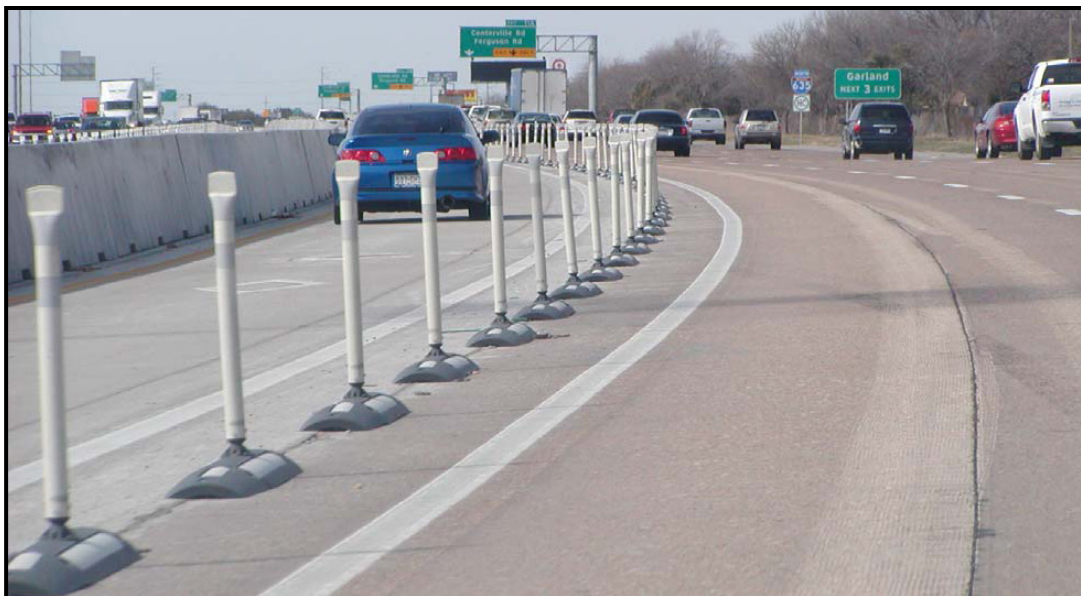
Figure 17. Curb-Pylon Implementation on IH 635 in Dallas ([8](#)).

The IH 635 HOV/Managed Lane facility (shown in [Figure 17](#)), located in northeast Dallas, is a 12-mile long concurrent flow facility with two intermediate entry/exit access points that operates 24 hours per day ([14](#)). The facility was opened for traffic in January 2008 at a cost of \$50.6 million. The IH 635 corridor (HOV/managed facility and general purpose lanes) carries about 207,000 vehicles per day on average at the north end of the facility and 188,000 vehicles per day on average at the south end of the facility. The IH 635 HOV lanes were retrofitted by reducing the lane width from 12 ft. to 11 ft. and taking the left shoulder. The HOV lane width at IH 635 is 11 ft. with a buffer space of 5 ft. between the HOV and freeway mainlanes. Compared to the US 75 HOV facility, this facility has narrower lanes but a wider buffer space.

The curb-pylon system on IH 635 consists of 58 in. long curbs with a single pylon attached to each curb, as shown in [Figure 16](#). The curb base is 3 in. high, and the pylons are 39 in. high (measured from the pavement surface). The pylon spacing is 14 ft., and a curb spacing of 9 ft. is provided between the curbs for drainage purposes. The bid price for furnish and install of each curb-pylon assembly was \$385.15 ([6](#)).

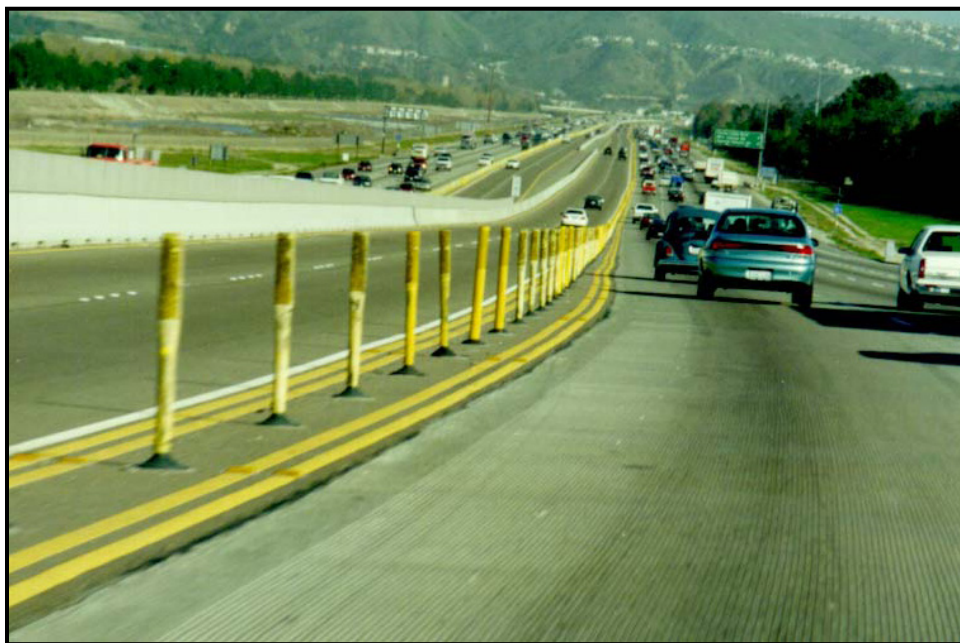
Figure 18. Pylon Installation on SR 91 Managed Lane Facility in California.

The SR 91 Express Lanes (shown in Figure 18) consist of a 10-mile segment with two toll lanes in each direction. The SR 91 Express Lane was designed and built by the California Private Transportation Company (CPTC) under the strict supervision of the California Department of Transportation (CALTRANS). The SR 91 toll lanes began operation in 1995, leased and operated by CPTC. However, in April 2002, the SR 91 Express Lane facility was purchased by the Orange County Transportation Authority (OCTA), and in a few months the SR 91 toll road was converted to a High Occupancy Toll (HOT) road facility (16).

The HOT lanes are separated from the general purpose lanes by double painted stripes with a buffer space of 4 ft. Pylon posts are installed in the buffer space to provide a soft physical barrier. The pylon spacing is 12 ft. The HOT lane was 12 ft. wide. Cooner and Ranft reported that even with the pylons, many drivers violate the access requirements and, as a result, OCTA replaces approximately 1000 pylons per month (6). However, the cost of maintaining the pylons is considered essential for successful operation of the facility (6).

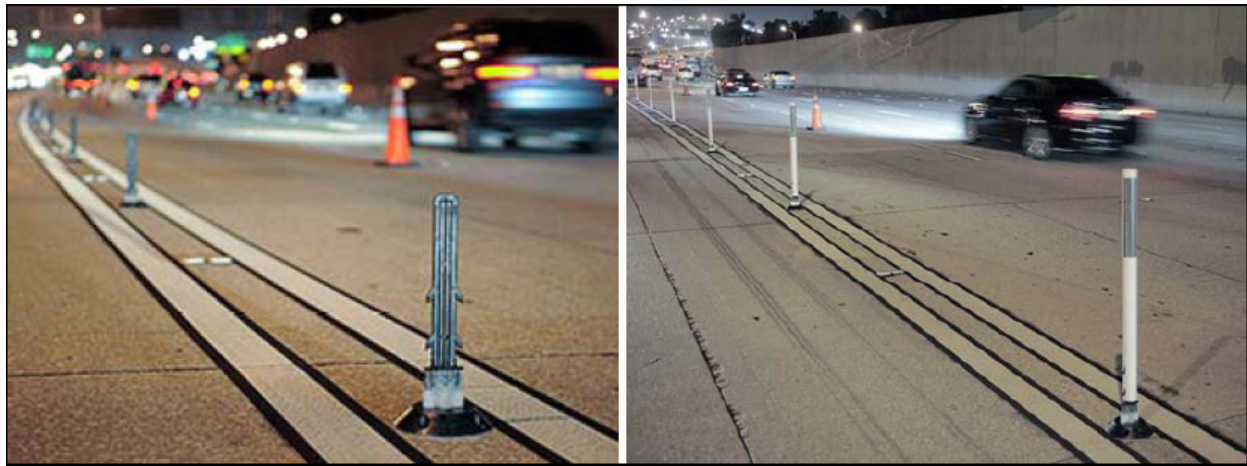
Figure 19. Pylons Used on IH 95 Express Lanes in Miami, Florida (6).

Surface mounted pylons separate the express lanes from the general purpose lanes. As shown in Figure 19, several different types of pylons were deployed as an experiment on this facility (6). FHWA specified 20 ft. as the minimum pylon spacing; therefore an initial pylon spacing of 20 ft. was used. However, there was frequent weaving between the pylons with the 20 ft. spacing. In response, the pylon spacing was reduced to 10 ft. (6). After initial use of white colored pylons, the initial 500 ft. of an access point were replaced with yellow pylons to increase visibility in contrast to the white concrete pavement, as seen in Figure 20 (6). The pylon implementation on the IH 95 Express Lanes has a buffer width of 2 ft.

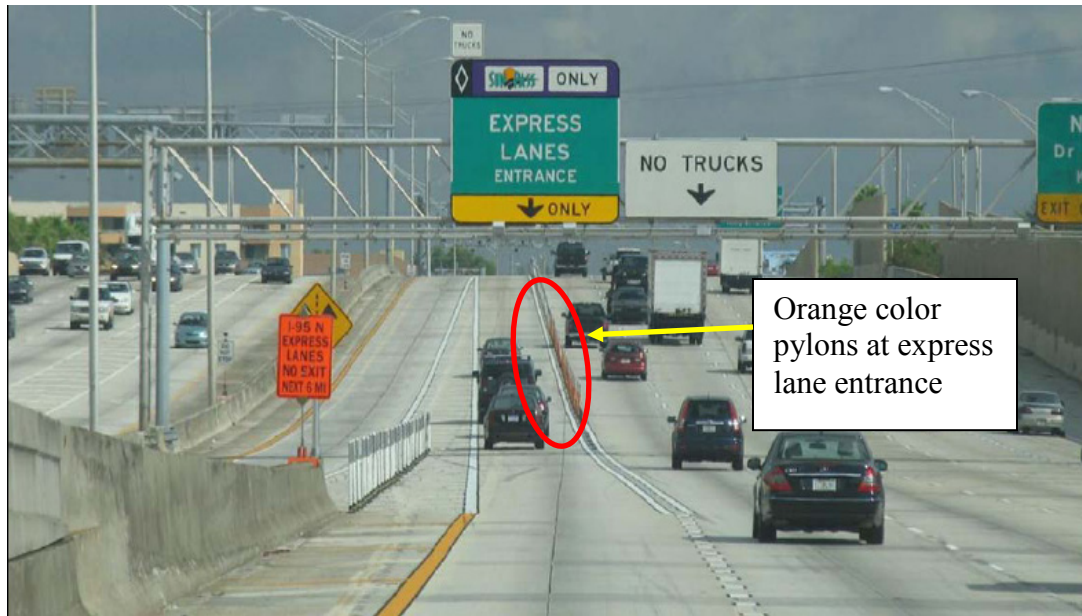
Figure 20. Orange Color Pylons Used to Increase Contrast at Access Points on IH 95 Express Lanes (6).

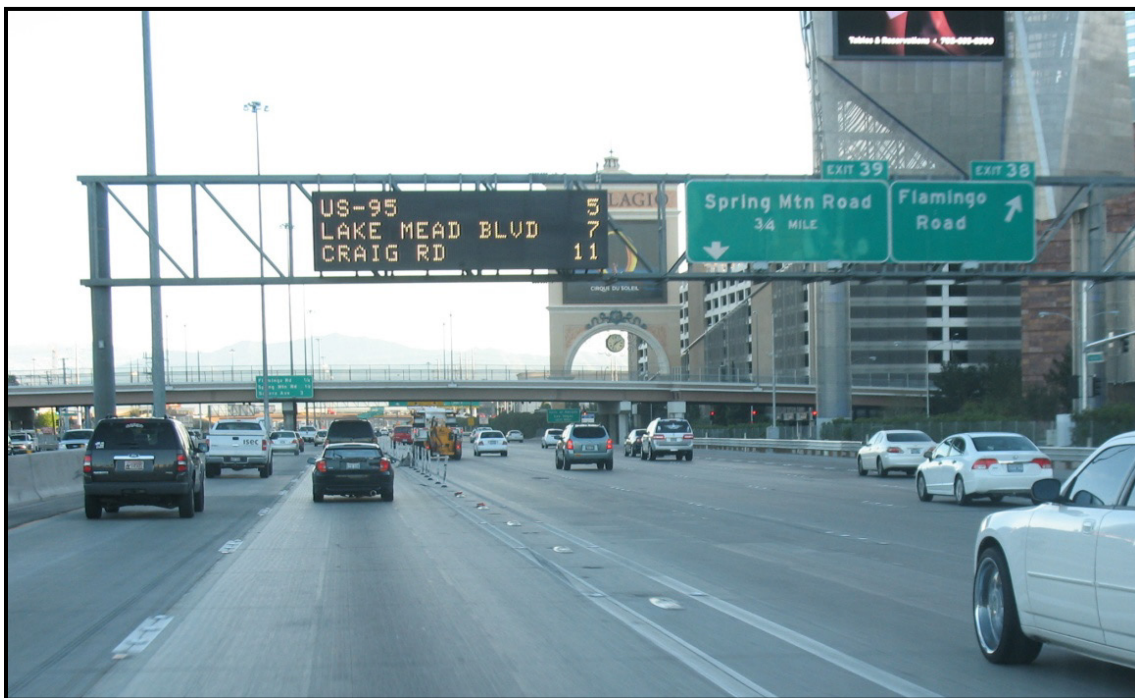
Figure 21. Pylons Used to Separate Express Lane from General Purpose Lanes in Las Vegas, Nevada.

Flexible pylons were installed on a 3-mile segment on the IH 15 Express Lanes in Las Vegas, Nevada, in mid-2010 to provide additional separation of the express lanes from the general purpose lanes (as shown in Figure 21). The IH 15 Express Lanes allow HOV vehicles to travel free while single occupant vehicles pay a toll through the use of a transponder. Tolls vary based on the number of miles traveled, and the congestion of the lanes at the time of entry.

The pylons were initially installed with a spacing of 25 ft., but was later reduced to 12.5 ft. due to motorists frequently weaving between the pylons. The facility has two preferential lanes with 12 ft. wide adjacent lanes. The facility has a very small buffer of 1.5 ft. and uses a 36 in. high white color pavement mounted pylons for lane separation. Every section of the IH 15 Express Lanes is hit frequently, although if the agency had to name one area that was hit the hardest, it would be at the access point. “Motorists appear to hit pylons along the lane indiscriminately” says a Nevada DOT Engineer (19). The Nevada Department of Transportation (NDOT) has reported a very high replacement rate for the pylons. Due to the lack of space within the lanes, there is little to no enforcement (19).

NDOT has experimented with changes in the pylon deployment scheme to reduce the number of hits with limited success. In addition to reducing the spacing between the pylons from 25 to 12.5 ft., the agency has replaced the original white pylons with orange pylons at access areas and tried using curbed pylons at the access points, but no reduction in hits was realized. While not yet implemented, NDOT has also considered reducing the raised pavement marking spacing and further reducing the pylon spacing from 12.5 ft. to 6 ft. (19).

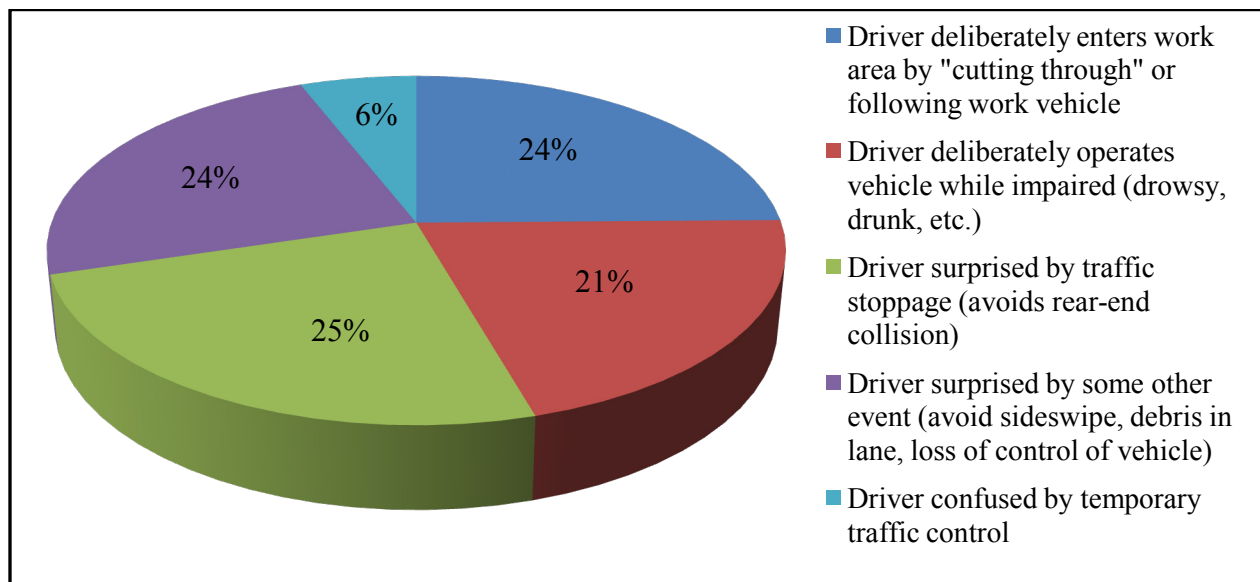
Figure 24. Factors Contributing to Work Zone Lane Closure Intrusions.

beyond the channelizing devices. Although pylons are different from work zone channelizing devices in size, shape, and color, their intended purpose is similar: to keep traffic from crossing lane lines (and intruding into the adjacent lane). A recent study of work zone intrusions included an in-depth analysis of intrusion causes and development of potential countermeasures to reduce intrusions (27). The intrusion analysis was based on six years (2000–2005) of data taken from the New York State Department of (NYSDOT) work zone incident database. The researchers categorized the incident reports, and then examined each report to determine the sequence of events that led to the intrusion. A summary of the findings are shown in Figure 24.

One of the major findings of that research was the recognition that many intrusions are actually the result of deliberate driver decisions and behaviors to intrude. For example, the researchers found that deliberate decisions and actions on the part of the driver accounted for almost one-half (45 percent) of the intrusions between the channelizing devices into lane closures. More than one-half of those deliberate intrusions (24 percent of all intrusions) were a result of drivers deliberately entering the work area by either cutting through the closed lane (to reach an exit, intersection, or driveway) or following a work vehicle into the closed lane. Furthermore, the fact that many of these occurred without striking any of the channelizing devices indicates that the drivers knew the channelizing devices were there and decided to cross the lane line anyway. In other words, device visibility or conspicuity was likely not a factor in these types of intrusions. It is likely that many impacts of pylons separating managed lanes and

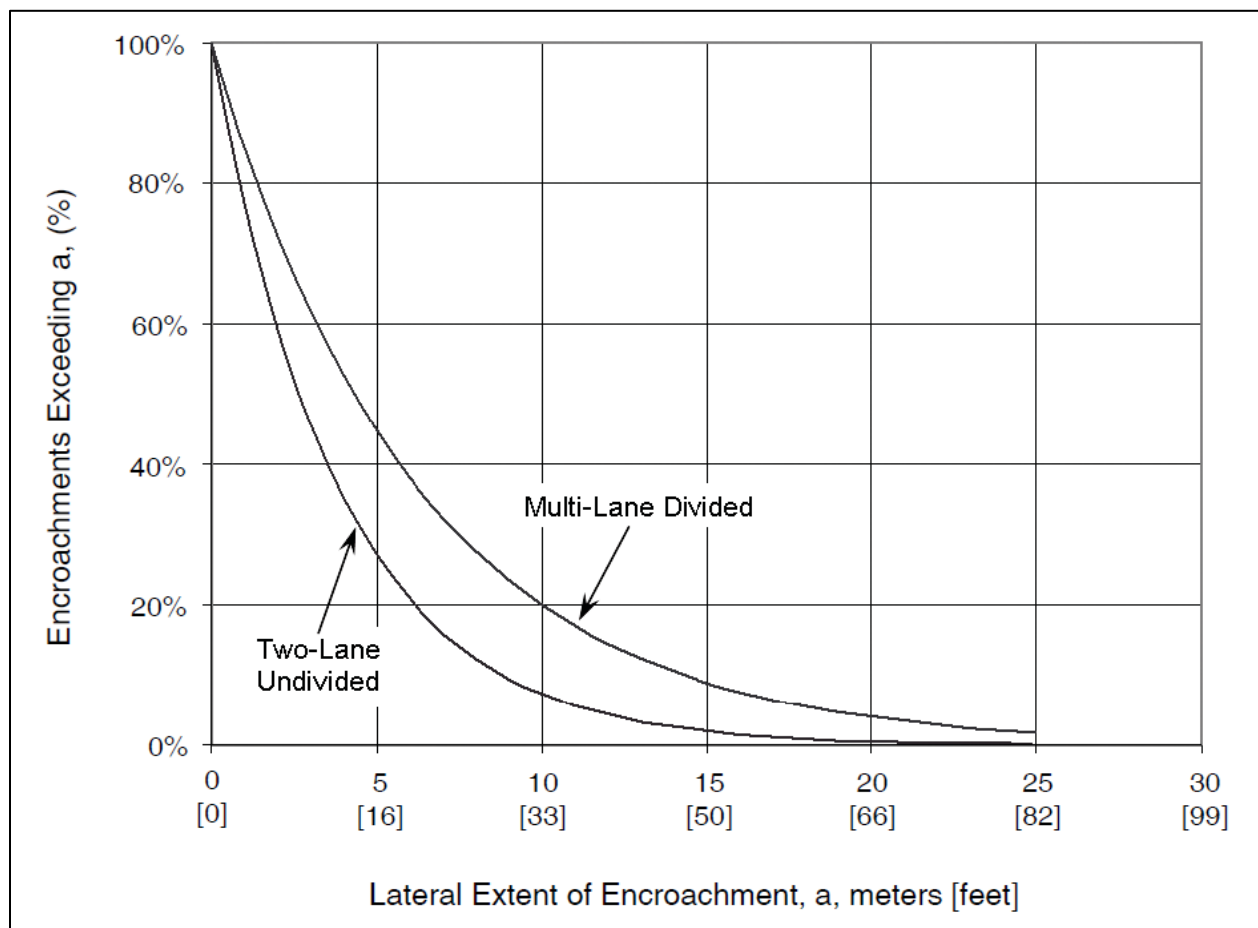
Figure 25. Lateral Extent of Encroachment Distribution (27).

The *Roadside Design Guide* (2) and in the *Roadside Safety Analysis Program (RSAP)* (33) are based largely on past encroachment studies. More specifically, the crash prediction module in the RSAP uses a lateral extent of encroachment distribution (shown in Figure 25). This lateral distance distribution is the basis for the clear-zone concept for roadside safety design because it describes the probability of an errant vehicle reaching specific lateral distance when a departure event occurs.

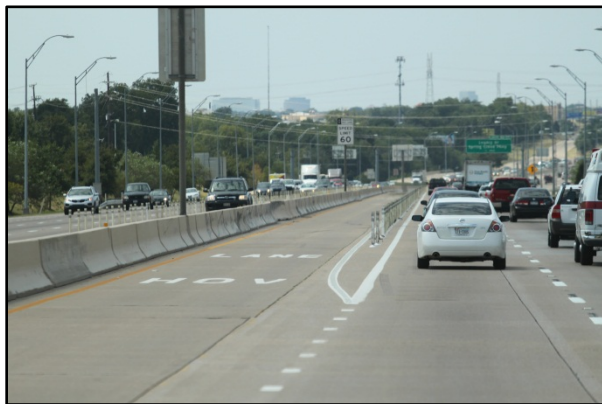
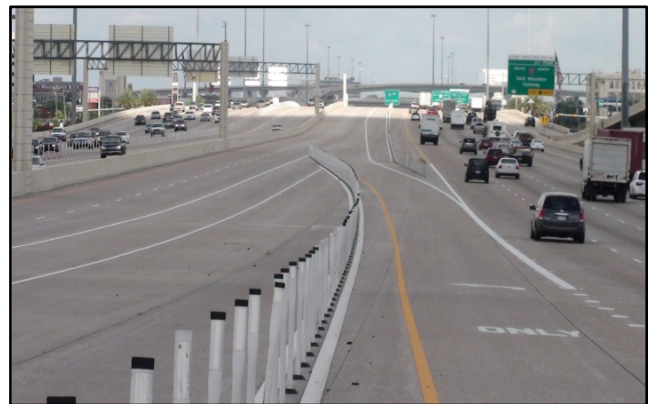
(a) US 75 HOV SB at Bethany Drive

(b) IH 10 ML WB at Gessner Road

Figure 35. Example Photos of Preferential Lane Entrance Study Locations.

Some representative examples of the managed lane entrance, exit, and tangent locations used in the case studies are shown in [Figure 35](#), [Figure 36](#), and [Figure 37](#). Photographs of all the sites considered in this case study are presented in the [Appendix F](#). As shown in these figures, the Dallas access locations were exit (northbound) and entry (southbound) access locations at the end of the preferential lane, while the Houston access locations were all intermediate access locations with a slip ramp setup. Also seen in [Figure 37](#), the Dallas tangent sections have a narrow buffer compared to Houston tangent sections.

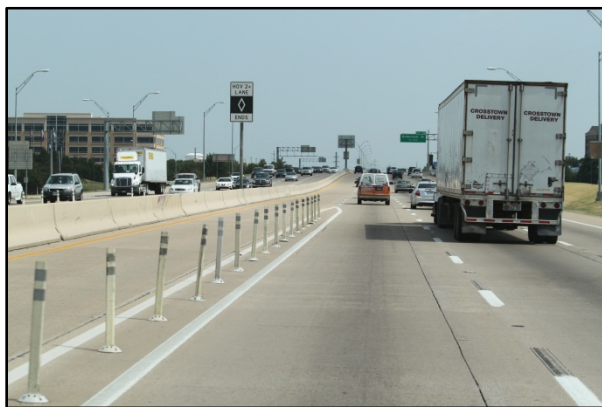
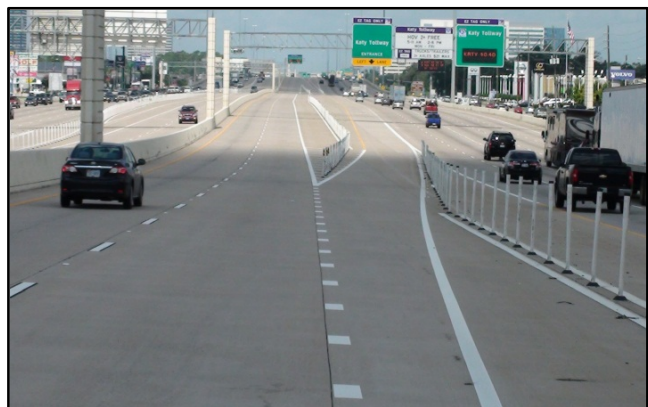
(a) US 75 HOV NB at Bethany Drive

(b) IH 10 ML WB at Tully Road

Figure 36. Example Photos of Preferential Lane Exit Study Locations.

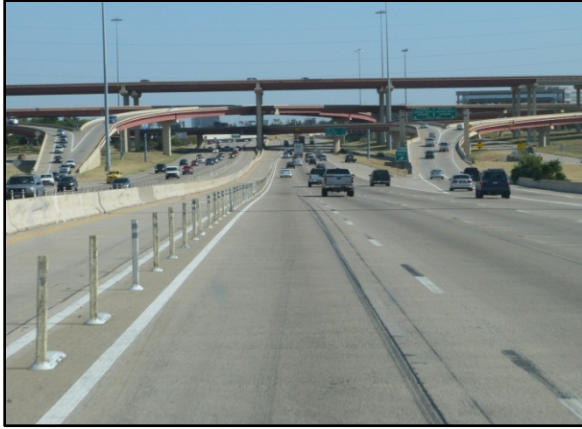
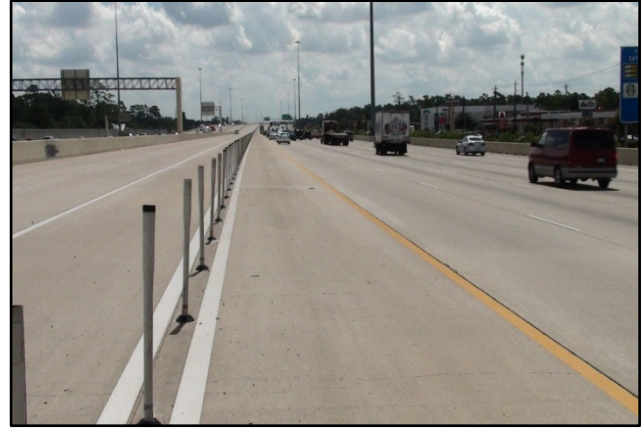
(a) US 75 HOV NB at George Bush Turnpike (b) IH 10 ML EB at Voss Road

Figure 37. Example Photos of Preferential Lane Tangent Study Locations.

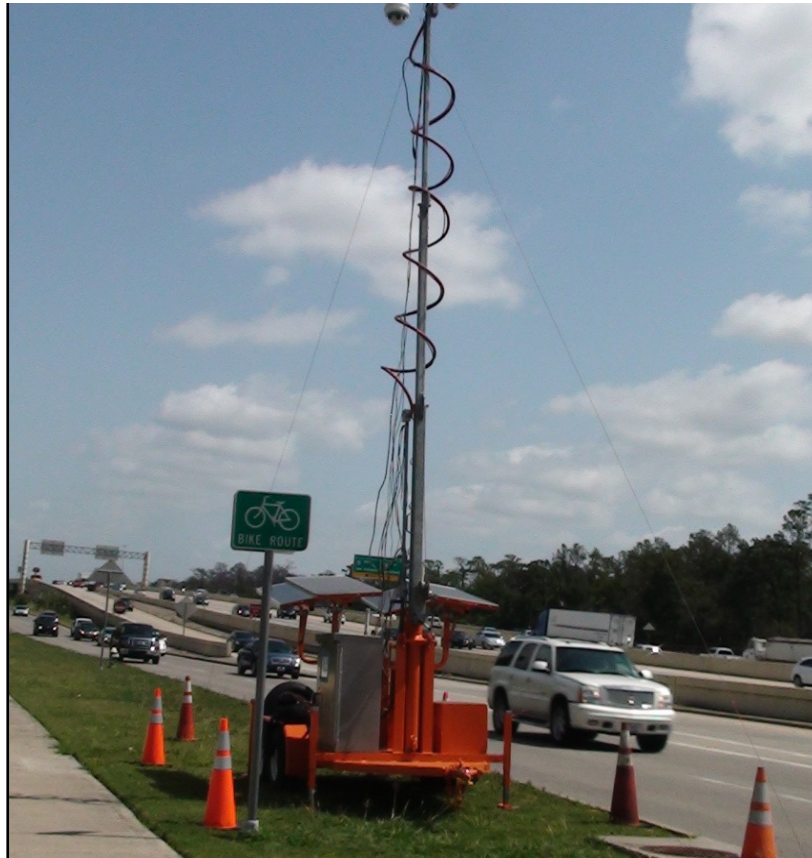
Figure 38. TTI Data Collection Trailer Deployed at a Freeway Ramp Location in Houston.

For Katy Managed Lane locations in Houston, video was recorded using permanent HCTRA CCTV cameras. For each location, the camera that provided the best view of operations was selected and a preset was created of the required view. Researchers recorded data for at least one week for each case study site. Because the cameras were still being used for roadway monitoring and incident management, occasional interruption to the recordings occurred. For all Dallas locations, video was recorded using DalTrans CCTV cameras in methods similar to the Katy Managed Lane videos. However, when significant disruptions to recording were noted, additional days of video were subsequently recorded. The video on all the freeway ramp locations were recorded using a TTI portable data collection trailer as shown in [Figure 38](#). Researchers had some flexibility to place the data collection trailer at the most convenient location at each site to record the video with optimal settings. A total of roughly 2800 hours of

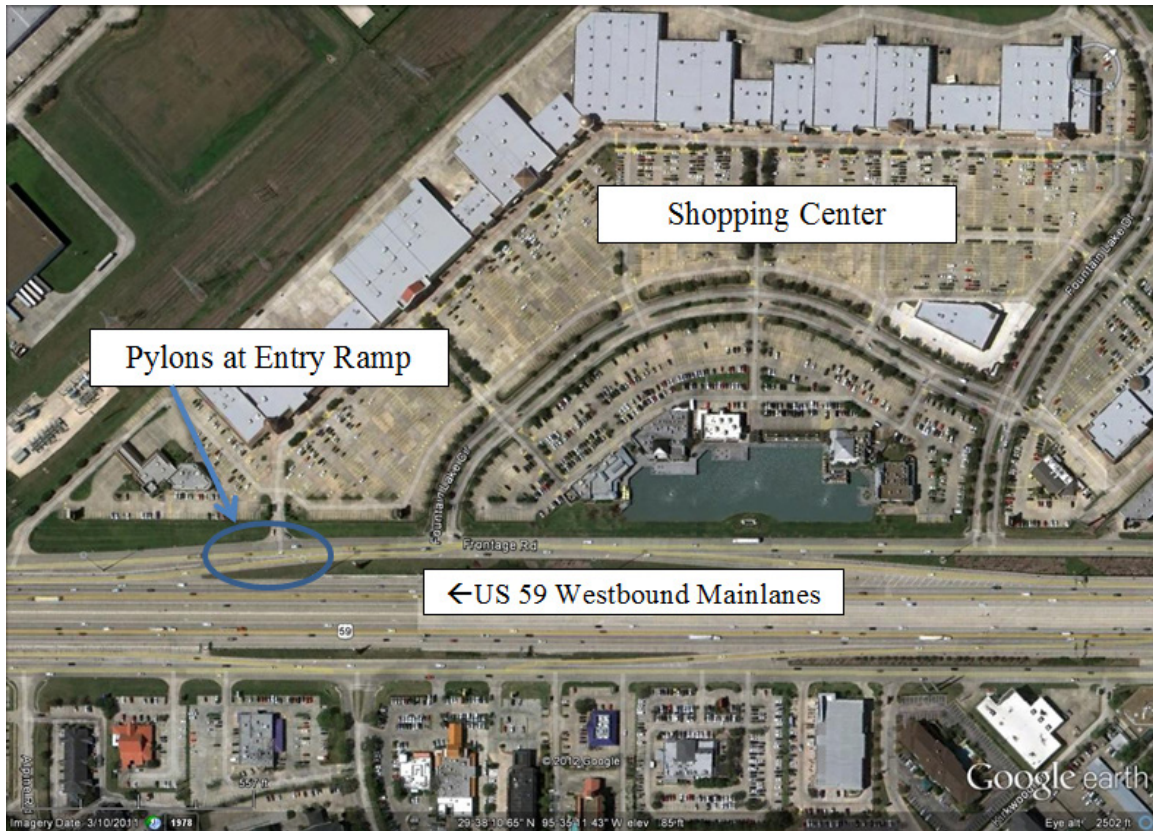
Figure 42. Land Use near Kirkwood Entry Ramp to US 59 Westbound Study Site.

Figure 41 shows the hit and near miss rates for the freeway ramp locations. The Kirkwood entrance ramp to US 59 SB freeway had a significantly higher pylon hit and near miss rate as compared to the other freeway ramp location study sites. One potential reason for the higher hit rates observed at the Kirkwood entrance ramp to US 59 westbound could be the land use adjacent to this ramp, which predominantly consists of busy retail shopping and restaurants with several closely spaced driveways (as shown in Figure 42). At this location, it was difficult to extend the pylons farther east because that would have limited the weaving distance on the frontage road auxiliary lane between exit and entry ramps. This is often a consideration when deploying pylons at frontage road entry or exit ramps.

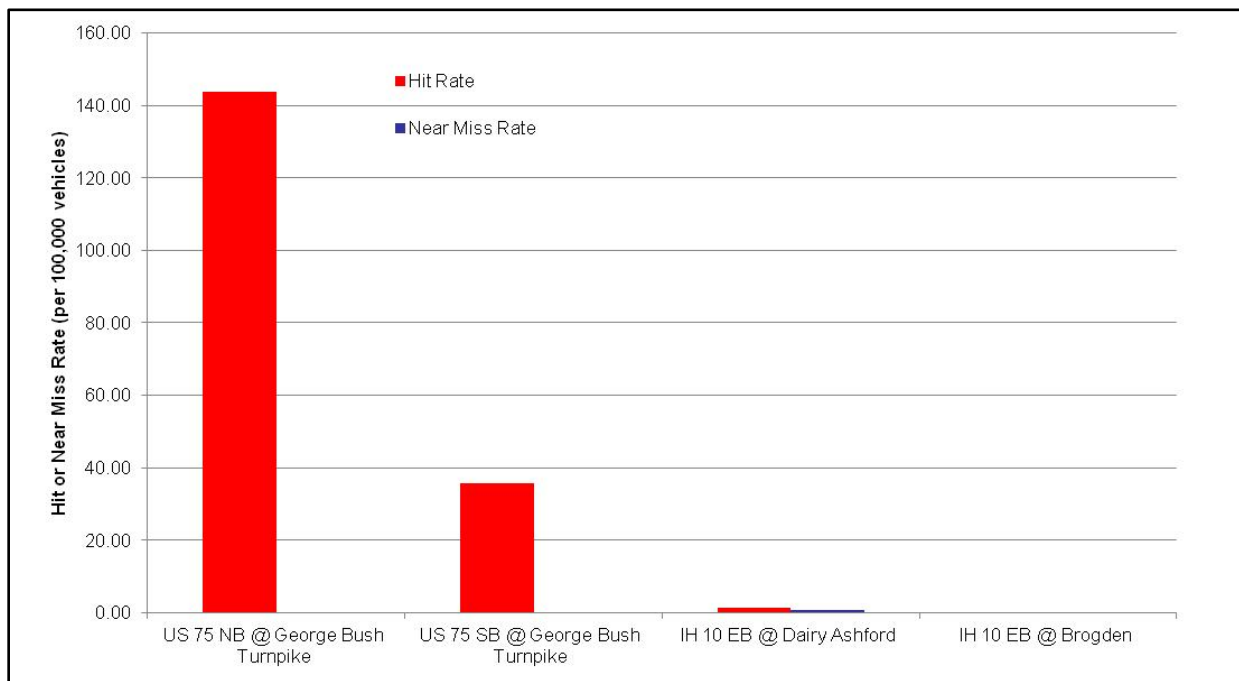
Figure 43. Pylon Hit and Near Miss Rate for Preferential Lane Tangent Locations.

As shown in Figure 43, US 75 NB HOV south of President George Bush turnpike had the highest number of hit among the preferential lane tangent sections. US 75 HOV lane tangent sections had significantly higher hit rate compared to IH 10 Katy Managed Lanes sections potentially due to smaller buffer width on US 75 HOV compared to Katy Managed Lanes.

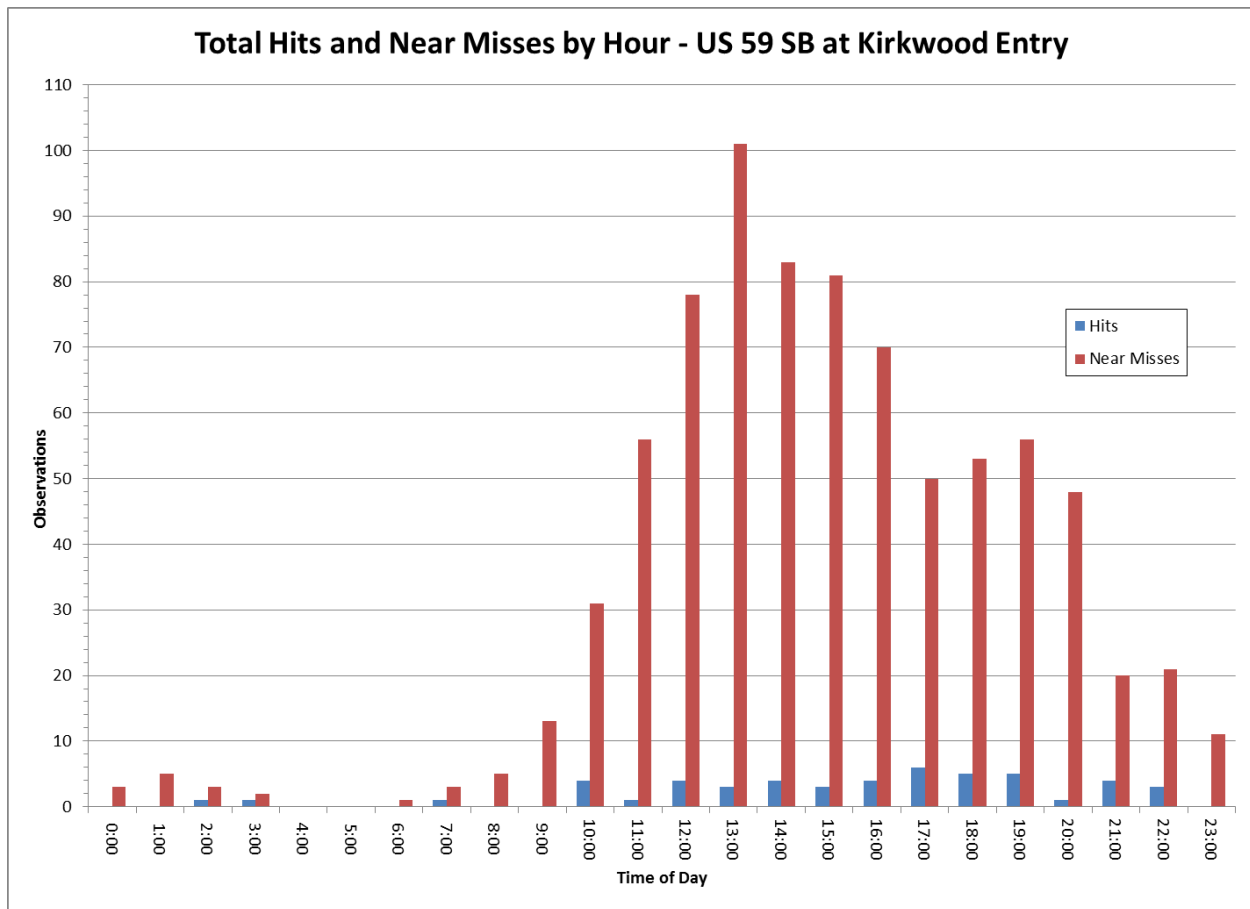
Figure 44. Time of Day Hits and Near Misses at Kirkwood Entrance Ramp.

The pylon hit data were further analyzed to find any trends in the hit or near miss pattern with respect to time of day (and day of week) by plotting frequency histograms. As examples, the charts in [Figure 44](#) and [Figure 45](#) show the time of day distribution of pylon hits and near misses at the US 59 Southbound at Kirkwood Road entry ramp study site and the SH 249 Northbound at Cypresswood Drive entry study site, respectively. The effect of land use on hits and near misses is apparent by observing the time of day charts for each freeway ramp sites. At the US 59 Southbound entry ramp at Kirkwood Road site, the peak of near misses was during the middle of the day as the land use drives activity near the entry ramp (retail shopping and restaurants). In contrast, at the SH 249 at Cypresswood Road Northbound entry ramp, the peak of the near misses occurs during the evening hours as commuter patterns are experienced.
