1. Report No. FHWA/TX-13/0-6643-1		2. Government Accession No.		3. Recipient's Catalog No.	
4. Title and Subtitle GUIDANCE FOR EFFECTIVE USE OF PYLONS FOR LANE SEPARATION ON PREFERENTIAL LANES AND FREEWAY RAMPS				5. Report Date Published: May 2013

GUIDANCE FOR EFFECTIVE USE OF PYLONS FOR LANE SEPARATION ON PREFERENTIAL LANES AND FREEWAY RAMPS

Report 0-6643-1

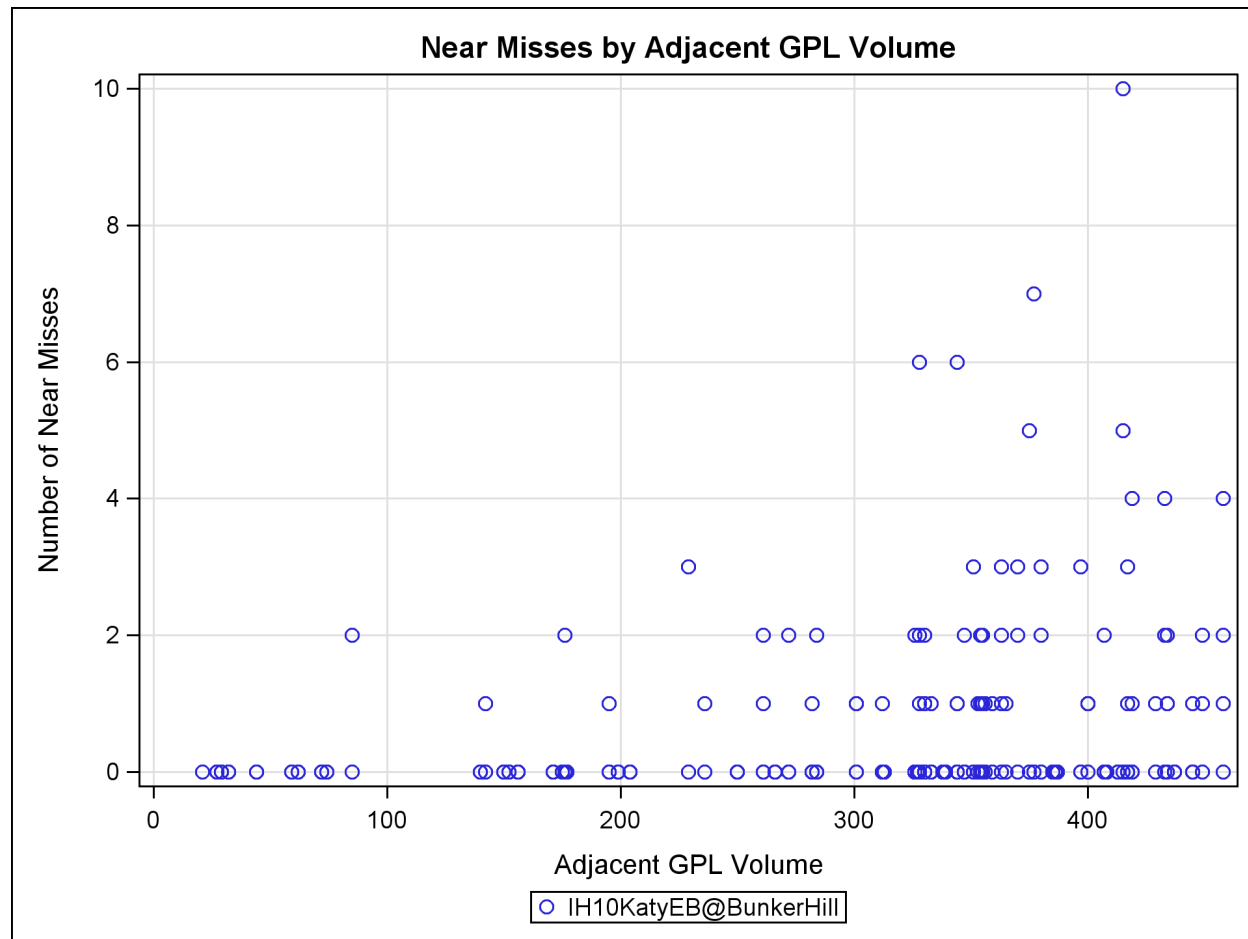
Figure 46. Scatter Plot of Near Misses vs. 15-Minute General Purpose Lane Traffic Volume, IH 10 Katy Managed Lanes at Bunker Hill Road Entry.

data points, an increasing trend in the near misses with increase in the adjacent general purpose lane volume can be seen.

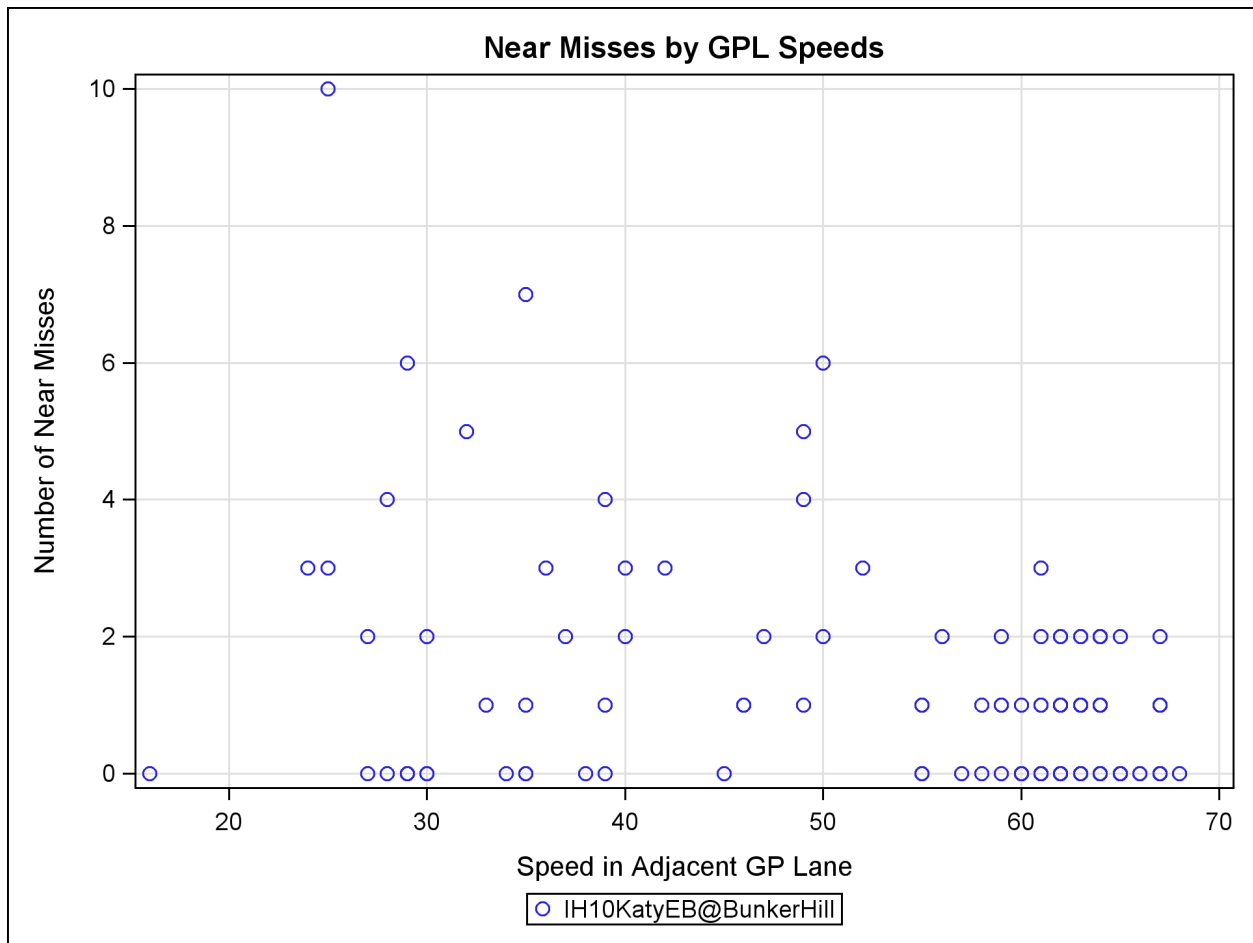
Figure 47. Scatter Plot of Near Misses vs. 15-Minute Average General Purpose Lane Traffic Speed, IH 10 Katy Managed Lanes at Bunker Hill Road Entry.

A similar increasing trend in the number of near misses with decrease in general purpose lane speeds can be seen from [Figure 47](#). Also a trend between the number of near misses and the speed differential between the managed lane and general purpose lane was observed. [Figure 48](#) shows that greater the speed between the managed lane and the general purpose lane, the number of near crashes tend to increase. However the trends in near misses as shown for the IH 10 Managed Lane entry at Bunker Hill was not consistently seen from data at all other access locations. The trends between hits and/or near misses and various traffic variables showed significant dispersion, with no clear patterns, at tangent and freeway ramp locations.

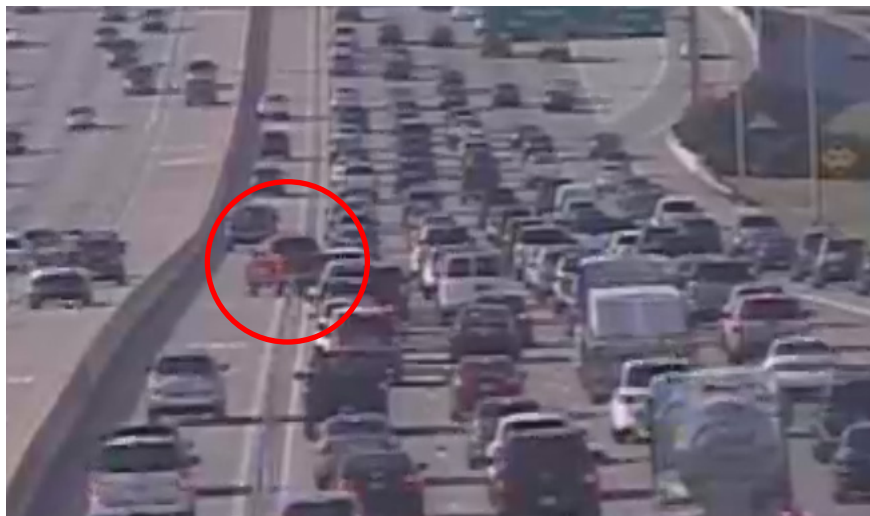
Figure 53. Example of GP Cross Facility Weave to ML (US 75 Dallas).

When GP lanes are congested and the ML are separated by a narrow buffer, there can be a resulting slowdown in the ML. The slowdown in the ML is a result of a natural driver behavior to react to a high speed differential in adjacent lanes (and vice versa). The slowdown can be from a motorist's perception that it would be possible for a cross facility weaving movement to occur. [Figure 53](#) illustrates the maneuver described above. The use of CTB prevents motorist from making a cross facility weave so the speed in the ML is typically not affected by GP incidents.

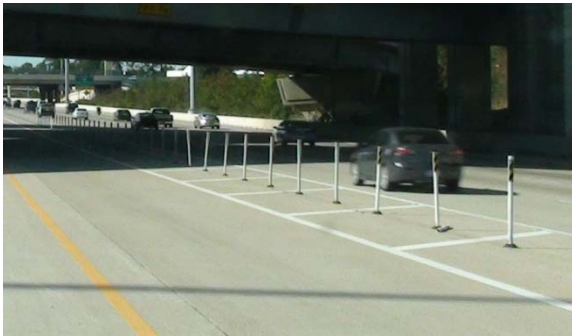
Figure 55. Pavement Mounted Pylon.

The agencies surveyed prefer to use direct-pavement mounted pylons on higher speed facilities as shown in **Error! Not a valid bookmark self-reference.** TxDOT pr refers to use

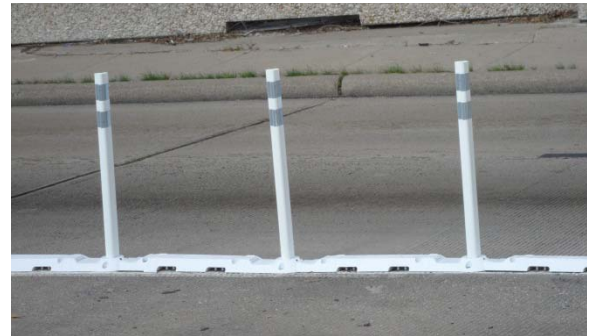
Figure 56. Curb Mounted Pylon.

curbs in urban areas with lower speeds as shown in [Figure 56](#). TxDOT indicated that they felt the curbs added more of a deterrent at the lower speeds.

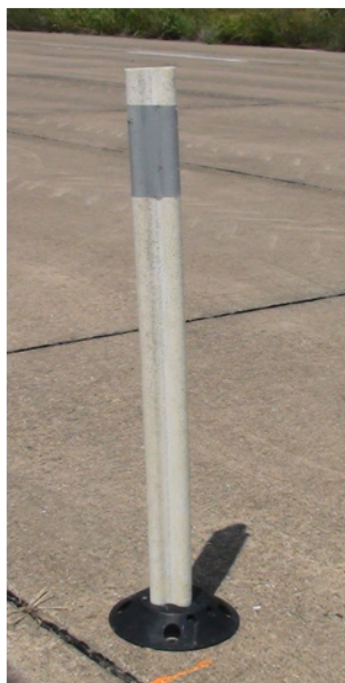
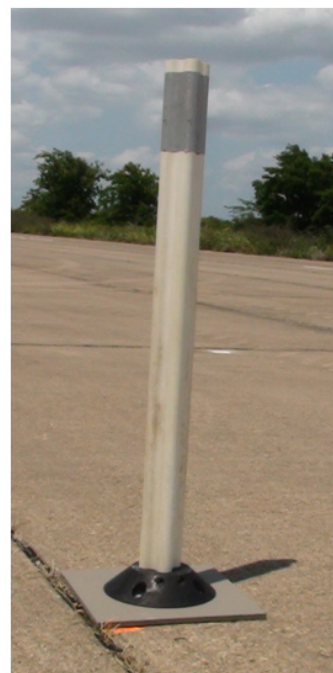
(a) End Pylons

(b) Pylons fitted with Wooden Base

Figure 61. Pylons Used for the Experimental Setup.

Runway 35L consists of concrete pavement, with 12.5 ft. joints along the width of the runway and 20 ft. joints along the length. Concrete joints along the length were considered as lane lines for setting up the experiment. About 12 to 14 pylons were set up near the center of the runway along the longitudinal pavement joint as shown in [Figure 60](#). Two pylons on both ends of the setup were temporarily glued to the pavement to be as realistic as possible to replicate as they are deployed in field (see [Figure 61\(a\)](#)), while the remaining pylons in-between were attached to 12 in. × 12 in. plywood base (see [Figure 61\(b\)](#)) and were deployed without gluing to the pavement so that the pylon spacing could be changed easily. As described in more detail

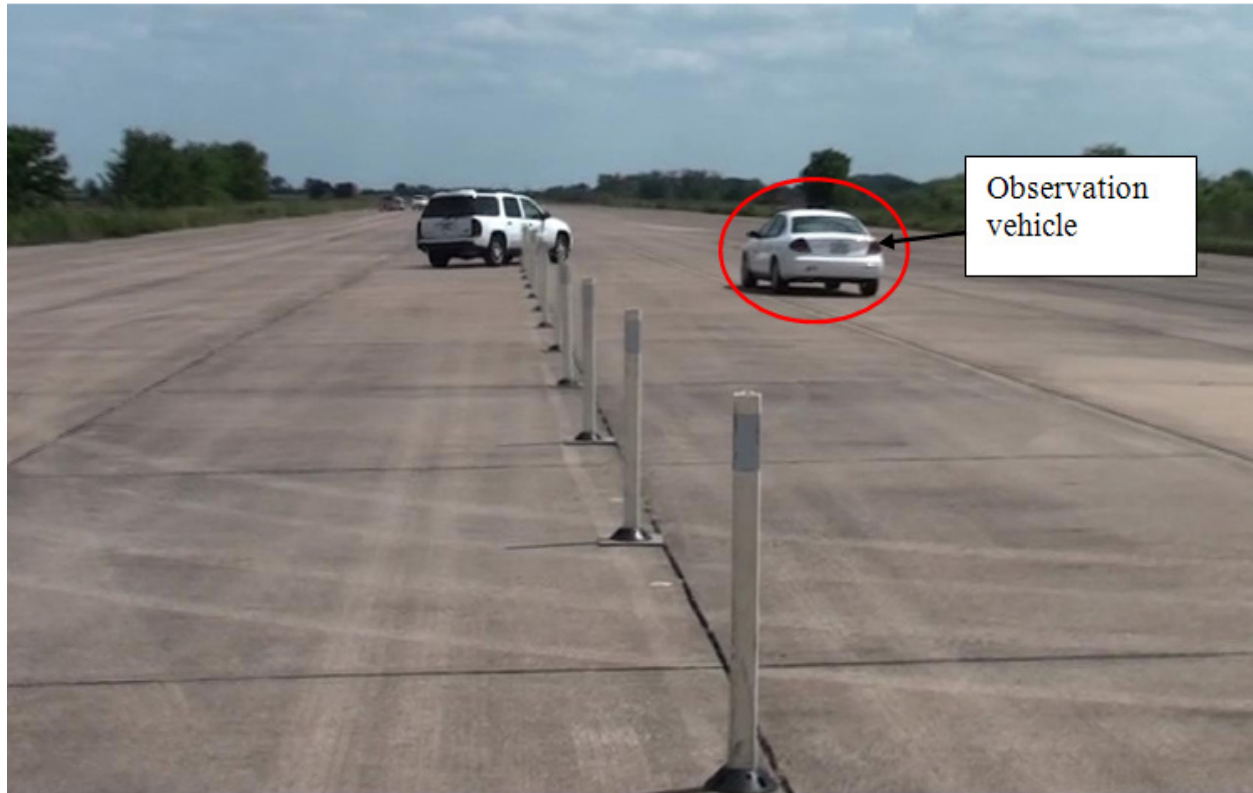
Figure 63. Data Collection from the Observation Vehicle.

A second data collection crew was located on the encroachment lane slightly upstream of the point where test vehicles were instructed to weave between the last two pylons. [Figure 63](#) shows a test vehicle weaving between the pylons during a test run, and an observation vehicle with data collection crew parked on the encroachment lane. The data collection crew in the observation vehicle noted any grazes or hits to the back pylons and as well noted the extent of

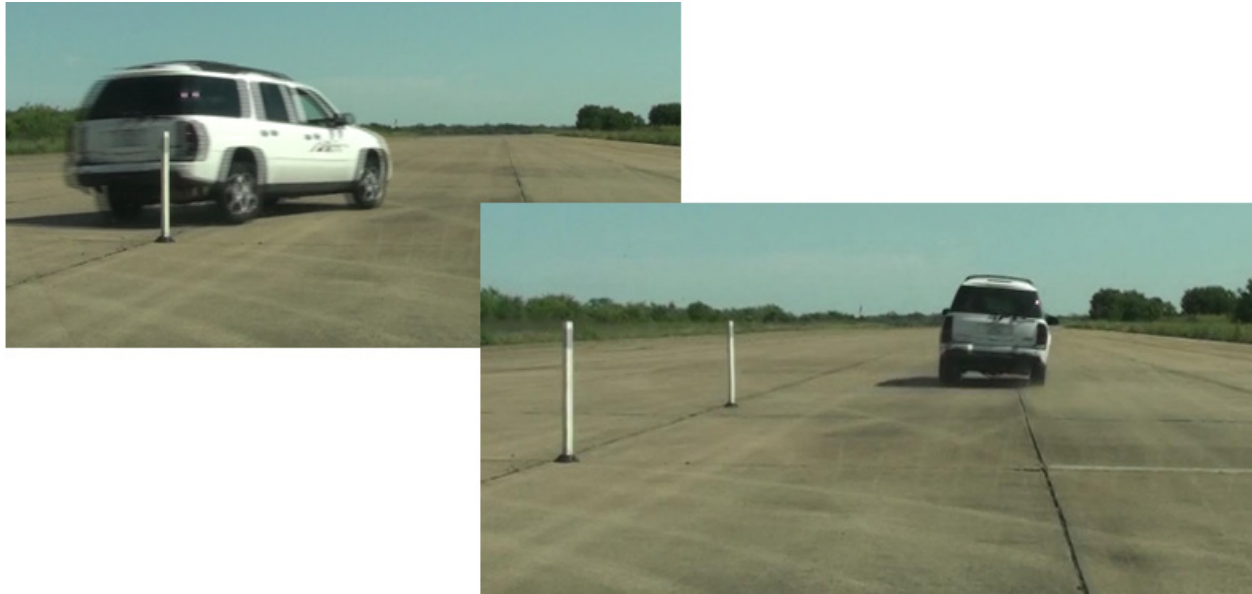
Figure 64. Test Vehicle Encroaching 1/4 Lane after Weaving between Pylons.

encroachments that happened during the test run. [Figure 64](#) shows an example of a test subject encroaching one-fourth of the lane adjacent to the travel lane after weaving between the pylons. A walkie-talkie was used to communicate test results from the passenger observing from the test vehicle to the data collection crew in the observation car. The data collection crew in the observation car was also responsible for coordinating the test runs and instructing the subjects by walkie-talkie. [Table 30](#) shows a sample data collection sheet filled by the data collection crew.

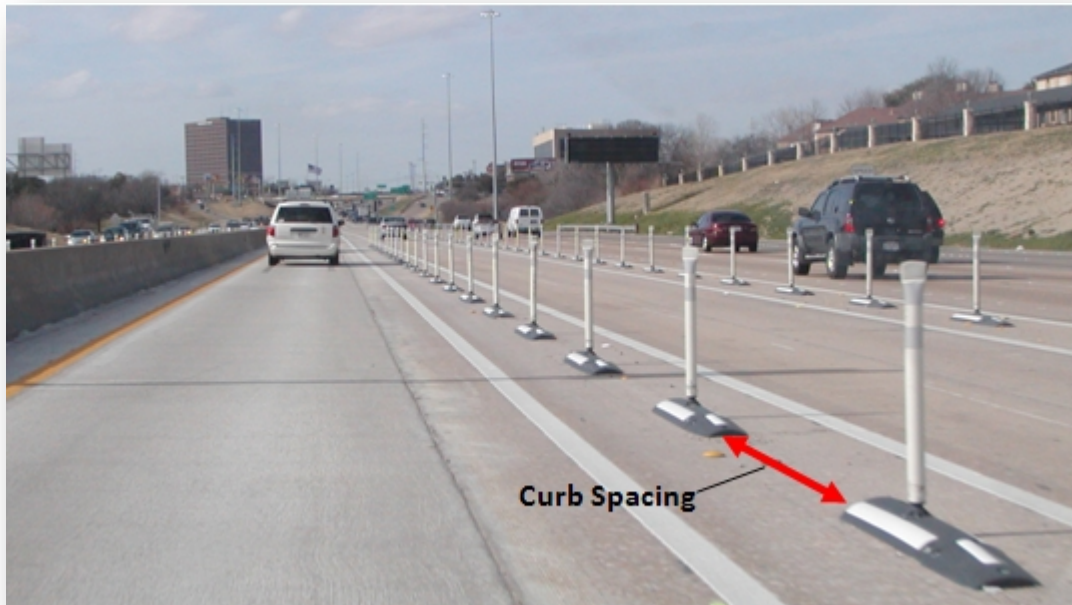
Curb Height

Curb height is measured from the pavement surface to top of the curb (or top most point on the curb in case of varying height). Curb height does not include the height of the pylon post, when pylons are attached to the curb.

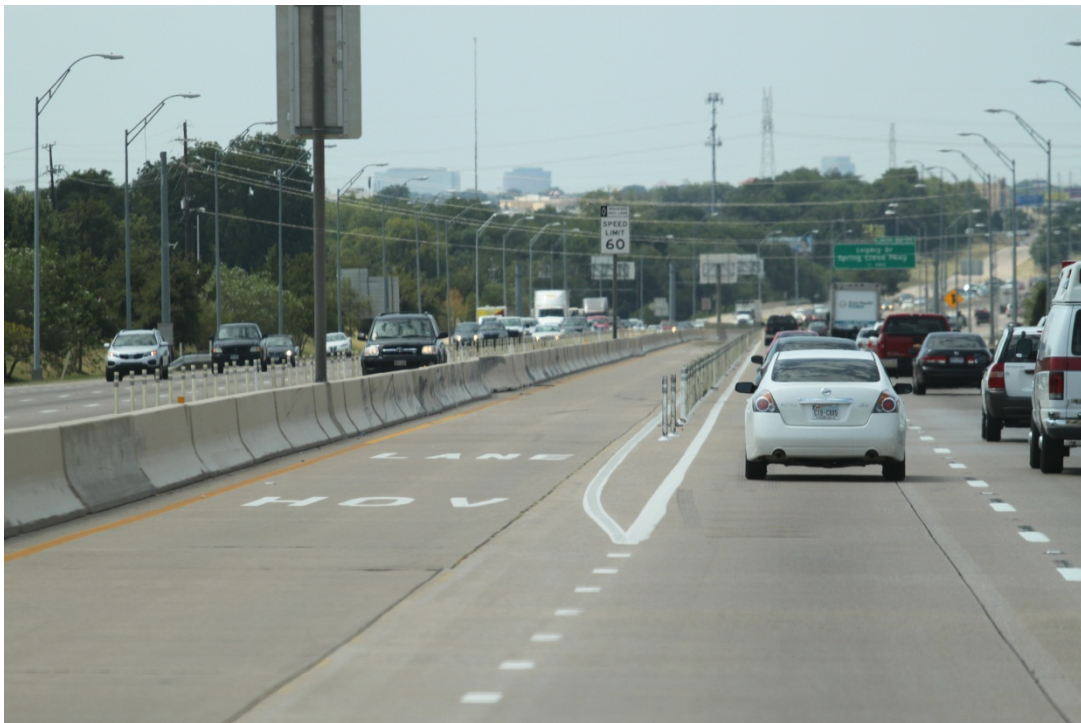
Figure F-1. Entrance to US 75 SB HOV at Bethany Drive.

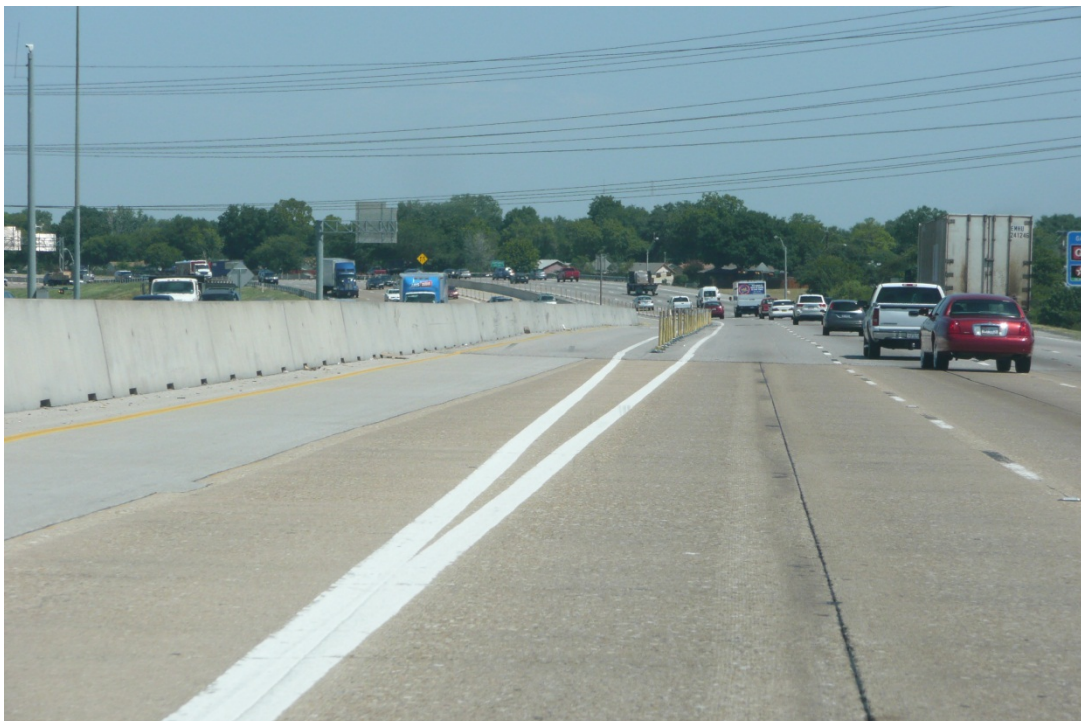
Figure F-2. Entrance to IH 635 NB HOV at Oates Drive (just North of IH 30).

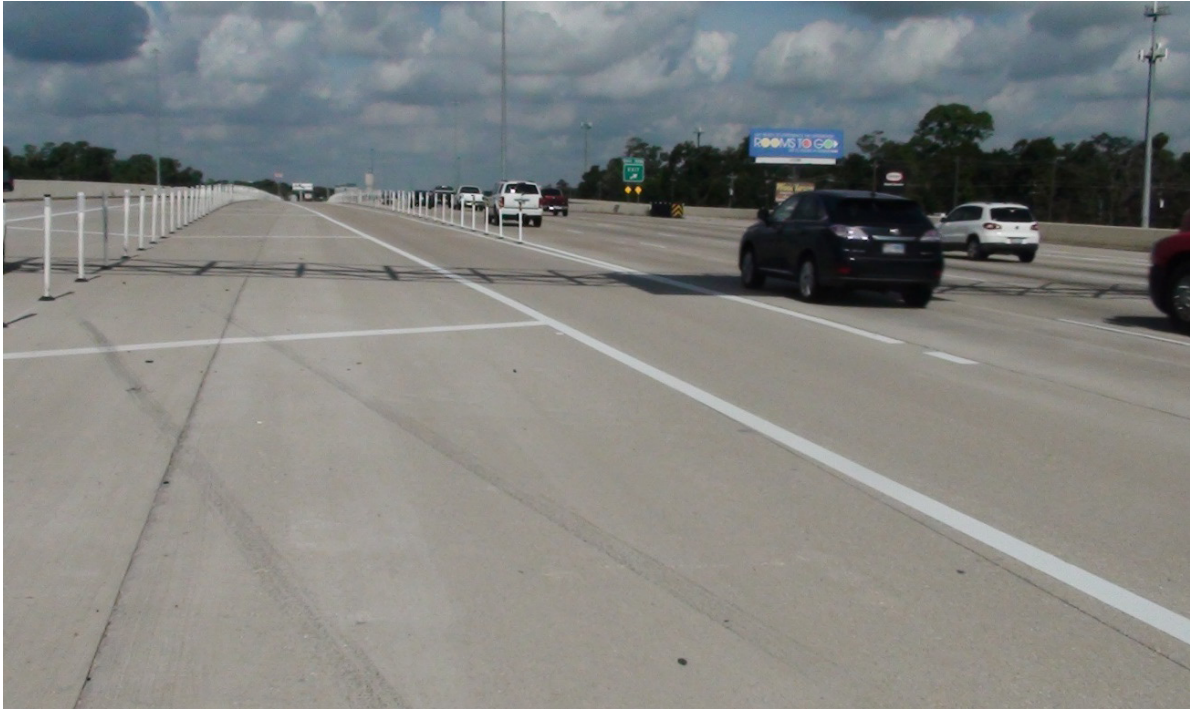
Figure F-3. Entrance to IH 10 WB Managed Lane at Silber Road (just West of IH 610).

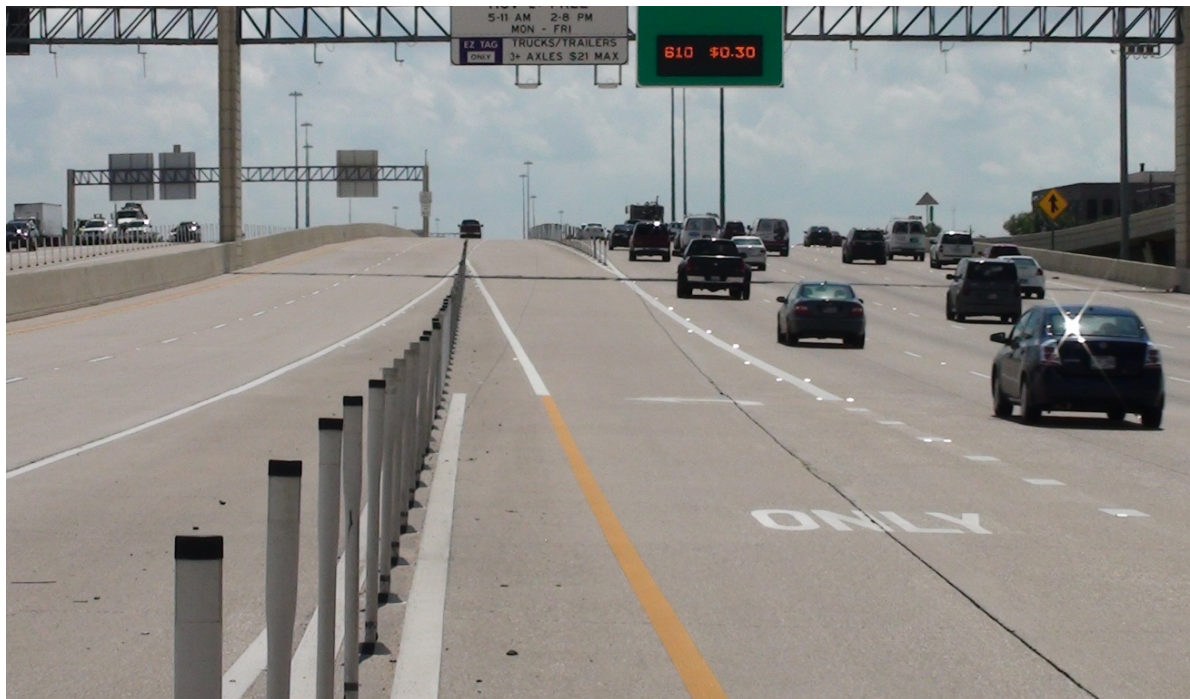
Figure F-4. Entrance to IH 10 EB Managed Lane at Bunker Hill Road.

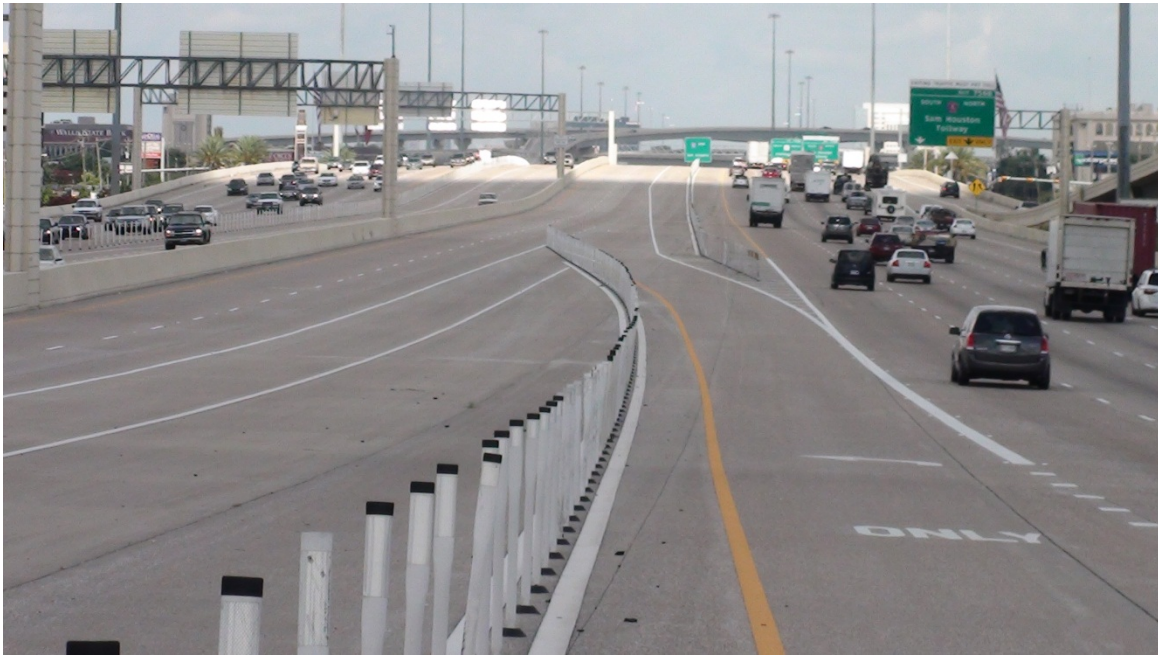
Figure F-5. Entrance to IH 10 WB Managed Lane at Gessner Road (in Houston).

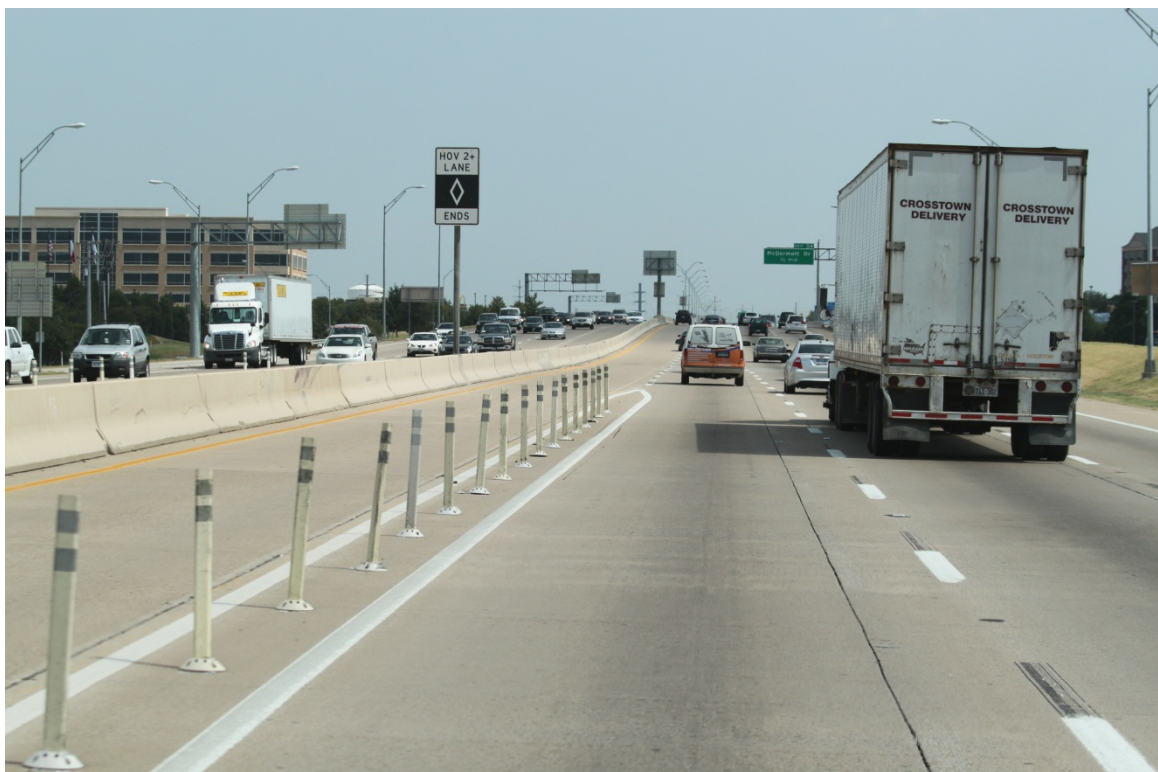
Figure F-6. Exit from US 75 NB HOV Lane at Bethany Drive (Dallas District).

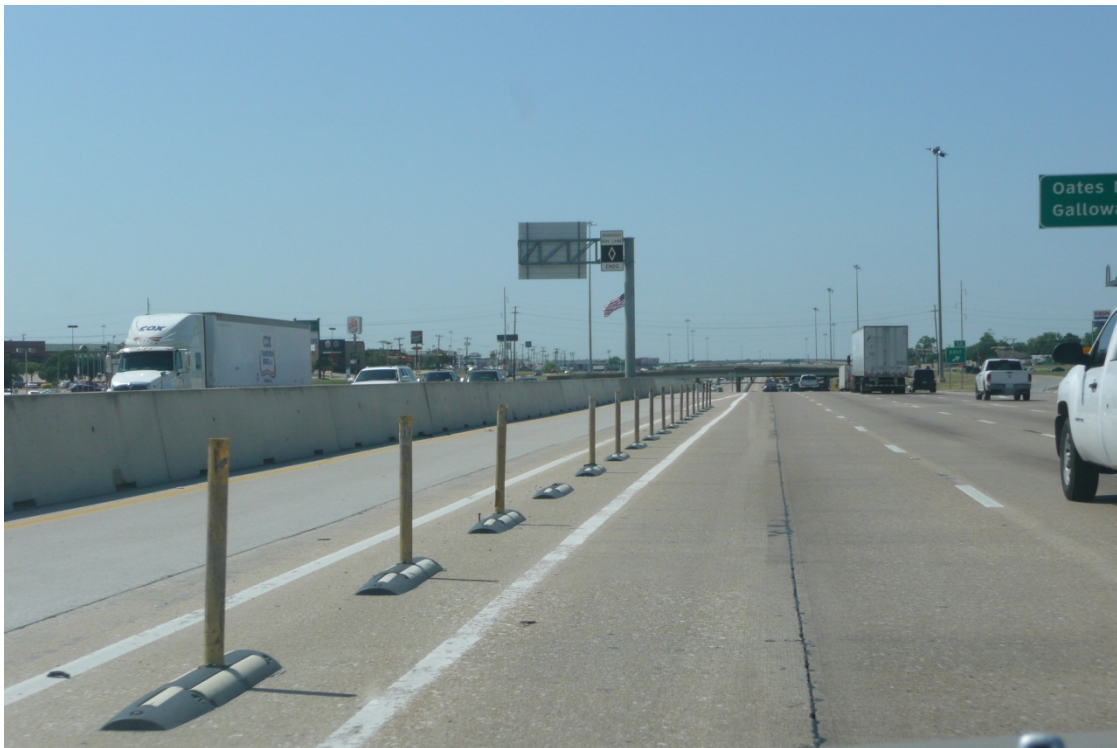
Figure F-7. Exit from IH 635 SB HOV Lane at Oates Drive (Dallas District).

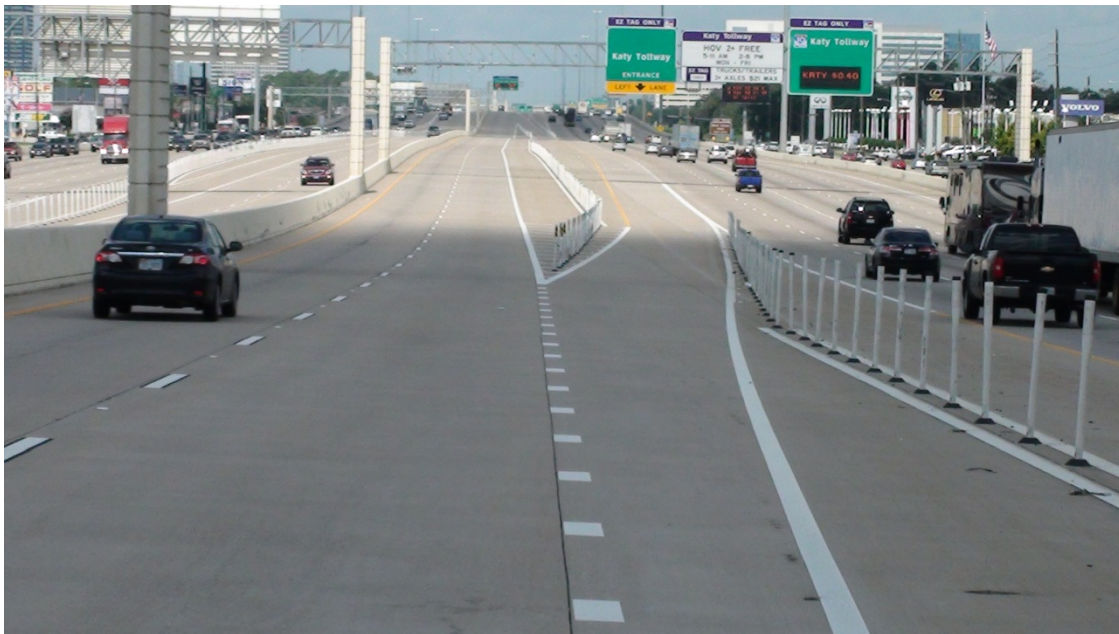
Figure F-8. Exit from IH 10 Katy Managed Lane at Tully Road (between Beltway 8 and SH 6 in Houston, TX).

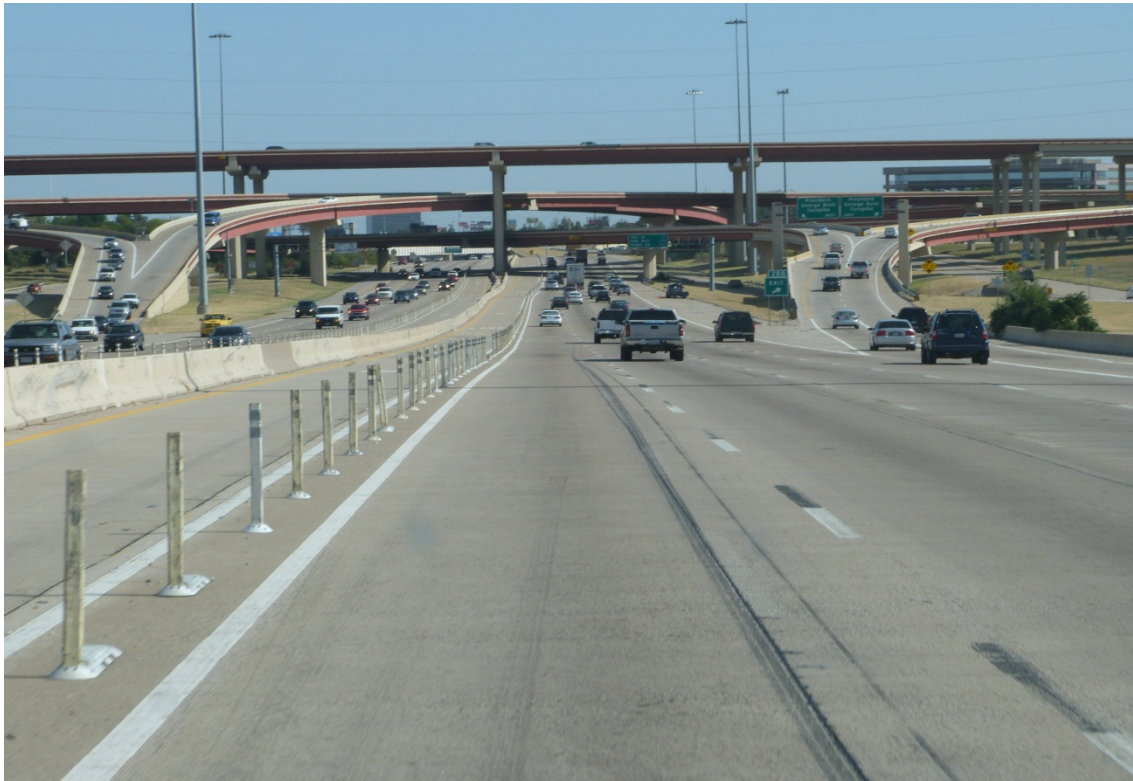
Figure F-9. US 75 NB HOV Lane South of George Bush Turnpike.

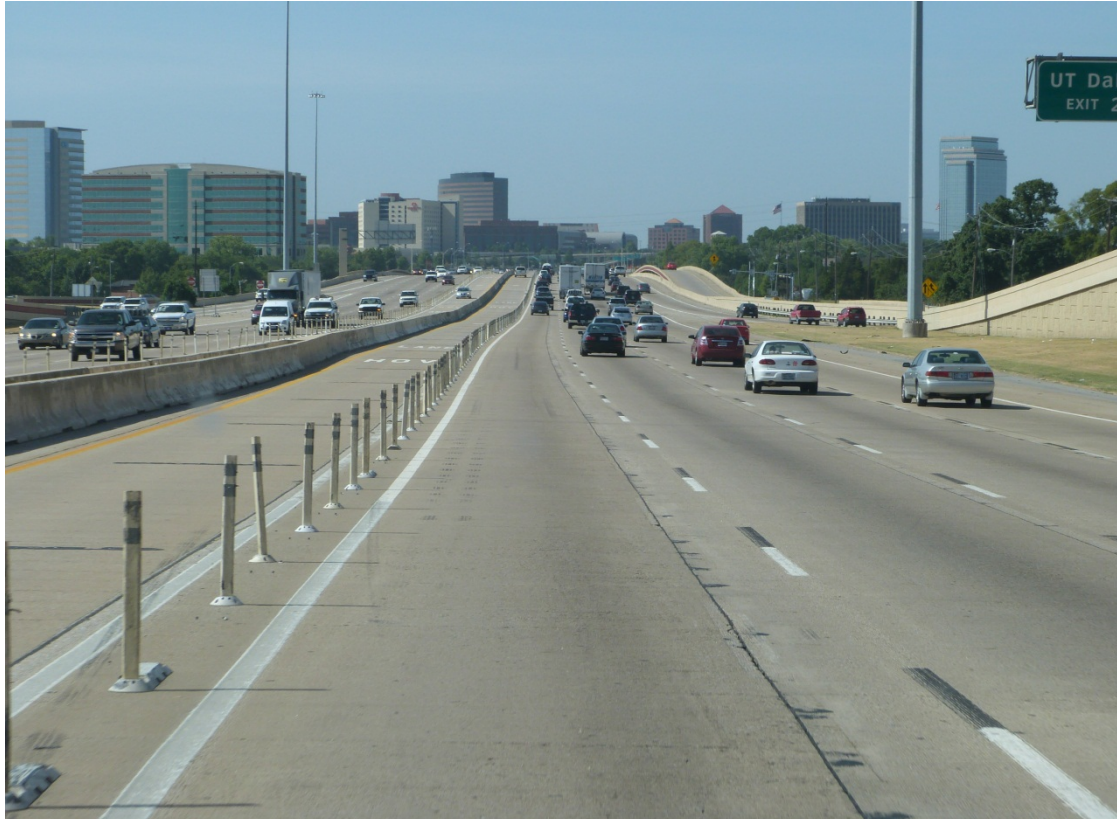
Figure F-10. US 75 SB HOV Lane South of George Bush Turnpike.

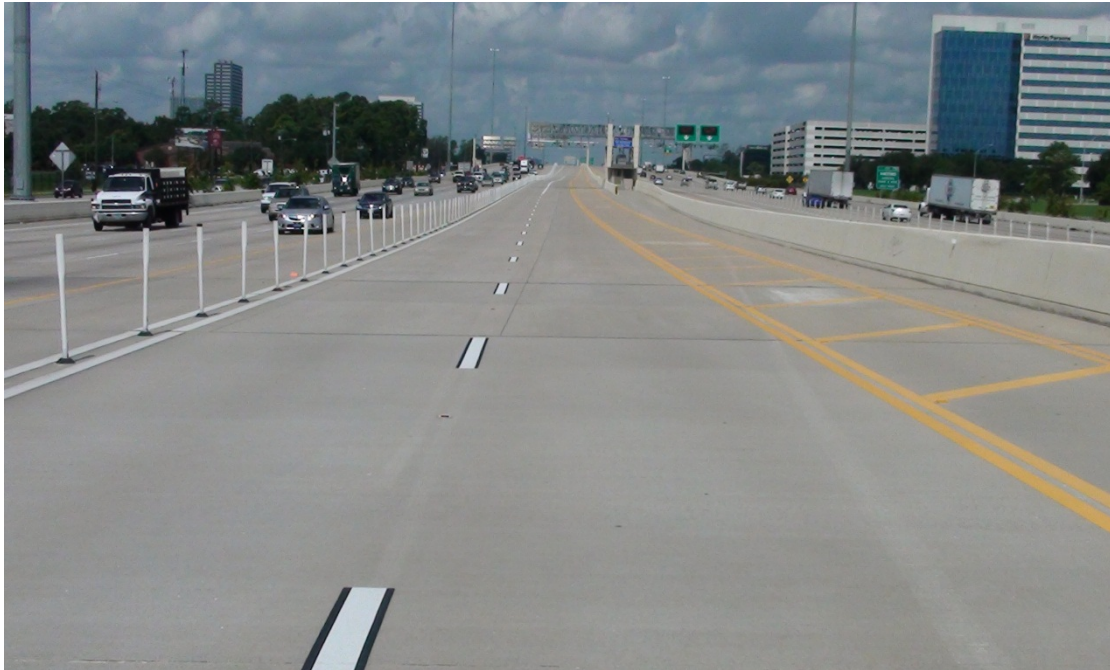
Figure F-11. IH 10 Katy Managed Lane EB near Dairy Ashford Road.

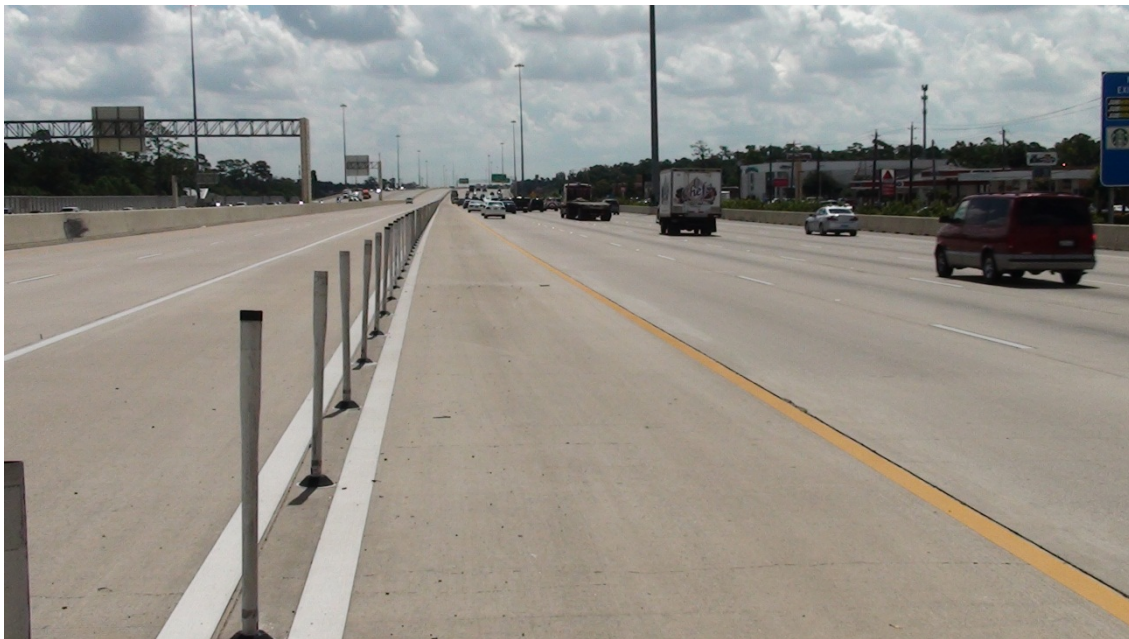
**Figure F-12. IH 10 Katy Managed Lane EB at Voss Road
(between Beltway 8 and IH 610 West Loop).**

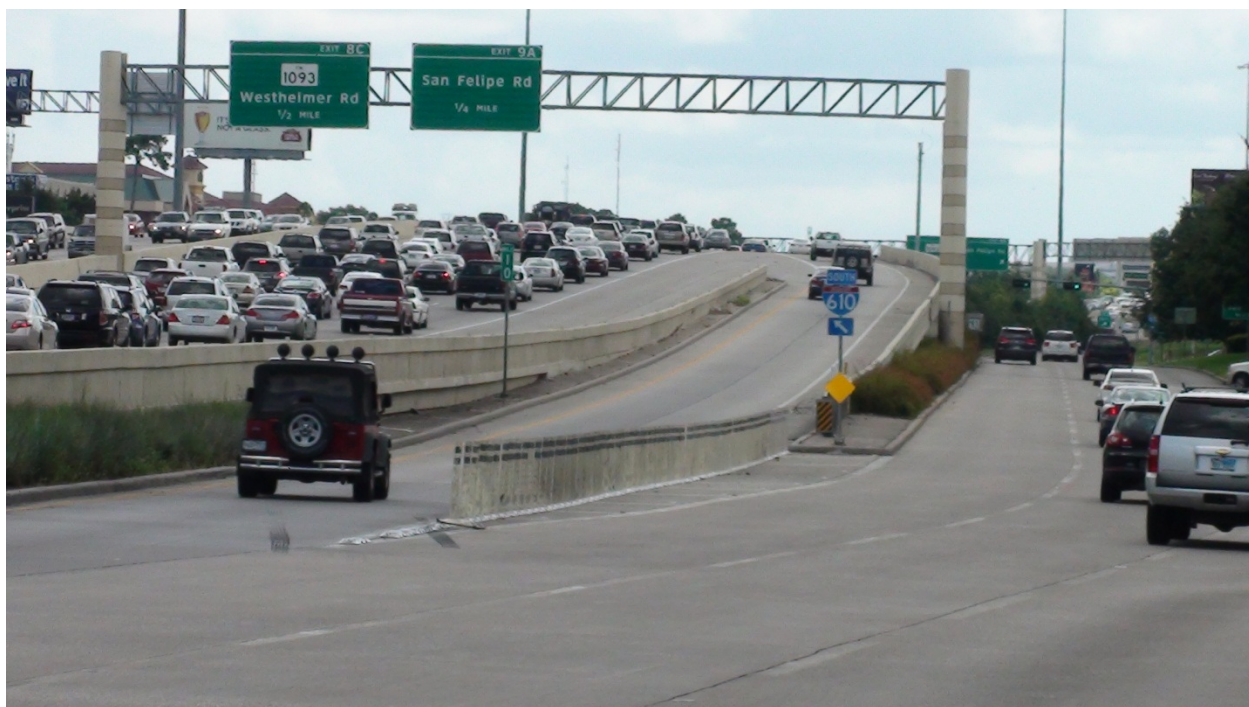
Figure F-13. IH 610 West Loop SB Woodway Drive Entrance Ramp in Houston, TX.

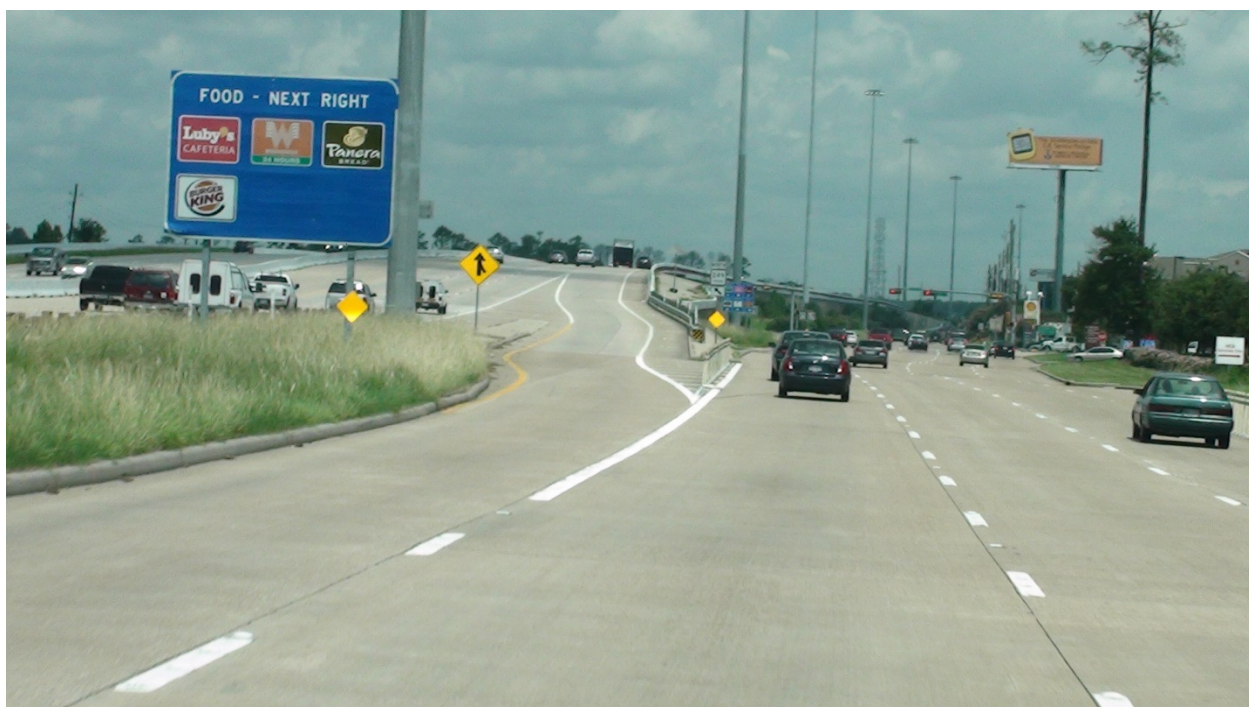
Figure F-14. SH 249 NB Cypresswood Drive Entry Ramp in Houston, TX.

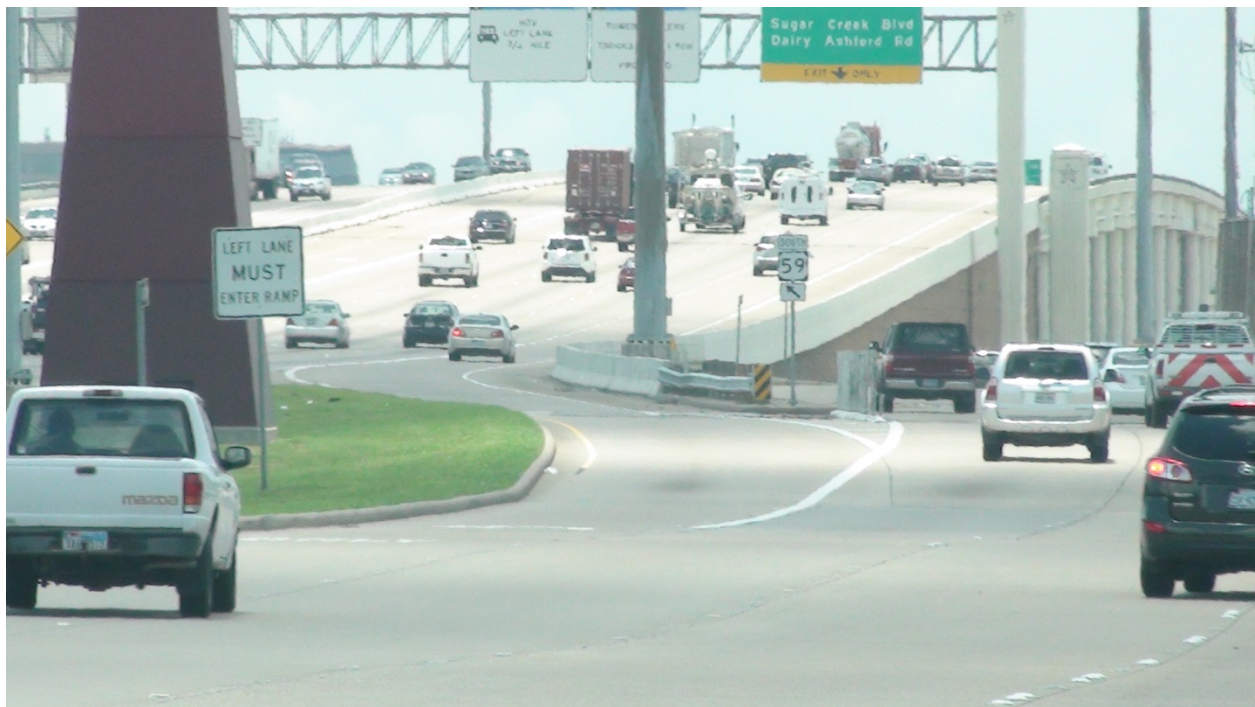
Figure F-15. US 59 WB Kirkwood Rd Entrance Ramp in Houston, TX.

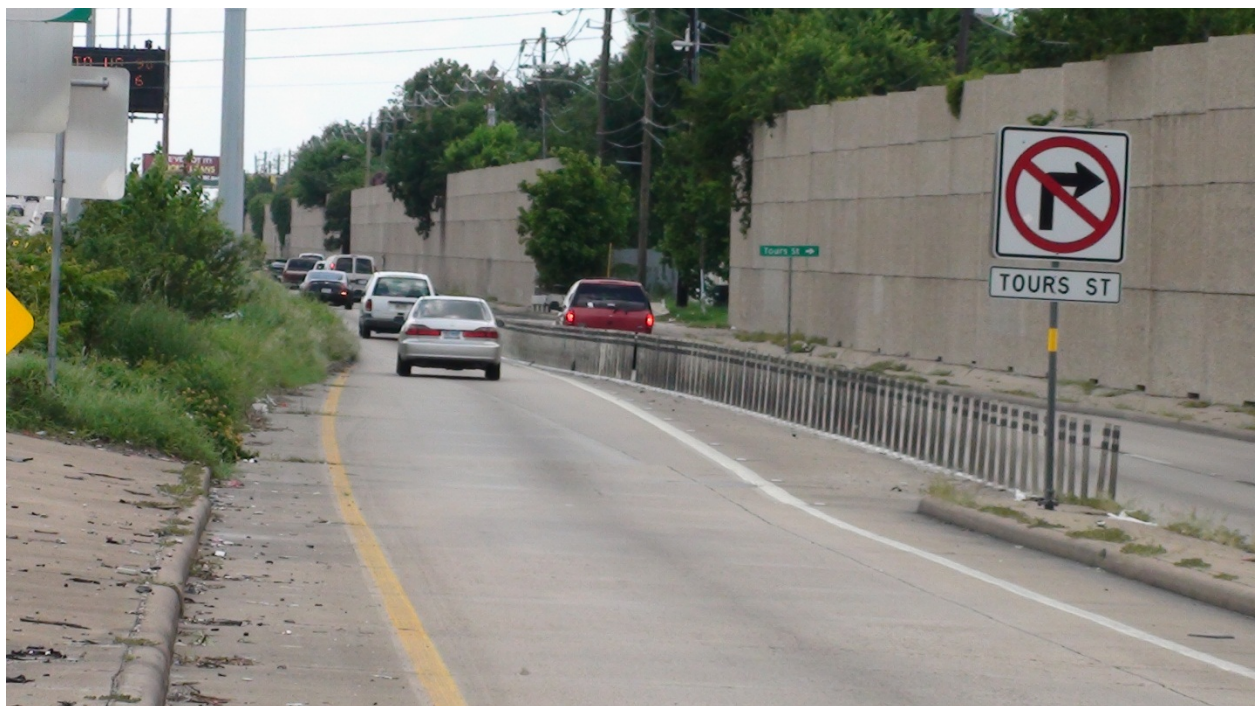
Figure F-16. US 59 WB Beechnut St Exit Ramp in Houston, TX.

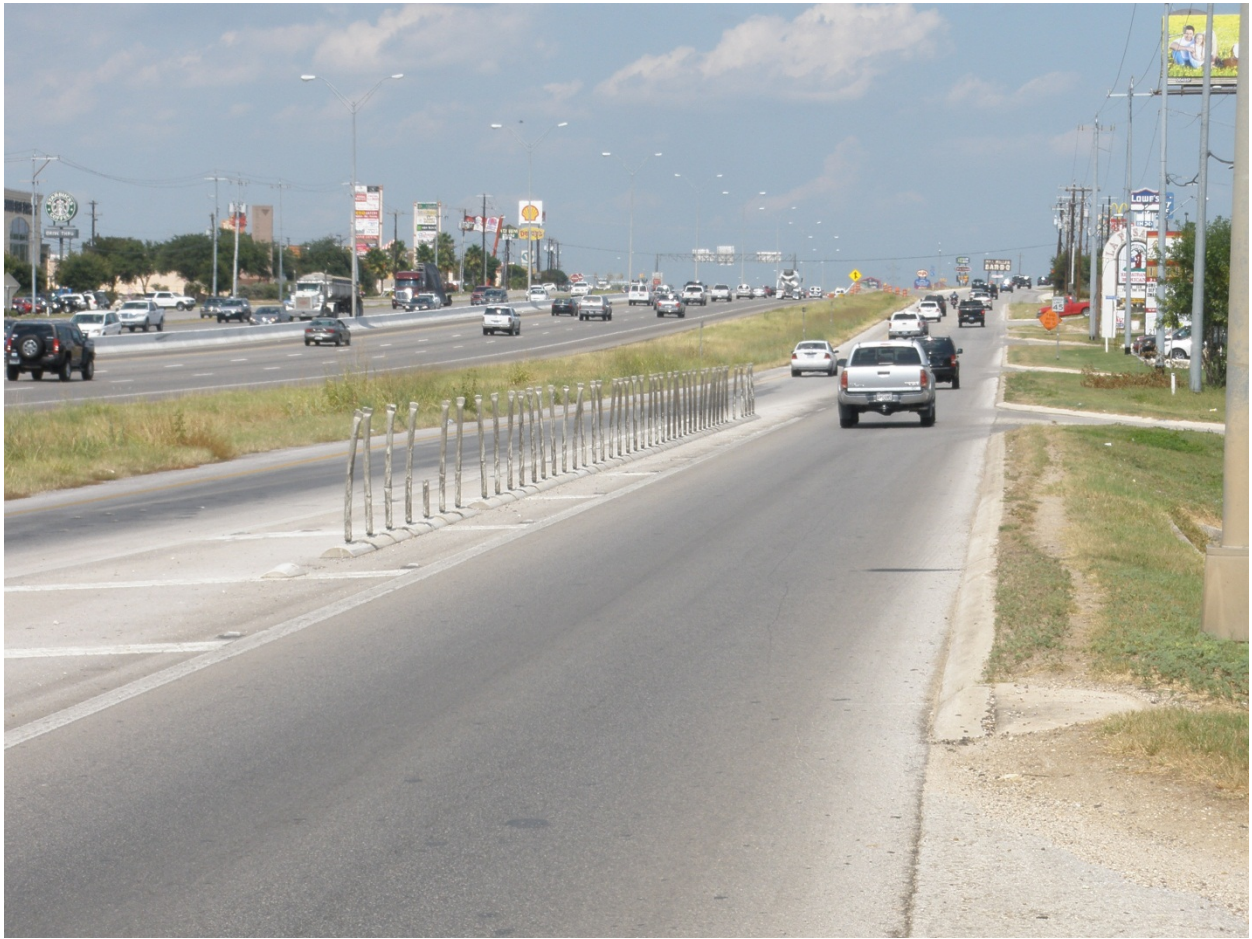
Figure F-17. IH 35 NB FM 3009 Exit Ramp in San Antonio, TX.
