## **MASH TEST 4-12 OF SHALLOW ANCHORAGE SINGLE SLOPE TRAFFIC RAIL (SSTR)**

### **Test Report 0-6968-R10**

**TEXAS A&M TRANSPORTATION INSTITUTE  
COLLEGE STATION, TEXAS**

**TEXAS DEPARTMENT OF TRANSPORTATION**

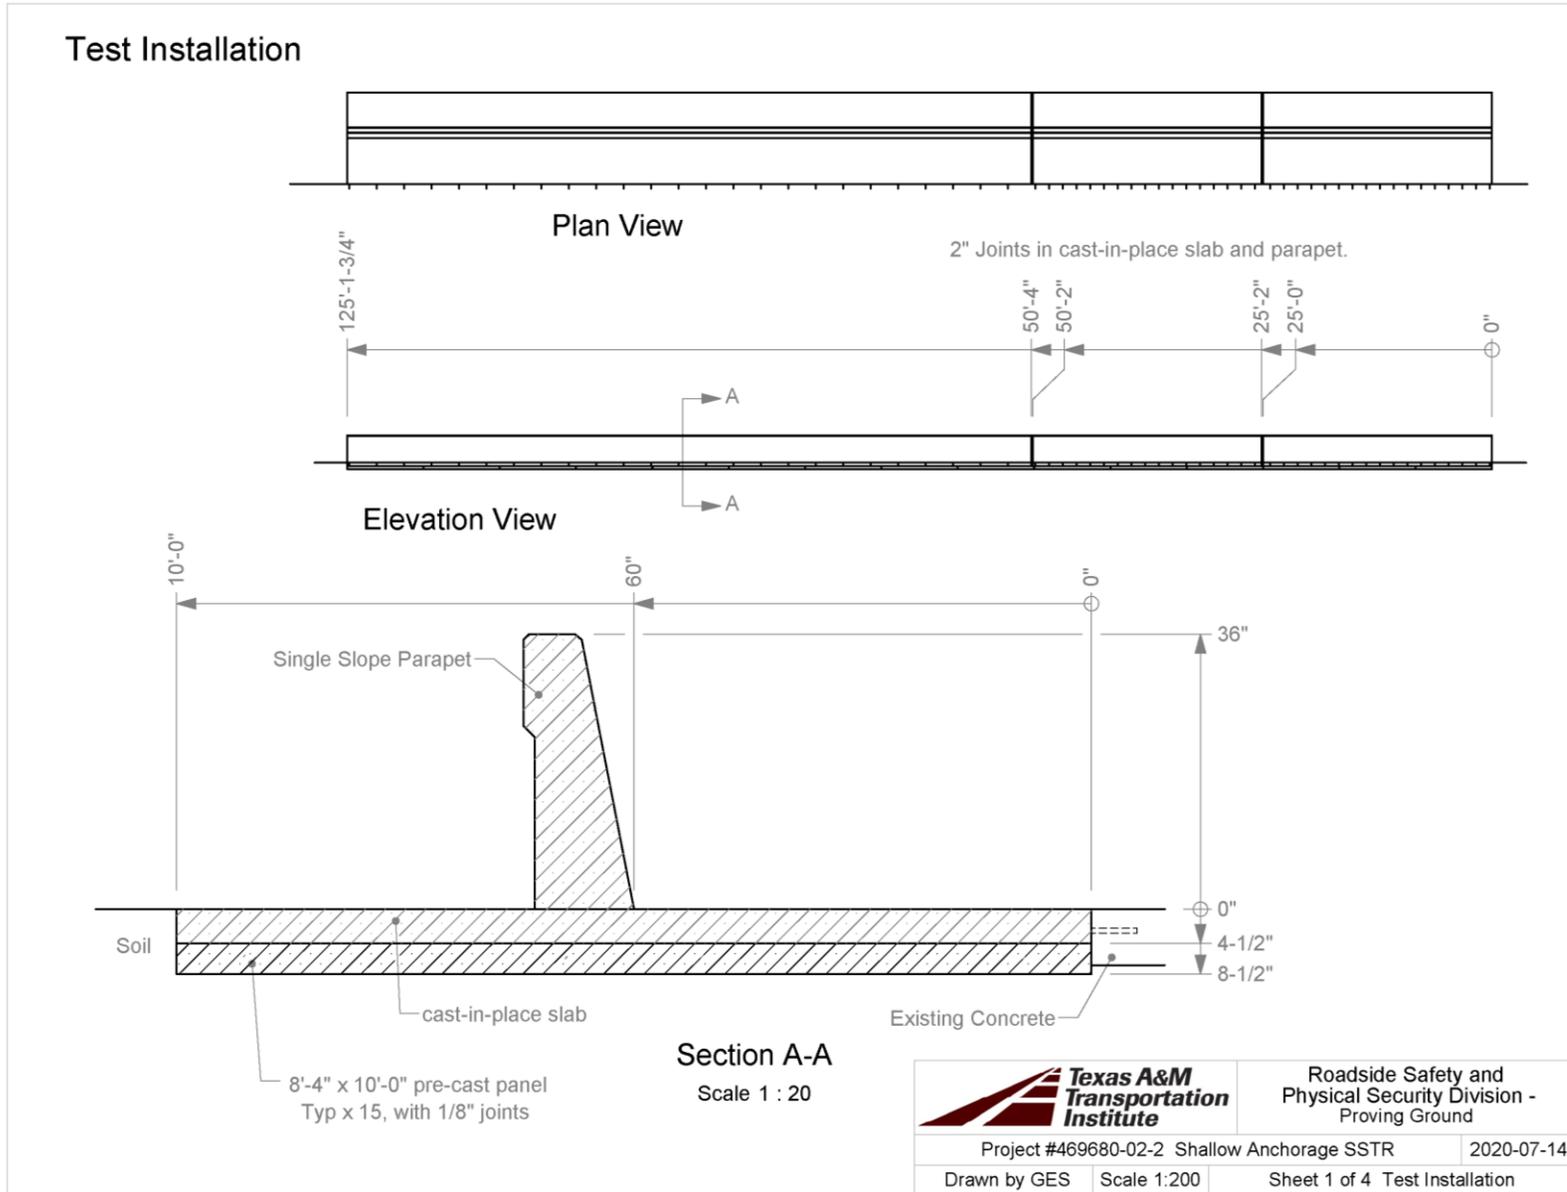
**Figure 2.1. TxDOT Shallow Anchorage SSTR Details.**

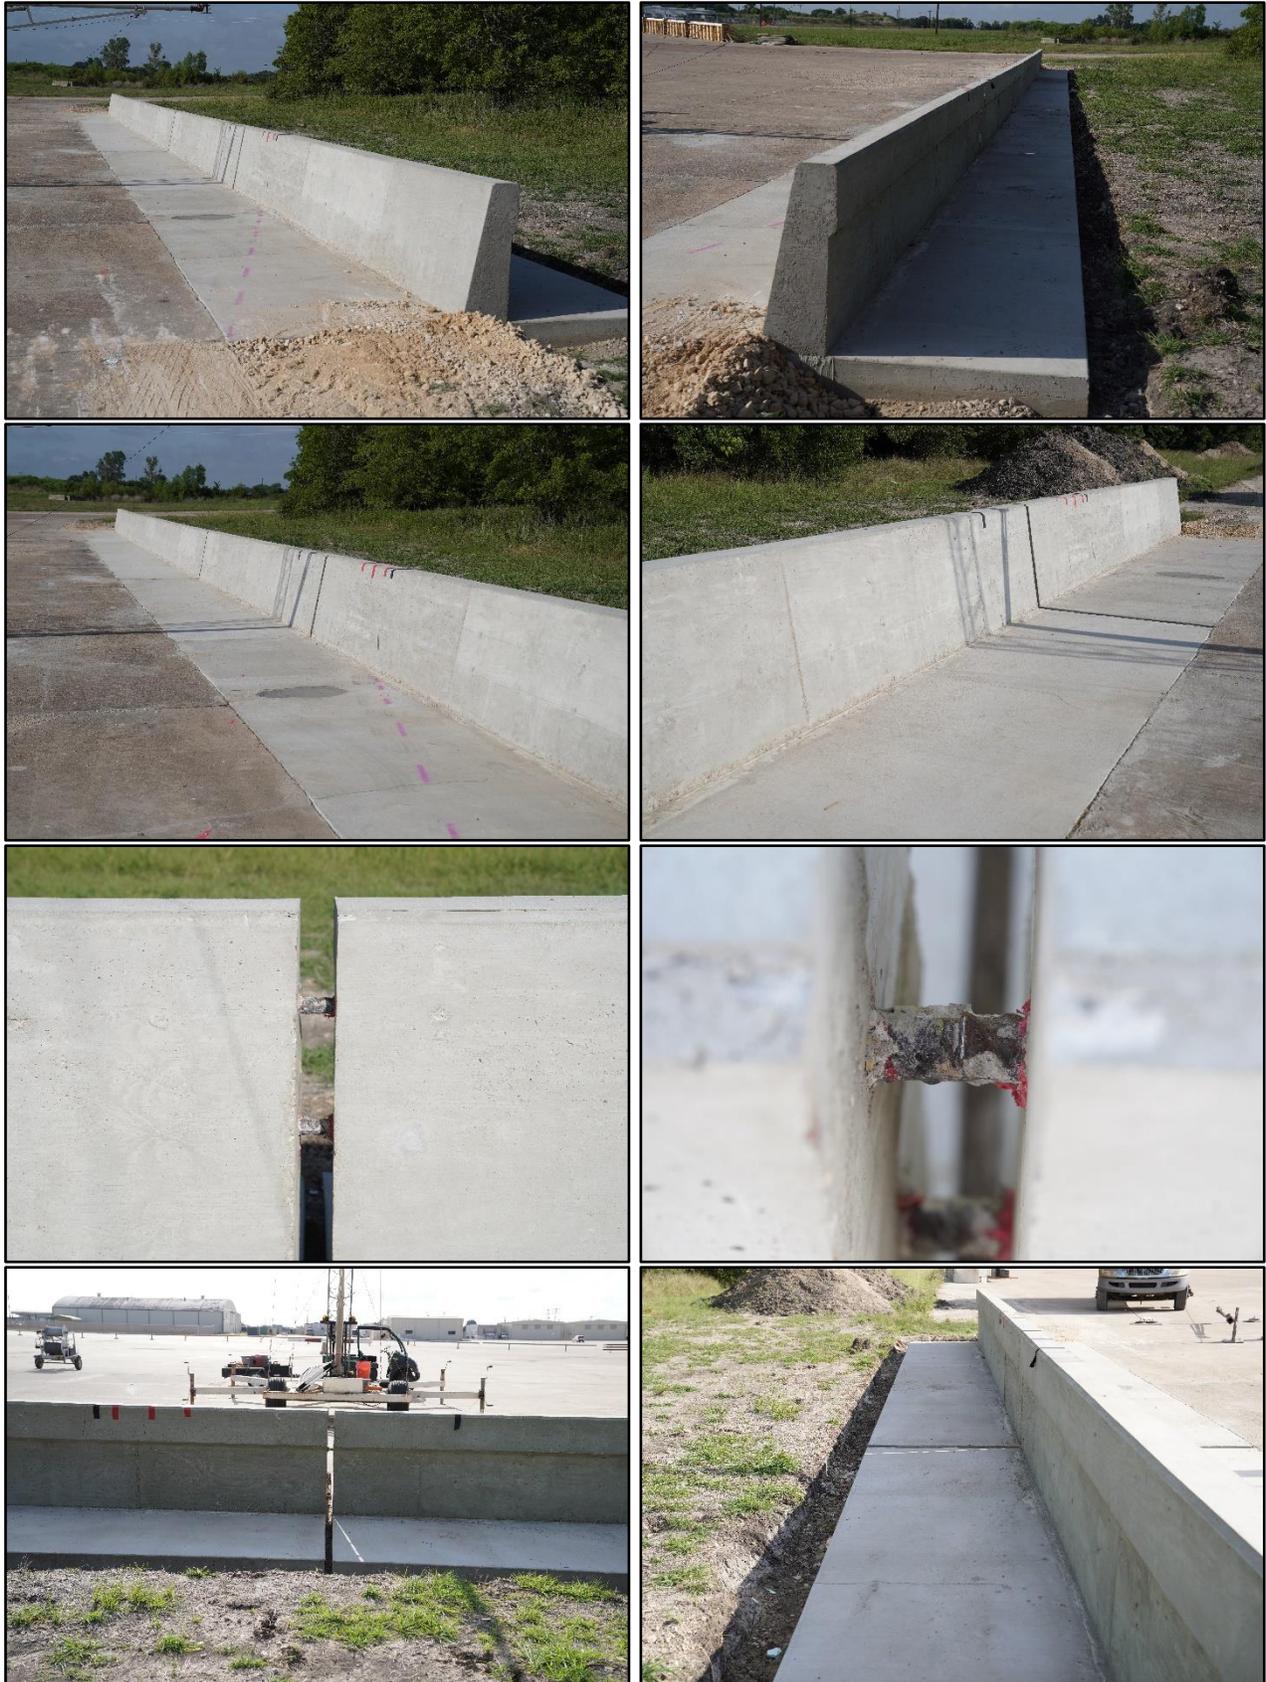
**Figure 2.2. TxDOT Shallow Anchorage SSTR prior to Testing.**

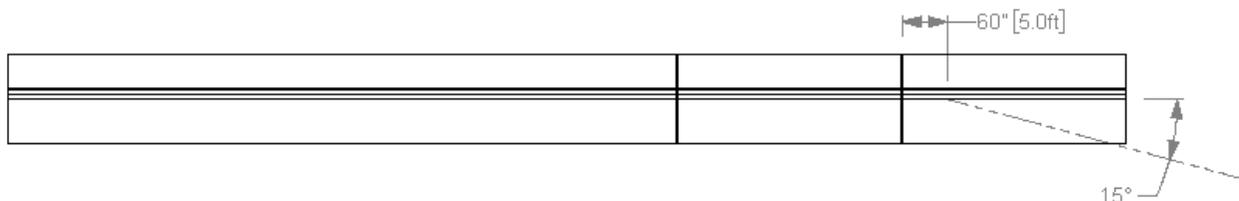
The target critical impact point (CIP) for the test was determined using the information provided in *MASH* Section 2.2.1, Section 2.3.2, and Table 2-8. Figure 3.1 shows the target CIP for *MASH* Test 4-12 on the TxDOT shallow anchorage SSTR, which is 5 ft. upstream of an expansion joint.

**Figure 3.1. Target CIP for First and Third *MASH* Test 4-12 on TxDOT Shallow Anchorage SSTR (Test No. 469680-02-1 and 3).**

*MASH* Test 4-12 involves a 10000S vehicle weighing 22,000 lb  $\pm$  660 lb impacting the CIP of the longitudinal barrier at an impact speed of 56 mi/h  $\pm$  2.5 mi/h and an angle of 15 degrees  $\pm$  1.5 degrees. The CIP for *MASH* Test 4-12 on the TxDOT shallow anchorage SSTR was 5 ft  $\pm$  1 ft upstream of the centerline of the joint between Segments 1 and 2. Figure 3.1 and Figure 5.1 depict the target impact setup.

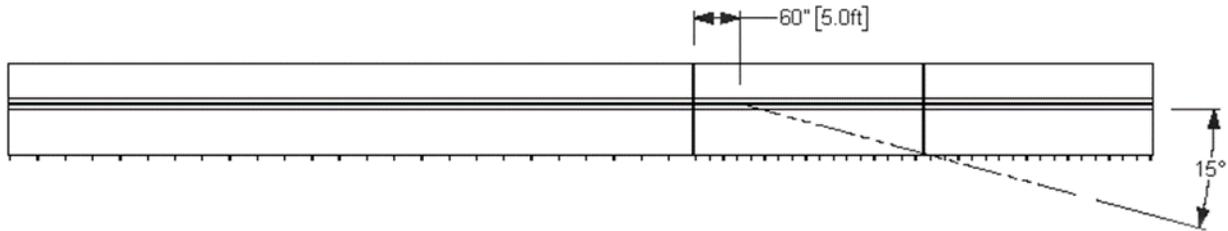
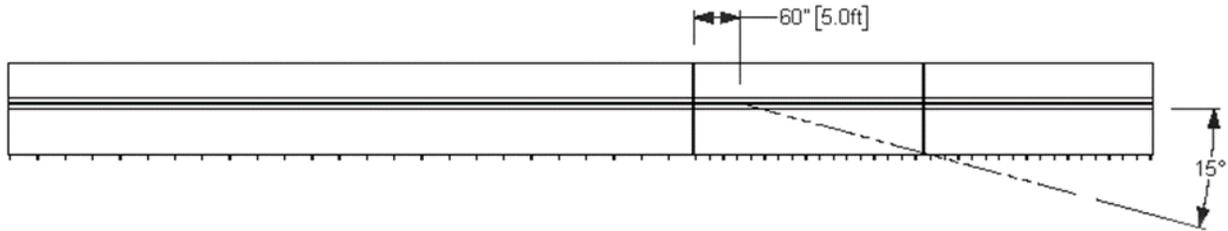
**Figure 3.2. Target CIP for Second *MASH* Test 4-12 on TxDOT Shallow Anchorage SSTR (Test No. 469680-02-2)**

For Test No. 469680-02-2, the dowel bars between barrier segments across the expansion joints were cut through such that the barrier segments were not connected. The CIP for *MASH* Test 4-12 on the TxDOT shallow anchorage SSTR without dowel bars was 5 ft ± 1 ft upstream of the centerline of the joint between Segments 2 and 3. This downstream joint was selected to avoid the need for barrier repair at the previously impacted joint.

Figure 3.2 and Figure 6.1 depict the target impact setup. The remaining target impact conditions for *MASH* Test 4-12 are stated in Section 5.1.

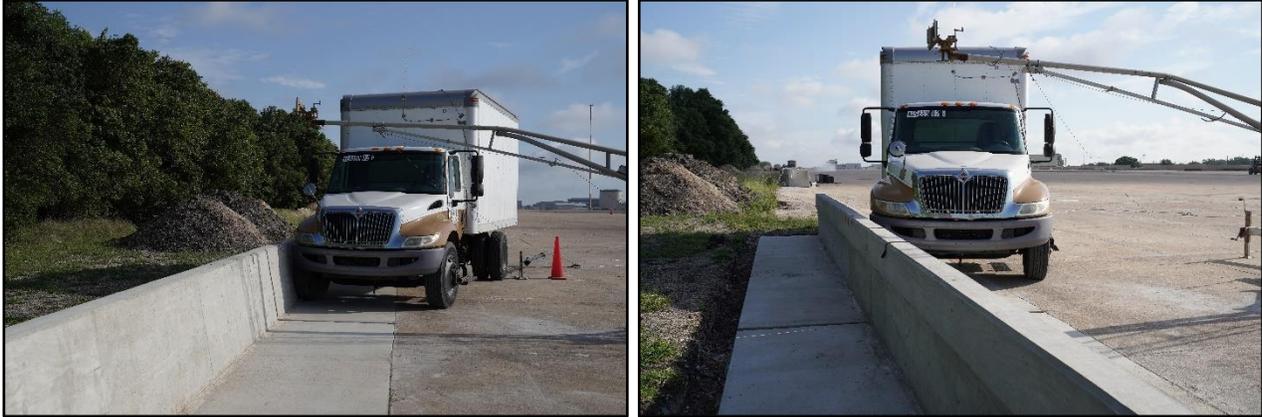
**Figure 5.1. TxDOT Shallow Anchorage SSTR/Test Vehicle Geometrics for Test No. 469680-02-1.**

The 10000S vehicle weighed 22,340 lb, and the actual impact speed and angle were 56.9 mi/h and 14.6 degrees. Minimum target impact severity (IS) was 142 kip-ft, and actual IS was 153 kip-ft. The actual impact point was 3.4 ft upstream of the centerline of the joint between Segments 1 and 2, which is 1.6 ft downstream of the target impact point and 0.6 ft outside the recommended *MASH* tolerance for impact point, and thus is out of specifications for *MASH*. When speaking about the impact point for large trucks, *MASH* Section 2.3.2.2 states that “the critical impact point for these vehicles should be chosen to maximize loading on critical barrier elements such as joints and splices.” Section A2.3.2.2 further elaborates that “impact point selection guidelines presented in Section 2.3.2.2 are based on the distance from initial contact to the location of maximum lateral force.” The objective of *MASH* Test 4-12 on the TxDOT shallow anchorage SSTR was to evaluate the effectiveness of the shallow anchorage system at a critical area near a barrier end/joint. Film analysis of this test showed that both the initial frontal impact and the subsequent rear impact of the truck occurred on the downstream end of the impacted barrier segment in advance of the joint. In fact, the lateral impact forces were applied to the barrier at a point closer to the segment end than initially planned, making it even more critical for evaluation of both the barrier and anchorage system. Thus, the outcome of the test was considered valid despite the actual impact point falling 0.6 ft downstream of the recommended *MASH* tolerance for CIP.

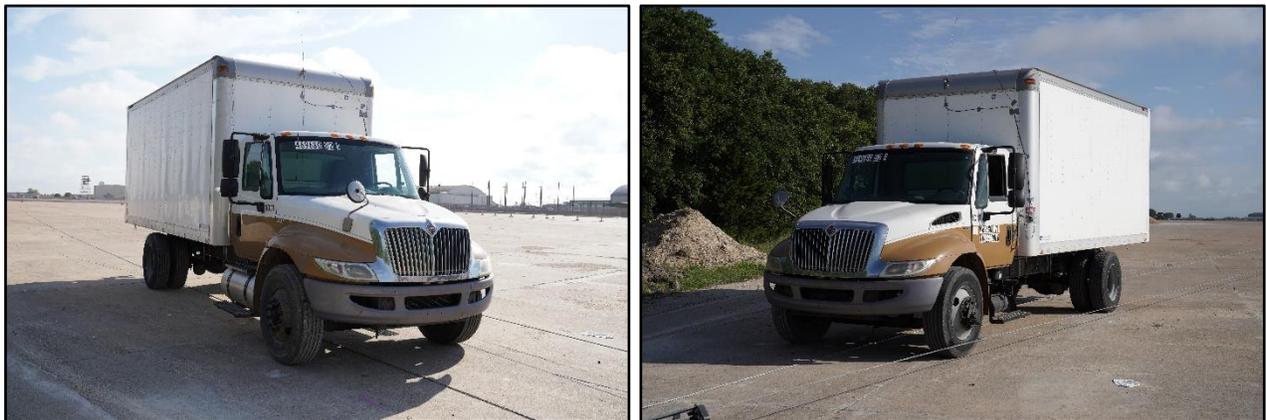
Figure 5.2 shows the 2011 International 4300 single-unit truck (SUT) used for the crash test. The vehicle's test inertia weight was 22,340 lb, and its gross static weight was 22,340 lb. The height to the lower edge of the vehicle bumper was 18.5 inches, and height to the upper edge of the bumper was 33.5 inches. The height to the center of gravity of the vehicle's ballast was 61.75 inches. Table C.1 in Appendix C.1 gives additional dimensions and information on the vehicle. The vehicle was directed into the installation using a cable reverse tow and guidance system and was released to be freewheeling and unrestrained just prior to impact.

Figure 5.2. Test Vehicle before Test No. 469680-02-1.

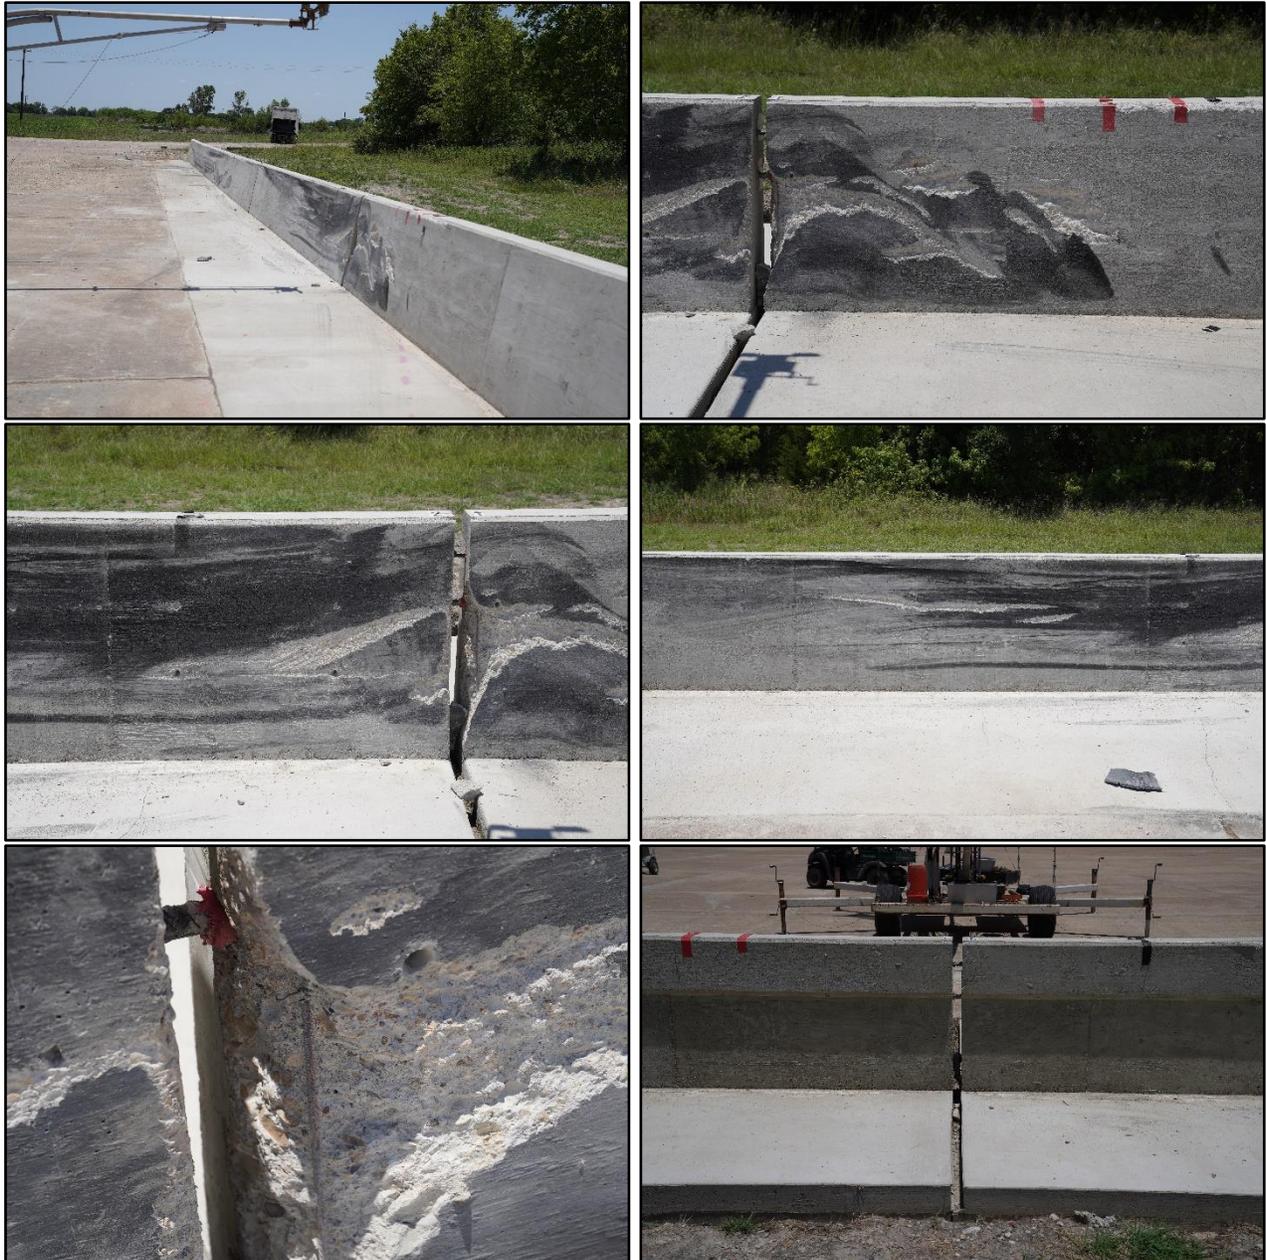
Figure 5.3 shows the damage to the TxDOT shallow anchorage SSTR. Before the test, any cracks in the deck and barrier were noted with a black paint marker. No additional cracks or enlarging of existing cracks were evident after the test. The deck was tested for delamination at the interface between the two concrete slabs, and none were detected. There was gouging and scuffing present on the traffic face of the barrier at the impacted joint. Rebar was exposed on the downstream end of Segment 1 at the joint between Segments 1 and 2. There was also gouging at the top of the field side corner of Segments 1 and 2 from contact with the bottom frame of the box of the truck. Working width\* was 78.4 inches, and height of working width was 152.2 inches. No dynamic deflection during the test or permanent deformation after the test was observed.

**Figure 5.3. TxDOT Shallow Anchorage SSSTR after Test No. 469680-02-1.**

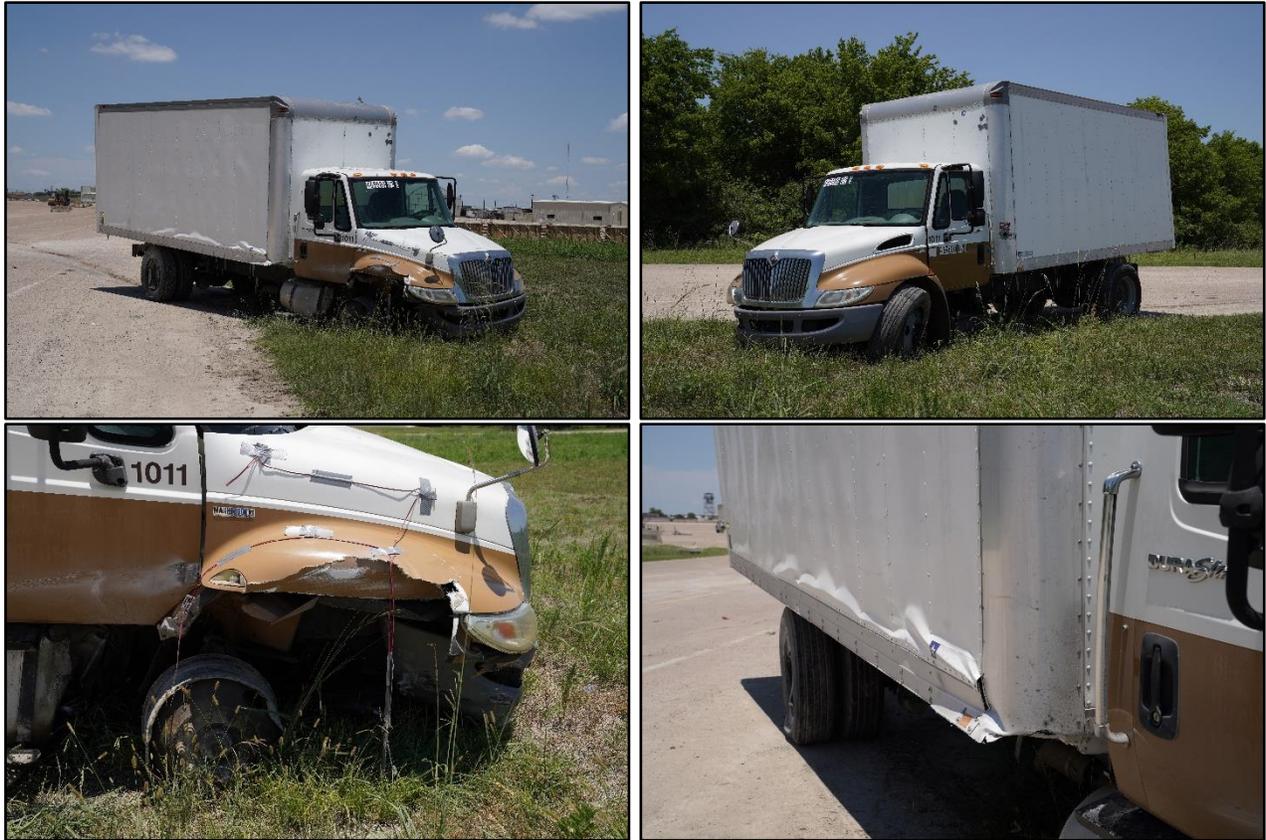
Figure 5.4 shows the damage sustained by the vehicle. The front bumper, hood, right front tire and rim, right front spring assembly and U-bolts, right fuel tank and side steps, right door, right floor pan, right lower edge of box, right rear outer tire and rim, and right rear U-bolts were damaged. Maximum exterior crush to the vehicle was 18.0 inches in the front plane at the right front corner at bumper height. Maximum occupant compartment deformation was 2.5 inches in the right front floor pan/firewall. Figure 5.5 shows the interior of the vehicle.

**Figure 5.4. Test Vehicle after Test No. 469680-02-1.**

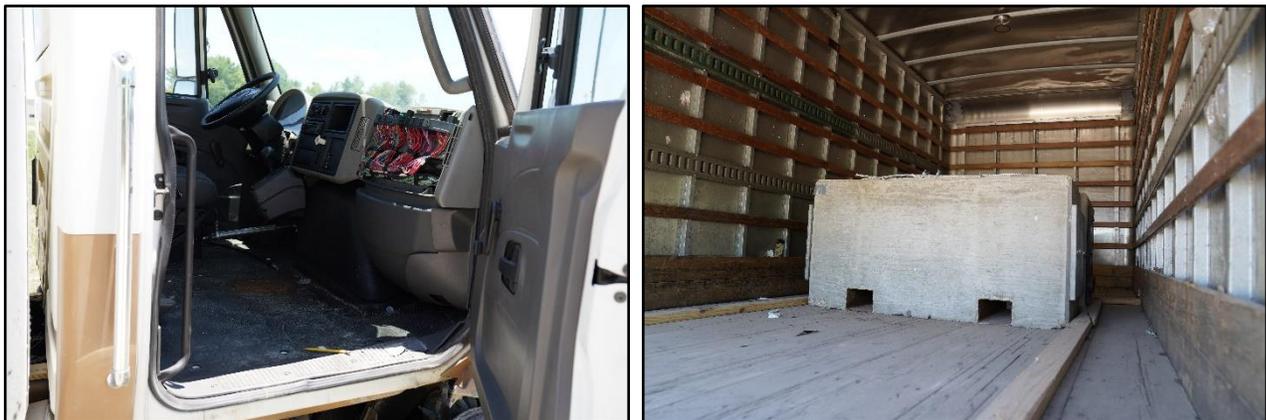
**Figure 5.5. Interior of Test Vehicle after Test No. 469680-02-1.**

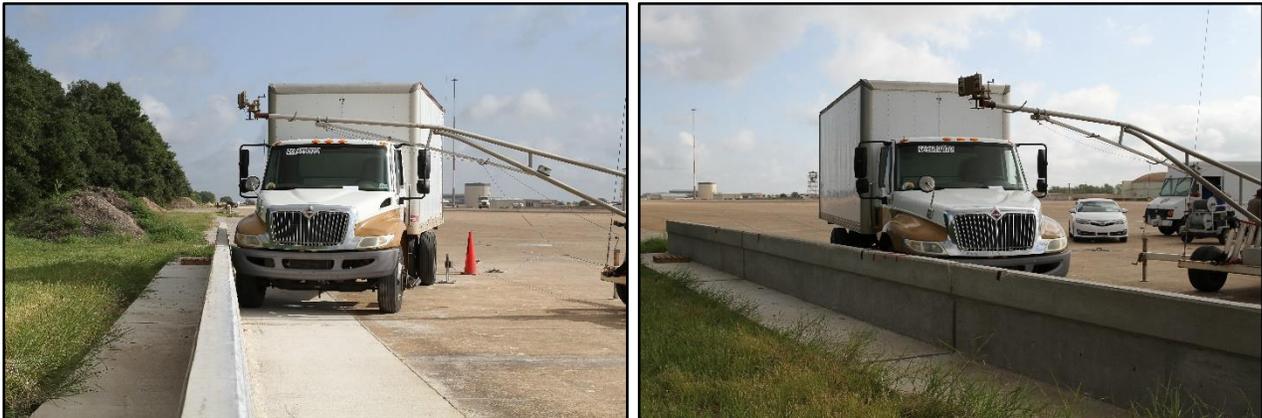
**Figure 6.1. TxDOT Shallow Anchorage SSTR without Dowel Bars/Test Vehicle Geometrics for Test No. 469680-02-2.**

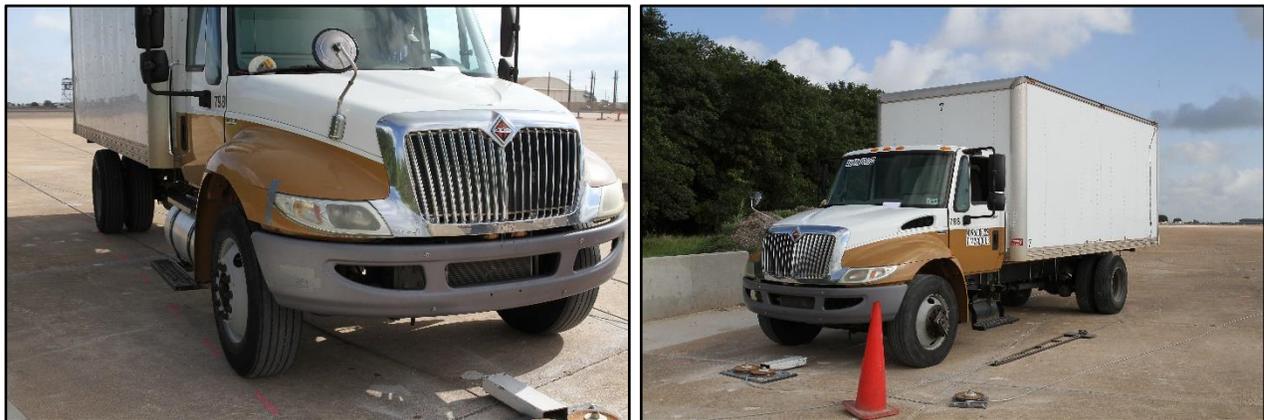
Figure 6.2 shows the 2011 International 4300 SUT used for the crash test. The vehicle's test inertia weight was 22,190 lb, and its gross static weight was 22,190 lb. The height to the lower edge of the vehicle bumper was 18.25 inches, and height to the upper edge of the bumper was 33.25 inches. The height to the center of gravity of the vehicle's ballast was 63.4 inches. Table D.1 in Appendix D.1 gives additional dimensions and information on the vehicle. The vehicle was directed into the installation using a cable reverse tow and guidance system, and was released to be freewheeling and unrestrained just prior to impact.

Figure 6.2. Test Vehicle before Test No. 469680-02-2.

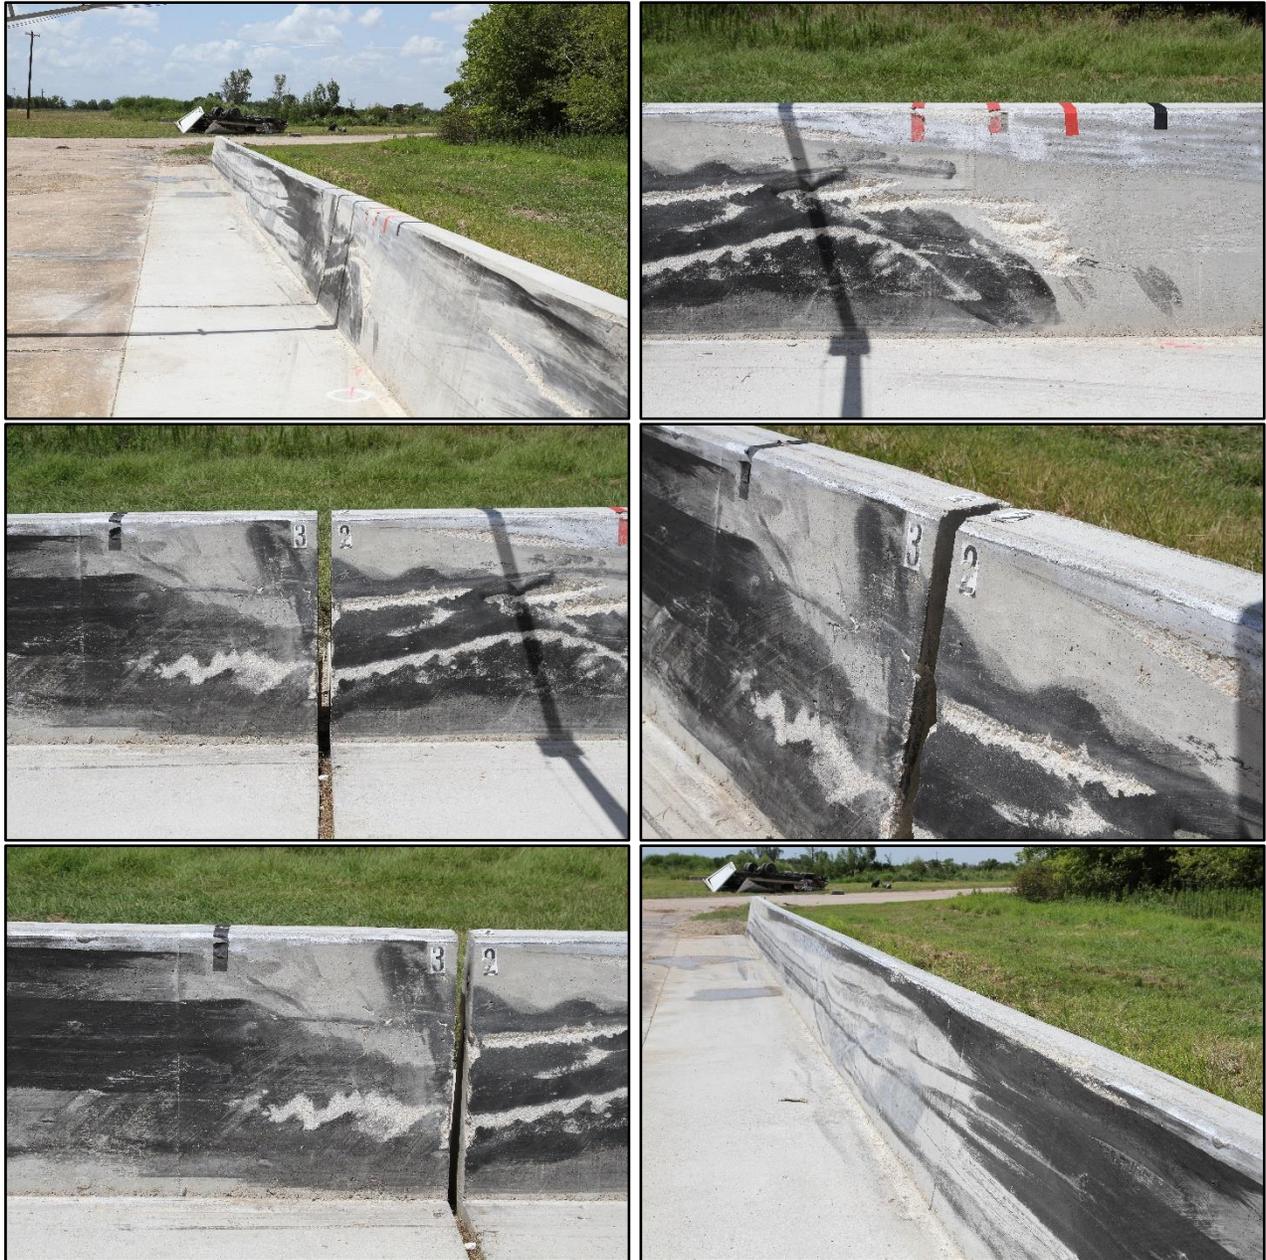
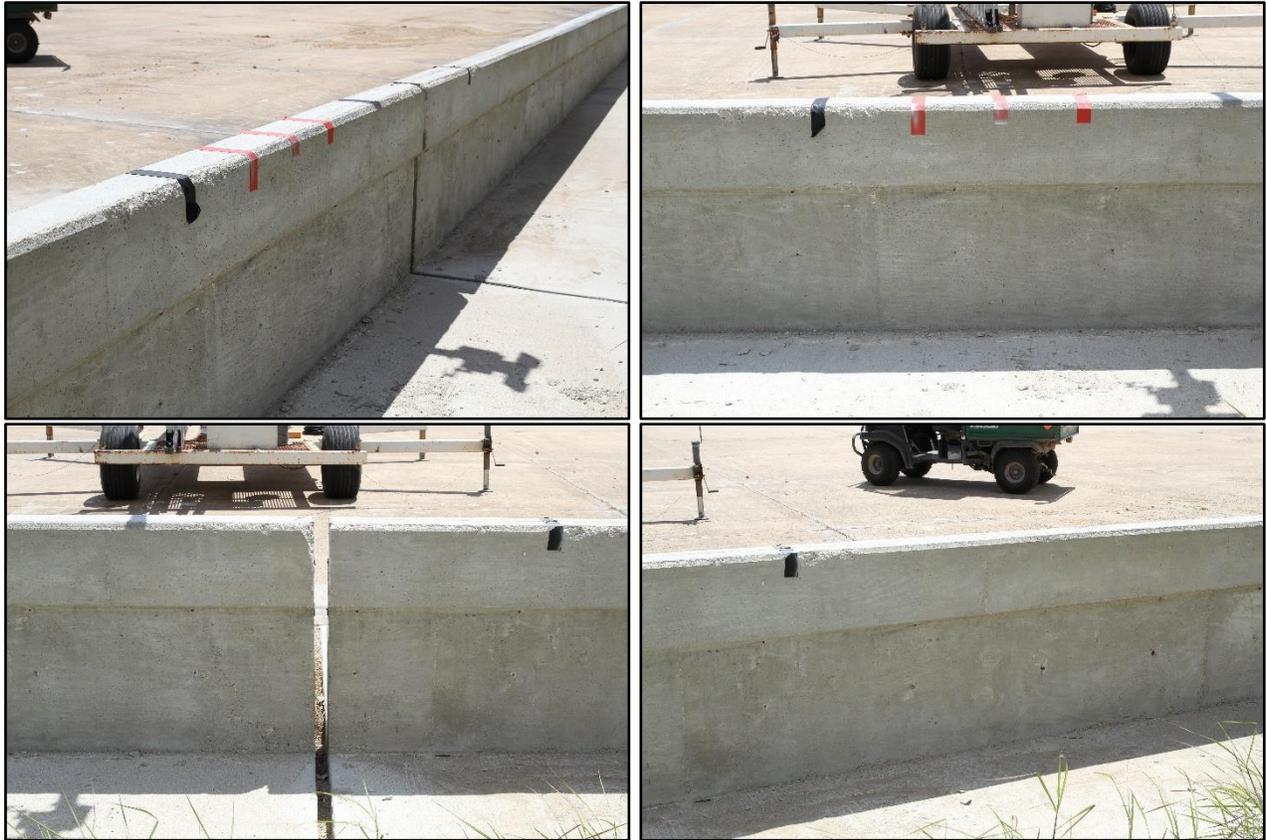
Figure 6.3 and Figure 6.4 show the damage to the TxDOT shallow anchorage SSTR without dowel bars. No cracks were observed in the barrier or deck slab. No delaminations were detected at the interface between the two concrete slabs. Some gouging occurred on the traffic face of the barrier in the impact region, and contact and scuff marks were evident from the point of impact to the end of the barrier. Working width\* was 60.6 inches, and height of working width was 150.9 inches. No dynamic deflection during the test nor permanent deformation after the test was observed.

**Figure 6.3. TxDOT Shallow Anchorage SSTR without Dowel Bars after Test No. 469680-02-2.**

**Figure 6.4. Field Side of SSTR without dowel bars after Test No. 469680-02-2.**

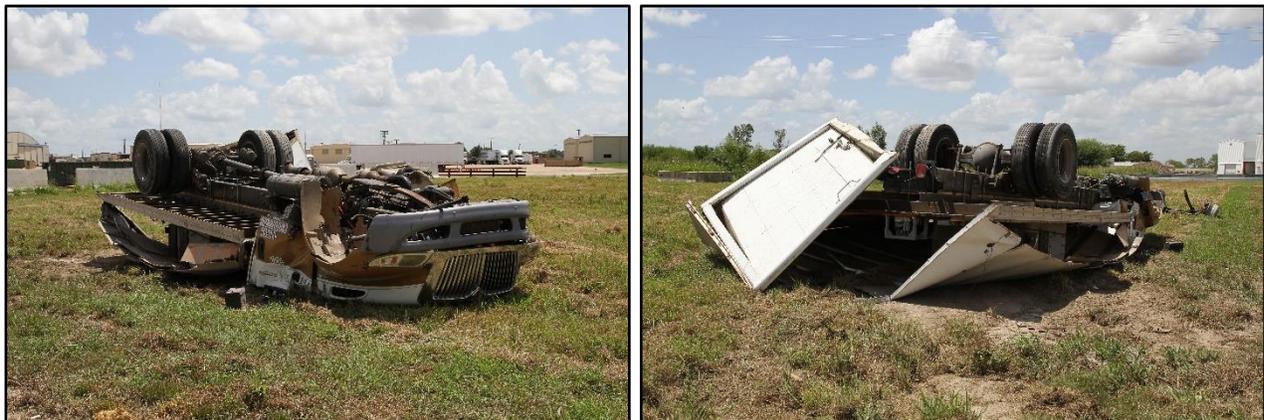
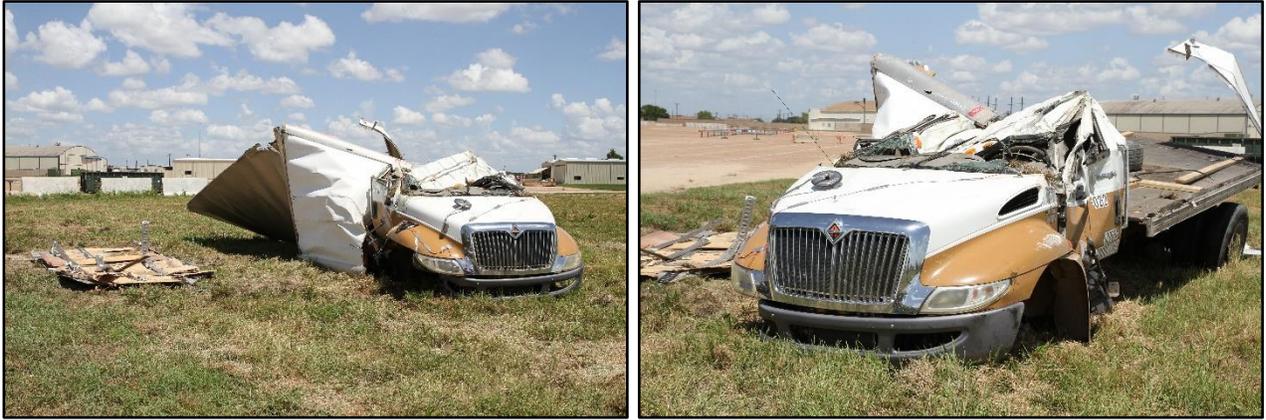
Figure 6.5 and Figure 6.6 show the damage sustained by the vehicle. After loss of contact with the barrier, the vehicle rolled 192 degrees and came to rest on its roof. Before the vehicle rolled over, the front bumper, hood, front axle, right and left front spring assembly and U-bolts, right front tire and rim, right front door, right fuel tank and side steps, rear of cab, lower edge of the box, and right rear outer rim were damaged. Maximum exterior crush to the vehicle before rollover was 16.0 inches in the side plane at the right front corner at bumper height. Due to rollover, the occupant compartment deformation was unable to be measured.

**Figure 6.5. Test Vehicle after Test No. 469680-02-2.**

**Figure 6.6. Test Vehicle (Uprighted) after Test No. 469680-02-2.**

<p>G. <i>It is preferable, although not essential, that the vehicle remain upright during and after collision.</i></p>	<p>The 10000S vehicle rolled 192° and came to rest on its roof. MASH Section A2.2.1 permits only a ¼ roll of the vehicle.</p>	<p>Fail</p>

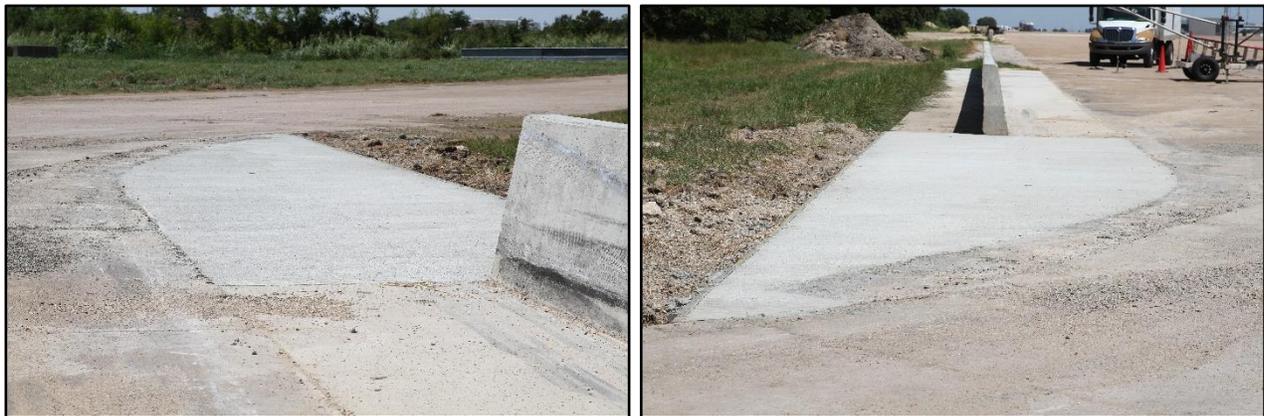
Consequently, *MASH* Test 4-12 was repeated with a modification to the runout area. Figure 7.1 shows how the concrete apron was extended downstream of the test installation to replace the existing soil immediately beyond the end of the barrier. The extension of the concrete downstream of the barrier is considered more representative of the field applications for this system on high-speed bridge structures. The CIP for *MASH* Test 4-12 on the TxDOT shallow anchorage SSTR without dowel bars was 5 ft ± 1 ft upstream of the centerline of the joint between Segments 1 and 2. Damage to the barrier at this location from Test No. 469680-02-1 was repaired using a non-shrink grout. Figure 3.1 and Figure 7.2 depict the target impact setup. The remaining target impact conditions for *MASH* Test 4-12 are described in Section 5.1.

Figure 7.1. Runout Area Extended for Test No. 469680-02-3.

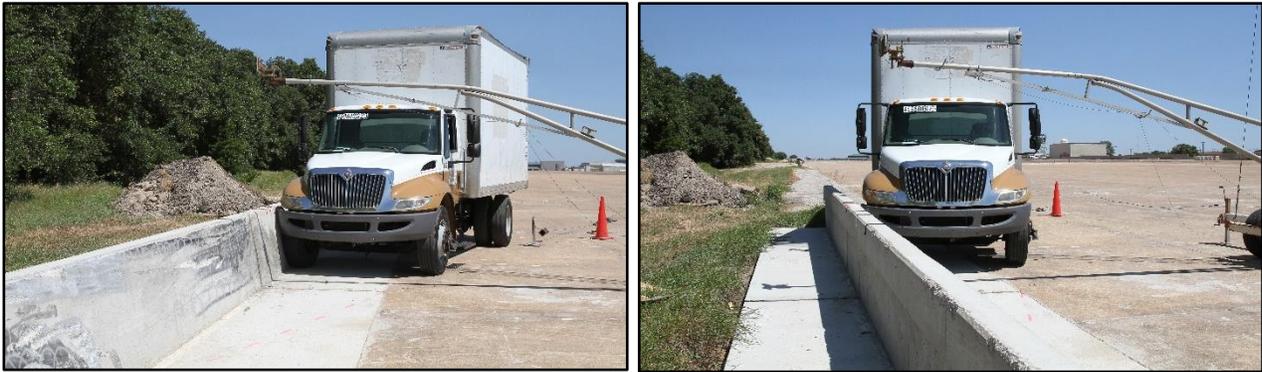
The 10000S vehicle weighed 22,500 lb, and the actual impact speed and angle were 57.4 mi/h and 14.7 degrees. The actual impact point was 5.0 ft upstream of the centerline of the joint between Segments 1 and 2. Minimum target IS was 142 kip-ft, and actual IS was 160 kip-ft.

**Figure 7.2. TxDOT Shallow Anchorage SSSTR without Dowel Bars and with Concrete Apron Extended Downstream of Barrier/Test Vehicle Geometrics for Test No. 469680-02-3.**

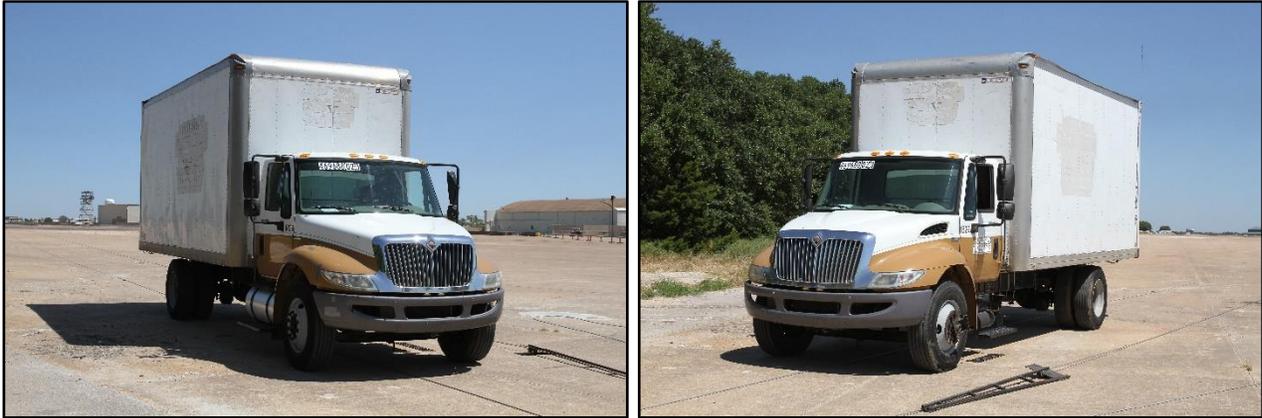
Figure 7.3 shows the 2009 International 4300 SUT used for the crash test. The vehicle’s test inertia weight was 22,500 lb, and its gross static weight was 22,500 lb. The height to the lower edge of the vehicle bumper was 18.25 inches, and height to the upper edge of the bumper was 33.25 inches. The height to the center of gravity of the vehicle’s ballast was 61.25 inches. Table E.1 in Appendix E.1 gives additional dimensions and information on the vehicle. The vehicle was directed into the installation using a cable reverse tow and guidance system, and was released to be freewheeling and unrestrained just prior to impact.

**Figure 7.3. Test Vehicle before Test No. 469680-02-3.**

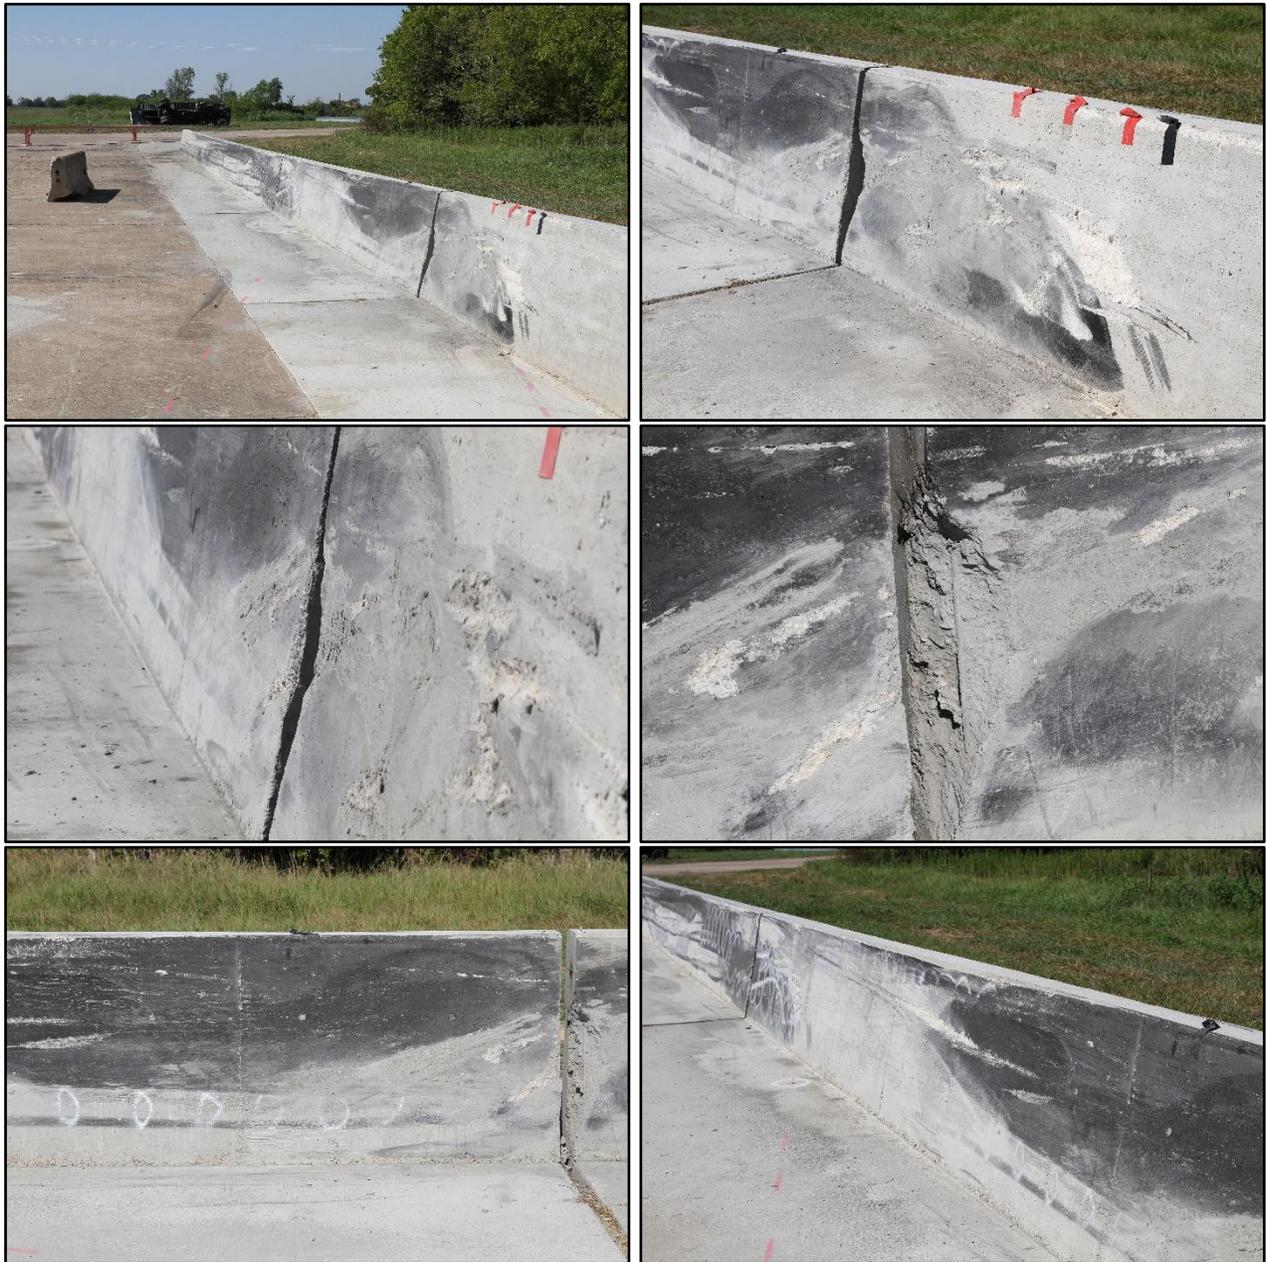
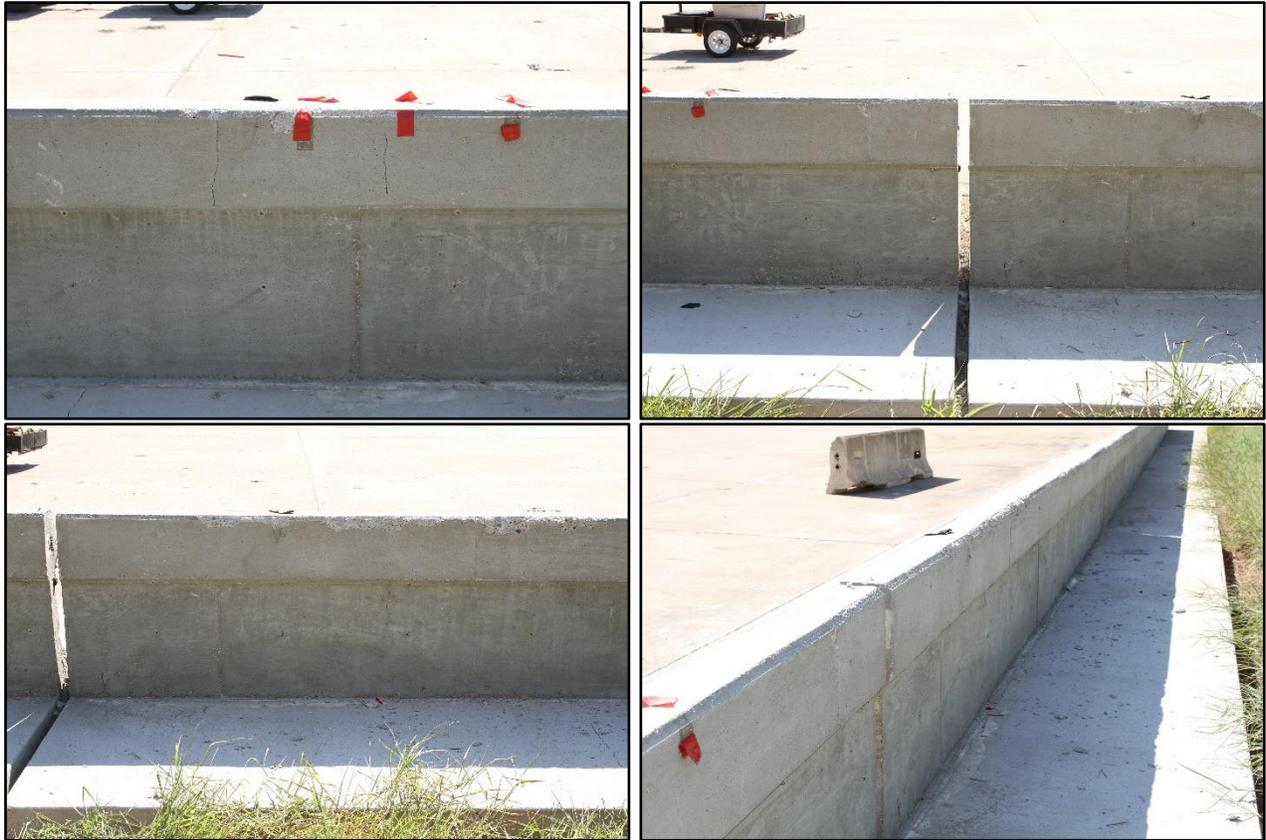
Figure 7.4 and Figure 7.5 show the damage to the TxDOT shallow anchorage SSTR without dowel bars. No cracks were observed in the barrier or deck slab. No delamination was detected at the interface between the two concrete slabs. There was some gouging on the face of the concrete barrier in the impact region and on Segment 2, with scuffing running along the length of the barrier. A section of rebar was exposed on the traffic side of Segment 1 at the joint between Segments 1 and 2. Working width\* was 81.5 inches, and height of working width was 142.5 inches. No dynamic deflection during the test nor permanent deformation after the test was observed.

**Figure 7.4. TxDOT Shallow Anchorage SSTR without Dowel Bars and with Concrete Apron Extended Downstream of Barrier after Test No. 469680-02-3.**

**Figure 7.5. Field Side of SSTR without Dowel Bars and with Concrete Apron Extended Downstream of Barrier after Test No. 469680-02-3.**

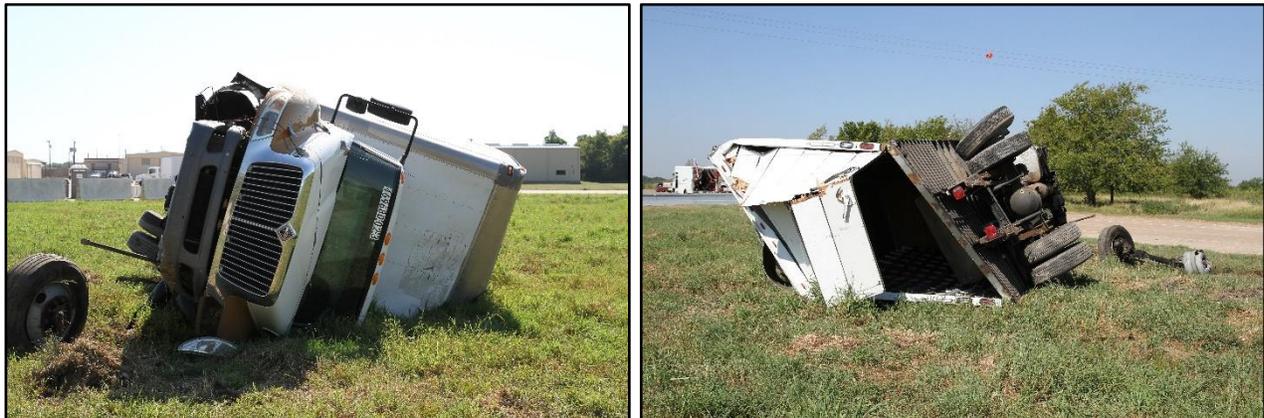
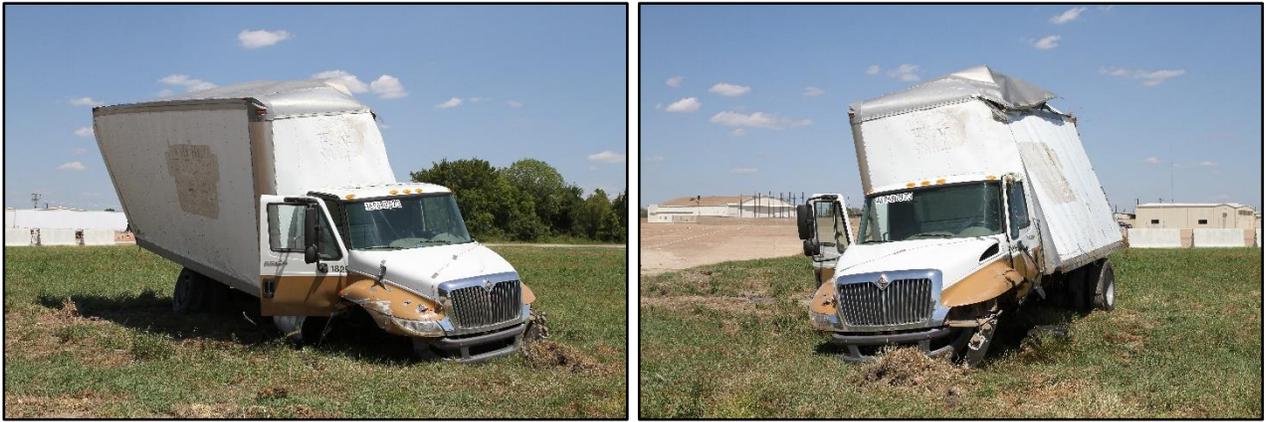
Figure 7.6 and Figure 7.7 show the damage sustained by the vehicle. The front bumper, hood, right floor pan, front axle, U-bolts, spring assembly, right front tire and rim, right fuel tank and side steps, right front corner of the box, and right rear outer tire and rim were damaged due to contact with the barrier. After loss of contact with the barrier, the vehicle rolled onto its left side, which caused damage to the left front door, windshield, left side steps and battery box, and left air tanks. Maximum exterior crush to the vehicle was 16.0 inches in the side plane at the

**Figure 7.6. Test Vehicle after Test No. 469680-02-3.**

**Figure 7.7. Test Vehicle (Uprighted) after Test No. 469680-02-3.**
