## **MASH TEST 4-12 OF SHALLOW ANCHORAGE SINGLE SLOPE TRAFFIC RAIL (SSTR)**

### **Test Report 0-6968-R10**

**TEXAS A&M TRANSPORTATION INSTITUTE  
COLLEGE STATION, TEXAS**

**TEXAS DEPARTMENT OF TRANSPORTATION**

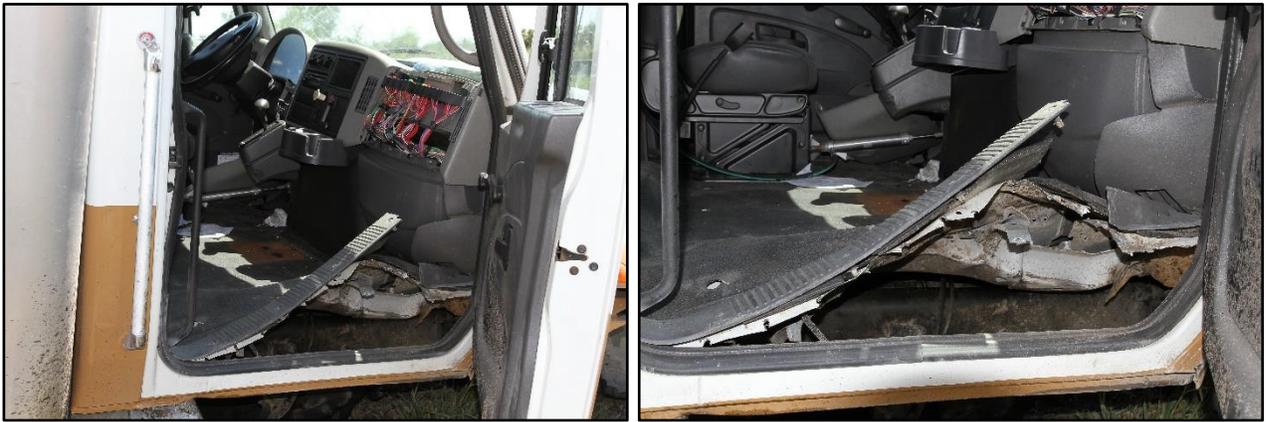
right front corner at bumper height. Maximum occupant compartment deformation was 9.75 inches in the right floor pan area at the seam with the right door. Figure 7.8 shows the interior of the vehicle after the test.

**Figure 7.8. Interior of Test Vehicle after Test No. 469680-02-3.**

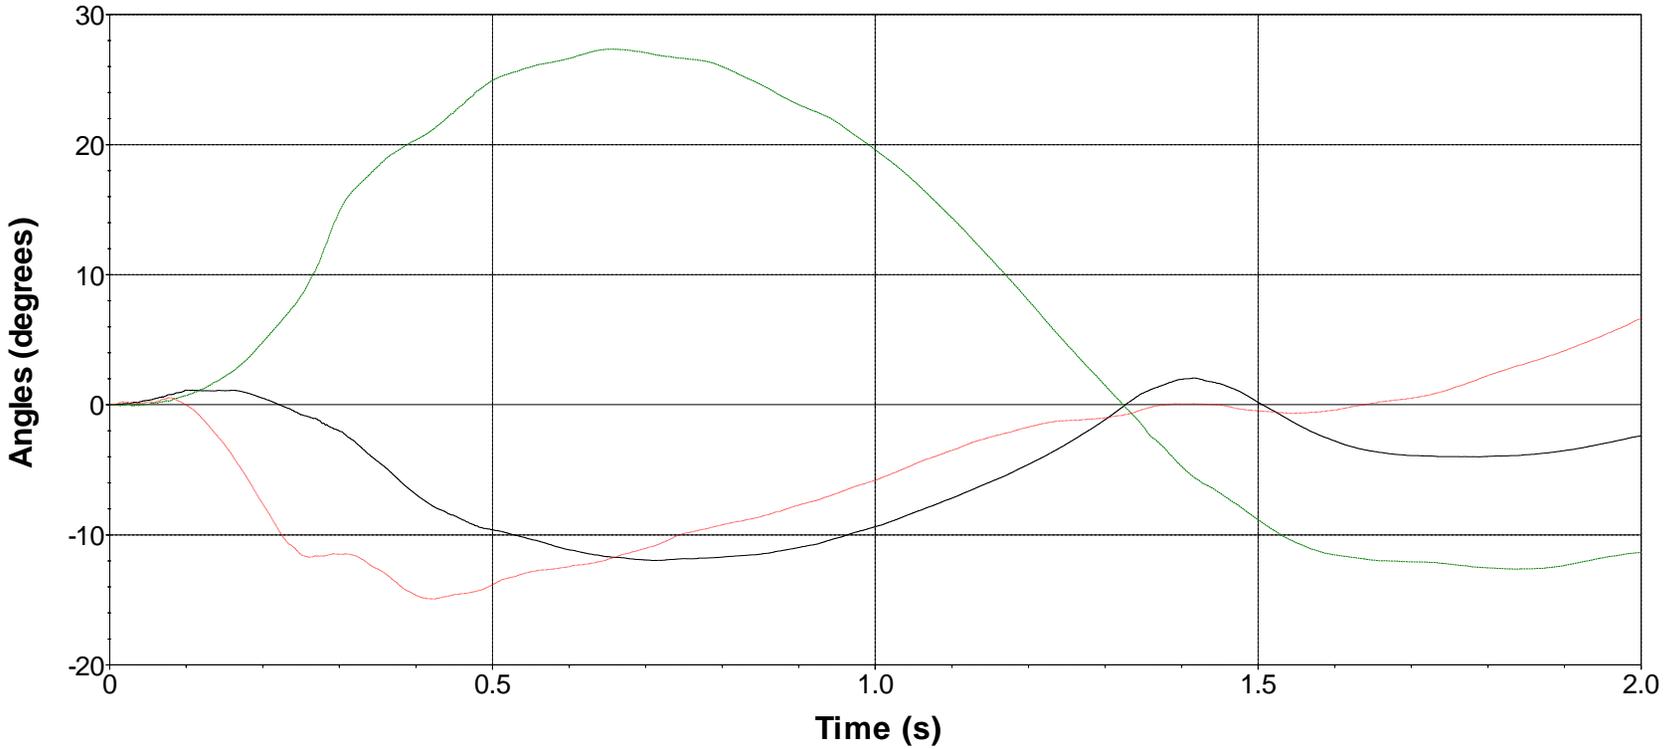
Figure C.3. Vehicle Angular Displacements for Test 469680-02-1.

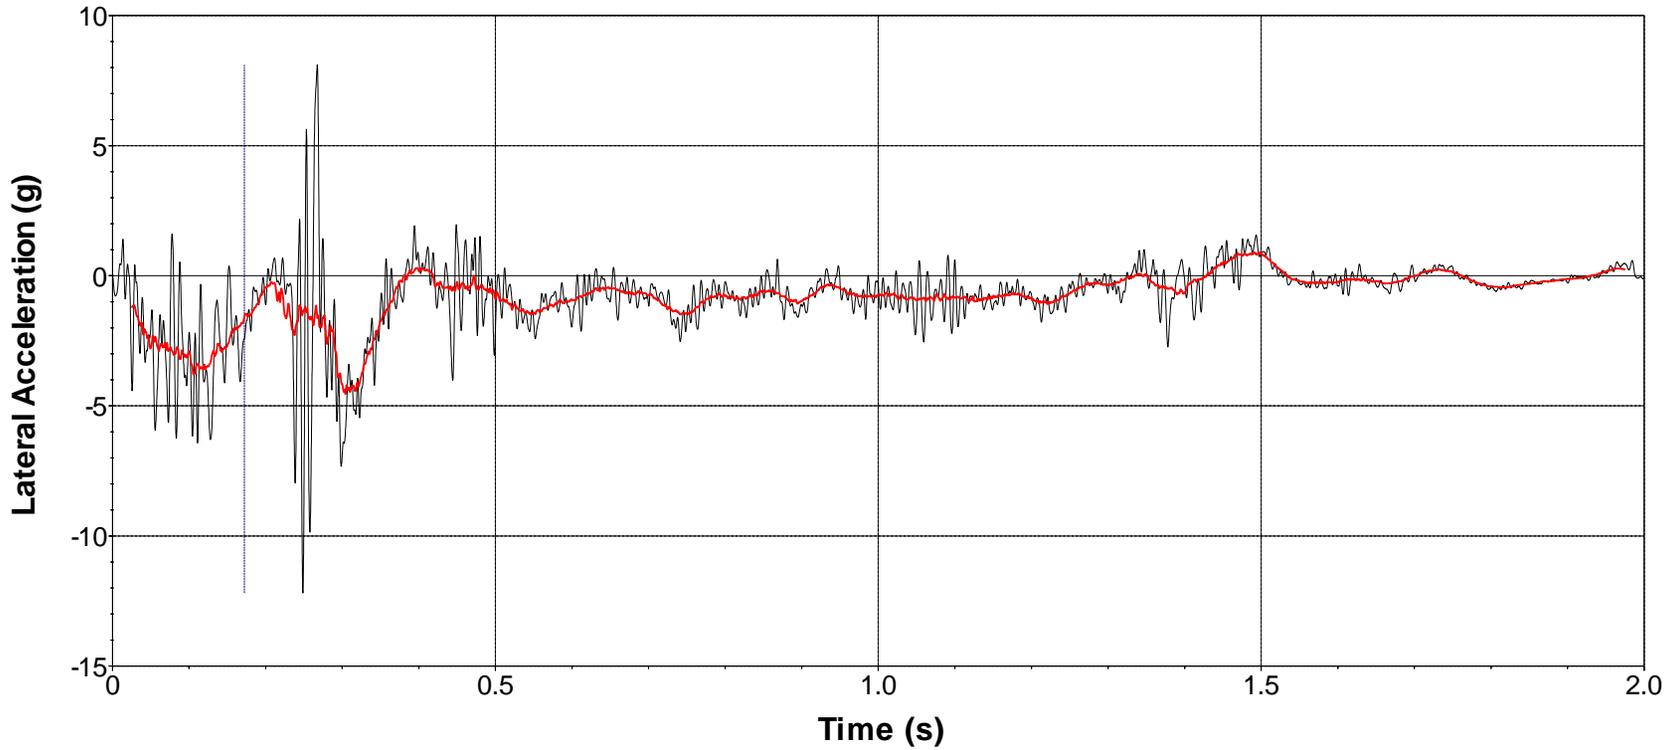
**Figure C.5. Vehicle Lateral Accelerometer Trace for Test No. 469680-02-1 (Accelerometer Located at Center of Gravity).**

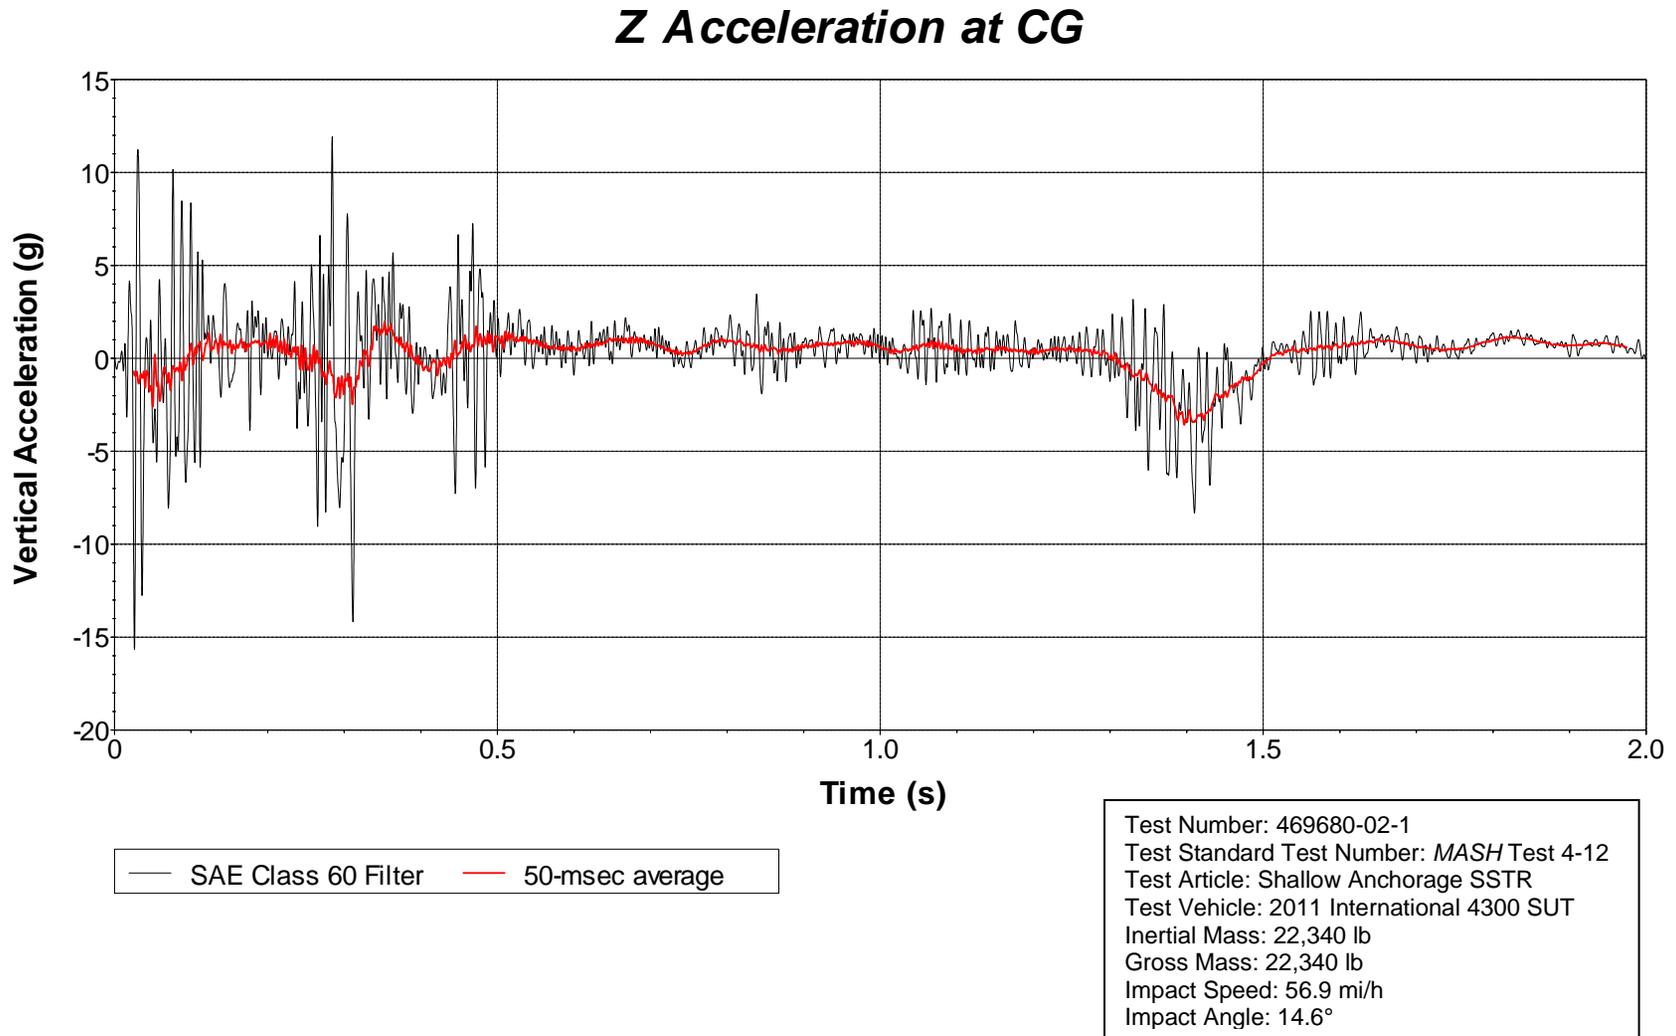
**Figure C.6. Vehicle Vertical Accelerometer Trace for Test No. 469680-02-1  
(Accelerometer Located at Center of Gravity).**

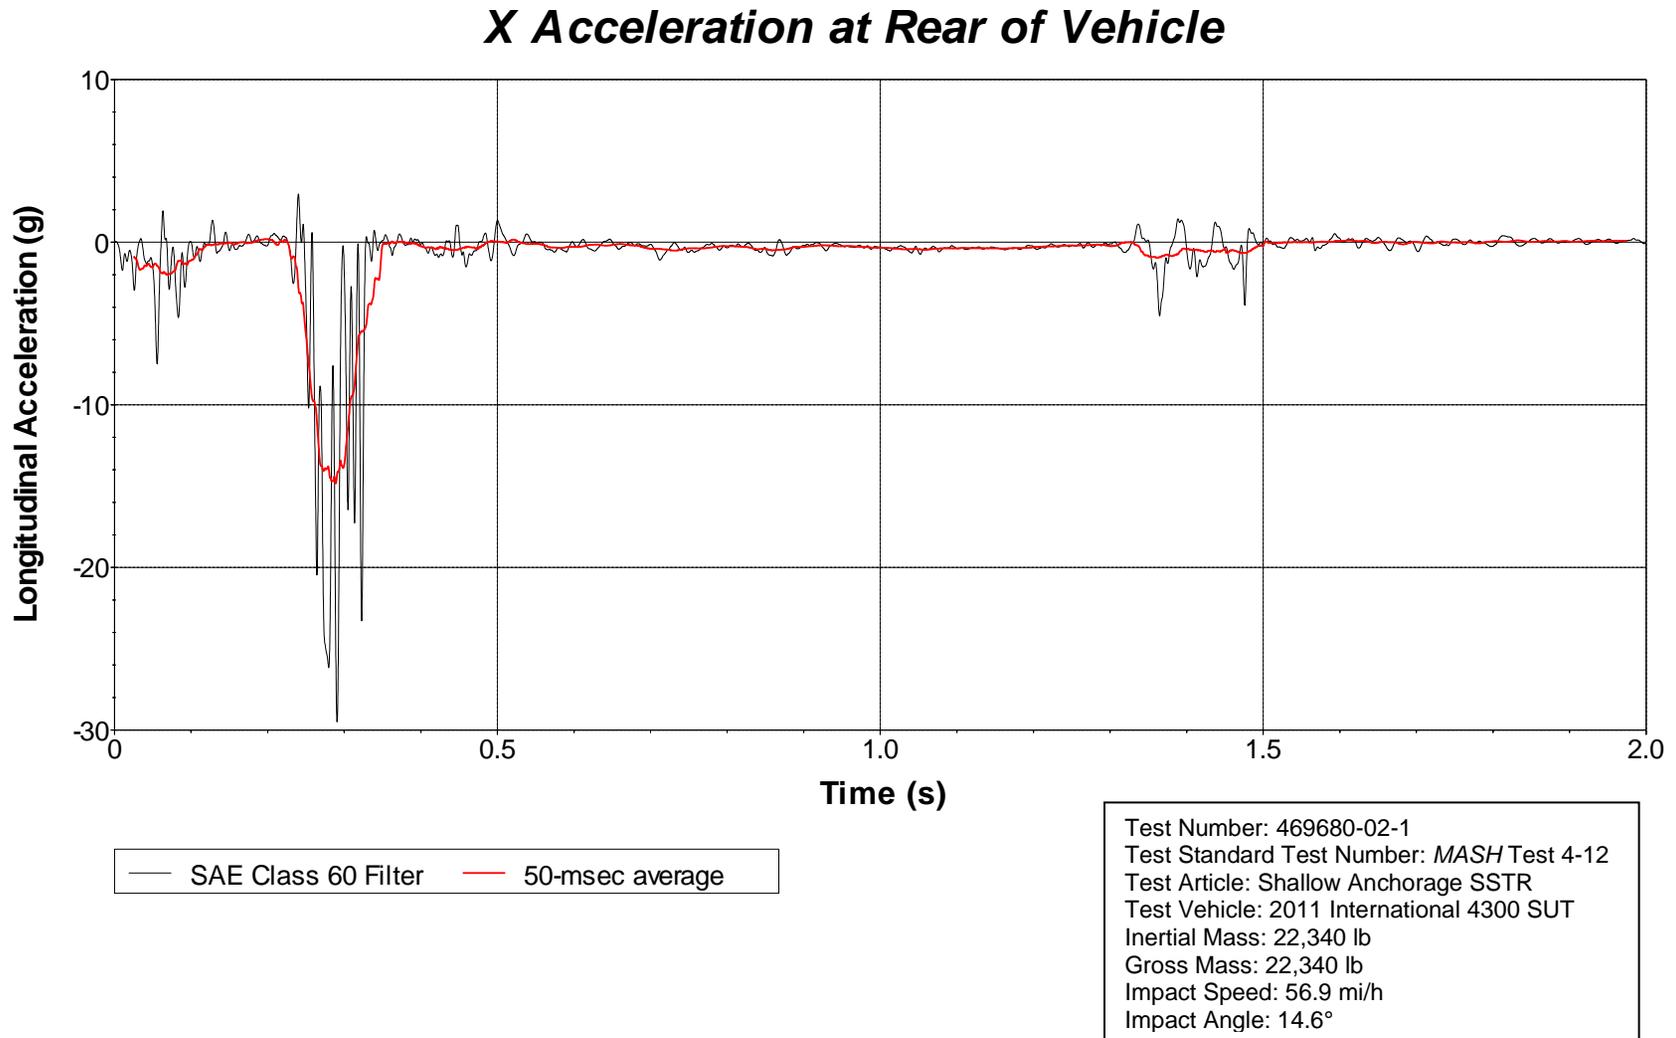
**Figure C.7. Vehicle Longitudinal Accelerometer Trace for Test No. 469680-02-1  
(Accelerometer Located at Rear of Vehicle).**

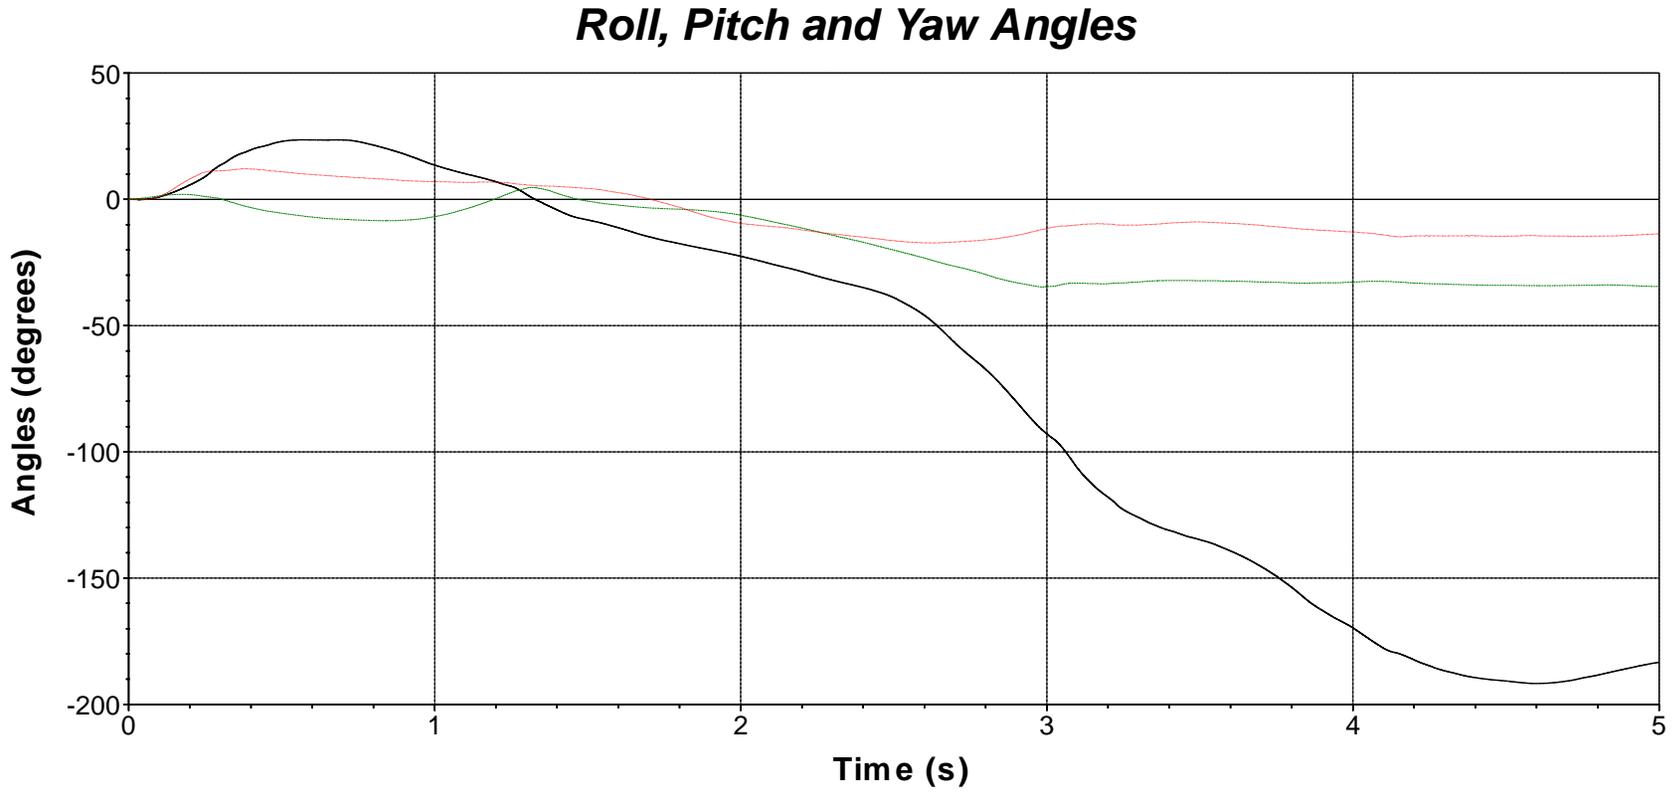
**Figure D.2. Vehicle Angular Displacements for Test No. 469680-02-2.**

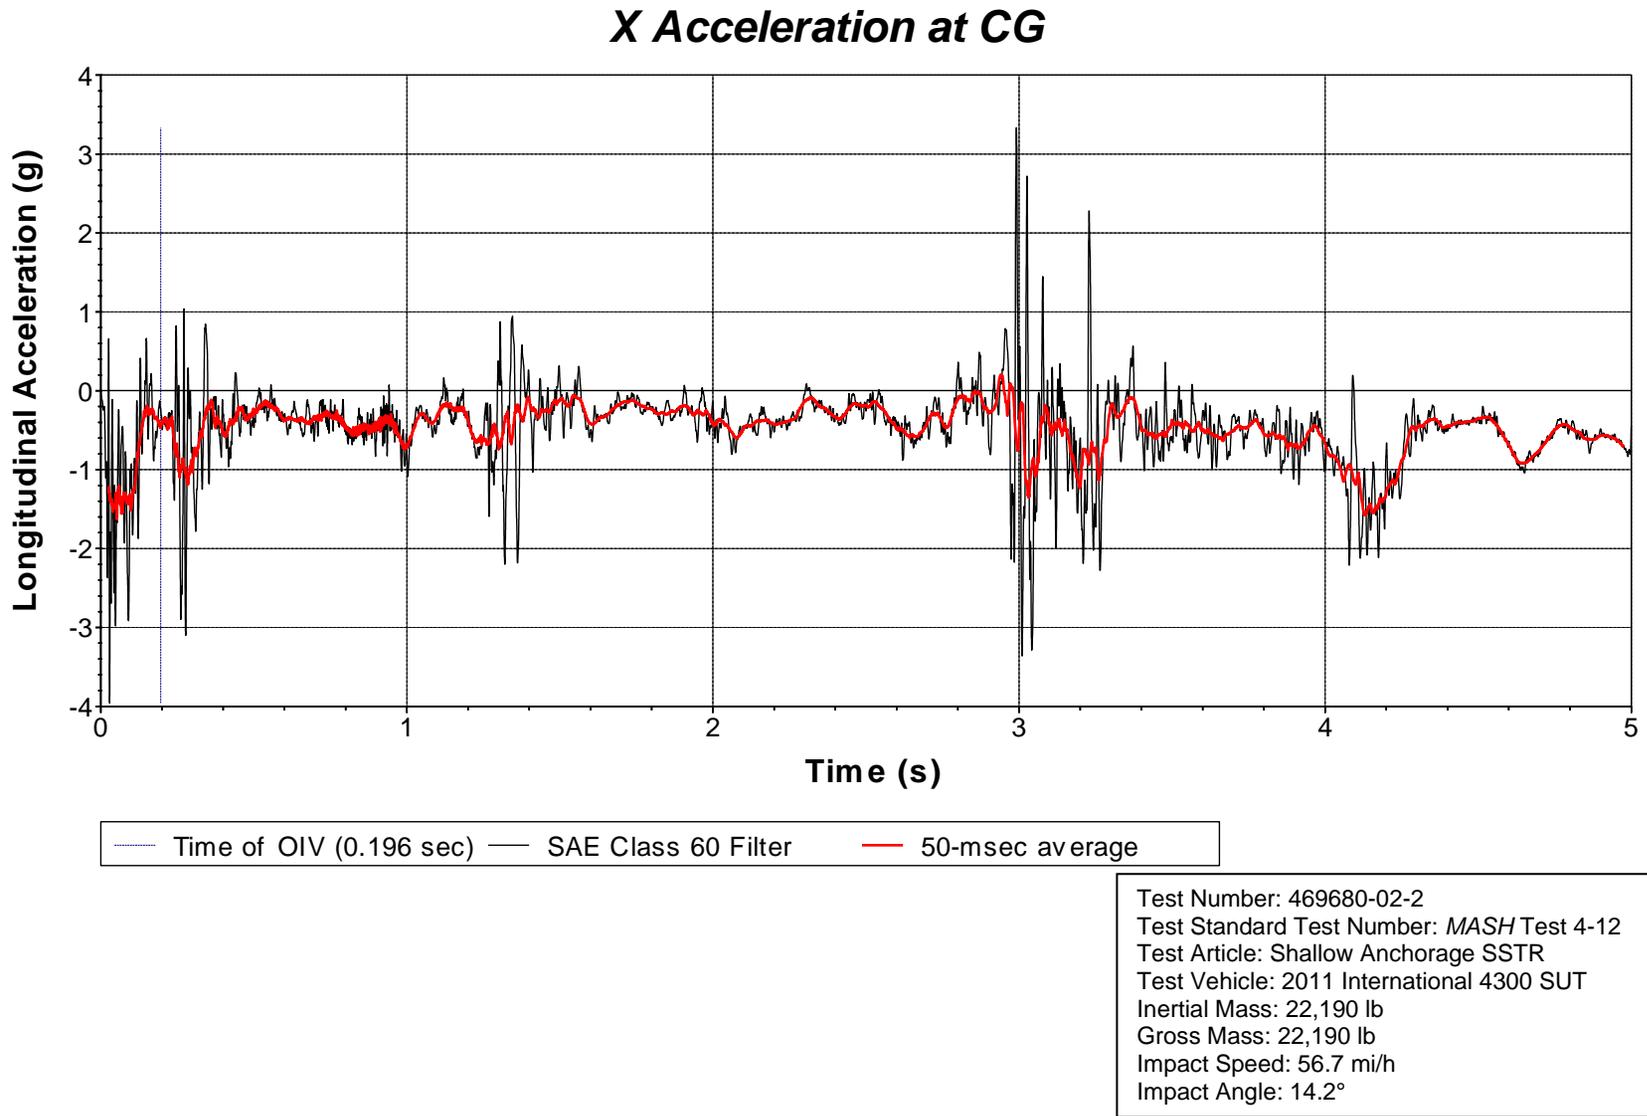
**Figure D.3. Vehicle Longitudinal Accelerometer Trace for Test No. 469680-02-2  
 (Accelerometer Located at Center of Gravity).**

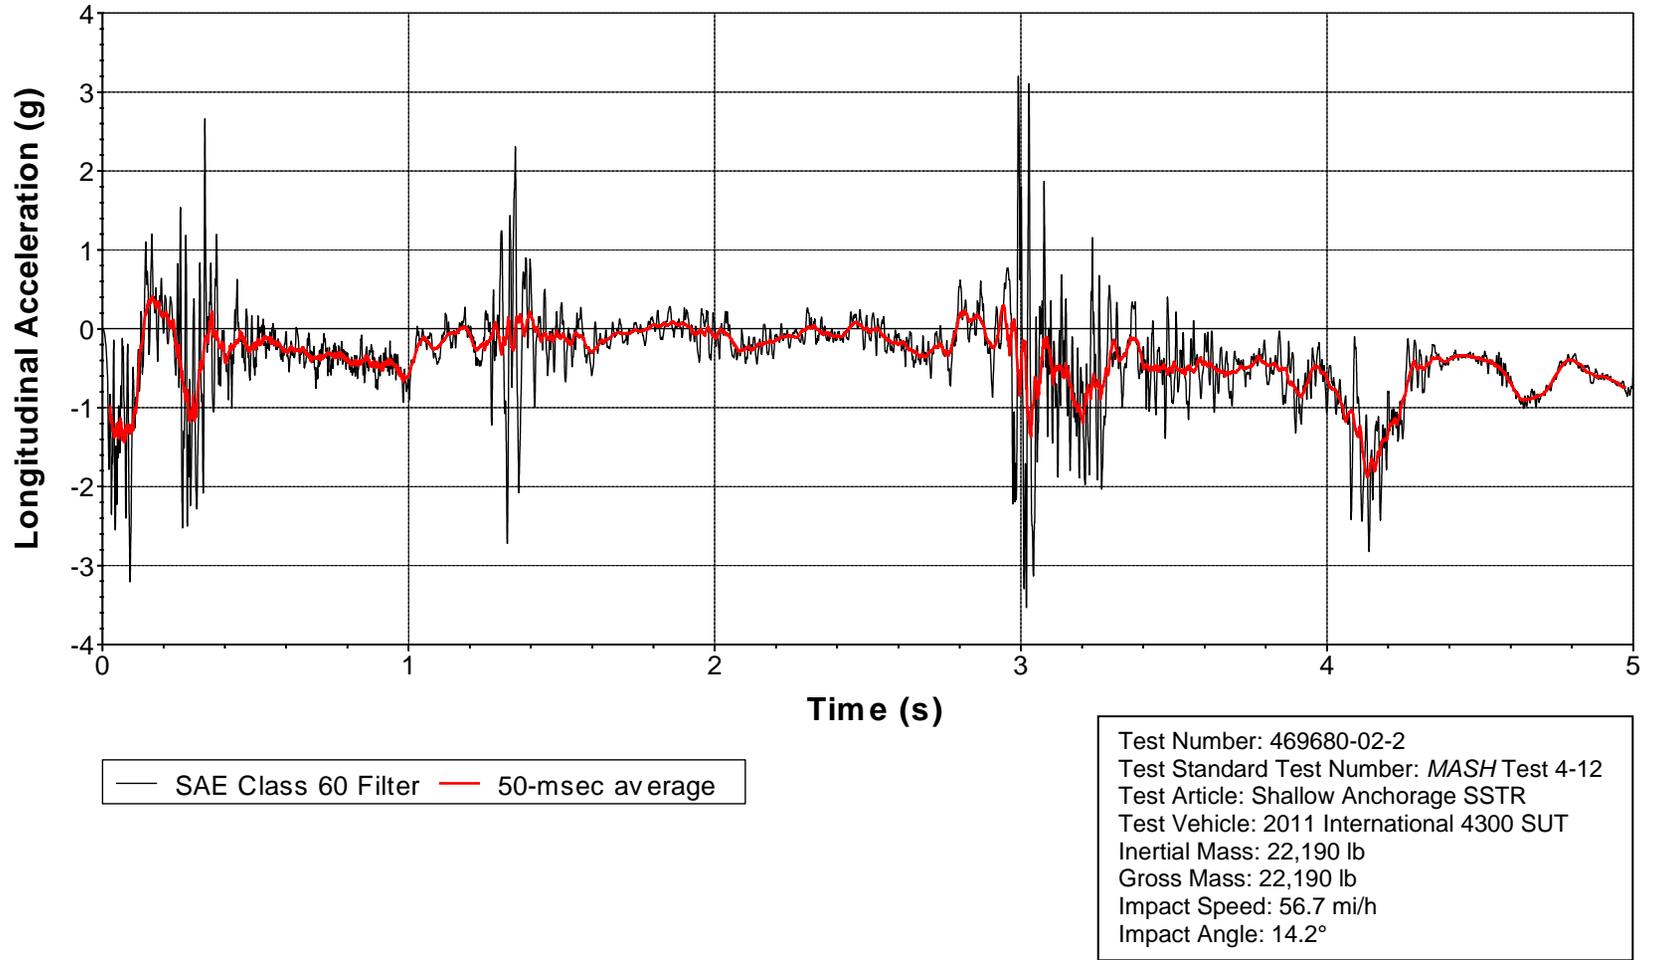
**Figure D.6. Vehicle Longitudinal Accelerometer Trace for Test No. 469680-02-2 (Accelerometer Located at Rear of Vehicle).**

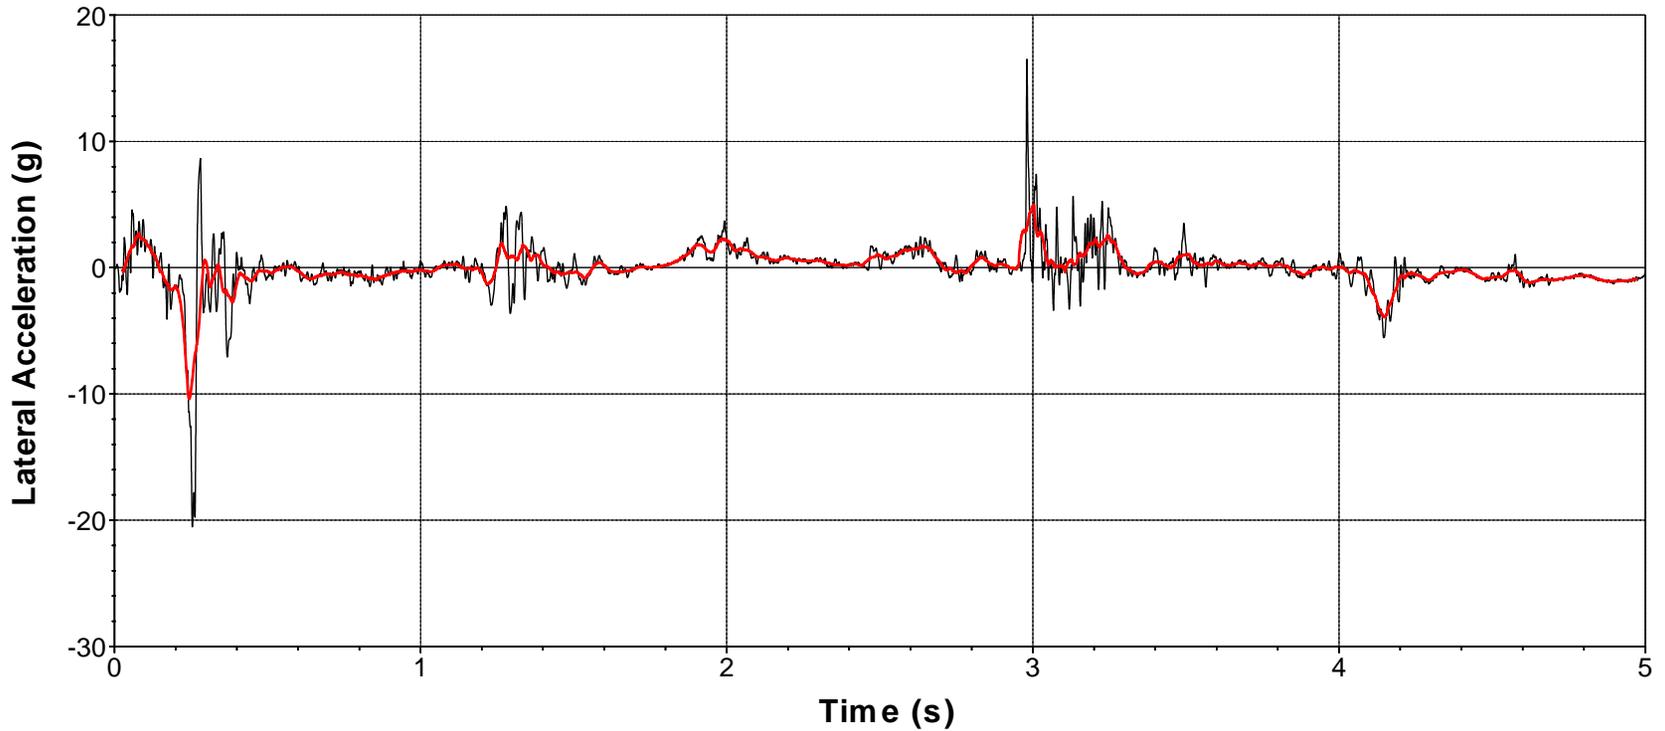
**Figure D.7. Vehicle Lateral Accelerometer Trace for Test No. 469680-02-2  
(Accelerometer Located at Rear of Vehicle).**

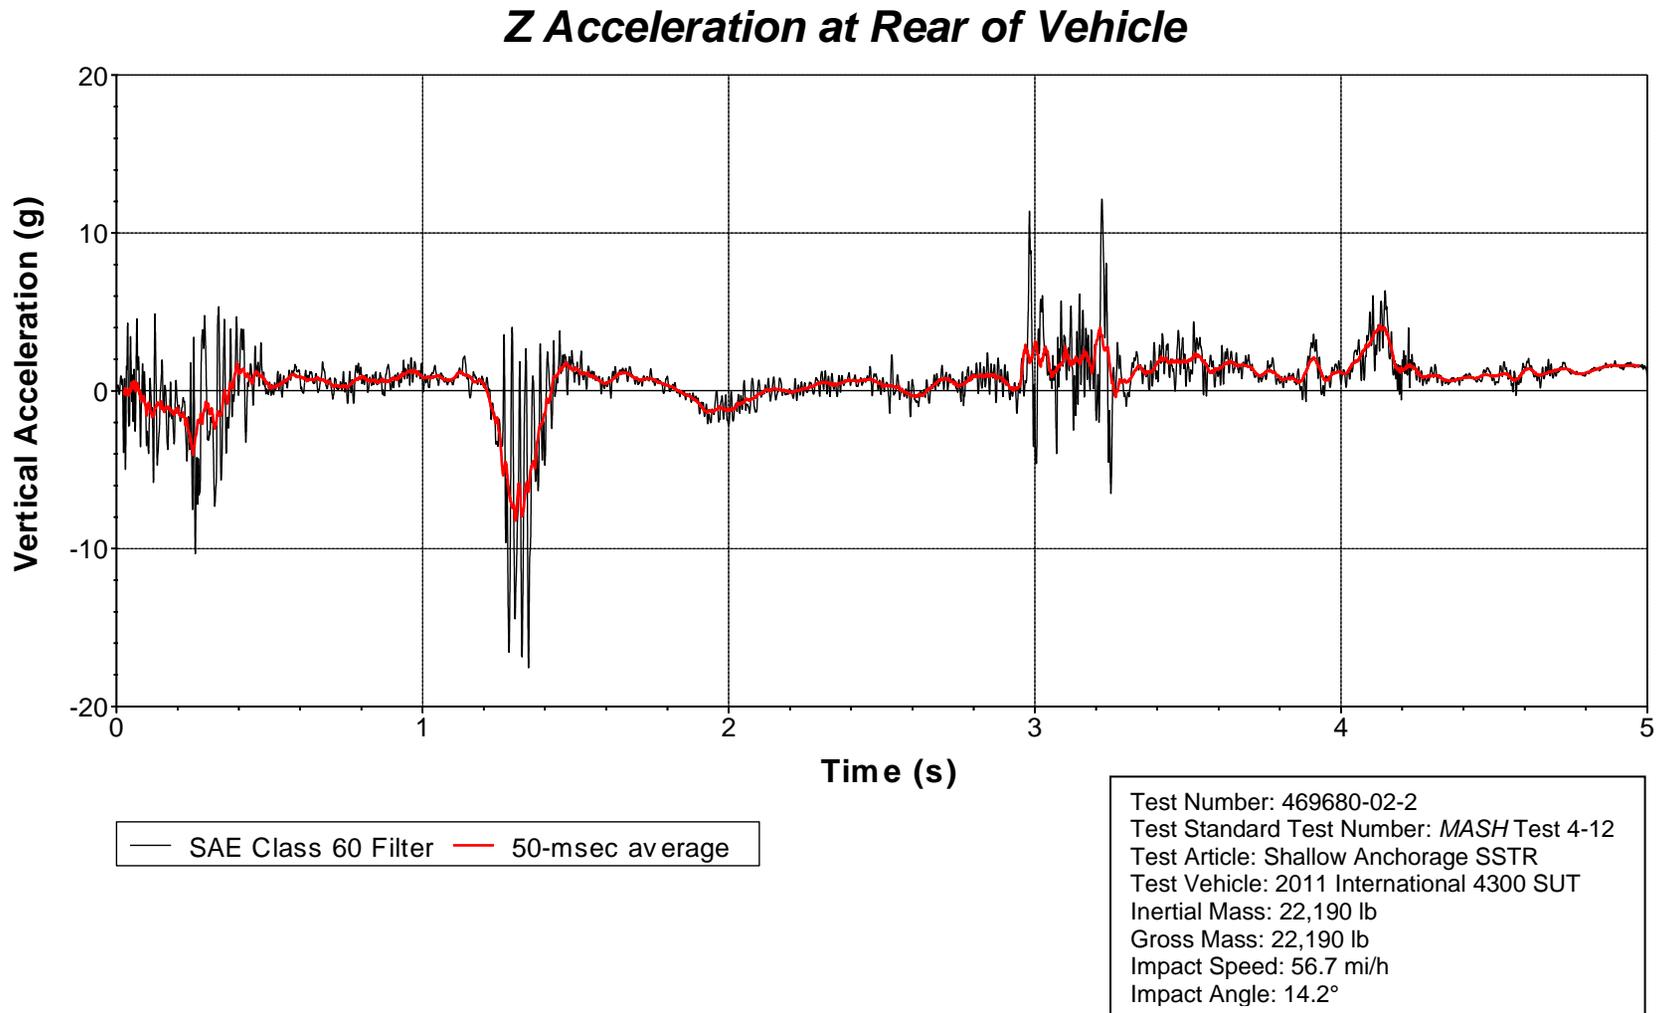
**Figure D.8. Vehicle Vertical Accelerometer Trace for Test No. 469680-02-2  
(Accelerometer Located at Rear of Vehicle).**

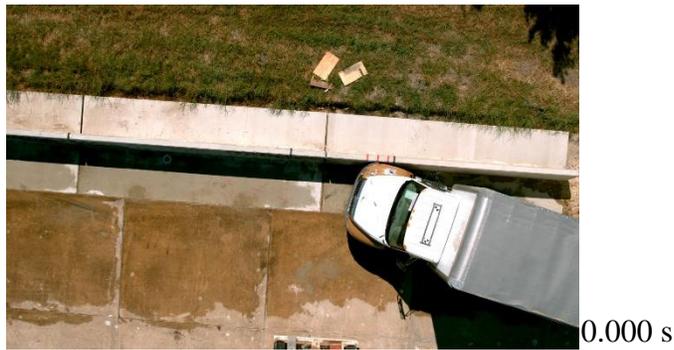
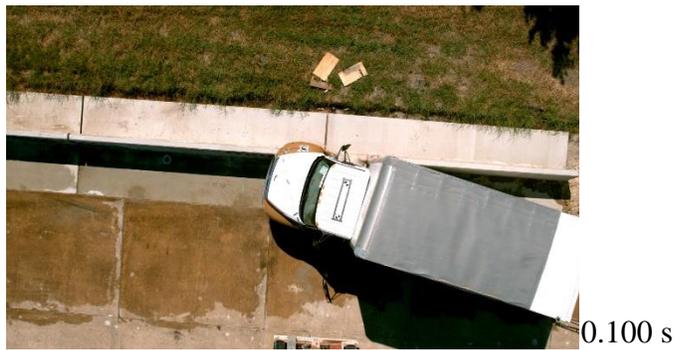
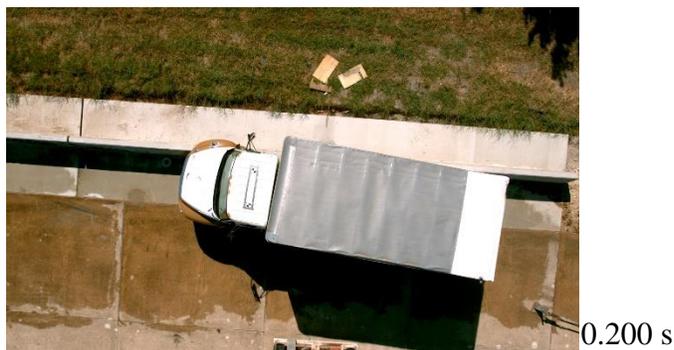
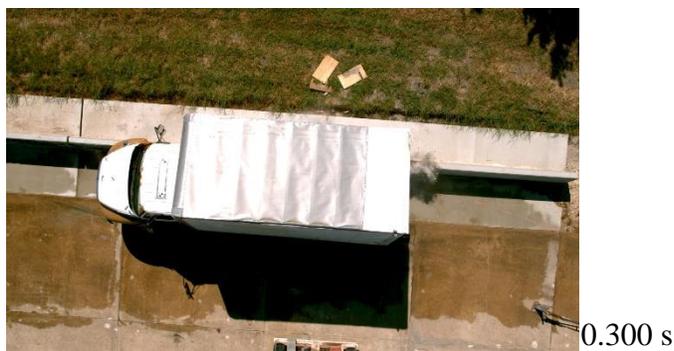
**Figure E.1. Sequential Photographs for Test No. 469680-02-3 (Overhead and Frontal Views).**

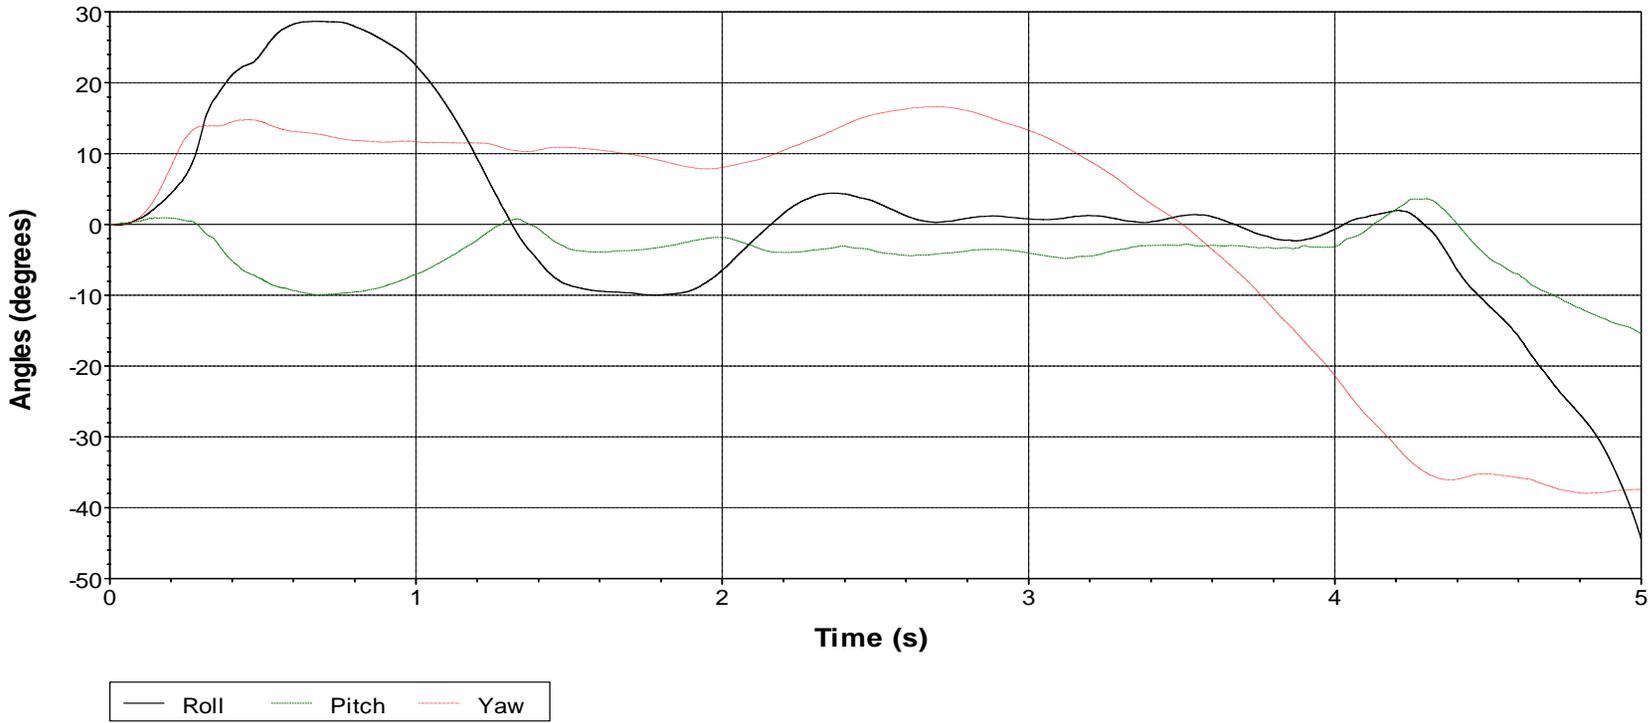
Figure E.3. Vehicle Angular Accelerations for Test No. 479680-02-3.

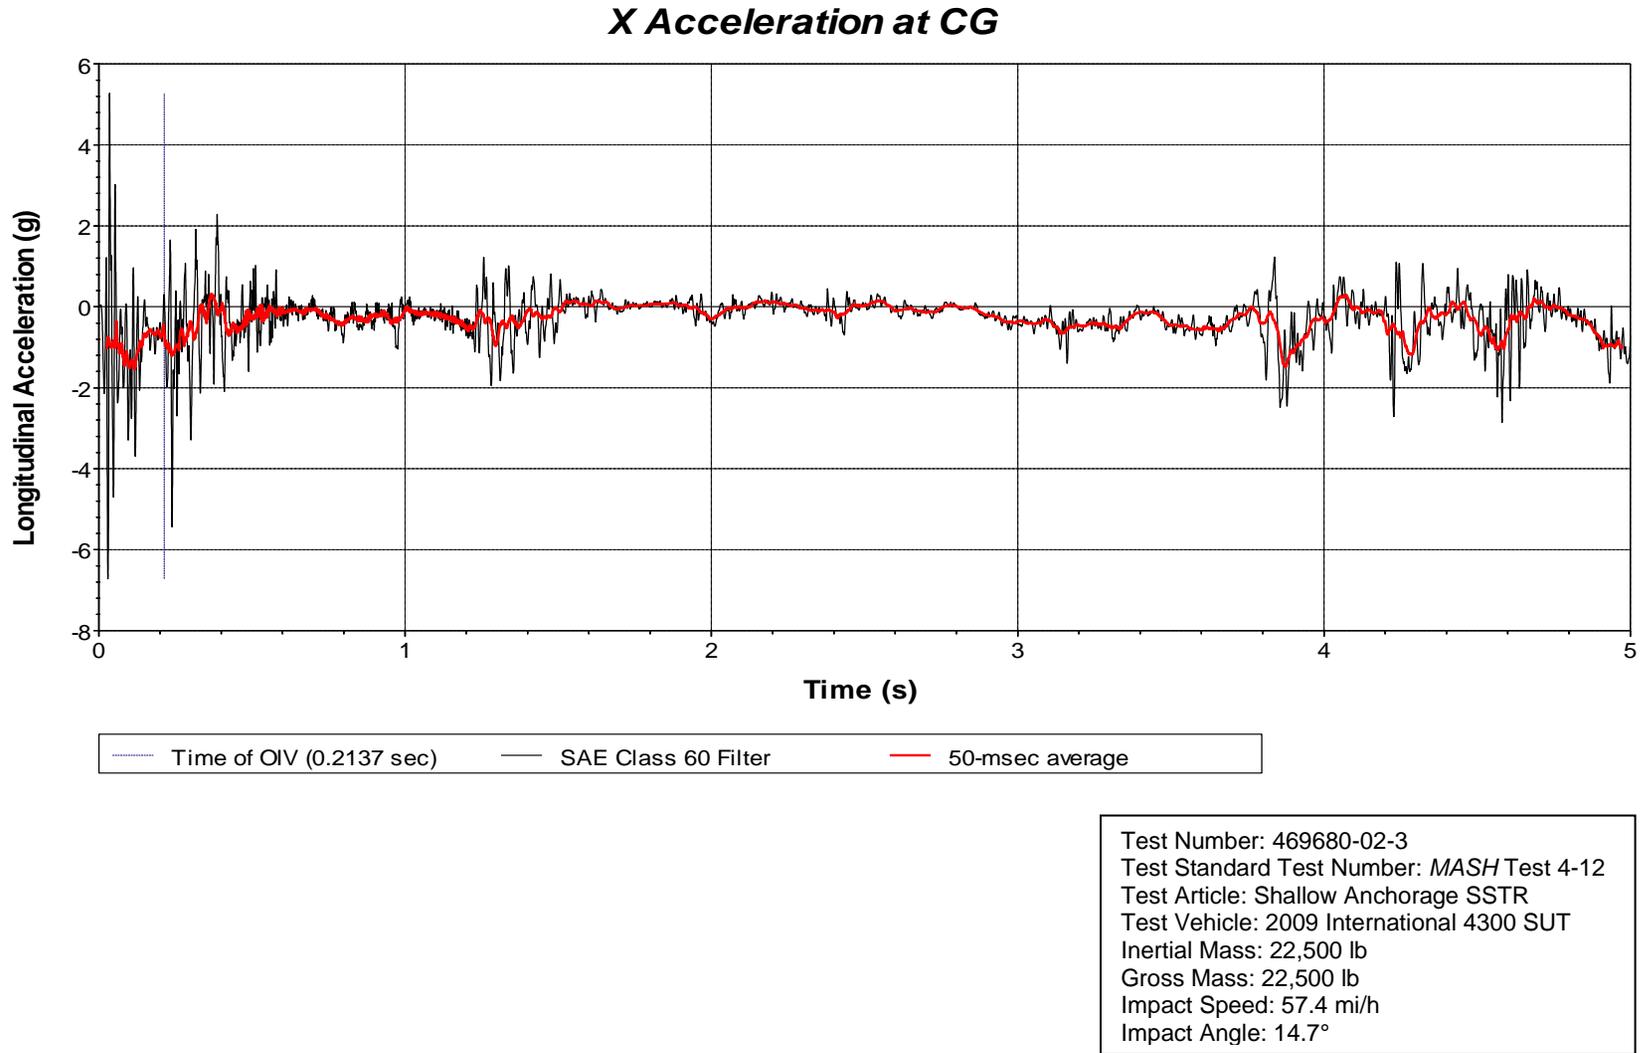
**Figure E.4. Vehicle Longitudinal Accelerometer Trace for Test No. 469680-02-3  
(Accelerometer Located at Center of Gravity).**

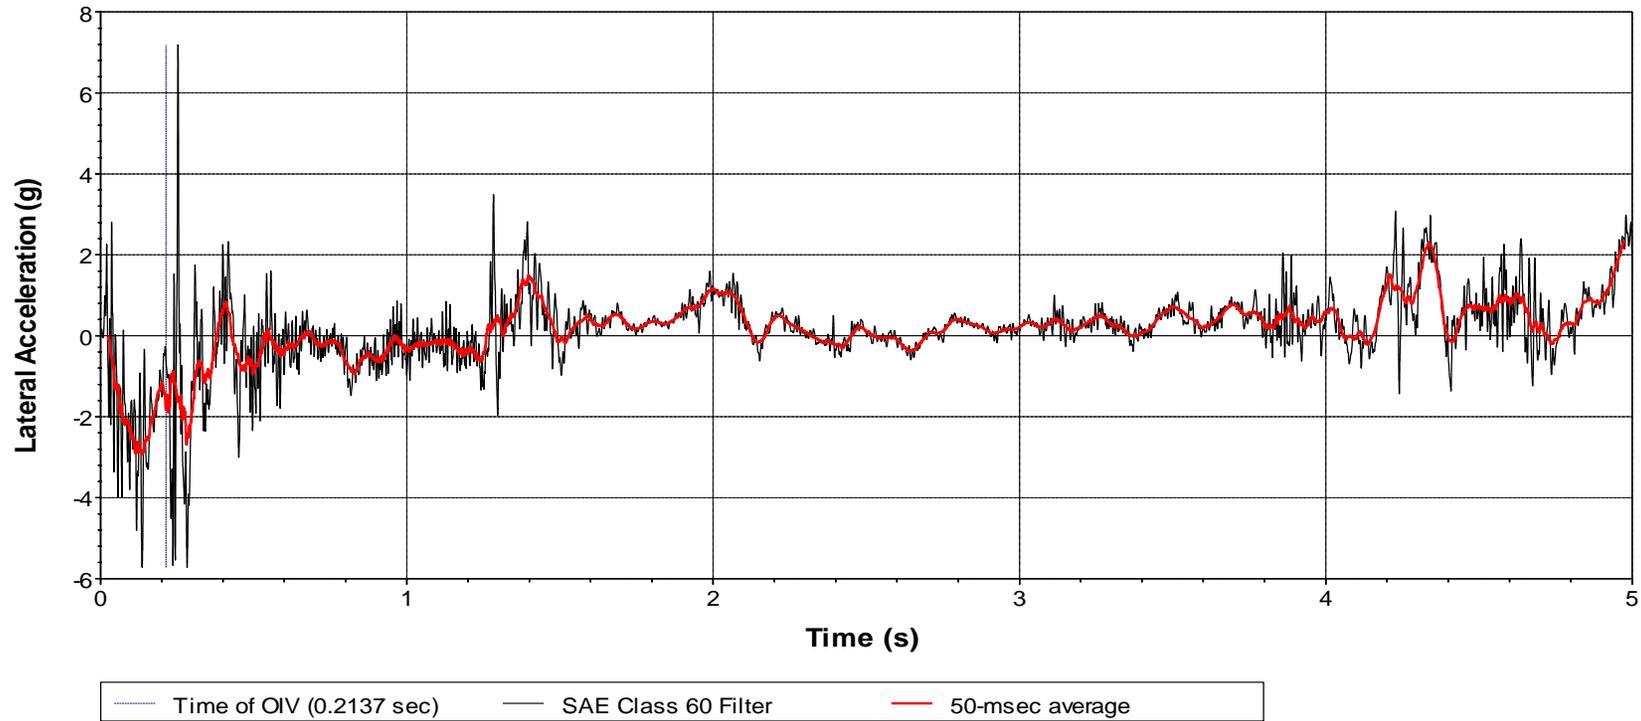
**Figure E.5. Vehicle Lateral Accelerometer Trace for Test No. 469680-02-3  
(Accelerometer Located at Center of Gravity).**

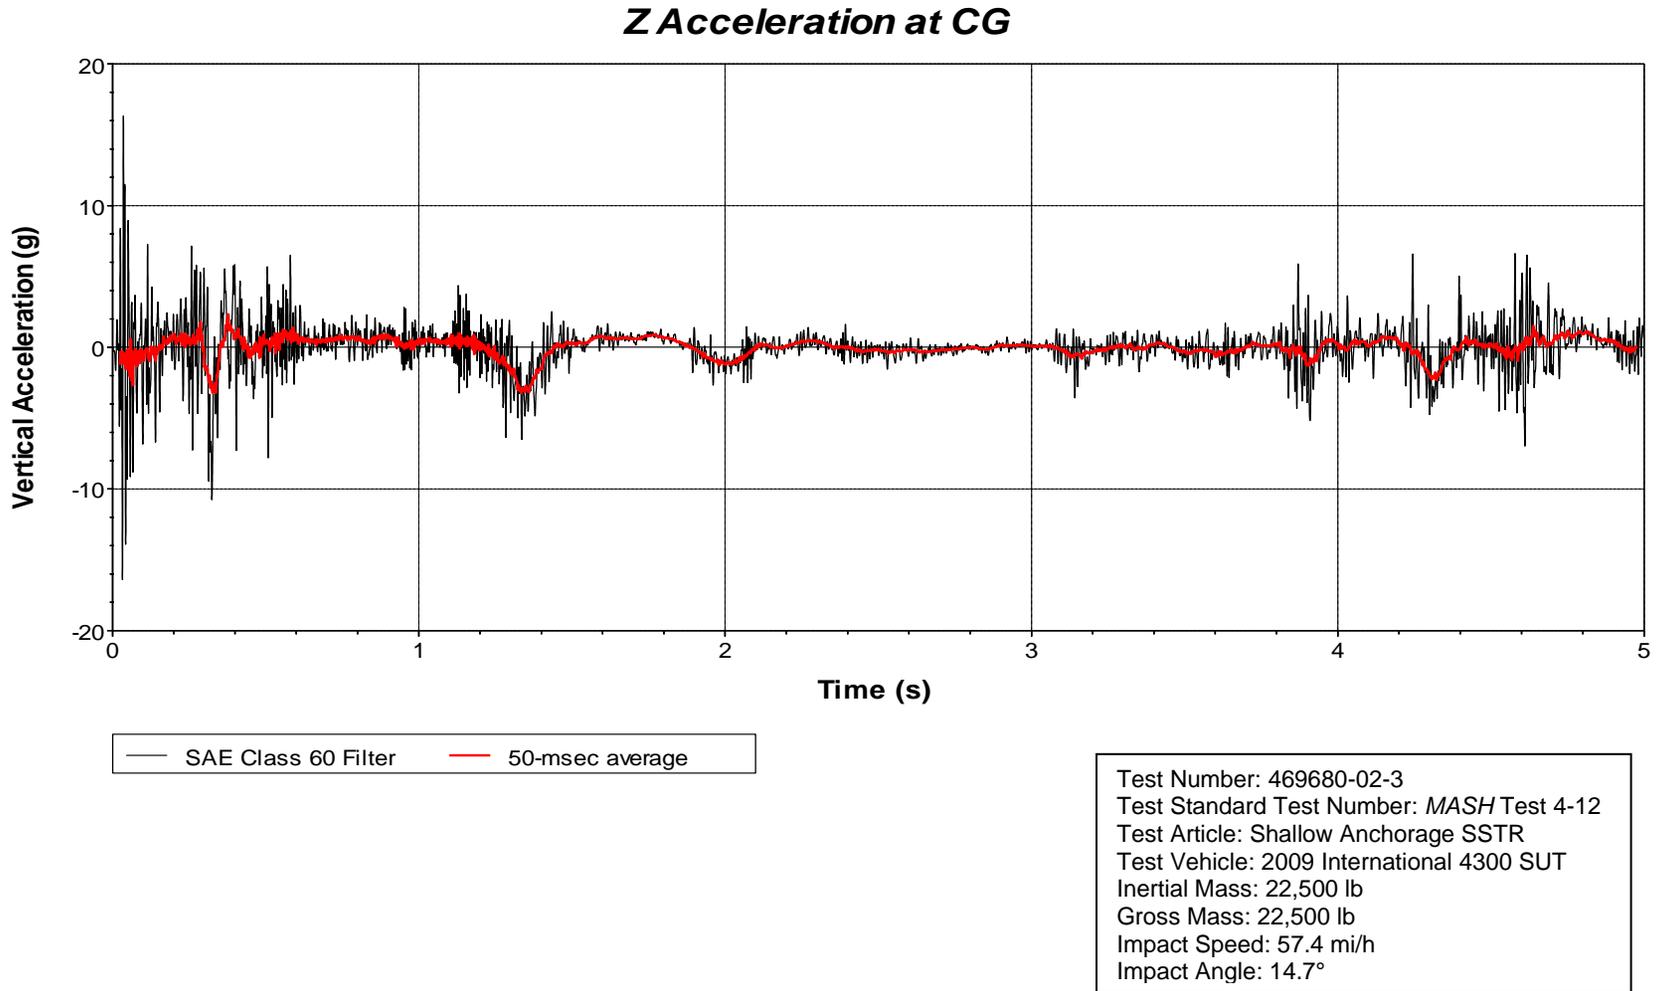
**Figure E.6. Vehicle Vertical Accelerometer Trace for Test No. 469680-02-3  
(Accelerometer Located at Center of Gravity).**

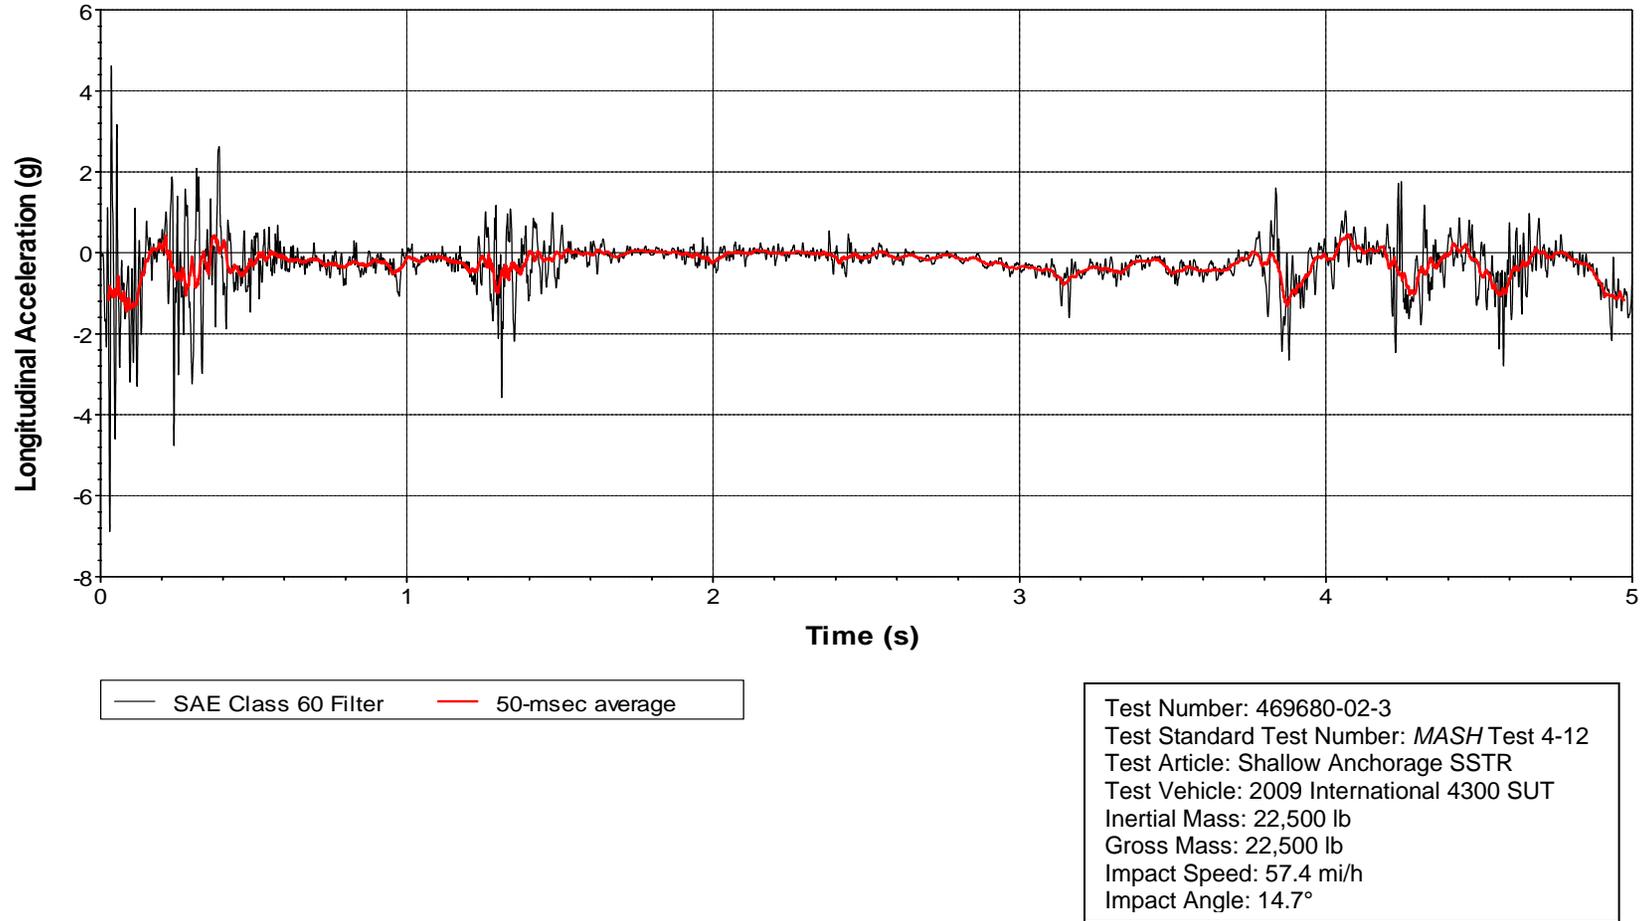
**Figure E.7. Vehicle Longitudinal Accelerometer Trace for Test No. 469680-02-3  
 (Accelerometer Located at Rear of Vehicle).**
