## **MASH TEST 4-12 OF SHALLOW ANCHORAGE SINGLE SLOPE TRAFFIC RAIL (SSTR)**

### **Test Report 0-6968-R10**

**TEXAS A&M TRANSPORTATION INSTITUTE  
COLLEGE STATION, TEXAS**

**TEXAS DEPARTMENT OF TRANSPORTATION**

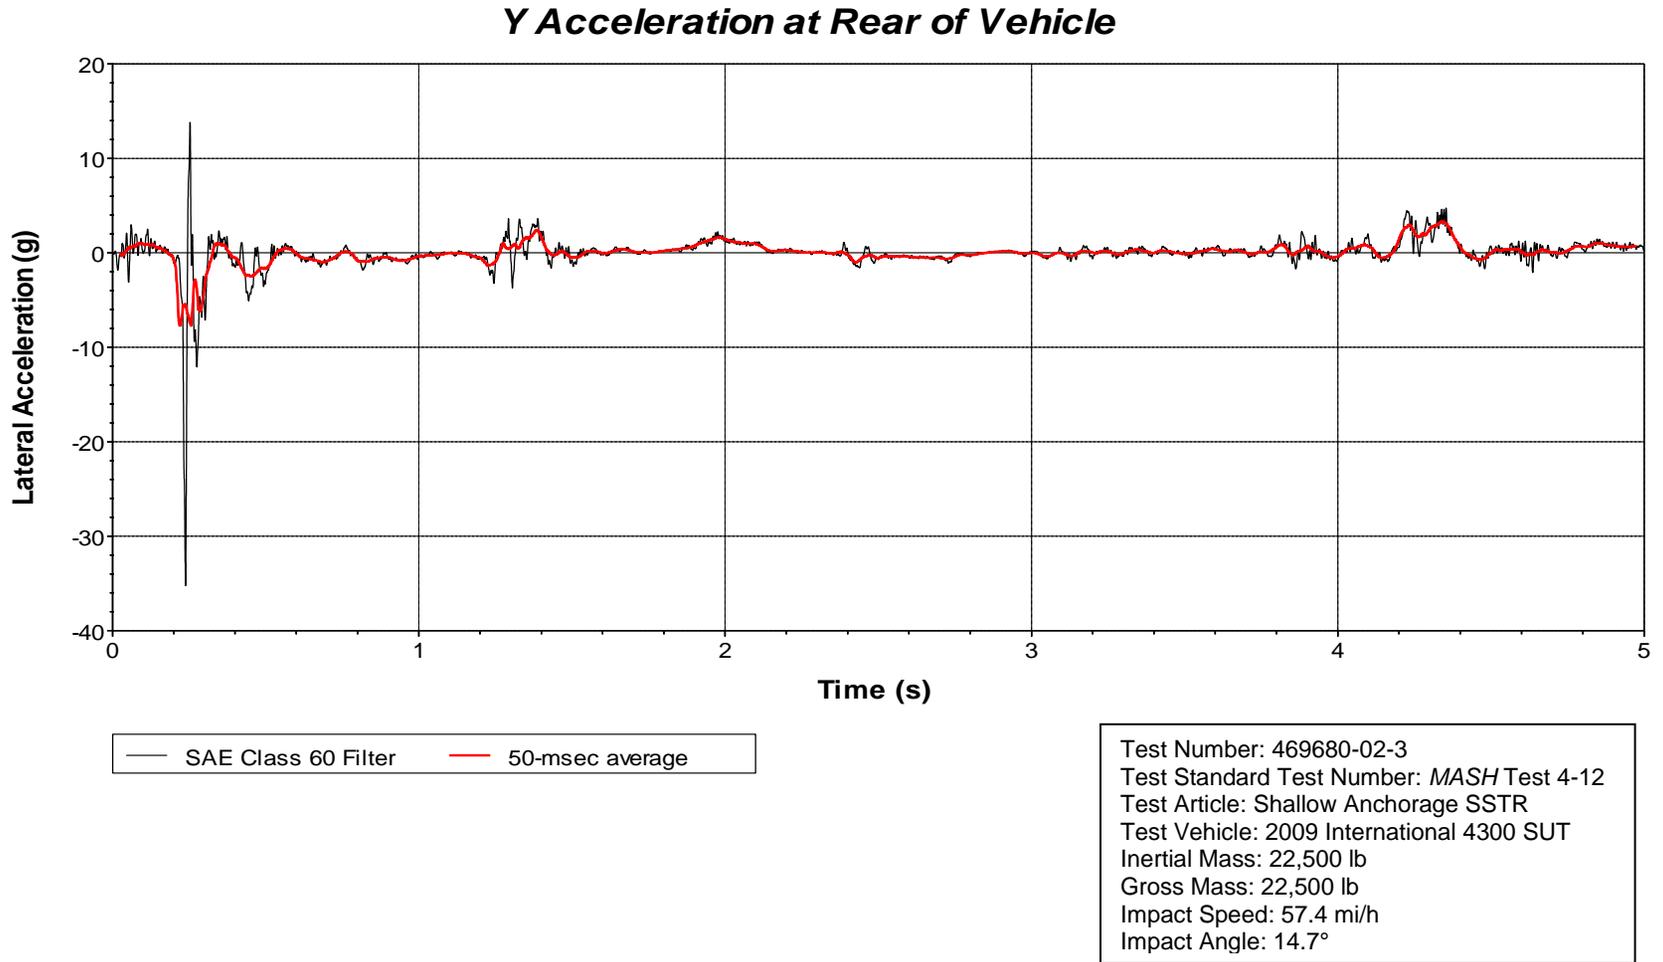
**Figure E.8. Vehicle Lateral Accelerometer Trace for Test No. 469680-02-3  
 (Accelerometer Located at Rear of Vehicle).**

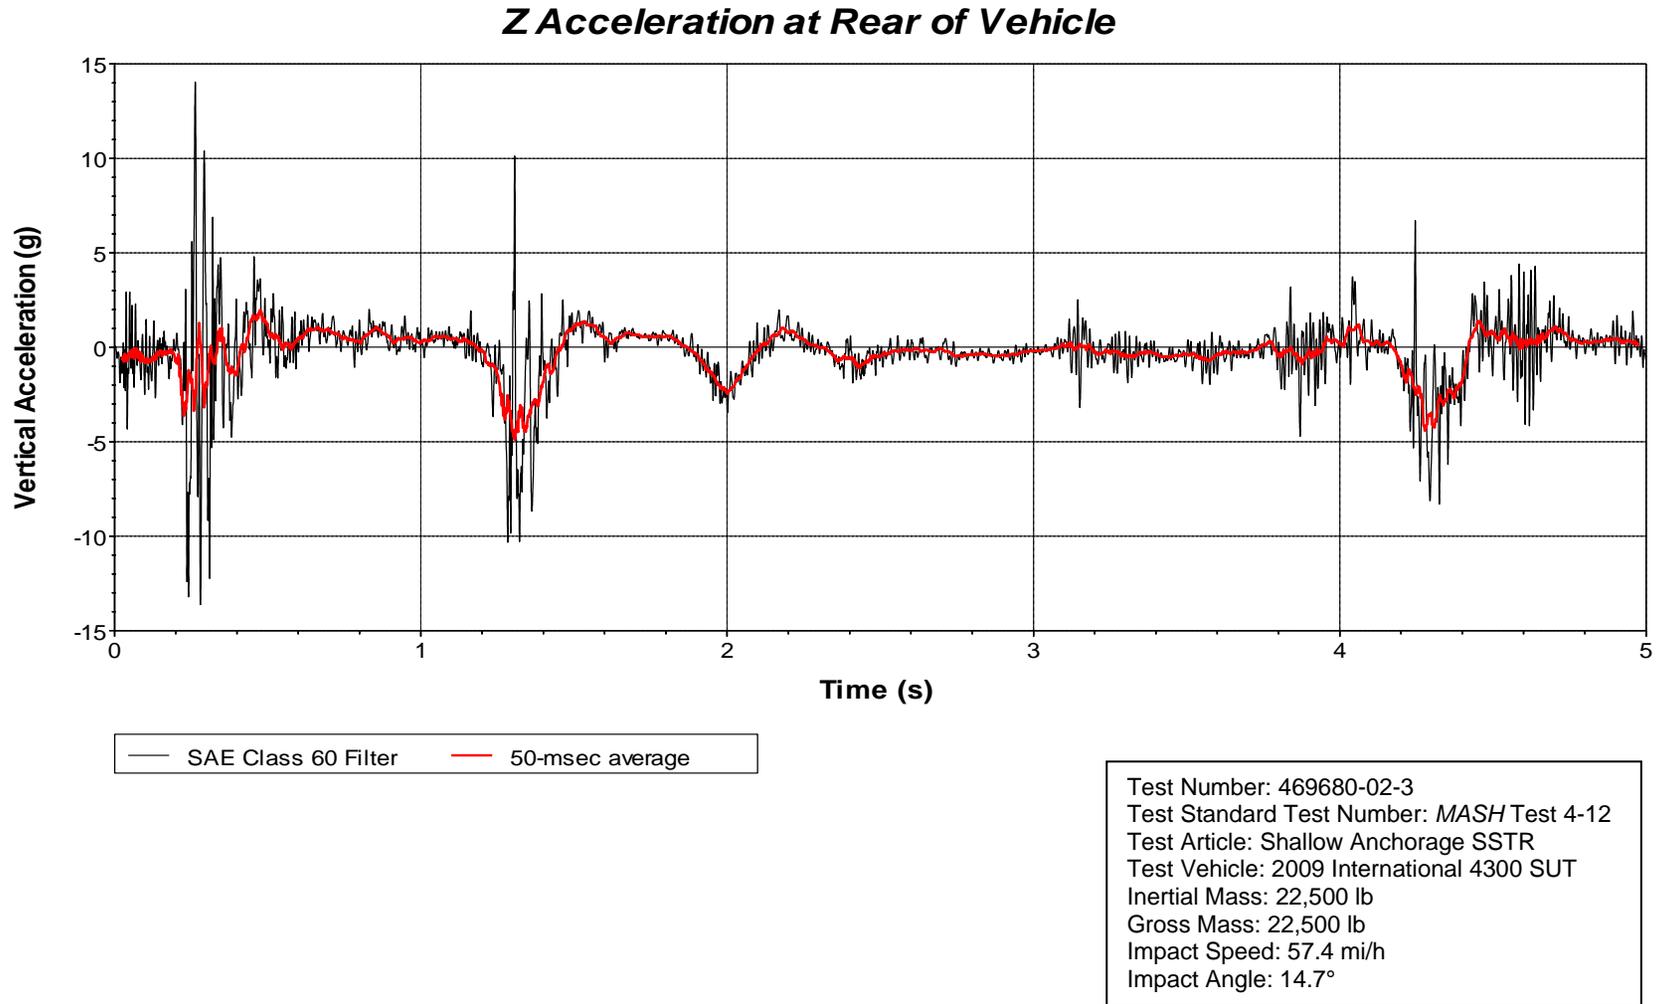
**Figure E.9. Vehicle Vertical Accelerometer Trace for Test No. 469680-02-3  
(Accelerometer Located at Rear of Vehicle).**
