**EVALUATION OF ALLOWABLE TAPER RATES OF FREESTANDING
SINGLE-SLOPE CONCRETE BARRIERS**

TEXAS A&M TRANSPORTATION INSTITUTE PROVING GROUND

1. Report No. FHWA/TX-23/0-7086-R2		2. Government Accession No.		3. Recipient's Catalog No.	
4. Title and Subtitle EVALUATION OF ALLOWABLE TAPER RATES OF FREESTANDING SINGLE-SLOPE CONCRETE BARRIERS				5. Report Date Published: August 2023

6. Performing Organization Code	
7. Author(s) Roger P. Bligh, Sofokli Cakalli, Nauman M. Sheikh, William J. L. Schroeder, and Darrell L. Kuhn				8. Performing Organization Report No. Report 440862-03 3-4

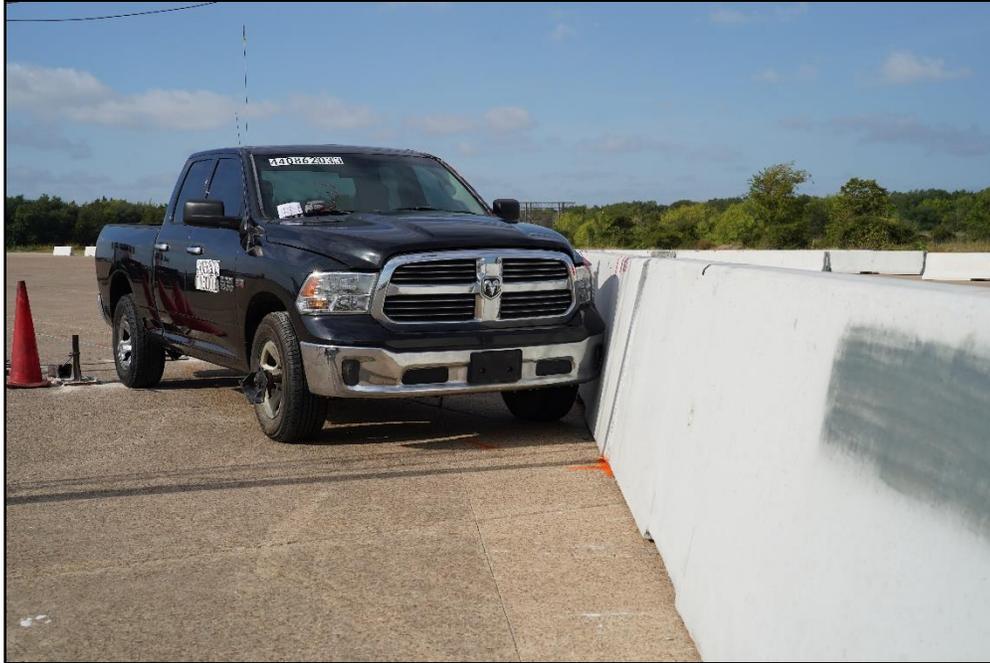
Figure 6.1. Flared Single-Slope Portable Concrete Barriers/Test Vehicle Geometrics for Test 440862-03-3.

See Table 6.1 for details on the *MASH* impact conditions and Table 6.2 for the exit parameters of Test 440862-03-3. Figure 6.1 and Figure 6.2 depict the target impact setup.

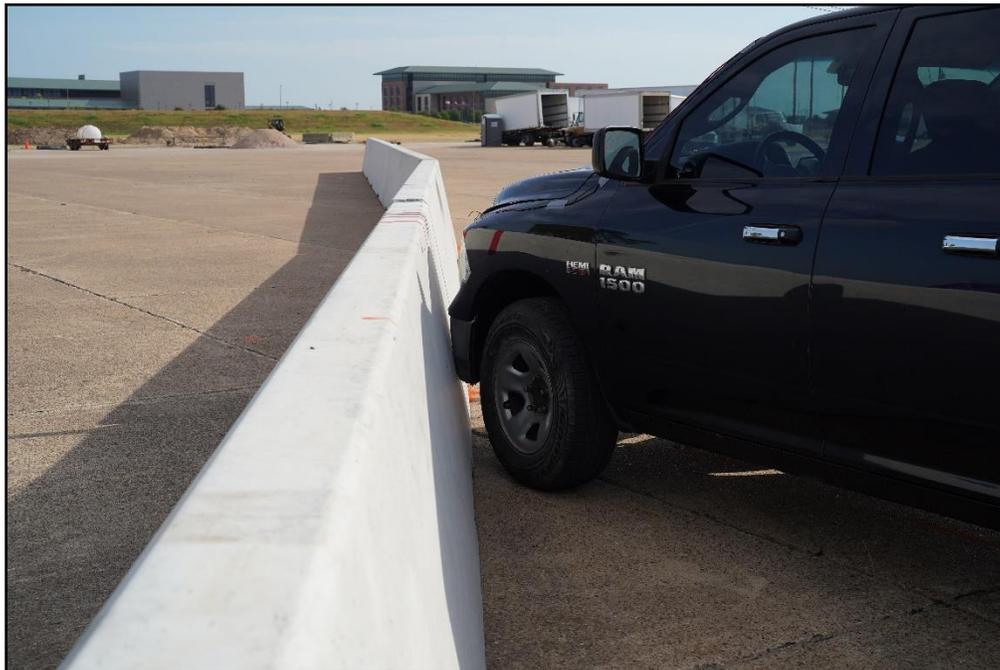
Figure 6.2. Flared Single-Slope Portable Concrete Barriers/Test Vehicle Impact Location for Test 440862-03-3.

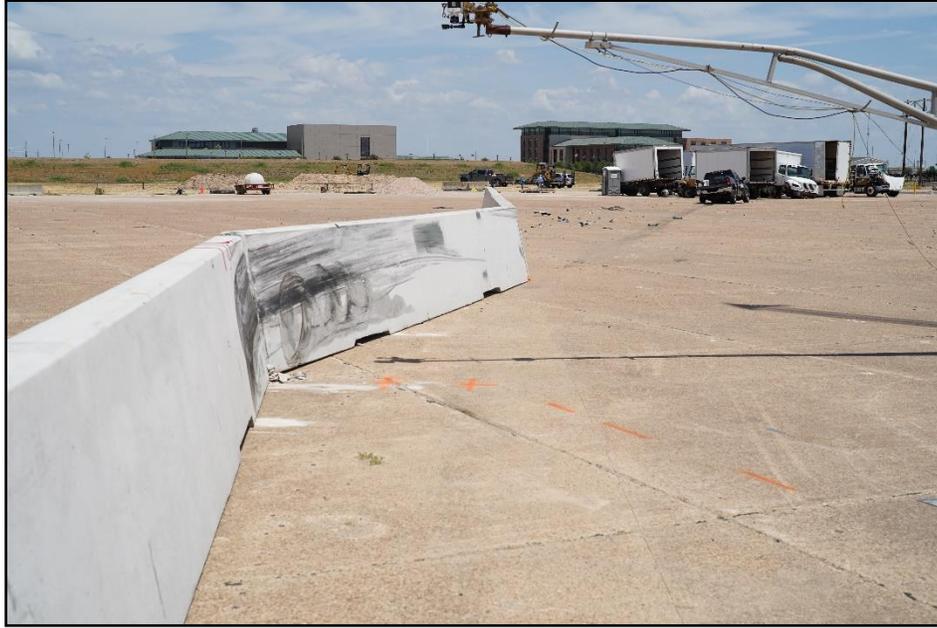
Figure 6.5. Flared Single-Slope Portable Concrete Barriers after Test 440862-03-3.

There was concrete scuffing and spalling at impact. There was concrete spalling at the joint between barriers 2 and 3, with exposed rebar on barrier 2. There were cracks in barriers 2 and 3. The concrete was also spalled on the field side at the joint between barriers 3 and 4.

Table 6.6 and Table 6.7 describe the damage to the flared single-slope PCBs. Figure 6.5 and Figure 6.6 show the damage to the flared single-slope PCBs.

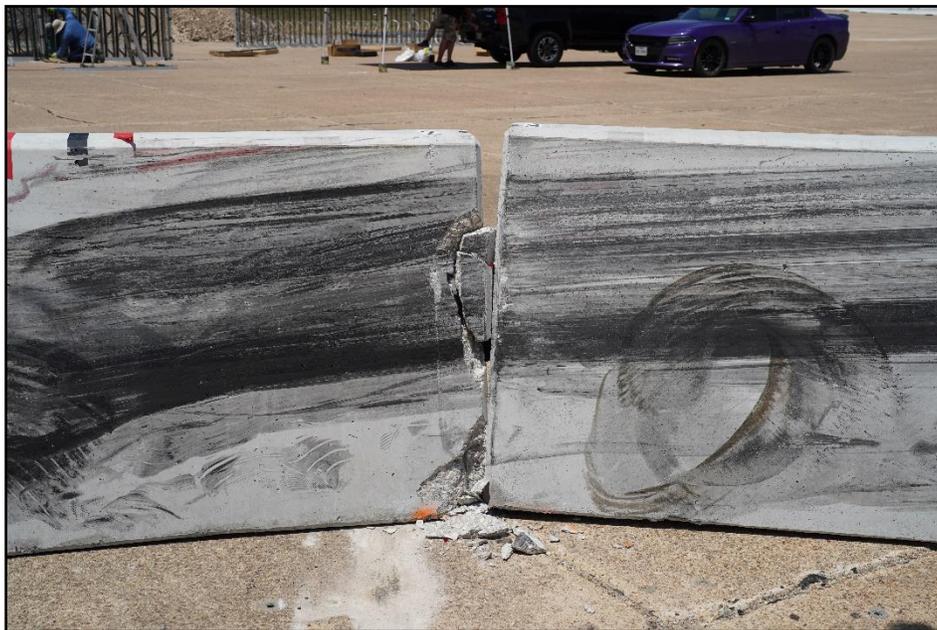
Figure 6.6. Flared Single-Slope Portable Concrete Barriers after Test at Impact Location, Test 440862-03-3.

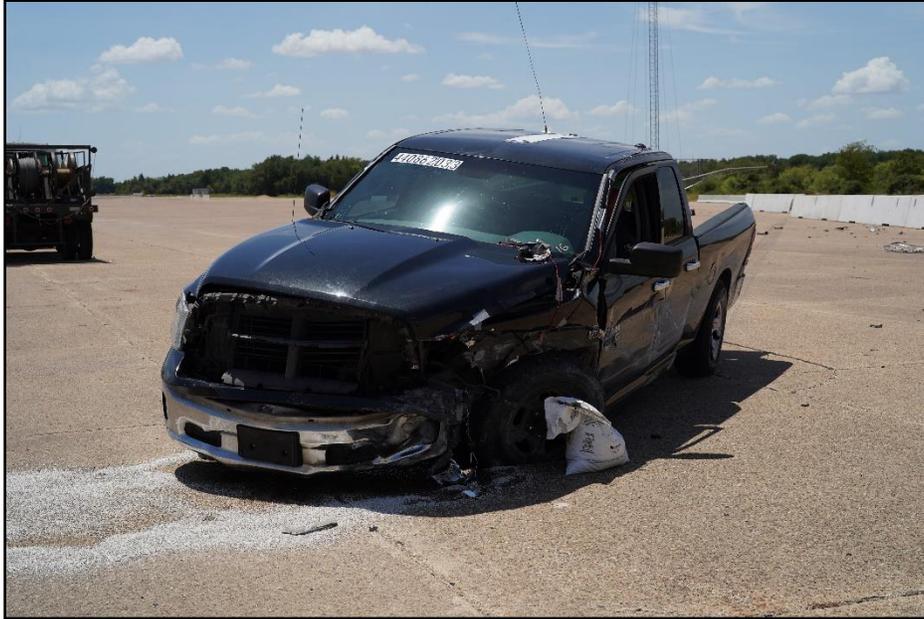
Figure 6.7. Impact Side of Test Vehicle after Test 440862-03-3.

Figure 6.7 and Figure 6.8 show the damage sustained by the vehicle. Figure 6.9 and Figure 6.10 show the interior of the test vehicle. Table 6.8 and Table 6.9 provide details on the occupant compartment deformation and exterior vehicle damage. Figures B.2 and B.3 in Appendix B.1 provide exterior crush and occupant compartment measurements.

Side Windows	The left side window shattered due to deformation of the door.
Maximum Exterior Deformation	9 inches in the front plane at the left front corner at bumper height.
VDS	11LFQ4
CDC	11FLEW5
Fuel Tank Damage	None
Description of Damage to Vehicle:	The front bumper, hood, grill, left headlight, left front quarter fender, left front tire and rim, windshield, left front door and glass, floor pan, left rear door, left rear cab corner, left rear quarter fender, left rear rim, left taillight, and rear bumper were damaged. The windshield had some cracking (caused by flexing of the body), and the left front door had a 2.5-inch gap at the top of the door.

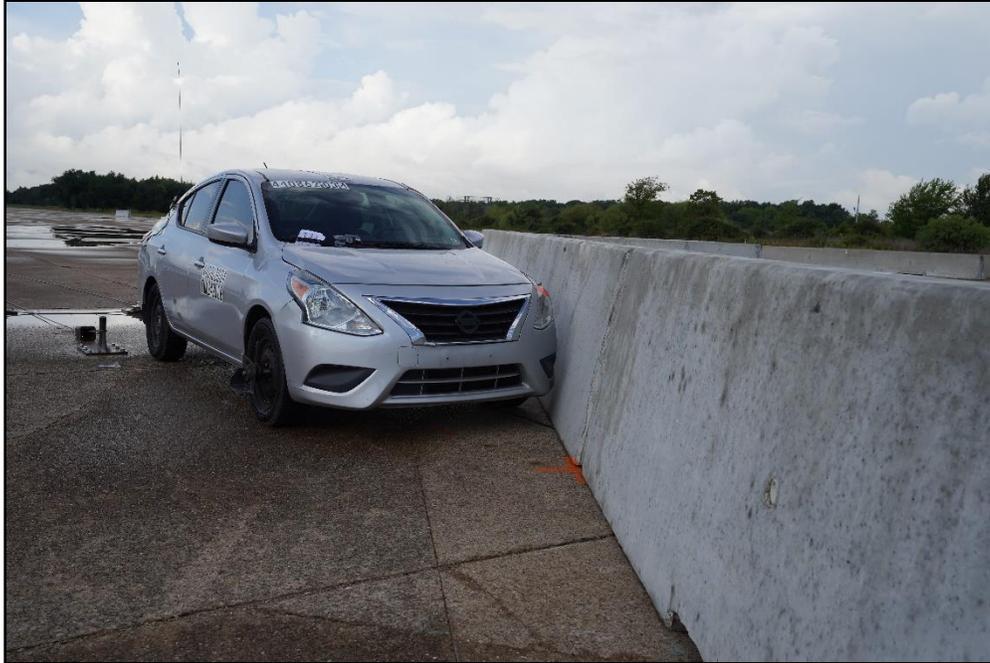
Figure 7.1. Flared Single-Slope Portable Concrete Barriers/Test Vehicle Geometrics for Test 440862-03-4.

See Table 7.1 for details on the *MASH* impact conditions and Table 7.2 for the exit parameters for Test 440862-03-4. Figure 7.1 and Figure 7.2 depict the target impact setup.

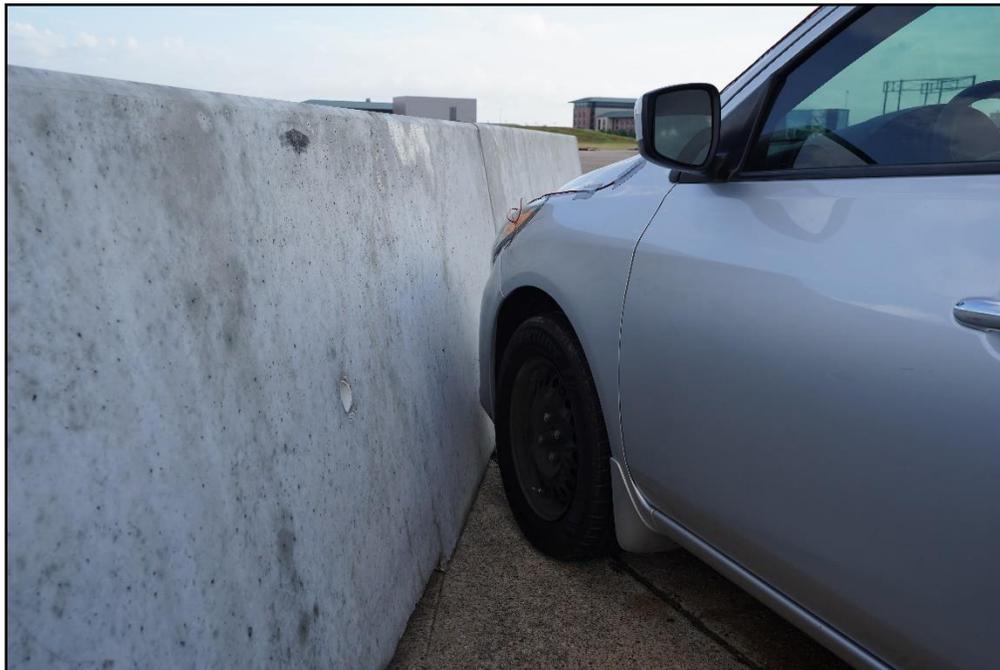
Figure 7.2. Flared Single-Slope Portable Concrete Barriers/Test Vehicle Impact Location for Test 440862-03-4.

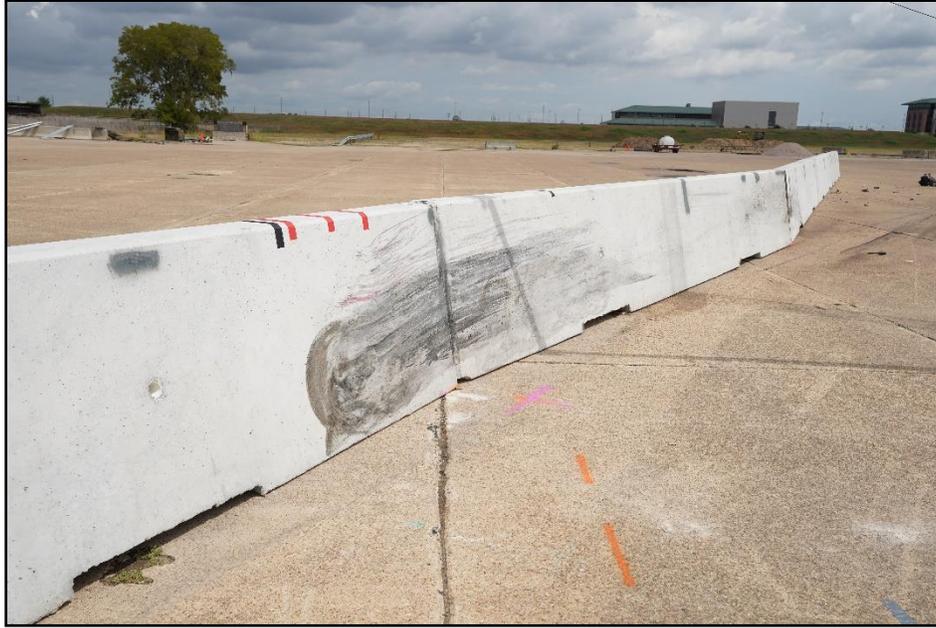
Figure 7.5. Flared Single-Slope Portable Concrete Barriers after Test at Impact Location, Test 440862-03-4.

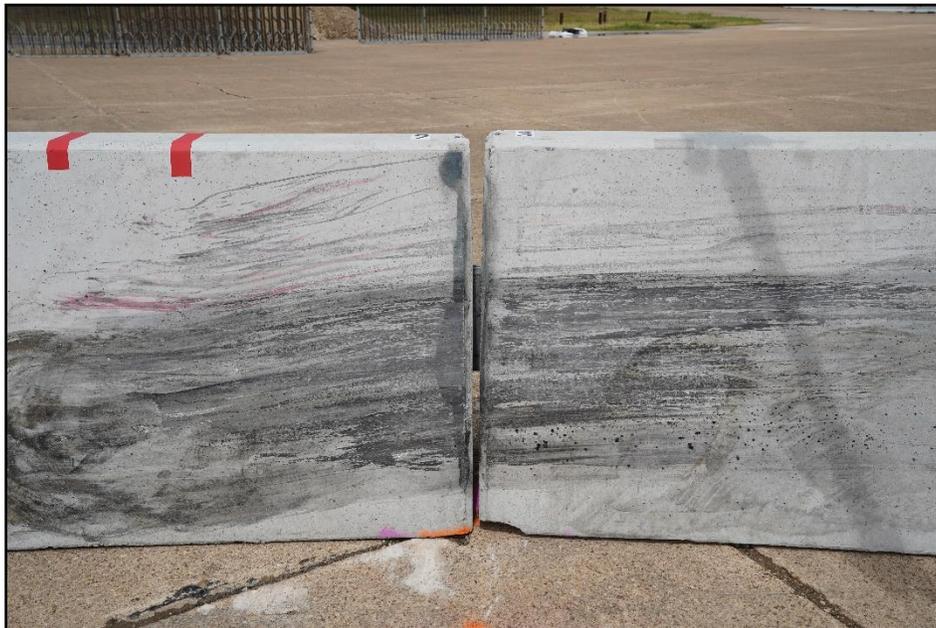
Figure 7.6. Flared Single-Slope Portable Concrete Barriers after Test at the Joint of Barriers 2 and 3, Test 440862-03-4.

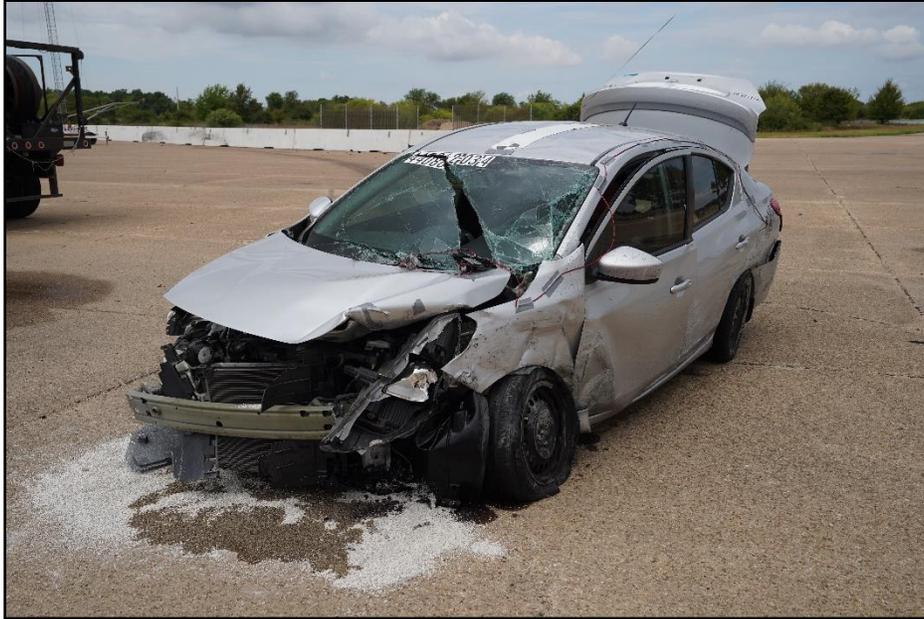
Figure 7.7. Impact Side of Test Vehicle after Test 440862-03-4.

Figure 7.7 and Figure 7.8 show the damage sustained by the vehicle. Figure 7.9 and Figure 7.10 show the interior of the test vehicle. Table 7.8 and Table 7.9 provide details on the occupant compartment deformation and exterior vehicle damage. Figures C.2 and C.3 in Appendix C.1 provide exterior crush and occupant compartment measurements.
