ENGINEERING ASPECTS  
OF  
RAIL-HIGHWAY GRADE CROSSING SAFETY EVALUATION

RESEARCH REPORT NUMBER 111-3(F)  
RAIL-HIGHWAY GRADE CROSSING SAFETY EVALUATION  
RESEARCH STUDY NUMBER 2-8-67-111

Texas Transportation Institute  
Texas A&M University  
College Station, Texas

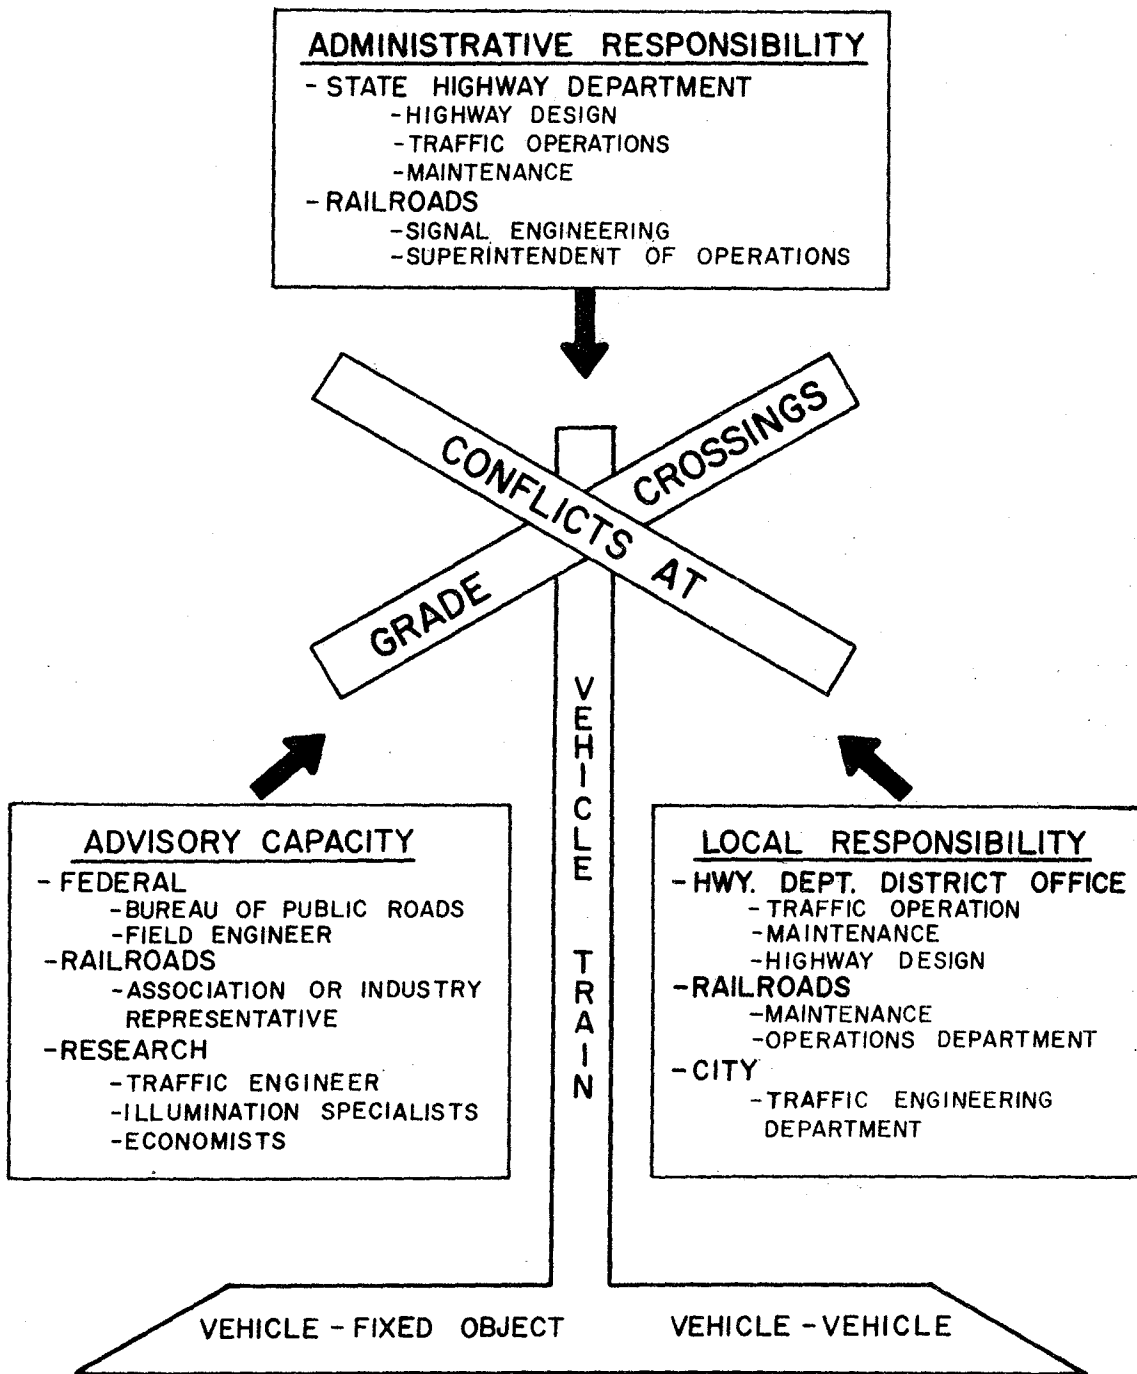
FIGURE 1

# DIAGNOSTIC TEAM STRUCTURE

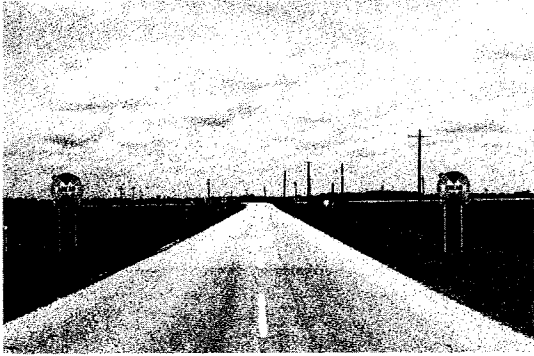
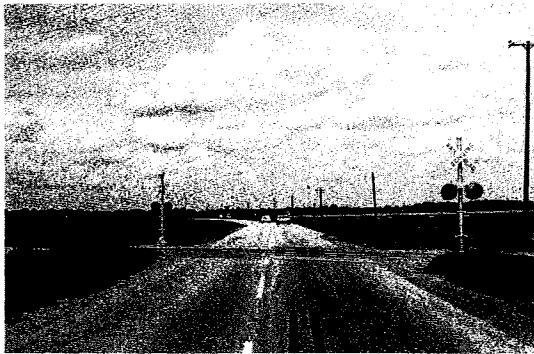
STUDY SITE 9A  
FIGURE 6

INITIAL VIEW OF ADVANCE WARNING SIGNS

SECOND VIEW OF ADVANCE WARNING SIGNS

VIEW OF CROSSING

CLOSE-UP OF SECOND ADVANCE WARNING SIGN

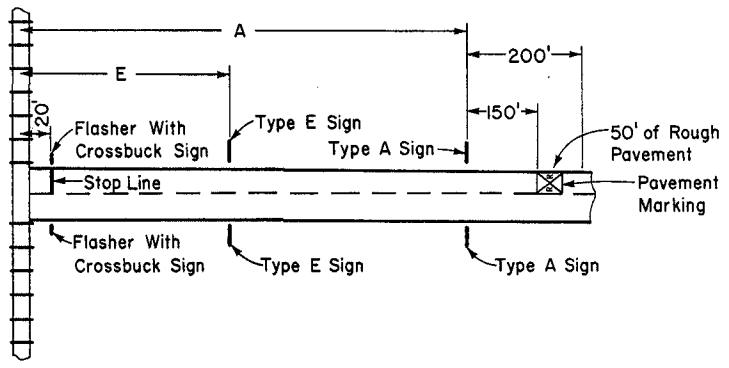
**PROTECTED CROSSING  
OBSTRUCTED VIEW**

SPEED MPH	DISTANCE	
	A(FT)	E <sup>⊙</sup> (FT)
40	300	150
50	450	225
60	600	300
70	800	400
80	950	525

⊙Based on braking distance from AASHO Geometric Design of Rural Highways.

**PROTECTED CROSSING  
UNOBSTRUCTED VIEW**

**FIGURE IA (1)  
STANDARDS FOR APPLICATION  
ADVANCE WARNING SIGNS FOR  
PROTECTED CROSSINGS**

There are eight proposed new sign designs which are illustrated in Figure 2A. These signs are applied as indicated in the standards of application (Figure 1A).
