1. Report No. FHWA/TX-88/89/1179-2F	2. Government Accession No.	3. Recipient's Catalog No.	
4. Title and Subtitle CRASH TEST OF TEXAS T202 BRIDGE RAIL		5. Report Date May 1989

CRASH TEST OF TEXAS T202 BRIDGE RAIL

Research Report 1179-2

Research Study No. 2-5-88/89-1179
Crash Test of Modified C202 Bridge Rail

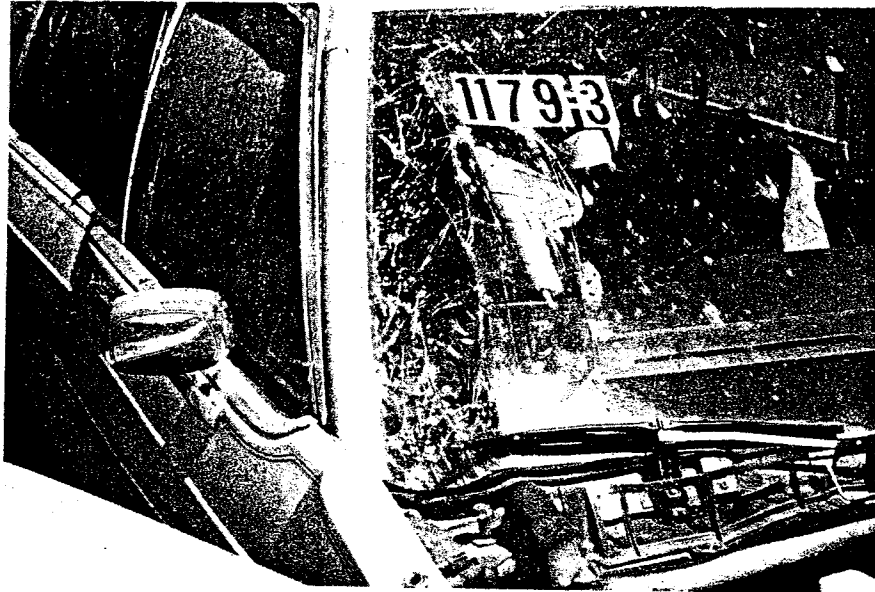
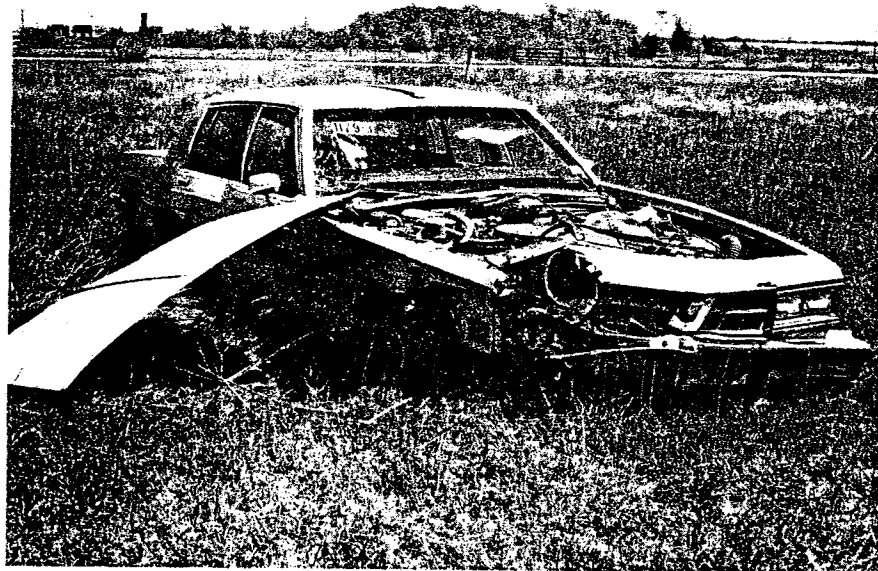
Figure 11. Damage to Windshield and Right Front of Vehicle after Test 1179-3.

The vehicle sustained severe damage to the right side, as shown by Figures 11 and 12. Maximum crush at the right front corner at bumper height was 14.0 in. (35.6 cm). The right A-arm, the tie rod, and the upper and lower ball joints were damaged and the subframe was bent. The instrument panel in the passenger compartment was bent as well as the floor pan and roof, and the windshield was broken. The right front rim was bent and the tire damaged. There was damage to the hood, grill, bumper, right front quarter panel, the right front and rear doors, the right rear quarter panel and the rear bumper.

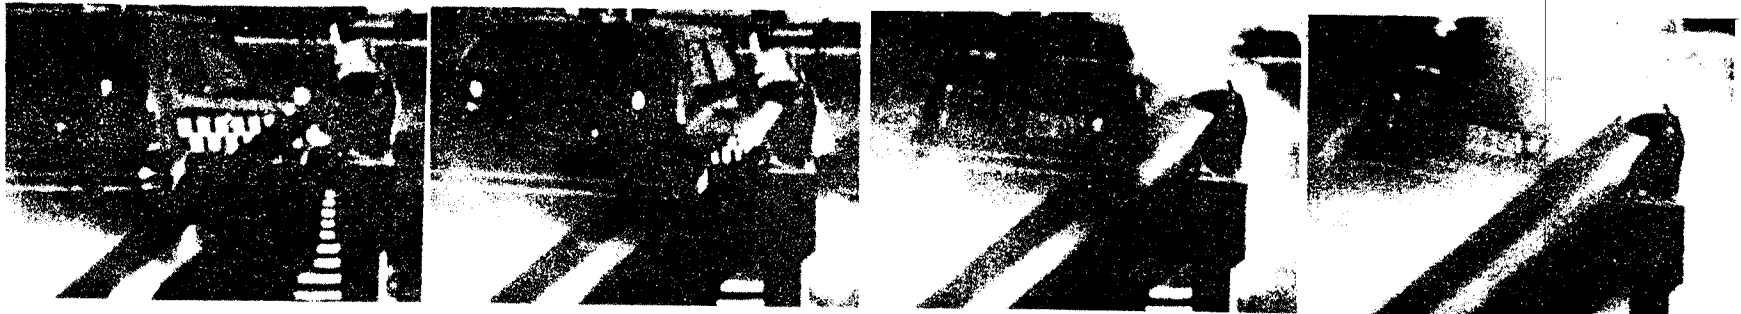
Figure 14. Summary of results for test 2230-4.

Test No. 2230-4
 Date 02/06/80

Test Installation . Mod.T202 Bridge Rail
 Installation length . . 101 ft (31 m)

Vehicle 1974 Honda Civic
 Vehicle Weight
 Test Inertia 1,800 lb (817 kg)
 Vehicle Damage Classification
 TAD 01RFQ4
 CDC 01RFEE7

Impact Speed 59.4 mi/h (95.6 km/h)
 Impact Angle 15.0 degrees
 Speed at Parallel . . 47.4 mi/h (76.3 km/h)
 Exit Speed 43.4 mi/h (69.9 km/h)
 Exit Trajectory . . . 6.5 degrees

Vehicle Accelerations
 (Max. 0.050-sec Avg)
 Longitudinal . . . -6.6 g
 Lateral 12.2 g

Occupant Impact Velocity
 Longitudinal . . . 23 ft/s (7 m/s)
 Lateral 22 ft/s (6.7 m/s)

Occupant Ridedown Accelerations
 Longitudinal . . . -1 g
 Lateral 4 g

Figure 14 presents a summary of the Honda crash test conducted in 1980 and reported in Research Report 230-3 (reference 1). The 1,800 lb (817 kg) Honda impacted the bridge rail at 59.4 mi/h (95.6 km/h) and a 15.0 degree angle. The impact point was at midspan between two posts. The vehicle exit speed was 43.4 mi/h and 6.5 degrees.

The summary of the crash test data presented in Figure 14 meets these requirements with only one exception--vehicle trajectory--Item I. This item says, "In tests where the vehicle is judged to be redirected into or stopped while in adjacent traffic lanes, vehicle speed change during test article collision should be less than 15 mph and the exit angle from the test article should be less than 60 percent of test impact angle, both measured at time of vehicle loss of contact with test device." The exit angle was 6.5 degrees which is less than the 9 degrees recommended and the change in speed of the vehicle was 16 mph which is 1 mph greater than the 15 mph recommended overall. This test 2230-4 is considered to meet these safety evaluation criteria.

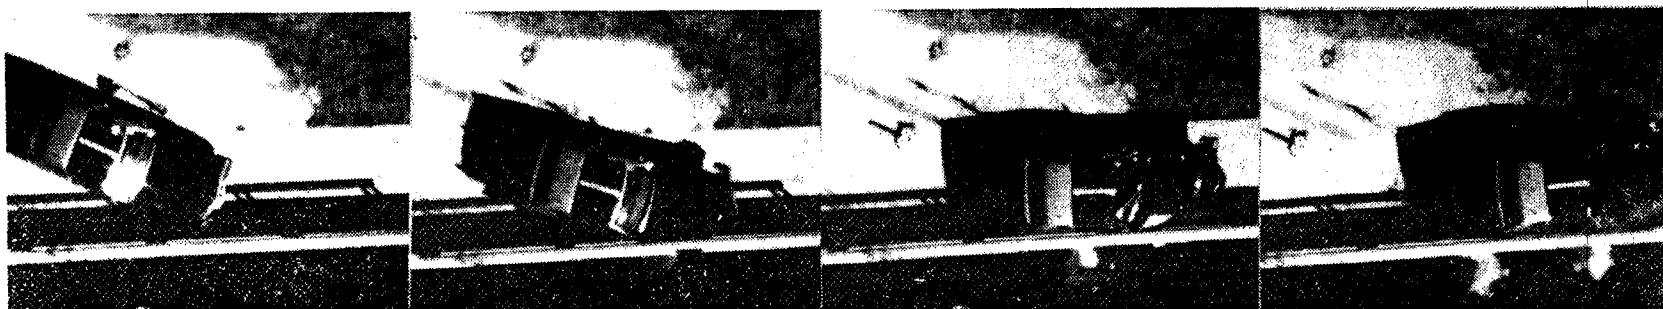
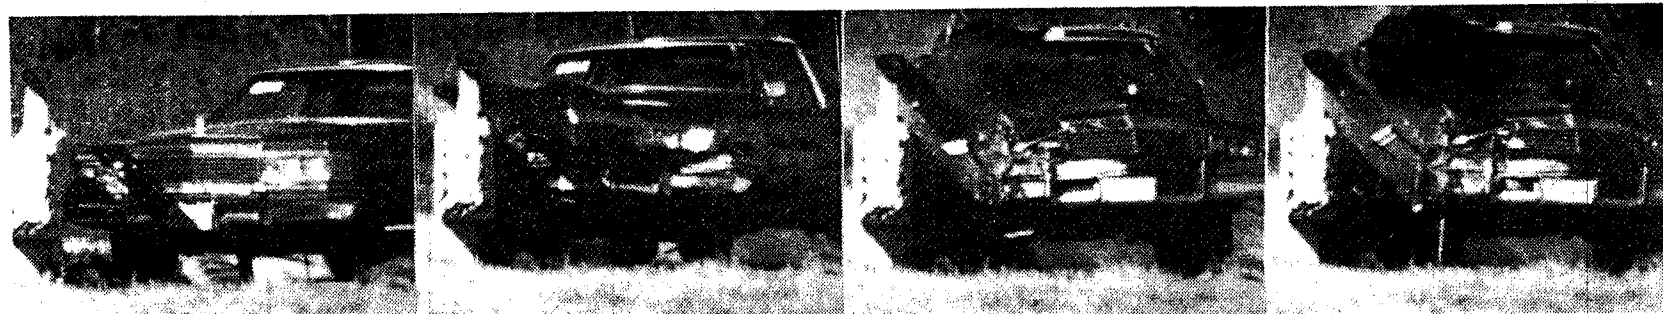
Figure 17. Summary of results for test 1179-2.

Test No	1179-2	Impact Speed	59.4 mi/h (95.6 km/h)
Date	12/01/87	Impact Angle	25.9 deg
Test Installation	C202 Bridge Rail with C4 Steel Rail	Exit Speed	44.5 mi/h (71.6 km/h)
Length of Installation	101 ft (31 m)	Exit Angle	2.0 deg
Vehicle	1979 Cadillac	Vehicle Accelerations at C.G. (Max. 0.050-sec Avg)	
Vehicle Weight		Longitudinal	-9.7 g
Test Inertia	4,400 lb (1,998 kg)	Lateral	+14.3 g
Vehicle Damage Classification		Occupant Impact Velocity	
TAD	01RFQ6	Longitudinal	23.9 ft/s (7.3 m/s)
CDC	01RYAS4	Lateral	27.3 ft/s (8.3 m/s)
		Occupant Ridedown Accelerations	
		Longitudinal	-4.9 g
		Lateral	-16.7 g
