1. Report No. FHWA/TX-98/1360-2F		2. Government Accession No.		3. Recipient's Catalog No.	
4. Title and Subtitle CROSS FRAME DIAPHRAGM FATIGUE AND LOAD DISTRIBUTION BEHAVIOR IN STEEL HIGHWAY BRIDGES				5. Report Date September 1997

CROSS FRAME DIAPHRAGM FATIGUE AND LOAD DISTRIBUTION BEHAVIOR IN STEEL HIGHWAY BRIDGES

Research Report 1360-2F
Research Study Number 0-1360
Research Study Title: Repair Procedures for Fatigue Damage
in Steel Highway Bridges

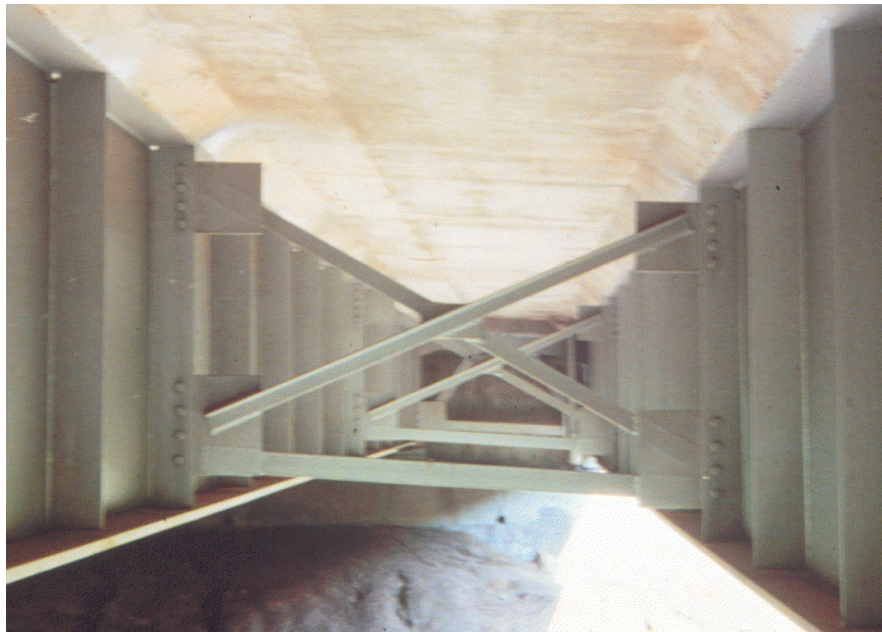
Figure 1-2: Typical cross frame diaphragm and connection plate detail.

The cross frame diaphragms are normally attached to the girder by either welding or bolting them to a vertical connection plate. Typically, the connection plate is of the same design as an intermediate transverse shear stiffener and serves as one also. A typical cross frame diaphragm and connection plate detail is shown in [Fig. 1-2](#).

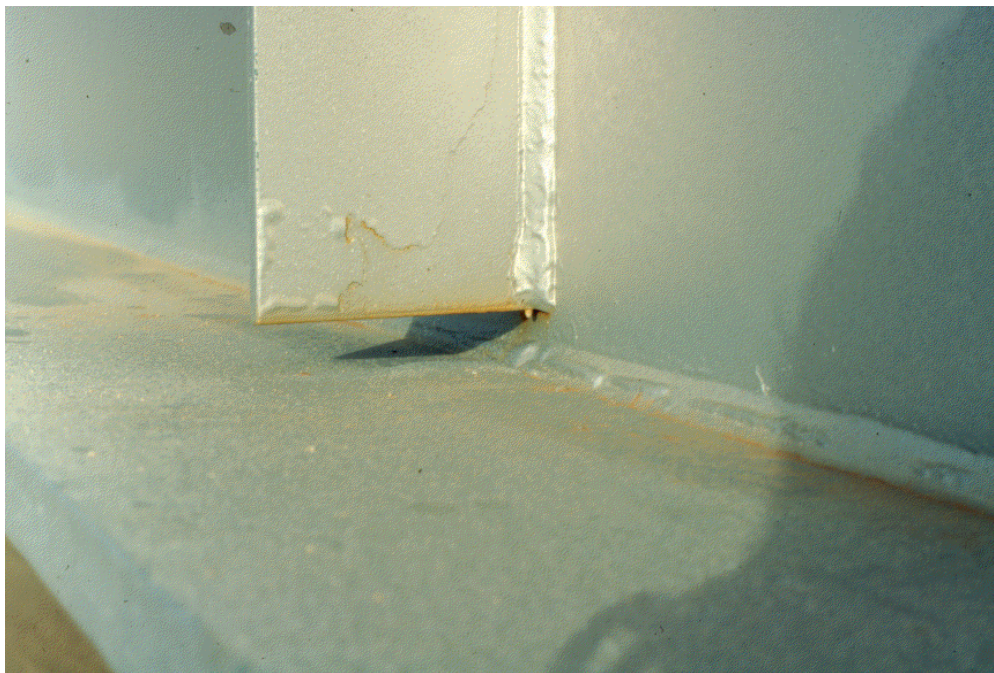
Figure 1-3: View of typical cut-short stiffener detail.

Two different details were used for the termination of the connection plate at the tension flange: cut-short and tight-fit. The cut-short detail, one of which is shown in [Fig. 1-3](#), terminates the connection plate short of the tension flange by 25 to 100 mm (1 to 4 in). Application of the web crippling criteria for intermediate shear stiffeners has led to a recommended gap of four to six times the web thickness. The tight-fit detail, on the other hand, is cut to the full depth of the girder web but is only welded to the web and compression flange. An example of a tight-fit detail is given in [Fig. 1-4](#).

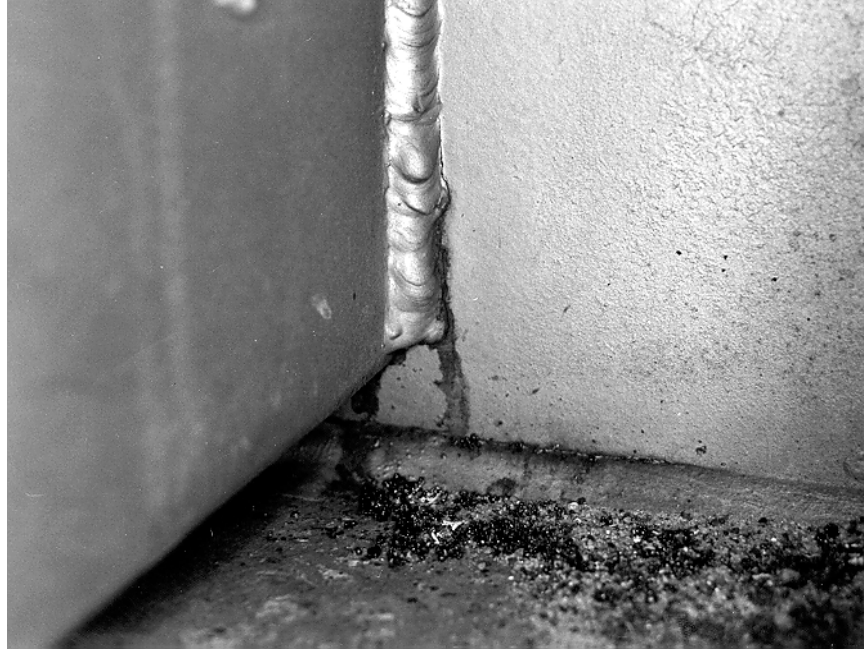
Figure 1-6: Fatigue crack at end of unstiffened web gap of cut-short termination detail.

The web gap bending stresses are caused by trucking loading and are therefore cyclic in nature. Consequently, fatigue cracks will develop in the web plate around the web gap region if the distortion level is high enough. With both termination details, a crack will develop in the toe of the web-to-flange fillet weld. An example of this type of fatigue cracking is given in [Fig. 1-6](#) for the cut-short detail. In addition, fatigue cracks can also develop in the toe at the termination of the connection plate fillet weld, also shown in [Fig. 1-6](#). The vertical weld toe crack is more critical since it is driven not only by the out-of-plane distortion stresses but also by the in-plane bending stress. Fortunately, this crack is shielded from the flange by the web-to-flange crack.

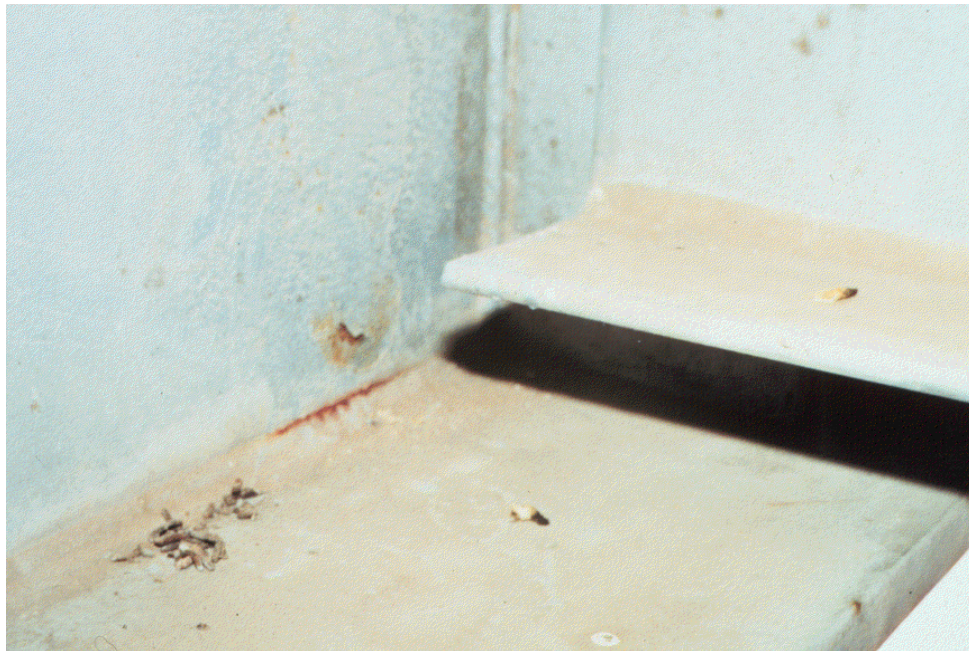
Figure 1-7: Fatigue crack at unstiffened web gap with tight-fit connection detail.

The tight-fit detail will also experience web gap fatigue cracking but is usually limited to the web-to-flange fillet weld unless unusually high levels of distortion exist. [Figure 1-7](#) shows an example of a fatigue cracked cut-short detail. The connection plate detail causing the distortion is actually on the opposite side of the web plate from the view shown. The diaphragms on this bridge were offset slightly at this location.

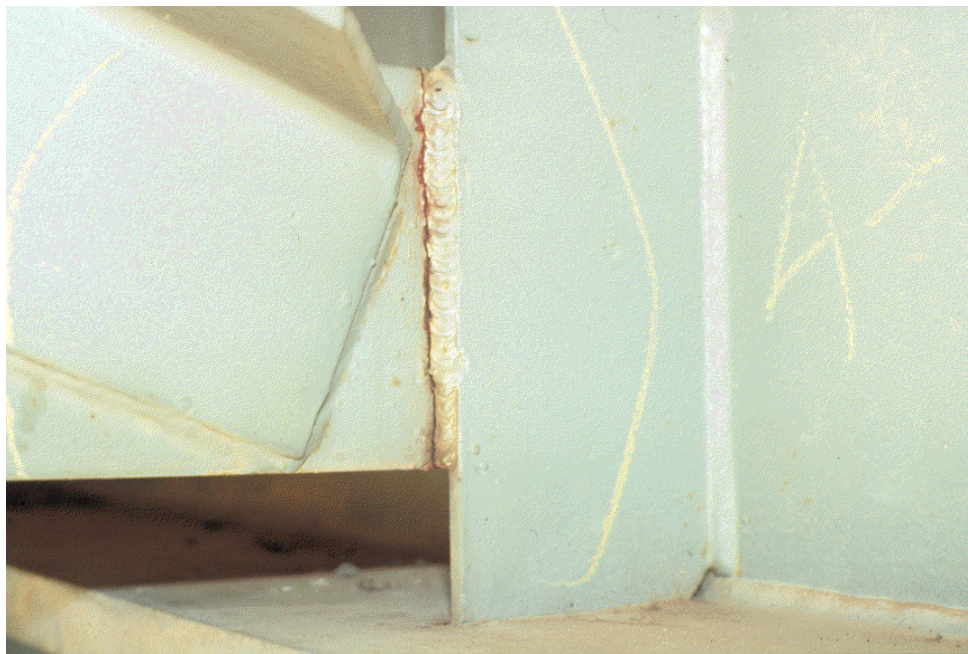
Figure 1-8: Fatigue crack in fillet weld between cross frame diaphragm lower strut and connection plate.

In addition to the web gap cracking, the diaphragm members and their connections can be susceptible to fatigue damage. [Figure 1-8](#) shows an example of a fatigue crack that developed in the toe of the fillet weld between the cross frame lower strut angle section and the connection plate. This cracking was caused by the eccentric loading between the diagonal and lower strut members resulting in bending stress in the weld to the connection plate. This crack separated the diaphragm from the connection plate and helped minimized fatigue damage to the tight-fit web gap detail. [Figures 1-9](#) and [1-10](#) show examples where the cross frame members themselves have developed fatigue cracks. Again, this type of cracking can be attributed to poor detailing of the member connections that result in bending stresses from eccentric loading.

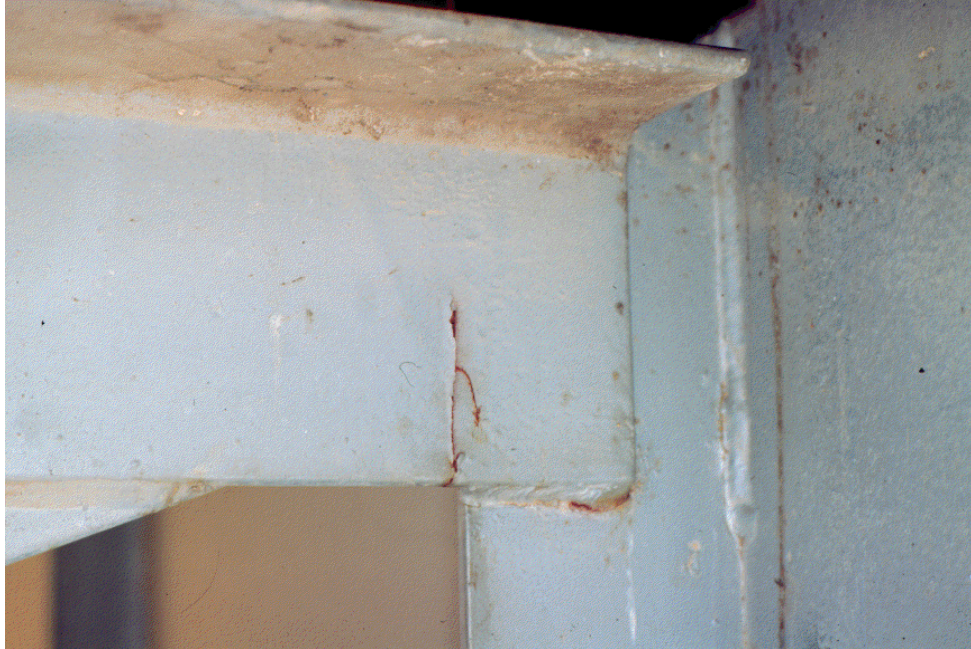
Figure 1-9: Fatigue crack in cross frame upper strut at diagonal connection.

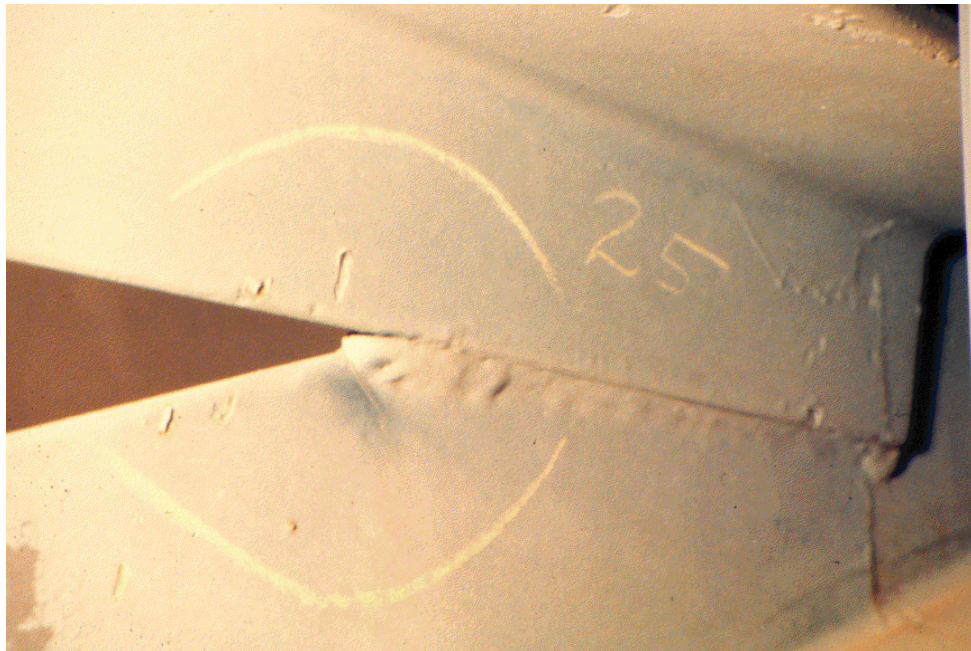
Figure 1-10: Fatigue crack in cross frame lower strut at diagonal connection.

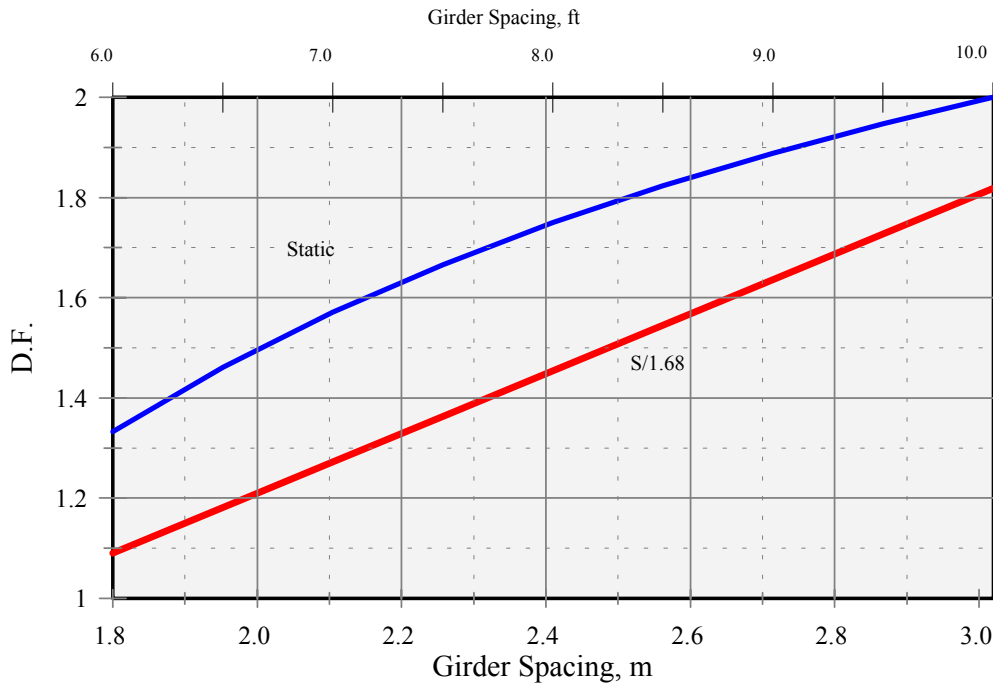
Figure 2-4: Comparison of AASHTO and static *D.F.*s, two lanes loaded.

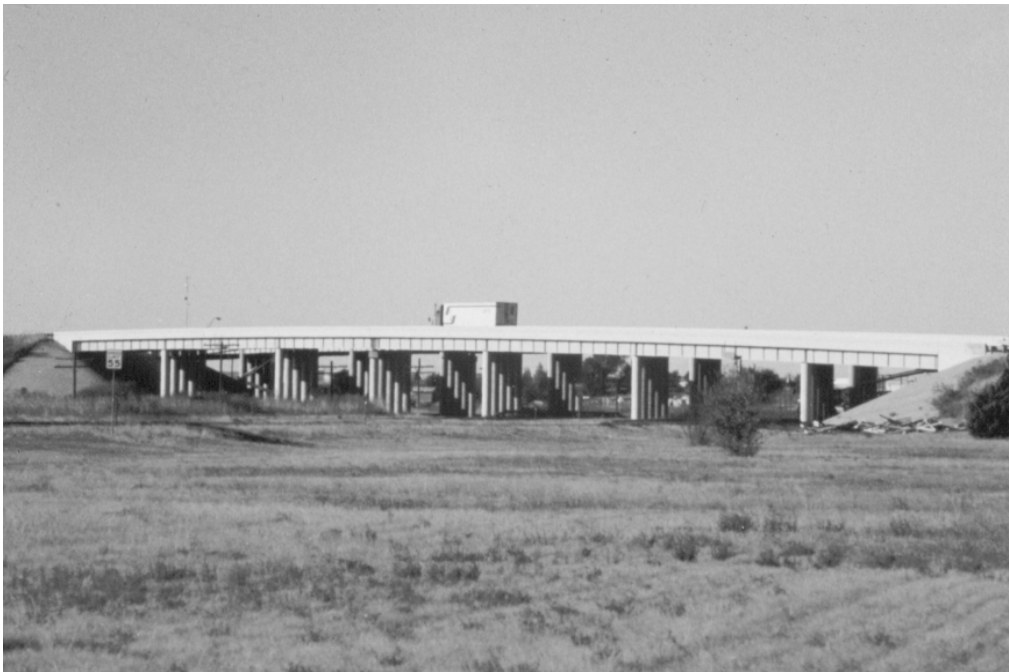
Figure 3-1: View of IH-20 Midland County Bridge.

An inspection of the IH-20 Midland County (Texas) bridge that was performed in 1989 indicated that the structure had experienced fatigue related problems due to the unintended interaction between the longitudinal girders and the cross frame diaphragms (Diaz and Andrews 1990, Keating and Crozier 1992). The original construction of the bridge did not specify a rigid attachment between the ends of the connection plate and the flanges. Figure 3-1 provides a view of the twin structure.

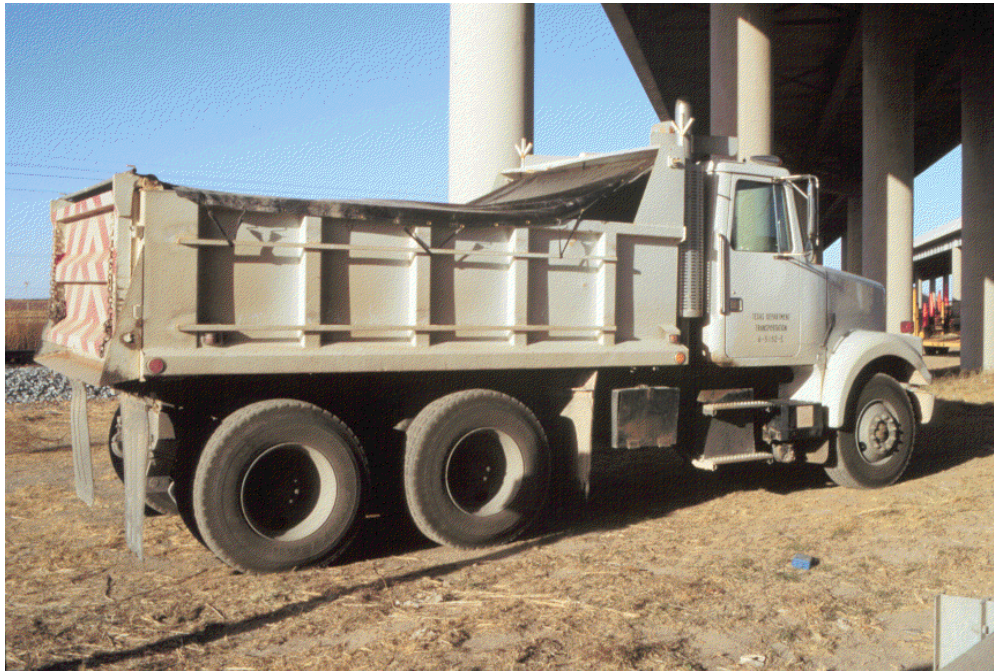
Figure 3-3: View of TxDOT vehicle used as test vehicle for Field Test No. 2.

The acquisition of Field Data Set 2 was obtained by passing a TxDOT vehicle of known weight, as shown in [Fig. 3-3](#), over the bridge and recording the strains at various locations. The gross vehicle weight was measured at 205 kN (46.1 kips). Axle loads and configurations are given in [Appendix A](#).

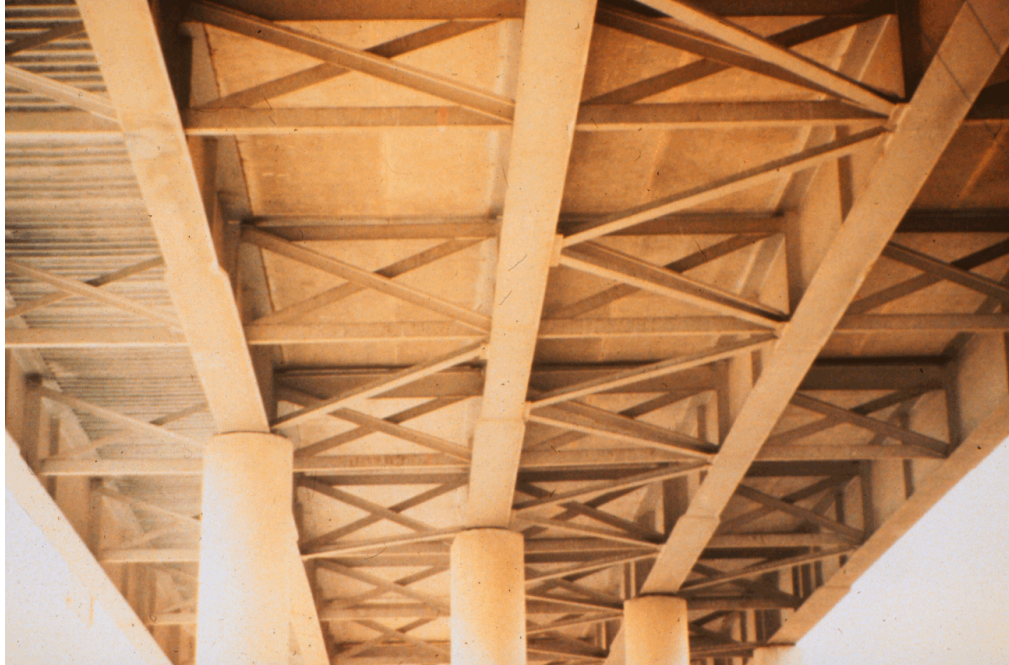
Figure 3-8: View of old (pre-1992) diaphragm configuration.

[Figure 3-7](#) shows the gage groups used for Field Test No. 3 and are summarized in [Table 3-4](#). Eight gage groups were used for this field test. In addition to the four gage groups used in Field Test No. 2, diaphragm members were gaged for the four other gage groups. The new diaphragm lines were offset from the old diaphragm lines so that the new connection plates were not installed over web gap cracking repairs. [Figures 3-8](#) and [3-9](#) are views of the old diaphragm configuration and the new reduced configuration, respectively.

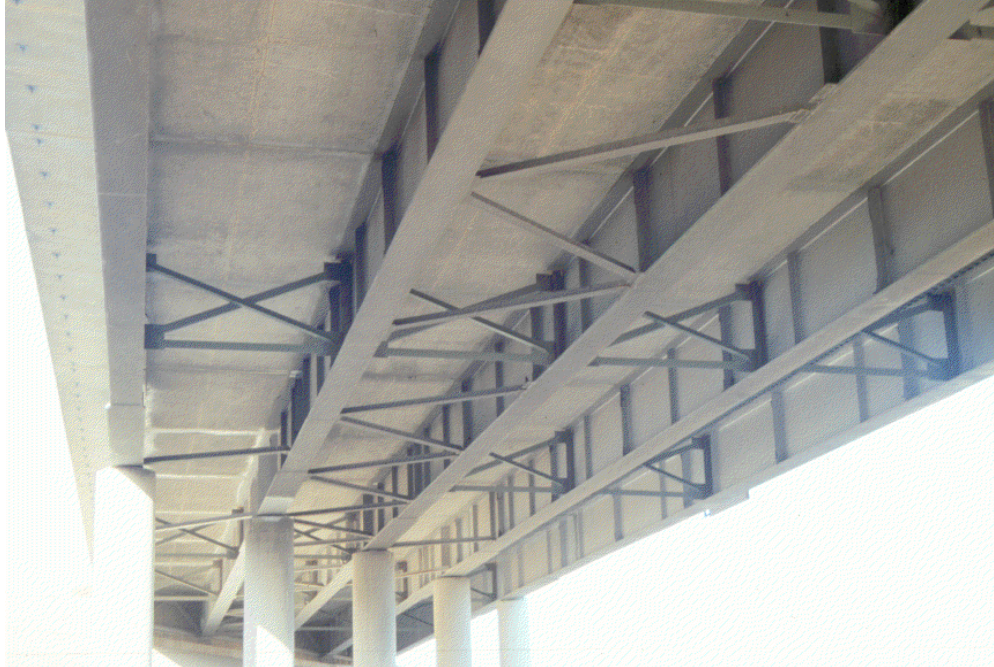
Figure 3-9: View of new diaphragm configuration.

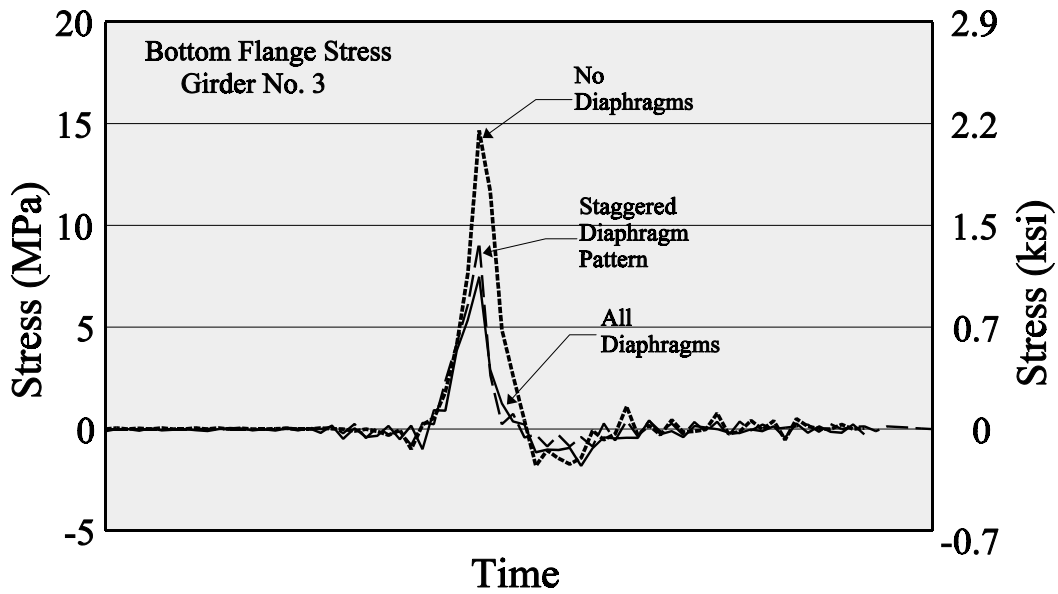
Figure 3-11: Comparison of stress histories for different diaphragm configurations, Girder No. 3 bottom flange, test vehicle centered in driving lane.

The measured increases in the peak stresses for the different diaphragm configurations are consistent with the finding of TxDOT Research Report 1313. A 100 percent increase in girder flange stresses with all diaphragms removed was found to be intolerable and was the governing factor behind the staggered diaphragms pattern recommended for the repair. It was observed by the construction crew performing the repairs, that there was a noticeable increase in the vibration and deflection of the structure when all diaphragms were completely removed. Even though the recommendation required the reinstallation of diaphragms, the total number of diaphragms was decreased from 488 diaphragms used in the original configuration to 156 for the staggered configuration, a decrease of 68 percent.

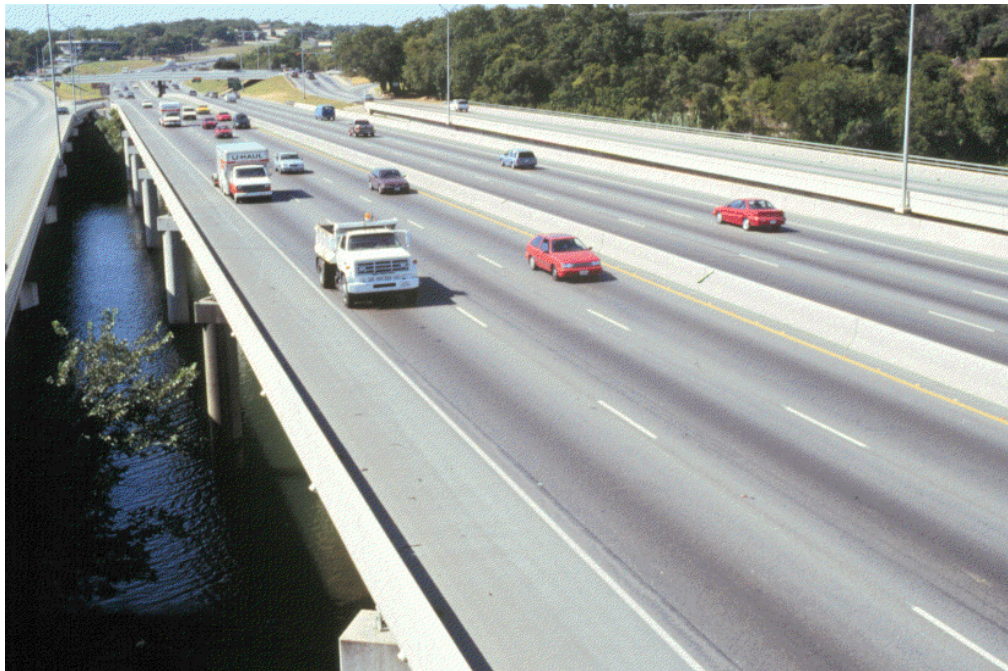
Figure 4-1: View of Town Lake bridge, looking in the southbound direction.

It was determined through discussions with TxDOT personnel that the Town Lake Bridge carrying IH-35 over the Colorado River in Austin, Texas, would be an ideal candidate for field testing because it is a moderately skewed bridge with recently detected fatigue cracking. This bridge was originally composed of two identical structures, one carrying three lanes northbound, and the other carrying three lanes southbound. A view of the bridge roadway is given in [Fig. 4-1](#), looking in the southbound direction.

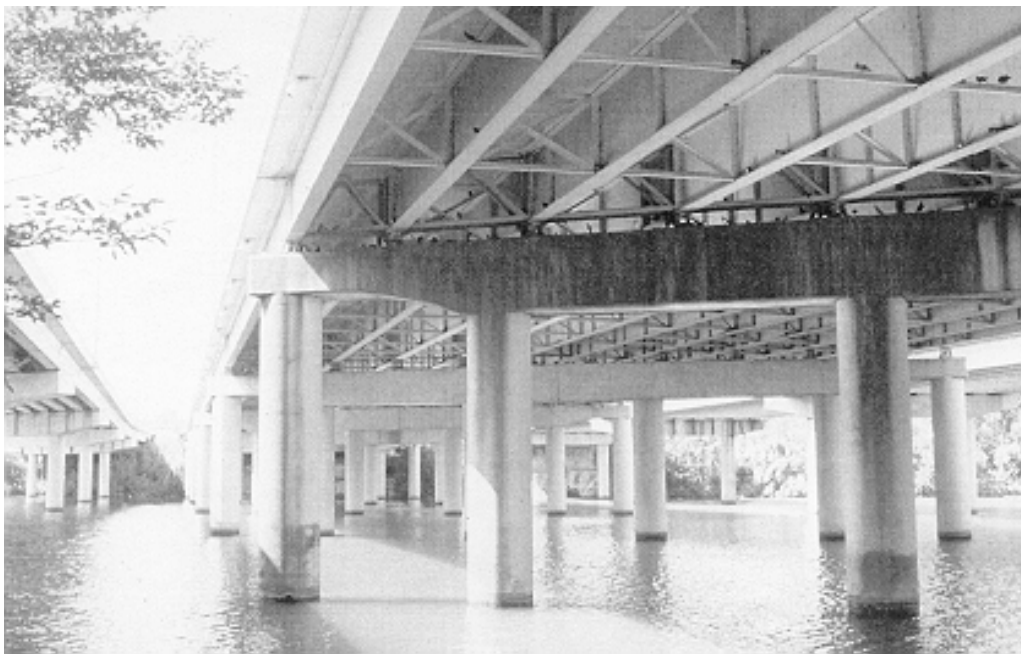
Figure 4-7: View of diaphragm framing of northbound structure looking south from the north shore of Town Lake.

The framing plan for the 134 m (440 ft) unit is shown in Fig. 4-3. Diaphragm lines are spaced at 3.81 m (12.5 ft) or 4.57 m (15 ft), with some additional lines of diaphragms added at the interior supports. Two types of diaphragms, shown in Figs. 4-4 and 4-5, were used in the original construction, designated as types D2 and D3 on the original drawings. The diaphragm types were alternated longitudinally throughout the length of the bridge. At each diaphragm line, the same type was used between the original five girders. The transverse stiffeners that the diaphragms connect to had a tight-fit detail at the girder flanges, but were not welded. When the bridge was widened, additional diaphragm types were used, designated as D4 and D5. Except for the width of the diaphragm, as determined by the girder spacing, diaphragms D4 and D5 are identical. Figure 4-6 shows the configuration of this diaphragm type. The connection plates for this diaphragm type utilize a 25 mm (1 in) web gap at the girder tension flange. (The D1 diaphragm configuration was used at the end supports.) Figure 4-7 provides a view of the diaphragm framing from beneath the bridge.

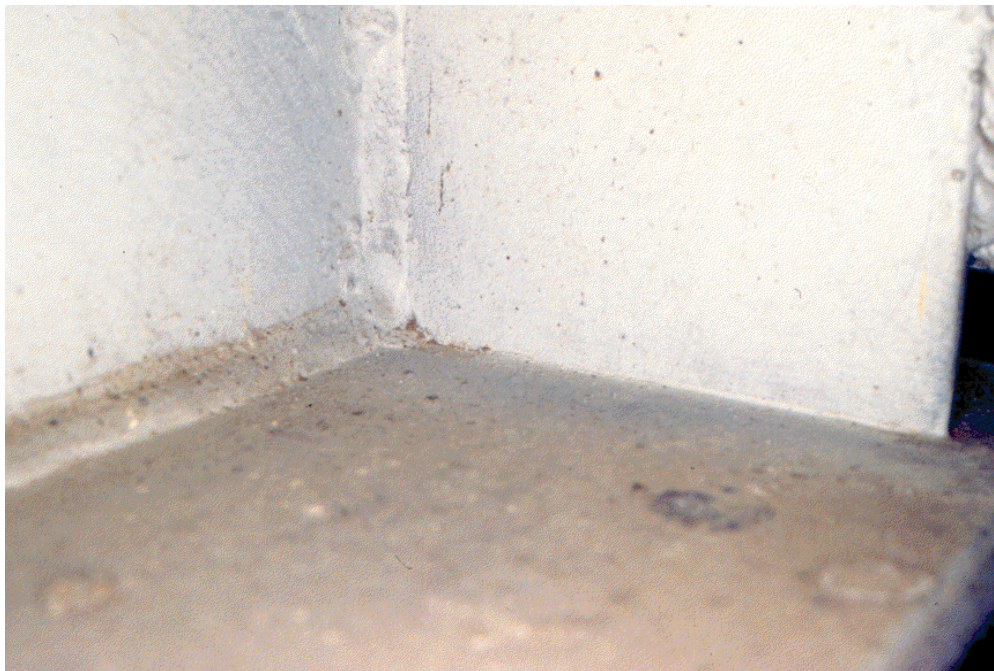
Figure 4-8: Example of tight-fit detail with intersecting welds, Town Lake Bridge.

The tight-fit detail used on the Town Lake Bridge is different than the tight-fit detail used on the Midland County bridges. The corner cope of the connection plate provides little clearance for the web-to-flange fillet weld. Consequently, the fillet weld between the connection plate and web extends into the web-to-flange weld, as shown in [Fig. 4-8](#). This weld configuration increases the stiffness of the detail to the cross frame diaphragm out-of-plane distortion. However, the resulting intersecting welds increase restraint stresses and the possibility of weld defects and should therefore be avoided. Again, with the tight-fit detail, the end of the connection plate is not welded to the tension flange.

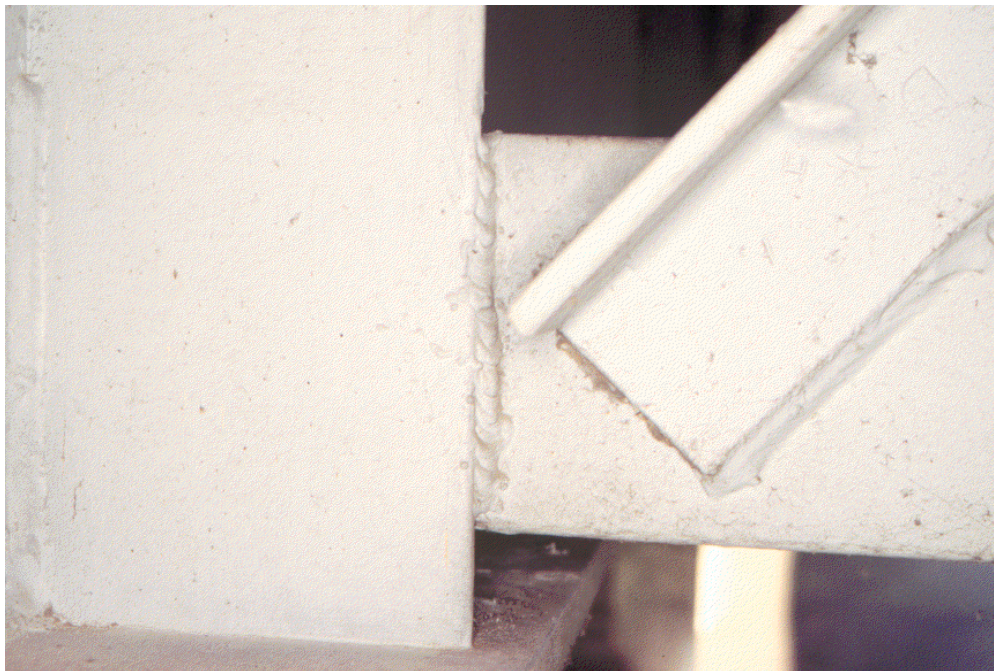
Figure 4-9: View of cracked fillet weld at diaphragm connection, Town Lake Bridge.

An inspection of the Town Lake Bridge in 1978 revealed that the structure had been experiencing continuing fatigue damage. It was observed that several diaphragms had broken welds where the diaphragm lower strut connects to the connection plate, and consequently the diaphragm had broken free of the connection plate. The connection was rewelded, but again broke free due to continued fatigue cracking. [Figure 4-9](#) shows an example of a cracked lower strut to connection plate weld. The 1978 inspection indicated that this type of fatigue damage occurred exclusively to diaphragms connected to Girder 3 and was, in most cases, confined to the positive moment region. [Figure 4-10](#) shows the location of the fatigue damage on the framing plan for the Town Lake Bridge. Types D2 and D3 diaphragms both experienced this separation of lower strut from the connection plate. Other fatigue damage has occurred but has not been documented.

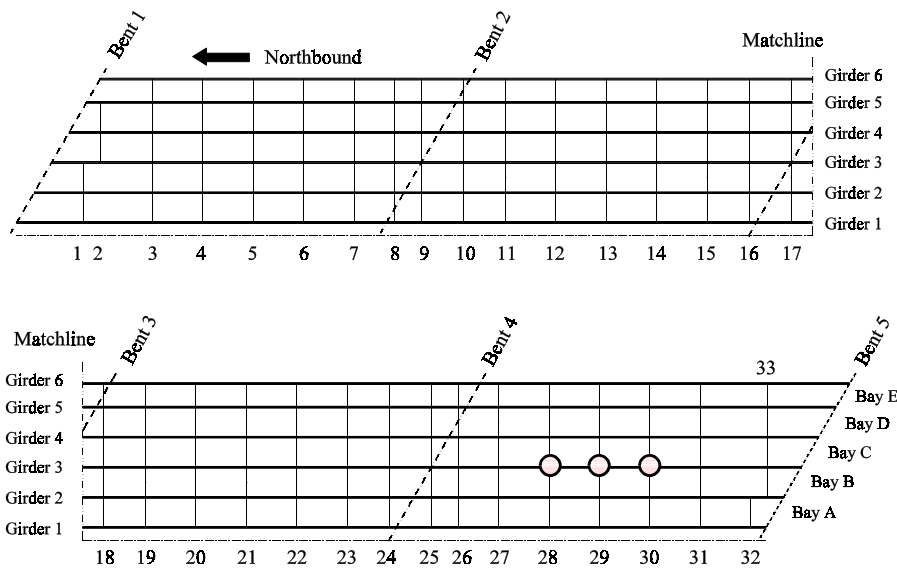
Figure 4-10: Framing plan with locations of repaired fatigue damage.

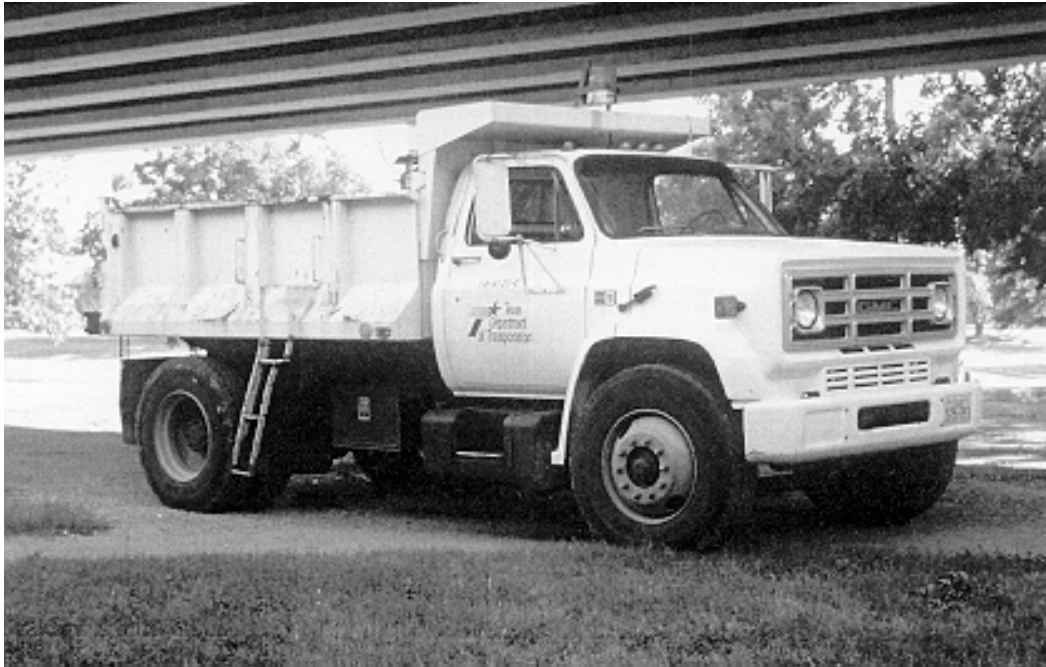
Figure 4-11: View of test vehicle used for Town Lake Bridge.

The tests were conducted by passing a TxDOT vehicle of known weight, as shown in [Fig. 4-11](#), over the bridge and recording the strains at various locations. The gross vehicle weight of the test truck was 117.4 kN (26.4 kips). A vehicle speed of approximately 80.5 kph (50 mph) was used for all tests. An attempt was made to isolate the test vehicle from other traffic while it traversed the bridge. Since this bridge carries Interstate 35, there was always some other vehicle in the vicinity of the test vehicle and lane closures were precluded by safety concerns. The driver was instructed to isolate the test vehicle from other trucks. Testing was performed on a

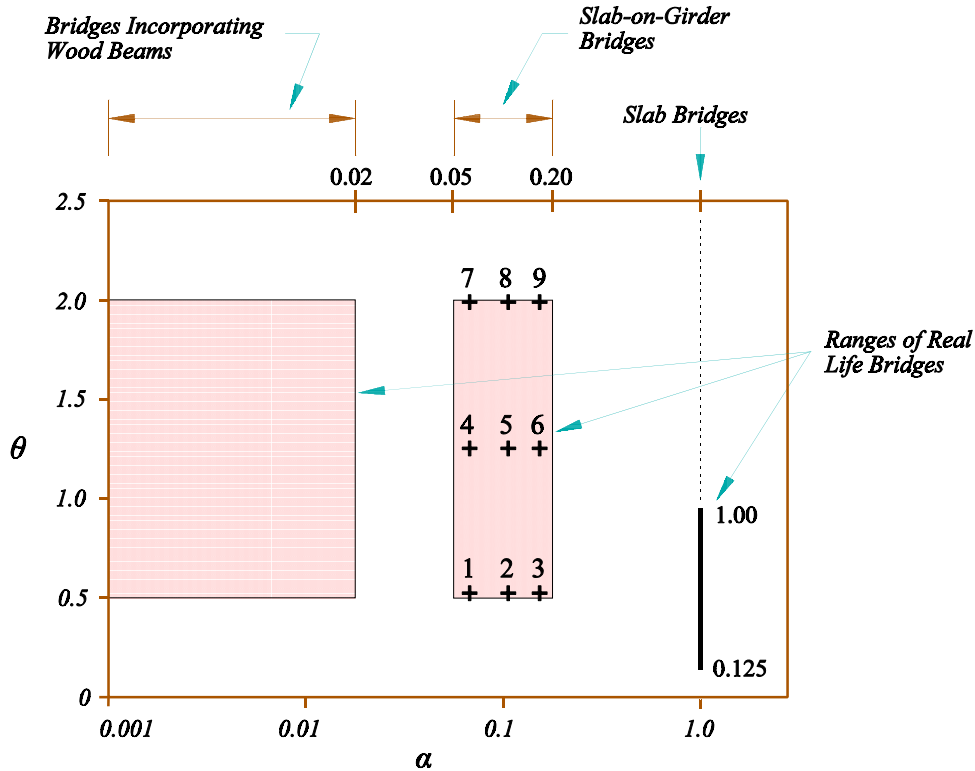
Figure 6-2: Realistic ranges for $\alpha - \theta$ space (Bakht and Moses 1988).

[Bakht and Moses \(1988\)](#) used the $\alpha - \theta$ space to establish realistic limits of bridge geometry and planform ratio for slab-on-girder bridges. In their study they establish 0.05 to 0.20 as a realistic range for α , and 0.50 to 2.0 as a realistic range for θ in slab-on-girder highway bridges. These ranges are shown on the $\alpha - \theta$ space in [Fig. 6-2](#). Concrete slab-on-concrete girder bridges can have α values of up to 0.20 since the longitudinal torsional inertia of the girders is significant. However, for concrete slab-on-steel girder bridges, it is recommended that the limits for α in this study be narrowed to a maximum value of 0.17. Since the value of α for a concrete slab-on-steel girder bridge depends heavily on the slab thickness, it would be unrealistic to obtain values of up to 0.20. This would require bridges with slab thicknesses of 305 mm (12 in) or more, even with moderate girder spacings.

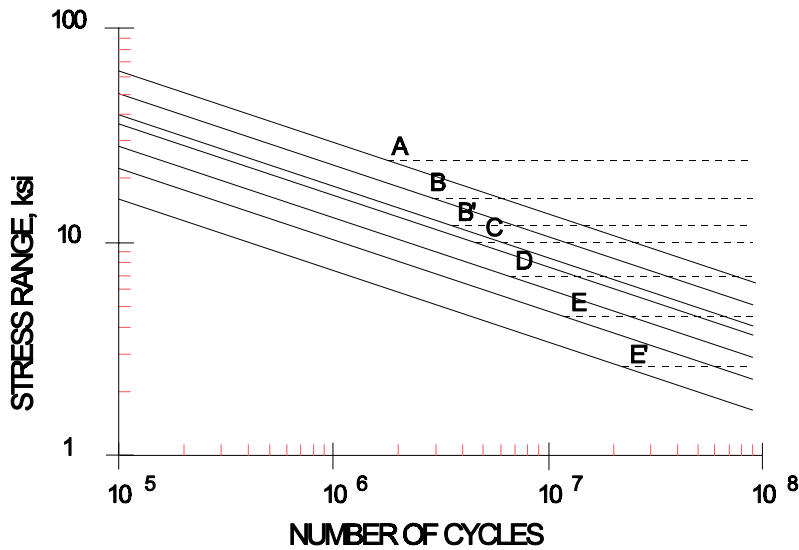
Figure E-1: AASHTO Fatigue Design Curves.
