Laboratory and Field Performance of PGxx-28 and PGxx-34 Binders and New Binder Type Selection Catalog

Technical Report 5-6674-01-R1

TEXAS A&M TRANSPORTATION INSTITUTE
COLLEGE STATION, TEXAS

sponsored by the
Federal Highway Administration and the
Texas Department of Transportation
<https://tti.tamu.edu/documents/5-6674-01-R1.pdf>

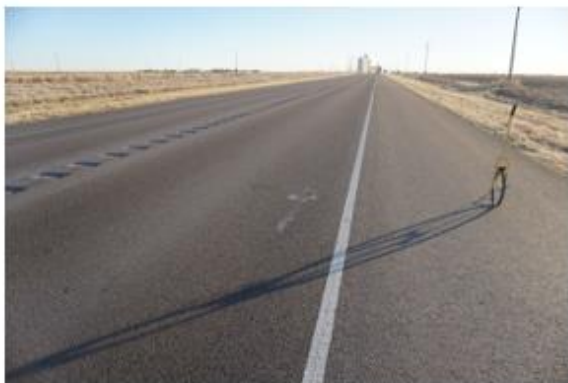
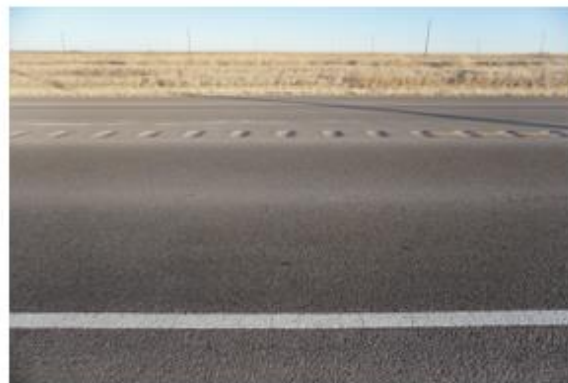
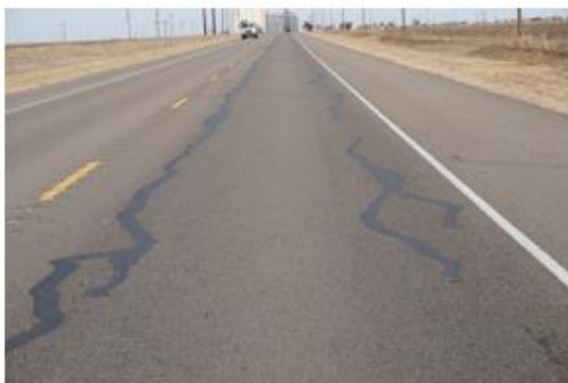
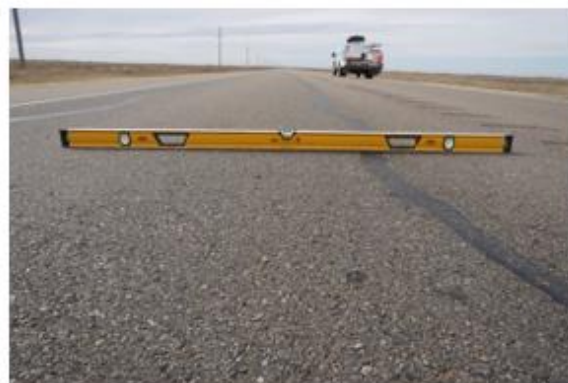
Figure 18. SH 15 Test Section 1: Survey Pictures.

Alligator Cracking: 03/07/2017

Transverse Cracking: 03/07/2017

Overall Cracking: 01/10/2018

Rutting (1/16 in.): 01/10/2018

Researchers detected rutting in each section for the first time in January 2018. The detected rut depth was only about 1/16 in., as shown in Figure 18 through Figure 21. They had not observed any rutting before this survey.

Section 1: Researchers spotted cracking in this section for the first time in March 2016 (see Figure 22). At the time, 14 transverse cracks totaled 213 ft/mile, and 8 different stretches of alligator cracking totaled 20.5 percent of the total lane area. In September 2017, researchers found that almost all cracks healed, most likely due to heat in the summer. In March 2017, cracks reappeared with much higher severity, with a total of 22 transverse cracks that totaled 3052 ft/mile and 13 different stretches of alligator cracking that totaled 25.5 percent of the total lane area. The most recent survey conducted on January 10, 2018, showed that cracks have interconnected throughout the section covering both wheel paths, as shown in Figure 18.

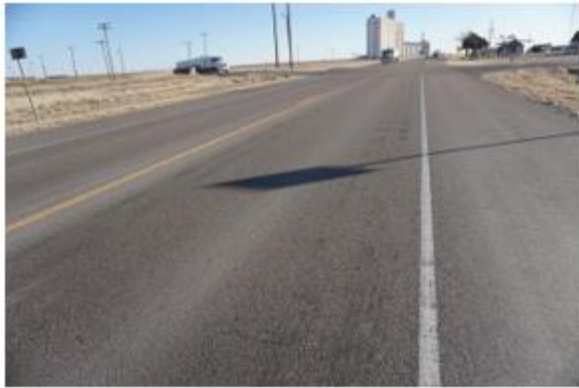
Alligator Cracking: 03/07/2017

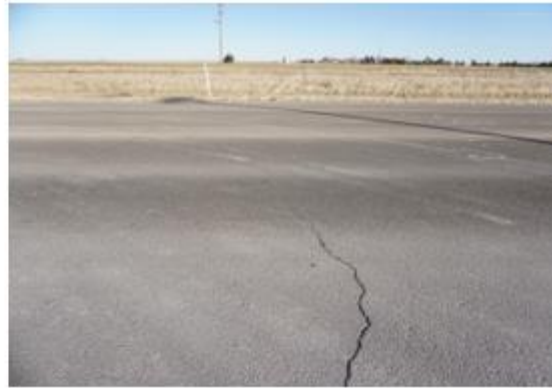
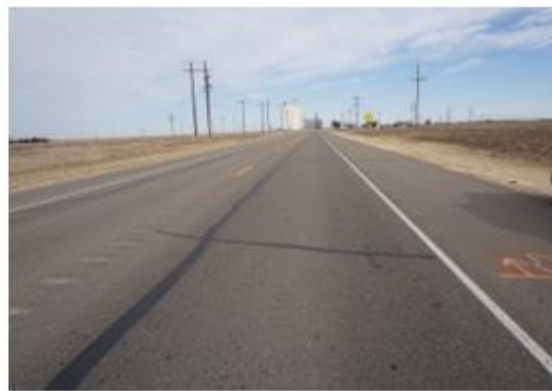
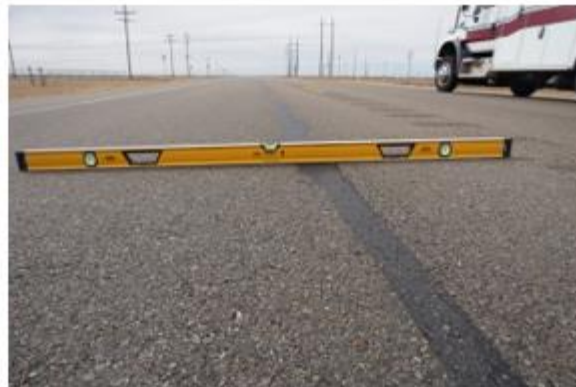
Figure 19. SH 15 Test Section 2: Survey Pictures.

Transverse Cracking: 03/07/2017

Cracking: 01/10/2018

Rutting (1/16 in.): 01/10/2018

1 longitudinal crack that totaled 29 ft/mile. In March 2017, researchers detected more cracks: 10 transverse cracks totaled 179 ft/mile, 7 longitudinal cracks totaled 183 ft/mile, and 2 stretches of alligator cracking totaled 3.3 percent of the total lane area. Healing was not observed in this section. In January 2018, researchers found that the transverse cracks covered the full width of the sections and that cracks have interconnected with each other, more noticeably in the inner wheel path throughout the section, as shown in Figure 19.

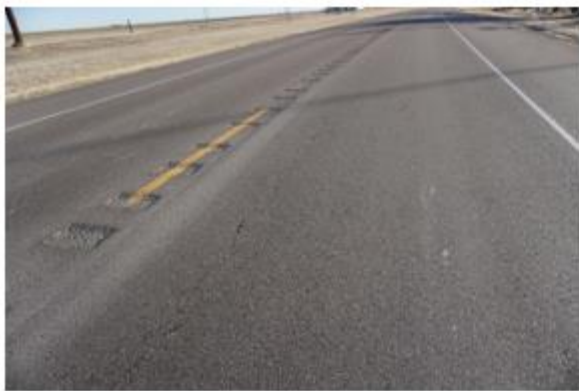
Longitudinal Cracking: 03/07/2017

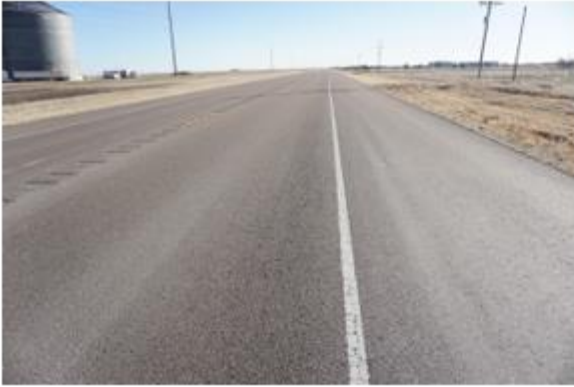
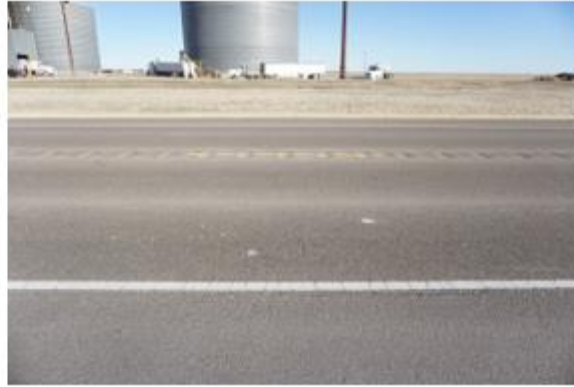
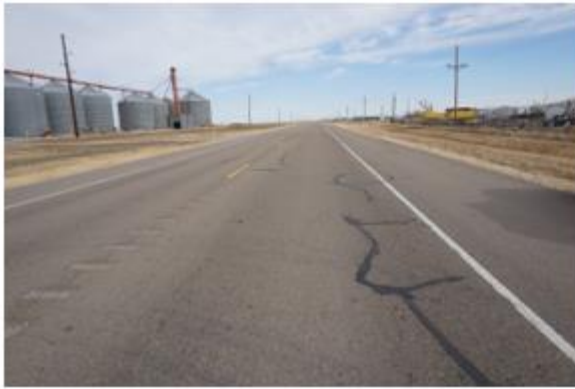
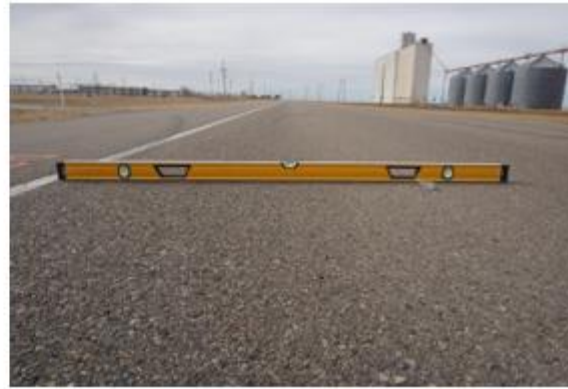
Figure 20. SH 15 Test Section 3: Survey Pictures.

Alligator Cracking: 03/07/2017

Transverse Cracking: 03/07/2017

Overall Cracking: 01/10/2018

Rutting (1/16 in.): 01/10/2018

Section 3: Researchers observed cracking in this section for the first time in September 2016 (see Figure 22). At the time, only 1 stretch of alligator cracking totaled 1.8 percent of the total area. In March 2017, researchers detected 3 new transverse cracks that totaled 53 ft/mile and 7 new stretches of alligator cracking that totaled 18.4 percent of the total lane area. A recent survey in March 2018 showed that all these cracks have interconnected, as shown in Figure 20.

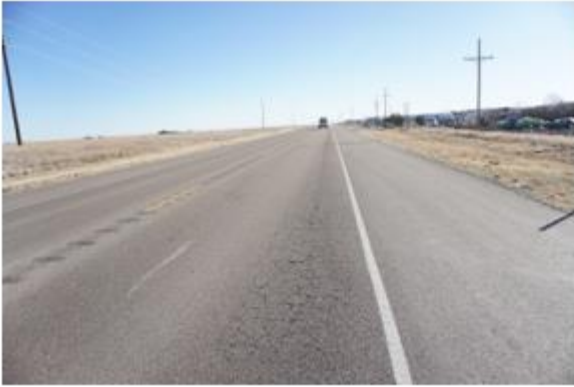
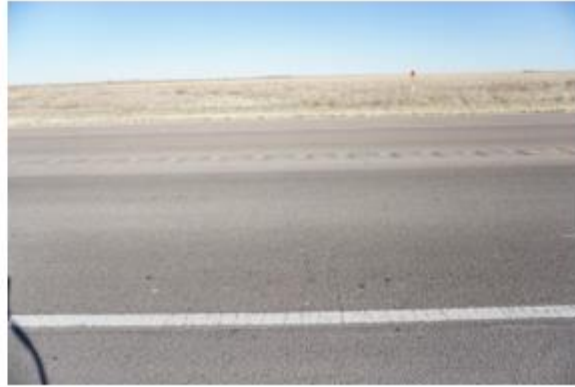
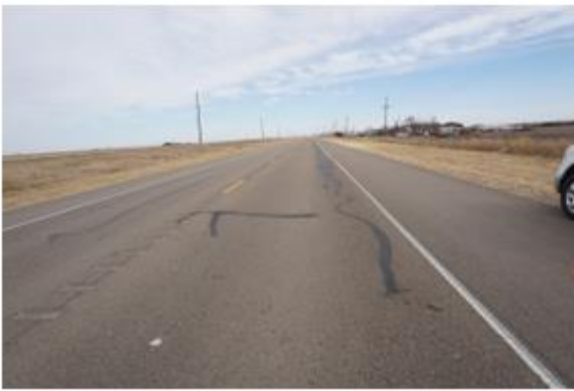
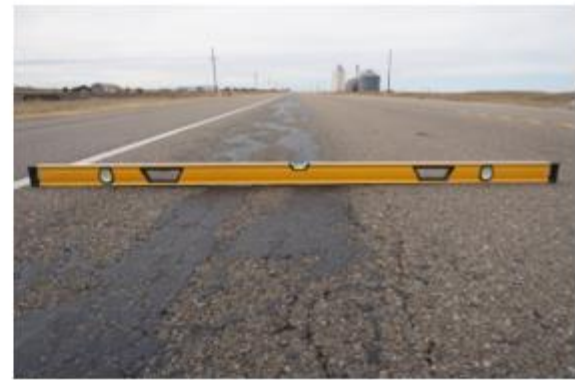
Figure 21. SH 15 Test Section 4: Survey Pictures.

Alligator Cracking: 03/07/2017

Transverse Cracking: 03/07/2017

Overall Cracking: 01/10/2018

Rutting (1/16 in.): 01/10/2018

Section 4: Researchers observed cracking in this section for the first time in March 2017 (see Figure 22). At the time, they detected 3 transverse cracks totaling 54 ft/mile and 6 stretches of alligator cracks totaling 21.3 percent of the total lane area. The survey in January 2018 showed that transverse cracks have extended full width, and alligator cracks have interconnected with each other, as shown in Figure 21.

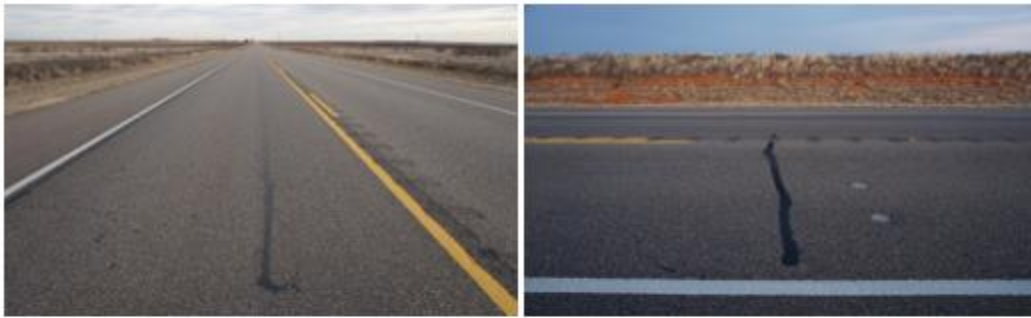
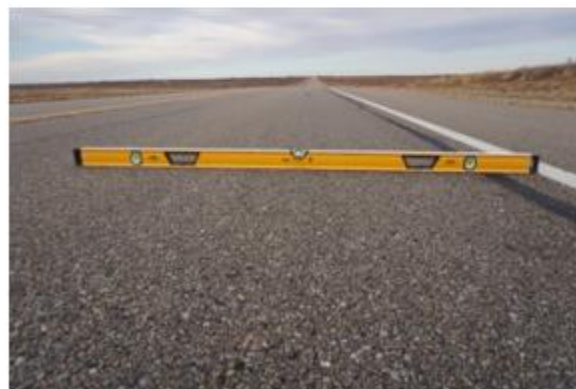
Figure 24. US 62 Test Section 1: Survey Pictures.

Longitudinal Cracking: 01/10/2018

Transverse Cracking: 01/10/2018

Rutting (None): 01/10/2018

None of these sections has exhibited any noticeable rutting as of January 10, 2018 (see Figure 24 through Figure 26).

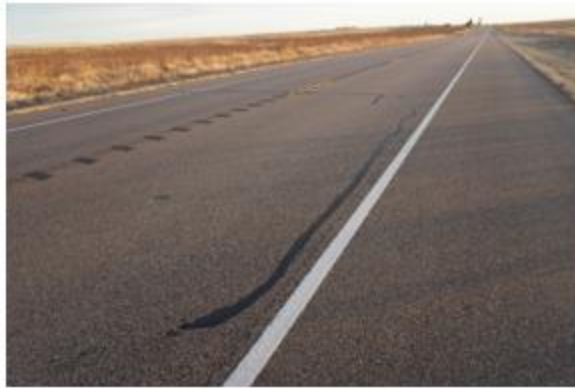
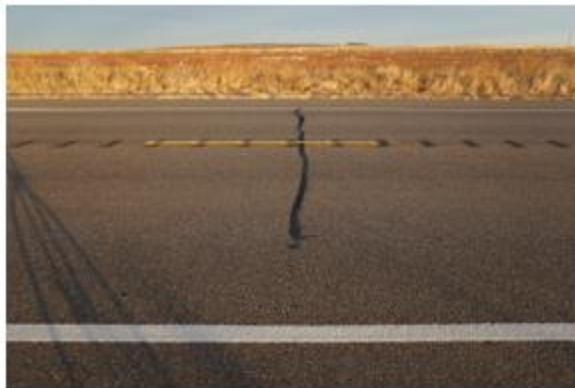
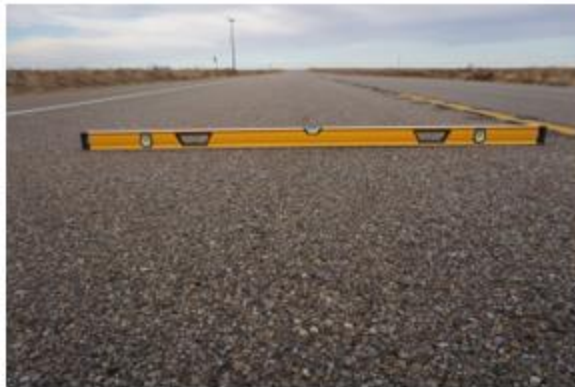
Figure 25. US 62 Test Section 2: Survey Pictures.

Longitudinal Cracking: 01/10/2018

Transverse Cracking: 01/10/2018

Rutting (None): 01/10/2018

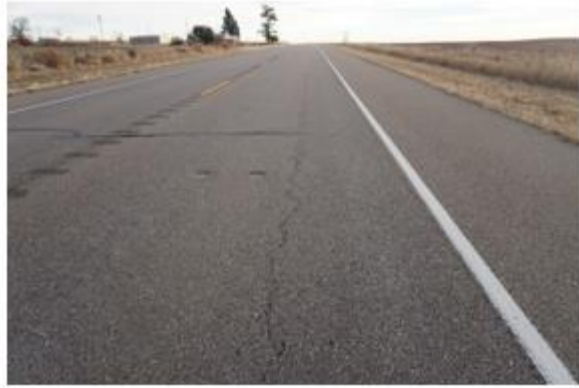
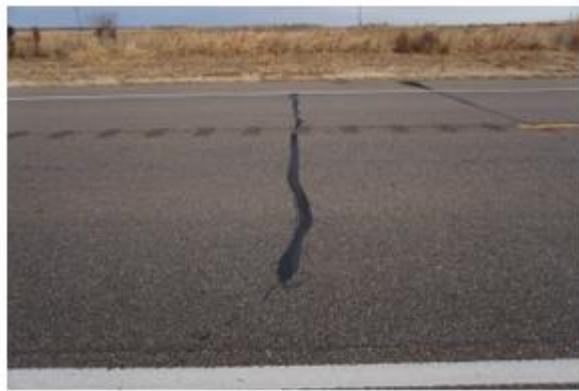
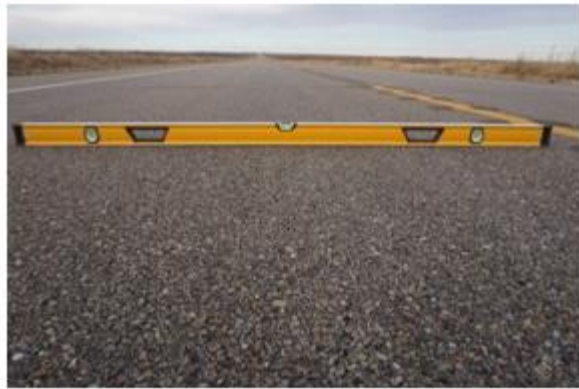
Figure 26. US 62 Test Section 3: Survey Pictures.

Longitudinal: 01/10/2018

Transverse Cracking: 01/10/2018

Rutting: 01/10/2018 (None)

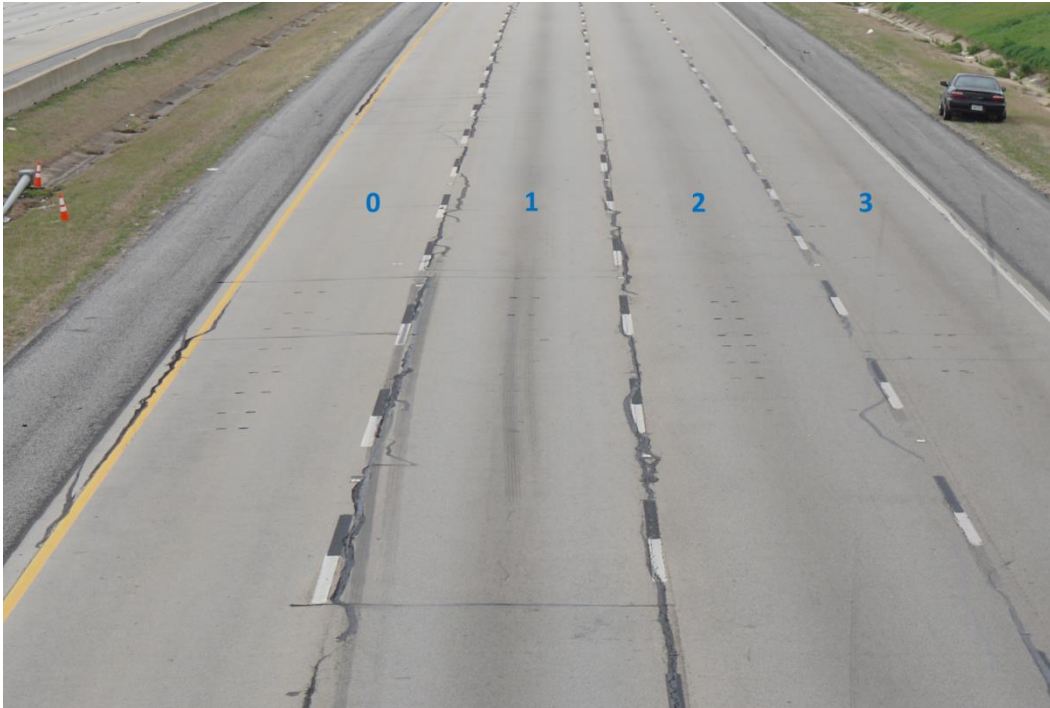
Figure 29. Loop 820 Test Sections 0 to 3: Survey Pictures.

View from Quebec Bridge on 03/26/2018

None of these sections has exhibited any noticeable rutting as of March 26, 2018 (see Figure 29).

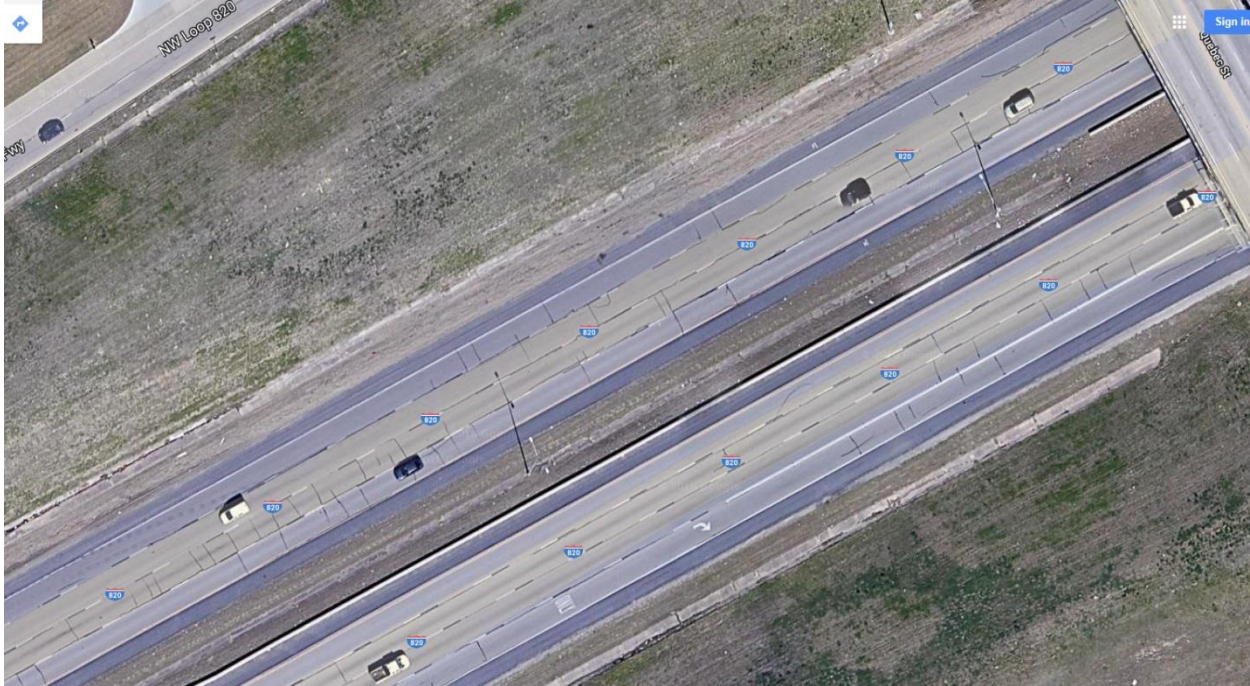
Figure 30. Loop 820 Test Sections: Cracking Conditions.

Satellite View Accessed on 06/25/2018 via Google Maps

Loop 820 is a very busy road; four test sections were paved side by side, resulting in a survey problem. It was possible to determine the cracking conditions of Sections 0 and 3 clearly, but the conditions of Sections 1 and 2 could not be well observed. Many efforts were made, but no fruitful result was obtained. Thus, TTI researchers had to turn to Google Maps for an overall comparison. Figure 30 shows overall pavement conditions. Section 1 has the most reflective cracking, followed by Section 0; Section 2 has the least reflective cracking, and Section 3 has the second least reflective cracking. Such observation indicated that using soft but modified asphalt binder could improve cracking resistance; adding more virgin asphalt binder into the mix can also increase the cracking resistance of asphalt binder mixes with RAP/RAS.

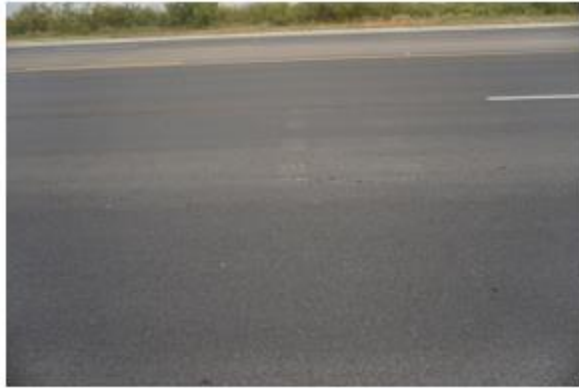
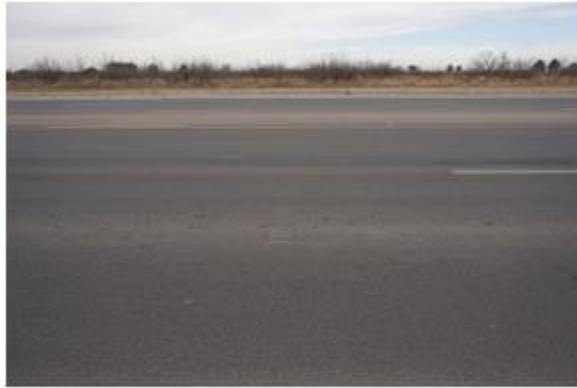
Figure 32. North Fairground Road Test Section 1: Survey Pictures.

Rutting/Cracking: None; Pull-Up: One
07/03/2017

Rutting/Cracking: None, Pull-Up: One
03/27/2018

Since the construction, the sections have been surveyed twice, on July 3, 2017, and March 27, 2018. Figure 32 and Figure 33 present the conditions of sections as observed in these two surveys. These sections have shown no distress to date except for one pull-up in Section 1.

Both these sections have exhibited no sign of rutting as of March 27, 2018 (Figure 32 and Figure 33).

Both these sections have exhibited no sign of any type of cracking as of March 27, 2018 (Figure 32 and Figure 33).

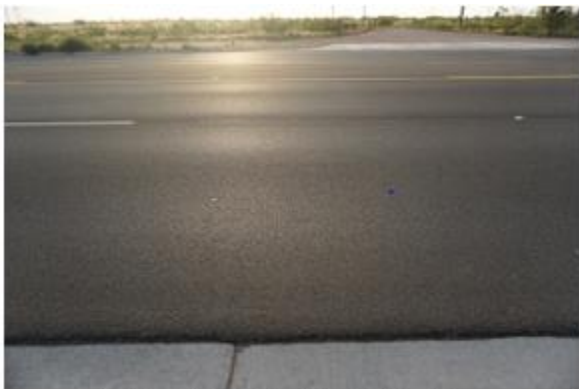
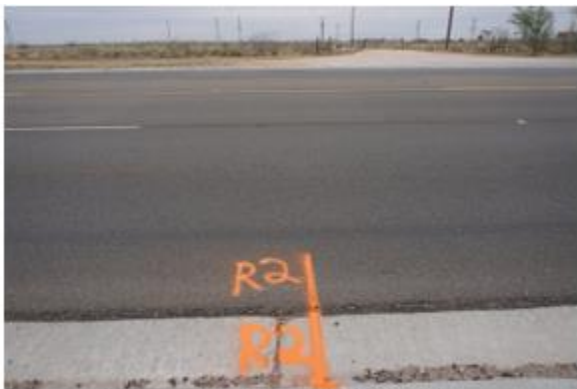
Figure 33. North Fairground Road Test Section 2: Survey Pictures.

Rutting/Cracking/Pull-Up: None
03/07/2017

Rutting/Cracking/Pull-Up: None
03/27/2018

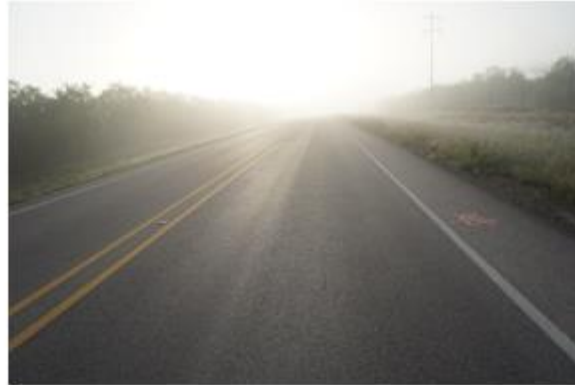
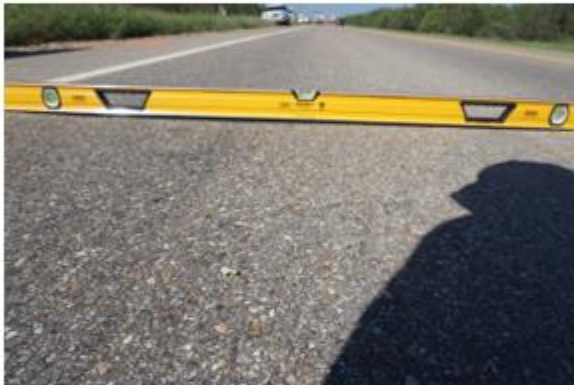
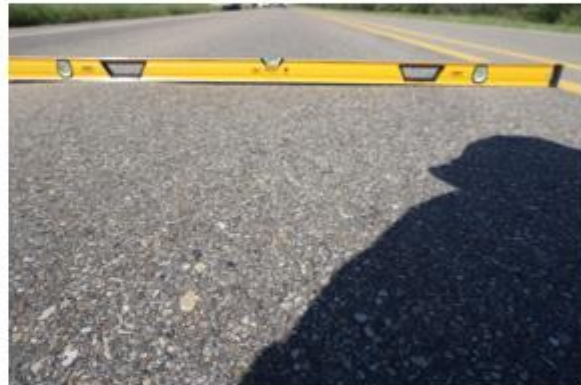
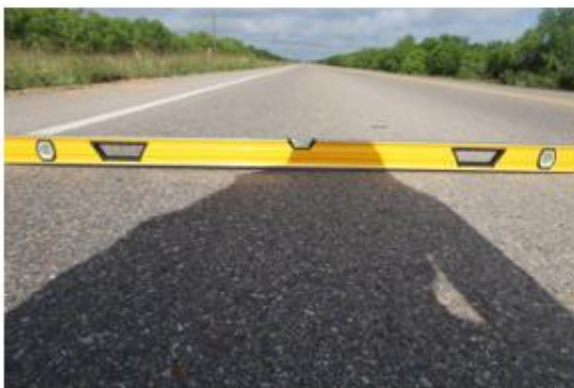
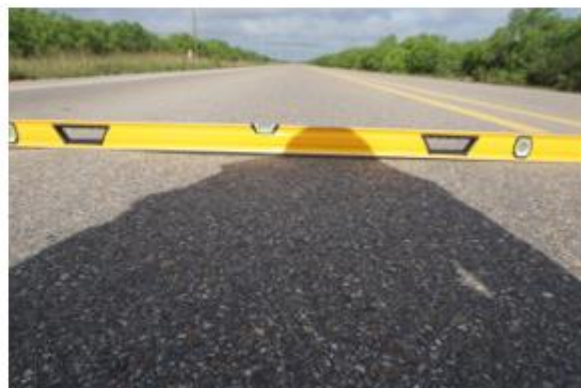
Figure 35. FM 468 Test Section 1: Survey Pictures.

No Cracking: 03/29/2017

Rutting in Outer Wheel Path: 1/16–8/16 in.
10/09/2017

Rutting in Inner Wheel Path: 1/16–8/16 in.
10/09/2017

Rutting in Outer Wheel Path: 1/16–8/16 in.
03/29/2018

Rutting in Inner Wheel Path: 1/16–8/16 in.
03/29/2018

Both sections showed no sign of rutting in the first survey conducted on April 8, 2016. When the sections were surveyed on October 9, 2017, both showed some rutting. Section 1 showed 1/16 to 8/16 in. of rut depth in outer wheel paths and 1/16 to 5/16 in. of rut depth in the inner wheel paths (see Figure 35). Similarly, Section 2 showed 1/16 to 2/16 in. in depth in outer wheel paths and 1/16 in. in the inner wheel paths (see Figure 36). When these sections were surveyed on March 29, 2018, they showed that rut depths barely increased in both these sections, possibly due to lower temperatures that are prevalent from October to March.

As of March 29, 2018, both these sections have exhibited no sign of cracking (see Figure 35 and Figure 36).

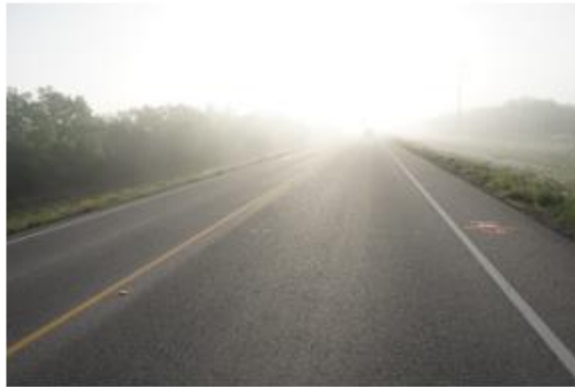
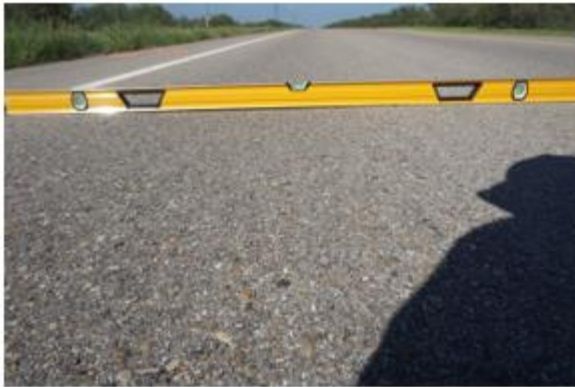
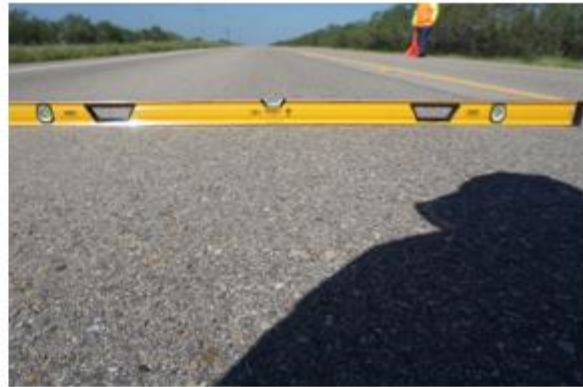
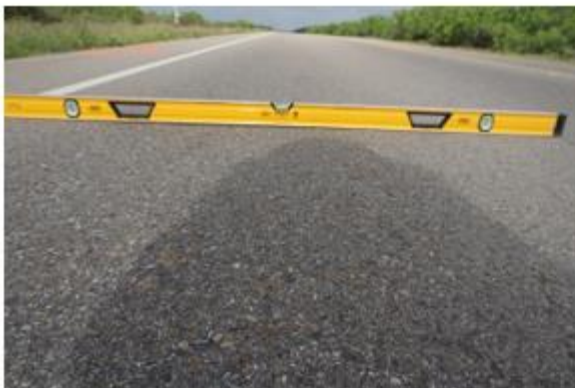
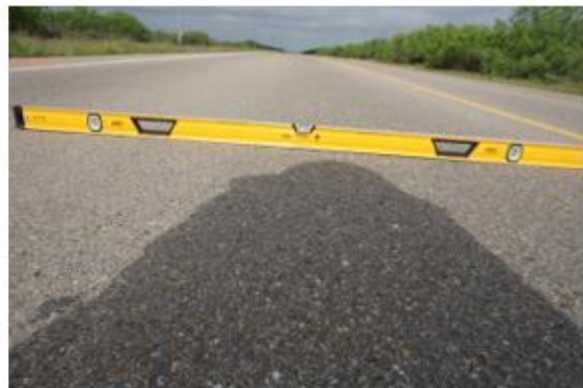
Figure 36. FM 468 Test Section 2: Survey Pictures.

No Cracking

Rutting in Outer Wheel Path: 1/16–2/16 in.

Rutting in Inner Wheel Path: 1/16 in.

Rutting in Outer Wheel Path: 2/16–3/16 in.

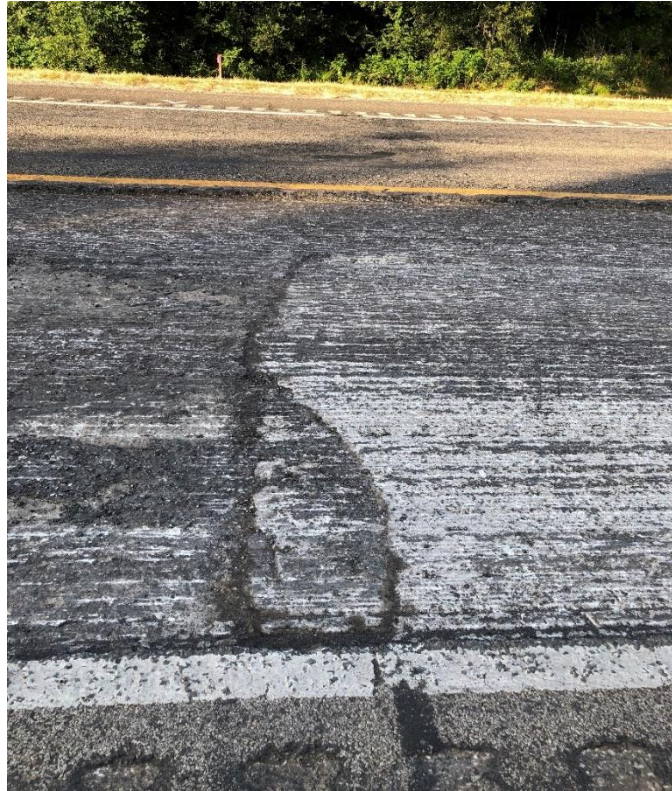
Figure 38. Example of SH 7 Pavement Condition after the 2-In. Milling.

Project SH 7 in the Bryan District is in Robertson County from the Robertson County line to FM 937 for a length of 5.10 miles. Figure 37 shows the project location. The existing maintenance strategy was to mill and inlay 2-in. asphalt overlay with Superpave-C mix with PG64-22. After discussing with the Bryan District and the contractor, the mix design for the test section was kept the same as the control mix except for switching the virgin binder to PG64-28 from PG64-22. Table 2 shows the mix compositions. The existing pavement condition of SH 7 looked poor. Distress, including fatigue cracking and transverse cracking, was observed. Even after the 2-in. milling in the night of June 18, 2020, some cracking could still be clearly observed, as shown in Figure 38.

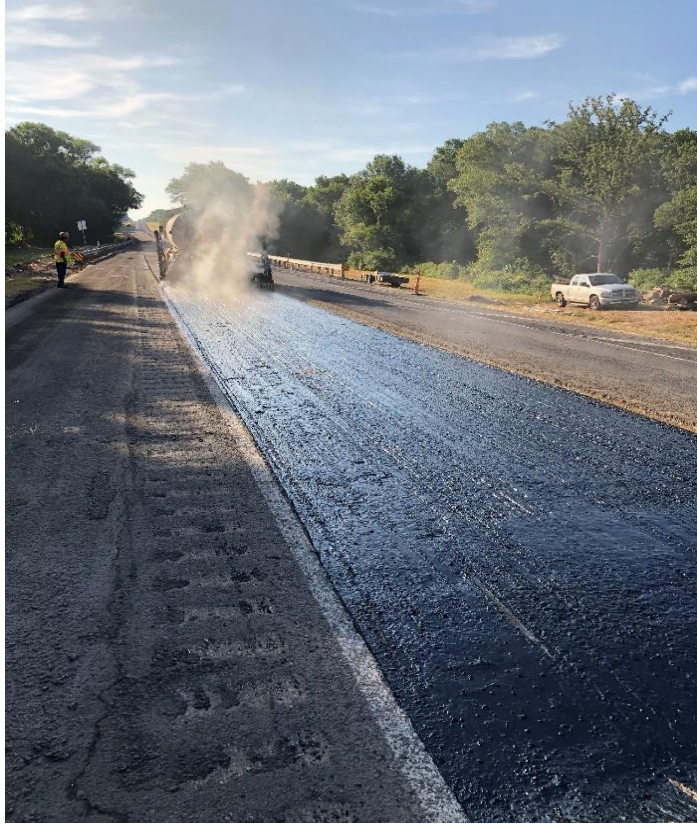
Figure 39. Applying Tack Coat.

The construction of the field test sections on westbound SH 7 started in the morning of June 19, 2020, but the paving direction was toward the east. The test section with PG64-28 was paved first, followed by the test section with PG64-22. The construction process included asphalt tack coat (Figure 39), paving (Figure 40), and compaction (Figure 41).

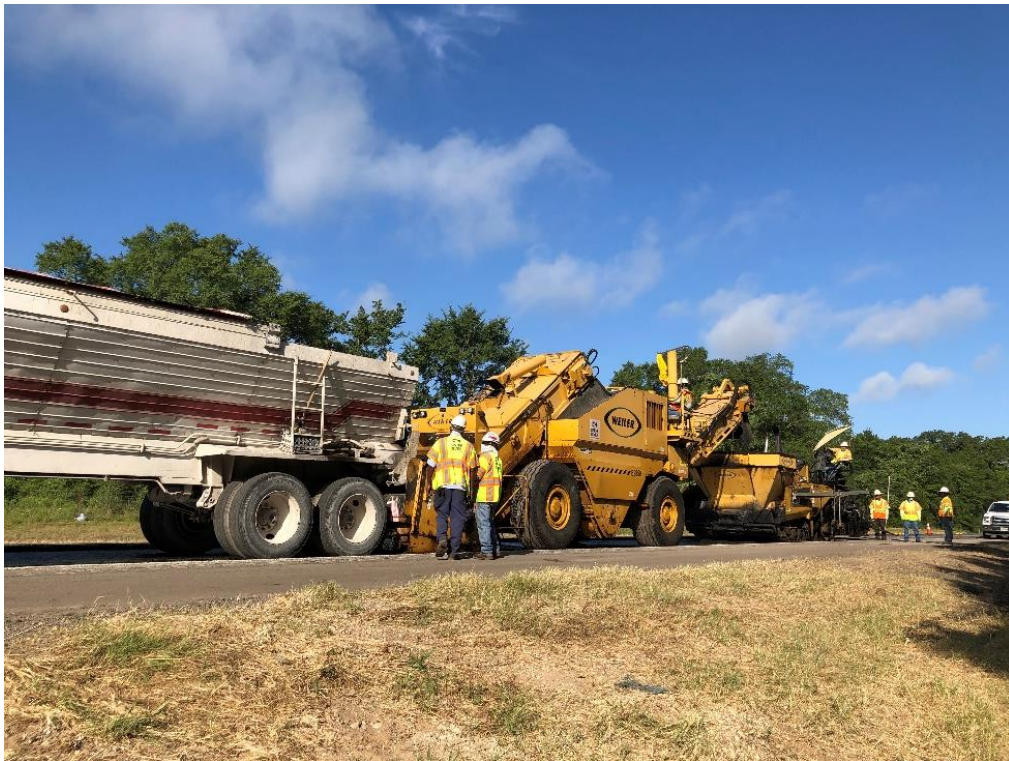
Figure 40. Paving Asphalt Mix.

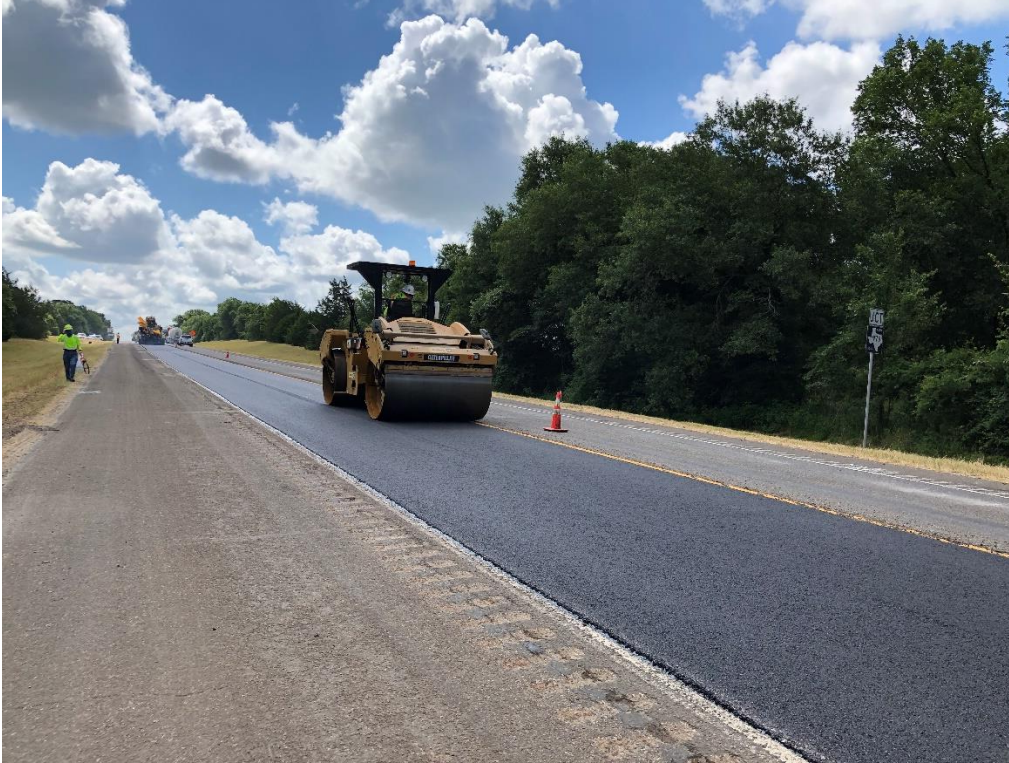
Figure 41. Compacting the Mat.

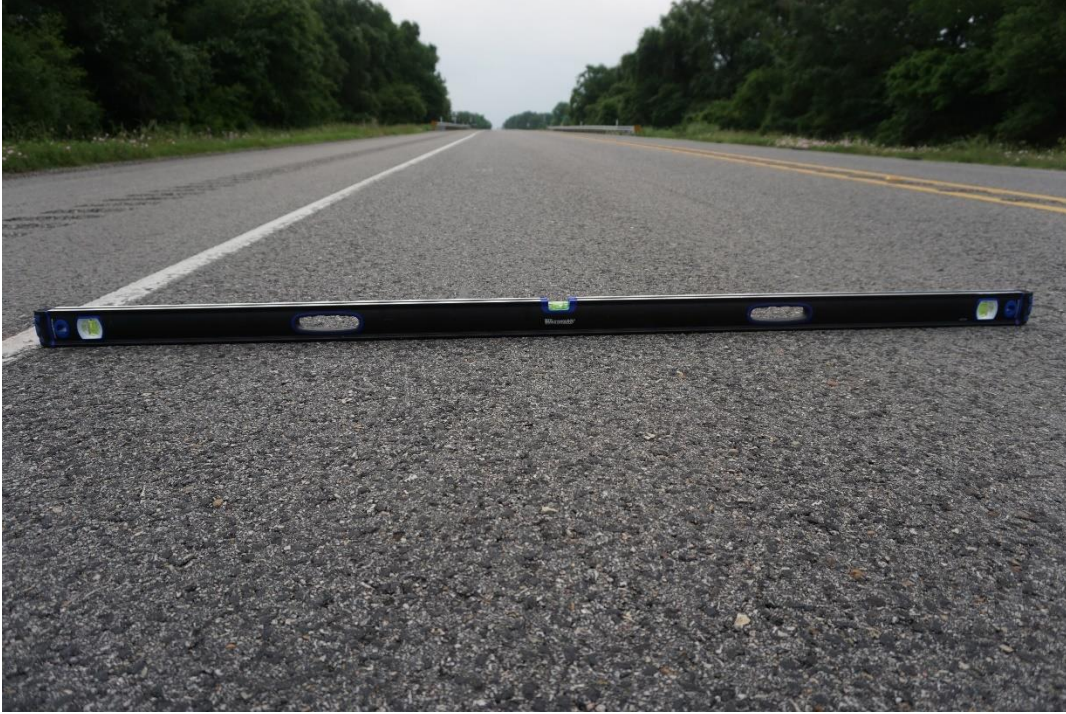
Figure 42. No Rutting on Both Test Sections on SH 7.

Since the construction in June 2020, the research team has continuously monitored the sections. The latest field survey was completed on May 5, 2022. No rutting was observed in either test section (Figure 42). Two cracks were observed on the control test section with PG64-22, as shown in Figure 43. No cracking was seen on the test section with PG64-28 (Figure 44).

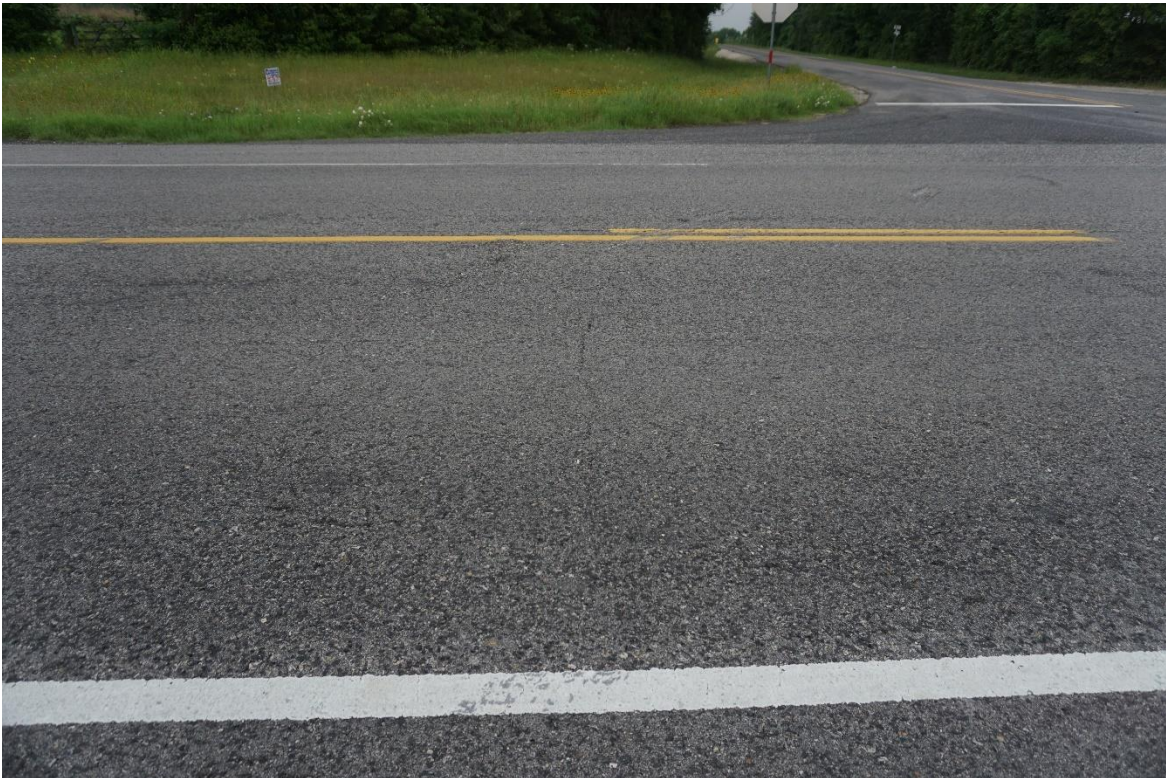
Figure 43. Cracking Observed on Control Section with PG64-22.

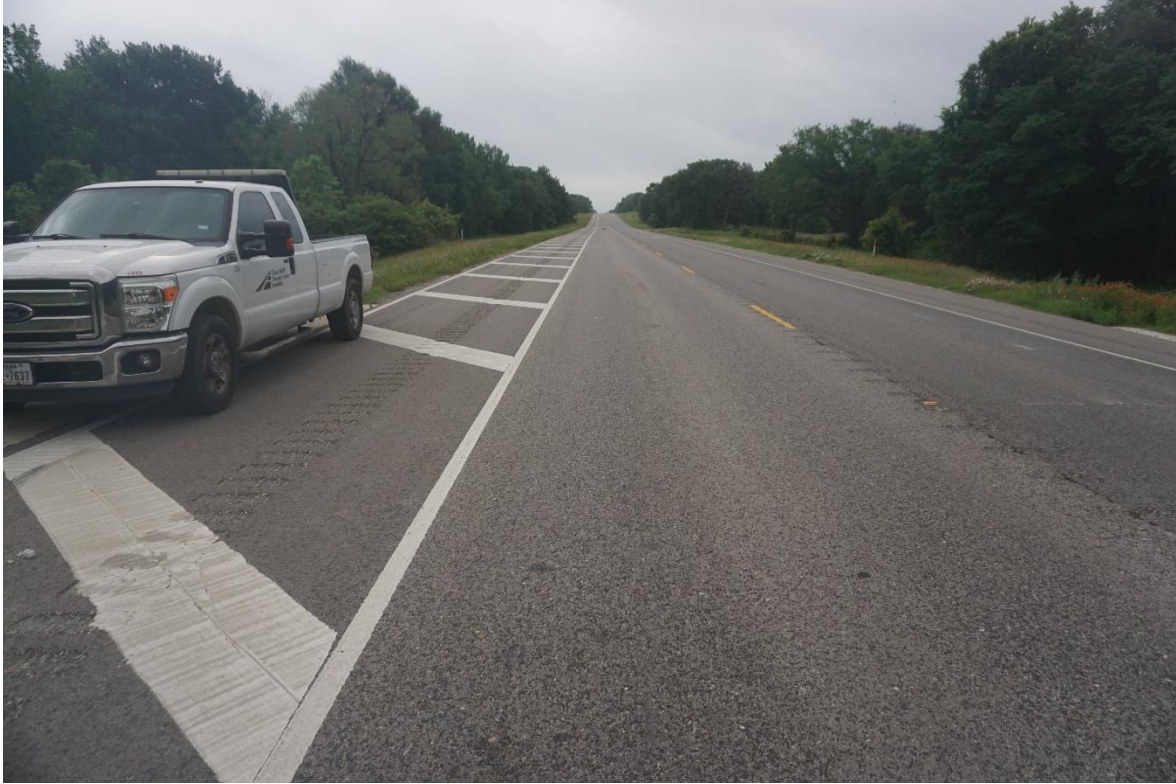
Figure 44. No Cracking on Test Section with PG64-28.

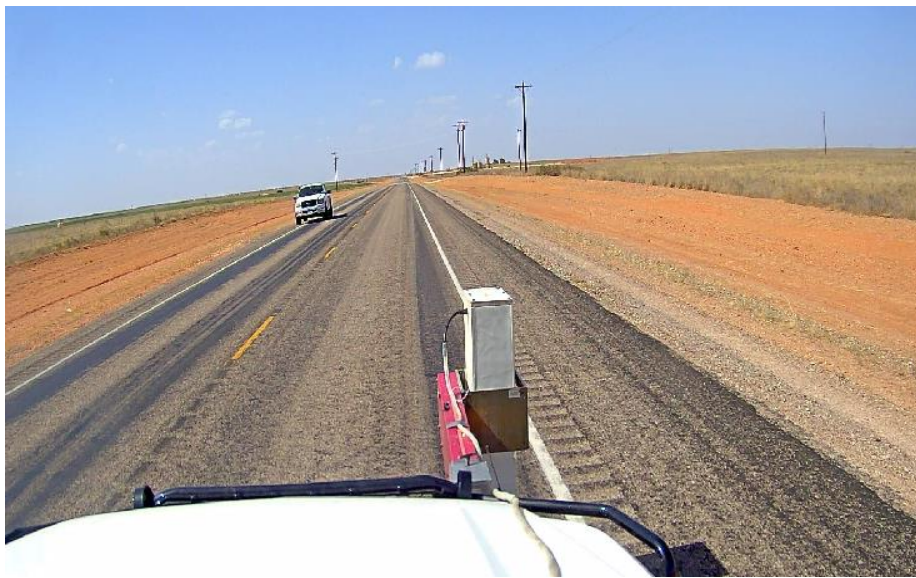
Figure 46. Pavement Condition of SH 214.

Project SH 214 is located in Yoakum County from the Yoakum County line to US82, as shown in Figure 45. The existing pavement has multiple seal coats with transverse cracking (Figure 46). The original pavement rehabilitation strategy includes a 0.75-in. level-up with Ty-D, fabric interlayer (to stop cracking), and a 1.75-in. overlay with stone-matrix asphalt (SMA)-C and PG70-28. After discussions with the Lubbock District and the contractor, all the level-up layer and fabric and SMA-C mix designs were kept the same for the test section. The only change was to the virgin binder of the SMA-C mix, switching to PG64-34 from PG70-28. Table 4 lists the mix compositions.

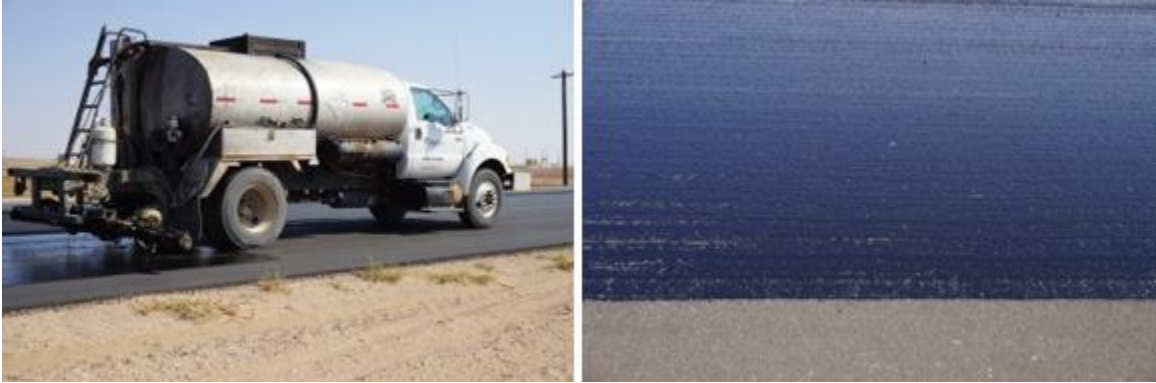
Figure 47. Applying Tack Coat.

The construction of the field test sections on southbound SH 214 started in the morning of October 8, 2020. The test section with PG64-34 was paved first, followed by the test section with PG70-28. The construction process included asphalt tack coat (Figure 47), fiberglass fabric interlayer (Figure 48), paving (Figure 49), and compaction (Figure 50).

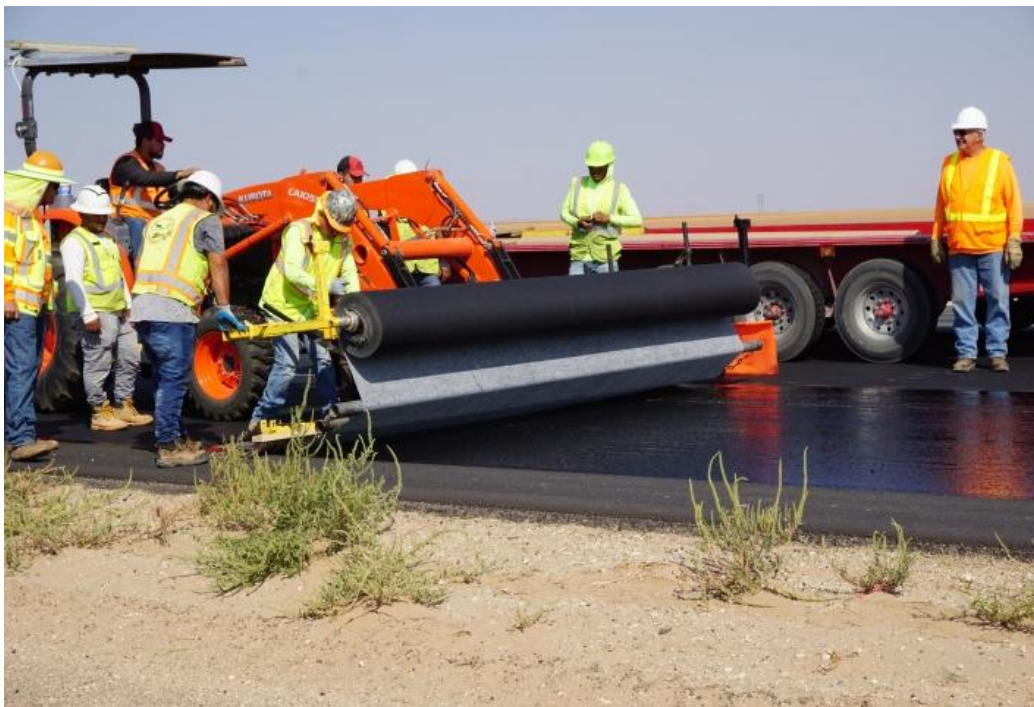
Figure 48. Paving Fiberglass Fabric Interlayer.

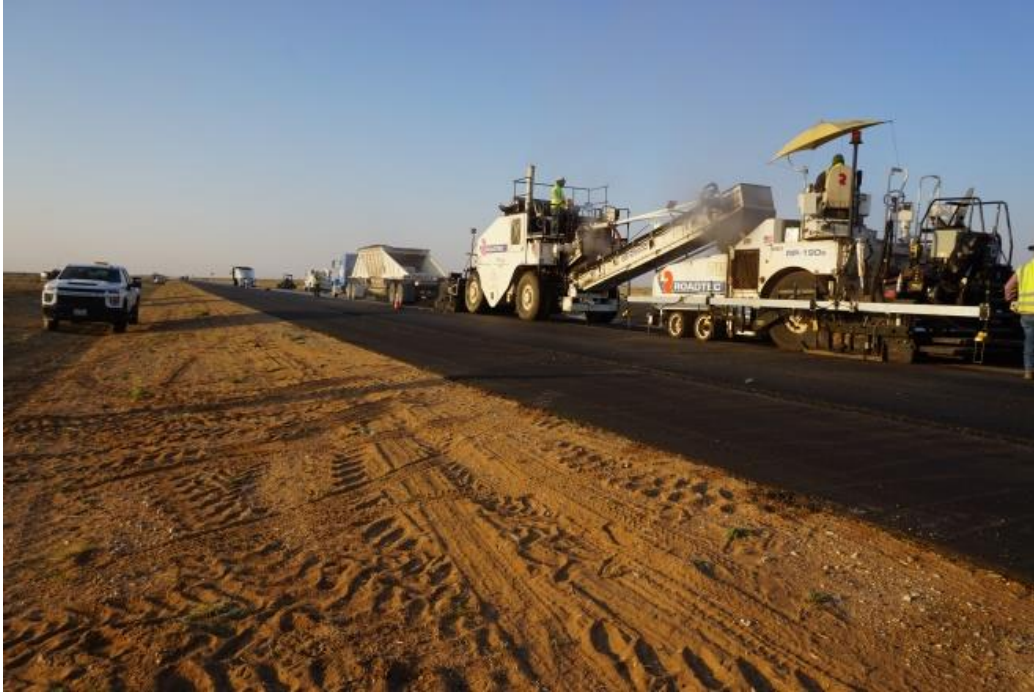
Figure 49. Paving Asphalt Mix.

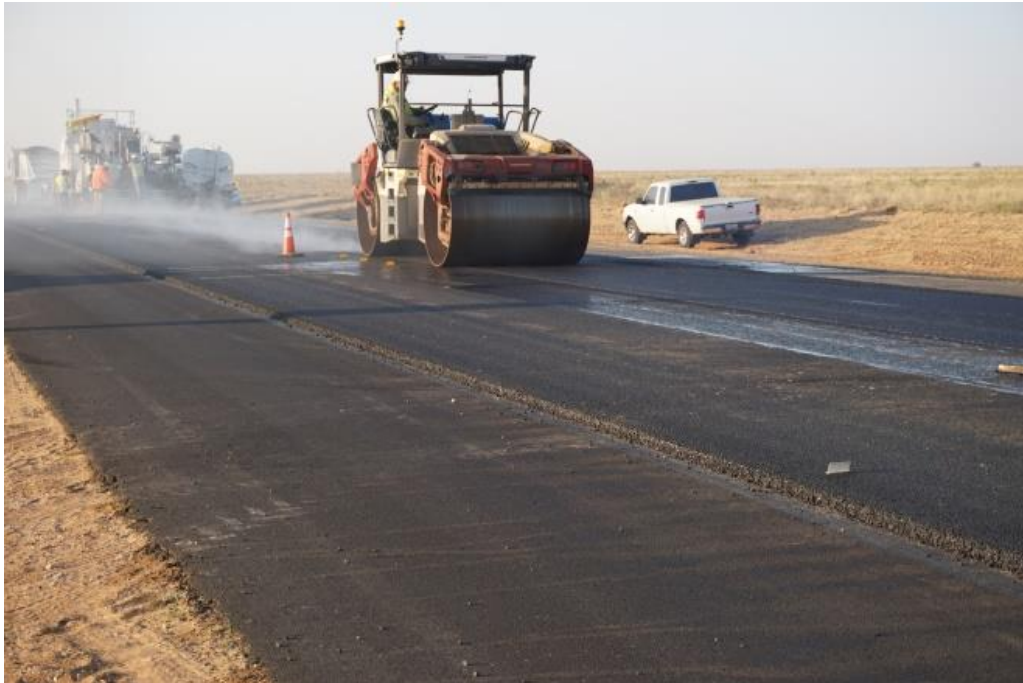
Figure 50. Compacting the Mat.

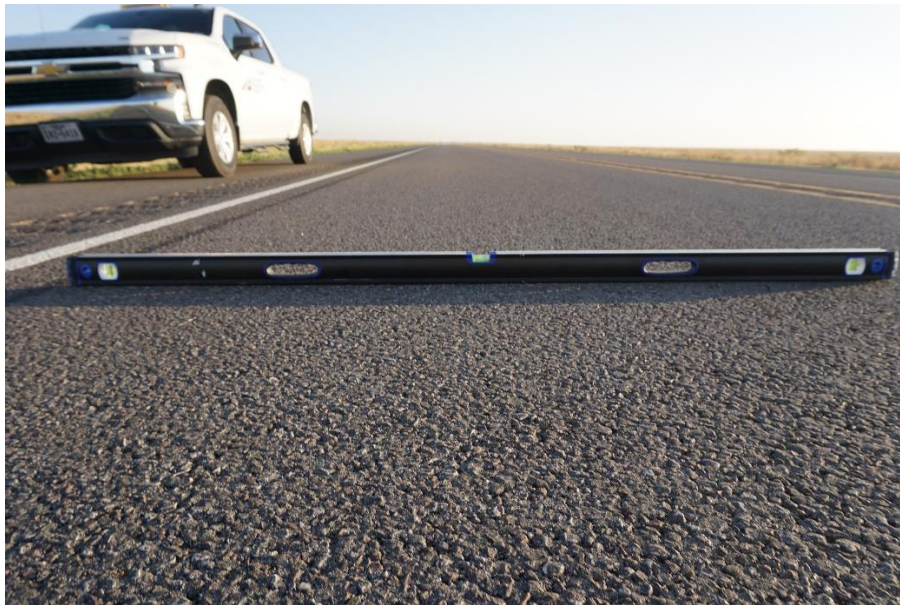
Figure 51. No Rutting on the Test Section with PG64-34 on SH 214.

Since the construction in April 2021, researchers have continuously monitored the sections. The latest field survey was completed on May 10, 2022. Neither rutting nor cracking was observed in either test section, as shown in Figure 51 through Figure 54.

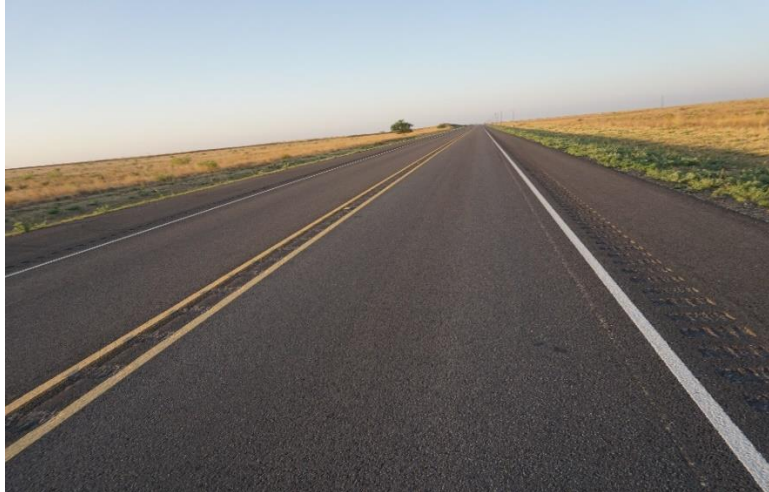
Figure 52. No Cracking on the Test Section with PG64-34 on SH 214.
