Laboratory and Field Performance of PGxx-28 and PGxx-34 Binders and New Binder Type Selection Catalog

Technical Report 5-6674-01-R1

TEXAS A&M TRANSPORTATION INSTITUTE
COLLEGE STATION, TEXAS

sponsored by the
Federal Highway Administration and the
Texas Department of Transportation
<https://tti.tamu.edu/documents/5-6674-01-R1.pdf>

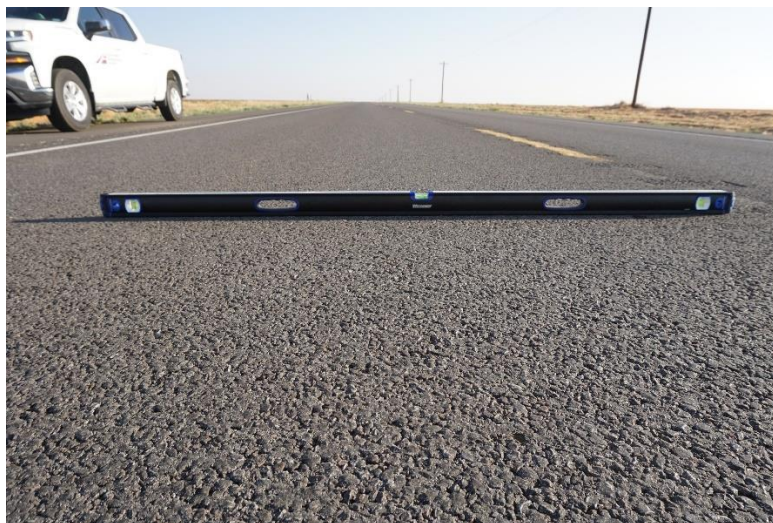
Figure 53. No Rutting on the Test Section with PG70-28 on SH 214.

Since the construction in April 2021, researchers have continuously monitored the sections. The latest field survey was completed on May 10, 2022. Neither rutting nor cracking was observed in either test section, as shown in Figure 51 through Figure 54.

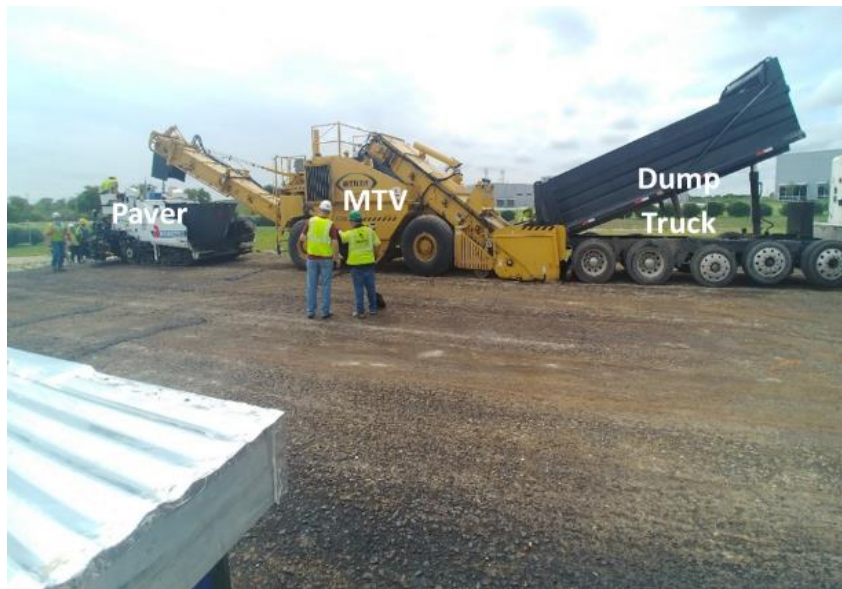
Figure 57. Paving Operation at Dallas Test Sections.

Mix 2 with PG70-22 was paved on September 3, 2020, and Mix 4 with PG64-28 was paved on September 4, 2020. The paving and compaction process is shown in Figure 57 and Figure 58, respectively.

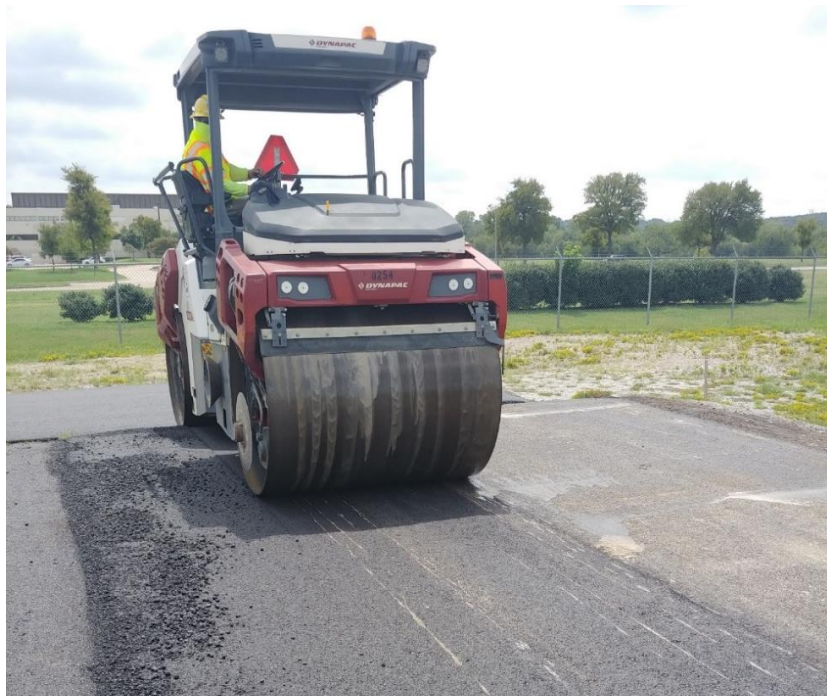
Figure 58. Compacting Test Sections at Dallas Test Sections.

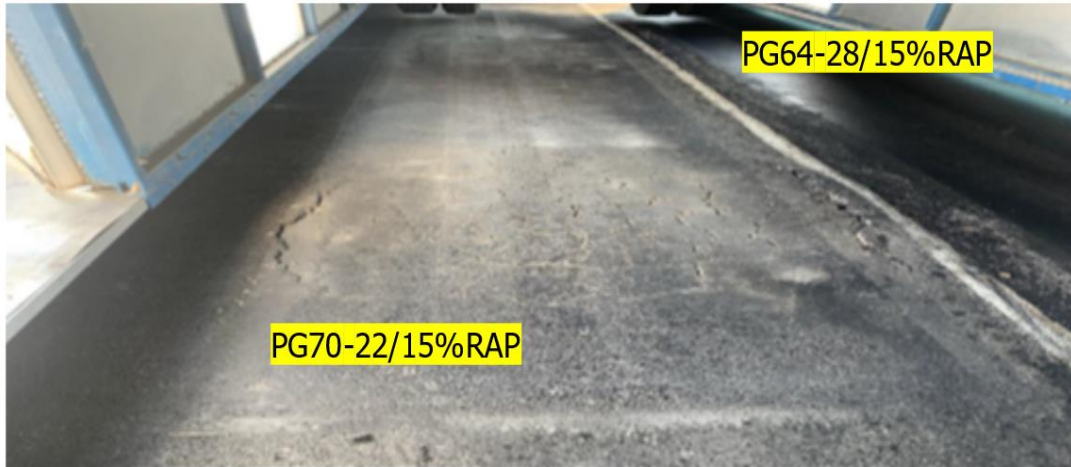
Figure 59. Fatigue Cracking on Test Section O with PG70-22 (Left) and Section P with PG64-28 (Right).

- Mix 2: PG70-22 with 15% RAP -64% fatigue cracking after 350,000 passes
- Mix 4: PG64-28 with 15% RAP -57% fatigue cracking after 350,000 passes

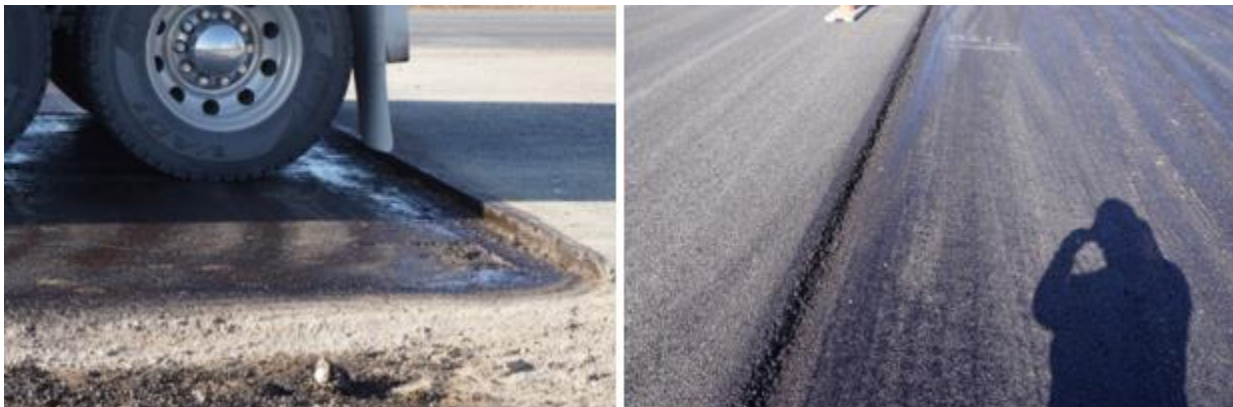
Figure 61. Applying Tack Coat on FM 2105.

The field test sections were paved on the westbound of FM 2105 on April 1, 2021. The test section with PG70-28 was first paved, followed by the control section with PG70-22. The construction process included 1) asphalt tack coat (Figure 61), 2) paving the mixes (Figure 62), and 3) compaction (Figure 63).

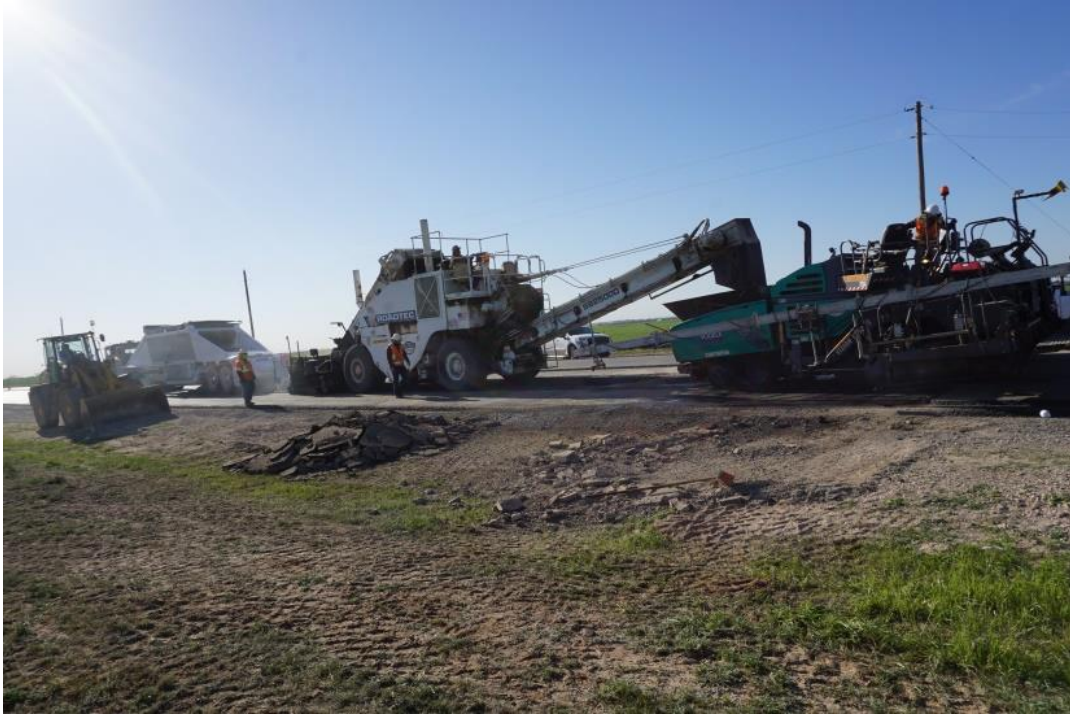
Figure 62. Paving Operation on FM 2105.

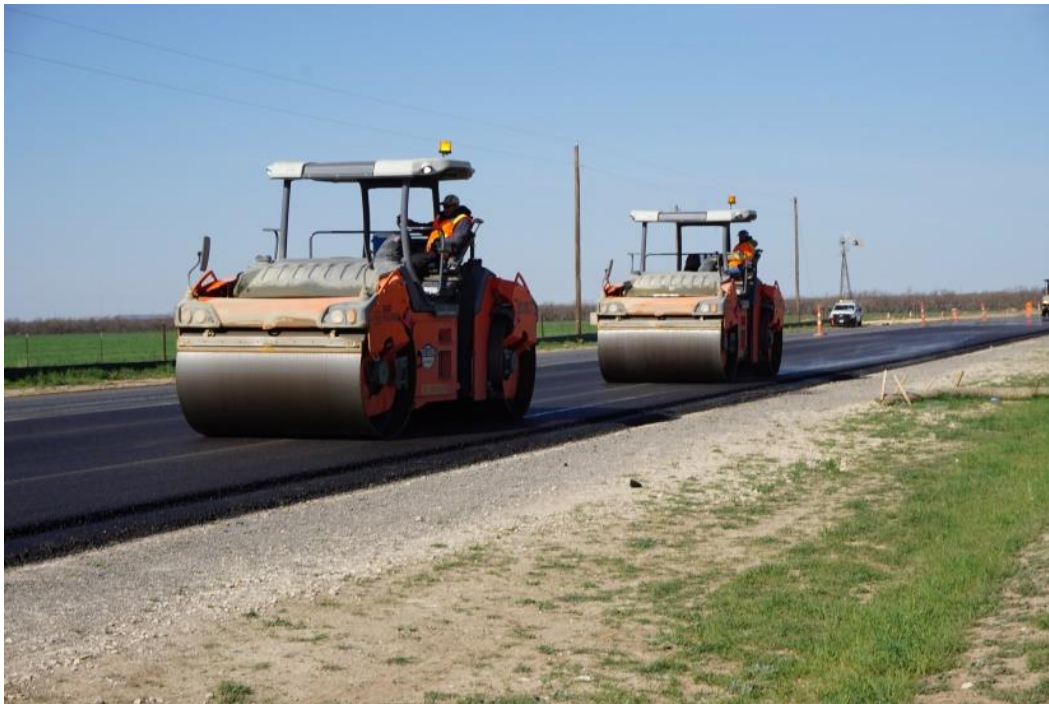
Figure 63. Compacting Test Sections on FM 2105.

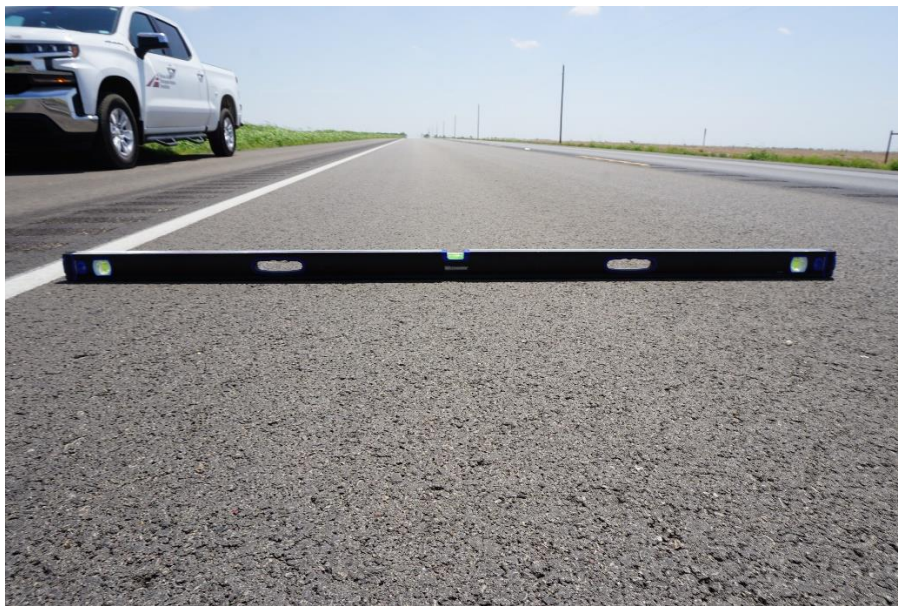
Figure 64. No Rutting on the Test Section with PG70-28 on FM 2105.

Since the construction in April 2021, the research team has continuously monitored the sections. The latest field survey was completed on May 11, 2022. Neither rutting nor cracking was observed in either test section, as shown in Figure 64 through Figure 67.

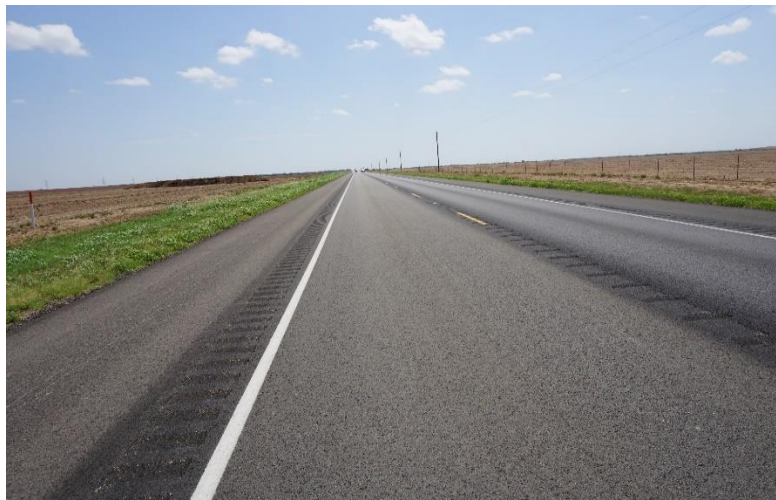
Figure 65. No Cracking on the Test Section with PG70-28 on FM 2105.

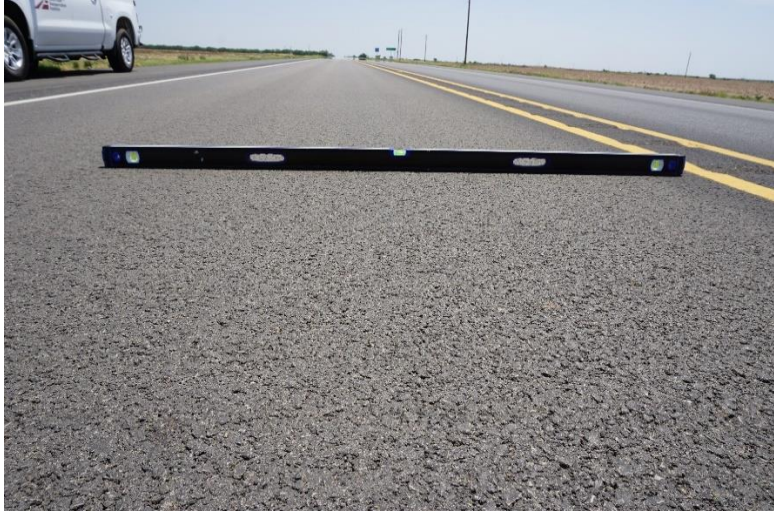
Figure 66. No Rutting on the Test Section with PG70-22 on FM 2105.

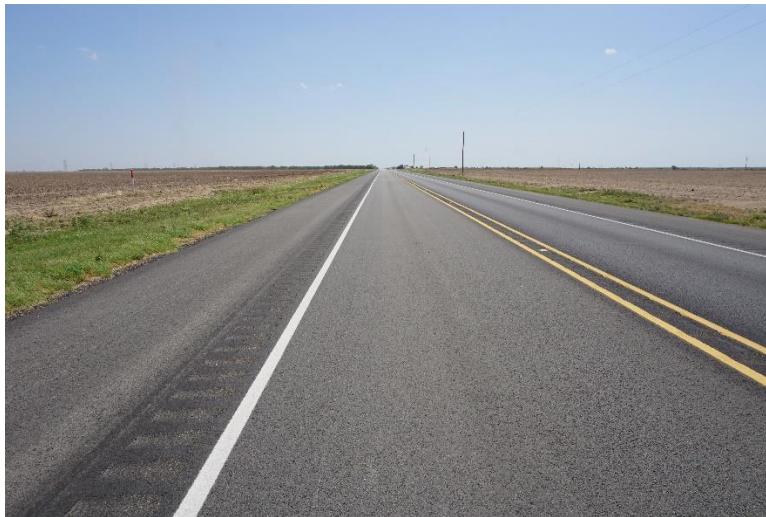
Figure 67. No Cracking on the Test Section with PG70-22 on FM 2105.

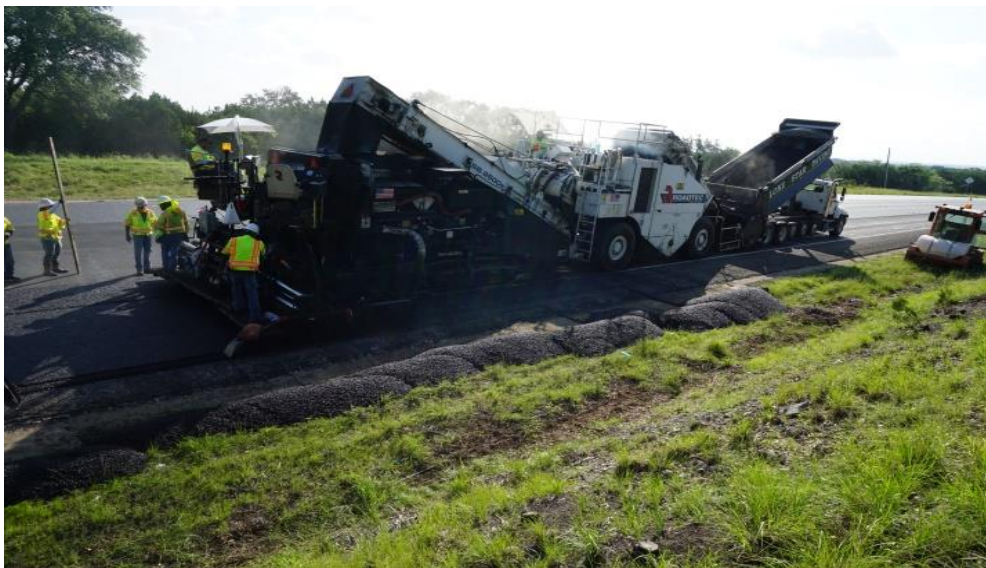
Figure 69. Paving Operation on SH 71.

The field test sections were paved on eastbound SH 71 on June 11, 2021. The test section with PG70-28 was first paved, followed by the control section with PG70-22. Figure 69 and Figure 70 show the construction process.

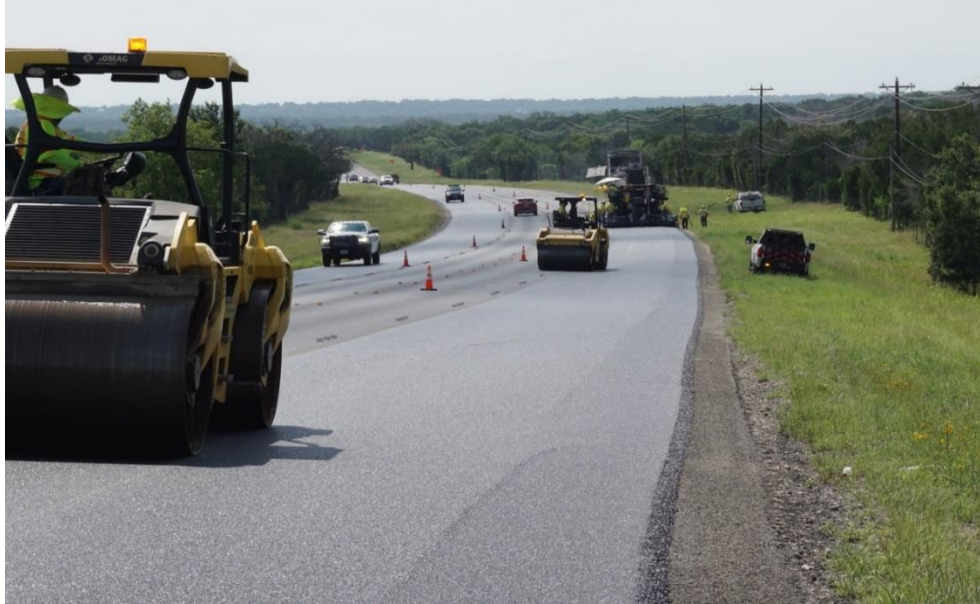
Figure 70. Compaction Operation on SH 71.

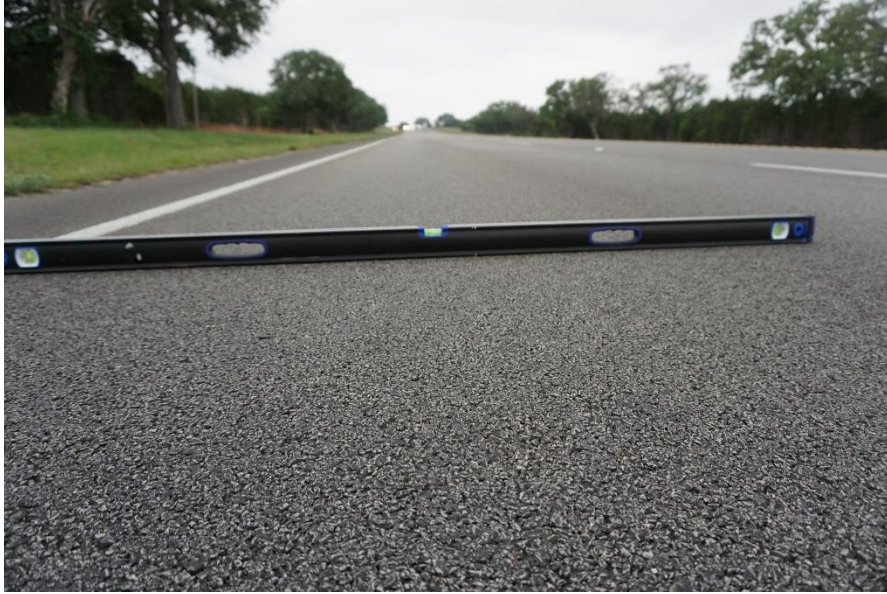
Figure 71. No Rutting on the Test Section with PG70-28 on SH 71.

Since the construction in June 2021, the research team has been monitoring the sections. The latest field survey was completed on May 4, 2022. Neither rutting nor cracking was observed in either test section, as shown in Figure 71 through Figure 74.

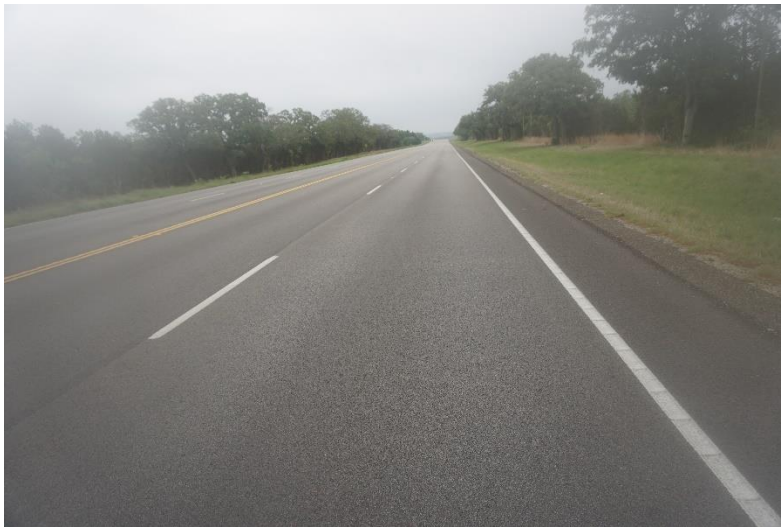
Figure 72. No Cracking on the Test Section with PG70-28 on SH 71.

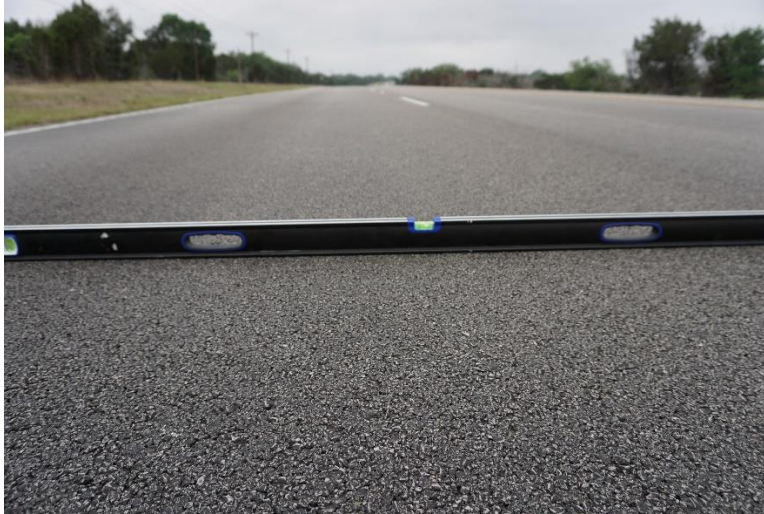
Figure 73. No Rutting on the Test Section with PG70-22 on SH 71.

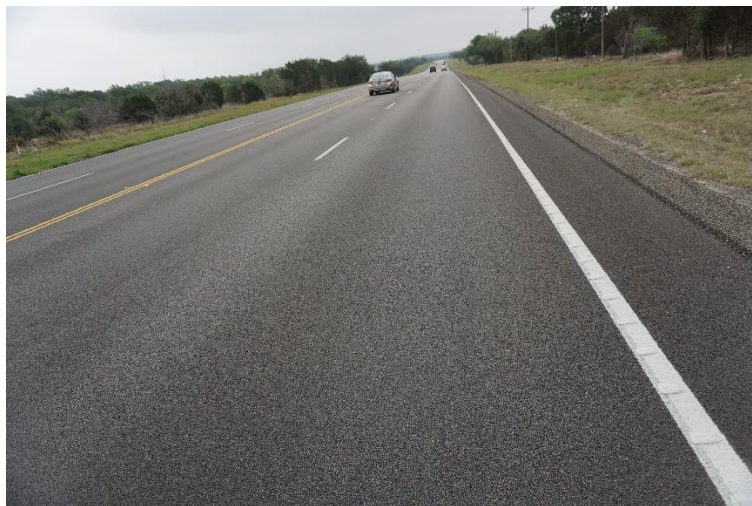
Figure 74. No Cracking on the Test Section with PG70-22 on SH 71.

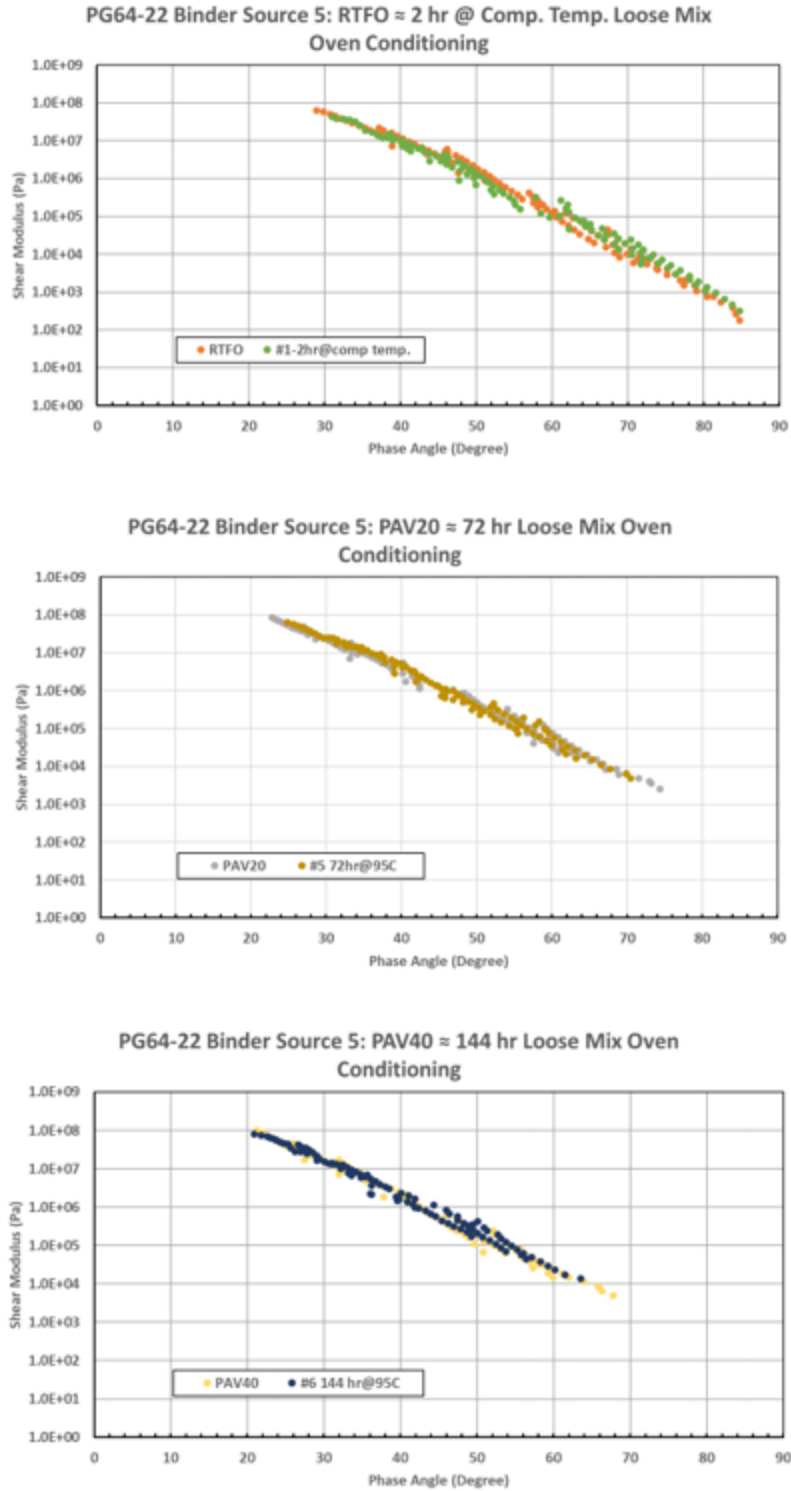
Figure 86. Comparison between Binder RTFO, PAV20, PAV40 Aging, and Loose Mix Oven Conditioning.
