CRASH TESTING AND EVALUATION OF THE TXDOT SHORT-SPAN SHORT-RADIUS GUARDRAIL SYSTEM

Test Report 9-1002-15-9

1. Report No. FHWA/TX-17/9-1002-15-9		2. Government Accession No.		3. Recipient's Catalog No.	
4. Title and Subtitle CRASH TESTING AND EVALUATION OF THE TXDOT SHORT-SPAN SHORT-RADIUS GUARDRAIL SYSTEM				5. Report Date Published: January 2018

16. Abstract <p>This research evaluated the impact performance of the TxDOT short-span short-radius guardrail system according to the safety-performance evaluation guidelines included in American Association of State Highway and Transportation Officials, entitled <i>Manual for Assessing Safety Hardware (MASH)</i> for Test Level Three (TL-3).</p> <p>This report describes the TxDOT short-span short-radius guardrail system, documents the impact performance of the guardrail system according to <i>MASH</i> TL-3 evaluation criteria, and presents recommendations for implementation.</p> <p>The short-span short-radius guardrail system performed acceptably according to <i>MASH</i> for modified tests 3-33 and 3-32.</p>

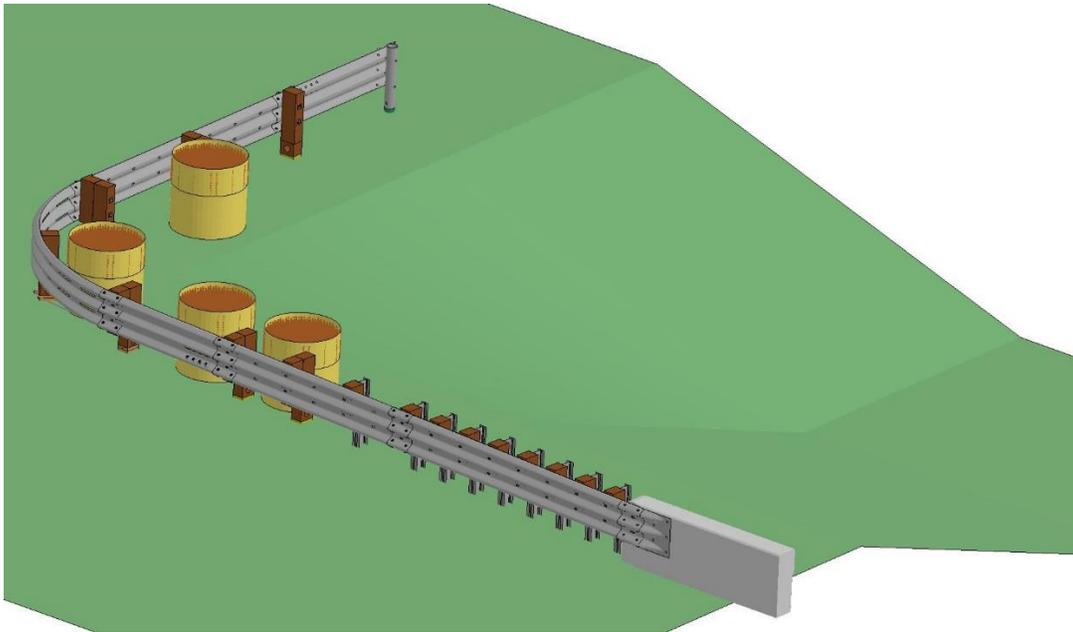
Figure 2.1. Isometric View of Short Radius Guardrail.

The model of the short-radius guardrail system consists of a steel thrie-beam representing the short radius system and four 700-lb sand barrels placed on the inner side of the short radius. The rail is supported by a rigid rotating anchor post on one end, and it is attached to a rigid concrete parapet at the other end. Figure 2.1 shows an isometric view of the model. The model includes a representation of ditch placed 5 ft offset from the thrie-beam on each side. The ditch is sloped at 3H:1V starting at the 5-ft offset.

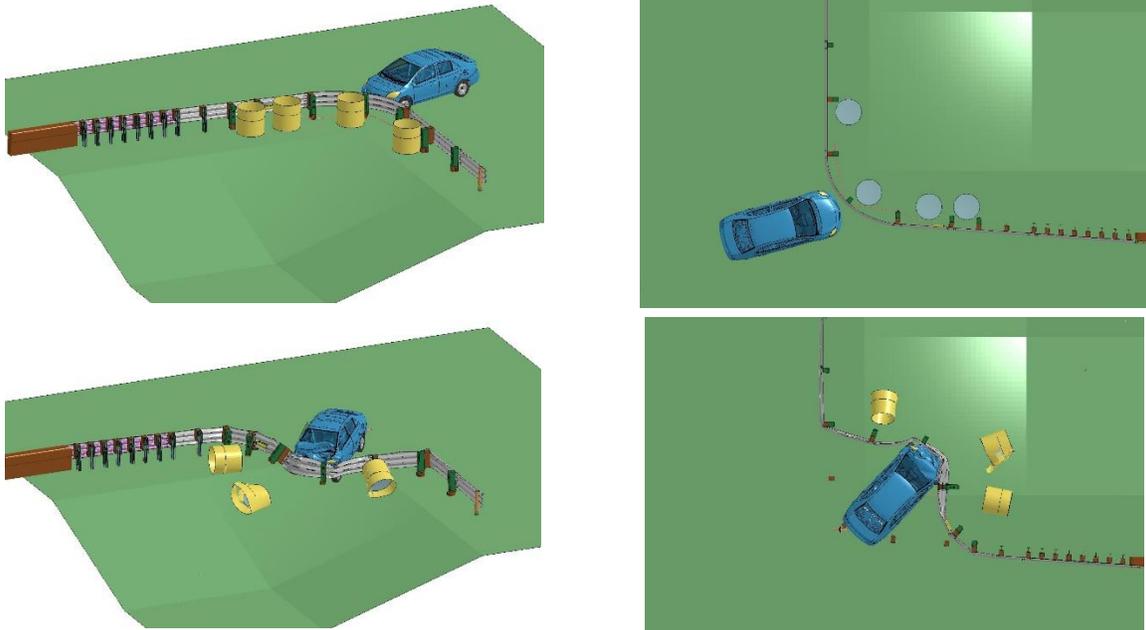
Figure 2.2. Small Car Impact with Four Barrel System Short Radius (Case #1).

Figures 2.2 and 2.3 show that the short radius successfully contained the vehicle. The hood sustained damage as shown in Figure 2.4, but the vehicle did not underride the rail.

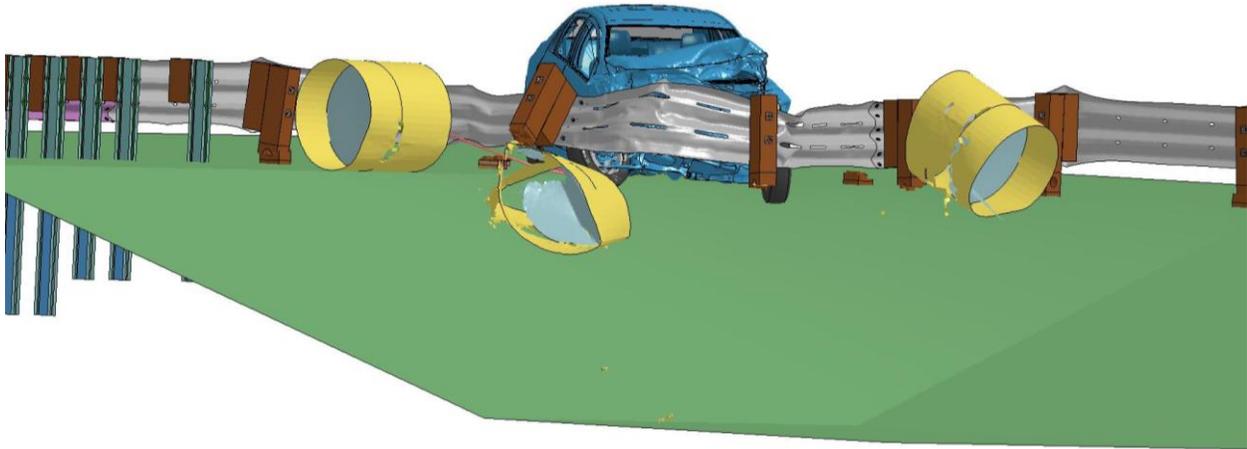
Figure 2.3. Small Car Interaction with Short Radius during Impact (Case #1).

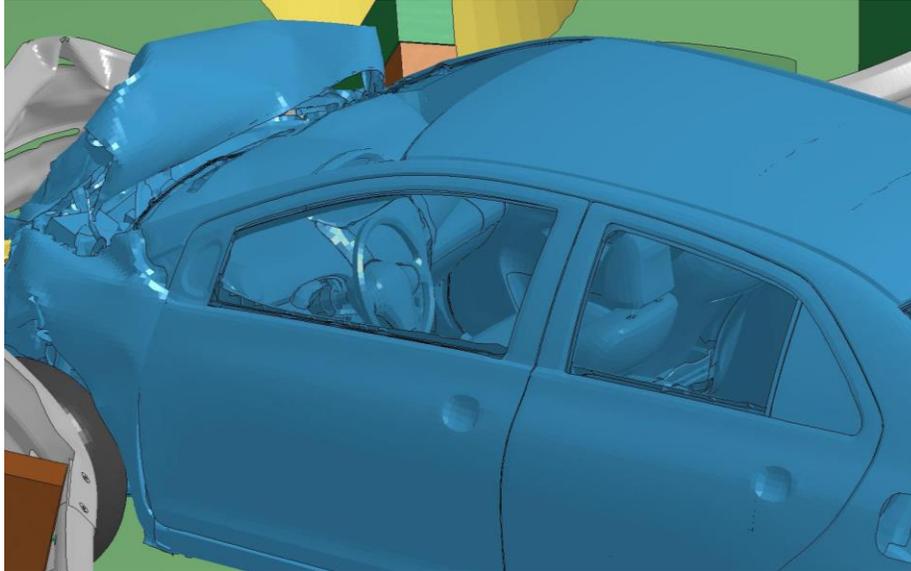
Figure 2.4. Side View of Small Car after Collision (Case #1).

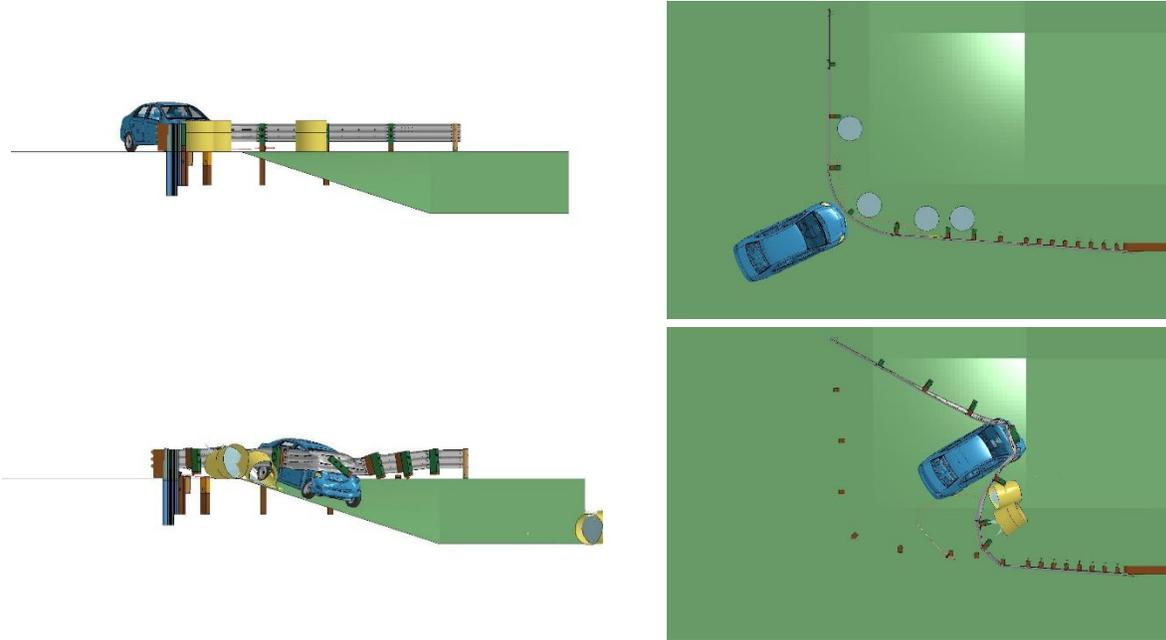
Figure 2.5. Photos from Simulation before and after Collision (Case #2).

The impact angle for this simulation was 25° from the face of the parapet, and the impact point was at the nose of the radius. This impact angle was chosen to check the system adequacy to this impact angle that is used for redirecting impacts. Figure 2.5 shows that the short radius with four barrels successfully contained the vehicle. However, Figures 2.6 and 2.7 indicate that there is a greater potential for the vehicle to under ride as compared the 15° impact angle simulation in Case #1. Hence, an impact angle of 25° seems to be more critical for the short radius with 3H:1V ditch than an impact angle of 15°.

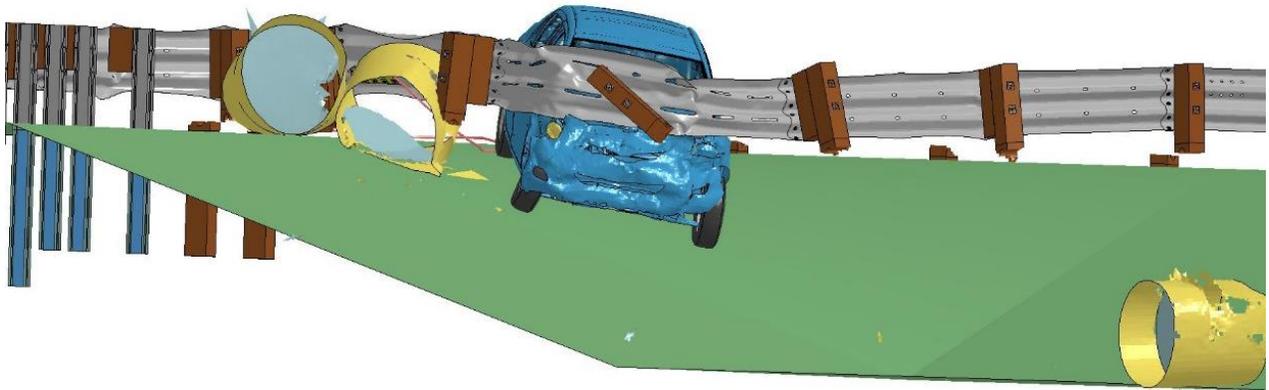
Figure 2.6. Front View of Vehicle after Collision (Case #2).

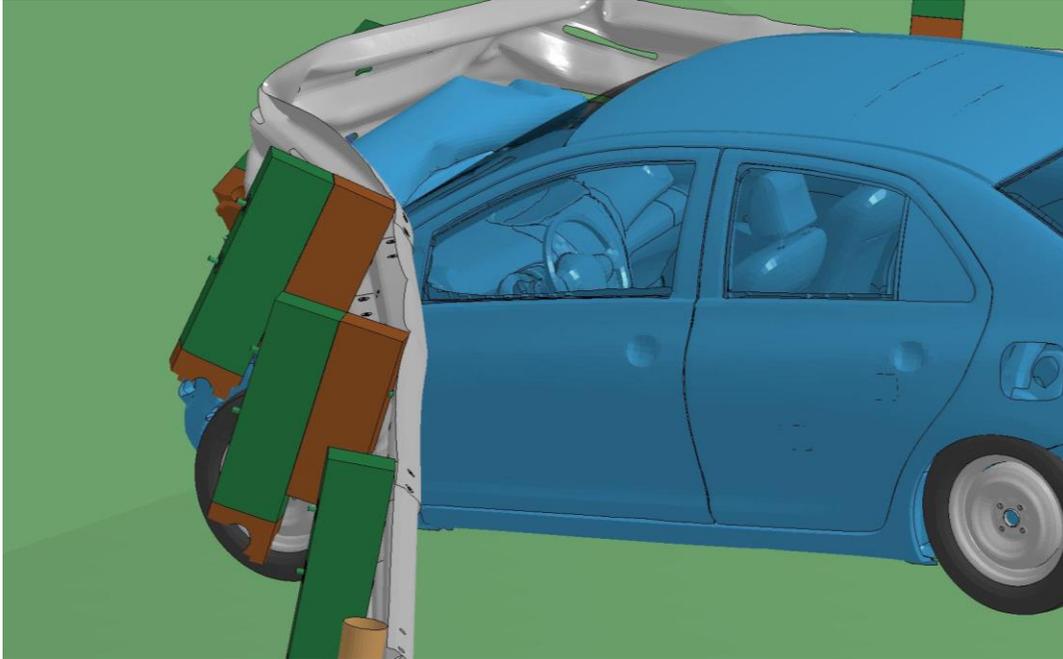
Figure 2.7. Side View of Vehicle after Collision (Case #2).

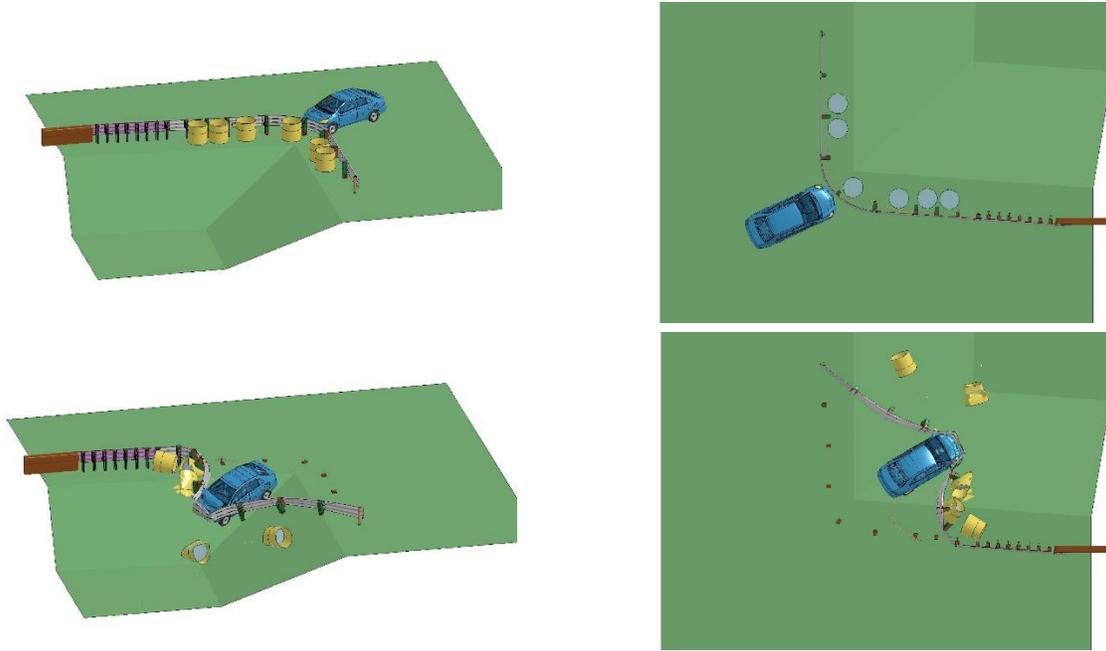
Figure 2.8. Photos from Simulation before and after Collision with Short Radius (Case #3).

This simulation represents a design solution to reduce the under-ride potential observed in Case #2. The impact angle is 25° from the face of the parapet, but the number of barrels was increased to six as a design change that is simple to implement since structural components of the system were not changed.

Figure 2.8 shows the short radius with six sand barrels successfully contain the vehicle. The increased number of sand barrels reduced the potential of underride of the rail as shown in Figure 2.9. The hood buckled inward but did not interact with the windshield of the car as shown in Figure 2.10.

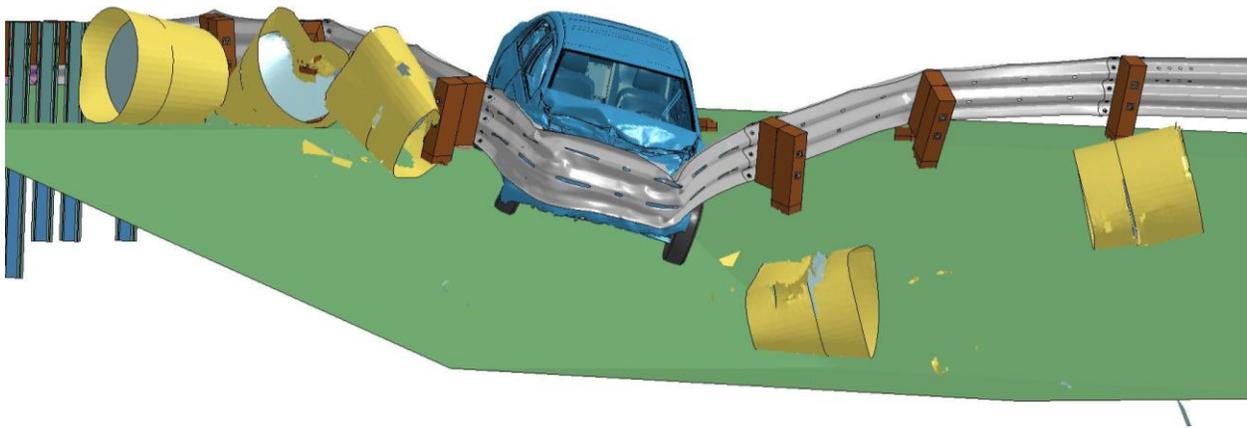
Figure 2.9. Front View of Vehicle after Collision (Case #3).

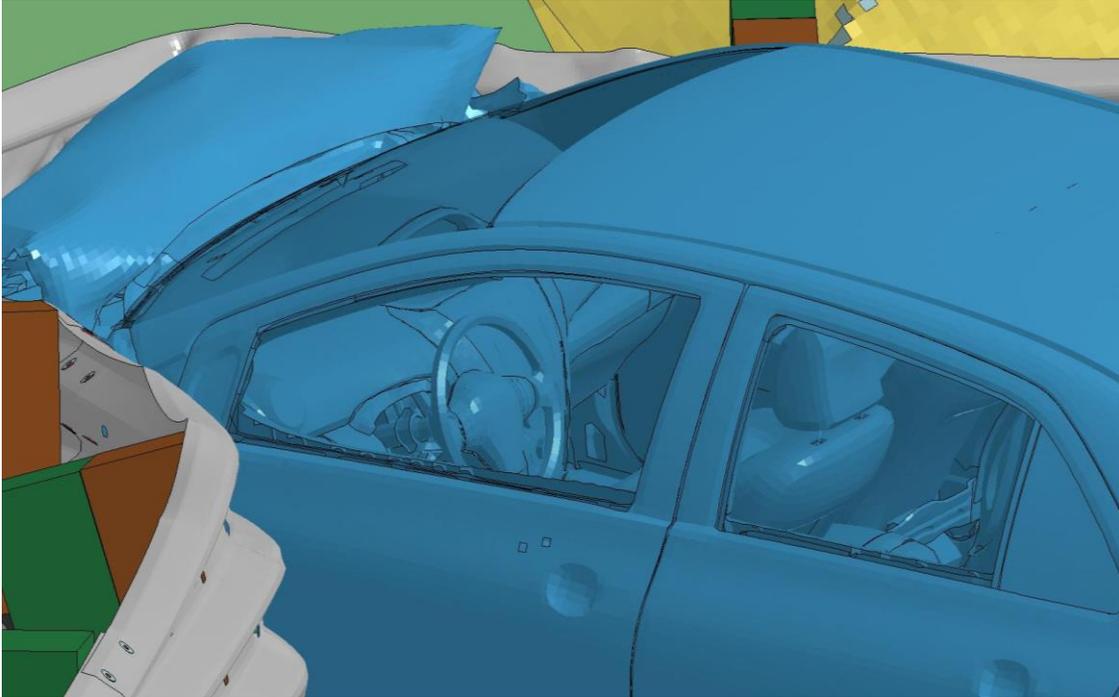
Figure 2.101. Side View of Vehicle after Collision (Case #3).

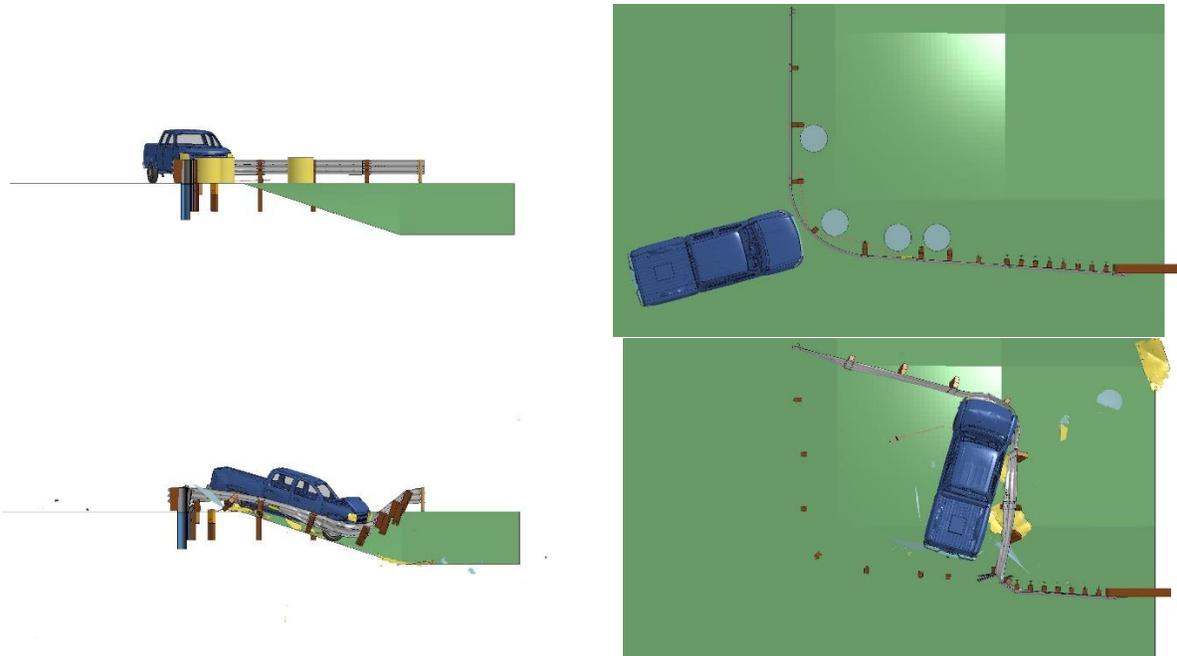
Figure 2.11. Photos from Simulation before and after Collision (Case #4).

Figure 2.11 shows that the short radius with four sand barrels successfully contained the truck with no over-riding issues.

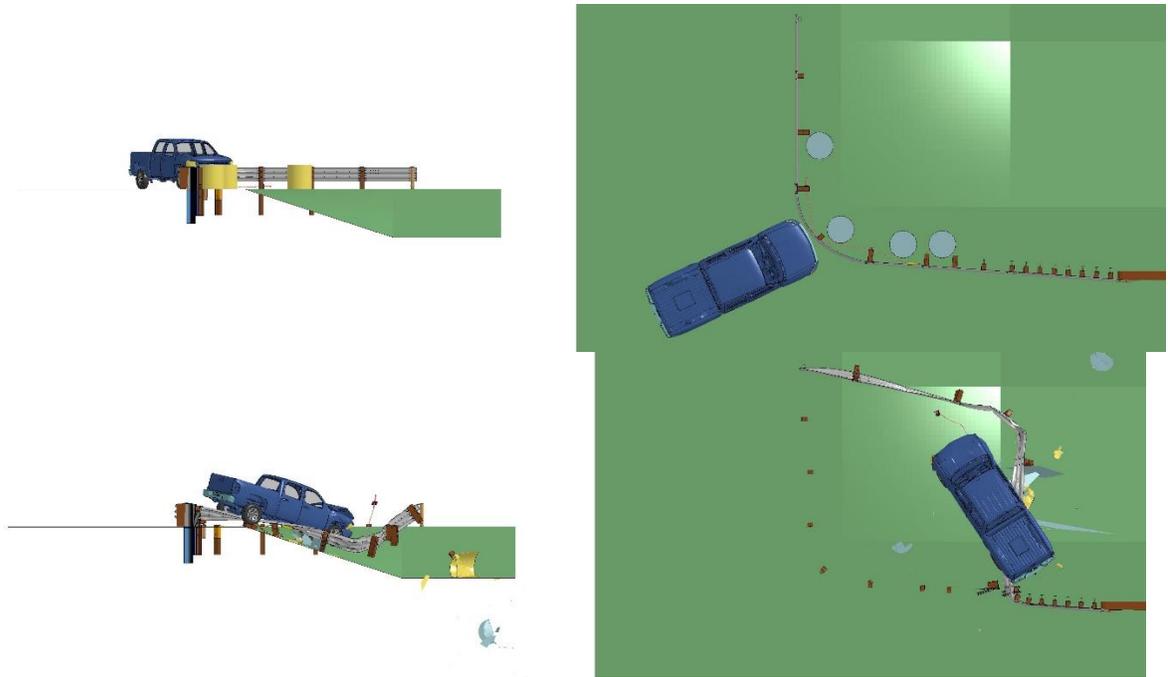
Figure 2.12. Photos from Simulation before and after Collision with Short Radius (Case #5).

The impact angle for this simulation was 25° from the face of the parapet, and the impact point was at the nose of the radius. Just like Case #2 for the small car, this impact angle was chosen to check the system adequacy to this impact angle that is used for length of need or redirecting type of impacts. Figure 2.12 shows that the short radius with four barrels successfully contained the truck. It is worth noting from Figure 2.12 that there is a potential for the rear right wheel of the truck to straddle the rail. This is not considered an adverse outcome since the truck was safely contained and stable on the sloped terrain.

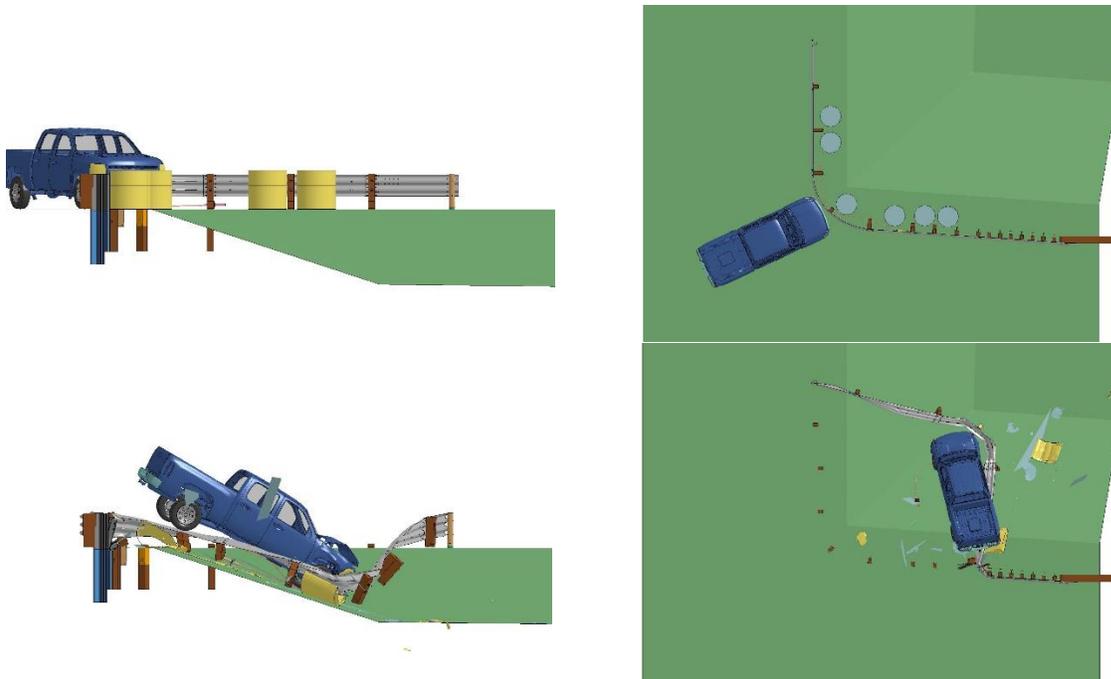
Figure 2.13. Photos from Simulation before and after Collision (Case #6).

The impact angle for this simulation was 25° from the face of the parapet, and the impact point was at the nose of the radius. Just like Case #3 for the small car, this simulation was conducted to evaluate the effect of the additional barrels on the system performance. Figure 2.13 shows that the short radius with six barrels successfully contained the truck. It is worth noting from Figure 2.13 that there is a potential for the rear right wheel of the truck to straddle the rail just like the simulation with four barrels in Case #5. This is not considered an adverse outcome since the truck was safely contained and stable on the sloped terrain.

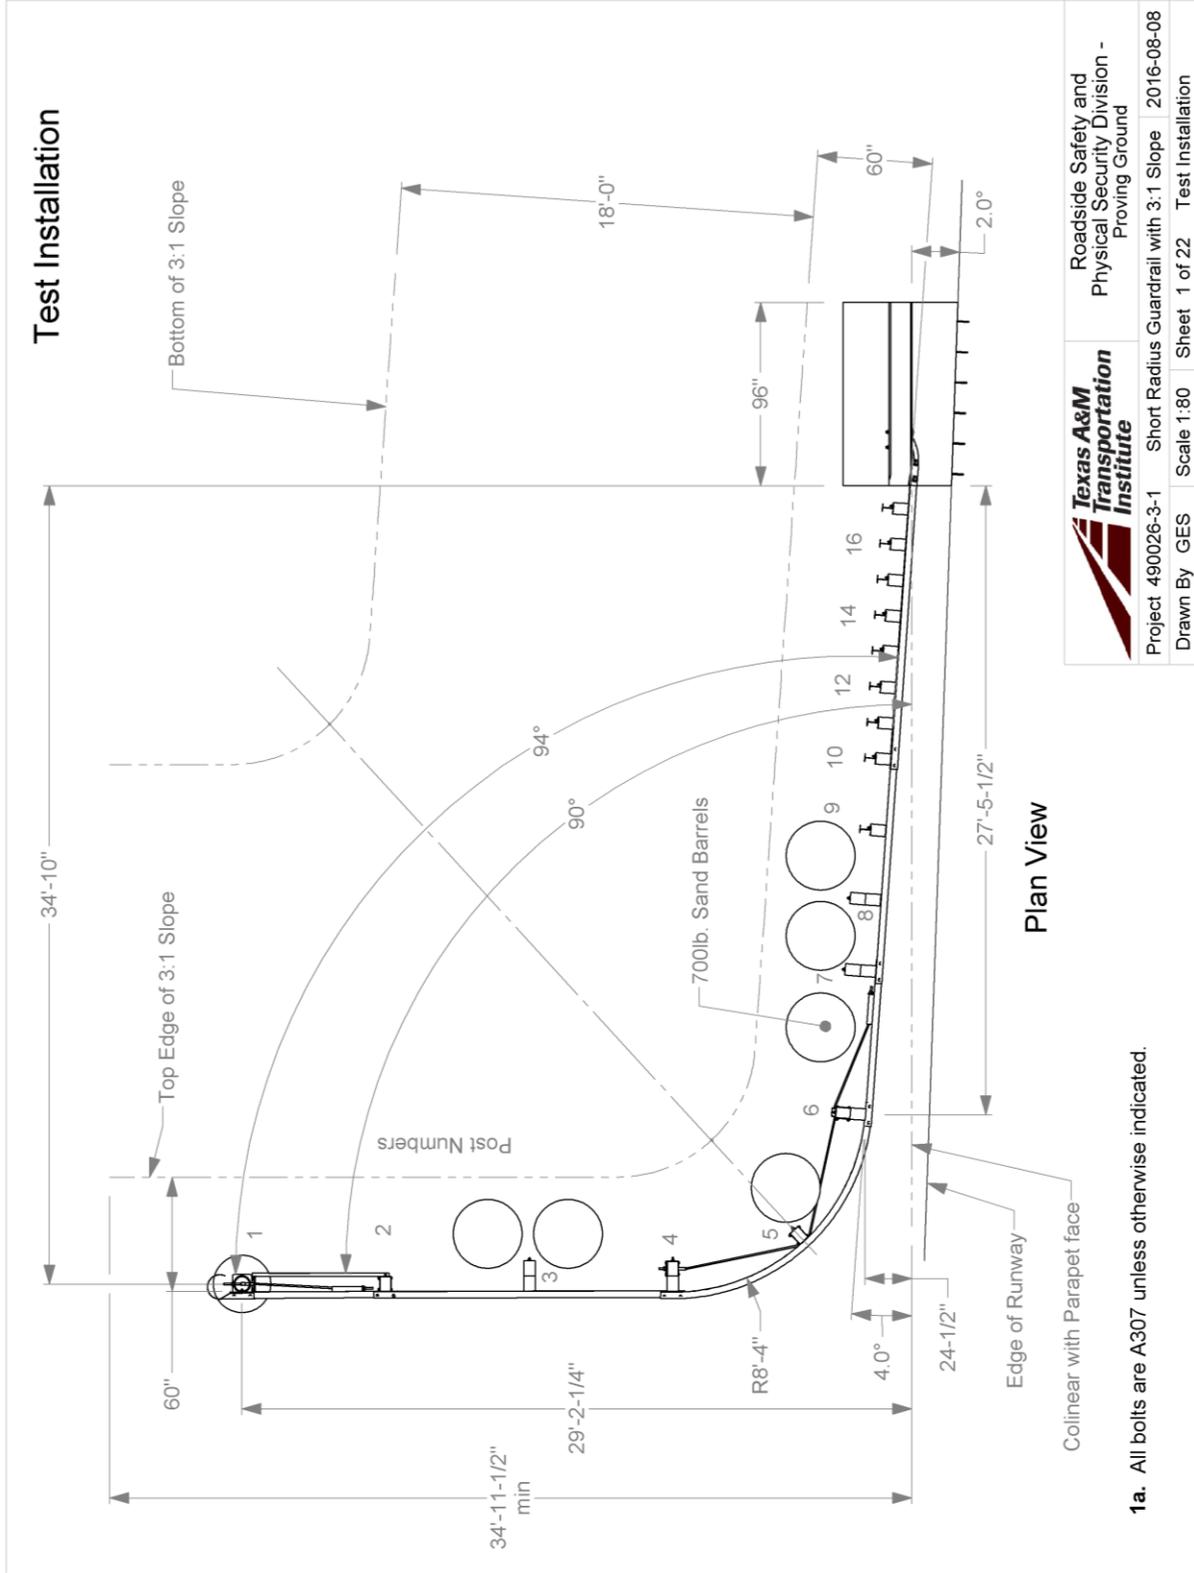
Roadside Safety and Physical Security Division - Proving Ground		
	Project 490026-3-1	Short Radius Guardrail with 3:1 Slope	2016-08-08
Drawn By GES	Scale 1:80	Sheet 1 of 22	Test Installation

Figure 3.1. Overall Setup of the Short-Span Short-Radius Guardrail System Installation.

Figure 3.1 shows details of the test installation. Figure 3.2 presents photographs of the completed test installation. Further details may be found in Appendix A.

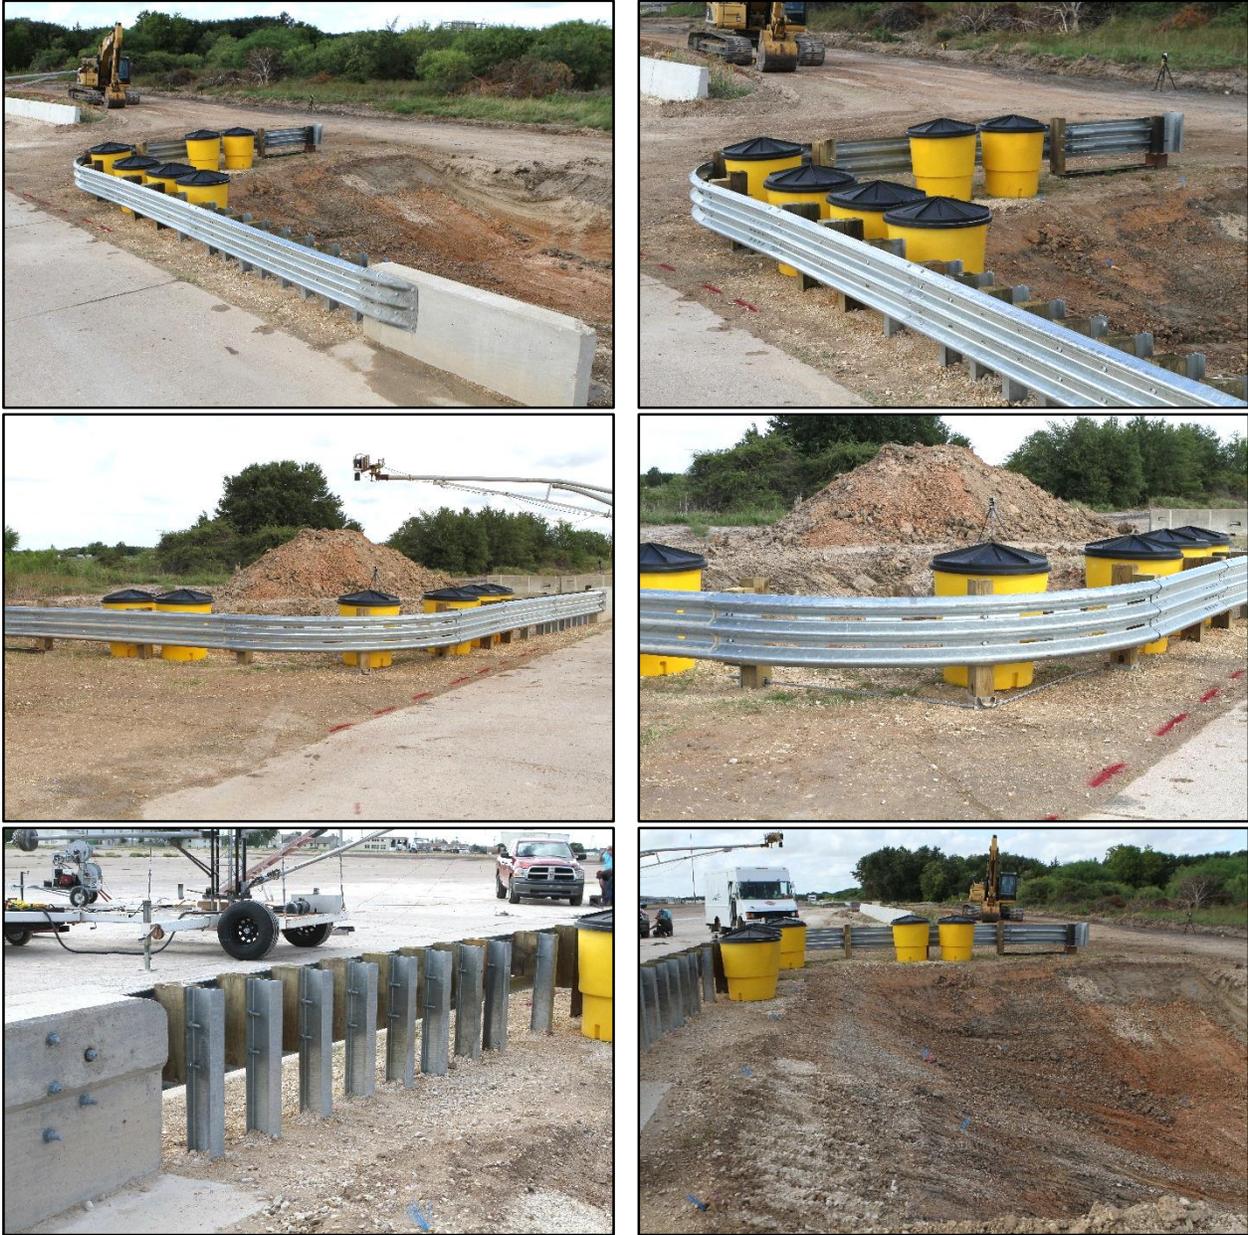
Figure 3.2. TxDOT Short-Span Short-Radius Guardrail System before Test No. 490026-3-1.

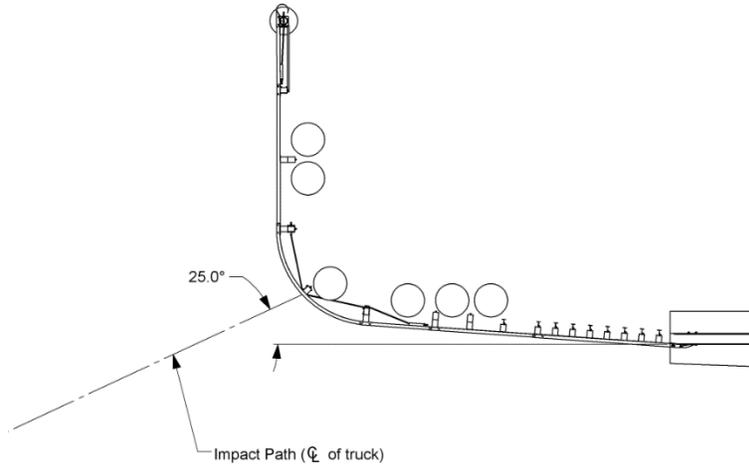
Figure 4.1. Target CIP for Modified *MASH* Test 3-33 on the Short-Radius Guardrail System.

Table 4.1 shows the test conditions and evaluation criteria for terminals and redirective crash cushions under *MASH* Test Level 3. The impact performance of the short-radius guardrail system was evaluated using modified *MASH* Tests 3-32 and 3-33 for non-gating terminals. Researchers believe a 25° impact angle (measured tangent with the traffic face of the concrete parapet) would be more critical in determining the performance of the short radius guardrail system, so the target critical impact angle (CIA) was selected to be 25°. The target CIP for each test was determined according to the information provided in *MASH* and is shown in Figures 4.1 and 4.2.

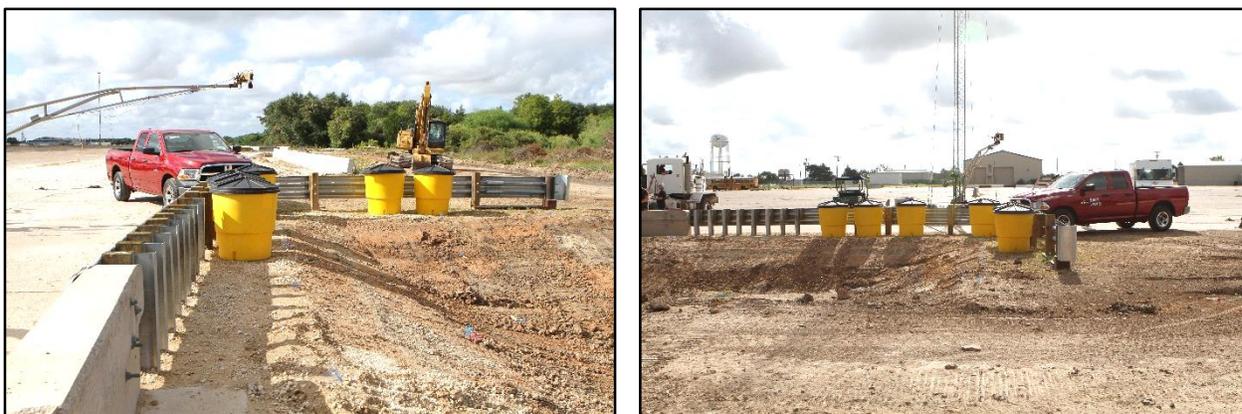
Figure 6.1. TxDOT Short-Span Short-Radius Guardrail System/Test Vehicle Geometrics for Test No. 490026-3-1.

Figures 6.1 and 6.2 show the 2012 Dodge RAM 1500 pickup truck used for the crash test. Test inertia weight of the vehicle was 5036 lb, and its gross static weight was 5036 lb. The height to the lower edge of the vehicle bumper was 11.75 inches, and the height to the upper edge of the bumper was 26.0 inches. The height to the center of gravity of the vehicle was 28.6 inches. Tables D.1 and D.2 in Appendix D.1 gives additional dimensions and information on the vehicle. The vehicle was directed into the installation using a cable reverse tow and guidance system, and was released to be freewheeling and unrestrained just prior to impact.

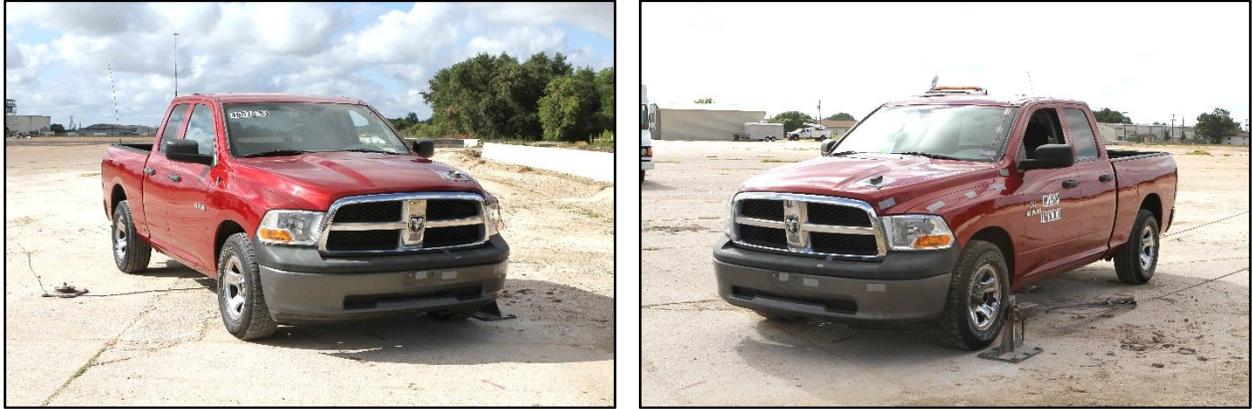
Figure 6.2. Test Vehicle before Test No. 490026-3-1.

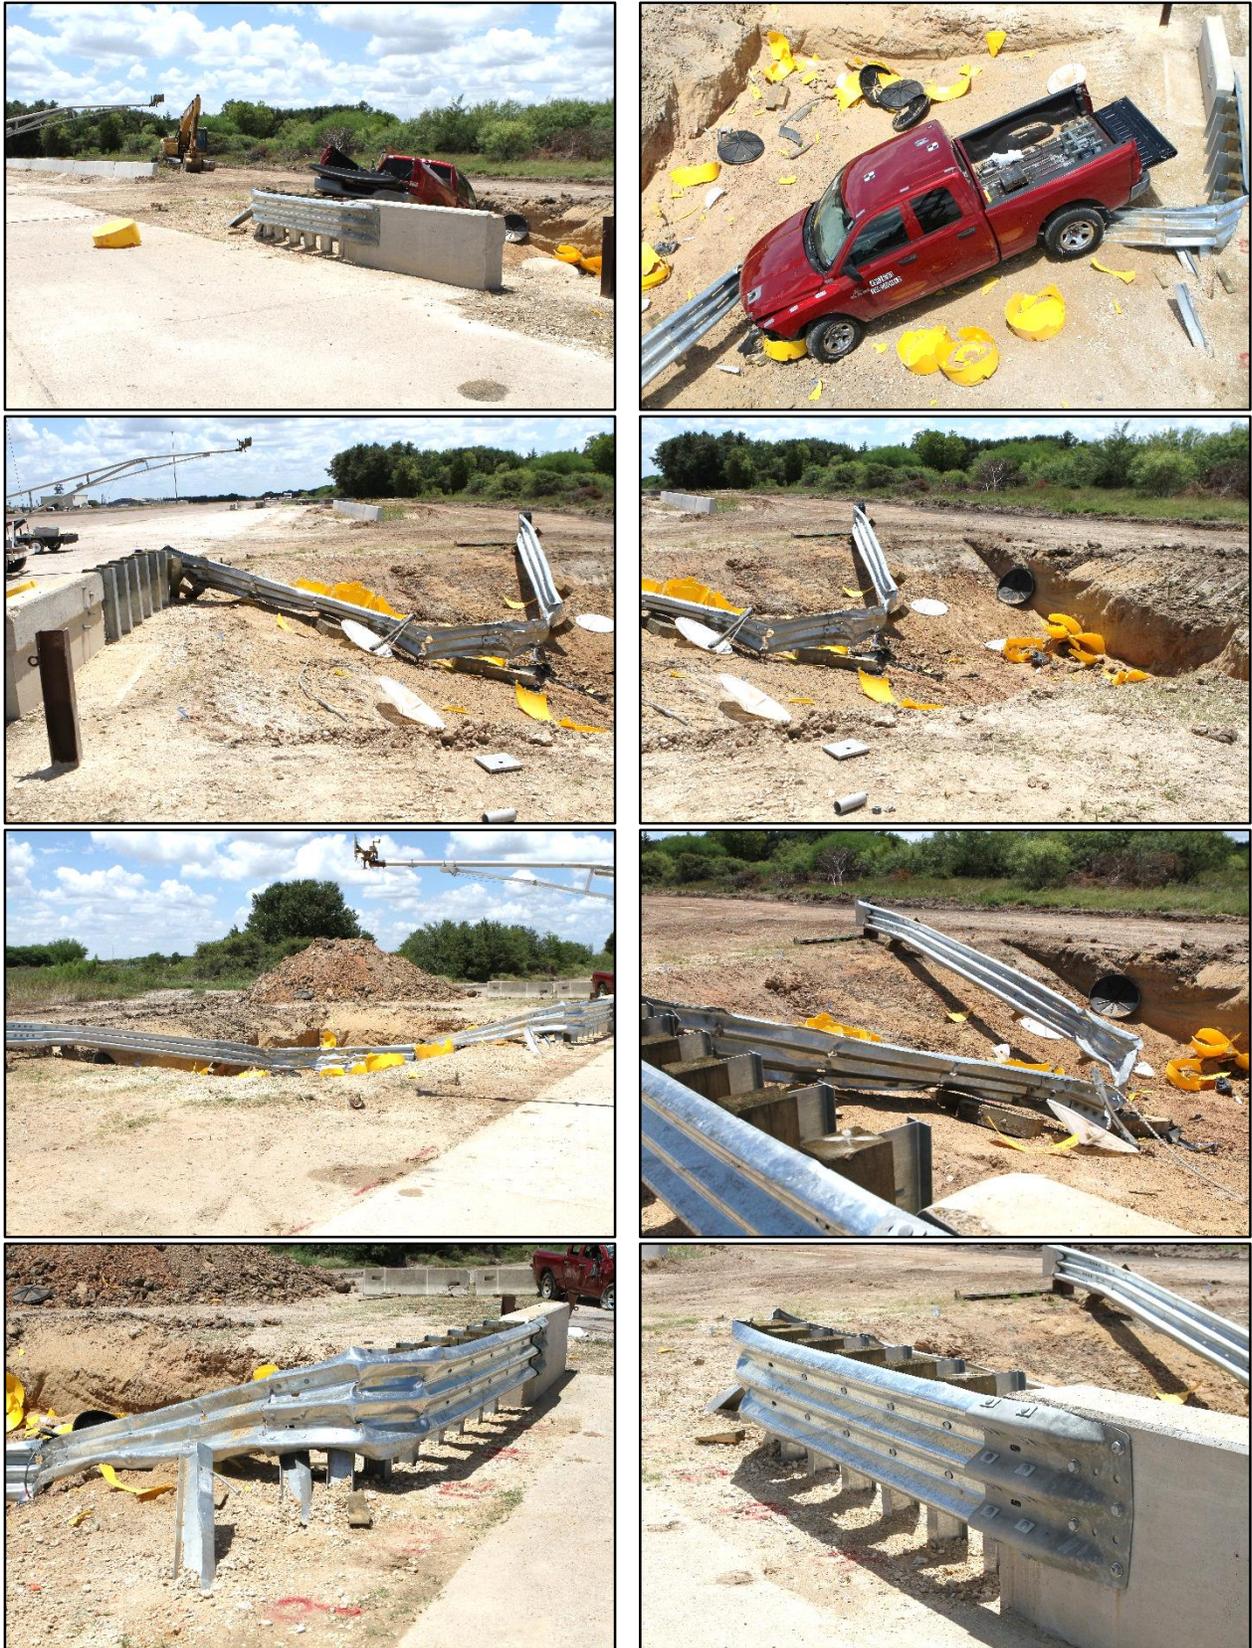
Figure 6.3. TxDOT Short-Span Short-Radius Guardrail System after Test No. 490026-3-1.

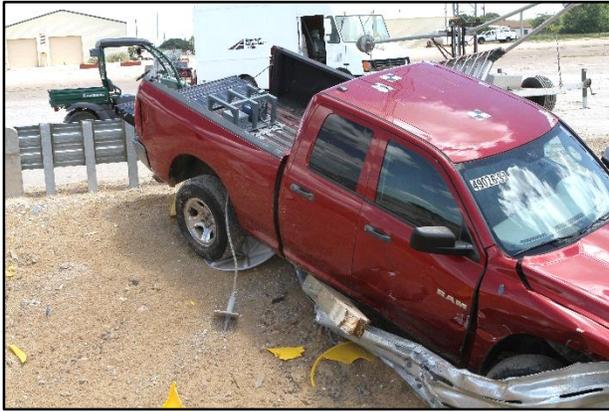
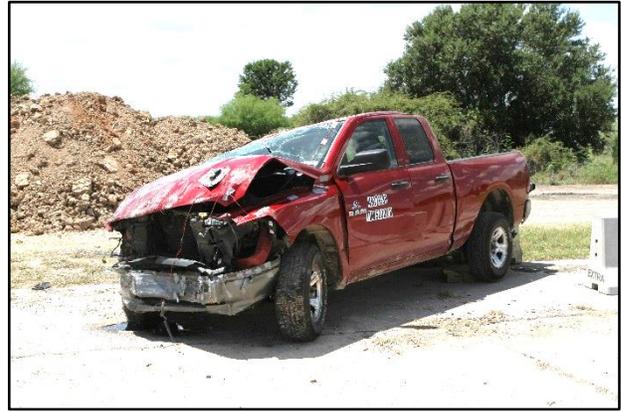
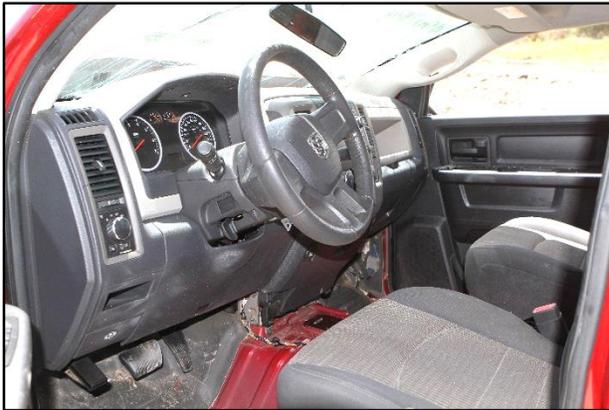
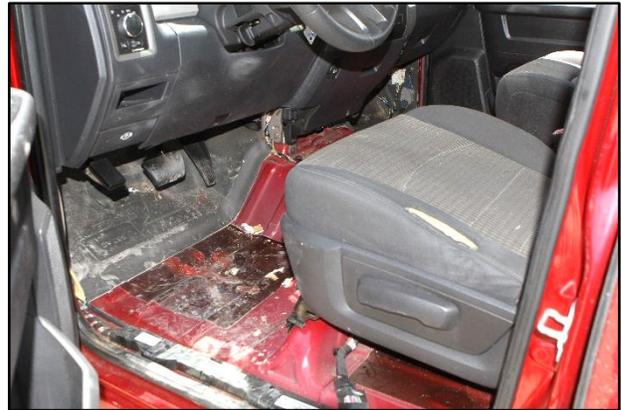
Damage to roof occurred when pulling vehicle out of system

Figure 6.4. Vehicle after Test No. 490026-3-1.

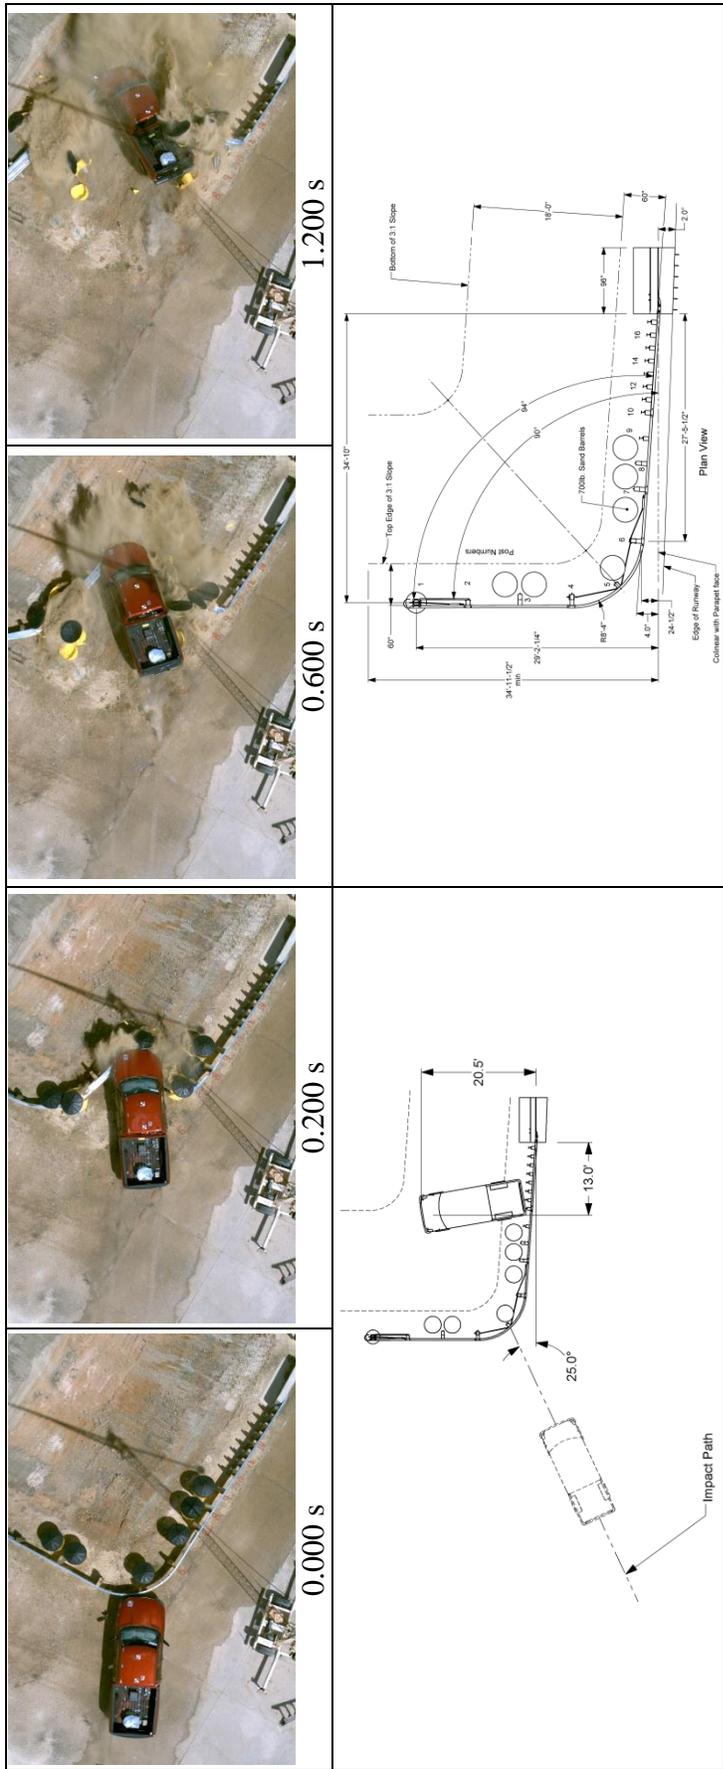
General Information	Texas A&M Transportation Institute (TTI)
Test Agency	Modified MASH Test 3-33
Test Standard Test No.	490026-3-1
TTI Test No.	2016-08-09
Test Date	
Test Article	Short-Radius Terminal
Type	Short-Span Short-Radius Guardrail
Name	42.8 ft x 29.2 ft
Installation Length	31-inch tall, 58-ft-10-inch long three-beam short-radius guardrail
Material or Key Elements	AASHTO M147-65(2004), grading B Soil (crushed limestone), dry
Soil Type and Condition	
Soil Type	
Soil Condition	
Test Vehicle	
Type/Designation	2270P
Make and Model	2010 Dodge RAM 1500
Curb	4848 kb
Test Inertial	5036 lb
Dummy	No dummy
Gross Static	5036 lb

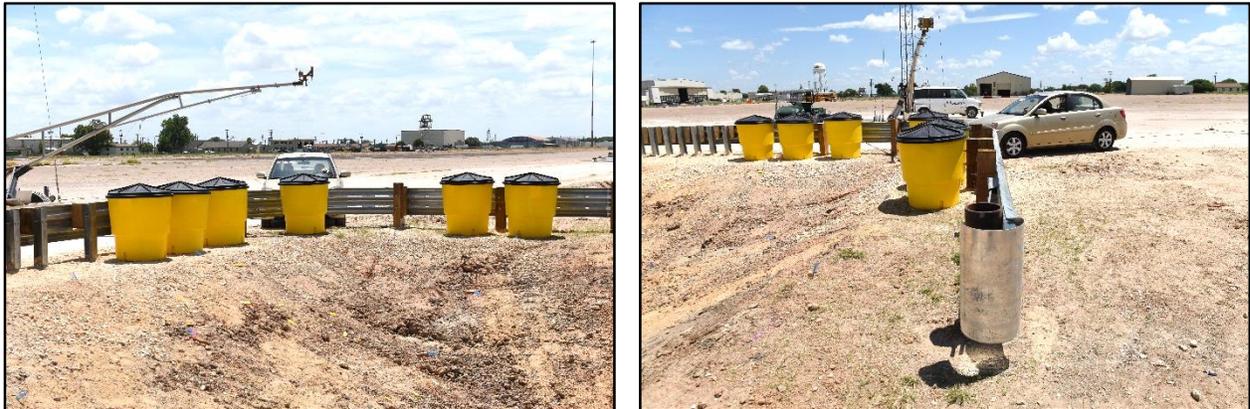
Figure 7.1. TxDOT Short-Span Short-Radius Guardrail System/Test Vehicle Geometrics for Test No. 490026-3-2.

Figures 7.1 and 7.2 show the 2011 Kia Rio used for the crash test. Test inertia weight of the vehicle was 2453 lb, and its gross static weight was 2618 lb. The height to the lower edge of the vehicle bumper was 8.0 inches, and the height to the upper edge of the bumper was 21.25 inches. Table E.1 in Appendix E.1 gives additional dimensions and information on the vehicle. The vehicle was directed into the installation using a cable reverse tow and guidance system, and was released to be freewheeling and unrestrained just prior to impact.

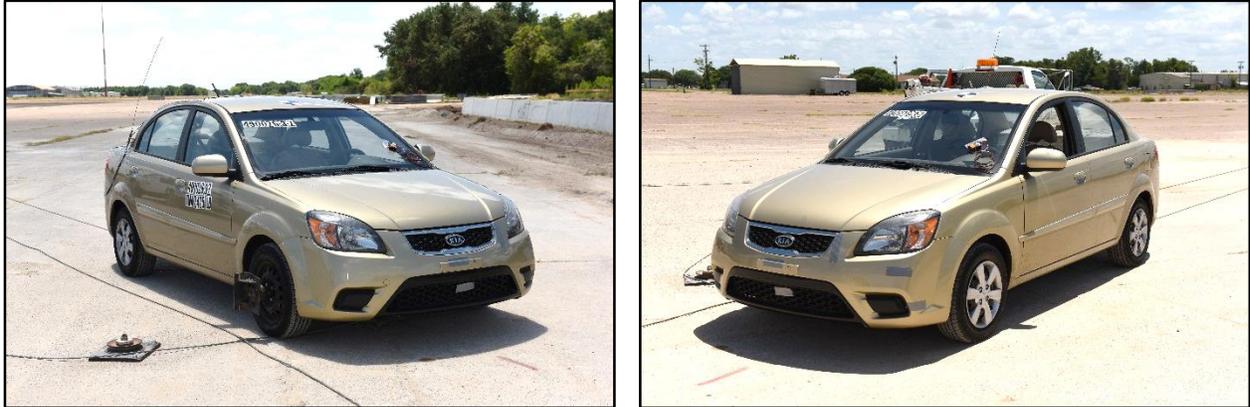
Figure 7.2. Test Vehicle before Test No. 490026-3-2.
